Appendix C

Viewpoint Analysis

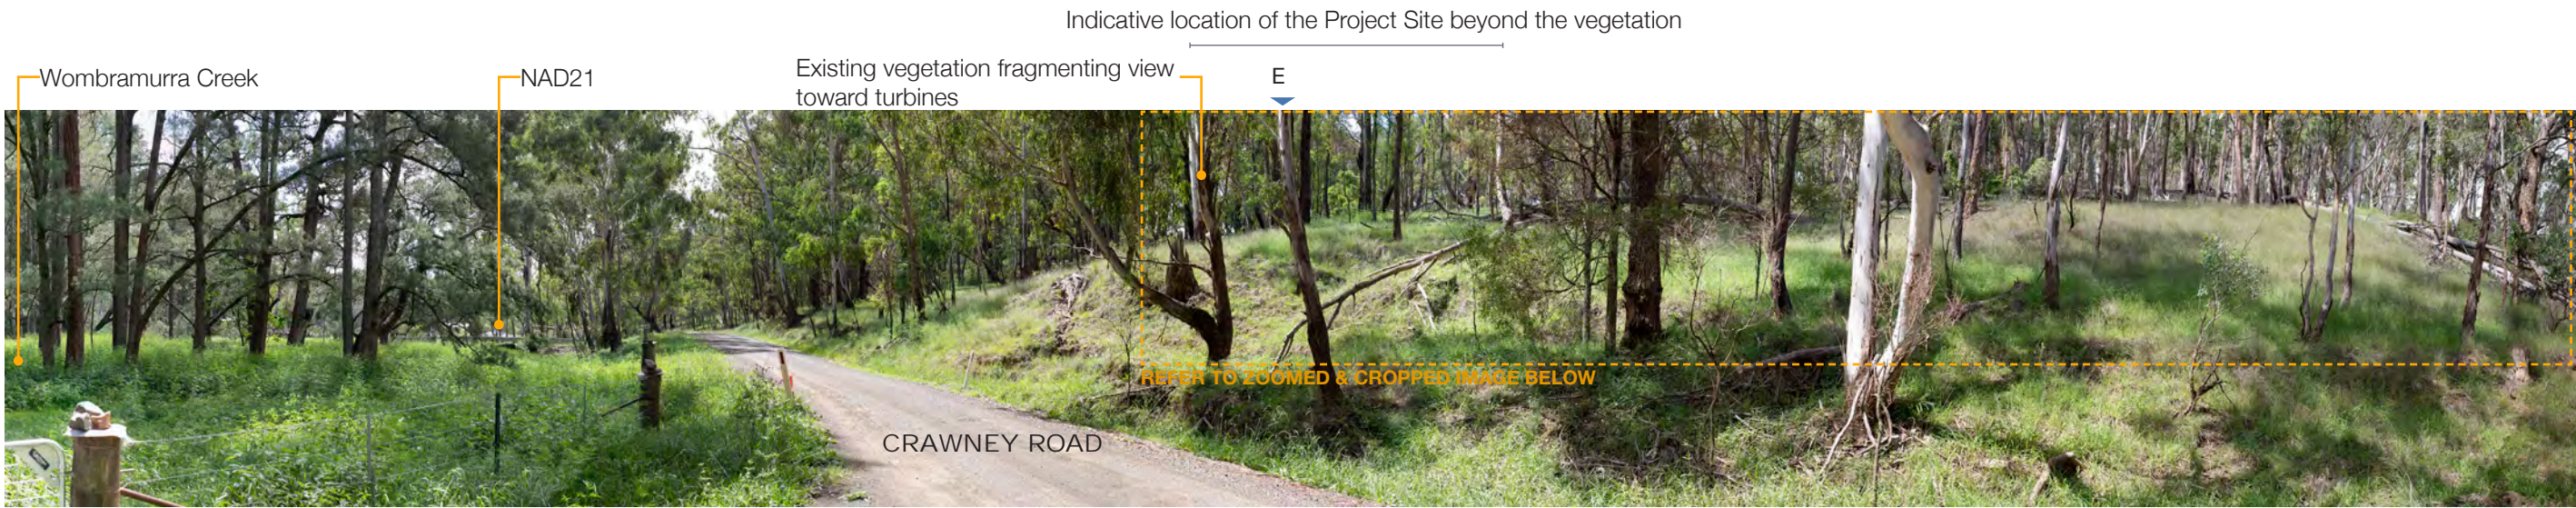
VIEWPOINT HOG12

Viewpoint Summary		Viewpoint Description	Visual Performance Objectives: VIZ3
Location:	Elevation:	This viewpoint is taken from along Crawney Road approximately 200m from NAD21. The land to the NNW of the viewpoint is characterised by rural residential land with some light agriculture activities on undulating land. Vegetation associated with the banks of the Wombramurra Creek can be seen in the north of the view. The land to the east of the viewpoint is steep and densely vegetated. The transmission line associated with the project are proposed to be located approx. 800m to the south of the view, however due to the dense vegetation surrounding the viewpoint it would be unlikely to be visible from this viewpoint.	Visual Magnitude: There are no visual performance objectives that apply to this viewpoint due to the Visual Influence Zone Rating (VIZ3).
Crawney Road	766m		
Coordinates:	Viewing Direction:

151°2'46.20"E 31°34'17.80"S	Generally East		
Distance to WTG:	Visibility Distance Zone:		
Approx. 3.3km	Near Middleground (NM)	Potential Visual Impact A preliminary assessment indicates the tips of 3 turbines may be visible from this location. However, it is highly unlikely that they would be visible from this location due to the dense vegetation in the foreground.	
Land Use:	Viewer Sensitivity Level:		
Low Use Road	Level 3: Low		
LCU:	Scenic Quality Rating:	Nearby Residences:	
Nundle Rolling Foothills	Moderate	NAD21	
Visual Influence Zone VIZ3

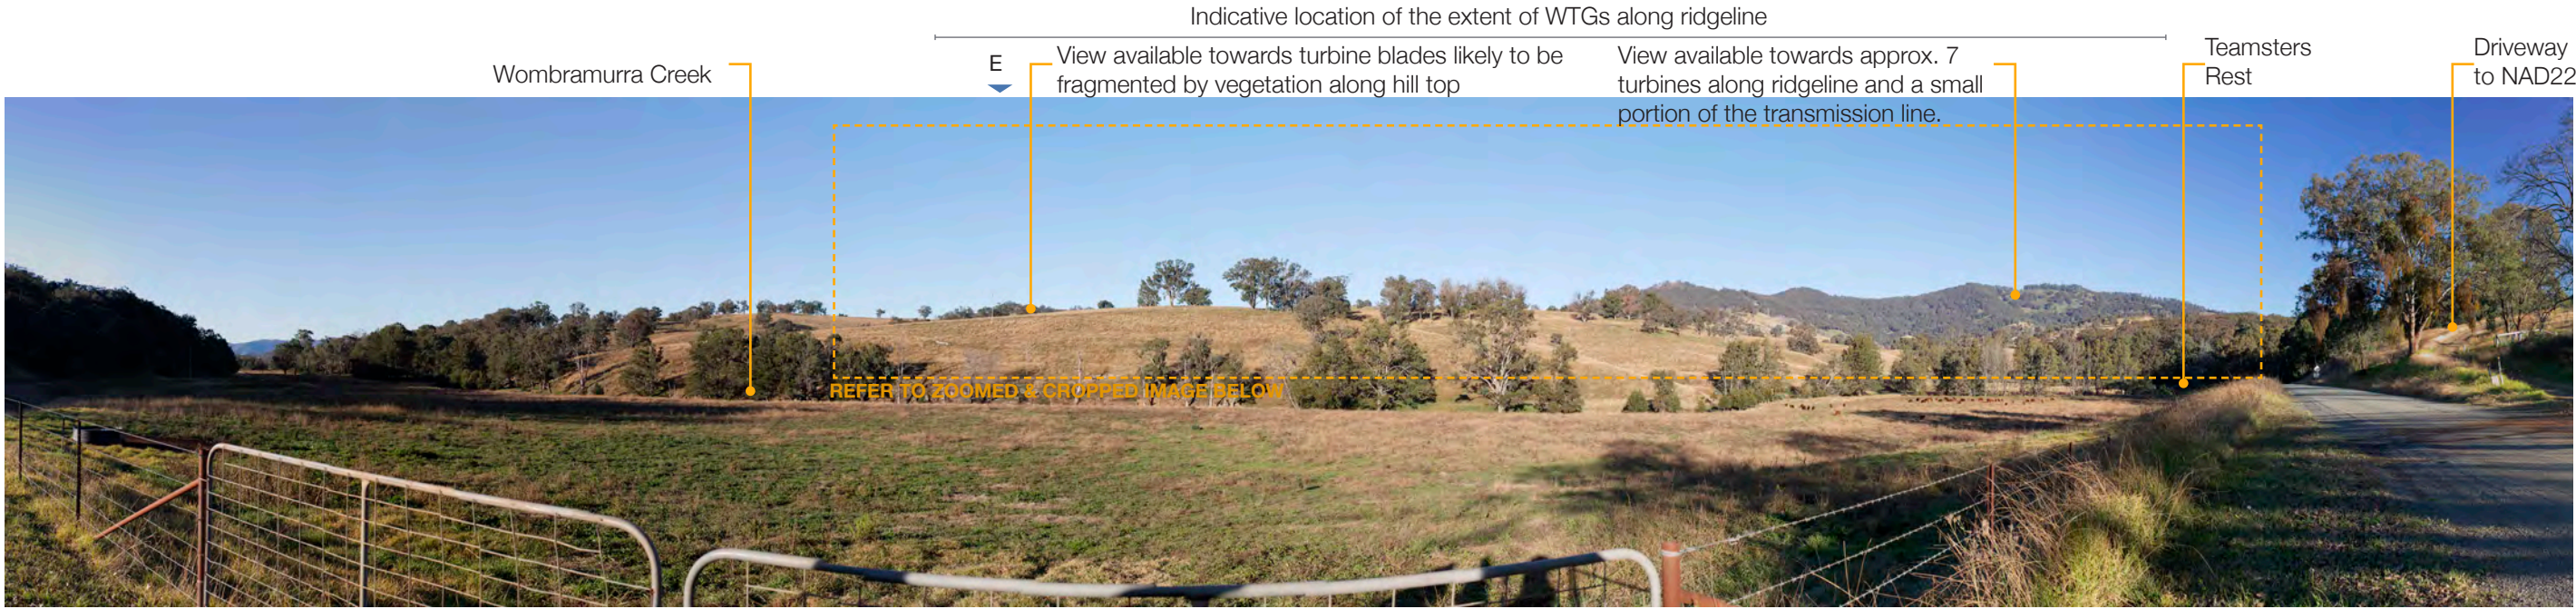
VIEWPOINT HOG13

Viewpoint Summary		Viewpoint Description	Visual Performance Objectives: VIZ3
Location:	Elevation:	<p>This viewpoint is taken 80m north of the entry to 'Brooklyn' residence (NAD22) and NAD74 along Crawney Road. The land is cleared agricultural and rural residential used for grazing. The landform is undulating with scattered vegetation. Scattered creek line vegetation associated with Wombramurra Creek is visible in the middleground. Dense boundary vegetation associated with 'Brooklyn' residence can be seen to the south of the view. The view is expansive with the ridgeline visible in the background of the view.</p> <p>Potential Visual Impact</p> <p>A preliminary analysis based on topography alone suggests that approximately 27 WTG's may be visible from this location. A combination of distance and existing vegetation along the hilltop are likely to reduce the visibility of a number of the turbines. There may be a small number of WTG's visible along the ridge to the SE of the view. A small portion of the transmission line is likely to be visible in the south east of the view.</p> <p>Nearby Residences:</p>	<p>Visual Magnitude:</p> <p>There are no visual performance objectives that apply to this viewpoint due to the Visual Influence Zone Rating (VIZ3).</p> <p>Detailed assessment of nearby dwellings are included in <i>Appendix E. See PM24.</i></p>

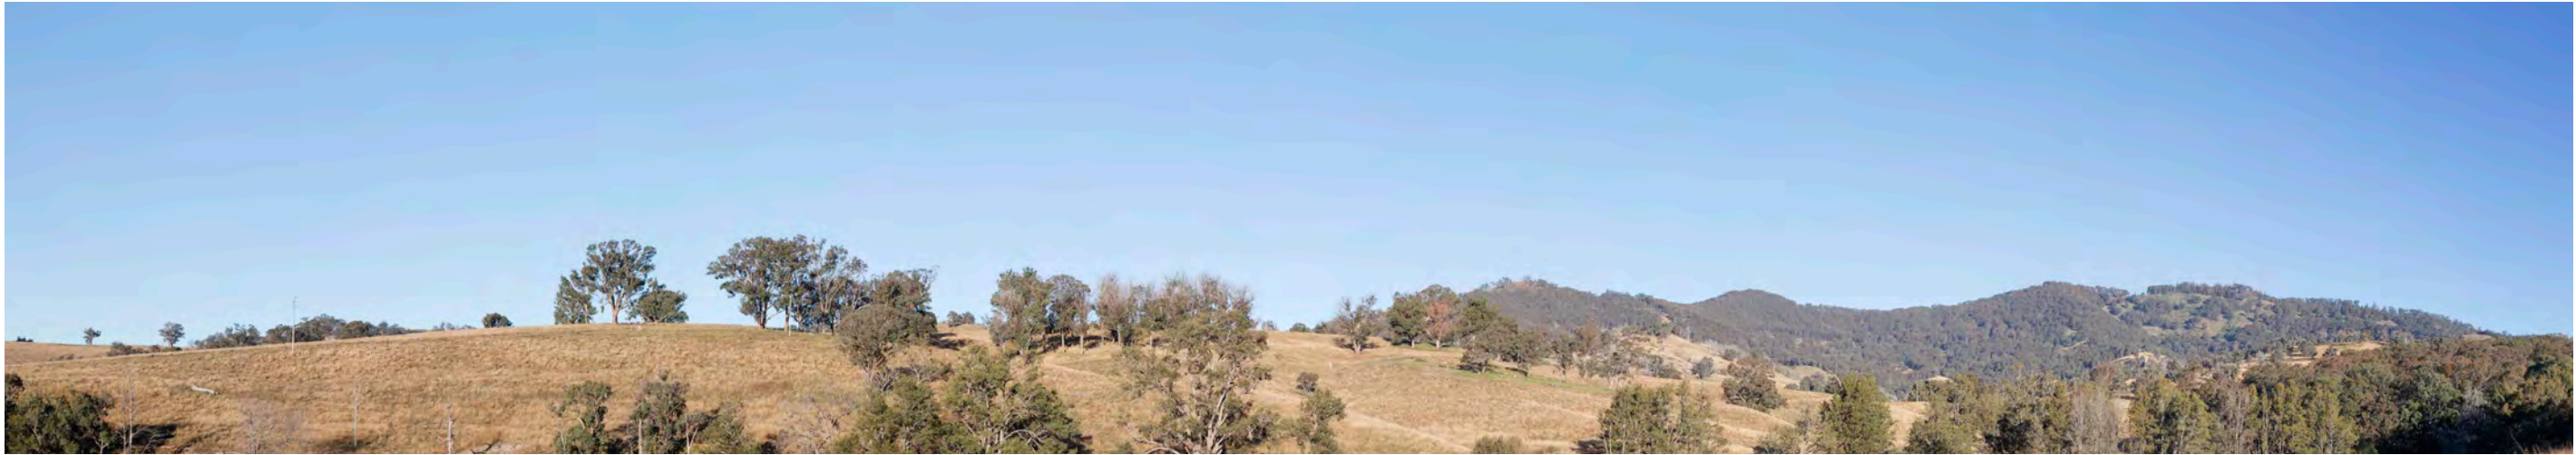
Crawney Road	711m		
Coordinates:	Viewing Direction:		
151° 3'23.26"E 31°33'11.78"S	Generally South East		
Distance to WTG:	Visibility Distance Zone:		
Approx. 4.4km	Far Middleground (FM)		
Land Use:	Viewer Sensitivity Level:		
Local Road	Level 3: Low		
LCU:	Scenic Quality Rating:		
Nundle Valley Pastures	Moderate	NAD22, AD74	
Visual Influence Zone VIZ3

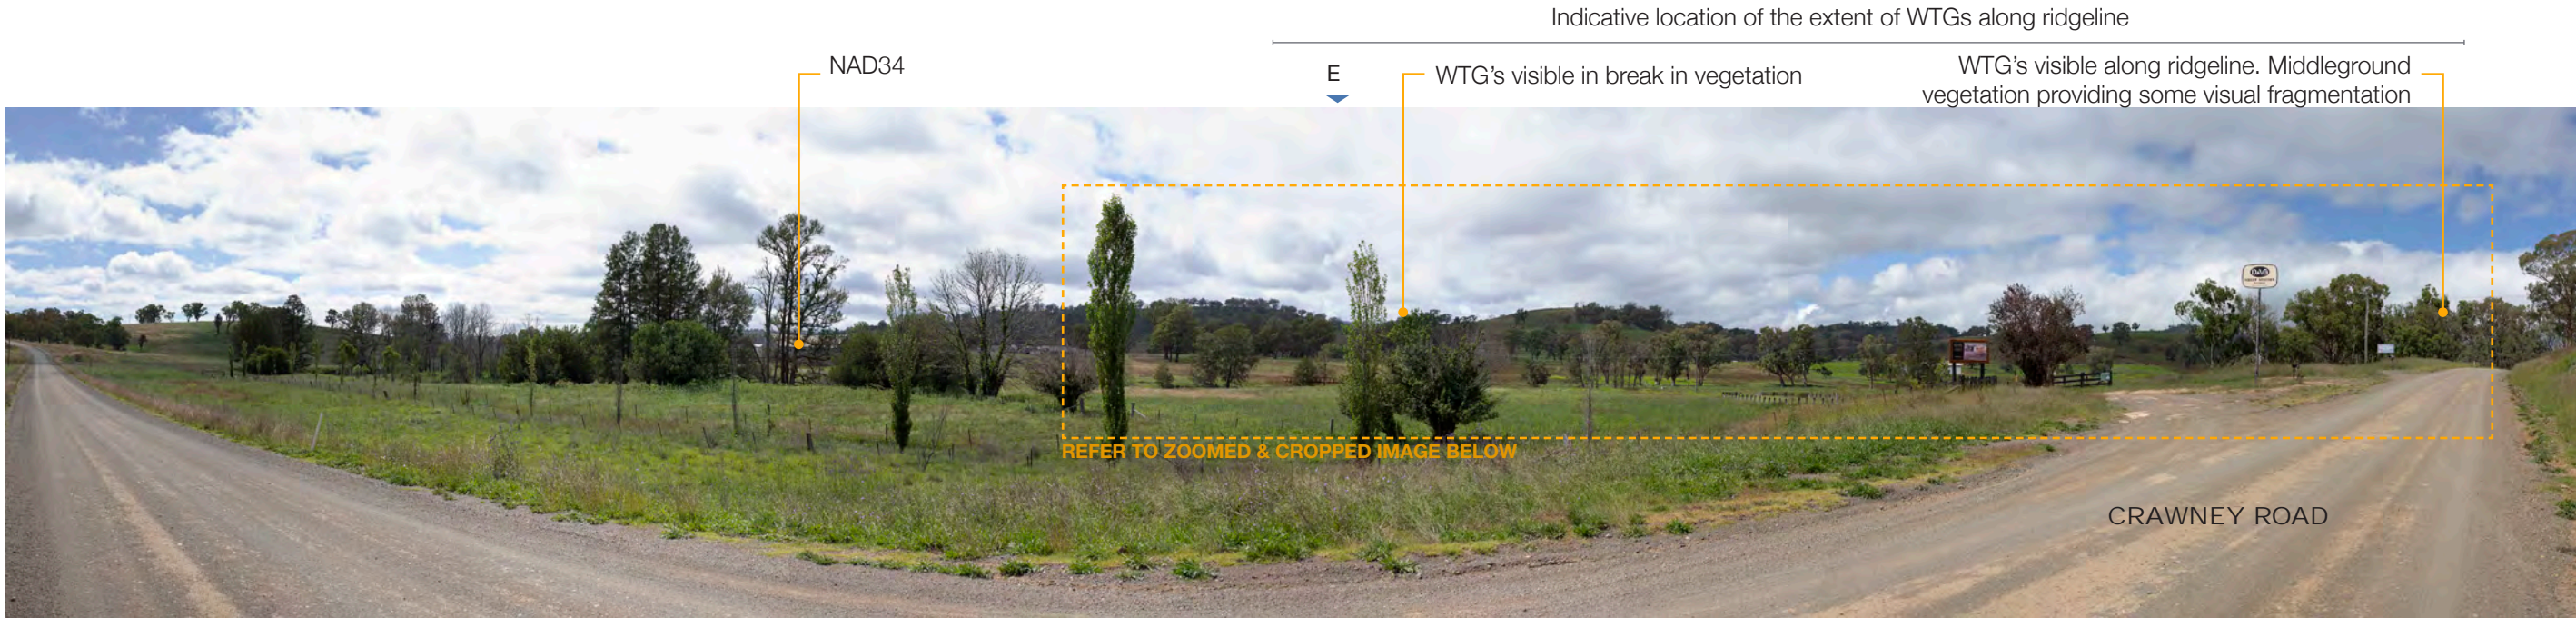
VIEWPOINT HOG14

Viewpoint Summary		Viewpoint Description	Visual Performance Objectives: VIZ2
Location:	Elevation:	<p>This viewpoint is taken around 50m north of the entrance to 'The Dag Station' (NAD34) and 400m from NAD49 along Crawney Road. The land is characterised by cleared agricultural grasslands used for grazing. The 'The Dag Station' is used as an event space and accommodation provider and therefore has been assessed accordingly. The landform is undulating with scattered vegetation located along the hillside in the distance and smalls copses of vegetation along the roadside in the middleground of the view.</p> <p>Potential Visual Impact</p> <p>From this location an assessment based on topography alone indicates approximately 18 WTG's may be visible, however vegetation along the roadside in the middleground is likely to fragment views to some of the WTG's, slightly reducing the number of visible WTG's from this location.</p>	<p>Landscape Scenic Integrity:</p> <p>The wind turbines will be a noticeable element in the landscape, however the WTG's are unlikely to dominate the visual catchment from this location.</p> <p>Key Feature Disruption:</p> <p>The proposed WTGs will be occupy a small portion of the range. The range and cleared pastures will remain the most visually prominent feature from this location.</p> <p>Detailed assessment of nearby dwellings are included in <i>Appendix E</i>.</p>

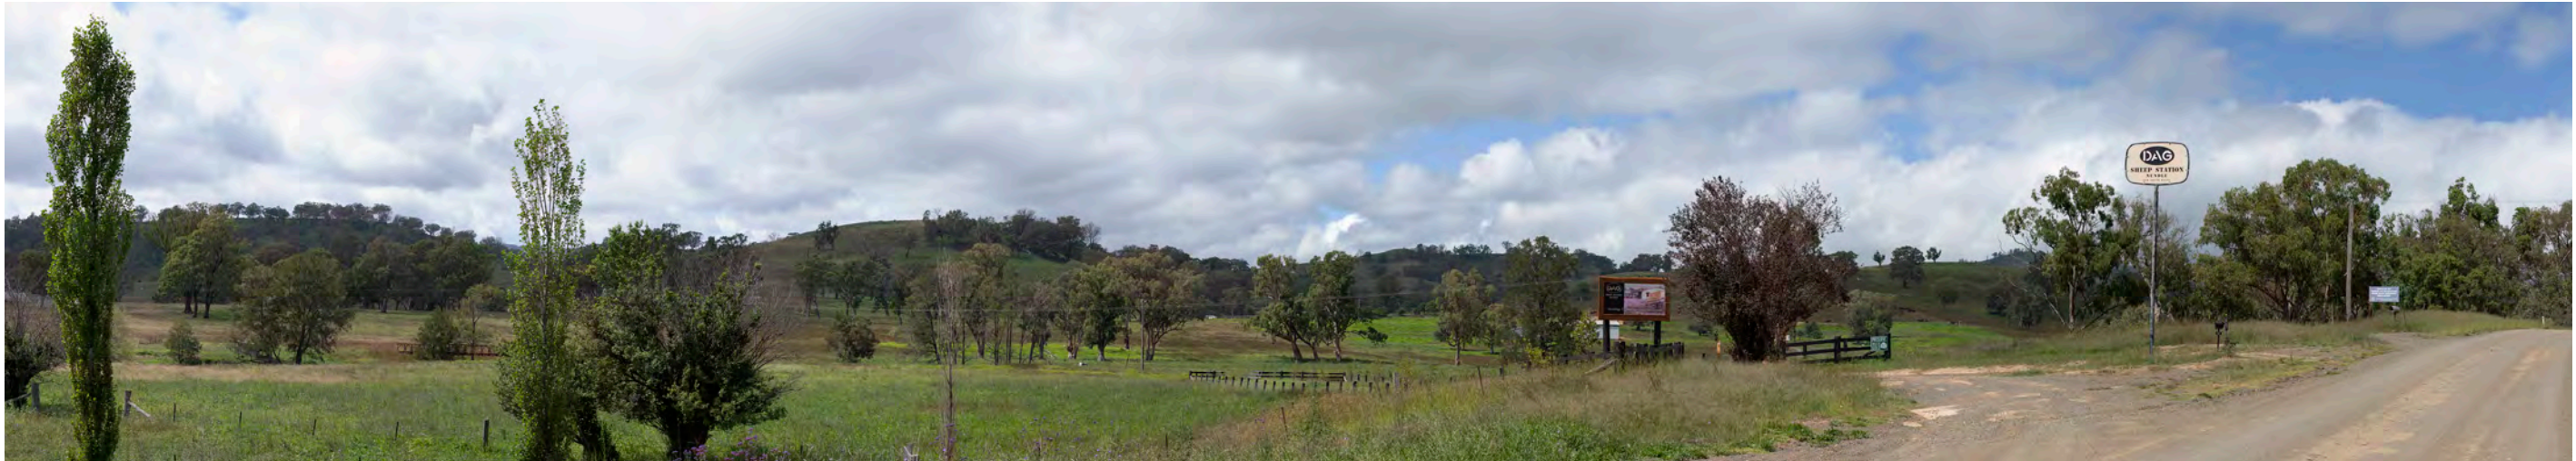
Crawney Road	670m		
Coordinates:	Viewing Direction:		
151°4'8.32"E 31°32'6.65"S	Generally East		
Distance to WTG:	Visibility Distance Zone:		
Approx. 5.9km	Far Middleground (FM)		
Land Use:	Viewer Sensitivity Level:		
Tourist and Visitor Accommodation	Level 2: Mod		
LCU:	Scenic Quality Rating:	Nearby Residences:	
Nundle Valley Pastures	Moderate	NAD34, NAD49	
Visual Influence Zone VIZ2

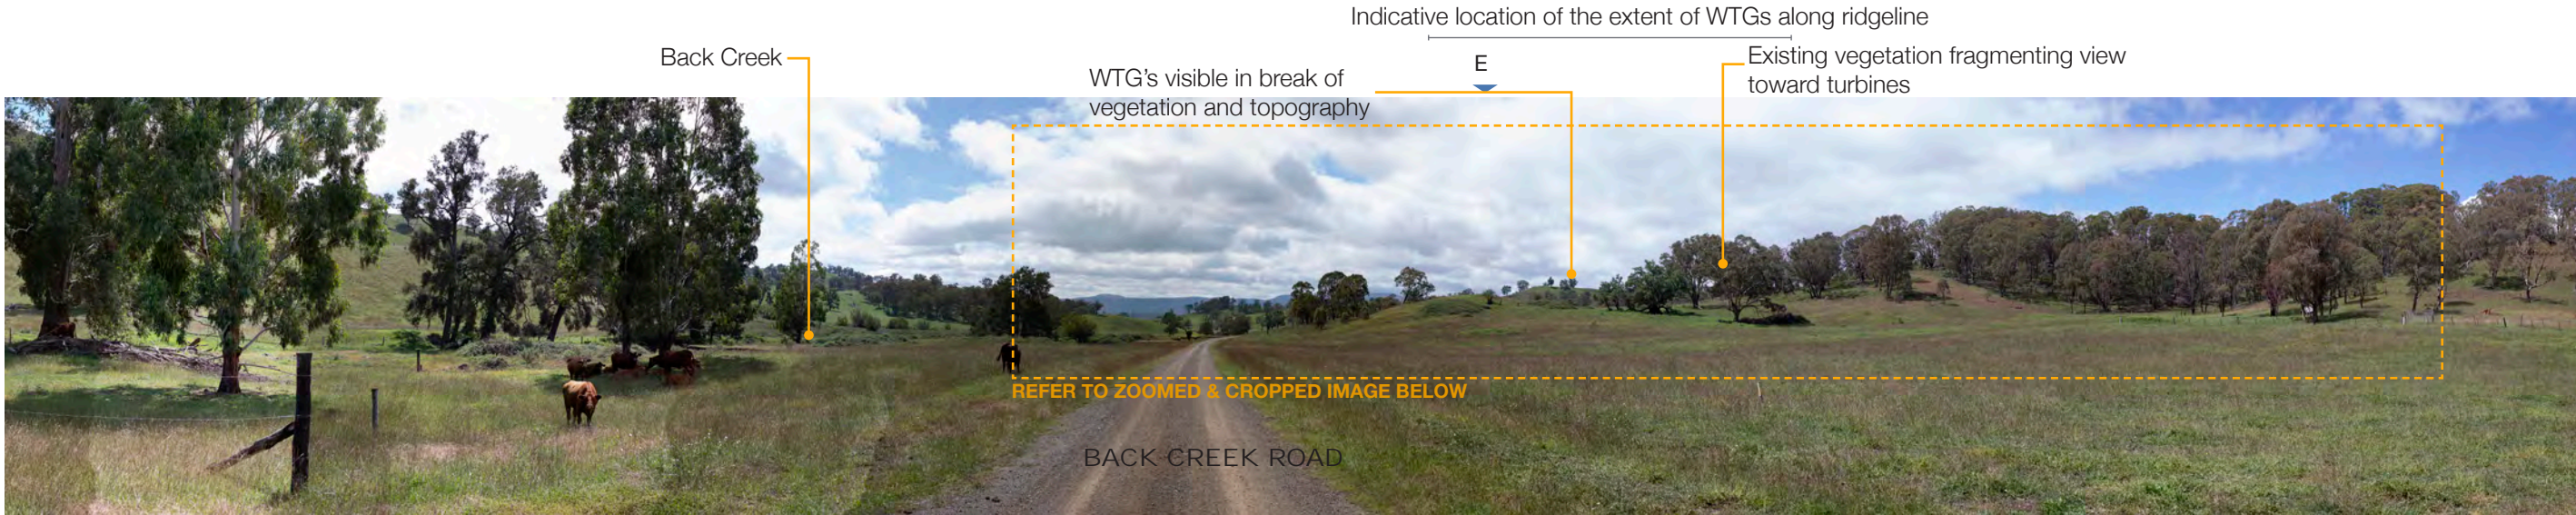
VIEWPOINT HOG15			
Viewpoint Summary		Viewpoint Description	Visual Performance Objectives: VIZ3
Location:	Elevation:	The viewpoint location is 400m NE from NAD54, at the termination of Back Creek Road. The land is characterised by cleared agricultural grassland used for grazing. The landform is undulating with scattered vegetation. Dense vegetation can be seen on the rise to the east of the viewpoint providing some visual screening toward the project site. Back Creek, which runs generally in north east direction, is visible to the north of the view. The view is expansive, extending toward the ridgeline to the north east. Potential Visual Impact From this location 16 WTG's may be visible. It is likely vegetation in the middleground may fragment these views and when combined with the distance to the Site they would be difficult to discern.	There are no visual performance objectives that apply to this viewpoint due to the Visual Influence Zone Rating (VIZ3)

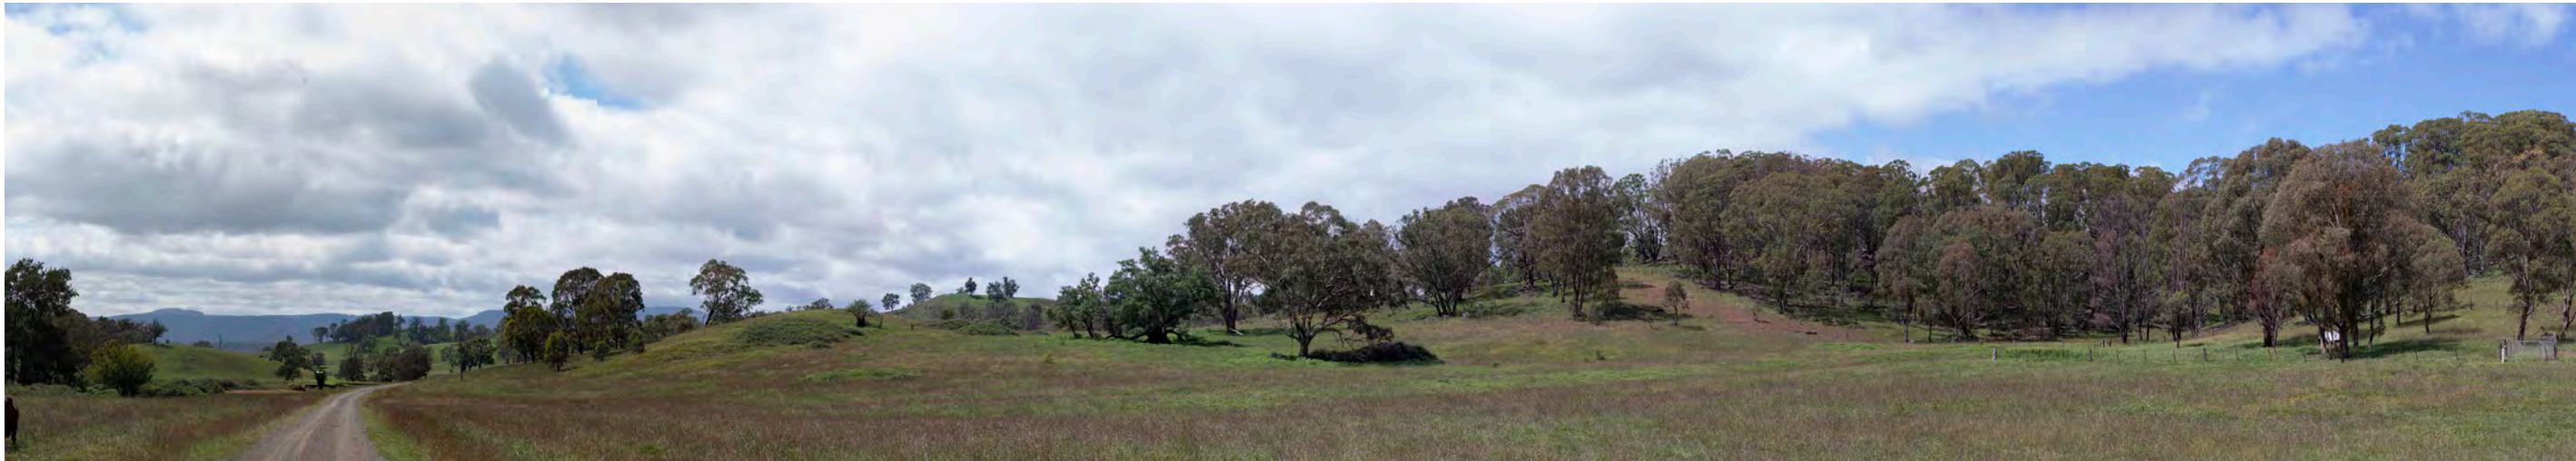
Back Creek Road	730m		
Coordinates:	Viewing Direction:		
151°2'0.59"E 31°32'24.17"S	Generally East		
Distance to WTG:	Visibility Distance Zone:		
Approx. 6.8km	Far Middleground (FM)		
Land Use:	Viewer Sensitivity Level:	Nearby Residences:	
Low Use Road	Level 3: Low		
LCU:	Scenic Quality Rating:		
Nundle Valley Pastures	Moderate	NAD54	
Visual Influence Zone VIZ3

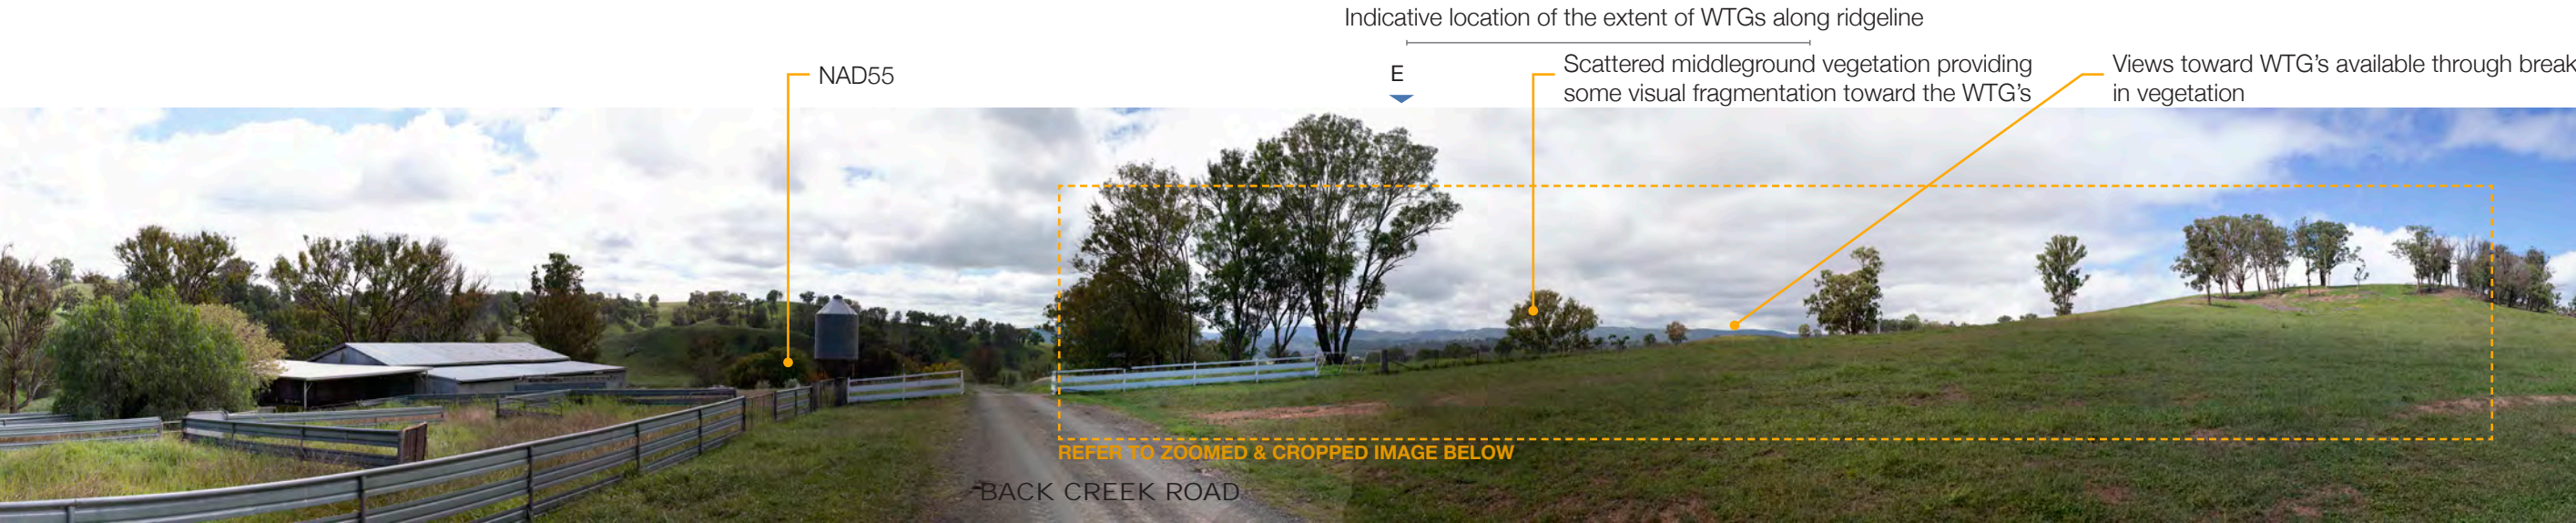
VIEWPOINT HOG16			
Viewpoint Summary		Viewpoint Description	Visual Performance Objectives: VIZ3
Location:	Elevation:	This viewpoint is taken from nearby 'Banoon' NAD55 along Back Creek Road. Land in this area is predominately cleared for grazing. Farm structures associated with 'Banoon' property are located in the north of the view. The land is undulating and sparsely vegetated. Views to the south east are contained by a low rise in topography in the middleground. Views extend toward the ridge, which is partially fragmented by vegetation in the middleground of the view.	There are no visual performance objectives that apply to this viewpoint due to the Visual Influence Zone Rating (VIZ3)
Back Creek Road	717m		
Coordinates:	Viewing Direction:		
151°2'52.87"E 31°31'56.42"S	Generally East		
Distance to WTG:	Visibility Distance Zone:		
Approx. 6.8km	Far Middleground (FM)	Potential Visual Impact From this location 18 WTG's may be visible. It is likely vegetation in the middleground may fragment these views and when combined with the distance from the Site, may not dominate the view.

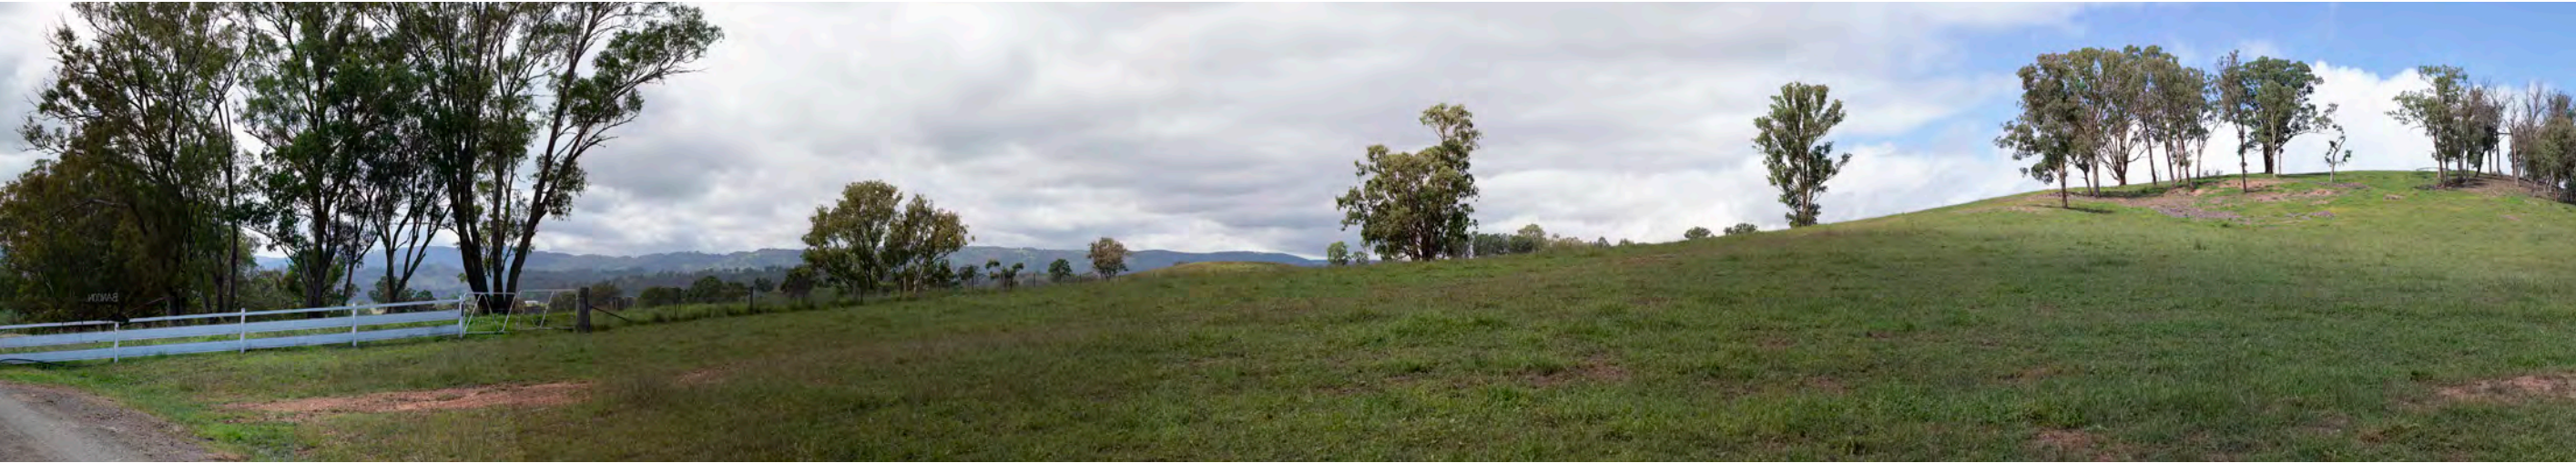
Land Use:	Viewer Sensitivity Level:		
Low Use Road	Level 3: Low		
LCU:	Scenic Quality Rating:	Nearby Residences:	
Nundle Valley Pastures	Moderate	NAD55	
Visual Influence Zone VIZ3

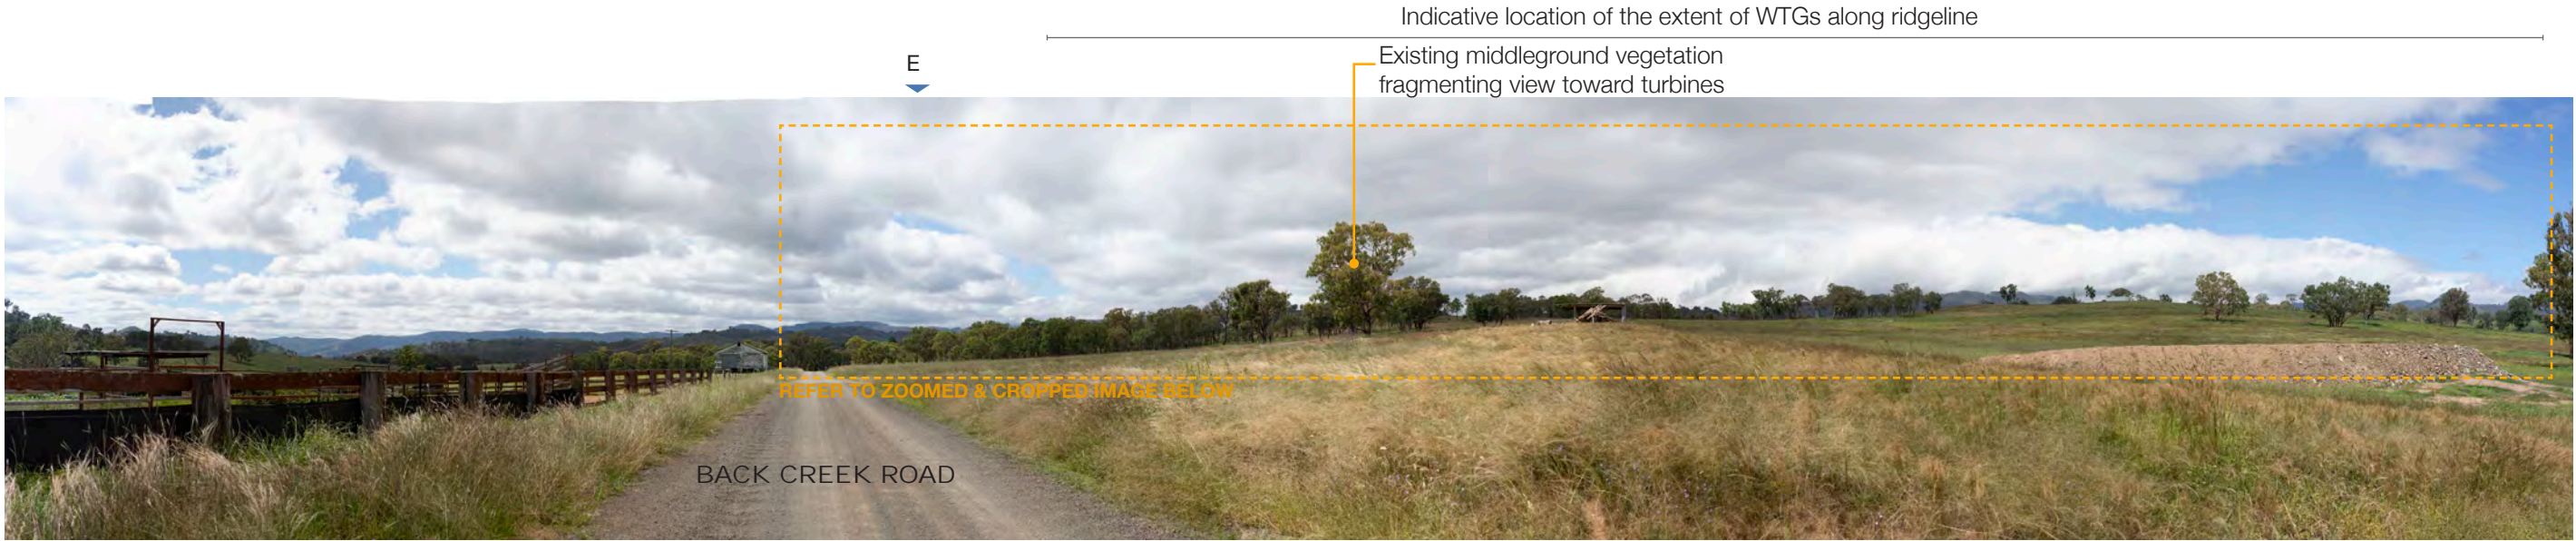
VIEWPOINT HOG17			
Viewpoint Summary		Viewpoint Description	Visual Performance Objectives: VIZ3
Location:	Elevation:	The viewpoint is located around 100m west of the driveway entry to NAD49 along Back Creek Road and 350m from Crawney Road. It is also located nearby NAD 56, though the driveway for this dwelling is located off Old Wallabadah Road. The land in this area is predominately cleared and gently undulating with remnant stands of vegetation in the middleground. Cattle yards associated with the grazing activities of the area are visible in the foreground of the view. Views from this location extend to the east towards the distant vegetated ridge associated with the project area. The slight rise contains views toward the south.	There are no visual performance objectives that apply to this viewpoint due to the Visual Influence Zone Rating (VIZ3)
Back Creek Road	669m		
Coordinates:	Viewing Direction:

151°4'1.54"E 31°31'32.90"S	Generally East		
Distance to WTG:	Visibility Distance Zone:		
Approx. 7km	Far Middleground (FM)	Potential Visual Impact According to preliminary analysis based on topography alone suggests 60-70 WTG's may be visible from this location. The scattered vegetation located on the rise to the south may fragment the view to a small number of WTG's. The distance to the WTG's may also reduce the dominance of these items within the context of the view. A distant view toward a small portion of the transmission line may be available to the south of the view.	
Land Use:	Viewer Sensitivity Level:		
Low Use Road	Level 3: Low		
LCU:	Scenic Quality Rating:	Nearby Residences:	
Nundle Valley Pastures	Moderate	NAD49, NAD56	
Visual Influence Zone VIZ3

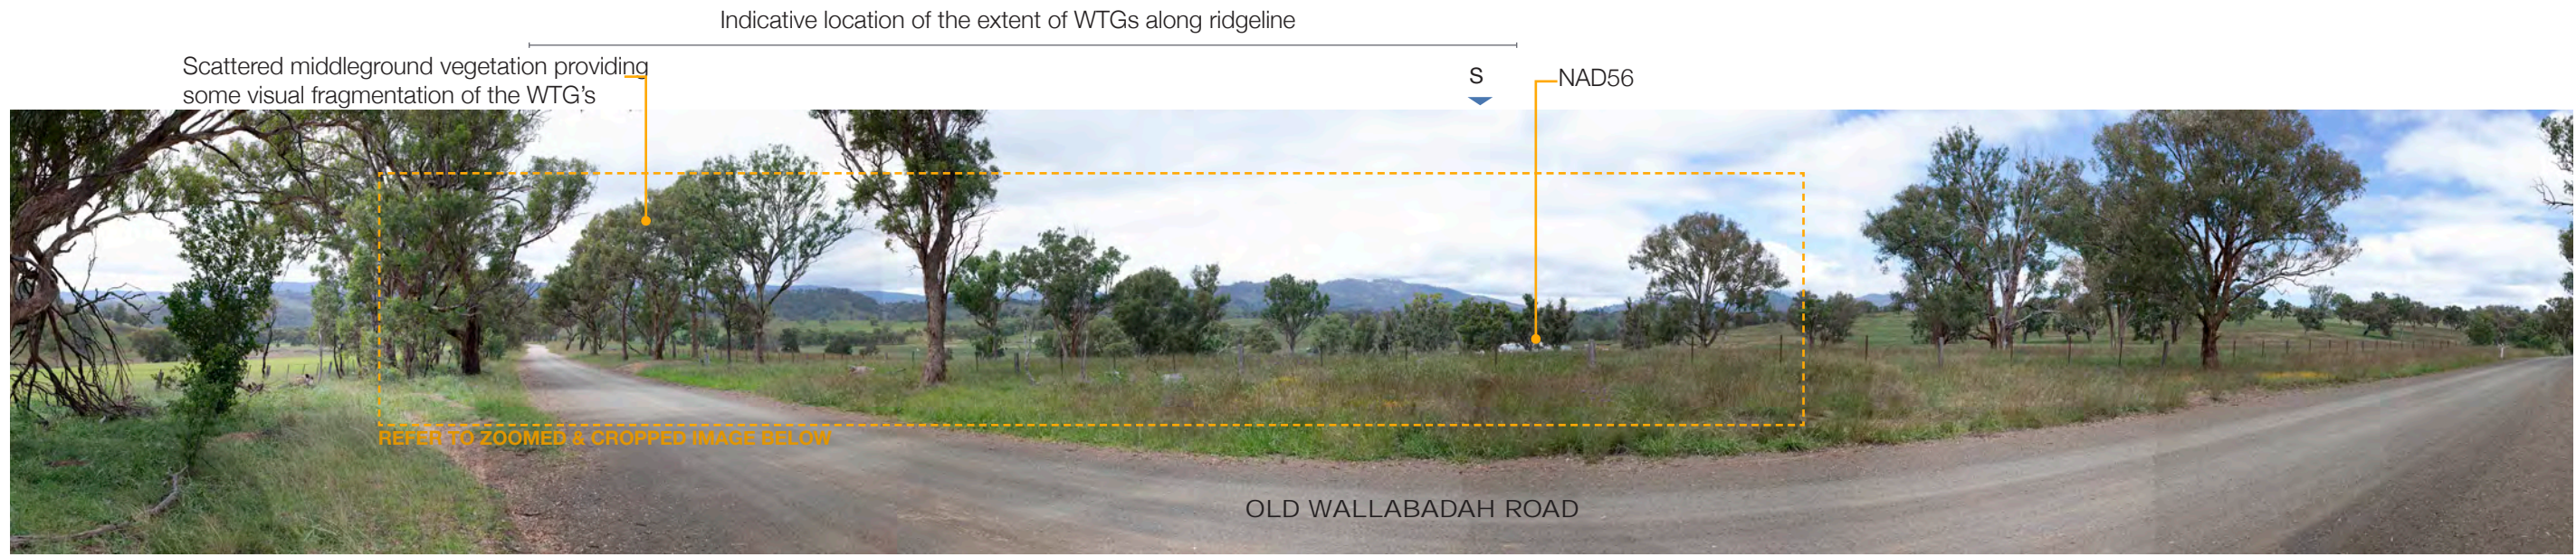
VIEWPOINT HOG18					
Viewpoint Summary		Viewpoint Description	Visual Performance Objectives: VIZ3		
Location:	Elevation:	This viewpoint is located approximately 250m west of the entry to NAD56 along Old Wallabadah Road. The landscape is characterised by mostly cleared grassland used for grazing and other agricultural activities. There is scattered native vegetation along the roadside and in the middleground. The landform is slightly undulating, falling away to the south east to reveal views to the vegetated ridge associated with the Site. A shed associated with the property is visible in the middleground of the view.	There are no visual performance objectives that apply to this viewpoint due to the Visual Influence Zone Rating (VIZ3)		
Old Wallabadah Road	685m				
Coordinates:	Viewing Direction:				
151°3'50.84"E 31°31'10.46"S	Generally South				
Distance to WTG:	Visibility Distance Zone:	Potential Visual Impact According to preliminary analysis based on topography alone, 60-70 WTG's may be visible from this location. It is likely vegetation in the middleground may fragment these views, slightly reducing the number of visible WTG's.

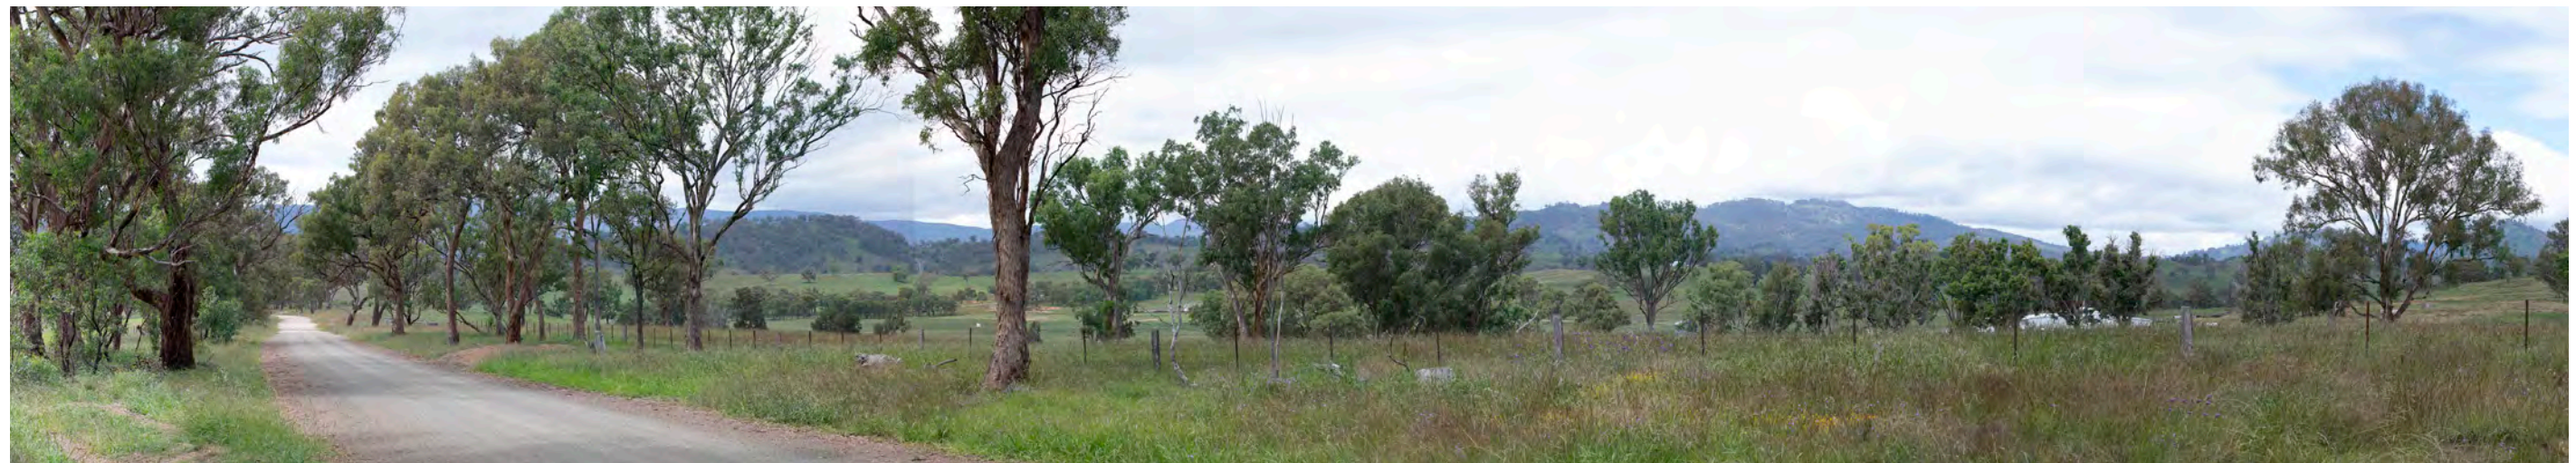
Approx. 7.6km	Far Middleground (FM)				
Land Use:	Viewer Sensitivity Level:				
Low Use Road	Level 3: Low				
LCU:	Scenic Quality Rating:	Nearby Residences:			
Nundle Valley Pastures	Moderate	NAD56			
Visual Influence Zone VIZ3

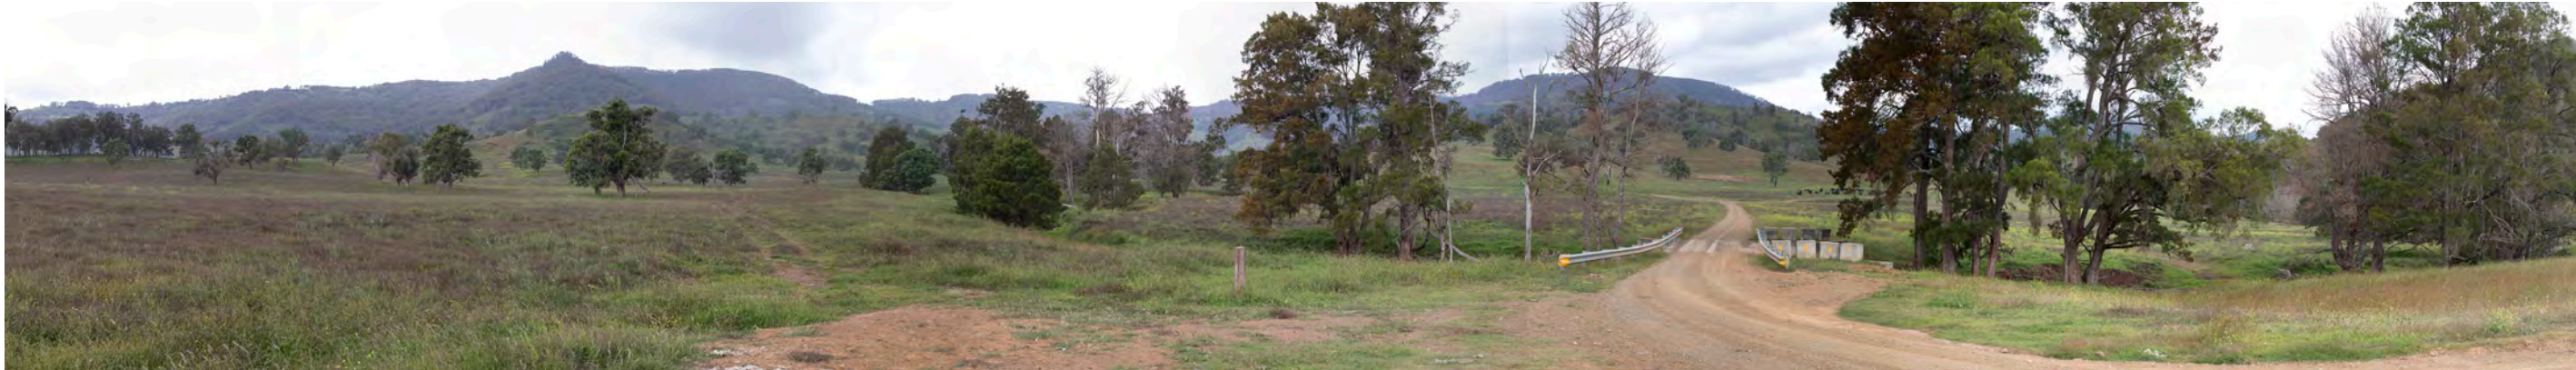
VIEWPOINT HOG19

Viewpoint Summary		Viewpoint Description	Visual Performance Objectives: VIZ3
Location:	Elevation:	<p>This viewpoint is located along Head of Peel Road, 200m north of Kirks Road intersection, around 1.8km south east of AD3. Head of Peel Road is a low use road. The Peel River is visible running under the bridge in the foreground. The land is situated within a valley. It is cleared gently undulating, agricultural land used for grazing. Scattered vegetation is visible in the foreground associated with the Peel River. There are expansive views to the vegetated ridge associated with the project area. A steep rise to the west conceals some views towards the project site.</p> <p>Potential Visual Impact</p> <p>According to preliminary analysis based on topography alone, 40-50 WTG's may be visible from this location. The vegetation in the foreground is likely to fragment a small number of the WTG's, slightly reducing the number visible.</p> <p>There is potential for some loss of roadside vegetation due to the access road associated with the Project Site, which may effect this section of Head of Peel Road.</p> <p>Nearby Residences:</p>	<p>There are no visual performance objectives that apply to this viewpoint due to the Visual Influence Zone Rating (VIZ3).</p>

Head Of Peel Road	741m		
Coordinates:	Viewing Direction:		
151°7'44.30"E 31°35'11.55"S	Generally South		
Distance to WTG:	Visibility Distance Zone:		
Approx. 3.3km	Near Middleground (NM)		
Land Use:	Viewer Sensitivity Level:		
Low Use Road	Level 3: Low		
LCU:	Scenic Quality Rating:		
Nundle Valley Pastures	Moderate	AD3	
Visual Influence Zone VIZ3

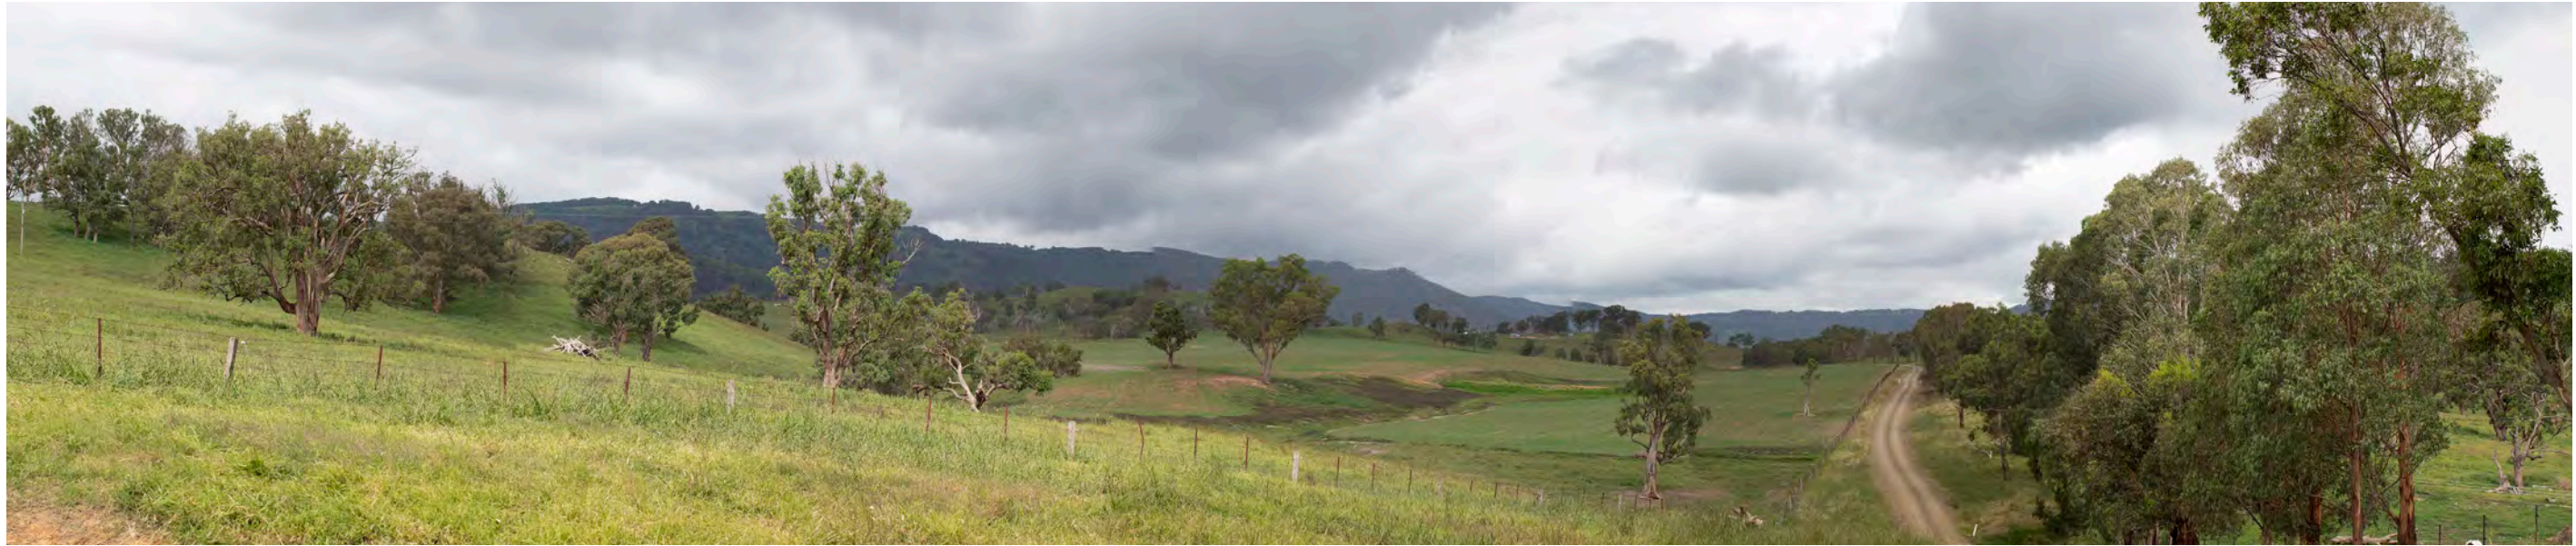
VIEWPOINT HOG20			
Viewpoint Summary		Viewpoint Description	Visual Performance Objectives: VIZ3
Location:	Elevation:	This viewpoint is taken from a slight rise along Head of Peel Rd, 40m from the driveway to NAD33. Head of Peel Road is a low use road. The area is characterised by undulating topography surrounded by steep vegetated ridges. The land is mostly cleared, agricultural land used for grazing for cattle and horses. There is scattered vegetation throughout the view, with dense vegetation running along the fence line in the middleground. The rise continues in an easterly direction, concealing a small portion of views toward the project site. Potential Visual Impact An assessment based on topography alone, identifies 60-70 WTG's may be visible in the distance from east to south. Stands of vegetation along the fence line may fragment views to a small number of WTG's, slightly reducing the number of visible WTG's. There is potential for some loss of roadside vegetation due to the access road associated with the Project Site, which may effect this section of Head of Peel Road. Mitigation methods in this report seek to reduce potential impacts resulting from the road upgrade.	There are no visual performance objectives that apply to this viewpoint due to the Visual Influence Zone Rating (VIZ3) Detailed assessment of nearby dwellings associated with Head of Peel Road are included in Appendix E. See PM21.

Head Of Peel Road	695m		
Coordinates:	Viewing Direction:		
151° 6'30.23"E 31°32'12.01"S	Generally East		
Distance to WTG:	Visibility Distance Zone:		
Approx. 5.8km	Far Middleground (FM)		
Land Use:	Viewer Sensitivity Level:		
Low Use Road	Level 3: Low		
LCU:	Scenic Quality Rating:	Nearby Residences:	
Nundle Valley Pastures	Moderate	NAD33	
Visual Influence Zone VIZ3
