Appendix C

Viewpoint Analysis

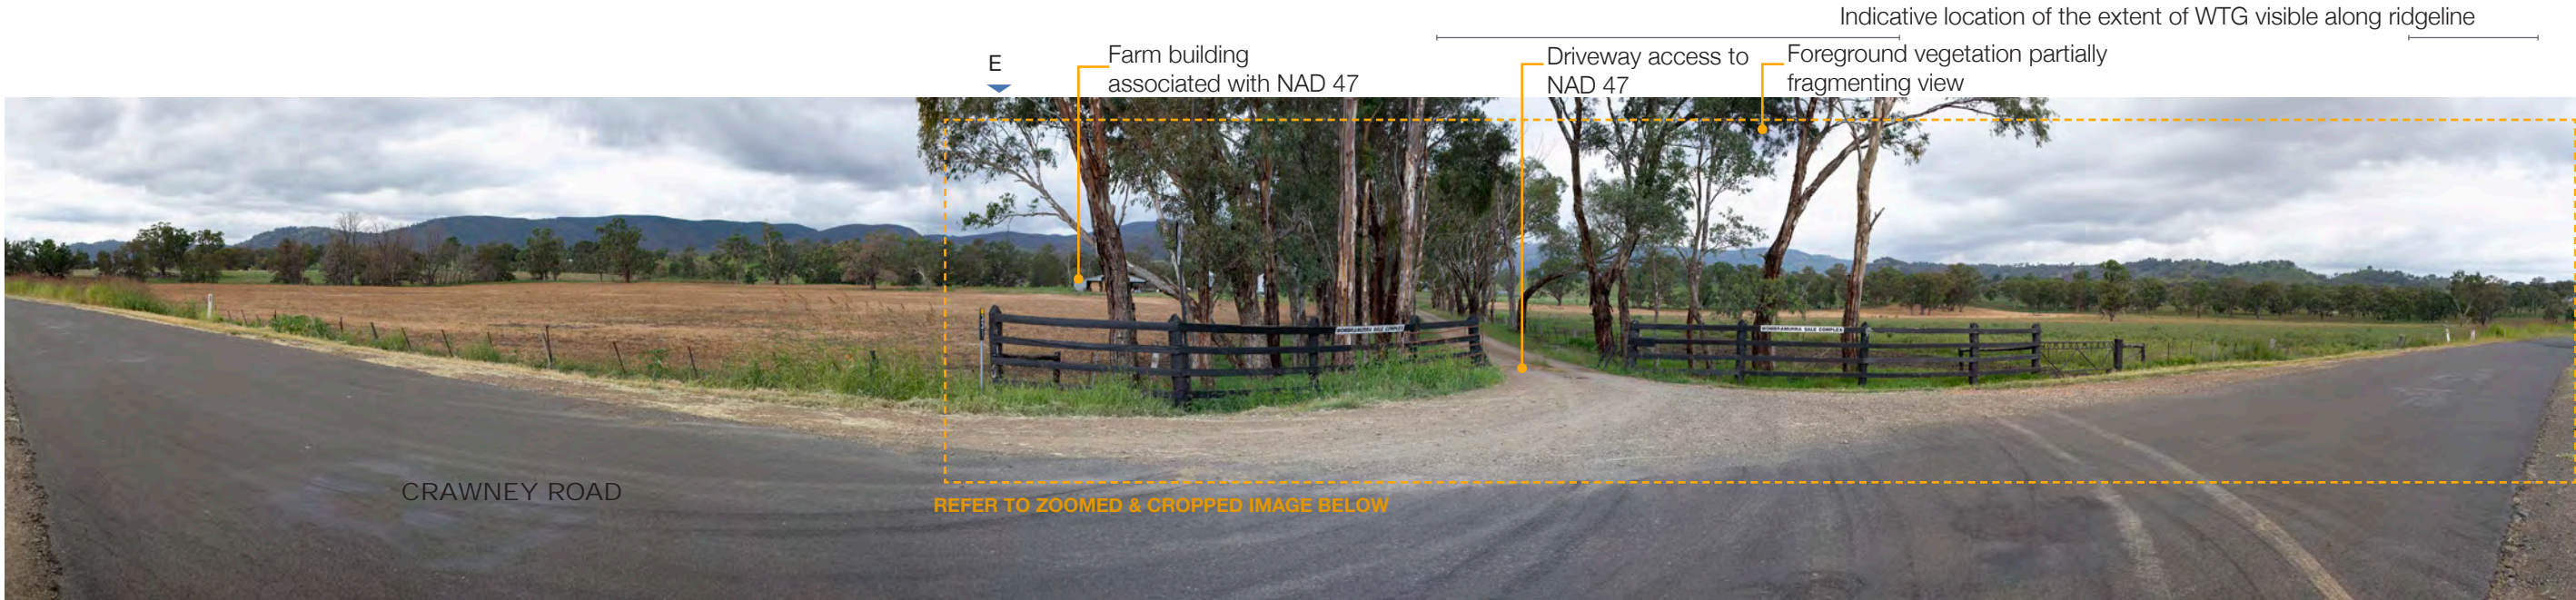
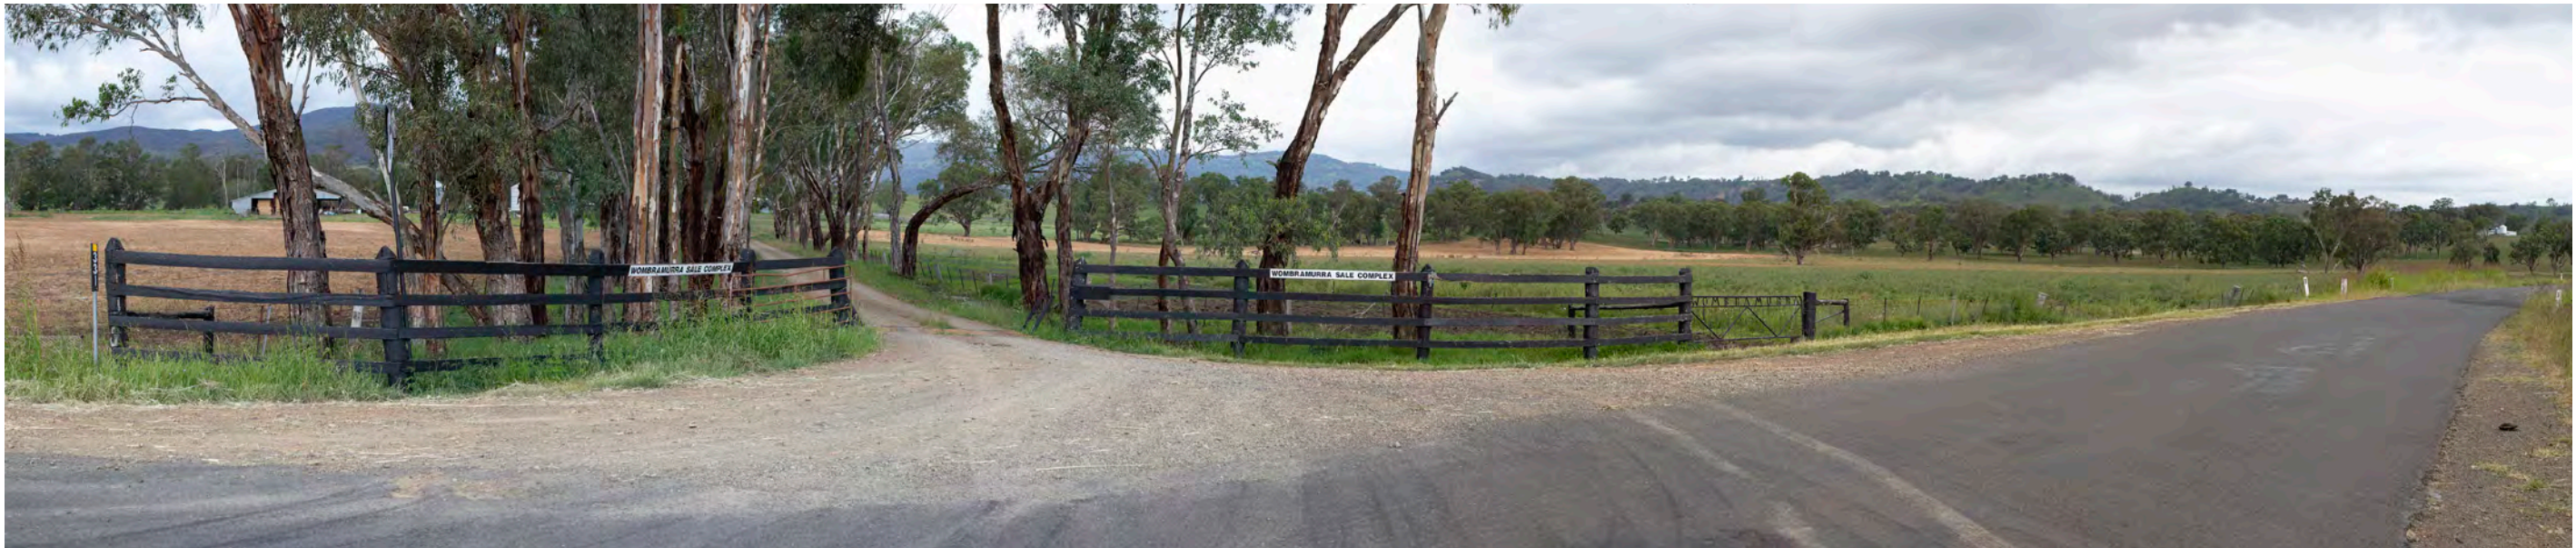
VIEWPOINT HOG21			
Viewpoint Summary		Viewpoint Description	Visual Performance Objectives: VIZ3
Location:	Elevation:	This viewpoint is taken from Crawney Rd, south of Nundle, at the entrance to the Wombramurra Sale Complex, NAD 47. NAD76, 75, 77 & 45 are all located within 1km of this viewpoint. The land is flat, agricultural land used for cropping and grazing. A row of mature native trees line the entrance to the property and are visible in the foreground. Large stands of trees are visible in the middleground. The ridge associated with the project site is visible in the background.	There are no visual performance objectives that apply to this viewpoint due to the Visual Influence Zone Rating (VIZ3) Detailed assessment of nearby dwellings associated with Crawney Road are included in Appendix E .
Crawney Road	610m		
Coordinates:	Viewing Direction:		
151°6'40.6"E 31°29'7.9"S	Generally South East

Distance to WTG:	Visibility Distance Zone:		
Approx. 7.9km	Far Middleground (FM)	Potential Visual Impact An assessment based on topography alone, identifies 40-50 WTG's associated with the project may be visible from this location. Vegetation in the foreground is likely to partially fragment views toward the project area, slightly reducing the number of WTG's visible from this location however outside of this vegetation coverage area, the WTG's are likely to be visible when travelling in a north east or south westerly direction along Crawney Road.	
Land Use:	Viewer Sensitivity Level:		
Low Use Road	Level 3: Low		
LCU:	Scenic Quality Rating:	Nearby Residences:	
Nundle Valley Pastures	Moderate	NAD47, NAD76, NAD75, NAD77, NAD45	
Visual Influence Zone VIZ3

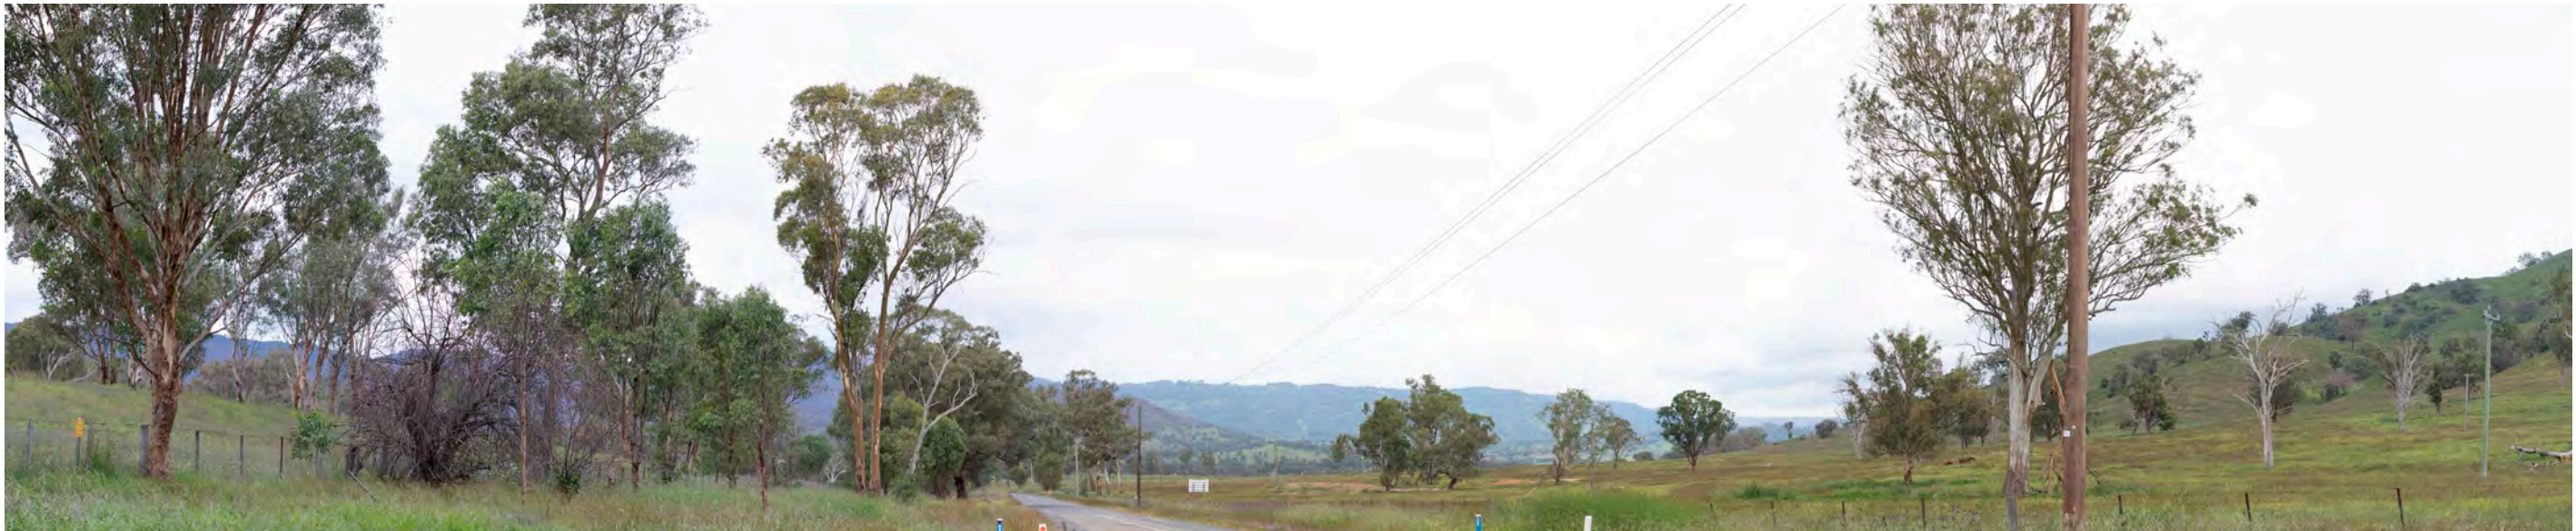
VIEWPOINT HOG22			
Viewpoint Summary		Viewpoint Description	Visual Performance Objectives: VIZ3
Location:	Elevation:	This viewpoint is located along Nundle Road, a main road connecting Nundle to Tamworth. The land is cleared, undulating to gently undulating grassland. There are powerlines visible in the middleground. There are grain and hay infrastructure visible in the middleground. A steep, vegetated rise partially contains views to the south. The view extends south east along Nundle Rd toward the densely vegetated ridge associated with the project visible in the distance.	There are no visual performance objectives that apply to this viewpoint due to the Visual Influence Zone Rating (VIZ3) <i>Refer Photomontage 01</i>
Nundle Road	653m		
Coordinates:	Viewing Direction:		
151°6'7.7"E 31°27'6.7"S	Generally South		
Distance to WTG:	Visibility Distance Zone:	Potential Visual Impact An assessment based on topography alone, identifies 36 WTG's associated with the project may be visible in the distance to the SE.

Approx. 11.5km	Near Background (NB)		
Land Use:	Viewer Sensitivity Level:		
Main Road	Level 3: Low		
LCU:	Scenic Quality Rating:	Nearby Residences:	
Nundle Village	Low/Moderate	-	
Visual Influence Zone VIZ3

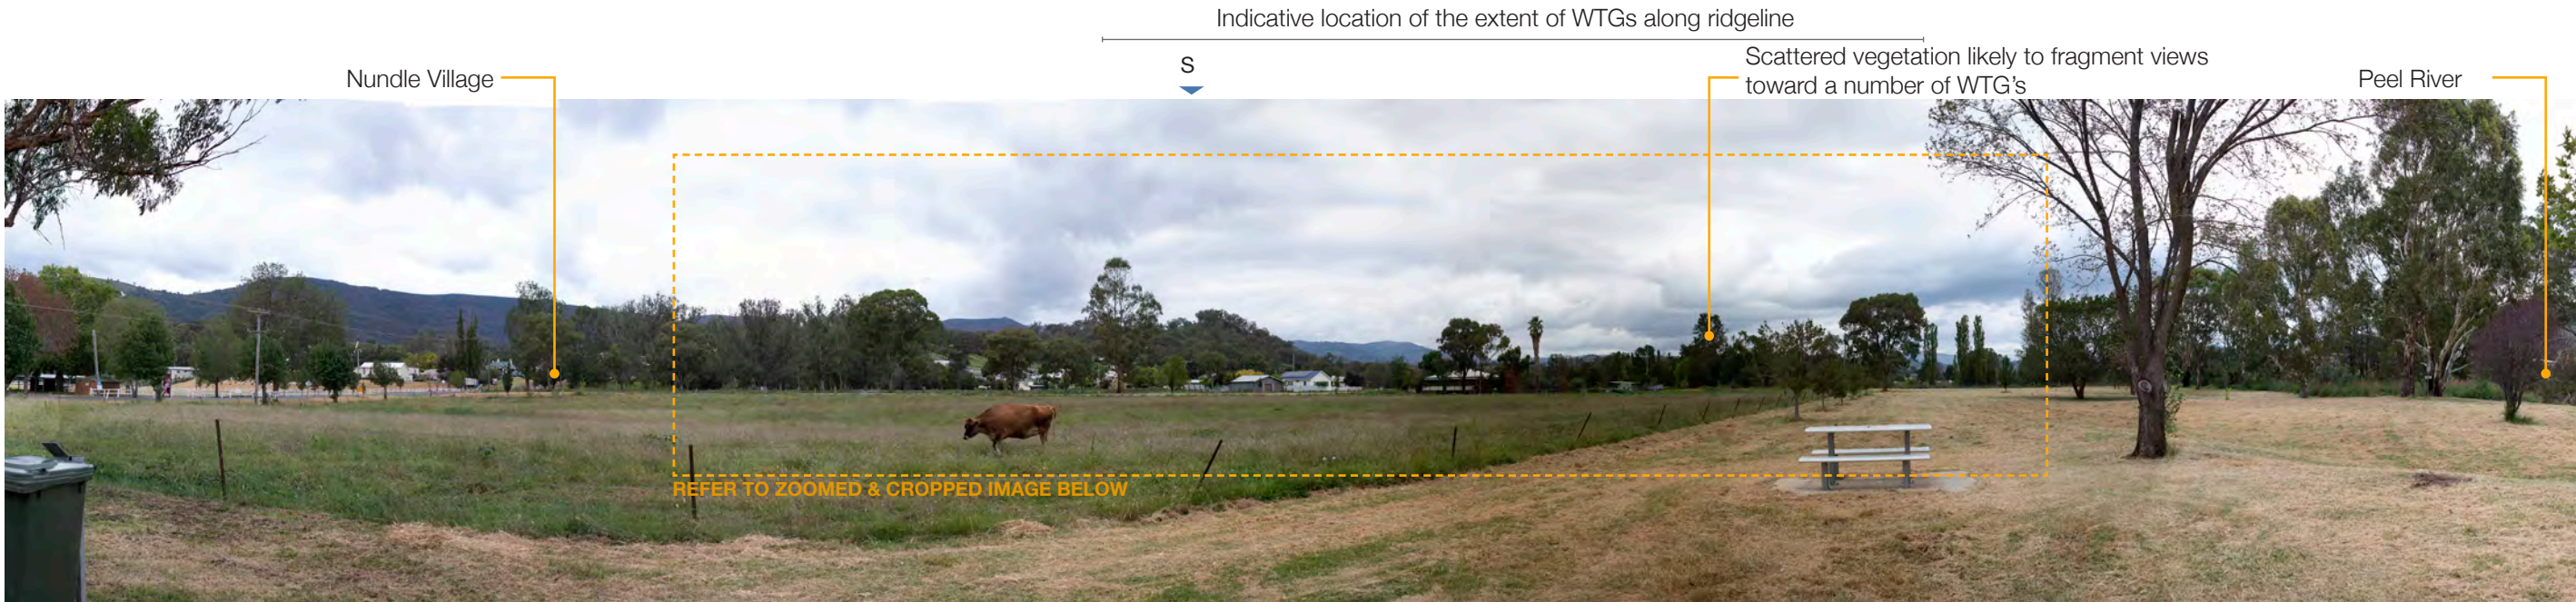
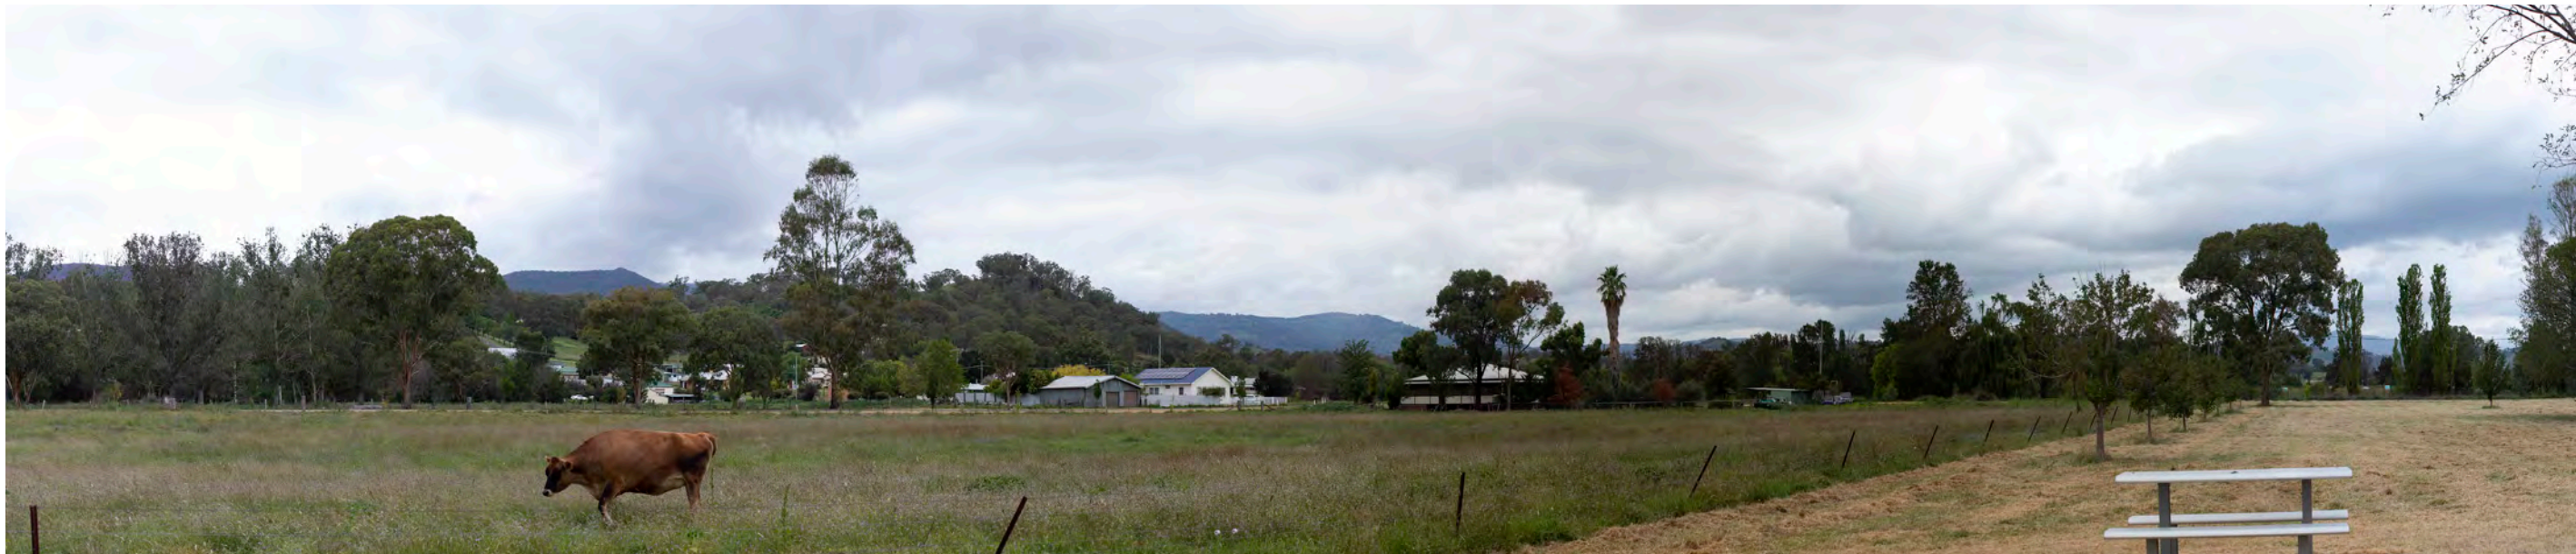
VIEWPOINT HOG23

Viewpoint Summary		Viewpoint Description	Visual Performance Objectives: VIZ3
Location:	Elevation:	This viewpoint is located within a picnic area situated on Mary Street. The picnic area is set by the Peel River, which runs generally in a north-south direction. The land is characterised by cleared, flat land used for recreation and agricultural purposes. Scattered vegetation is visible in the foreground of the view. The view is expansive, extending south east toward Nundle Village in the middleground and the ridge associated with the project site in the background.	There are no visual performance objectives that apply to this viewpoint due to the Visual Influence Zone Rating (VIZ3)
Mary Street	598m		
Coordinates:	Viewing Direction:		
151° 7’27.11”E 31°27’36.70”S	Generally South		
Distance to WTG:	Visibility Distance Zone:		
Approx. 9.8m	Near Background (NB)	Potential Visual Impact An assessment based on topography alone, identifies 60-70 WTG’s associated with the project may be visible from this location. Vegetation in the middleground is likely to partially fragment views to the project area, slightly reducing the number of WTG’s visible from this location. When combined with the distance to the project area, a number of WTG’s may be difficult to discern.

Land Use:	Viewer Sensitivity Level:		
Recreation	Level 2: Moderate		
LCU:	Scenic Quality Rating:	Nearby Residences:	
Nundle Village	Low/Moderate	-	
Visual Influence Zone VIZ3

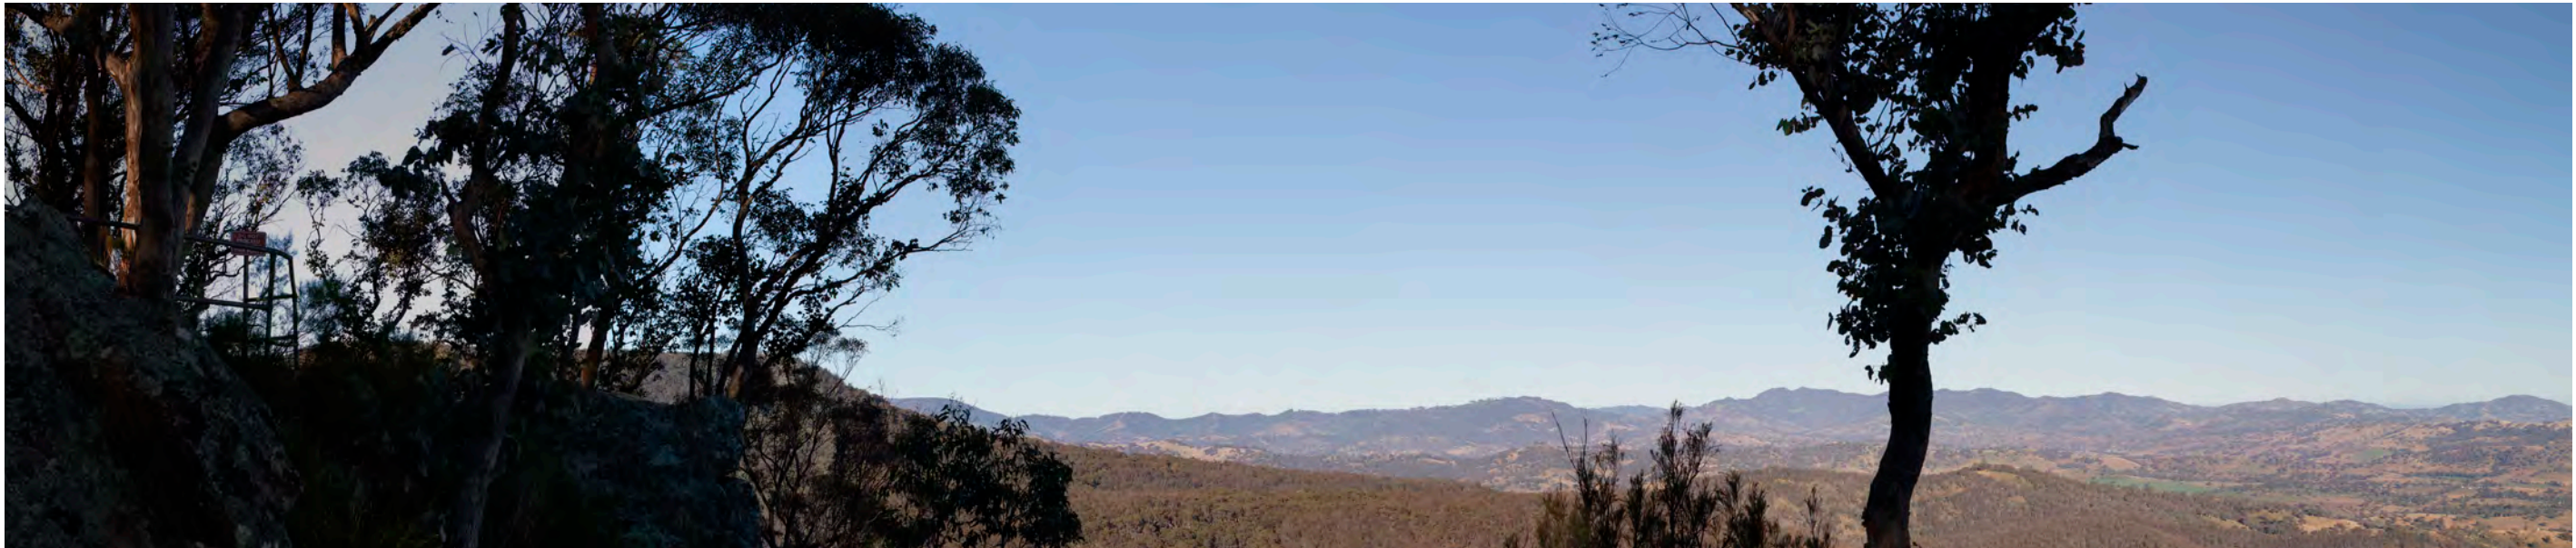
VIEWPOINT HOG24

Viewpoint Summary		Viewpoint Description	Visual Performance Objectives: VIZ2
Location:	Elevation:	This viewpoint is taken from the Hanging Rock Lookout located off Hanging Rock Lookout Rd. The land is characterised by steep topography, dense vegetation and rocky outcrops. The view is expansive, opening up to the SW. The steep ridges on either side of the view partially conceal views toward the south.	Landscape Scenic Integrity: The wind turbines will be a major element in the landscape, however they are unlikely to dominate the visual catchment from this location. Key Feature Disruption: The ridgeline forms a visual backdrop to this viewpoint. The proposed WTGs will be a major feature on the ridge, however the range will still be the most visually prominent feature from this location. <i>Refer Photomontage 06</i>
Hanging Rock Lookout	1090m		
Coordinates:	Viewing Direction:		
151°10’43.06”E 31°28’52.92”S	Generally South West

Distance to WTG:	Visibility Distance Zone:		
Approx. 5.7km	Far Middleground (FM)	Potential Visual Impact An assessment based on topography alone, identifies 22 WTG’s associated with the project may be visible from this location. Vegetation in the foreground of the view is likely to fragment the view toward a number of the WTG’s and combined with the distance to the WTG’s, may reduce the dominance of them within the context of the view.	
Land Use:	Viewer Sensitivity Level:		
Recreation	Level 1: High		
LCU:	Scenic Quality Rating:		
Forested Mountain Ranges	Mod/High		
Visual Influence Zone VIZ2		Nearby Residences:

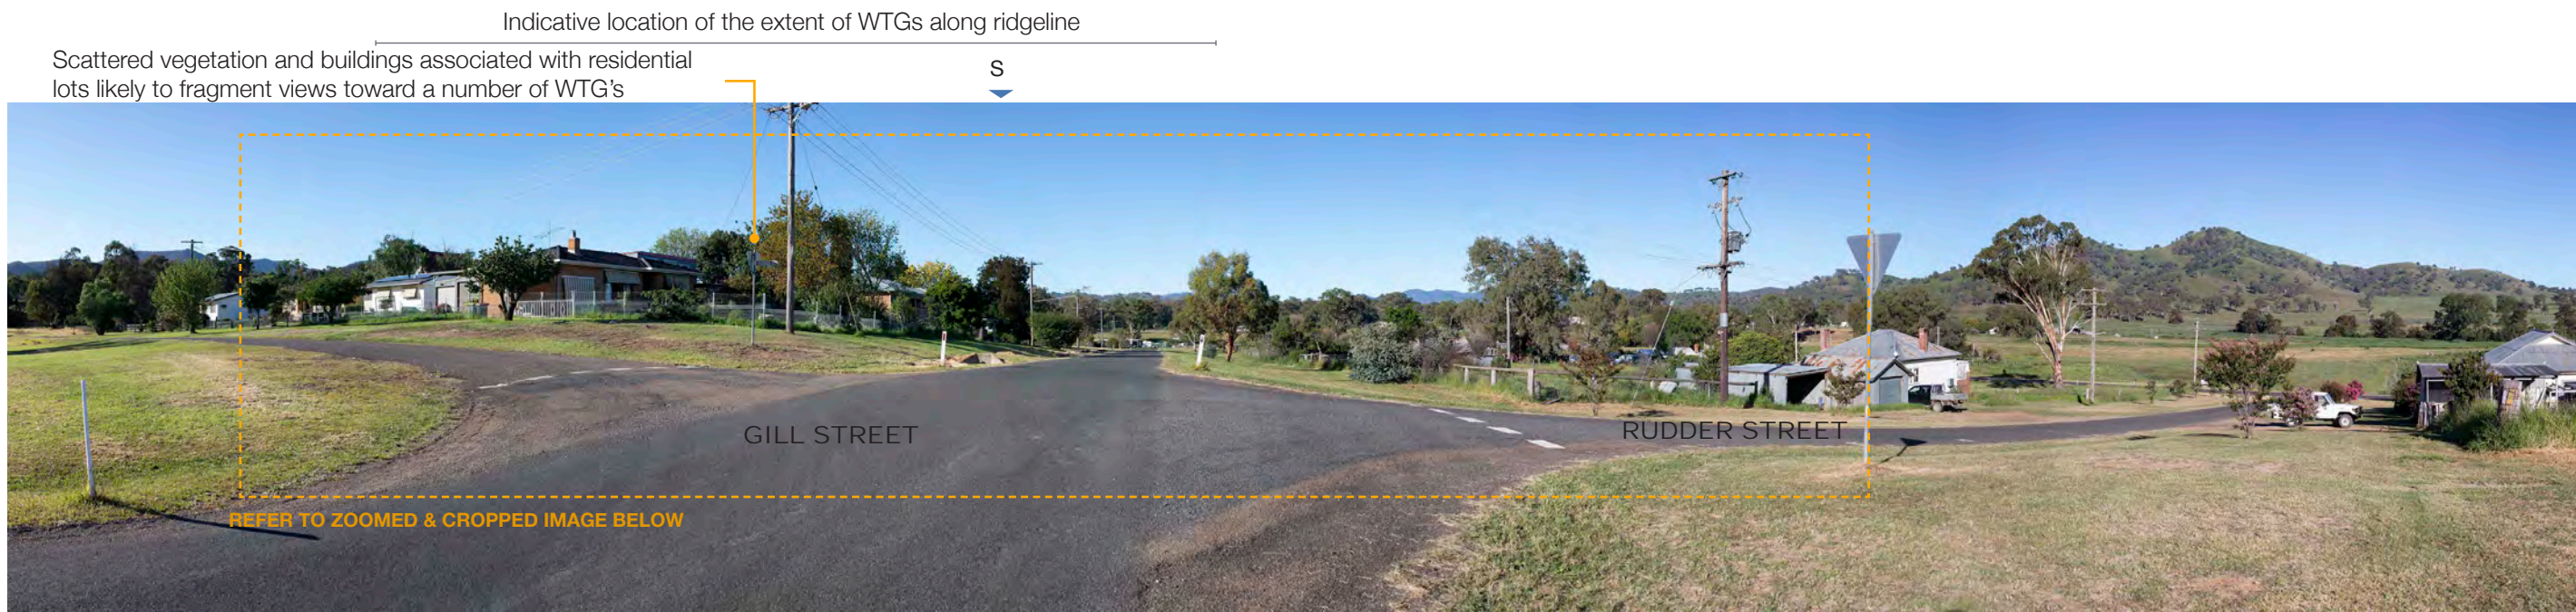
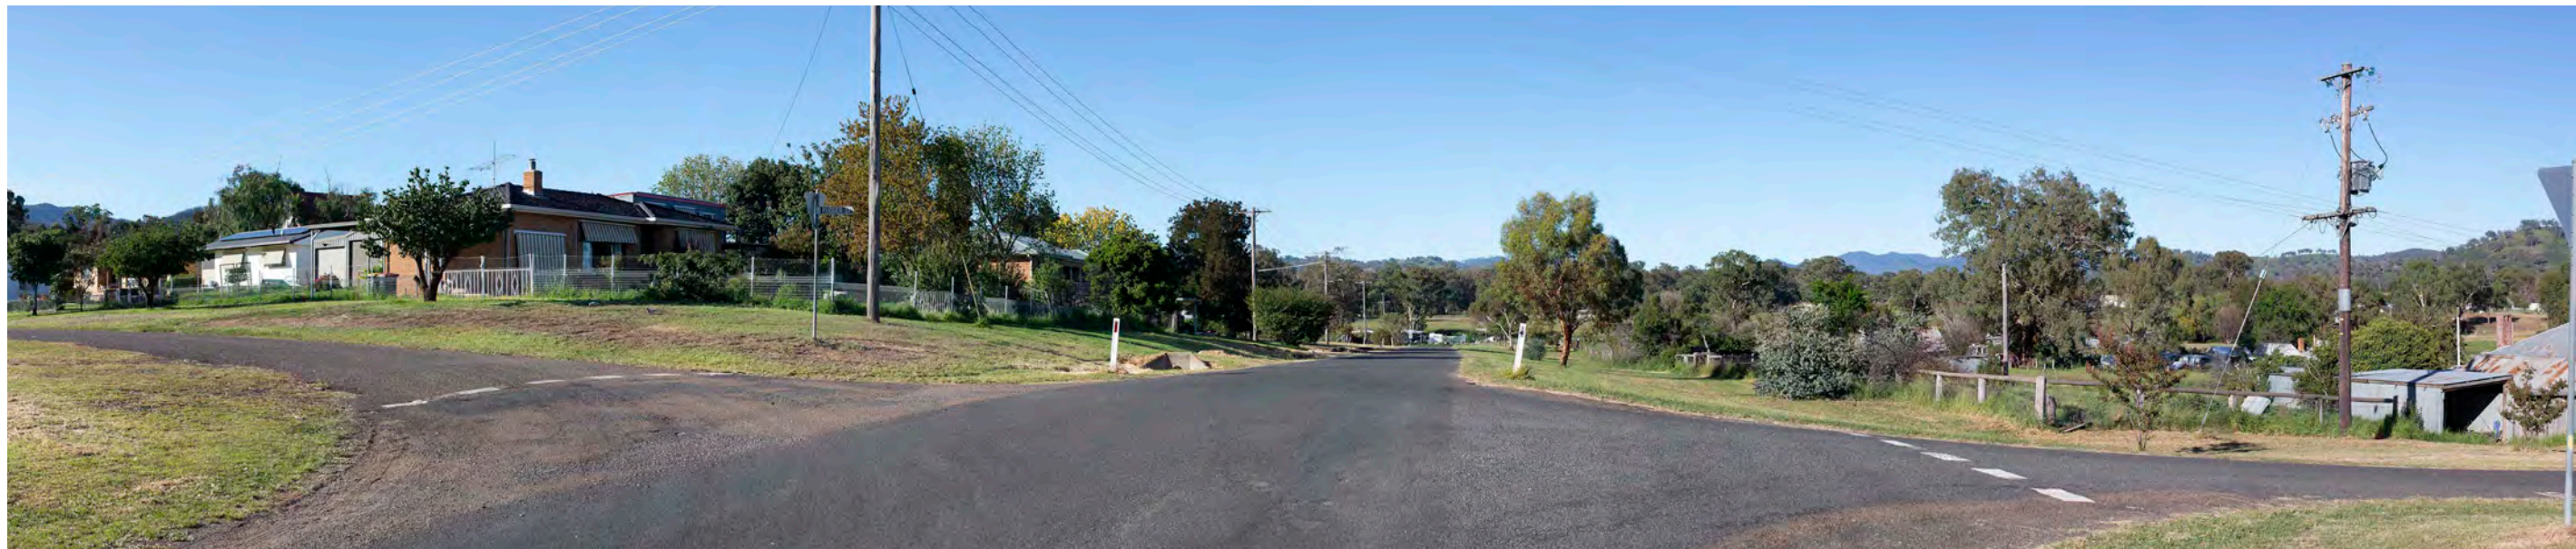
VIEWPOINT HOG25			
Viewpoint Summary		Viewpoint Description	Visual Performance Objectives: VIZ2
Location:	Elevation:	This viewpoint is taken on a rise on the corner of Rudder and Gill Street. The land is characterised by low density residential on large blocks. The land is undulating, sloping to the west. Scattered vegetation associated with the dwellings is visible in the mid ground. The crest of the hill and residential buildings located in the SE of the view contains some views toward the ridge. Potential Visual Impact A preliminary analysis based on topography alone suggests 41 WTG's may be visible from this location. It is likely existing buildings and associated vegetation in the middleground may conceal views and when combined with the distance from the project area may be difficult to discern.	Landscape Scenic Integrity: The wind turbines will be a noticeable element in the landscape, however they are unlikely to dominate the visual catchment from this location. Vegetation associated with the residential lots would fragment views from this location. Key Feature Disruption: The vegetated ranges form a visual backdrop to this viewpoint. The proposed WTGs will be visible on a small portion of the vegetated range, however the undulating residential character along with range will still be the most visually prominent feature from this location.

Corner of Rudder and Gill St.	608m		
Coordinates:	Viewing Direction:		
151°7'34.27"E 31°28'8.48"S	Generally South		
Distance to WTG:	Visibility Distance Zone:		
Approx. 8.9km	Near Background (NB)	Nearby Residences:	
Land Use:	Viewer Sensitivity Level:		
Residential	Level 1: High		
LCU:	Scenic Quality Rating:		
Nundle Village	Low/Moderate	Nundle Village	
Visual Influence Zone VIZ2

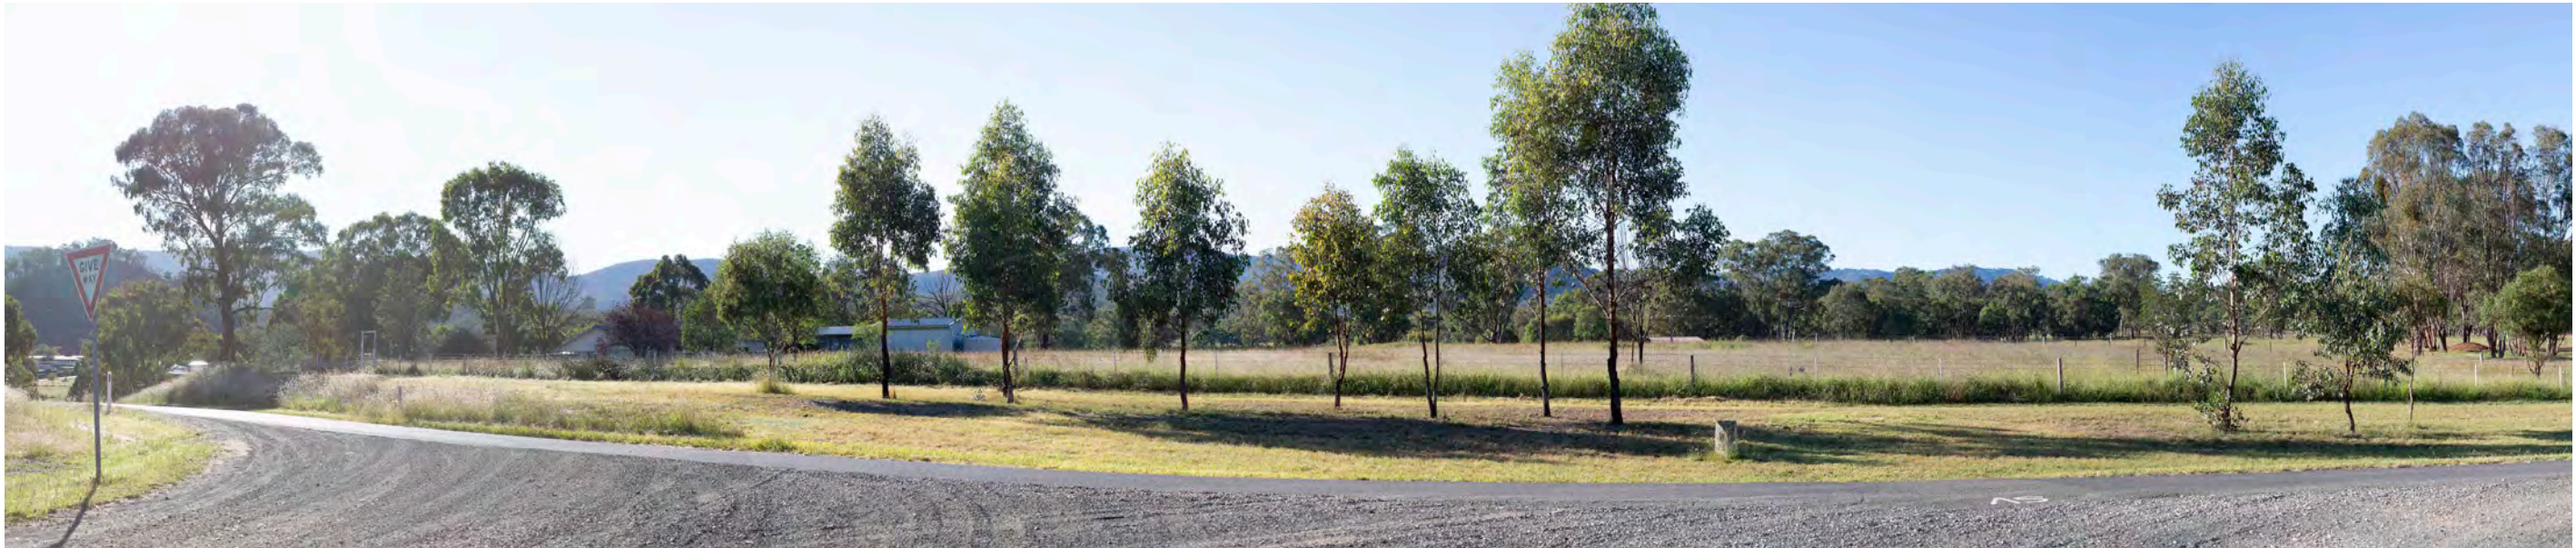
VIEWPOINT HOG26

Viewpoint Summary		Viewpoint Description	Visual Performance Objectives: VIZ2
Location:	Elevation:	<p>This viewpoint is taken from the corner of Crawney Road/Jenkins Street and Herring Street. The land is flat, cleared residential land, set on large blocks. Dense juvenile native vegetation is visible in the foreground of the view. Filtered views south east toward the ridge associated with the project are available through a break in vegetation.</p> <p>Potential Visual Impact</p> <p>A preliminary analysis based on topography alone suggests approx. 49 WTG's may be visible from this location. It is likely the dense vegetation in the foreground may fragment views, reducing the visibility of a number of the WTG's from this viewpoint.</p>	<p>Landscape Scenic Integrity:</p> <p>The wind turbines will be a noticeable element in the landscape, however they are unlikely to dominate the visual catchment from this location.</p> <p>Key Feature Disruption:</p> <p>The Ridge forms a visual backdrop to the east of this viewpoint. The proposed WTGs will be visible on the range, however the range will still be the most visually prominent feature from this location.</p>

Corner Crawney Rd/ Jenkins St and Herring St.	607m		
Coordinates:	Viewing Direction:		
151° 7'15.40"E 31°28'17.95"S	Generally East		
Distance to WTG:	Visibility Distance Zone:		
Approx. 8.7km	Near Background (NB)		
Land Use:	Viewer Sensitivity Level:		
Residential	Level 1: High		
LCU:	Scenic Quality Rating:		
Nundle Village	Low/Moderate		
Visual Influence Zone VIZ2

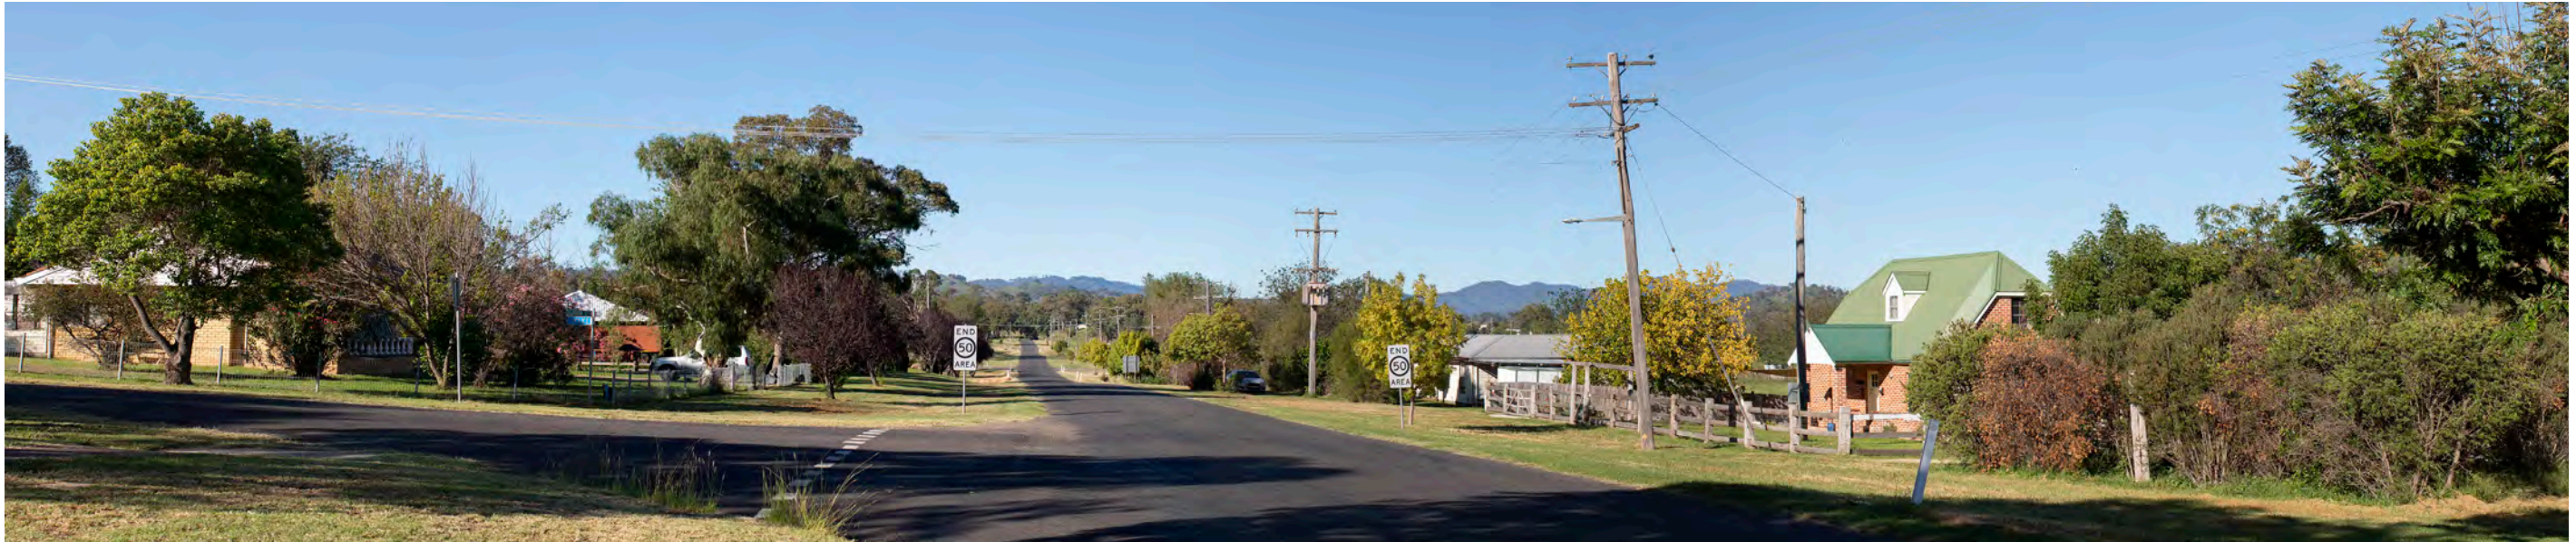
VIEWPOINT HOG27

Viewpoint Summary		Viewpoint Description	Visual Performance Objectives: VIZ2
Location:	Elevation:	This viewpoint is taken on the corner of Jenkins and Durban Street, near the Old Courthouse Museum. The land is characterised by low density residential. The land is flat with dense vegetation associated with the dwellings visible in the middleground. Filtered views of the vegetated ridge associated with the project is visible to the south along Jenkins St.	Landscape Scenic Integrity: The wind turbines are likely to be a noticeable element in the landscape from this location, however they are unlikely to alter the existing visual landscape. Key Feature Disruption: The proposed WTGs are likely to be visible in the distance. Views across the undulating residential area and the ridgeline are likely to remain the key feature of the landscape from this location. Refer to Photomontage 28
Jenkins Street	601m

Coordinates:	Viewing Direction:		
151°7'35.68"E 31°27'53.09"S	Generally South		
Distance to WTG:	Visibility Distance Zone:	Potential Visual Impact An assessment based on topography alone identifies 30 WTG's may be visible from this location. It is likely existing buildings and associated dense vegetation in the middleground may fragment views and when combined with the distance from the project area, may reduce the number of the WTG's to approximately 10 WTG's, which are in excess of 15.5km from this location.	
Approx. 9.2km	Near Background (NB)		
Land Use:	Viewer Sensitivity Level:		
Residential	Level 1: High		
LCU:	Scenic Quality Rating:	Nearby Residences:	
Nundle Village	Low/Moderate	Nundle Village	
Visual Influence Zone VIZ2

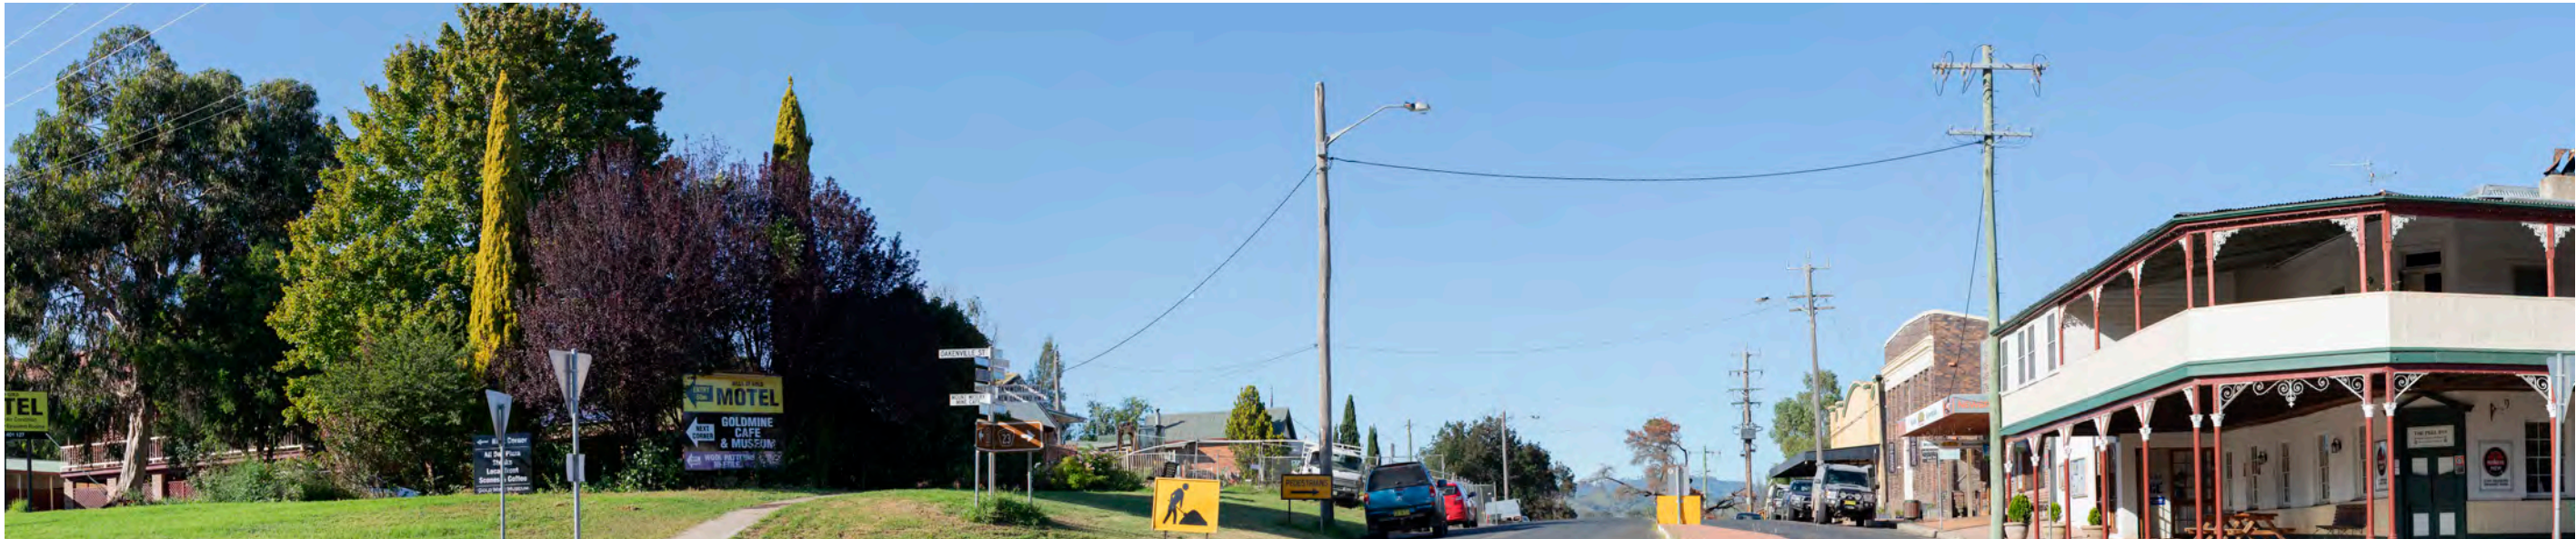
VIEWPOINT HOG28

Viewpoint Summary		Viewpoint Description	Visual Performance Objectives: VIZ2
Location:	Elevation:	This viewpoint is located within the main street of Nundle, at the intersection of Jenkins and Oakenville St. The landform is sloping, with a slight rise to the south of the view. The land is classed as a rural village. The Peel Inn and dense vegetation associated with the motel are visible in the foreground and contain views toward the project site. Powerlines are visible in the foreground. A filtered view toward the ridge is visible in the distance.	Landscape Scenic Integrity: The wind turbines are likely to be noticeable in the landscape from this location, however they are unlikely to alter the existing visual landscape. Key Feature Disruption: The proposed WTGs are likely to be visible in the distance however, the village character and buildings are likely to remain the key feature of the landscape from this location. <i>Refer Photomontage 02</i>

Jenkins Street	600m		
Coordinates:	Viewing Direction:		
151°7'40.55"E 31°27'37.90"S	Generally South		
Distance to WTG:	Visibility Distance Zone:	Potential Visual Impact An assessment based on topography alone identifies approx. 10 WTG's may be visible from this location. The the existing dense vegetation and buildings in the foreground fragment views to a number of the WTG's, reducing the amount visible to 6. The distance to the project site may further reduce the appearance of the WTG's within the context of the view.	
Approx. 9.6km	Near Background (NB)		
Land Use:	Viewer Sensitivity Level:	Nearby Residences:	
Village	Level 1: High		
LCU:	Scenic Quality Rating:		
Nundle Village	Low/Moderate	Nundle Village	
Visual Influence Zone VIZ2

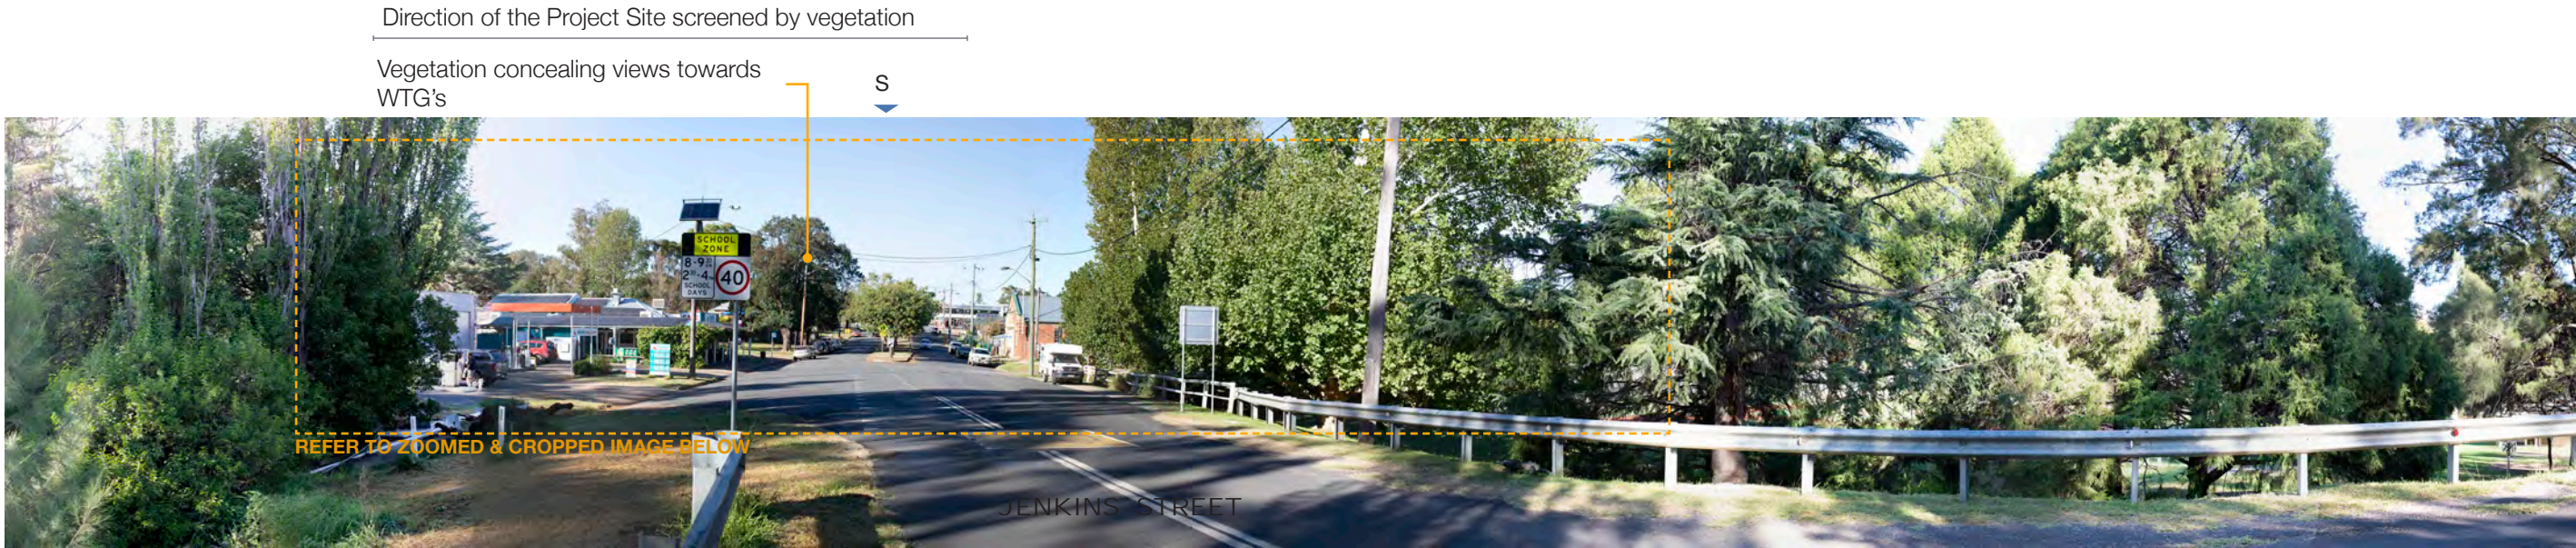
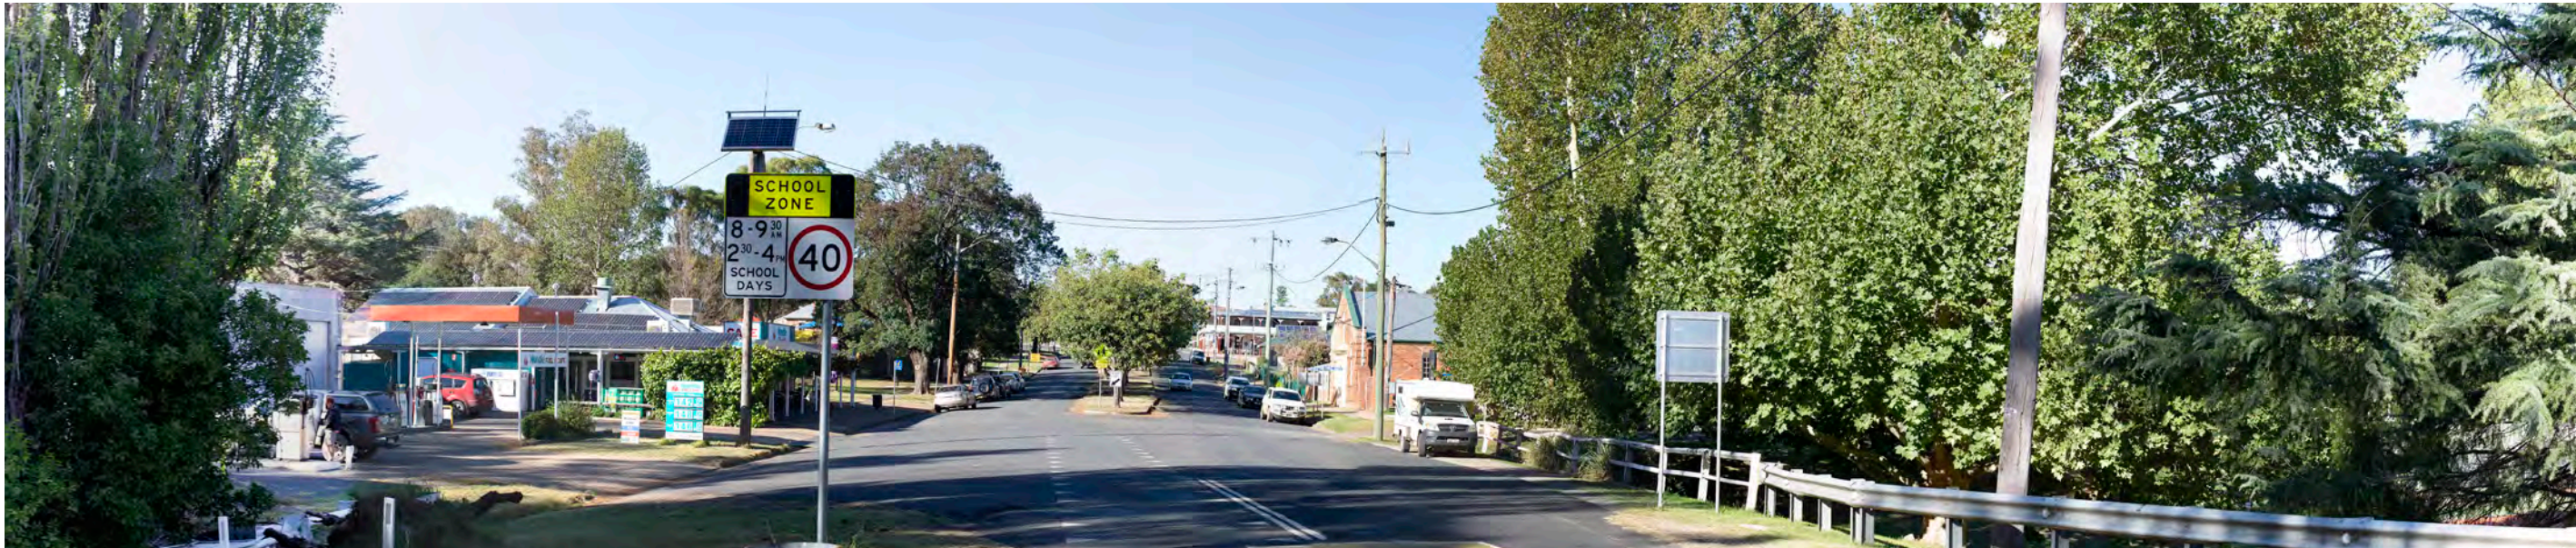
VIEWPOINT HOG29

Viewpoint Summary		Viewpoint Description	Visual Performance Objectives: VIZ2
Location:	Elevation:	This viewpoint is taken from the northern end of Jenkins Street, next to the tennis courts and petrol station. The view is from within the bounds of the town (rural village) area. The landform is sloping, rising up toward the south. Views are contained by the dense vegetation in the foreground. Potential Visual Impact An assessment based on topography alone identifies a around 14-27 WTG's may be visible from this location, however due to the dense vegetation in the foreground it is highly unlikely that any WTG's will be visible.	Landscape Scenic Integrity: The wind turbines are unlikely to alter the existing visual landscape from this location. Key Feature Disruption: The proposed WTGs are unlikely to be visible. Views within the village across are likely to remain the key feature of the landscape from this location.

Jenkins Street	598m		
Coordinates:	Viewing Direction:		
151°7'42.82"E 31°27'32.56"S	Generally South		
Distance to WTG:	Visibility Distance Zone:		
Approx. 9.7km	Near Background (NB)	Nearby Residences: Nundle Village	
Land Use:	Viewer Sensitivity Level:		
Village	Level 1: High		
LCU:	Scenic Quality Rating:		
Nundle Village	Low/Moderate		
Visual Influence Zone VIZ2
