Appendix C

Viewpoint Analysis

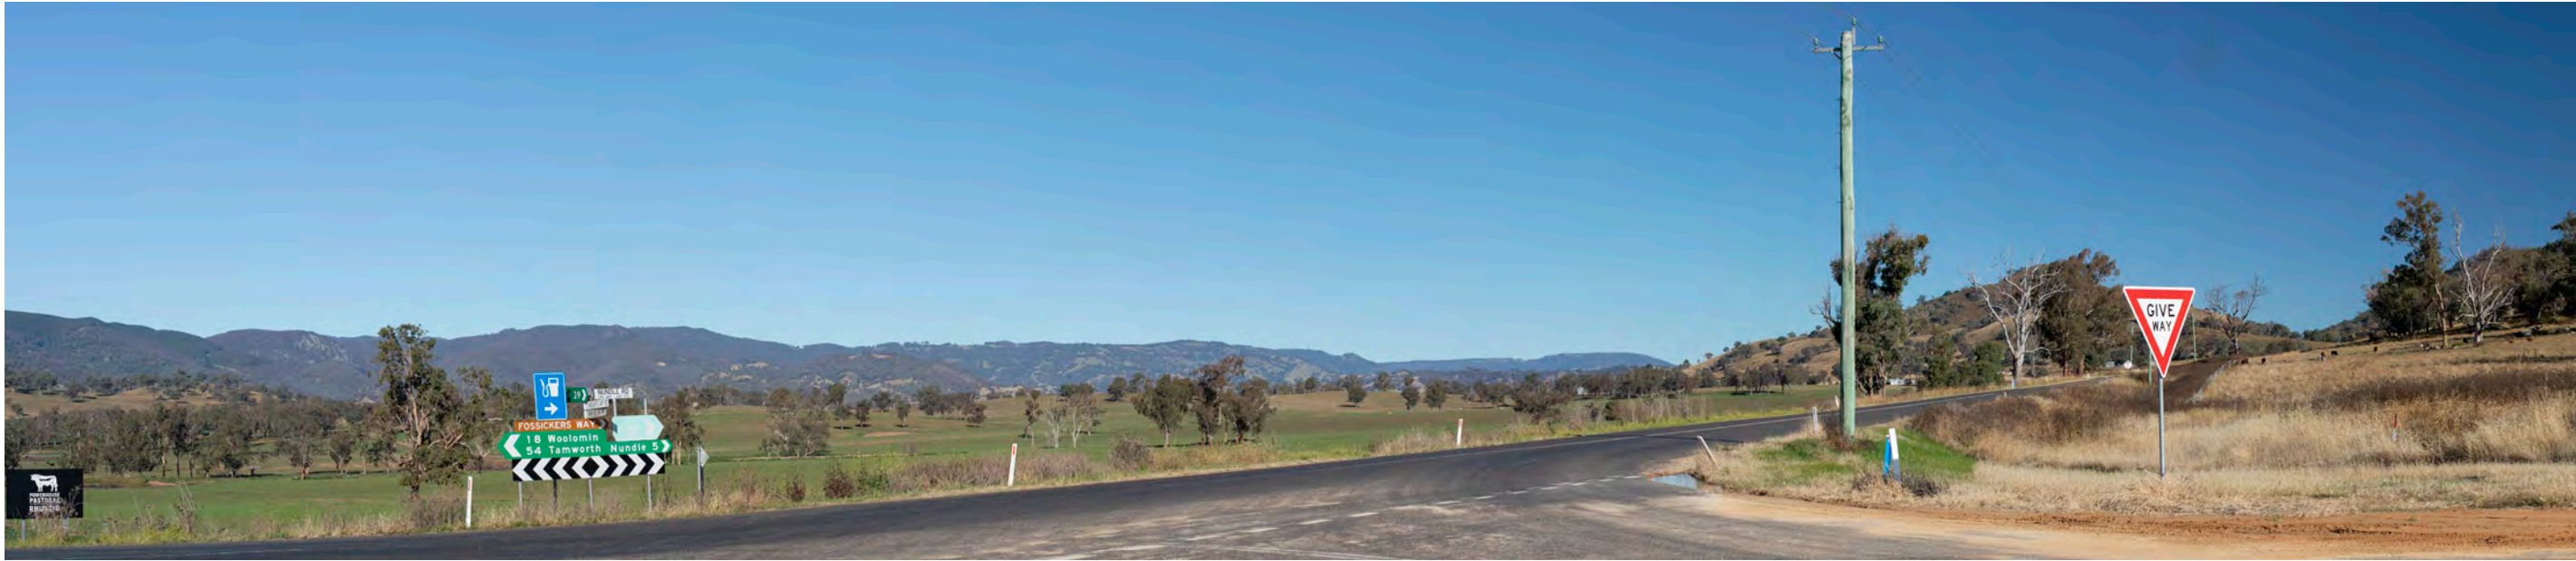
VIEWPOINT HOG30

Viewpoint Summary		Viewpoint Description	Visual Performance Objectives: VIZ3
Location:	Elevation:	This viewpoint is taken from the Corner of Lindsay's Gap Road and Nundle Road. The land is characterised by flat, cleared agricultural land used for cropping and grazing. The land rises to the south of the view, containing views to the south. Scattered vegetation associated with the creeks connecting with the Peel River are visible in the background of the view. The densely vegetated ridge is visible in the distance.	There are no visual performance objectives that apply to this viewpoint due to the Visual Influence Zone Rating (VIZ3) <i>Refer Photomontage 08</i>
Corner Lindsay's Gap Road & Nundle Road	633m		
Coordinates:	Viewing Direction:		
151° 6'7.79"E 31°26'18.77"S	Generally South East		
Distance to WTG:	Visibility Distance Zone:		
Approx. 12.8km	Mid Background (MB)	Potential Visual Impact An assessment based on topography alone identifies around 49 WTG's are likely to be visible on the ridge from this location. The distance to the turbines may dilute the prominence of this element in the landscape.

Land Use:	Viewer Sensitivity Level:		
Main Road	Level 3: Low		
LCU:	Scenic Quality Rating:	Nearby Residences:	
Nundle Village	Low/Moderate		
Visual Influence Zone VIZ3

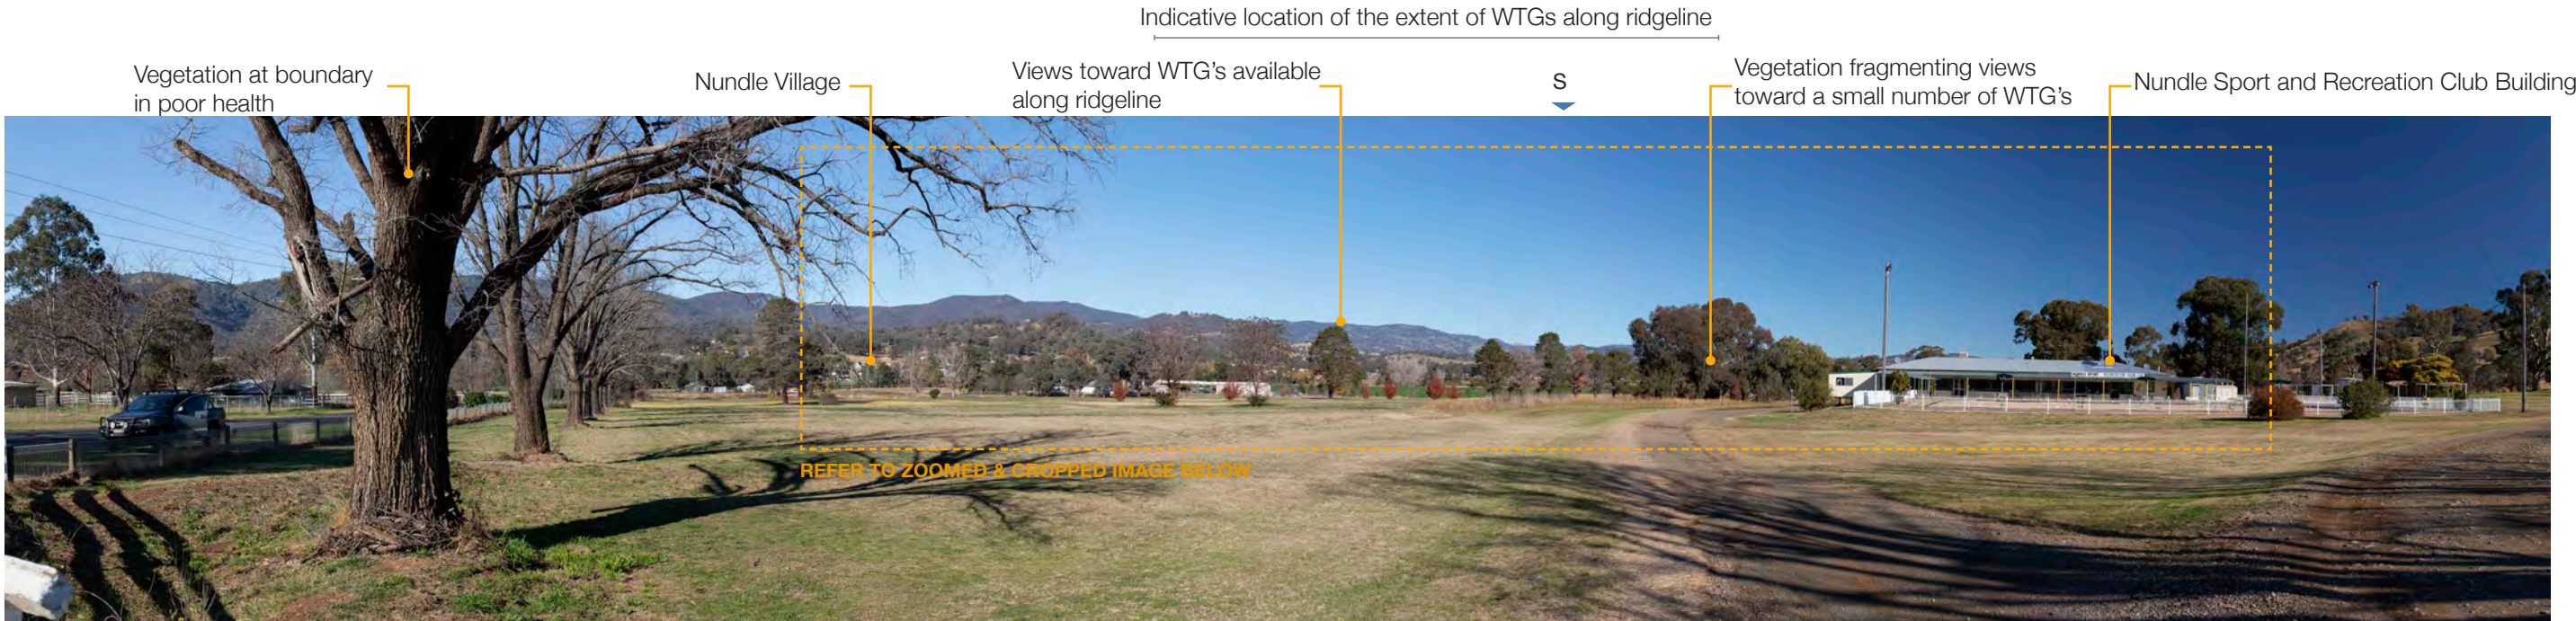
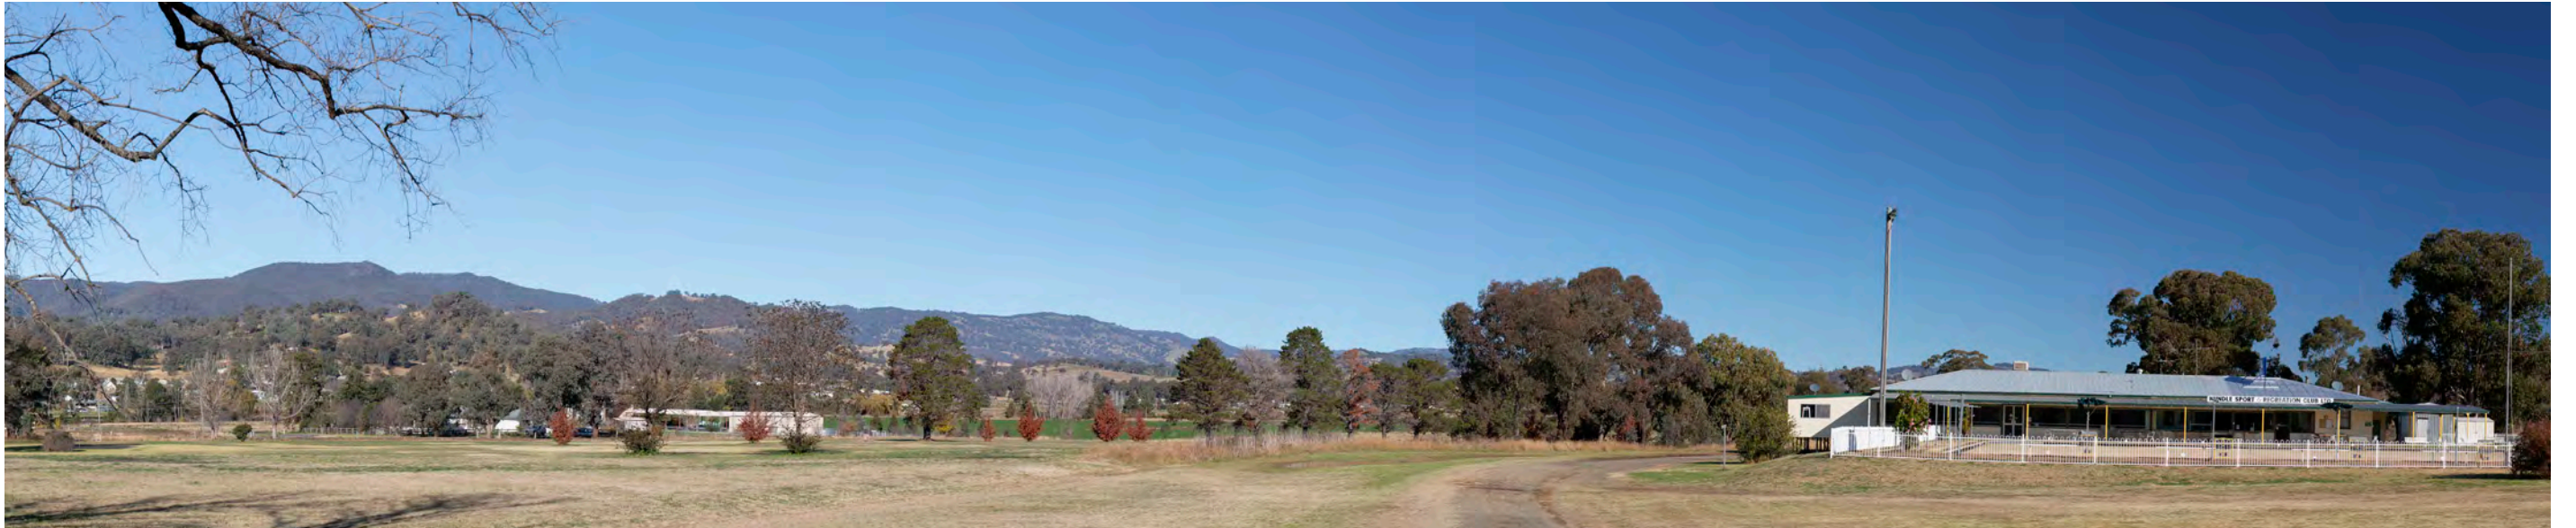
VIEWPOINT HOG31

Viewpoint Summary		Viewpoint Description	Visual Performance Objectives: VIZ2
Location:	Elevation:	<p>This viewpoint is taken from opposite the entry to Nundle Sport & Recreation Club along Nundle Road. Nundle Road is the main entry into Nundle Village. The land is cleared and used predominantly for recreational purposes. The landform is sloping to the east. Unhealthy vegetation is visible at the boundary. The recreational facility building and associated vegetation can be seen in the middleground. The view extends toward the town and vegetated ranges form a backdrop to views into Nundle.</p> <p>Potential Visual Impact</p> <p>An assessment based on topography alone identifies around 60-70 WGTG's associated with project may be available along the ridgeline from this location. Vegetation in the middleground may partially fragment views to a number of WGTG's, reducing this number to approx. 53 WGTG's. The distance to the project site may further dilute the appearance of the WGTG's within the context of the view.</p> <p>Nearby Residences:</p> <p>-</p>	<p>Landscape Scenic Integrity:</p> <p>The wind turbines will be a noticeable element in the landscape, however they are unlikely to dominate the visual catchment from this location.</p> <p>Key Feature Disruption:</p> <p>The proposed WGTG's will occupy a small portion be a feature on the range. The range along with the undulating area associated with the village will still be the most visually prominent feature from this location.</p> <p><i>Refer Photomontage 09</i></p>

Nundle Road	608m		
Coordinates:	Viewing Direction:		
151° 7'5.89"E 31°27'31.85"S	Generally South		
Distance to WGTG:	Visibility Distance Zone:		
Approx. 10.1km	Near Background (NB)		
Land Use:	Viewer Sensitivity Level:		
Recreation	Level 1: High		
LCU:	Scenic Quality Rating:		
Nundle Village	Low/Moderate		
Visual Influence Zone VIZ2

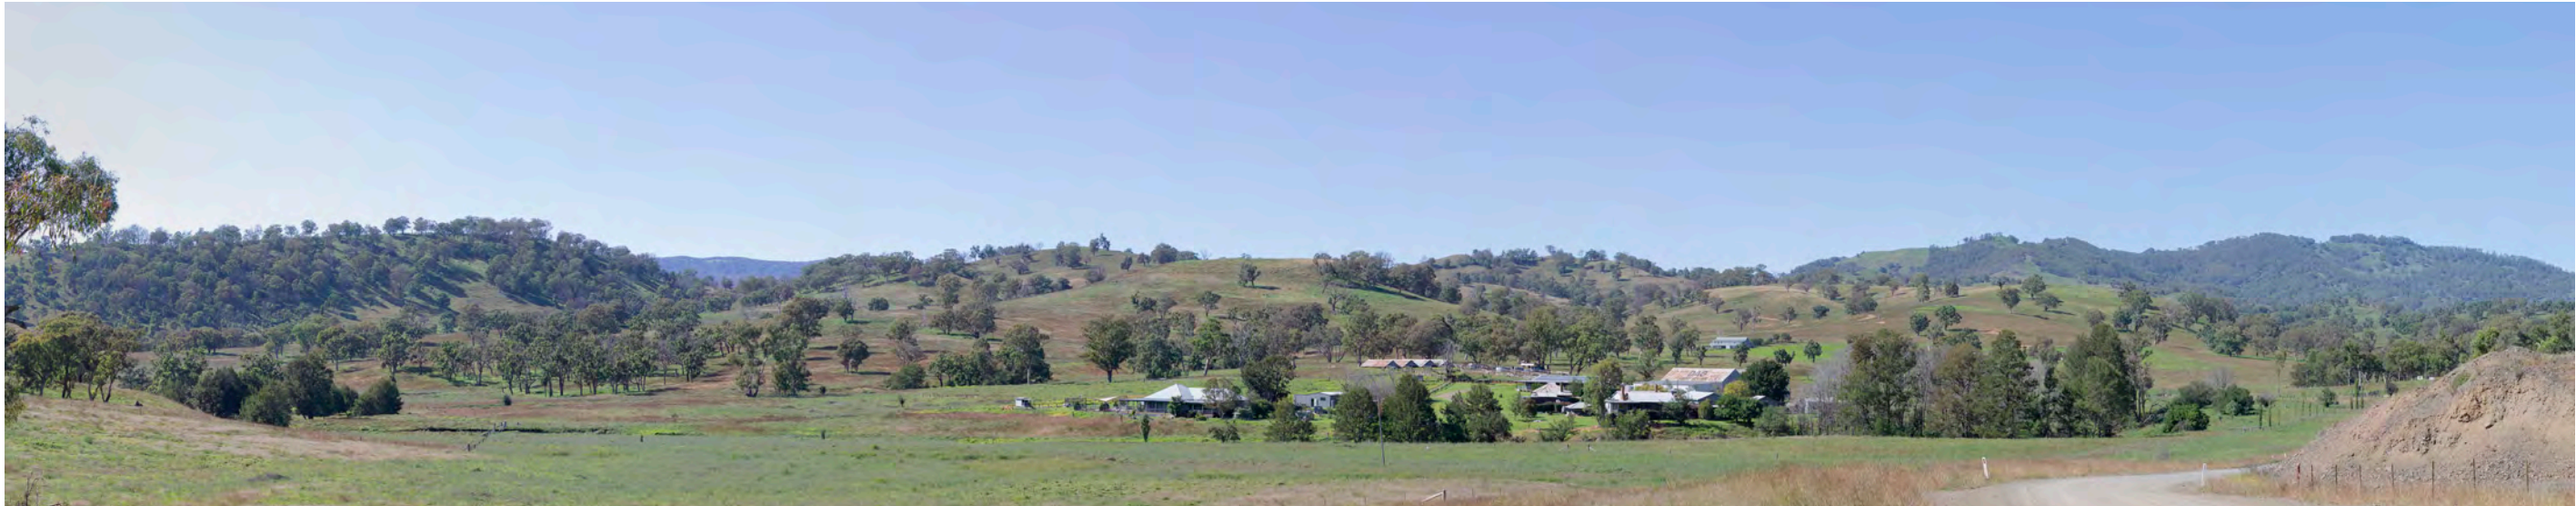
VIEWPOINT HOG32

Viewpoint Summary		Viewpoint Description	Visual Performance Objectives: VIZ3
Location:	Elevation:	This viewpoint is taken from Crawney Road, approximately 300m from the 'Dag Sheep Station', NAD34. The view is taken from a rise which extends south toward the ridge in the background. A copse of vegetation is visible in the foreground to the east of the view. The land is characterised by cleared agricultural grasslands used for grazing. The area is also used for rural residential and hosting events. The 'Dag Station' structures and associated vegetation can be seen in the middleground of the view. The view extends south toward the ridge which can be seen in the background of the view. The ridgetop has areas of dense vegetation, particularly in the east of the viewpoint.	There are no visual performance objectives that apply to this viewpoint due to the Visual Influence Zone Rating (VIZ3). Refer Photomontage 03

Crawney Road	683m		
Coordinates:	Viewing Direction:		
151°4'9.35"E 31°31'52.02"S	South		
Distance to WTG:	Visibility Distance Zone:		
Approx. 6.4km	Far Middleground (FM)	Potential Visual Impact An assessment based on topography alone suggests 40-50 WTG's may be visible from this location. The vegetation along the ridge is likely to provide some screening toward a small number of the WTG's, reducing the number visible from this location to 38.	
Land Use:	Viewer Sensitivity Level:		
Low Use Road	Level 3: Low		
LCU:	Scenic Quality Rating:	Nearby Residences:	
Nundle Valley Pastures	Moderate	NAD34, NAD49	
Visual Influence Zone VIZ3

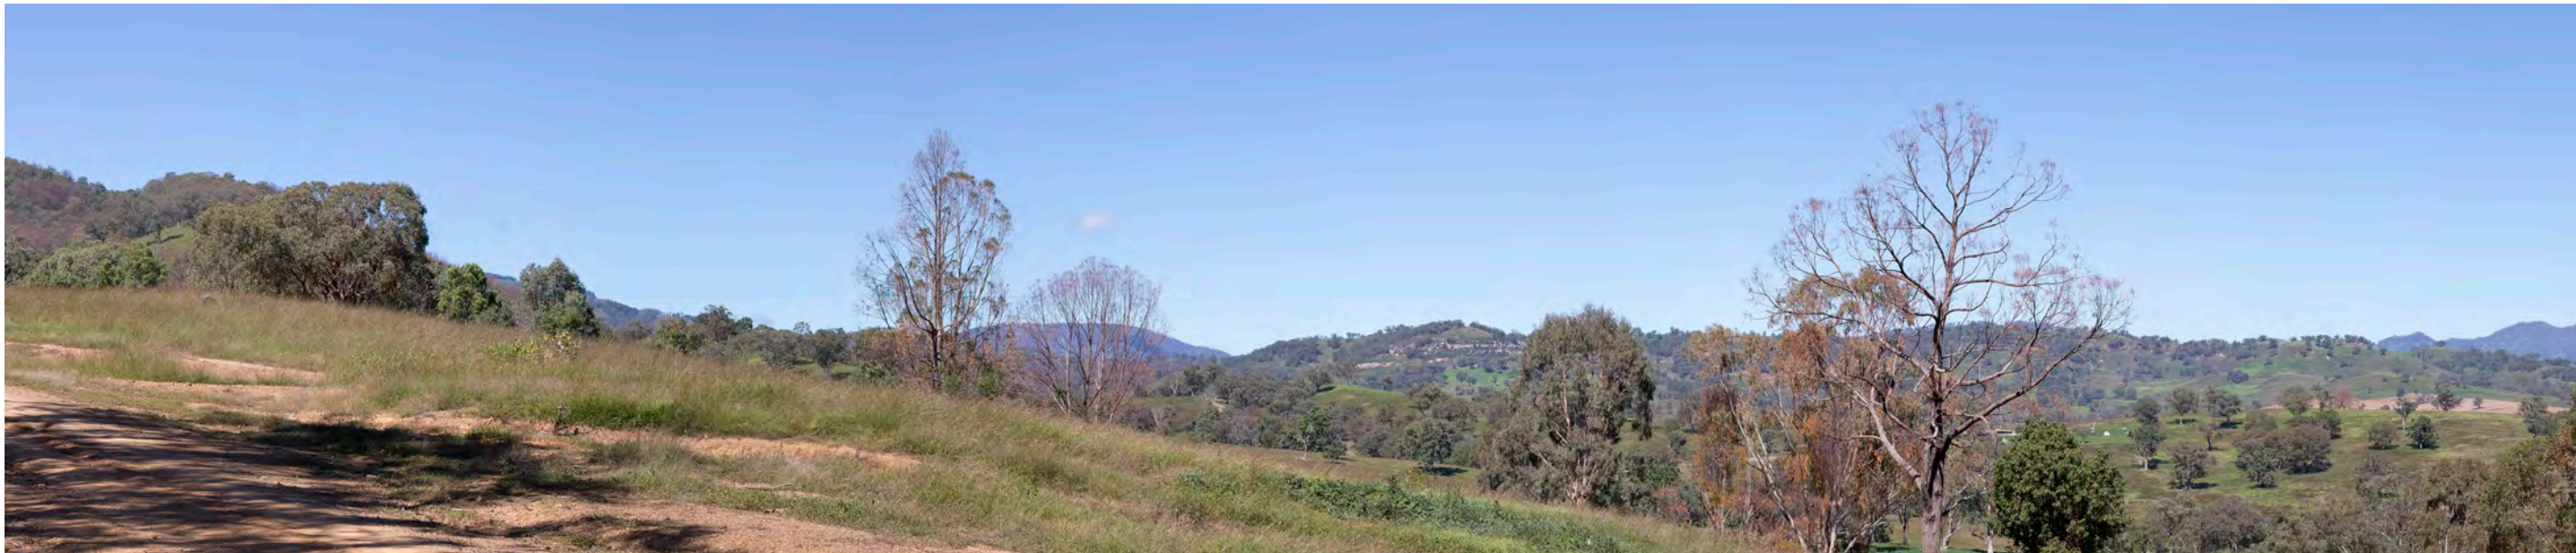
VIEWPOINT HOG33

Viewpoint Summary		Viewpoint Description	Visual Performance Objectives: VIZ3
Location:	Elevation:	This viewpoint is taken from at Splitters Gully Road - a low use road used to access a handful of nearby rural residences. The driveway to access NAD68 is located approximately 550m south east of the viewpoint. The view is from an elevated position within an undulating landscape that slopes to the south west. The landform rises to the south east containing views. Scattered vegetation, most of which is in a poor state, is visible in the foreground. Scattered vegetation is visible in the middleground and along hillsides and gullies in the distance.	There are no visual performance objectives that apply to this viewpoint due to the Visual Influence Zone Rating (VIZ3)
Splitters Gully Road	713m		
Coordinates:	Viewing Direction:		
151°8'22.64"E 31°28'56.33"S	Generally South		
Distance to WTG:	Visibility Distance Zone:

Approx. 7km	Far Middleground (FM)	Potential Visual Impact An assessment based on topography alone suggests that approximately 50 WTG's may be visible from this location. The vegetation in the foreground may fragment the view, slightly reducing the number of visible WTG's however, the viability of these trees into the future is unknown. A large proportion of the WTG's are located at a distance from the viewpoint location and may be difficult to discern from this location.	
Land Use:	Viewer Sensitivity Level:		
Low Use Road	Level 3: Low		
LCU:	Scenic Quality Rating:	Nearby Residences:	
Nundle Village	Low/Moderate	NAD68	
Visual Influence Zone VIZ3

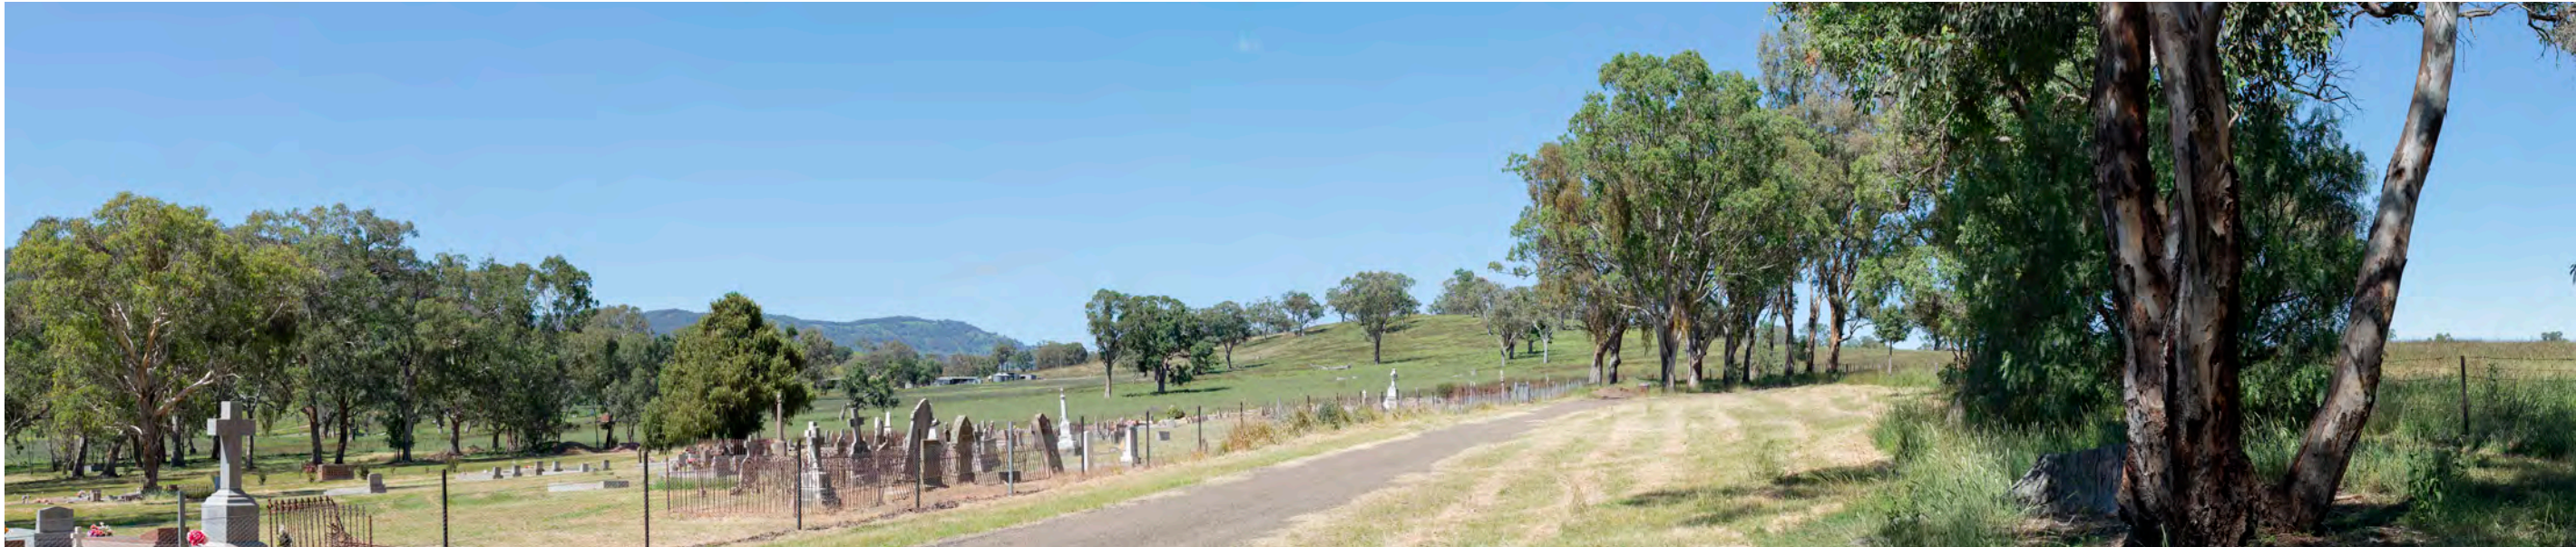
VIEWPOINT HOG34			
Viewpoint Summary		Viewpoint Description	Visual Performance Objectives: VIZ2
Location:	Elevation:	This viewpoint is taken from Nundle Cemetery Road, on the western side of the Nundle Cemetery. The area is characterised by the cemetery which can be seen in the foreground of the view. The landform slopes to the east with dense native vegetation in the middleground of the view, which extends to the boundary of the cemetery and wraps around the car parking area. A dense copse of vegetation is visible in the middleground to the south east of the viewpoint. A slight rise with scattered vegetation can be seen to the south in the background of the view. The vegetated ridge associated with the project area is visible in the background.	Landscape Scenic Integrity: The wind turbines will be a major element in the landscape, however they are unlikely to dominate the visual catchment from this location. Key Feature Disruption: The ridgeline forms a visual backdrop to the south east of this viewpoint. The proposed WTGs will be a major feature on the range in this location, however the ridgeline, undulating hillside character and cemetery will still be the most visually prominent feature from this location. Refer Photomontage 04

Nundle Cemetery	636m		
Coordinates:	Viewing Direction:		
151°7'50.71"E 31°28'49.73"S	Generally South East		
Distance to WTG:	Visibility Distance Zone:		
Approx. 7.5km	Far Middleground (FM)	Potential Visual Impact An assessment based on topography alone suggests that 27-40 WTG's may be visible from this location. The vegetation along the boundary fence and copse of trees to the south east may fragment the view to a number of the WTG's, reducing the numbers visible from this location to approx. 19 WTG's.	
Land Use:	Viewer Sensitivity Level:		
Cultural Site	Level 2: Moderate		
LCU:	Scenic Quality Rating:	Nearby Residences:	
Nundle Village	Low/Moderate	NAD68	
Visual Influence Zone VIZ2

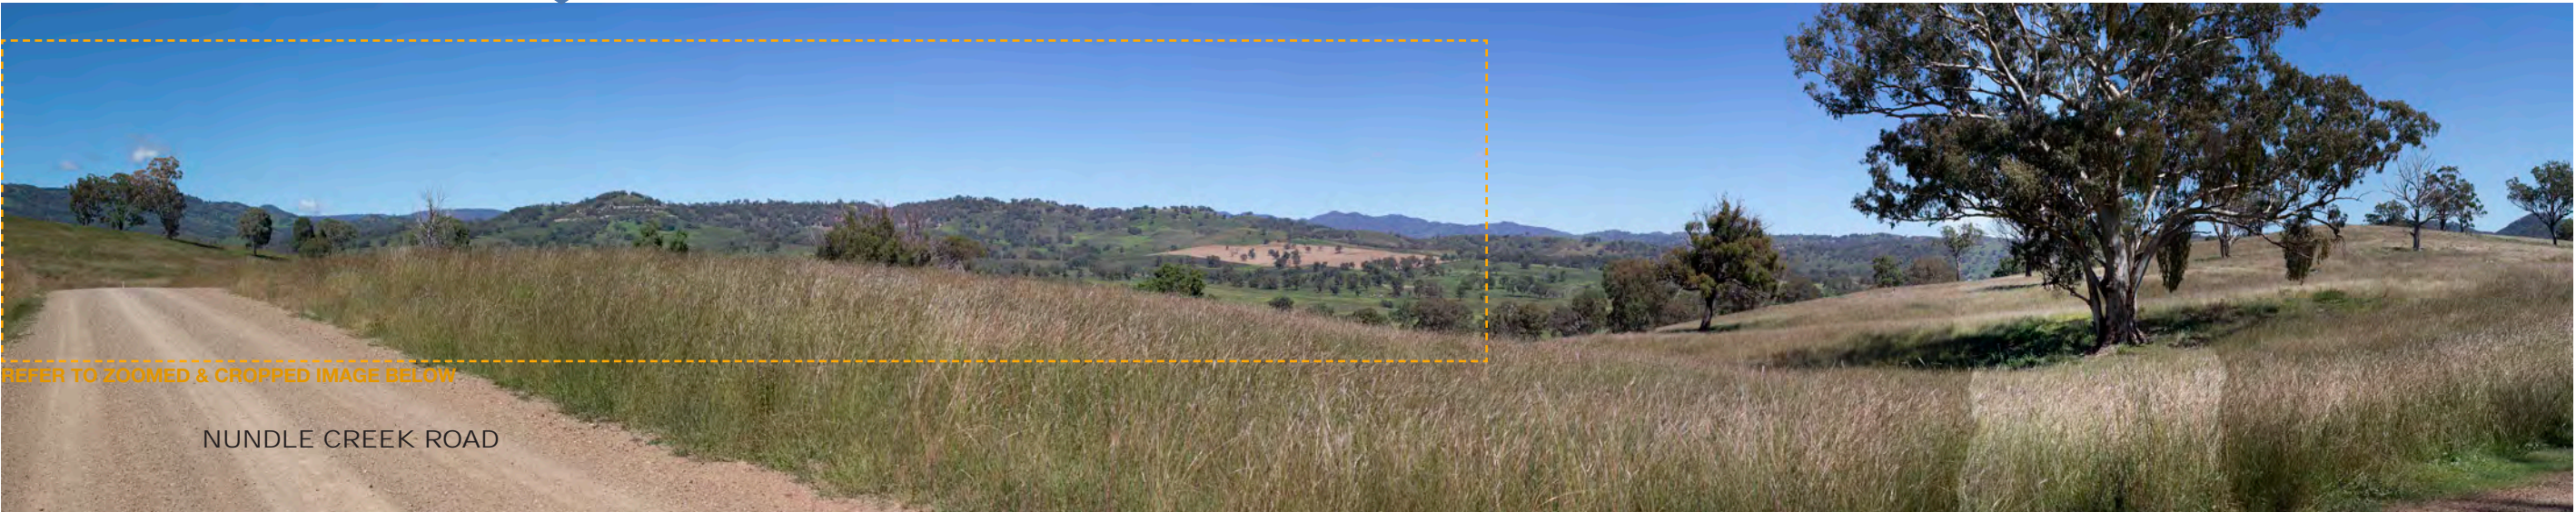
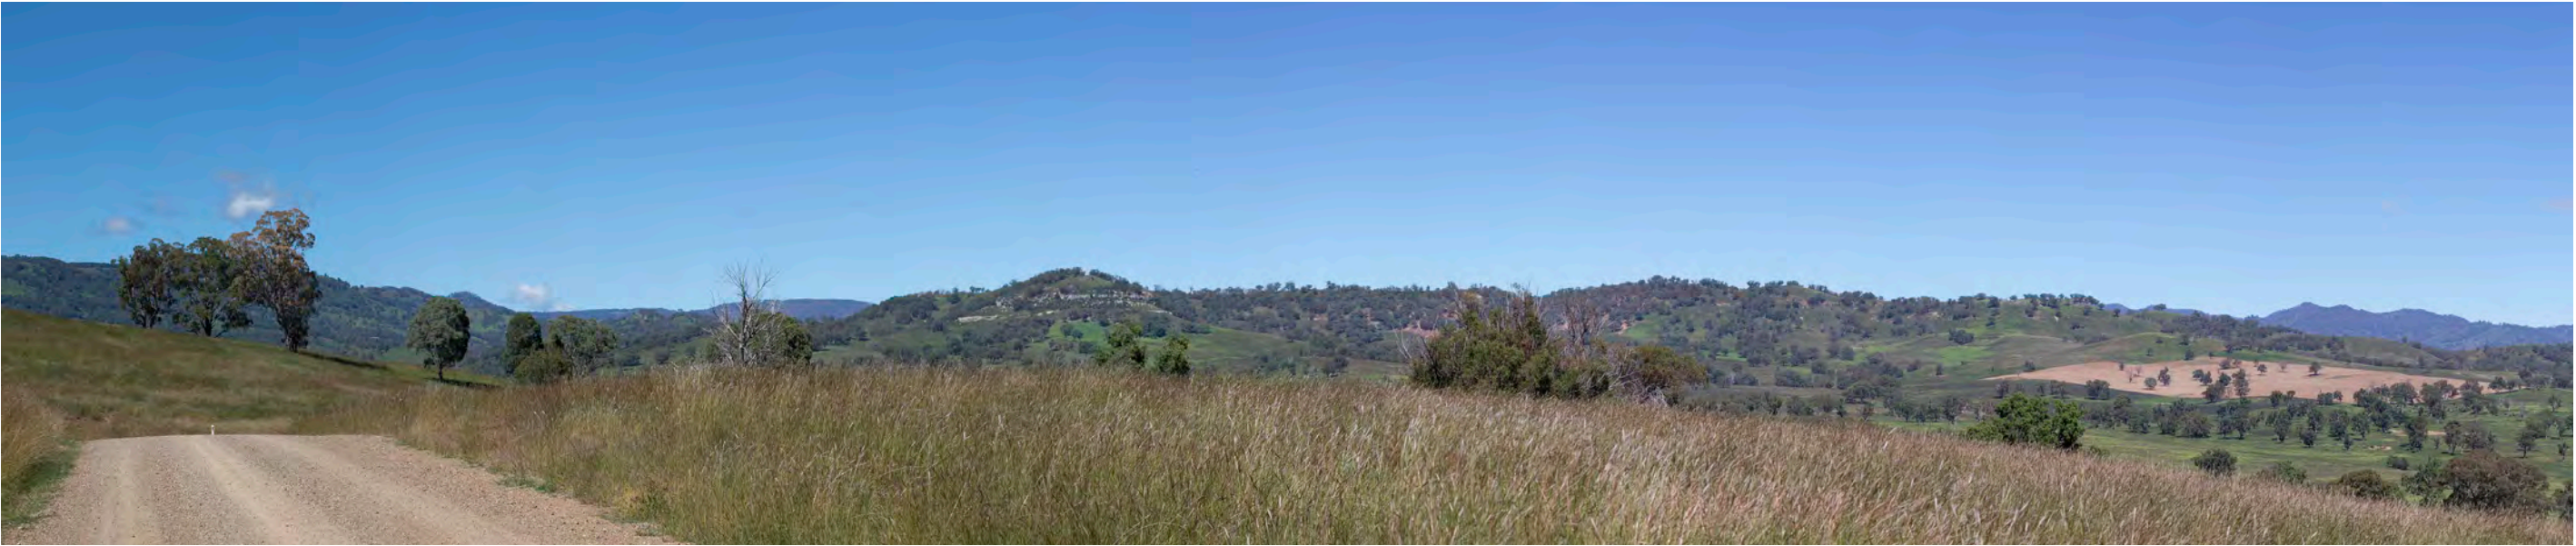
VIEWPOINT HOG35

Viewpoint Summary		Viewpoint Description	Visual Performance Objectives: VIZ3
Location:	Elevation:	<p>This viewpoint is located along Nundle Creek Road. The land is characterised by the cleared, undulating, open grassland. The landform falls away to the west. There is scattered vegetation in the middleground of the view. The view is expansive and extends toward the vegetated ridge in the distance.</p> <p>Potential Visual Impact</p> <p>An assessment based on topography alone suggests that approximately 60-70 WTG's may be visible from this location. A small number of WTG's are located at a distance from the viewpoint location and may be difficult to discern from this location.</p>	<p>There are no visual performance objectives that apply to this viewpoint due to the Visual Influence Zone Rating (VIZ3)</p>
Nundle Creek Road	700m		
Coordinates:	Viewing Direction:		
151°08'05.3"E 31°29'32.6"S	Generally South West

Distance to WTG:	Visibility Distance Zone:		
Approx. 6.1km	Far Middleground (FM)		
Land Use:	Viewer Sensitivity Level:		
Low Use Road	Level 03: Low	<p>Nearby Residences:</p>	
LCU:	Scenic Quality Rating:		
Nundle Valley Pastures	Moderate		
Visual Influence Zone VIZ3

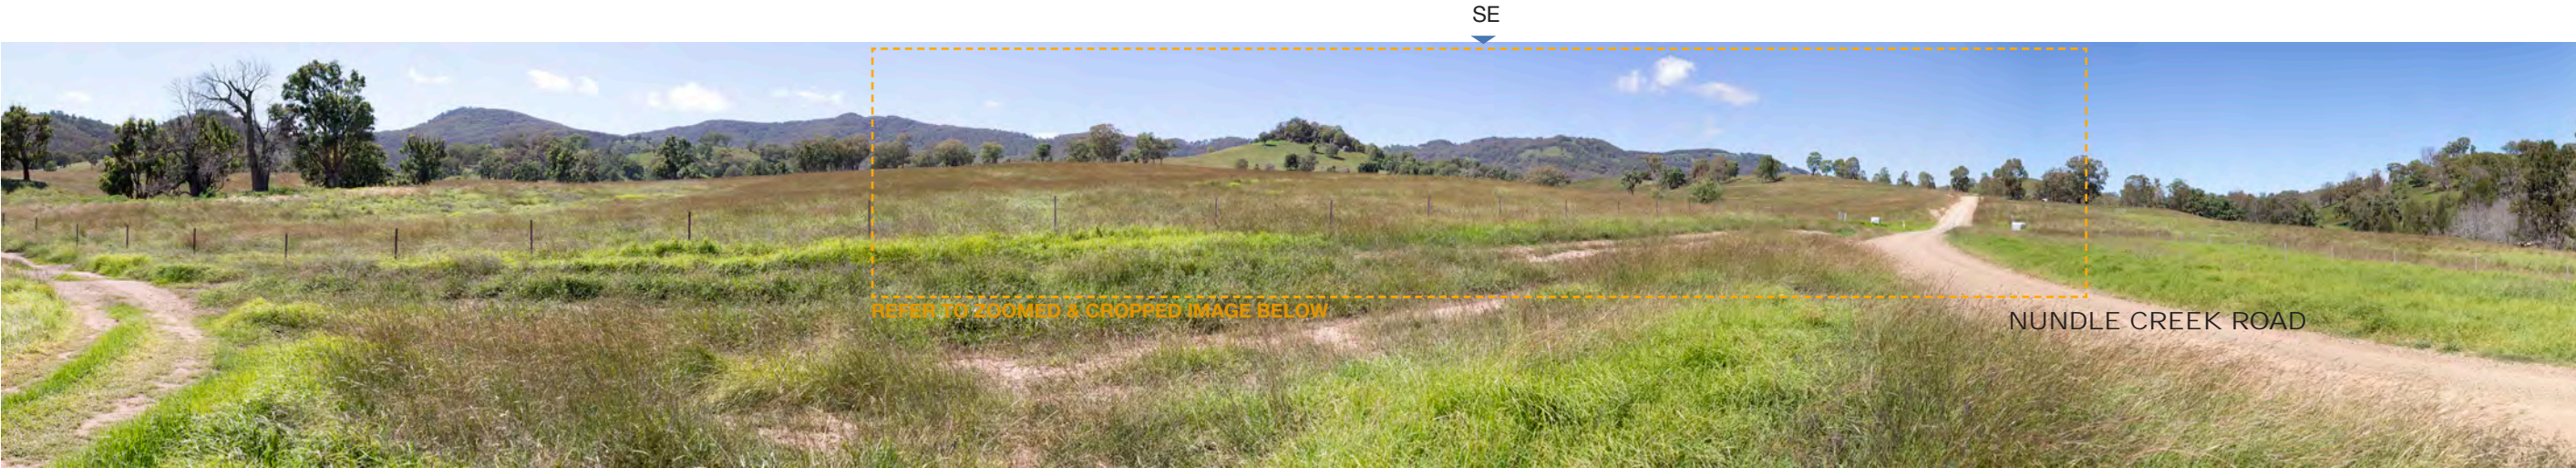
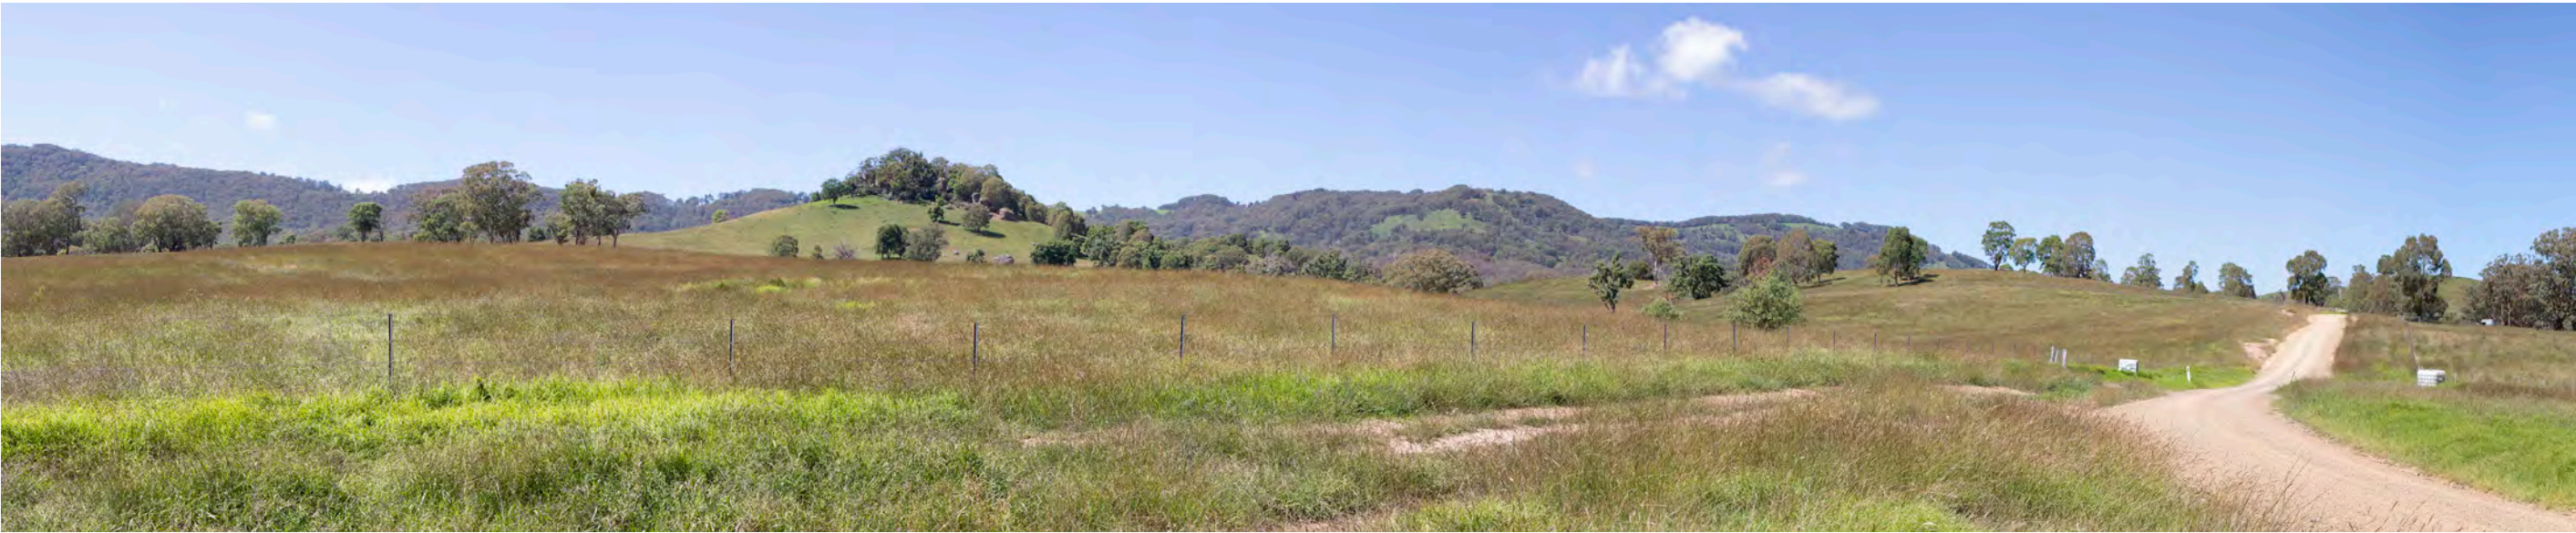
VIEWPOINT HOG36

Viewpoint Summary		Viewpoint Description	Visual Performance Objectives: VIZ3
Location:	Elevation:	This viewpoint is located along Nundle Creek Road, approximately 50m from NAD66. The land is characterised by undulating, cleared grassland used predominantly for grazing. A slight vegetated rise along with a dense row of vegetation can be seen in the middleground of the view. The view is expansive, extending toward the vegetated ranges including those associated with the project area.	There are no visual performance objectives that apply to this viewpoint due to the Visual Influence Zone Rating (VIZ3), however if deemed necessary, nearby residence NAD66 (located within the blue line) may require mitigation measures.
Nundle Creek Road	684m		
Coordinates:	Viewing Direction:		
151°8'42.04"E 31°31'55.37"S	Generally South East		
Distance to WTG:	Visibility Distance Zone:		
Approx. 3.5km	Near Middleground (NM)	Potential Visual Impact An assessment based on topography alone suggests that approximately 21 WTG's are likely to be visible to the south east of the view.

Land Use:	Viewer Sensitivity Level:		
Low Use Road	Level 03: Low		
LCU:	Scenic Quality Rating:	Nearby Residences:	
Nundle Creek	Moderate	NAD66	
Visual Influence Zone VIZ3

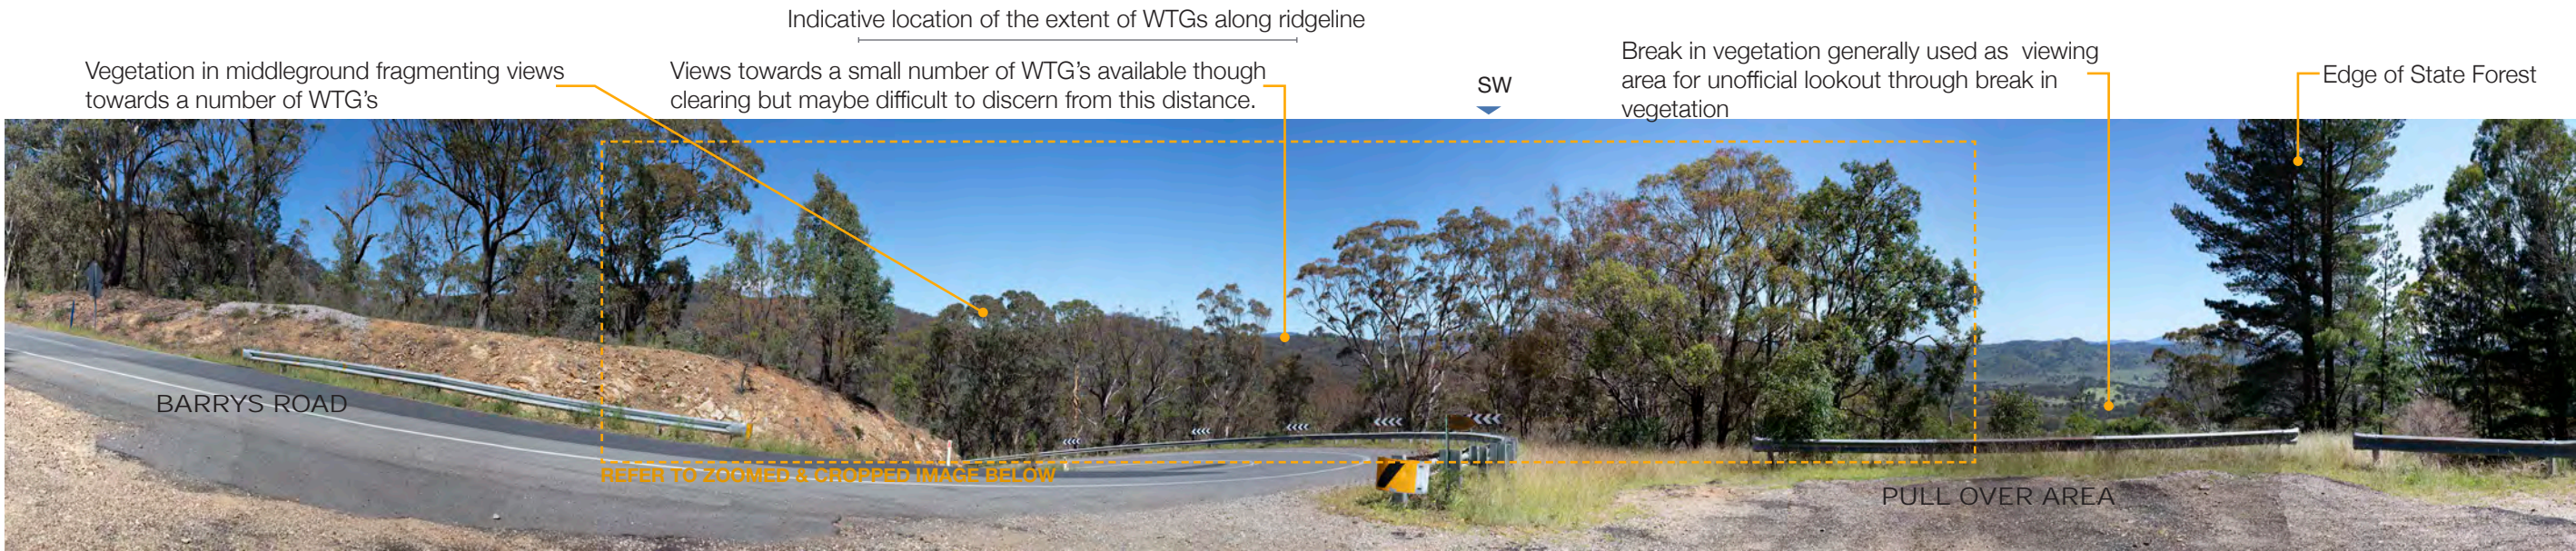
VIEWPOINT HOG37

Viewpoint Summary		Viewpoint Description	Visual Performance Objectives: VIZ2
Location:	Elevation:	<p>This viewpoint is located at the 'Devils Elbow': an unofficial lookout area located along Barrys Road. The area is a relatively flat and open area within a characteristically steep and densely vegetated landscape. The view is surrounded by State Forest and is utilised for forestry purposes. Dense native and non native vegetation is visible in middleground, with a clearing visible to the west of the view.</p> <p>Potential Visual Impact</p> <p>An assessment based on topography alone identifies around 14-27 WTG's may be visible from this location. It is likely the dense vegetation in the foreground may fragment the view, reducing the number of WTG's visible from this location to approximately 9. It is likely upgrades to the road will be required in this location, resulting in the removal of vegetation.</p> <p>Nearby Residences:</p> <p>-</p>	<p>Landscape Scenic Integrity:</p> <p>The wind turbines are unlikely to significantly modify the visual catchment from this location. The majority of the turbines are likely to be screened by vegetation and will be difficult to discern in the distance of this location.</p> <p>Key Feature Disruption:</p> <p>The proposal is unlikely to have major visual impact on visually significant landform, waterform, vegetation or cultural features that have visual prominence or are focal points from this location due to vegetation. The view out to the west is likely to remain the key feature of this viewpoint.</p>

'Devils Elbow'	903m		
Coordinates:	Viewing Direction:		
151°10'14.01"E 31°28'28.81"S	Generally South West		
Distance to WTG:	Visibility Distance Zone:		
Approx. 6.6km	Far Middleground (FM)		
Land Use:	Viewer Sensitivity Level:		
Cultural	Level 2: Moderate		
LCU:	Scenic Quality Rating:		
Forested Mountain Ranges	Mod/High		
Visual Influence Zone VIZ2

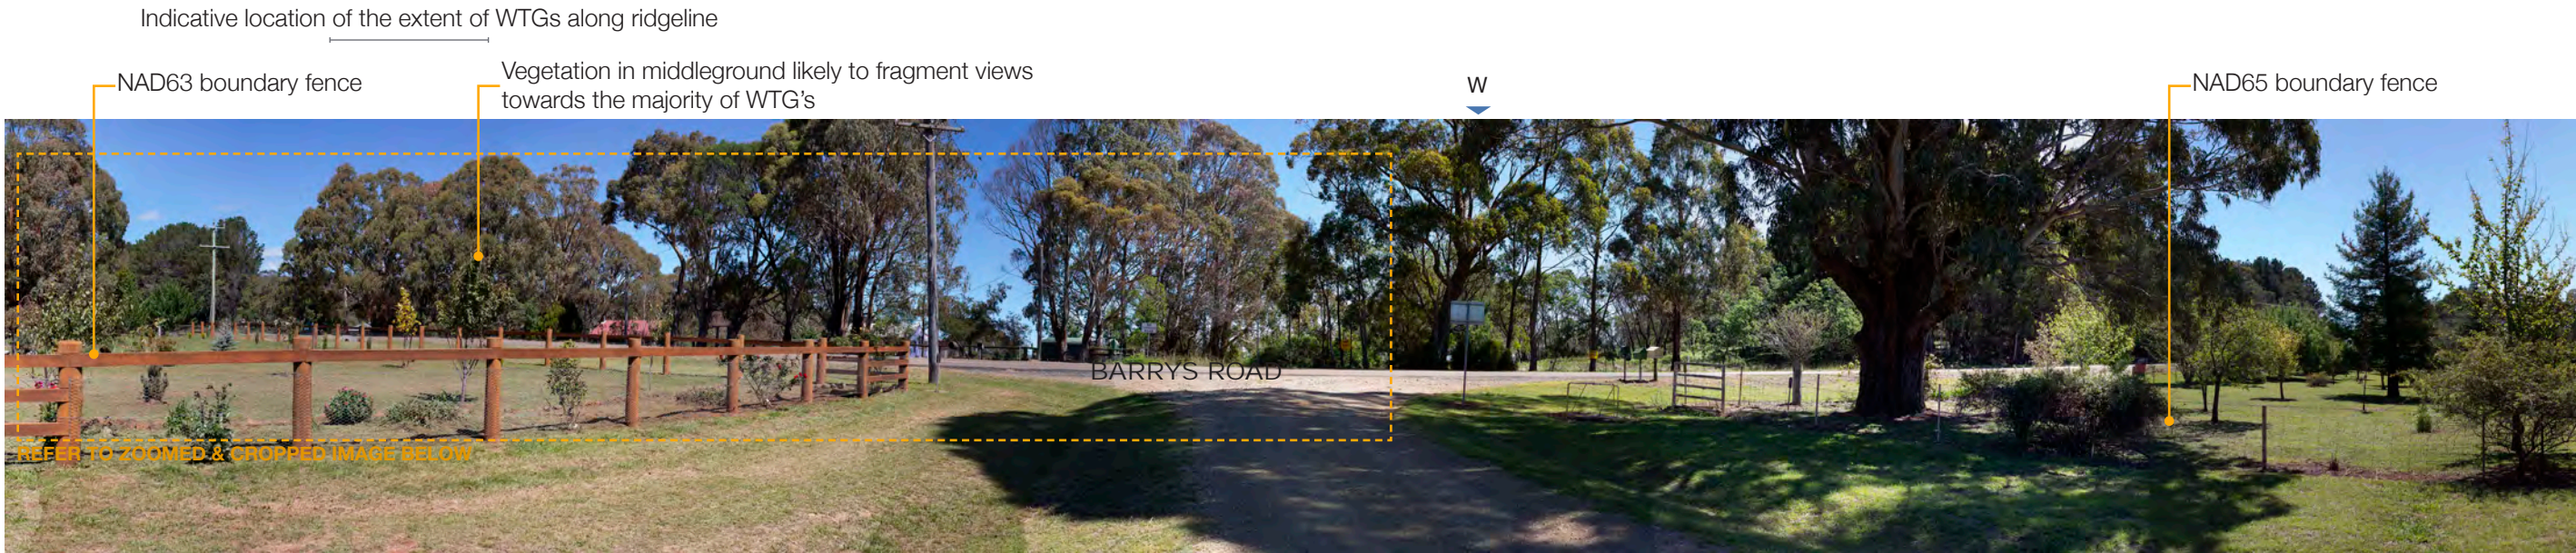
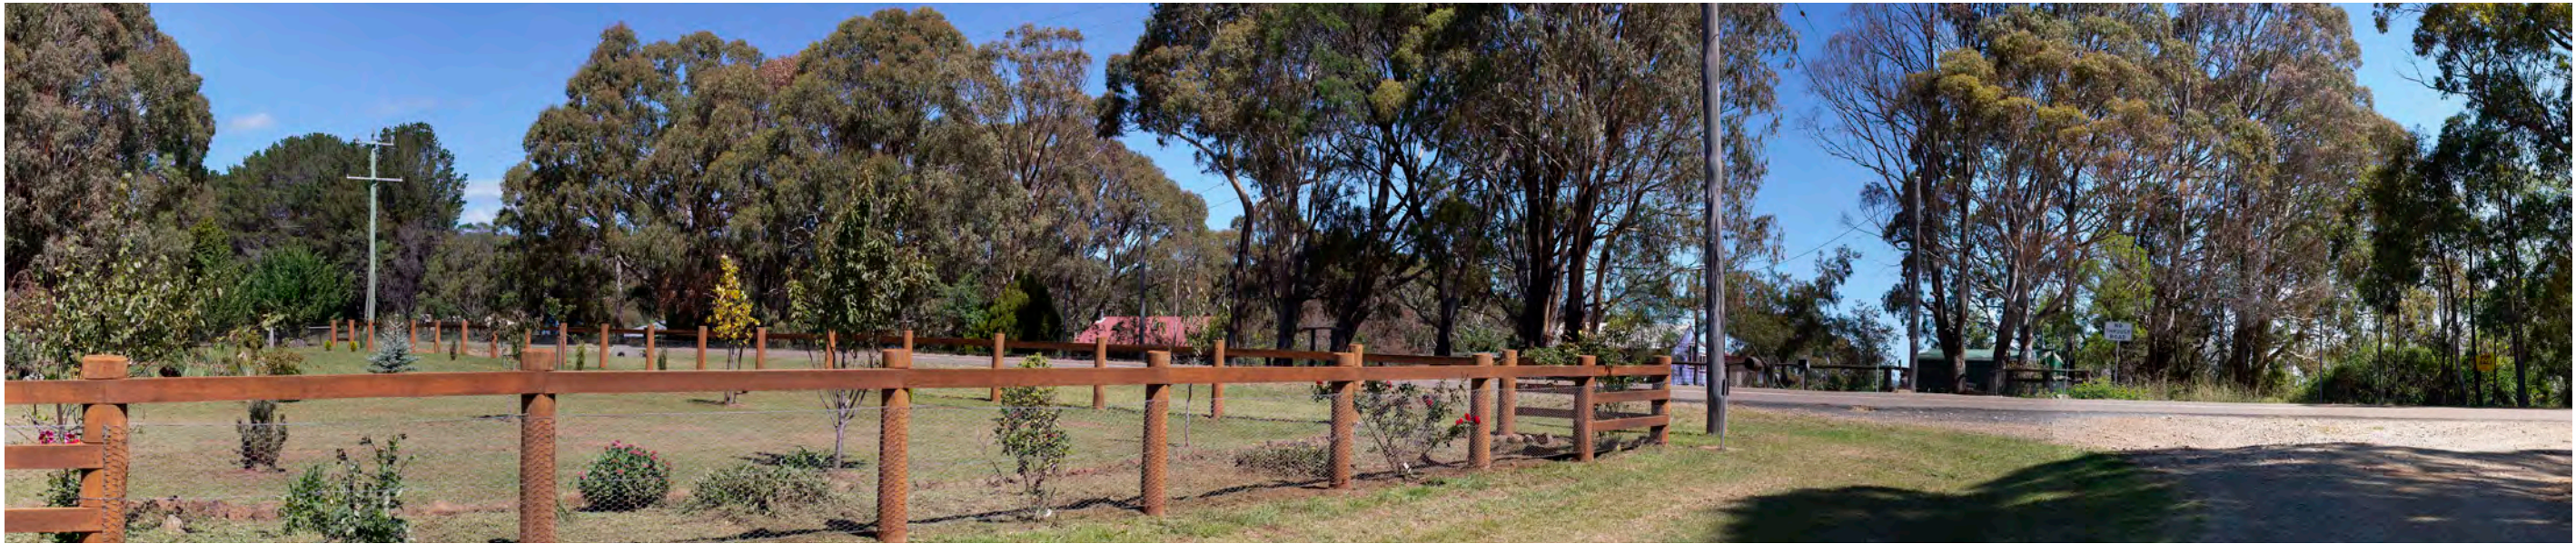
VIEWPOINT HOG38

Viewpoint Summary		Viewpoint Description	Visual Performance Objectives: VIZ2
Location:	Elevation:	This viewpoint is located on the corner of Andeva & Barrys Road nearby the NAD63, 61 & 64. The area is characterised by rural residential properties within a relatively flat area situated on a ridgeline. Groupings of shrubs are visible in the foreground. Dense native vegetation is visible in the middleground and contains views out of the area. Potential Visual Impact Vegetation typical of the area is likely to screen the WTG's.	Landscape Scenic Integrity: The wind turbines are unlikely to modify the visual catchment from this location. The wind turbines will not be visible due to vegetation in the middleground. Key Feature Disruption: The proposal is unlikely to have any major visual impact on visually significant landform, waterform, vegetation or cultural features that have visual prominence or are focal points from this location due to vegetation.

Corner of Andeva & Barrys Road	1110m		
Coordinates:	Viewing Direction:		
151°11'30.49"E 31°29'10.27"S	Generally West		
Distance to WTG:	Visibility Distance Zone:		
Approx. 5.2km	Far Middleground (FM)		
Land Use:	Viewer Sensitivity Level:	Nearby Residences:	
Low Use Road	Level 3: Low		
LCU:	Scenic Quality Rating:		
Forested Mountain Ranges	Mod/High		
Visual Influence Zone VIZ2
