Appendix C

Viewpoint Analysis

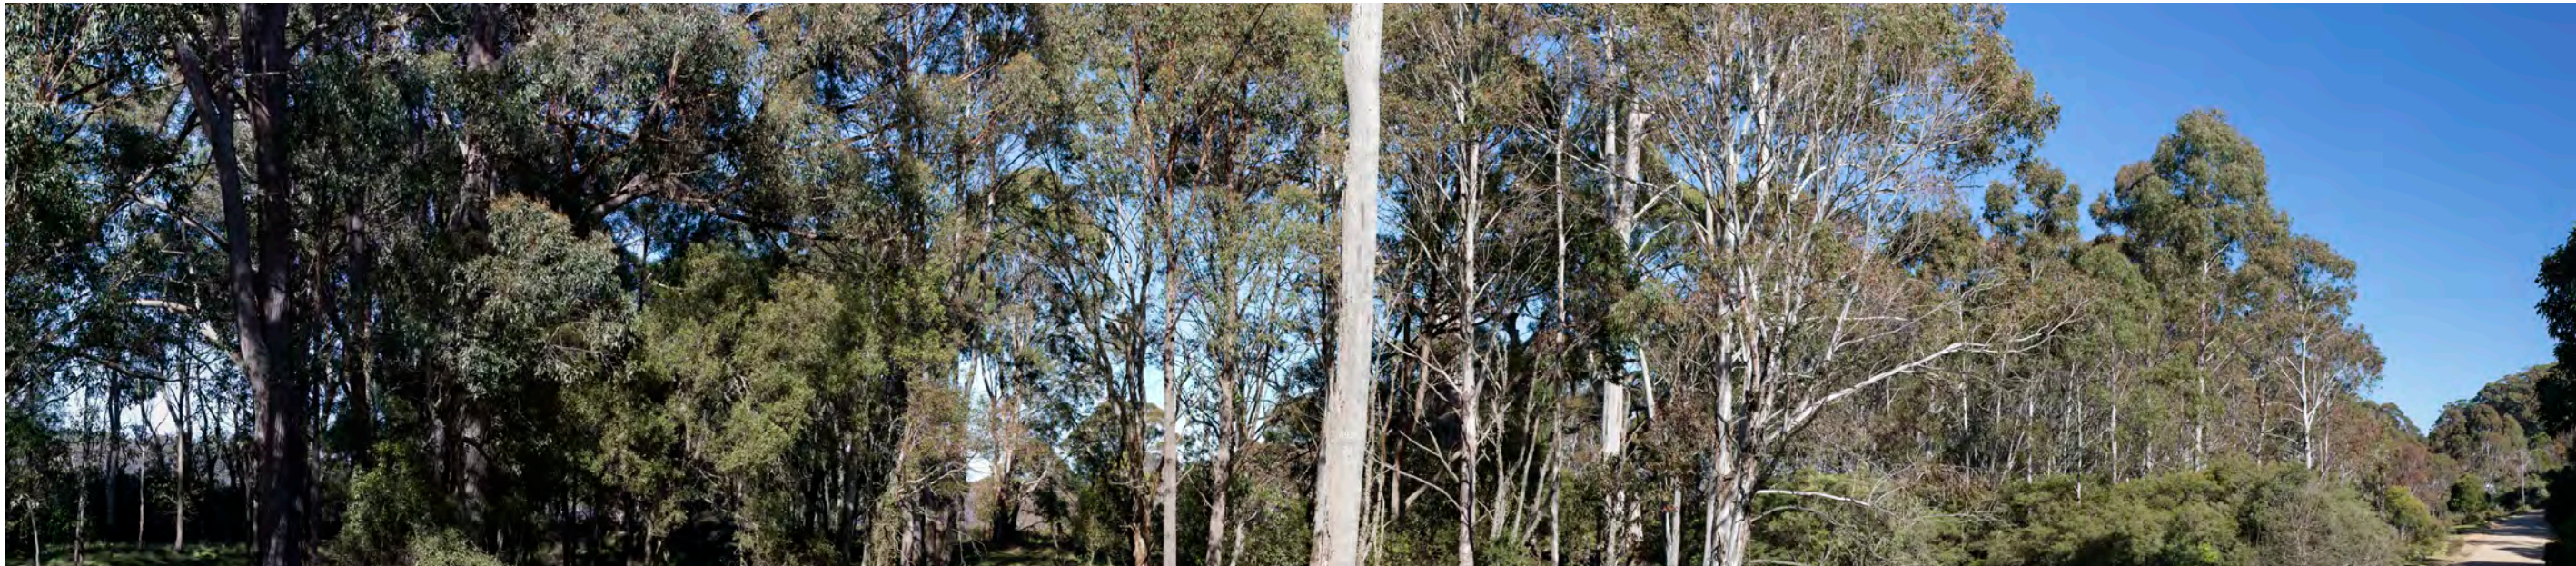
VIEWPOINT HOG39			
Viewpoint Summary		Viewpoint Description	Visual Performance Objectives: VIZ2
Location:	Elevation:	This viewpoint is located along Morrisons Gap Road, nearby the driveways accessing NAD15 & NAD16, around 150m NE of the driveway access to NAD14 and around 350 NE of NAD13. The area is characterised by rural residential properties within a relatively flat area situated on a ridge line. Vegetation typical of the area contains views out of the viewpoint location. Potential Visual Impact An assessment based on topography alone suggests that 50-60 WTG's may be visible to the south this location however vegetation typical of the area is likely to screen views to the WTG's.	Visual Magnitude: Viewpoint is located within the 'black line' (3100m). If deemed necessary, mitigation methods are to be considered for nearby residences NAD15, NAD13, NAD14 & NAD16 in accordance with the Visual Performance Objectives. Refer to Appendix E for detailed assessment for dwellings associated with Morrisons Gap Road. Landscape Scenic Integrity: The wind turbines are unlikely to modify the visual catchment from this location. The wind turbines will be difficult to discern due to vegetation in the foreground. Key Feature Disruption: The proposal is unlikely to have any major visual impact on visually significant landform, waterform, vegetation or cultural features that have visual prominence or are focal points from this location due to prominence of the vegetation in the foreground.

Morrisons Gap Road	1286m		
Coordinates:	Viewing Direction:		
151°11'35.75"E 31°30'52.80"S	Generally South East		
Distance to WTG:	Visibility Distance Zone:		
Approx. 2.10km	Near Middleground (NM)	Nearby Residences: NAD15, AD12, AD14 & NAD16	
Land Use:	Viewer Sensitivity Level:		
Low Use Road	Level 3: Low		
LCU:	Scenic Quality Rating:		
Forested Mountain Ranges	Mod/High		
Visual Influence Zone VIZ2

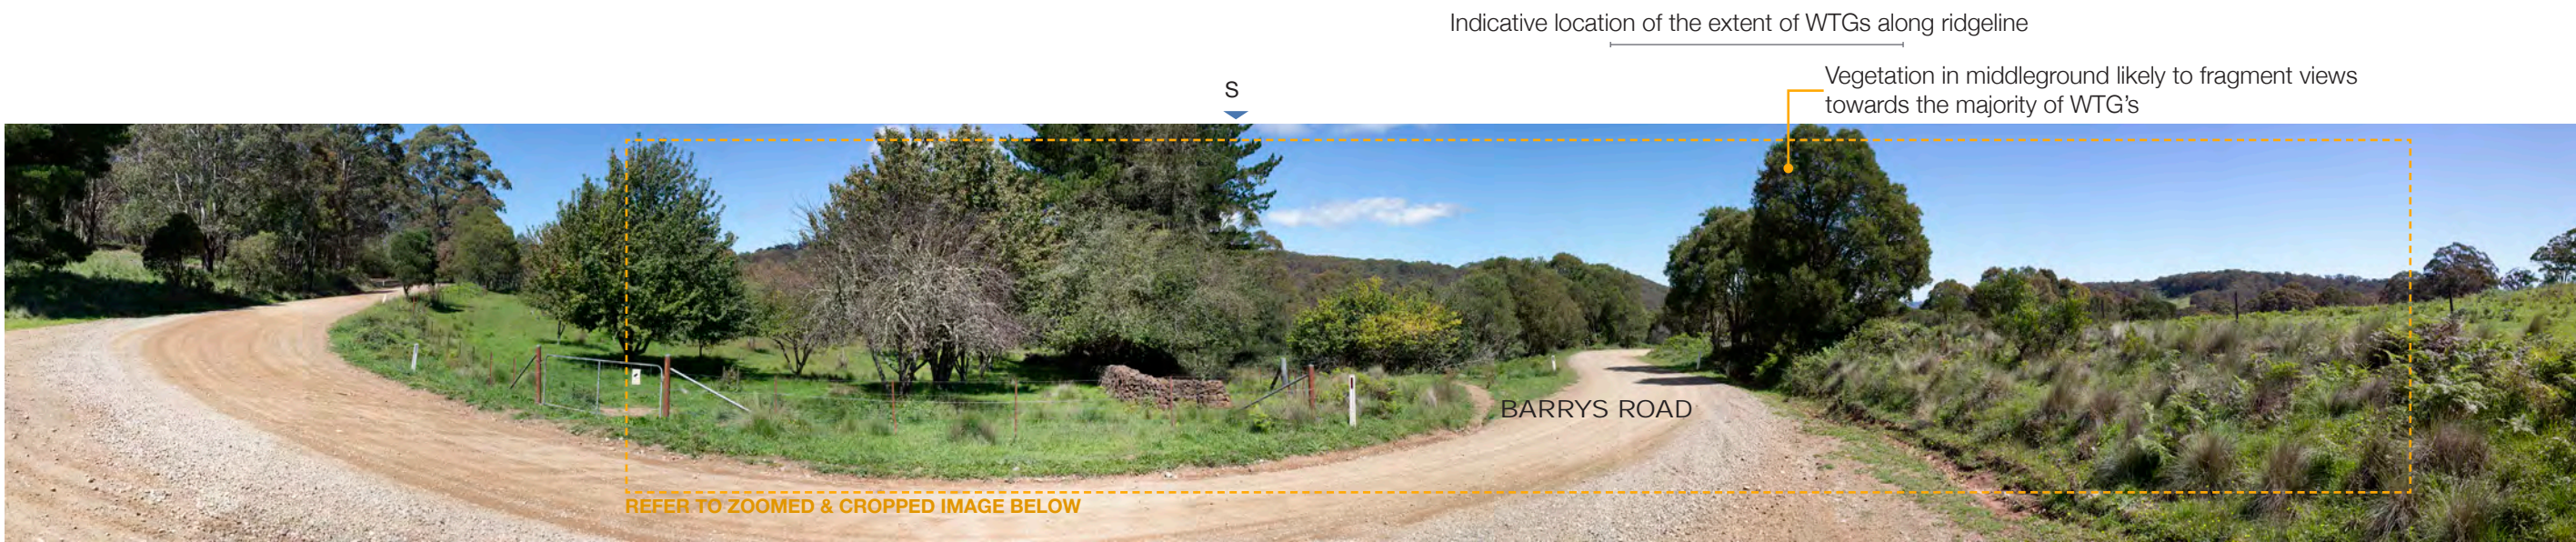
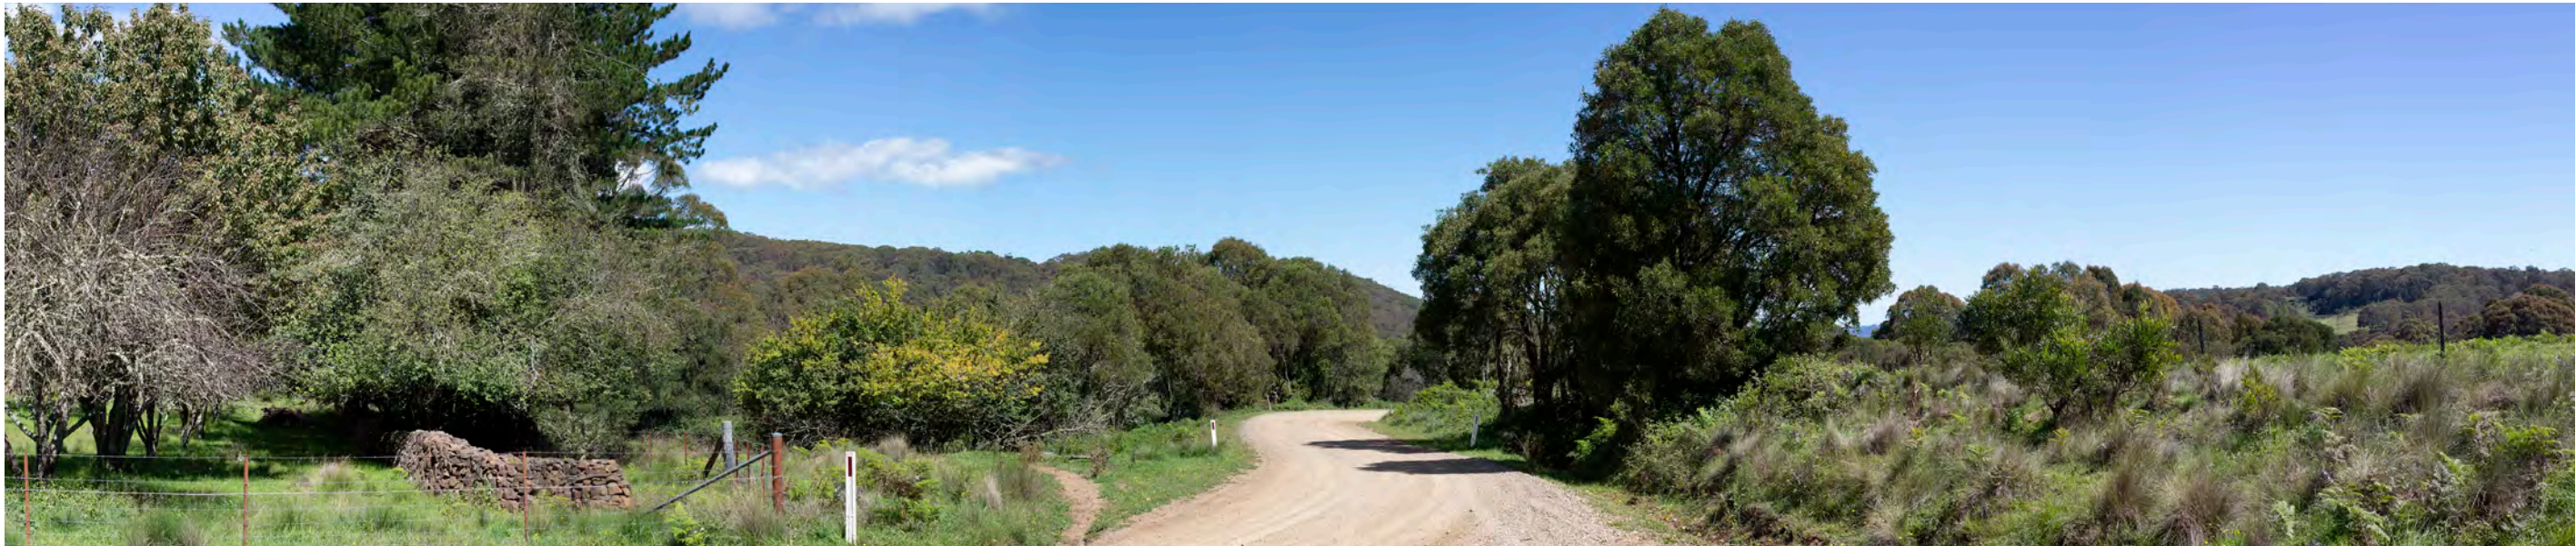
VIEWPOINT HOG40

Viewpoint Summary		Viewpoint Description	Visual Performance Objectives: VIZ2
Location:	Elevation:	<p>This viewpoint is located along Barrys Road approximately 150m from NAD32 and around 500m from the driveway of NAD30. The land is characterised by rural residential land that has been partially cleared. The area is used for light agricultural purposes. The landform is relatively flat to slightly undulating, with a slight rise to the south of the view. There is scattered vegetation in the foreground containing views toward the south and south west. Dense vegetation is visible in the distance along the forested mountain ranges.</p> <p>Potential Visual Impact</p> <p>An assessment based on topography alone suggests that 36 WTG’s may be visible to the south west of this location. Roadside vegetation located in the foreground of the view is likely to fragment views toward the majority of the WTG’s from this location. It may be possible to have fleeting views of the turbines for approximately 80m when travelling in a south westerly direction.</p> <p>Nearby Residences:</p> <p>NAD32, NAD30, NAD39</p>	<p>Visual Magnitude:</p> <p>Viewpoint is located within the 'blue line' (4550m). If deemed necessary, mitigation methods are to be considered for nearby residences, NAD39, NAD32 and NAD30 in accordance with the Visual Performance Objectives.</p> <p>Refer to Appendix E for detailed dwelling assessment.</p> <p>Landscape Scenic Integrity:</p> <p>The wind turbines are unlikely to be a major element in the landscape, and are unlikely to dominate the visual catchment from this location. When travelling in a south westerly direction for approximately 80m, the turbines are likely to be a visible element in the landscape, though this will be fleeting.</p> <p>Key Feature Disruption:</p> <p>The ridgeline forms a visual backdrop to the south west of this viewpoint. The proposed WTGs will be a visible element on the range however the undulating vegetated landform will still be the most visually prominent feature from this location.</p>

Barrys Road	1280m		
Coordinates:	Viewing Direction:		
151°12’37.24”E 31°30’33.78”S	Generally South West		
Distance to WTG:	Visibility Distance Zone:		
Approx. 3.5km	Near Middleground (NM)		
Land Use:	Viewer Sensitivity Level:		
Low Use Road	Level 3: Low		
LCU:	Scenic Quality Rating:		
Forested Mountain Ranges	Mod/High		
Visual Influence Zone VIZ2

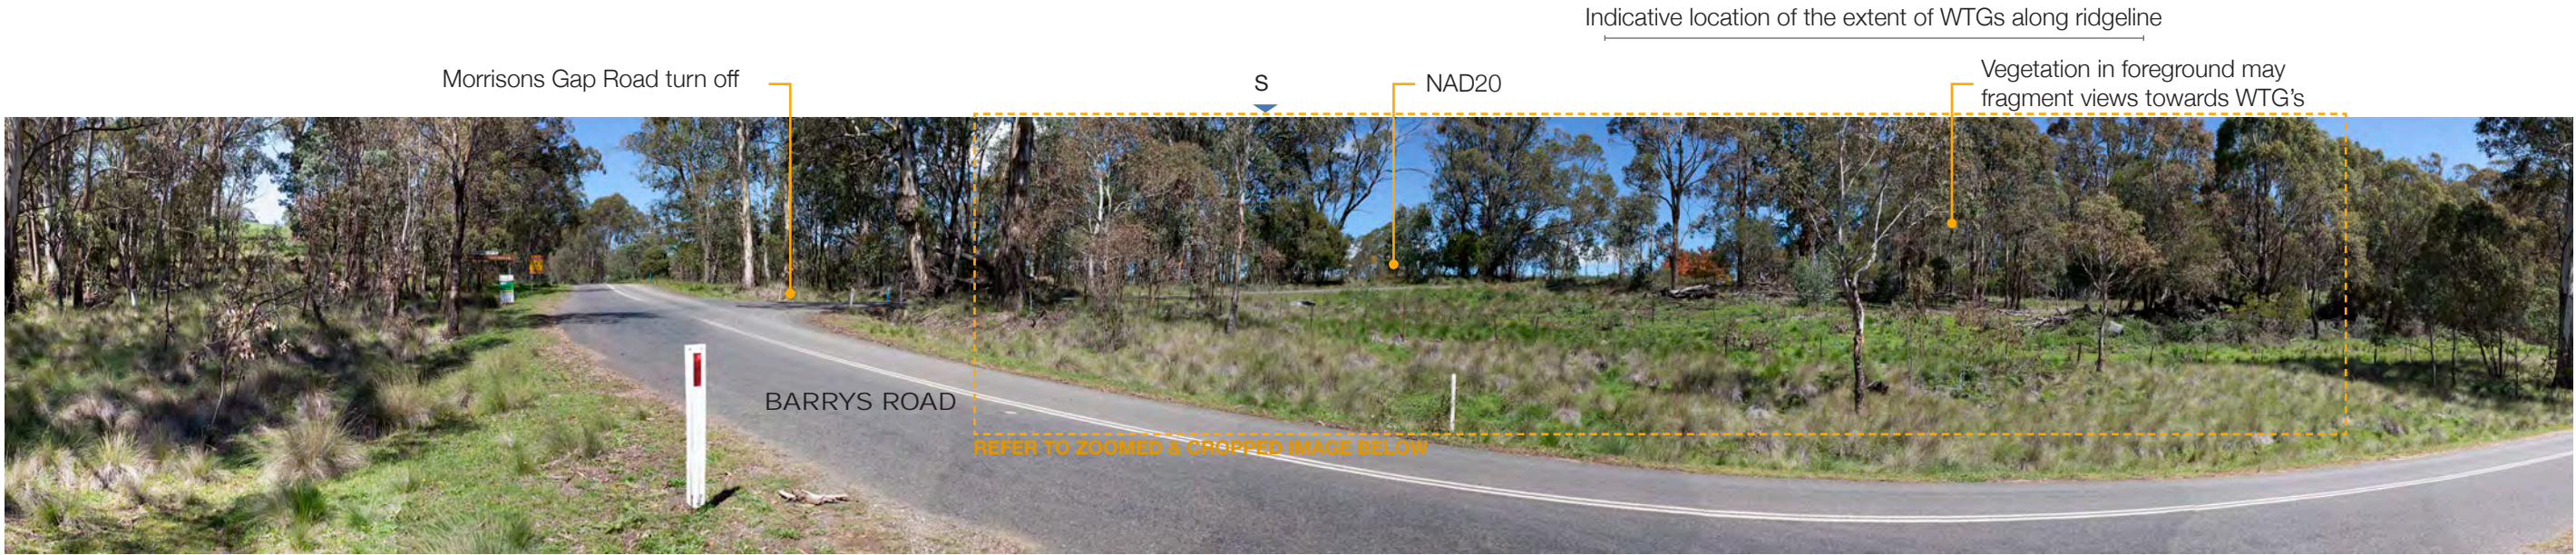
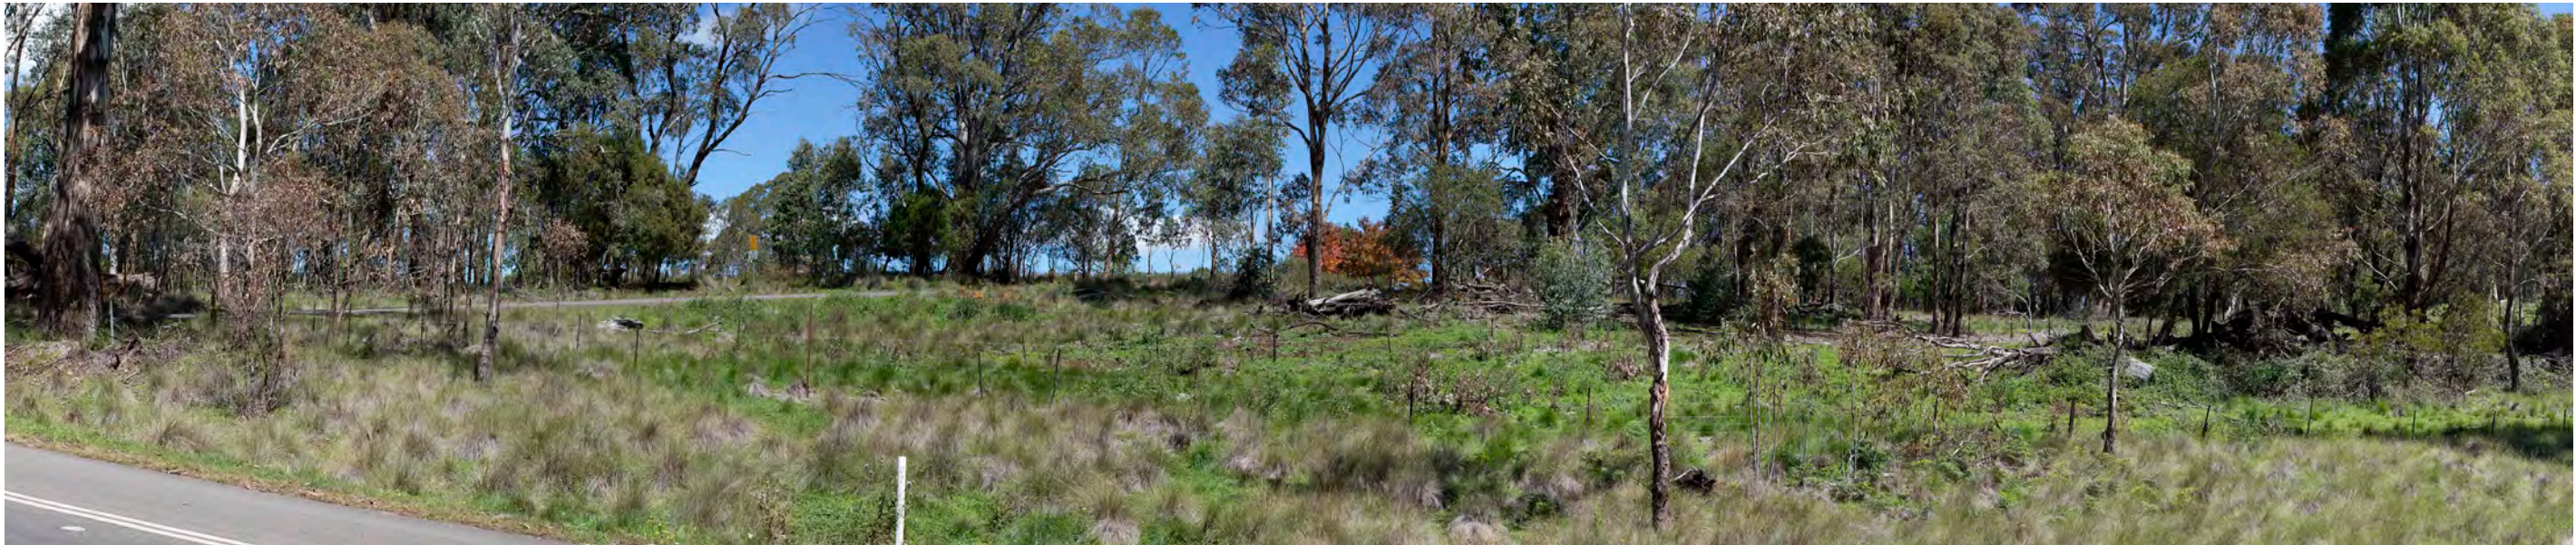
VIEWPOINT HOG41

Viewpoint Summary		Viewpoint Description	Visual Performance Objectives: VIZ2
Location:	Elevation:	This viewpoint is located on the corner of Barrys Road and Morrisons Gap Road, nearby to NAD20, NAD19 and NAD18. The area is characterised by wooded, native grass land within rural residential land. The landform is undulating. There is vegetation in the foreground which contains views out of the area.	Visual Magnitude: Viewpoint is located within the 'blue line' (4550m). If deemed necessary, mitigation methods are to be considered for nearby residences, NAD20, NAD18 and NAD19 in accordance with the Visual Performance Objectives. Refer to Appendix E for detailed dwelling assessment.
Corner Barrys Road and Morrisons Gap Road	1250m		
Coordinates:	Viewing Direction:	Potential Visual Impact An assessment based on topography alone suggests that 40-50 WTG's may be visible from this location however vegetation typical of the area is likely to screen the majority of the WTG's.	Landscape Scenic Integrity: The wind turbines are unlikely to significantly modify the visual catchment from this location. The wind turbines will be difficult to discern due to vegetation in the foreground. Key Feature Disruption: The proposal is unlikely to have any major visual impact on visually significant landform, waterform, vegetation or cultural features that have visual prominence or are focal points from this location due to prominence of the vegetation in the foreground.

151°12'15.6"E 31°30'32.8"S	Generally South		
Distance to WTG:	Visibility Distance Zone:		
Approx. 3.2km	Near Middleground (NM)		
Land Use:	Viewer Sensitivity Level:		
Low Use Road	Level 3: Low	Nearby Residences:	
LCU:	Scenic Quality Rating:		
Forested Mountain Ranges	Mod/High	NAD20, NAD19 and NAD18	
Visual Influence Zone VIZ2

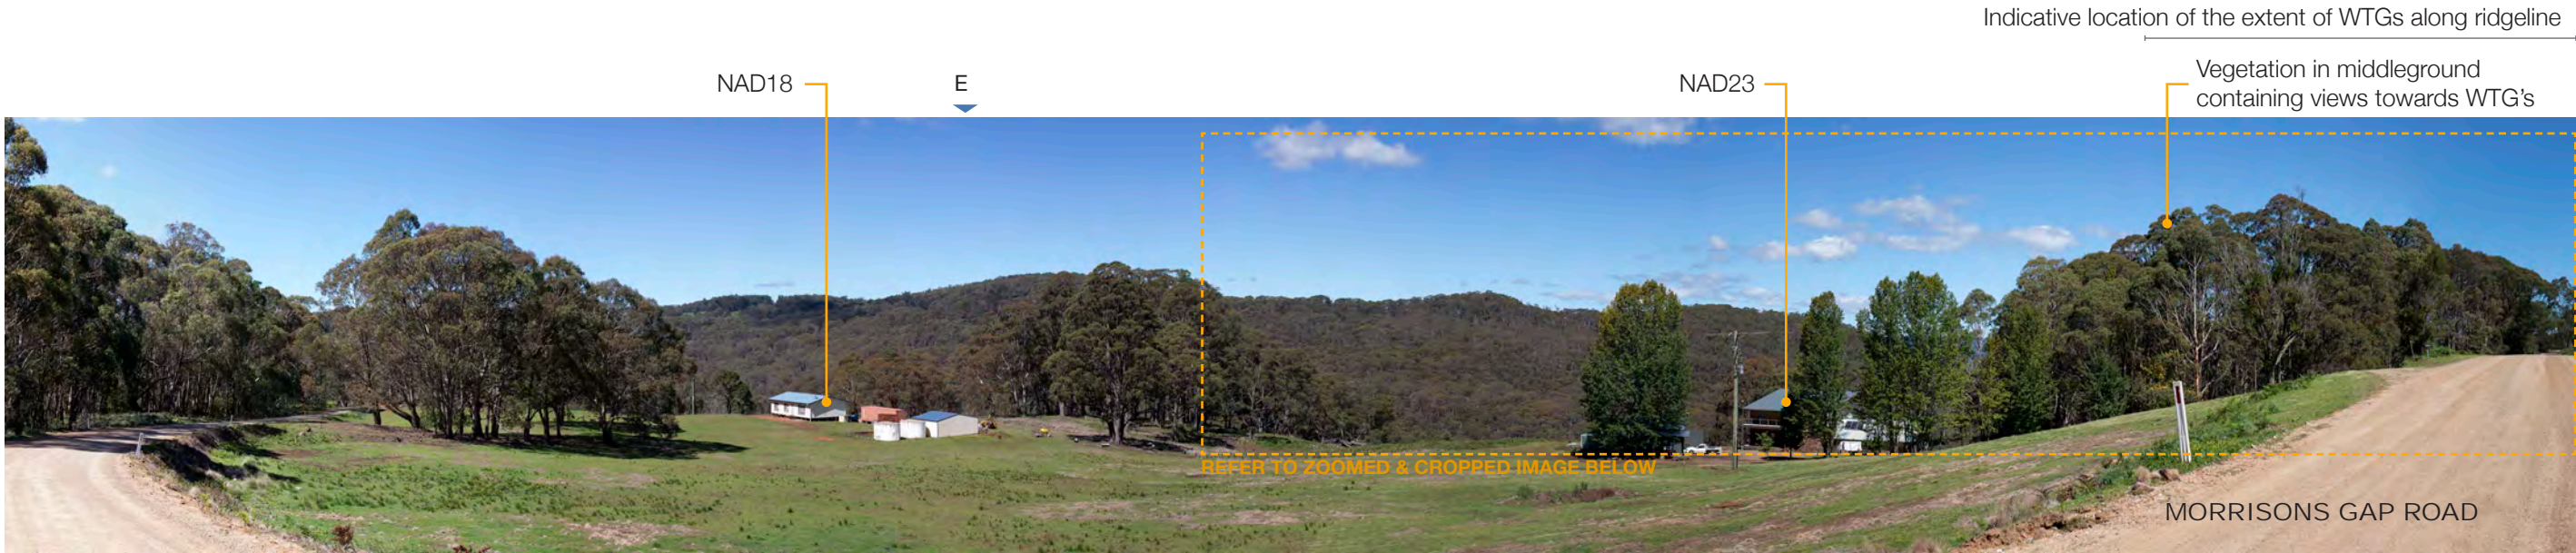
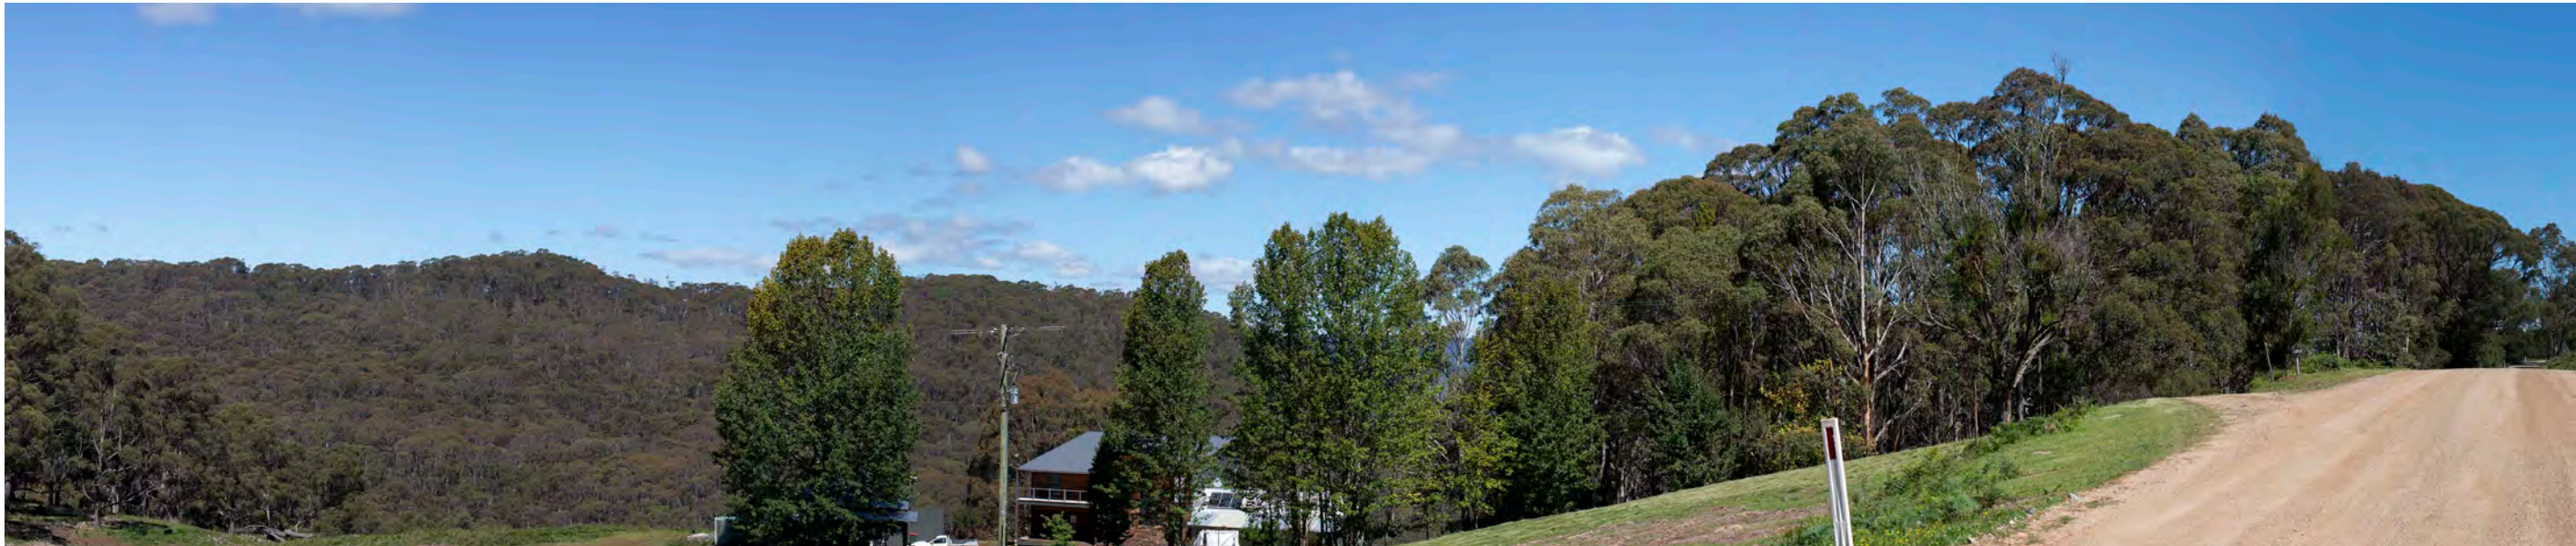
VIEWPOINT HOG43

Viewpoint Summary		Viewpoint Description	Visual Performance Objectives: VIZ2
Location:	Elevation:	This viewpoint is located on Morrisons Gap Rd, nearby NAD18, NAD19 & AD23. The landscape is characterised by sloping to undulating, partially cleared land used for rural residential purposes, set within densely wooded surrounds. Dense vegetation is visible in the middleground containing views to the south of the view. The residences and associated vegetation are also visible in the middleground. A heavily vegetated ridge is visible in the back ground of the view.	Visual Magnitude: Viewpoint is located within the 'black line' (3100m). If deemed necessary, mitigation methods are to be considered for nearby residence NAD23, NAD19 & NAD18 in accordance with the Visual Performance Objectives. Refer to Appendix E for detailed dwelling assessment. Landscape Scenic Integrity: The wind turbines are unlikely to significantly modify the visual catchment from this location. The majority of the Project is likely to be screened by vegetation from this location. Key Feature Disruption: The proposal is unlikely to have any major visual impact on visually significant landform, waterform, vegetation or cultural features that have visual prominence or are focal points from this location due to vegetation.

Morrisons Gap Road	1289m		
Coordinates:	Viewing Direction:		
151°11'54.40"E 31°30'42.50"S	Generally South East		
Distance to WTG:	Visibility Distance Zone:	Potential Visual Impact An assessment based on topography alone suggests that 40-50 WTG's may be visible from this location. It is likely that the dense vegetation located in the middleground of the view will contain views toward the WTG's from this location.	
Approx. 2.6km	Near Middleground (NM)		
Land Use:	Viewer Sensitivity Level:		
Low Use Road	Level 3: Low		
LCU:	Scenic Quality Rating:	Nearby Residences:	
Forested Mountain Ranges	Mod/High	AD23 , NAD19 & NAD18	
Visual Influence Zone VIZ2

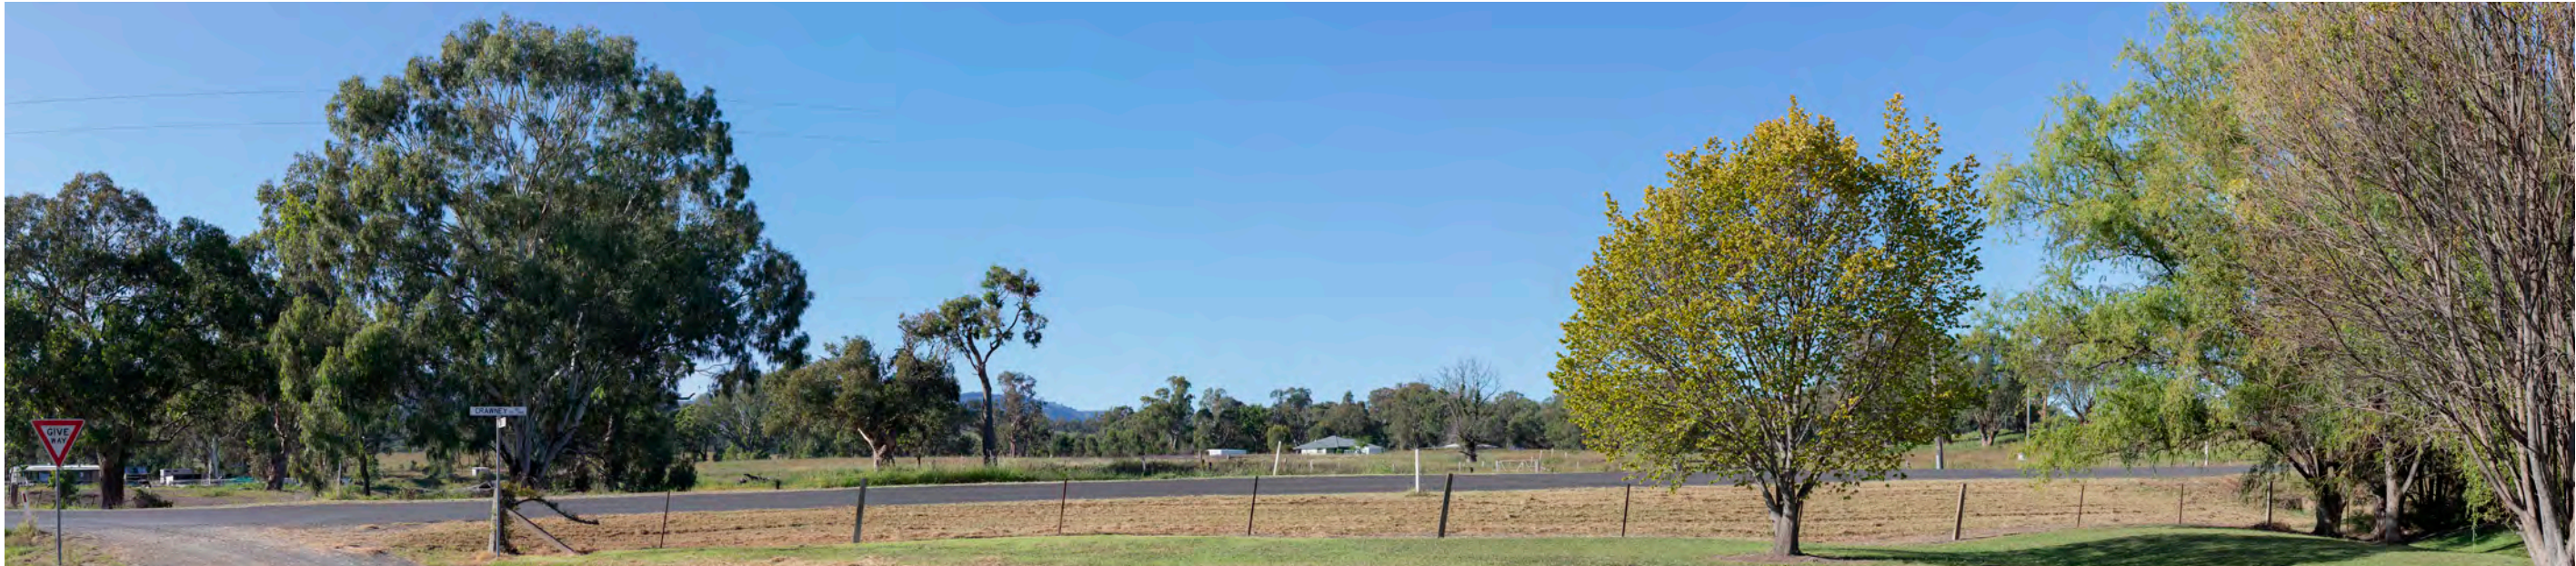
VIEWPOINT HOG44

Viewpoint Summary		Viewpoint Description	Visual Performance Objectives: VIZ2
Location:	Elevation:	This viewpoint is taken from the corner of Crawney Rd/Point St. The land is flat, cleared residential land, set on large blocks. Dense vegetation is visible in the middleground to the south east and south west of the view. Dense vegetation is also visible in the background of the view and filters views toward the ridgeline associated with the project area. Potential Visual Impact A preliminary analysis based on topography alone suggests 60-70 WTG's may be visible from this location. It is likely the dense vegetation in the background and middleground may fragment views, reducing the visibility of a number of the WTG's from this viewpoint to approx. 12. These are likely to be available through the break in vegetation to the south of the view.	Landscape Scenic Integrity: The wind turbines will be a noticeable element in the landscape, however they are unlikely to dominate the visual catchment from this location. Key Feature Disruption: The Ridge forms a visual backdrop to the south and south east of this viewpoint. The proposed WTGs will be visible on the range, however the range will still be the most visually prominent feature from this location. Refer Photomontage 05

Crawney Road/Point Street	601m		
Coordinates:	Viewing Direction:		
151° 7'24.61"E 31°28'14.15"S	Generally South		
Distance to WTG:	Visibility Distance Zone:		
Approx. 8.7km	Near Background (NB)	Nearby Residences:	
Land Use:	Viewer Sensitivity Level:		
Residential	Level 1: High		
LCU:	Scenic Quality Rating:		
Nundle Village	Low/Mod	Nundle Village	
Visual Influence Zone VIZ2

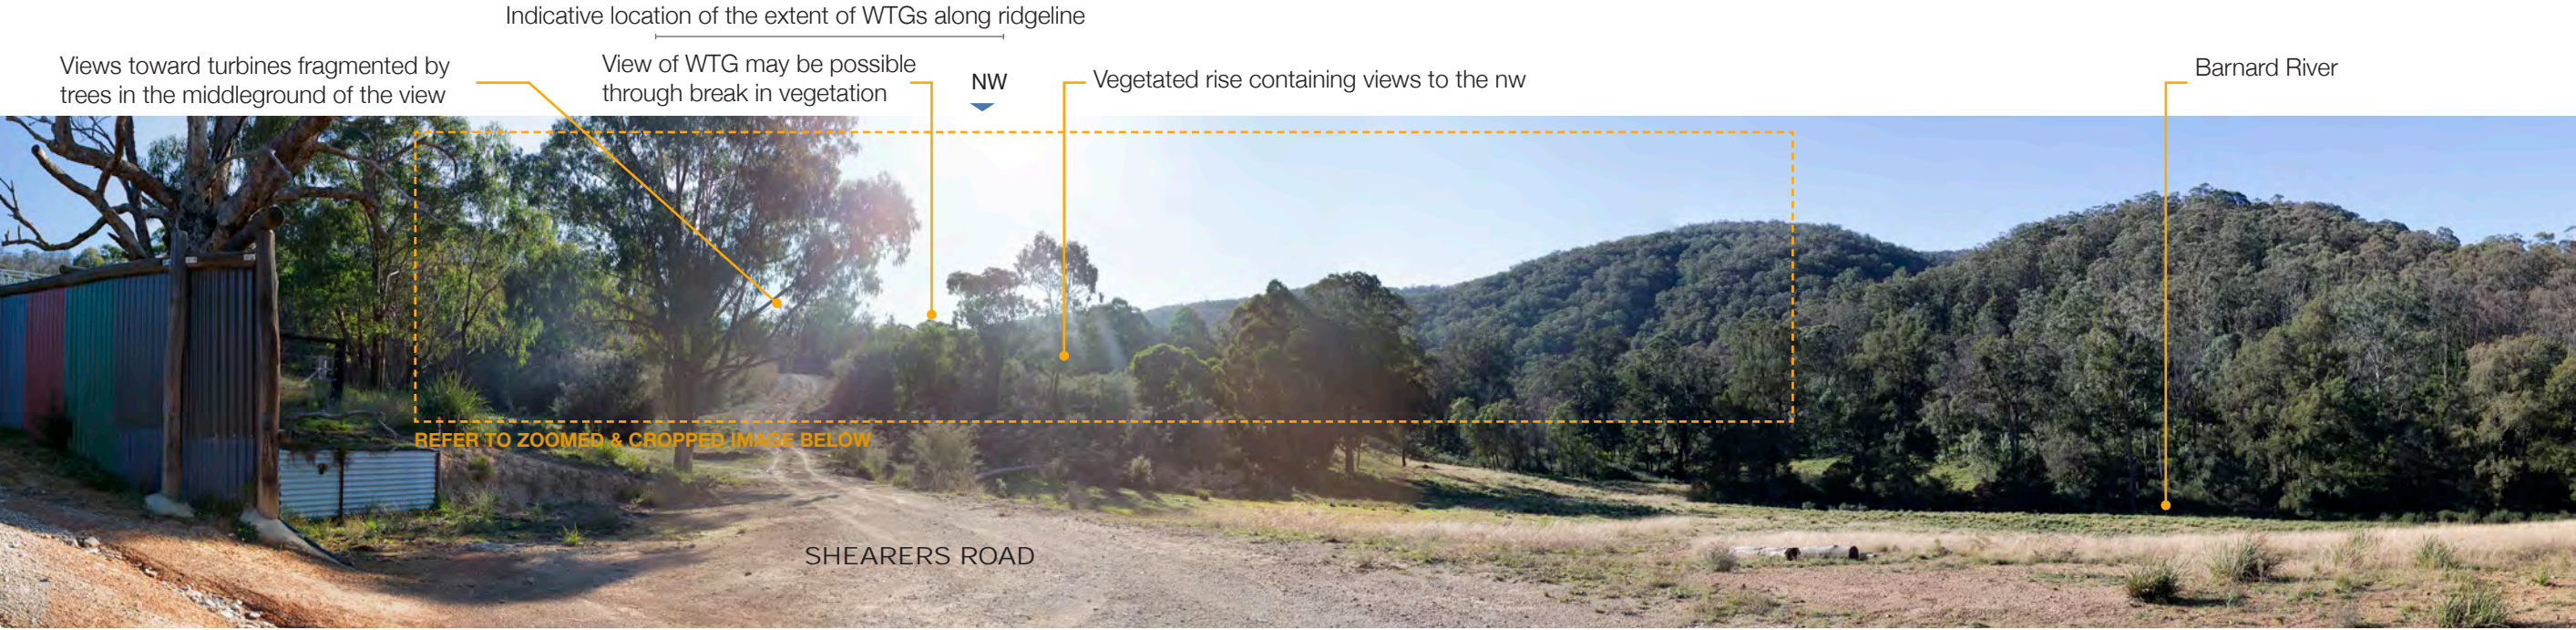
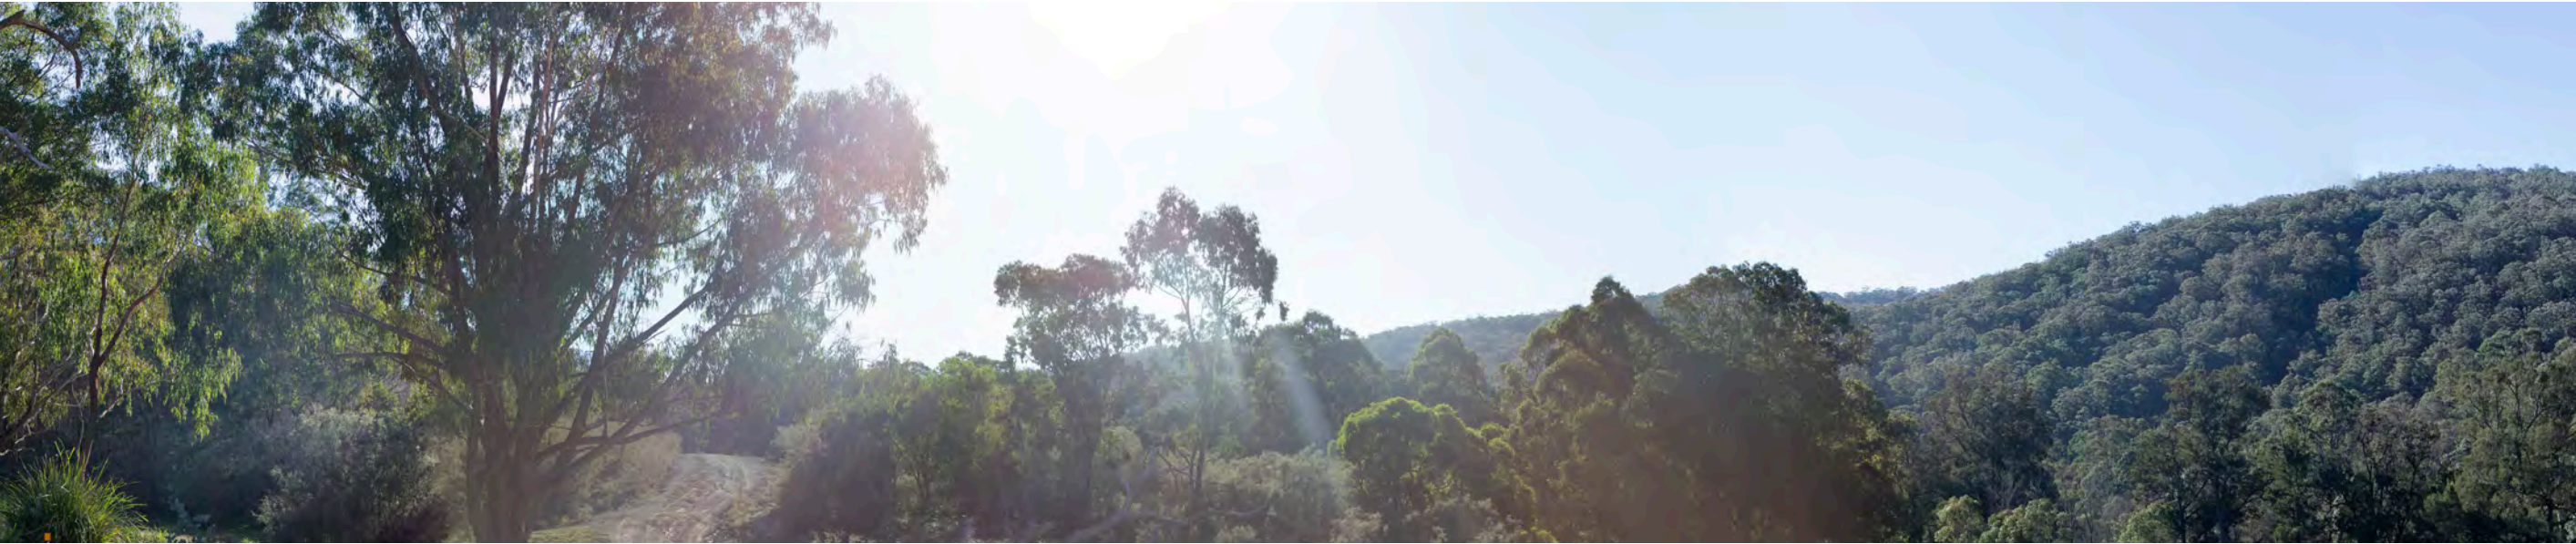
VIEWPOINT HOG45			
Viewpoint Summary		Viewpoint Description	Visual Performance Objectives: VIZ2
Location:	Elevation:	This viewpoint is located at the driveway of NAD48, along Shearers Rd. The landscape is characterised by the river flats and associated creek line vegetation of the Barnard River in the middleground. The surrounds are characterised by densely wooded, undulating hillsides. A slight vegetated rise is located in the NW of the view, containing views to the NW.	Visual Magnitude: Viewpoint is located within the 'blue line' (4550m). If deemed necessary, mitigation methods are to be considered for nearby residence, NAD48 in accordance with the Visual Performance Objectives. Refer to Appendix E for detailed dwelling assessment.
Shearers Road	805m		
Coordinates:	Viewing Direction:		
151°13'17.32"E 31°33'59.80"S	Generally North West		
Distance to WTG:	Visibility Distance Zone:		
Approx. 4.5km	Far Middleground (FM)	Potential Visual Impact A preliminary assessment based on topography alone suggests that 5 WTG's may be visible from this location. It is likely that the dense vegetation located in the middleground of the view may contain views toward a majority of the WTG's from this location.	Landscape Scenic Integrity: The wind turbines are unlikely to significantly modify the visual catchment from this location. The majority of the Project is likely to be screened by vegetation from this location.

Land Use:	Viewer Sensitivity Level:		
Low Use Road	Level 3: Low		
LCU:	Scenic Quality Rating:	Nearby Residences:	Key Feature Disruption: The proposal is unlikely to have any major visual impact on visually significant landform, waterform, vegetation or cultural features that have visual prominence or are focal points from this location due to vegetation.
Forested Mountain Ranges	Mod/High	NAD48	
Visual Influence Zone VIZ2
