Orica Australia Pty Ltd  
Remediation Action Plan

28 McPherson Street  
Banksmeadow, NSW

15 May 2019

54709/119224 Rev 0

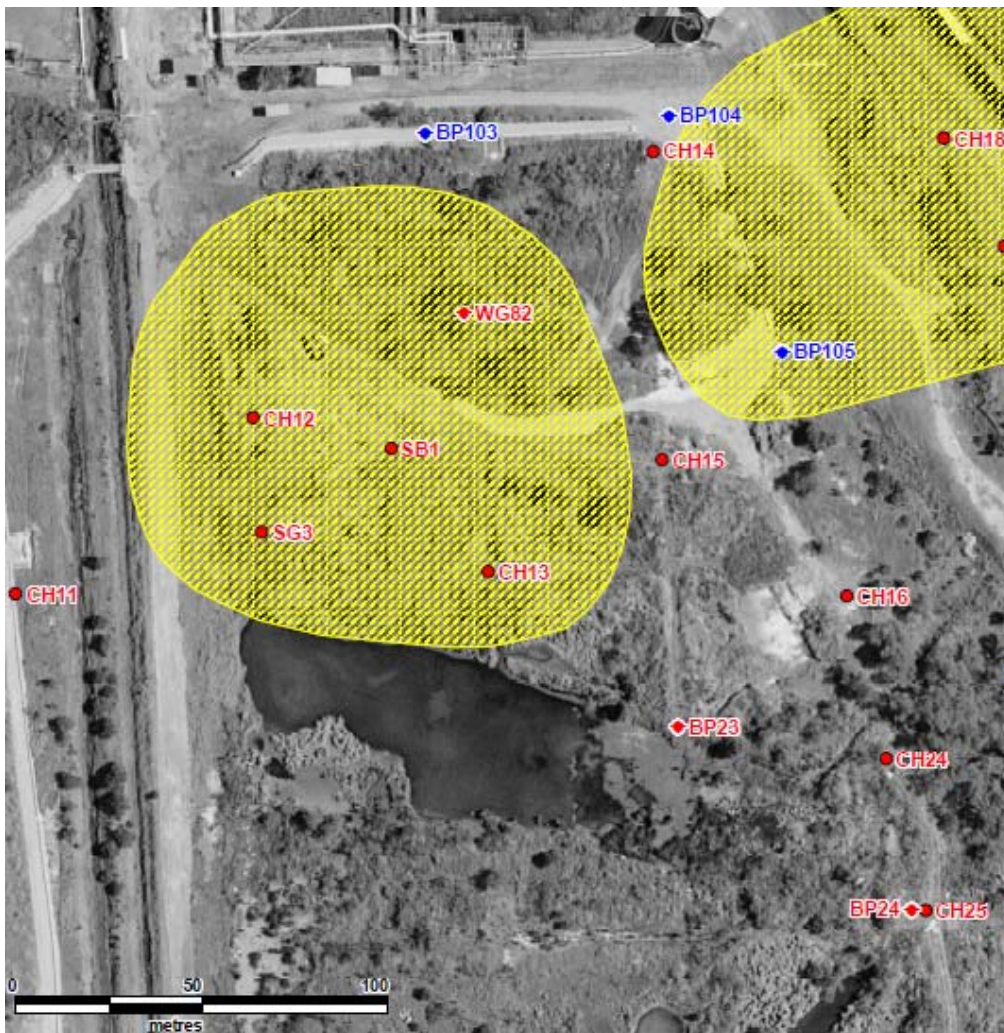
Detailed assessments of the distribution of dense non-aqueous phase liquid (DNAPL) have been undertaken at the site. The figure below has been taken from URS (2006) and shows a summary of investigation locations WG82, CH12, CH13, SB1, SG3 and SG4) where DNAPL has been positively identified.

At locations on the site, DNAPL was observed (as liquid or as positive dye tests) at the following depths;

- WG82 – from 13 to 14 m (positive dye test) and at 21.5 m (liquid in drilling mud);
- CH12 – from 23.9 to 24.0 m (positive dye test);
- CH13 – from 21.85 to 21.9 m (positive dye test);
- SB1 (SG1) – from 21 to 23 m (liquid in pore water). An elevated soil concentration was also identified in a thin band at 10 m at this location although DNAPL was not directly observed;
- SG3 – from 21 to 24 m (based on soil concentrations); and
- SG4 - - at a thin band at 21 m and from 25.6 to 25.8 m (liquid in pore water).

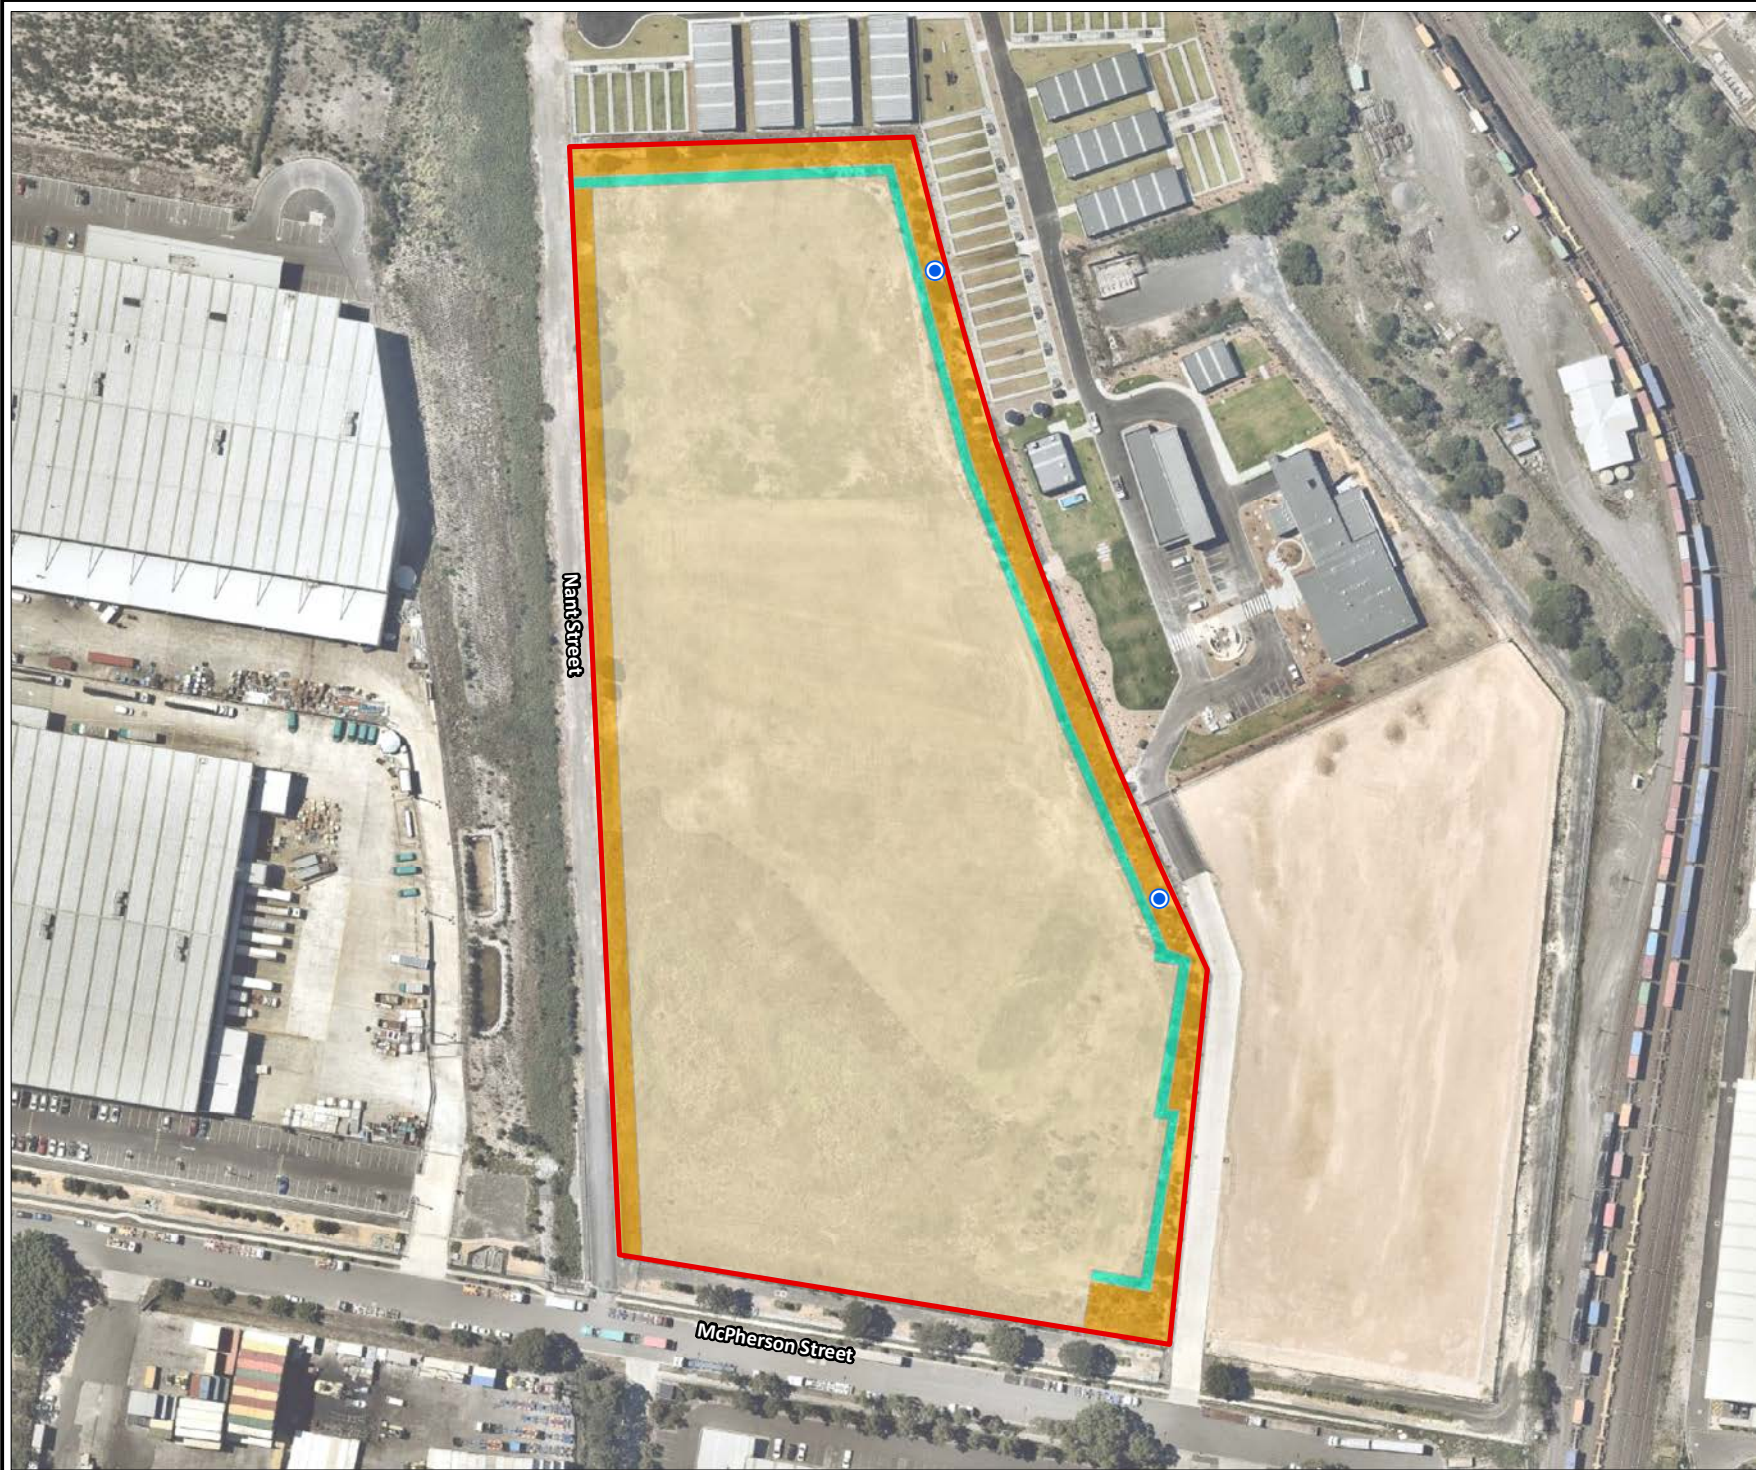
- Approximate Site Boundary
- 0.1m Hardstand Barrier Layer
- 0.1m Sealed Hardstand Barrier Layer
- No Marker / Barrier Layer
- Surface Water Entry Points

It is noted there are two surface stormwater entry points on the eastern boundary of the site as shown on **Figure 3**. The ground surface in these areas will be treated with appropriate erosion control measures.

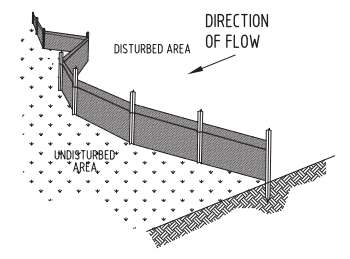
TYPICAL SILT FENCE DETAIL  
N.T.S.  
PROVIDE 1m RETURNS AT 30m INTERVALS.  
TYPICAL

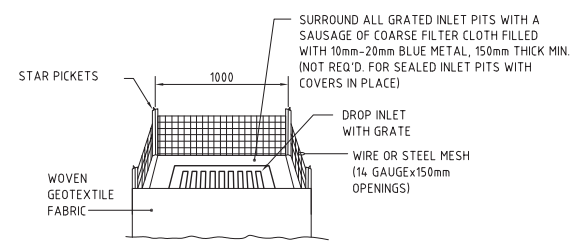
GRADED INLET PIT FILTER DETAIL  
N.T.S.

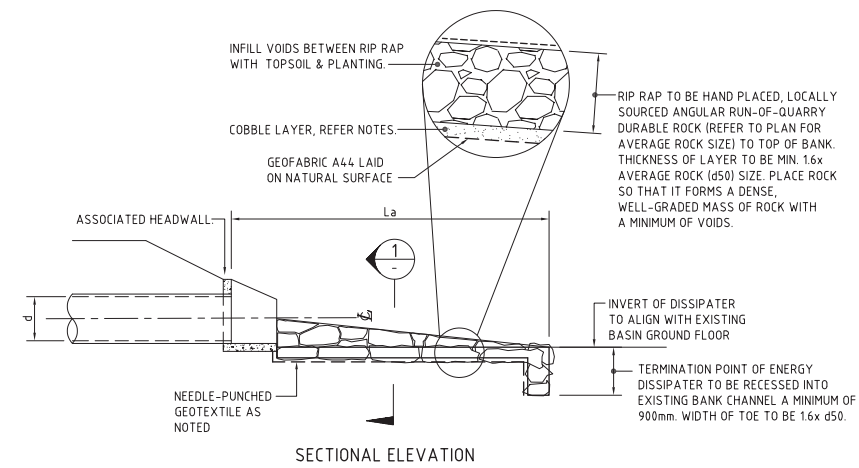
STORMWATER OUTLET DISSIPATER WITH HEADWALL  
SCALE 1:50

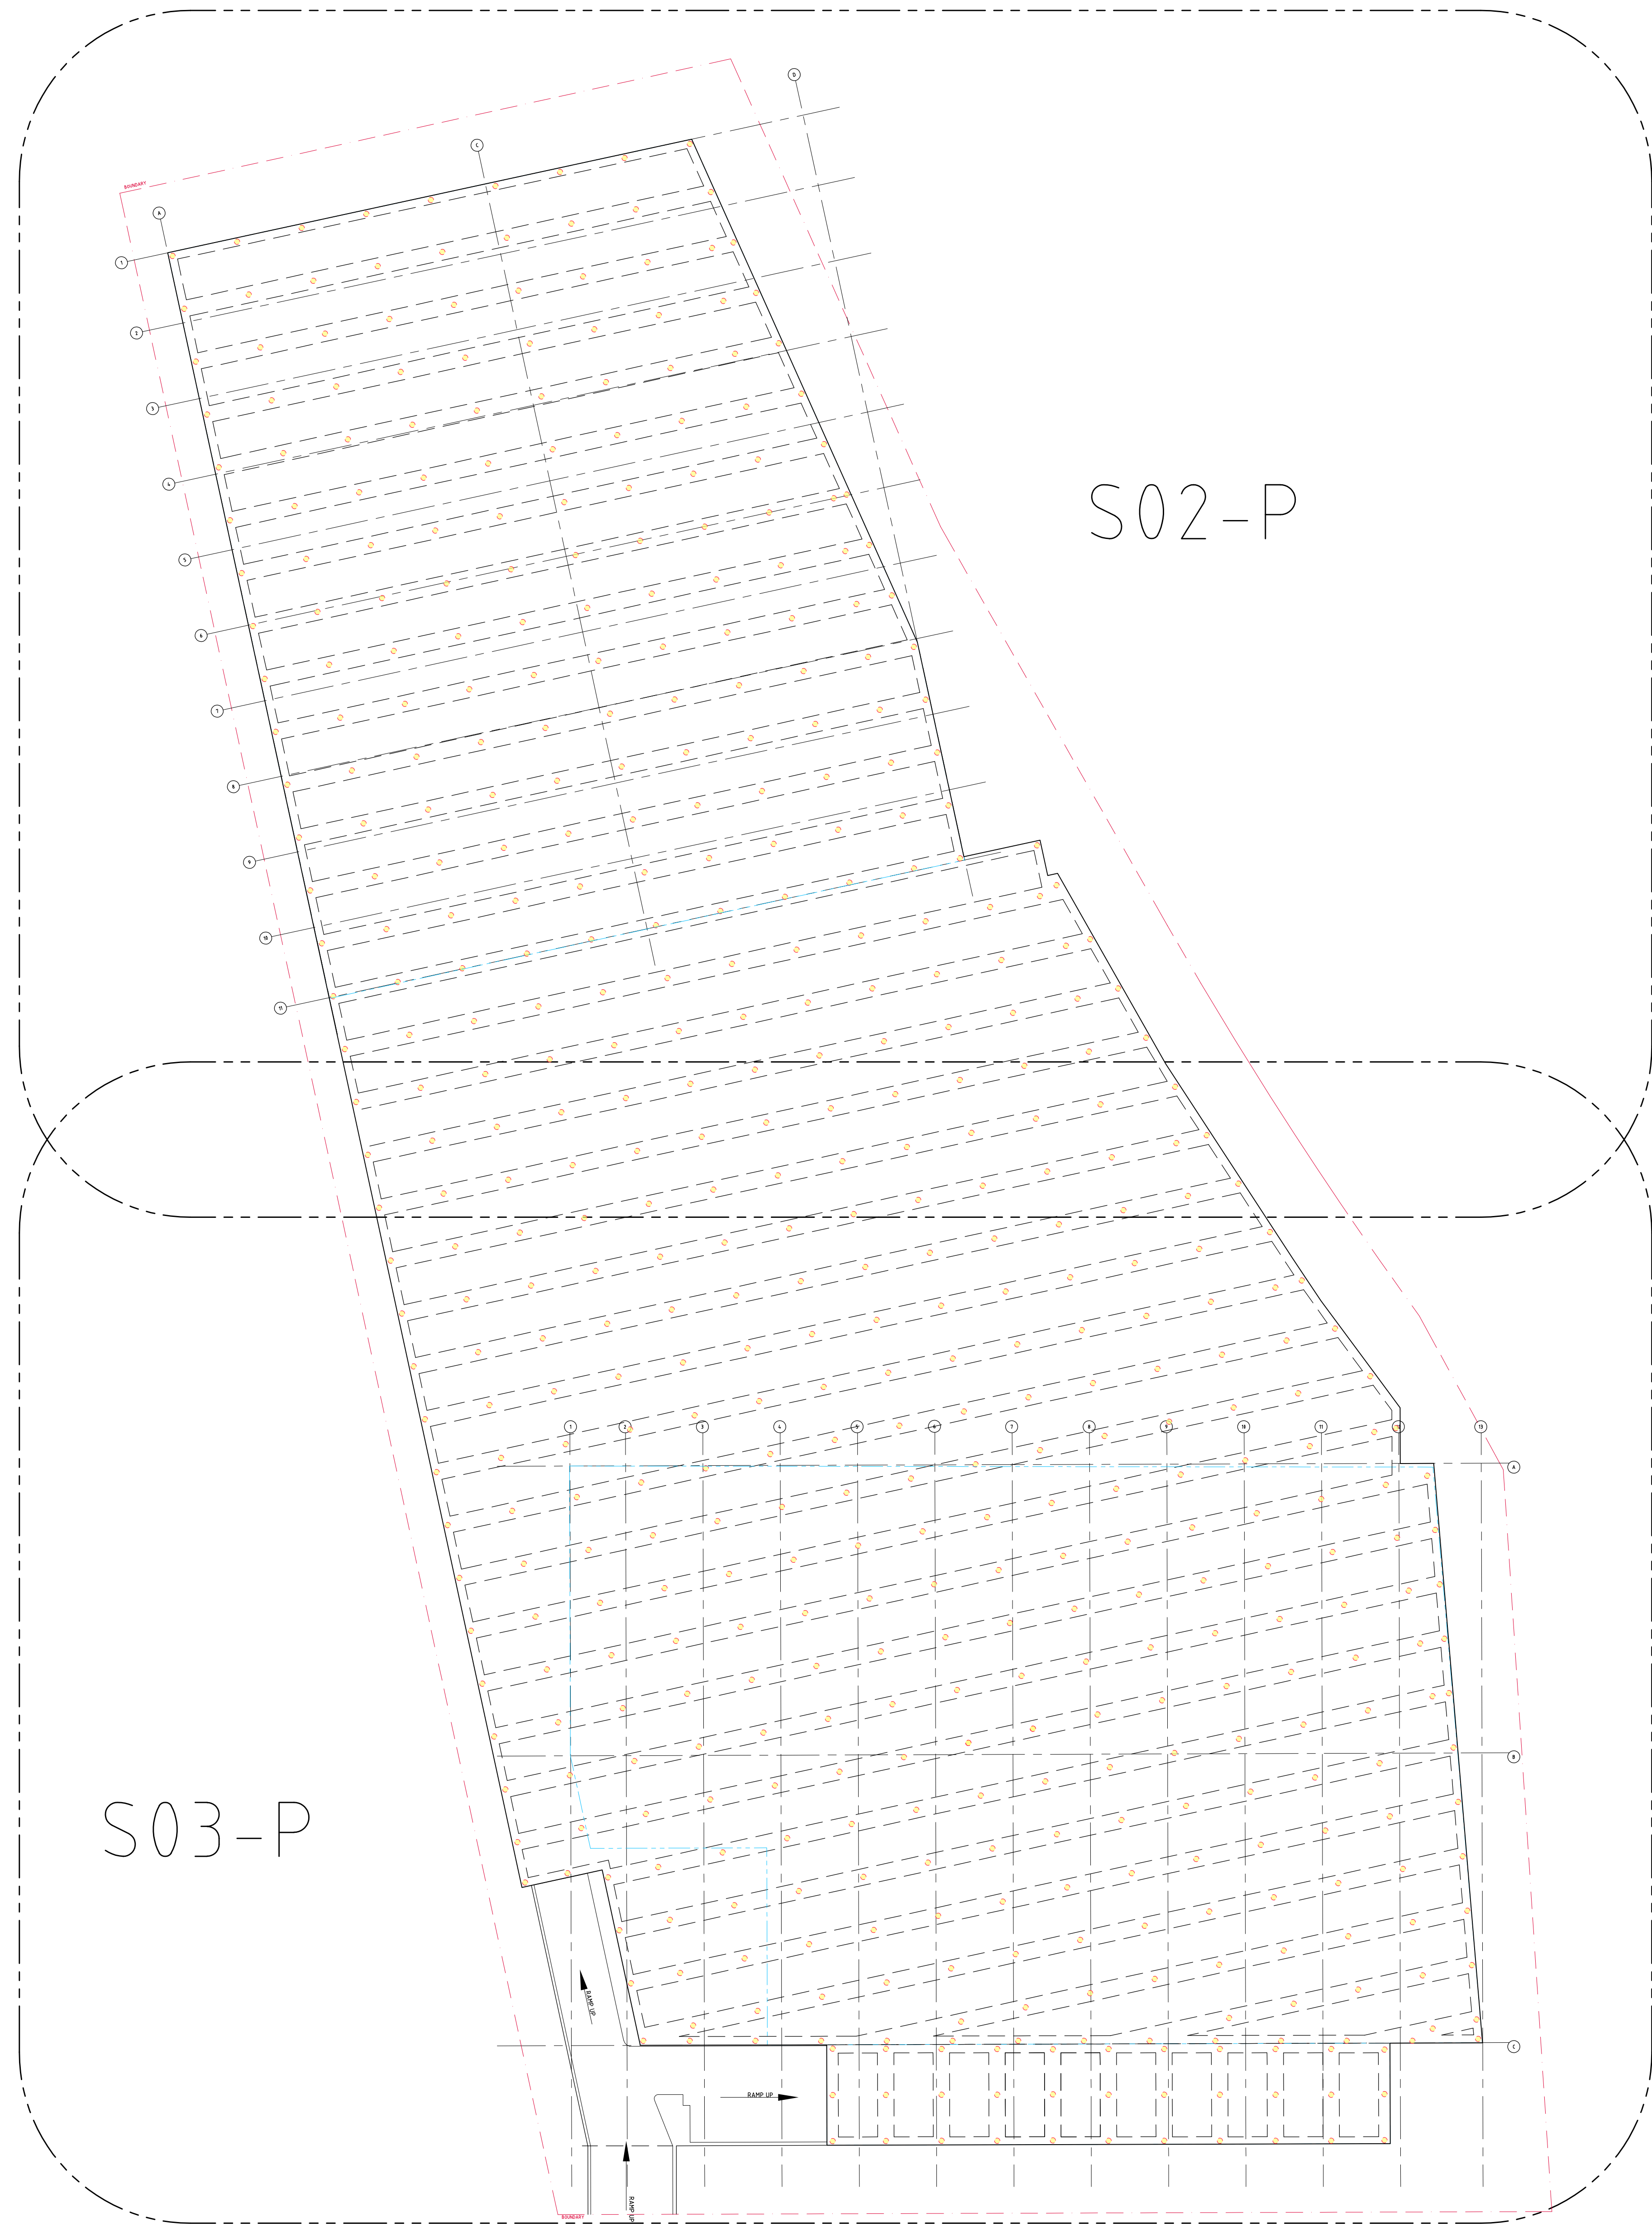
250 MIN. THICK SUSPENDED PT BANDED SLAB  
ON CONCRETE COLUMNS OVERALL PLAN  
SCALE 1500

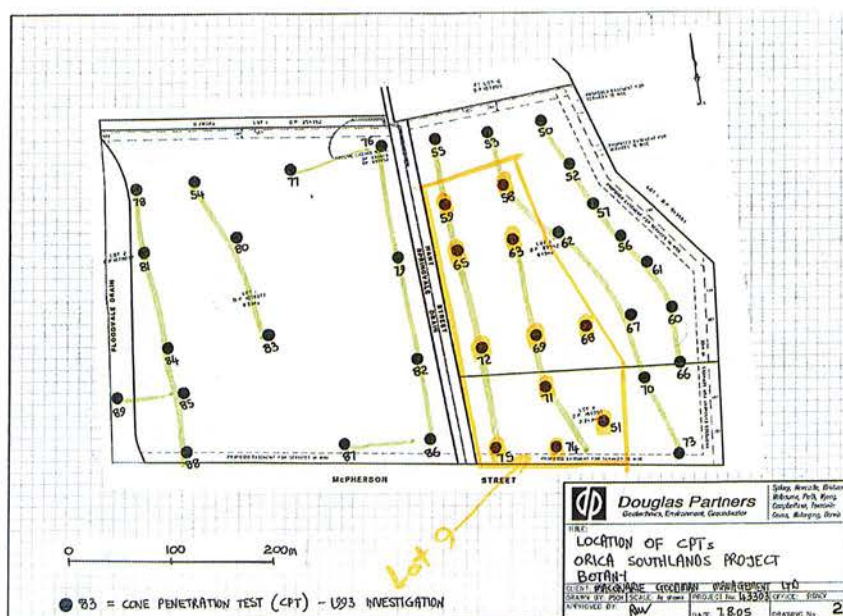
Figure 2 1993 Douglas Partners CPTs undertaken at Lot 9 (Taken from DP report dated 9 Aug 2005).

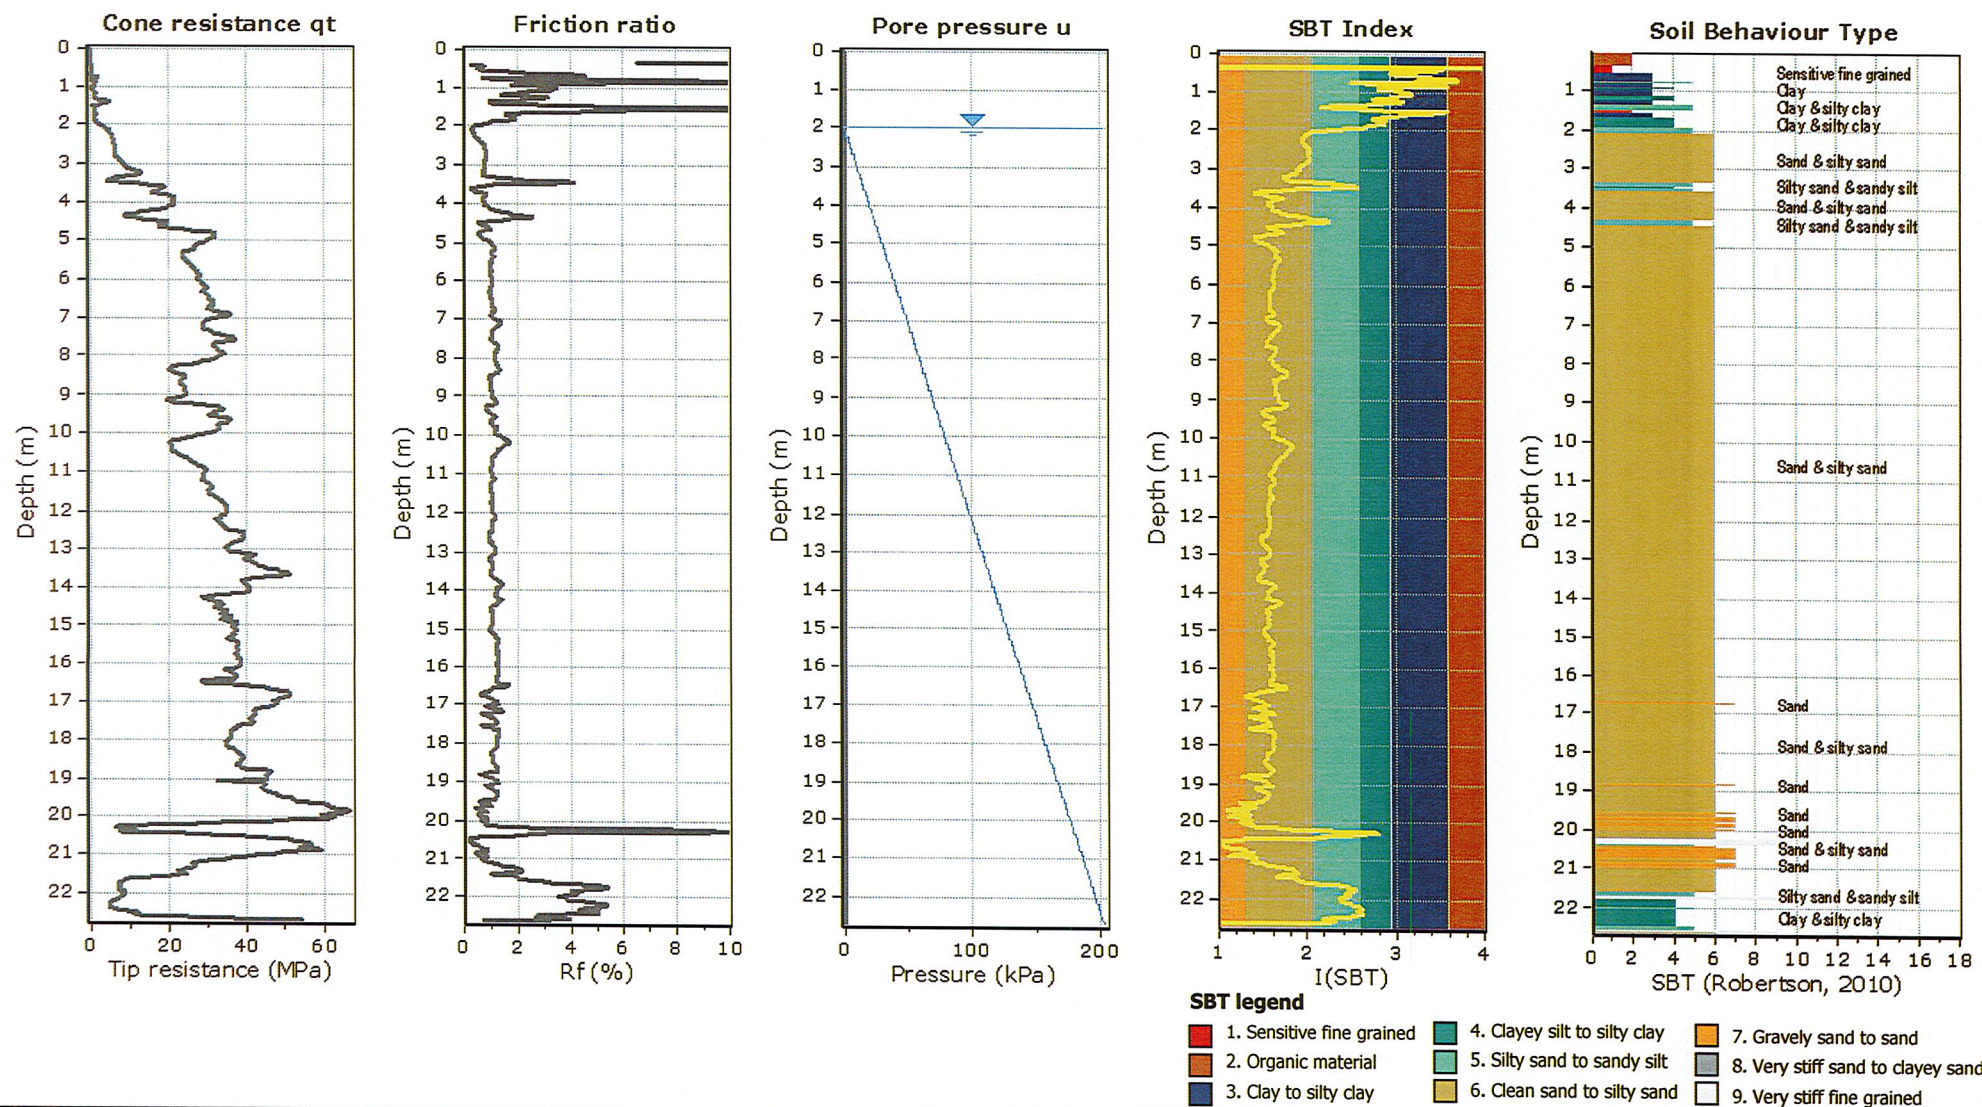
**CPT: CPT51**

Total depth: 22.70 m, Date: 17/12/2018  
Surface Elevation: 0.00 m  
Coords: X:0.00, Y:0.00  
Cone Type: Unknown  
Cone Operator: Unknown

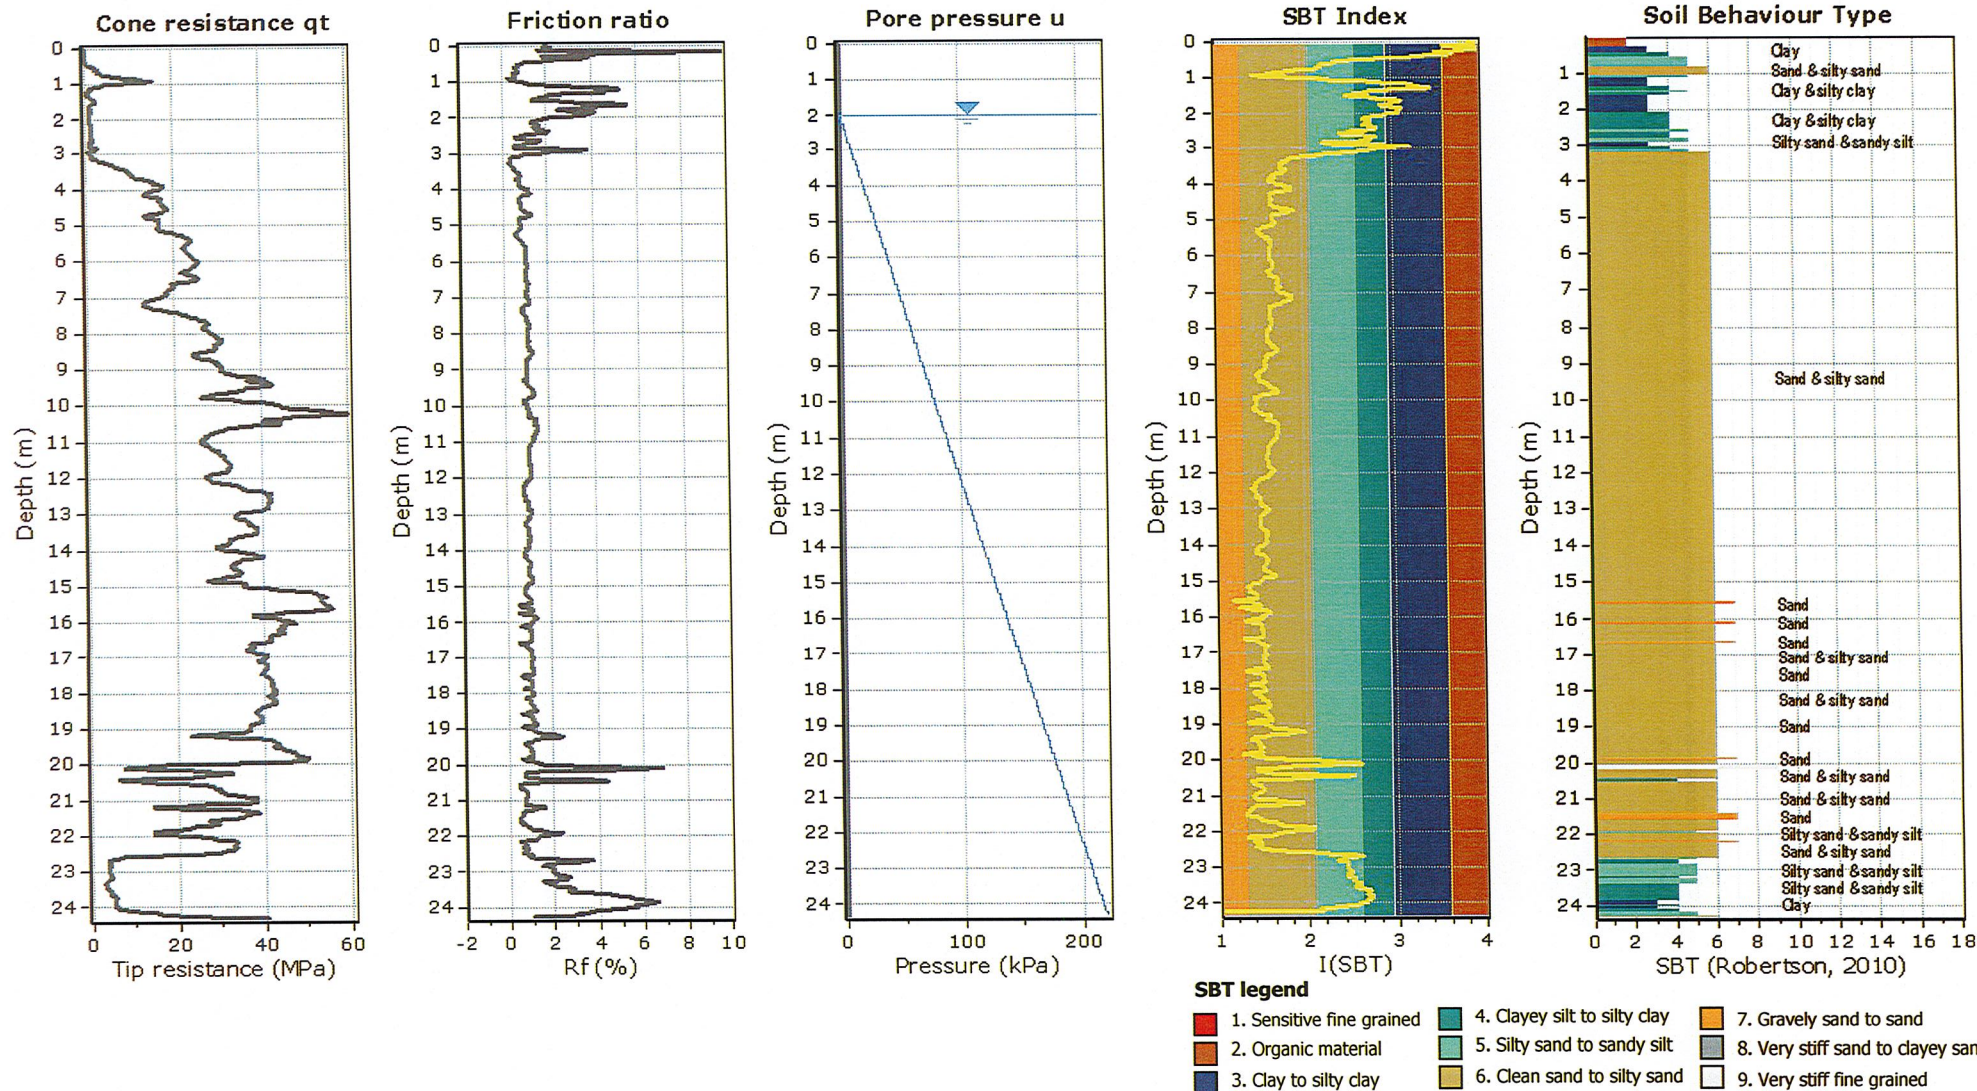
**CPT: CPT74**

Total depth: 24.34 m, Date: 17/12/2018  
Surface Elevation: 0.00 m  
Coords: X:0.00, Y:0.00  
Cone Type: Unknown  
Cone Operator: Unknown

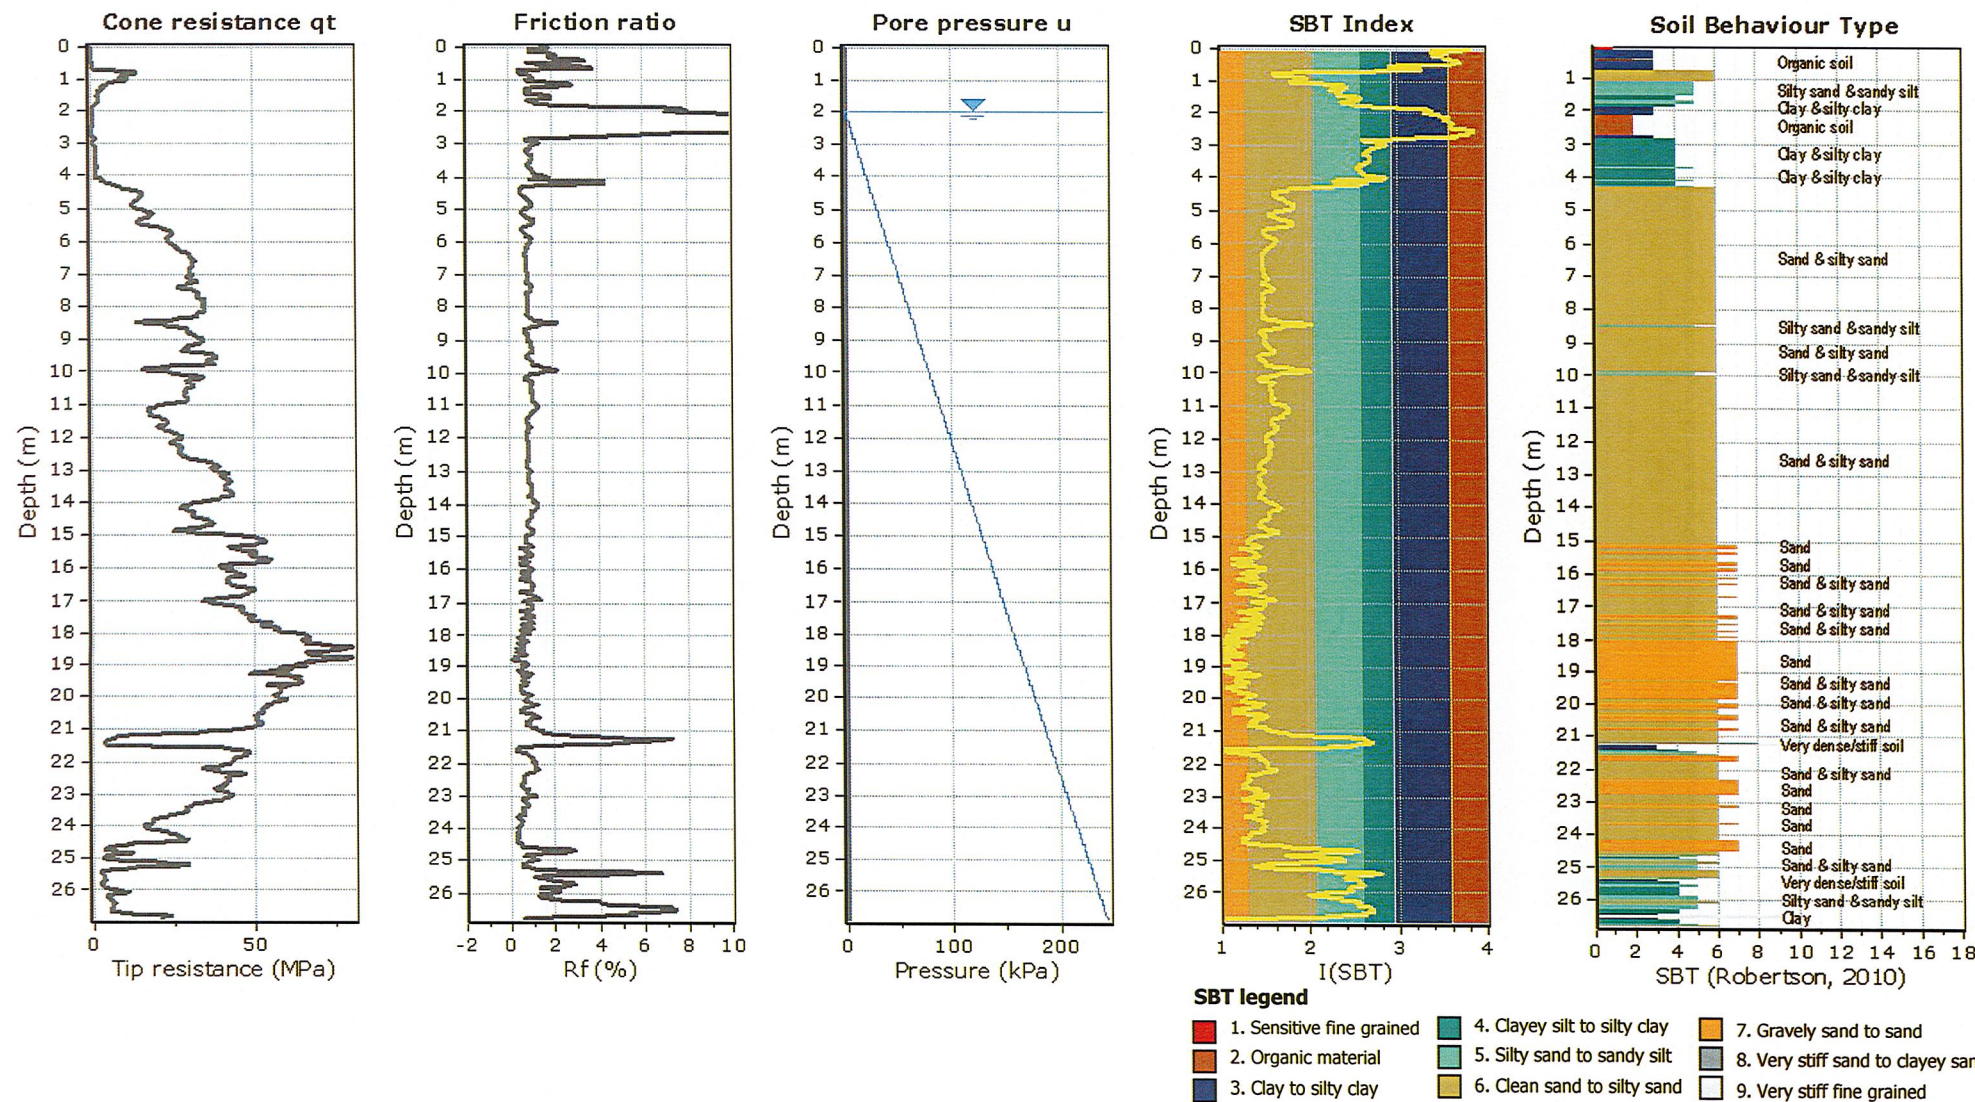
**CPT: CPT75**

Total depth: 26.86 m, Date: 17/12/2018  
Surface Elevation: 0.00 m  
Coords: X:0.00, Y:0.00  
Cone Type: Unknown  
Cone Operator: Unknown
