Report on
Geotechnical Investigation

Meriden Centre of Music and Drama
13 Margaret Street, Strathfield

Prepared for
Meriden School

Project 86568.00
May 2019

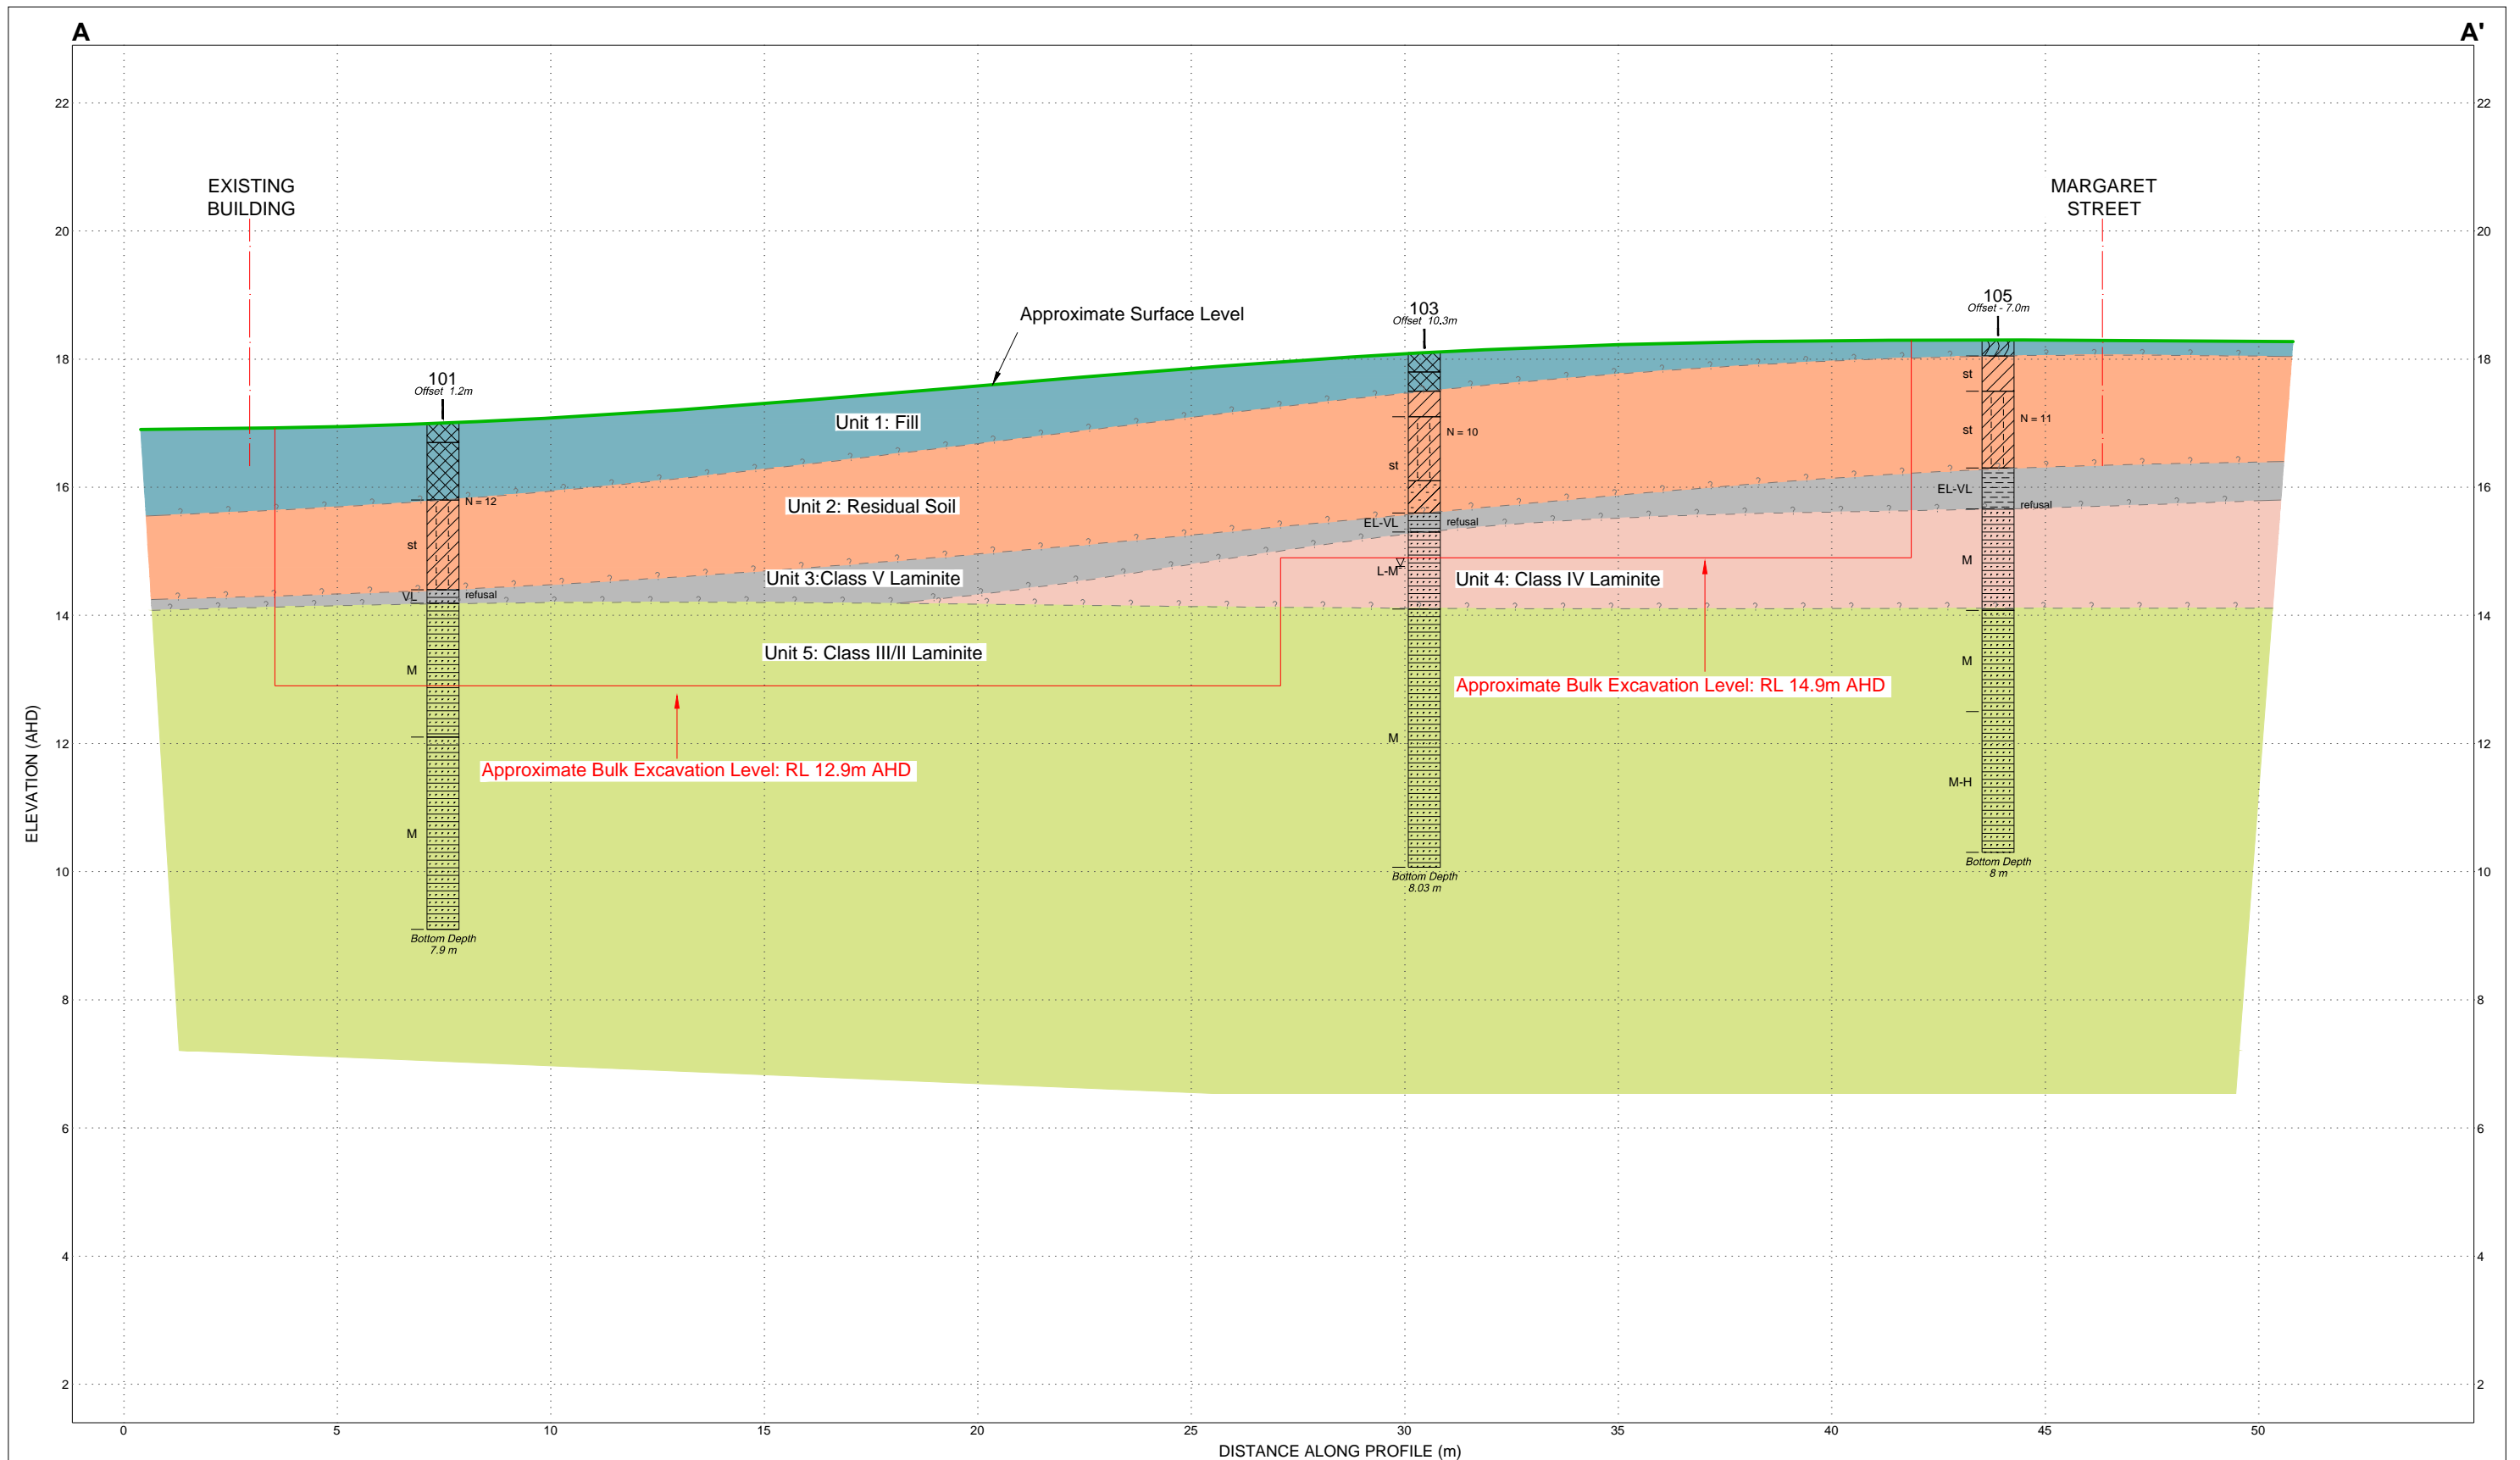
PROJECT No: 86568.00
 DRAWING No: 2
 REVISION: 0

TITLE: Cross-section A-A'
 Meriden Centre of Music and Drama
 13 Margaret Street, Strathfield

For design purposes, the observed subsurface profile during the investigation has been grouped into five geotechnical units. Two geotechnical cross sections (Section A-A' and Section B-B') showing the interpreted subsurface profile between the borehole locations are shown on Drawing 2 and 3 in Appendix B, respectively.

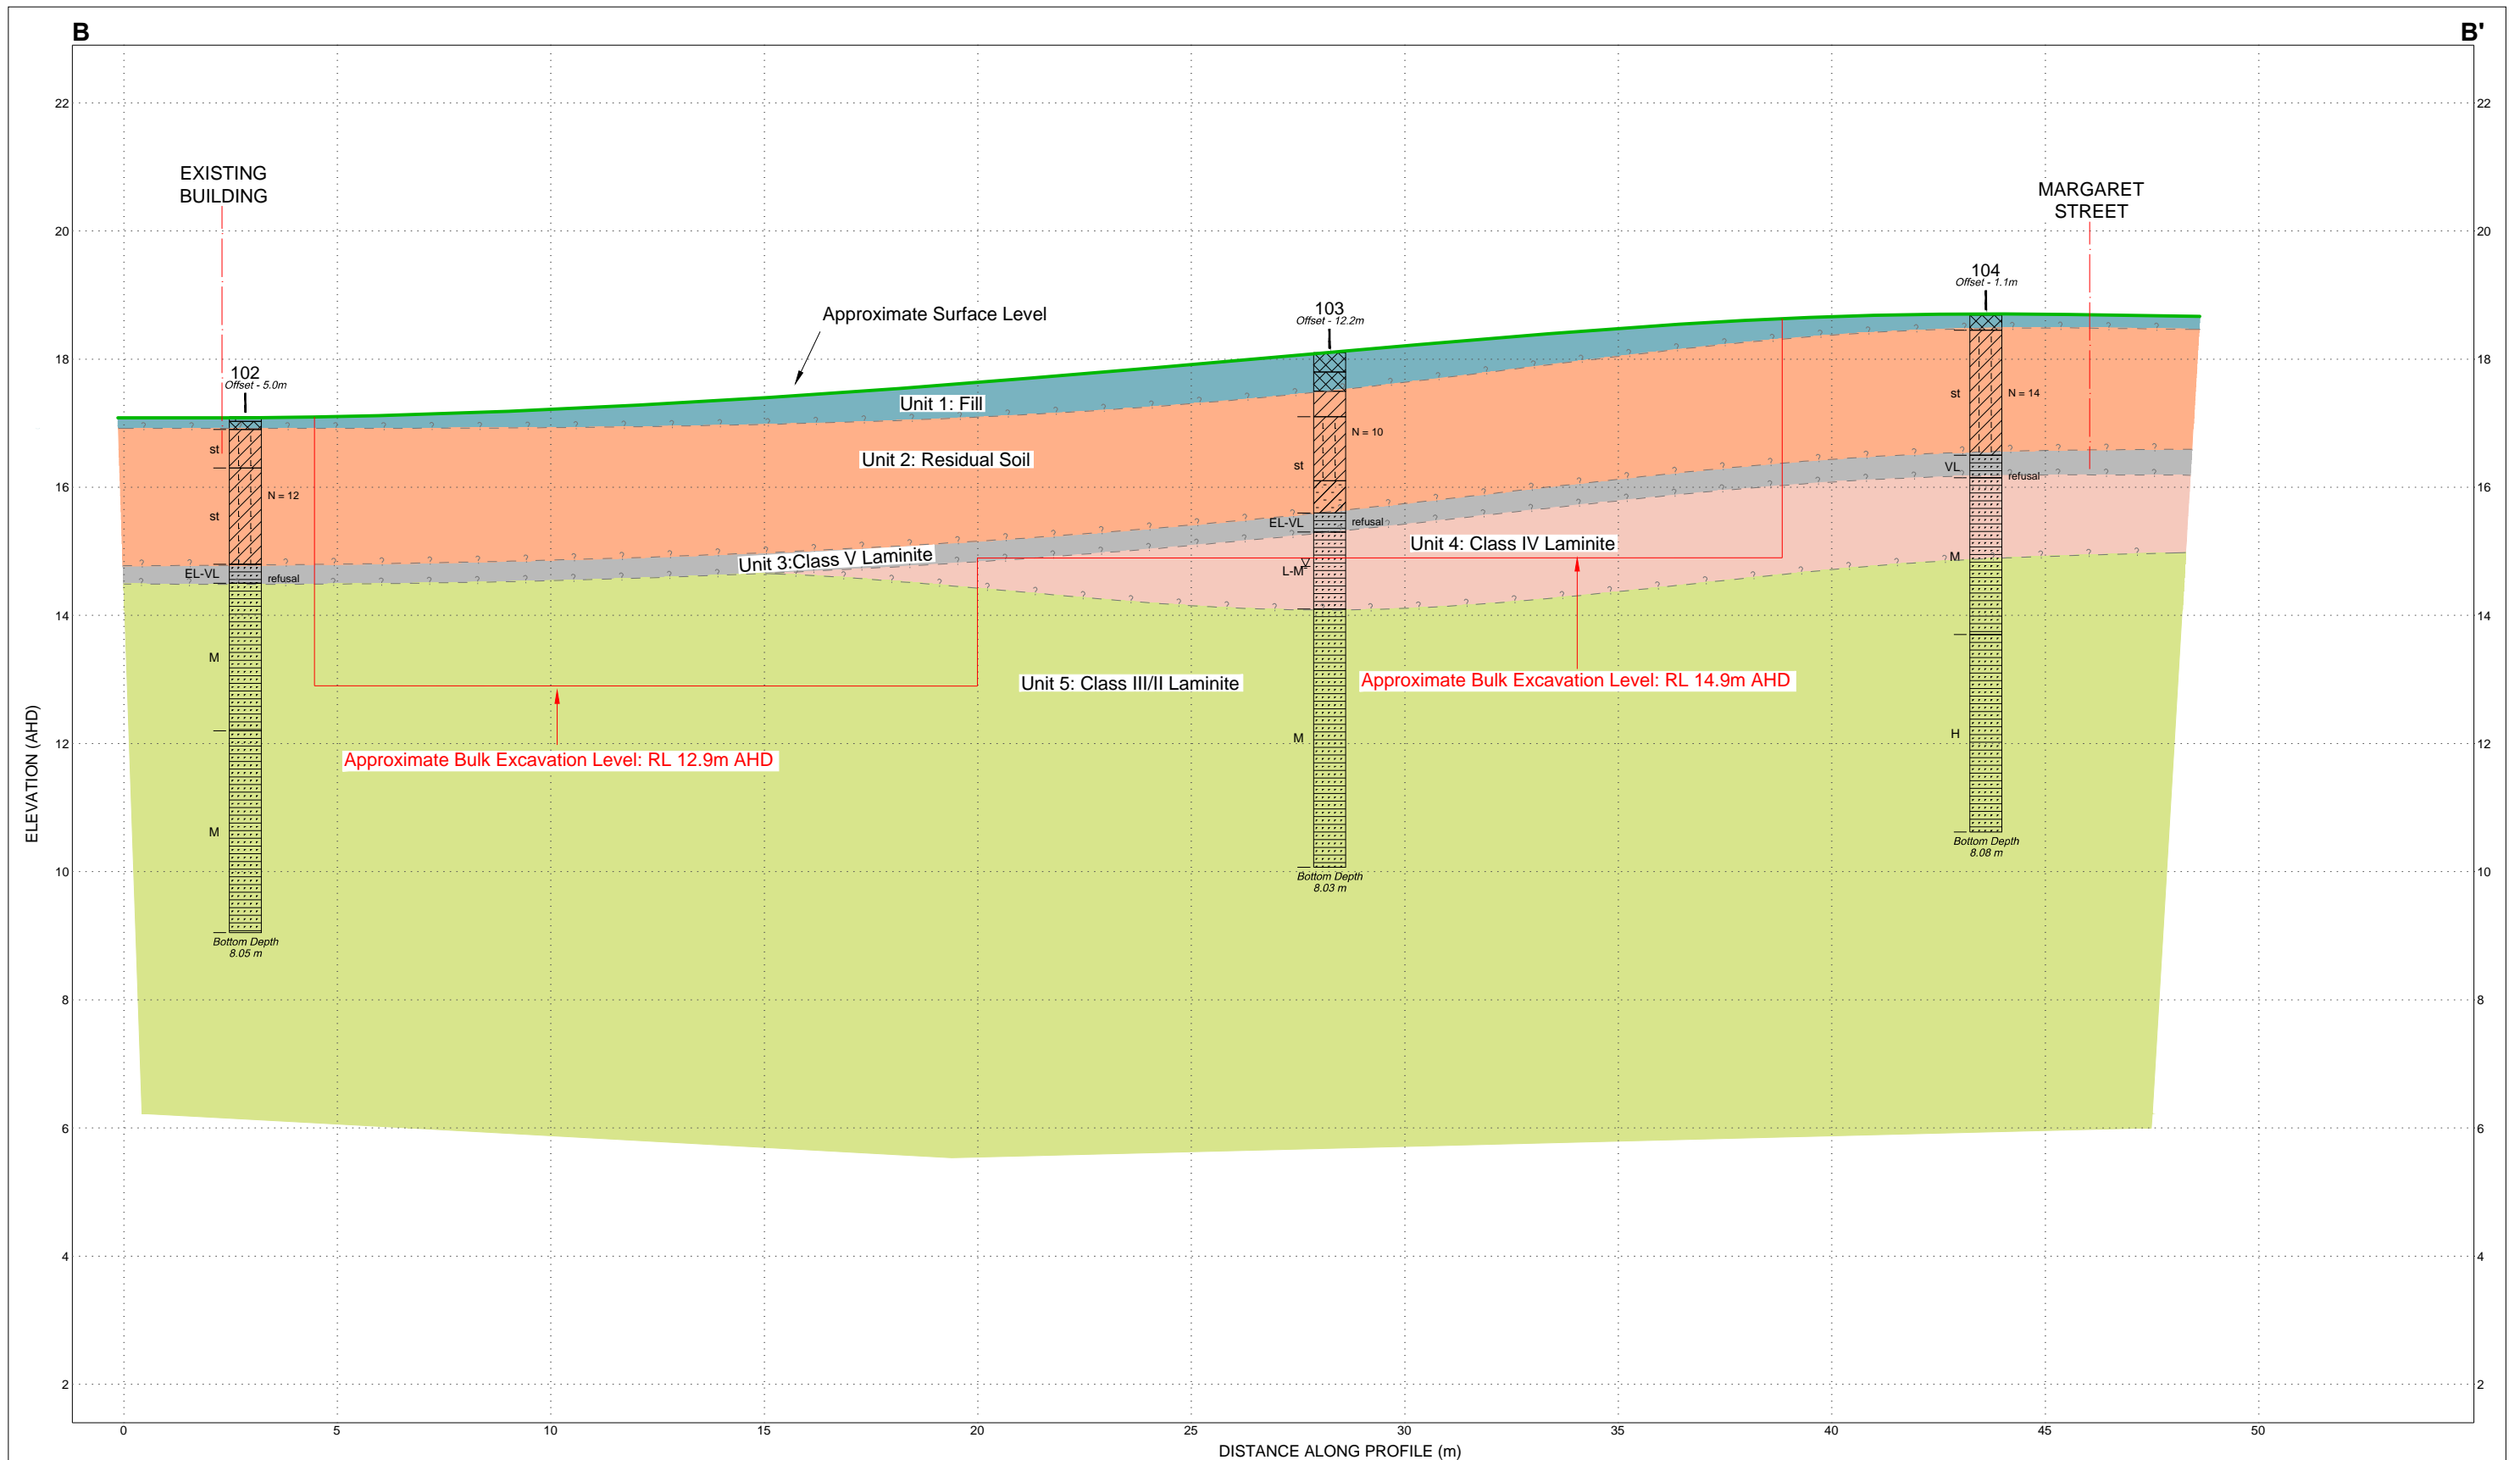
PROJECT No: 86568.00
 DRAWING No: 3
 REVISION: 0

TITLE: Cross-section B-B'
 Meriden Centre of Music and Drama
 13 Margaret Street, Strathfield

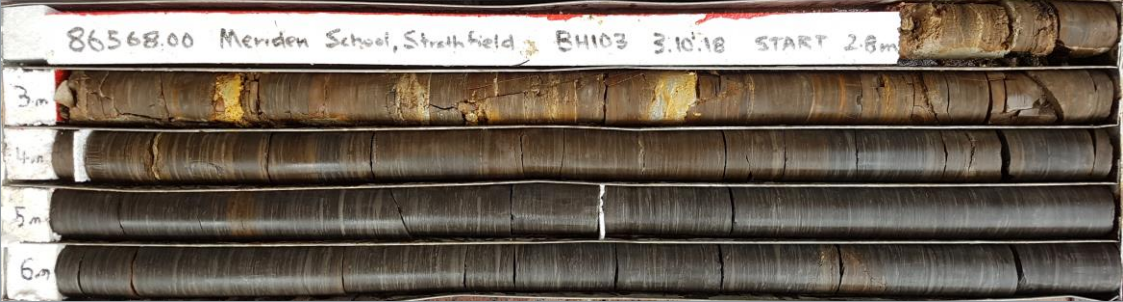
Project No: 86568.00
BH ID: 103
Depth: 2.80-7.00m
Core Box No.: 1/2

2.80 - 7.00m

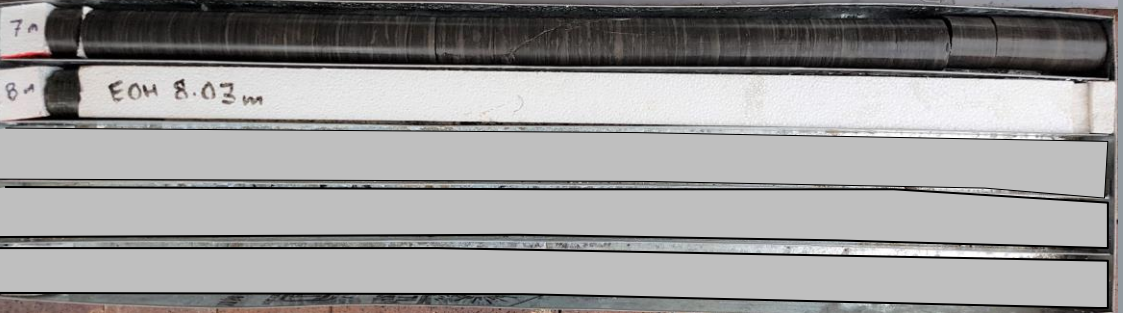
Project No: 86568.00
BH ID: 103
Depth: 7.00-8.03m
Core Box No.: 2/2

7.00 - 8.03m

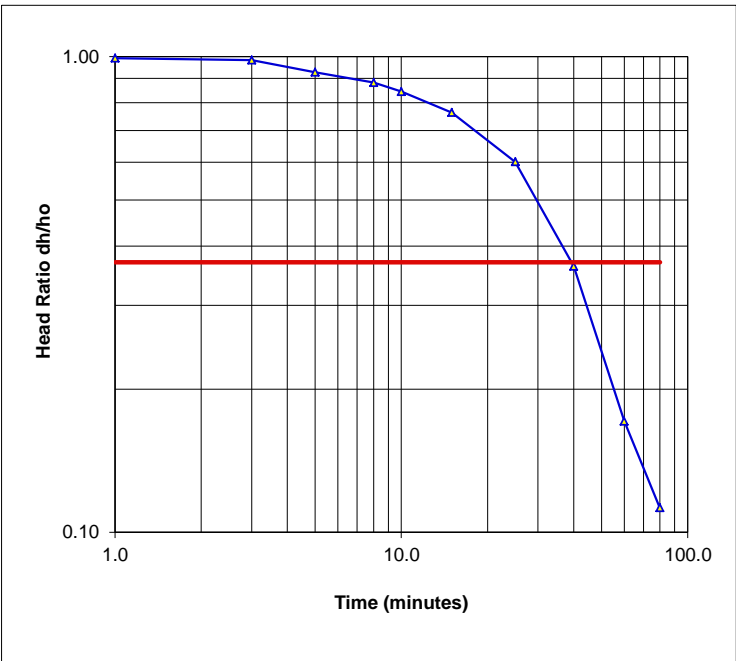
Permeability Testing - Falling Head Test Report

Details of Well Installation			
Well casing diameter (2r)	76 mm	Depth to water before test	3.36 m
Well screen diameter (2R)	76 mm	Depth to water at start of test	7.8 m
Length of well screen (Le)	4.5 m

Test Results			
Time (sec)	Depth (m)	Change in Head: dH (m)	dH/Ho
0	7.8		
1.0	7.77	4.41	0.993
3.0	7.73	4.37	0.984
5.0	7.48	4.12	0.928
8.0	7.28	3.92	0.883
10.0	7.11	3.75	0.845
15.0	6.75	3.39	0.764
25.0	6.03	2.67	0.601
40.0	4.97	1.61	0.363
60.0	4.12	0.76	0.171
80.0	3.86	0.50	0.113

To = 40 Minutes

Theory: Falling Head Permeability calculated using equation by Hvorslev
 $k = [r^2 \ln(Le/R)]/2Le T_o$
 where r = radius of casing
 R = radius of well screen
 Le = length of well screen
 To = time taken to rise or fall to 37% of initial change

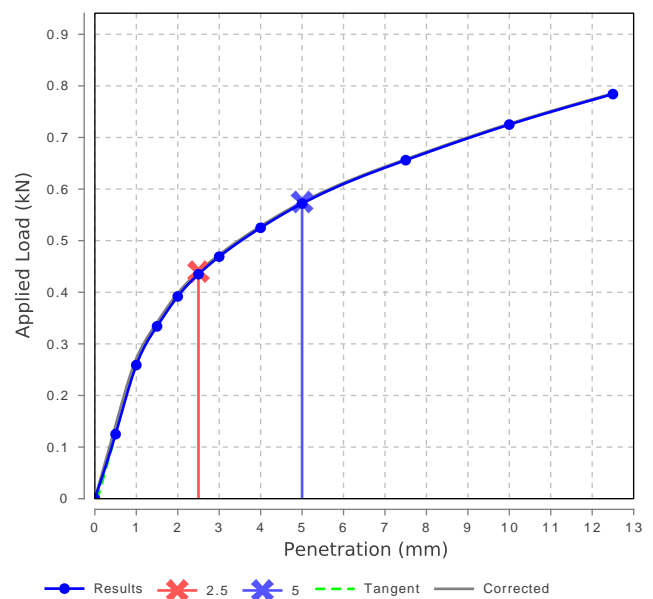
California Bearing Ratio (AS 1289 6.1.1 & 2.1.1)		Min	Max
CBR taken at	2.5 mm		
CBR %	3.5		
Method of Compactive Effort	Standard		
Method used to Determine MDD	AS 1289 5.1.1 & 2.1.1		
Method used to Determine Plasticity	Visual Assessment		
Maximum Dry Density (t/m ³)	1.51		
Optimum Moisture Content (%)	27.5		
Laboratory Density Ratio (%)	100.0		
Laboratory Moisture Ratio (%)	101.0		
Dry Density after Soaking (t/m ³)	1.50		
Field Moisture Content (%)	30.7		
Moisture Content at Placement (%)	27.6		
Moisture Content Top 30mm (%)	30.2		
Moisture Content Rest of Sample (%)	28.6		
Mass Surcharge (kg)	4.5		
Soaking Period (days)	4		
Curing Hours	170		
Swell (%)	0.0		
Oversize Material (mm)	19		
Oversize Material Included	Excluded		
Oversize Material (%)	0

The bulk soil sample that was tested returned a CBR value of 3.5%. Upon inspection of the bulk sample, it was noted that the sample contained some ironstone gravels, which can have the effect of artificially increasing the CBR value.
