Bayswater Water and Other Associated Operational Works Project

Appendix G – Land Contamination Constraints Assessment

Land Contamination Constraints Assessment

AGL Macquarie: Bayswater Power Station
New England Highway, Muswellbrook NSW

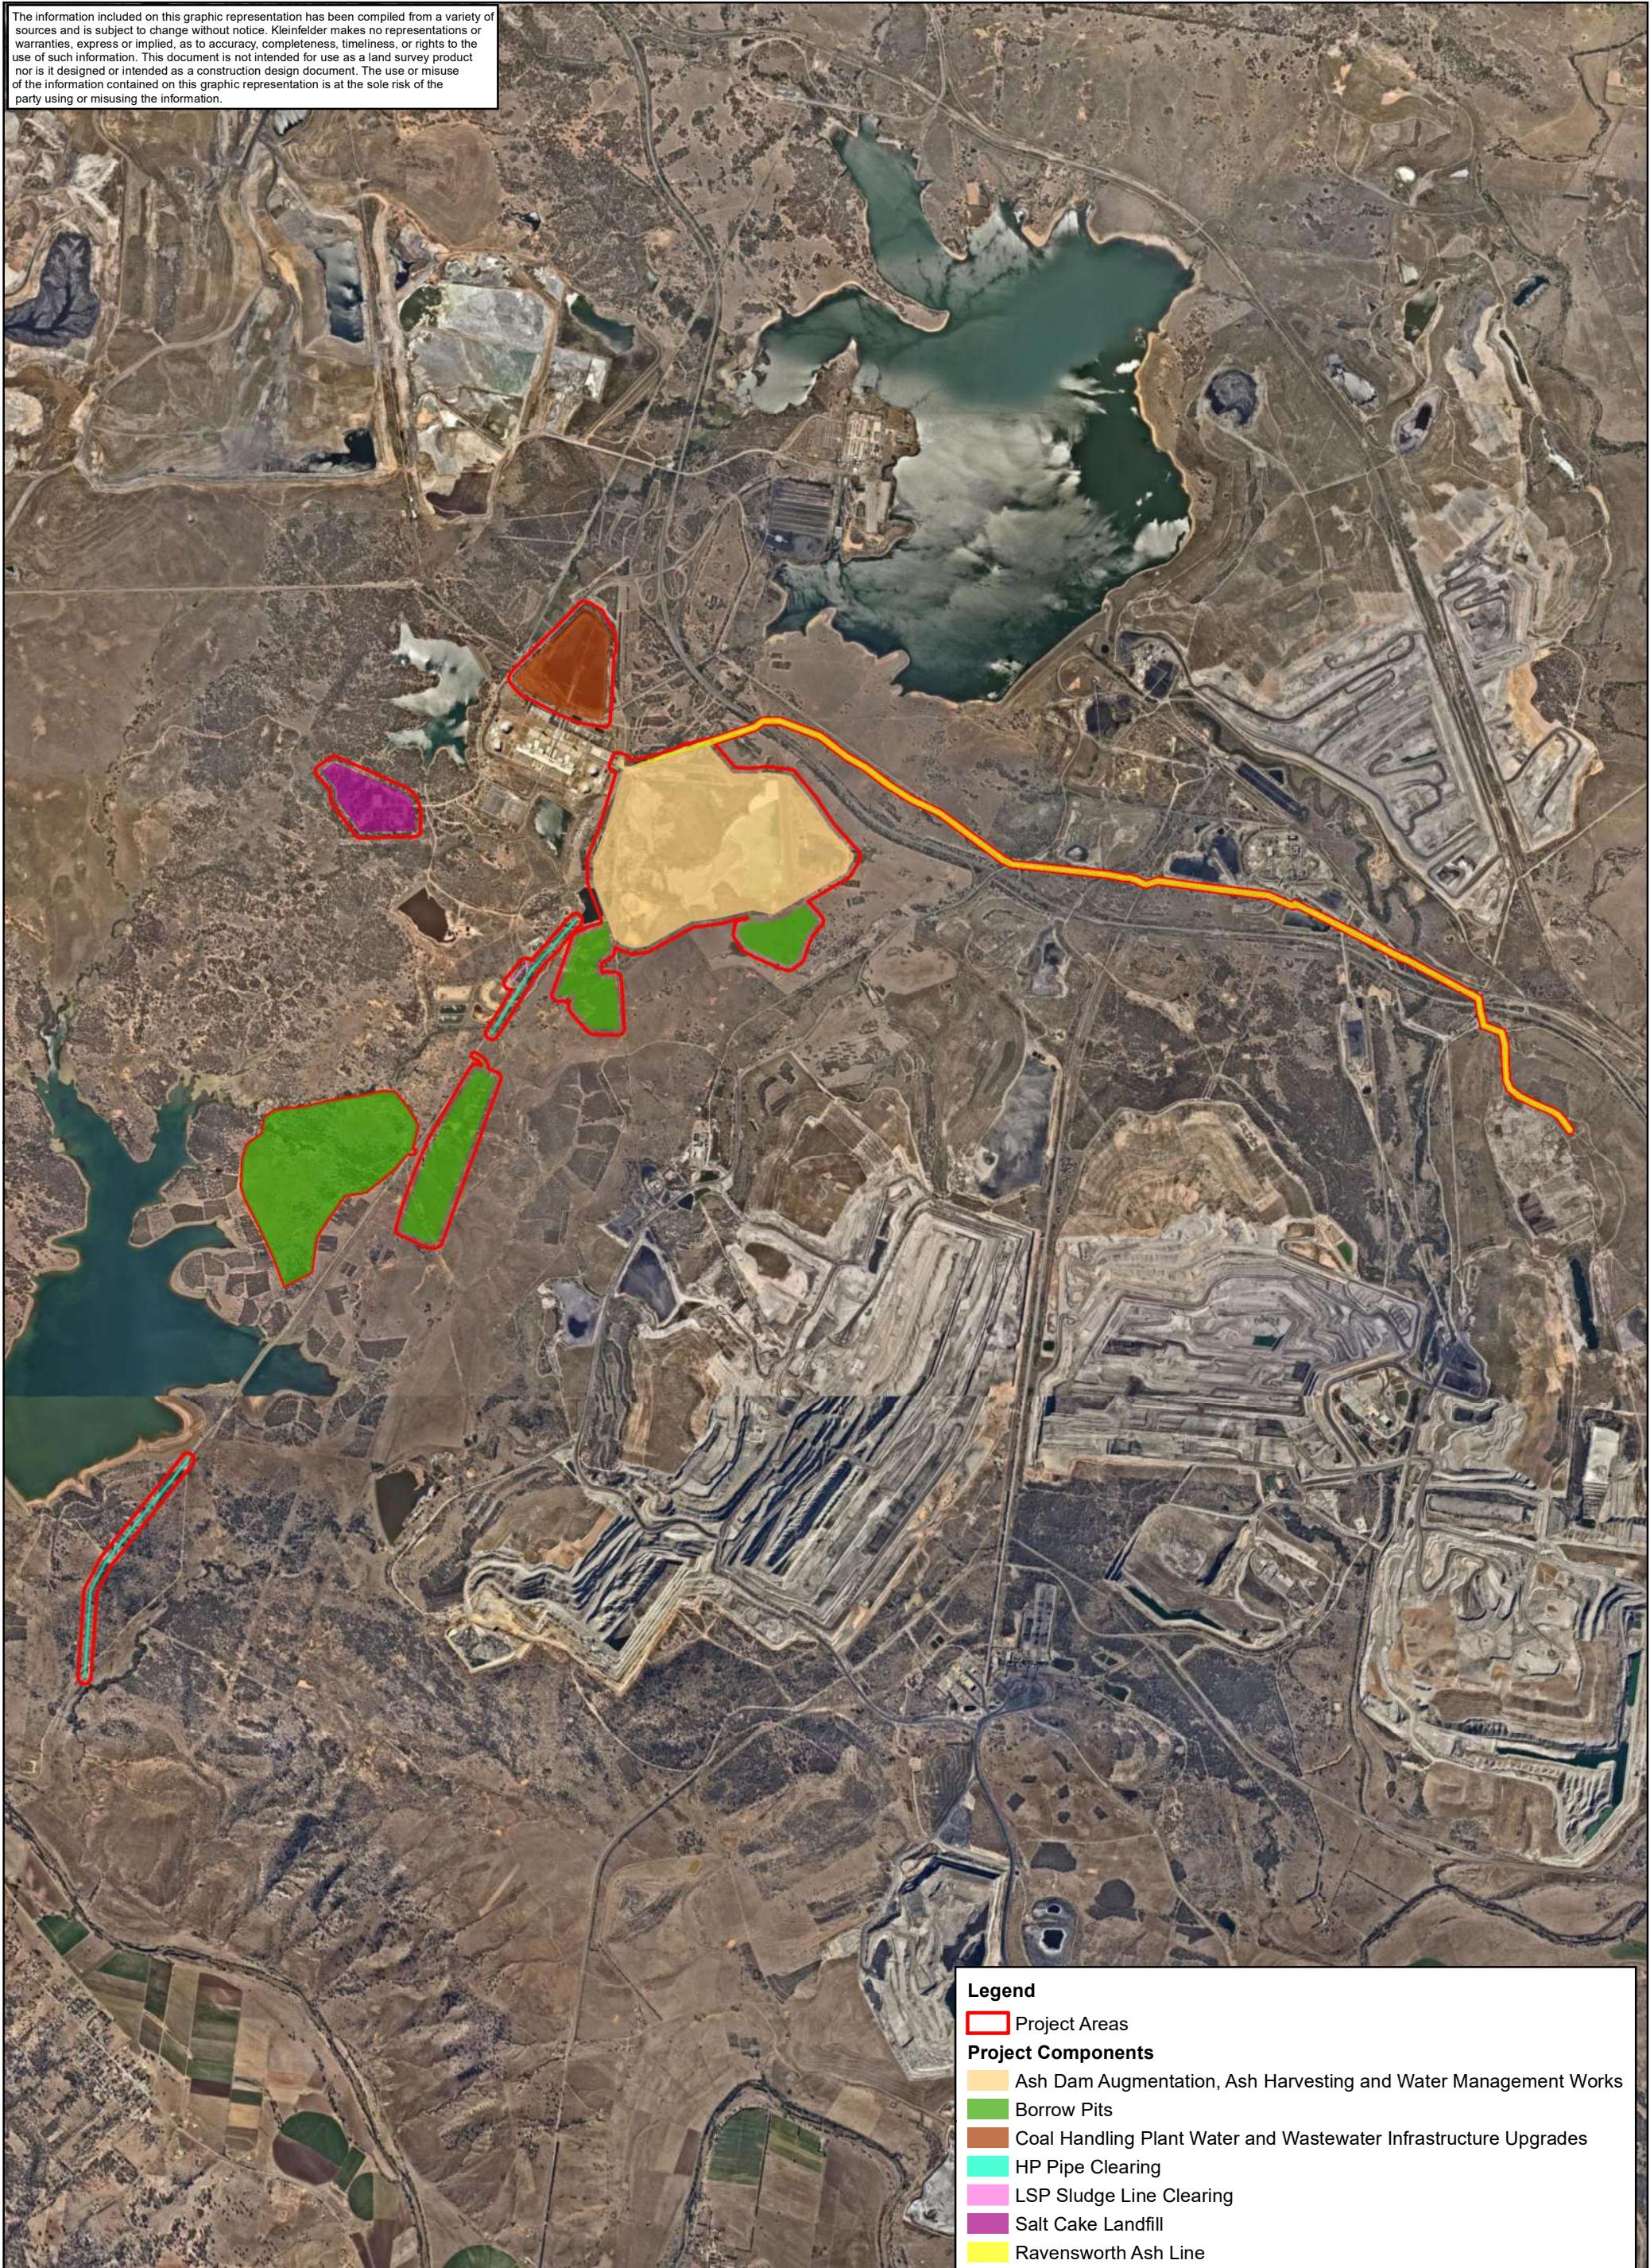
0 0.25 0.5 1 1.5 2 2.5 km	N	Project Components	FIGURE: 2
KLEINFELDER Bright People. Right Solutions. www.kleinfelder.com		Jacobs Group Land Assessment Bayswater Power Station

Refer to **Figure 2** for indicative study areas.

Given the geographically separated nature of the respective study areas across the BPS site (**Figure 2**), each of the six study areas has been assessed independently. The following section outlines the findings from the detailed visual inspection undertaken of each study area. A summary of the results of sampling undertaken within each area, either through a review of analytical data provided from previous assessments or as part of this current assessment by Kleinfelder, is also provided.

Refer to **Figure 2** for proposed Borrow Pit Locations.

Spatial boundaries: the lateral boundary of the investigation is limited to the boundary of the designated project areas (Refer to Figure 2). The vertical boundary is limited to the depth of sampling of surface soils.

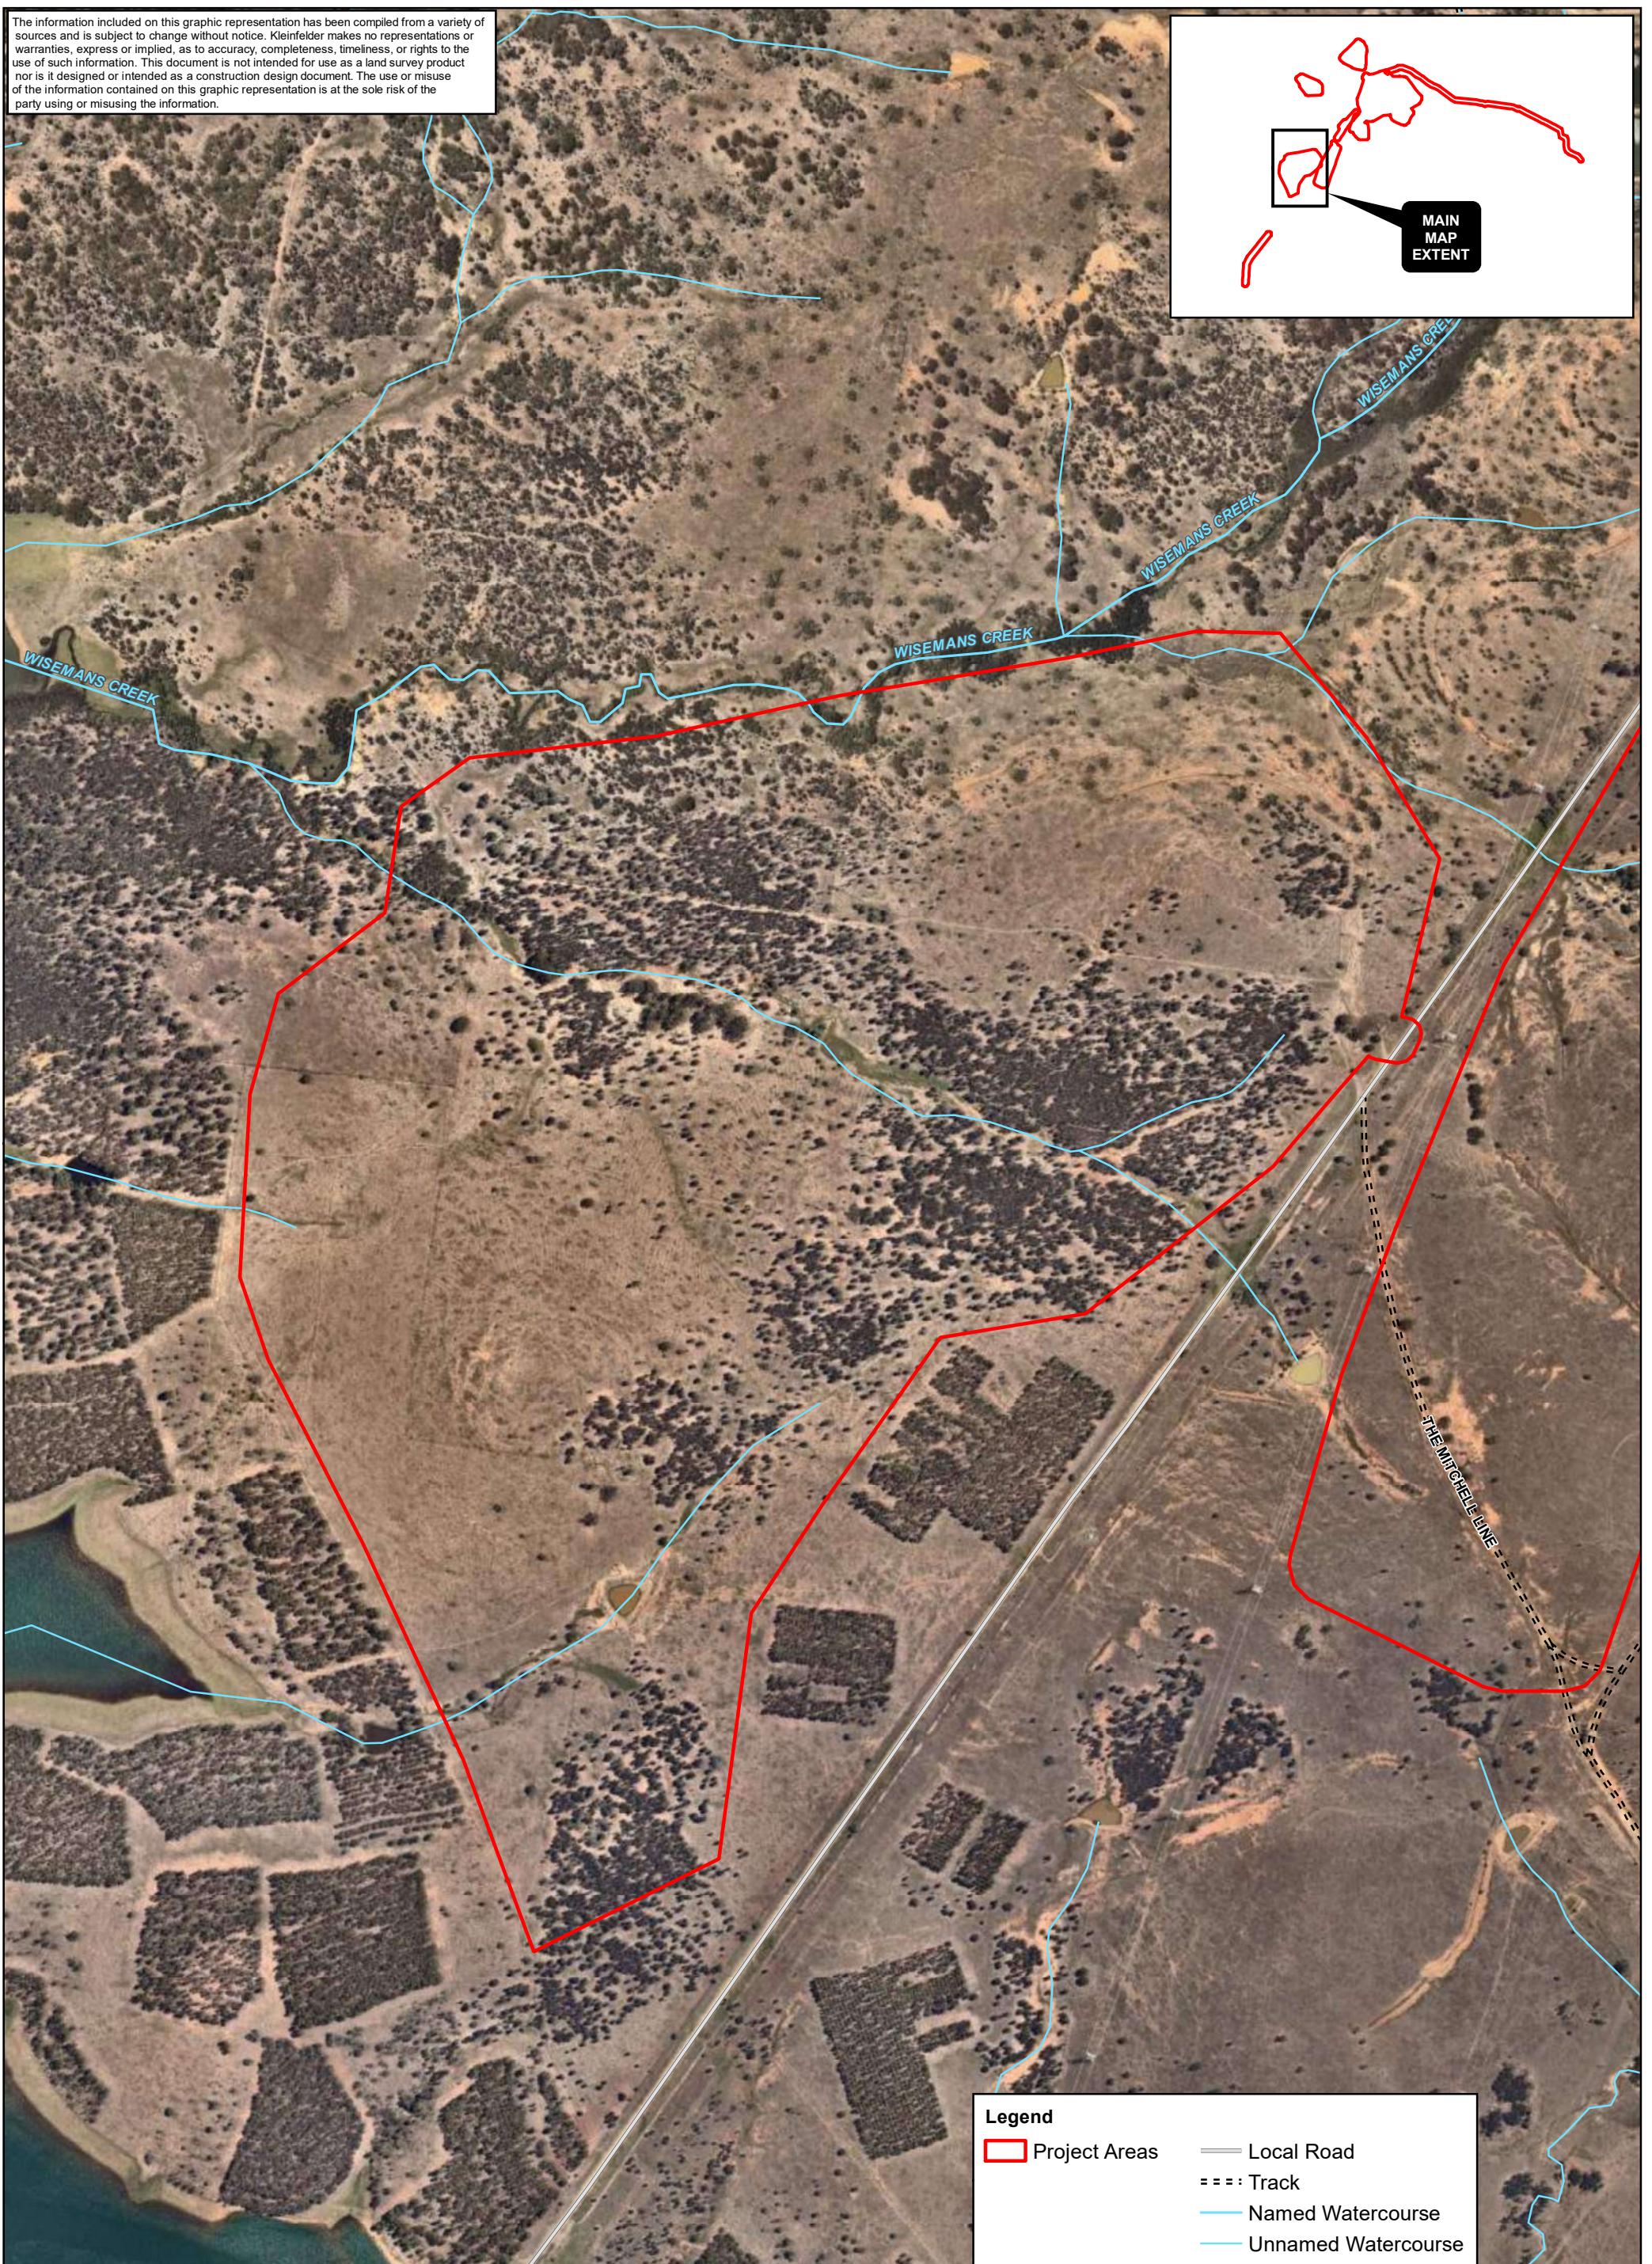
0 50 100 200 300 400 500 Metres	N	Jacobs Group Land Assessment Bayswater Power Station	FIGURE: 3
KLEINFELDER Bright People. Right Solutions. www.kleinfelder.com

Global Positioning System (GPS) and Historical Imagery	All locations were recorded using a GPS and camera. Locations of all samples are provided on Figure 3 . Photographs obtained during this investigation are provided in Appendix B .

Three surface soil samples were collected from locations with varied aspects across the proposed area (Refer to **Figure 3** for sample locations). Surface soils (up to depth of 150 mm) were observed to consist of natural dry, red/brown silty clays.

Three surface soil samples were collected from across the area (Refer to **Figure 3** for sample locations). Samples were collected from locations with varied aspects across the proposed area. Surface soils (up to depth of 150 mm) were observed to consist of dry, light brown silty clays.

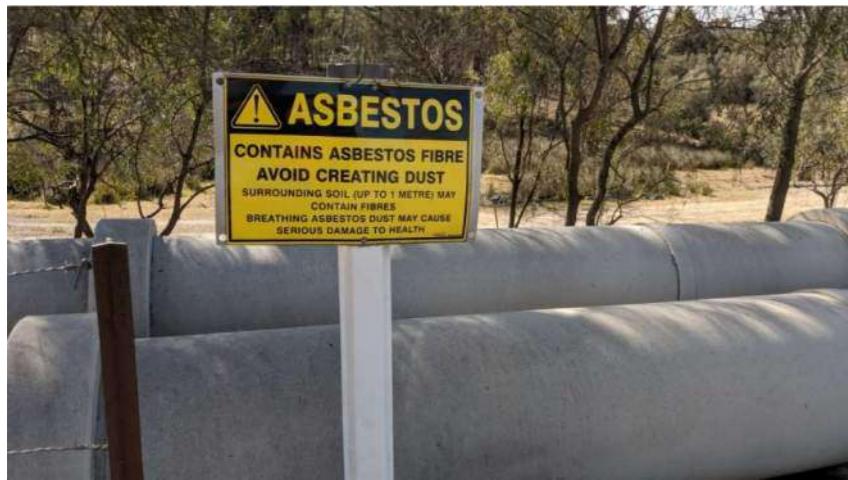
Above ground pipelines signed as asbestos containing material (**ACM**) were observed running from the return pumping station to the east of the ash dam wall, along the northern side of the ash dam to the return water holding tanks located to west of the ash dam. Signs were placed intermittently along the pipelines with the warning “contains asbestos fibre, avoid creating dust, surrounding soil (up to 1 metre) may contain fibres” (**Appendix B – Photo 1**). The pipelines appeared aged, but in reasonable condition, with limited visual indicators of deterioration.

Photo 1: Signage for ACM piping - north of the Fly Ash Plant

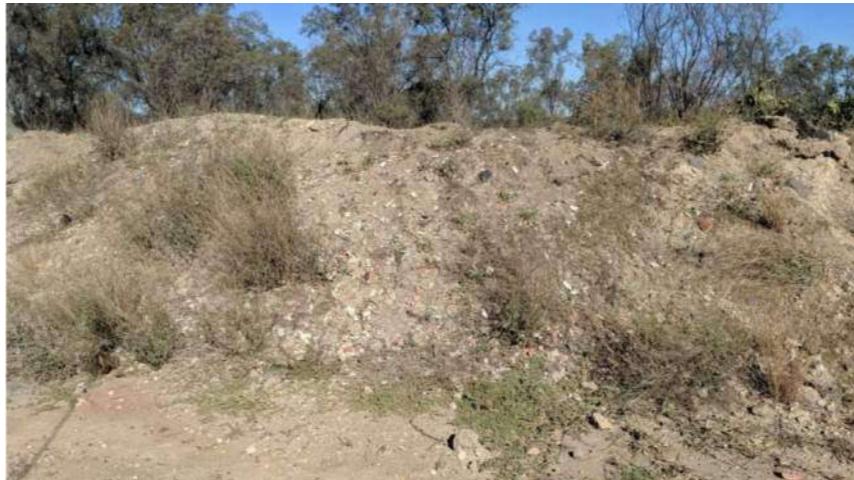
portion of the area appears to still be utilised by various contractors, including land maintenance contractors, for the storage of various equipment and materials. A wide variety of machinery and materials are currently stored in the area, including numerous shipping containers, large rolls of rubber conveyer belts, various industrial and former plant and equipment and empty drums. The area was also observed to contain multiple stockpiles of inert silty clay fill material, containing minor amounts of gravel, bricks, building rubble, wood chips and various anthropogenic materials, including concrete, plastics and timber (Refer to **Appendix B – Photo 2**).

Photo 2: Stockpiles of silty clay fill with anthropogenic materials – Former Contractor Storage Area

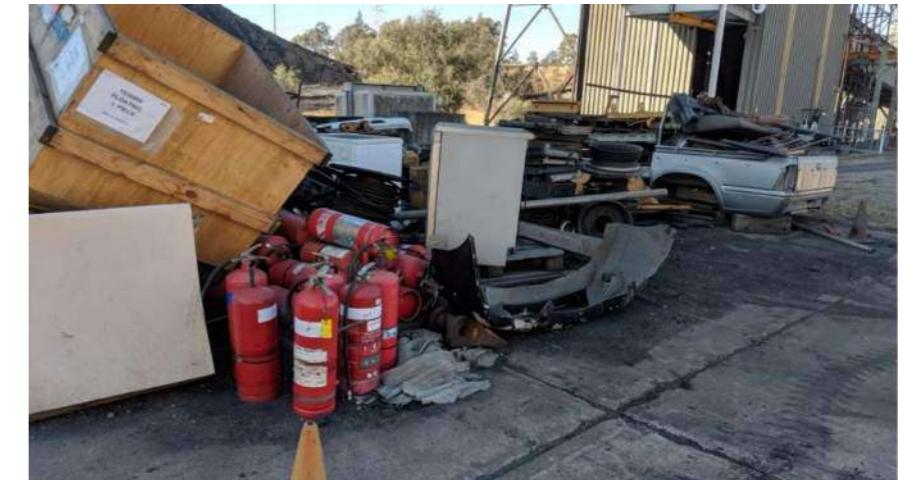
The mobile plant workshop and refuelling area is located directly to the south of the coal storage area and comprises an area of approximately 2,500 m². Numerous surface stains on the concrete in the refuelling and lubrication areas were observed, indicative of potential historical diesel spills and leaks (**Appendix B – Photo 3**).

Photo 3: Storage area – Mobile Plant Workshop and Storage Area

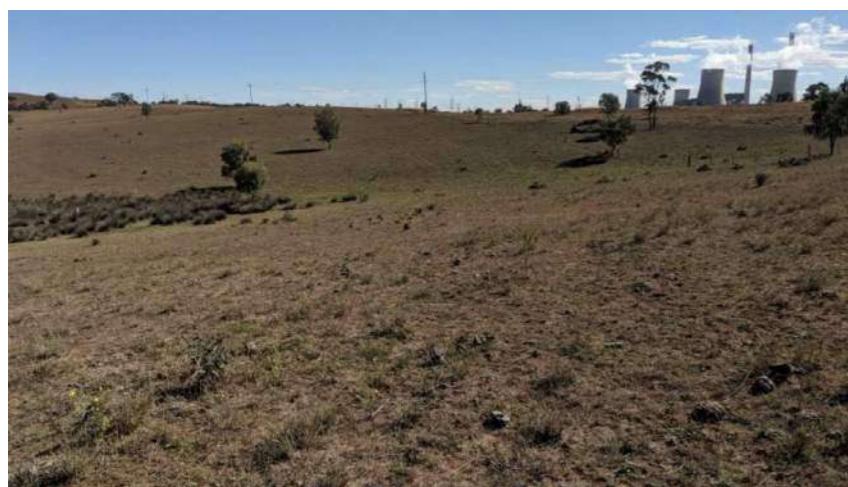
Visual indicators of contamination, such as surface staining, odours, fill materials or visibly stressed vegetation were not observed within the area during the inspection.

Photo 4: Borrow Pit 1 Area – Looking west toward operational area

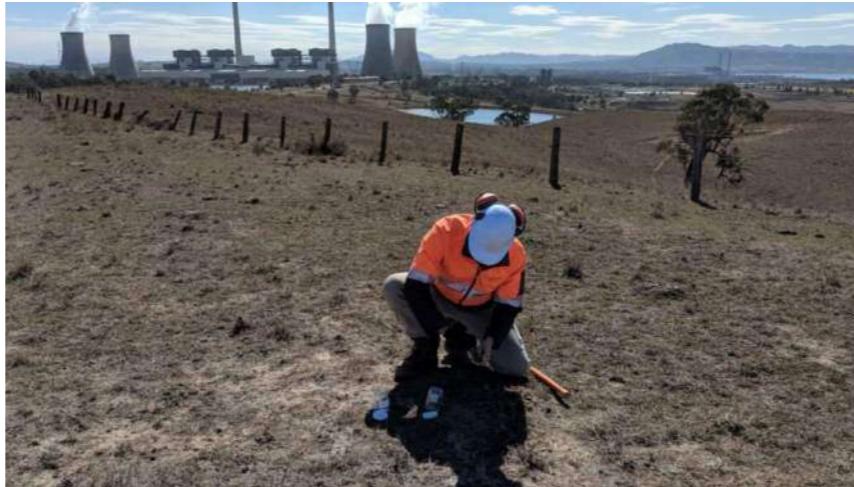
Visual indicators of contamination, such as surface staining, odours, fill materials or visibly stressed vegetation were not observed within the area during the inspection.

Photo 5: Borrow Pit 2 – Sample location with operational area to the north in the background

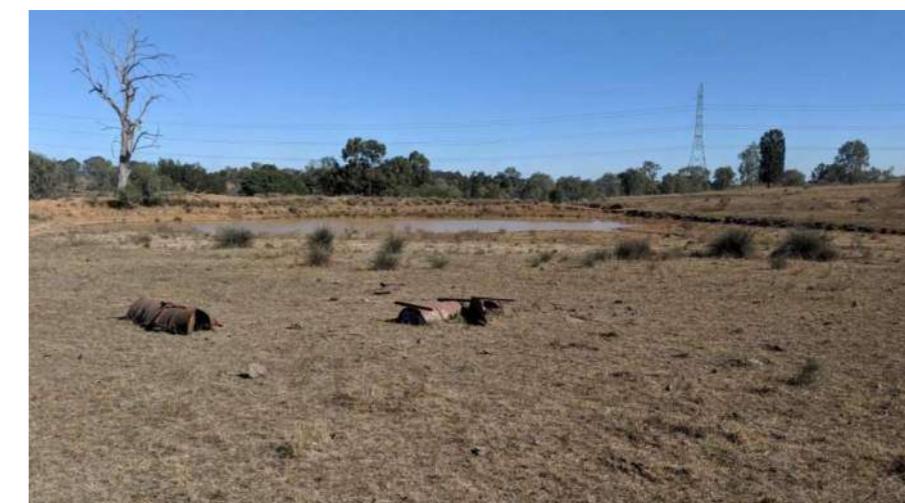
Visual indicators of contamination, such as surface staining, odours, fill materials or visibly stressed vegetation were not observed within the area during the inspection.

Photo 6: Borrow Pit 3 Area – looking west

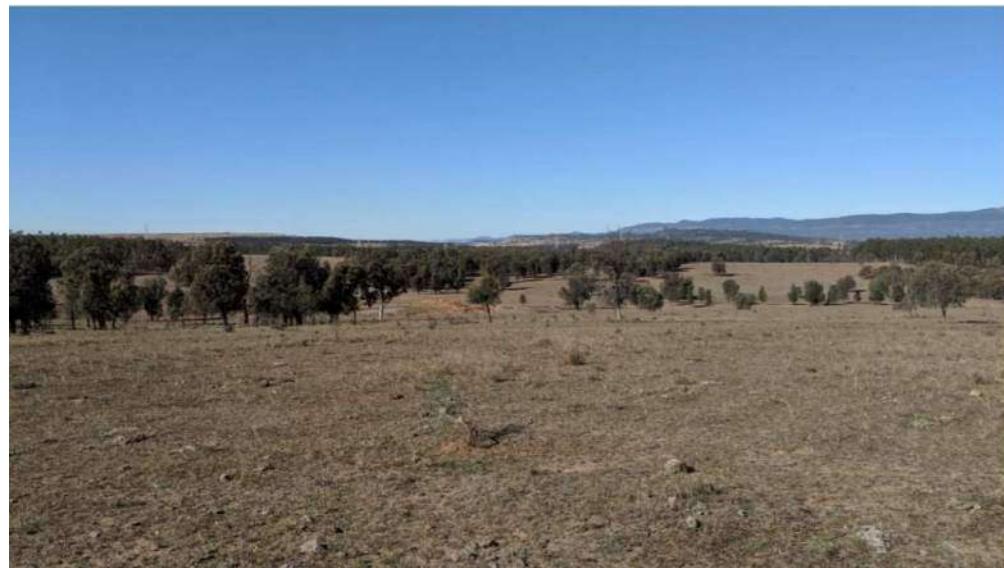
empty 40-gallon drums and a storage container. Visual indicators of contamination, such as surface staining, odours, fill materials or visibly stressed vegetation were not observed within the area during the inspection.

Photo 7: Borrow Pit 4 area – Looking south

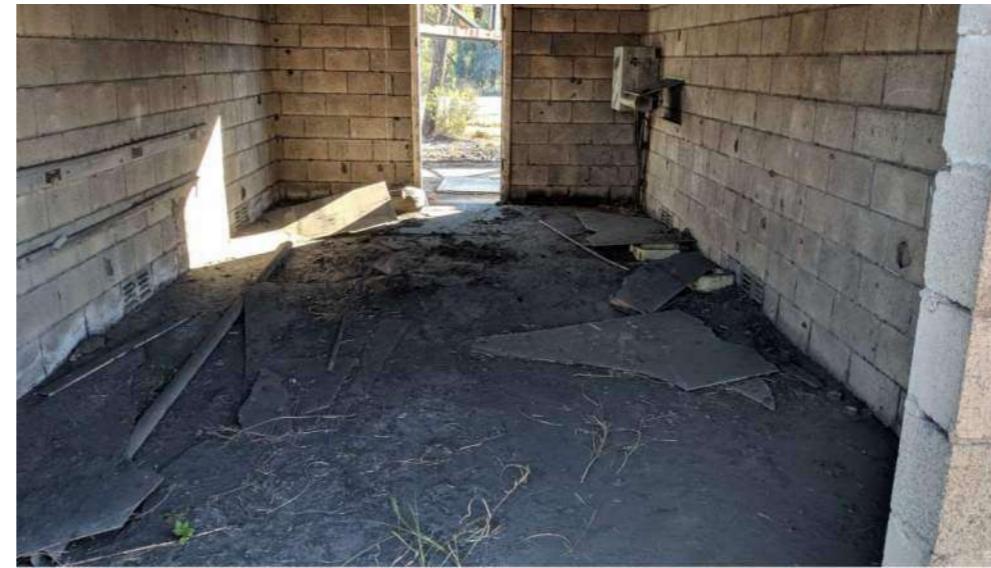
Suspected sheets of bonded asbestos-containing materials were observed on the ground within an abandoned concrete building adjacent to the intersection of the current pipeline and Liddell Station Road (Refer to **Appendix B – Photo 8**). Up to a dozen small stockpiles

Photo 8: Potential ACM sheeting within abandoned concrete building – intersection of ash pipeline and Liddell Station Road

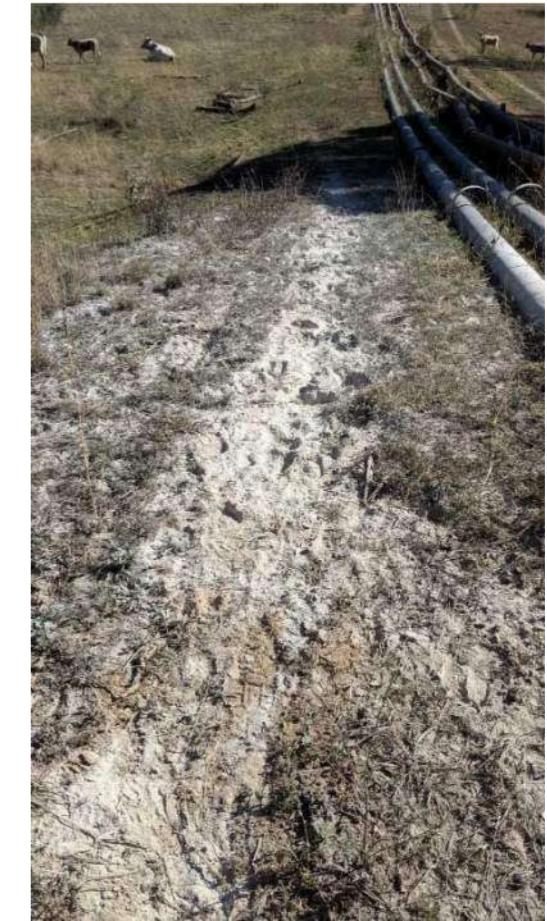
approximately 10-15 m³ in size of inert silty clay material with no observable anthropogenic materials were present at various locations along the existing ash line. A fine white/grey fly ash was observable on the surface in multiple locations along the current pipeline. AGL has advised that these are attributable to minor historical ruptures to the existing pipe. (Refer to **Appendix B – Photo 9**).

Photo 9: Suspected fly ash adjacent to minor pipeline rupture along Ravensworth Ash Line.

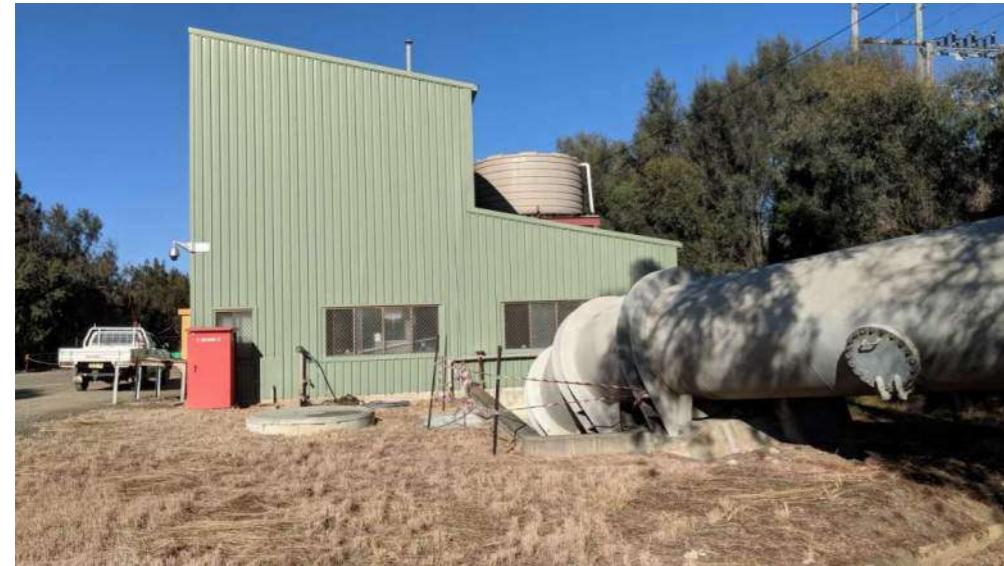
The High Pressure Pumping station is located approximately 8.6 km to the south-west of the operational area of BPS. BPS receives water from the High Pressure pumping station via the above and below ground pipelines (**Appendix B** – Photo 10). A small substation is located directly to the west of the main pump station building and is outside the study area. Visual indicators of contamination, such as surface staining, odours, fill materials or visibly stressed vegetation were not observed within the vicinity of the pumping station, or along the current pipeline during the inspection.

Photo 10: High Pressure Pumping Station

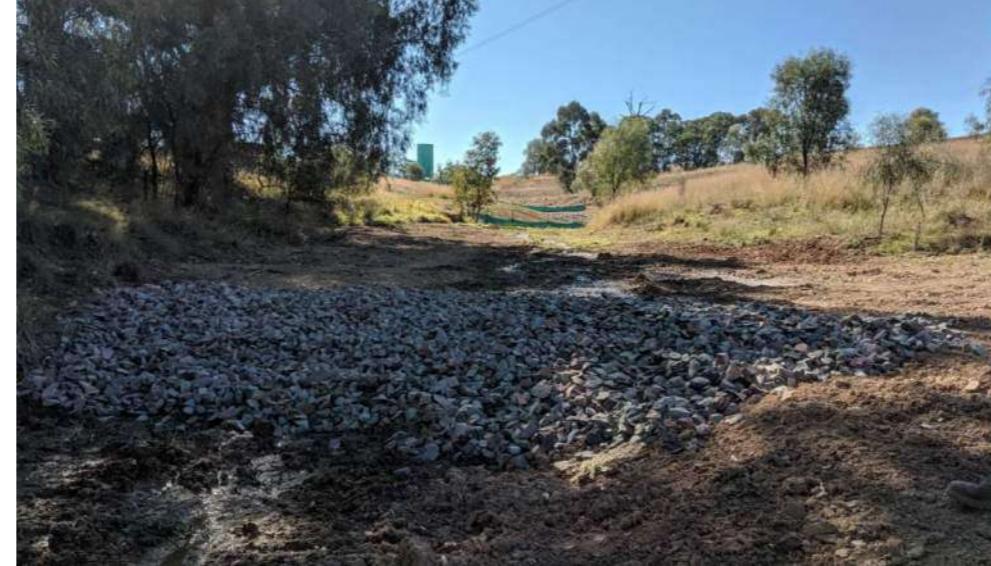
of inspection, the drainage line that runs adjacent to the area was undergoing rehabilitation (**Appendix 2 – Photo 11**). Visual indicators of contamination, such as surface staining, odours, fill materials or visibly stressed vegetation were not observed within the vicinity of the proposed LSP Sludge Line Area during the inspection.

Photo 11: LSP Sludge Line Area – Looking northward along drainage line undergoing rehabilitation.
