### Remedial Action Plan

Western Sydney University – Milperra Campus  
Horsley Road & Bullecourt Avenue, Milperra NSW

Report No:  
2300-RAP-01-300924.v1f

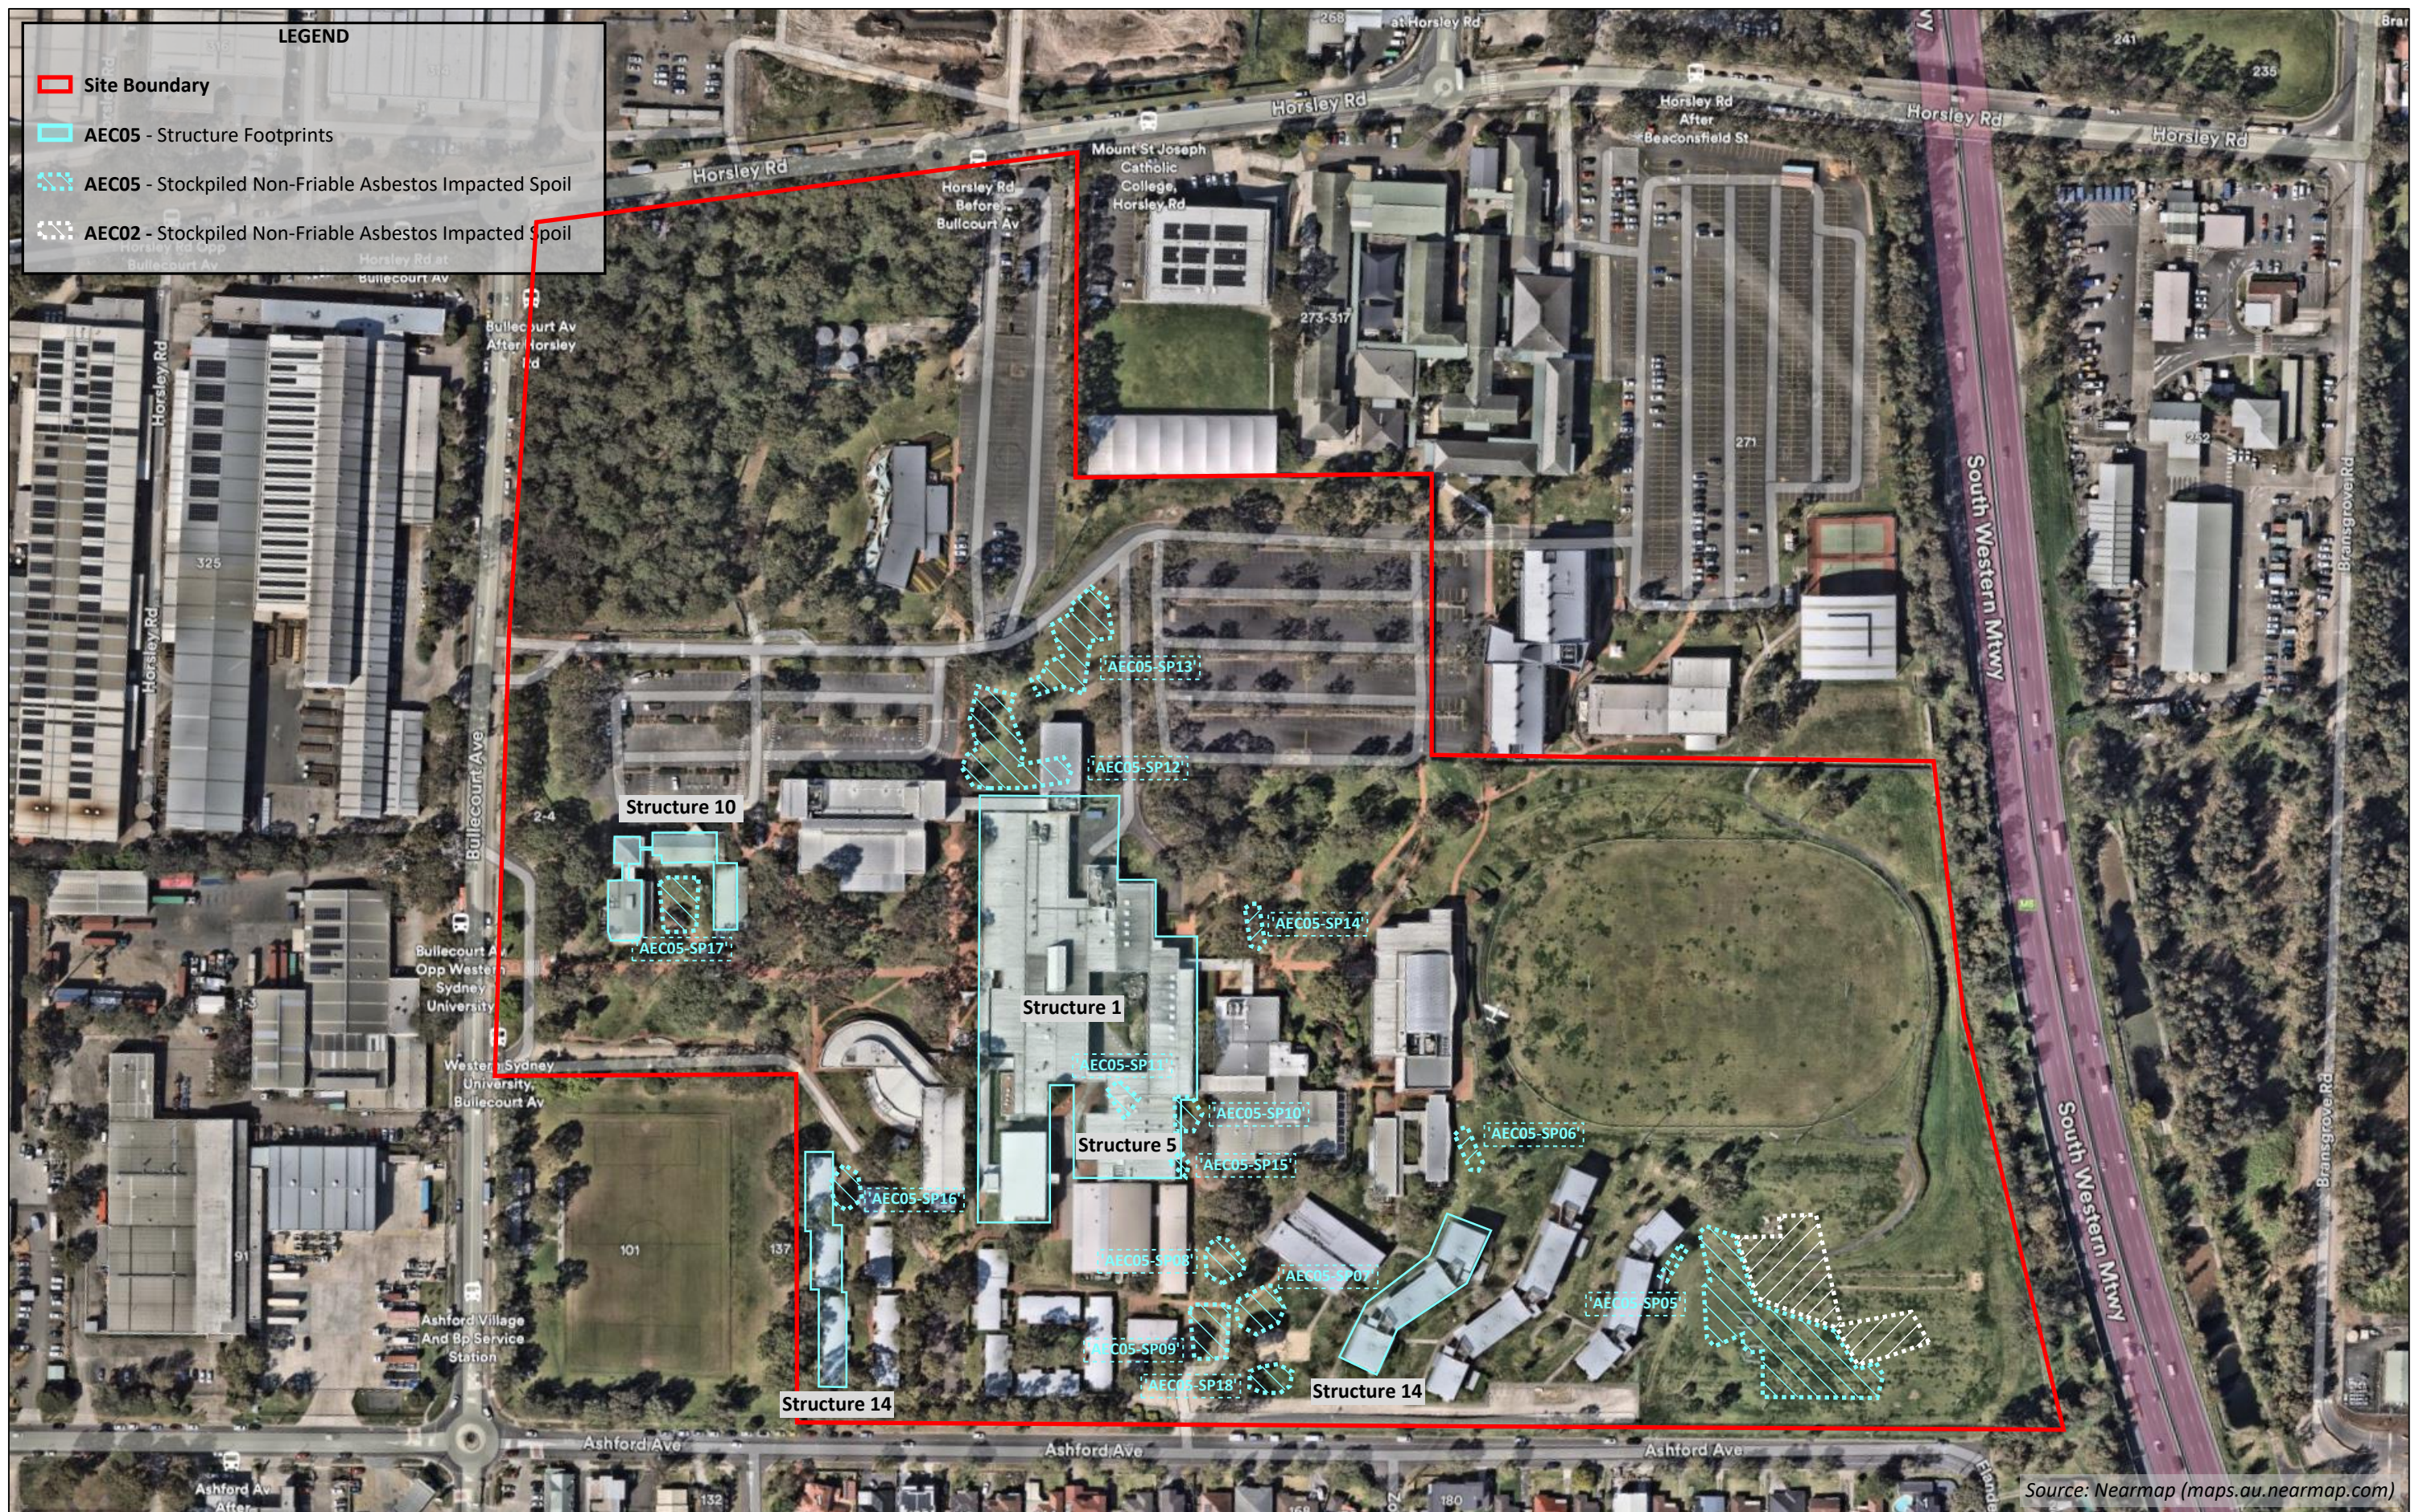
Approximate Remedial Extents - AEC05

Figure Number: 6  
 Figure Date: 7 August 2025  
 Report Number: 2300-RAP-01-300924.v1f
