Report on Detailed Site Investigation for Contamination

Proposed Sydney Swans HQ & Community Centre Royal Hall of Industries, 1 Driver Avenue, Moore Park

> Prepared for Sydney Swans Limited

> > Project 86724.00 May 2019

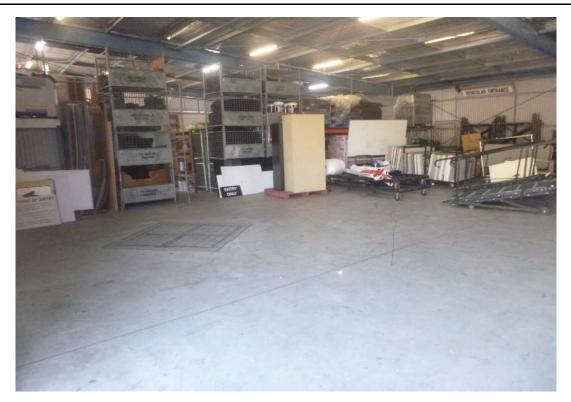
Photograph 3 - Inside shed

(Photograph 3, Appendix A). Paint cans were observed in the shed. The floor of the shed is a concrete slab and was observed to be in good condition.

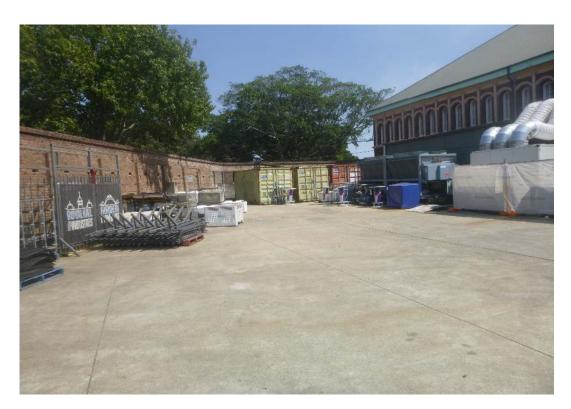
Photograph 4 - Southern end of site

The exterior area to the south, next to the shed and the Royal Hall of Industries building, was used for general storage of equipment and has a concrete surface (Photograph 4, Appendix A). A substation (kiosk) and air conditioning plant were next to the Royal Hall of Industries building.

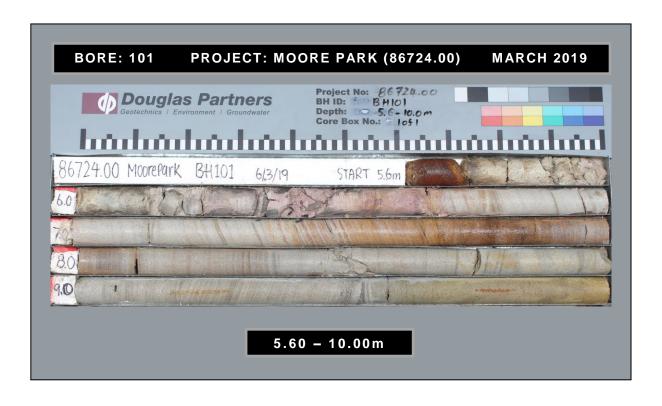
**PROJECT:** Sydney Swans HQ & Community Centre LOCATION: Royal Hall of Industries, 1 Driver Avenue, SURFACE LEVEL: 37.6 AHD

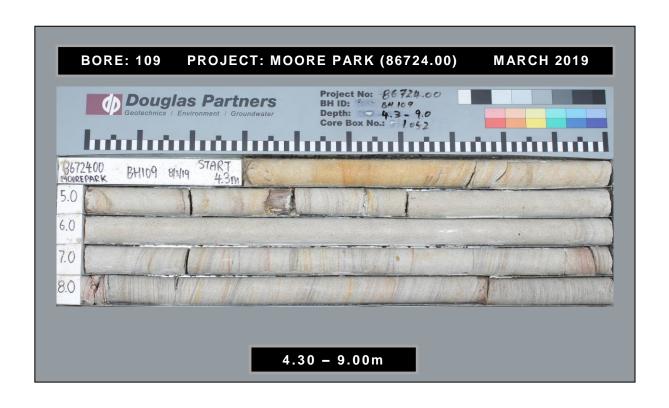
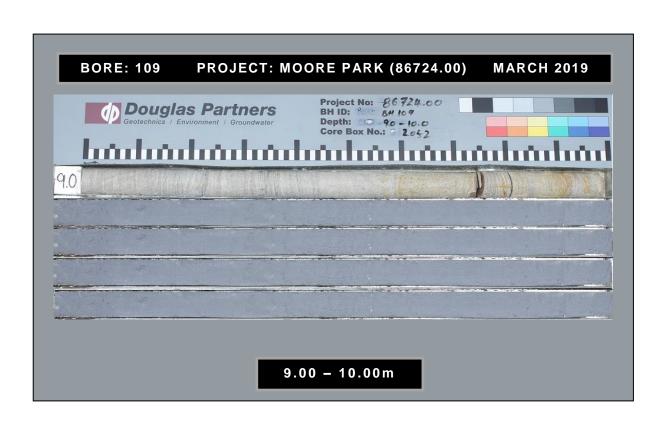
PROJECT: Sydney Swans HQ & Community Centre LOCATION: Royal Hall of Industries, 1 Driver Avenue,

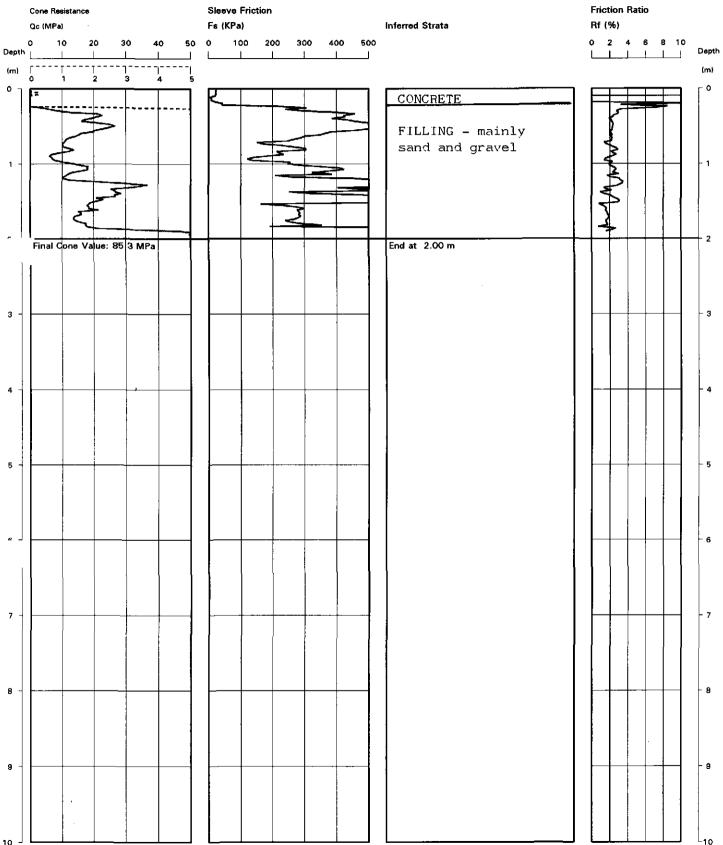
37.5 PROJECT No 24967

REMARKS: HOLE COLLAPSE AT 1.9 METRES DEPTH REFUSAL ON OBSTRUCTION

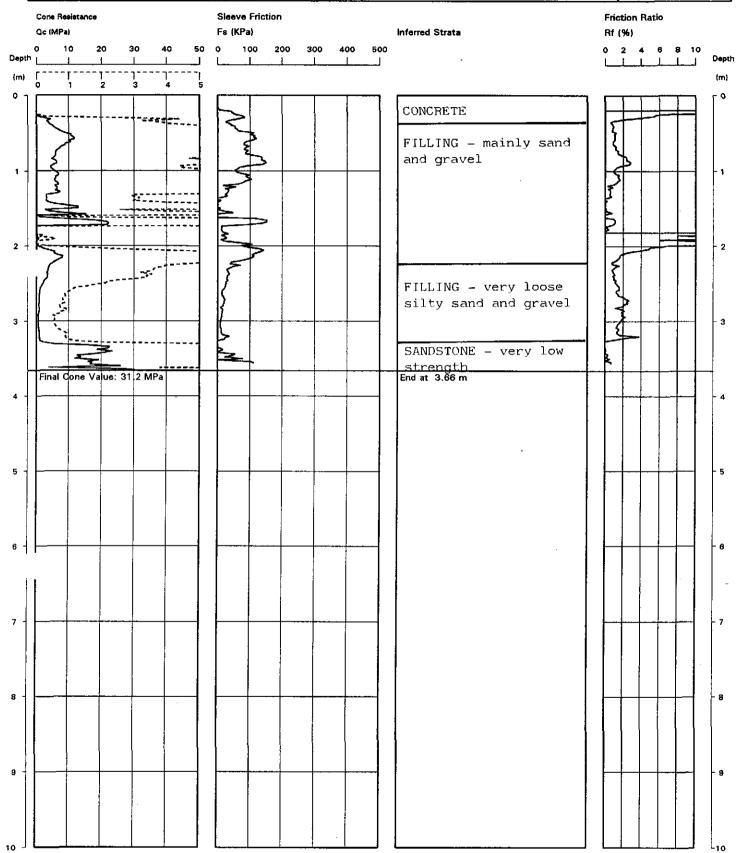
PROJECT No 24967

REMARKS: HOLE COLLAPSE AT 2.7 METRES DEPTH File: A:\24967-6A.CPT DUMMY CONE FROM 1.7-2.2 METRES DEPTH Cone ID: CONE 1010 Type: Standard

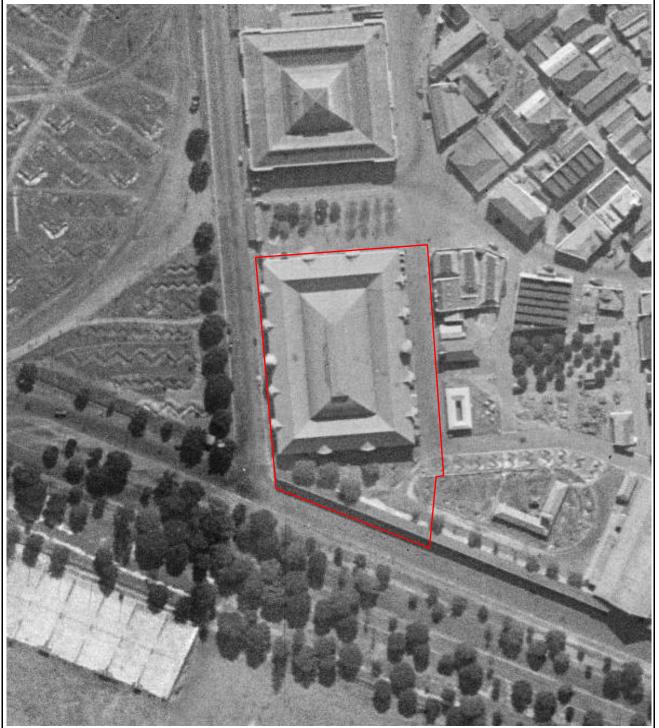
1943 Aerial Photograph	PROJECT:	86724.00
Royal Hall of Industries	PLATE No:	D2
1 Driver Avenue, Moore Park	REV:	0
CLIENT: Sydney Swans Limited	DATE:	28-Feb-19

The southern part of the site was a garden area in the 1930s and 1940s with bomb shelters/trenches present in 1943 (according to aerial photographs). By 1961, a structure appears to have been present at this part of the site and was then removed by 1986. A shed and external (concrete slab) storage area were established at this part of the site by 2009. The site walkover revealed that there was a small workshop in the shed, however, no (significant) chemical stores were observed. The existing
