**Re: Lane Cove Data Centre – summary of changes for resubmission
Addendum Bushfire Protection Assessment, Vegetation Management Plan,
Watercourse Assessment Report
1 Sirius Road, Lane Cove West**

Vegetation Management Plan

Lot 1, DP1151370
1 Sirius Road
Lane Cove West

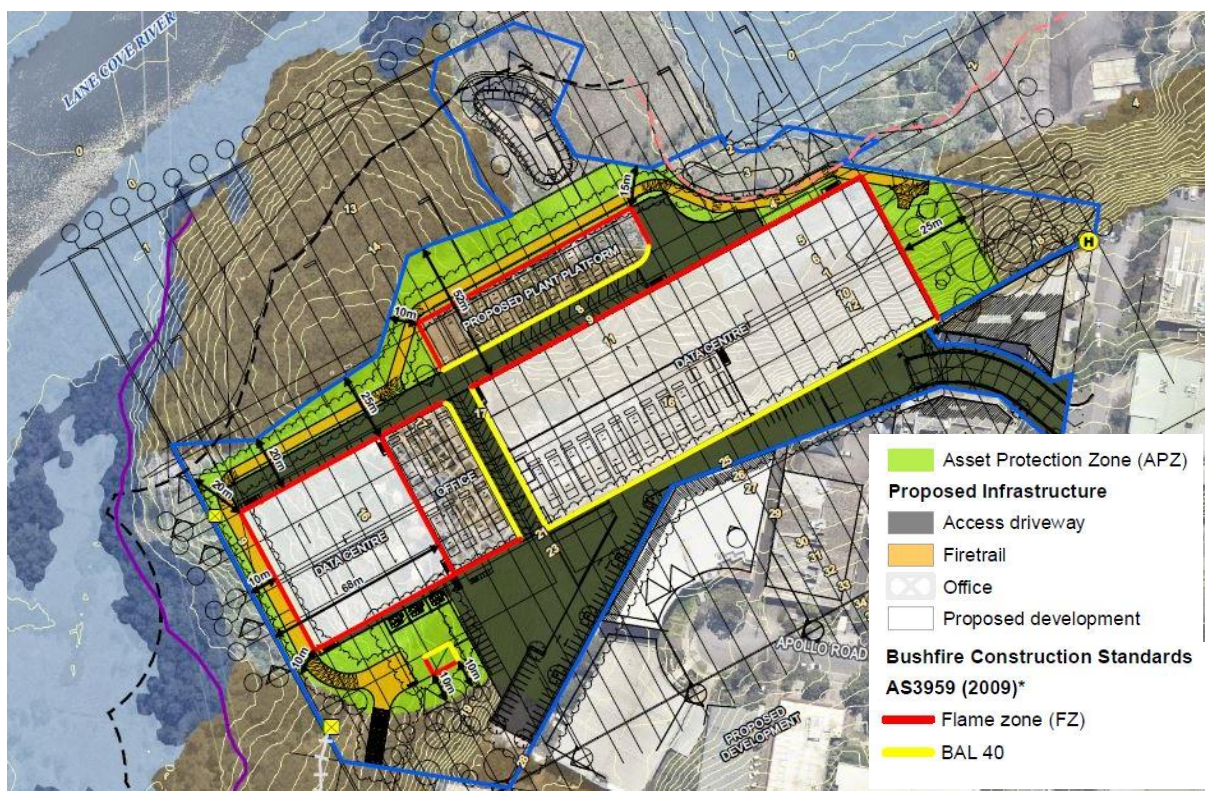
Figure 1 – Access design (July scheme)

Changes to the driveway include the provision of property access road around the southern, western and northern perimeter of the data centre building. The previous design depicted an access road through the centre of the site between the office and the data centre (refer Figure 1 – access in grey)

Changes in terms of building construction standards are highlighted in Figures 1 & 2. Based on the amended simplified design the roof, northern and western building facades of the data centre are to comply with BAL FZ. The remaining facades can step down to BAL 40. This is consistent with the recommendations from the NSW RFS.

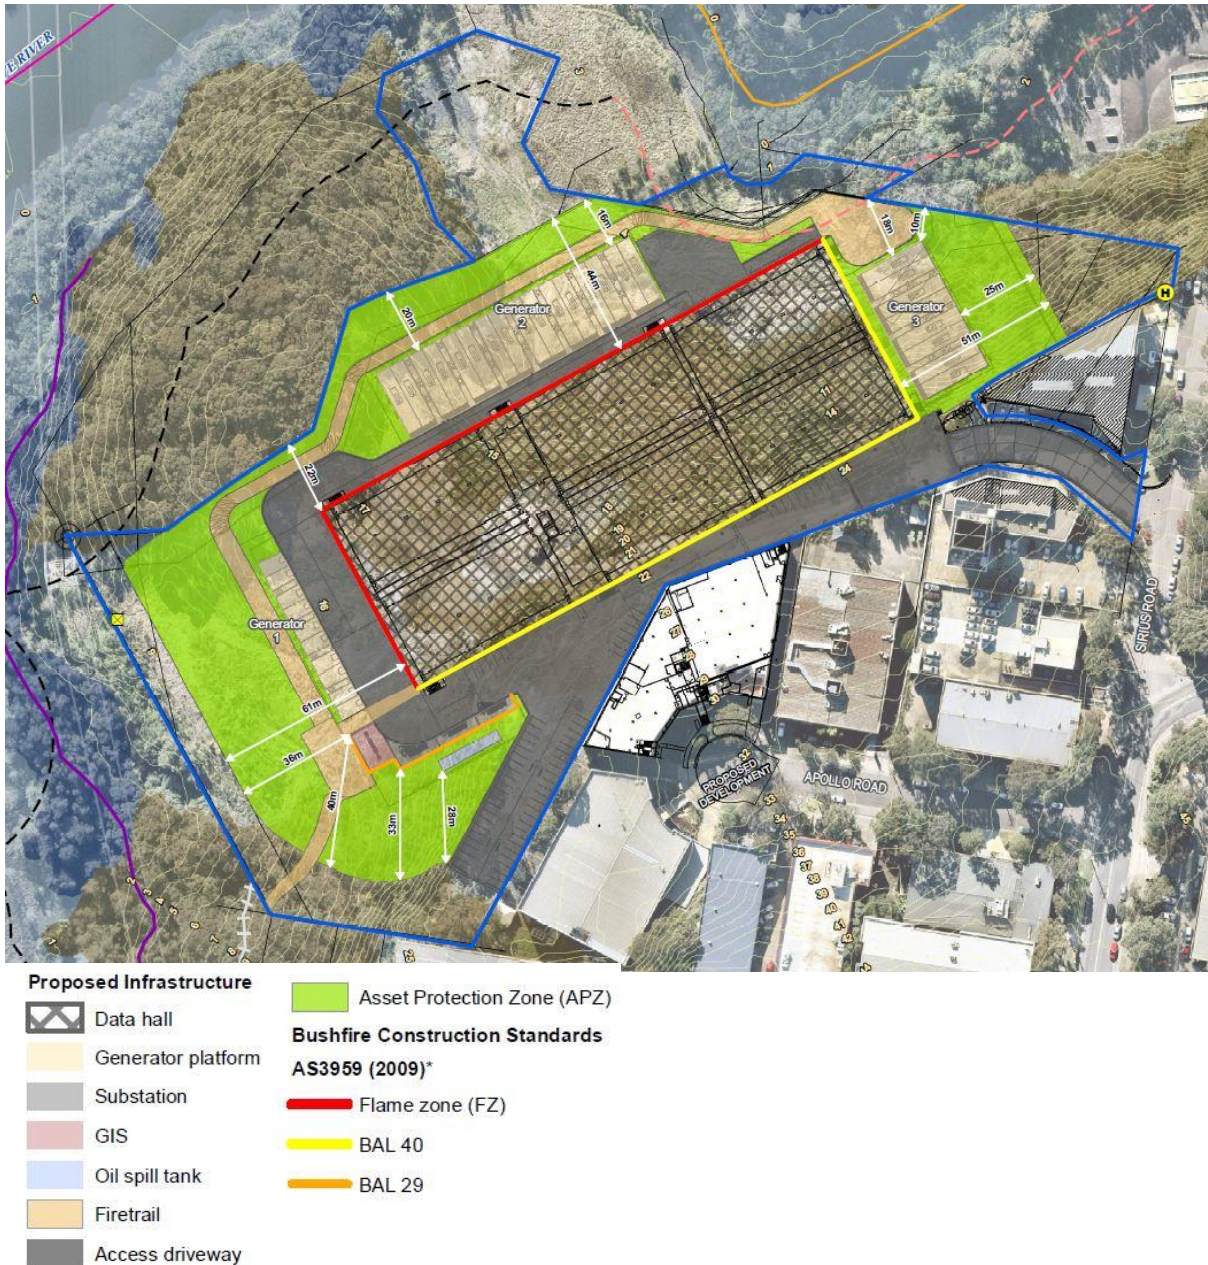
Figure 2 – Access design (new August scheme)

As outlined in the addendum bushfire report the revised scheme maintains compliance with the NSW RFS conditions for private roads. The revised scheme provides additional firefighting access and increased defendable space around the perimeter of the building therefore improving the bushfire protection measures afforded to the development.

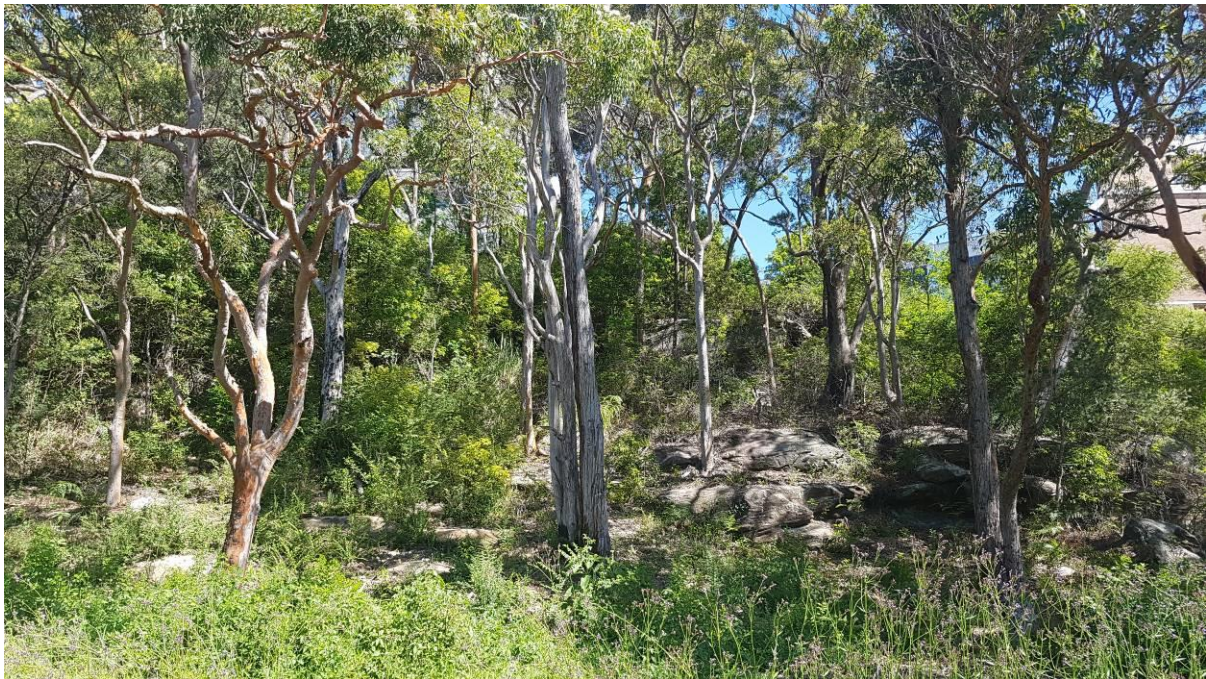
Photo 1 – Smooth-barked Apple - Red Bloodwood open forest (PCT 1776) in the north-eastern corner of the site.

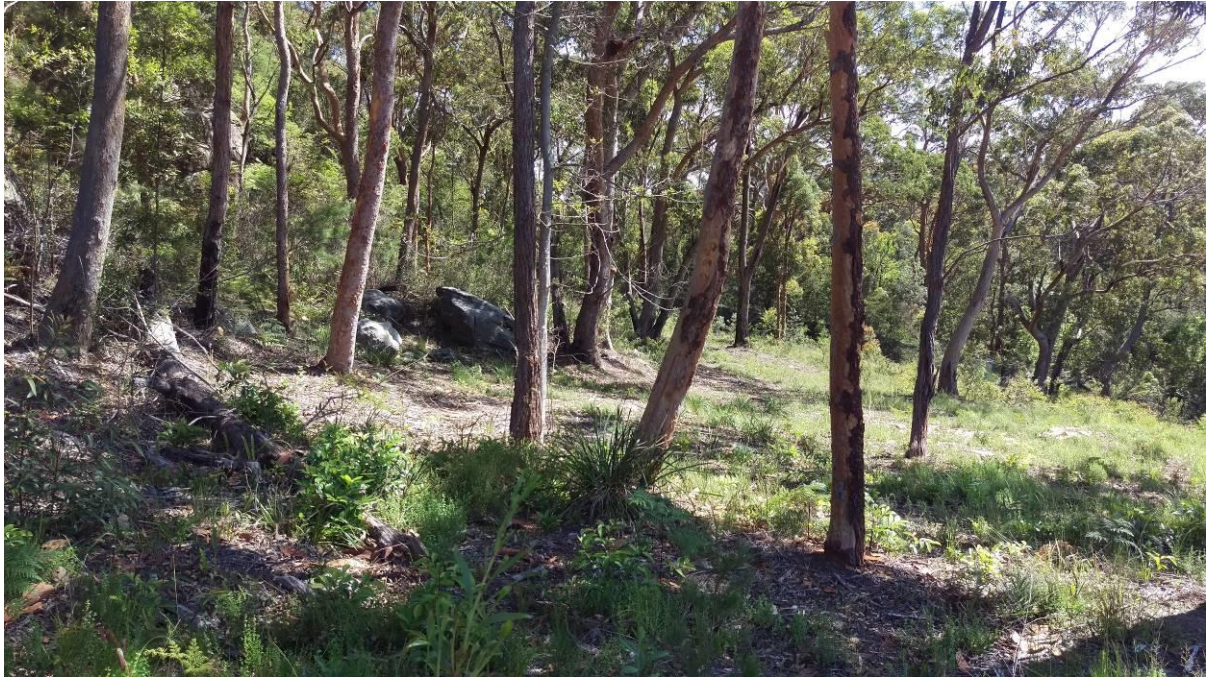
Photo 2 – Smooth-barked Apple - Red Bloodwood open forest (PCT 1776) in the southern corner of the site.

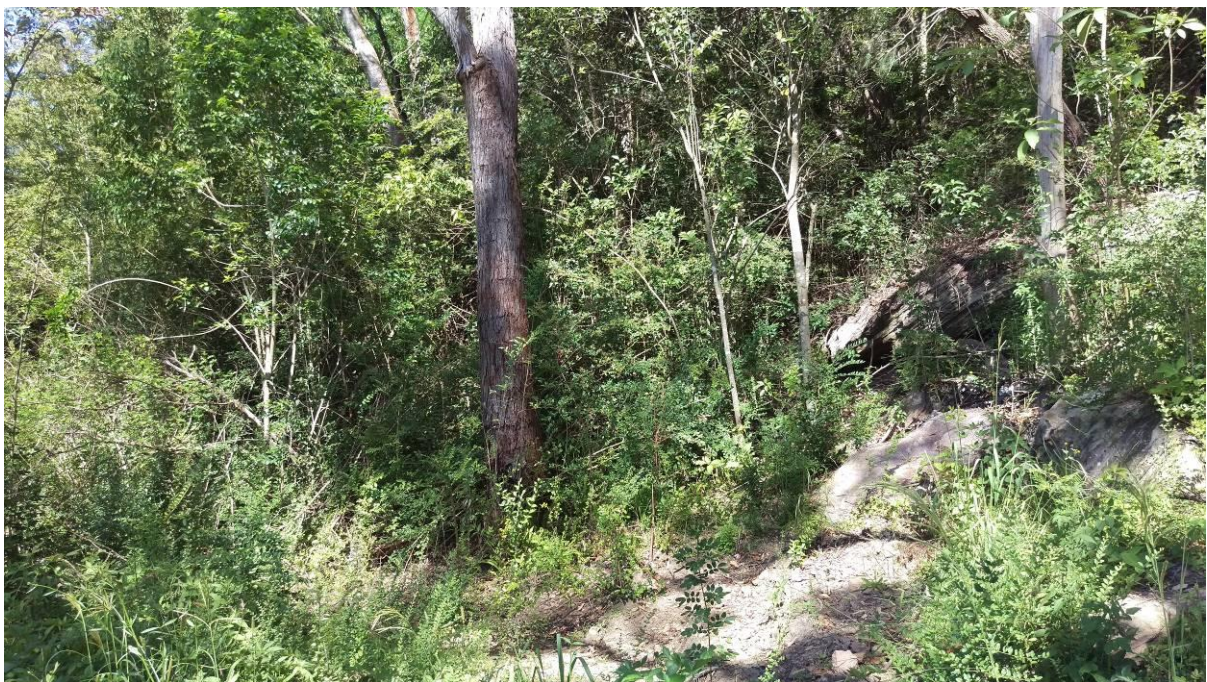
Photo 3 – Smooth-barked Apple - Red Bloodwood open forest (PCT 1776) with shrub layer dominated by exotic shrubs *Ligustrum sinense* and *Lantana camara*.

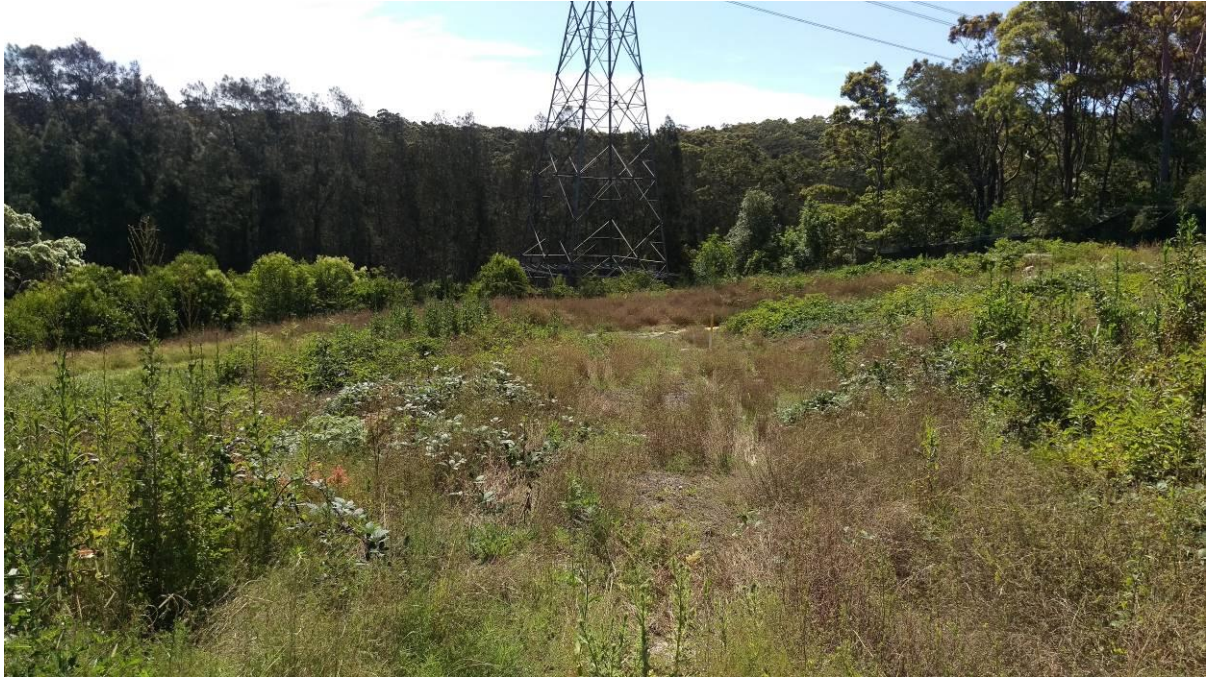
Photo 4 – Disturbed land / exotics in the south-west of the site looking south-west.

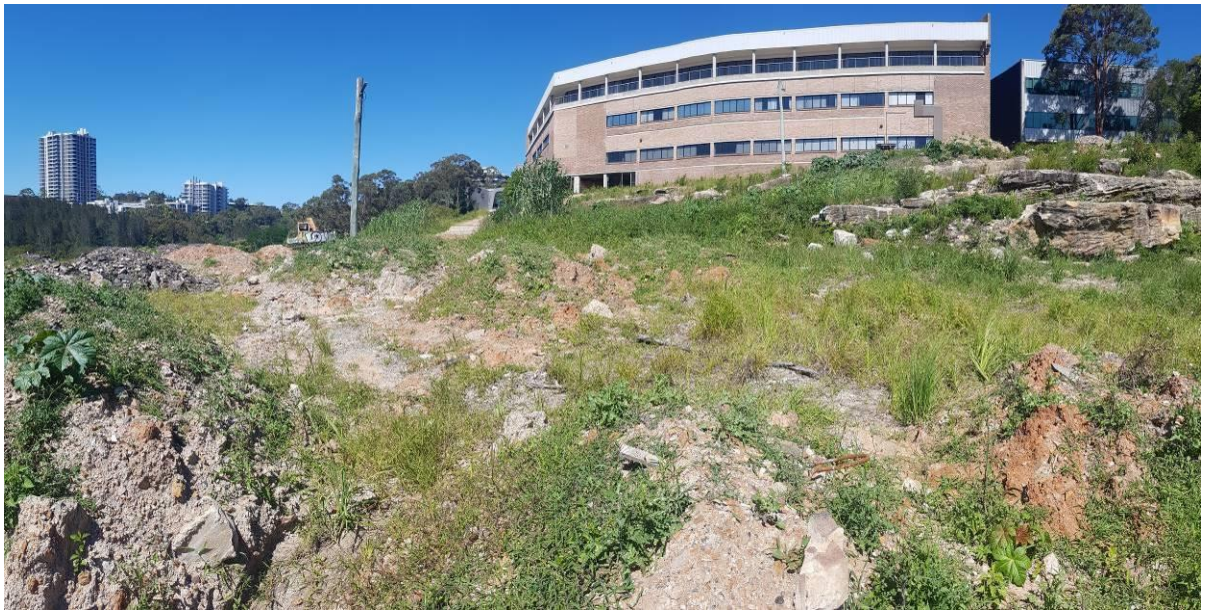
Photo 5 – Disturbed land / exotics in the centre of the site looking east.

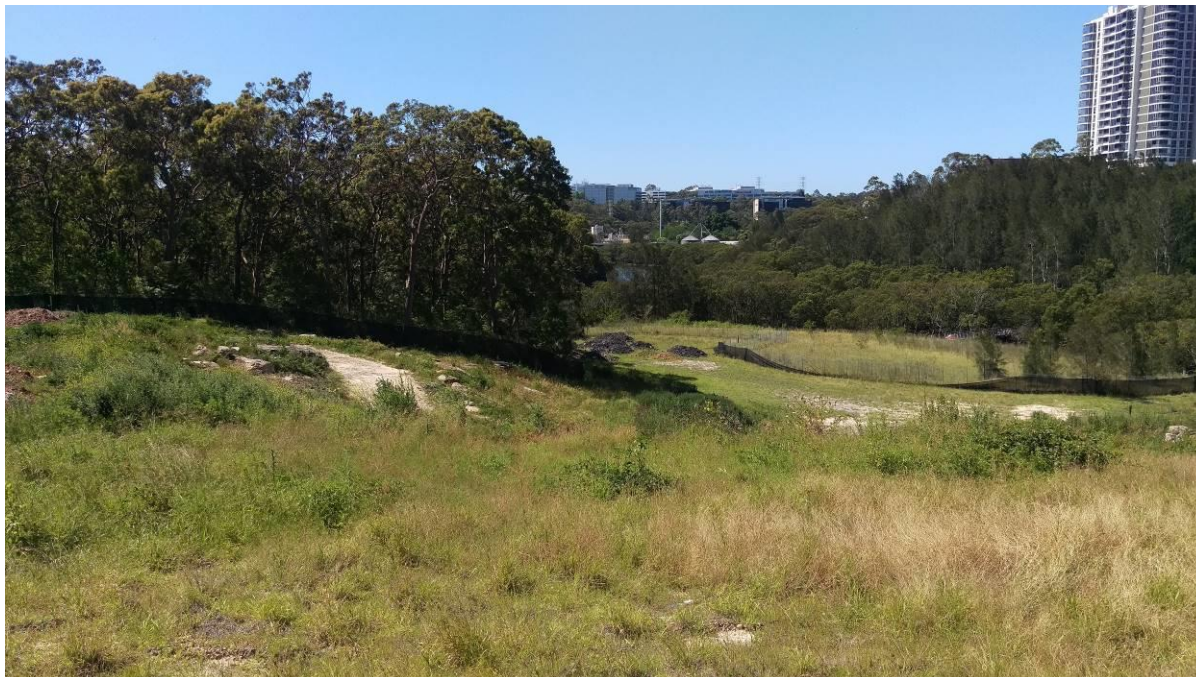
Photo 6 – Disturbed land / exotics in the centre of the site looking north.

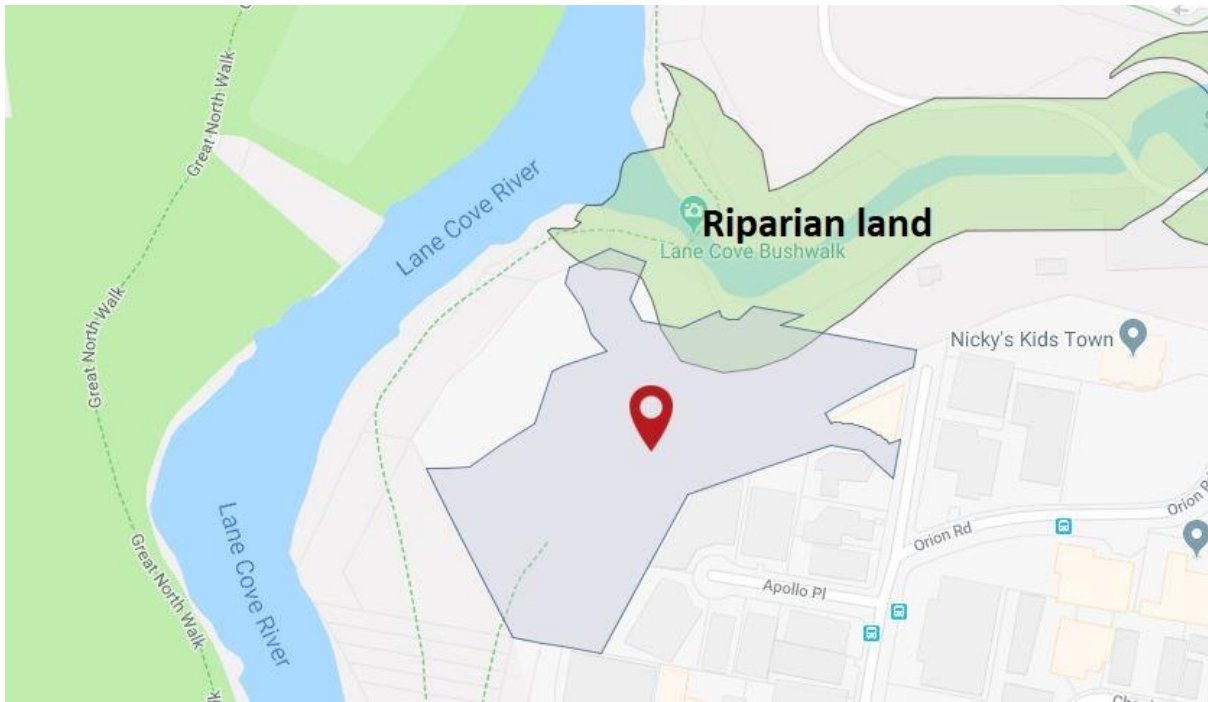
Figure 3 – Riparian land mapping (Lane Cove LEP mapping 2009)

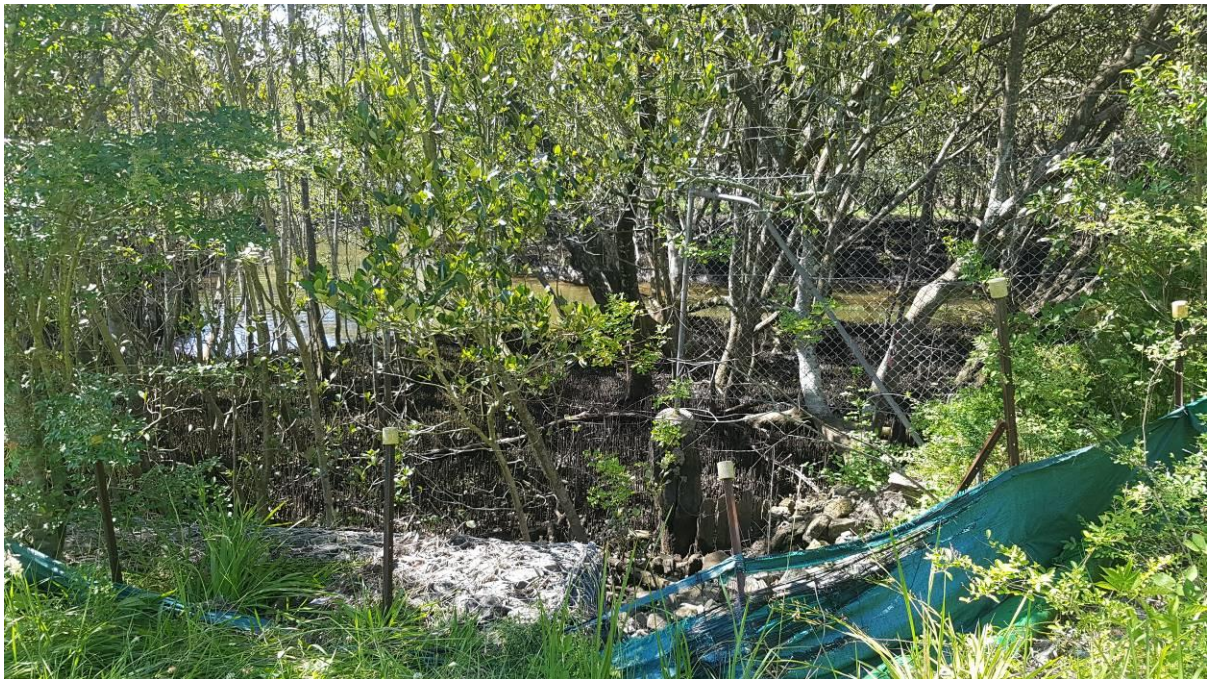
Photo 7 – Edge of Stringybark Creek just outside the northern boundary of the lot.

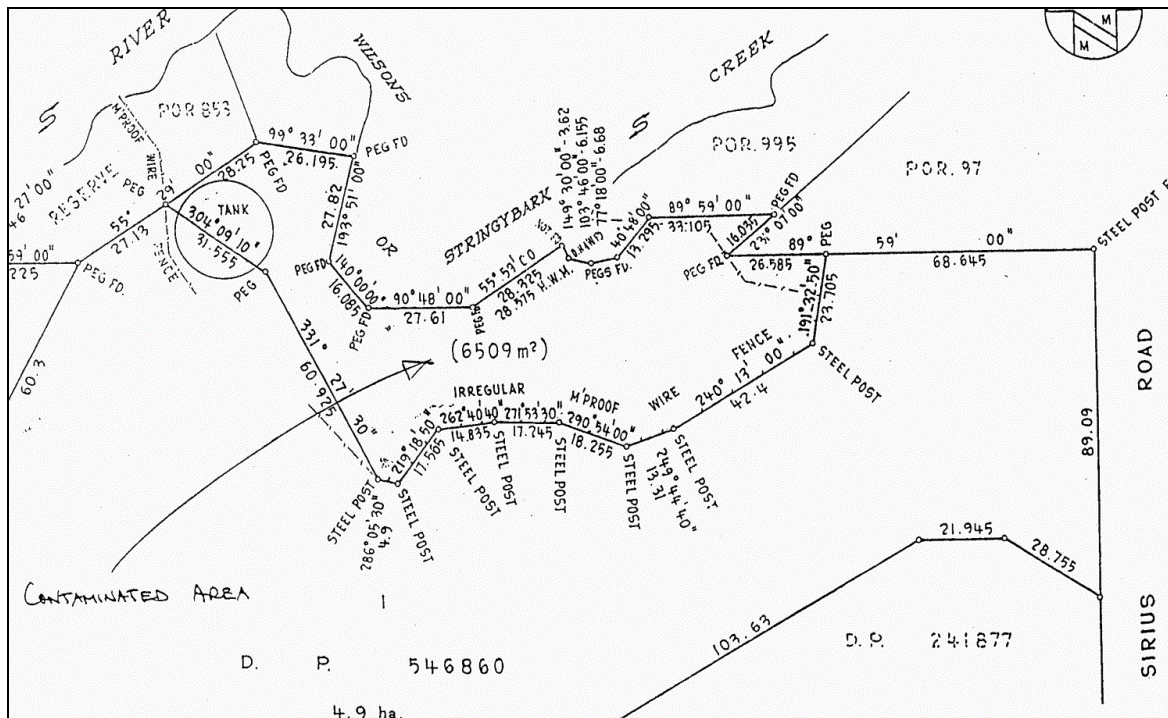
Figure 4 – Contaminated area in the north-east of the lot

A remediation action plan is to be prepared by *Sinversa* that sets out strategies to contain and manage the contaminated soil within the contaminated lands. These remediation works are to be completed before the implementation of any restoration works specified in this VMP within the contaminated lands.

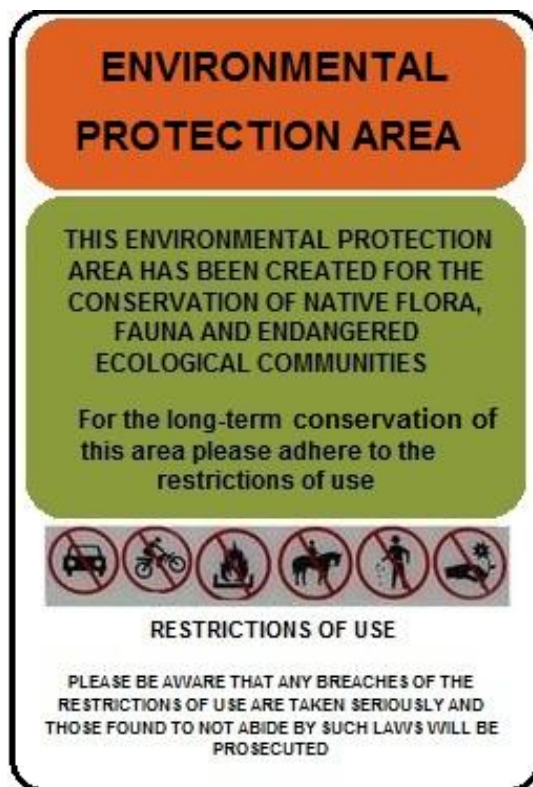
Figure 5 – Signage example

Signage is to be placed every 50m on the permanent fence around the edge of the restoration areas. This signage is to advise that the area is undergoing bushland rehabilitation works. An example of what may be suitable is provided in Figure 5.

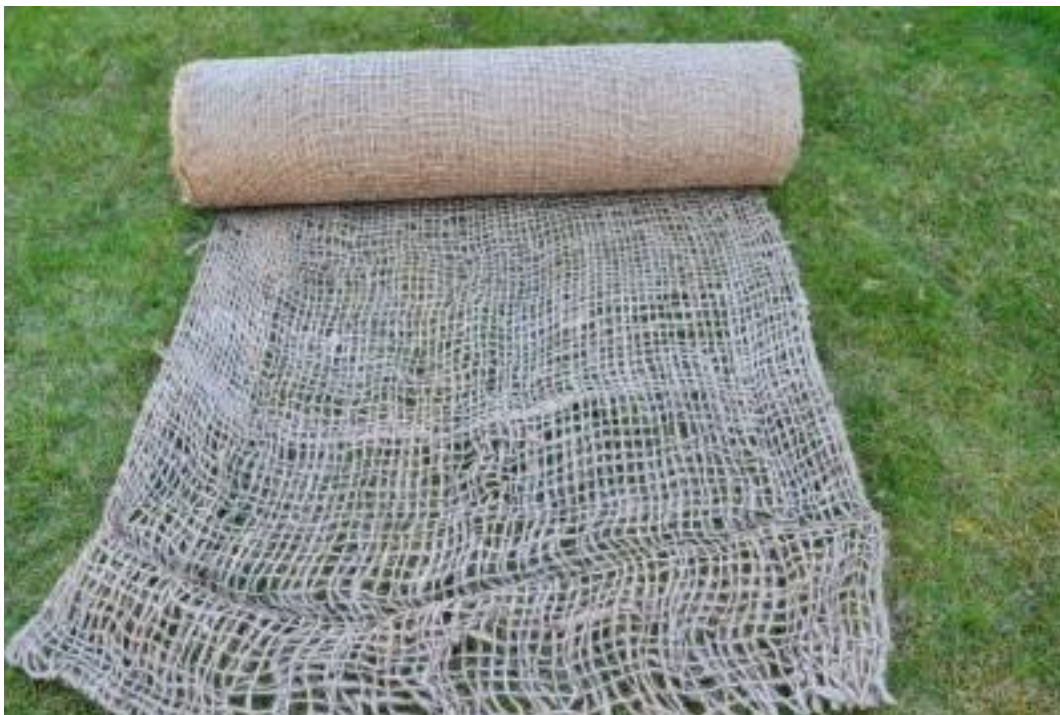
Figure 6 – Example of open weave jute mesh

To protect waterways, loose mulch should not be placed within 10m of the top of bank. Mulch under a covering of biodegradable erosion protection, such as pegged and overlapped open-weave jute mesh, is to be used for revegetation areas within 10m of the top of bank (see Figures 6 and 7).

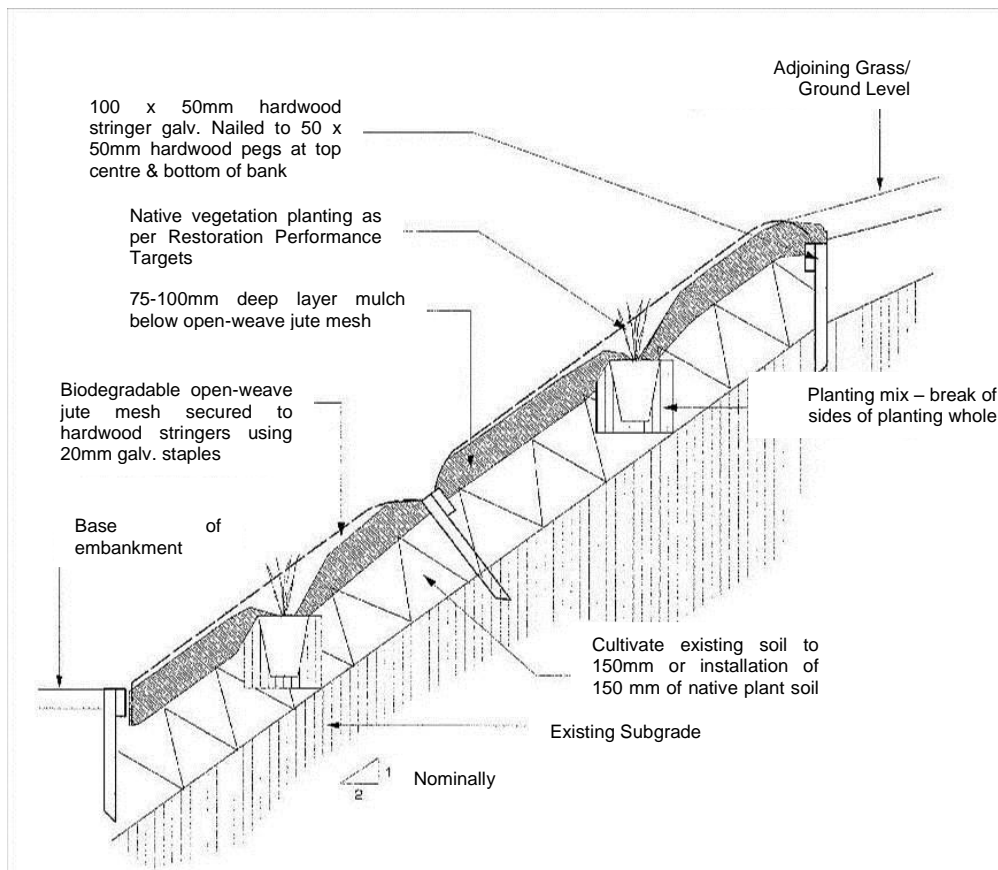
Figure 7 – Generic riparian bank stabilisation

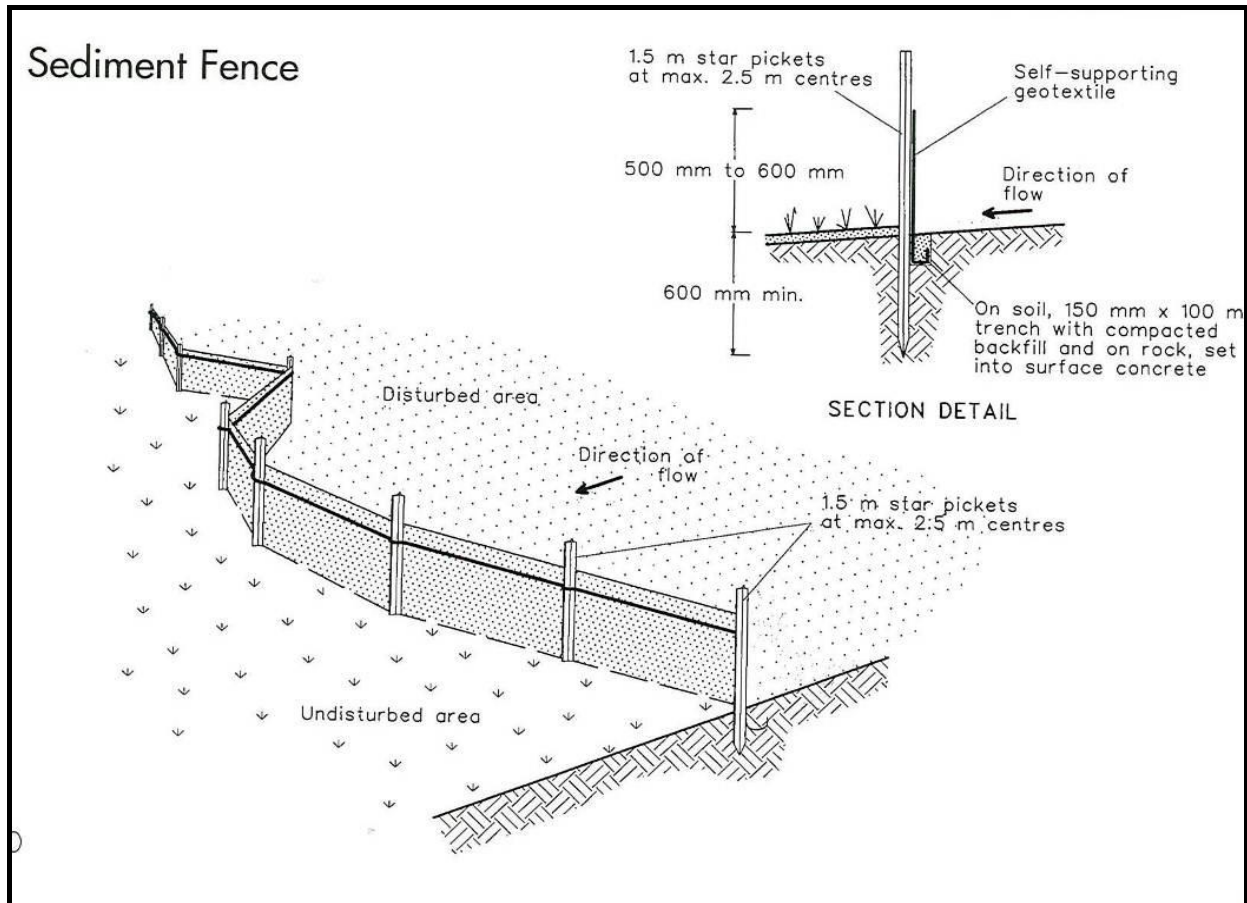
Figure 8 – Generic installation detail of geotextile filter fence

Kick-backs are to be installed along all sections of sediment fencing that run downslope to slow down any waters being directed down the fence line. The sediment fence is to be supported by fixed hay bales in low sections of the fence where concentrated runoff is directed through the fence.

Sediment and erosion controls throughout the construction area must be installed in accordance with Landcom's *'Managing Urban Stormwater: Soils and Construction'* (2004). (see Figures 8 and 9). Techniques and permanent or temporary infrastructure used for erosion and sediment control on site are to be adequately maintained and monitored at all times, particularly after periods of rain, and shall remain in proper operation until all development activities have been completed and the site is sufficiently stabilised with vegetation.

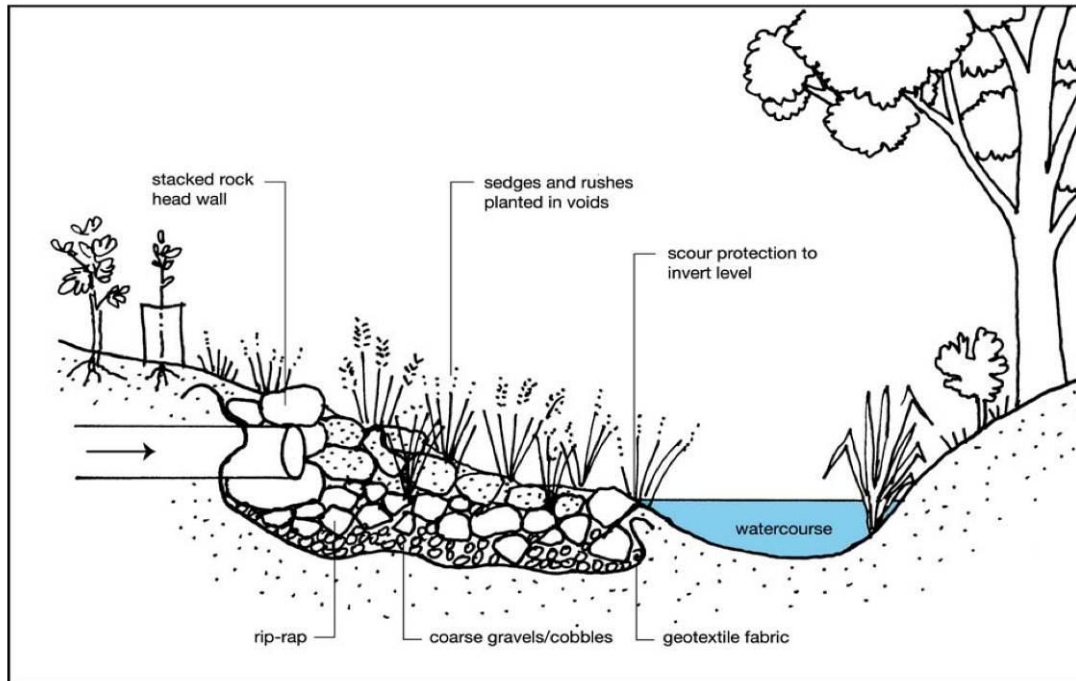
Figure 9 – Outlet scour protection

If outlet scour protection is required, it should be installed in accordance with Figure 9. The extent of scour protection is to be determined in consultation with the project ecologist but is to extend to the maximum extent of potential downstream scour. Additional plants are to be installed to assist in stabilisation of moist soils surrounding the outlet. If required, plants are to come from a local source and be typically present within the surrounding vegetation.

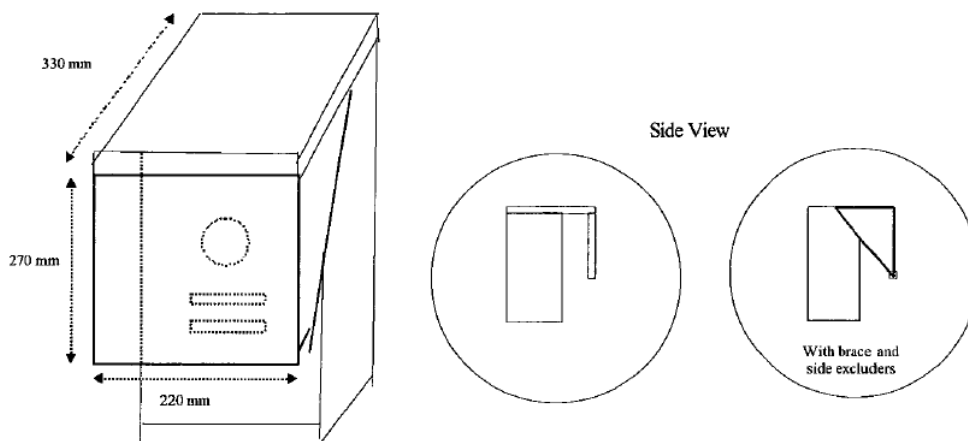
Diagram 1 - Anti-Myna Baffle

- Deterring Mynas and Starlings from re-nesting is not easy; these pests are very persistent, and constant vigilance is necessary. This also means that you must have convenient regular access to the nest-box, and that you must be aware of what creatures are using it for what purposes.
- Nest boxes found to be utilised by threatened or otherwise significant fauna may be prioritised for ongoing management to ensure their longevity and replicate their design/placement characteristics.

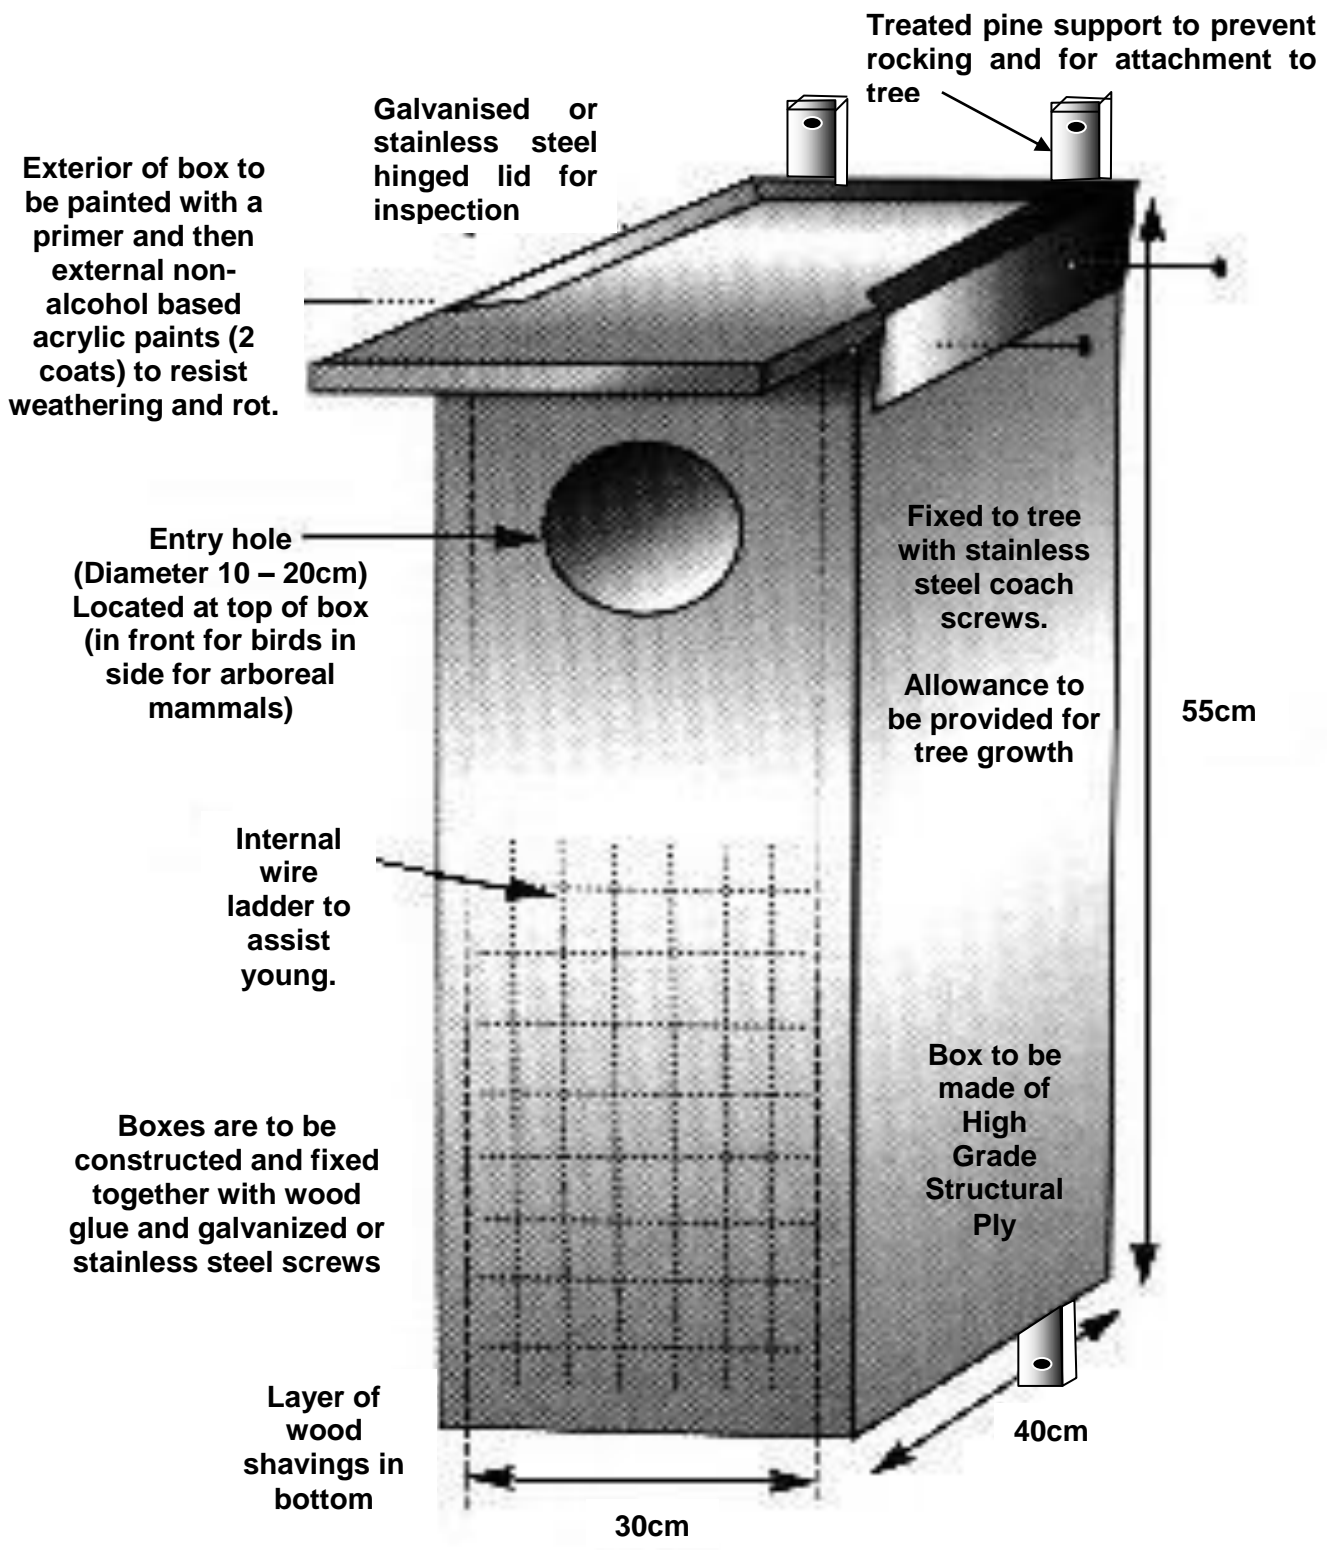
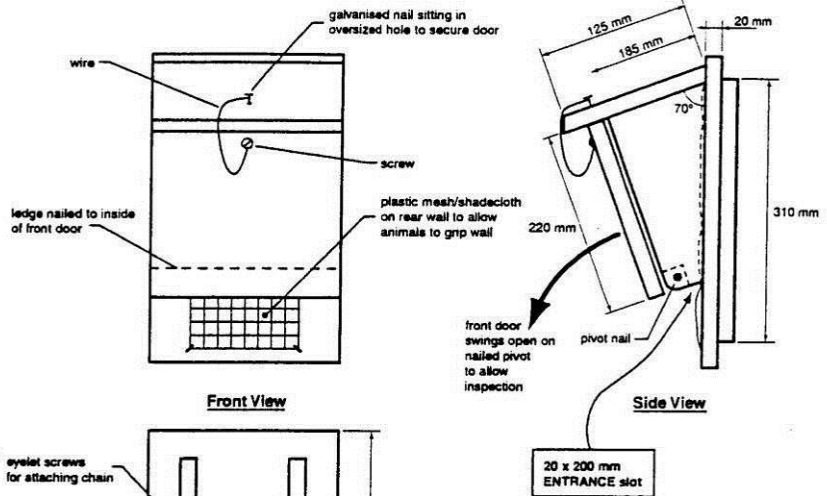
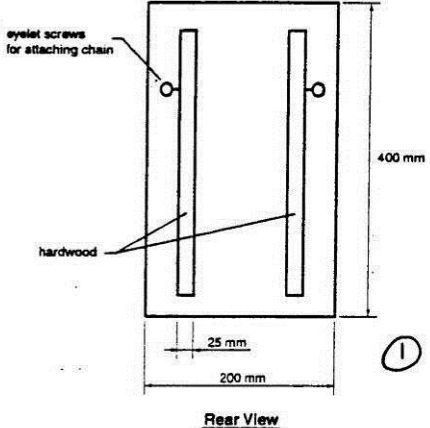
DESIGN 1 - PARROT & ARBOREAL MAMMAL NEST BOX DETAIL

Note: For dimensions of other target species see Table 1.
 (Size dimensions applied for a Large Parrot Box)

Fixed to tree with stainless steel coach screws.

Allowance to be provided for tree growth

Exterior of box to be painted with a primer and then 2 coats of external non-alcohol based acrylic paint to resist weathering and rot.

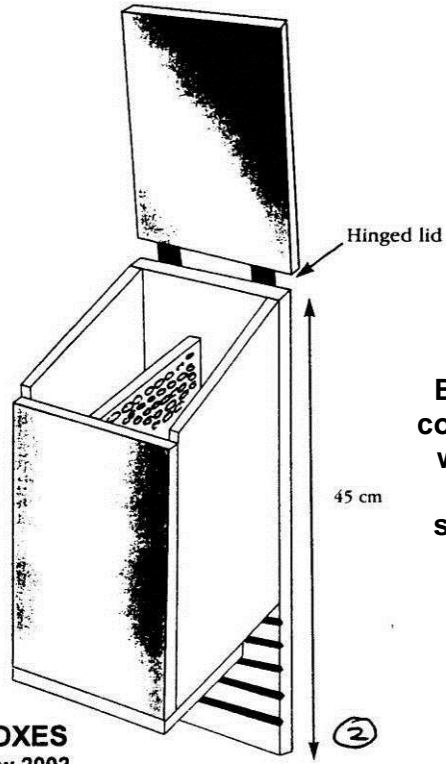
DESIGN 2 - MICROBAT NEST BOX DETAIL (Option 1 & 2)
 Note: Alternative designs available for alternative mounts

Box to be constructed with high grade structural ply

BAT ROOSTING BOXES
 1. From Smith and Agnew 2002
 2. From Gould League of Victoria 1997

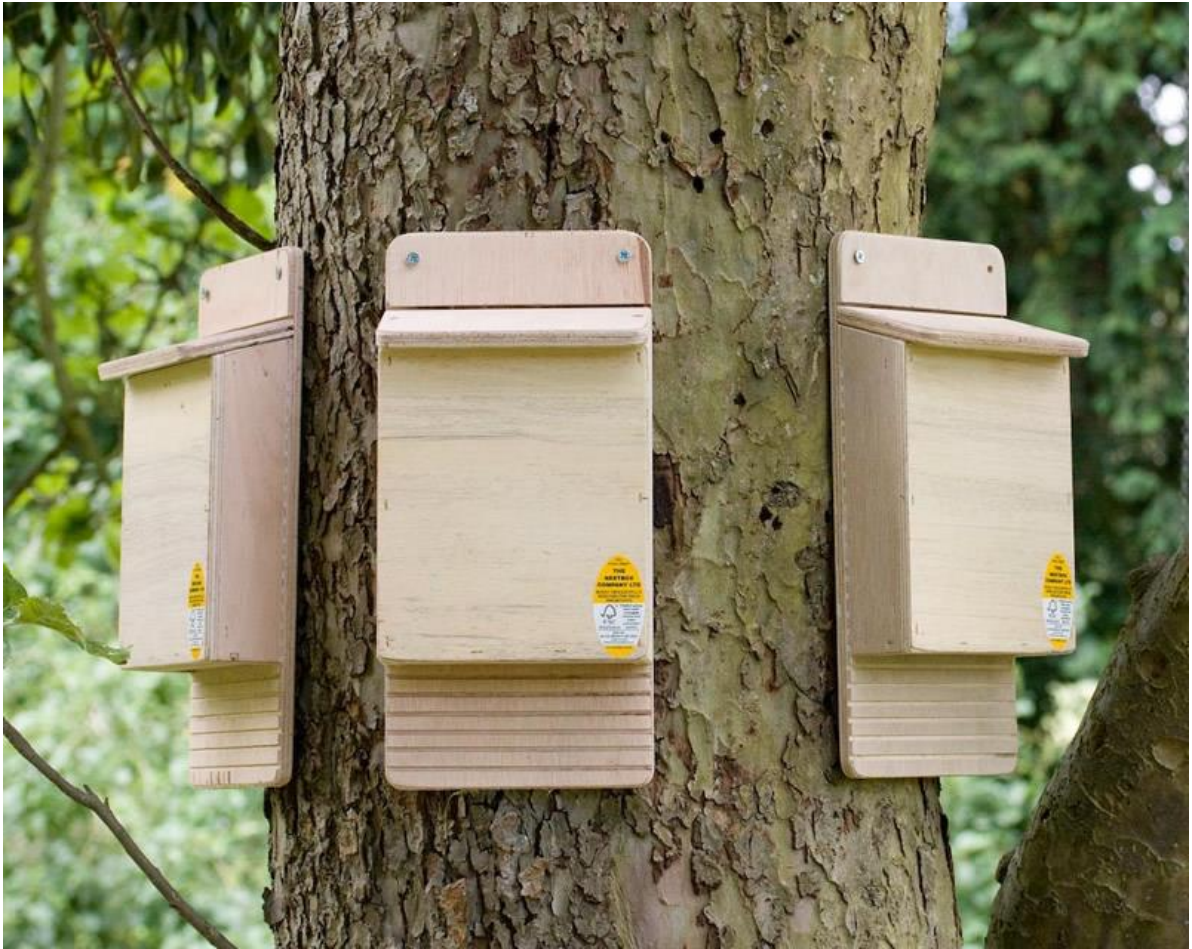
Photo 1 - Example of microbat design. Note: these boxes are not painted or appropriately affixed to the tree.
