**Re: Lane Cove Data Centre – summary of changes for resubmission
Addendum Bushfire Protection Assessment, Vegetation Management Plan,
Watercourse Assessment Report
1 Sirius Road, Lane Cove West**

Vegetation Management Plan

Lot 1, DP1151370
1 Sirius Road
Lane Cove West

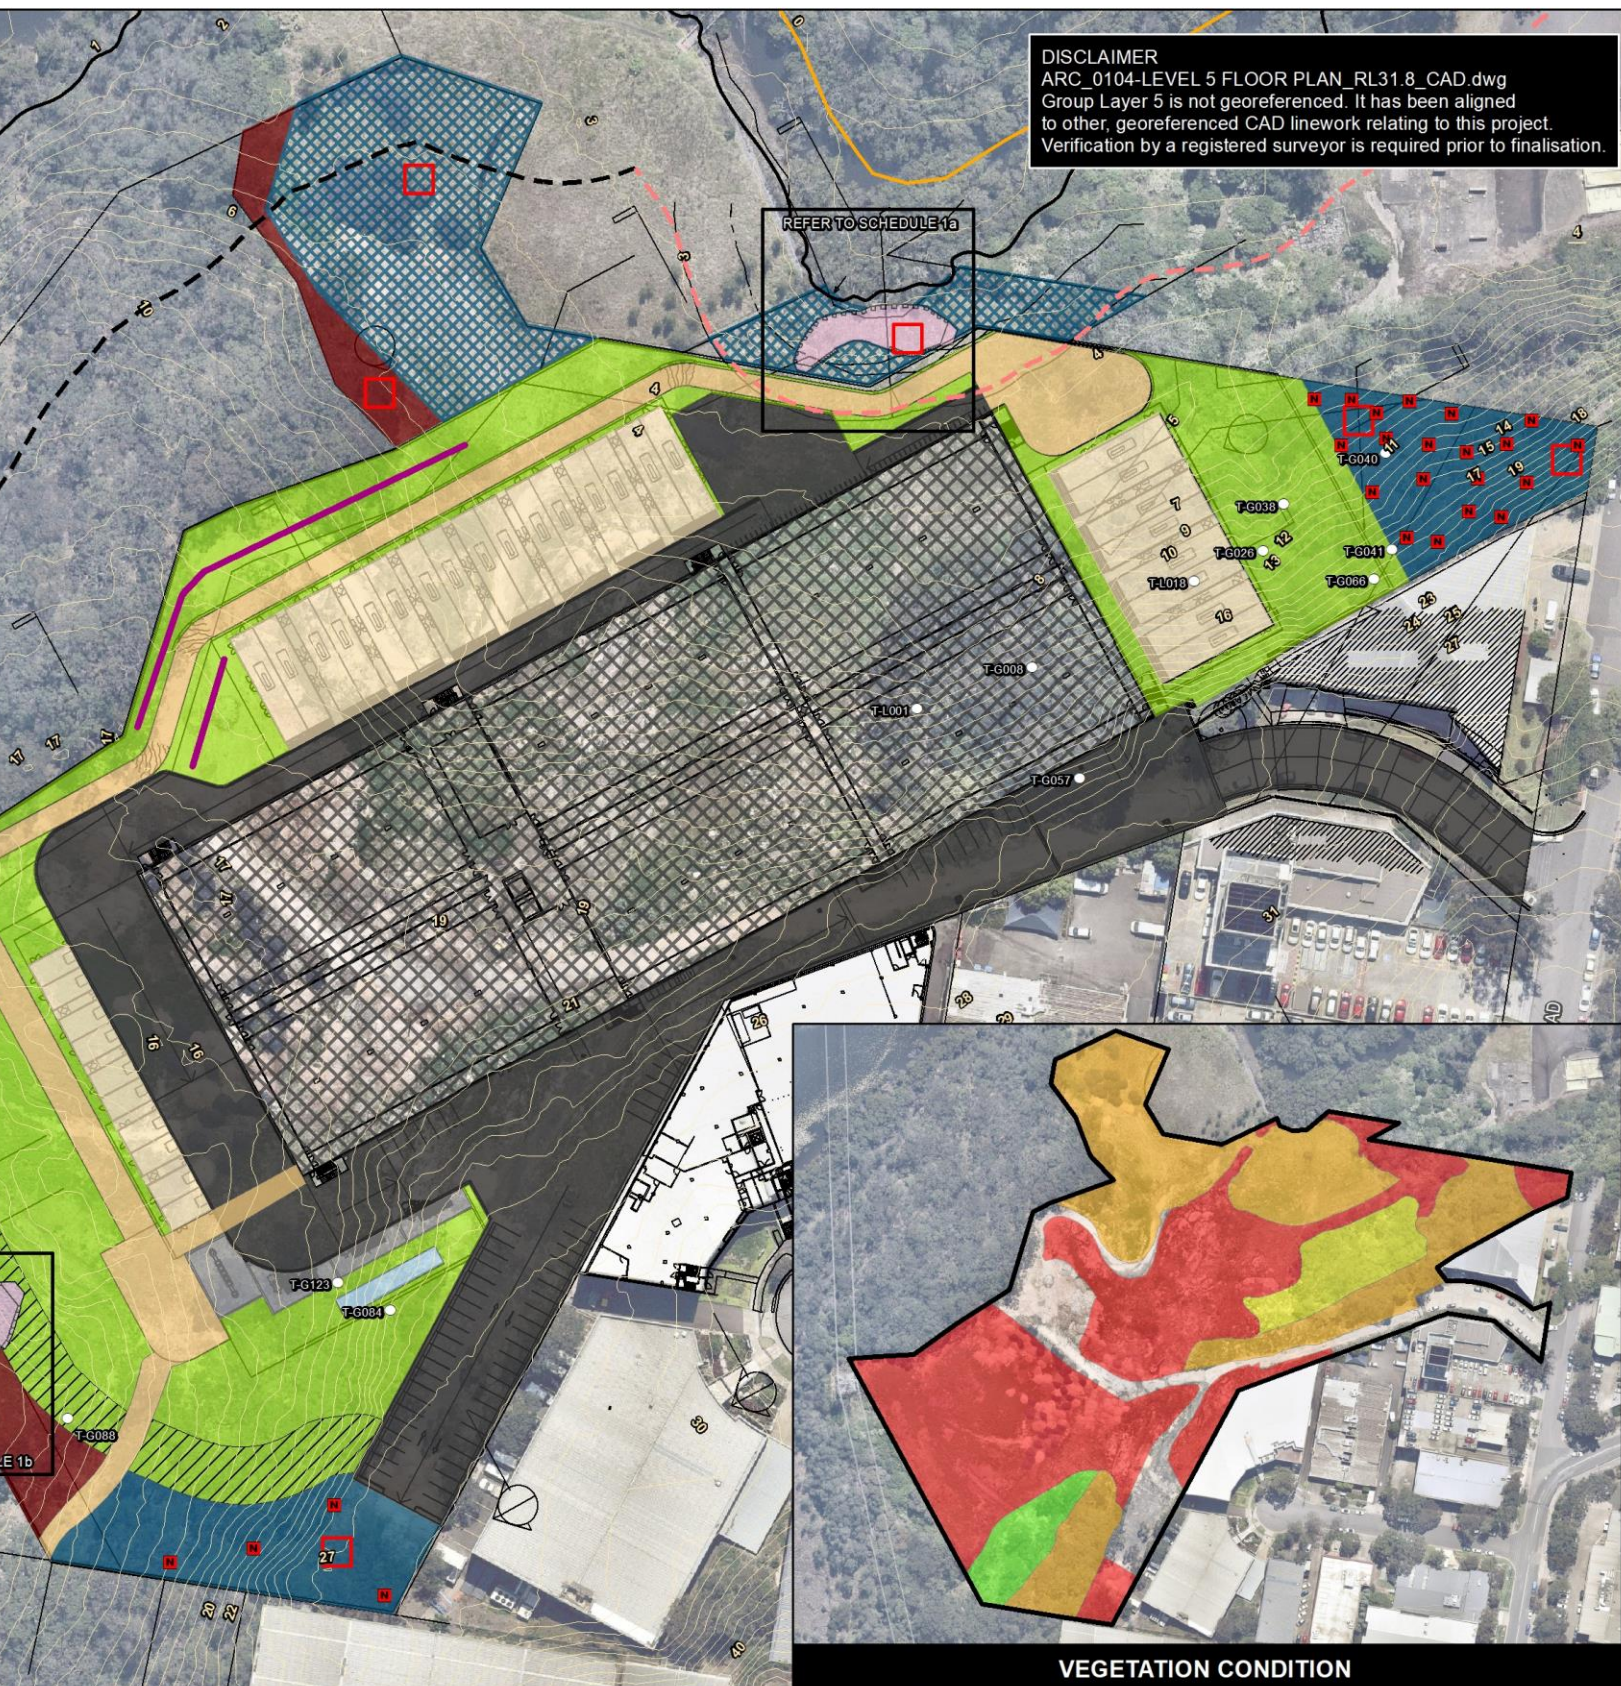
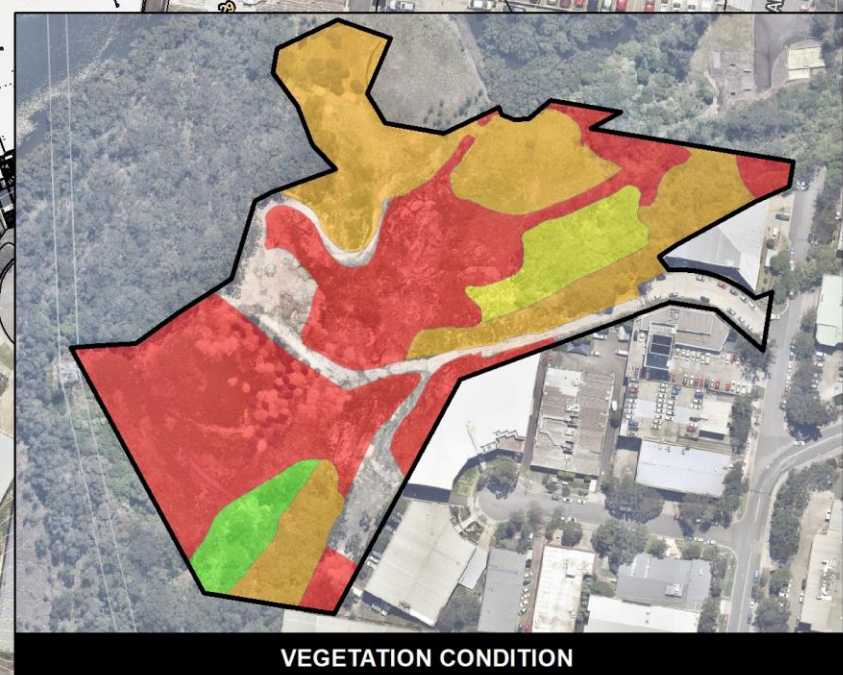
PROJECT & MXD REFERENCE 1 Sirius Road, Lane Cove West 18AWE02_VMP001	DATE & ISSUE NUMBER 28/08/2019 Issue 1	SCALE & COORDINATE SYSTEM 1:1,200 @A3 GDA 1994 MGA Zone 56
TITLE Schedule 1 - Vegetation Management Works Plan (Overview)

Legend	Proposed Infrastructure	Stream Order (source : LPI)	Restoration Works	Macrophyte Planting (0.035/ha)
Asset Protection Zone (APZ)	Data hall	Second order	Bush regeneration (0.20 ha)	Aerial Source: Nearmap
Monitoring quadrat (5x5m)(8)	Generator platform	Fifth order	Smooth-barked Apple - Red Bloodwood Open Forest	
Hollow-bearing tree	Substation	Vegetation Condition	Fully structured revegetation (0.17 ha)	
Nest box	Oil spill tank	Good (<10% weeds)	Smooth-barked Apple - Red Bloodwood Open Forest	
Permanent protection/ sediment fencing (209m)	Firetrail	Fair (10 - 30% weeds)	Shrub & groundcover plantings only (0.26ha)	
Top of bank	Riparian corridor	Poor (30 - 60% weeds)	Swamp Oak Floodplain Forest & Ecotonal Species	
	20m buffer	Very Poor (>60% weeds)	Screen Tree Planting (100 linear m)	
	40m buffer		Smooth Barked Apple - Red Bloodwood Open Forest	
			APZ compliant plantings (0.14ha)

Following completion of earthworks, and installation of stormwater outlets and riparian structures, permanent protection fencing in the form of a 1.2m high chainlink fence is to be installed around the restoration areas as shown on Schedule 1 – Vegetation Management Works. This is to replace the temporary protection fencing.

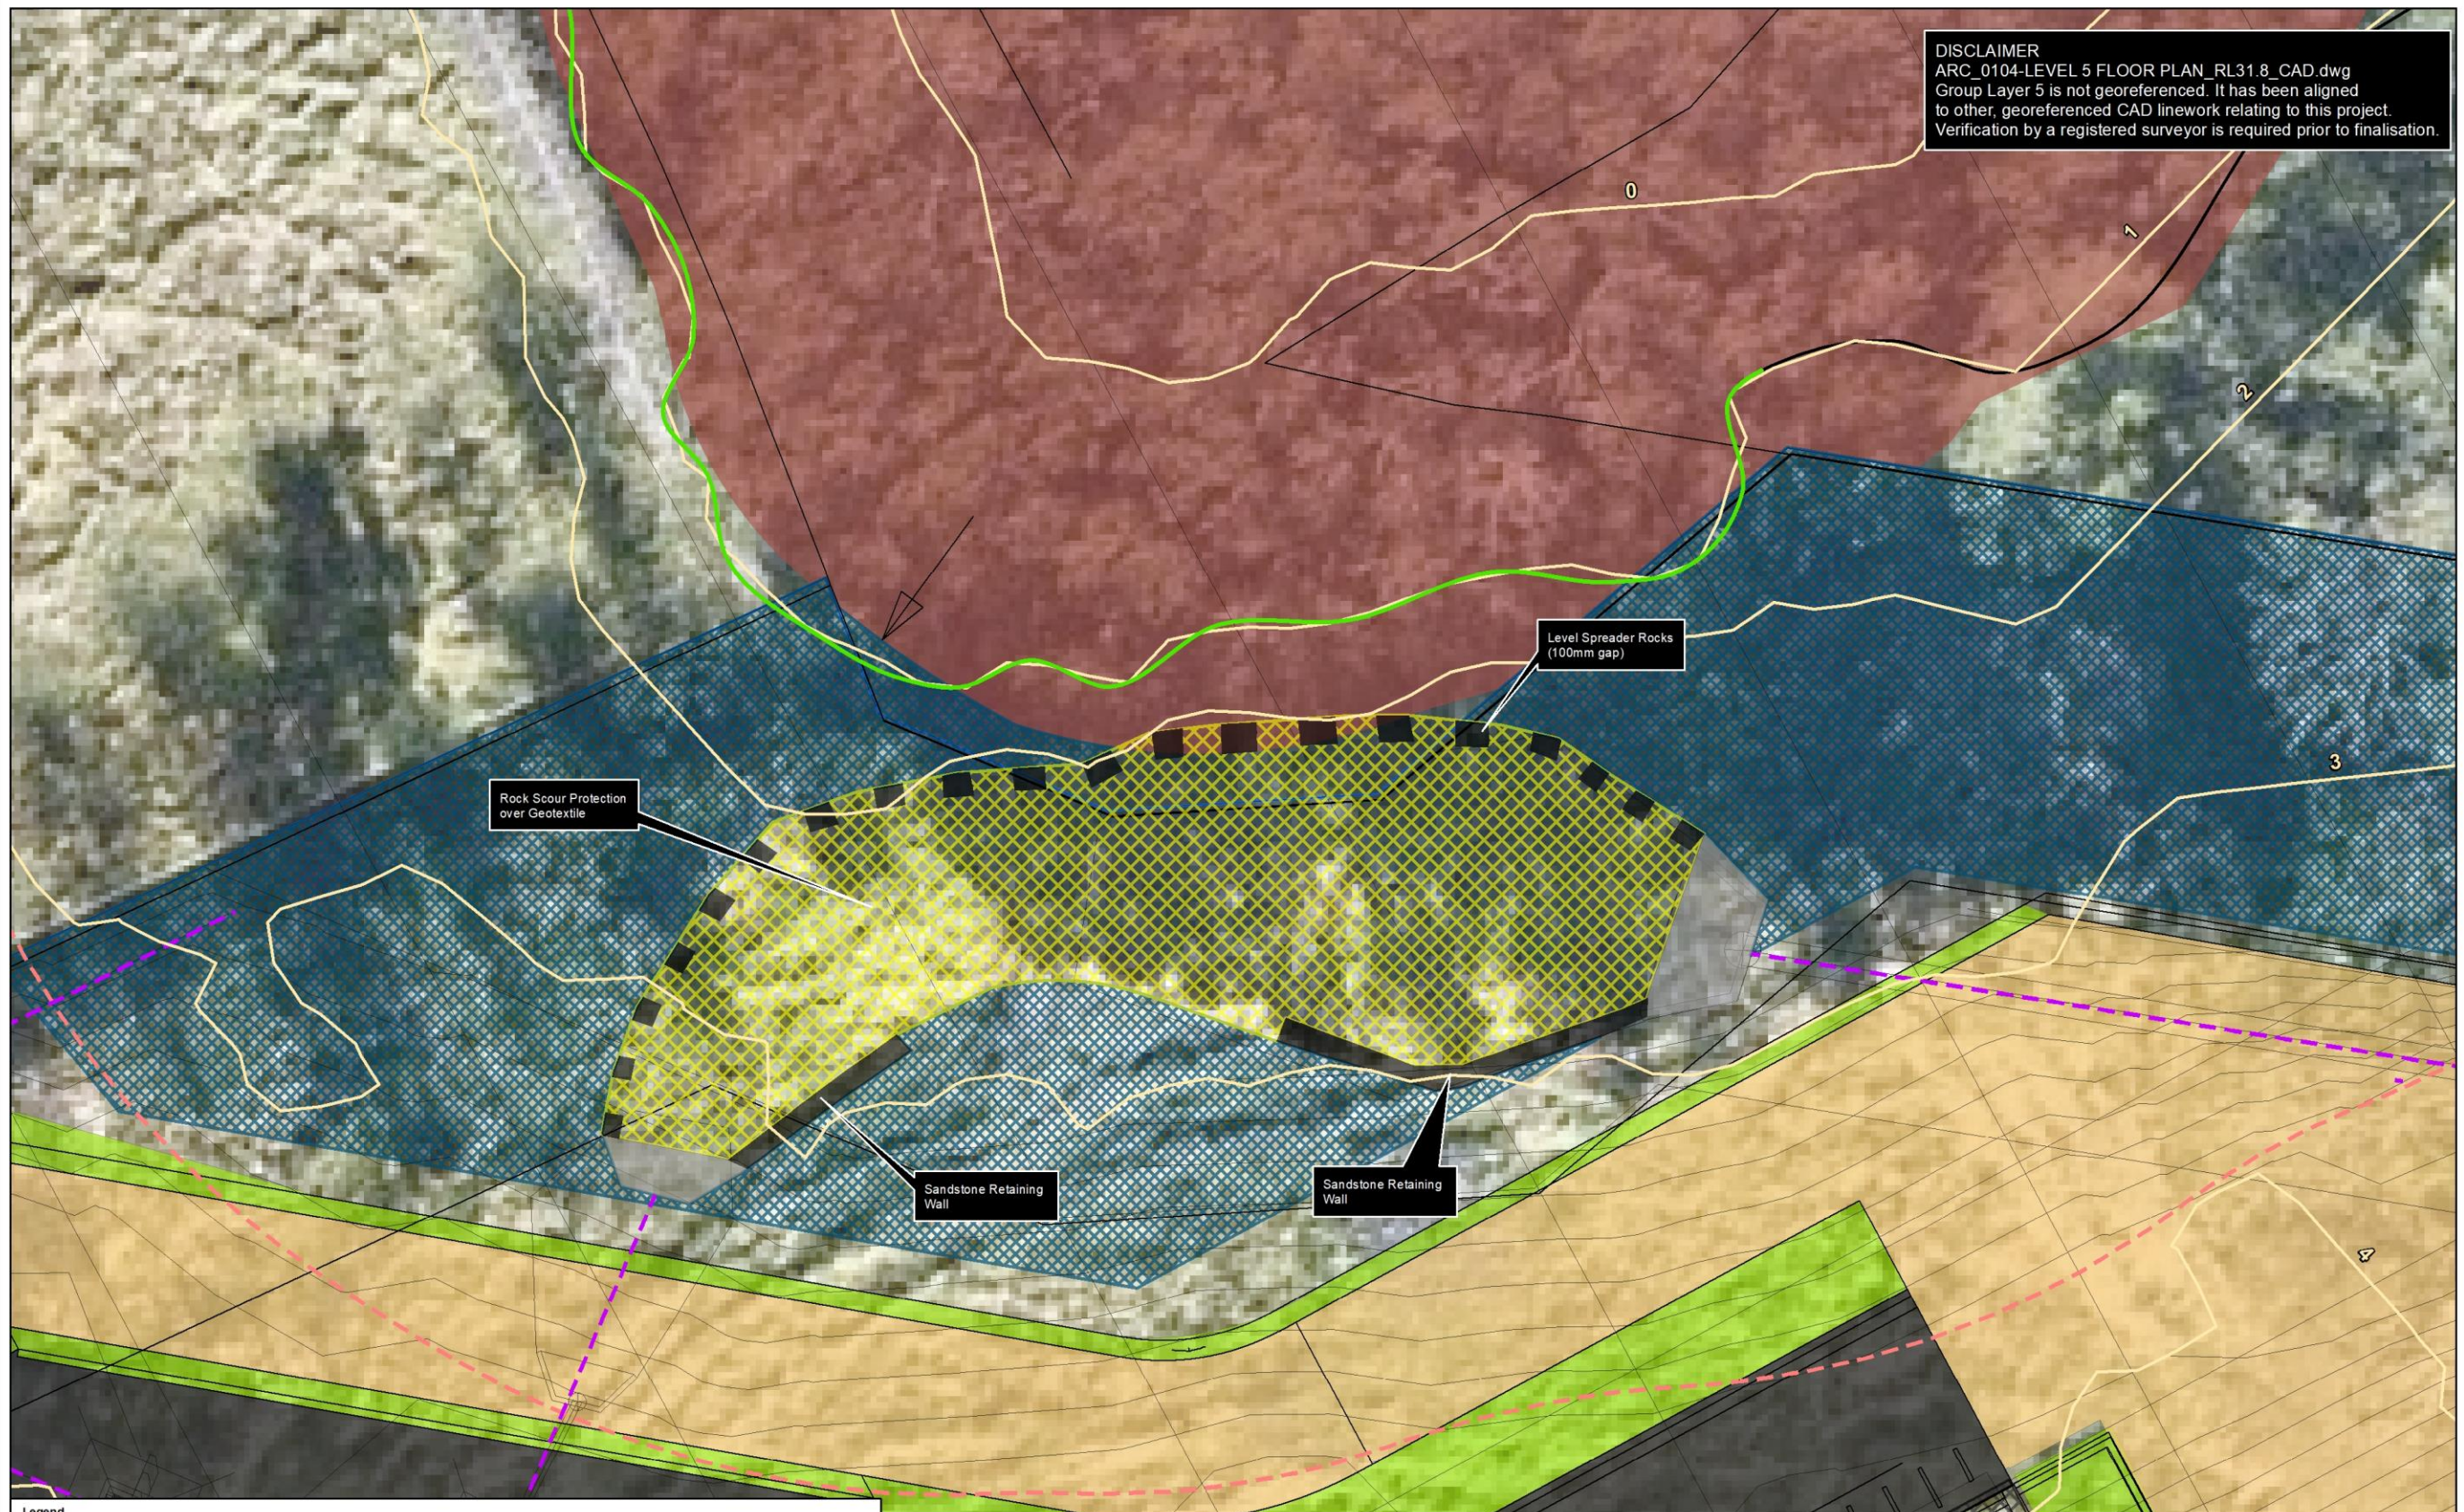
TITLE
 Schedule 1a - Drainage Revegetation Detail (North Eastern outlet)

- Contour (1m) (source: LIDAR)
- Top of bank
- Riparian corridor
 - 20m buffer
 - 40m buffer
- Edge of wetland
- Stormwater drain
- Headwall - East
- Sandstone rocks
- Rock Scour Protection (0.02ha)
