Watercourse Assessment Report

State Significant Development (SSD)

Proposed data centre
Warehouse / distribution centre

Lot 1 DP 1151370
1 Sirius Road
Lane Cove West

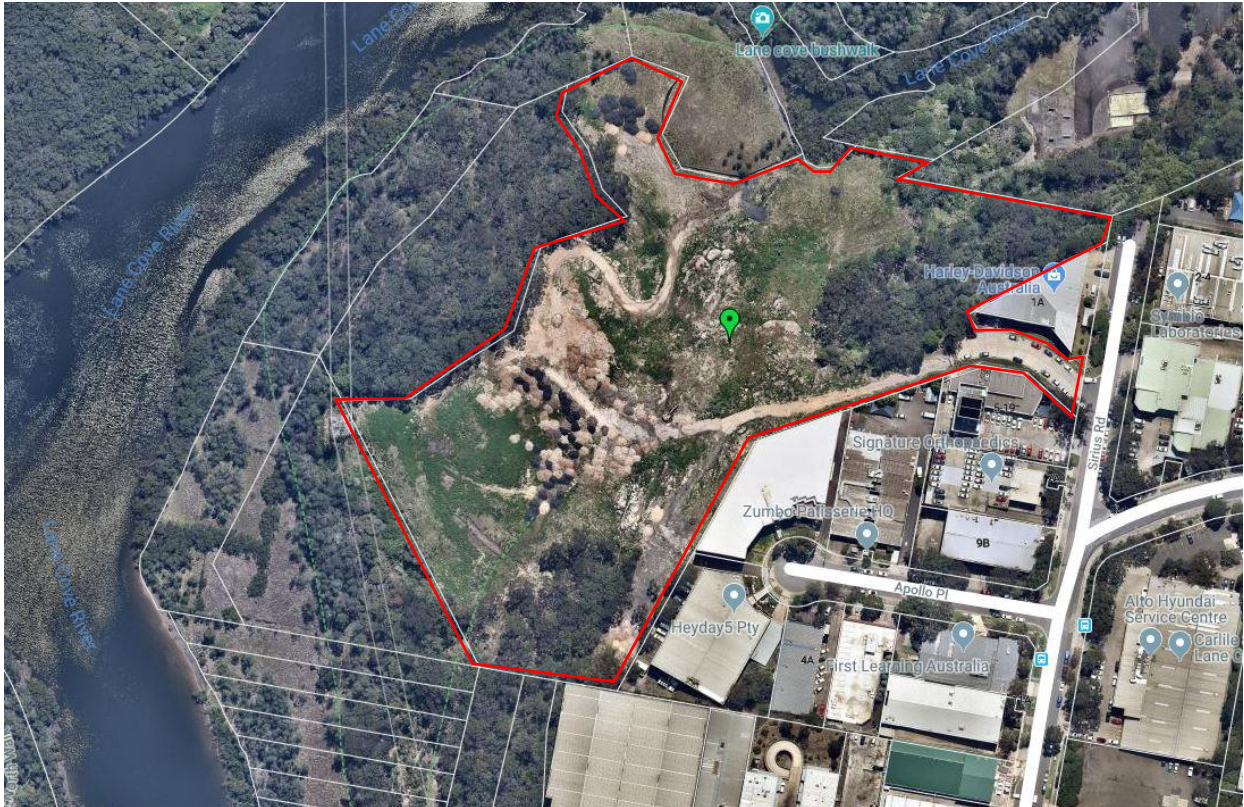
Figure 1 – Study area
(Source: SIX Maps)

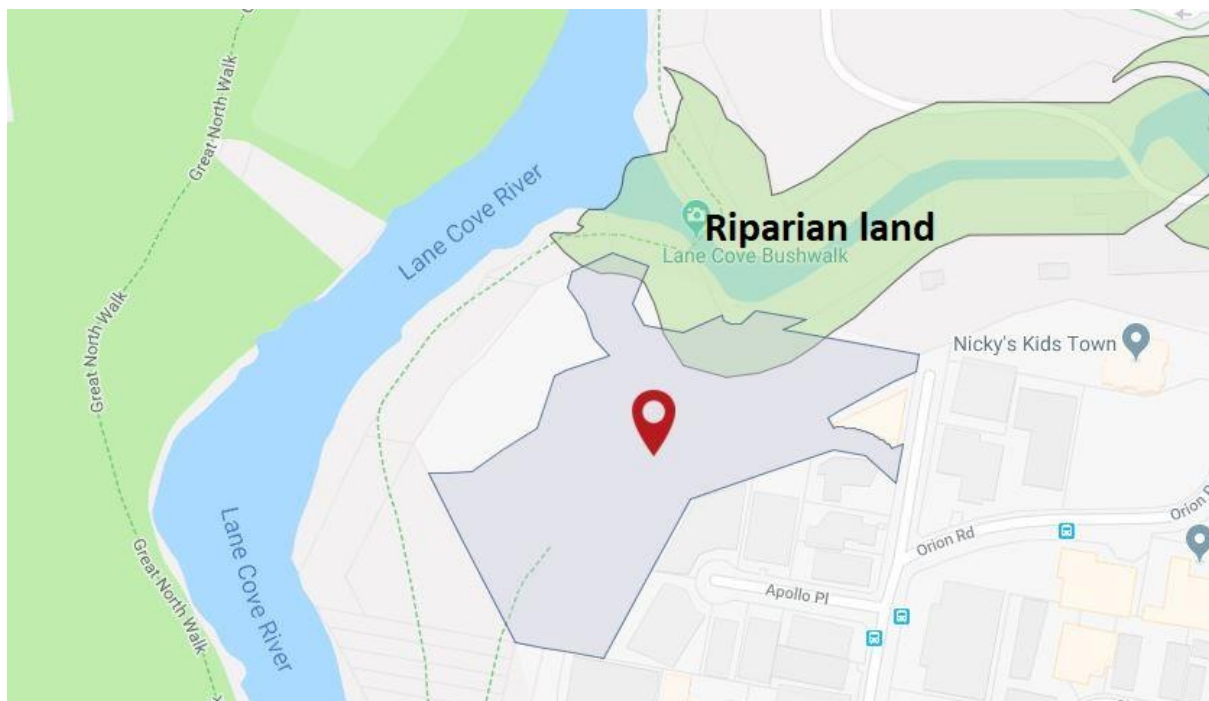
Figure 9 – Riparian land mapping (Lane Cove LEP mapping 2009)

The Lane Cove Local Environment Plan (LEP) mapping (2009) identifies a portion in the north of the site as Riparian Land. The mapped 'riparian land' overlaps with the proposed works.

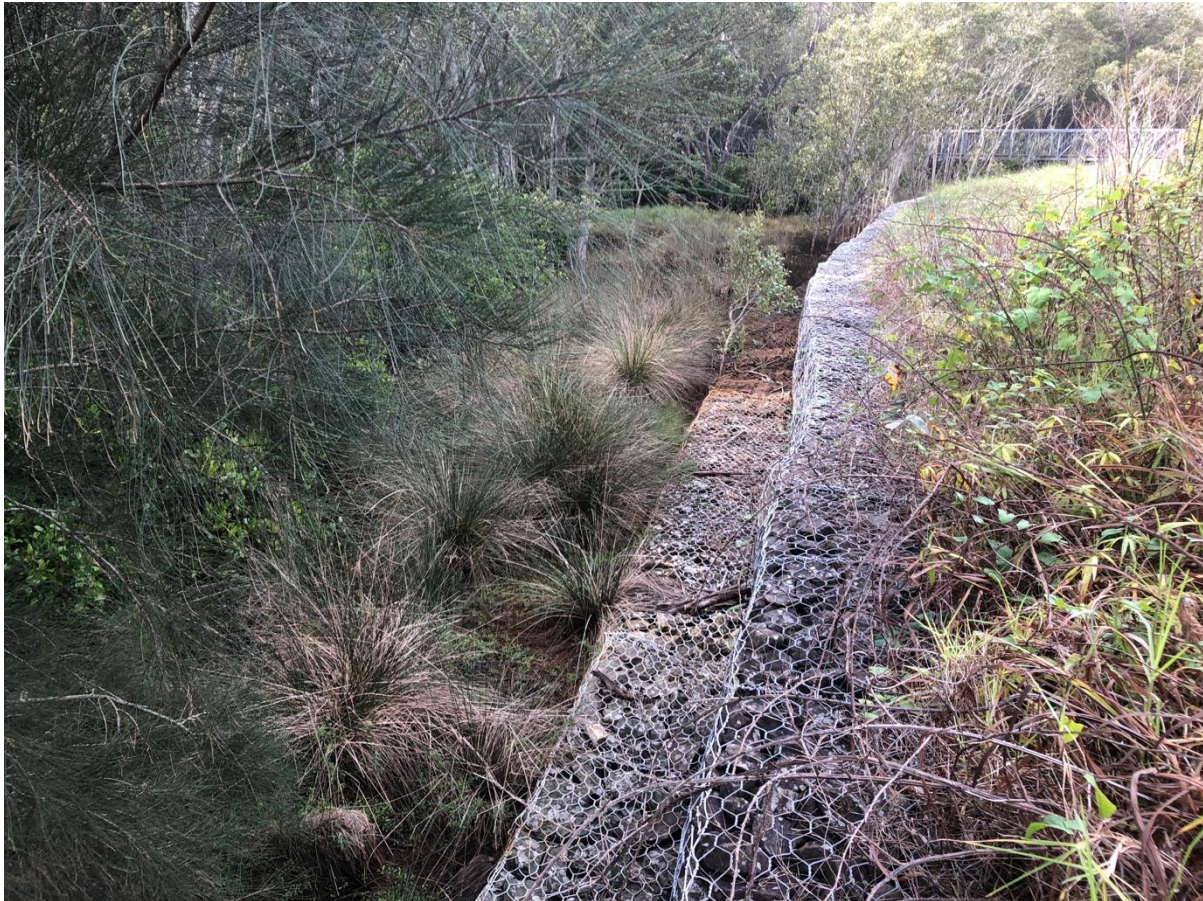
Photo 7 – Edge of Stringybark Creek showing gabion wall containing the contaminated fill lands – top of bank for Stringybark Creek coincident with the wetland vegetation boundary

The site's eastern lot boundary is 0m from the wetland boundary and has a rock gabion wall for the full length of the minimum 10.5m to the stormwater basin and 25m to the proposed building wall.

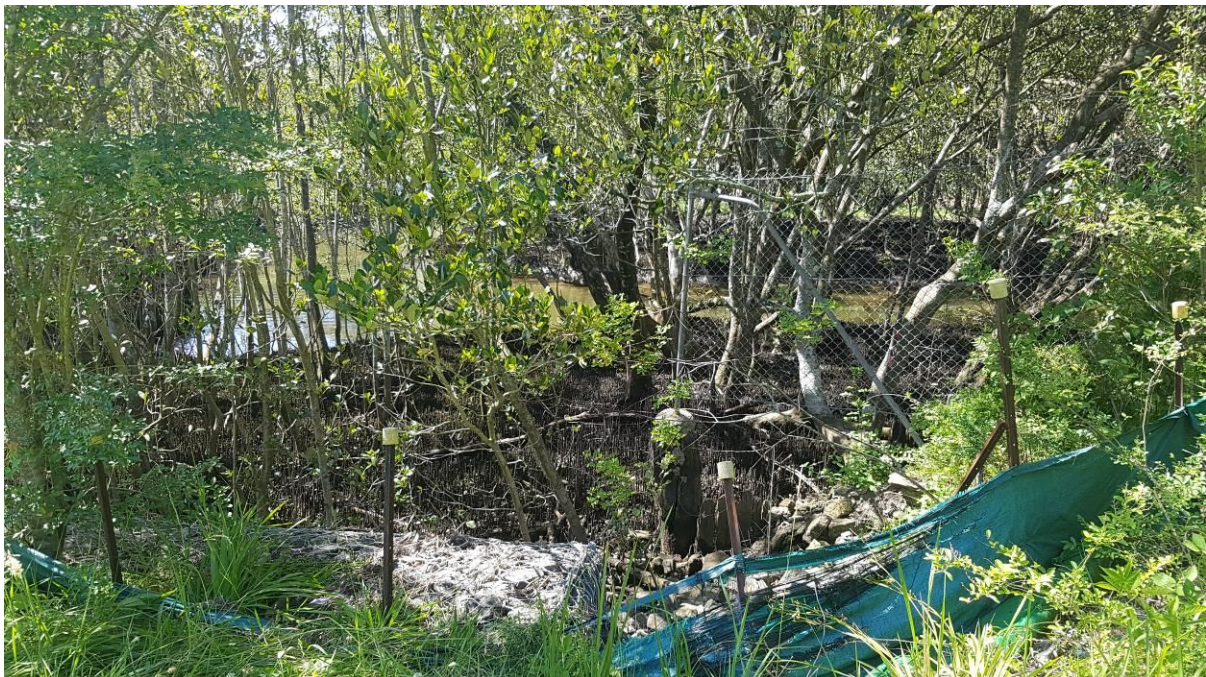
Photo 11 – Edge of Stringybark Creek just outside the northern boundary of the lot

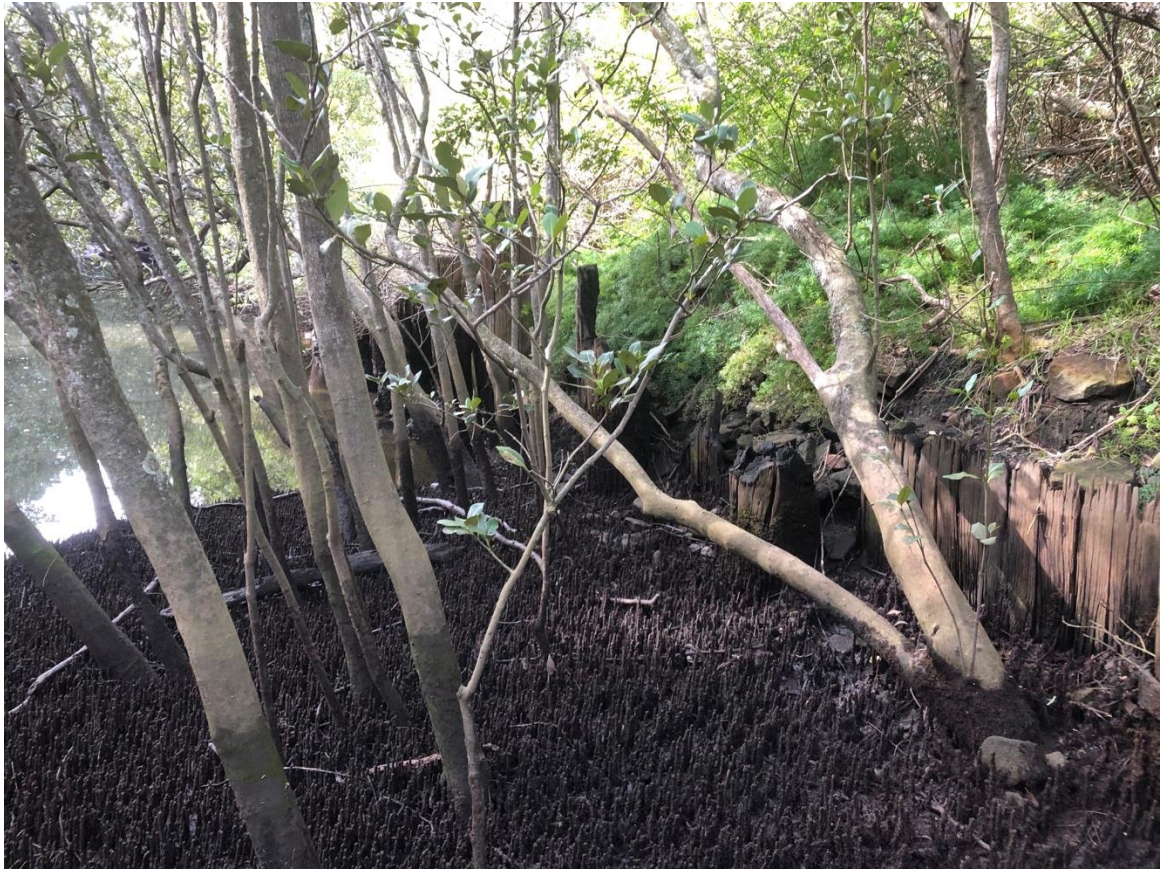
Photo 12 – Intertidal zone of Stringybark Creek nearest to the stormwater basin output

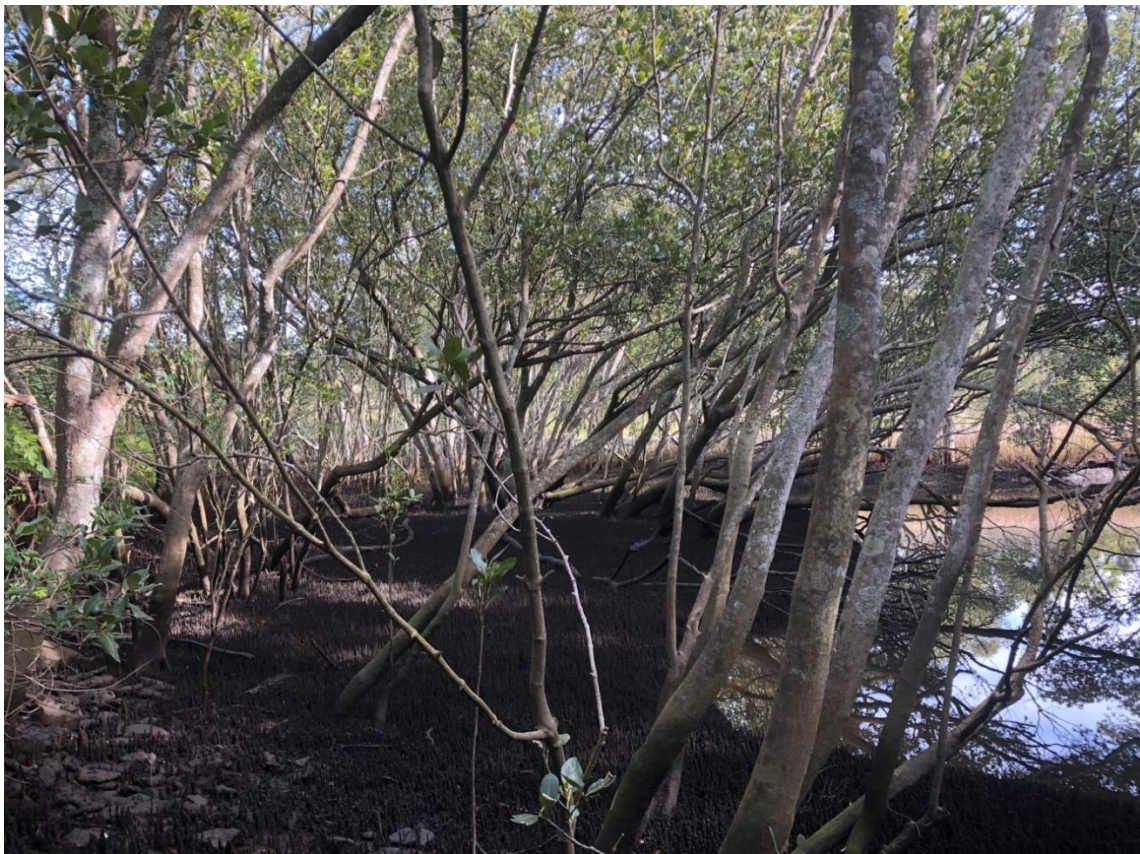
Photo 13 – Intertidal zone of Stringybark Creek

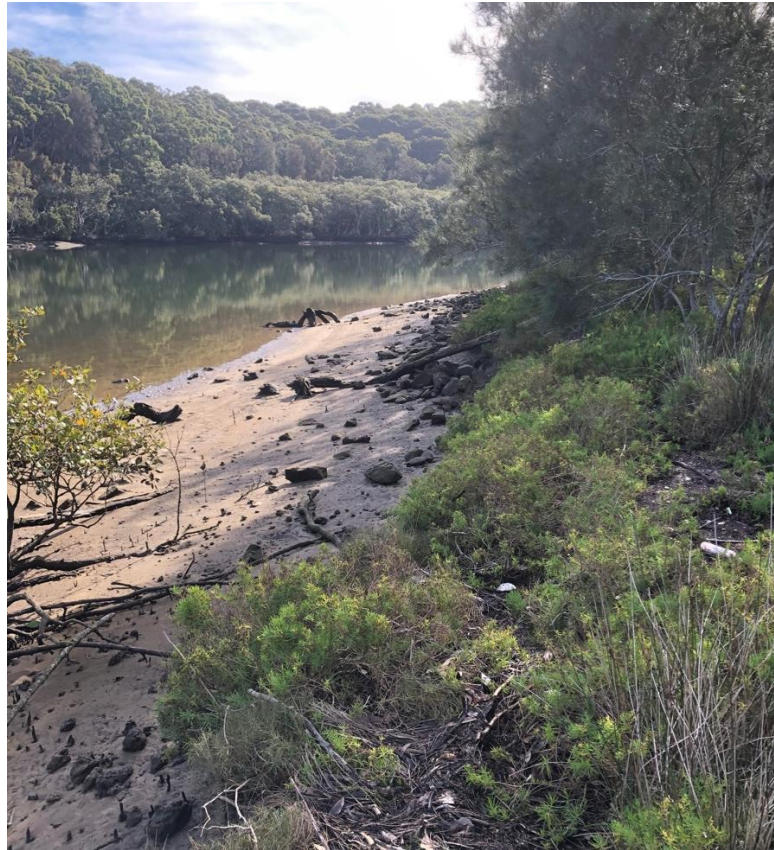
Photo 14 – Typical bank of Lane Cove River adjoining wetland vegetation looking upstream towards Stringybark Creek

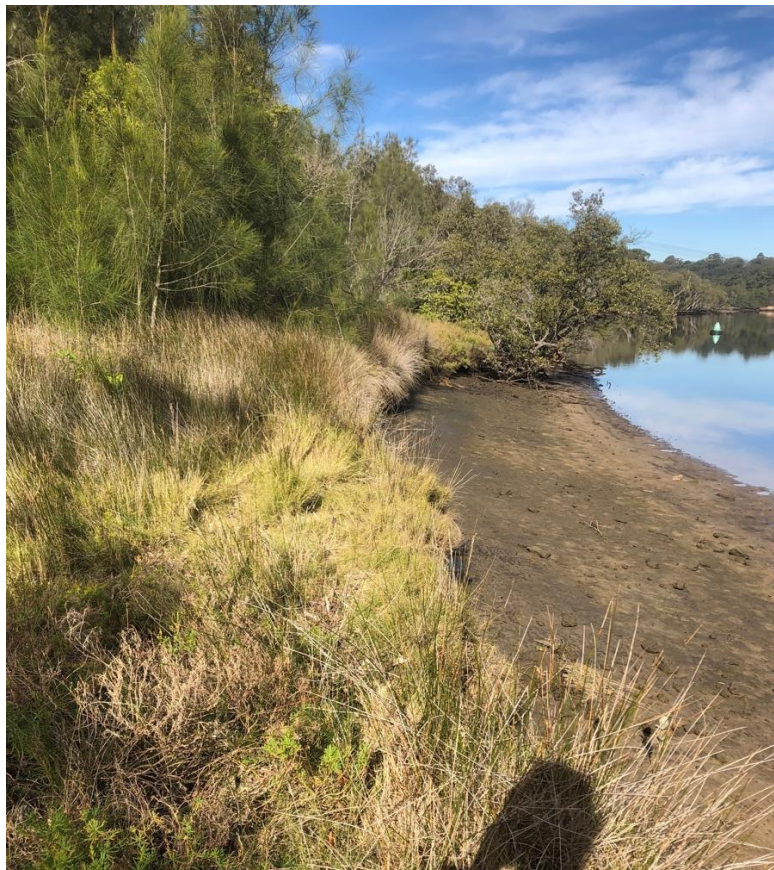
Photo 15 – Typical bank of Lane Cove River adjoining wetland vegetation looking downstream

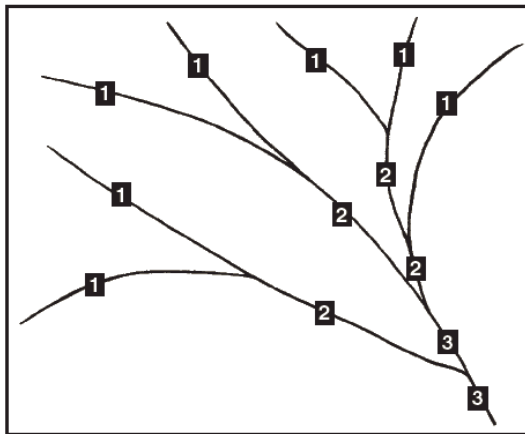
Figure 15- The Strahler System

The NSW Officer of Water recommends a VRZ width based on watercourse order as classified under the Strahler System of ordering watercourses and using current 1:25 000 topographic maps (see Figure 12 and Table 5). The width of the VRZ should be measured from the top of the highest bank on both sides of the watercourse (*NSW Department of Industry - Guidelines for controlled activities on waterfront land - Riparian corridors* (2018)).
