Site Hydrogeology Report 142-160 Oxford Street, 13 Gipps Street & 6 Shadforth Street, Paddington (NSW)

Reference: P3569_04

Date: 26 February 2026

Morrow Geotechnics Pty Ltd

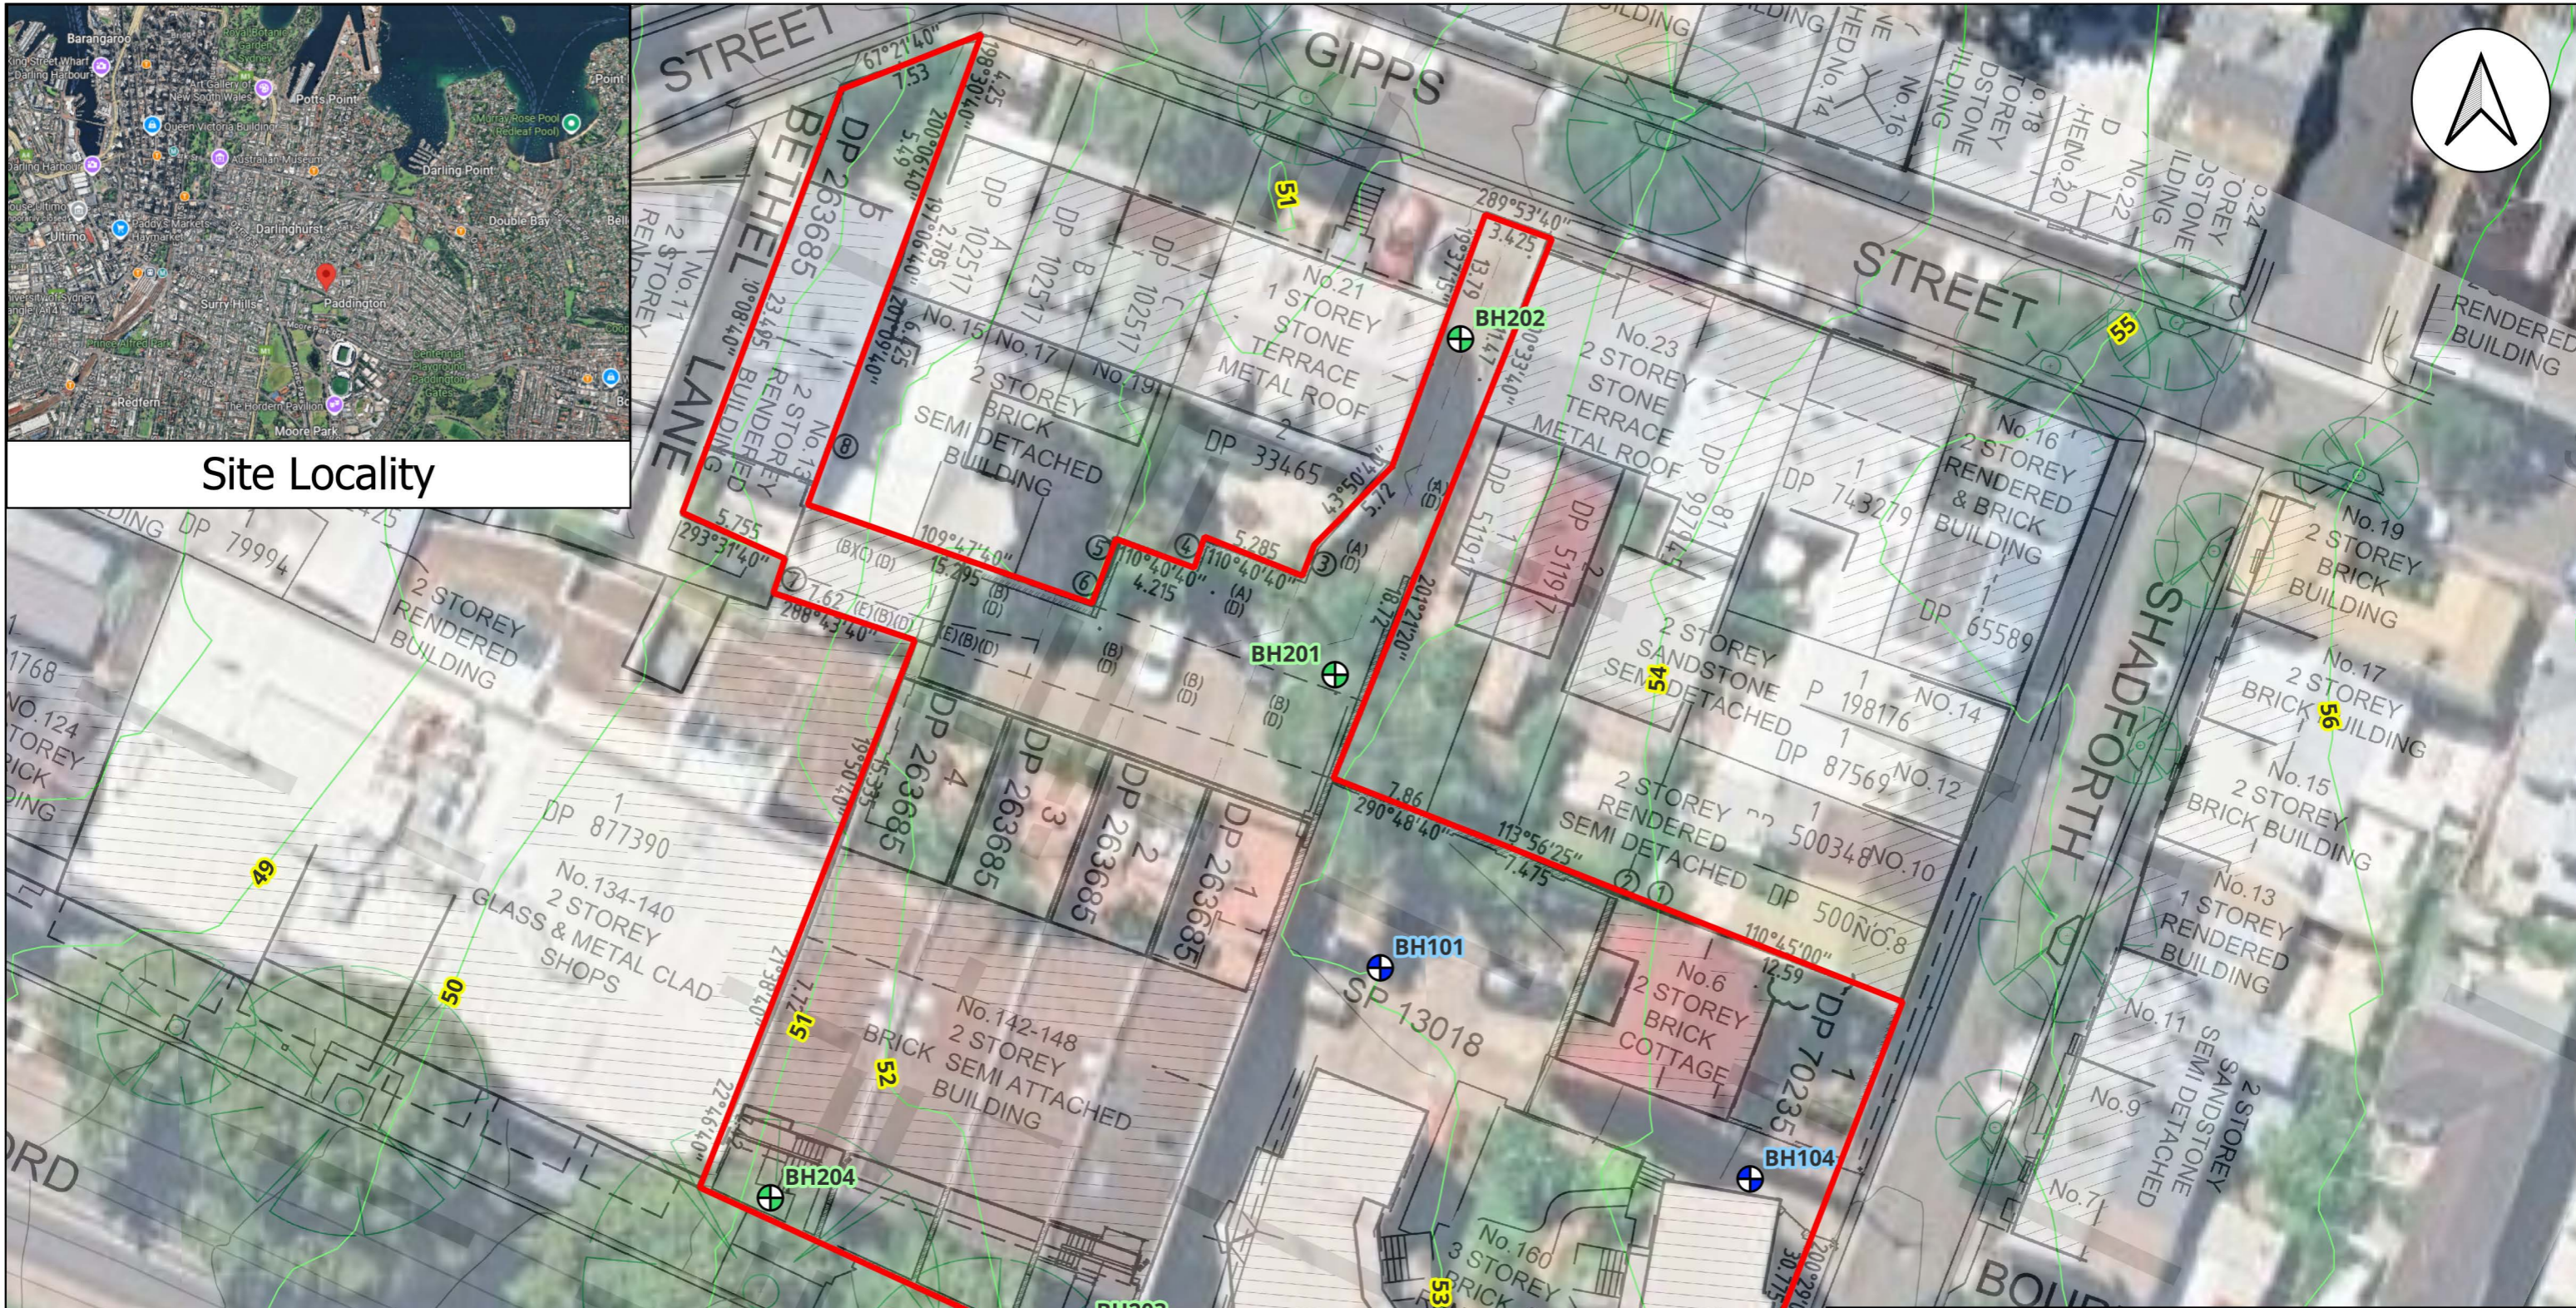
Drawing:	1
Project:	P3569
Revision:	0

Toohy Miller Pty Ltd
 Geotechnical Investigation
 142-160 Oxford Street, 13 Gipps Street & 6
 Shadeforth Street, Paddington NSW
 Borehole Location Plan

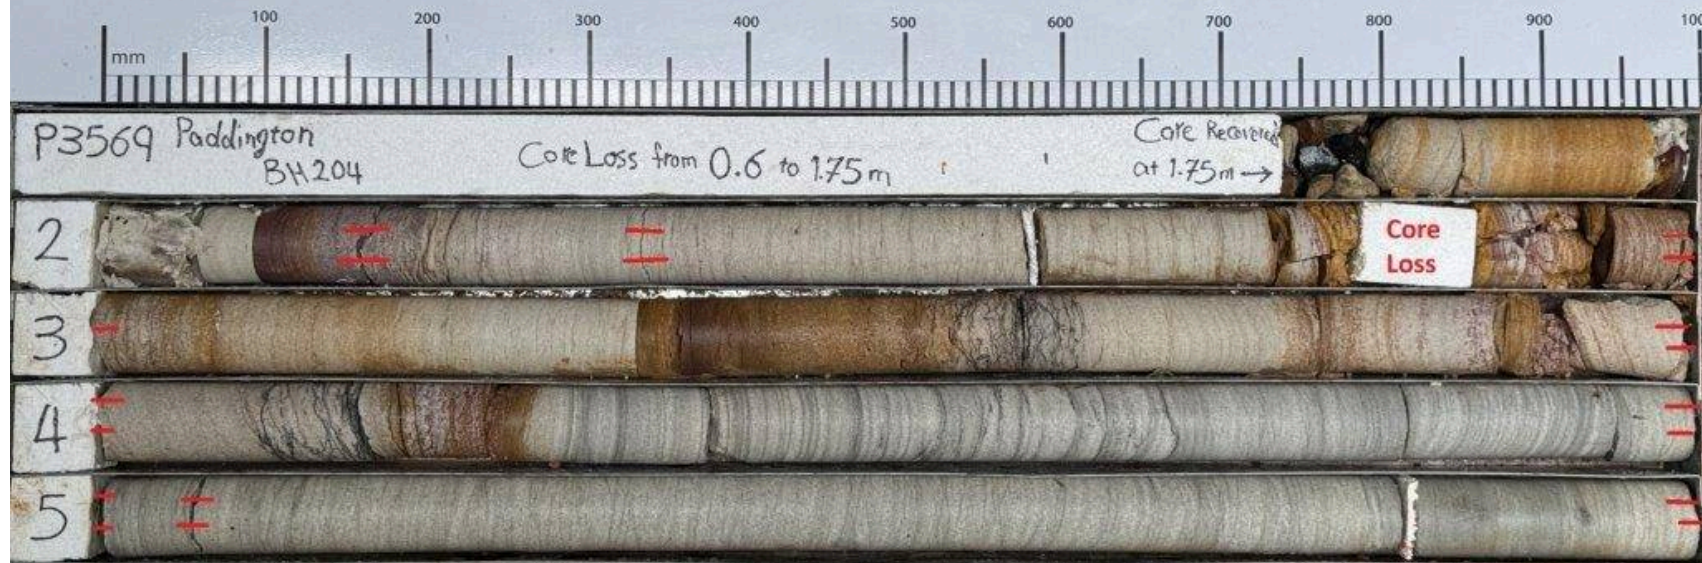
BOREHOLE ID: *BH204*
 DEPTH: *1.75 to 6.0 m*
 CORE TRAY NO.: *1 of 3*
 DATE: *22,10,25*

CLIENT NAME: *TOOHEY MILLER PTY LTD*
 PROJECT: *Paddington*
 LOCATION: *142 Oxford Street*
 JOB NUMBER: *P3569*
 LOGGED BY: *MJ*

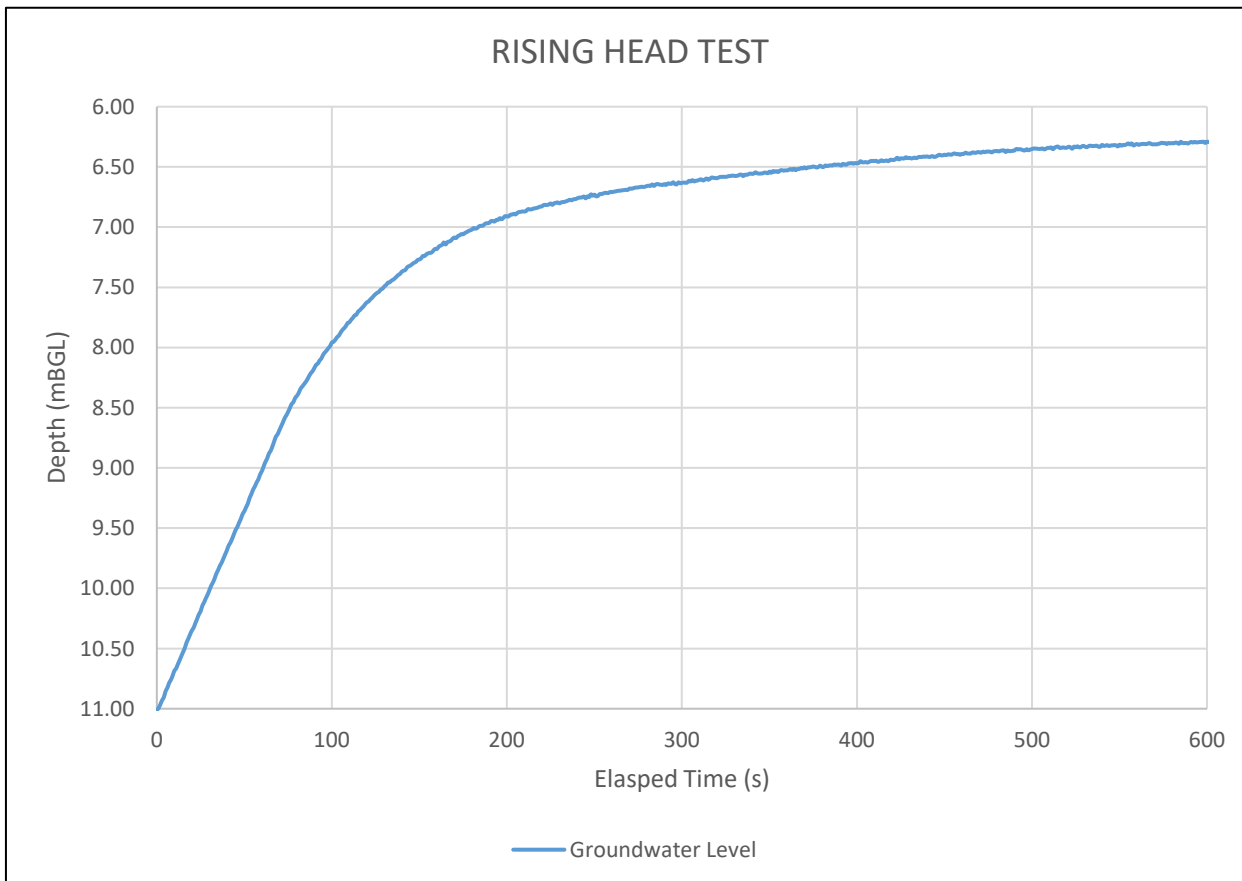
Time (t1) (s)	4
Time (t2) (s)	150
Initial Head (H1) at (t1)	10.91
Final Head (H2) at (t2)	7.77
Length of Response Zone (L)	19.07
Cross Sectional Area (A)	0.0038

$$\text{Intake Factor (F) Case D} = \frac{2pL}{\log_e [(L/D) + \sqrt{1 + (L/D)^2}]} = \frac{119.82}{6.30} = 19.02$$

$$\text{Permeability (k)} = \frac{A}{F(t_2 - t_1)} \log_e \frac{H_1}{H_2} = 4.70E-07 \text{ m/s}$$

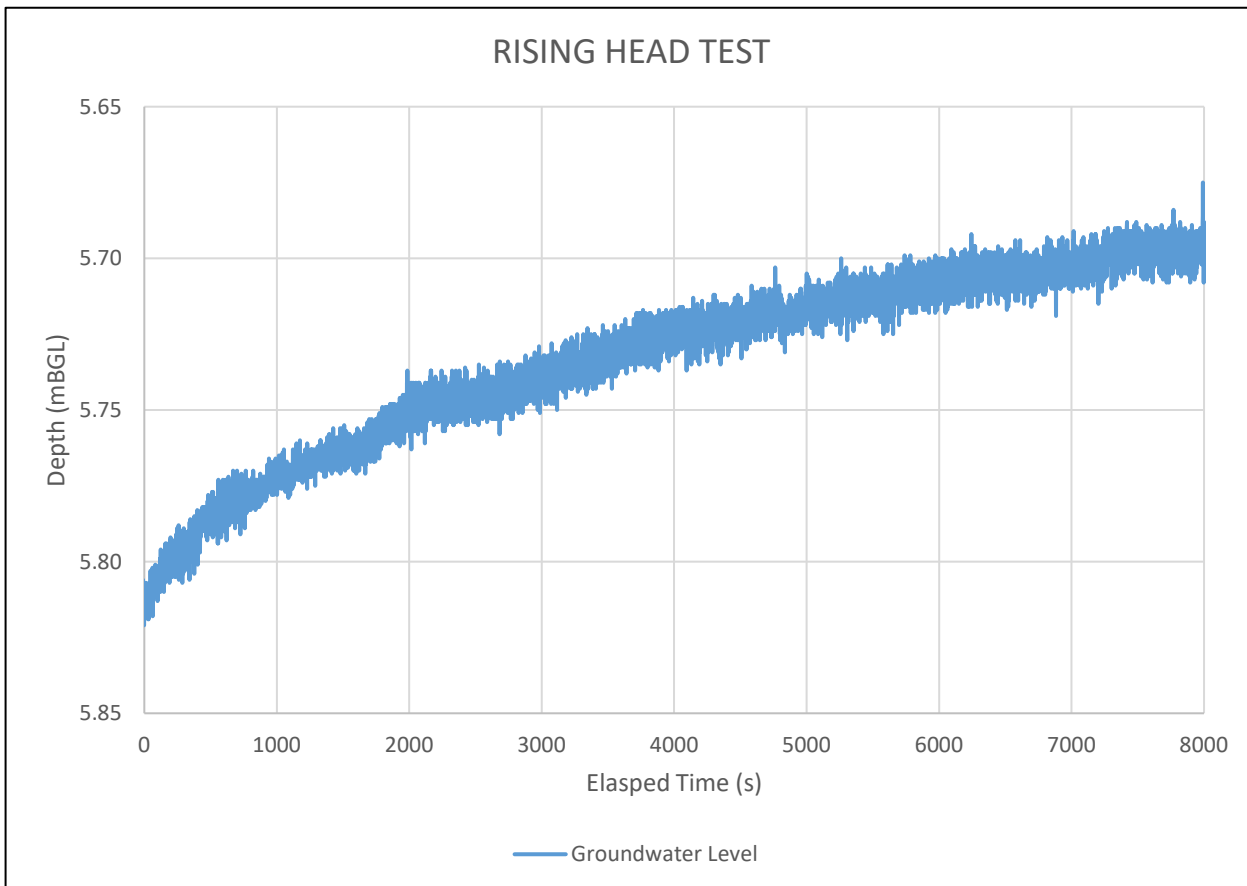
Time (t1) (s)	170
Time (t2) (s)	7000
Initial Head (H1) at (t1)	5.80
Final Head (H2) at (t2)	5.70
Length of Response Zone (L)	10.33
Cross Sectional Area (A)	0.0038

$$\text{Intake Factor (F) Case D} = \frac{2pL}{\log_e [(L/D) + \sqrt{1 + (L/D)^2}]} = \frac{64.91}{5.69} = 11.41$$

$$\text{Permeability (k)} = \frac{A}{F(t_2 - t_1)} \log_e \frac{H_1}{H_2} = 8.59E-10 \text{ m/s}$$

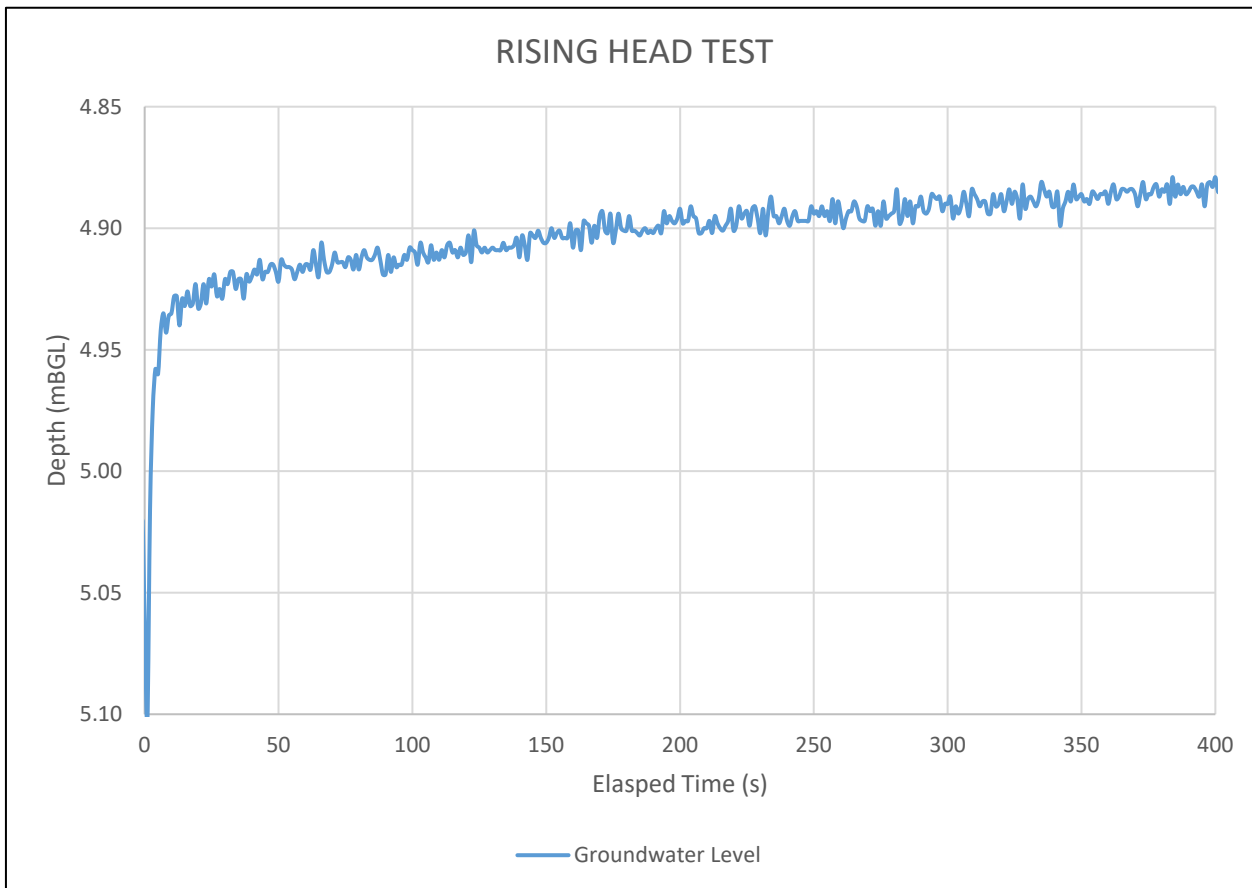
Static water level (mBGL)	4.85	Time (t1) (s)	17
Internal Diameter (D) (m)	0.07	Time (t2) (s)	394
Length of Standpipe below Ground Level (m)	15.13	Initial Head (H1) at (t1)	4.93
Height of Water above Ground Level (m)	0.00	Final Head (H2) at (t2)	4.89
Length of Standpipe above Ground Level (m)	0.00	Length of Response Zone (L)	10.28
Water level at start of test (mBGL)	4.85	Cross Sectional Area (A)	0.0038
Top of Response Zone (mBGL)	4.85		
Bottom of Response Zone (mBGL)	15.13

$$\text{Intake Factor (F) Case D} = \frac{2pL}{\log_e [(L/D) + \sqrt{1 + (L/D)^2}]} = \frac{64.59}{5.68} = 11.37$$

$$\text{Permeability (k)} = \frac{A}{F(t_2 - t_1)} \log_e \frac{H_1}{H_2} = 8.23E-09 \text{ m/s}$$
