# 225 - 245 Martin Road, Bradfield Bulk Earthworks SSD-97711727

## Riparian Land Assessment

### Goodman Property Services (Aust) Pty Ltd

16 March 2026

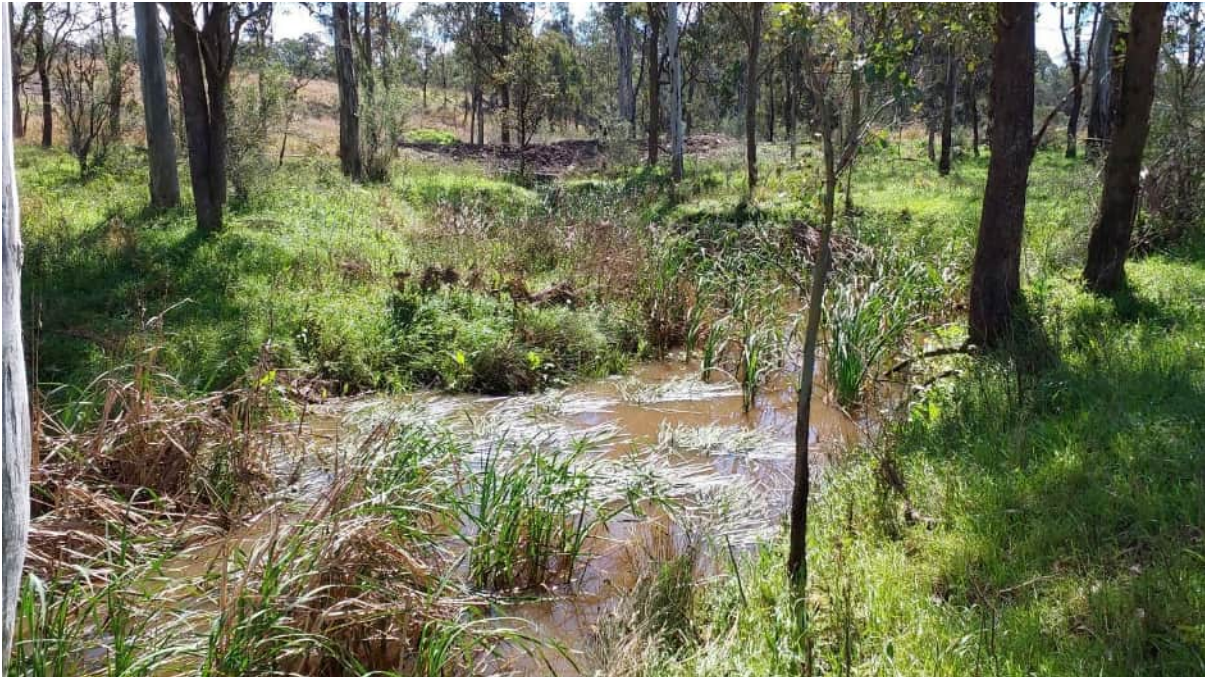
**Photograph 11 Watercourse C**

The watercourse is an overland flow path that is usually dry, but contains water following rainfall, and serves as a flow path into Quarry Pit 2. It lacks a defined channel with bed and bank structure (see **Photograph 11 to Photograph 13, Appendix A**). It is currently highly degraded and has been heavily modified for agricultural uses with the majority of native vegetation cleared and now consists primarily of exotic dominated grassland with scattered patches of *Juncus usitatus* present in the most waterlogged areas, and as a result contains low biodiversity value and does not serve as a suitable biodiversity corridor in its current form. Additionally, no frogs or aquatic species were observed from this area during the field surveys, which occurred after very heavy rainfall (**Table 1**). Stock have had access to this flow path for

many years and trampling and grazing have contributed to its current highly degraded condition.

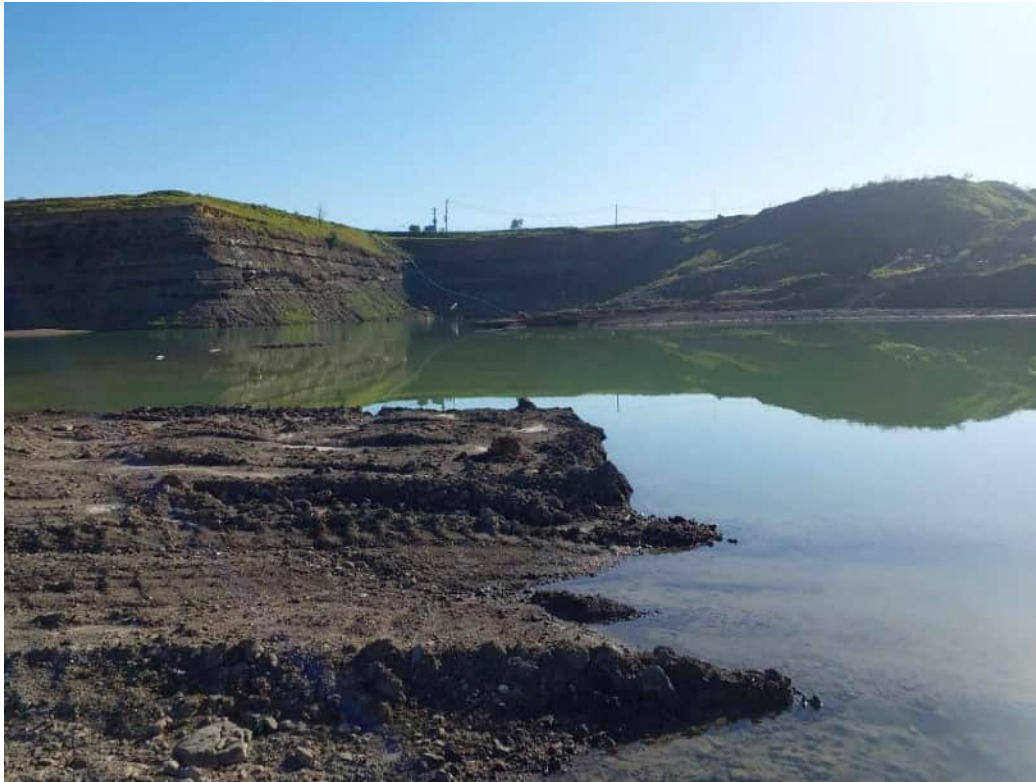
**Photograph 15 Quarry Pit 1 (since been dewatered under MP10\_0014)**

It should be noted that the two quarry pits contain surface water only and will be completely dewatered and removed under existing authority approvals issued under MP10\_0014.

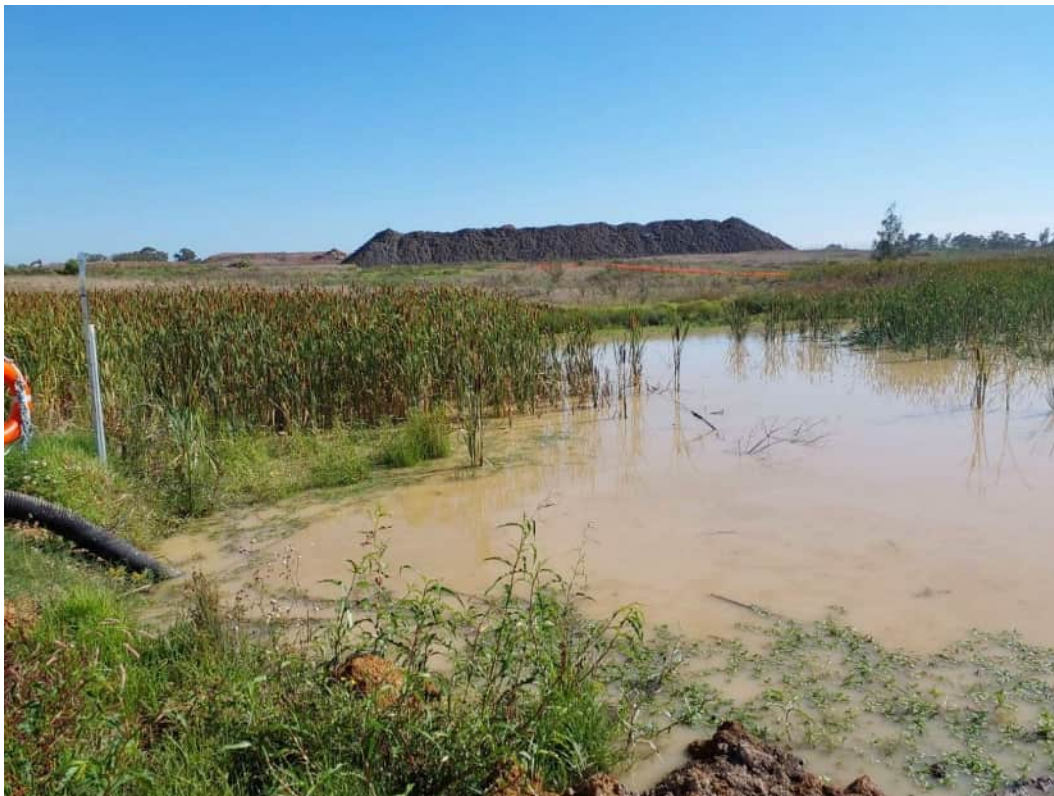
**Photograph 16 Quarry Pit 2 (since been dewatered under MP10\_0014)**
