Report on
Validation of Remediation

Nihon University
9 Church Street, Newcastle

Prepared for
Nihon Daigaku Australia Newcastle Pty Ltd

Project 91667.03
September 2021

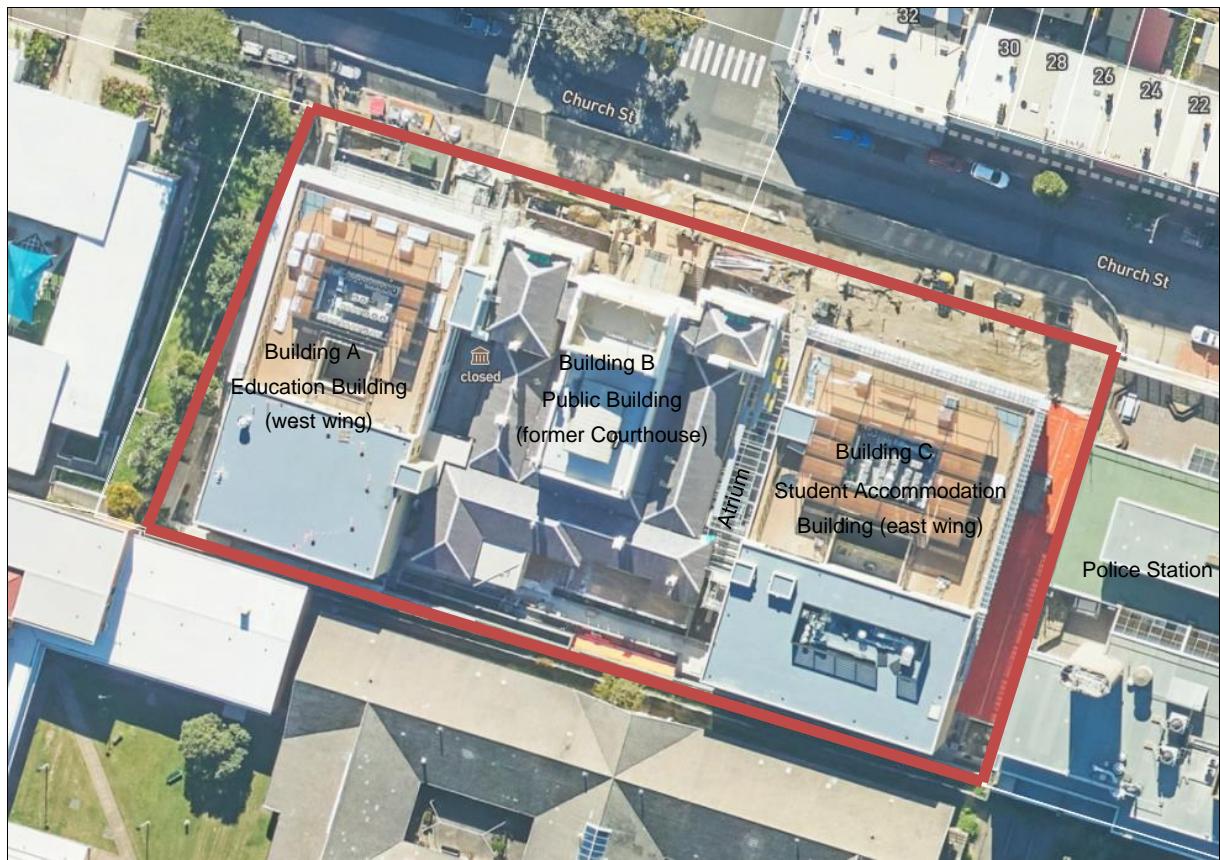
Figure 1: Approximate extent of development area ('the site') in red, Nihon University (Metromap Image dated 6 June 2020)

The site was formerly known as the Newcastle Courthouse which comprised three adjoining structures – the original Courthouse (central building nominated "Building B" which was retained during construction), the Administration Building and the Supreme Court Building with a rear carpark (south-east corner) and landscape areas. The site is shown on Drawing 1 in Appendix A (with the former Newcastle Courthouse building layouts), Geosurv Asbuilt Remediation Layers Plans in Appendix A and as shown in Figure 1 below.

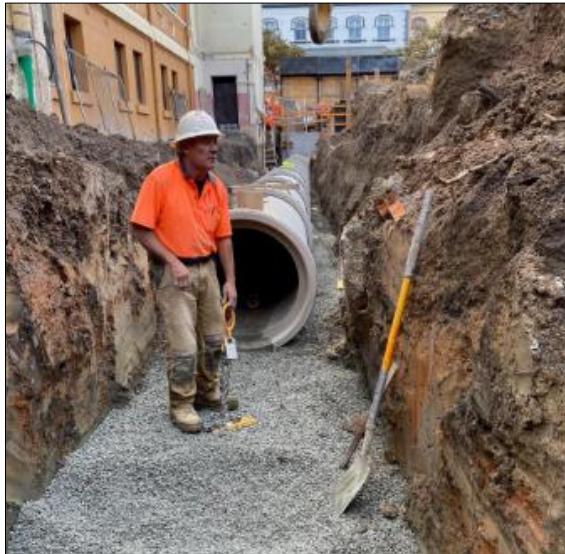
Figure 1: Pipe installation well within natural underling clays looking north (provided by Built Pty Ltd)

- The base of the trench was excavated well within 'clean' natural soils (refer to Figure 1);
- The degree of contamination remaining within filling at the site is considered to be low;

Relevant photos of the pipeline installation are shown below in Figures 1 to 3 and 5.

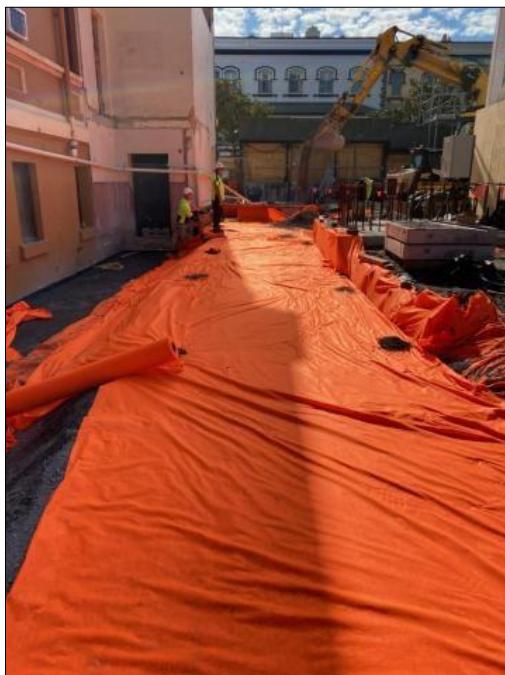
Figure 2: Orange geofabric sacrificial marker layer placed over pipe backfill looking north (provided by Built Pty Ltd) (16 July 2020)

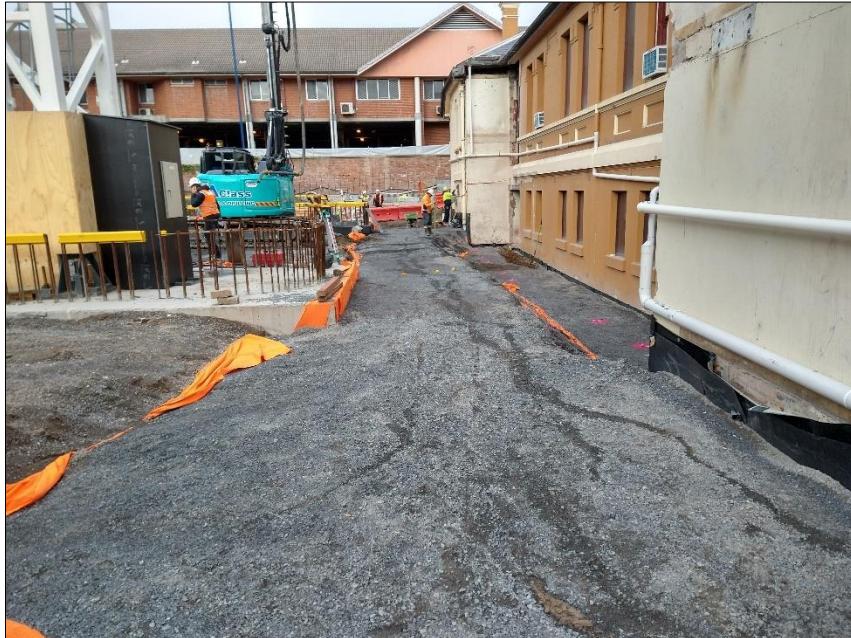
Figure 3: Imported fine crushed rock placed over orange geofabric marker layer placed over pipe backfill looking south (provided by Built Pty Ltd) (16 July 2020)

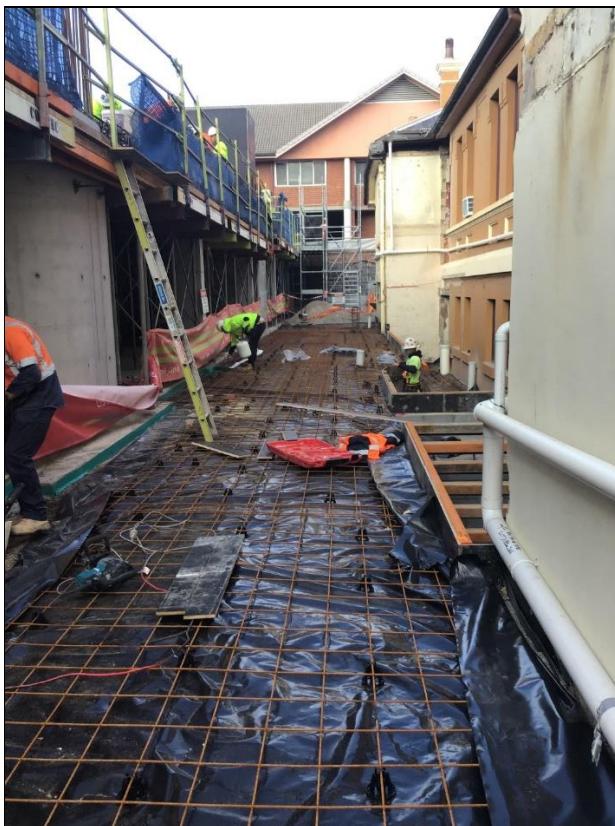
Figure 5 - Black plastic marker layer beneath Atrium concrete slab (25 August 2020 - supplied by Built)

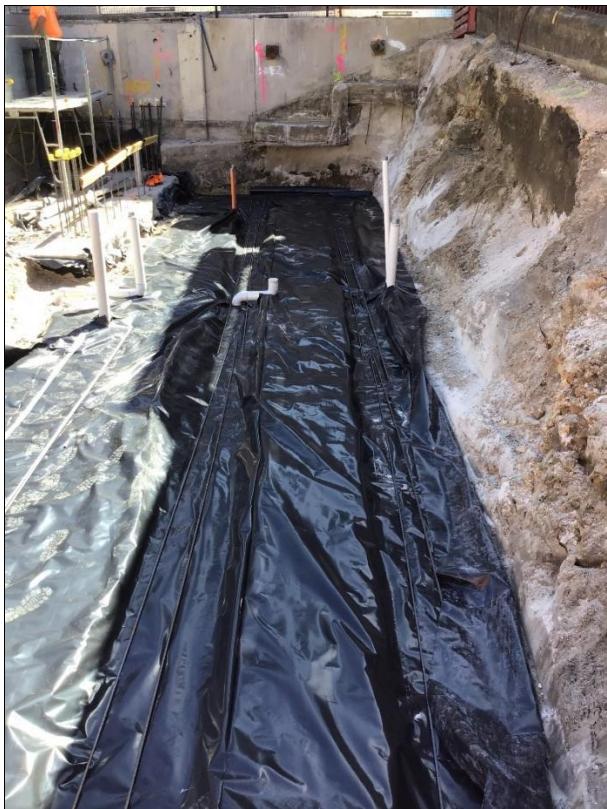
Figure 6 - Black plastic marker layer beneath concrete slab in north-west corner site (1 September 2020 - supplied by Built)

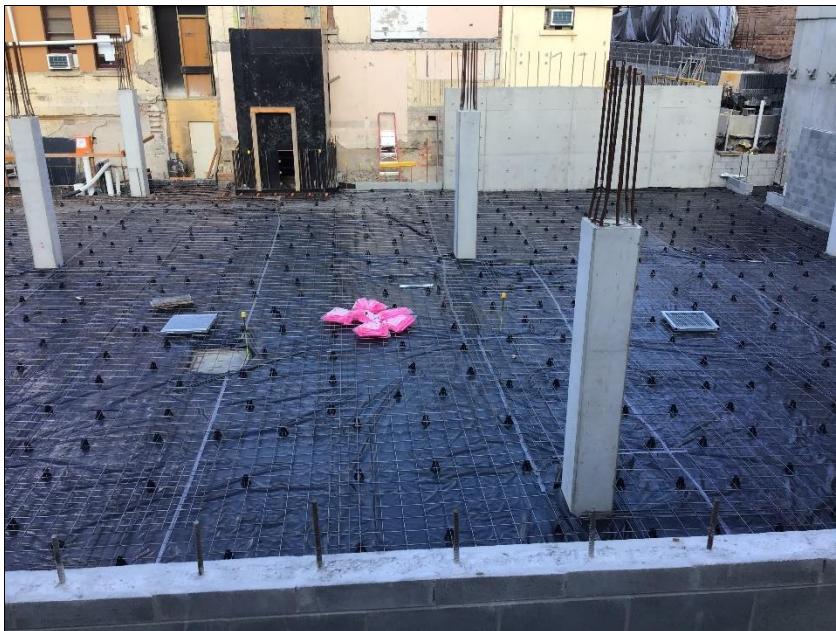
Figure 7 - Black plastic marker layer beneath Education Building concrete slab (16 September 2020 - supplied by Built)

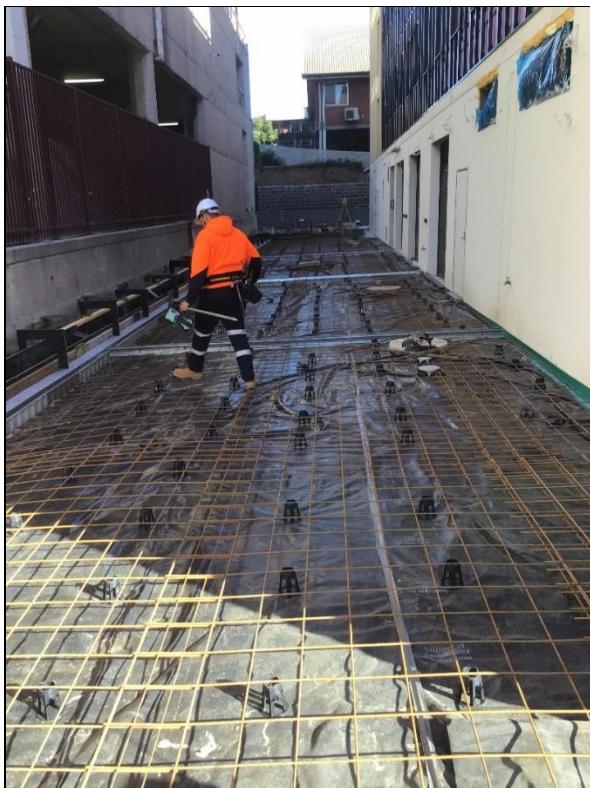
Figure 8 - Black plastic marker layer beneath concrete driveway to east of Student Accommodation Building (28 May 2021 - supplied by Built)

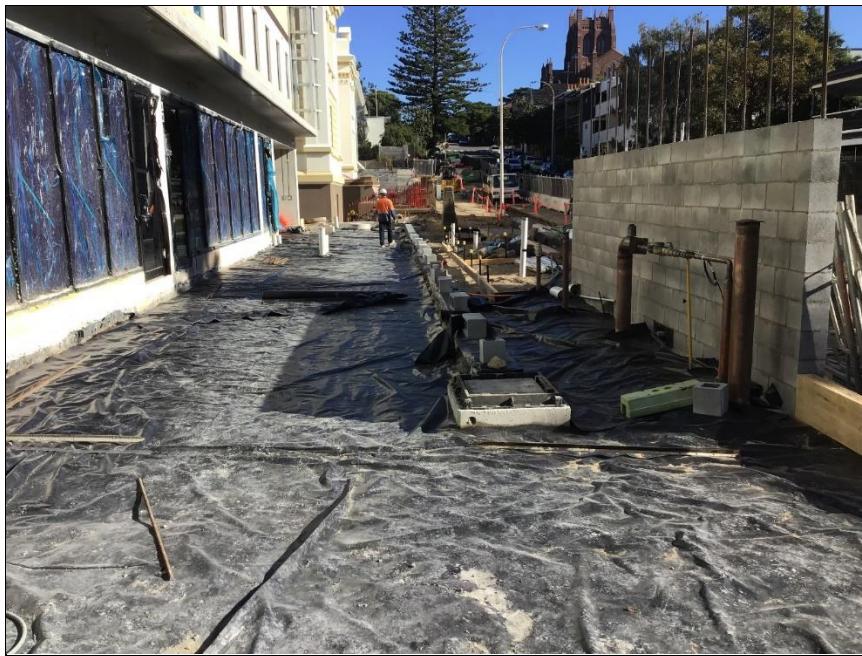
Figure 9 – Black plastic marker layer beneath concrete pavement on northern (front) side of Student Accommodation Building (26 June 2021 – supplied by Built)

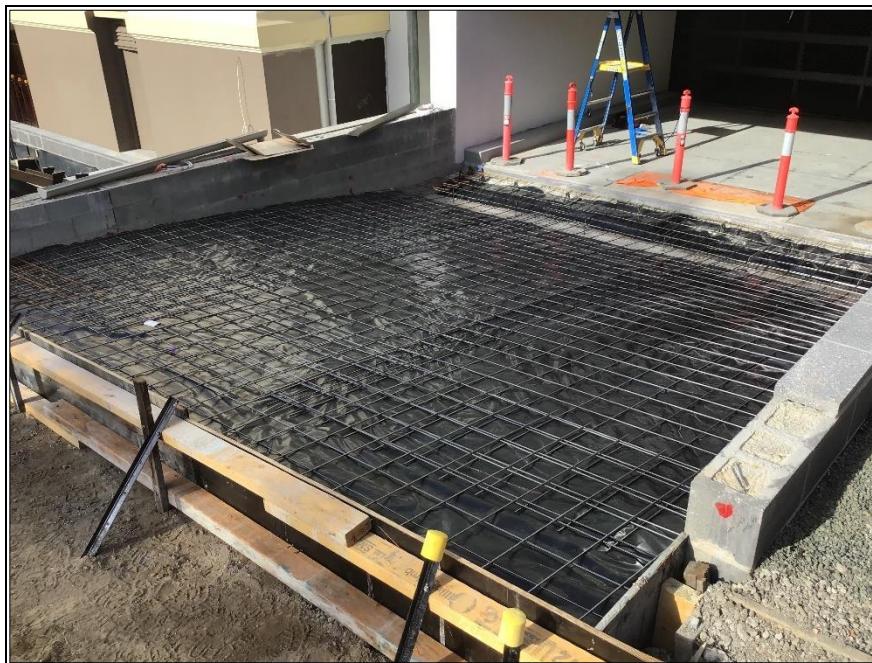
Figure 10 - Black plastic marker layer beneath driveway entrance concrete slab to Education Building carpark (6 July 2021 - supplied by Built)

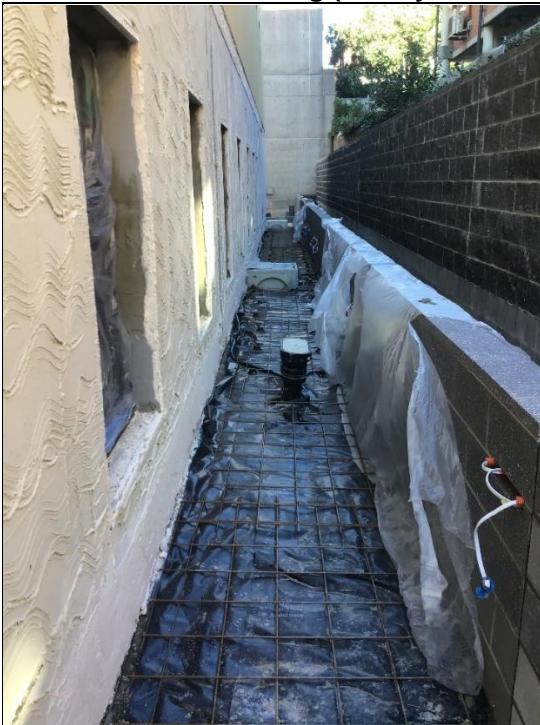
Figure 13 – Black plastic marker layer beneath concrete/crushed granite paths to rear of Student Accommodation Building (17 May 2021 - supplied by Built)

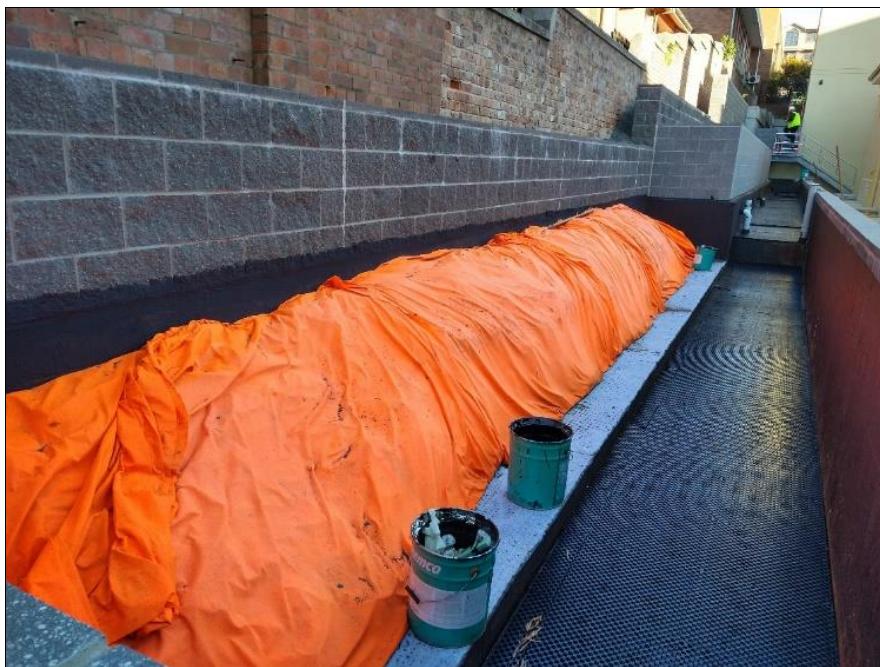
Figure 14 – Orange geofabric marker layer over impacted soils in garden bed and black geogrid matting beneath garden beds (over concrete) to rear of central building (13 July 2021)

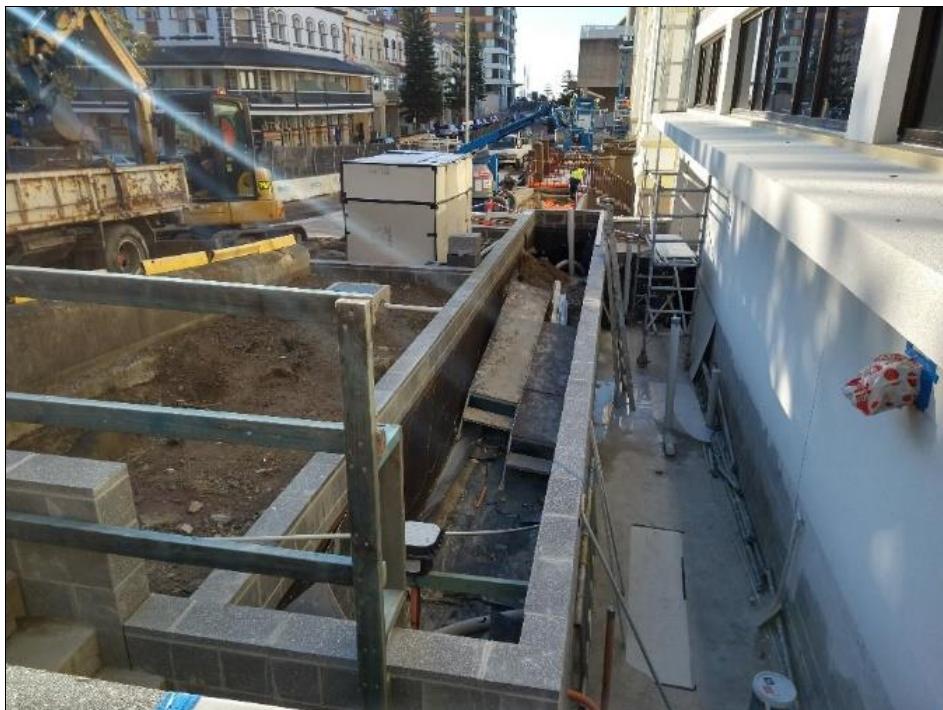
Figure 19 – Front landscaping including partially former garden beds and concrete slab (capping) planter box (right) along Education Building frontage and further east (13 July 2021)

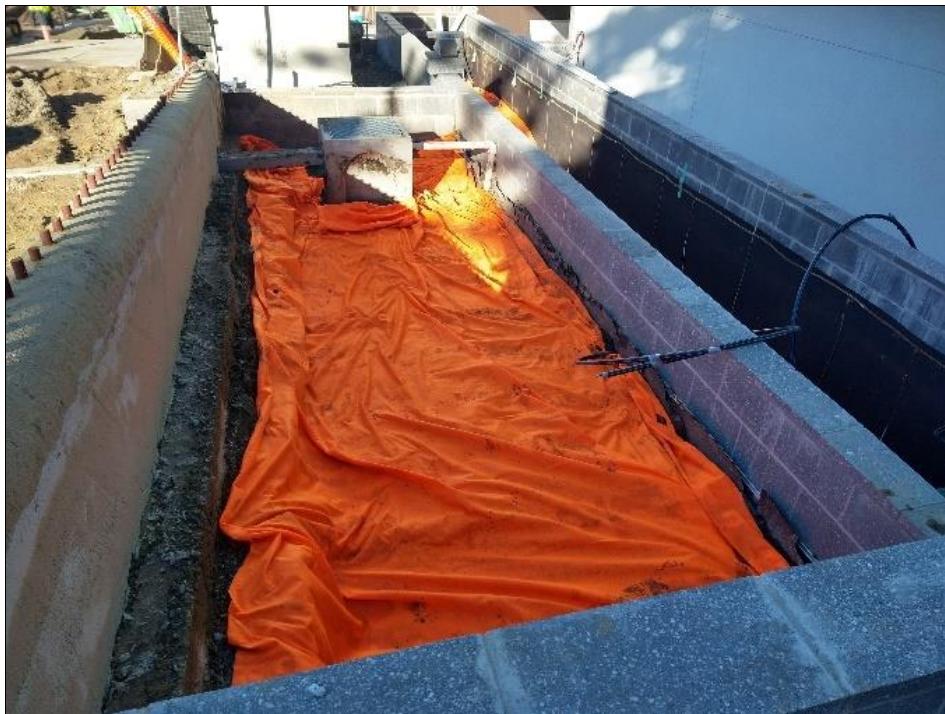
Figure 20 – Orange geofabric marker layer in garden beds at the front of the Education Building (16 July 2021)

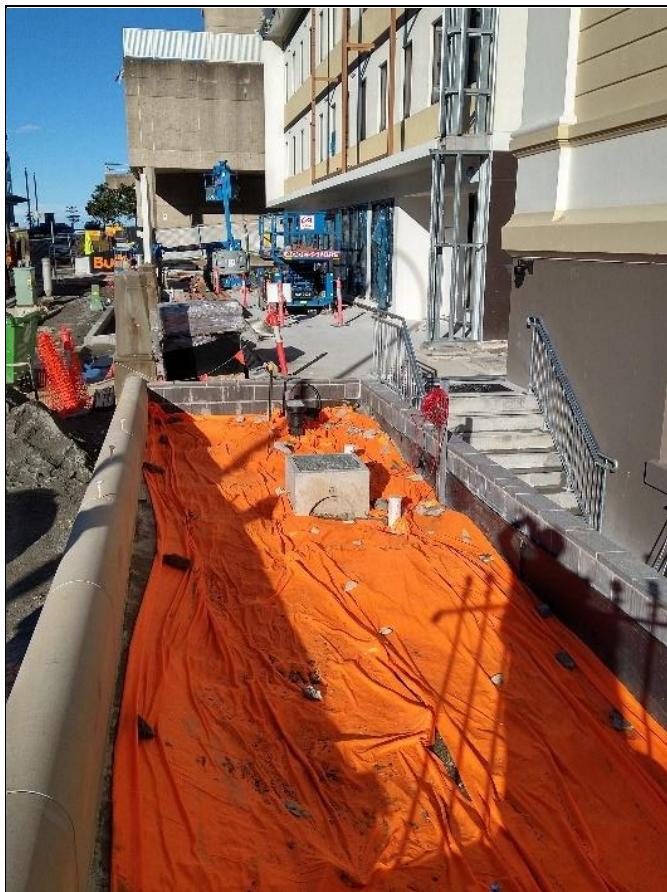
Figure 21 – Orange geofabric marker layer in garden beds at the front of the central building (16 July 2021)

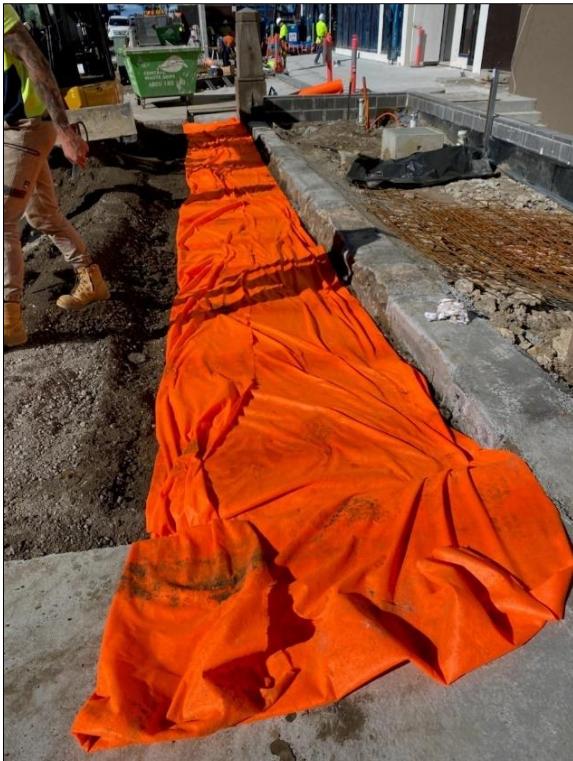
Figure 23 – Orange geofabric marker layer beneath the asphalt pavement along northern (front) boundary adjacent to footpath (19 July 2021 – supplied by Built)

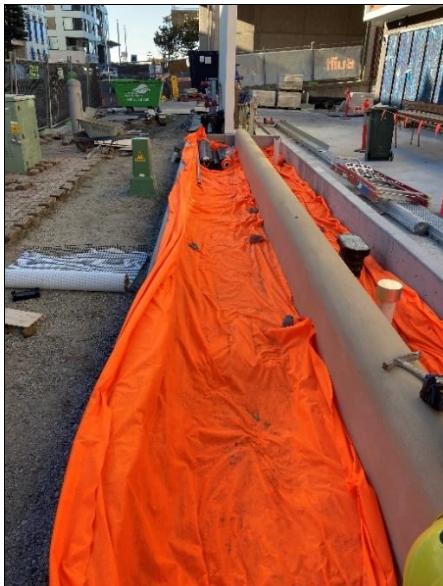
Figure 25 – Orange geofabric marker layer within garden bed on northern (front) side of the Student Accommodation Building (22 July 2021 – supplied by Built)

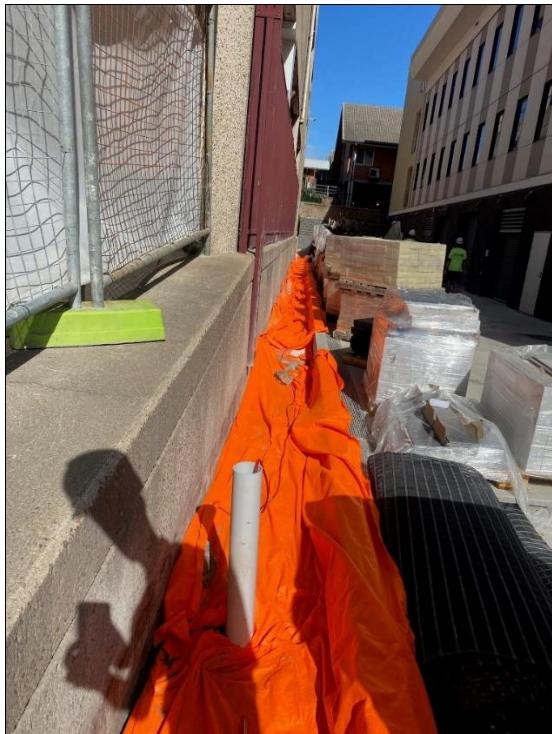
Figure 27 – Orange geofabric marker layer within garden bed/planter box on eastern side of the Student Accommodation Building (26 July 2021 – supplied by Built)

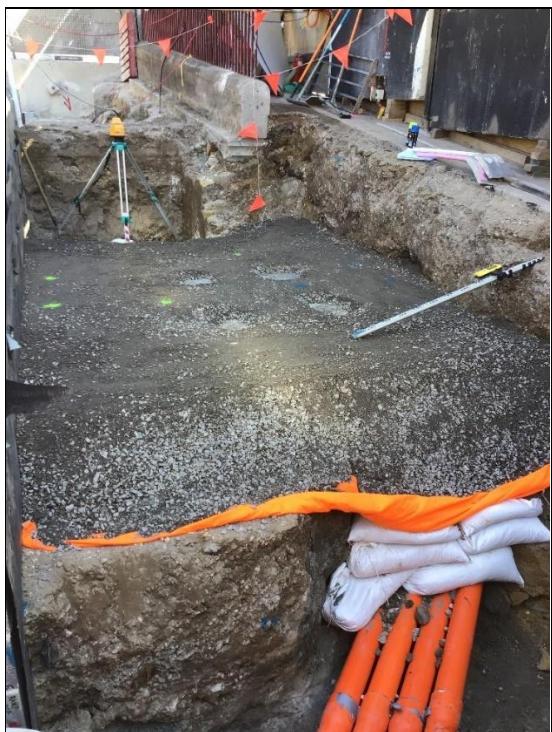
Figure 28 – Orange geofabric marker layer and imported roadbase from Boral Seaham quarry beneath electrical kiosk north of the Education Building (25 September 2020 – supplied by Built)

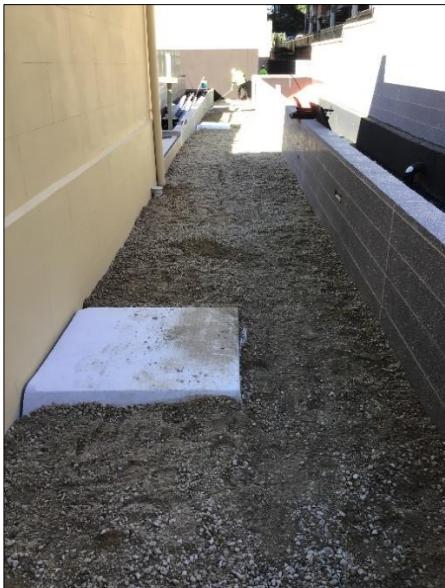
Figure 29 – Roadbase from Oz Landscape Supplies (Teralba quarry) being laid on footpaths prior to crushed granite screed (22 July 2021 -supplied by Built)

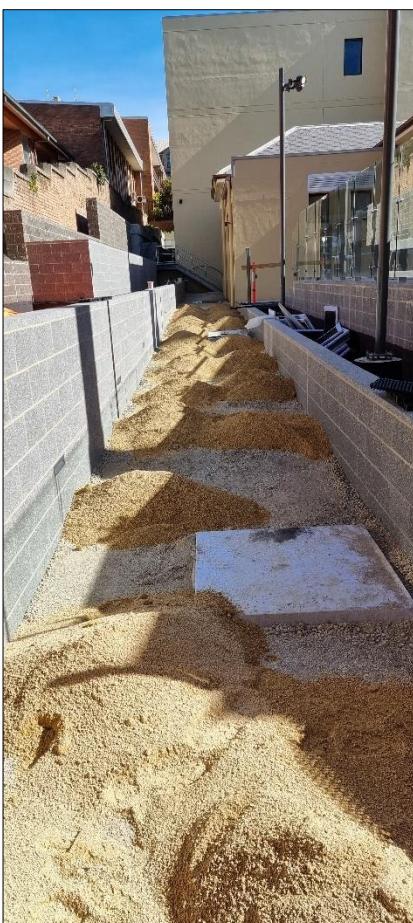
Figure 30 - Crushed granite (white Scoria) supplied by Saddingtons and Blue Gum Landscaping Centre (from Coastal Quarry Products) in process of being laid on footpath over roadbase (27 July 2021 -supplied by Built)

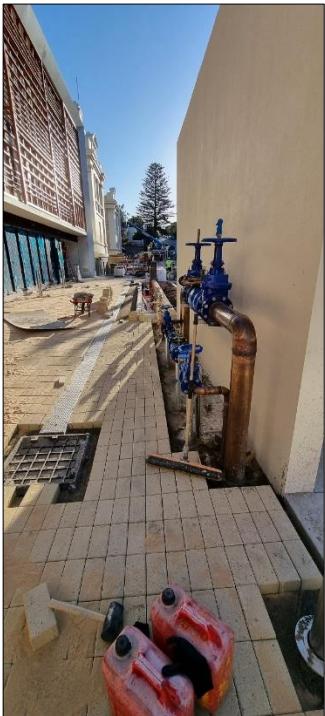
Figure 31 – Pavers laid over packing sand (from Saddingtons) over concrete (28 July 2021 – supplied by Built).

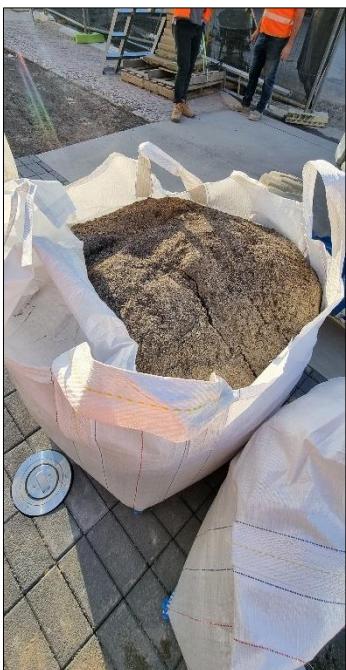
Figure 32 – Packing sand from Saddingtons used for Paving (28 July 2021 – supplied by Built).

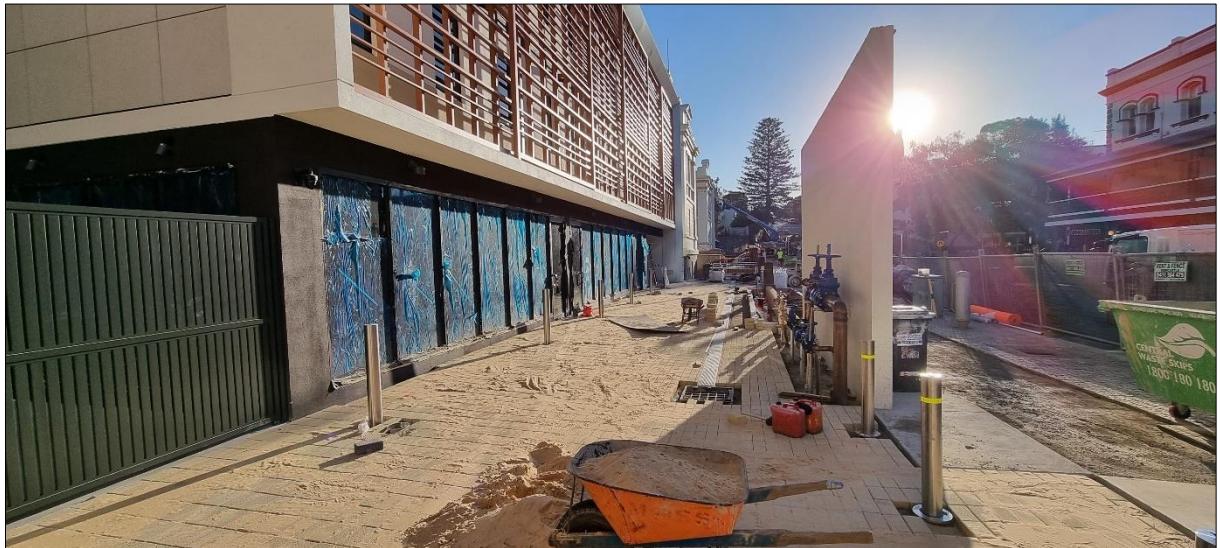
Figure 33 – Sand from Saddingtons (Mackas Sand & Soil - Williamtown quarry) used as paving sand at front of Student Accommodation building (28 July 2021 – supplied by Built). Pavers laid over packing sand (from Saddingtons) over concrete.

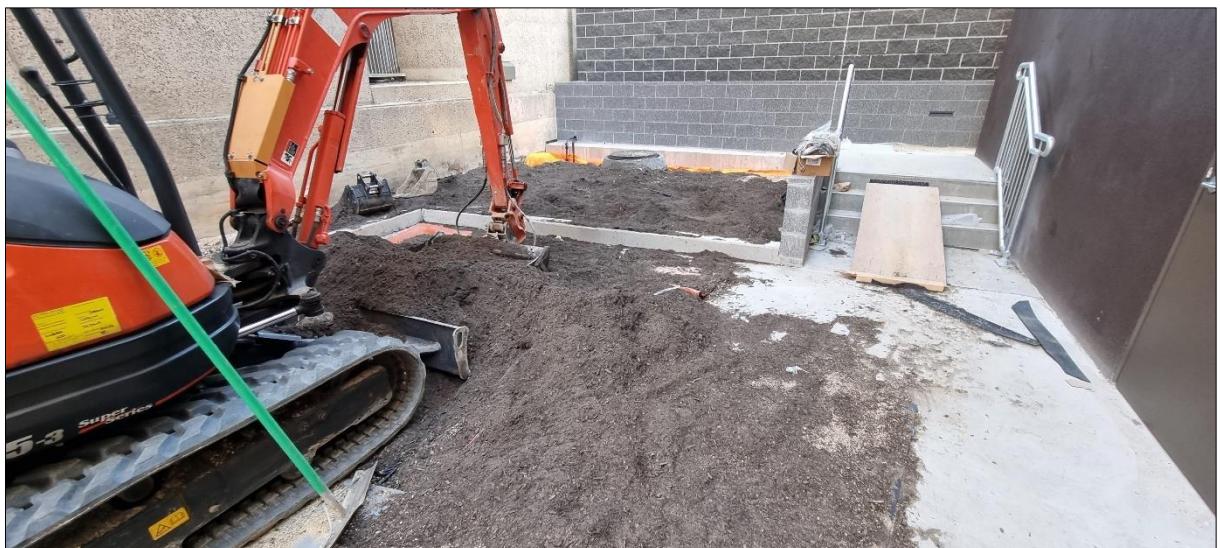
Figure 34 – Hills Premium Garden Mix used over geofab in garden beds in south east corner of site (17 August 2021 – supplied by Built)

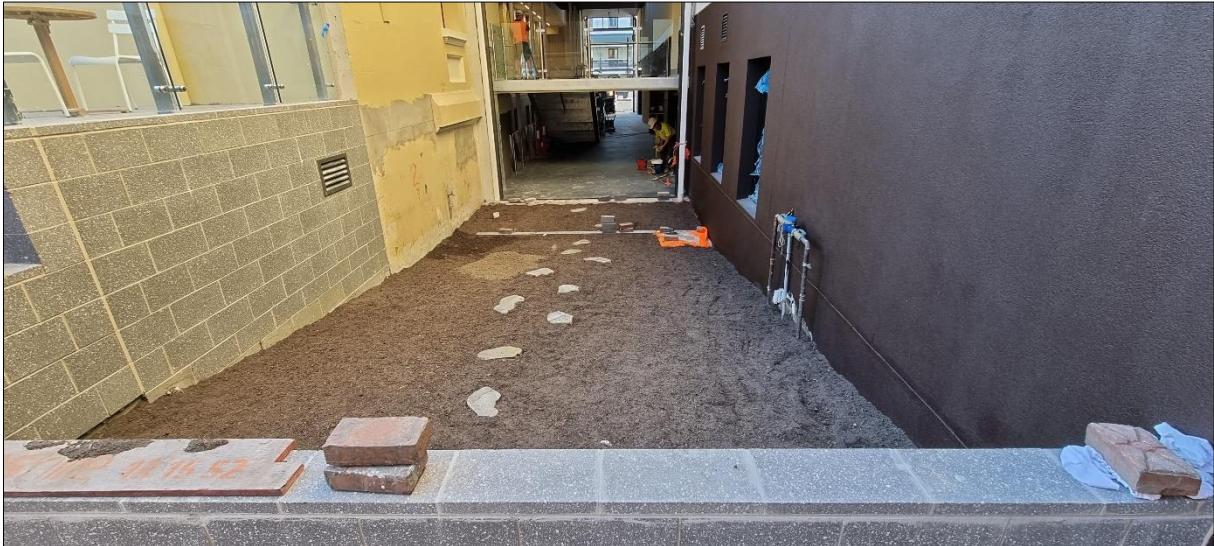
Figure 35 – Hills Premium Garden Mix used over geofab in garden beds (17 August 2021 – supplied by Built)

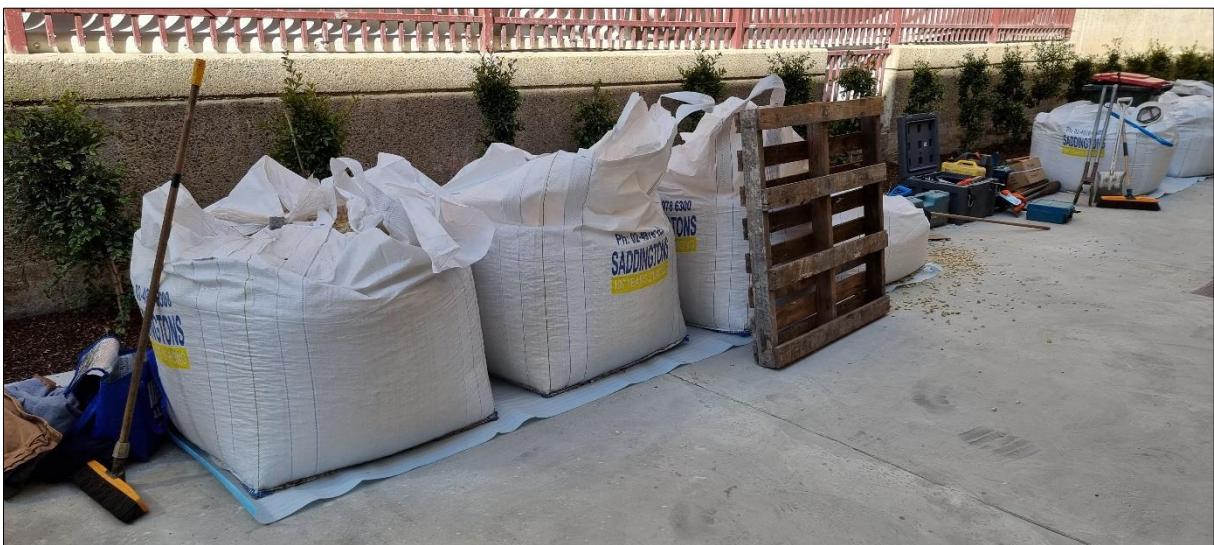
Figure 36 - White Scoria (crushed granite and gravel) supplied by Saddingtons and Blue Gum Landscaping Centre (from Coastal Quarry Products) for landscaping (17 August 2021 -supplied by Built)

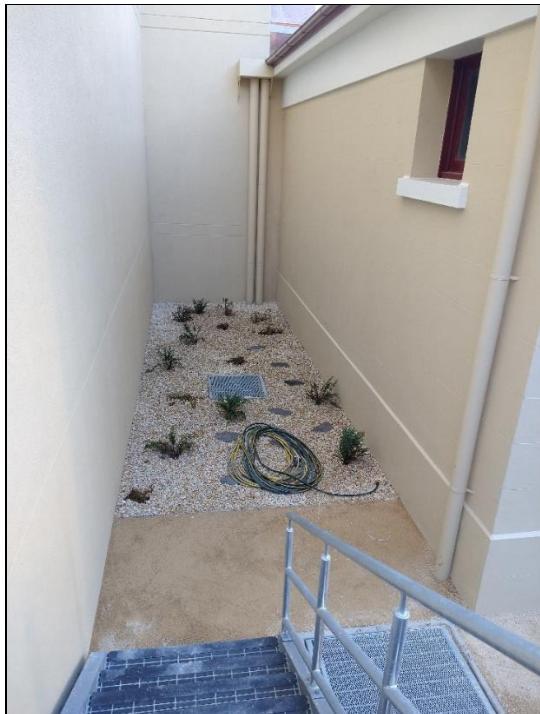
Figure 40 – Looking north at garden bed and walkway along southern side of Education Building. Crushed granite supplied by Saddingtons and Blue Gum Landscaping Centre (from Coastal Quarry Products) and white scoria gravel supplied from Saddingtons (20 August 2021)

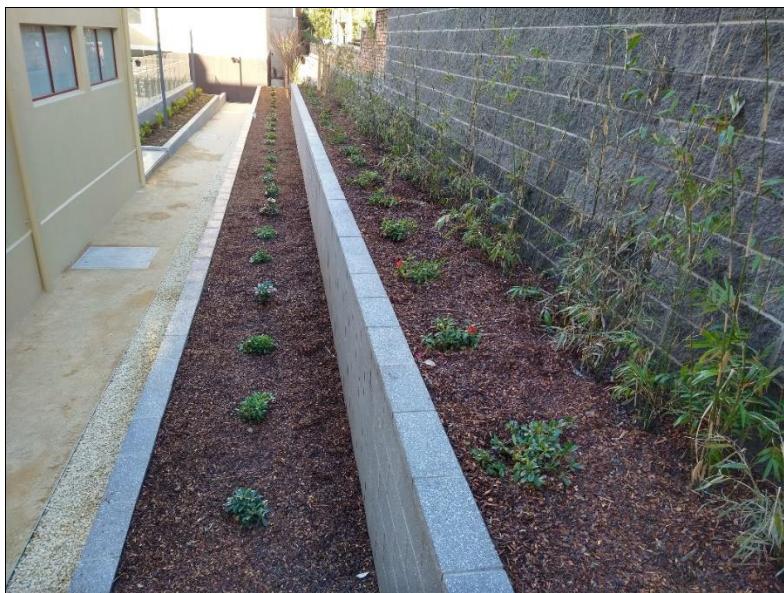
Figure 41 – Looking east at garden bed and walkway along southern side (rear) of central building. Crushed granite supplied by Saddingtons and Blue Gum Landscaping Centre (from Coastal Quarry Products) and mulch supplied from Oz LandscapeSupplies (20 August 2021)

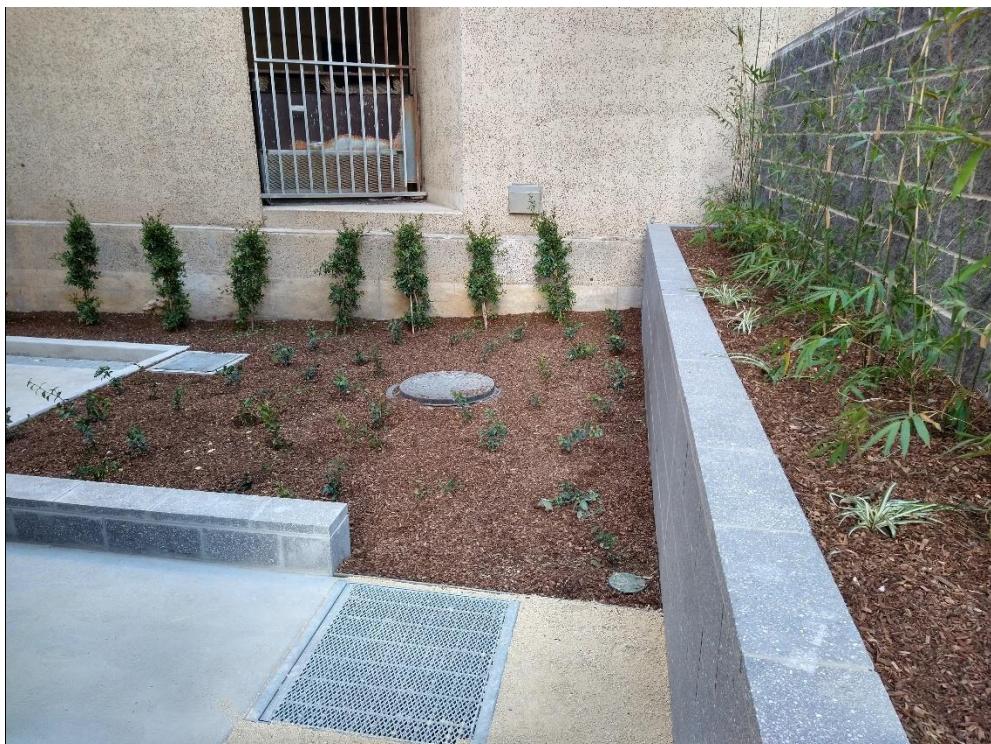
Figure 44 – Looking east at garden bed and walkway in south eastern corner of site. Crushed granite supplied by Saddingtons and Blue Gum Landscaping Centre (from Coastal Quarry Products) and mulch supplied from Oz LandscapeSupplies (20 August 2021)

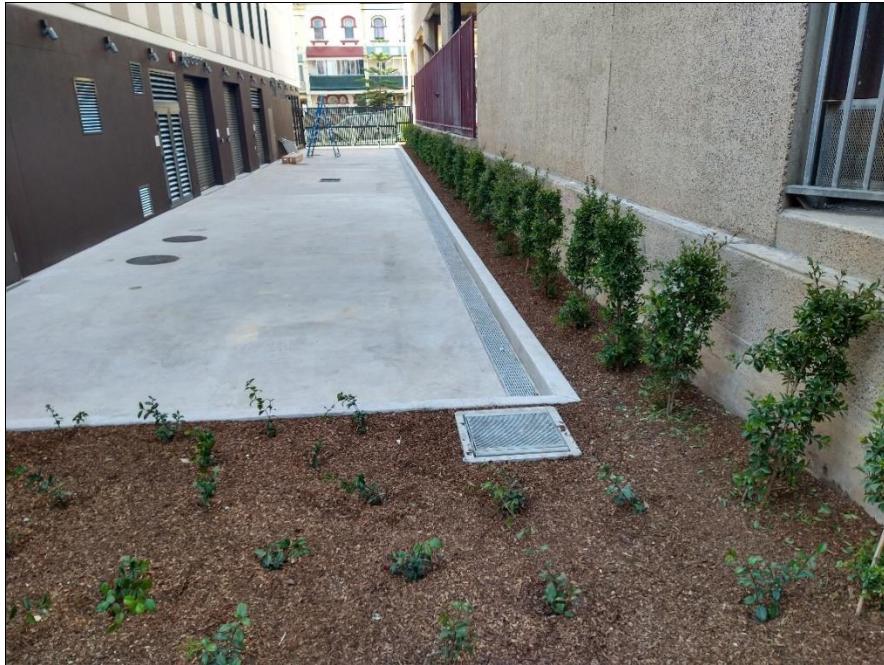
Figure 45 – Looking north at concrete driveway and adjacent garden bed along the eastern site boundary and Student Accommodation Building (left) and Police Station (right). Mulch supplied from Oz LandscapeSupplies (20 August 2021)

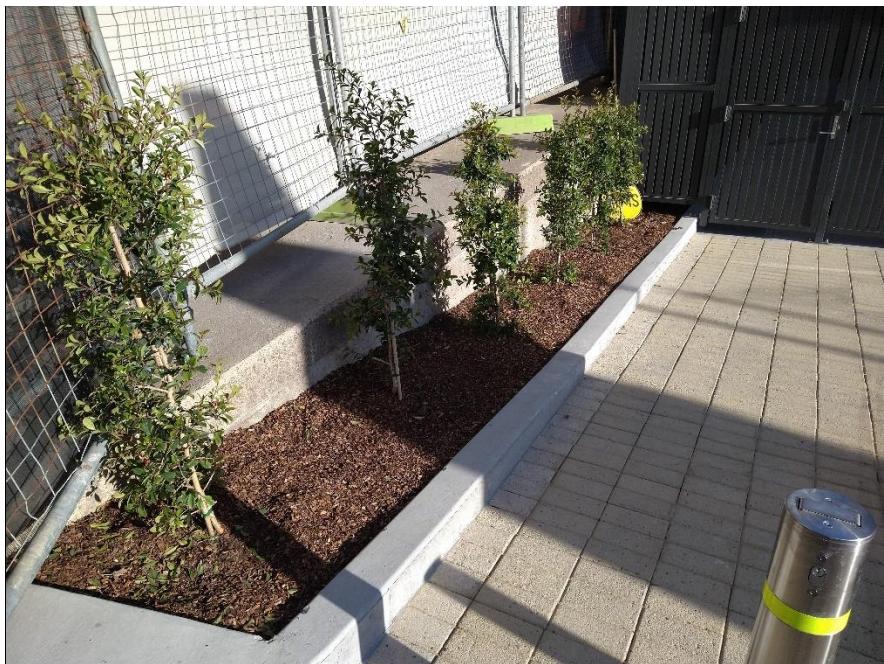
Figure 46 – Looking southeast at concrete paved driveway and adjacent garden bed along the eastern site boundary. Mulch supplied from Oz LandscapeSupplies (20 August 2021)

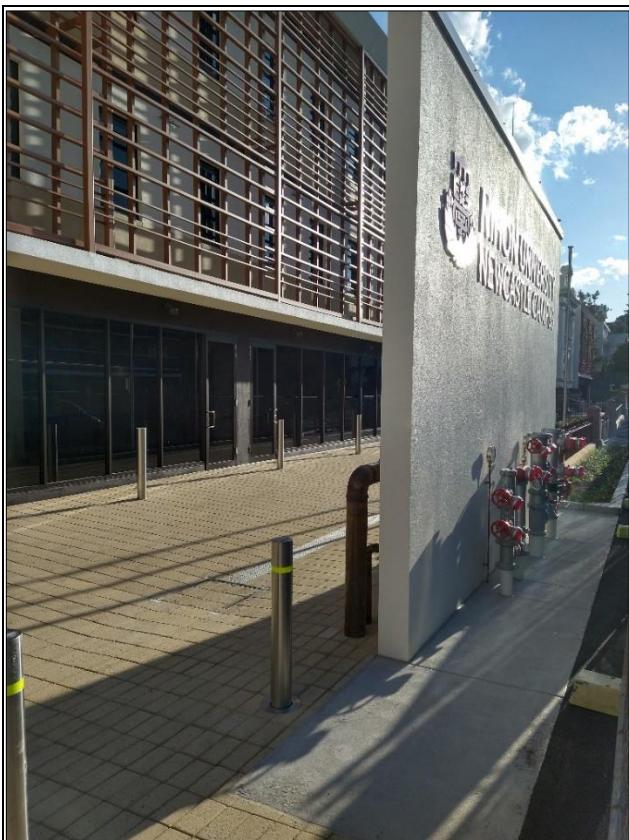
Figure 47 – Looking west at concrete paved driveway/footpath along the north side (front) of the Student Accommodation I Building (20 August 2021)

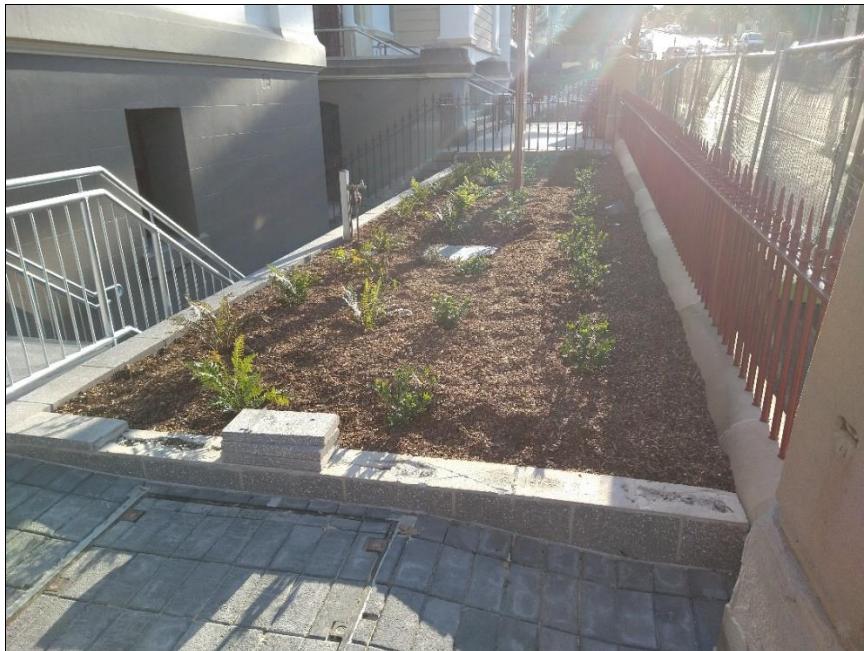
Figure 49 – Looking west at concrete paving and adjacent garden bed along the northern side (front) of the central building. Mulch supplied from Oz LandscapeSupplies (20 August 2021)

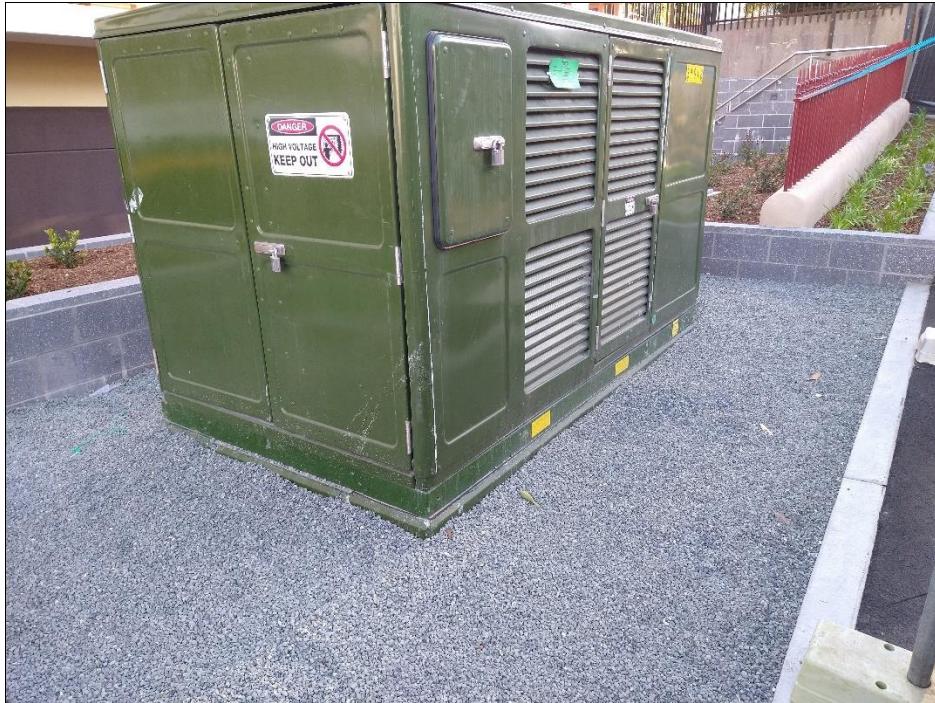
Figure 53 – Looking west at electrical kiosk and 10mm gravel supplied by Saddingtons - Quarry Products (Newcastle) along the northern side (front) of the Education Building (20 August 2021)

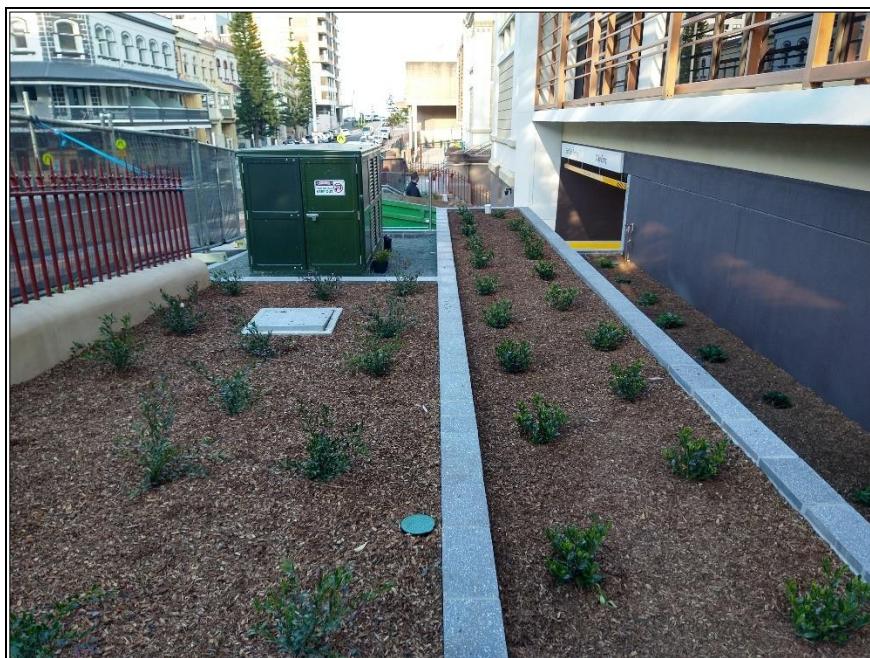
Figure 54 – Looking east at garden beds along the northern side (front) of the Education Building. Mulch supplied from Oz LandscapeSupplies (20 August 2021)

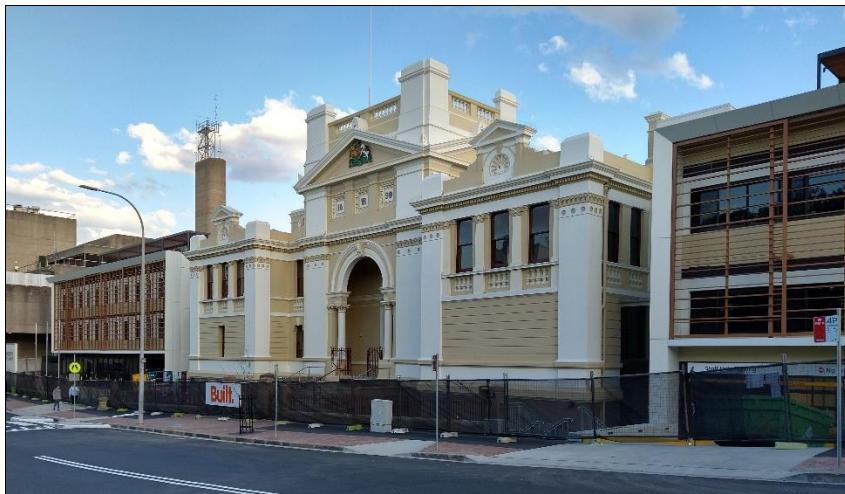
Figure 57 – Looking south east at Church Street and the Nihon University development site (20 August 2021)

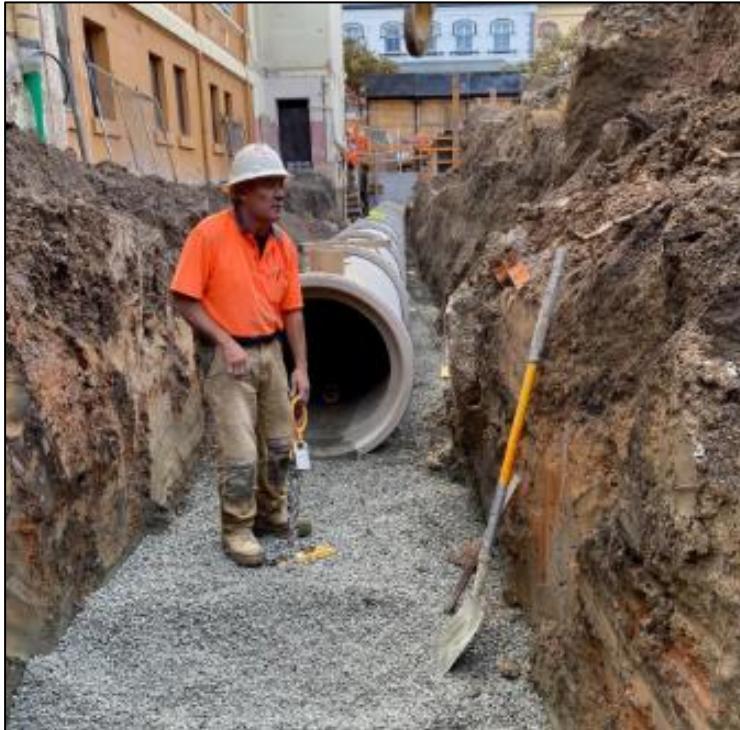
Figure 2: Pipe installation well within natural clays looking north (provided by Built Pty Ltd)

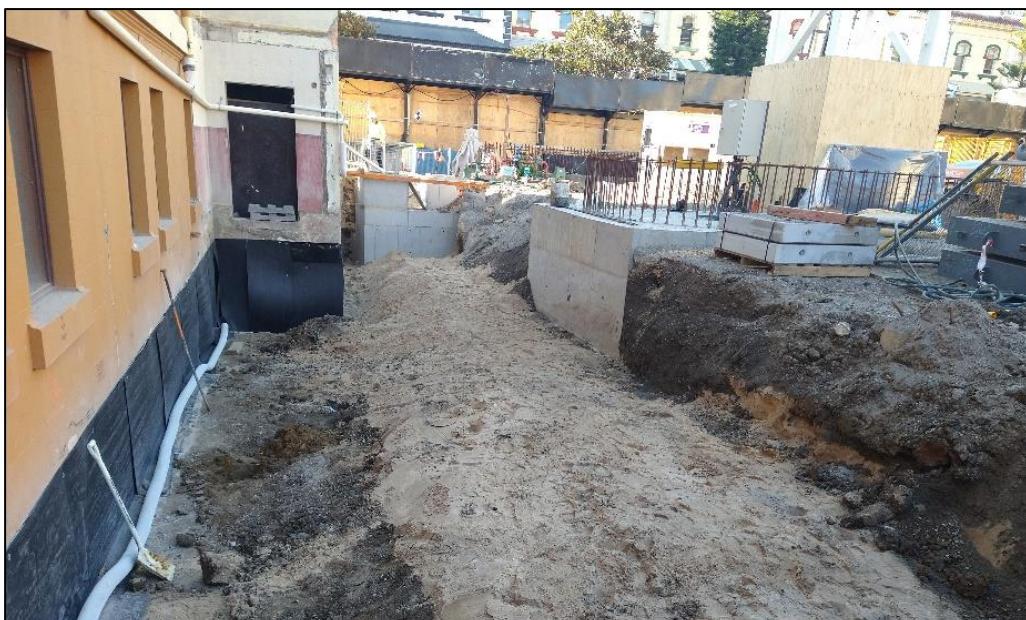
Figure 3: Imported “clean” sand over stormwater pipe looking north (building B on the left) (provided by DP – 3 July 2020), current trench condition.
