Remediation Action Plan

2 - 4 Gladstone Avenue & 357 - 363 Crown Street,
Wollongong NSW

Report Title: Remediation Action Plan:
2 - 4 Gladstone Avenue & 357 - 363 Crown Street, Wollongong NSW

Report No: E25862.E06.002_Rev0

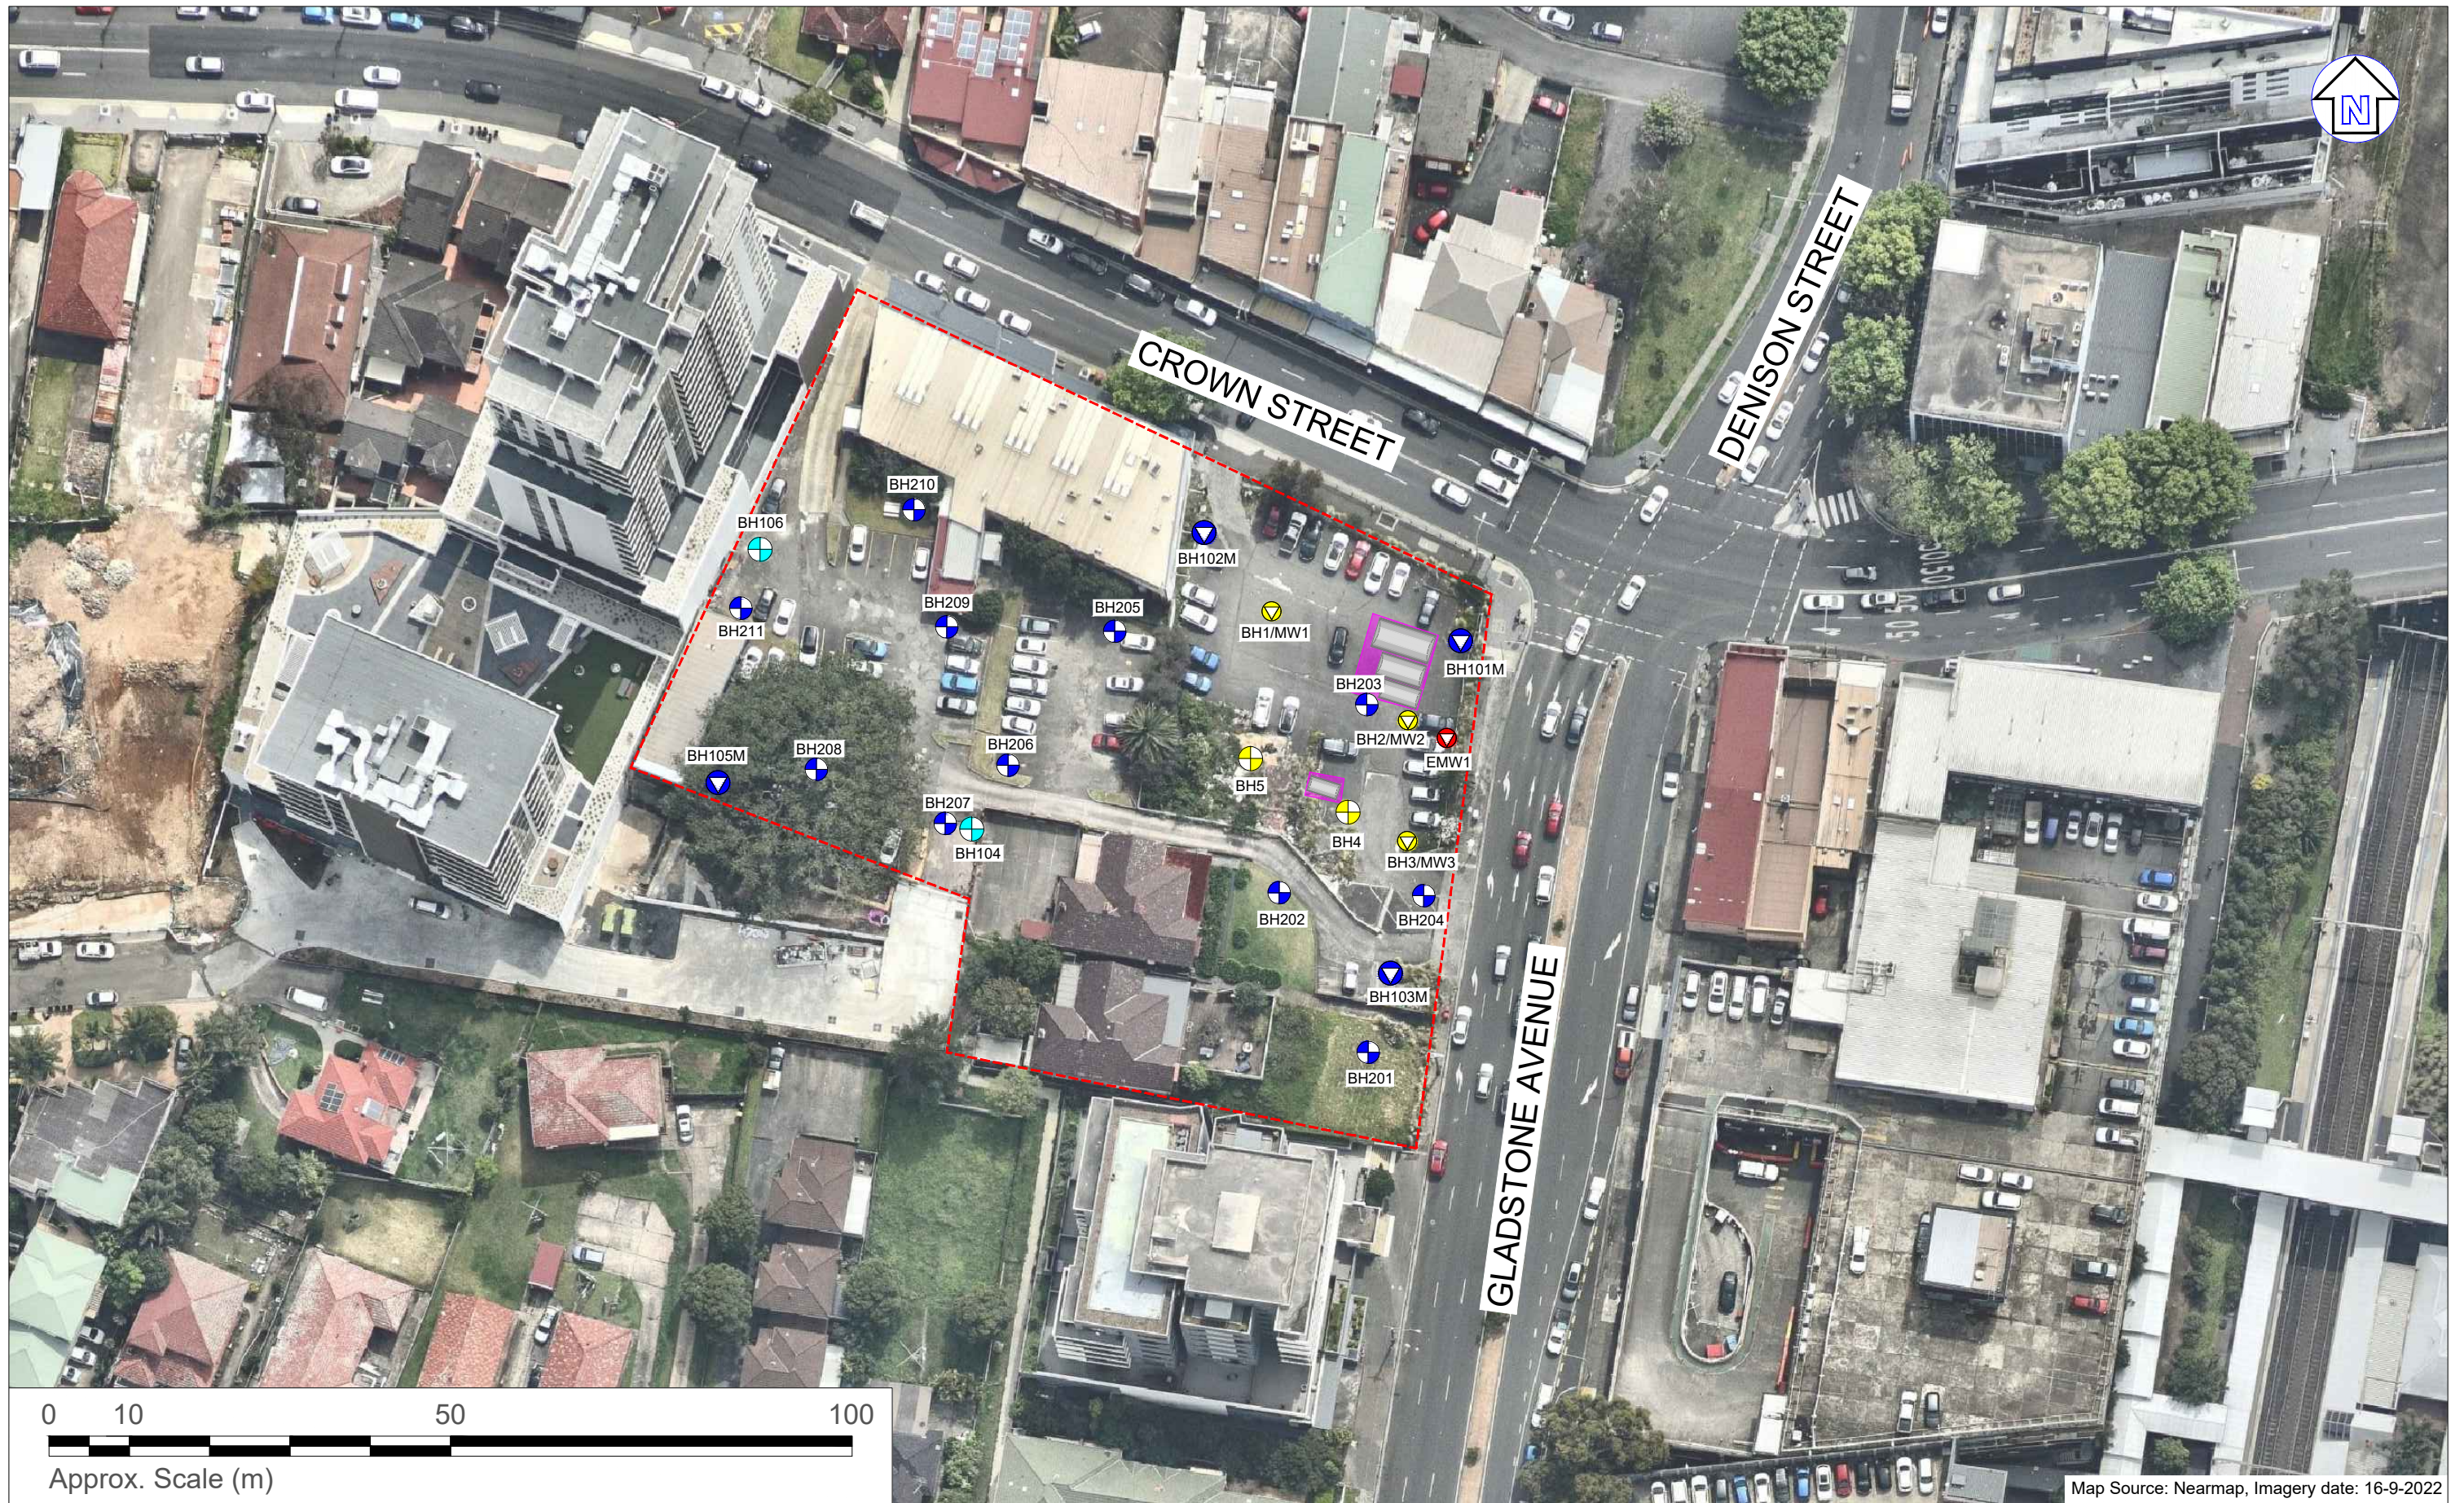
Figure:
A.3
 Project: E25862.E06

Wollongong Investments No.5 Pty Ltd
 Remediation Action Plan
 2-4 Gladstone Avenue & 357-363 Crown Street,
 Wollongong NSW
 Previous Sampling Location Plan

- - - Site boundary
- Inferred UST location
- Inferred UST area
- ▼ Environmental borehole / Monitoring well location (EI, 2023b)
- ▼ Previous monitoring well location (unknown origin)
- ▼ Previous borehole / Monitoring well location (Reditus, 2020)
- Inferred groundwater flow direction

This RAP follows on from previous investigations completed at 357-359 Crown Street, Wollongong by Reditus (2020), as well as across the entire site by EI (2022b, 2023b). The Reditus (2020) assessment identified one exceedance of the adopted criteria for asbestos at location BH5 within 357 Crown Street, however, visual inspection conducted during subsequent EI investigations (EI, 2022b, 2023b) did not identify any potential asbestos containing materials (ACM). Four in-situ underground storage tanks (USTs) were also identified using ground penetrating radar (GPR) within the eastern and southern portions of 357 Crown Street.

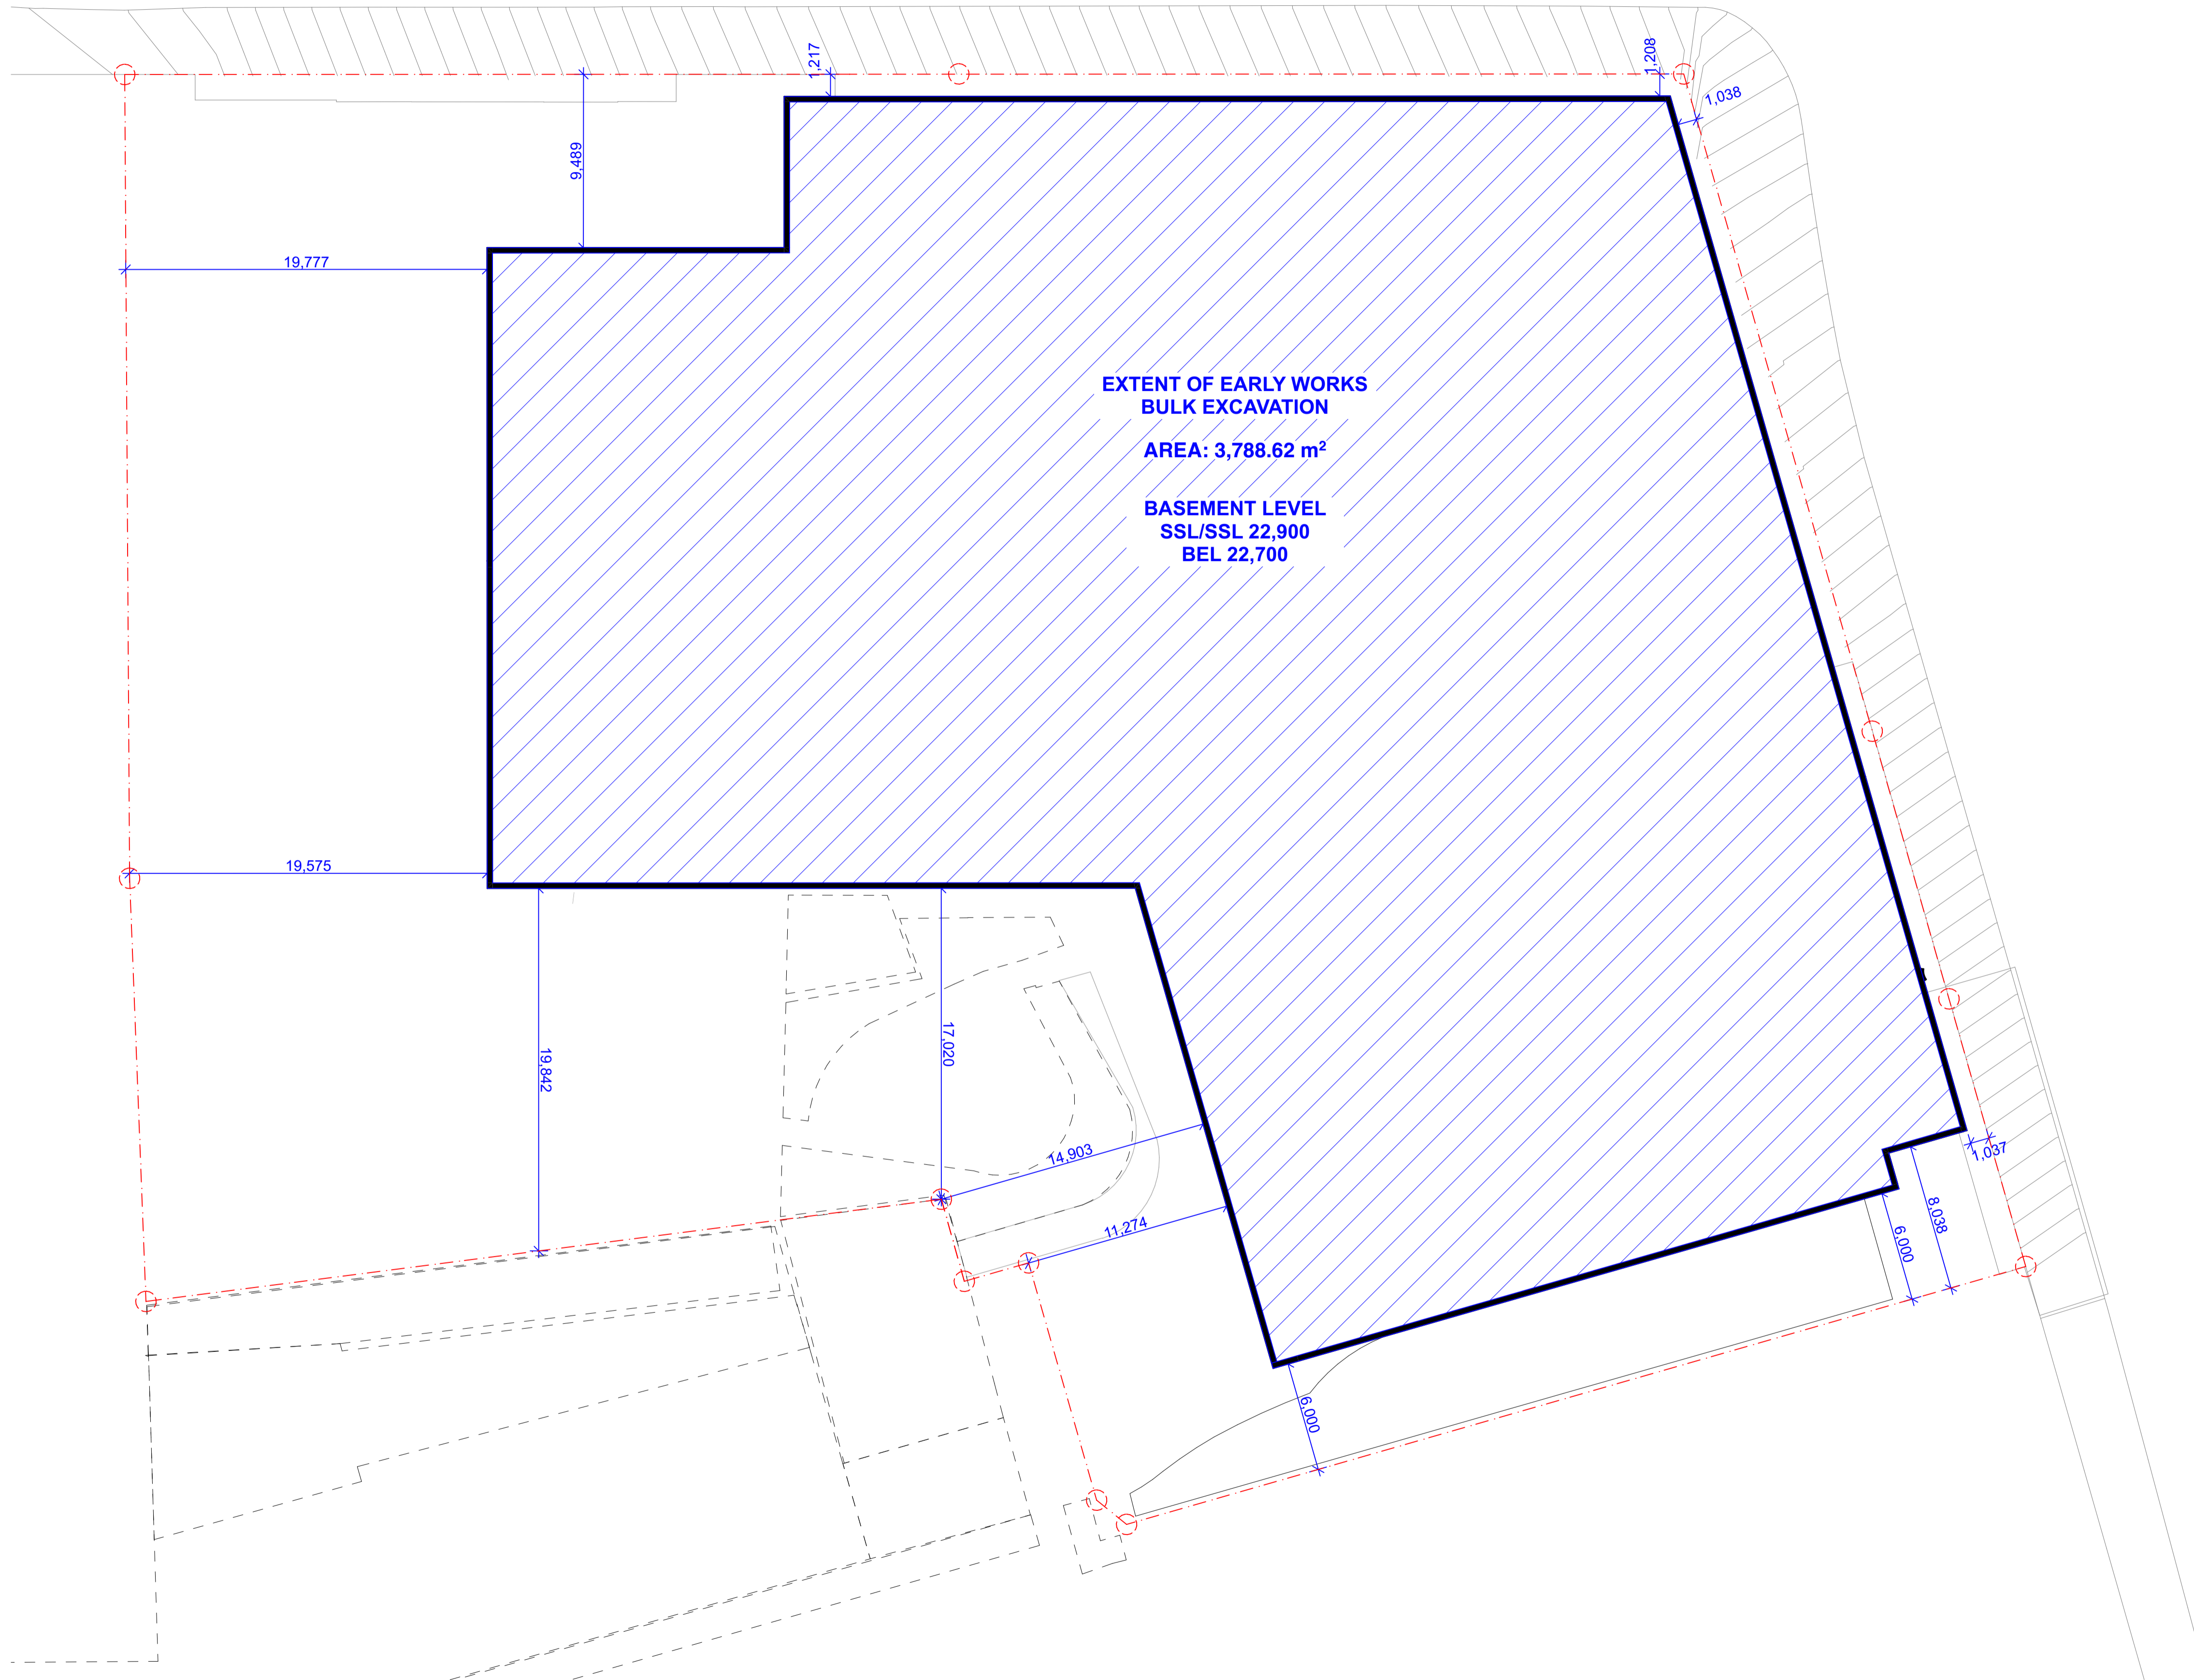
BASEMENT
1:200

Drawing
BULK EXCAVATION - BASEMENT

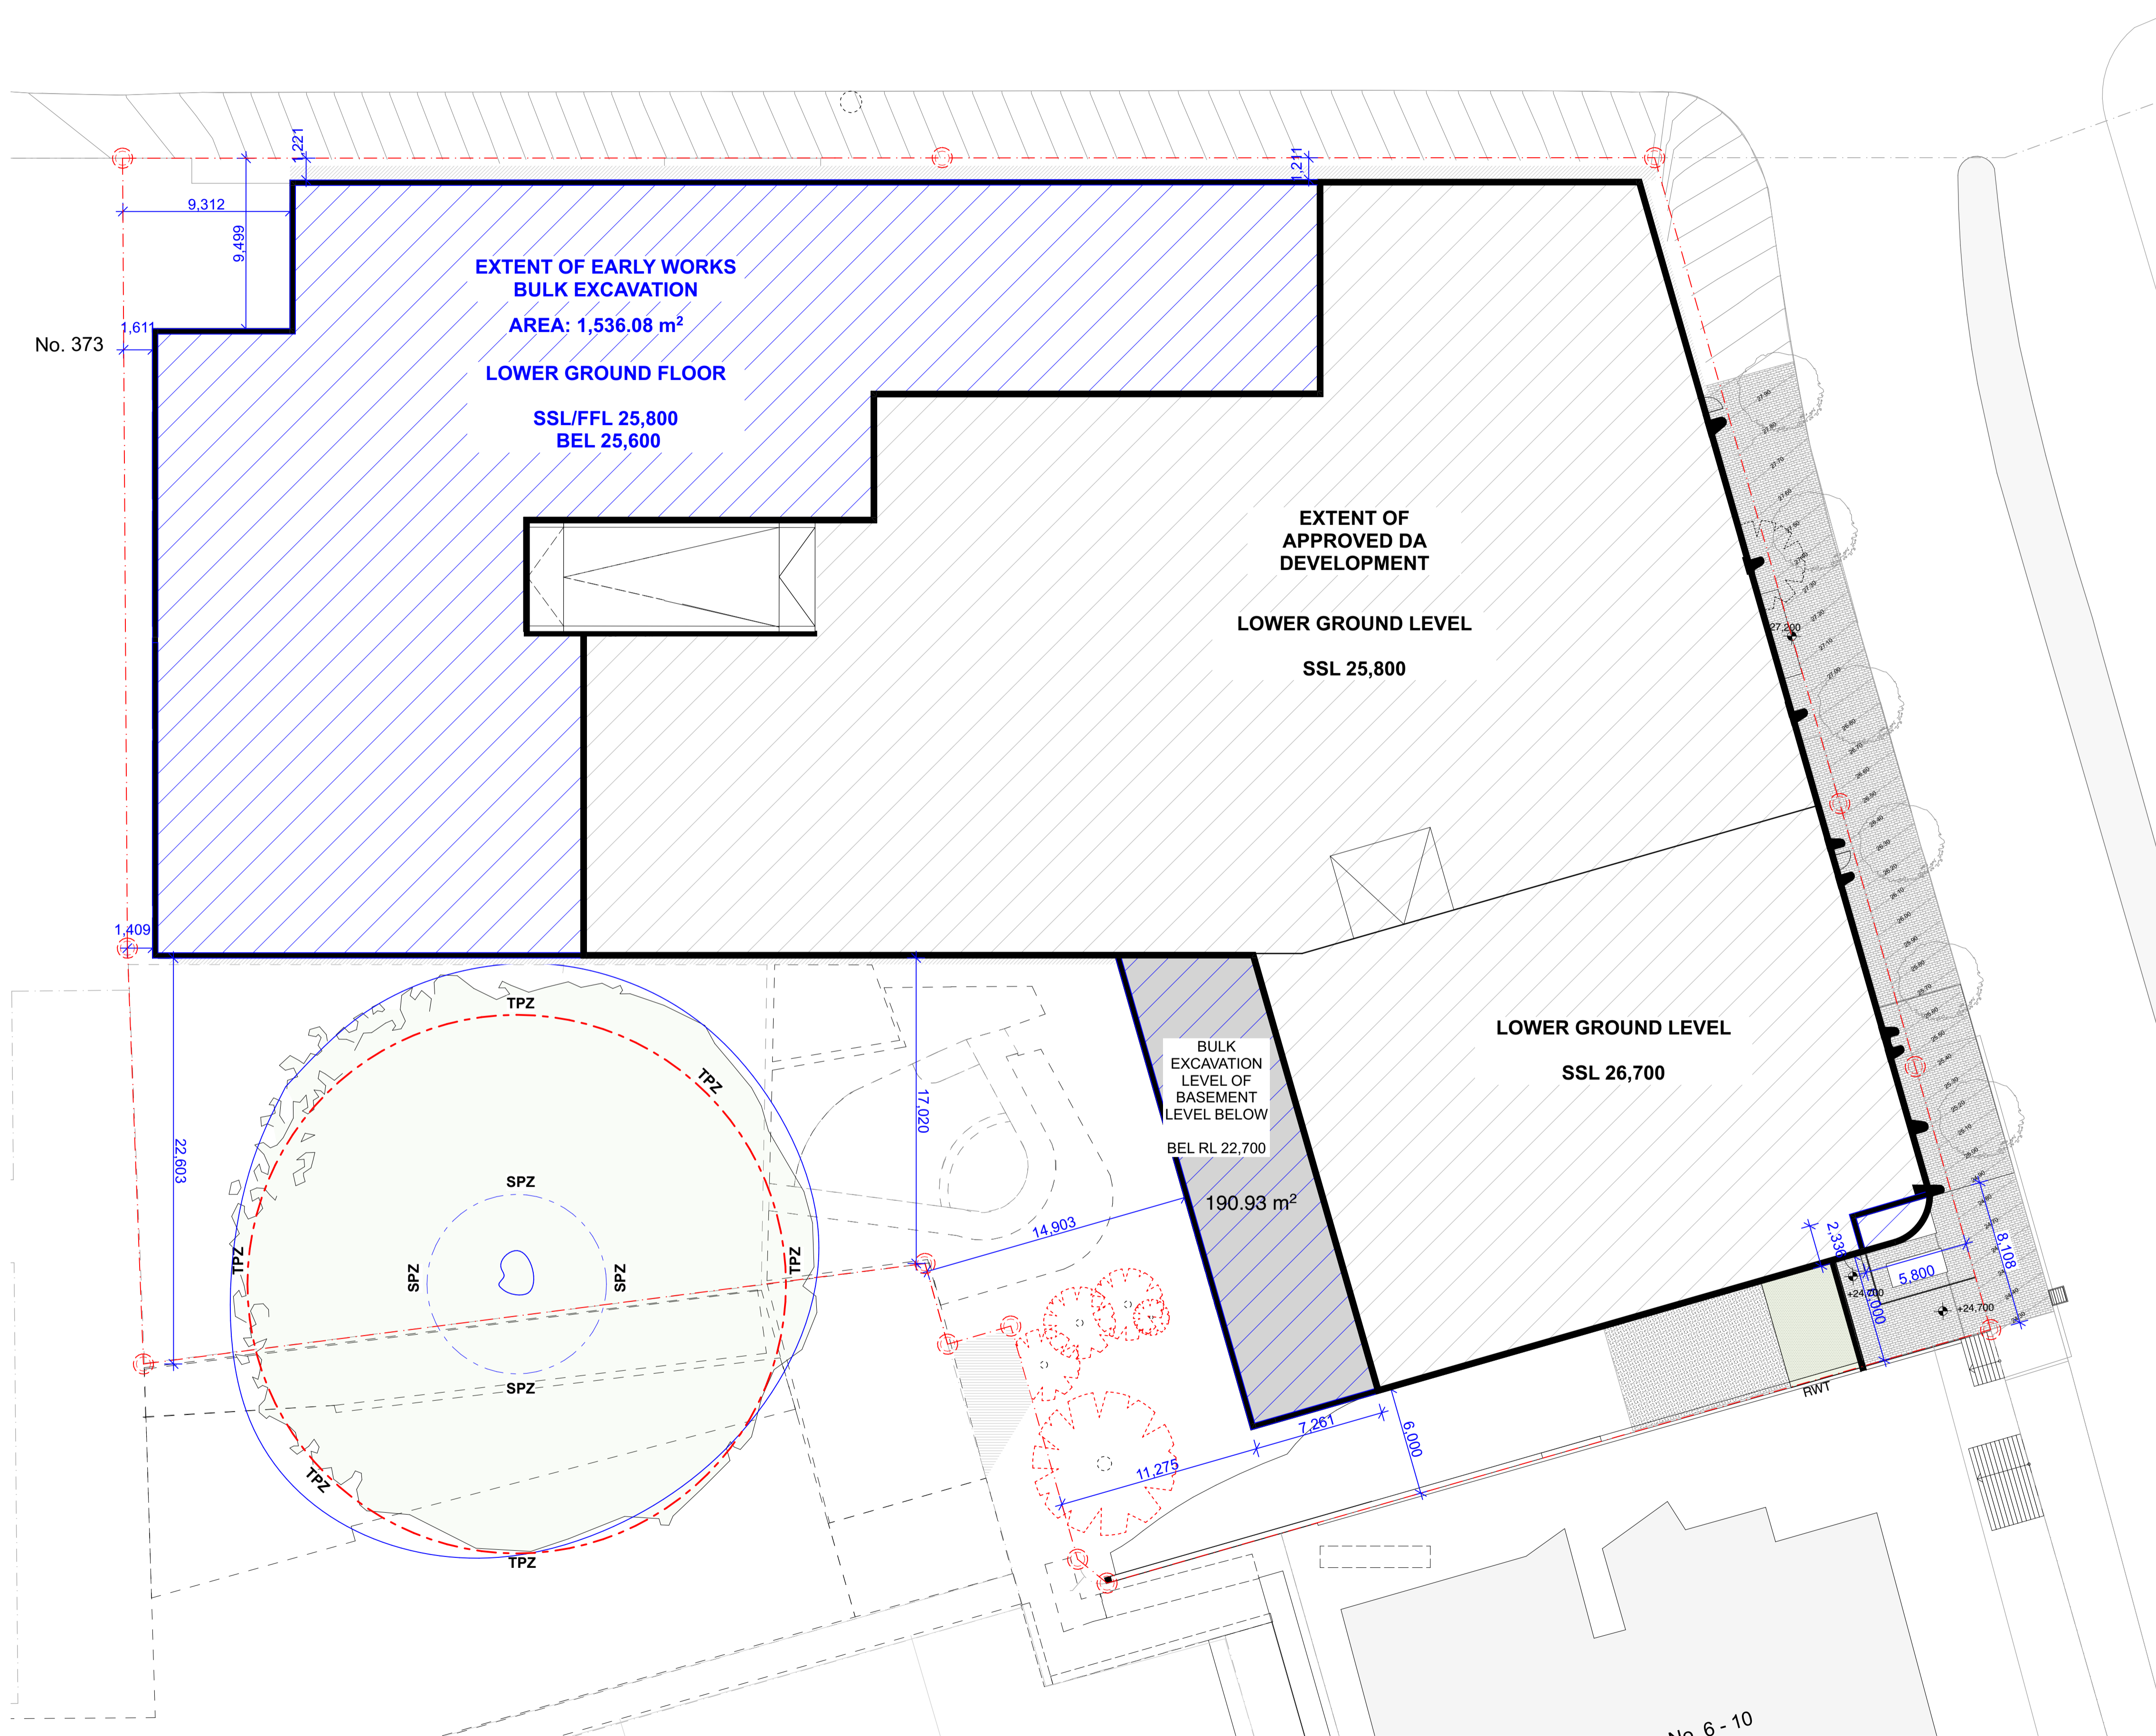
LOWER GROUND FLOOR
1:200

Drawing
BULK EXCAVATION - LOWER GROUND FLOOR
