Marsden Park New Primary School

Stormwater Management Plan

NSW Department of
Education

Date:
23 July 2019

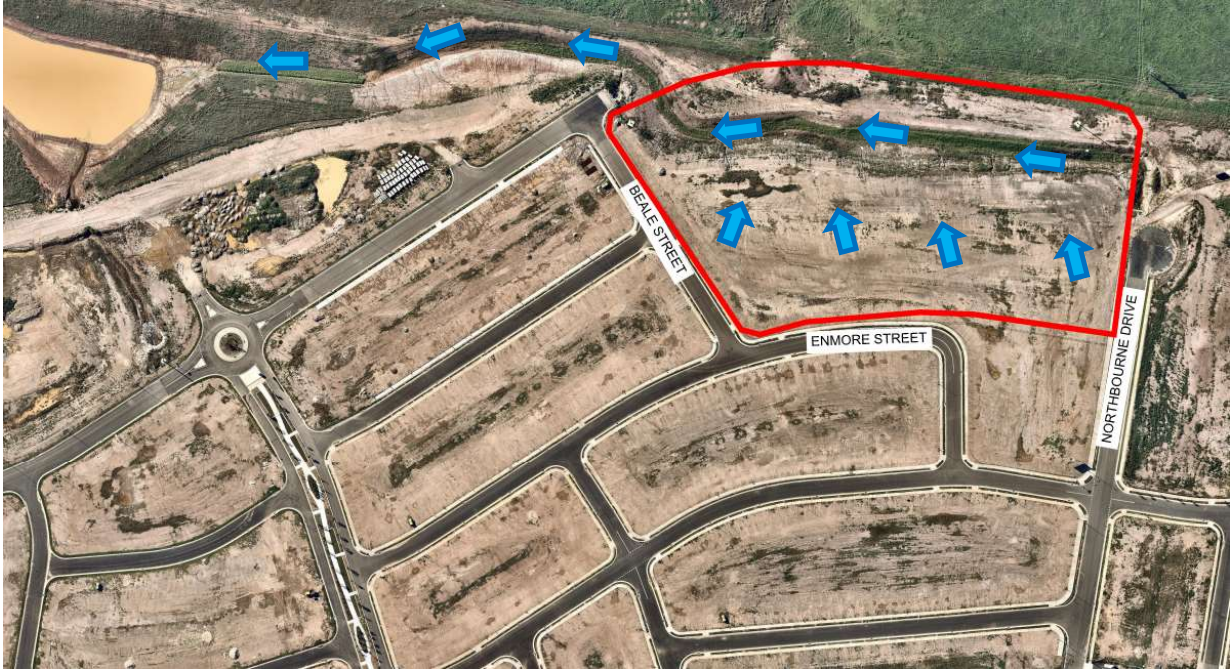
At the time of this report, the site is undeveloped and falls from South to North. The high point of the site is located at the Southern boundary at a level of RL 24.85m AHD with the low point located in the North Western corner at RL 21.00m AHD. Overland flow is captured by a vegetated swale and conveyed to a sediment basin west of the site. Refer below for existing overland flow.

Figure 2- Existing Overland Flow (Source : Nearthmaps 2019)

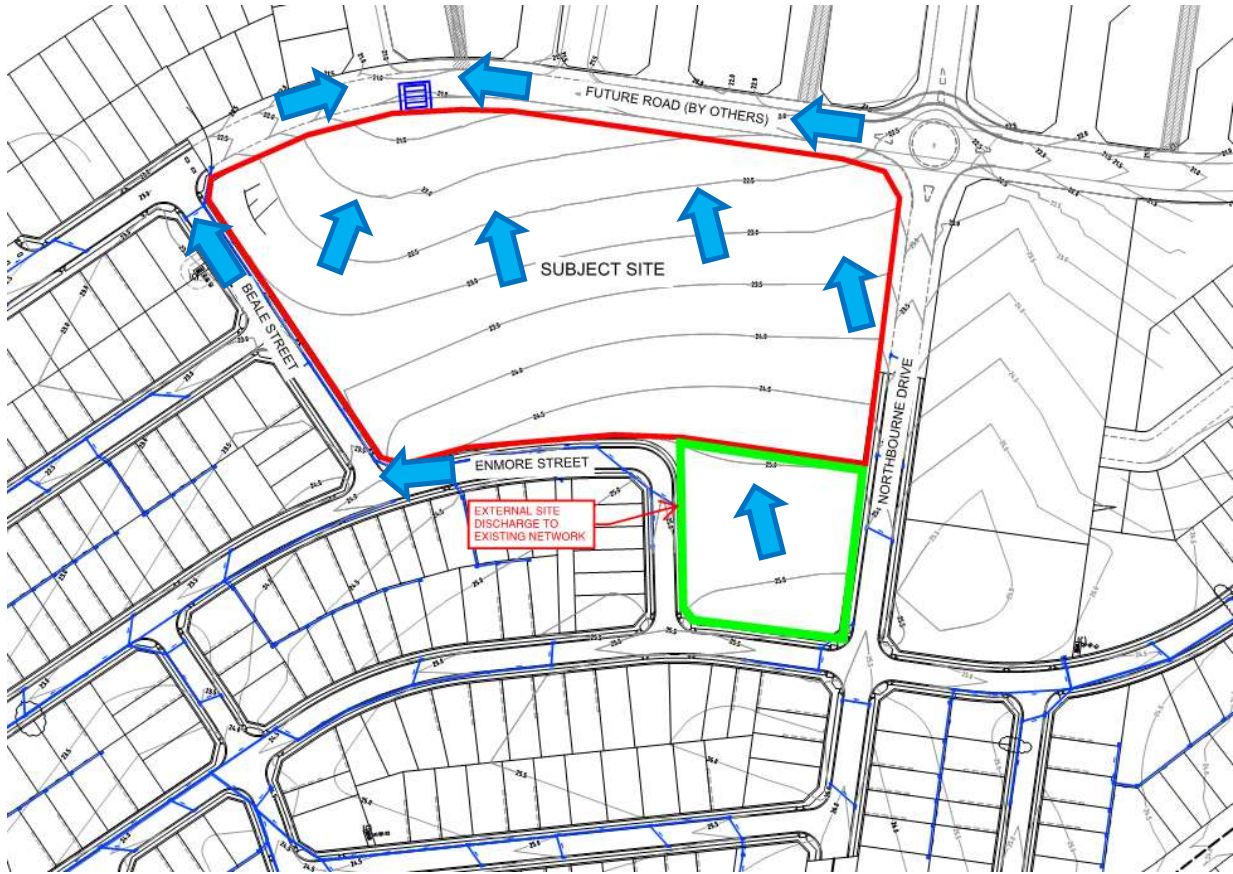
The surrounding area has been investigated to determine any impacts of existing external stormwater catchments on the proposed site. All overland flows will be captured and conveyed by the adjacent local roads. At the time of this report, a minor catchment south of the site drains into the subject site. The catchment from the external site will be diverted to the proposed stormwater infrastructure within the adjacent roads.

Figure 4 – Upstream Catchments (Source : Design by Cardno for Elara Stockland Precinct 3)

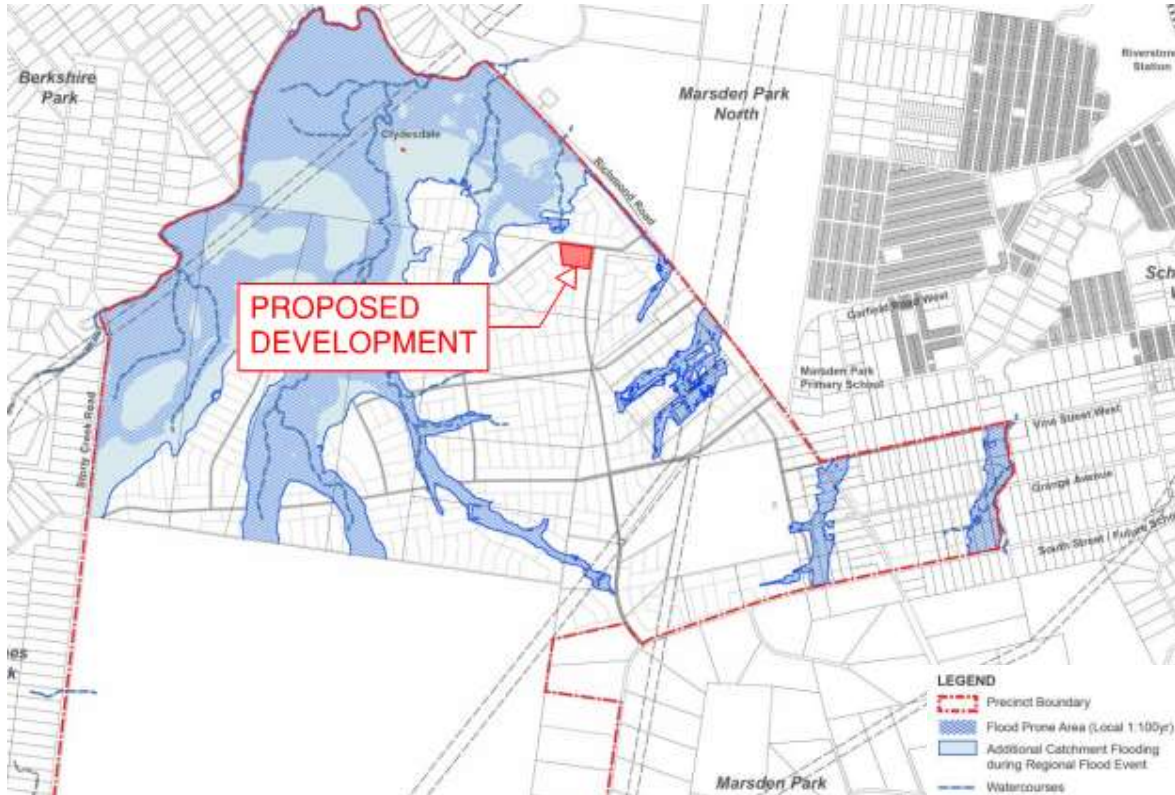
Wood and Grieve have reviewed Council flood maps; DCP and the Marsden Park Precinct DCP have determined that the site is located outside flood planning areas. The proposed development is not impacted 100 year ARI flooding.

Figure 7 – Flood Prone Land (Source: Marsden Park Precinct, NSW Planning & Environment June 2016)

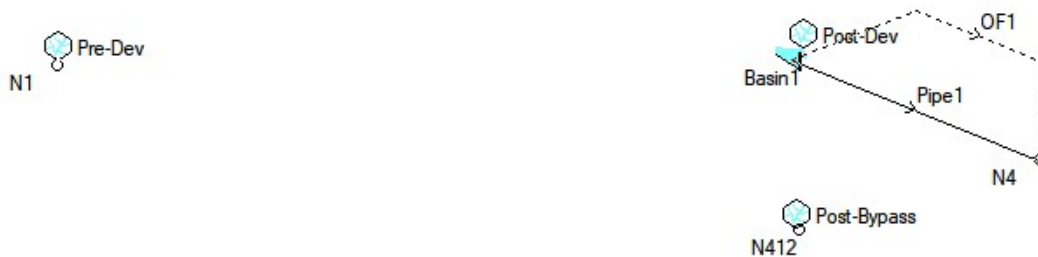
Figure 8 – DRAINS Model

Predevelopment Release Rate	Attenuated Post Development Release Rate
1 in 100 yr Storm Event	790 L/s	734 L/s

As can be seen in the table above, the post development release rate is lesser than the pre development release rate through the provision of an on-site detention (OSD) tank.

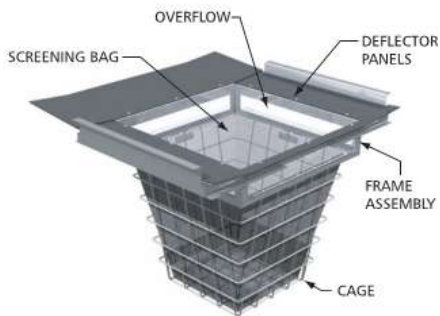
EnviroPod’s (or other similar approved equivalents) provide effective removal of TSS and gross pollutants. EnviroPod’s are a filter cage system which are inserted into roadway gully pits to filter and remove pollutants before the water enters the piped drainage system.

Parameters	TSS	TP	TN	GP
Input (mg/L)	100	10	10	14.8
Output (mg/L)	46	7	8.7	0
Reduction (%)	54	30	13	100

Figure 11 – EnviroPod Pit Inlet Trap (Source: Ocean Protect)

It is proposed to place a total of 15 x enviroPods throughout the site.

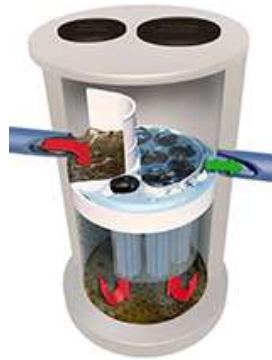
One Jellyfish JF-3250-24-4 has been proposed for the development, located in the Northern part of the site.

The MUSIC modelling parameters for this device are set by the manufacturer, Ocean Protect.

Figure 12 – Jellyfish infiltration Unit (Source: Ocean Protect)

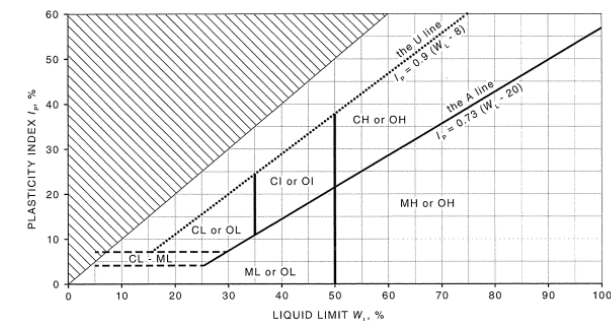
PLASTICITY CHART (after AS 1726:2017)

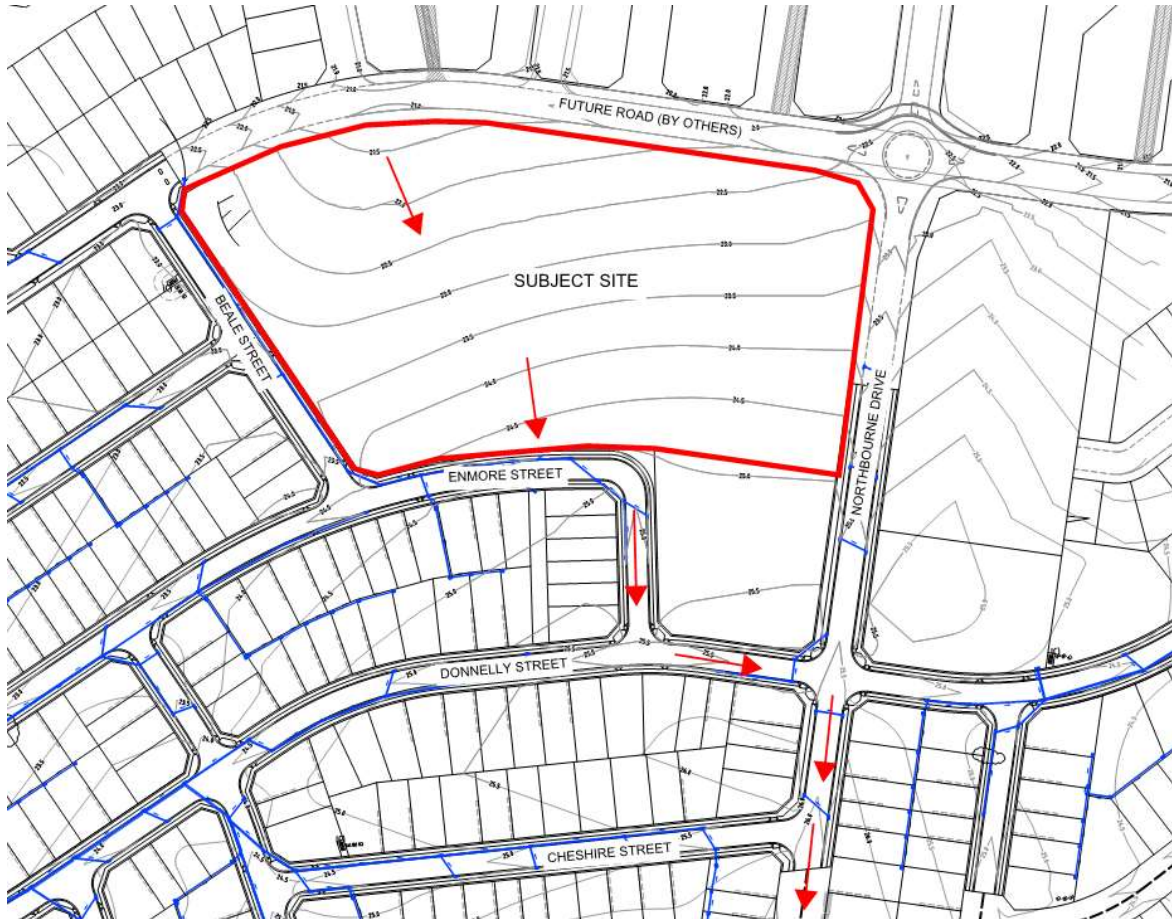
To ensure patrons are evacuated well in advance of flooding, the Building Manager will be reviewing weather and weather forecasts for the onset of severe weather, by subscribing to text messages and internet notifications from the Bureau of Meteorology Australia frequently throughout the day. Upon receipt of severe weather forecasts warnings, the building manager will start evacuating the entire building along the evacuation route to ensure patrons are evacuated well in advance before the flooding occurs within the site.

Figure 2 - Flood Evacuation Route
