Sydney Football Stadium Redevelopment Stage 2

Aboriginal Cultural Heritage Management Plan SFS-JHG-00-PLN-PM060007

SSD-9835

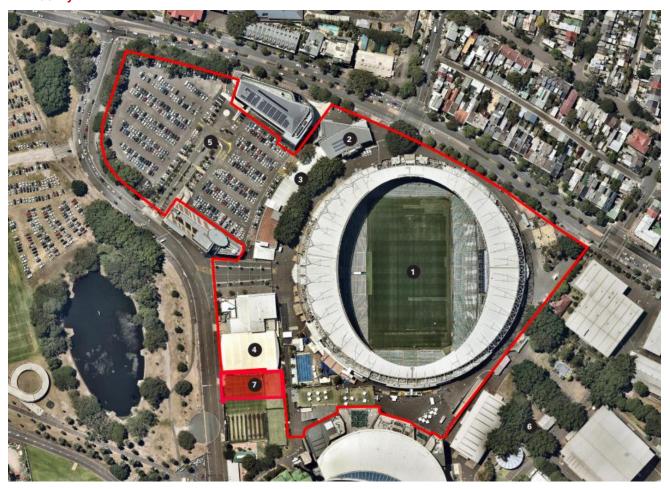
Figure 2: Site boundaries and structures: 1. Allianz stadium 2. Sheridan Centre 3. Sydney Roosters 4. Cricket NSW 5. MP1 Carpark 5. Fox Studios 7. Extension of boundary for the Stadium Fitness Facility

The site is largely surrounded by Centennial and Moore Parks, the Fox Studios and Entertainment Quarter precincts and the residential suburb of Paddington (

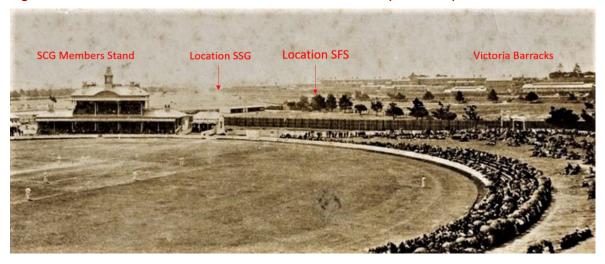
Figure 6: Cricket match at the SCG in 1892. View west north west. (Trove NLA)

A photograph of another cricket match played nine years later in 1892 looks slightly more to the west (**Figure 6**) and is taken from a higher elevation. This image shows the raised ground of the future Sydney Football Stadium and Sydney Sports Ground, and also illustrates that the Sydney Cricket Ground was likely cut significantly into local dunes to produce banked or bowl like sides as seating.

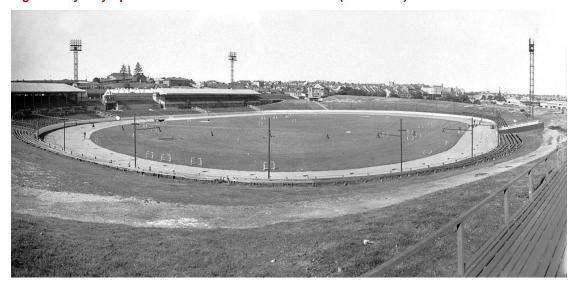
Figure 7: Sydney Sports Ground in 1937. View north east (Trove NLA)

This proven technique of excavating a flat playing surface into surrounding dunes appears almost certain to have been followed in construction of the Sydney Sports Ground located to the north east of the Sydney Cricket Ground and partly within the footprint of the Sydney Football Stadium. Dedicated in 1899, the Sydney Sports Ground was opened in 1903. It had been excavated to depth below the surrounding landscape and was formed with high banked earthen sides to provide both informal seating and a facility for motorcycle racing (**Figure 7**)⁹ The depth of excavation carried out to create this sunken bowl is estimated as at least five to six metres, based on the likely height of the two-storey stadium grandstand visible in **Figure 7**which does not appear significantly

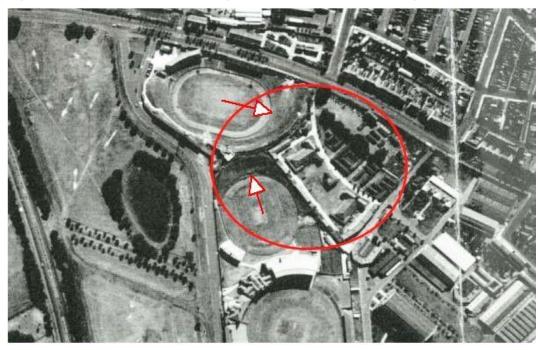
Figure 8: Project area in 1951, battering indicated with red arrows (Douglas Partners 2019)10

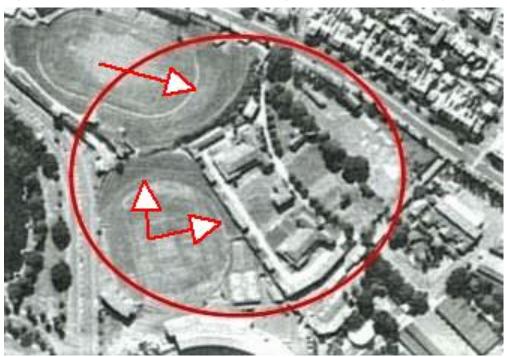
Figure 9: Added detail of excavation and battering visible in 1978 aerial (Douglas Partners 2019)

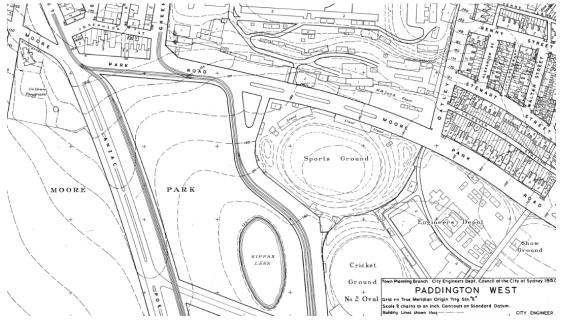
Figure 11: Excerpt from topographic map of Paddington West, 1950. (Trove NLA)

Topographic mapping produced in 1950 shows the extent of excavation for the Sydney Sports Ground (**Figure 11**). It also shows the preserved natural contour lines of the surrounding area, including Anzac Parade. These strongly indicate that the location of the Sydney Sports Ground previously sloped gradually over approximately 400 metres from a low point of 130 metres elevation in the south to a high point of 145 metres elevation in the north west. This gentle rise (4% or 1 in 25) is consistent with the images and their interpretation given above.
