**SPECIALIST ADVICE TO  
MONTEFIORE**

**ON  
GEOTECHNICAL INVESTIGATIONS**

**FOR  
PROPOSED AGED CARE AND RESIDENTIAL LIVING  
DEVELOPMENT**

**AT  
MASADA COLLEGE, COLLEGE ROAD, ST IVES, NSW**

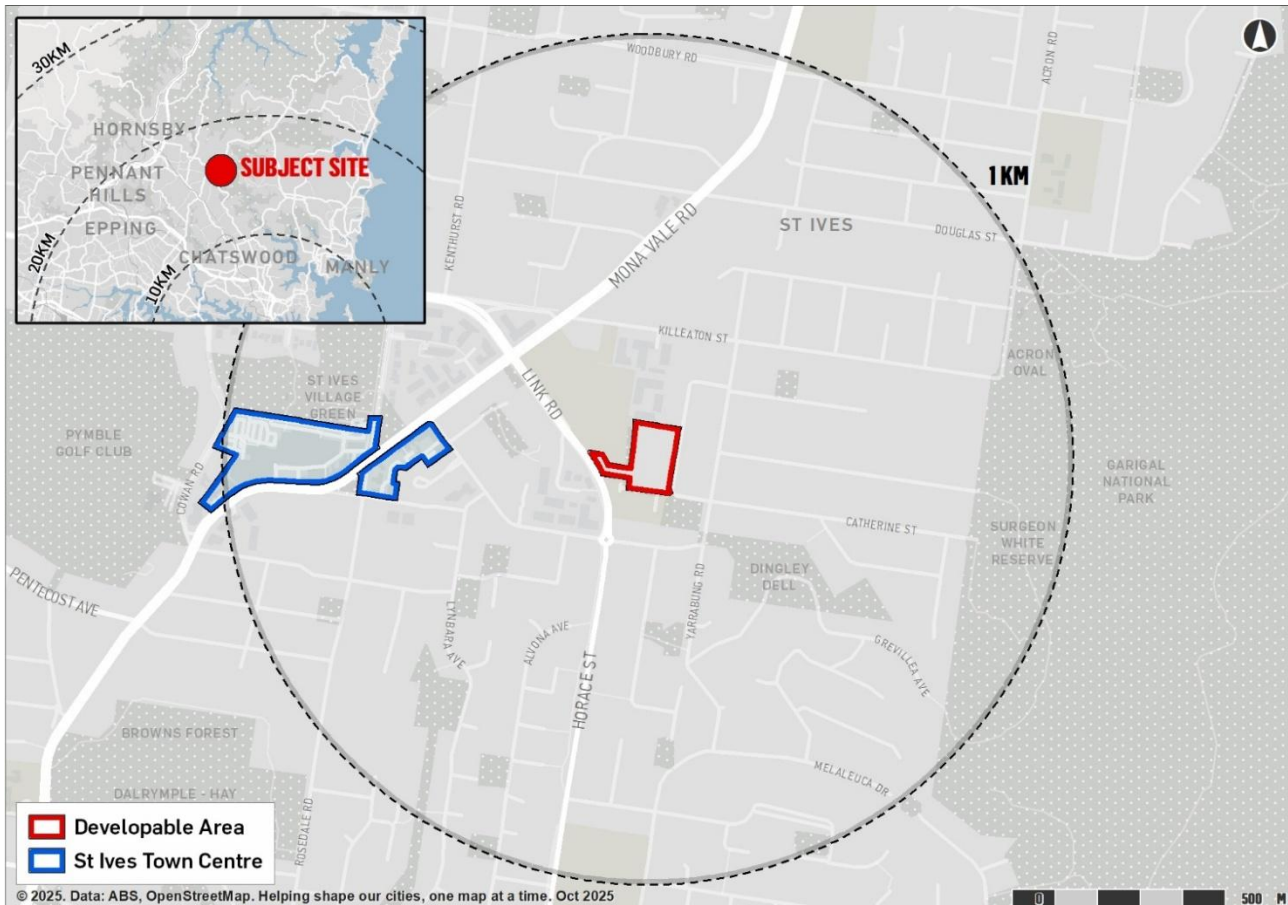
Plate 1 Regional Context

A map of the regional context of the site and an aerial of the site is shown in Plates 1 and 2 below 1 and Figure 2.
