DARLINGTON PUBLIC SCHOOL REDEVELOPMENT

Appendix Y — Geotechnical Report

Report on
Geotechnical Investigation

Proposed Upgrade Works
Darlington Public School, Darlington

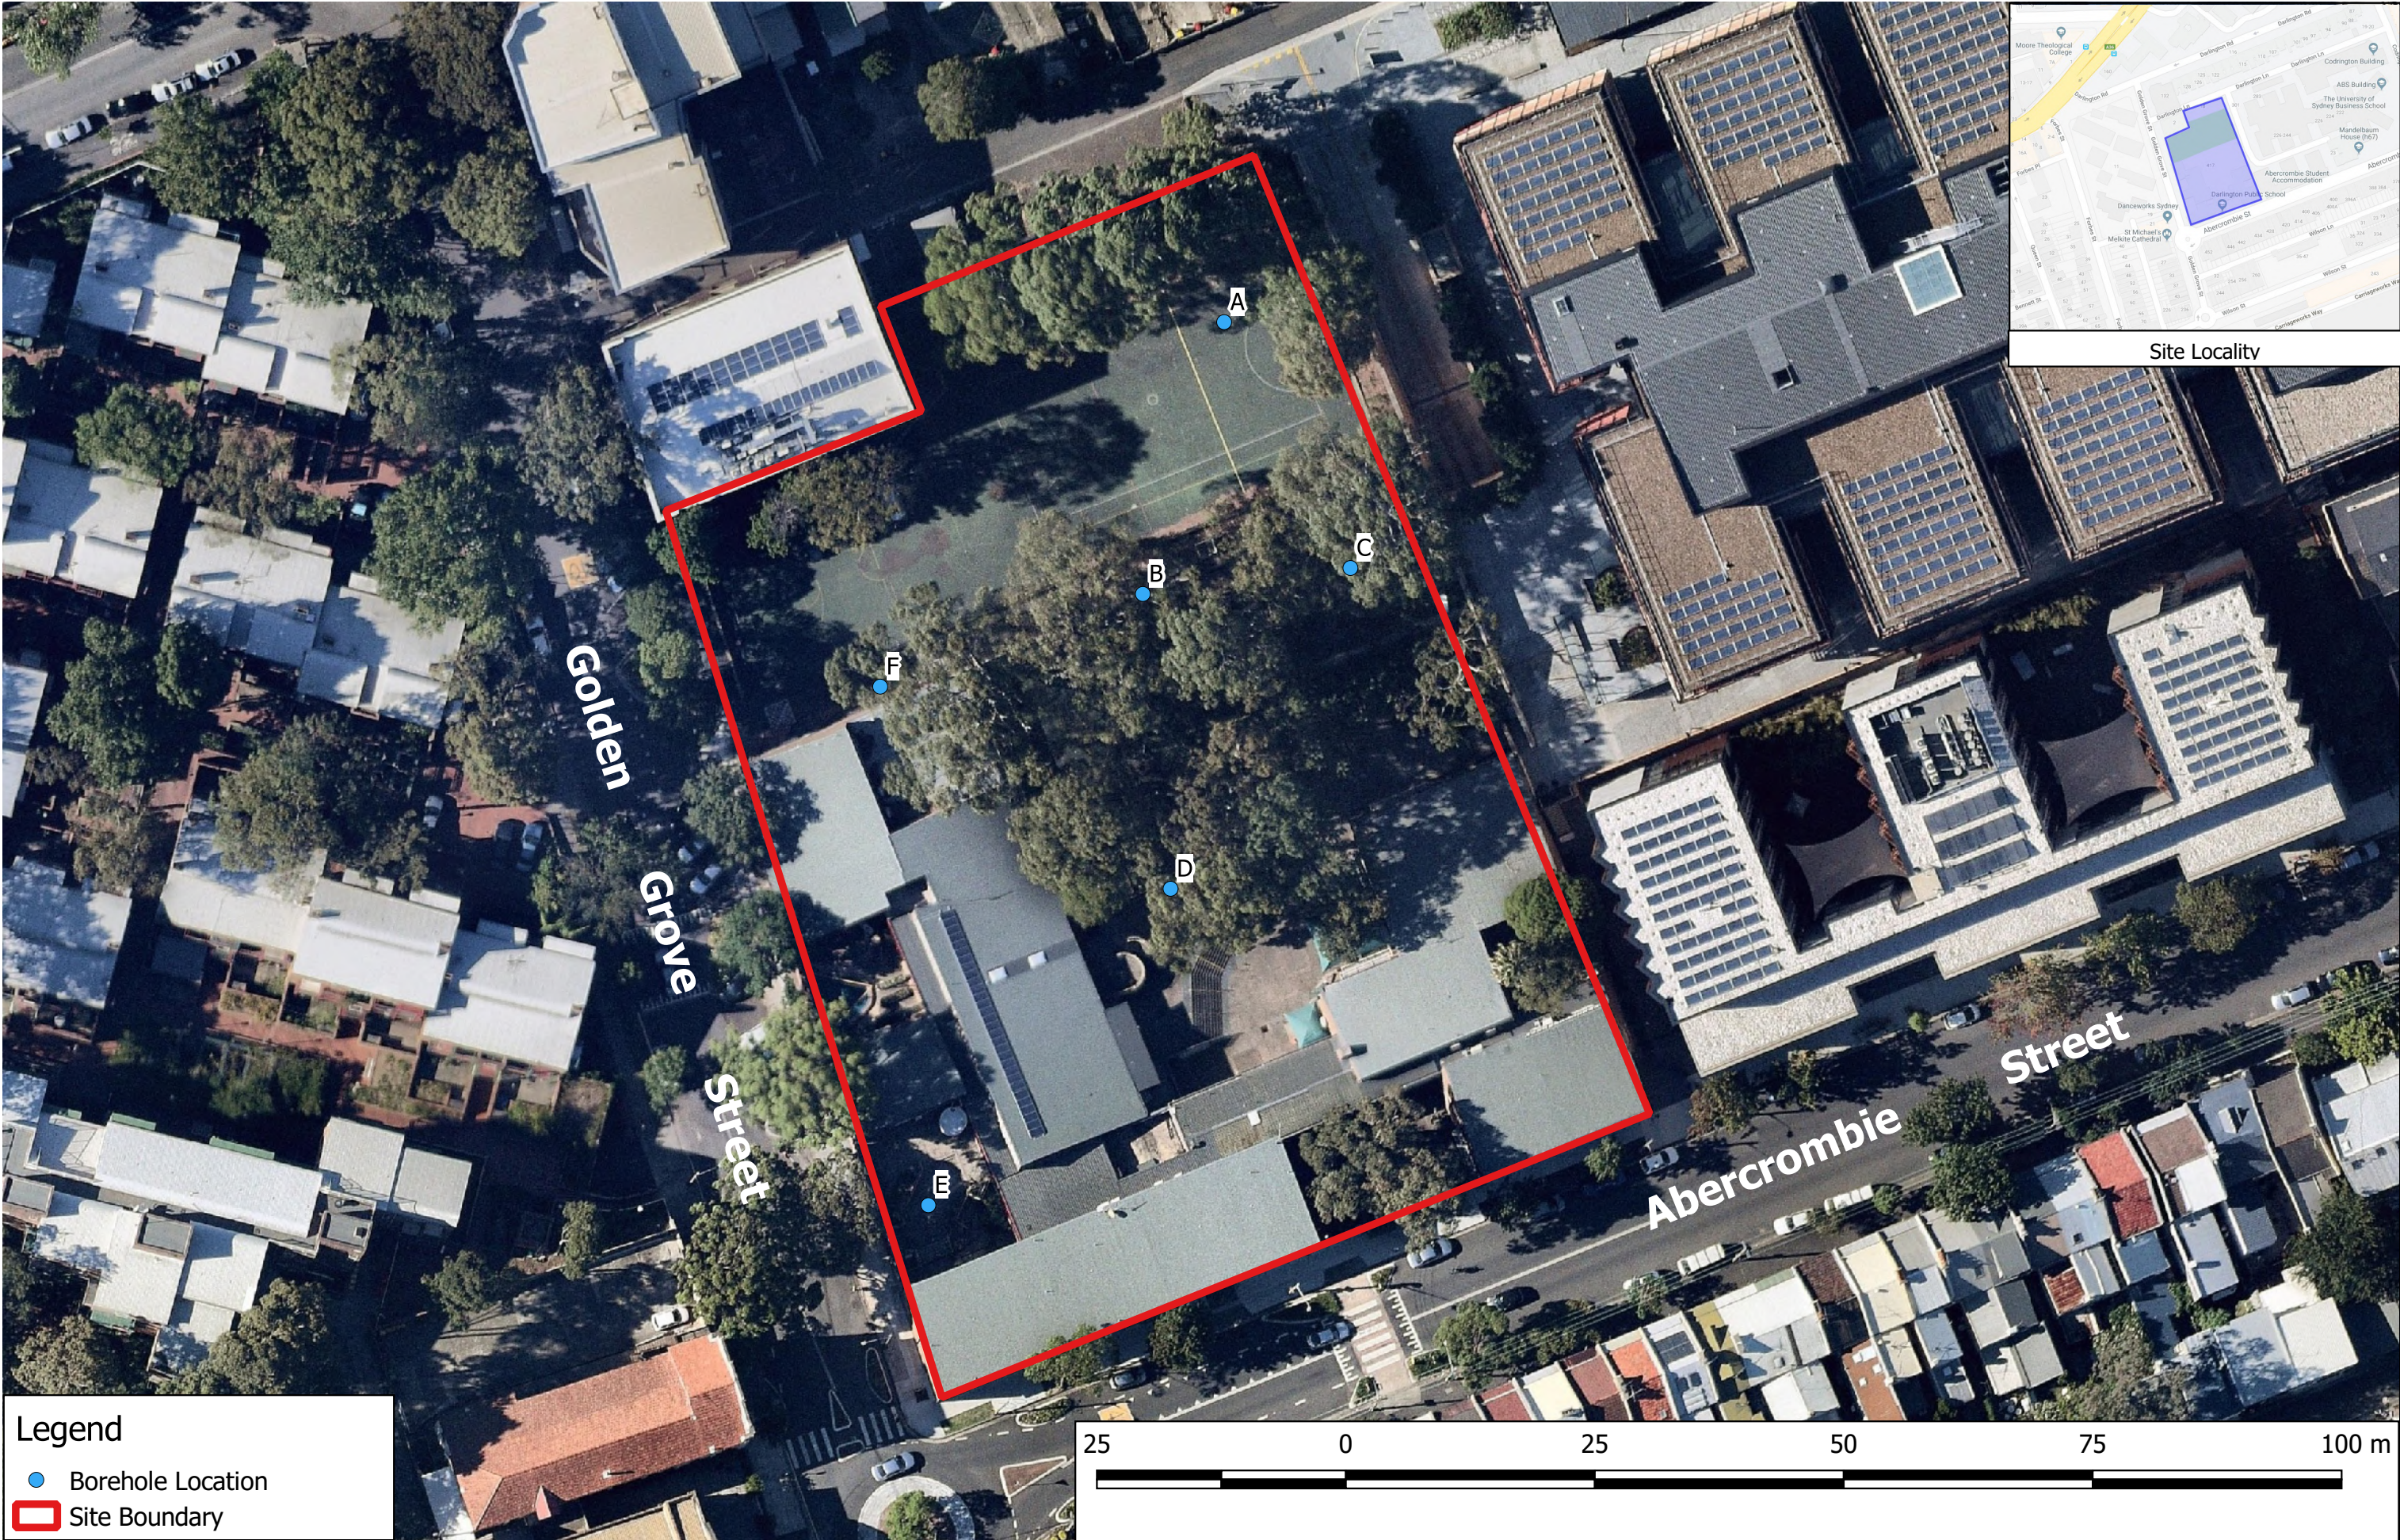
Legend

- Borehole Location
- ▭ Site Boundary
