# LEPPINGTON (1) 88 DEVELOPMENT PTY LTD

## Preliminary Geotechnical Investigation

173-183 Rickard Road, Leppington NSW  
SSD-99319962

Report No: E27124.G03

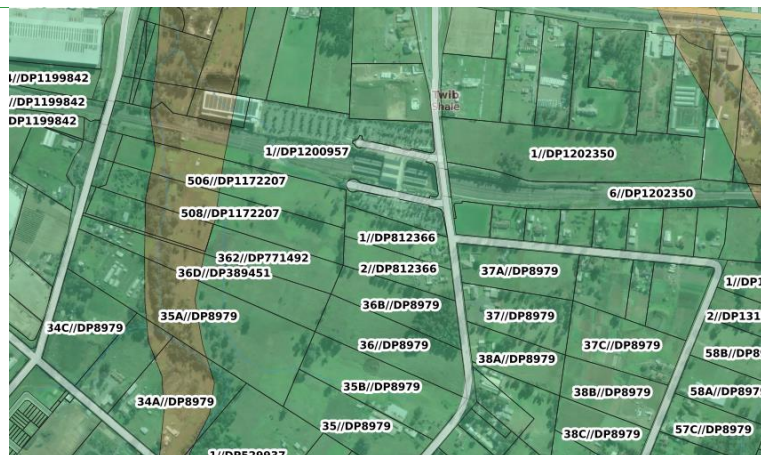
**Plate 2**

Excerpt of NSW Seamless Geology with site indicated (Source: MinView)

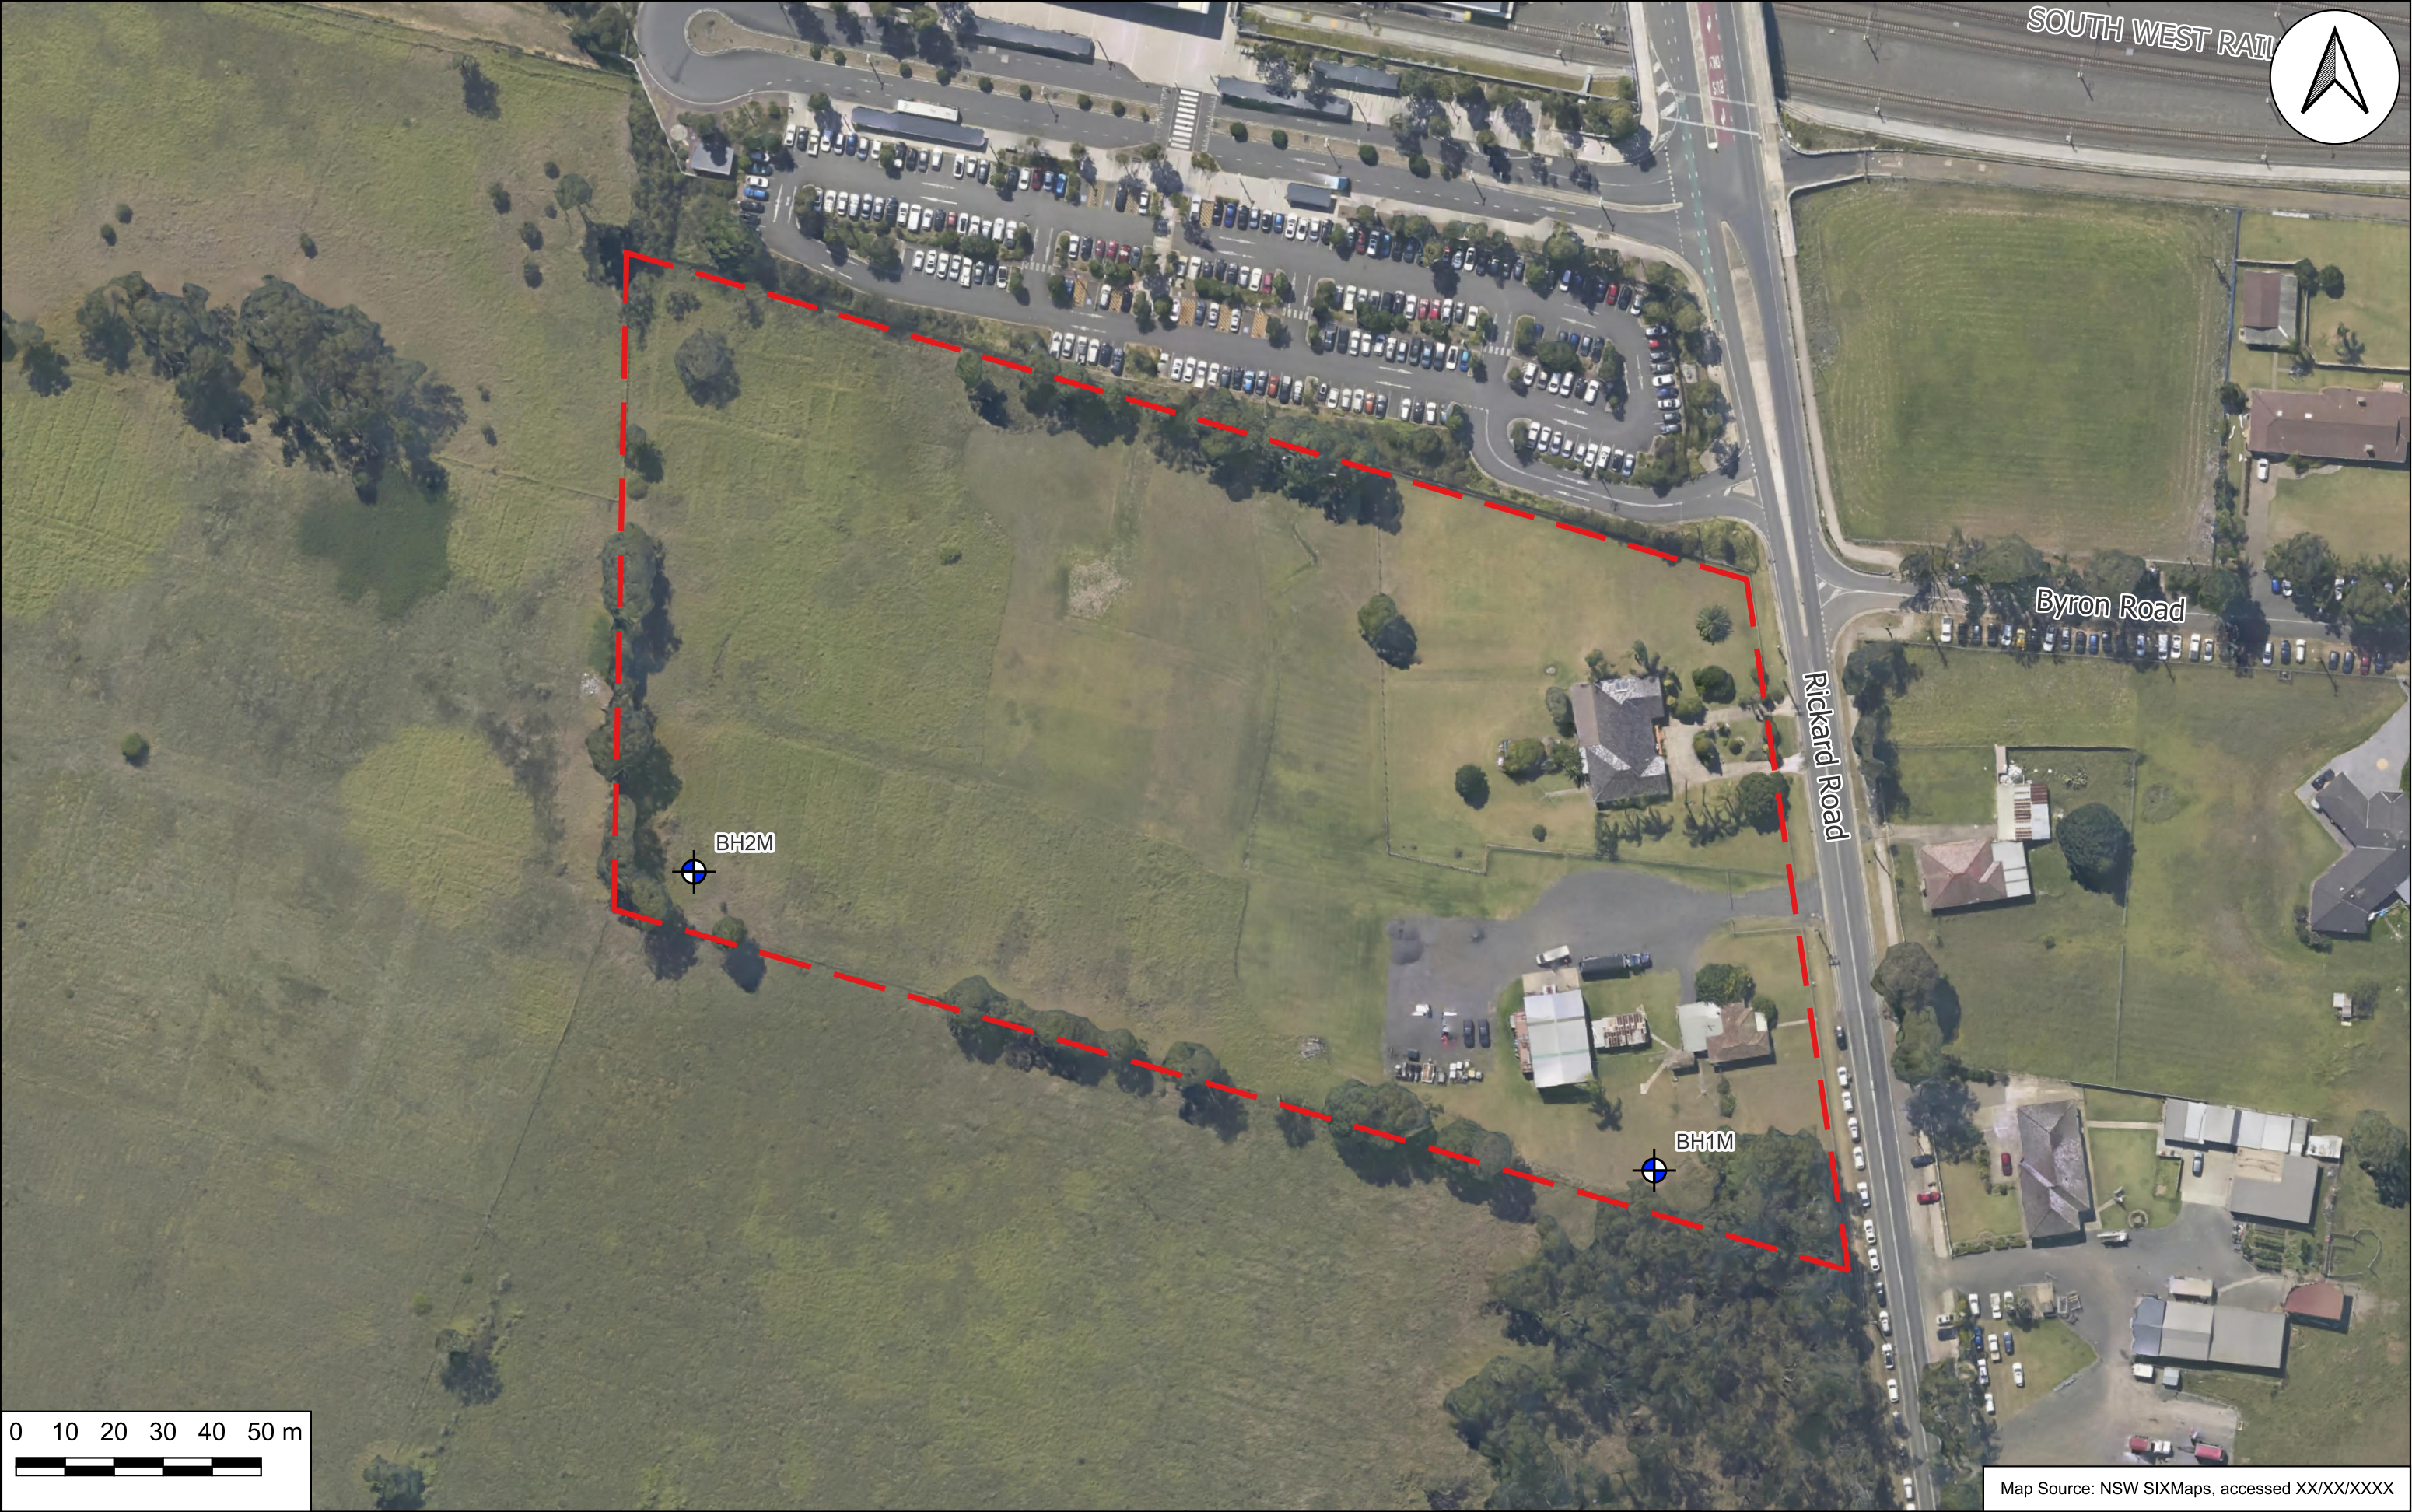
| <b>LEGEND</b> <small>Note: Areas are approximate</small><br><div><div></div> Site Boundary</div> <div><div></div> Boreholes</div> <div><div></div> Groundwater Monitoring Well</div> | <div>Practical Solutions for Built Environments<br/>Suite 6.01, 55 Miller Street, PYRMONT 2009<br/>Ph (02) 9516 0722 Fax (02) 9518 5088</div> | Drawn: | J.F. | <b>Client Name Pty Ltd</b><br>Geotechnical Investigation<br>173-183 Rickard Road, Leppington NSW<br>Borehole Location Plan | Figure:<br><b>2</b> |

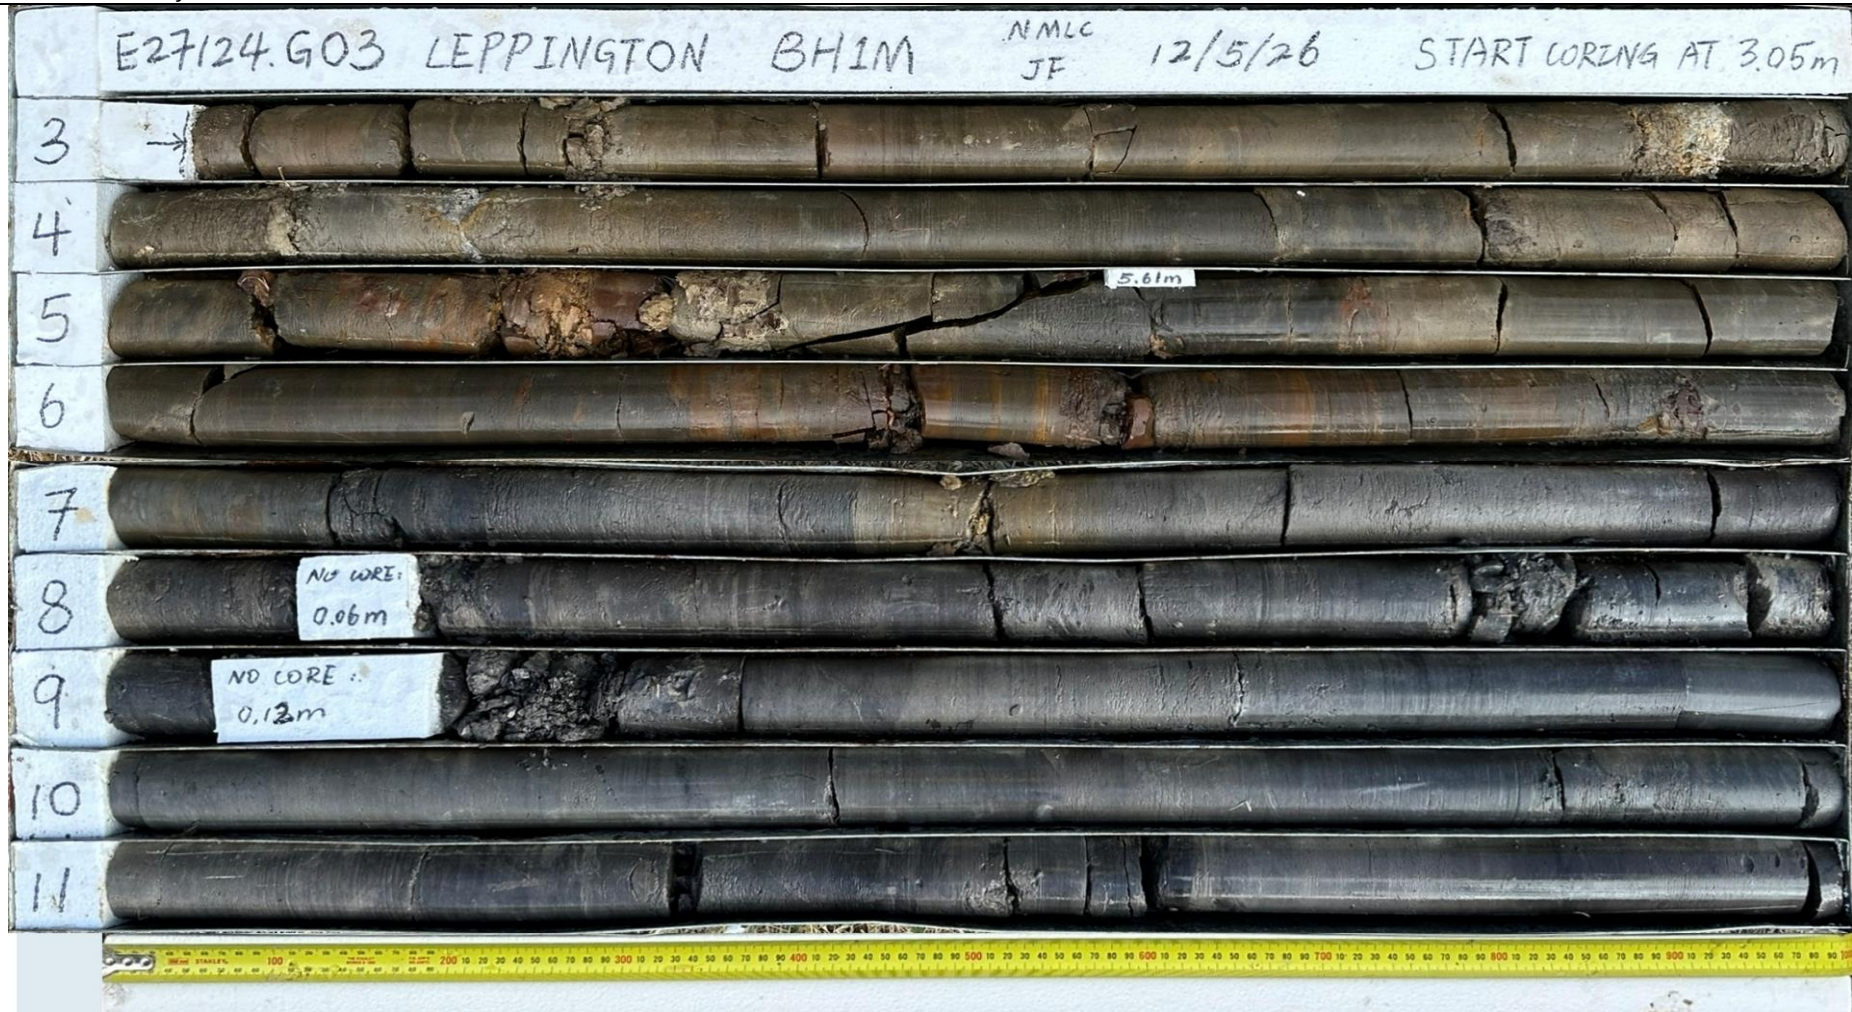
# CORE PHOTOGRAPH OF BOREHOLE: BH1M

| <b>Project</b> | Proposed Development | <b>East</b> | 297543.7 (MGA 56) | <b>Depth Range</b> | 3.05m to 29.63m | | |

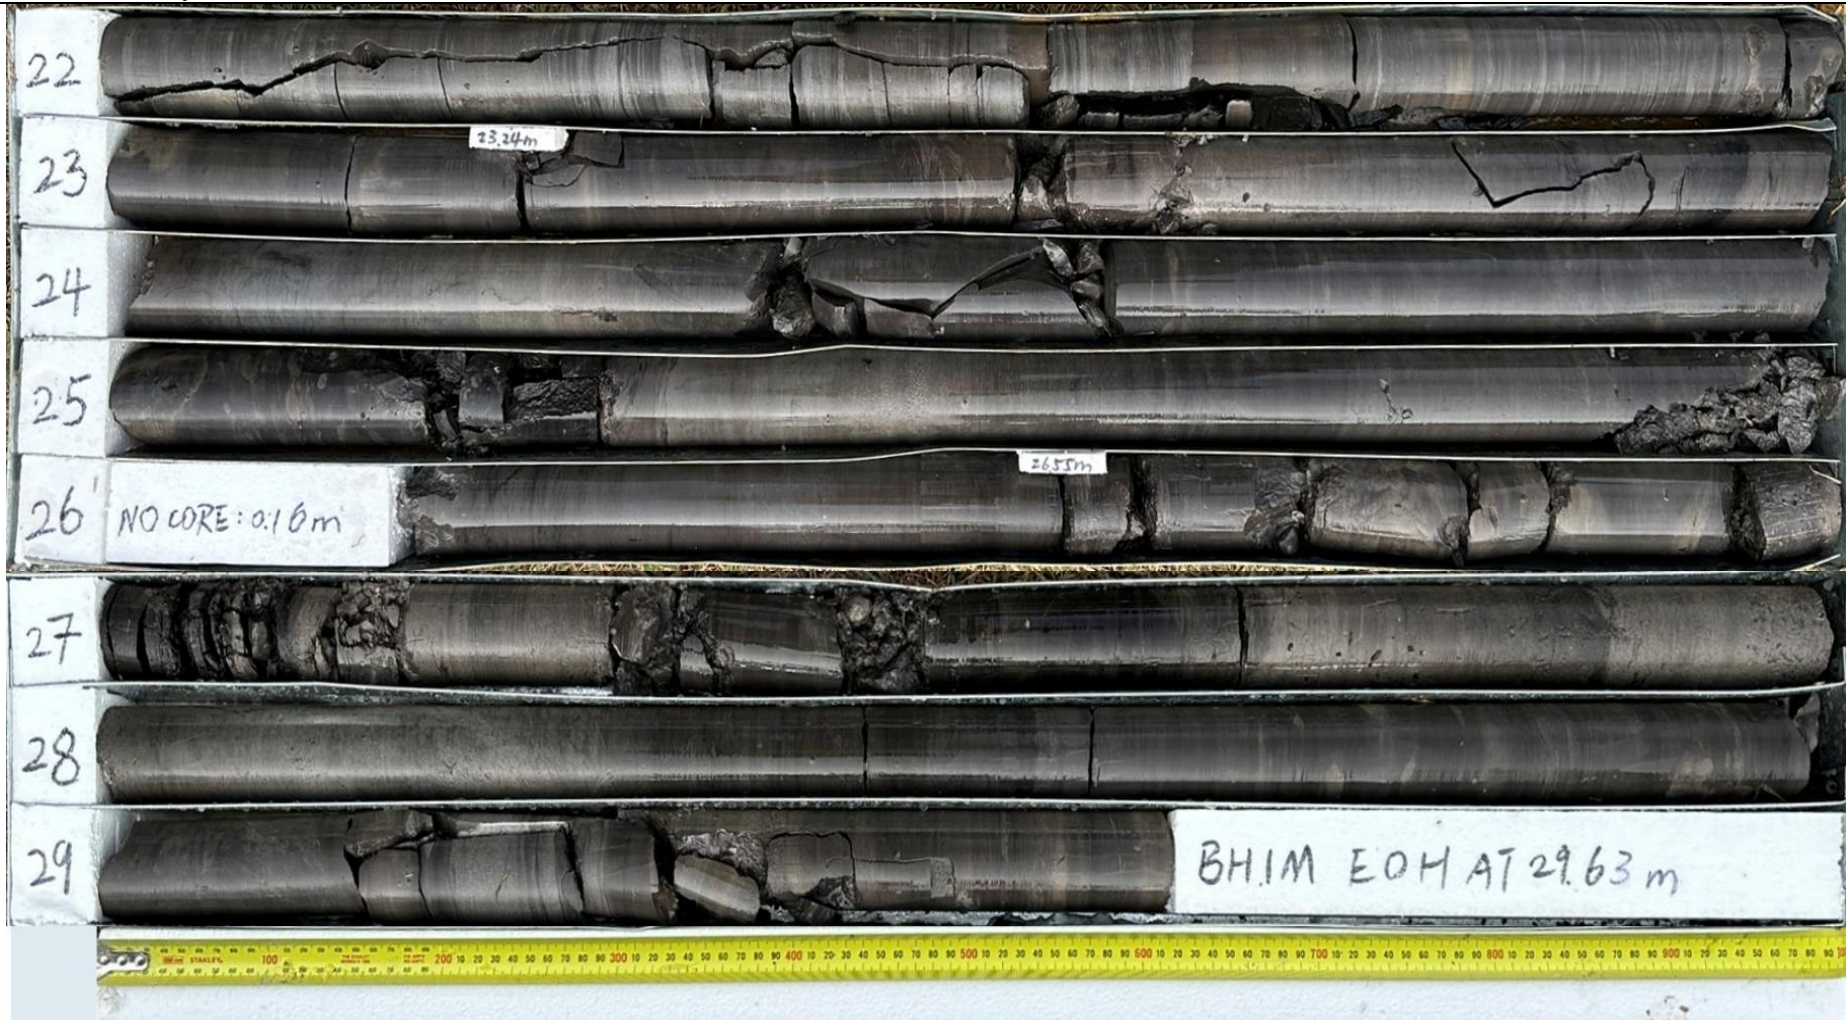
| <b>Client</b> | Aland Pty Ltd | <b>Box</b> | 5-6 of 6 | <b>Checked</b> | SK | <b>Date</b> | 28/05/2026 |

| <b>Job No.</b> | E27124.G03 | <b>Inclination</b> | 90° | <b>Logged</b> | JF | <b>Date</b> | 12/05/2026 |

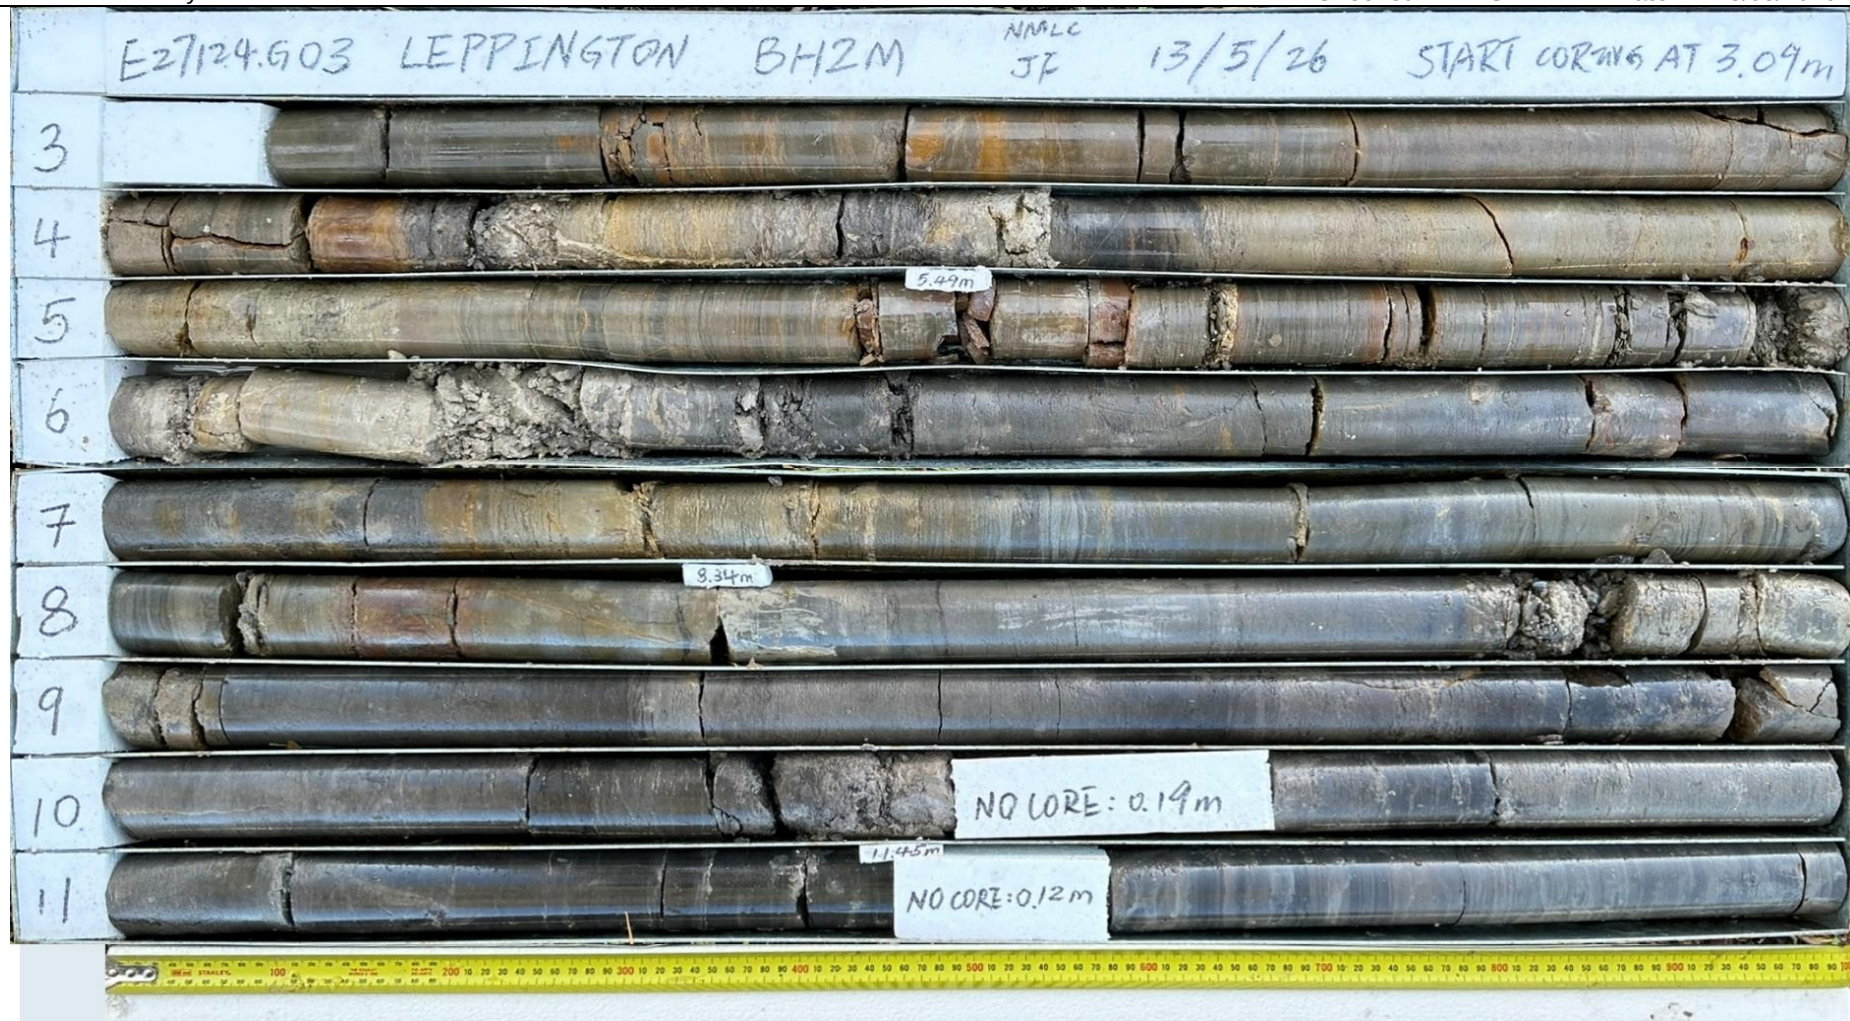
## CORE PHOTOGRAPH OF BOREHOLE: BH2

| <b>Project</b> | Proposed Development | <b>East</b> | 297369.5 (MGA 56) | <b>Depth Range</b> | 3.09m to 31.14m | | |

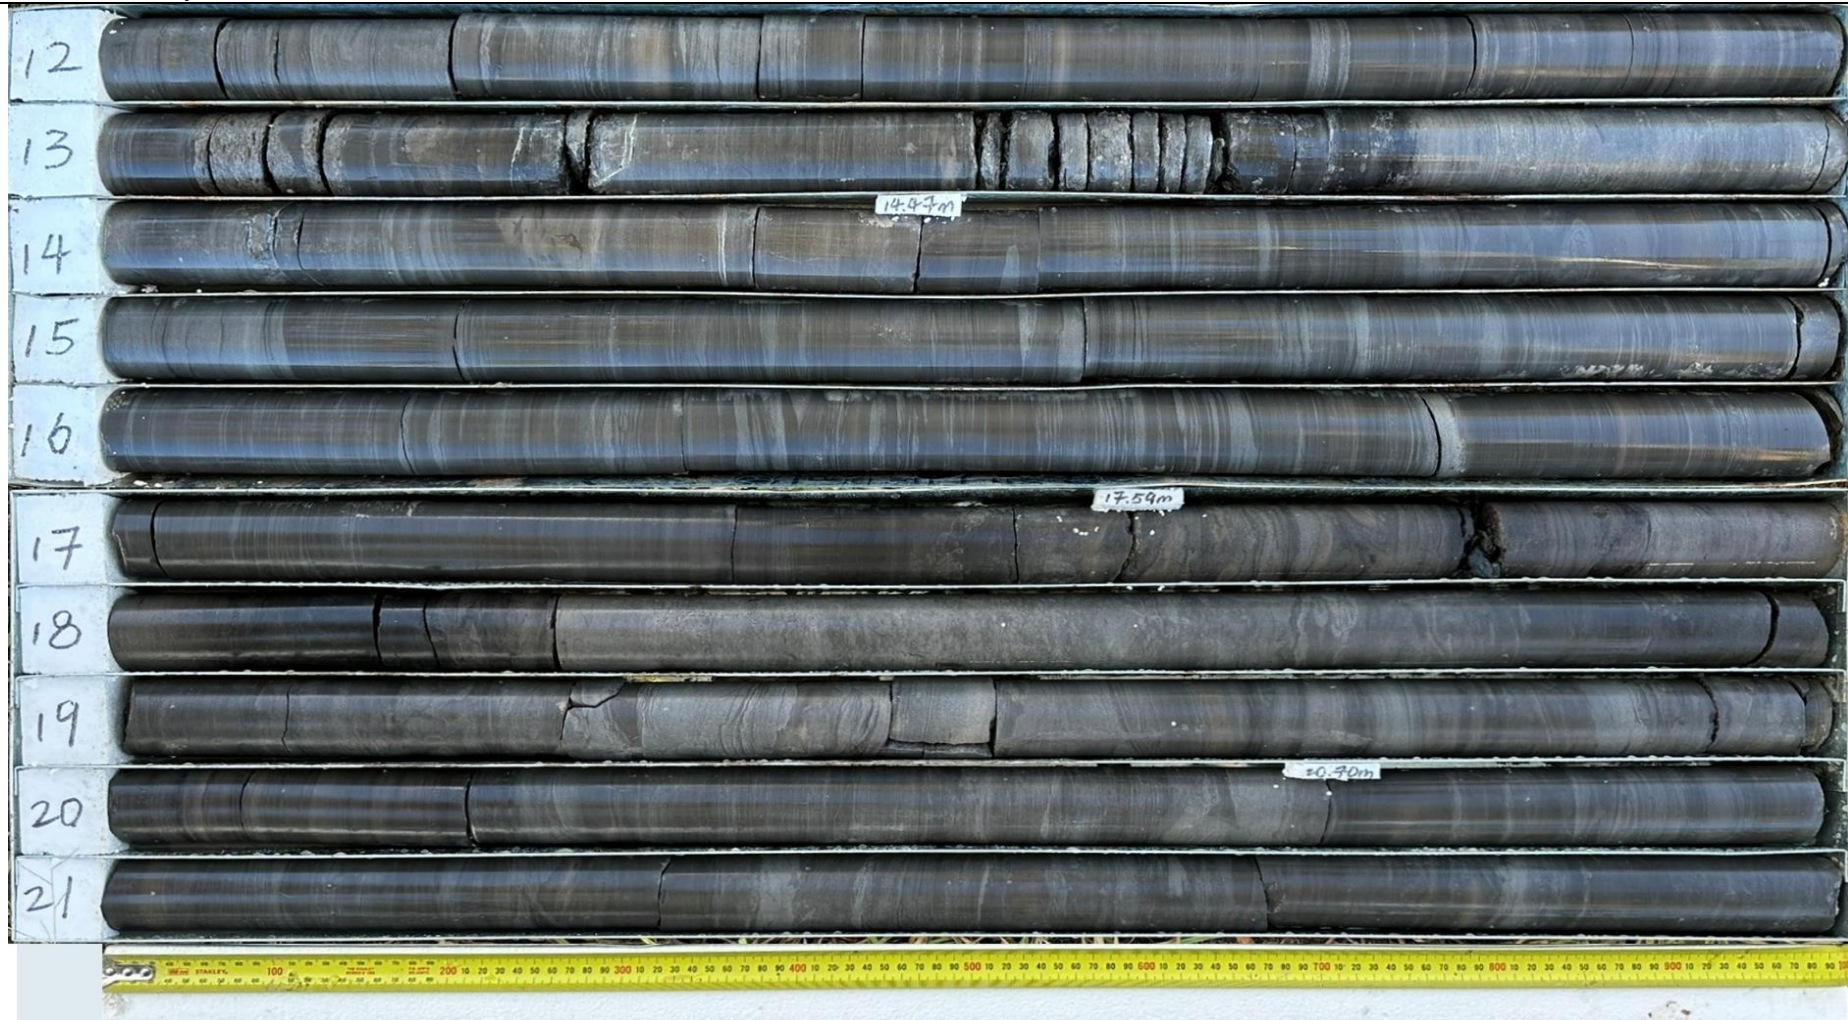
## CORE PHOTOGRAPH OF BOREHOLE: BH2

| <b>Project</b> | Proposed Development | <b>East</b> | 297369.5 (MGA 56) | <b>Depth Range</b> | 3.09m to 31.14m | | |

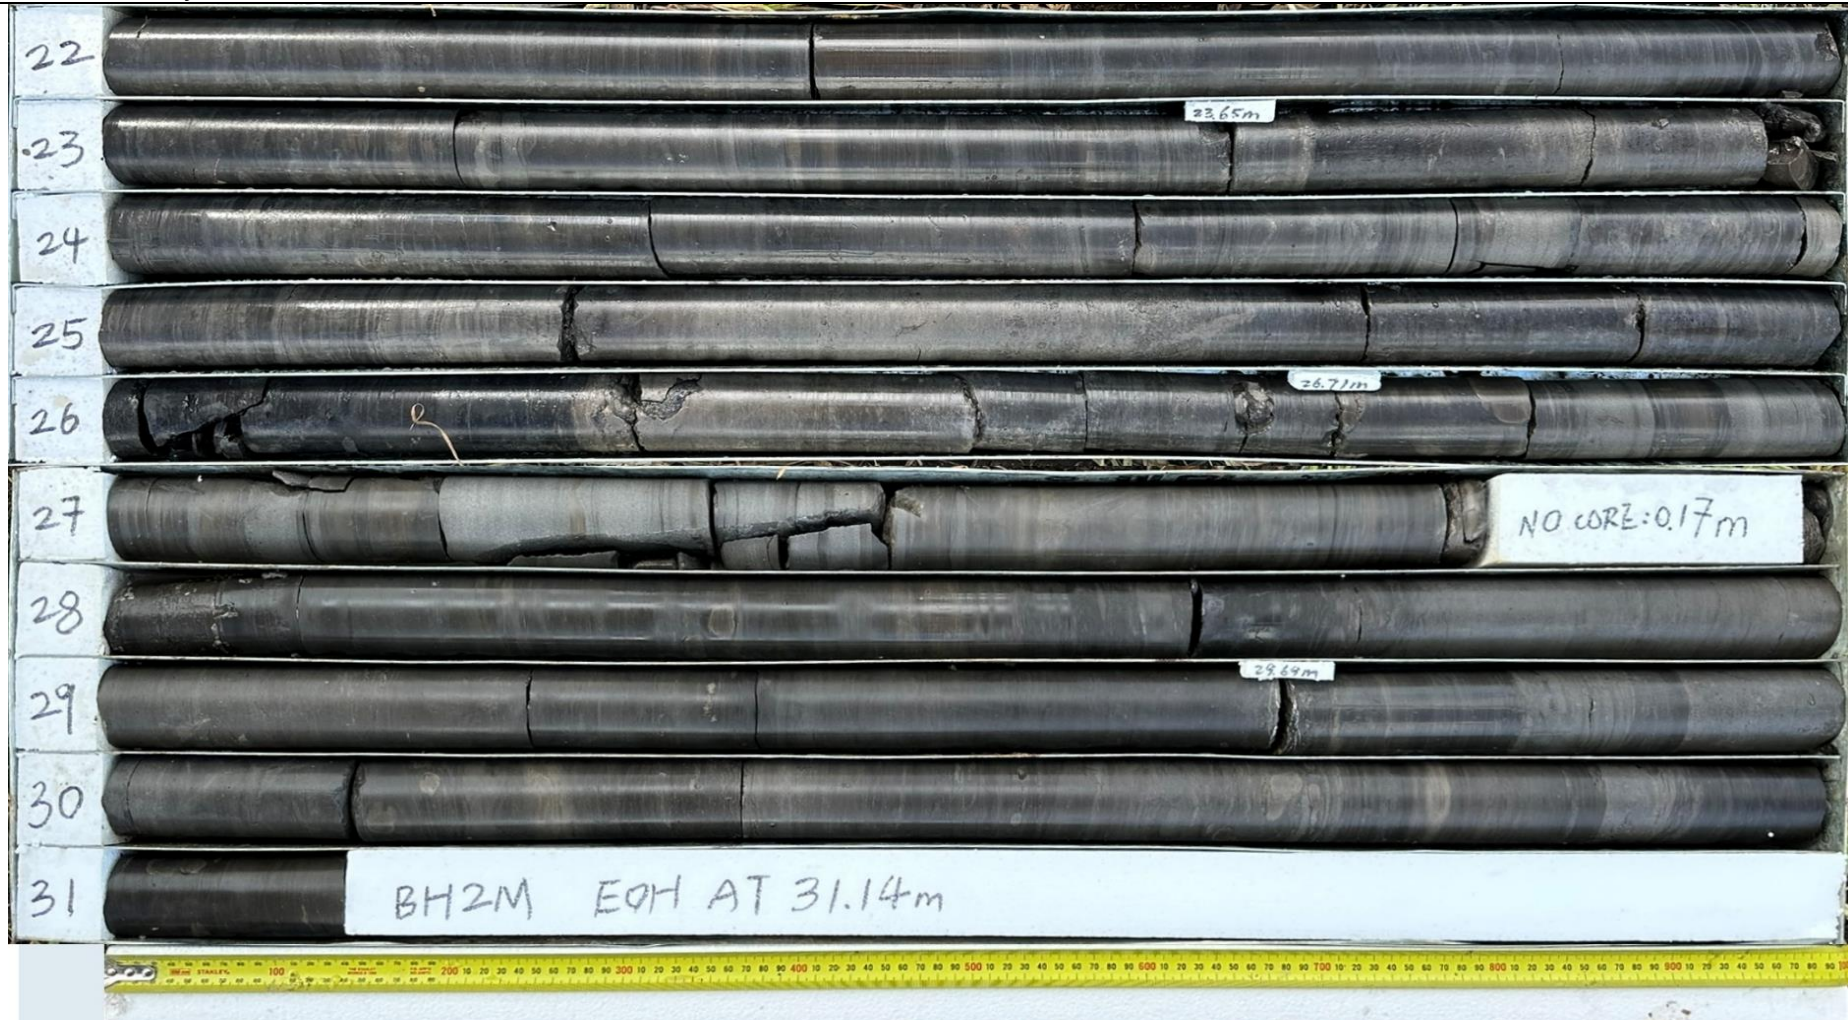
| <b>Client</b> | Aland Pty Ltd | <b>Box</b> | 5-6 of 6 | <b>Checked</b> | SK | <b>Date</b> | 28/05/2026 |

| <b>Job No.</b> | E27124.G03 | <b>Inclination</b> | 90° | <b>Logged</b> | JF | <b>Date</b> | 13/05/2026 |
