**April 2026**

# **Bobs Farm Sand Quarry Geological and Resource Assessment**

This report details the geological context and results of geological investigations for the Bob's Farm Quarry in order to evaluate the sand resources available on site to an extraction depth of 700mm above groundwater level. The site is accessed off Nelsons Bay Road at Bobs Farm within Lot 254 DP 753204, Parish of Tomaree. County Gloucester, located at 3631 Nelsons Bay Road, Bobs Farm, NSW.

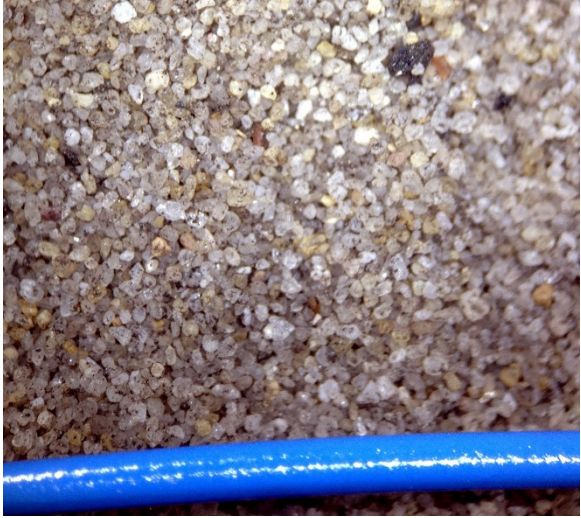
| Resource Unit | Photo |
|---|---|
| <p><b>Upper Grey Sand</b><br/> No organics<br/> Fine to Medium grained quartz sand<br/> Grain size: approximately 0.25mm.<br/> Colours observed: Lead Grey, Cloud Grey, Pearl Grey, Oyster, Koala grey.<br/> Grains are fine grained, clear and opaque.<br/> Photographed interval: BH2, 1.5 - 2m<br/> Scale: 1mm thick blue paper clip.</p> | <p><i>Photoplate 2.</i>      <i>Upper Grey Sand</i></p> |

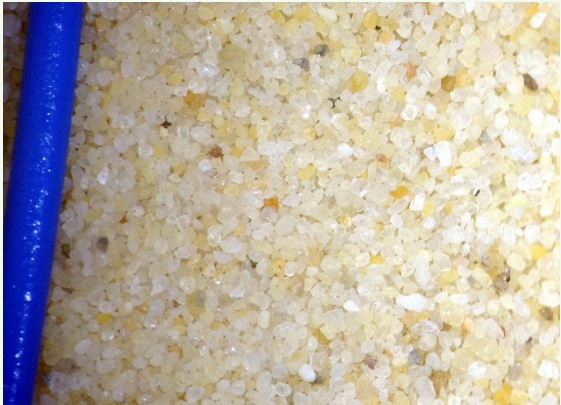
| Resource Unit | Photo |
|---|---|
| <p><b>Blonde Sand</b><br/> Fine to medium grained well sorted quartz sand.<br/> Grain size: approximately 0.25mm.<br/> Colours observed: Tan, Raffia, Buff, and Pale Ochre.<br/> Photographed interval: BH5, 9.5 – 10.5m<br/> Scale: 1mm thick blue paper clip.</p> | <p><i>Photoplate 3.</i>      <i>Blonde Sand</i></p> |
