# Hydrogeological Impact Assessment

3631 Nelson Bay Road, Bobs Farm, NSW

Final Report

P2511038JR07V02

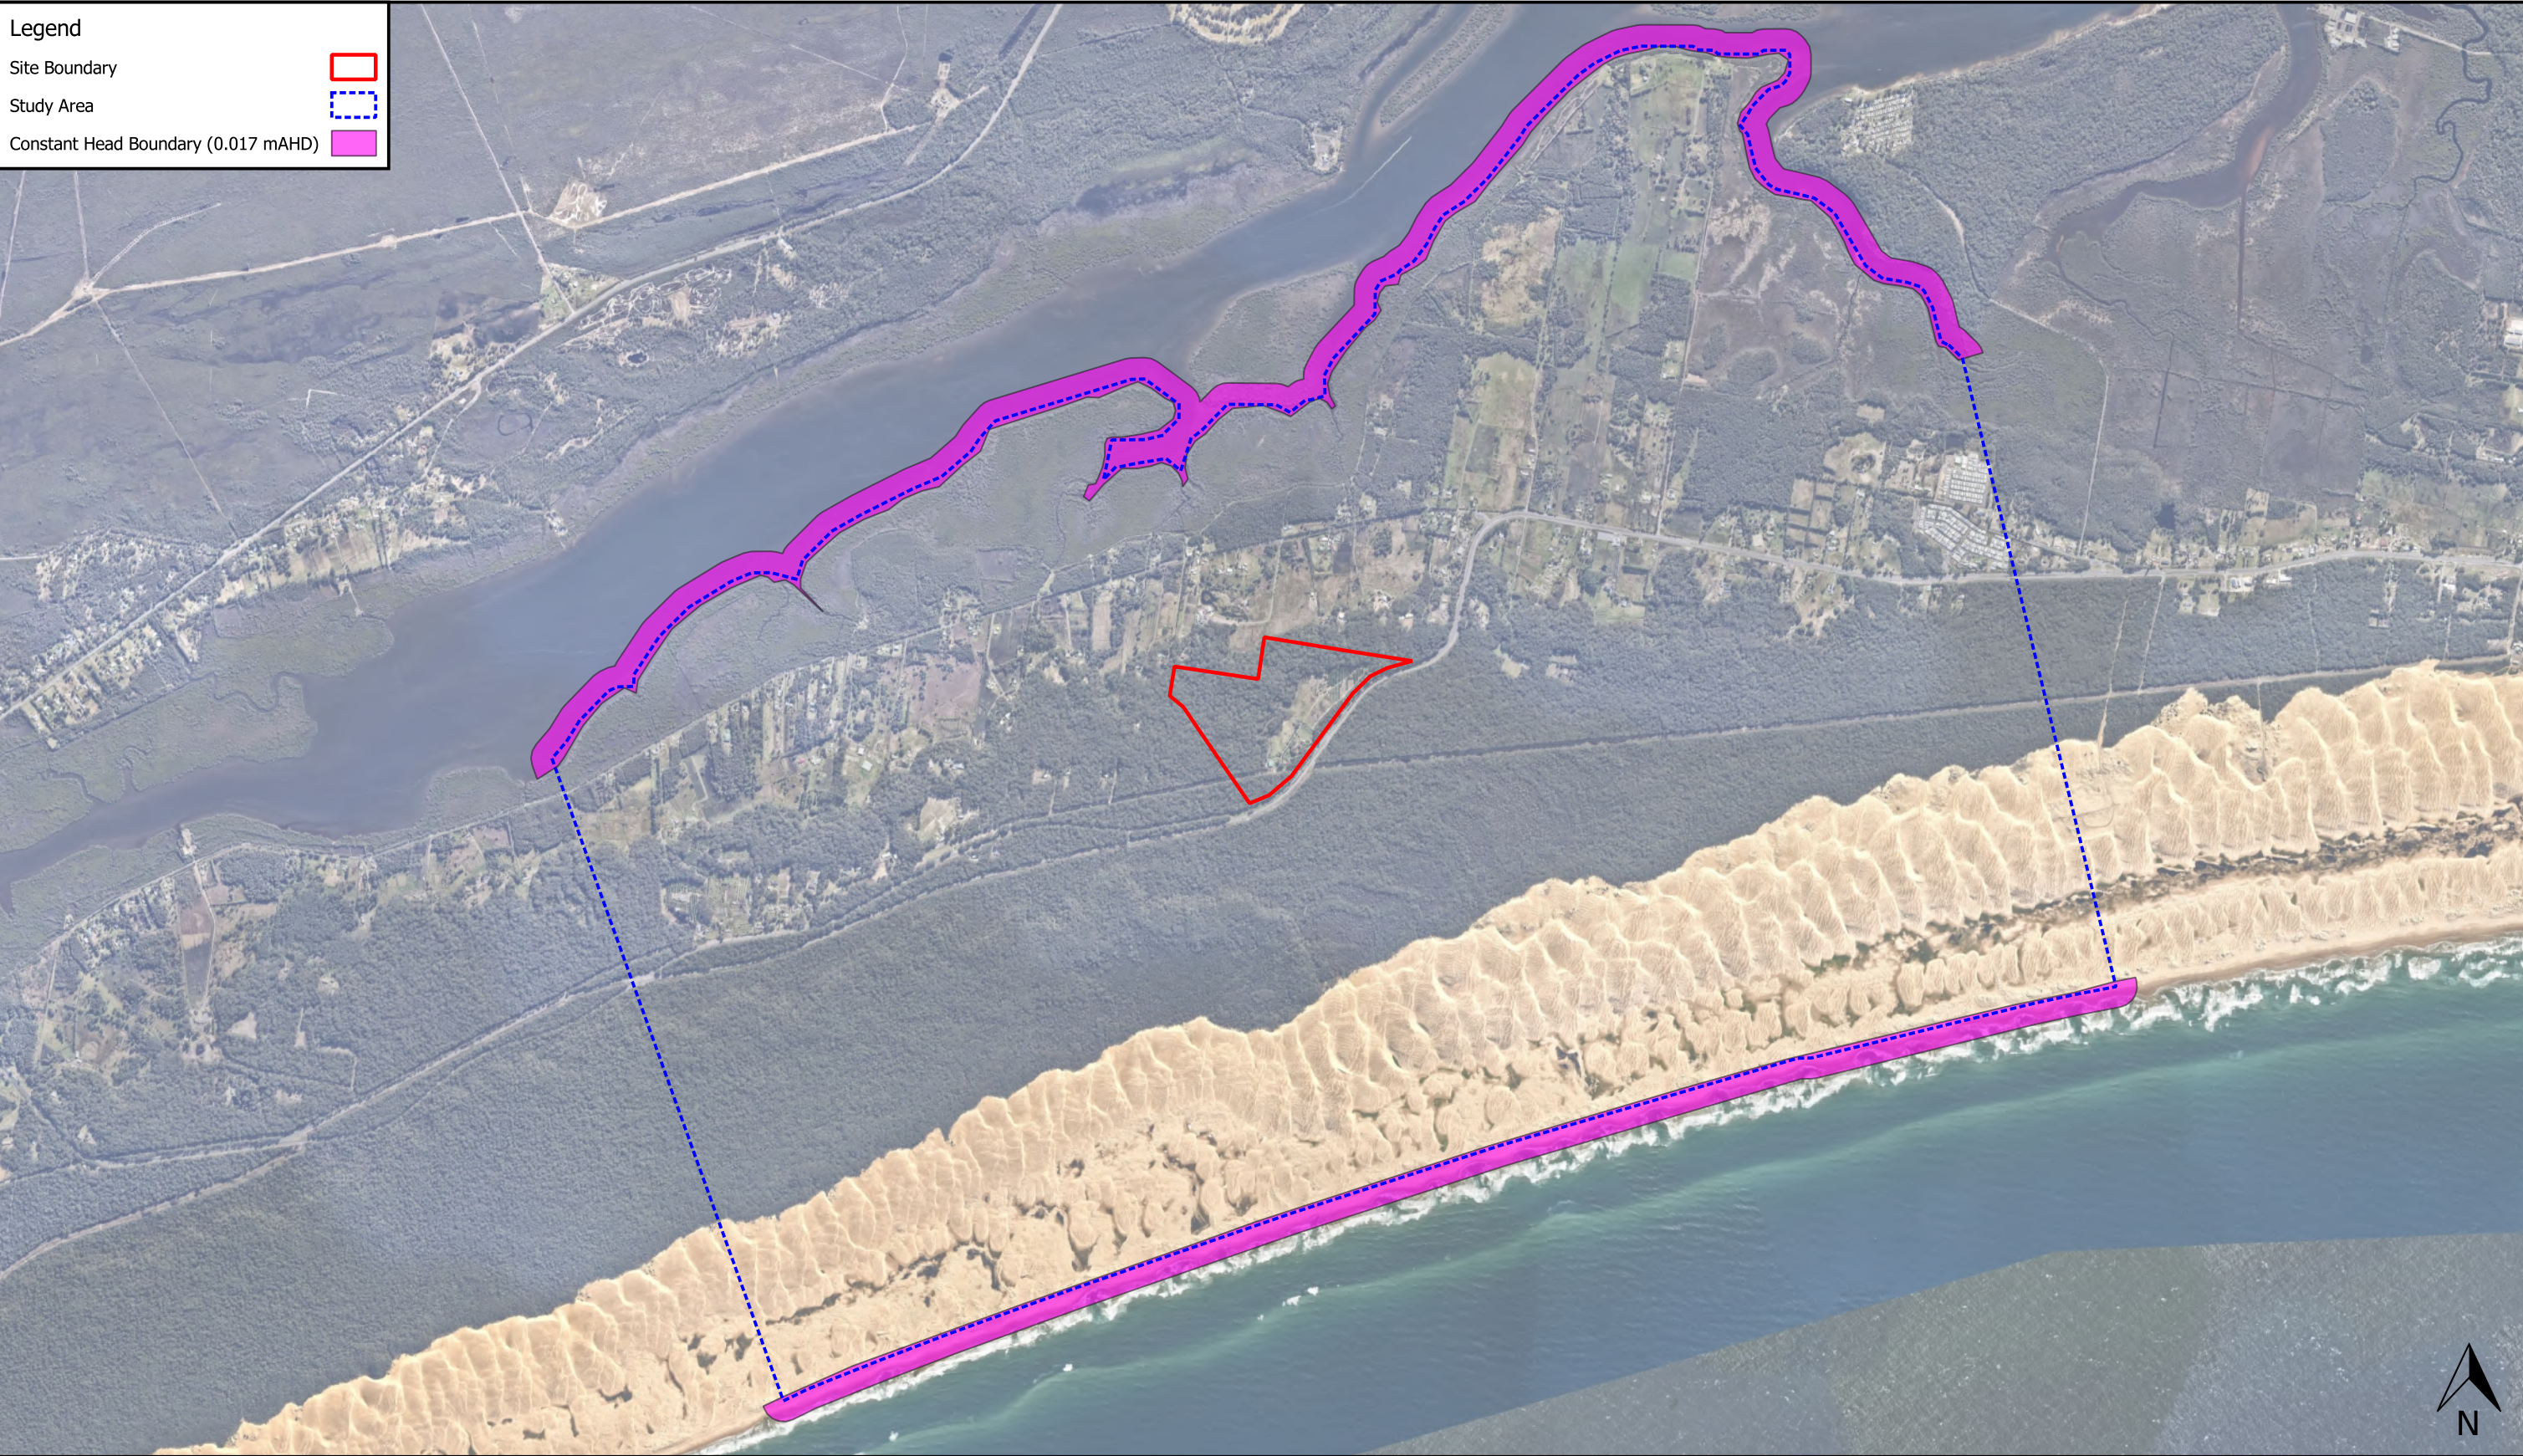
Zoning - Existing Conditions

Existing Conditions Recharge and Evapotranspiration Zoning

| Map | Title |
|---|---|
| Map 09 | Existing Conditions Recharge and Evapotranspiration Zoning |

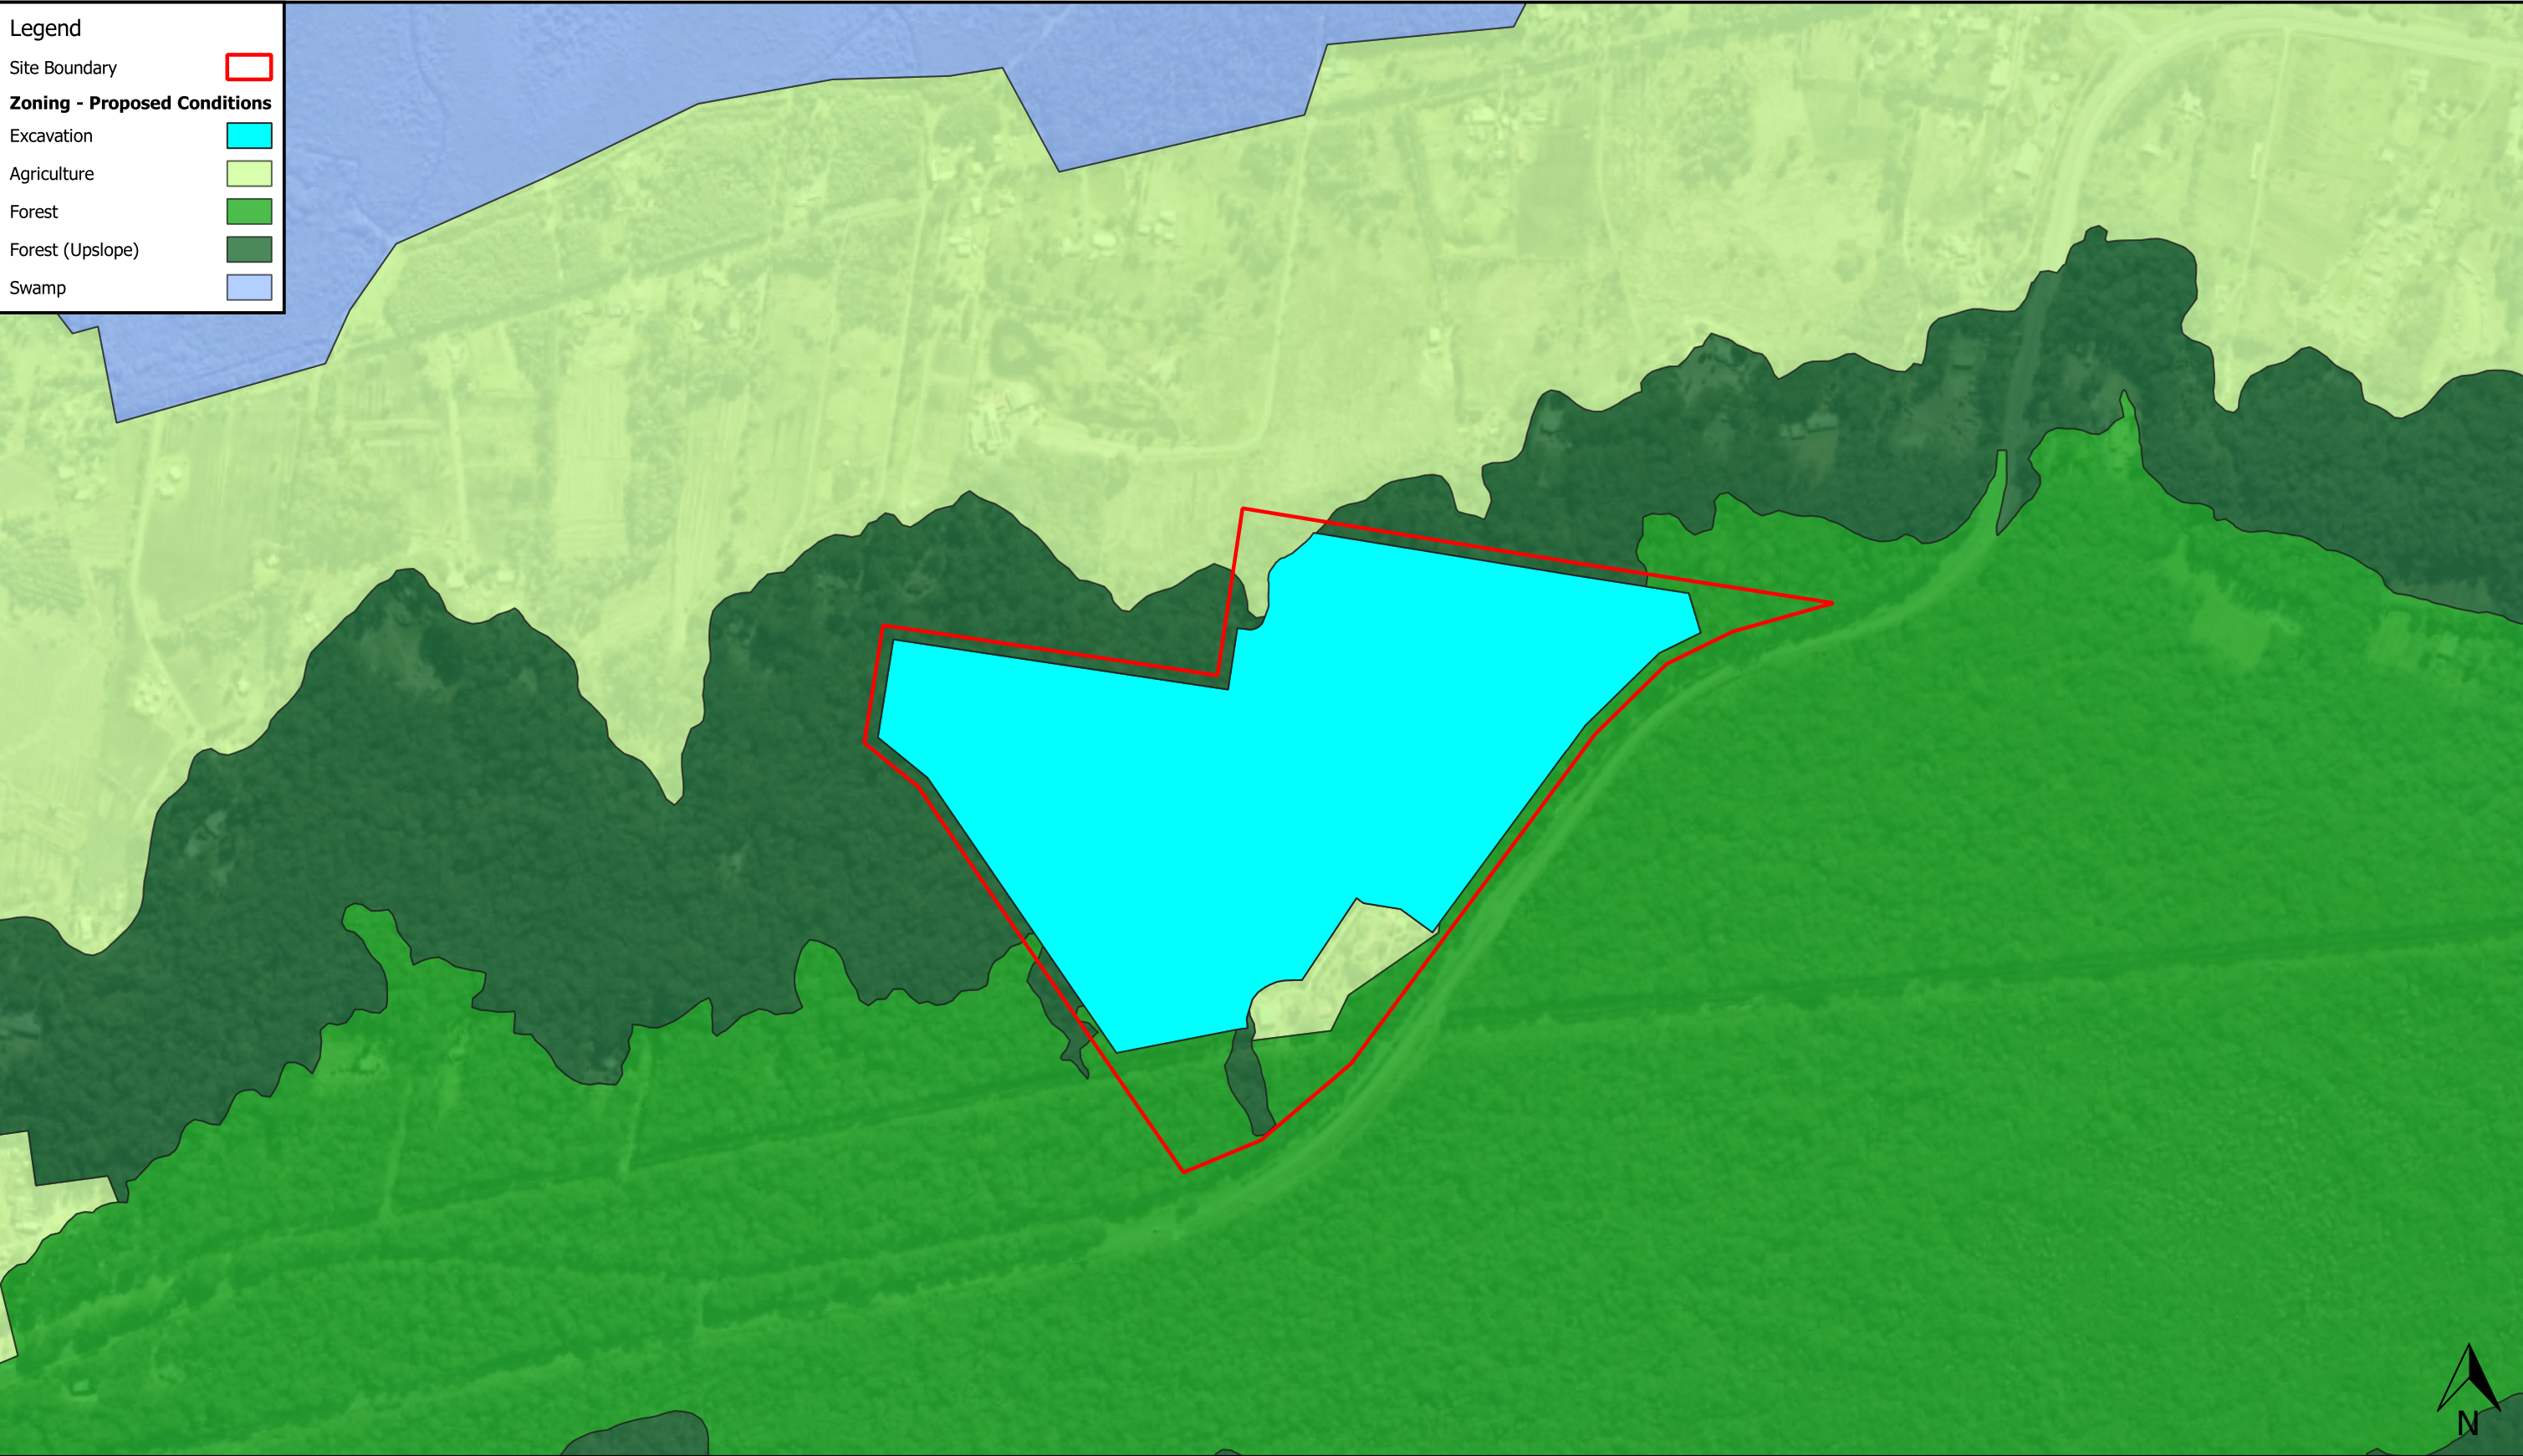
Map Title / Figure: Proposed Conditions Recharge and Evapotranspiration Zoning

Zoning - Proposed Conditions

| Map | Title |
|---|---|
| Map 11 | Proposed Conditions Recharge and Evapotranspiration Zoning |

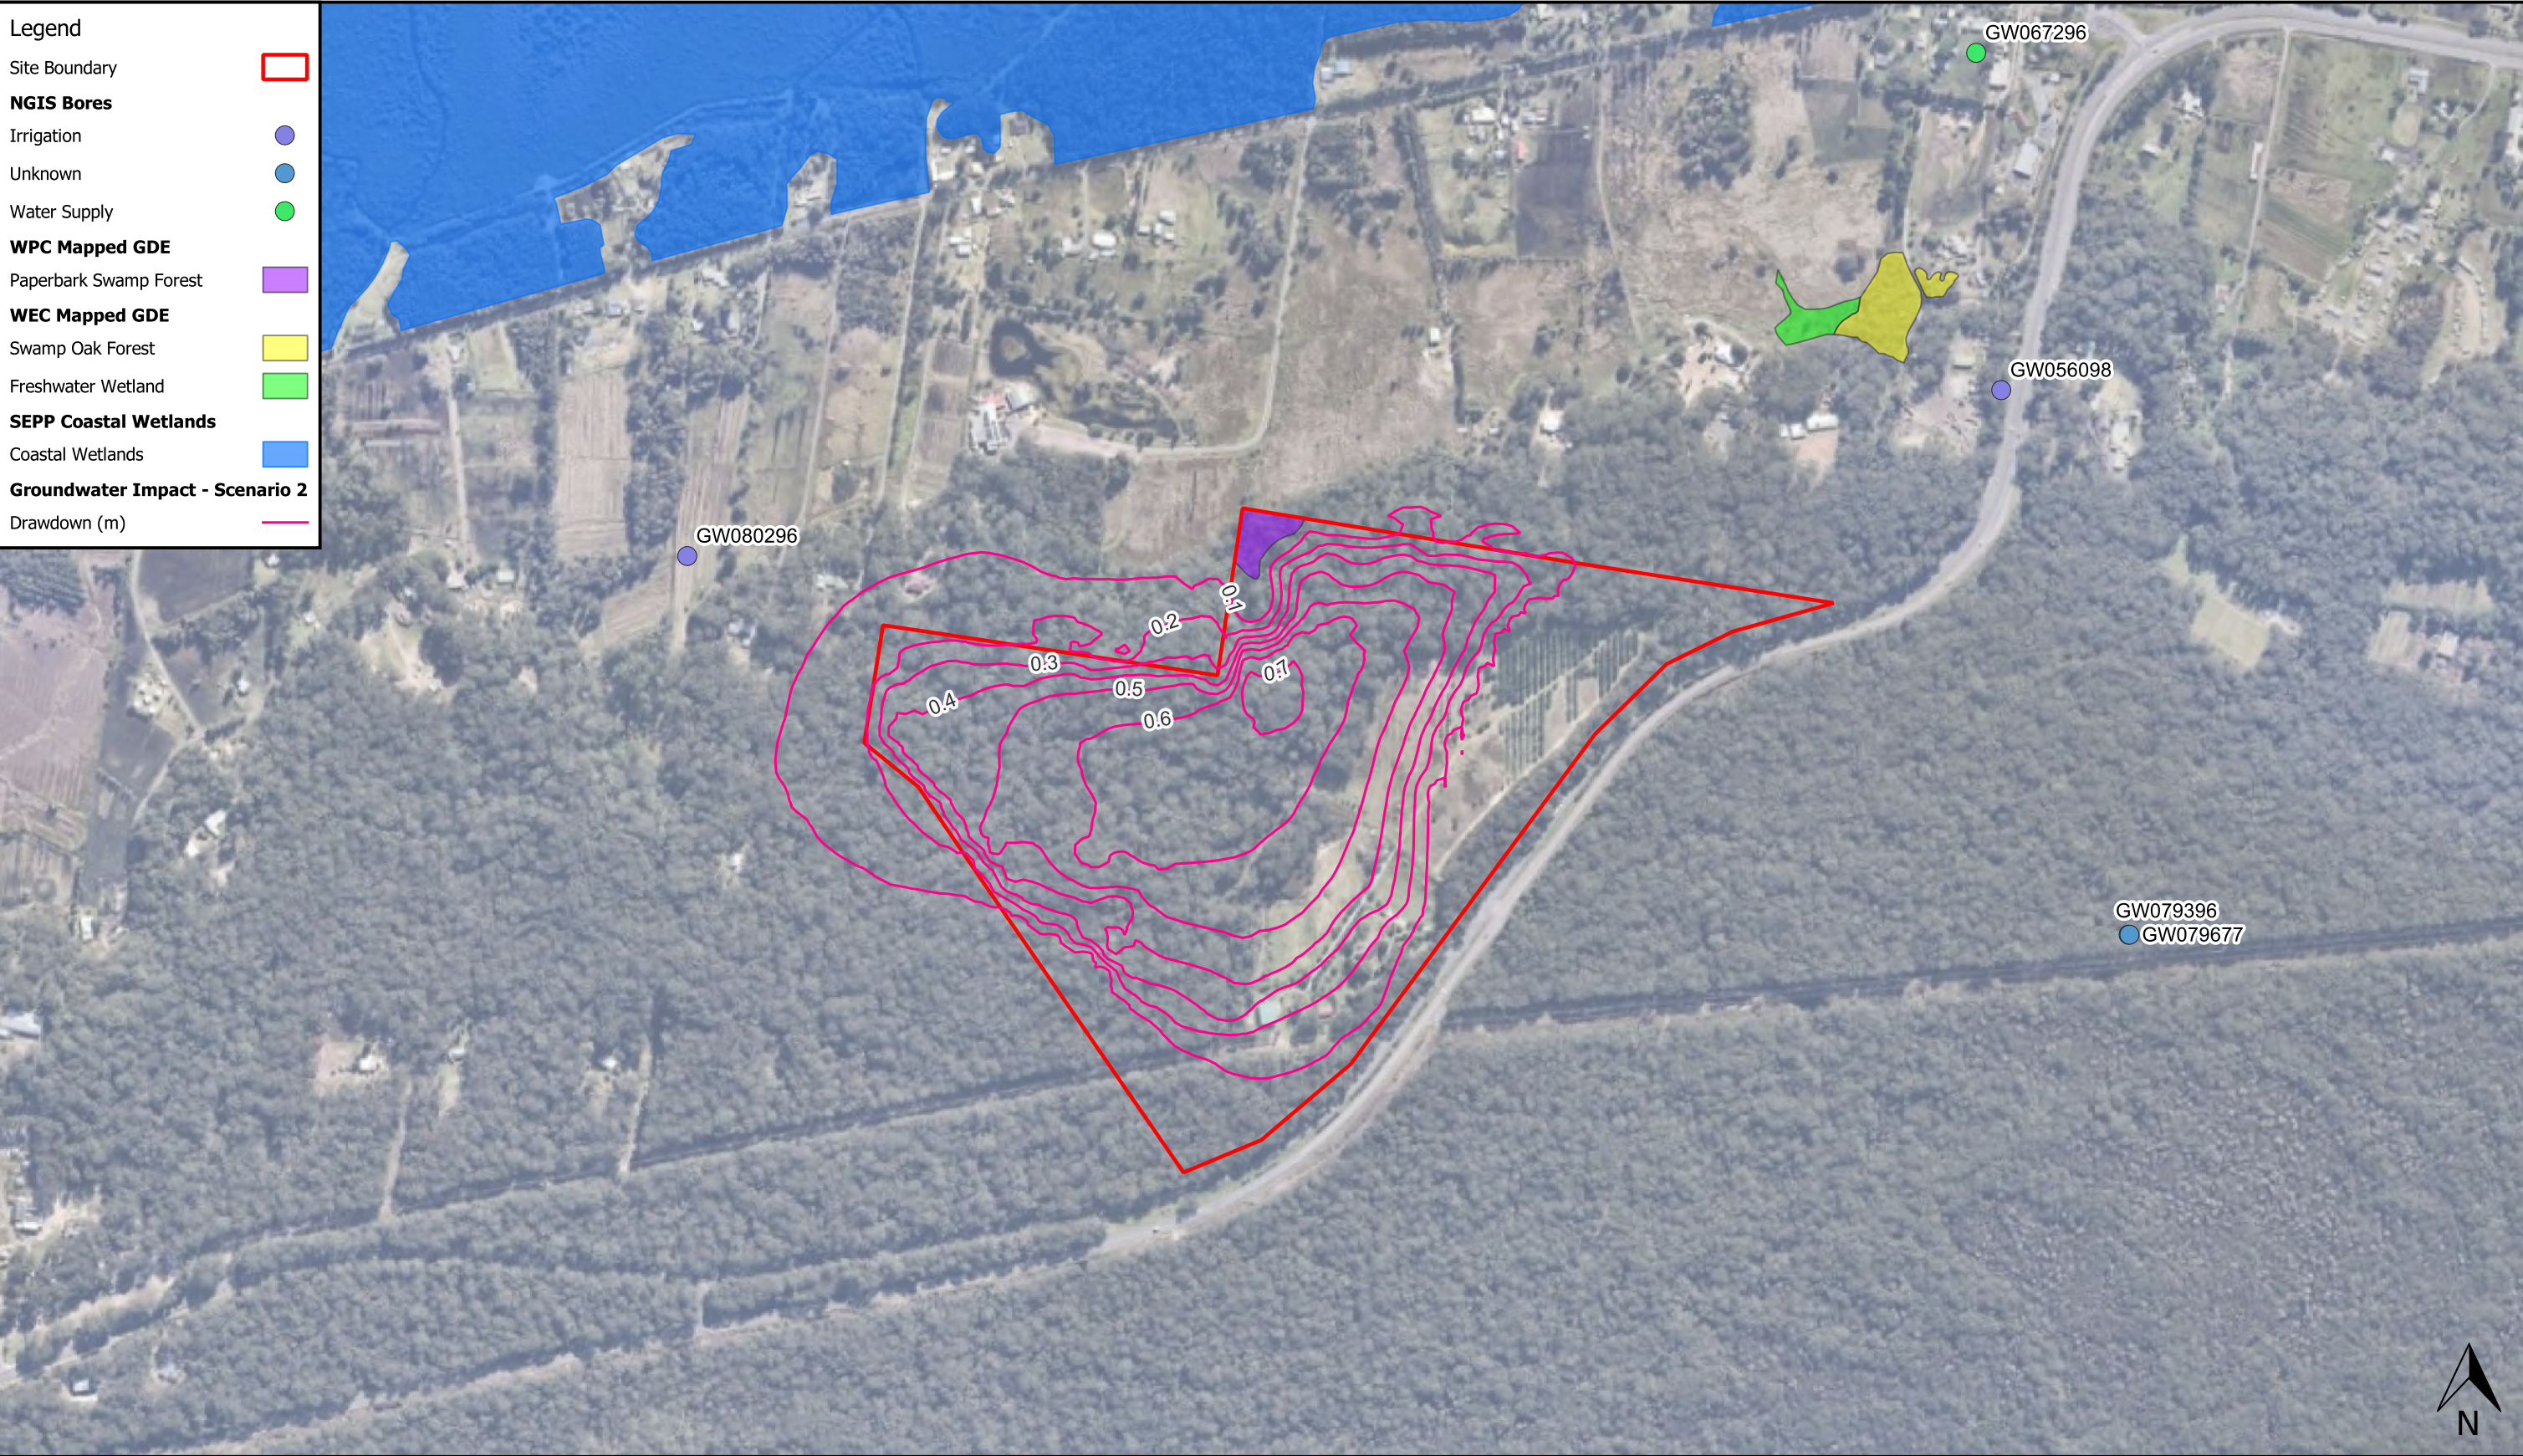
Map Title / Figure:  
Groundwater Impact - Scenario 1

- Aerial from Nearmap (2024).
- Registered bore locations from BOM Groundwater Explorer (2024).
- GDE locations from WEC (2020) and WPC.
- Coastal wetland locations from NSW SEPP (R&H) 2021

- **Scenario 1 – baseline rehabilitation scenario:** Recharge of 20% of rainfall was adopted, consistent with calibrated rural / agricultural land conditions and representing rehabilitation with vegetation broadly comparable with existing conditions.
- **Scenario 2 – low recharge scenario:** Recharge was reduced to 5% of rainfall, representing disturbed, compacted, or actively managed conditions where effective infiltration is limited. This scenario provides a conservative estimate of potential groundwater drawdown.
- **Scenario 3 – high recharge sensitivity scenario:** Recharge was increased to 40% of rainfall, representing conditions where exposed sandy materials allow increased infiltration following removal of vegetation.
