# **Appendix G. Aboriginal cultural heritage assessment report**

## **Shoalhaven Hydro Expansion Project - Main Works Environmental Impact Statement**

# Shoalhaven Hydro Expansion Project – Main Works

## Aboriginal cultural heritage assessment report

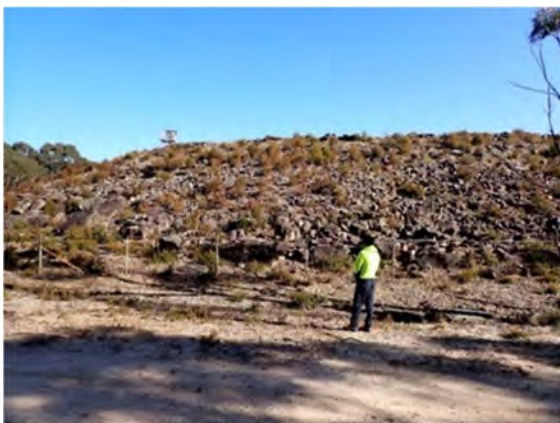
**Figure 4-1. Survey Unit 1, Promised Land Trail facing west towards Fitzroy Canal**

Survey Unit 1 is located in the northern portion of the project area, due south of Fitzroy Falls on the Promised Land Trail segment which intersects the Fitzroy Canal and WaterNSW pipeline. The area comprises the Promised Land Trail segment on the eastern side of Fitzroy Canal, extending south to the eastern side of the WaterNSW pipeline (**Figure 4-1** and **Figure 4-2**).

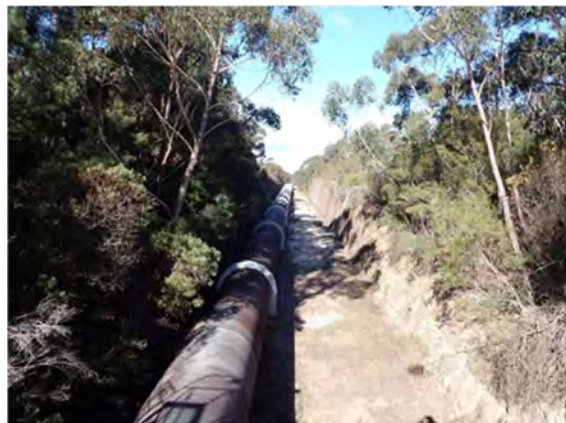
**Figure 4-2. WaterNSW pipeline as seen from Survey Unit 1, facing south**

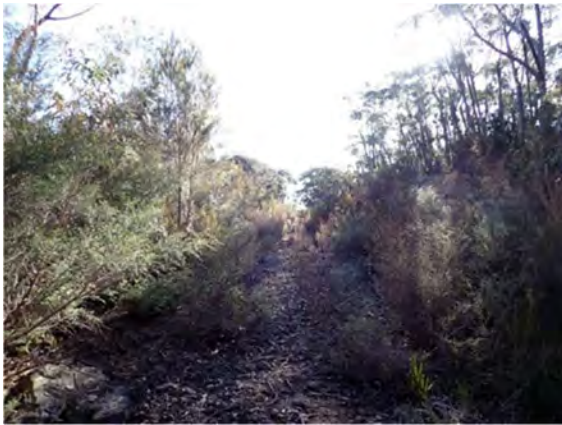
Figure 4-3. Overgrown vehicle track on eastern side of WaterNSW pipeline, facing north

Vegetation in the area comprises juvenile regrowth of open woodland, which has reduced the potential for scarred trees to be located in the immediate area. The open woodland also comprises low-lying scrub with bush wattle that impacted GSV and survey access (**Figure 4-3**).

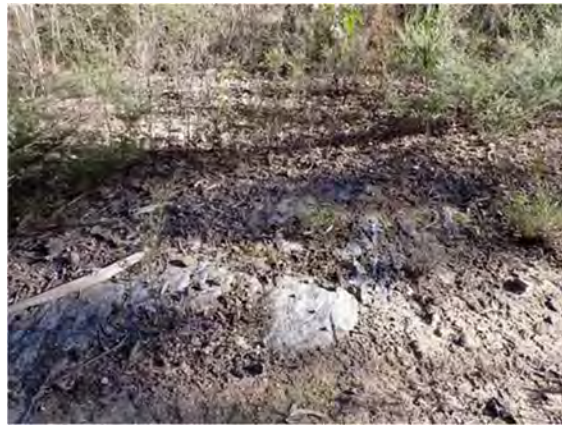
Figure 4-4. GSV conditions, eastern overgrown track of Survey Unit 1, facing west

Exposures generally comprised sandstone outcrops and exposed soils on the vehicle tracks. GSV was generally 90% with 40% exposures (**Figure 4-4** and **Figure 4-5**). Soils generally comprised eroding yellowish brown sands consistent with the local geology and use of local fill for road base. The survey was however limited by excessive slope on the eastern side of the Promised Land Trail which limited the ability of the survey team to have safe access.

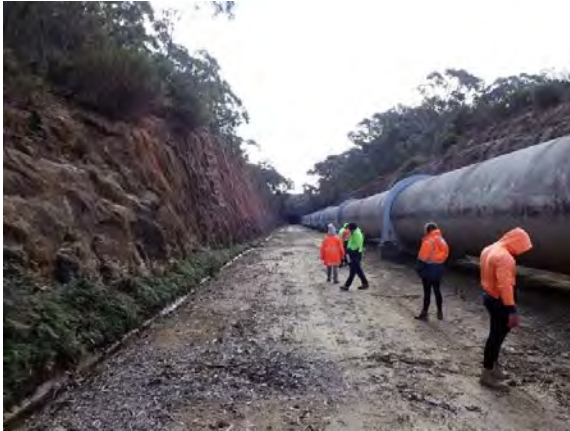
Figure 4-6. Survey Unit 2 within the pipeline cutting, facing north

Survey Unit 2 comprises a section of the pre-existing WaterNSW alignment to the south of Survey Unit 1. This area is accessed via Promised Land Trail. The area has been subject to historic cut and fill disturbance associated with the construction of the pipeline. Bulk earthworks have been undertaken to cut into the underlying geology, with the pipeline positioned at the base of the cut (**Figure 4-6**).

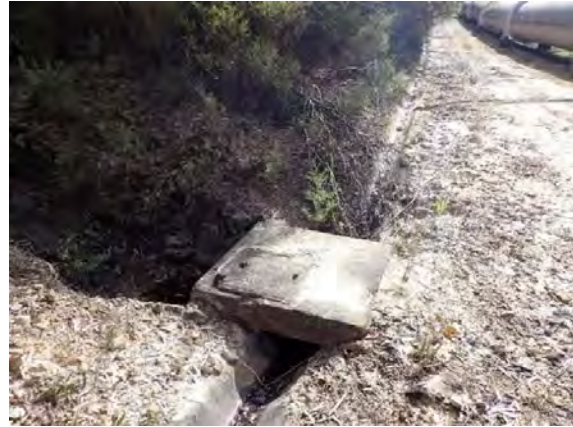
Figure 4-7. Survey Unit 2 box culvert and concrete drainage, facing north

The adjacent vehicle track comprises a sandy roadbase fill containing metal fragments and fractured sandstone. Concrete drains and box culverts have also been cut into the alignment to facilitate drainage downslope to the south (**Figure 4-7**). GSV is at 90% with 40% visibility and 70% exposure due to stripping of vegetation and erosion / removal of topsoils (**Figure 4-8**).

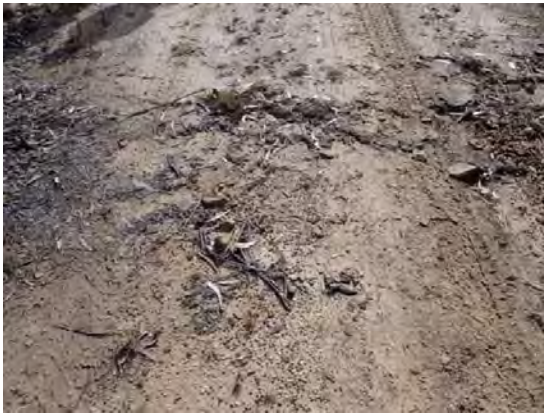
Figure 4-8. Survey Unit 2 GSV, facing north

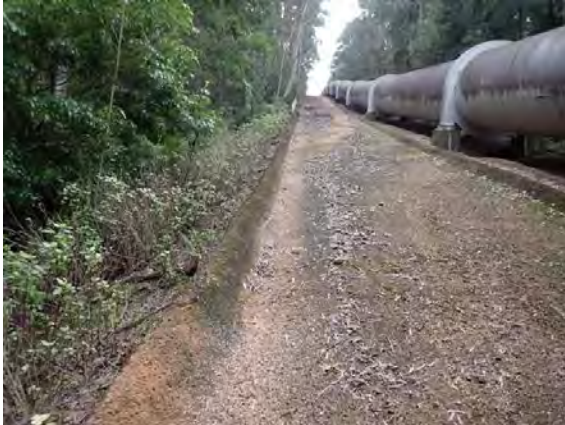
**Figure 4-9.** Survey Unit 3 facing north along pipeline easement

Survey Unit 3 is located on the Promised Land Trail and WaterNSW pipeline vehicle easement, due south of Survey Unit 2. The section of pipeline within Survey Unit 3 is located over a low-lying creek. The vehicle easement along the pipeline has been built up above the natural ground surface with large amounts of fill, including soil bunds and drainage (**Figure 4-9**).

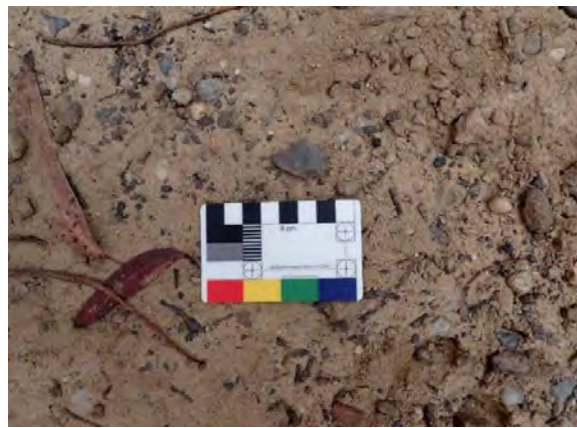
**Figure 4-12.** Promised Land Trail IF01 dorsal surface

One potential chalcedony flake was noted on the Promised Land Trail at the eastern boundary of the survey unit. However, it was determined the object was a result of heat fracture due to temperature change / splintering rock due to the concave nature of the dorsal side of the object (**Figure 4-12**).

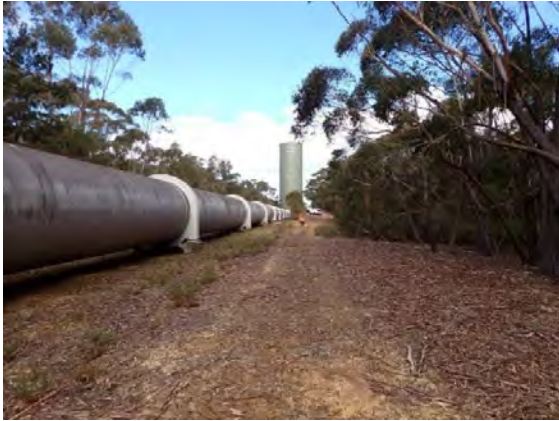
**Figure 4-13. South facing view of Survey Unit 4 towards surge tower**

Survey Unit 4 is located south of Survey Unit 3, due east of the Promised Land Trail within the WaterNSW pipeline alignment and vehicle easement. This area is generally north of the southern surge tower on the escarpment within a rolling hills landform which has been significantly disturbed by bulk earthworks associated with the cut and fill construction methodology for the pipeline alignment (**Figure 4-13**).

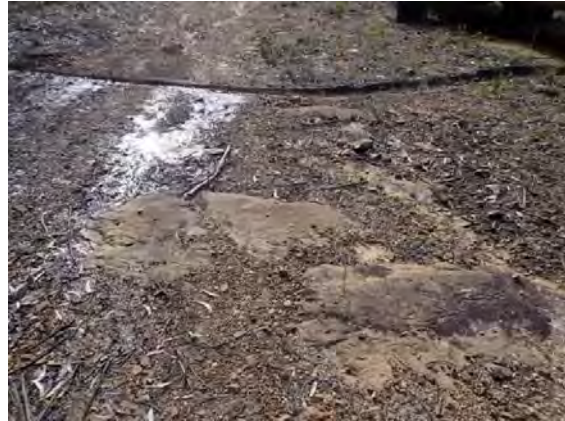
**Figure 4-14. North facing view of ground surface and sandstone outcropping of Survey Unit 4**

Topsoils within the easement have been predominantly cleared down to the natural clay / sandstone outcroppings, with residual sandy topsoil patches remaining in thin layers over the surface (**Figure 4-14**). Vegetation in the area comprises juvenile regrowth of < 50 years old due to historic forestry practices and construction of the pipeline (**Figure 4-15**).

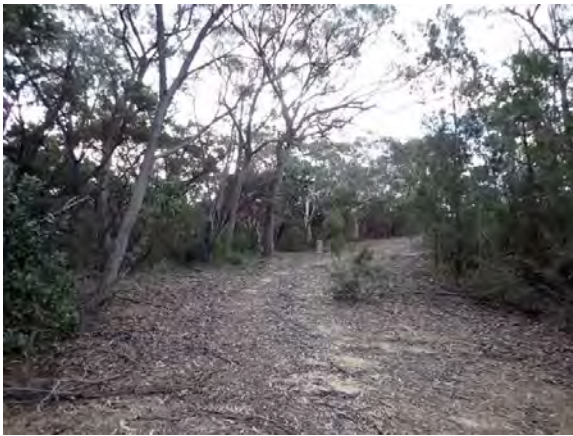
**Figure 4-15. West facing view of Promised Land Trail and juvenile vegetation adjacent to Survey Unit 4**

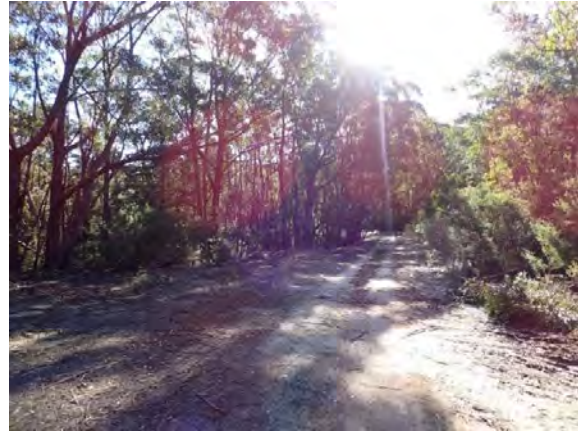
Figure 4-17. Regrowth surrounding Promised Land Trail at Survey Unit 5, facing north

While vegetation in the vicinity is dense, it comprises historic regrowth of < 50 years as a result of forestry practice and construction of the water pipeline (**Figure 4-17**). Soils in the area are generally sandy and likely comprise disturbed / introduced fill deposits of eroded escarpment sands. Some outcropping was additionally observed within the trail alignment. Visibility was generally 80% with 40% exposures due to erosion of the track (**Figure 4-18**).

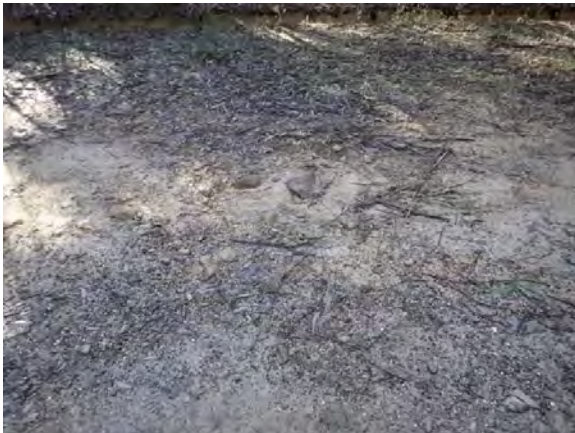
Figure 4-18. Typical ground surface of Survey Unit 5 within Promised Land Trail, facing north

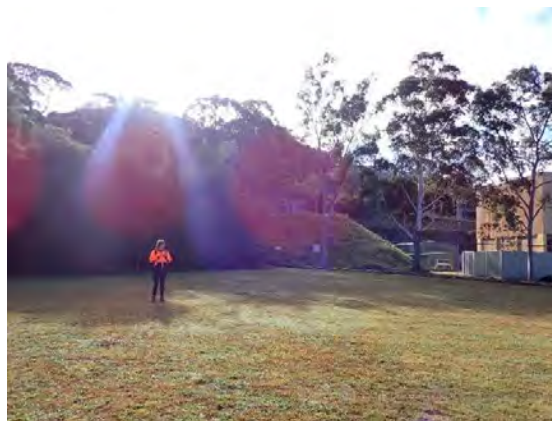
**Figure 4-20. Survey Unit 6, north facing view of the Kangaroo Valley Power Station cut**

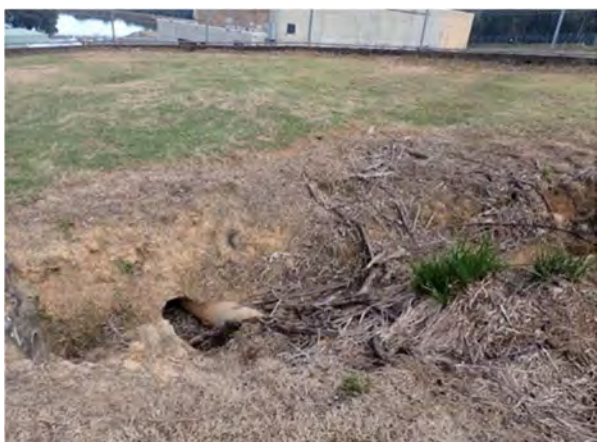
**Figure 4-23. Survey Unit 6 drainage / erosion exposure, facing west**

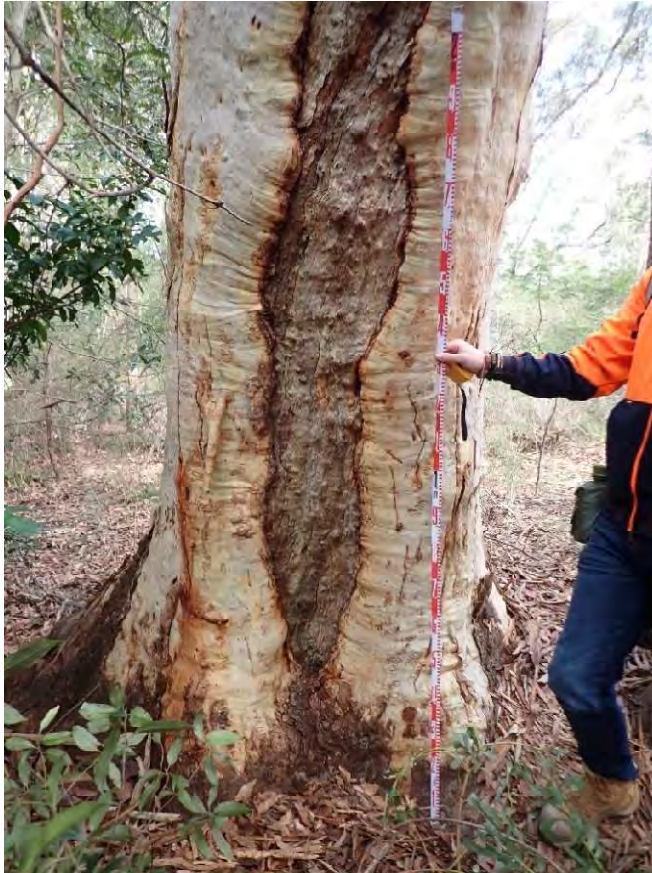
Figure 4-32. Survey Unit 8, northwest facing view of natural scar

One potential scarred tree was noted by Michelle Bennett, being a mature Eucalyptus spp. with a low-lying scar on the trunk. It was the opinion of Jacobs personnel that due to the uneven shape, the low height of the scar from the surface and the shape being consistent with fire scarring of trees, that this particular tree is not culturally scarred (**Figure 4-32**).

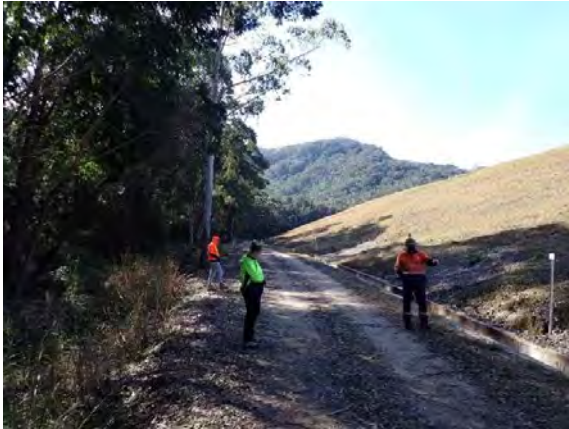
Figure 4-33. Survey Unit 9, facing north

Survey Unit 9 comprises the immediate loop road surrounding the Bendeela Pondage, located adjacent to the south of the Kangaroo Valley Power Station (Survey Unit 6). This area is significantly disturbed from bulk earthworks and vegetation clearing associated with the raising of the pondage and installation of surface and sub-surface infrastructure, amenities and drainage (**Figure 4-33**)

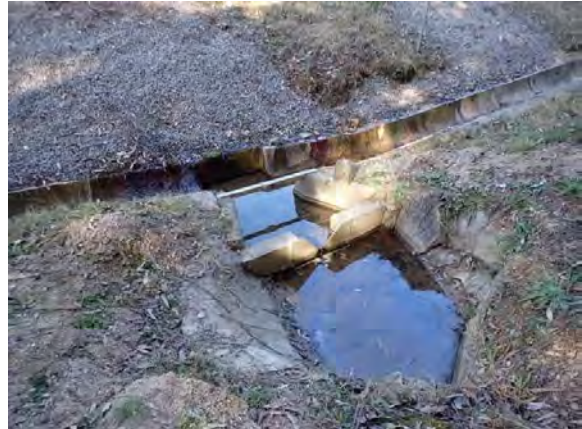
Figure 4-34. Survey Unit 9, southeast view of culvert and drain

Spoon drains and concrete box culverts and have been constructed perpendicular to the pondage walls to assist in drainage (**Figure 4-34**). What soils were visible generally comprise a soft sandy alluvium which has been significantly disturbed and reworked with imported gravel in association with construction of the pondage to create an elevated vehicle track (**Figure 4-35**). Visibility was generally 40% with 50% exposures where erosion and subsidence were observable. Surrounding vegetation comprised juvenile regrowth due to historic forestry and clearing for the hydro plant and pondage (**Figure 4-36**).

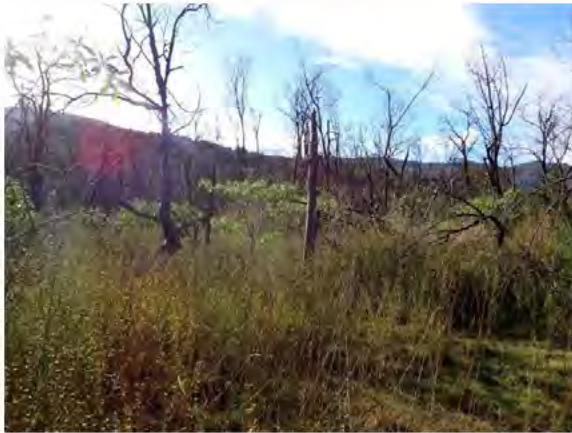
Figure 4-37. North facing view of Survey Unit 10, undergrowth and foliage

The area is highly vegetated with thick head-high scrub that has likely regrown after the 2019 / 2020 bushfire season. Survey was limited by this thick scrub, as well as dense grass and a lack of exposures. Where exposures were identified, soils were generally determined to be a dark sandy loam (Figure 4-37).

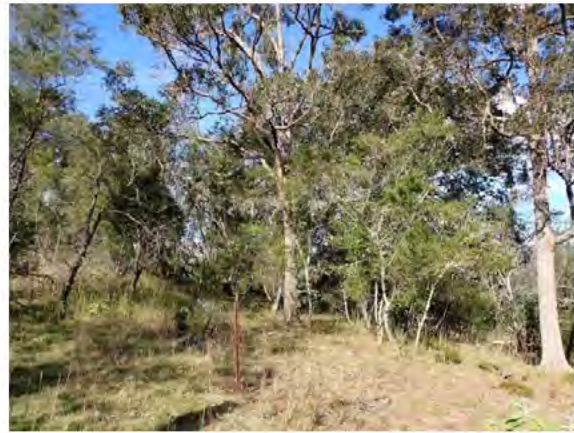
Figure 4-38. South facing view of Survey Unit 10 towards Kangaroo River

Visibility and exposure were both determined to be at 10% owing to thick low-lying vegetation and lack of observable exposures or erosion (Figure 4-38).

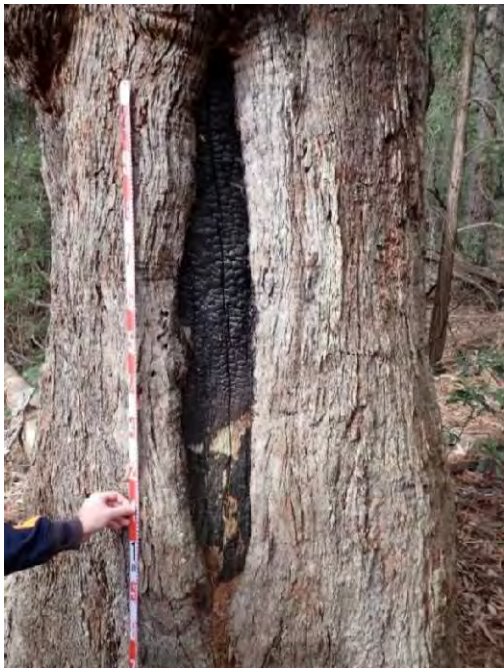
**Figure 4-40. Photo of Promised Land Trail ST01 scar, facing east**

**RAP Comments:** ██████████ commented that the tree type appears consistent with local / regional scarred trees and that it could possibly be a shield tree.

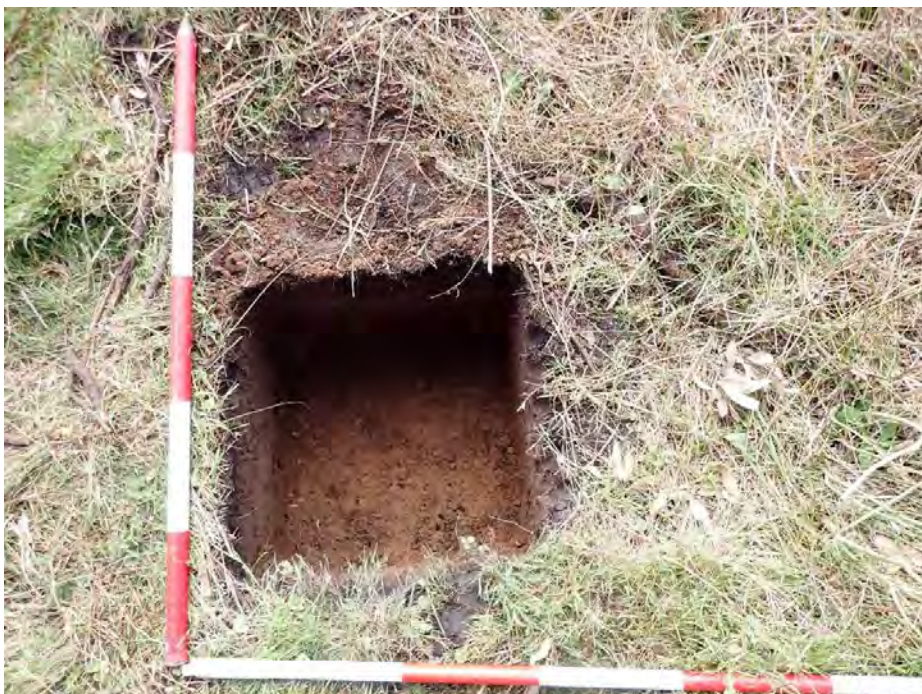
Figure 5-2. Test Pit 1 termination, vantage point north

Spit	Depth (mm)	Notes	No. Artefacts
1	0 – 100	Dark (Black) sandy loam, humic deposit with a top layer of grass. Frequent rooty bioturbation is present and the deposit is fine grained.	3
2	100 – 200	Light brown sandy loam, but similar to Spit 1. Frequent gravel inclusions are present with less rooty bioturbation.	4
3	200 – 300	Same as Spit 2. Light brown sandy loam with frequent gravel inclusions are present with less rooty bioturbation.	0
4	300 – 400	Same as Spit 2 and 3. Light brown sandy loam with frequent gravel inclusions are present with some rooty bioturbation.	0
5	400 – 500	Same as Spit 2, 3 and 4. Light brown sandy loam with frequent gravel inclusions are present with less rooty bioturbation. This layer is at the interface with a red / orange clay at 500 mm depth at northern side of test pit and 450 mm at southern end.  Termination of test pit.	1

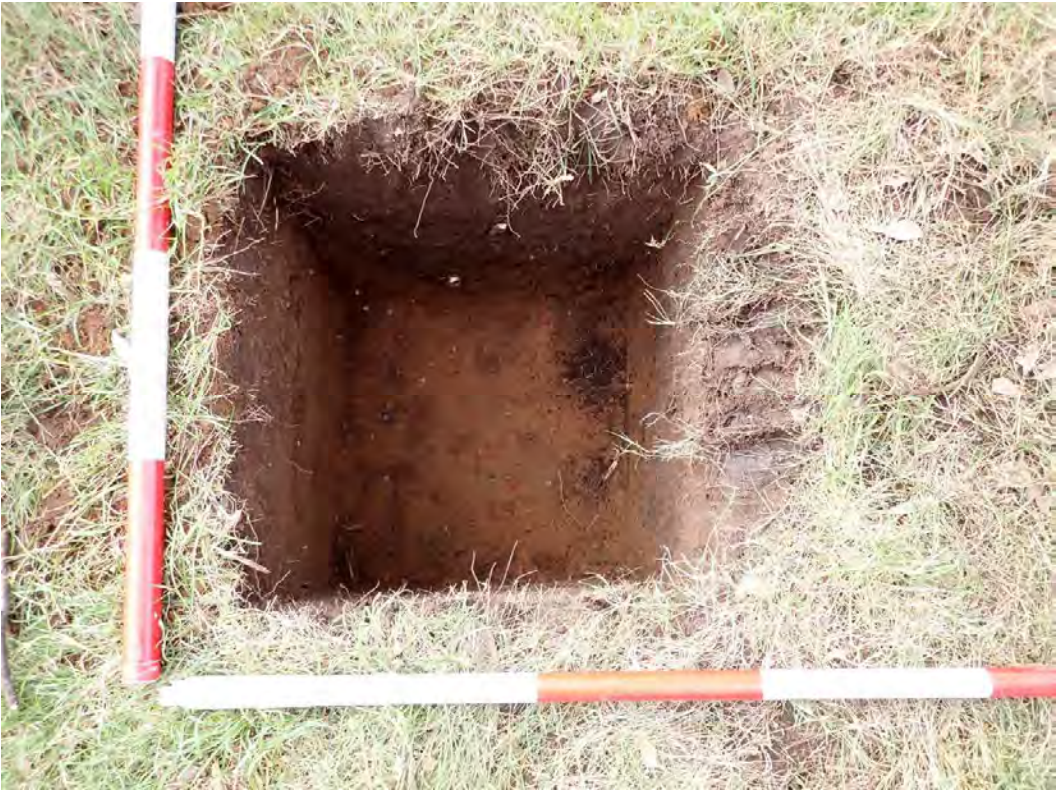
Figure 5-4. Test Pit 2 termination, vantage point north

Spit	Depth (mm)	Notes	No. Artefacts
1	0 – 100	Dark (Black) sandy loam, humic deposit with a top layer of grass. Rooty bioturbation is present.	1
2	100 – 200	Dark brown sandy loam, slightly lighter than the previous humic layer. Fewer root inclusions are present with some gravel.	6
3	200 – 300	Same as Spit 2. Dark brown sandy loam. Root inclusions are present with some gravel.	0
4	300 – 400	Same as Spit 2 and 3. Dark brown sandy loam. Root inclusions are present with some gravel.	0
5	400 – 500	Same as Spit 2, 3 and 4. Dark brown sandy loam. Root inclusions are present with some gravel.	0
6	500 – 600	Same as Spit 2, 3 and 4, 5. Dark brown sandy loam. Root inclusions are present with some gravel. Lower layer of the deposit at the interface of the red / orange clay which was encountered at 600 mm.  Termination of Test Pit.	0

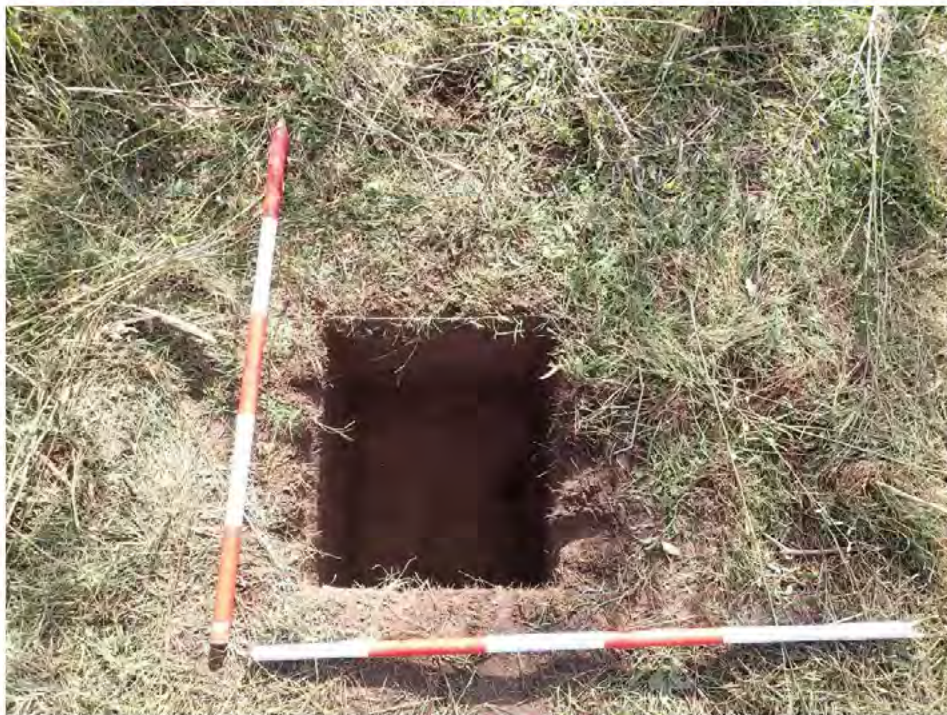
**Figure 5-6. Test Pit 3 termination, vantage point north**

Spit	Depth (mm)	Notes	No. Artefacts
1	0 – 100	Dark brown sandy loam, very humic deposit with a top layer of thick grass. Rooty bioturbation is present as well as clay inclusions.	3
2	100 – 200	As per Spit 1, Dark brown sandy loam, very humic deposit. Rooty bioturbation is present, however there are no clay inclusions.	4
3	200 – 300	Same as Spit 2. Dark brown sandy loam. Root inclusions are present with some gravel.	1
4	300 – 400	Same as Spit 2 and 3. Dark brown sandy loam. Root inclusions are present with some gravel.	0
5	400 – 500	Same as Spit 2, 3 and 4. Dark brown sandy loam. Root inclusions are present with some gravel.	0
6	500 – 600	Same as Spit 2, 3 and 4, 5. Dark brown sandy loam. Comprises the lower layer of the deposit at the interface of the compacted red / orange clay which was encountered at 600 mm.  Termination of Test Pit.	0

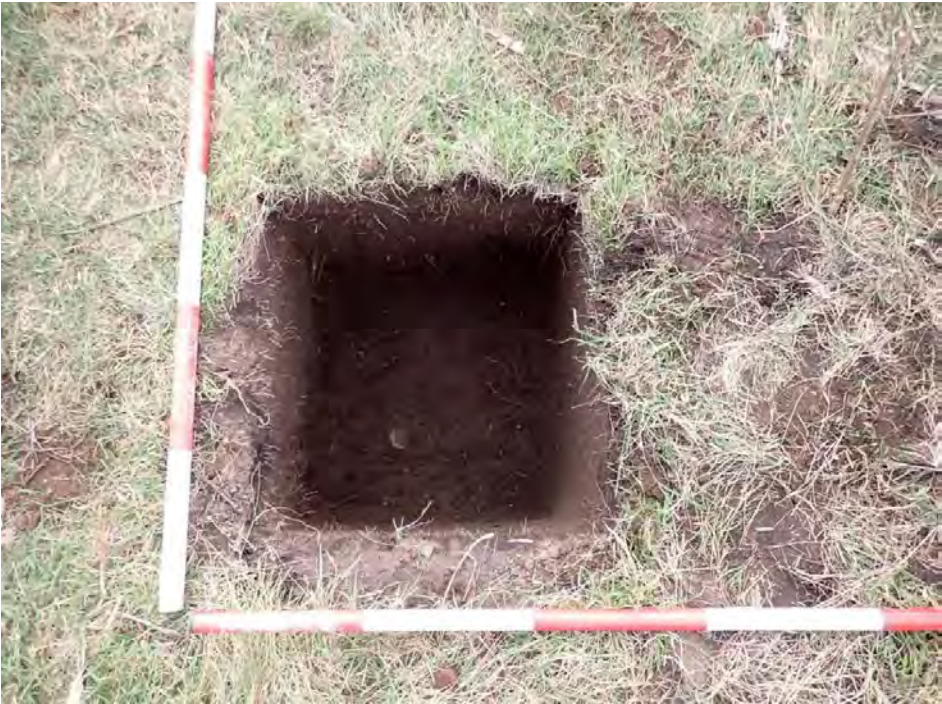
Figure 5-8. Test Pit 4 termination, vantage point north

10	450 – 500	Firm, clayish sand at the interface with the natural clay. Root and charcoal inclusions present with amounts of quartz and chert pebbles (< 30 mm)	0
11	500 – 550	Same as Spit 10. Charcoal and quartz pebble inclusions. The deposit is significantly rockier but with consistent soils as Spit 10.	0
12	550 – 600	Same as Spit 10. Charcoal and quartz pebble inclusions. The deposit is significantly rockier but with consistent soils as Spit 10.	1
13	600 – 650	Natural clay, light yellowish brown. Some imprinted charcoal from overlying topsoil, likely from burned roots.  Termination of Test Pit 4.	1

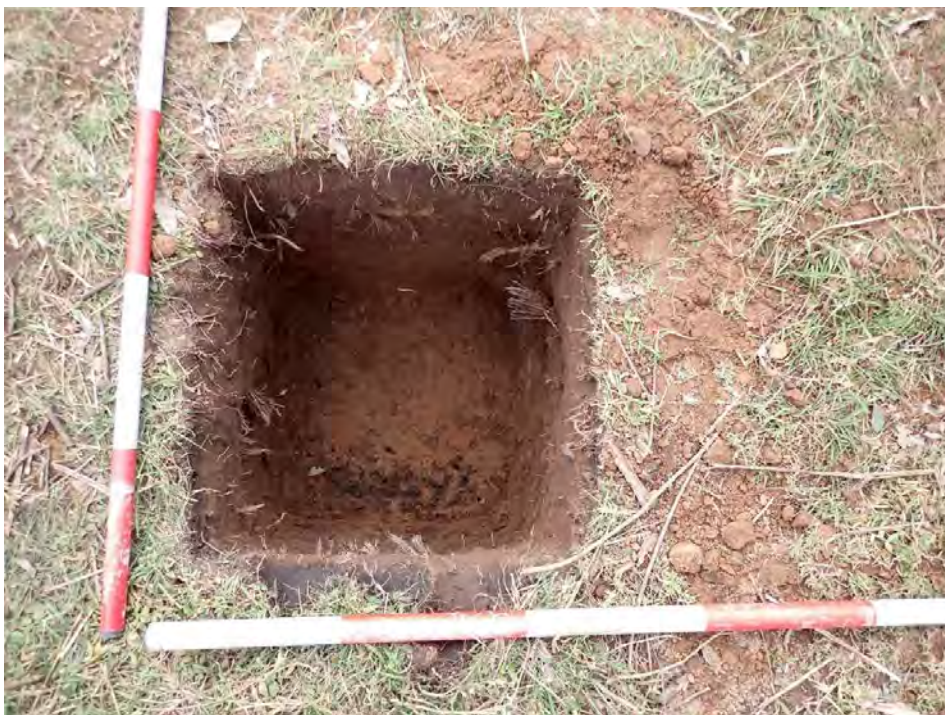
Figure 5-10. Test Pit 5 termination photo, vantage point north

Spit	Depth (mm)	Notes	No. Artefacts
1	0 – 50	Dark greyish brown sandy loam, very humic / charcoal deposit with a top layer of thick grass. Rooty bioturbation is present.	0
2	50 - 150	Dark yellowish brown sandy loam with charcoal, root bioturbation and quartz inclusions. Layer has been alluvially impacted by downslope erosion.	1
3	150 - 250	Same as Spit 2. Dark yellowish brown sandy loam with charcoal, root bioturbation and quartz inclusions. Layer has been alluvially impacted by downslope erosion. Fine deposit.	5
4	250 - 350	Dark yellowish brown sandy loam. Rocky layer of ironstone, quartz and sandstone fragments. 30 % inclusions, however the soils are consistent with Layer 2.	0
5	350 - 450	Same as Spit 4. Increasing rock content.	0
6	450 - 550	Same as Spit 4, increasing rock content.	1
7	550 - 650	Same as Spit 4 – 6. Charcoal and burned roots intermixed.  Charcoal sample taken (Sample #1).	0
8	650 – 750	Same as Spit 4 – 7. Charcoal and burned roots intermixed. Larger cobbles intermixed compared to Spit 4 to 7.  Large charcoal patch located on south side of test pit imprinted on natural clay surface.  Charcoal sample taken (Sample #2)  Terminated at Clay (750 mm)	0
