Proposed Segment Factory

Contamination Assessment

Prepared for Snowy Hydro Limited
September 2019

J17188 RP99

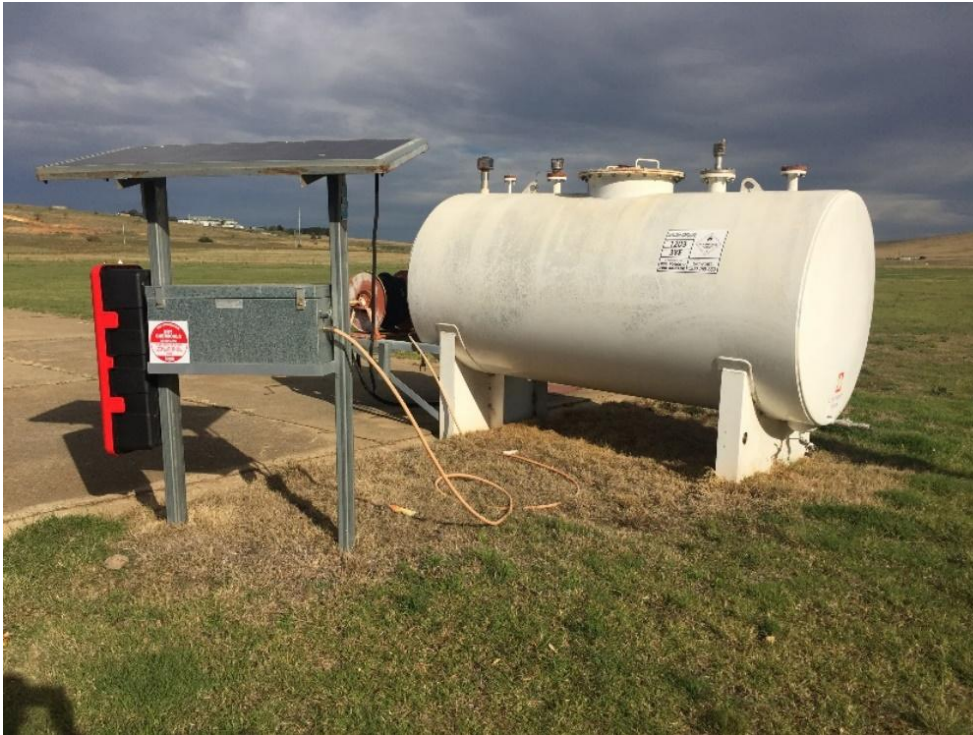
Photograph 6.1 2,000 L aviation fuel AST

- A 2,000 litre (L) aviation fuel above ground storage tank (AST) was observed in the central west section of Lot 14 in DP 250029 adjacent to the hangers (outside of the site). Refer to Photograph 6.1 and Photograph 6.2. The following observations were made:
 - The volume of fuel remaining in the tank could not be verified.
 - The tank is not bunded.
 - There was no visual evidence of staining, spills or surrounding contamination on the soil surface and no hydrocarbon odour was noted. However, grass beneath and in the vicinity of the AST was noted to be dead or stressed, indicating the potential for spills to have occurred in this area or for weed spraying to have occurred.

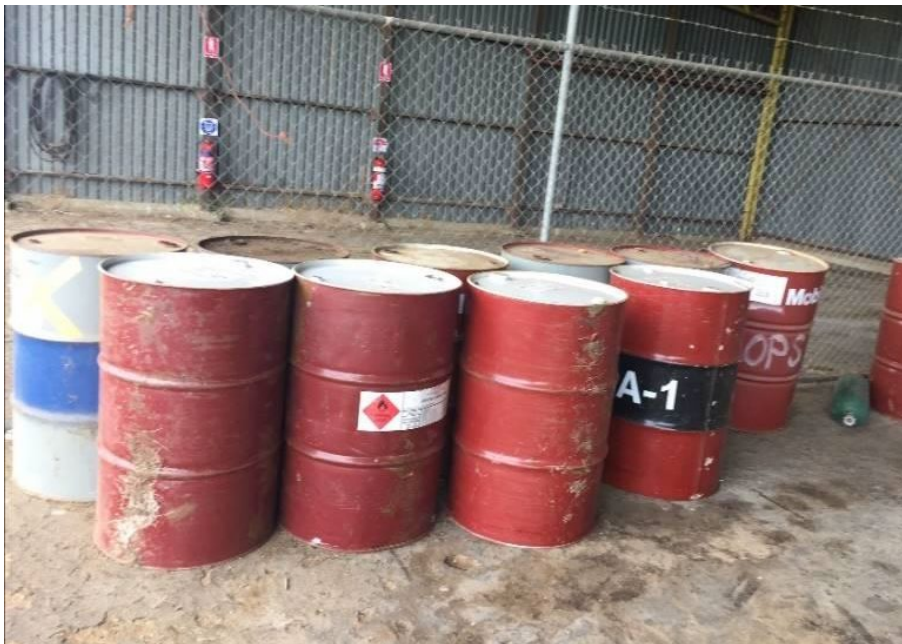
Photograph 6.3 **200 L aviation fuel drums**

- Multiple 200 L aviation fuel barrels were observed in one of the hangers. Refer to Photograph 6.3. The following observations were made:
 - Residual fuel and other fluids were found in most of the barrels.

- The drums were not stored within a bunded area.
 - Minor staining was observed on the ground surface near the drums. No evidence of significant contamination was observed and no hydrocarbon odours were noted.

- The barrels were removed by Snowy Hydro following the site inspection.

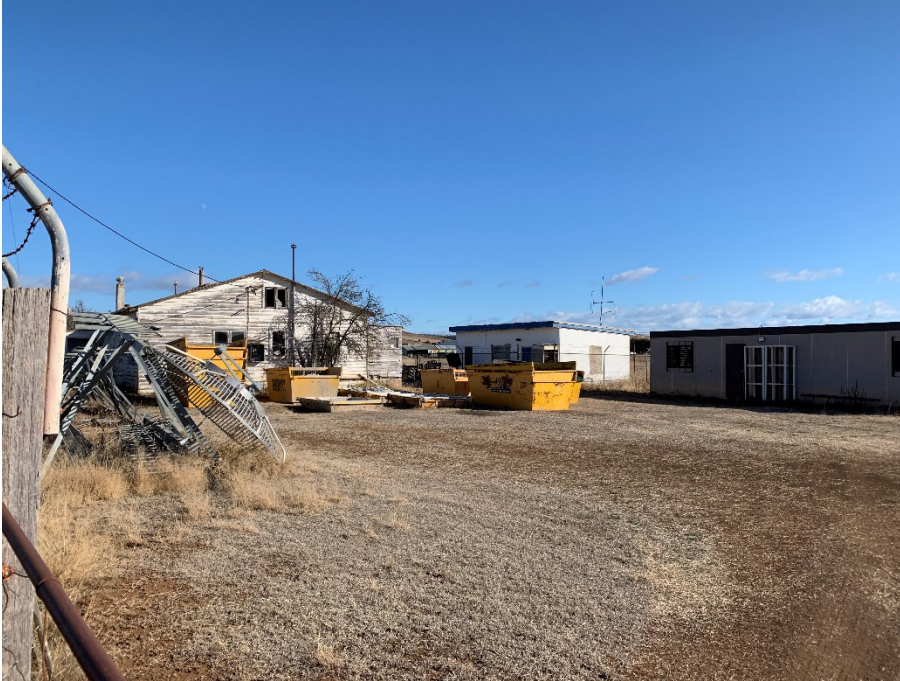
Photograph 6.4 Buildings and storage area in Lot 3 in DP 238762

- Three small buildings were observed in the southern portion of the site (refer Photograph 6.4), comprising a derelict house, a transmission building and a demountable unit. It is understood that the buildings were associated with radio transmission and are no longer used. The house was unoccupied but noted to contain a large amount of furniture, boxes, cables, etc. The roof of the house comprised fibre cement sheeting and is likely to contain asbestos. The house was in a poor condition, evidenced by broken windows, flaking paint and loose wooden panels, at the time of the site inspection. The transmission building was noted to be in better condition than the house, however no observations could be made inside this building. The transmission building may also contain asbestos.

- The buildings were surrounded by a storage area with seven skip bins containing concrete, rubble and mattresses. Scrap metal, cables, wooden pallets and bathtubs were observed in the surrounding storage area. The surface of the area was grass covered and several fragments of potential ACM were observed near the entrance gate and the front entry of the house.

- It is understood that the demountable building, skips and scrap metal will be removed prior to the project commencing.
- A services pit (approximately 1 m by 2.5 m, depth unknown) was observed immediately to the north of the buildings and appeared to contain water (the lid of the pit could not be lifted).

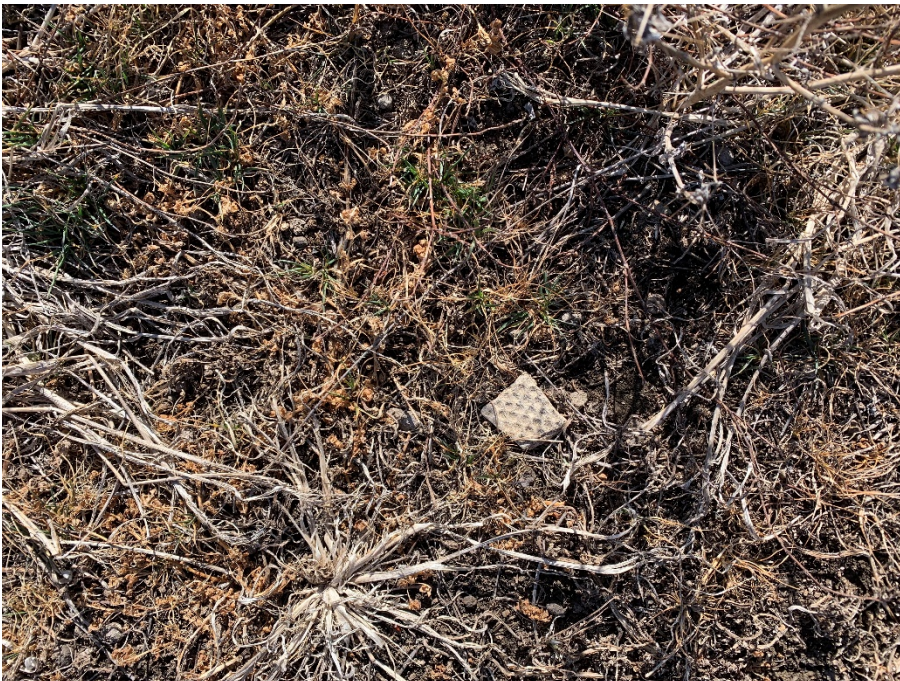
Photograph 6.5 Potential ACM in creek bed, Lot 3 in DP 238762

- A dry creek bed was present in the north-eastern portion of Lot 3. Several broken glass bottles, pieces of clay pipe and fragments of potential ACM were observed in the creek bed (refer to Photograph 6.5).

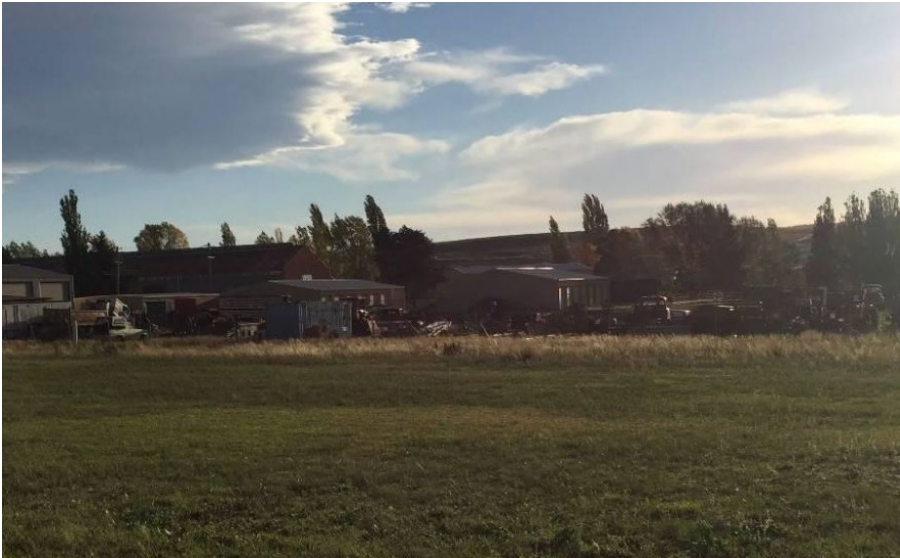
Photograph 6.6 **Adjacent industrial facilities**

Mixed industrial sites (warehouses, metal recyclers, scrap and wreck yards) were observed adjacent to the western boundary of the site. Refer to Photograph 6.6. Based on hydrogeological information and topography, these sites are located down hydraulic gradient from the site, and on-site migration of potential contamination is considered unlikely.

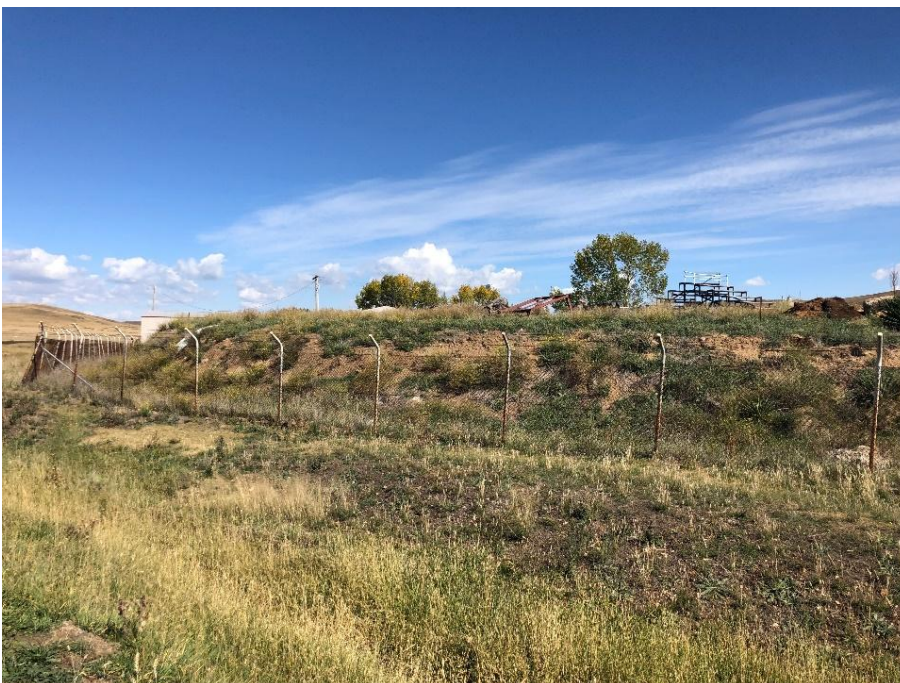
Photograph 6.7 **Property adjacent to western site boundary**

A council depot is located adjacent to the western boundary of the site. The depot is raised above natural ground by placement of fill materials, assumed to be a flood prevention measure. In some areas the ground level is raised up to 3 m from the surrounding natural ground levels (refer Photograph 6.7). A storage area containing drums and intermediate bulk containers (IBCs) was observed. The contents could not be confirmed during the inspection, but anecdotal information provided indicated the containers were likely used to store bitumen emulsion used in road paving.

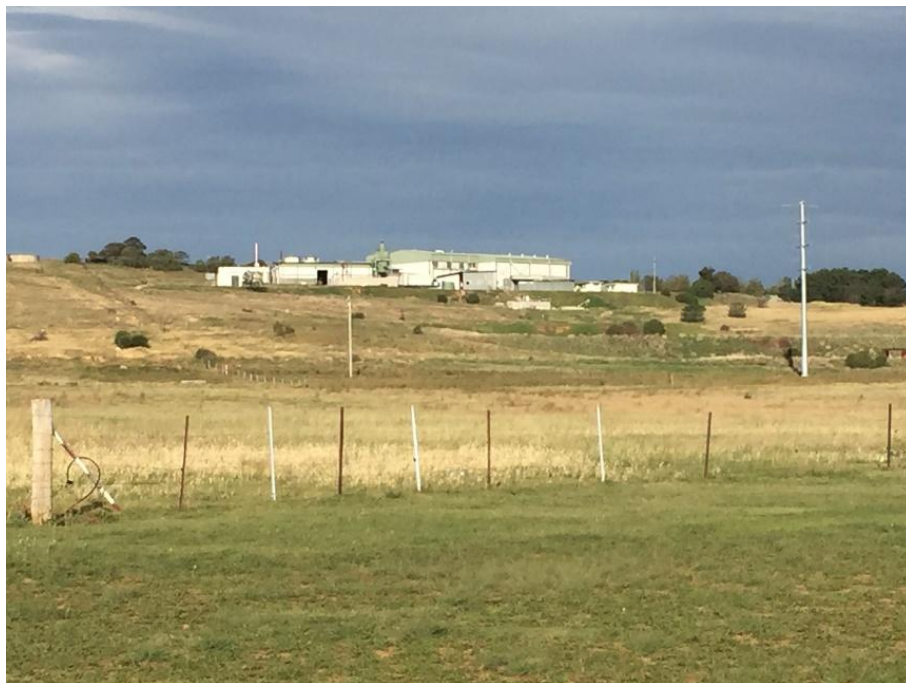
Photograph 6.8 **Abattoir east of the site**

An abattoir is located to the east of the site and topographically upgradient. Refer to Photograph 6.8. No indicators of contamination associated with this property were noted during the site inspection.

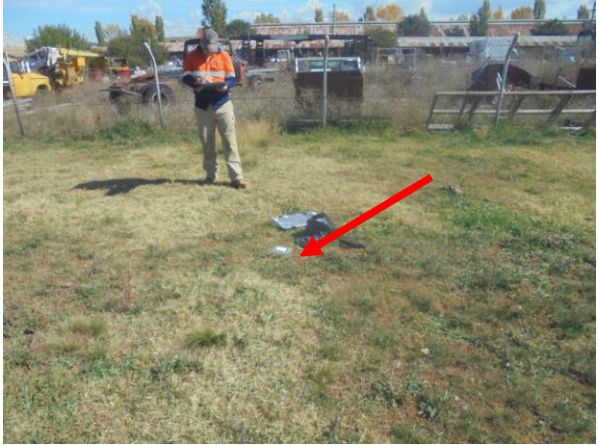
SAMPLE NO	LOCATION DESCRIPTION	MATERIAL	PHOTOGRAPH
B1400	Northwest section of Polo Flats Airport site - Fragments of sheet on soil surface	Sheet Debris

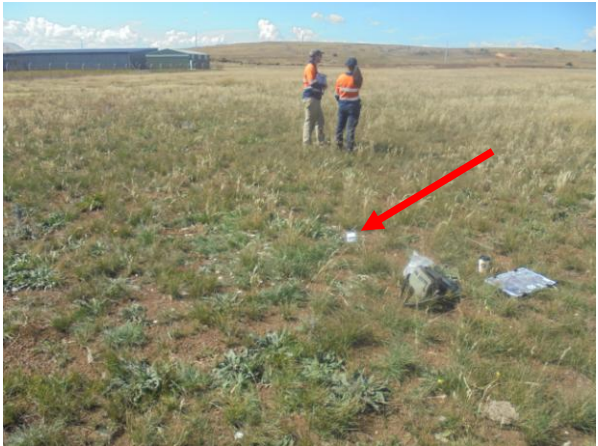
B1401	Central west section of Polo Flats Airport site - Fragments of sheet on soil surface	Sheet Debris

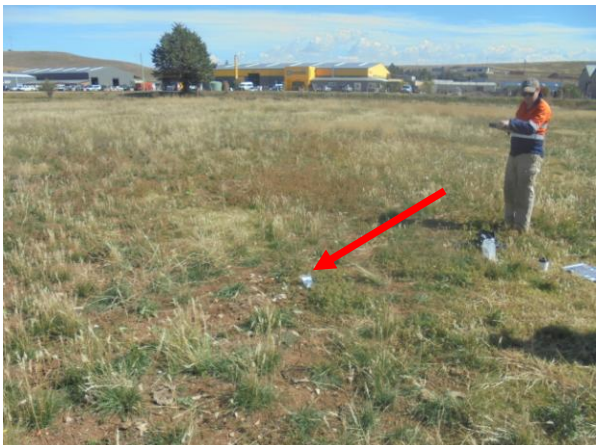
B1402	Central west section of Polo Flats Airport site - Fragments of sheet on soil surface	Sheet Debris

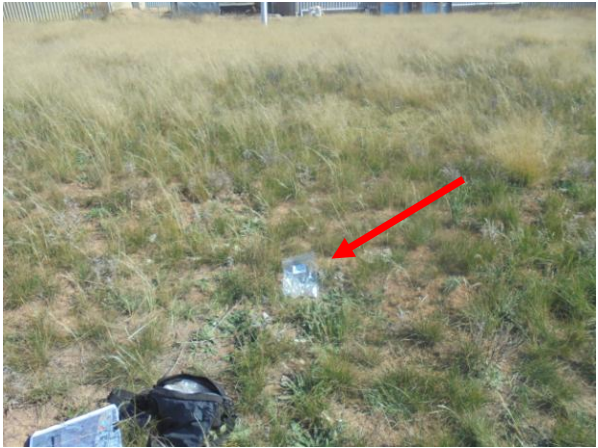
SAMPLE NO	LOCATION DESCRIPTION	MATERIAL	PHOTOGRAPH
B1418	North section of Polo Flats Airport site - Fragments of sheet on soil surface	Sheet Debris

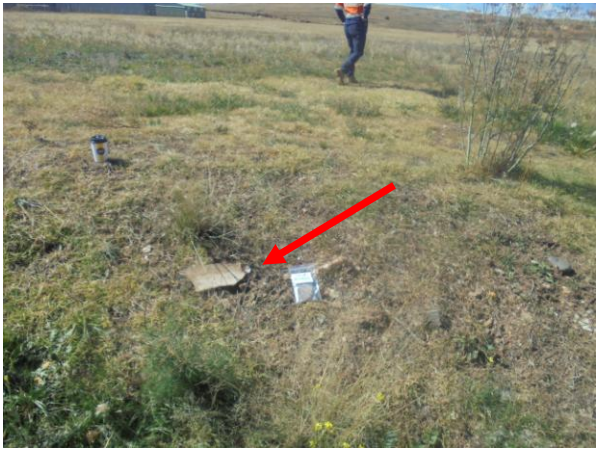
B1451	Central west section of Polo Flats Airport site - Fragments of sheet on soil surface	Sheet Debris

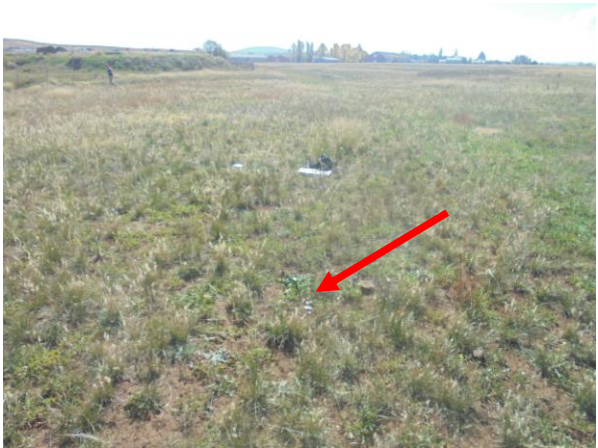
B1494	Central west section of Polo Flats Airport site - Fragments of sheet on soil surface	Sheet Debris

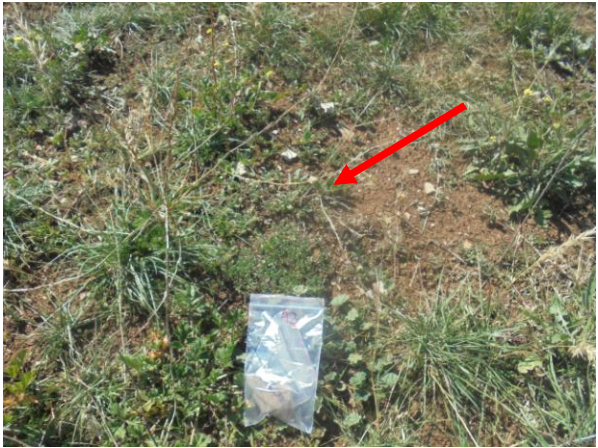
SAMPLE NO	LOCATION DESCRIPTION	MATERIAL	PHOTOGRAPH
B1495	Central west section of Polo Flats Airport site - Fragments of sheet on soil surface	Sheet Debris

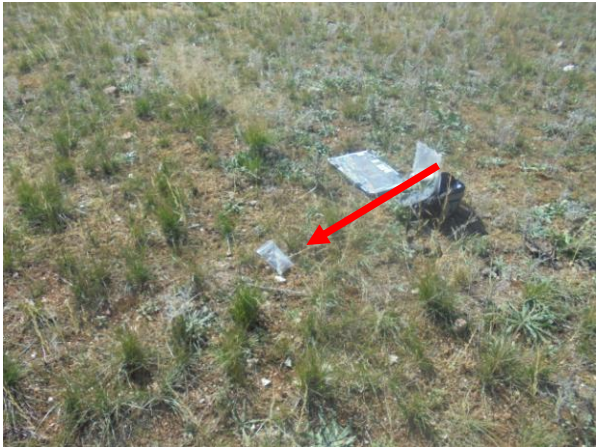
B1496	South section of Polo Flats Airport site - Fragments of sheet on soil surface	Sheet Debris

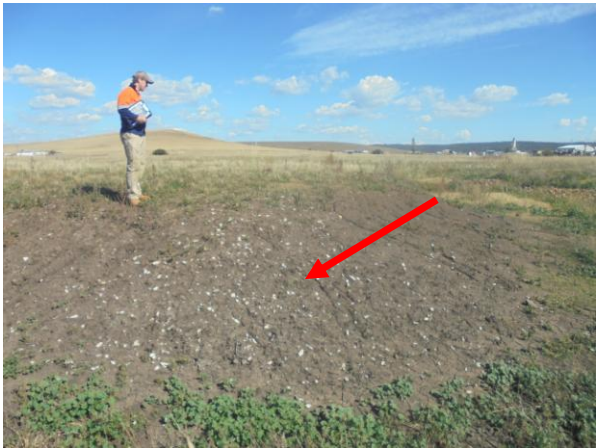
B1497	South central section of Polo Flats Airport site - Fragments of sheet on soil surface	Sheet Debris

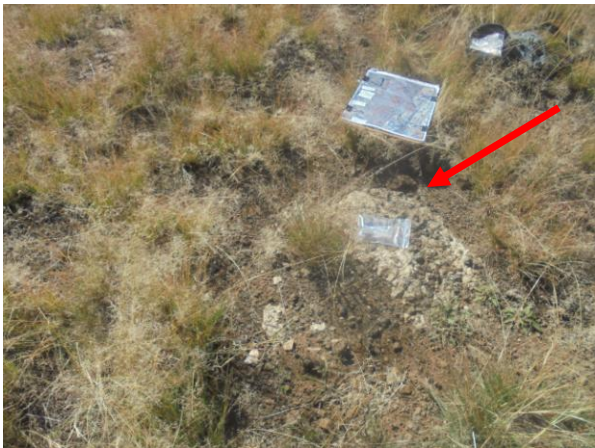
SAMPLE NO	LOCATION DESCRIPTION	MATERIAL	PHOTOGRAPH
B1498	South section of Polo Flats Airport site - Fragments of sheet on soil surface	Sheet Debris

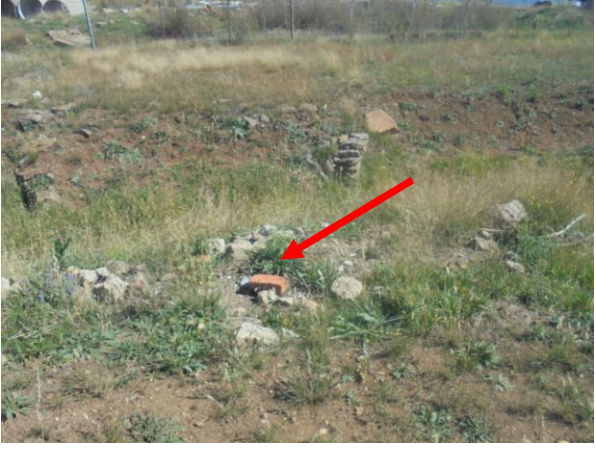
Location (L3)	Sheet fragments observed in rubble material	-

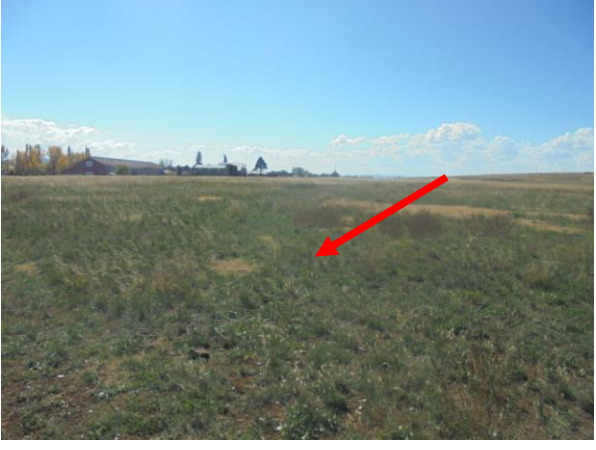
Location (L4)	Sheet fragments observed on soil surface	-

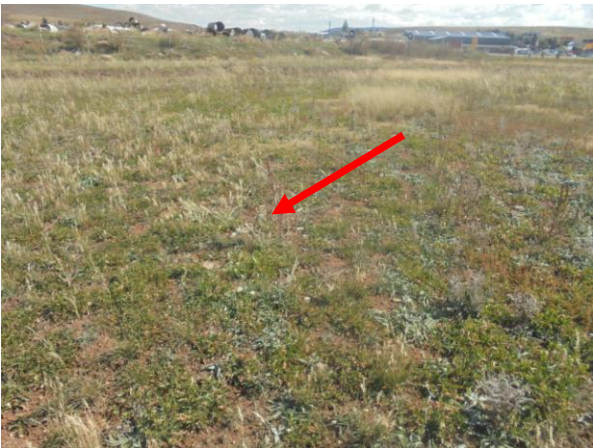
SAMPLE NO	LOCATION DESCRIPTION	MATERIAL	PHOTOGRAPH
Location (L5)	Sheet fragments observed on soil surface	-

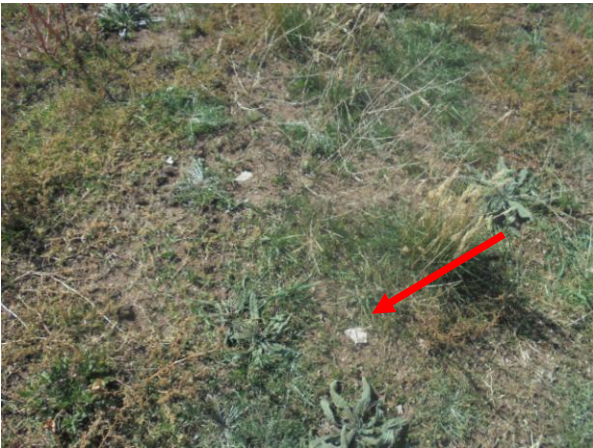
Location (L6)	Sheet fragments observed on soil surface	-

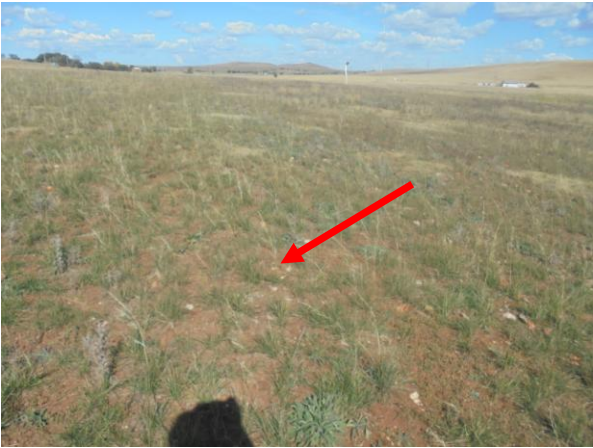
Location (L7)	Sheet fragments observed on soil surface	-

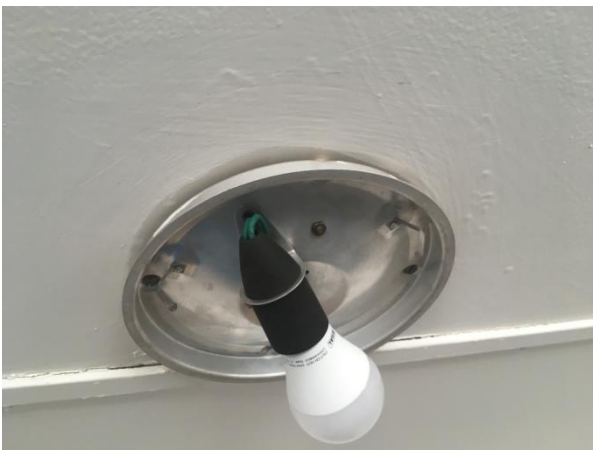
ASBESTOS - Administration Building			
SAMPLE NO	LOCATION	MATERIAL DESCRIPTION	PHOTOGRAPH
VA02	Ground floor toilets - Insulation to wiring	No Access to Woven product (Presumed Friable)

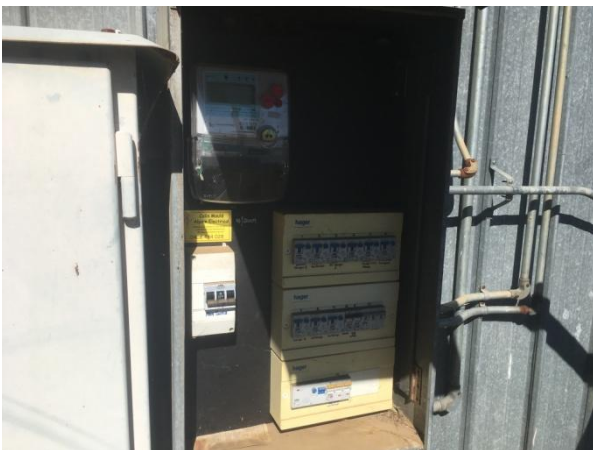
ASBESTOS - Polo Flat Airport			
SAMPLE NO	LOCATION	MATERIAL DESCRIPTION	PHOTOGRAPH
VA01	Ground floor hangar west end - electrical switchboard backing	Sheet (Presumed Non-Friable)

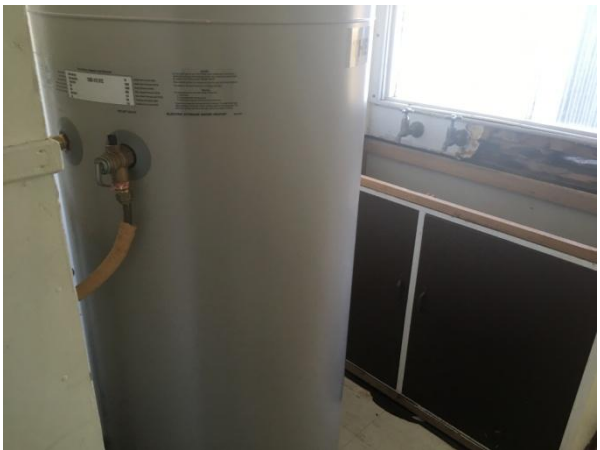
SMF - Administration Building			
ITEM NO	LOCATION	MATERIAL TYPE	PHOTOGRAPH
SMF121 9	Ground floor laundry – to hot water heater	Insulation

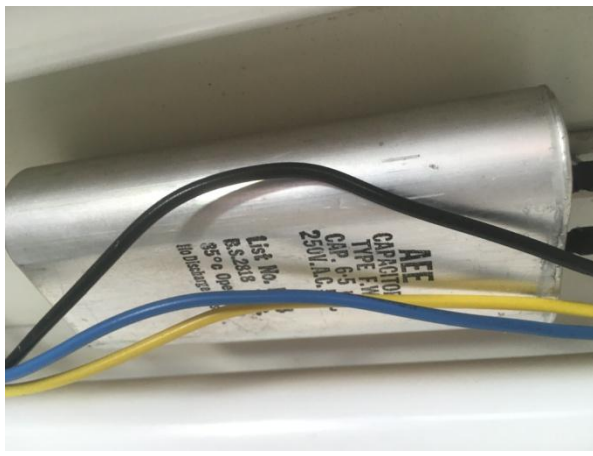
POLYCHLORINATED BIPHENYLS - Administration Building			
ITEM NO	LOCATION	MATERIAL TYPE	PHOTOGRAPH
PCB469	Ground floor warehouse and art workshop	AEE - FW

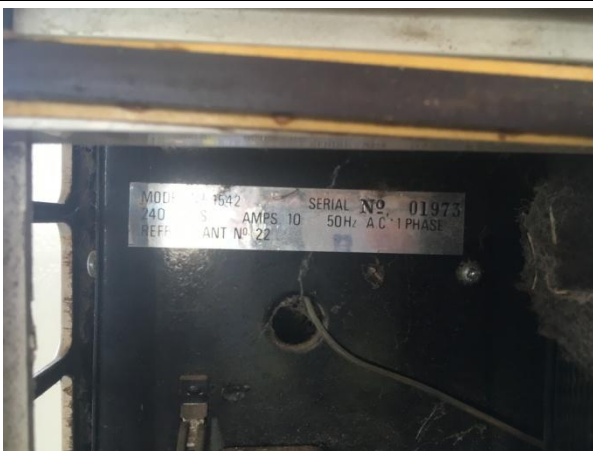
OZONE DEPLETING SUBSTANCES - Administration Building			
ITEM NO	LOCATION	MATERIAL TYPE	PHOTOGRAPH
ODS738	Ground floor offices, AC wall unit	R-22 Chlorodifluoro methane

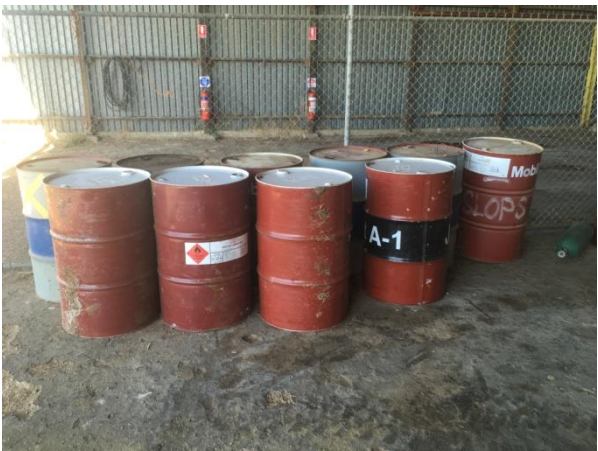
STORAGE FUEL DRUMS - Polo Flat Airport			
ITEM NO	LOCATION	MATERIAL	PHOTOGRAPH
FD112	Ground floor open hanger south end	Fuel drums
