Quarterly Environmental Monitoring Report

June 2022 - September 2022

Sydney Metro West
Parramatta

Prepared for: Delta Group
10th October 2022
Report no. 0121-023-01-Q3
Prepared by Mark Della Sabina

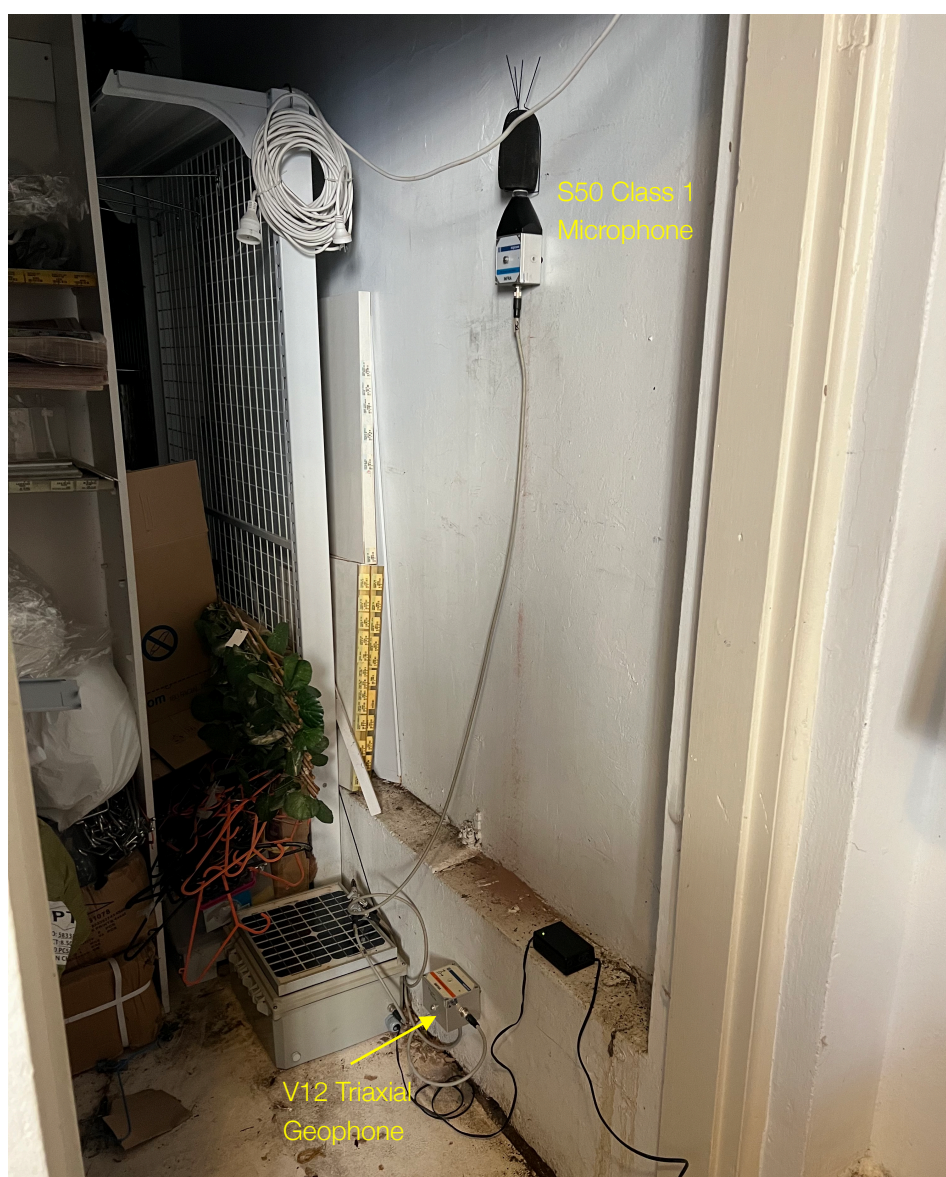
Figure 2: Monitor with V12 Geophone & S50 Microphone (218 Church St)

Noise and vibration levels were monitored throughout the quarter using the Sigicom INFRA environmental monitoring system. The INFRA system provides real-time, continuous noise and vibration monitoring through its network of Class 1 S50 noise microphones and V12 triaxial geophones (Figure 2), and C22 compact triaxial geophones (Figure 3). Data is uploaded automatically to a central server via the 4G network and is accessible via the INFRA Net web portal. A list of active monitoring points for the Parramatta site is provided in Section 3 below.
