Redfern Station Upgrade – New Southern Concourse

Appendix G - Geotechnical and Contamination Investigation Reports

Memorandum

To	Marijan Harris	From	David Zhang
Copy	Brian Killeen	Reference	39525-TAP04
Date	2020-01-08	Pages (including this page)	15 +Appendices
Subject	Redfern Station Upgrade Geotechnical Investigation Report

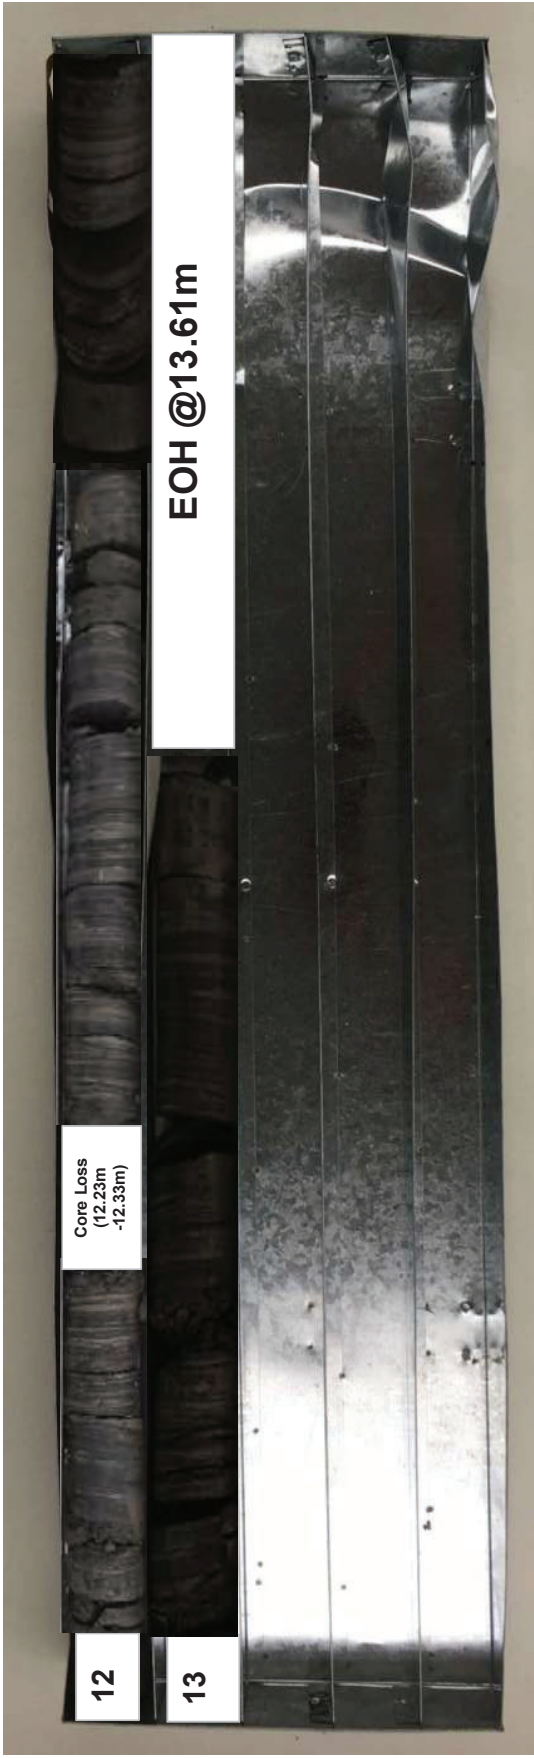
aurecon	Client Novo Rail Project Redfern Station Upgrade Project No. 39525-TAP04 Photo By: DZ	Core Photograph	
		BH02 12-13.61m

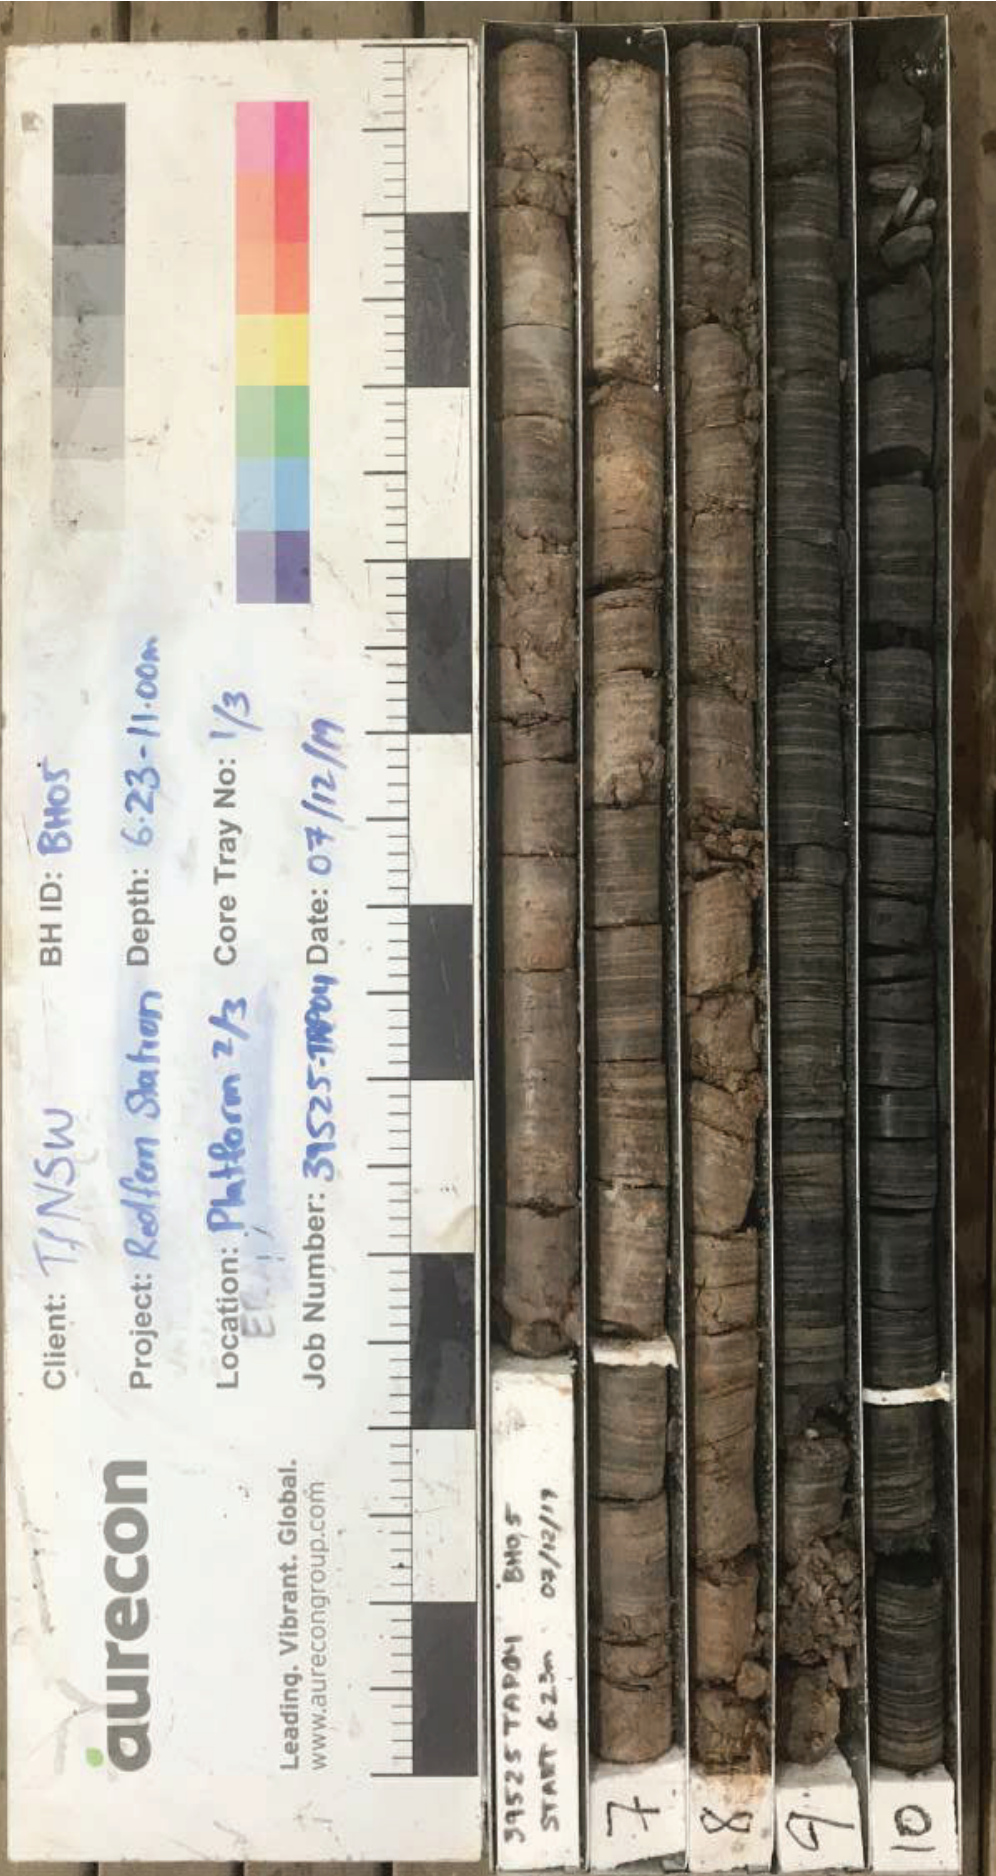
Client: **TJNSW** BH ID: **BH05**
Project: **Redfern Station** Depth: **6.23-11.00m**
Location: **Platform 2/3** Core Tray No: **1/3**
Job Number: **39525-TAP05** Date: **07/12/19**

Core Photograph
BH05 (6.23-11m)

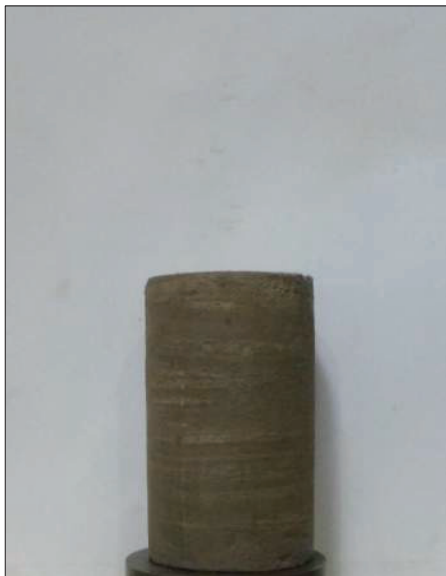
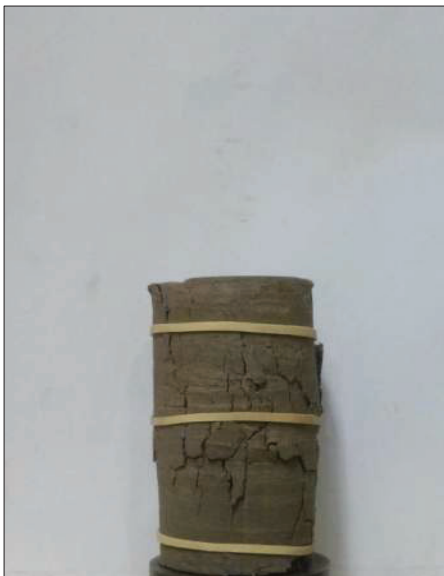
Uniaxial Compressive Strength			
Client:	Novo Rail	Sample Source:	BH03 8.35-8.45m
Address:	136 Railway Parade, Eveleigh, NSW, 2015	Sample Description:	Shale
Project:	Redfern Station Upgrade (39525-06037)	Report No.:	S47316-UCS
Job No.:	S19163	Lab No.:	S47316
Test Procedure:	AS 4133.4.2.2 Determination of uniaxial compressive strength-Rock strength less than 50 MPa		
Testing Machine:	Matest 2000 kN Compression Machine	Sample Curing:	-
Sampling Method:	Sampled by Client	Date Sampled:	Unknown
Storage History:	Core Box	Storage Environment:	Sealed at as received moisture condition
<div style="display: flex; justify-content: space-around;">

</div>			
Uniaxial Compressive Strength		0.99 MPa	
Date Tested:	13/04/2019	Moisture Content:	12.6 %
Specimen Height:	82.7 mm	Duration of Test:	604 seconds
Average Specimen Diameter:	50.8 mm	Rate of Displacement:	< 0.1 mm/min
Failure Type:	Tensile dominated		
Other Pertinent Observations:

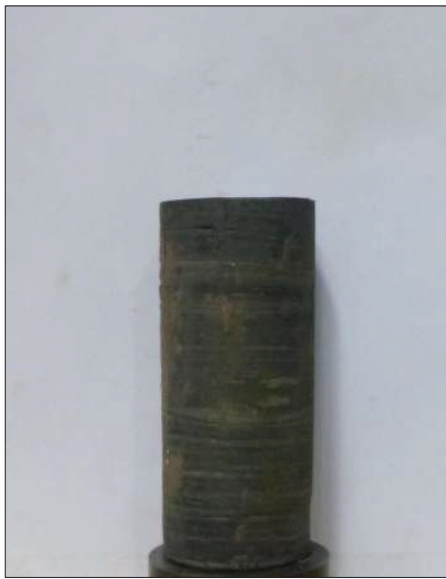
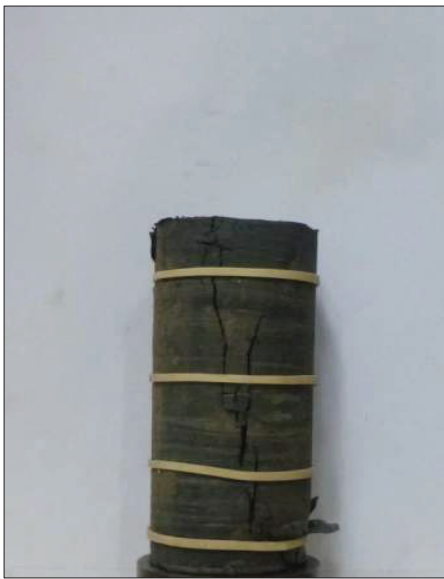
Uniaxial Compressive Strength			
Client:	Novo Rail	Sample Source:	BH03 9.96-10.11m
Address:	136 Railway Parade, Eveleigh, NSW, 2015	Sample Description:	Shale
Project:	Redfern Station Upgrade (39525-06037)	Report No.:	S47320-UCS
Job No.:	S19163	Lab No.:	S47320
Test Procedure:	AS 4133.4.2.2 Determination of uniaxial compressive strength-Rock strength less than 50 MPa		
Testing Machine:	Matest 2000 kN Compression Machine	Sample Curing:	-
Sampling Method:	Sampled by Client	Date Sampled:	Unknown
Storage History:	Core Box	Storage Environment:	Sealed at as received moisture condition
<div style="display: flex; justify-content: space-around;">

</div>			
Uniaxial Compressive Strength 2.6 MPa			
Date Tested:	13/04/2019	Moisture Content:	10.3 %
Specimen Height:	105.3 mm	Duration of Test:	621 seconds
Average Specimen Diameter:	50.8 mm	Rate of Displacement:	< 0.1 mm/min
Failure Type:	Single shear plane		
Other Pertinent Observations:

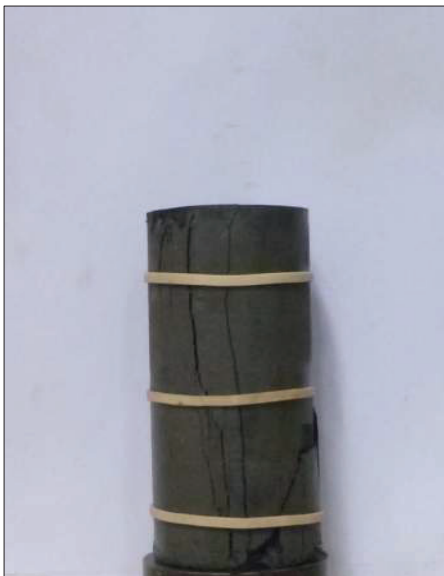
Uniaxial Compressive Strength			
Client:	Novo Rail	Sample Source:	BH03 14.00-14.14m
Address:	136 Railway Parade, Eveleigh, NSW, 2015	Sample Description:	Shale
Project:	Redfern Station Upgrade (39525-06037)	Report No.:	S47326-UCS
Job No.:	S19163	Lab No.:	S47326
Test Procedure:	AS 4133.4.2.2 Determination of uniaxial compressive strength-Rock strength less than 50 MPa		
Testing Machine:	Matest 2000 kN Compression Machine	Sample Curing:	-
Sampling Method:	Sampled by Client	Date Sampled:	Unknown
Storage History:	Core Box	Storage Environment:	Sealed at as received moisture condition
<div style="display: flex; justify-content: space-around;">

</div>			
Uniaxial Compressive Strength 19 MPa			
Date Tested:	13/04/2019	Moisture Content:	5.5 %
Specimen Height:	99.8 mm	Duration of Test:	679 seconds
Average Specimen Diameter:	51.6 mm	Rate of Displacement:	< 0.1 mm/min
Failure Type:	Tensile dominated		
Other Pertinent Observations:

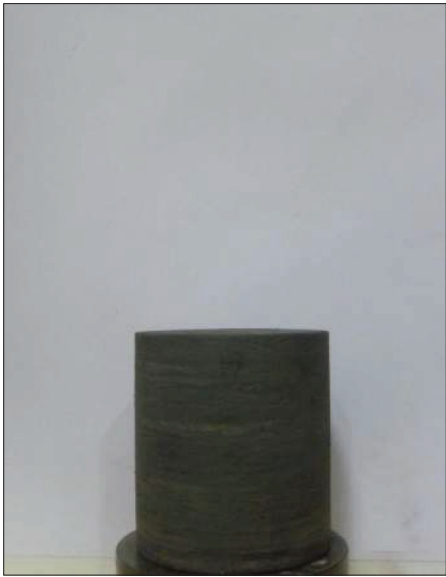
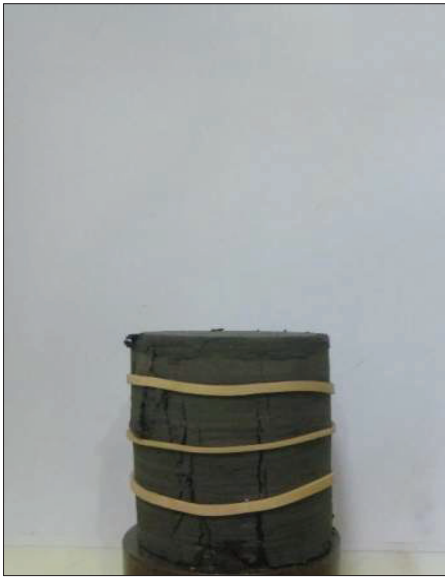
Uniaxial Compressive Strength			
Client:	Novo Rail	Sample Source:	BH04 6.41-6.47m
Address:	136 Railway Parade, Eveleigh, NSW, 2015	Sample Description:	Shale
Project:	Redfern Station Upgrade (39525-TAP04-06037)	Report No.:	S51188-UCS
Job No.:	S19163	Lab No.:	S51188
Test Procedure:	AS 4133.4.2.2 Determination of uniaxial compressive strength-Rock strength less than 50 MPa		
Testing Machine:	Matest 2000 kN Compression Machine	Sample Curing:	-
Sampling Method:	Sampled by Client	Date Sampled:	Unknown
Storage History:	Core Box	Storage Environment:	Sealed at as received moisture condition
<div style="display: flex; justify-content: space-around;">

</div>			
Uniaxial Compressive Strength 1.9 MPa			
Date Tested:	8/08/2019	Moisture Content:	9.5 %
Specimen Height:	59.2 mm	Duration of Test:	615 seconds
Average Specimen Diameter:	51.3 mm	Rate of Displacement:	< 0.1 mm/min
Failure Type:	Mixed mode		
Other Pertinent Observations:

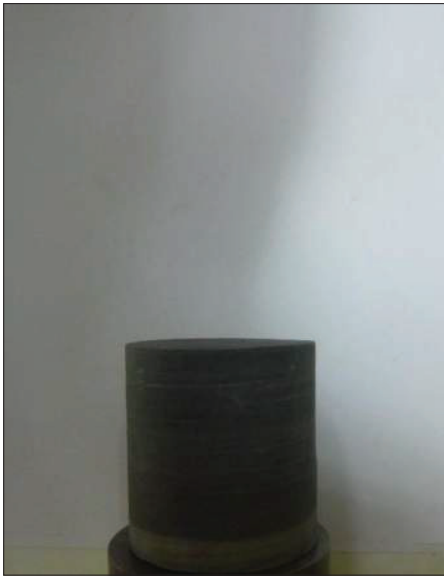
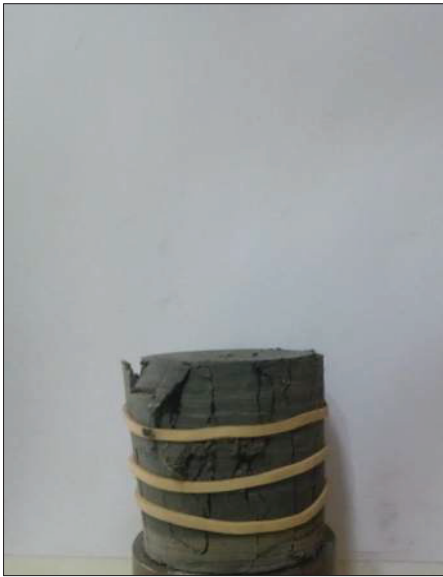
Uniaxial Compressive Strength			
Client:	Novo Rail	Sample Source:	BH04 7.89-7.95m
Address:	136 Railway Parade, Eveleigh, NSW, 2015	Sample Description:	Shale
Project:	Redfern Station Upgrade (39525-TAP04-06037)	Report No.:	S51190-UCS
Job No.:	S19163	Lab No.:	S51190
Test Procedure:	AS 4133.4.2.2 Determination of uniaxial compressive strength-Rock strength less than 50 MPa		
Testing Machine:	Matest 2000 kN Compression Machine	Sample Curing:	-
Sampling Method:	Sampled by Client	Date Sampled:	Unknown
Storage History:	Core Box	Storage Environment:	Sealed at as received moisture condition
<div style="display: flex; justify-content: space-around;">

</div>			
Uniaxial Compressive Strength 0.47 MPa			
Date Tested:	8/08/2019	Moisture Content:	8.2 %
Specimen Height:	54.8 mm	Duration of Test:	615 seconds
Average Specimen Diameter:	128.5 mm	Rate of Displacement:	< 0.1 mm/min
Failure Type:	Mixed mode		
Other Pertinent Observations:

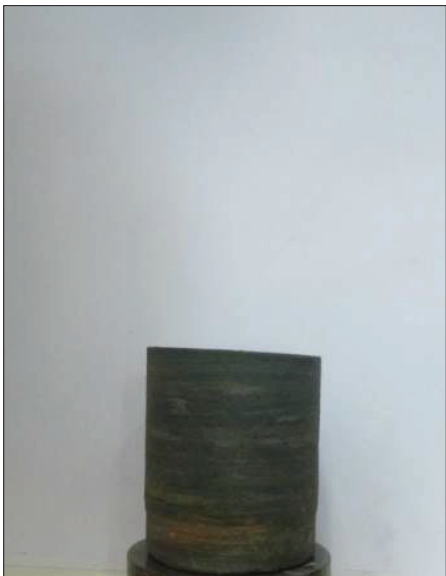
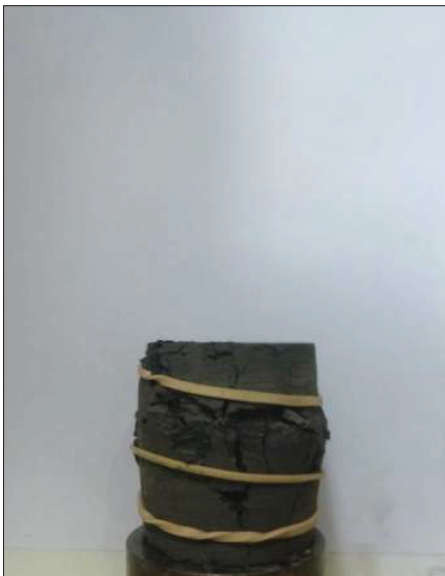
Uniaxial Compressive Strength			
Client:	Novo Rail	Sample Source:	BH04 8.63-8.69m
Address:	136 Railway Parade, Eveleigh, NSW, 2015	Sample Description:	Shale
Project:	Redfern Station Upgrade (39525-TAP04-06037)	Report No.:	S51193-UCS
Job No.:	S19163	Lab No.:	S51193
Test Procedure:	AS 4133.4.2.2 Determination of uniaxial compressive strength-Rock strength less than 50 MPa		
Testing Machine:	Matest 2000 kN Compression Machine	Sample Curing:	-
Sampling Method:	Sampled by Client	Date Sampled:	Unknown
Storage History:	Core Box	Storage Environment:	Sealed at as received moisture condition
<div style="display: flex; justify-content: space-around;">

</div>			
Uniaxial Compressive Strength 2.8 MPa			
Date Tested:	8/08/2019	Moisture Content:	8.6 %
Specimen Height:	58.3 mm	Duration of Test:	602 seconds
Average Specimen Diameter:	51.0 mm	Rate of Displacement:	< 0.1 mm/min
Failure Type:	Mixed mode		
Other Pertinent Observations:

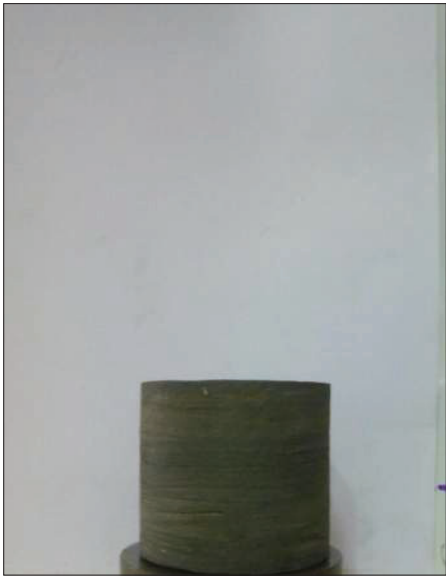
Uniaxial Compressive Strength			
Client:	Novo Rail	Sample Source:	BH04 9.78-9.83m
Address:	136 Railway Parade, Eveleigh, NSW, 2015	Sample Description:	Shale
Project:	Redfern Station Upgrade (39525-TAP04-06037)	Report No.:	S51194-UCS
Job No.:	S19163	Lab No.:	S51194
Test Procedure:	AS 4133.4.2.2 Determination of uniaxial compressive strength-Rock strength less than 50 MPa		
Testing Machine:	Matest 2000 kN Compression Machine	Sample Curing:	-
Sampling Method:	Sampled by Client	Date Sampled:	Unknown
Storage History:	Core Box	Storage Environment:	Sealed at as received moisture condition
<div style="display: flex; justify-content: space-around;">

</div>			
Uniaxial Compressive Strength 4.7 MPa			
Date Tested:	8/08/2019	Moisture Content:	10.3 %
Specimen Height:	45.3 mm	Duration of Test:	615 seconds
Average Specimen Diameter:	51.6 mm	Rate of Displacement:	< 0.1 mm/min
Failure Type:	Mixed mode		
Other Pertinent Observations:

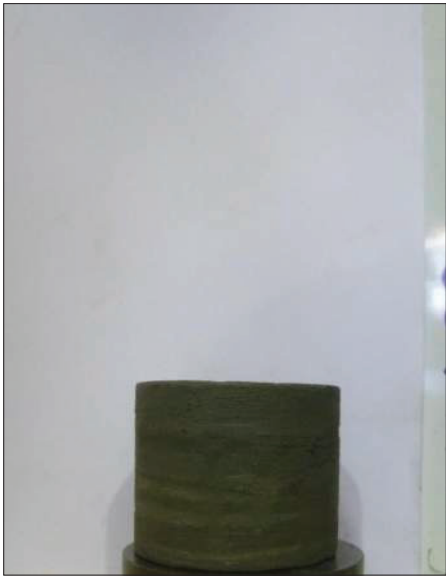
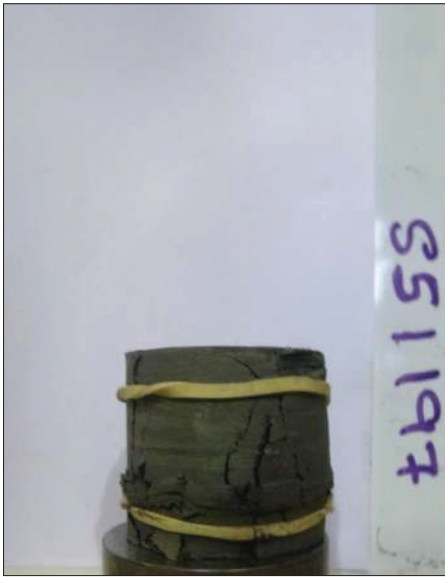
Uniaxial Compressive Strength			
Client:	Novo Rail	Sample Source:	BH04 10.94-11.00m
Address:	136 Railway Parade, Eveleigh, NSW, 2015	Sample Description:	Shale
Project:	Redfern Station Upgrade (39525-TAP04-06037)	Report No.:	S51197-UCS
Job No.:	S19163	Lab No.:	S51197
Test Procedure:	AS 4133.4.2.2 Determination of uniaxial compressive strength-Rock strength less than 50 MPa		
Testing Machine:	Matest 2000 kN Compression Machine	Sample Curing:	-
Sampling Method:	Sampled by Client	Date Sampled:	Unknown
Storage History:	Core Box	Storage Environment:	Sealed at as received moisture condition
<div style="display: flex; justify-content: space-around;">

</div>			
Uniaxial Compressive Strength		3.8 MPa	
Date Tested:	8/08/2019	Moisture Content:	10.0 %
Specimen Height:	41.5 mm	Duration of Test:	694 seconds
Average Specimen Diameter:	51.6 mm	Rate of Displacement:	< 0.1 mm/min
Failure Type:	Mixed mode		
Other Pertinent Observations:

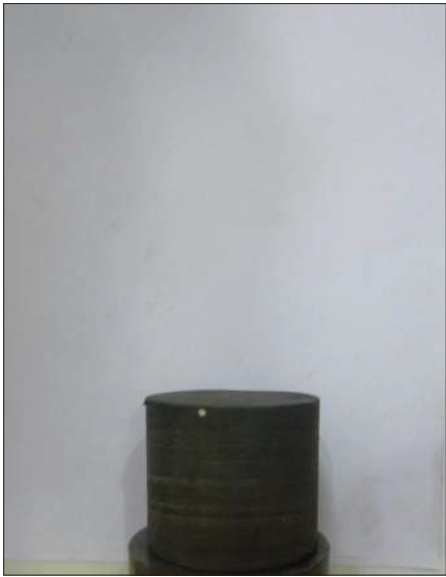
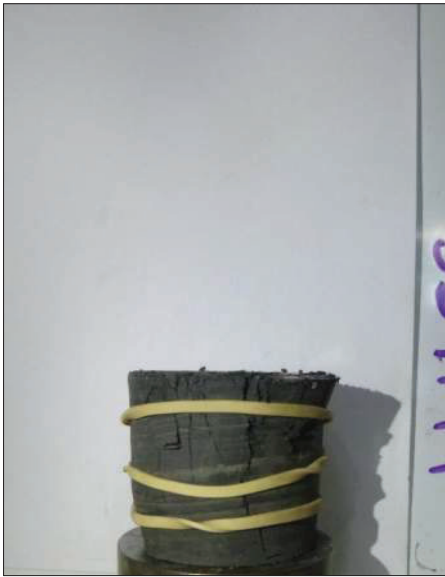
Uniaxial Compressive Strength			
Client:	Novo Rail	Sample Source:	BH04 12.82-12.89m
Address:	136 Railway Parade, Eveleigh, NSW, 2015	Sample Description:	Shale
Project:	Redfern Station Upgrade (39525-TAP04-06037)	Report No.:	S51199-UCS
Job No.:	S19163	Lab No.:	S51199
Test Procedure:	AS 4133.4.2.2 Determination of uniaxial compressive strength-Rock strength less than 50 MPa		
Testing Machine:	Matest 2000 kN Compression Machine	Sample Curing:	-
Sampling Method:	Sampled by Client	Date Sampled:	Unknown
Storage History:	Core Box	Storage Environment:	Sealed at as received moisture condition
<div style="display: flex; justify-content: space-around;">

</div>			
Uniaxial Compressive Strength 6.9 MPa			
Date Tested:	8/08/2019	Moisture Content:	7.7 %
Specimen Height:	42.3 mm	Duration of Test:	610 seconds
Average Specimen Diameter:	51.6 mm	Rate of Displacement:	< 0.1 mm/min
Failure Type:	Tensile dominated

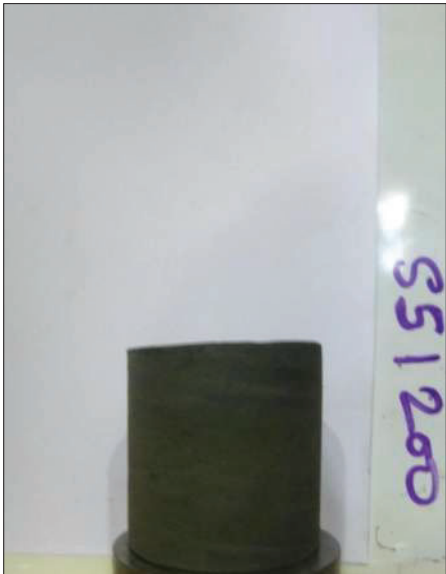
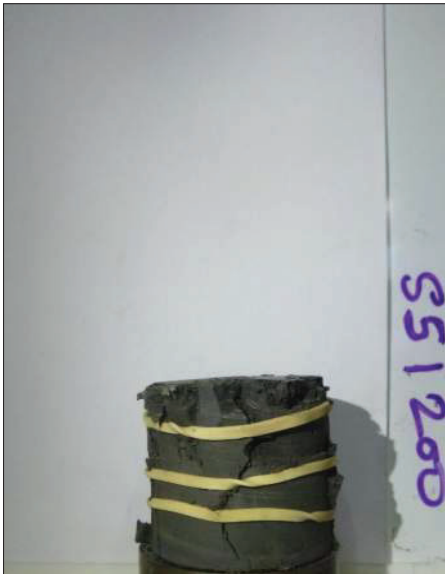
Uniaxial Compressive Strength			
Client:	Novo Rail	Sample Source:	BH04 13.26-13.32m
Address:	136 Railway Parade, Eveleigh, NSW, 2015	Sample Description:	Shale
Project:	Redfern Station Upgrade (39525-TAP04-06037)	Report No.:	S51200-UCS
Job No.:	S19163	Lab No.:	S51200
Test Procedure:	AS 4133.4.2.2 Determination of uniaxial compressive strength-Rock strength less than 50 MPa		
Testing Machine:	Matest 2000 kN Compression Machine	Sample Curing:	-
Sampling Method:	Sampled by Client	Date Sampled:	Unknown
Storage History:	Core Box	Storage Environment:	Sealed at as received moisture condition
<div style="display: flex; justify-content: space-around;">

</div>			
Uniaxial Compressive Strength 1.0 MPa			
Date Tested:	8/08/2019	Moisture Content:	11.1 %
Specimen Height:	51.8 mm	Duration of Test:	600 seconds
Average Specimen Diameter:	51.4 mm	Rate of Displacement:	< 0.1 mm/min
Failure Type:	Mixed mode		
Other Pertinent Observations:

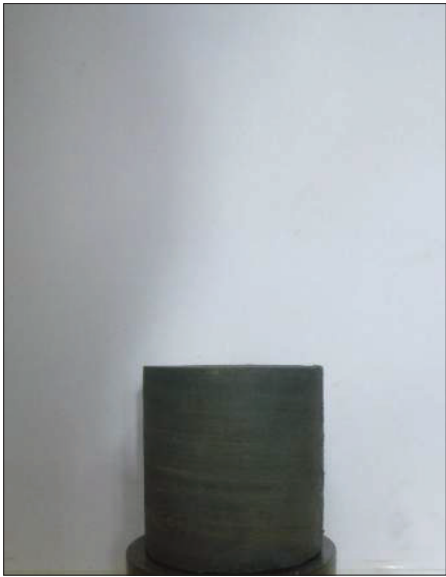
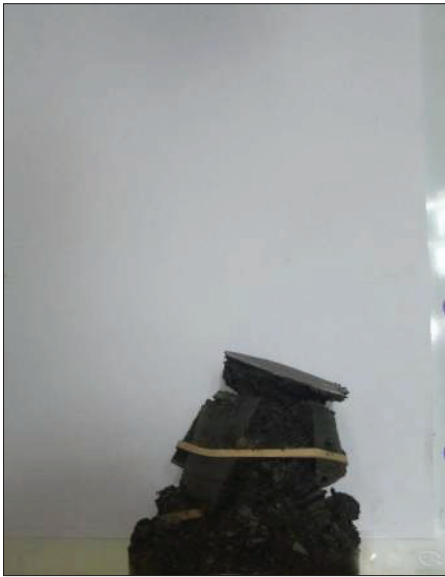
Uniaxial Compressive Strength			
Client:	Novo Rail	Sample Source:	BH04 14.93-15.00m
Address:	136 Railway Parade, Eveleigh, NSW, 2015	Sample Description:	Shale
Project:	Redfern Station Upgrade (39525-TAP04-06037)	Report No.:	S51203-UCS
Job No.:	S19163	Lab No.:	S51203
Test Procedure:	AS 4133.4.2.2 Determination of uniaxial compressive strength-Rock strength less than 50 MPa		
Testing Machine:	Matest 2000 kN Compression Machine	Sample Curing:	-
Sampling Method:	Sampled by Client	Date Sampled:	Unknown
Storage History:	Core Box	Storage Environment:	Sealed at as received moisture condition
<div style="display: flex; justify-content: space-around;">

</div>			
Uniaxial Compressive Strength 0.71 MPa			
Date Tested:	8/08/2019	Moisture Content:	11.2 %
Specimen Height:	53.2 mm	Duration of Test:	620 seconds
Average Specimen Diameter:	51.8 mm	Rate of Displacement:	< 0.1 mm/min
Failure Type:	Other - see photo

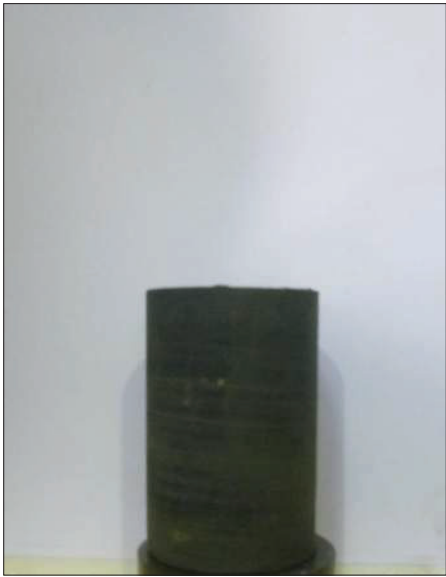
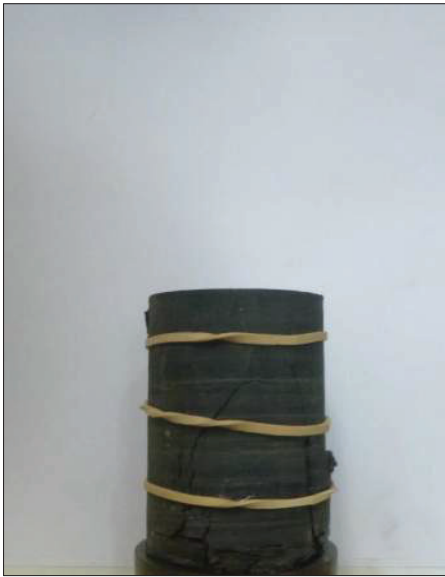
Uniaxial Compressive Strength			
Client:	Novo Rail	Sample Source:	BH04 15.14-15.23m
Address:	136 Railway Parade, Eveleigh, NSW, 2015	Sample Description:	Shale
Project:	Redfern Station Upgrade (39525-TAP04-06037)	Report No.:	S51204-UCS
Job No.:	S19163	Lab No.:	S51204
Test Procedure:	AS 4133.4.2.2 Determination of uniaxial compressive strength-Rock strength less than 50 MPa		
Testing Machine:	Matest 2000 kN Compression Machine	Sample Curing:	-
Sampling Method:	Sampled by Client	Date Sampled:	Unknown
Storage History:	Core Box	Storage Environment:	Sealed at as received moisture condition
<div style="display: flex; justify-content: space-around;">

</div>			
Uniaxial Compressive Strength 5.7 MPa			
Date Tested:	8/08/2019	Moisture Content:	8.2 %
Specimen Height:	81.1 mm	Duration of Test:	615 seconds
Average Specimen Diameter:	51.8 mm	Rate of Displacement:	< 0.1 mm/min
Failure Type:	Mixed mode		
Other Pertinent Observations:

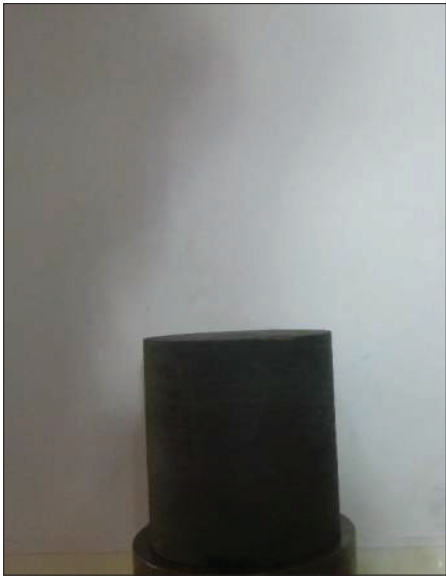
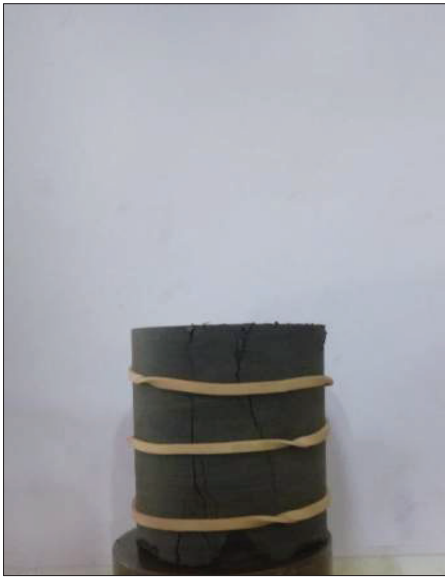
Uniaxial Compressive Strength			
Client:	Novo Rail	Sample Source:	BH04 16.87-16.95m
Address:	136 Railway Parade, Eveleigh, NSW, 2015	Sample Description:	Shale
Project:	Redfern Station Upgrade (39525-TAP04-06037)	Report No.:	S51208-UCS
Job No.:	S19163	Lab No.:	S51208
Test Procedure:	AS 4133.4.2.2 Determination of uniaxial compressive strength-Rock strength less than 50 MPa		
Testing Machine:	Matest 2000 kN Compression Machine	Sample Curing:	-
Sampling Method:	Sampled by Client	Date Sampled:	Unknown
Storage History:	Core Box	Storage Environment:	Sealed at as received moisture condition
<div style="display: flex; justify-content: space-around;">

</div>			
Uniaxial Compressive Strength 11 MPa			
Date Tested:	8/08/2019	Moisture Content:	7.9 %
Specimen Height:	56.7 mm	Duration of Test:	646 seconds
Average Specimen Diameter:	51.8 mm	Rate of Displacement:	< 0.1 mm/min
Failure Type:	Tensile dominated

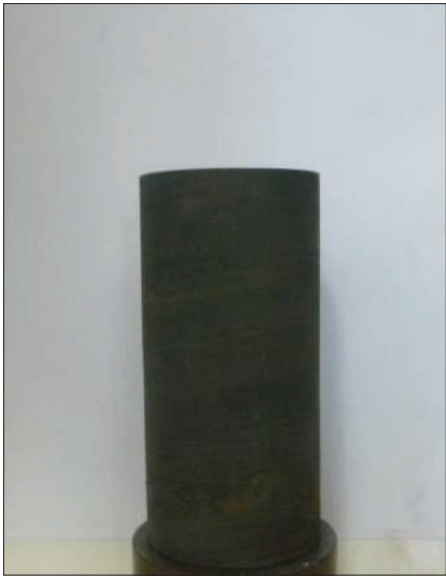
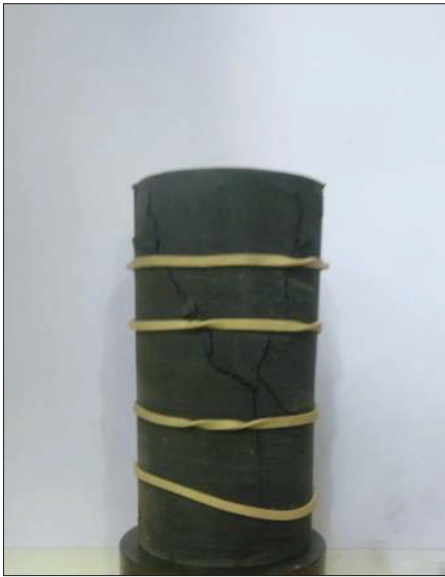
</div>			
Uniaxial Compressive Strength 8.3 MPa			
Date Tested:	5/08/2019	Moisture Content:	7.8 %
Specimen Height:	104.8 mm	Duration of Test:	610 seconds
Average Specimen Diameter:	51.8 mm	Rate of Displacement:	< 0.1 mm/min
Failure Type:	Mixed mode		
Other Pertinent Observations:

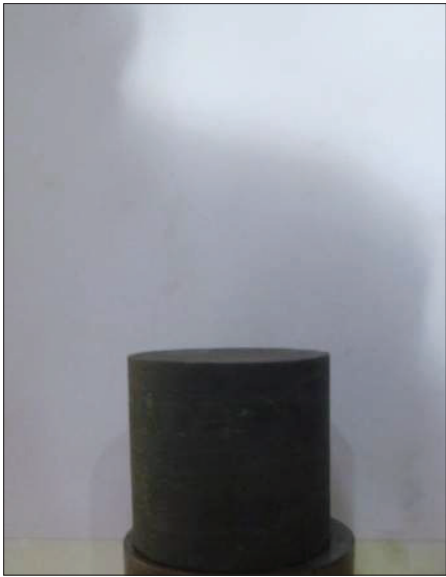
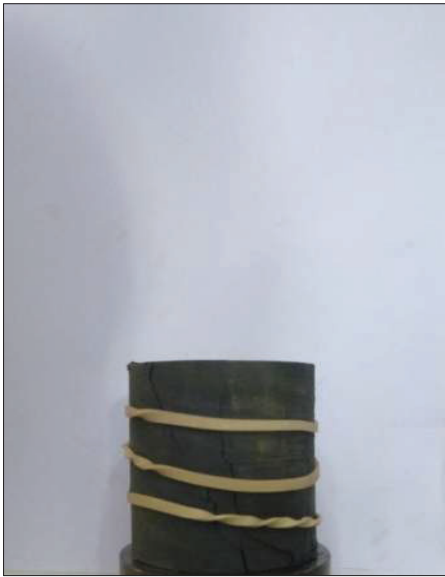
</div>			
Uniaxial Compressive Strength 11 MPa			
Date Tested:	8/08/2019	Moisture Content:	6.1 %
Specimen Height:	50.0 mm	Duration of Test:	681 seconds
Average Specimen Diameter:	51.7 mm	Rate of Displacement:	< 0.1 mm/min
Failure Type:	Mixed mode		
Other Pertinent Observations:

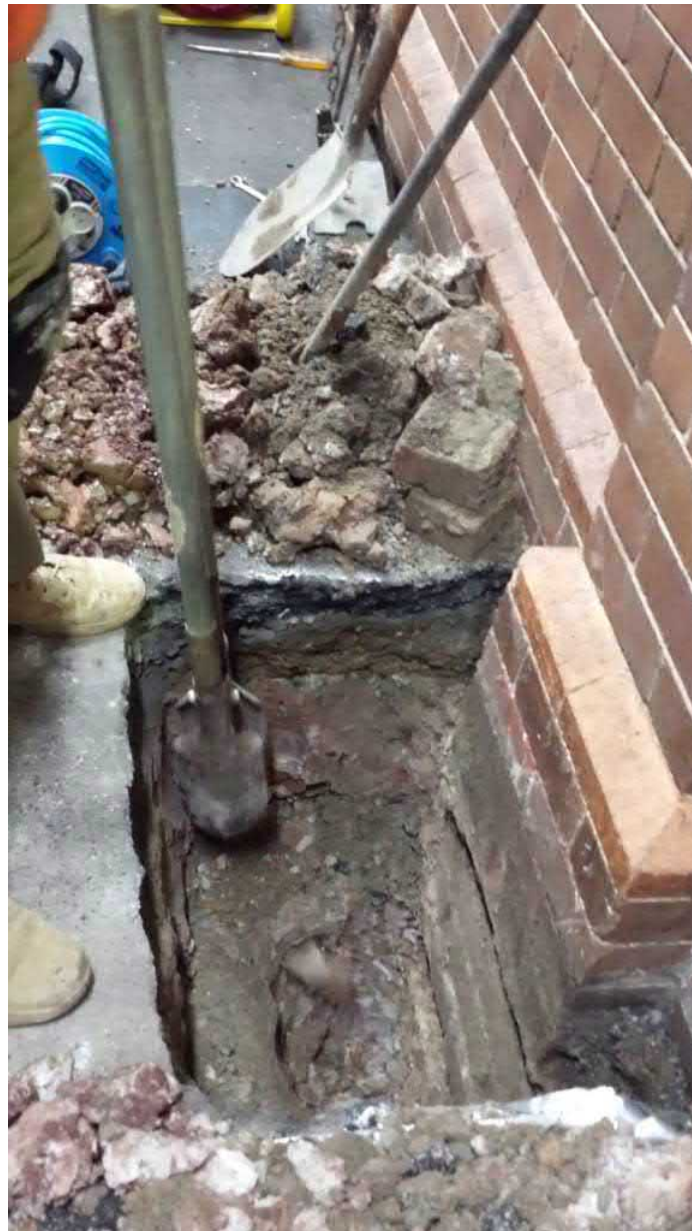
Photo 1: Footing excavation for Station Building

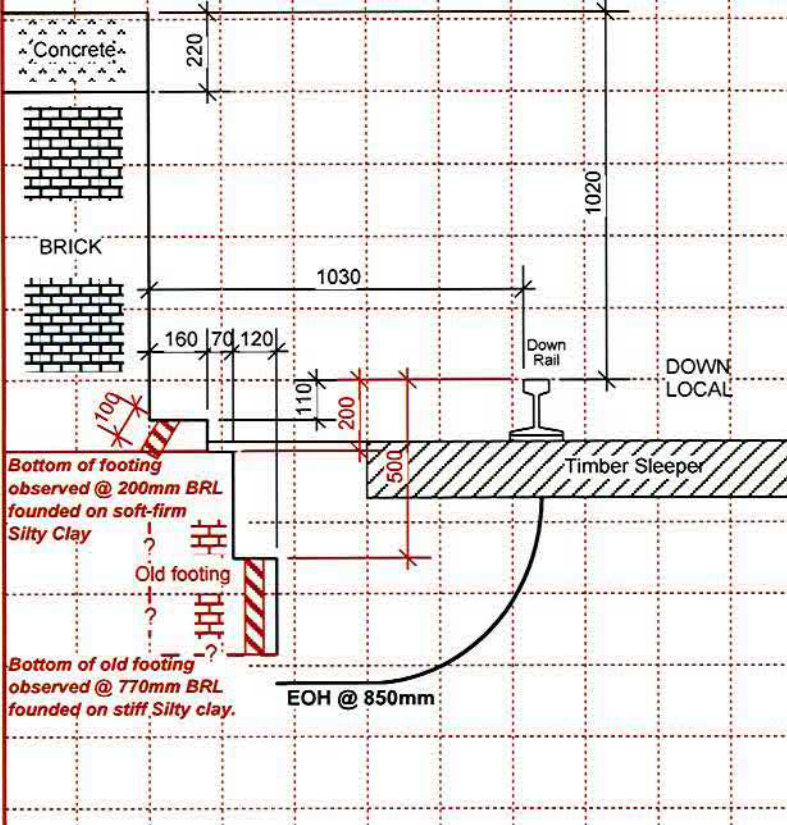
Rail Level	0.0						
	Silty clay.	0.2		Soft to Firm				
		0.4						
		0.6						
	Silty clay.	0.8		Stiff				
	EOH @ 850mm	1.0						
		1.2

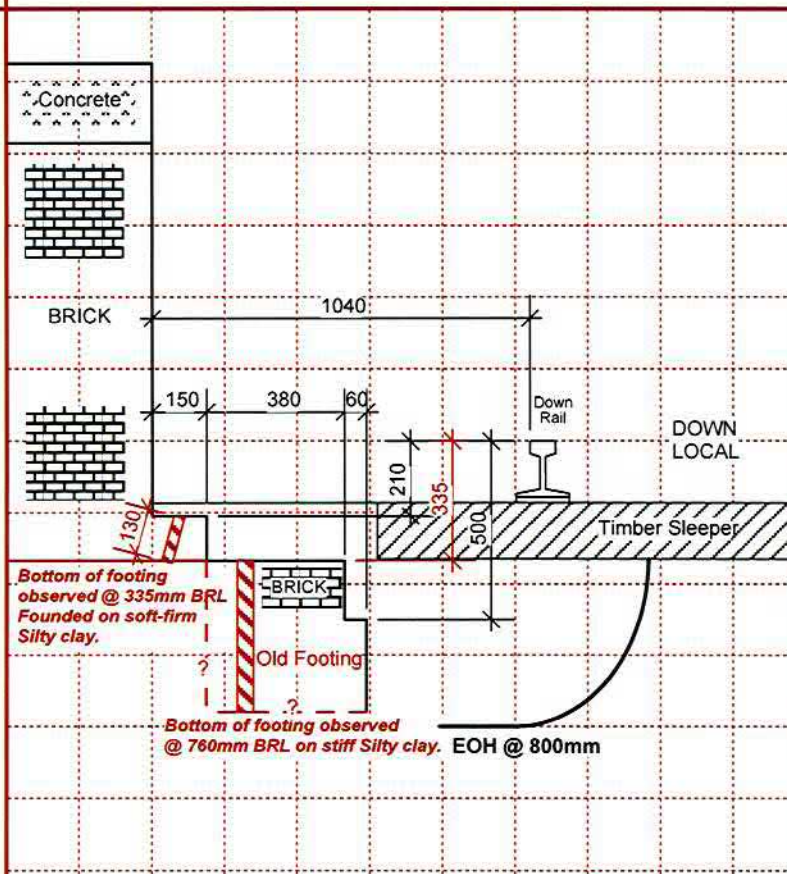
<p>Concrete</p> <p>BRICK</p> <p>1040</p> <p>150 380 60</p> <p>210 335 500</p> <p>Down Rail</p> <p>DOWN LOCAL</p> <p>Timber Sleeper</p> <p>Bottom of footing observed @ 335mm BRL Founded on soft-firm Silty clay.</p> <p>Old Footing</p> <p>Bottom of footing observed @ 760mm BRL on stiff Silty clay. EOH @ 800mm</p>					
	Rail Level	0.8						
		0.6						
		0.4						
		0.2						
		0.0						
		0.2						
	Silty clay.	0.4						
		0.6						
	Silty clay.	0.8						
	EOH @ 800mm	1.0						
		1.2

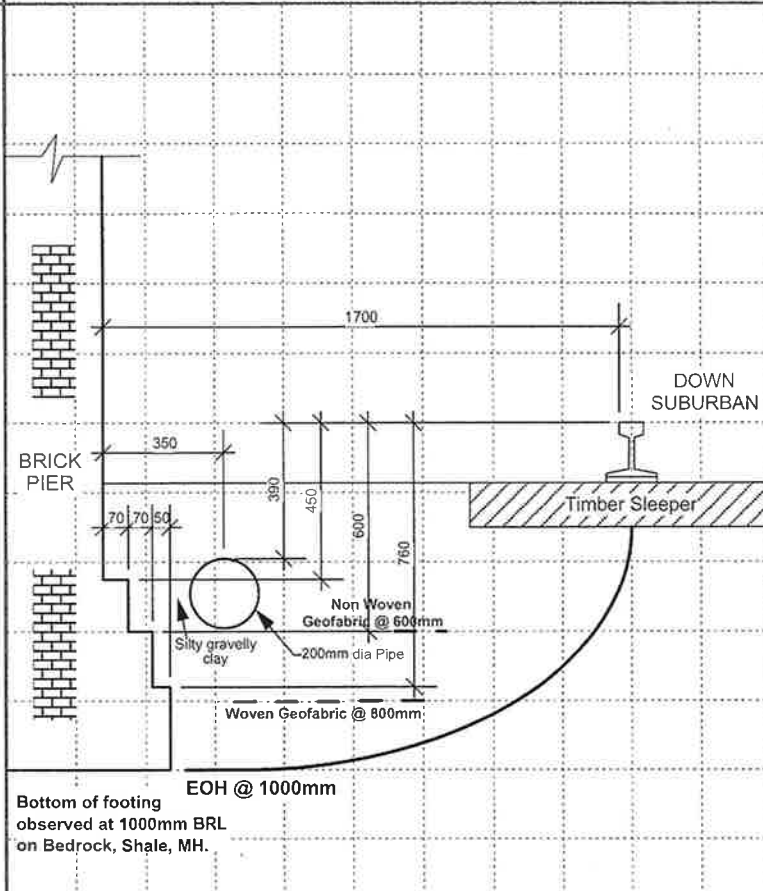
0.8						
		0.6						
		0.4						
		0.2						
		0.0						
		0.2						
BALLAST	Moderately fouled with silts, gravels & clay. Heavily fouled with clay & gravel. Non Woven Geofabric @ 600mm	0.4		Medium Dense		Wet		
CAPPING	Stabilised roadbase. Woven Geofabric @ 800mm	0.6		Medium Dense-Dense		Wet-Saturated		
RESIDUAL SOIL	Silty clay with some gravels.	0.8		Very Dense		Moist		
BEDROCK	Shale, W-MH.	1.0		Firm		MC>PL		
	EOH @ 1000mm	1.2

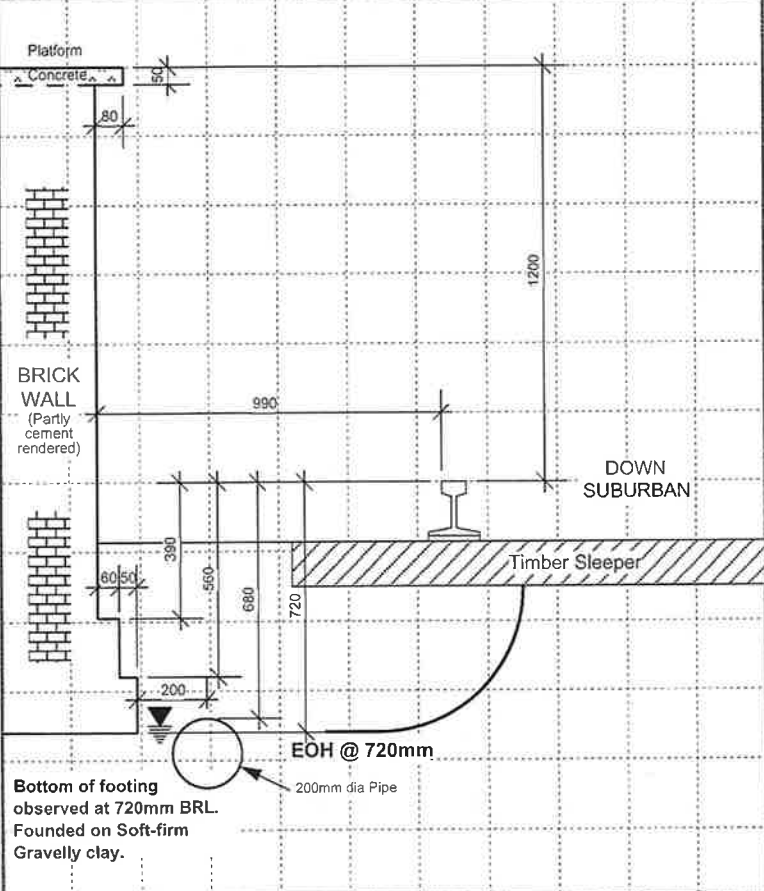
Below Down Rail	0.0						
BALLAST	Moderately fouled with silts, clay, sands & gravels. Water @ 700mm (Test Pit full of water)	0.2						
	EOH @ 720mm	0.4						
		0.6		Medium Dense		Wet		
		0.8						
		1.0

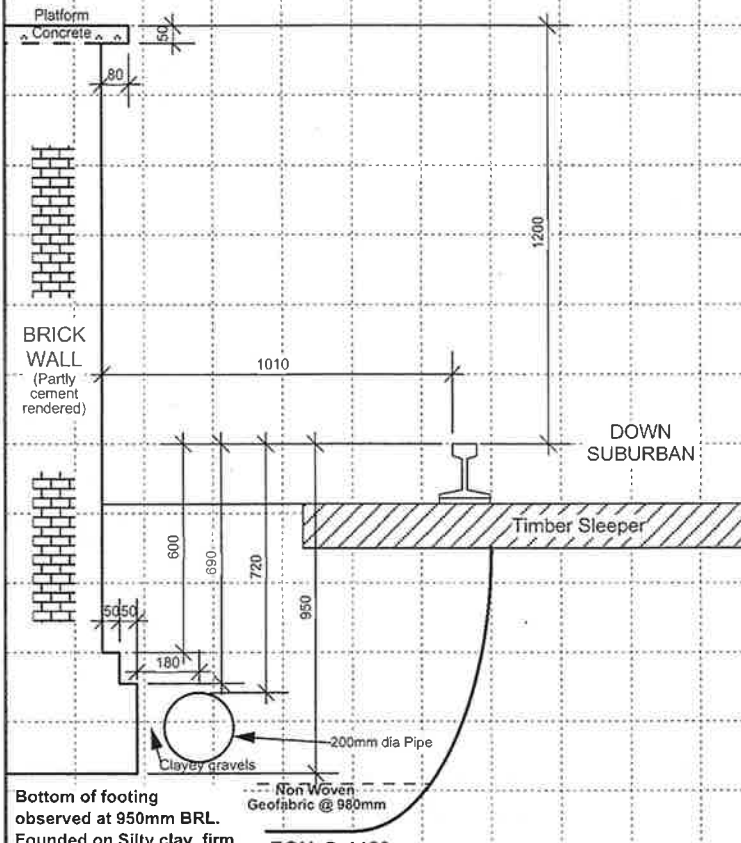
Below Down Rail	1.0						
		0.8						
		0.6						
		0.4						
		0.2						
		0.0						
		0.2						
		0.4						
		0.6						
BALLAST	Moderately fouled with sands, clay, & gravels.	0.8		Medium Dense		Moist-Wet		
	Heavily fouled with clay & gravels.	1.0		Medium Dense-Dense		Saturated		
CAPPING	Roadbase, sandy gravels, some clay, Non Woven Geofabric @ 980mm			Medium Dense		Moist		
FILL	Compacted gravels, some sand & clay.			Dense		Moist-Wet		
	EOH @ 1120mm

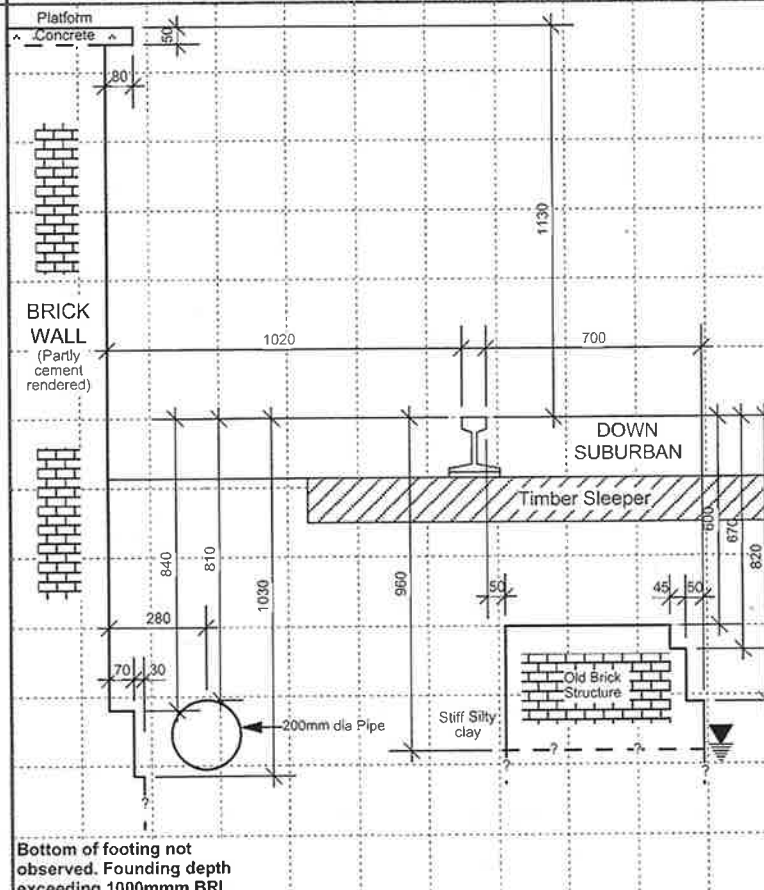
4 foot	0.8						
		0.6						
		0.4						
		0.2						
		0.0						
		0.2						
		0.4						
BALLAST	Moderately fouled with sands, gravels, silts & clay.	0.6			Medium Dense		Moist	
	Heavily fouled with clay & gravels.	0.8			Medium Dense-Dense		Saturated	
		1.0						
		1.2						
CAPPING	Roadbase & clay.	0.8		Medium Dense				
RESIDUAL SOIL	Silty clay with ironstone.	1.0		Stiff		MC=PL		
	EOH @ 1020mm
