**DUNGOWAN DAM AND PIPELINE EIS**

## **Contamination Preliminary Site Investigation**

Prepared for Water Infrastructure NSW

J200042 DUN-EMM-EN-RPT-006

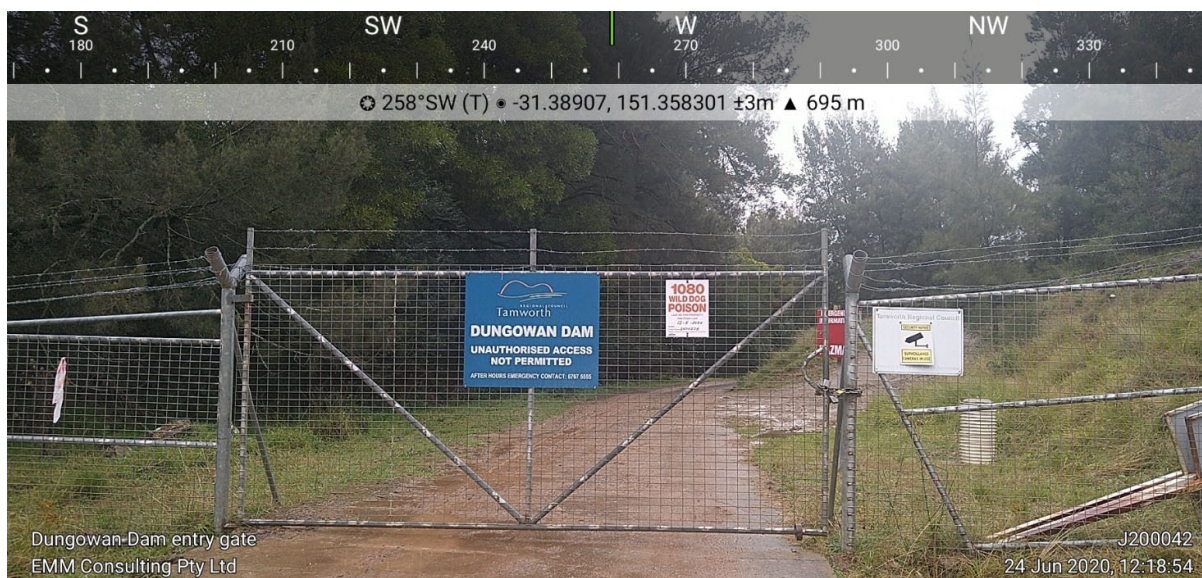
**Plate 1** Existing Dungowan Dam entry gate

- the existing Dungowan Dam area was fenced off and not accessible by the general public (Annexure B, Plate 1) and it is assumed that potentially contaminating activities would be highly restricted and limited within the operating facility;

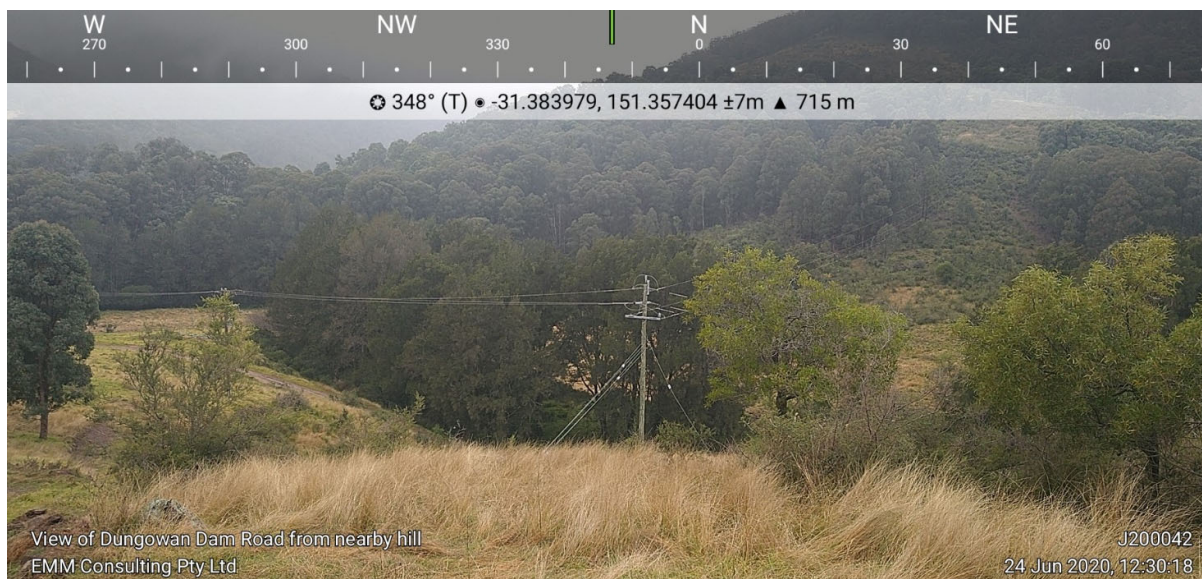
**Plate 2** View of Dungowan Dam Road and Dungowan Creek from nearby hill

- the general area is predominantly freehold agricultural land (Annexure B, Plate 2);
- areas of disturbed ground and cuttings were observed along hillslopes within 20 m of the project footprint along Dungowan Dam Road (Annexure B, plates 3, 4, 6, 10);

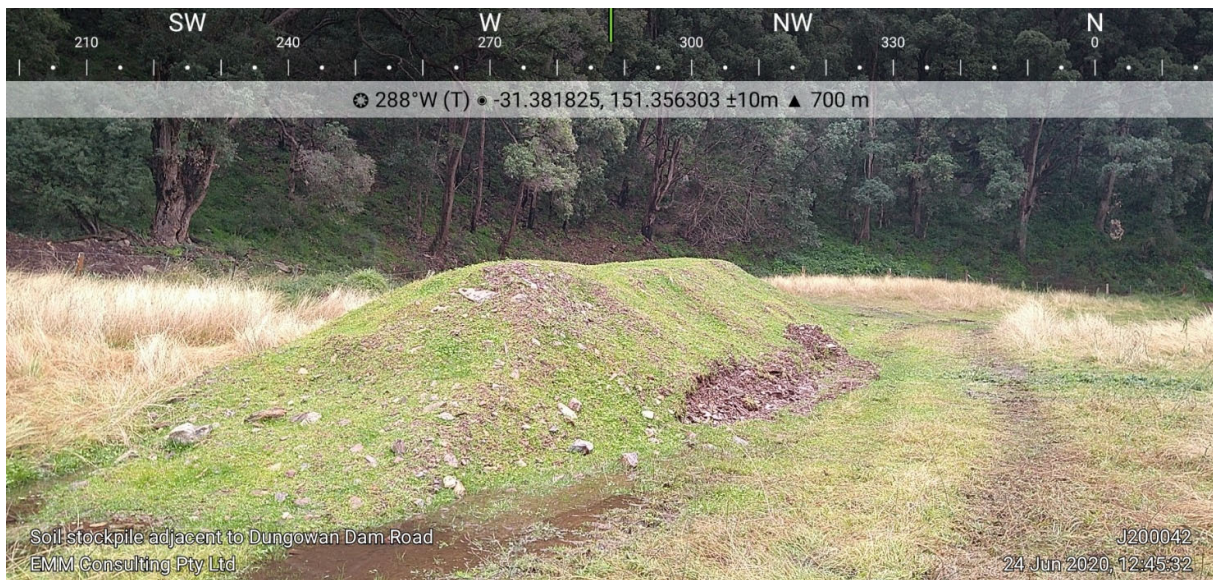
**Plate 5**      **Soil stockpile adjacent to Dungowan Dam Road**

- evidence of fill material including potential mounds were observed along Dungowan Dam Road (Annexure B, Plate 5);
- former/abandoned buildings were observed along Dungowan Dam Road (Annexure B, plates 7, 8);

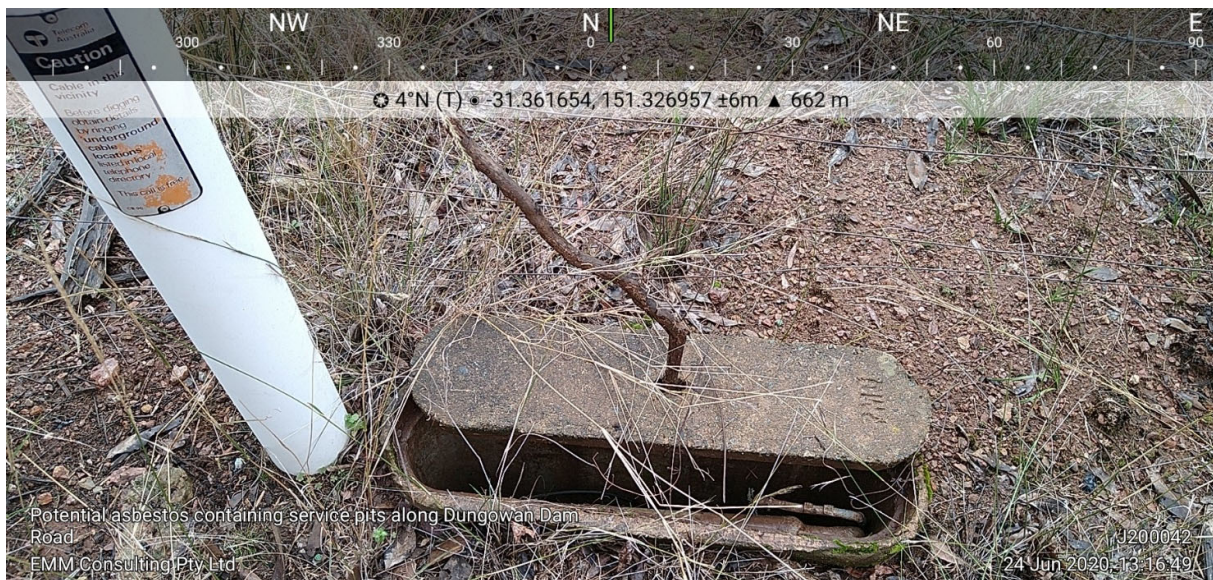
**Plate 9** Potential asbestos containing service pits along Dungowan Dam Road

- potentially asbestos containing service pits (eg telecommunications) were observed along Ogunbil and Dungowan Dam Road (Annexure B, Plate 9);
- the Ogunbil RFS building was observed to be a small shed situated along Ogunbil Road adjacent to the project footprint (Annexure B, Plate 11); and

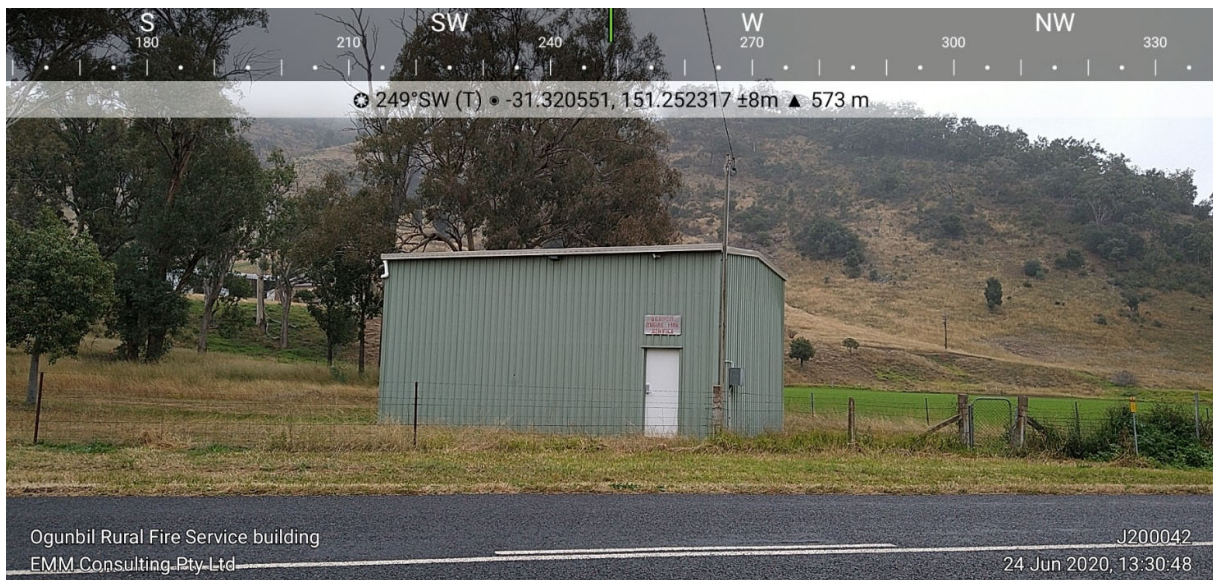
**Plate 11**

**Ogunbil Rural Fire Service building**

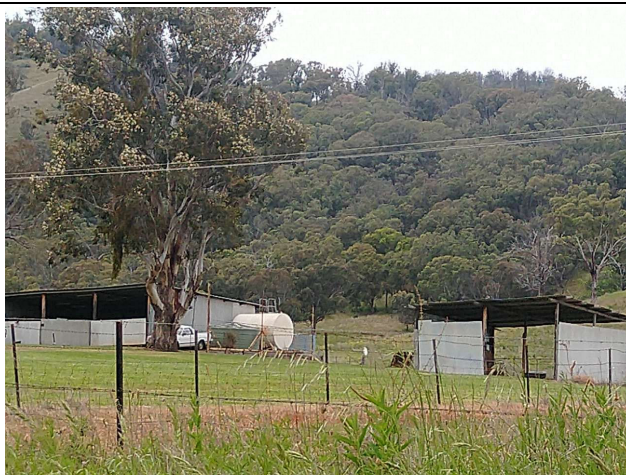
**Plate 16**

- an above ground storage tank (AST) with an estimated capacity of 5,000 litres (L), with unknown contents, approximately 50 m downgradient of the project footprint (Annexure B, Plate 16).
