# Preliminary Site Investigation – Kurnell

# Kamay Wharf Project

Preliminary Site Investigation – Kurnell Site

2nd December 2020

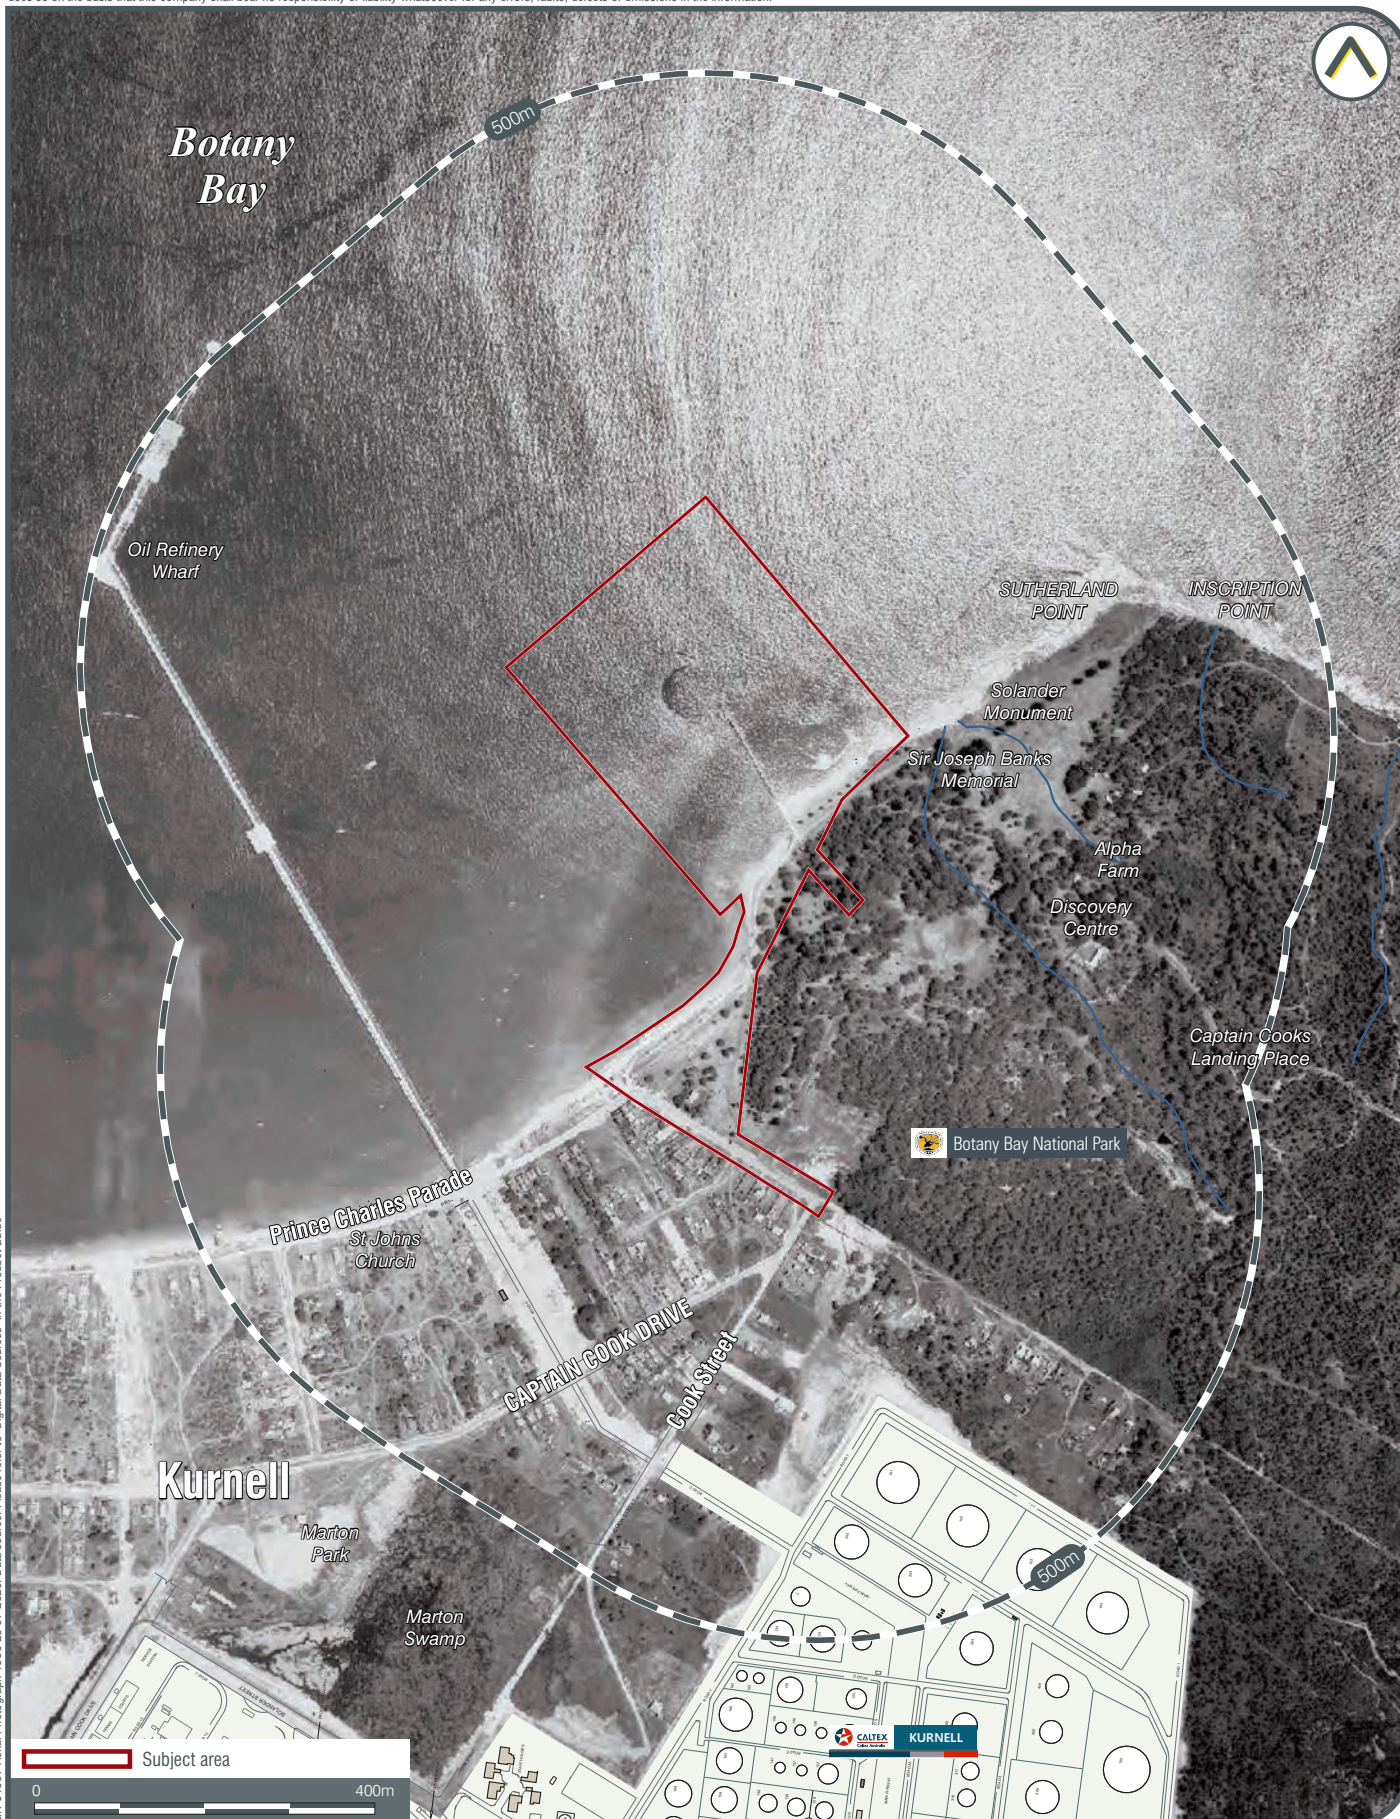
HISTORIC AERIAL PHOTOGRAPH - 1956

Year	Description
1956 – Black and White	<ul style="list-style-type: none"> <li>■ <b>Project Area:</b> The Project Area appears to be comprised of undeveloped land with scattered vegetation. Several access tracks are visible across the Project Area area. Captain Cook Drive is present in its current alignment but appears to be unsealed.</li> <li>■ <b>Surrounding Area:</b> The area surrounding the Project Area is comprised of Botany Bay to the north of the Project Area, undeveloped bushland (Kamay Botany Bay National Park) located to the south and east of the Project Area, low density residential dwellings to the west and the Kurnell Refinery / Caltex Terminal located to the south of the Project Area. The oil refinery wharf extending from the Kurnell refinery into Botany Bay is located approximately 500 m to the west of the Project Area.</li> </ul>
1961 – Black and White	<ul style="list-style-type: none"> <li>■ <b>Project Area:</b> A small jetty appears to be present within the central portion of the Project Area extending from the beach area into Botany Bay. .</li> <li>■ <b>Surrounding Area:</b> No significant changes since previous aerial photography.</li> </ul>

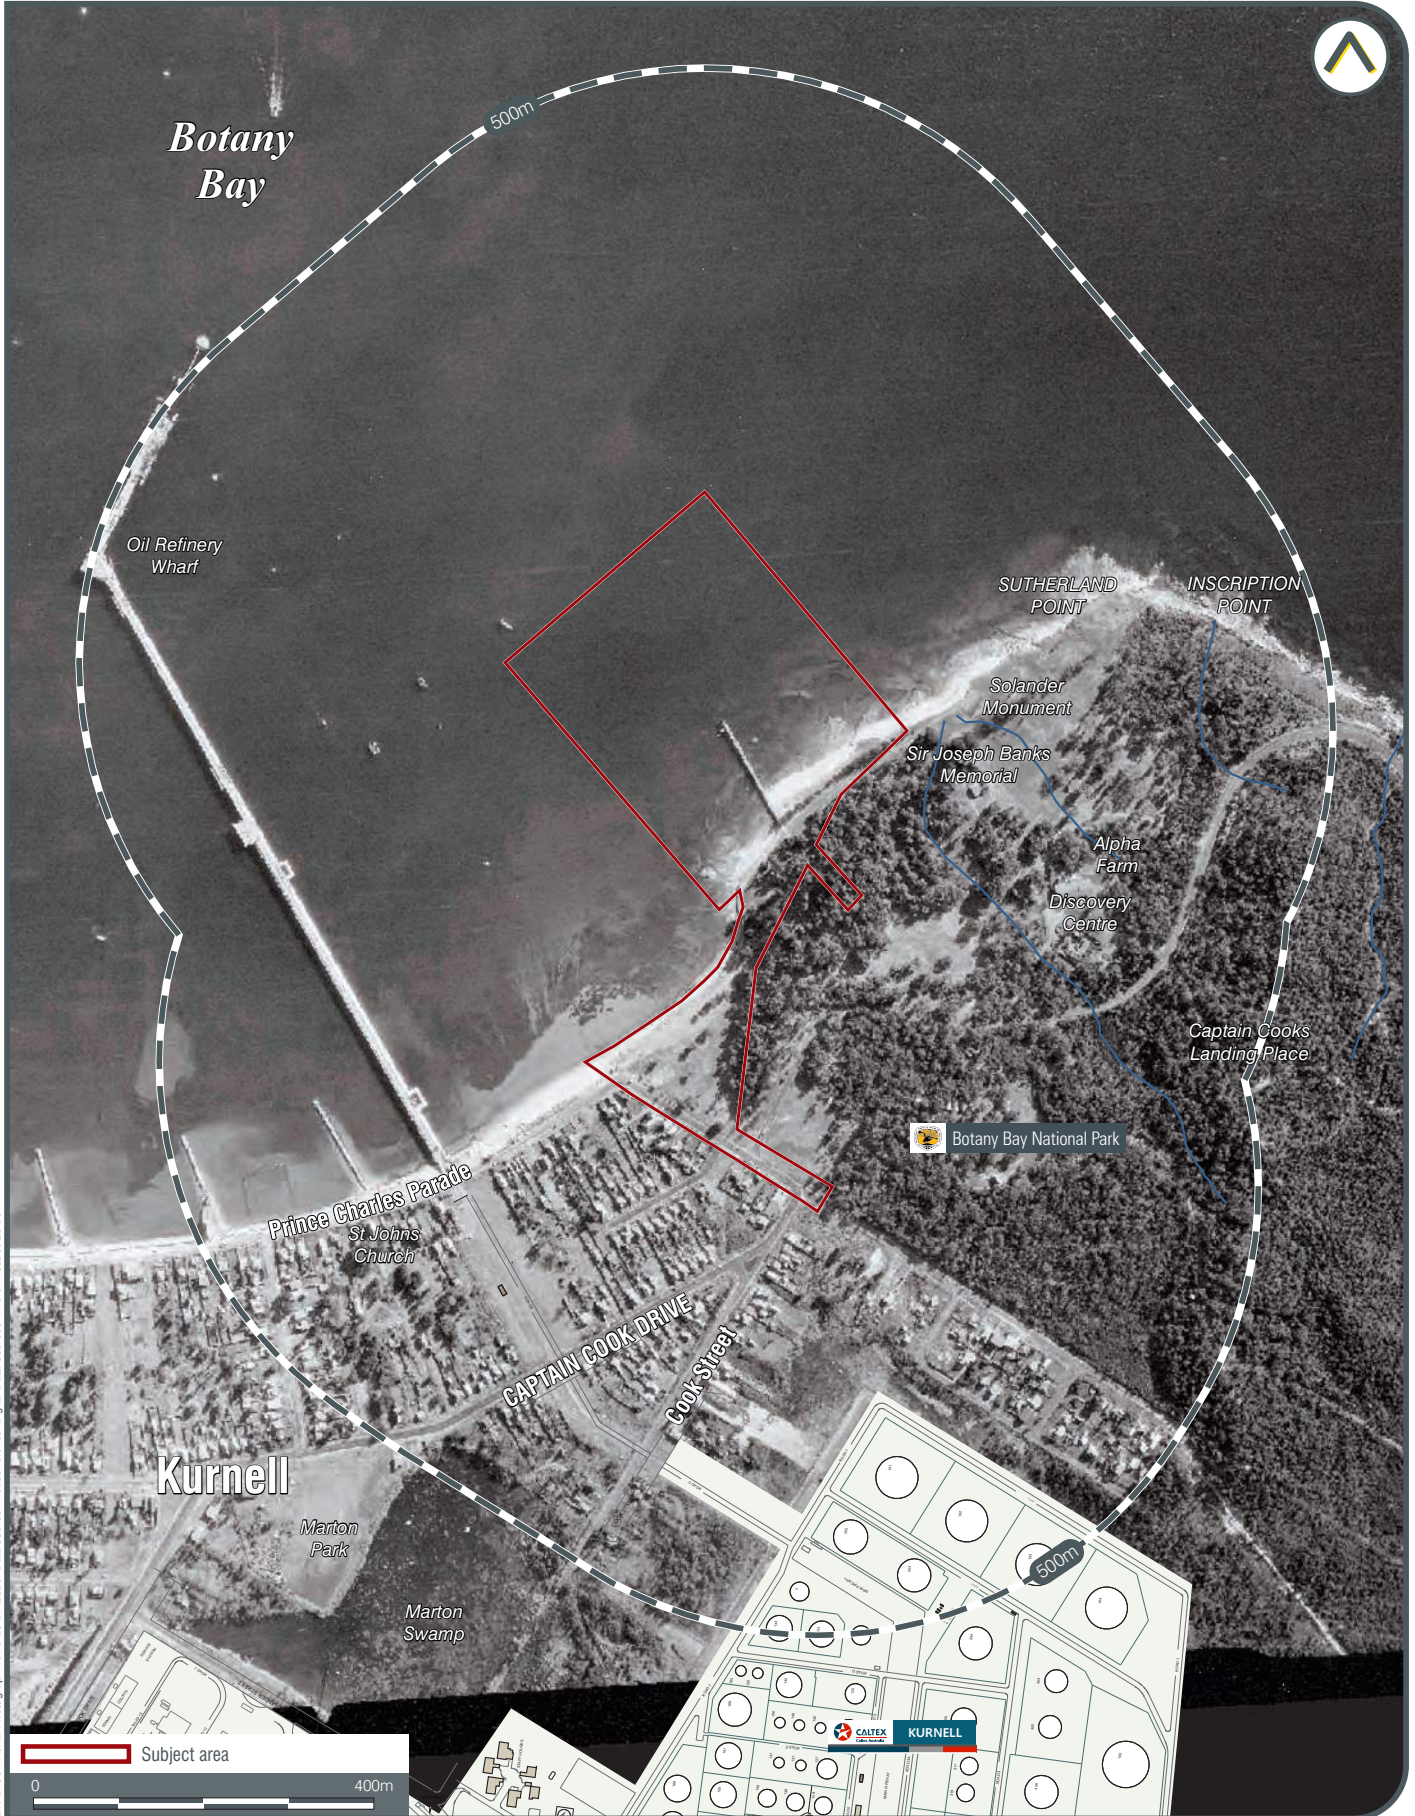
HISTORIC AERIAL PHOTOGRAPH - 1970

1970 – Black and White	<ul style="list-style-type: none"> <li>■ <b>Project Area:</b> No significant changes since previous aerial photography.</li> <li>■ <b>Surrounding Area:</b> Captain Cook Drive appears to have been sealed. Residential development has increased to the west of the Project Area with additional low density dwellings present along Captain Cook Drive.</li> </ul>
1972 – Black and White	<ul style="list-style-type: none"> <li>■ <b>Project Area:</b> No significant changes since previous aerial photography.</li> <li>■ <b>Surrounding Area:</b> No significant changes since previous aerial photography.</li> </ul>
1975 – Black and White	<ul style="list-style-type: none"> <li>■ <b>Project Area:</b> Significant sedimentation appears to have occurred within the Project Area boundary. Approximately 50% of the water side portion of the Project Area now appears to be sediments above the water line. The Jetty that was present within the 1961 imagery has been demolished.</li> <li>■ <b>Surrounding Area:</b> No significant changes since previous aerial photography within the landside portion of the Project Area. Significant sedimentation has occurred among the coastline with damage visible to the adjacent terminal wharf / jetty present.</li> </ul>

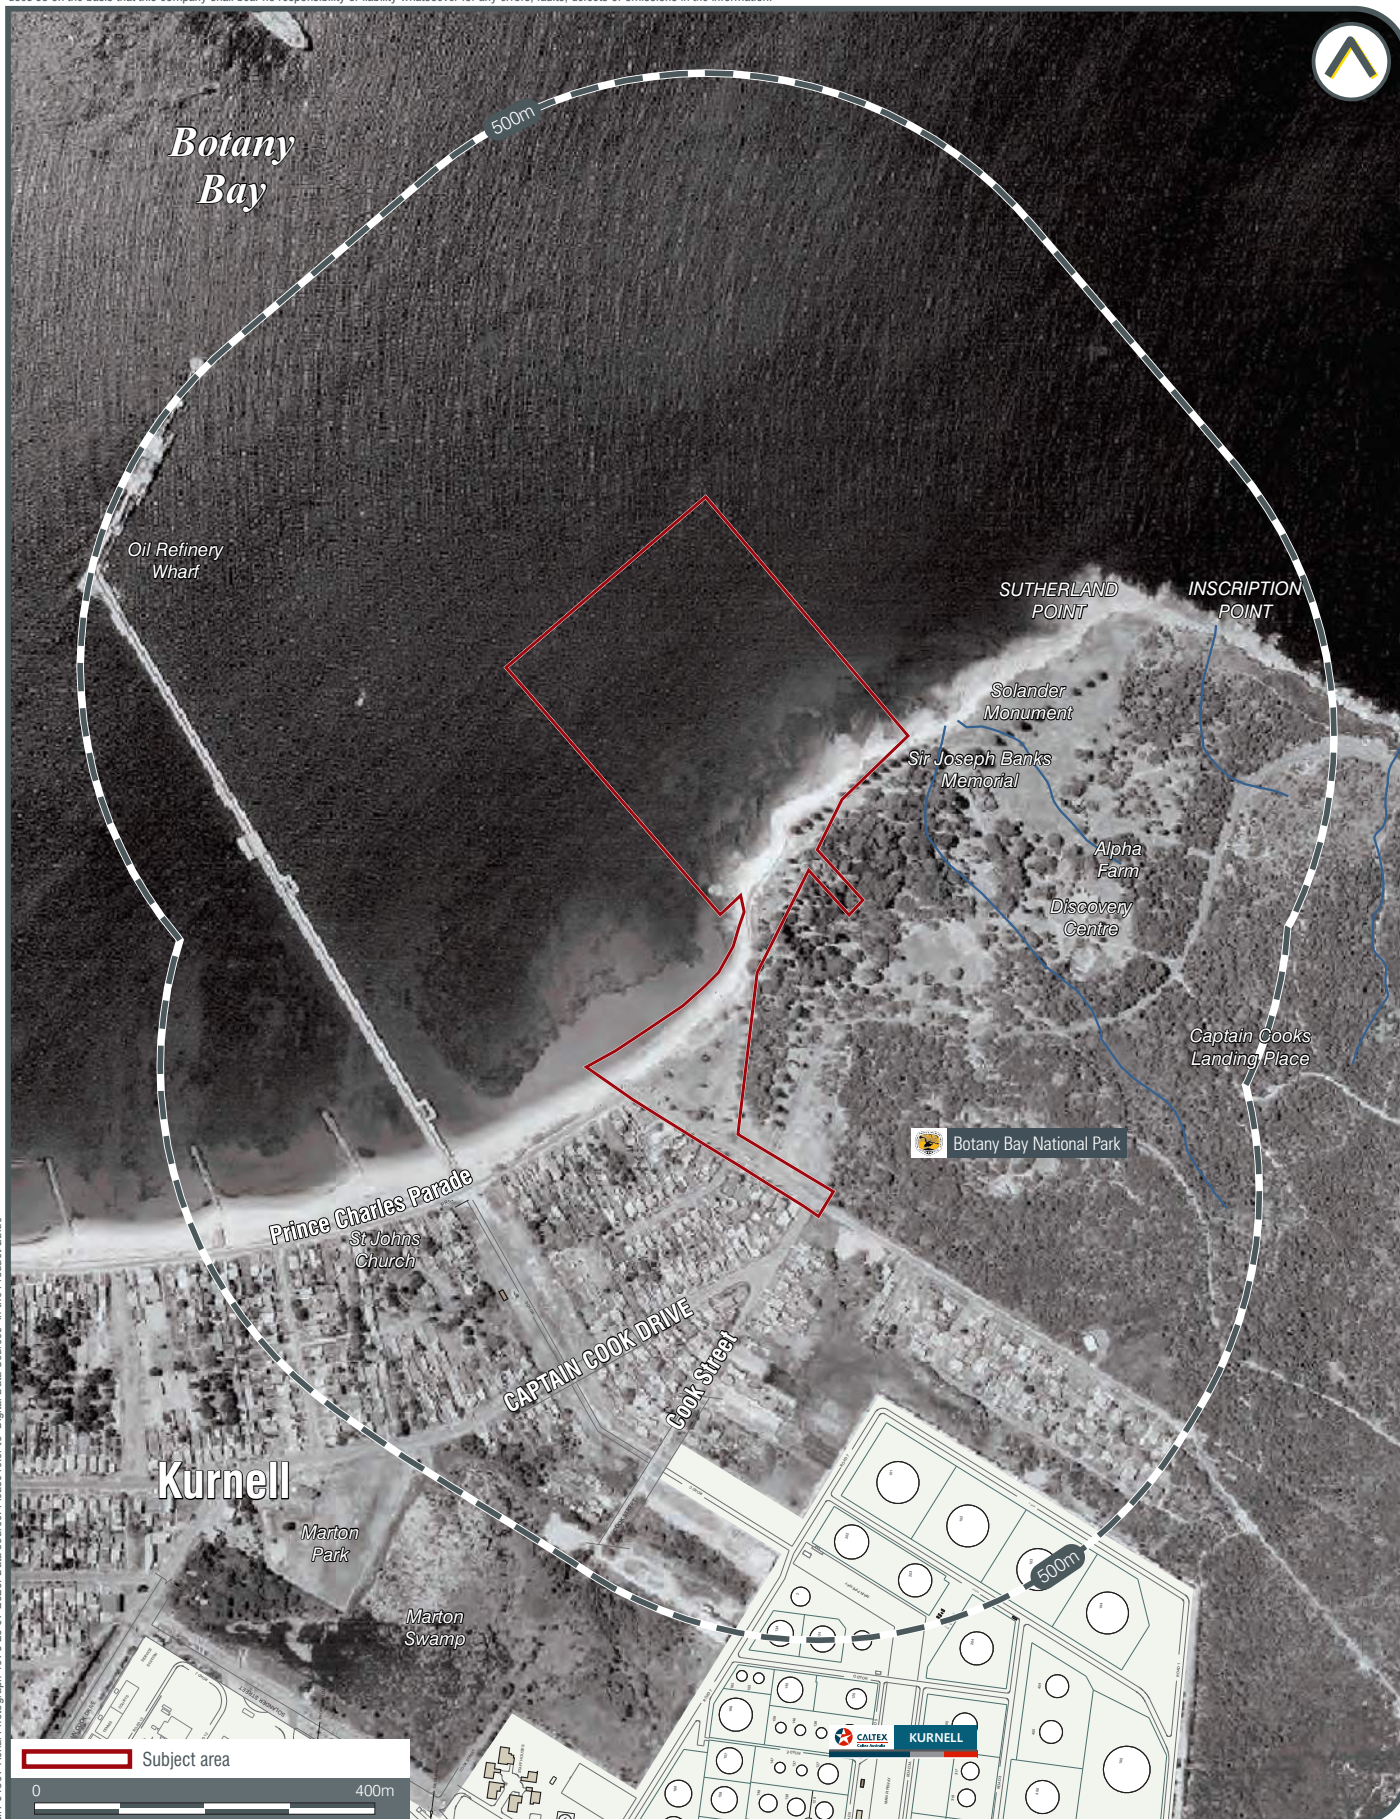
## HISTORIC AERIAL PHOTOGRAPH - 1978

1978 – Black and White	<ul style="list-style-type: none"> <li>■ <b>Project Area:</b> The abovementioned sedimentation appears to have been removed from the Project Area. The Project Area area is consistent with aerial photography from 1972.</li> <li>■ <b>Surrounding Area:</b> The surrounding area is consistent with aerial photography from 1972.</li> </ul>
1979 – Black and White	<ul style="list-style-type: none"> <li>■ <b>Project Area:</b> No significant changes since previous aerial photography.</li> <li>■ <b>Surrounding Area:</b> No significant changes since previous aerial photography</li> </ul>
1980 – Black and White	<ul style="list-style-type: none"> <li>■ <b>Project Area:</b> No significant changes since previous aerial photography.</li> <li>■ <b>Surrounding Area:</b> No significant changes since previous aerial photography</li> </ul>
1983 – Black and White	<ul style="list-style-type: none"> <li>■ <b>Project Area:</b> No significant changes since previous aerial photography.</li> <li>■ <b>Surrounding Area:</b> No significant changes since previous aerial photography.</li> </ul>

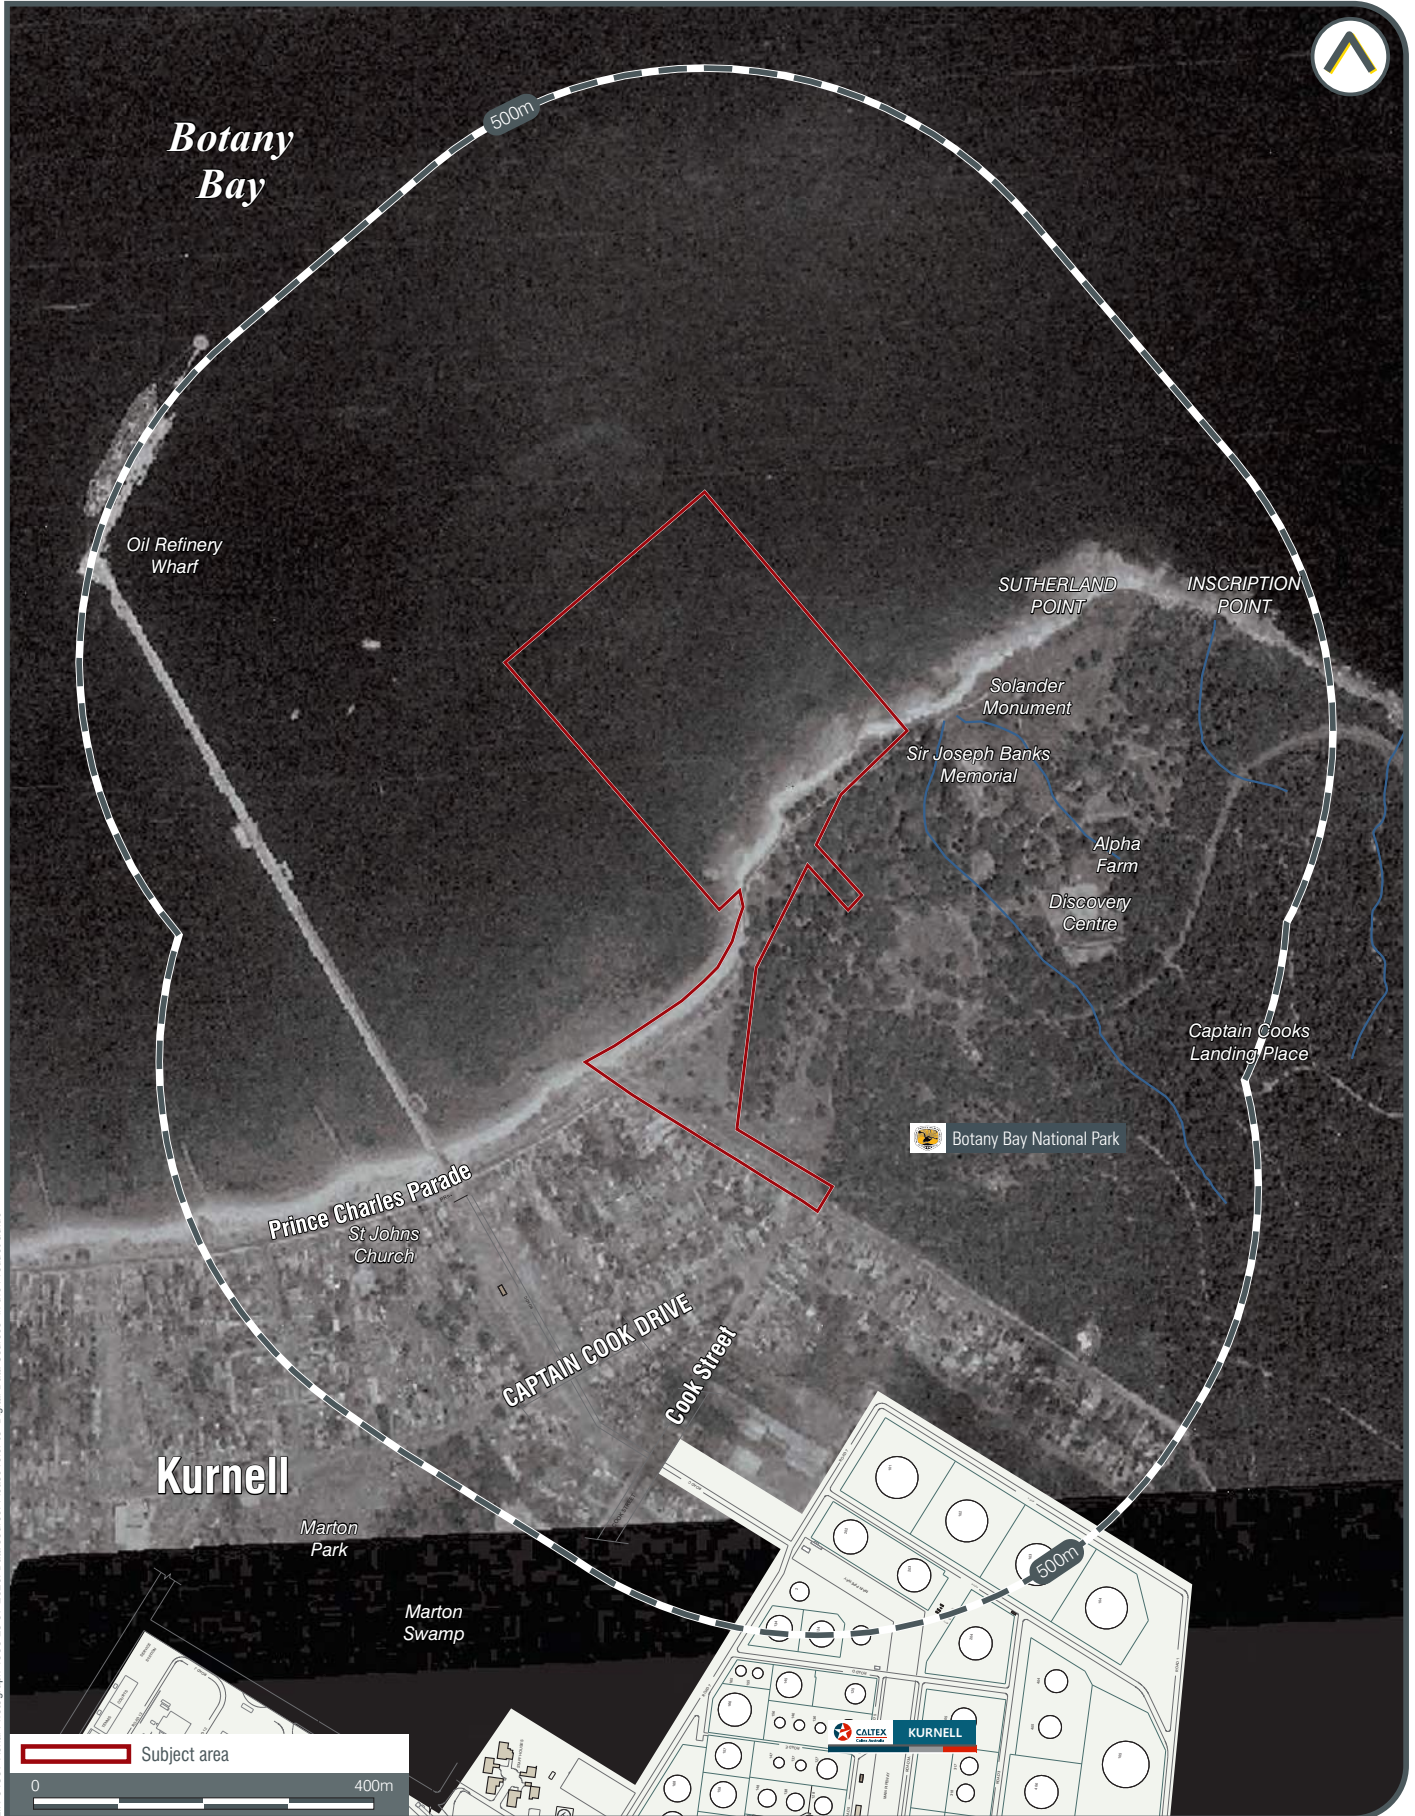
**HISTORIC AERIAL PHOTOGRAPH - 1988**

1988 – Black and White	<ul style="list-style-type: none"> <li>■ <b>Project Area:</b> No significant changes since previous aerial photograph.</li> <li>■ <b>Surrounding Area:</b> No significant changes since previous aerial photography.</li> </ul>
1990 - Colour	<ul style="list-style-type: none"> <li>■ <b>Project Area:</b> No significant changes since previous aerial photography.</li> <li>■ <b>Surrounding Area:</b> No significant changes since previous aerial photography</li> </ul>
