Kamay Wharf Project

Preliminary Site Investigation – La Perouse
Site

2nd December 2020

Project No.: 0564417

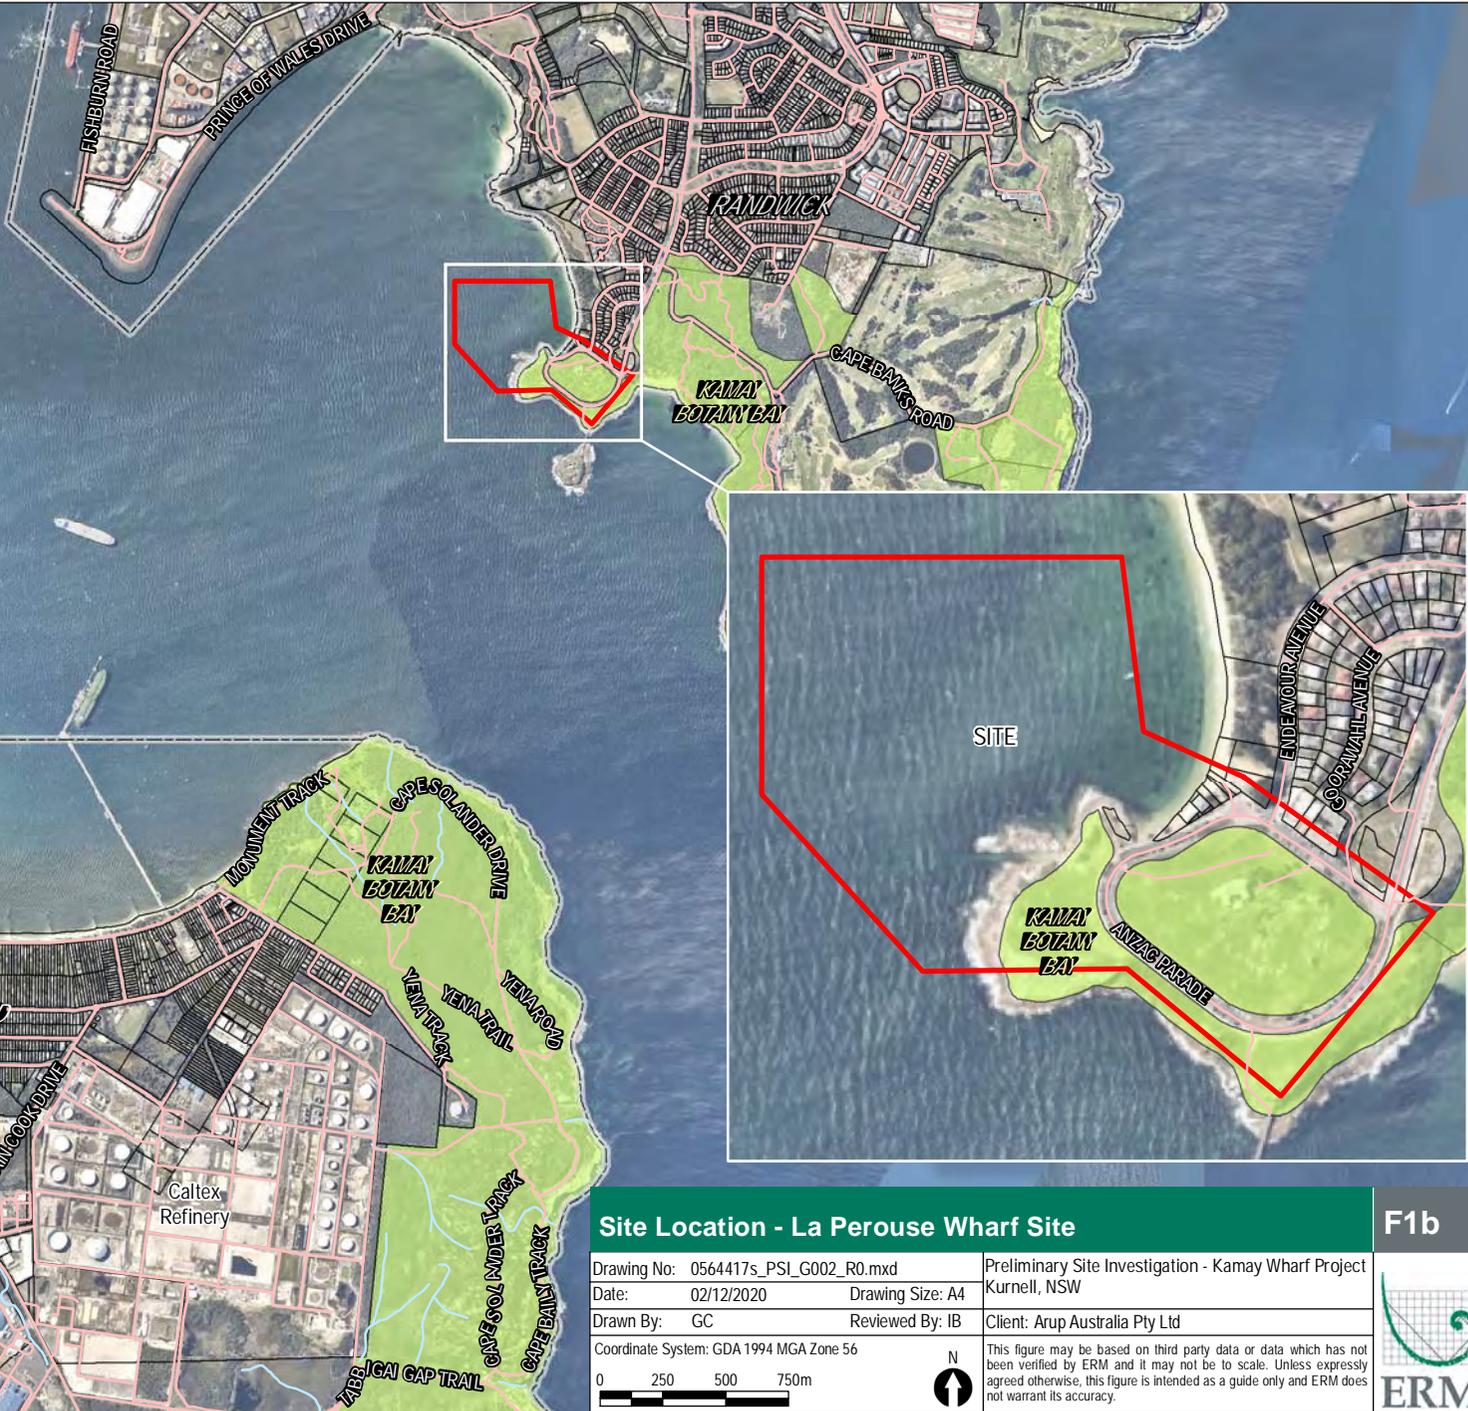
F1b

Site Location - La Perouse Wharf Site

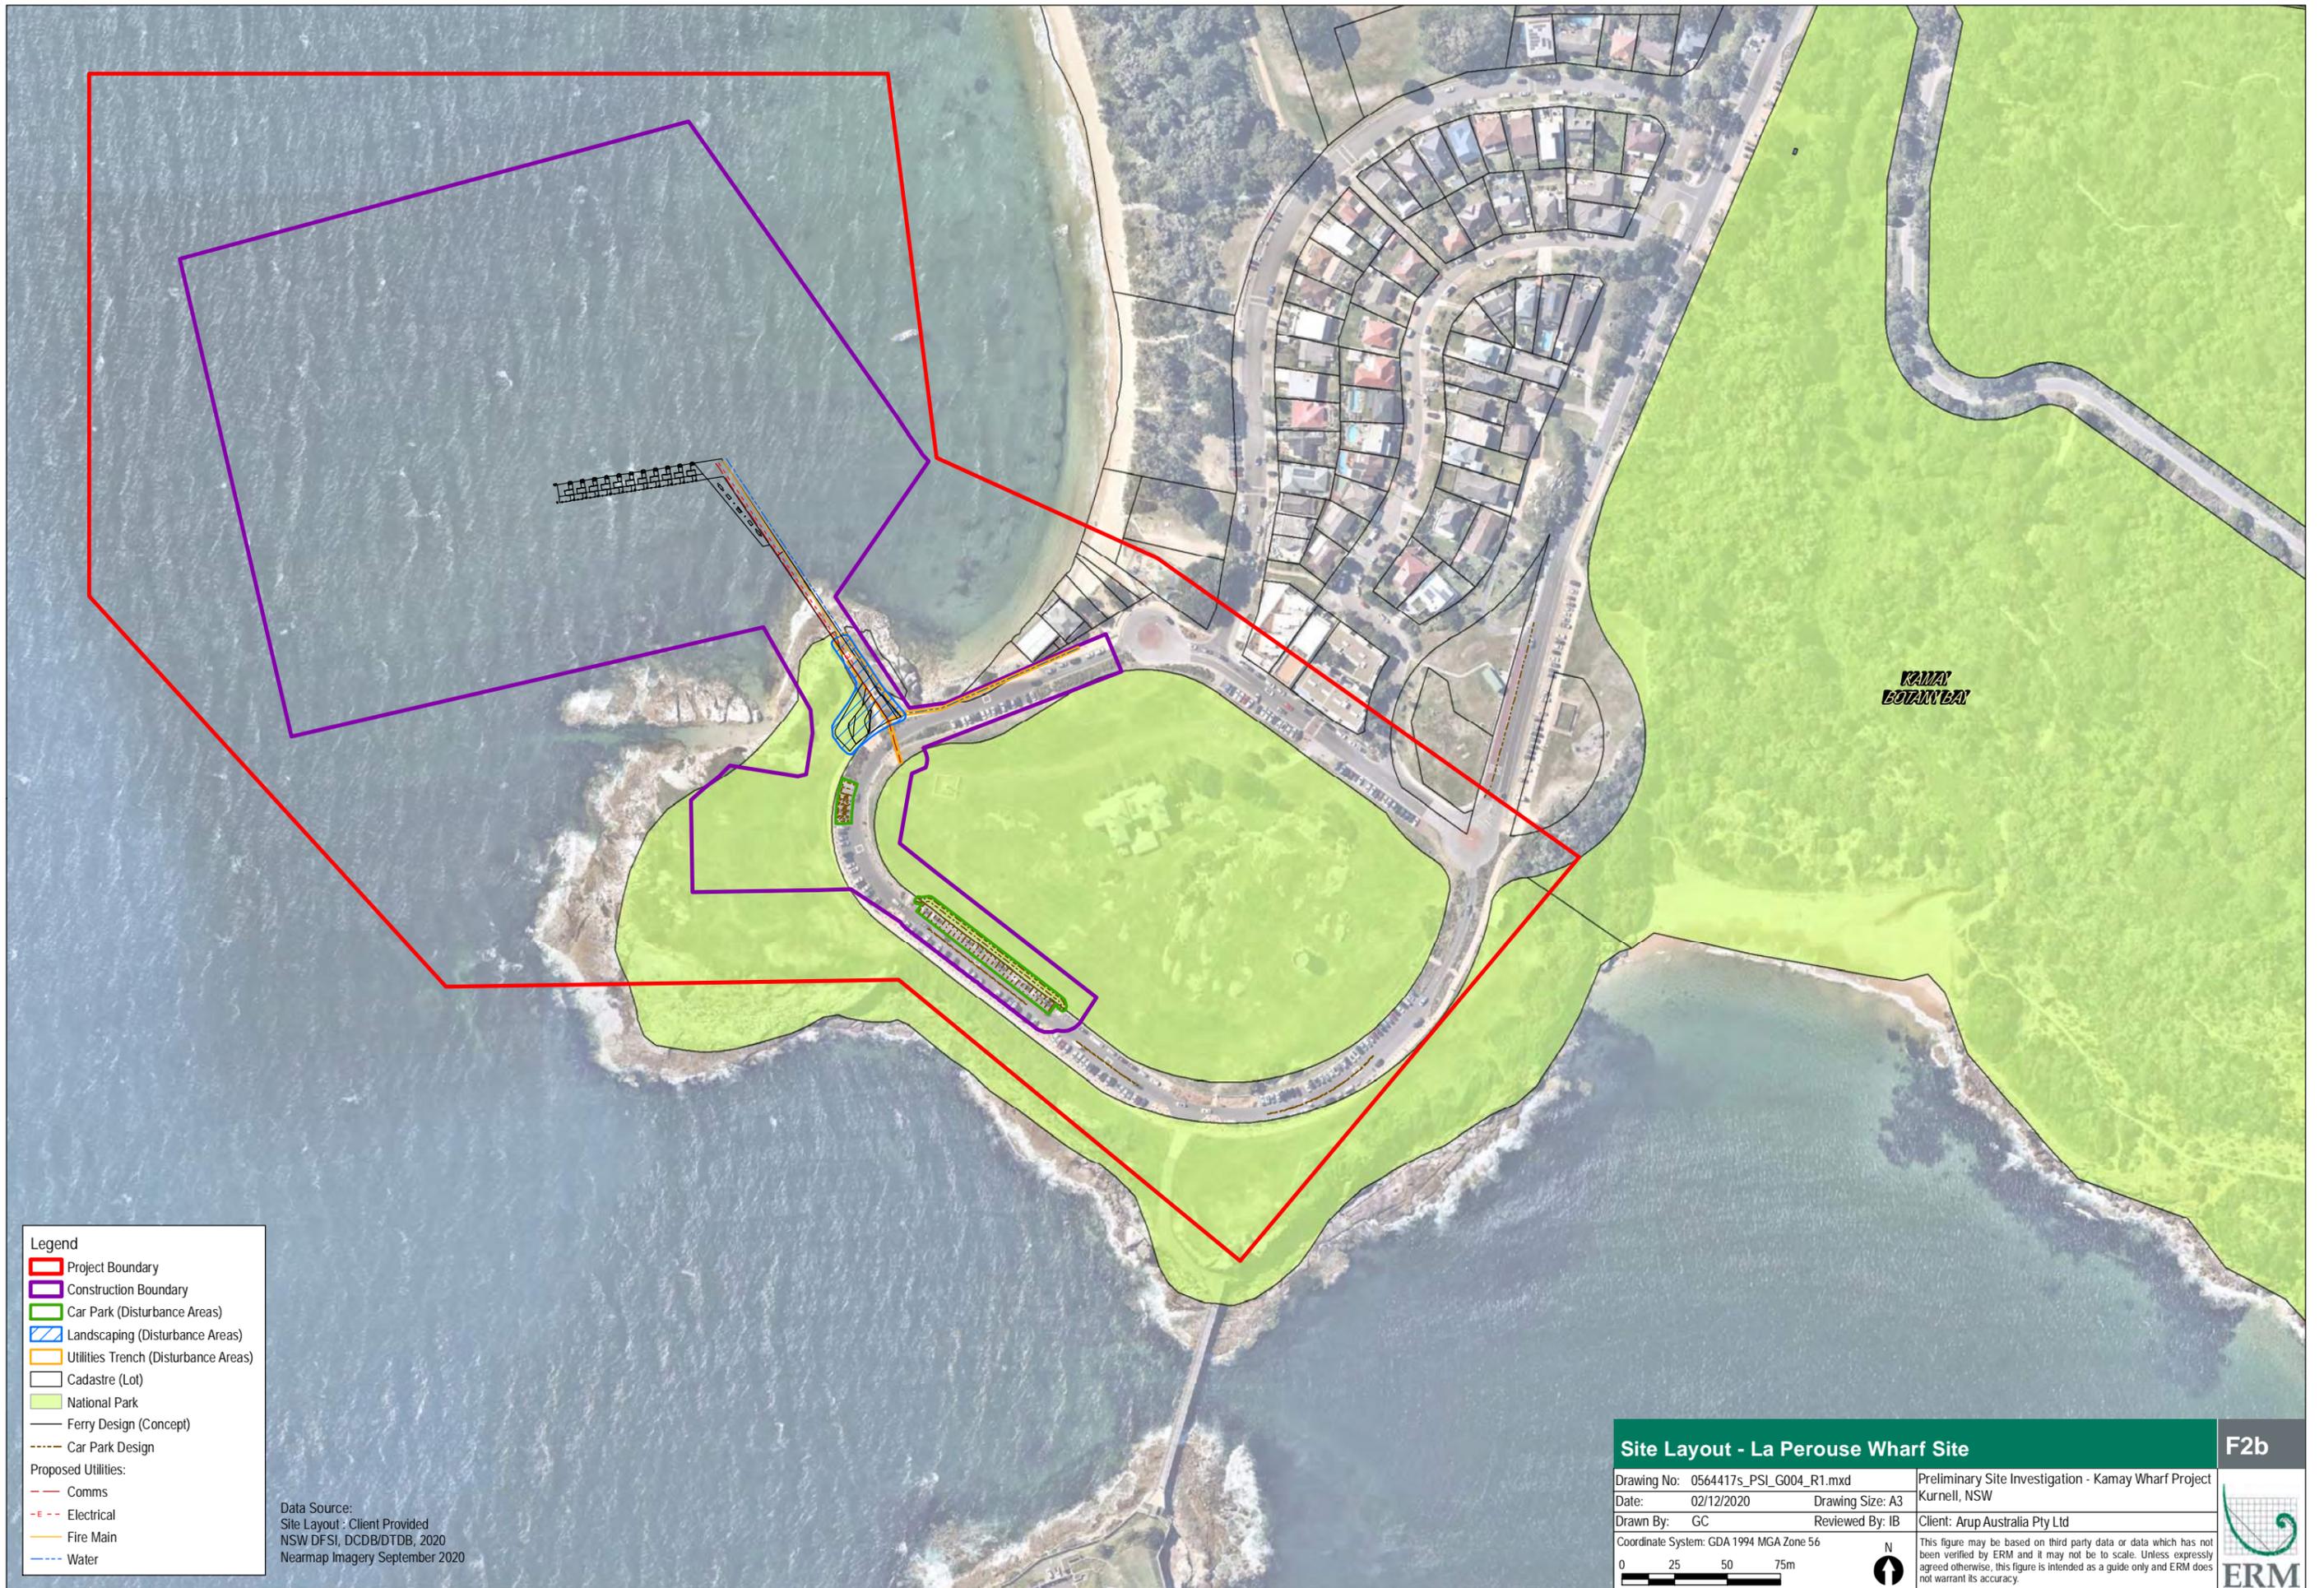
F2b

A site inspection to confirm that nature of current land uses was undertaken on 30 July 2020 by Ian Batterley, a suitably qualified and experienced ERM environmental scientist. Observed site features are presented on **Figure 2**.

- The Project Area is accessed via Anzac Parade located within the northern portion of the Project Area. Anzac Parade circles the eastern, southern and western boundaries of the landside portion of the Project Area. During the Project Area inspection, the roadway was noted to be in good condition and free from obvious cracks / staining and other major deformities.

- ERM notes that during the inspection, natural bedrock outcroppings were noted on the surface of the Project Area which were consistent with exposed rock within surrounding cliffs etc.

- While no surface waters (on the landside portion of the Project Area) were present during the Project Area inspection, during periods of rainfall it is considered likely that surface waters present would either be directed to stormwater infrastructure located along Anzac Parade, infiltrate the Project Area surface (within unsealed portions of the Project Area) or flow towards Botany Bay.

- During the Project Area inspection, no evidence (vents, risers, filler points etc.) of fuel / chemical storage or illegal waste disposal / buried drums etc. was noted.

Based on information reviewed as part of this PSI, it is the opinion of ERM that the risk to current onsite human health is generally considered to be low. ERM notes that where the Project Area is to be redeveloped and / or Arup require a greater understanding of liabilities or to inform site management controls a Detailed Site Investigation (DSI) of soil and groundwater conditions should be undertaken to assess the contamination status of the Project Area.

- a targeted sampling approach to assess potential point sources of contamination such as potential uncontrolled fill and contaminated soils, sediment, surface and groundwater associated with historical onsite and offsite land uses; and
- the collection of background samples to ensure collected results are assessed in consideration of naturally occurring conditions.
