ALBURY TO ILLABO ENVIRONMENTAL IMPACT STATEMENT

# ALBURY TO ILLABO (A2I) PROJECT

2-0008-210-EAP-00-RP-0012

## TECHNICAL PAPER 13 – CONTAMINATION

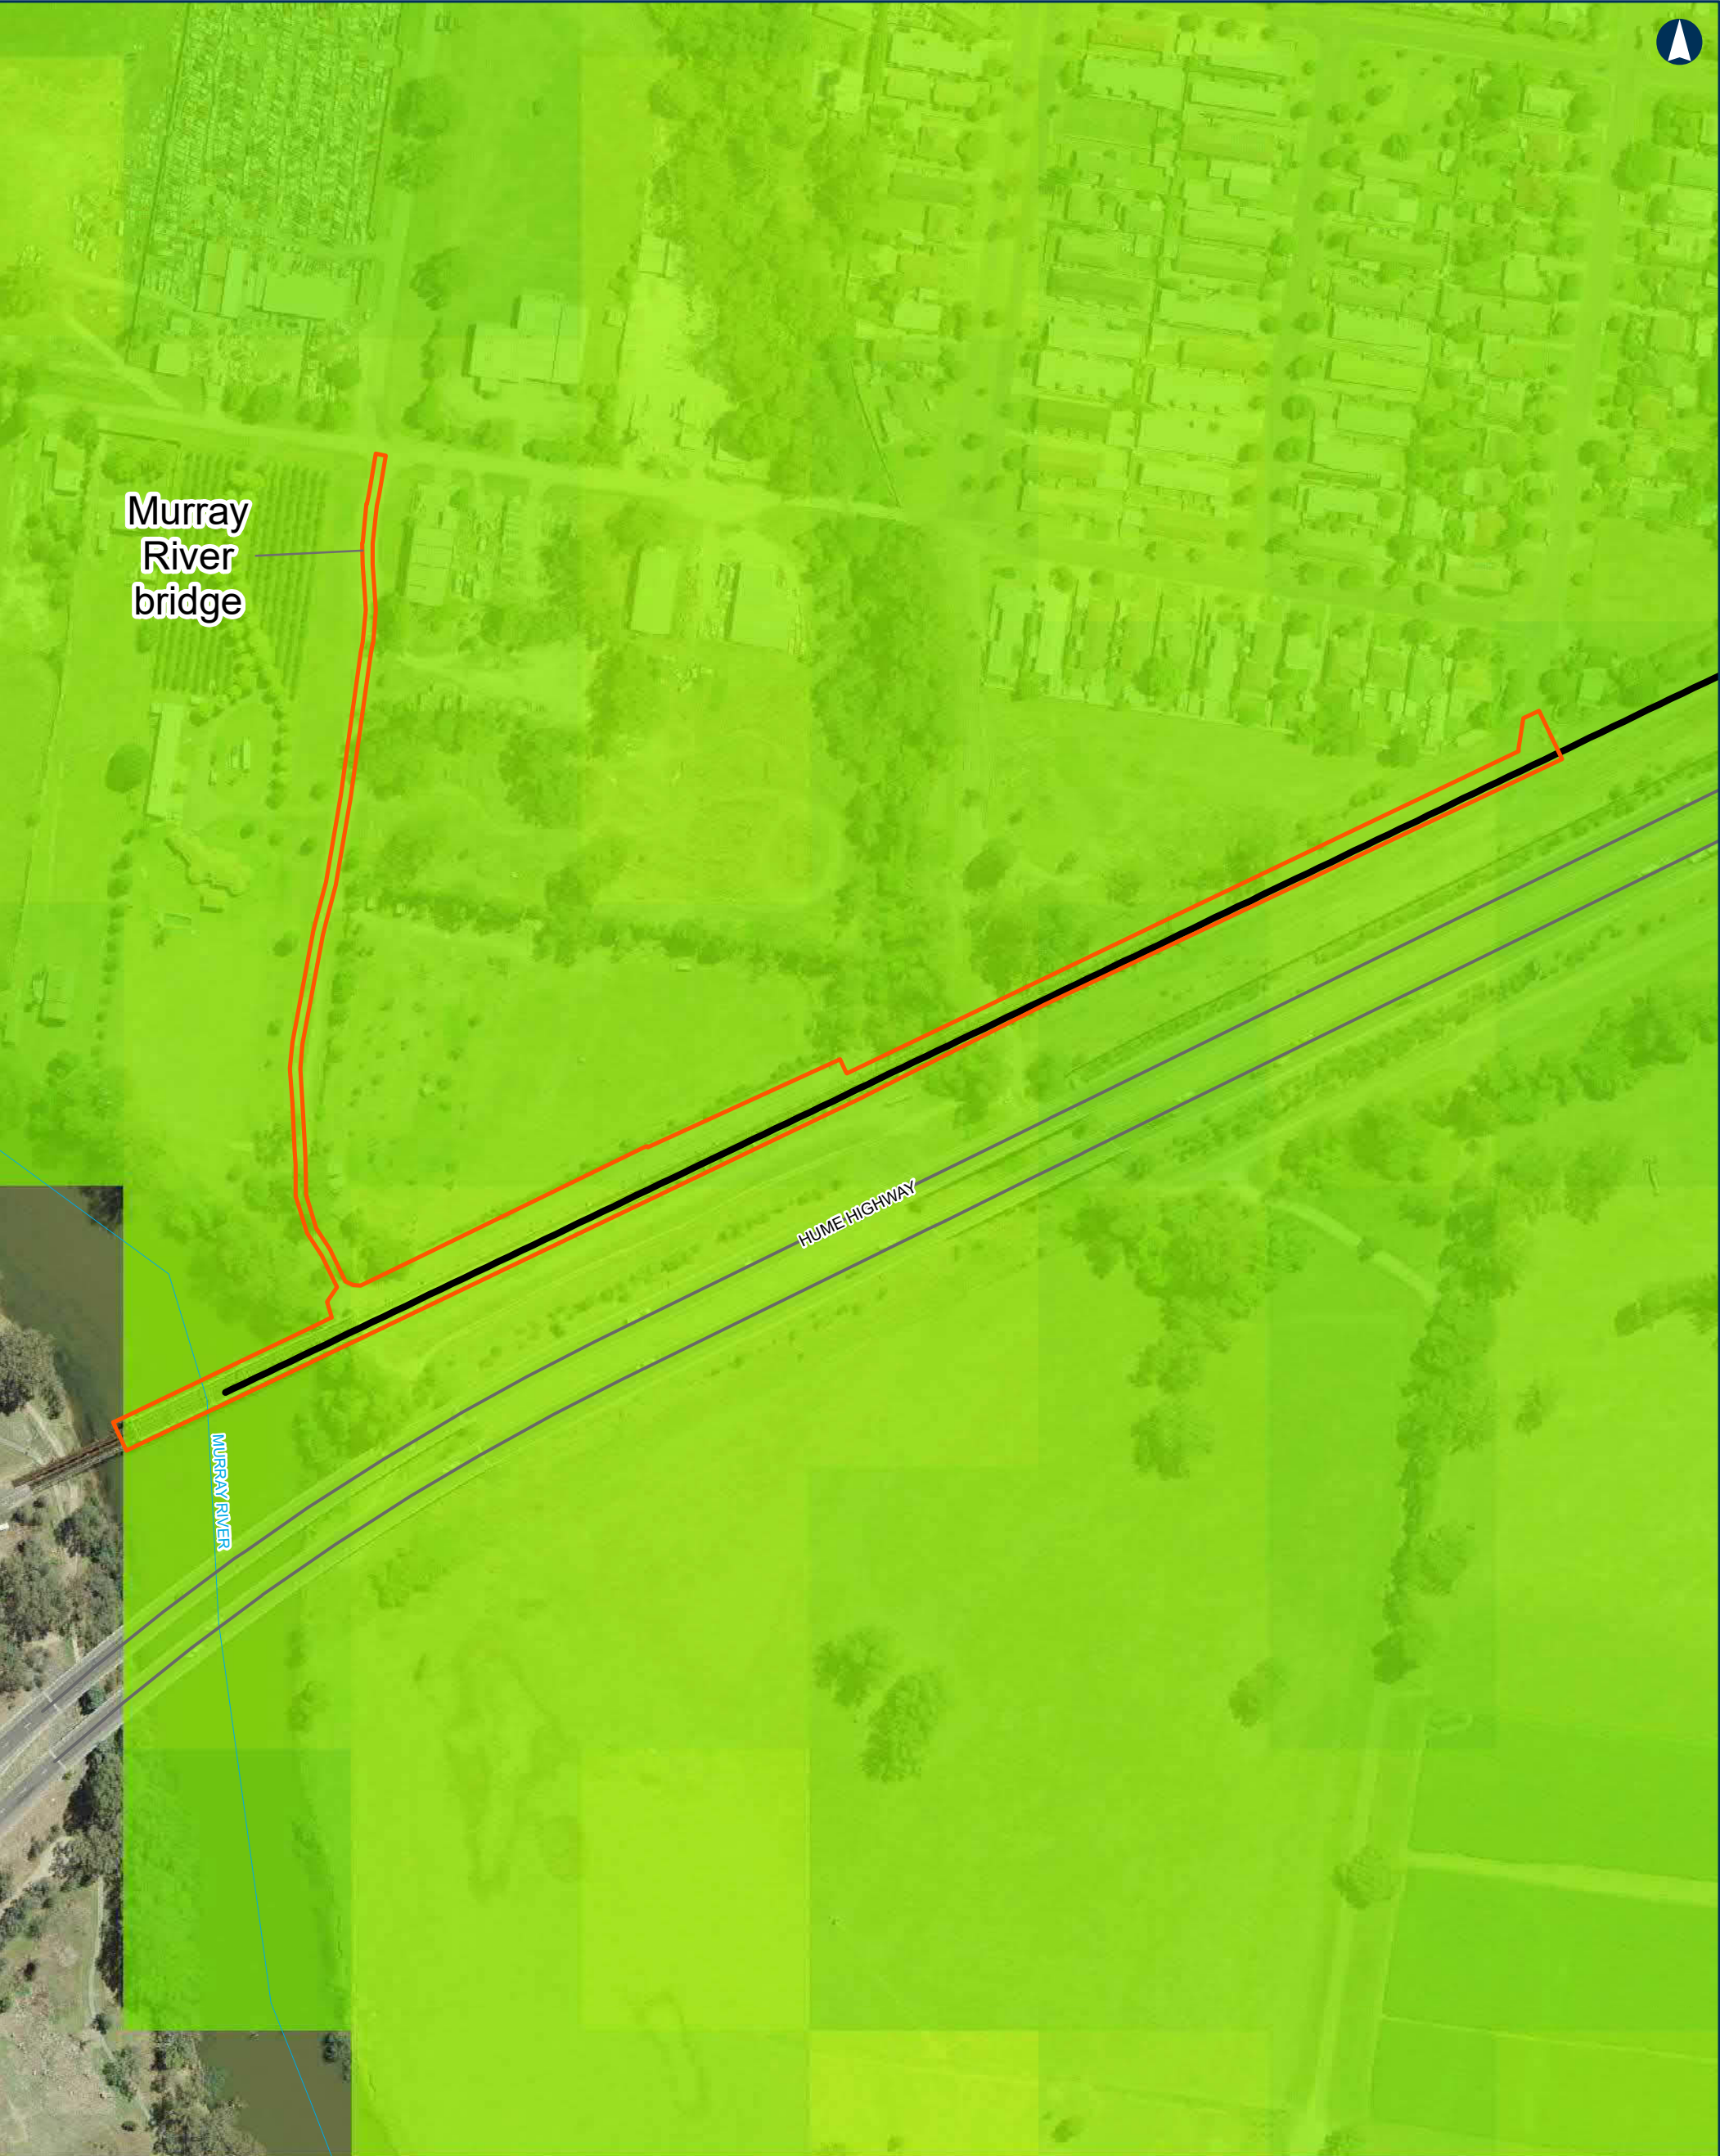
**APPENDIX A-1**  
**FIGURE 1 – SALINITY – 0–30cm**

The desktop review of soil types and electrical conductivity of those soils using the eSPADE portal (DPIE, 2020) across the proposal site indicates that a number of local soil types have potential salinity hazard associated with them (as discussed in section 4.2.3). These appear most prevalent in the northern half of the proposal site, particularly from Wagga Wagga north, but localised salinity hazards cannot be discounted from soils in the south of the proposal site.

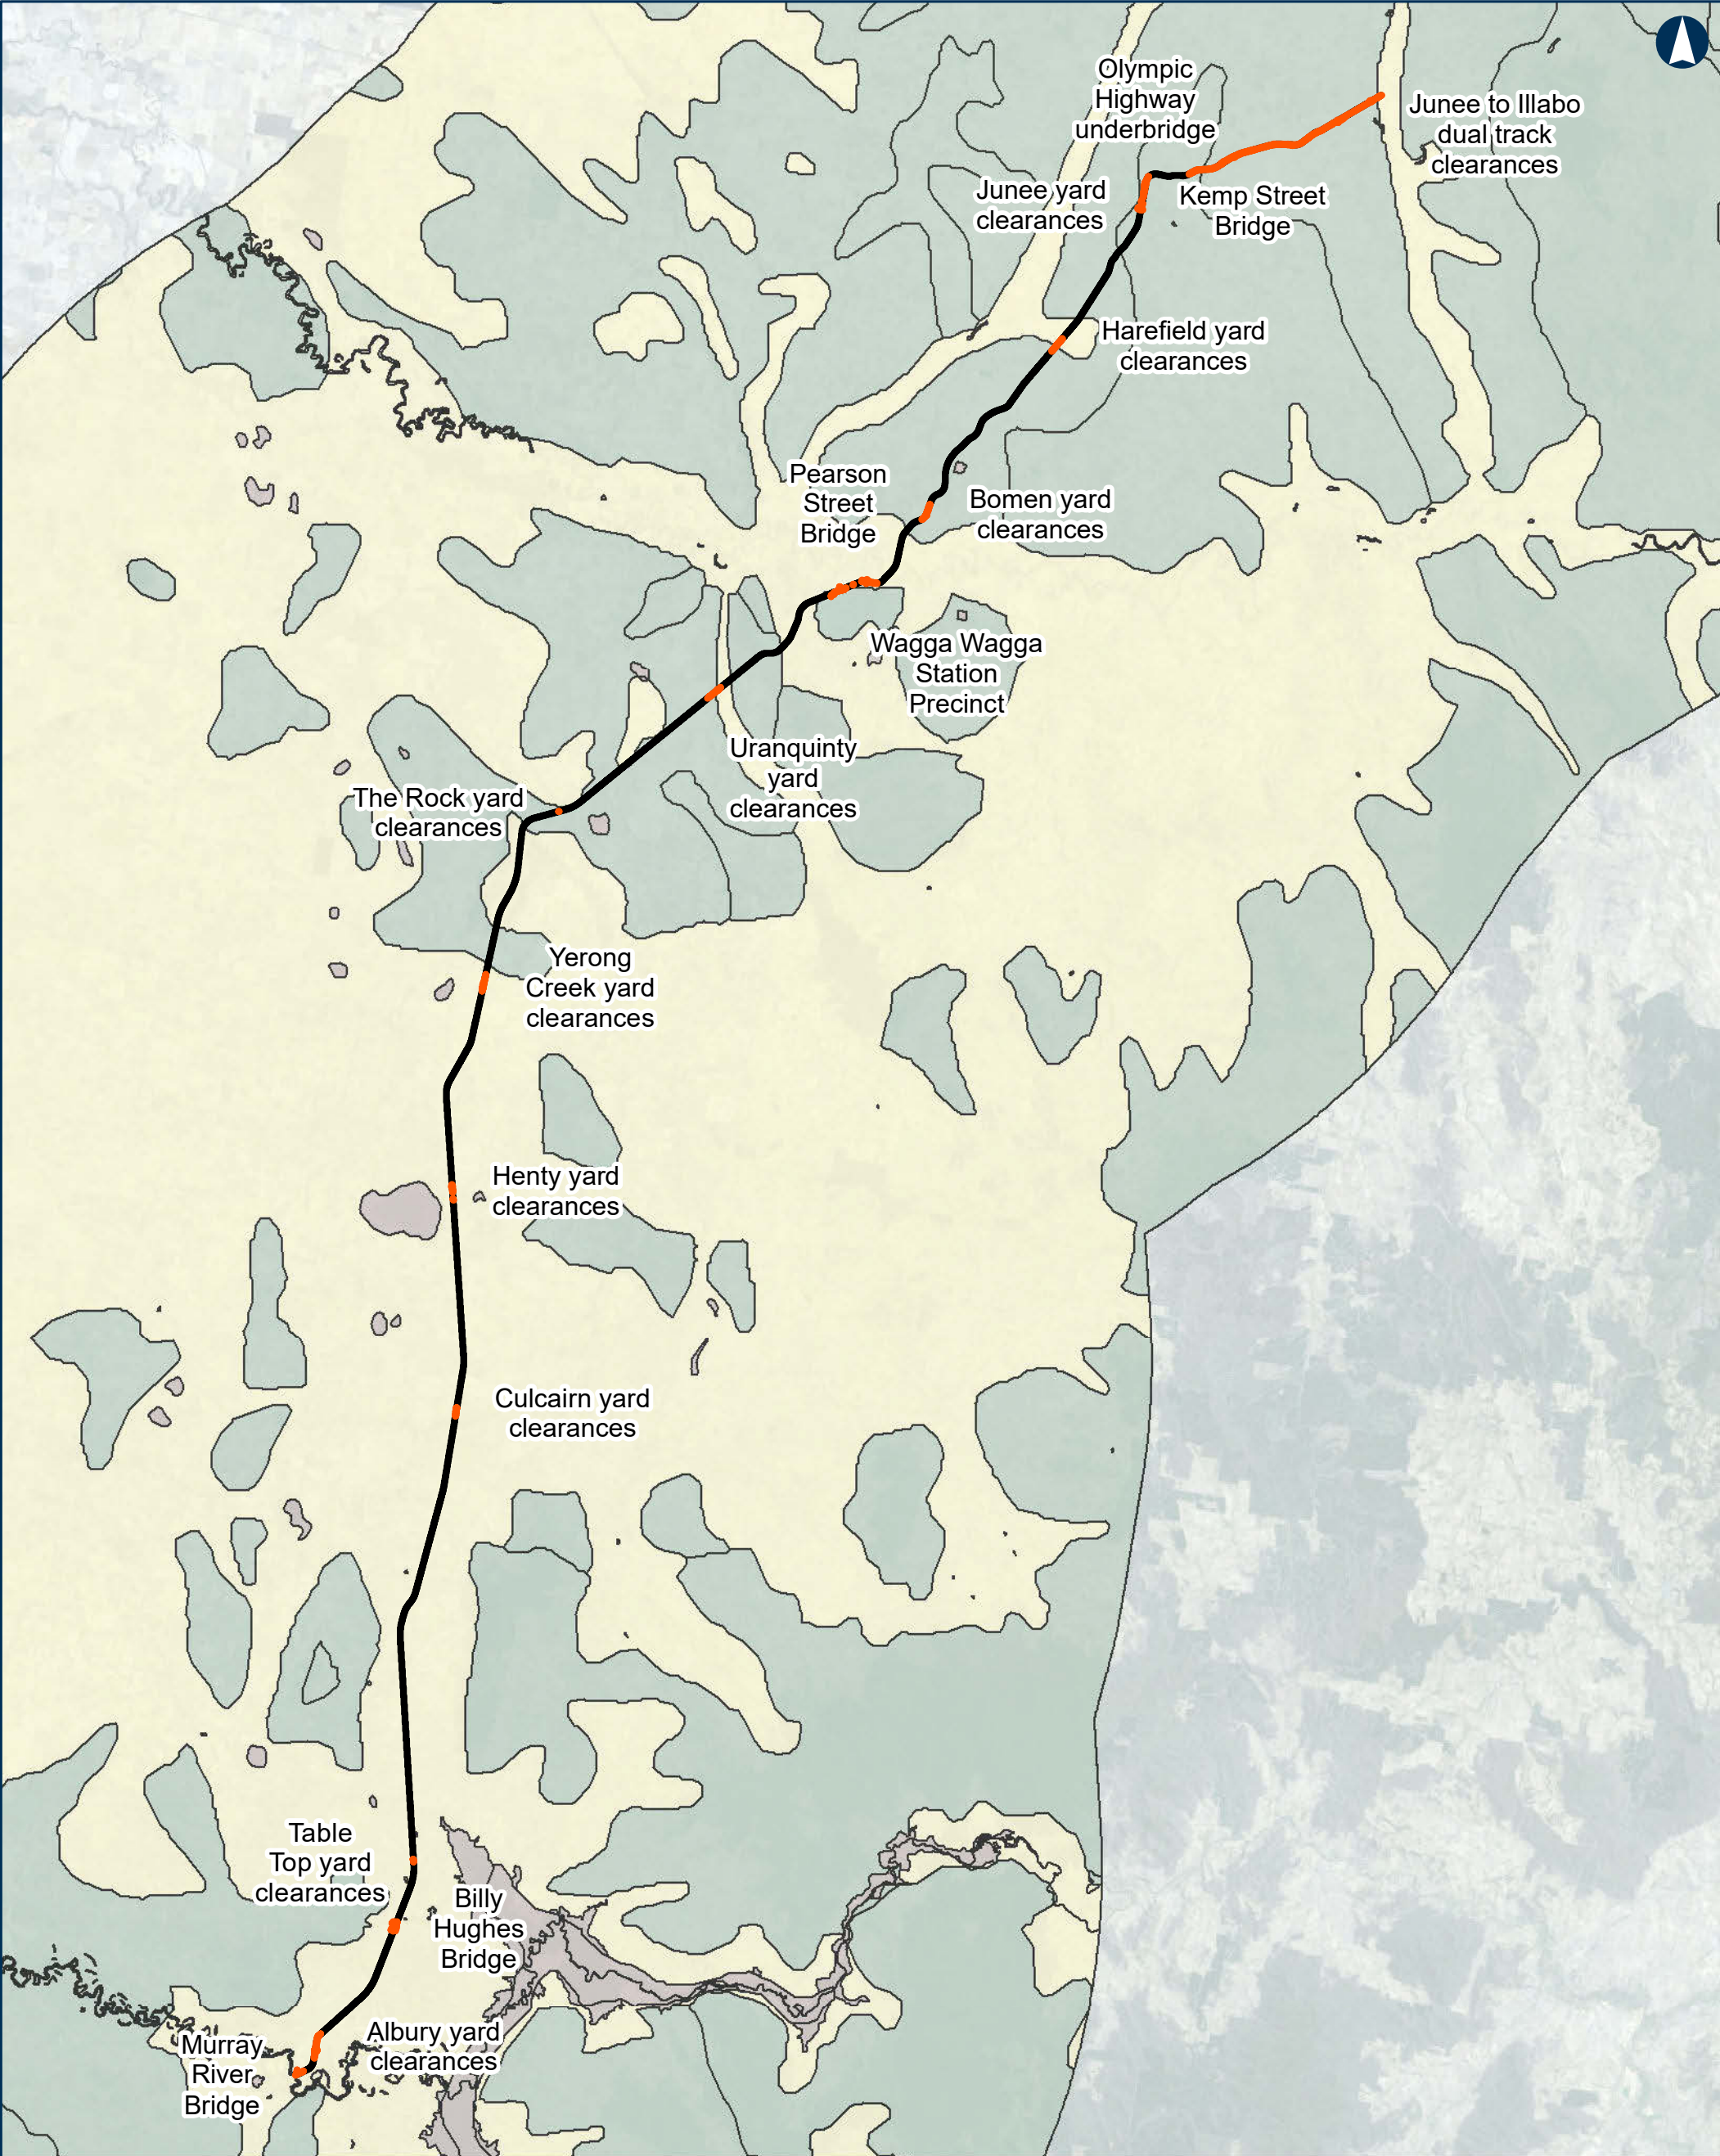
**APPENDIX A-4**  
**FIGURE 4 – ACID SULFATE**  
**SOIL MAPPING**

Soils in the vicinity of Murray River bridge are identified as containing potential acid sulfate soil (such as sediments below the water table at Murray River bridge). The potential for sulfidic rock may also occur within the proposal site. In addition, the majority of regional soils are associated with some localised potential salinity hazard.

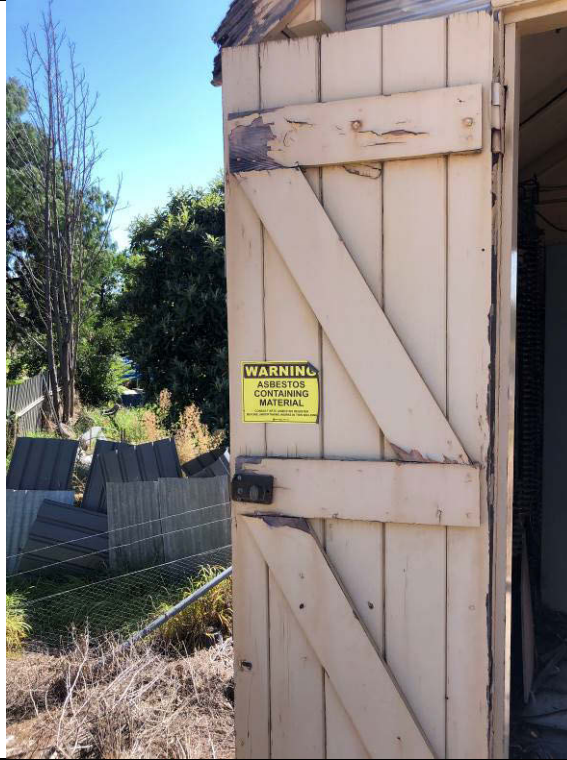
Murray River Bridge – Building containing asbestos (AEC 1)

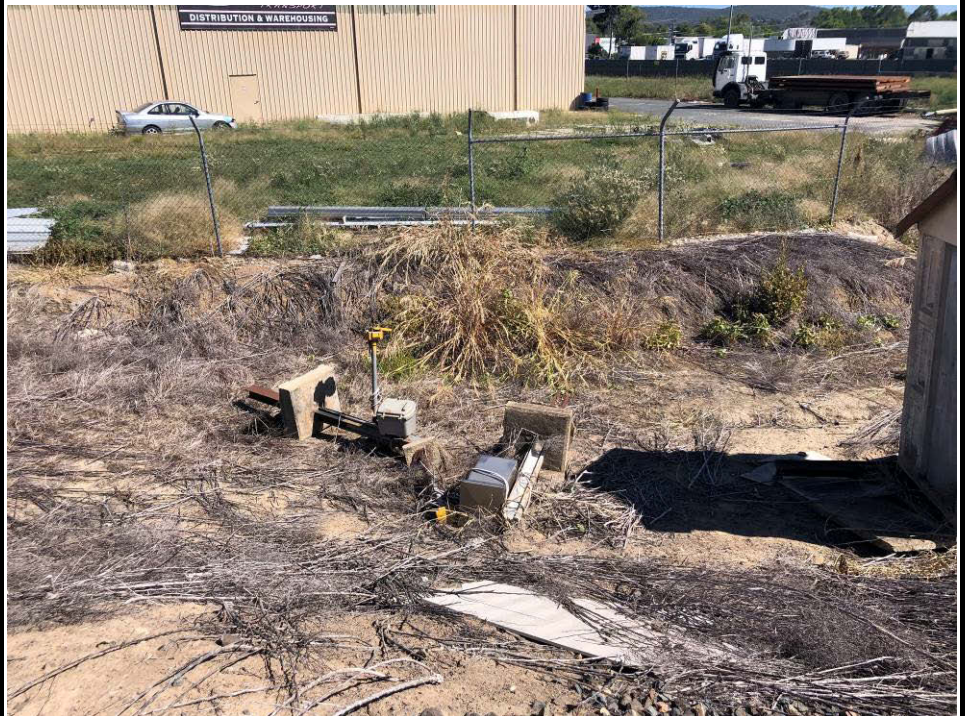
2

Murray River Bridge – Dumped waste (AEC 2)

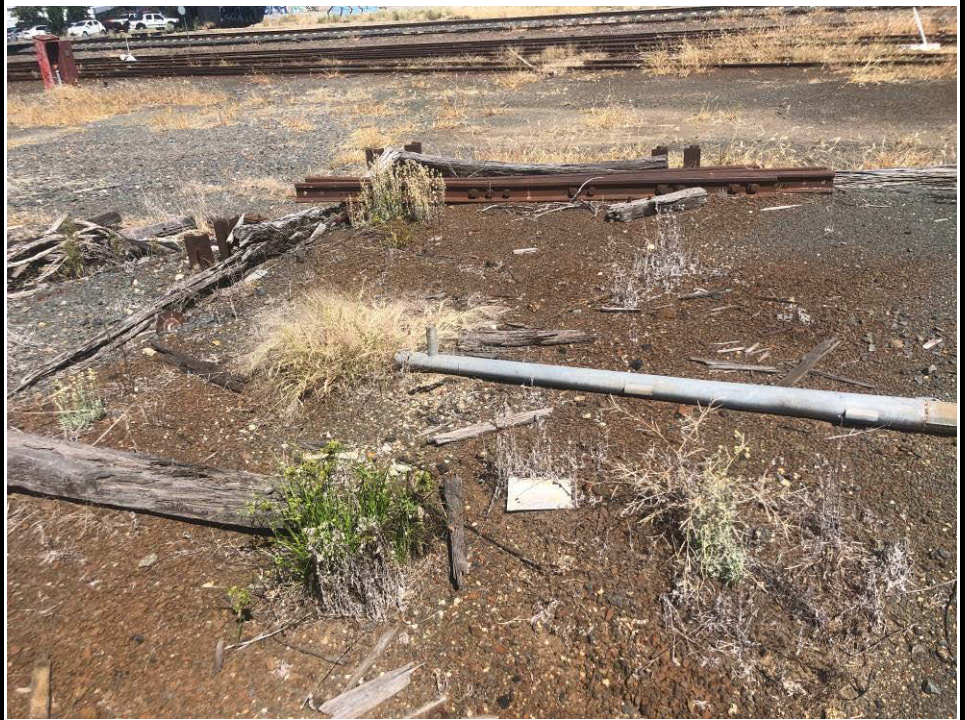
Albury Precinct - Piles of waste  
(AEC 7)

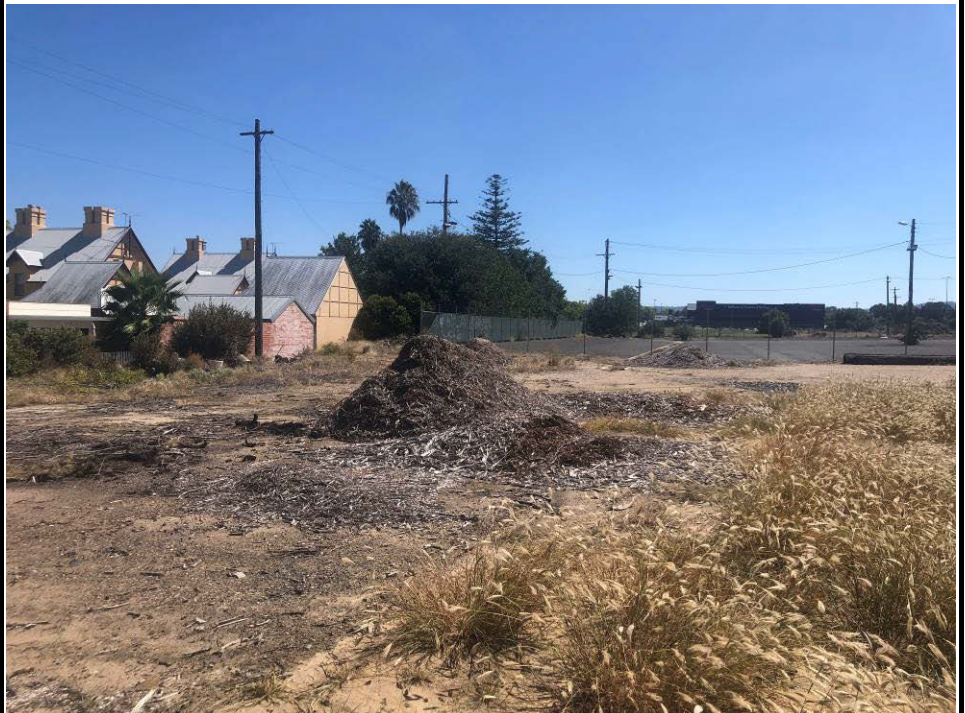
4

Albury Precinct - Piles of waste,  
including ballast (AEC 7)

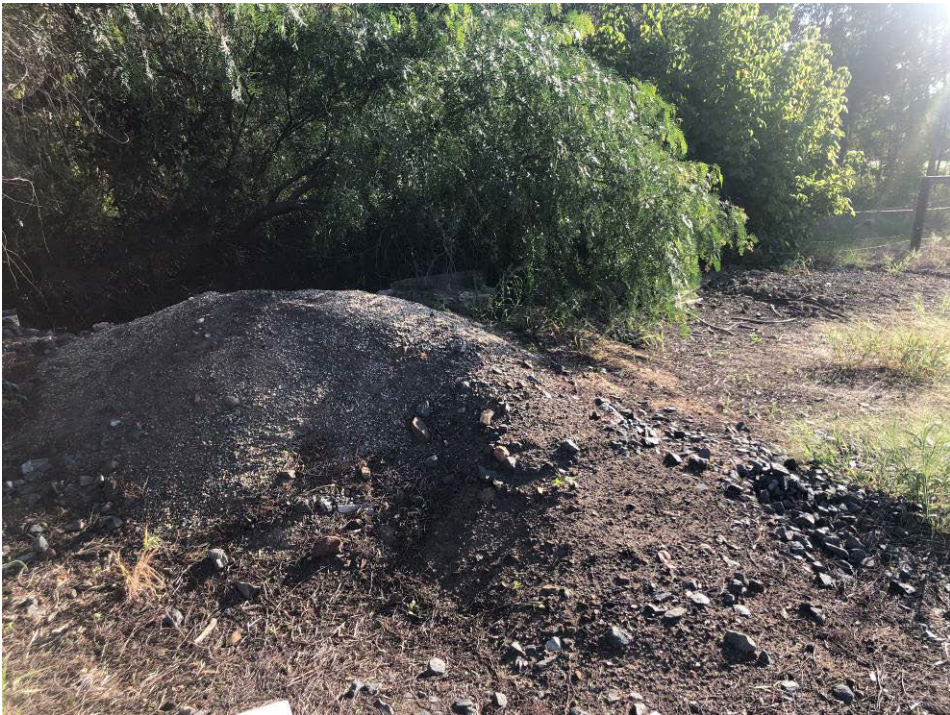
| 5 | 22/02/21 | |

| Culcairn Year Clearances -<br>Ballast stockpiles (AEC 14) | | |

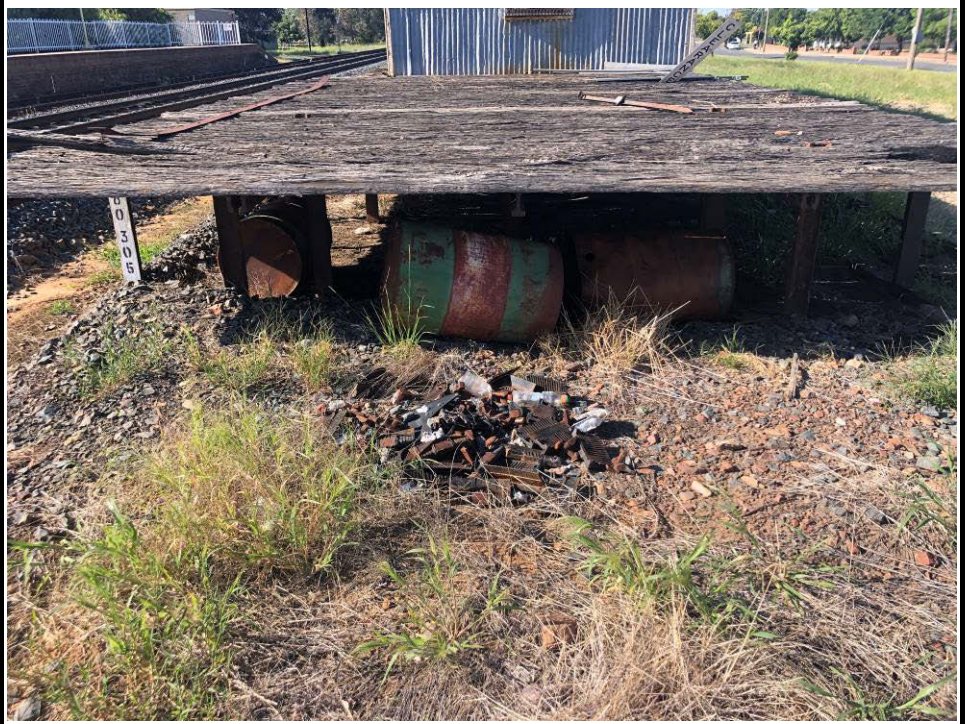
Henty Yard Clearances -  
Dumped metal drums (AEC 18)

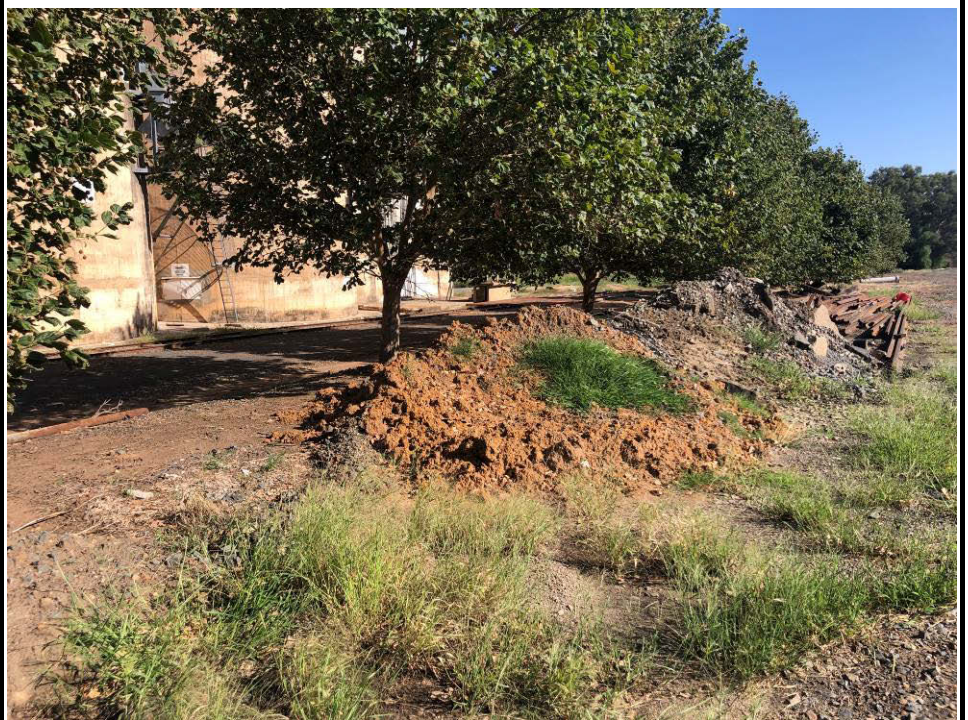
7

Henty Yard Clearances -  
Stockpiles of soil and ballast  
(AEC 17)

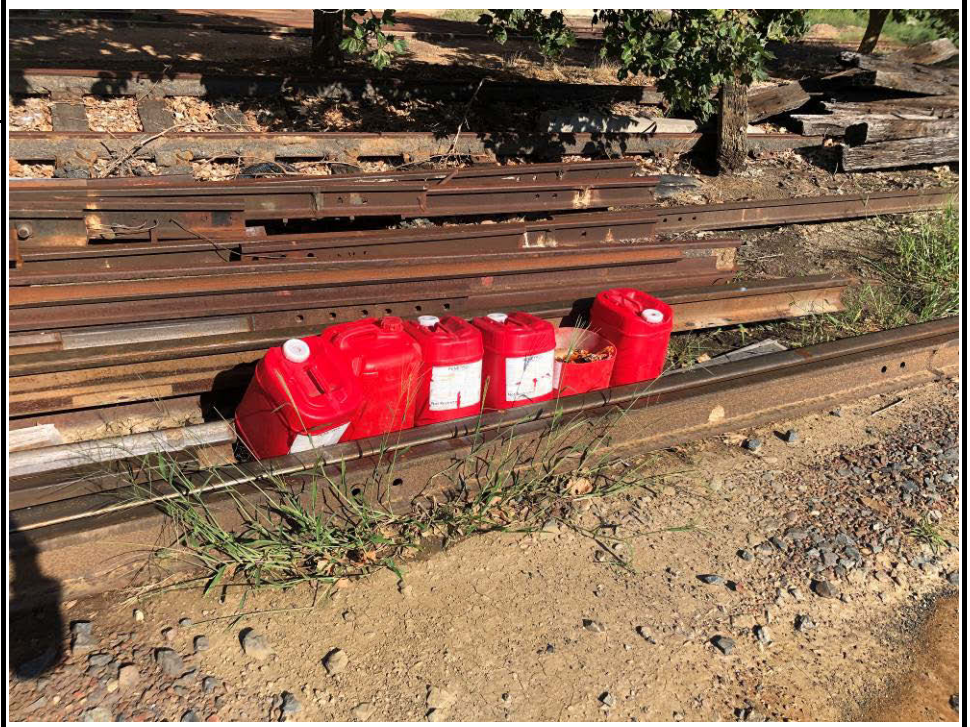
Henty Yard Clearances - Soil stockpiles, Chemical (Penetrol) storage and sleepers (AEC 16)

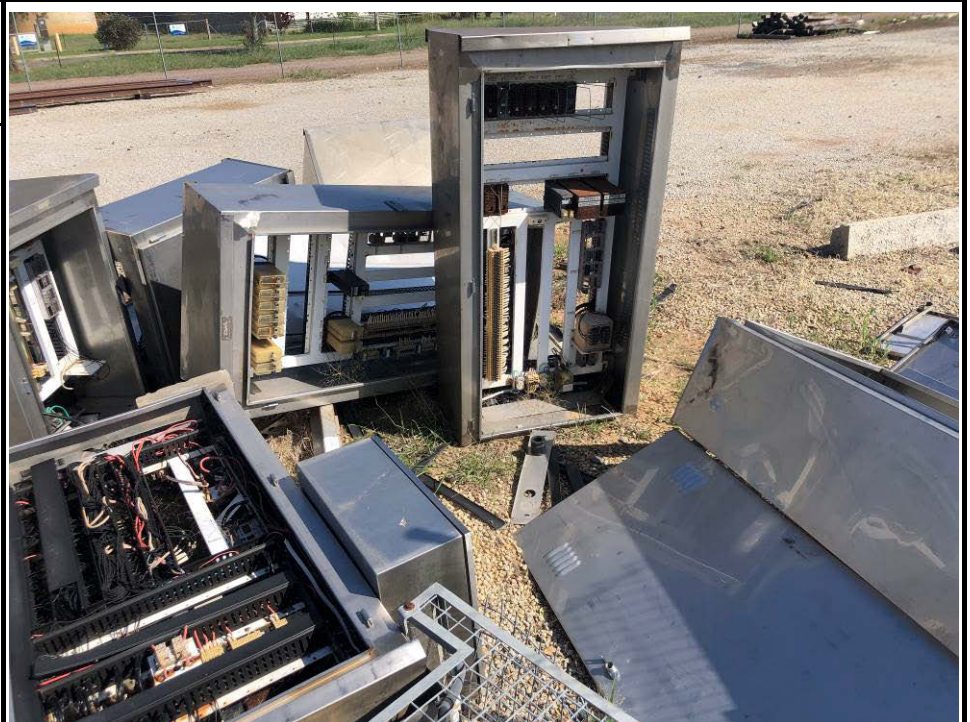
9

Yerrong Creek Yard Clearances - Storage of old electronic equipment including signal boxes, metal, pipes and ladders (AEC 22)

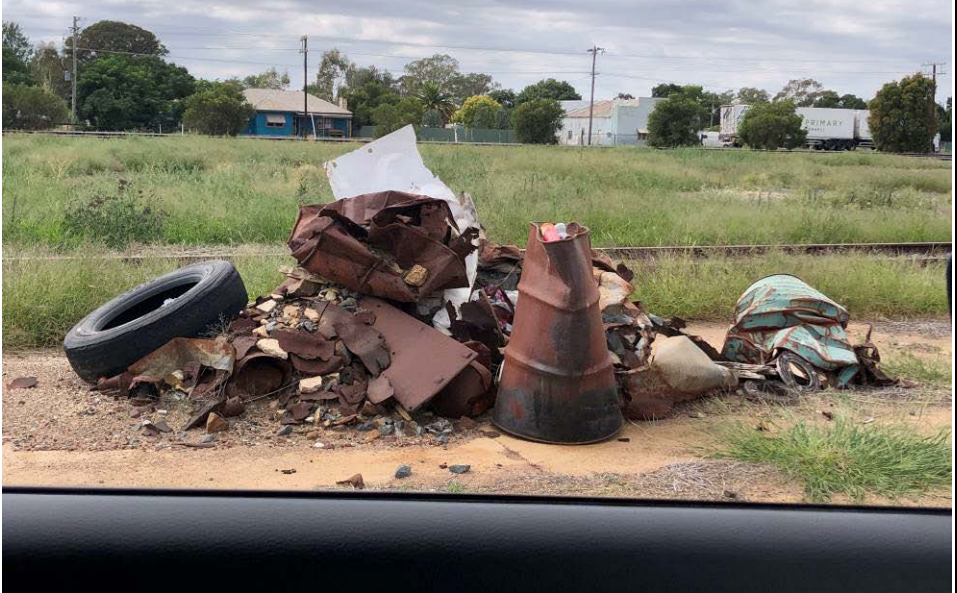
| Photo No. | Date | |
|---|---|---|
| 10 | 23/02/21 | |

| Photo No. | Date | |
|---|---|---|
| <b>Description</b><br><br>Henty Yard Clearances - Metals drums, tires and other debris stored (outside of site areas) AEC 21) | | |

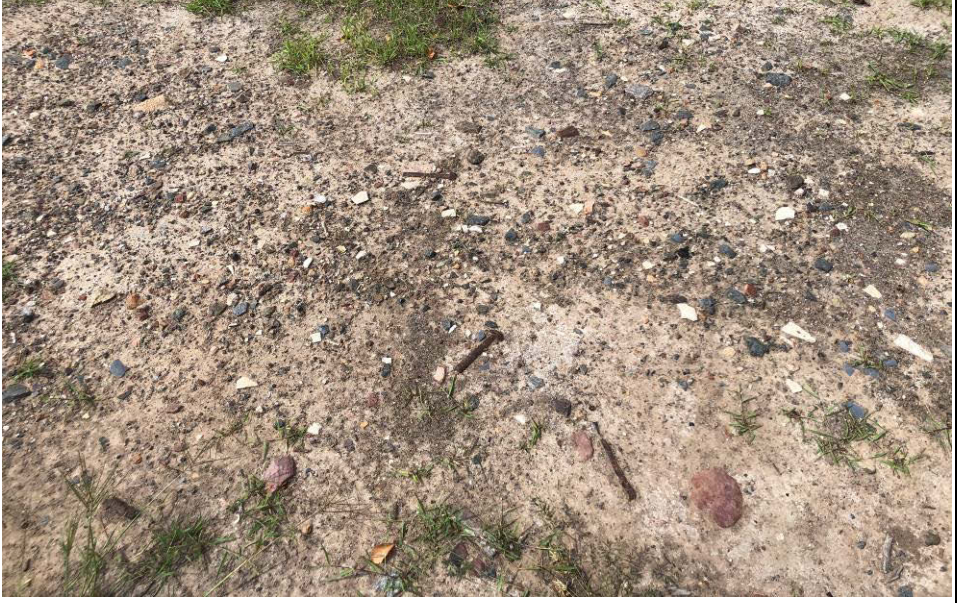
| Photo No. | Date | |
|---|---|---|
| 11 | 23/02/21 | |

| Photo No. | Date | |
|---|---|---|
| <b>Description</b><br><br>The Rock Yard Clearances - Potential ACM, glass and metal on the site surface (AEC 27) | | |

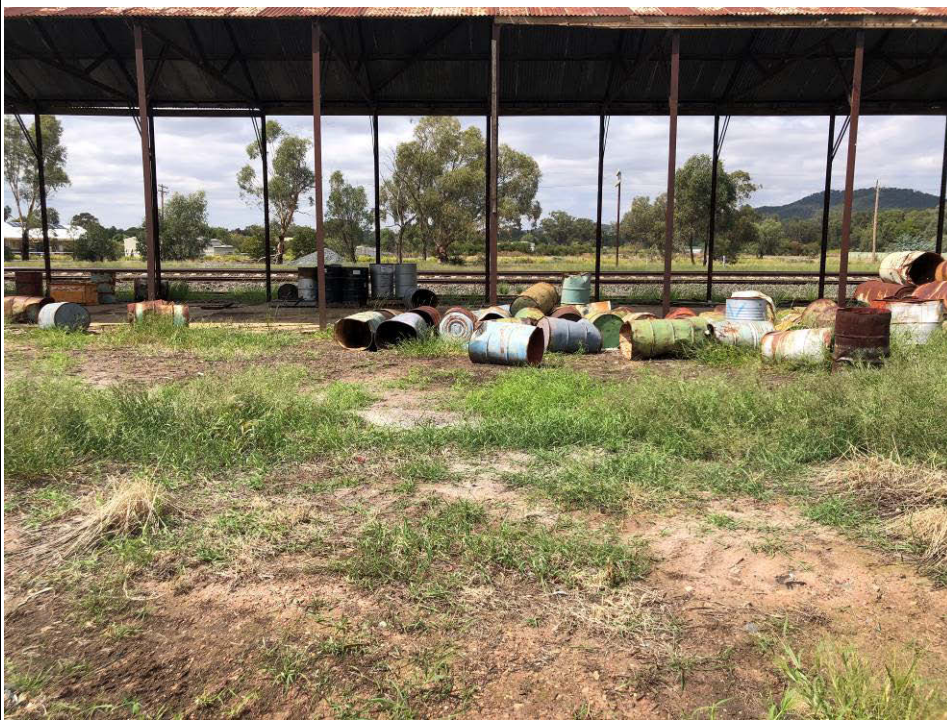
| Photo No. | Date | |
|---|---|---|
| 12 | 23/02/21 | |

| Photo No. | Date | |
|---|---|---|
| The Rock Yard Clearances -<br>Dumped metal drums (AEC 26) | | |

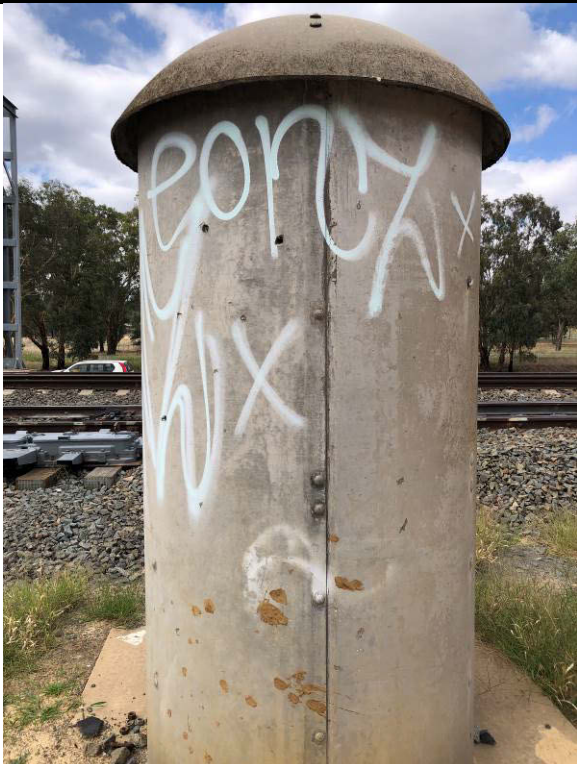
| Photo No. | Date | |
|---|---|--|
| The Rock Yard Clearances –<br>Potential ACM structure (AEC<br>28) | | |

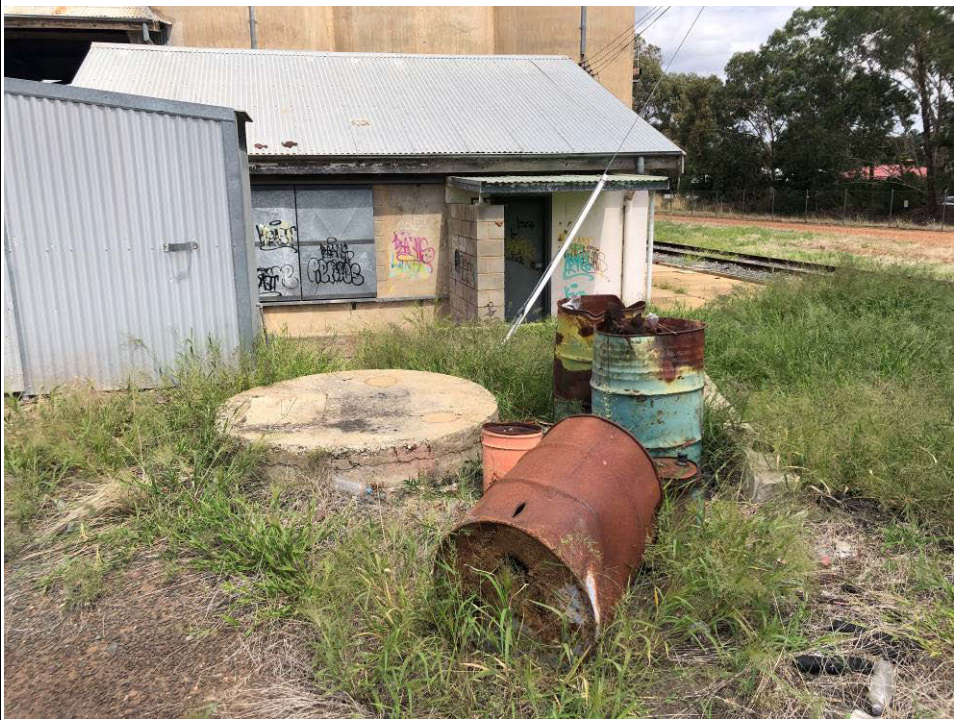
| Photo No. | Date | |
|---|---|---|
| 12 | 23/02/21 | |

| Photo No. | Date | |
|---|---|---|
| <b>Description</b><br><br>Uranquity Yard Clearances -<br>Dumped metal drums (AEC 29) | | |

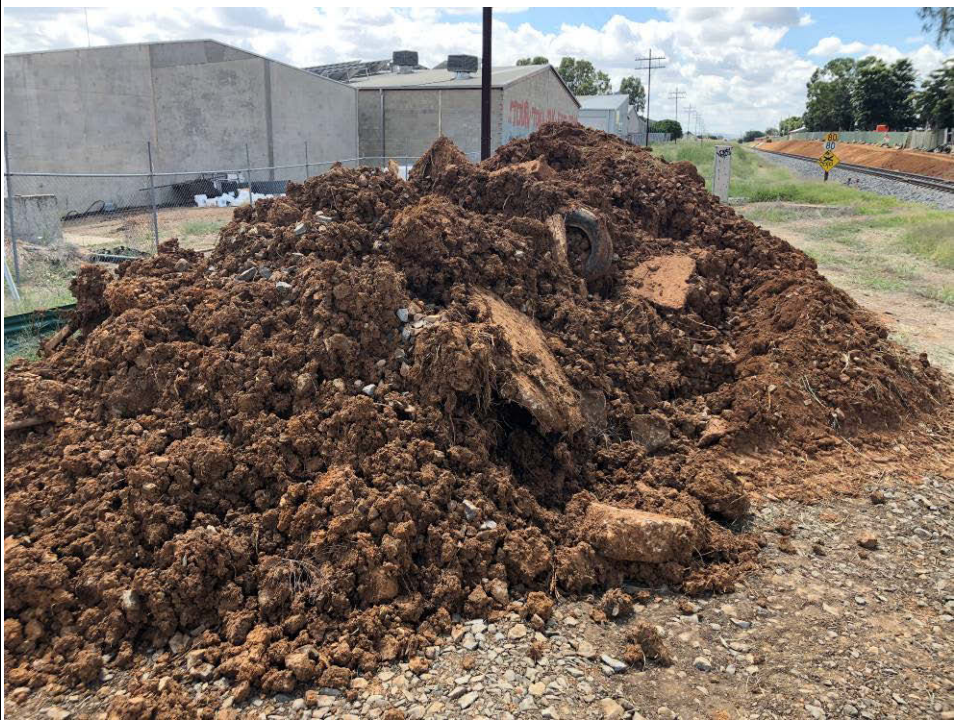
| Photo No. | Date | |
|---|---|---|
| 13 | 23/02/21 | |

| Photo No. | Date | |
|---|---|---|
| <b>Description</b><br><br>Pearson Street Track Lowering -<br>Potential ACM on the ground<br>surface and fill containing<br>anthropogenic material (AEC 33) | | |

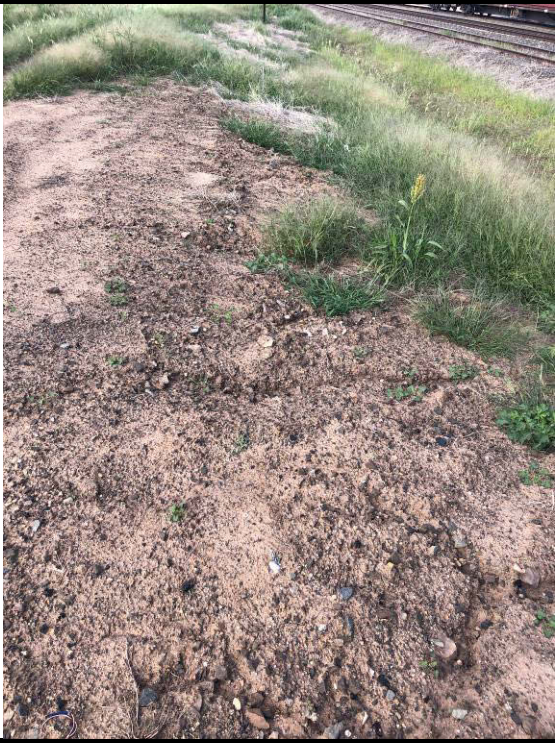
| Photo No. | Date | | |
|---|---|--|---|
| 14 | 23/02/21 | | |

| Photo No. | Date | | |
|---|---|--|---|
| <b>Description</b><br><br>Harefield Yard Clearances - Potential ACM and glass, ceramic, ballast and plastic on the site surface (AEC 41) | | | |

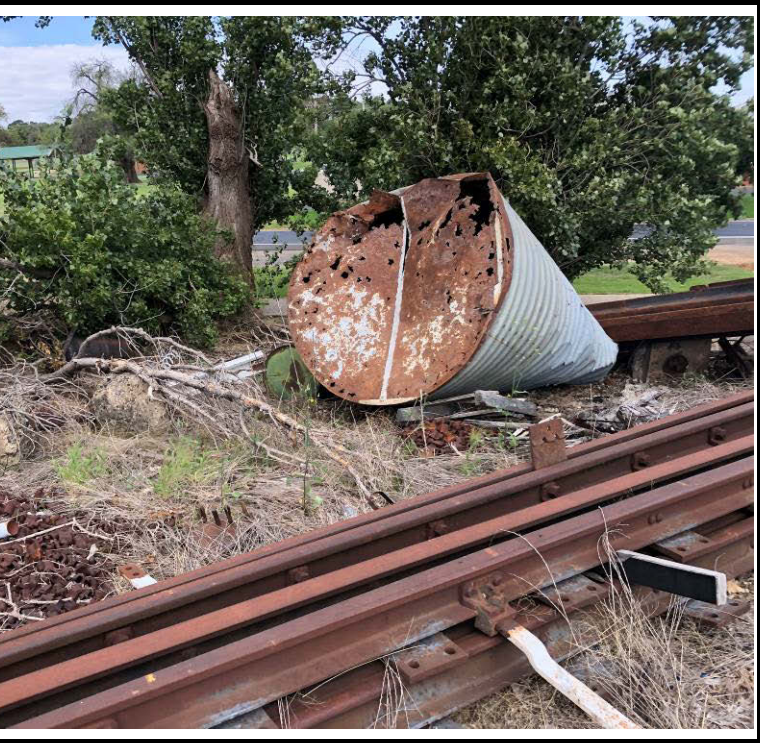
| Photo No. | Date | | |
|---|---|--|---|
| 15 | 23/02/21 | | |

| Photo No. | Date | | |
|---|---|--|---|
| <b>Description</b><br><br>Kemp Street Bridge and Junee Yard clearances - Dumped metals drums, sleepers and scrap metal (AEC 43) | | | |

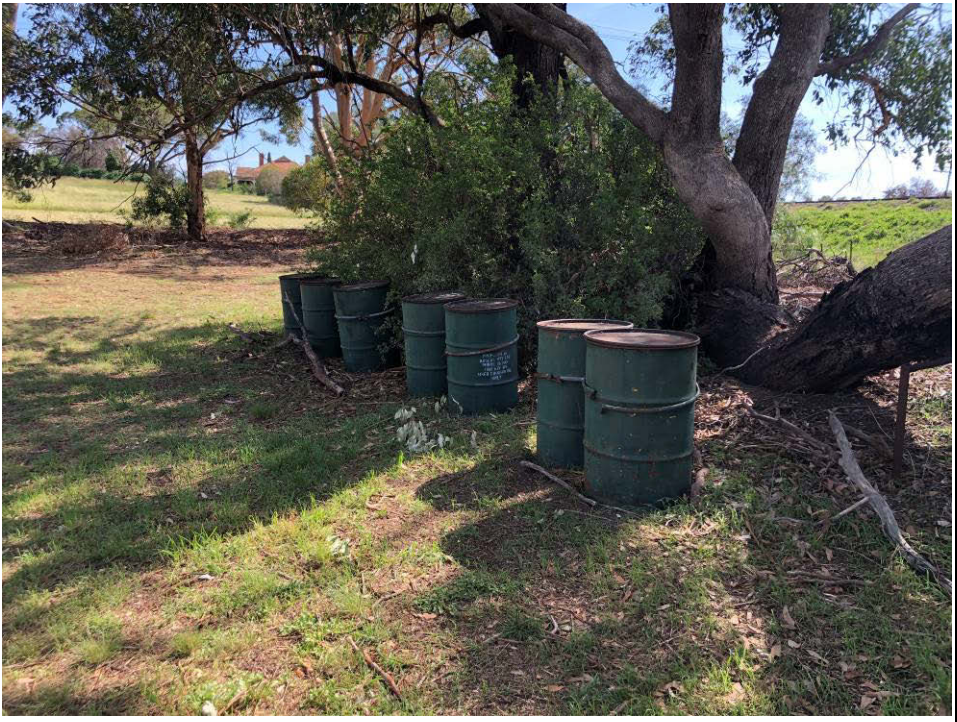
| Photo No. | Date | |
|---|---|---|
| 16 | 24/02/21 | |

| Photo No. | Date | |
|---|---|---|
| <b>Description</b><br><br>Olympic Highway Underbridge - Shell service station with drums labelled as cooking oil stored close to the tracks (AEC 33) | | |
