**OVEN MOUNTAIN PUMPED HYDRO
ENERGY STORAGE EIS**

Aquatic ecology impact assessment

Oven Mountain Pumped Hydro Energy Storage Project: Aquatic Ecology Impact Assessment

Prepared for EMM Consulting Pty Ltd | March 2023

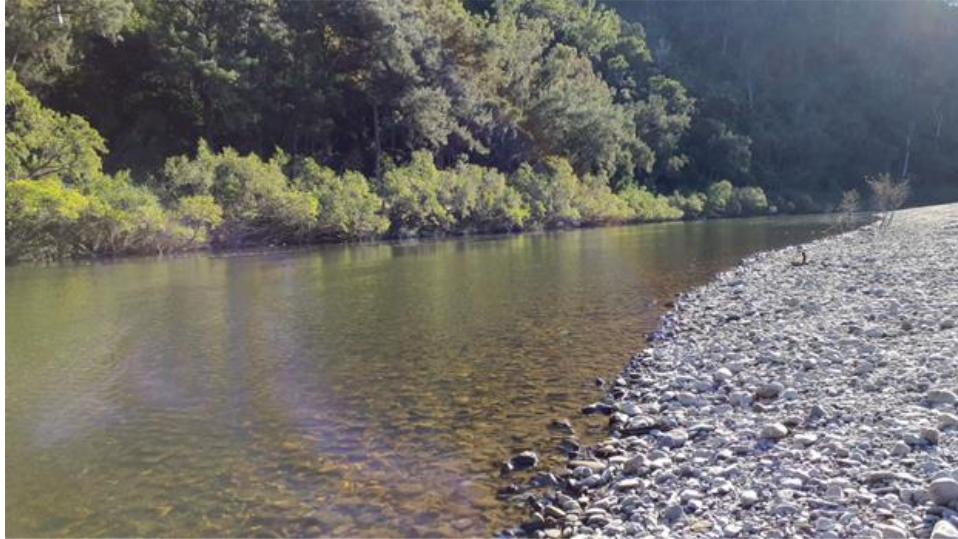
Plate 6-2: Sand and cobble bench, cobble substrate, overhanging riparian vegetation at Macleay River site MR01, June 2022.

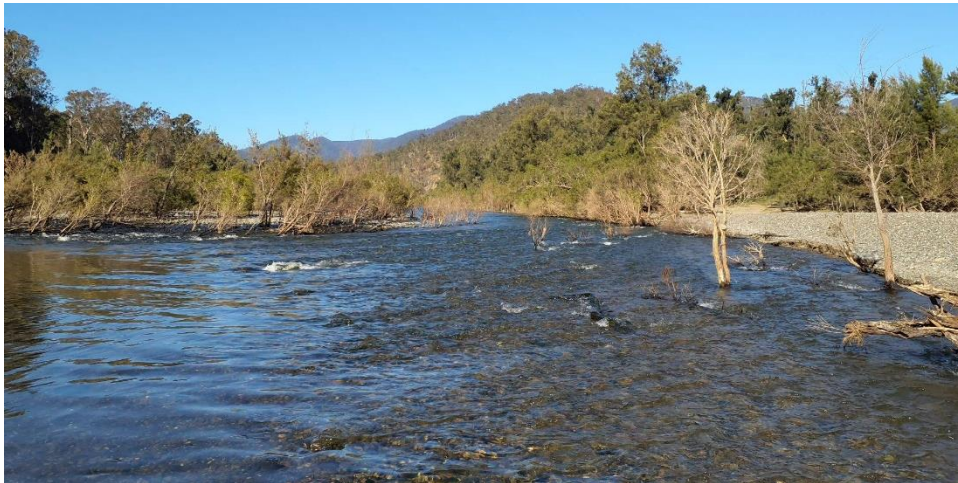
Plate 6-3: Riffle habitat at MR09.

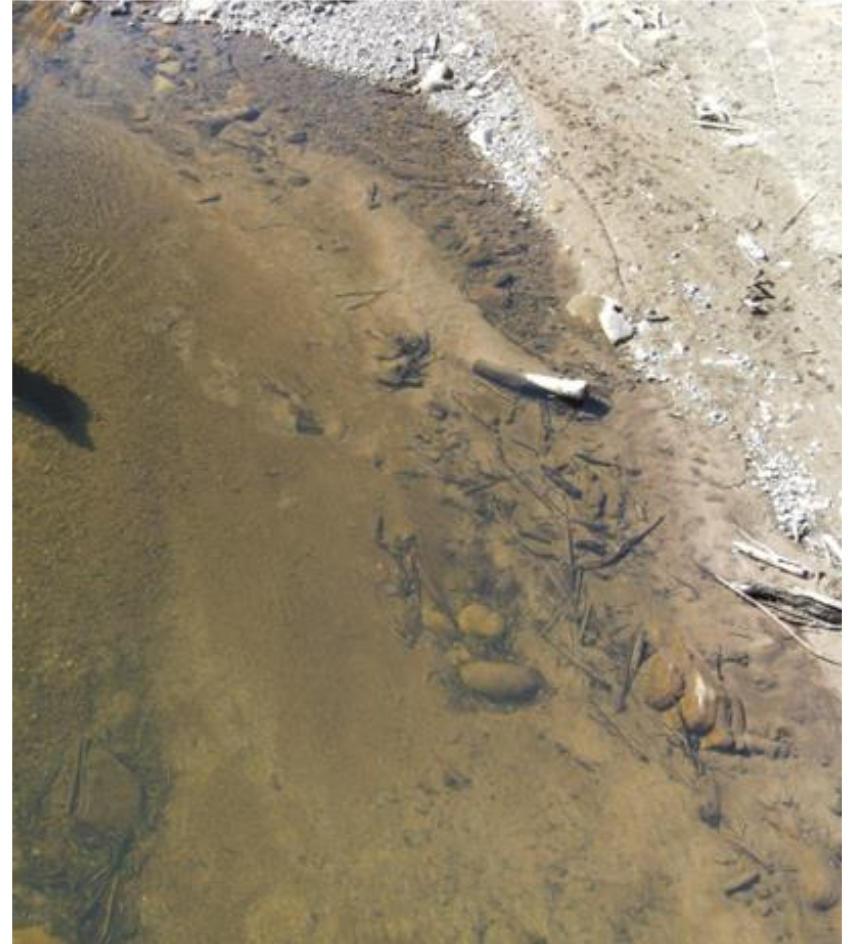
Plate 6-4: Fine sediment and detritus deposited along the banks of the Macleay River, June 2022.

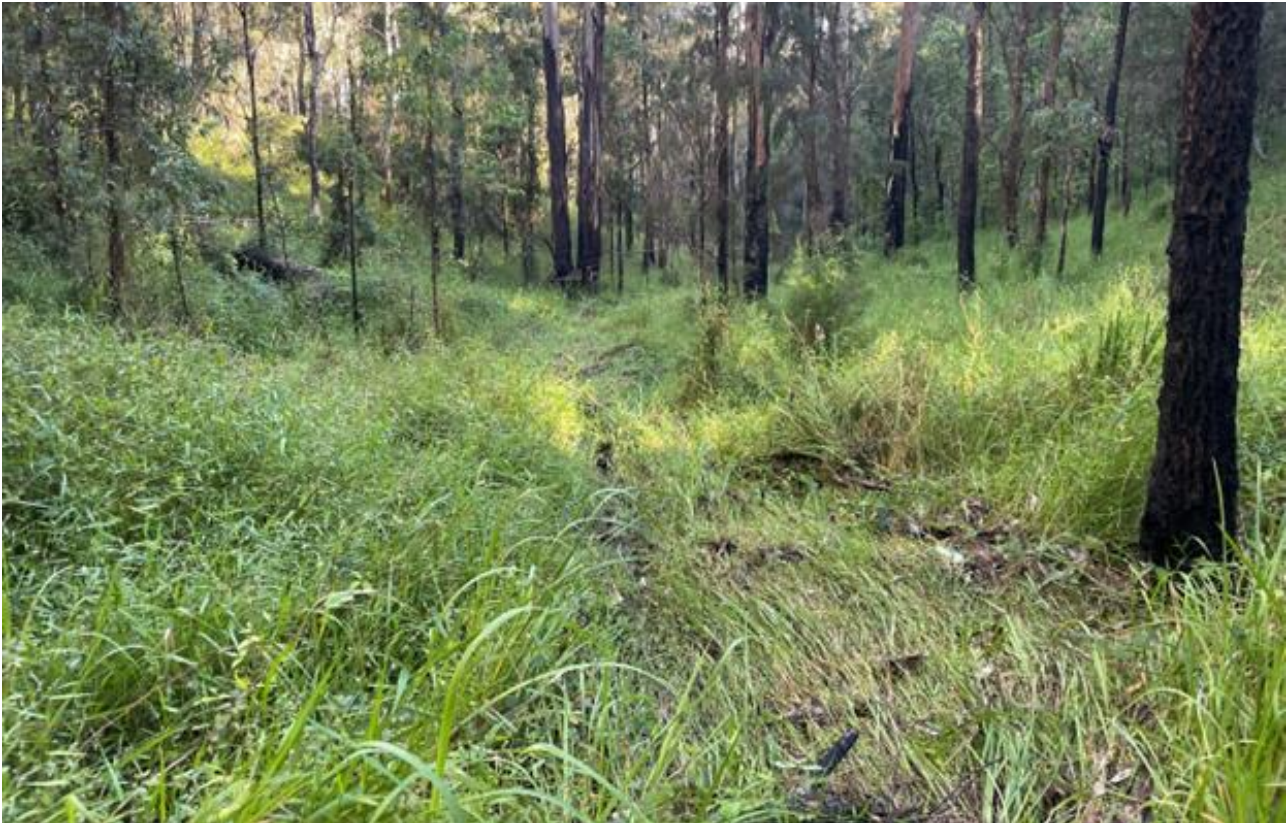
Plate 6-5: Flattened grass, showing recent flow, within the waterway channel at site UW06-01.

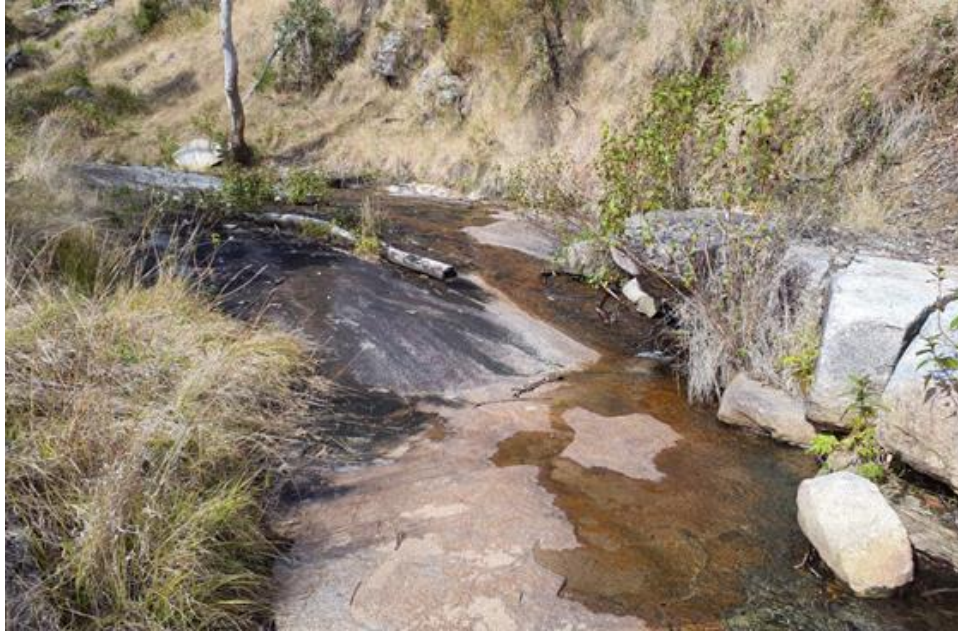
Plate 6-7: Bedrock channel at site UW08-01.

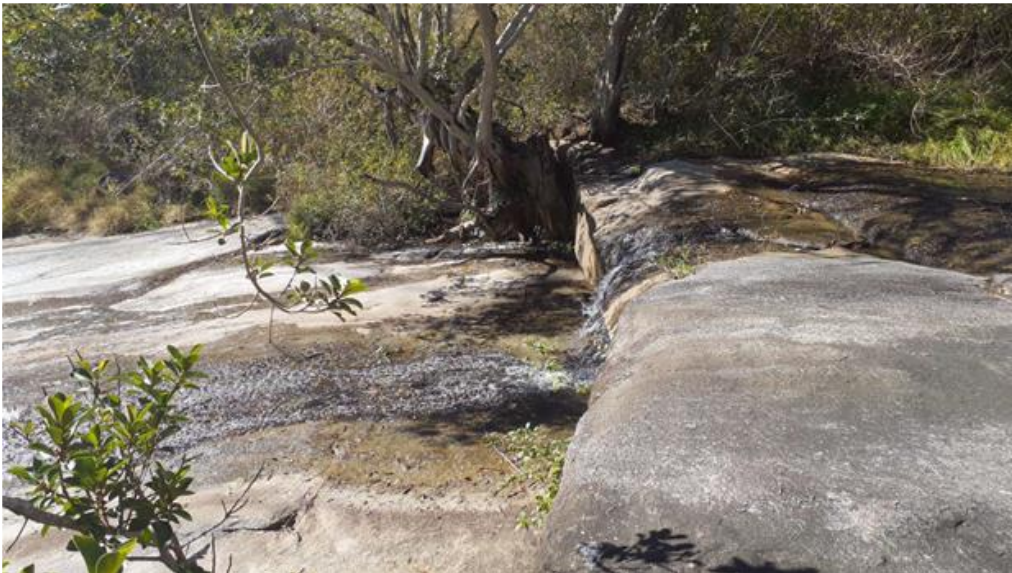
Plate 6-10: Stepped bedrock channel at site UW24-01.

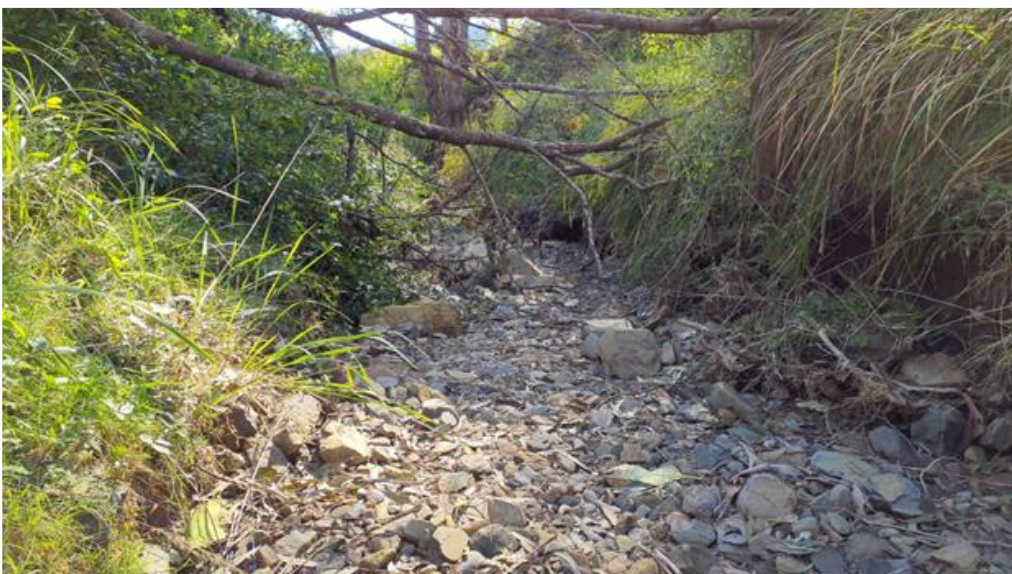
Plate 6-11: Cobble substrate at site UW27-01.

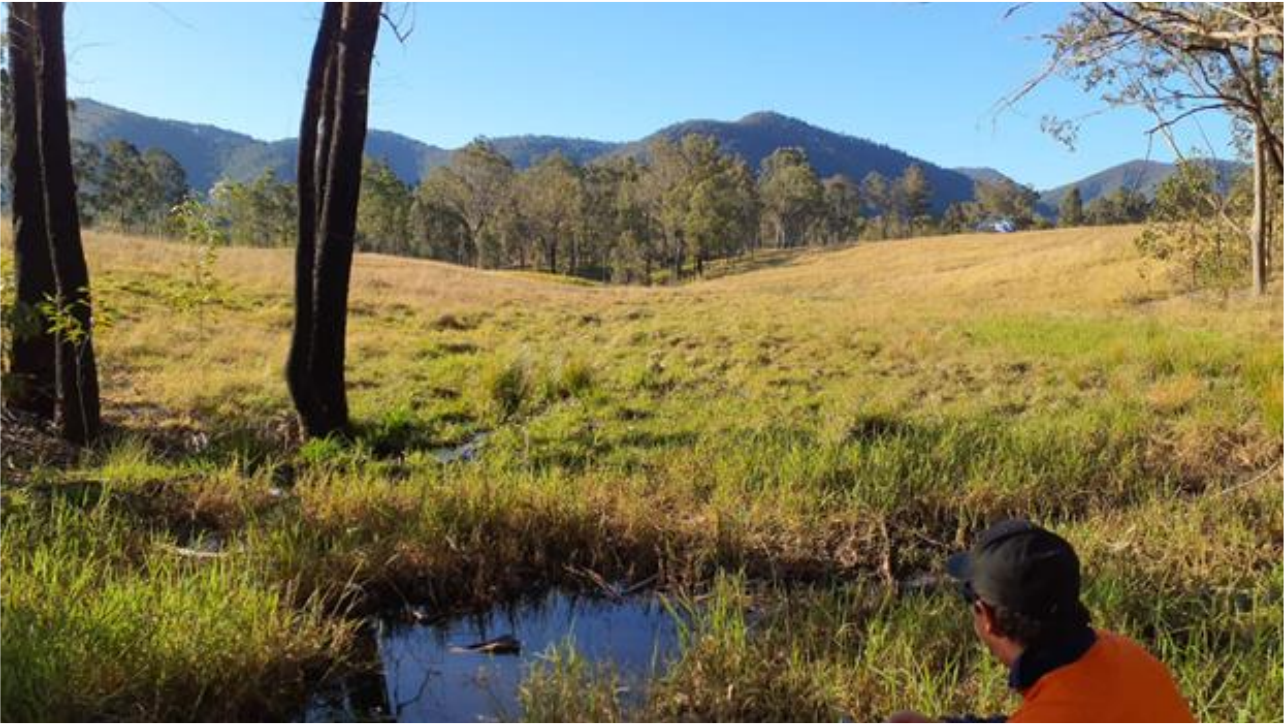
Plate 6-12: Isolated pools within an exotic grass swale at site UW35-01, draining to the Macleay River.

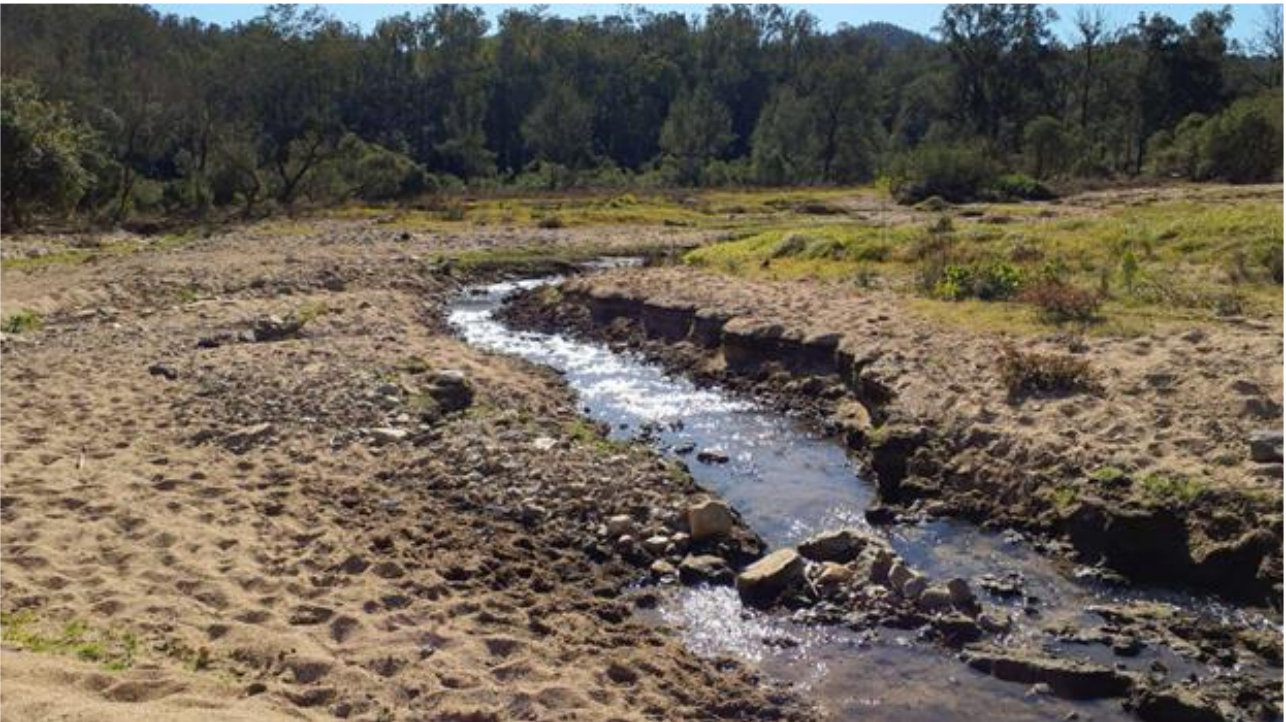
Plate 6-13: Alluvial material transported from upstream to the Macleay River channel, downstream of site UW26-01.

A number of sites that were dry at the time of the field surveys showed evidence of short duration high flow including debris trapped high in trees, and alluvial material deposition within the riparian zone, comprising predominantly Weeping Bottlebrush, and flood channel of the Macleay River, downstream of the tributary (Plate 6-13). This was common along the waterways traversed by the proposed Eastern Access Road and denotes the importance of these lower order streams as sources of alluvial material to the Macleay River. Emergent aquatic vegetation was present at a number of sites, comprising *Schoenalectus mucronatus* and *Juncus* sp.. Of the Eastern Access Road waterways surveyed, only one of three 4th order and above waterways contained surface water at the time of the field surveys (Carrolls Creek; site CC01).

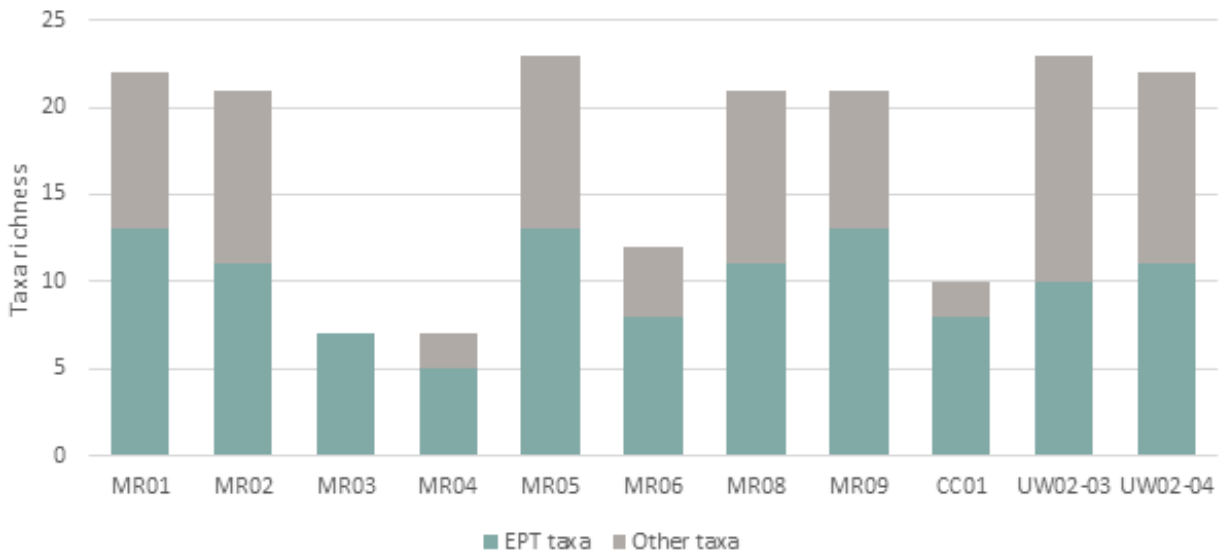
Figure 6-7: Genus-level taxa diversity per site demonstrating proportion of EPT taxa in each sample.

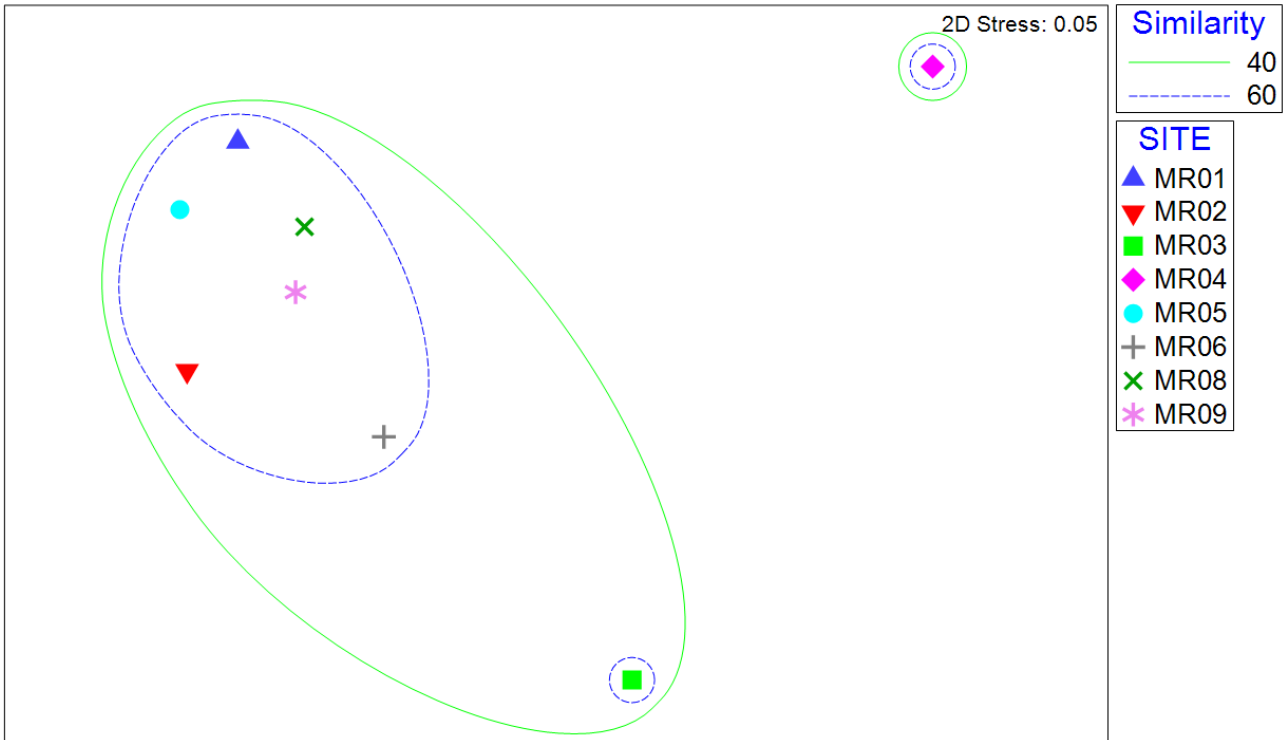
Figure 6-8: nMDS representing similarities in community composition at sites along the Macleay River during the June 2022 field survey.

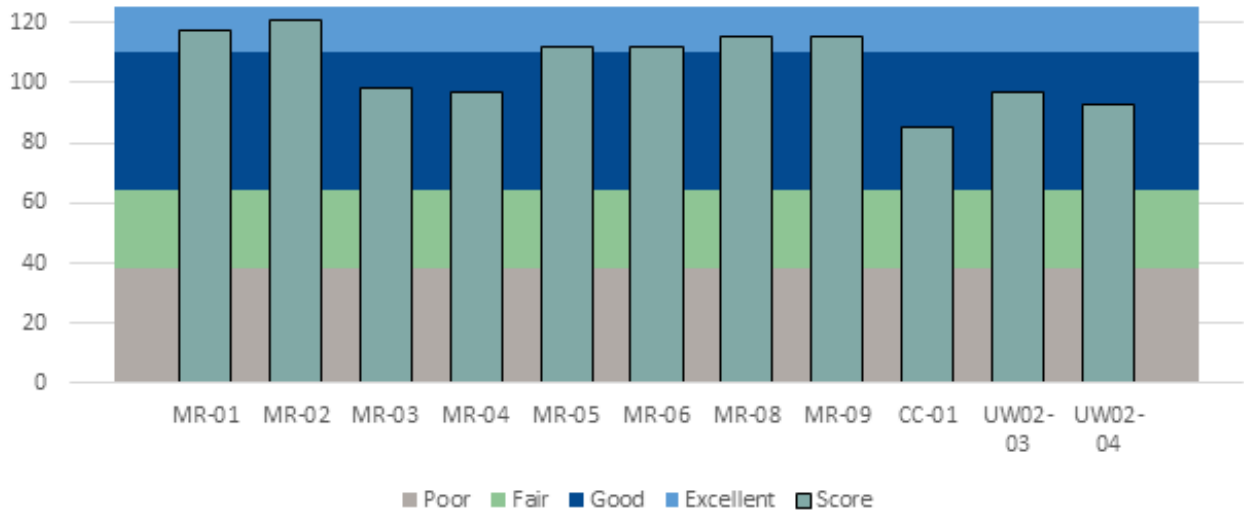
Figure 6-10: River Bioassessment Scores for all sites sampled for macroinvertebrates.

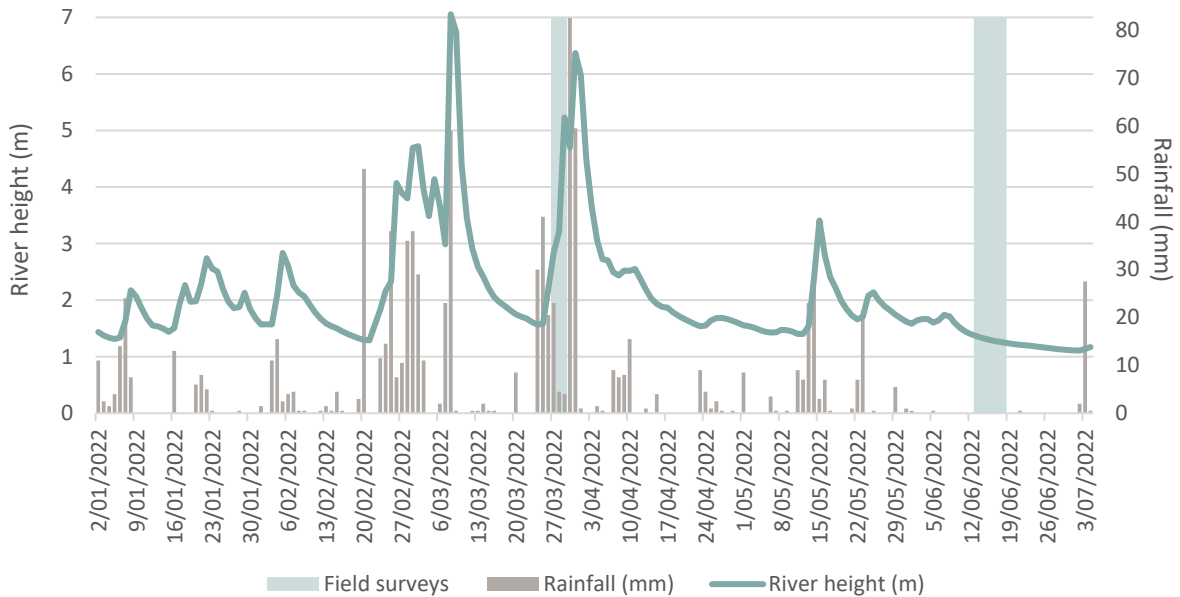
Figure 2 – Rainfall for the period January-July 2022 (Turners Flat) aligned with Macleay River height data (George’s Junction). Data from Water NSW (2022)

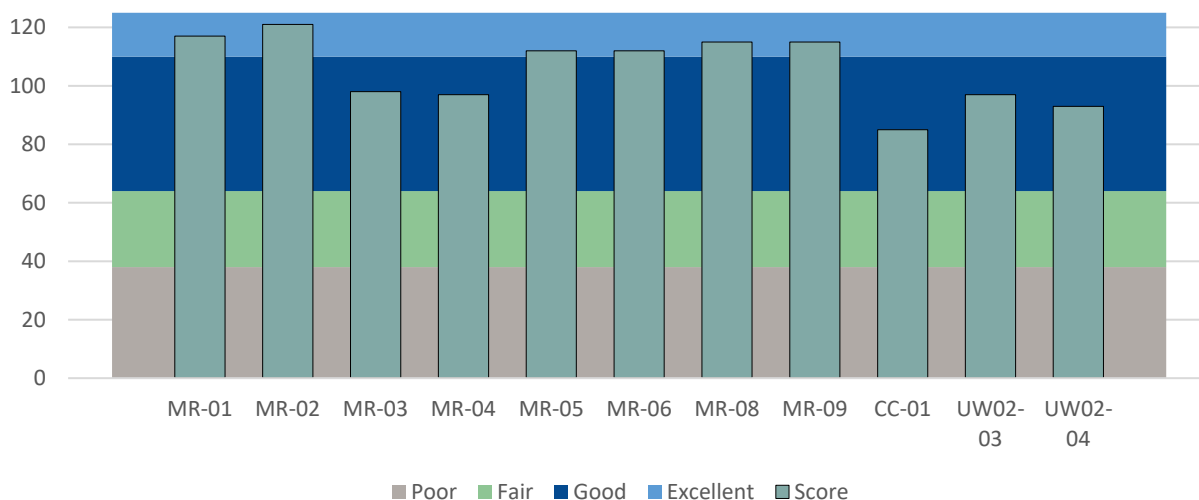
Figure 3 – River Bioassessment Scores for all sites sampled for macroinvertebrates

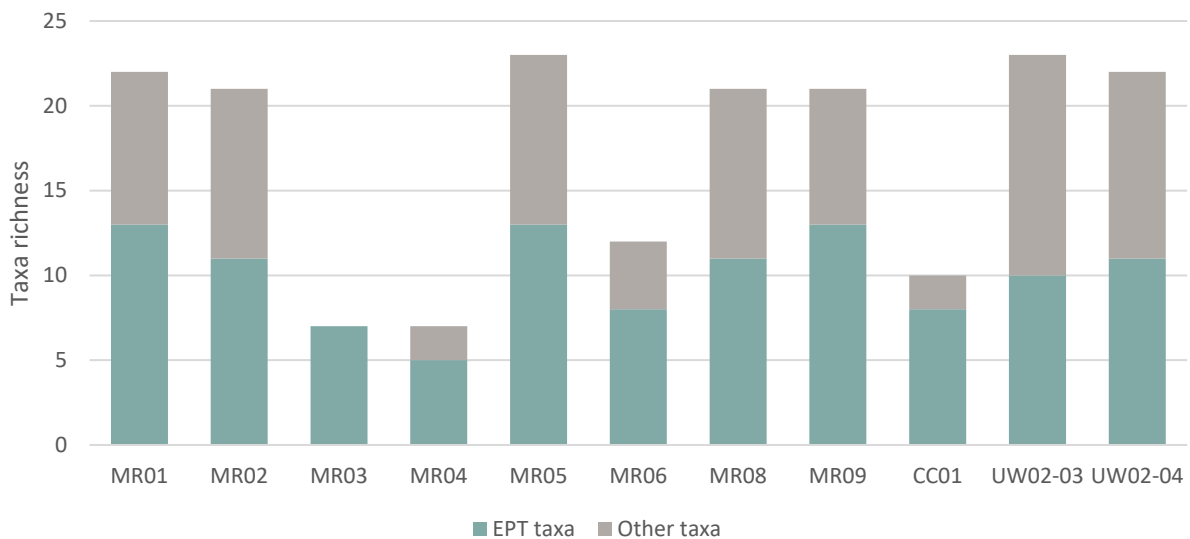
Figure 6 – Genus-level taxa richness of each site demonstrating proportion of EPT taxa in each sample
