OVEN MOUNTAIN PUMPED HYDRO
ENERGY STORAGE EIS

Aboriginal cultural heritage assessment report

Aboriginal Cultural Heritage Assessment

Oven Mountain Pumped Hydro Energy Storage

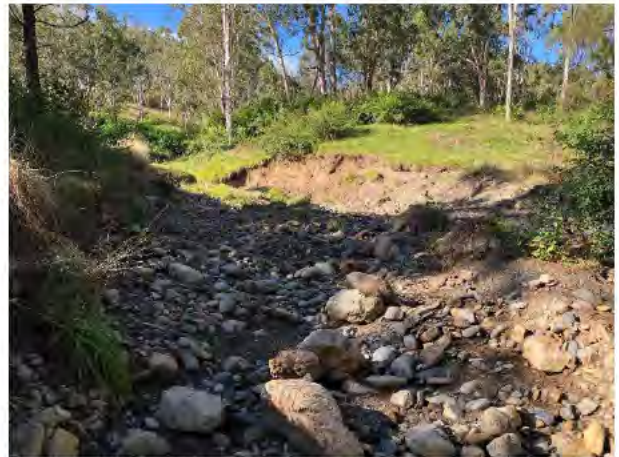
Plate 7.9 Example of high energy flood damage observed in various areas across the Project area, view south east

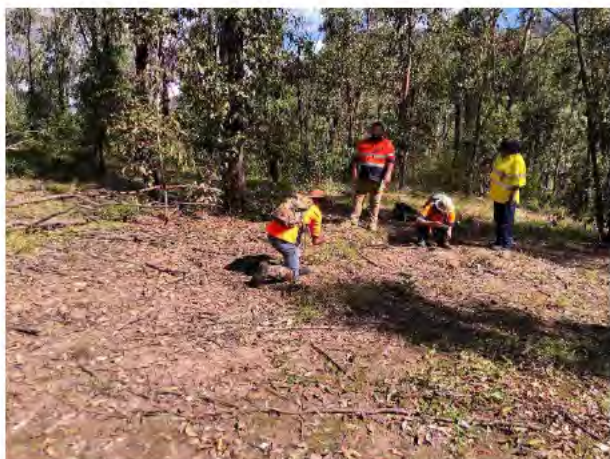
Plate 7.12 AHIMS 21-5-0142, a large artefact scatter identified on a long, relatively flat spurcrest, view south west

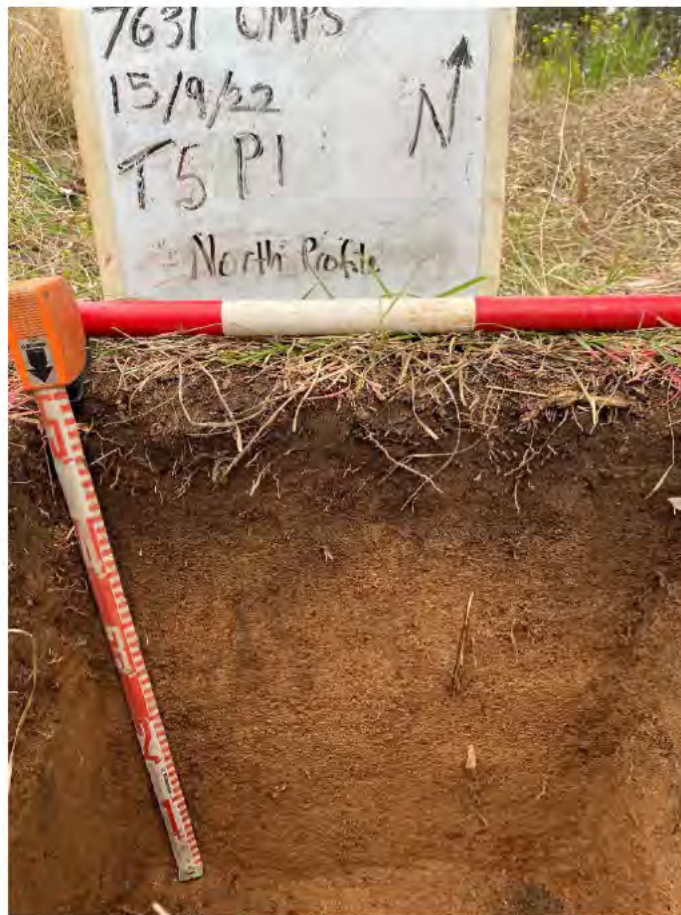
Plate 7.24 Stratigraphy of T5P1, which shows the typical soil profile on spurcrests, spurslopes and hill slopes

The second soil profile is consistent with a recent alluvium that has been deposited during flood and high water levels. The shallow topsoil has formed following the formation of the alluvium and is similarly potentially only decades old. Any artefactual material in this unit has likely either i) been recently deposited, and/or ii) eroded from upslope.

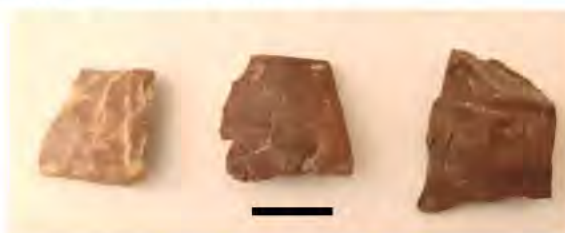
Plate 7.25 Examples of jasper artefacts recovered from T23P1 (id=435), T5P1 (id=84) and T4P13 (id=445) (left to right; scale = 1 cm)

Chronologically, the composition of the assemblage is all suggestive of a late Holocene (<5 ka) age. Artefact types recovered in the assemblage, such as atypical burin-blade cores and blades, are primarily found during this timeframe, with their increasing proliferation in the most recent period. Generally, a higher frequency of quartz is generally associated with a late-Holocene occupation. However, in this Project area, it may also reflect the limited availability of other raw material types immediately available.

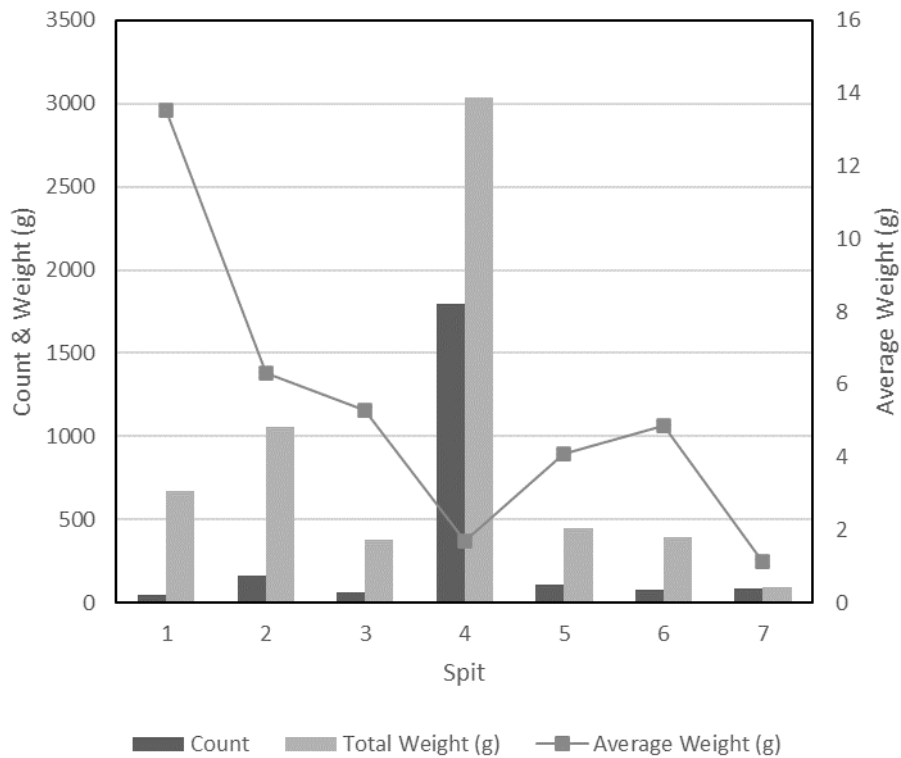
Figure 1 Artefact counts by spit and weight in the OMPS assemblage

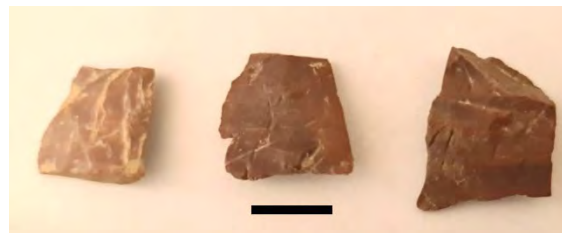
**Figure 2 Examples of red CCQ (jasper) artefacts in T23P1 (id=435), T5P1 (id=84) and T4P13(id=445)
From left to right (scale=1cm)**

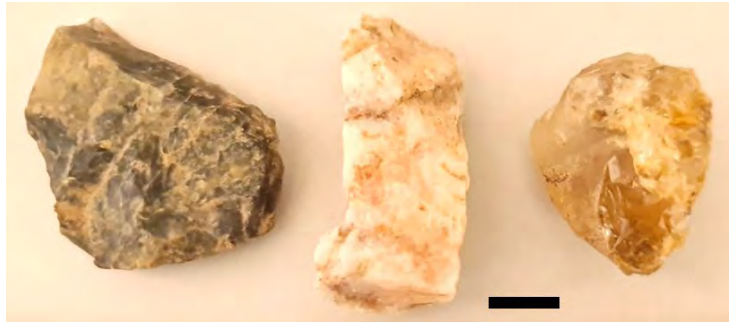
Figure 5 Cores found at OMPS
Left to right id=99, id=147, id=132 (scale 1 cm)

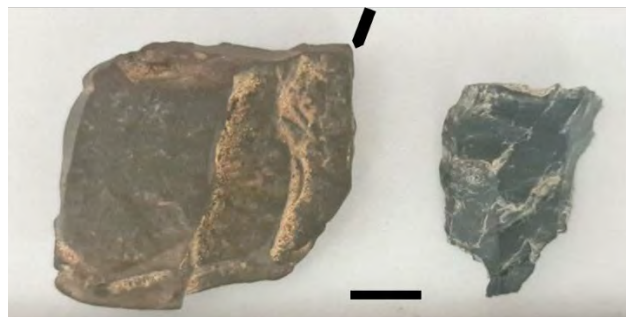
Figure 5 Systematic cores found at OMPS
Left to right id=501, id=147, id=502. Arrows show location of flake removal (scale 1 cm).

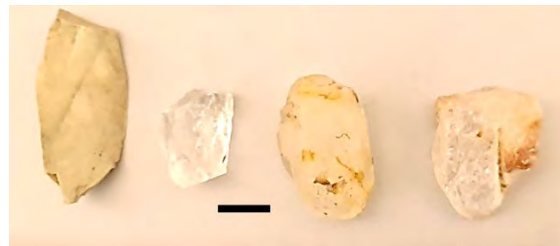
Figure 7 Tools found in the OMPS assemblage, Transect 5. Left to right, id=114, id=188, id=197, id=170 (scale=1cm)

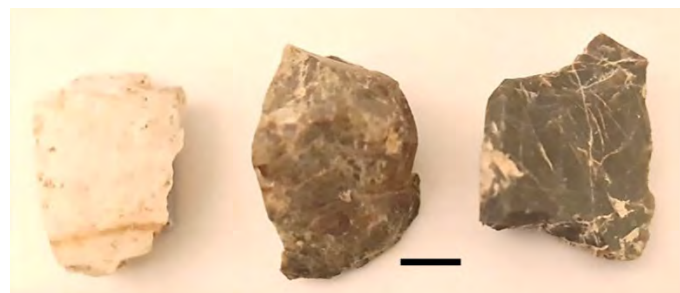
Figure 8 Large scraper and notch tools found in the OMPS assemblage. Left to right, id=456, id=471, id=82 (scale=1cm)

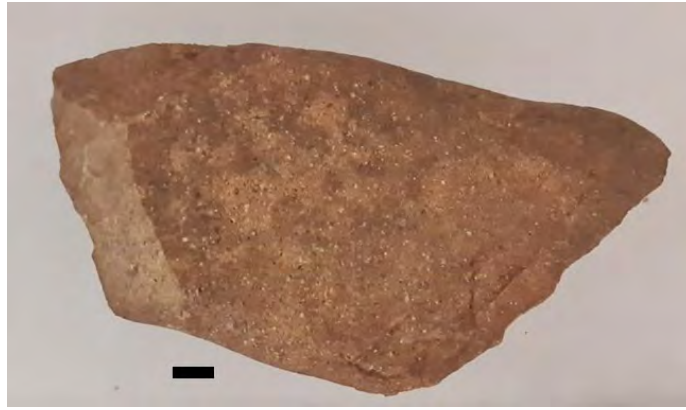
Figure 9 Fragment of grinding stone also used as a core from T22P1, id=71 (scale=1cm)
