**KURRI KURRI LATERAL PIPELINE  
PROJECT**

Aboriginal Cultural Heritage Assessment

Prepared by  
Umwelt (Australia) Pty Limited  
on behalf of  
APA Group

Project Director: Paul Douglass  
Project Manager: Marion O'Neil  
Technical Director: Nicola Roche  
Technical Manager: Steph Howden  
Report No. 21450/R07  
Date: March 2022

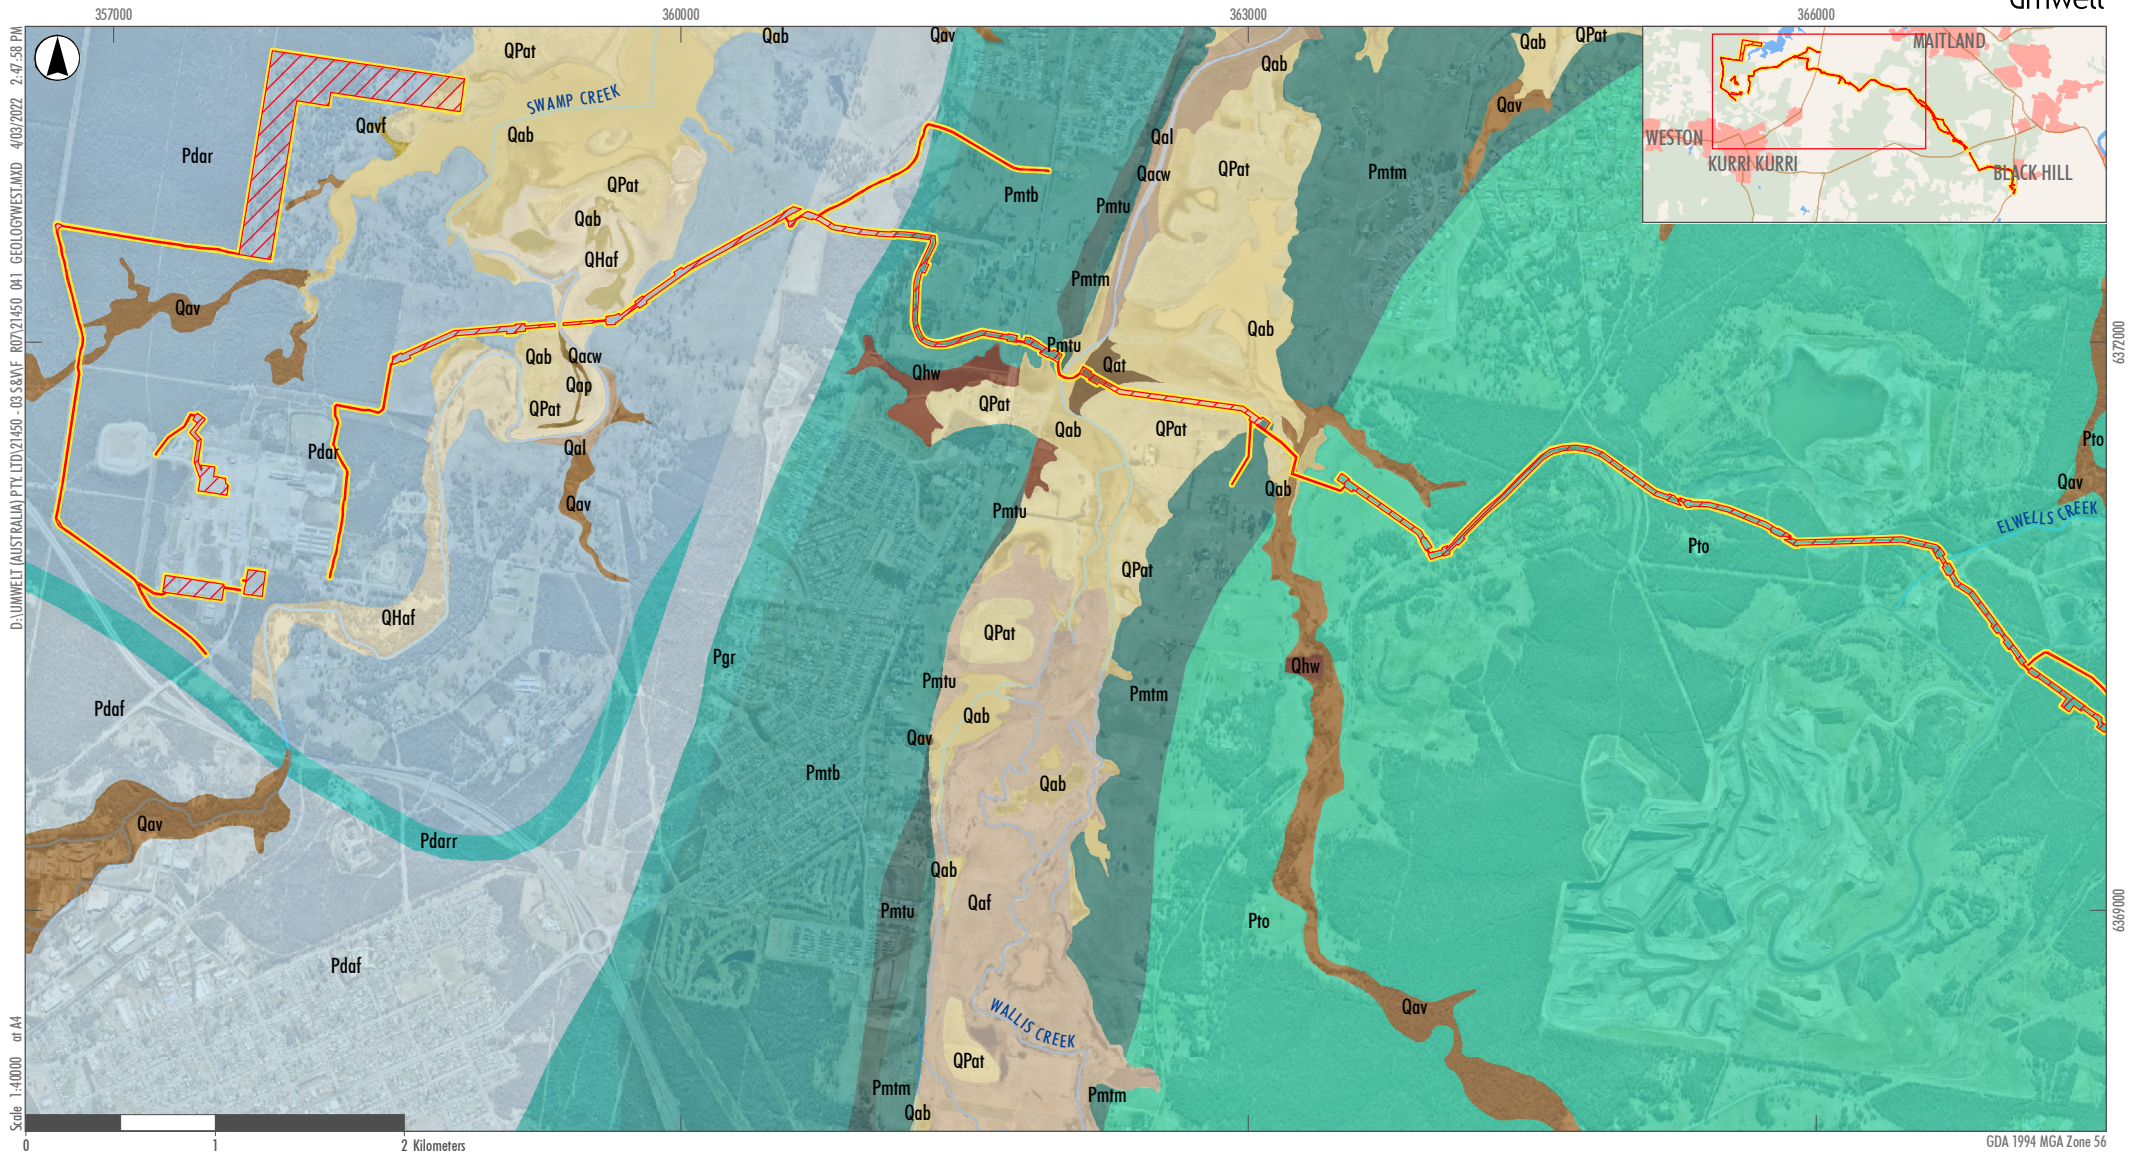
FIGURE 3.7  
Geology of the Study Area  
(East)

and Branxton Formation which occur adjacent to the Quaternary deposits associated with Buttai, Wallis and Swamp Creeks. The storage pipeline, interconnect pipeline, compressor station and delivery station fall within the Rutherford Formation and the Quaternary deposits associated with Black Waterholes Creek. The geology associated with these deposits and the potential uses as an Aboriginal resource are defined in **Table 3.2** and mapped on **Figure 3.7** and **Figure 3.8**.

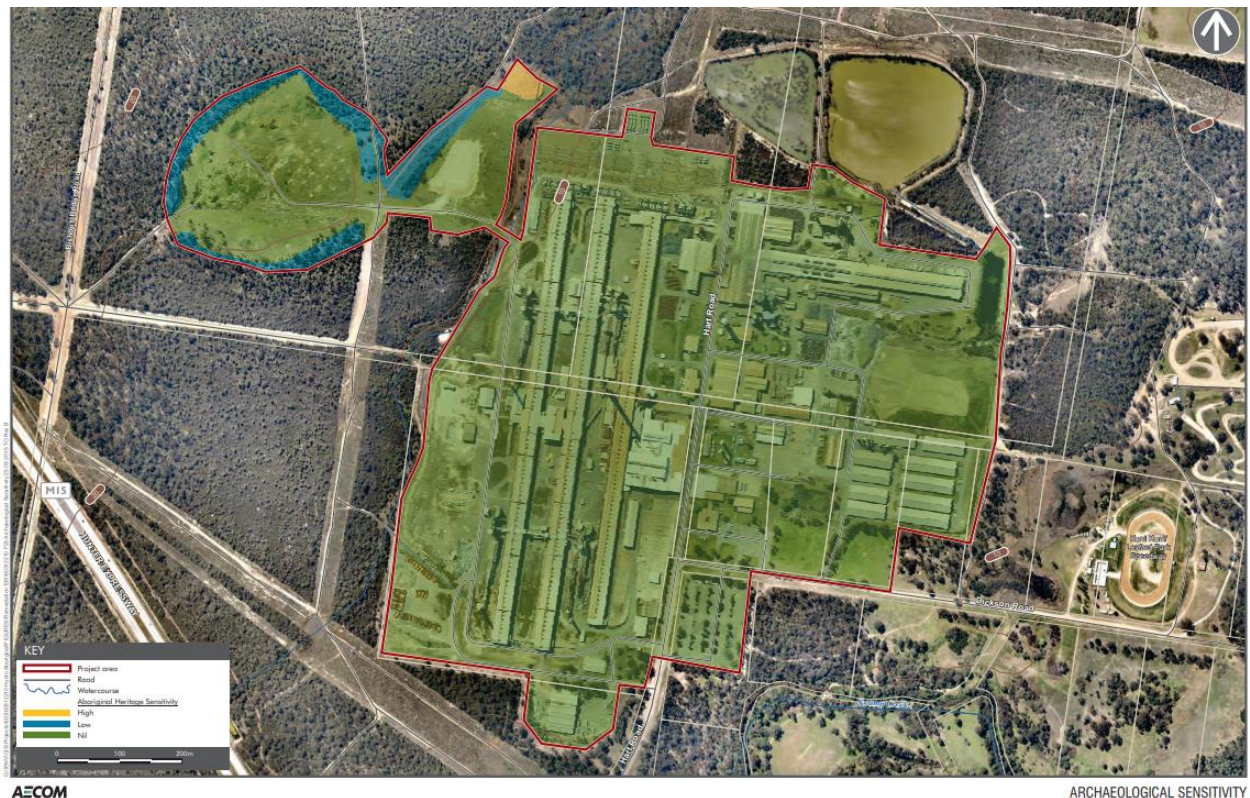
**Figure 4.6**      **Reproduction of AECOM mapping (2015: Figure 23) showing archaeological sensitivity**

AECOM (2015) recommended surface collection of the isolated artefact and identified that no further mitigation or management activities were required within the areas of nil or low archaeological sensitivity. In relation to the area of high archaeological sensitivity, AECOM (2015) identified that the area may be used for stockpiling of materials and, if this is to occur, protective geomattng should be put in place to provide protection against subsurface disturbance.

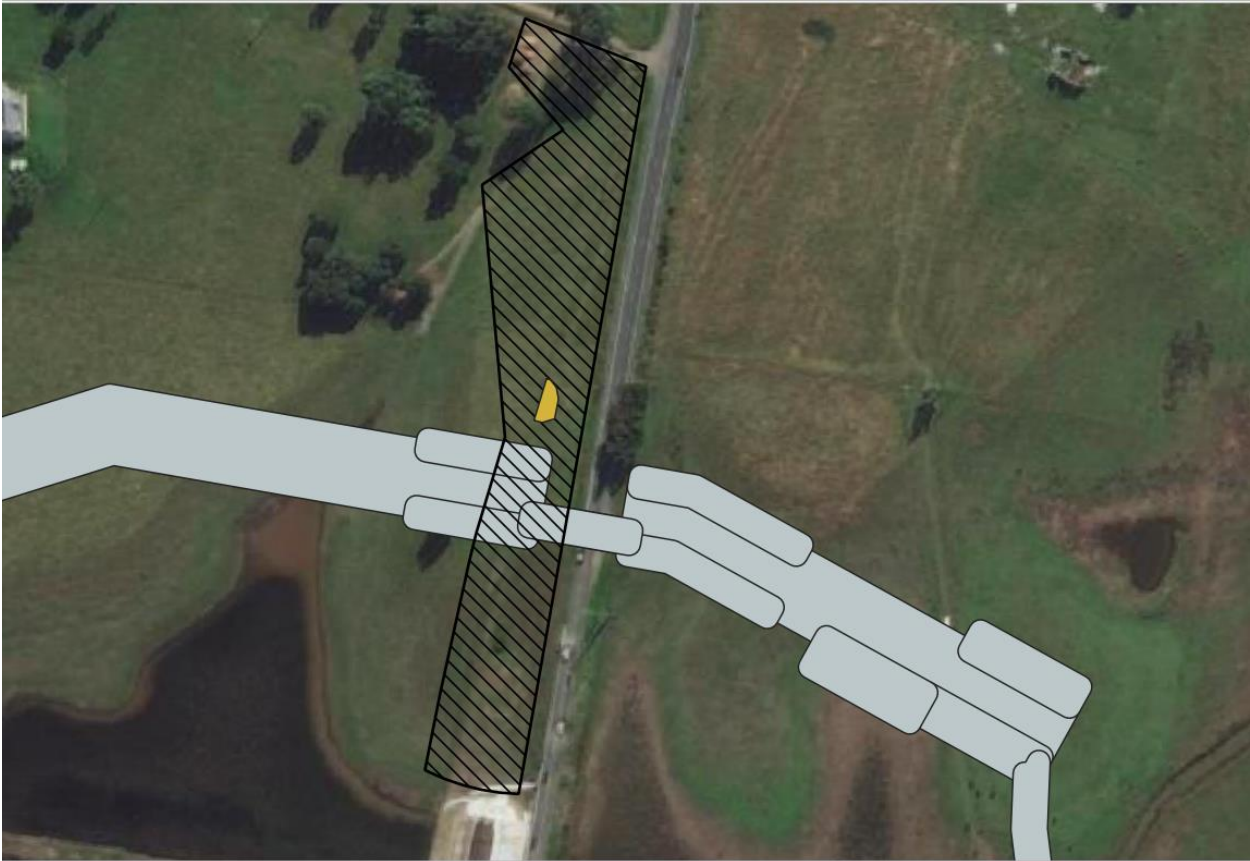
**Figure 4.7** Location of TH-PAD-001 (black hatching) and identified No Harm Area (yellow) in relation to current study area. Figure based on information supplied by TfNSW

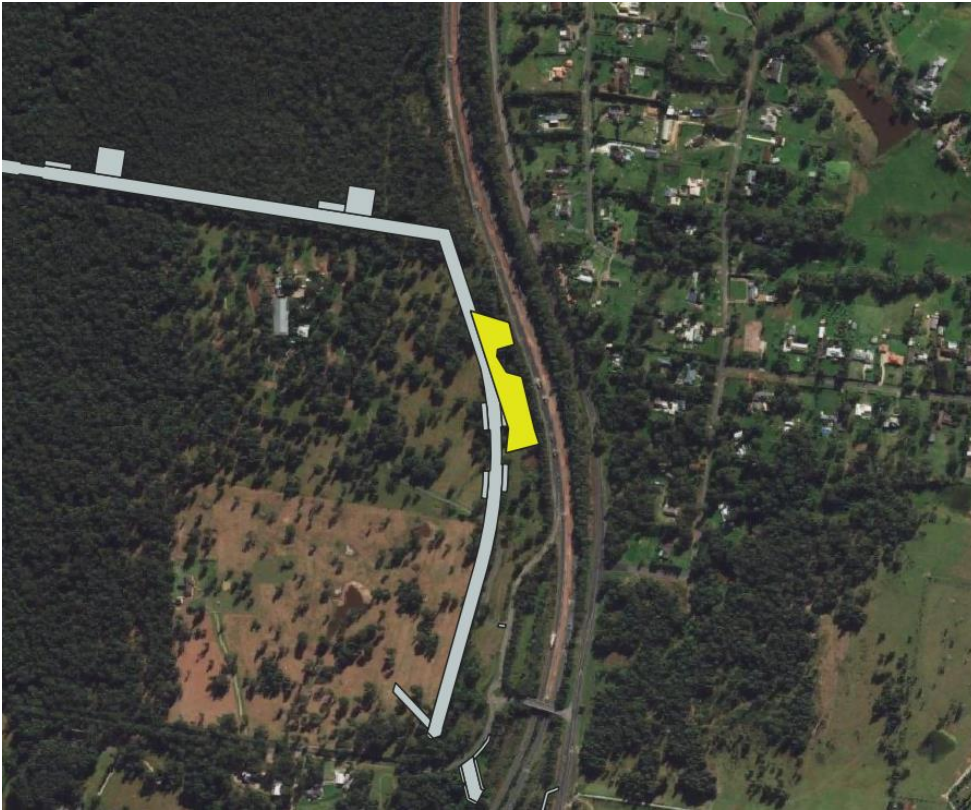
**Figure 4.8** Location of the Woods Gully conservation zone (in yellow) in relation to the current study area (grey)

Based on the significance of the Woods Gully site (AHIMS #38-4-0410), a portion of the site was set aside within a conservation zone and subject to a management plan (South East Archaeology 1999). The conservation zone established for the site extends into a portion of the current survey area, as shown in **Figure 4.8**. This area is limited to the extent of land within the freeway corridor. The conservation zone was identified as having high archaeological and Aboriginal cultural value (South East Archaeology 1999).

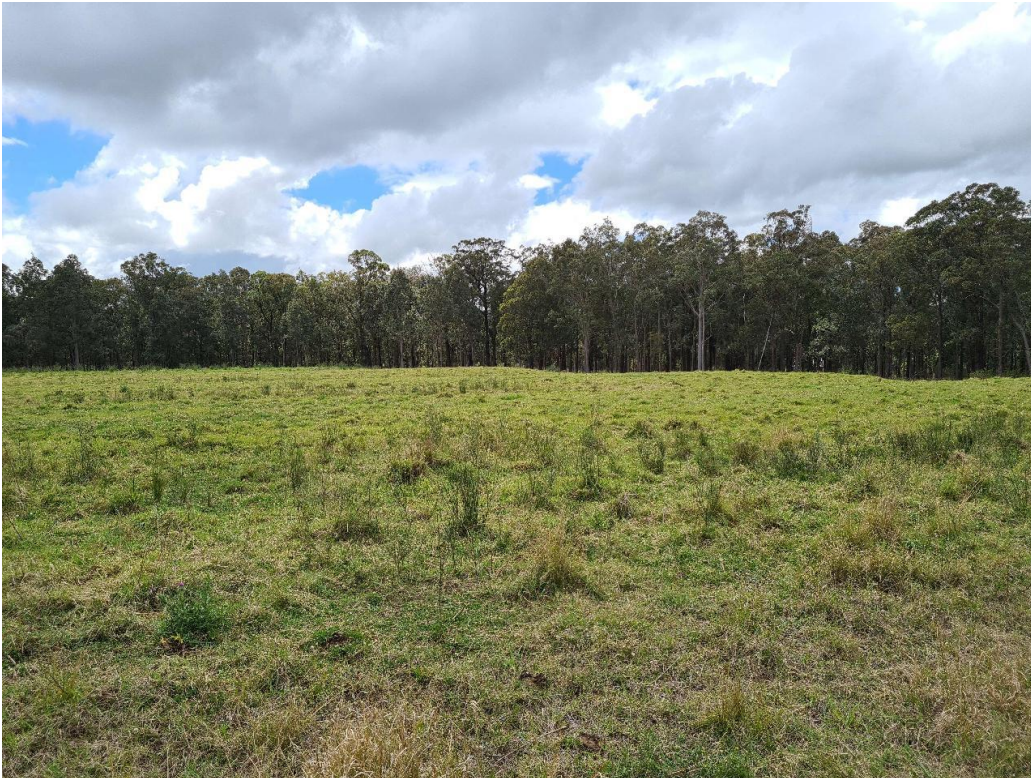
**Photo 6.3** SU2 landform disturbance as a result of former poultry shed, view approximately northeast

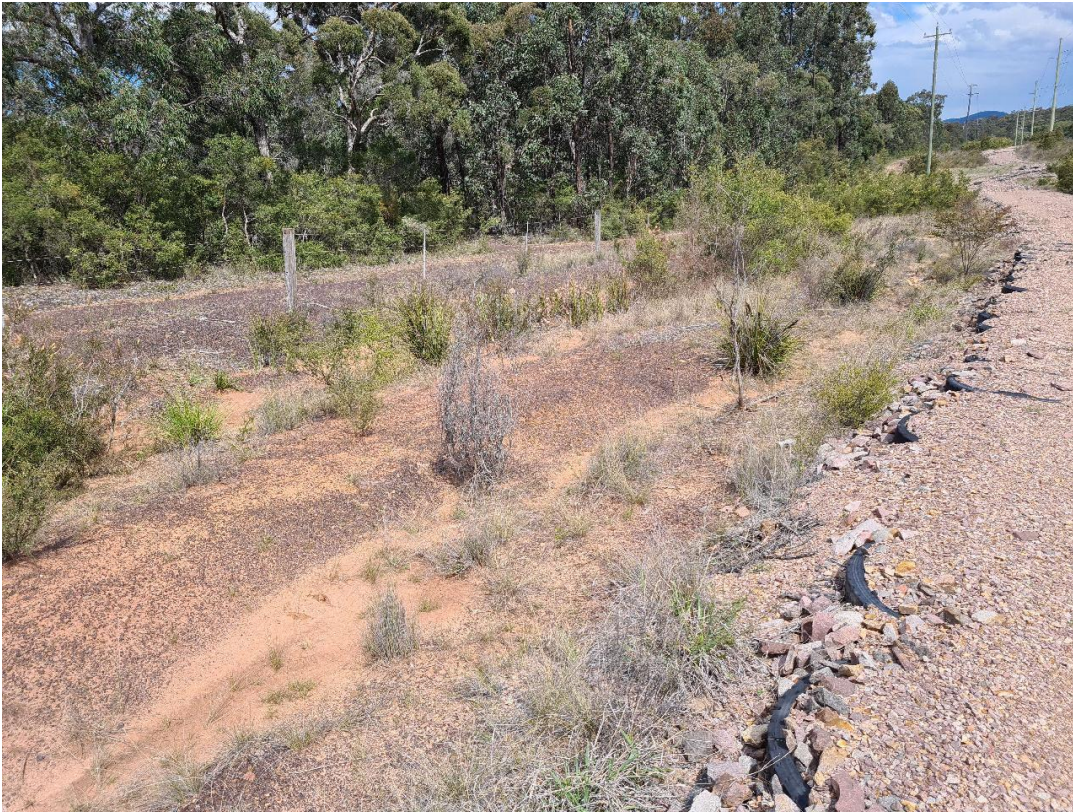
**Photo 6.17** SU10 access track disturbance, view approximately south

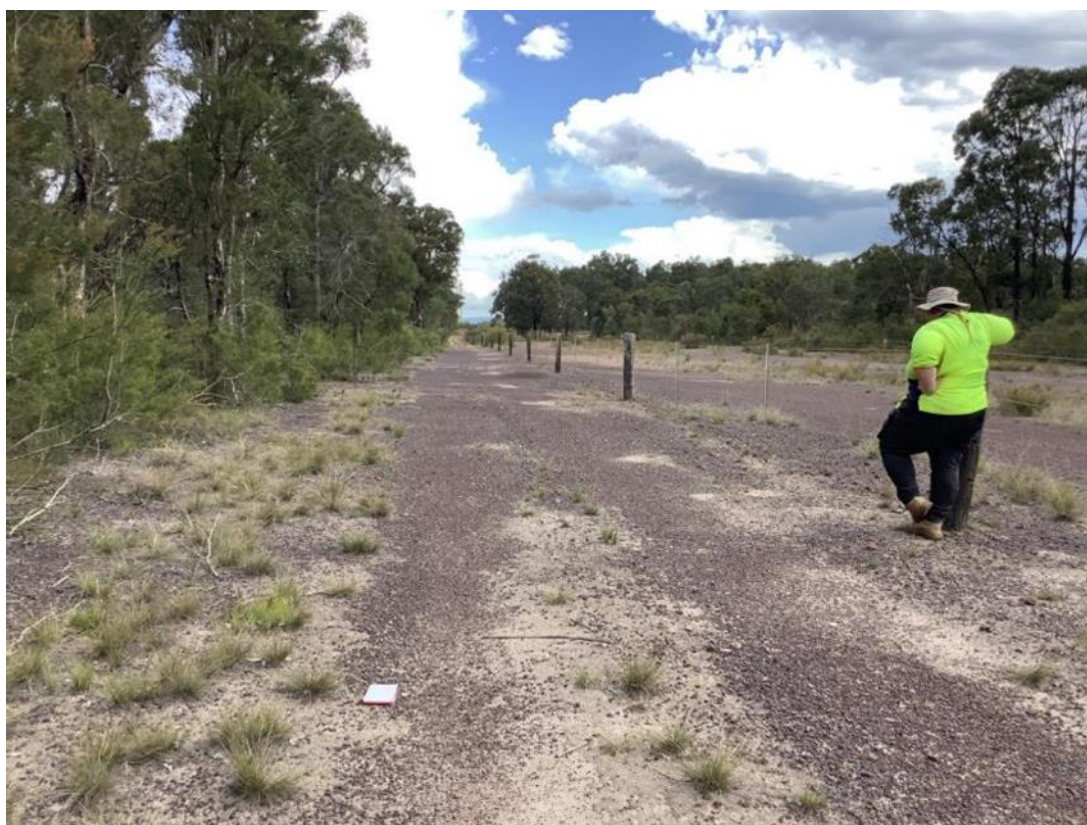
**Photo 6.19** KKLP AS1 site location, view approximately south

KKLP AS1 is an artefact scatter containing two artefacts located approximately 3 m apart on an existing access track (**Photo 6.19** to **Photo 6.21**). The artefacts are two yellow-red silcrete flakes. The artefacts were exposed on the access track which has imported gravels and other construction materials (e.g., tyres). The track is located on the former Kurri Kurri Hydro Aluminium Smelter and subject to vehicle traffic and minor erosion. The track runs along a gently inclined slope located approximately 400 m to the south of a tributary of Black Waterholes Creek. No additional artefacts were identified during the survey closer to the tributary; however, two large sites (Northern Swamp Tributaries 1 and 2) were reported by AECOM (2014) as extending over this area. As noted above there has been significant disturbance along the access track. KKLP AS1 has limited archaeological integrity and the artefacts are not likely in their original depositional context.

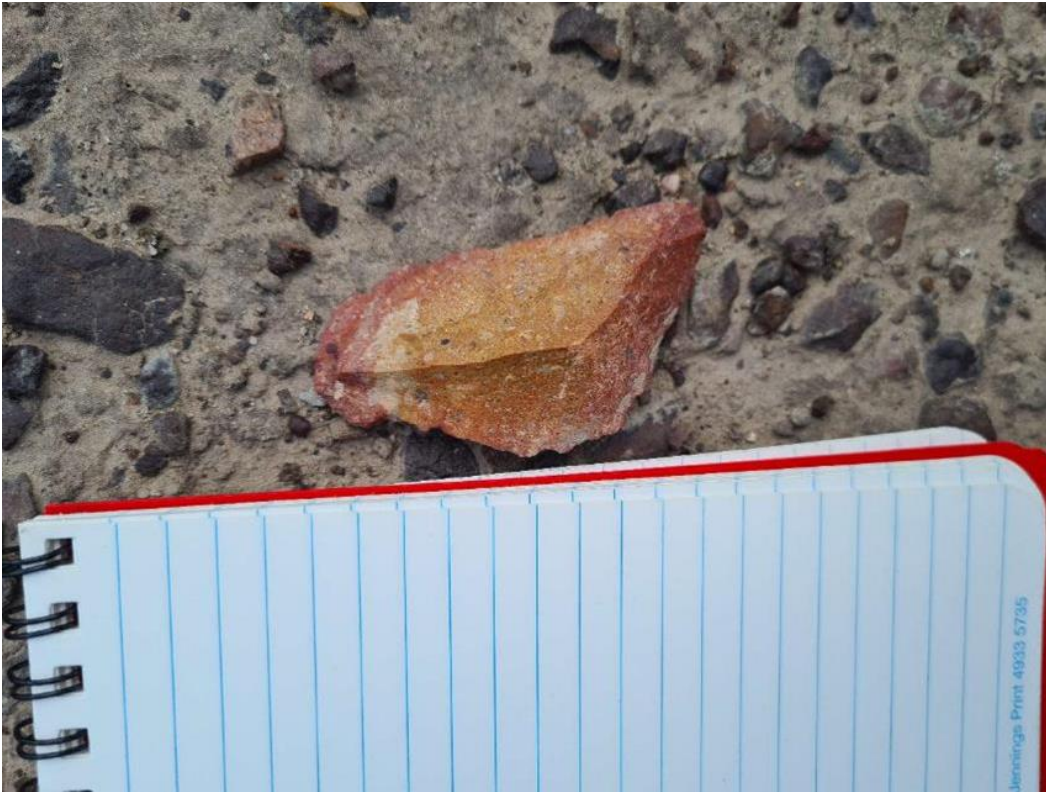
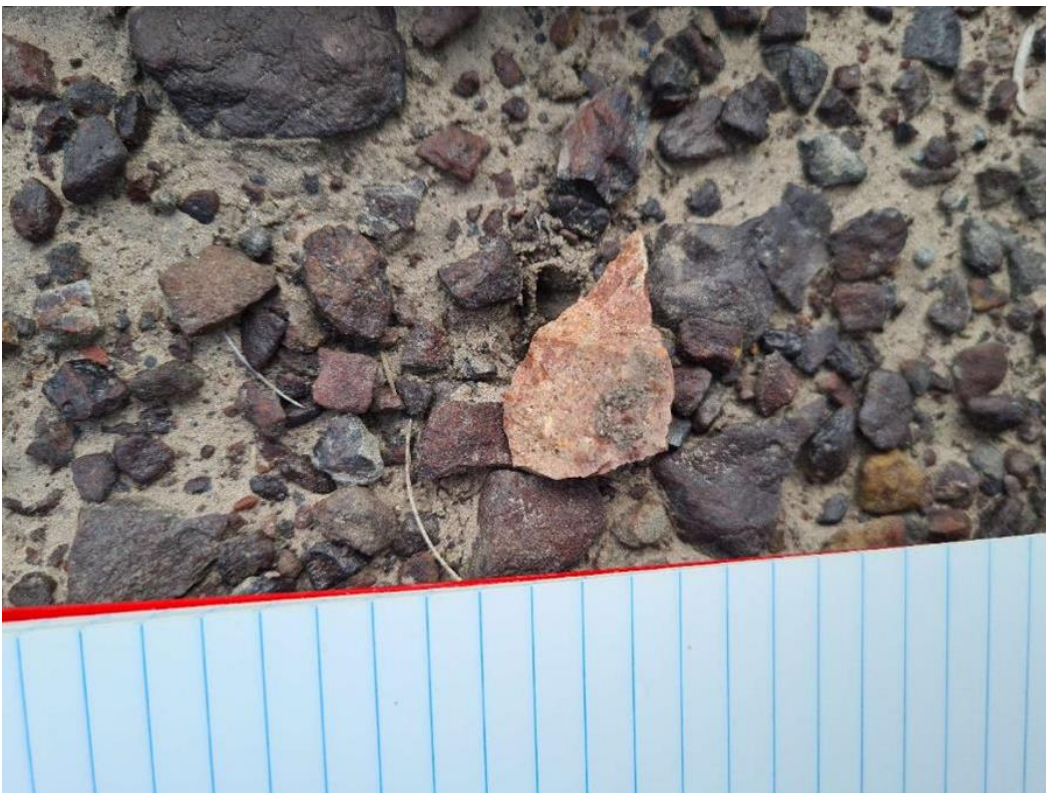
**Photo 6.20**      **KKLP AS1 red-yellow silcrete flake**

**Photo 6.21**      **KKLP AS1 silcrete flake**

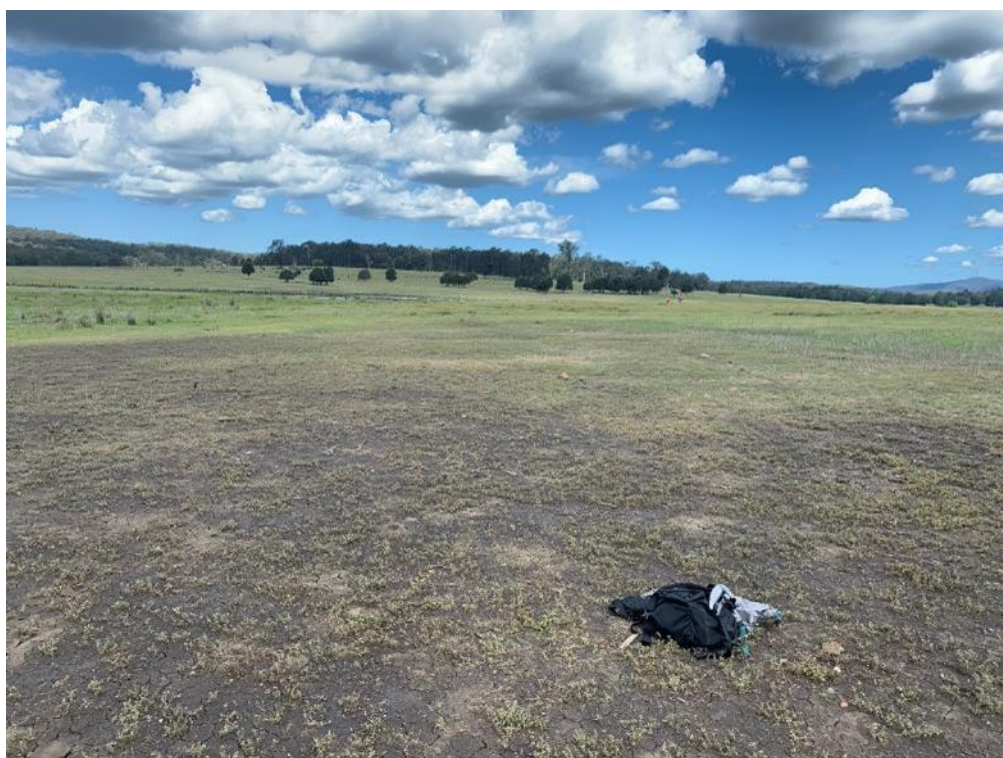
KKLP AS2 is an artefact scatter containing two artefacts located approximately 2 m apart within the drainage channel of Buttai Creek (**Photo 6.22** to **Photo 6.24**). The artefacts are a grey silcrete broken flake and a mudstone flake. The visibility within the site area was good (95%) and it is unlikely additional artefacts are present on the surface or as subsurface deposits. It is likely that the artefacts have washed into the area, along with other rubbish and debris located at the site. As such, KKLP AS2 has limited archaeological integrity and the artefacts are not in their original depositional context. The visibility in the surrounding area was low and an area of PAD (KKLP PAD 2) was recorded to the west of the site. The site is located outside of the study area.

**Photo 6.22** KKLP AS2 location, view approximately southeast

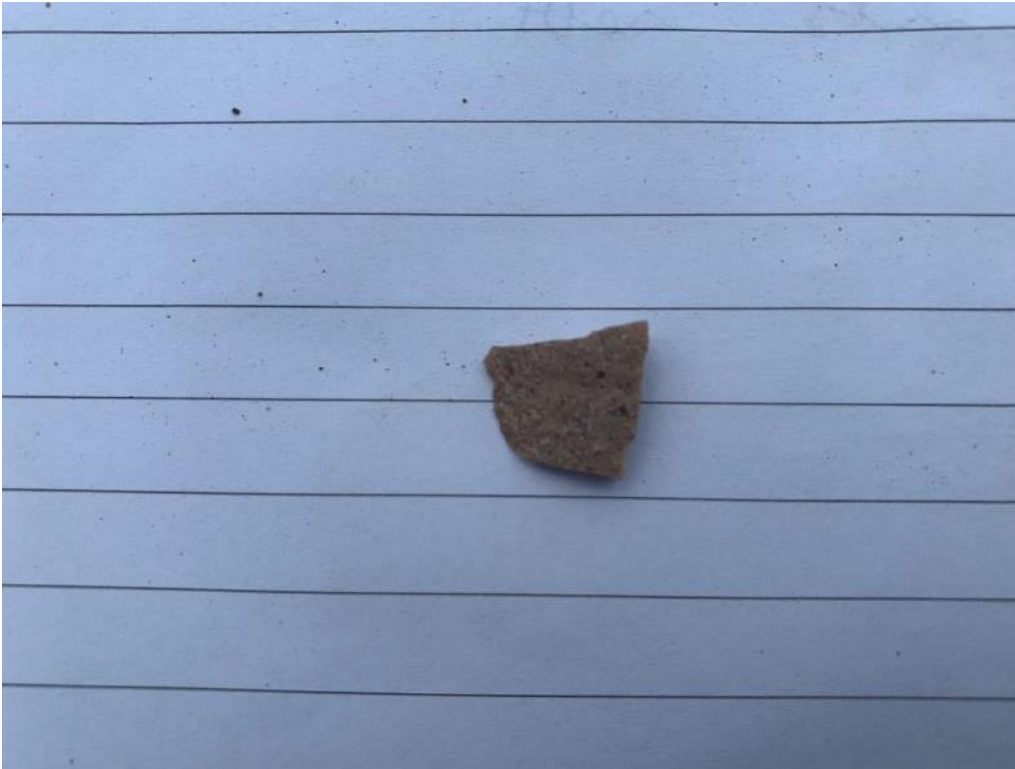
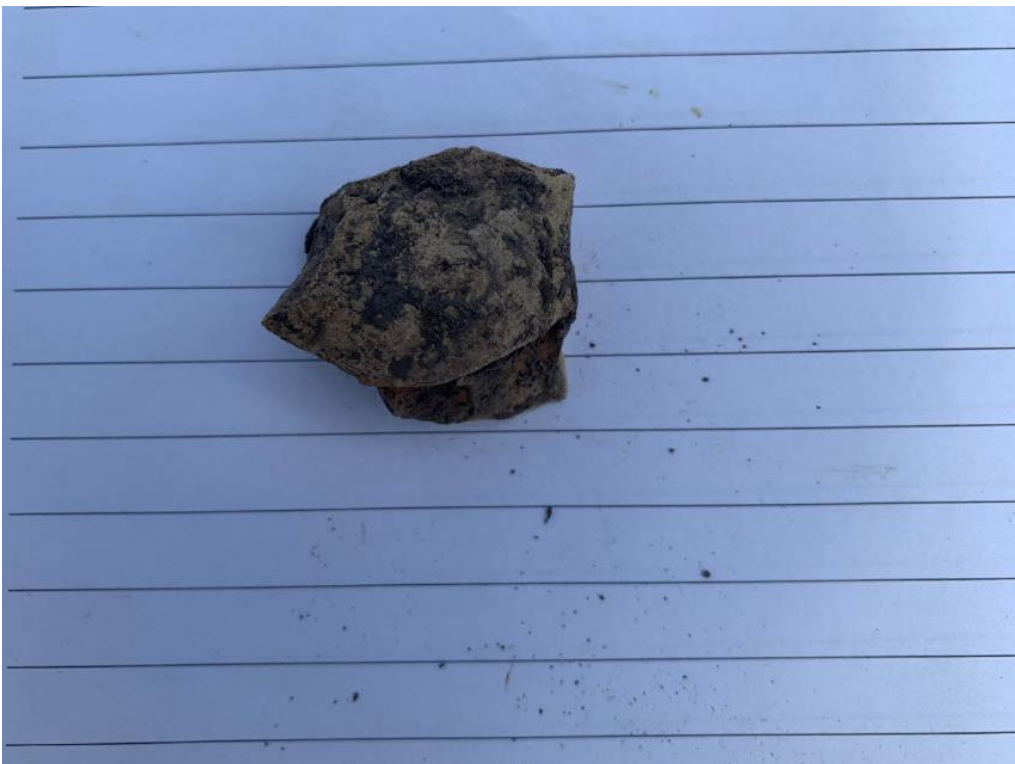
**Photo 6.23**      **KKLP AS2 grey silcrete broken flake**

**Photo 6.24**      **KKLP AS2 mudstone flake**

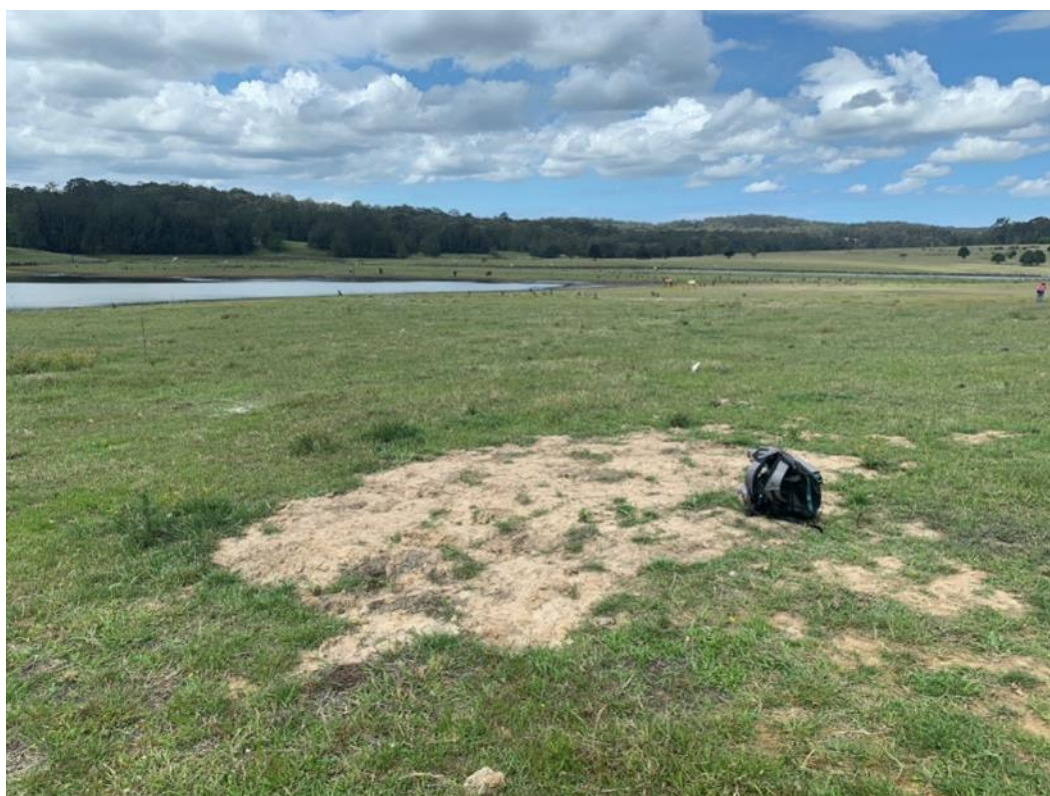
KKLP IA1 is an isolated grey silcrete broken flake located on a lower slope adjacent to Buttai Creek (refer to **Photo 6.25** and **Photo 6.26**). The artefact was located on a 3 x 2 m exposure created by a large animal burial. The visibility within the exposure was high (approximately 90%). The site is located approximately 50 m from Buttai Creek and is on the margin of the high-water mark. The visibility in the surrounding area was low, although there were two other large animal burial exposures in the vicinity with no artefacts located. The nearby KKLP AS2 (described above) was likely washed into the area. The landform to the west of the site was recorded as an area of PAD (KKLP PAD 2). The site is located outside of the study area.

**Photo 6.25** KKLP IA1 site location, view approximately east

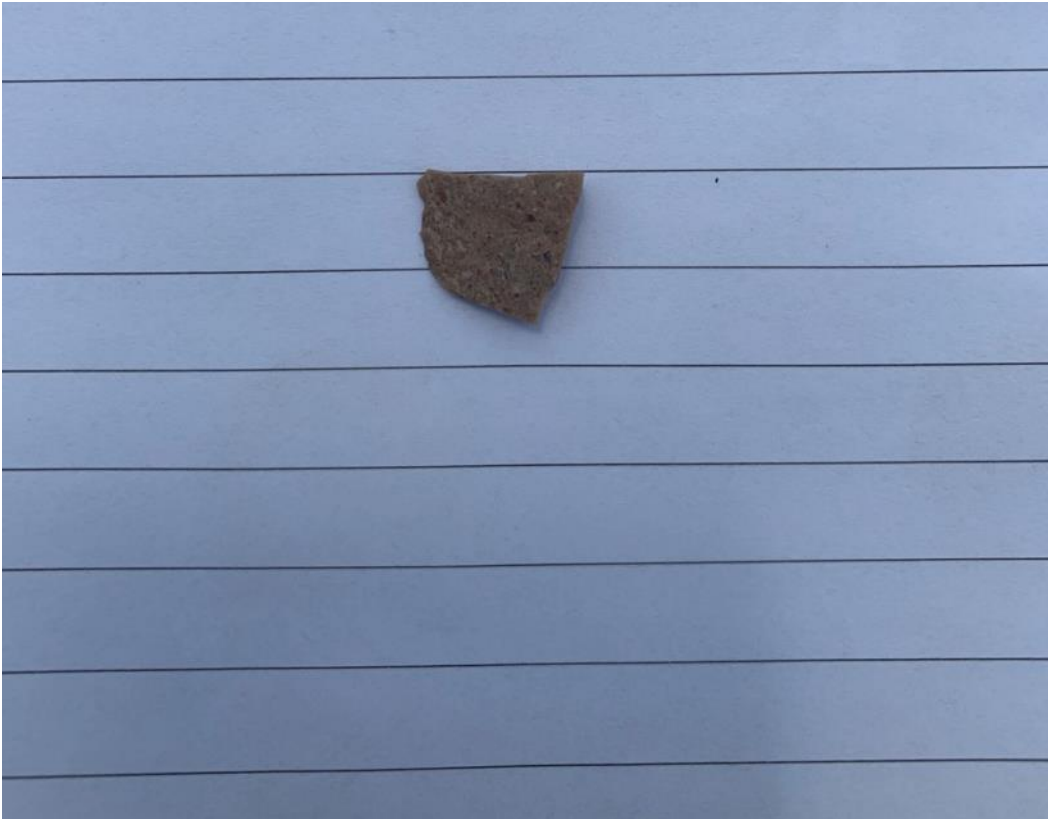
**Photo 6.26**      **KKLP IA1 broken silcrete flake**

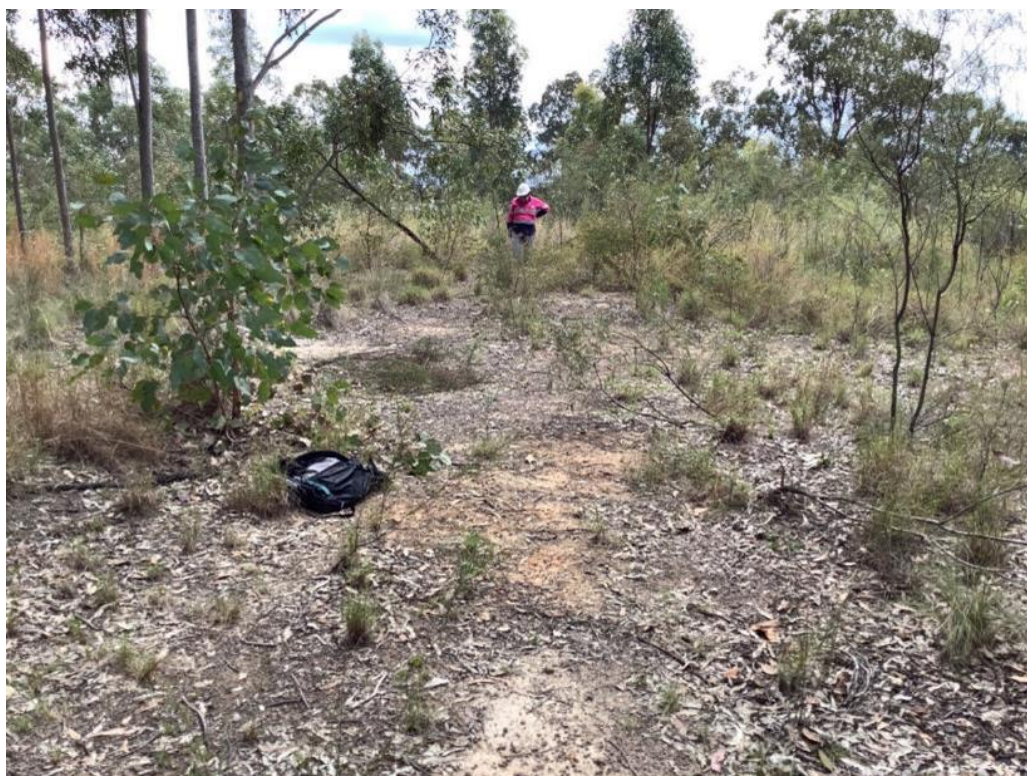
KKLP IA2 is an isolated grey silcrete flake located on an access track that runs along the crest of a spur (refer to **Photo 6.27** to **Photo 6.28**). The access track had not been used in some time and had begun revegetating. The visibility on the track was low (approximately 10%), being obscured by leaf litter and grasses. The site is located approximately 345m northwest of Elwells Creek. Given the distance from the nearest water source, it is unlikely that the site contains potential for additional subsurface artefacts. KKLP IA2 is located outside of the study area.

**Photo 6.27**      **KKLP IA2 site location, view approximately north**

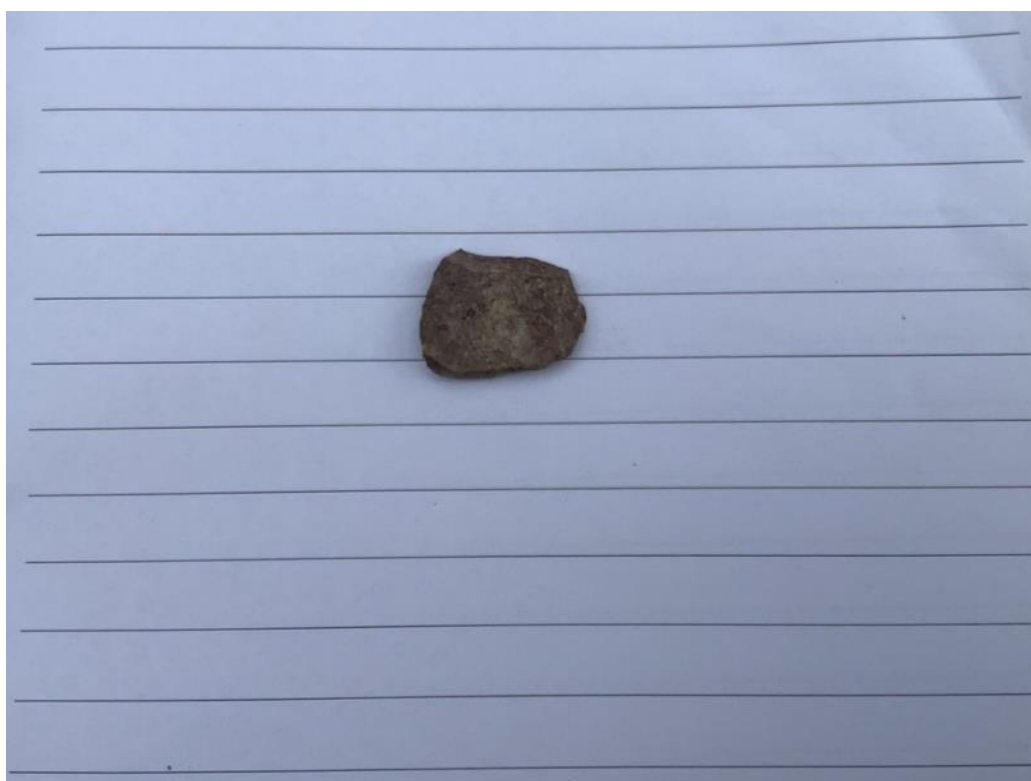
**Photo 6.28**      **KKLP IA2 grey silcrete flake**

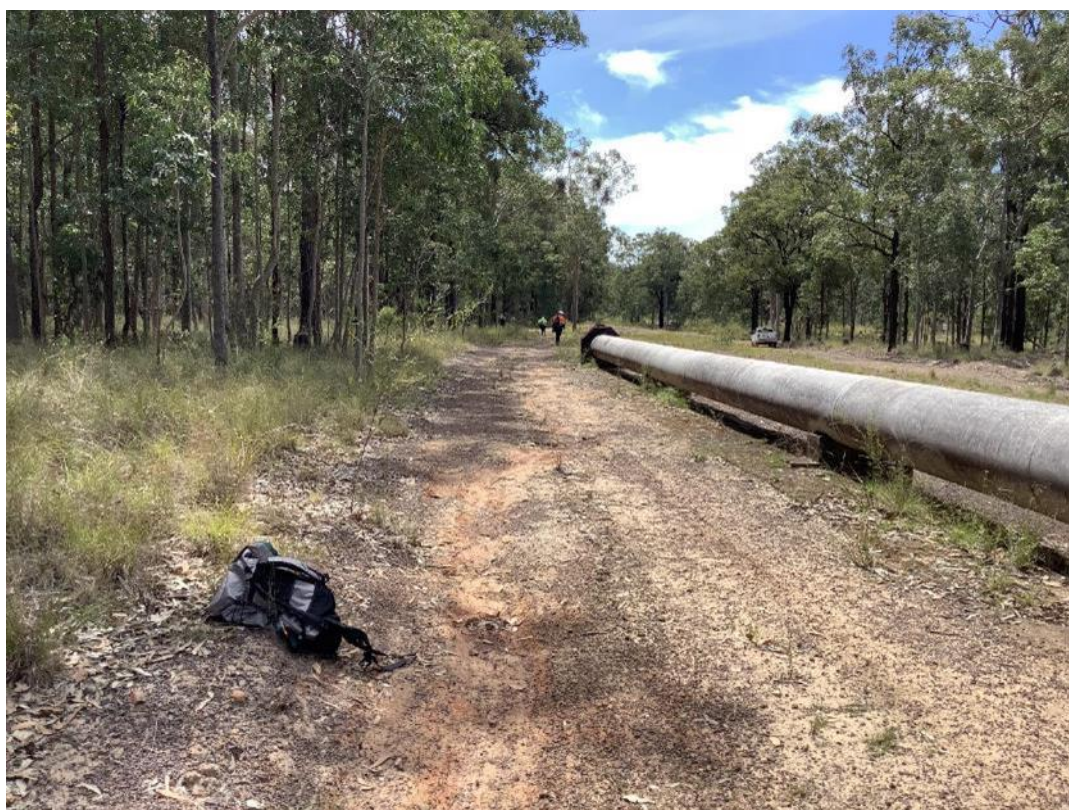
KKLP IA3 is an isolated mudstone flake located on an access track alongside a water pipeline (refer to **Photo 6.29** and **Photo 6.30**). The site is on a spur that runs north between Four Mile Creek and Whites Creek, which are 255 and 305 m from the site respectively. The access track is subject to minor sheetwash erosion and has been maintained in the past. The visibility of the access track was good (approximately 80%) and the visibility adjacent to the track was limited (0%). It is likely that the site area was disturbed during the construction of the water pipeline. Based on this and the nature of previously recorded sites in the area, it is assessed that there is limited potential for subsurface artefacts at this site. KKLP IA3 is located outside of the study area.

**Photo 6.29** KKLP IA3 site location, view approximately north-northwest

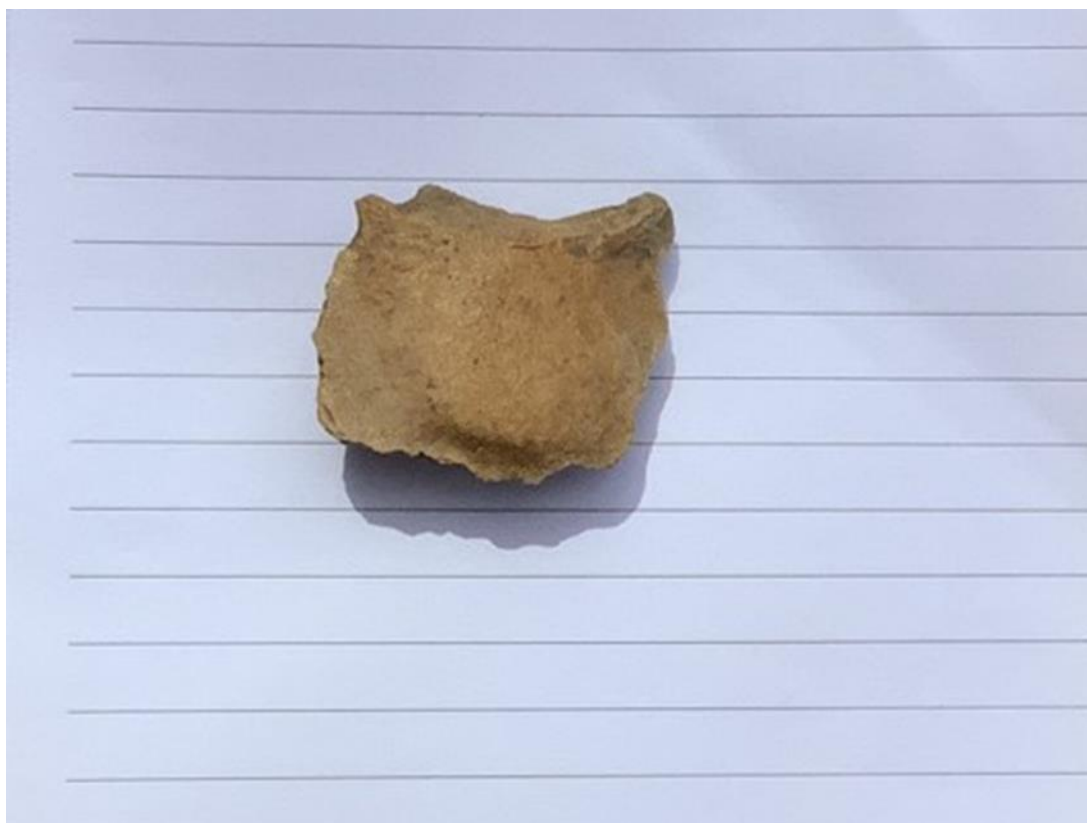
**Photo 6.30**      **KKLP IA3 mudstone flake**

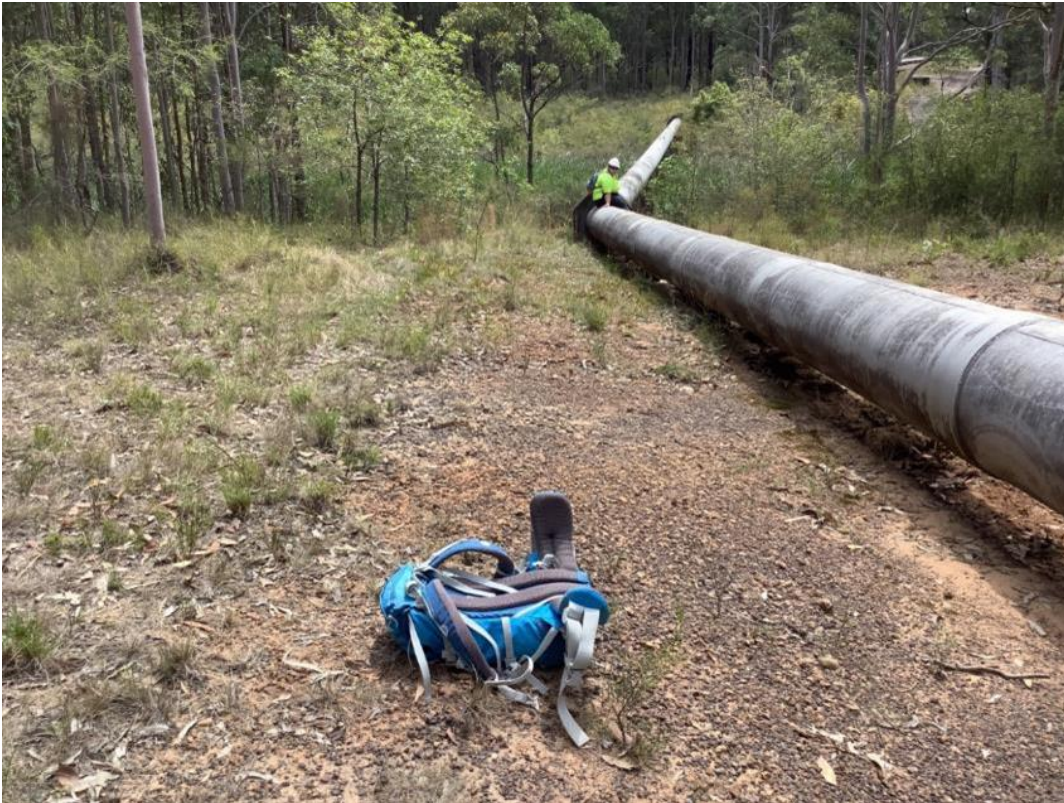
KKLP IA4 is an isolated red silcrete flake located adjacent to an existing water pipeline, on the lower slope of an unnamed tributary of Four Mile Creek (refer to **Photo 6.31** and **Photo 6.32**). The visibility of site area was good (approximately 40%) and the visibility of the surrounding area was variable (ranging from 10-20%). The site is approximately 30 m from the tributary. The site is subject to minor sheetwash erosion. It is likely that the site area was disturbed during the construction of the water pipeline. KKLP IA4 is located outside of the study area.

**Photo 6.31**      **KKLP IA4 site location, view approximately northwest**

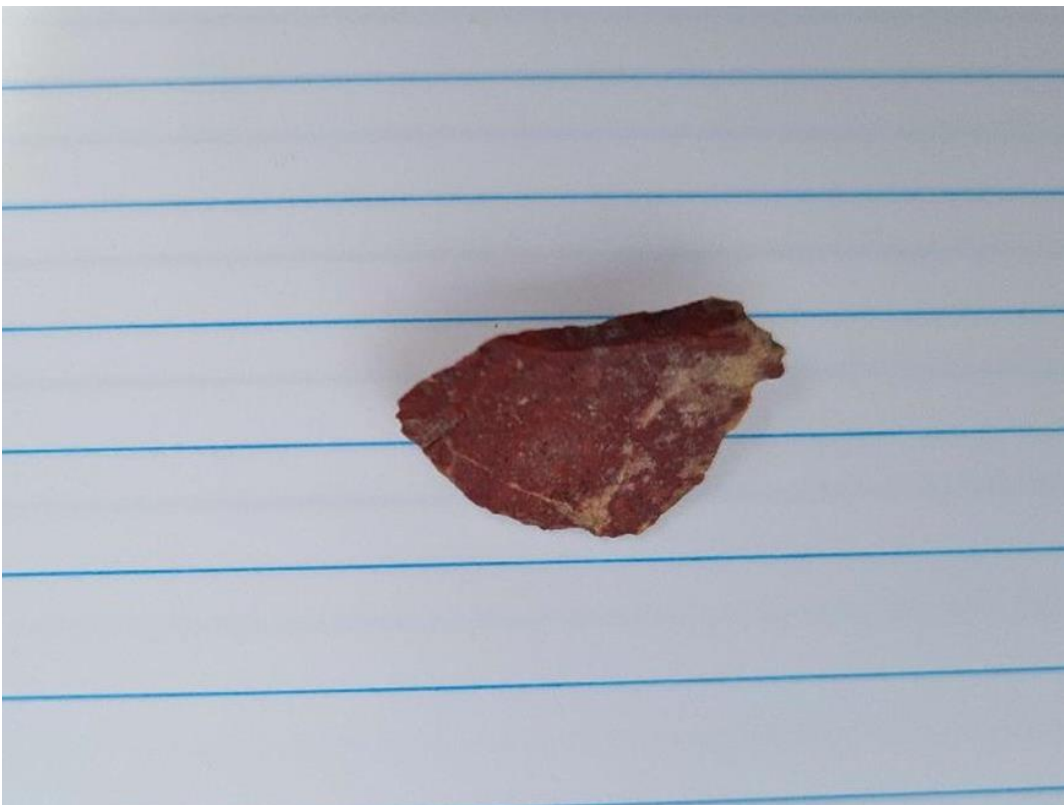
**Photo 6.32**      **KKLP IA4 red silcrete flake**

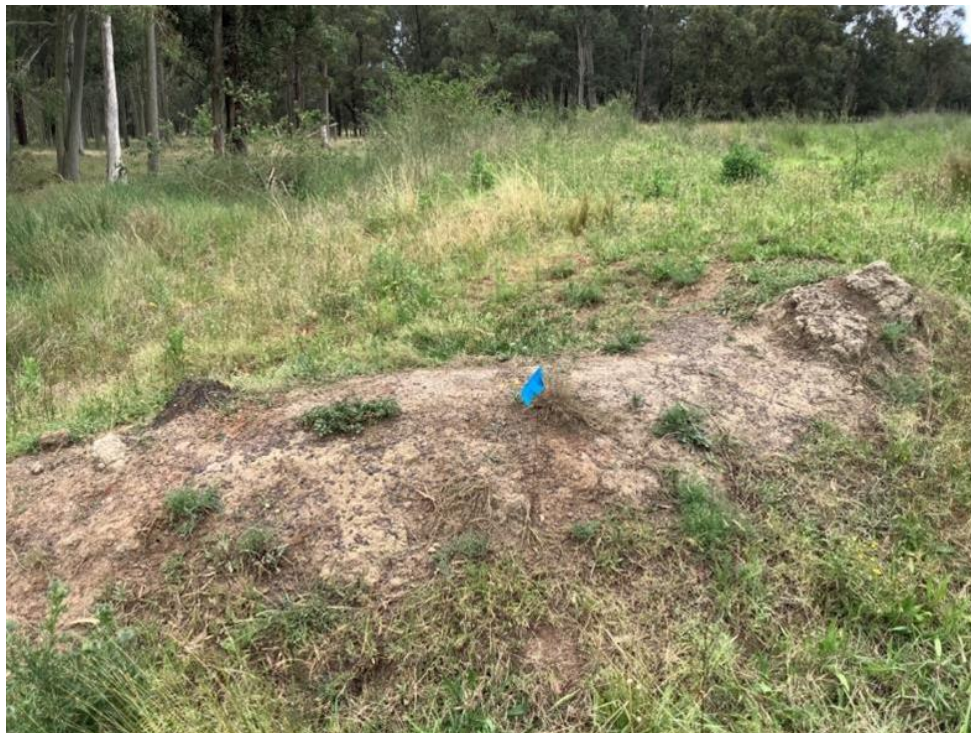
KKLP IA5 is an isolated quartz flake located on a spoil heap associated with the construction of the former chicken sheds in the area (**Photo 6.33** and **Photo 6.34**). The site is located 70 m to the southeast of a tributary of Weakleys Flat Creek. The site is entirely out of context and is located outside of the study area.

**Photo 6.33** KKLP IA5 site location, view approximately east

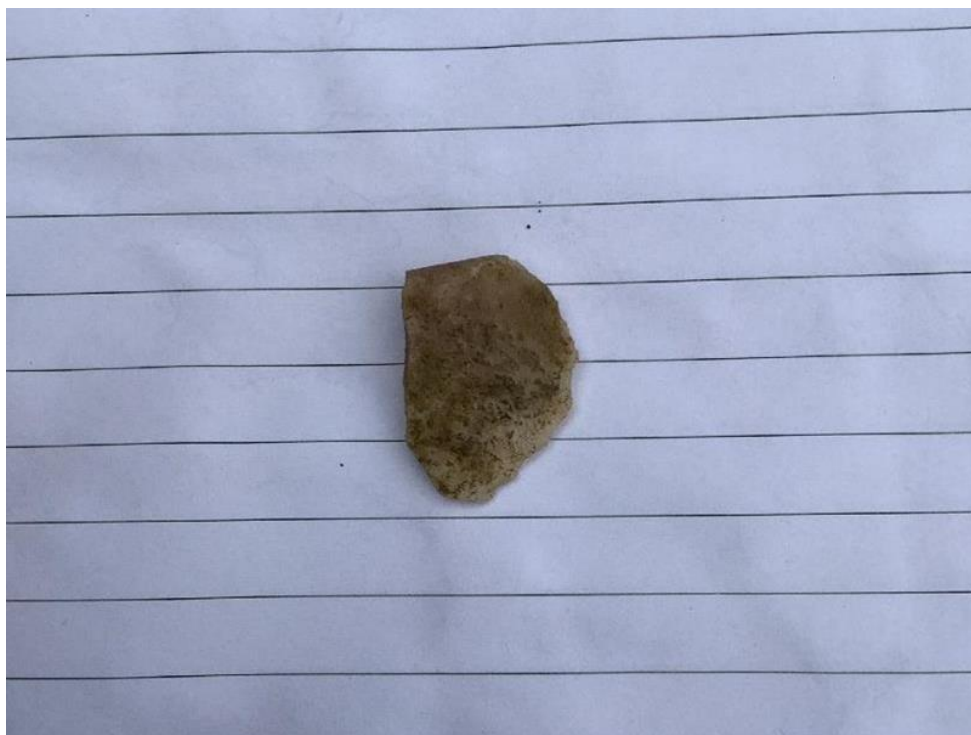
**Photo 6.34** KKLP IA5 quartz flake
