**KURRI KURRI LATERAL PIPELINE  
PROJECT**

Aboriginal Cultural Heritage Assessment

Prepared by  
Umwelt (Australia) Pty Limited  
on behalf of  
APA Group

Project Director: Paul Douglass  
Project Manager: Marion O'Neil  
Technical Director: Nicola Roche  
Technical Manager: Steph Howden  
Report No. 21450/R07  
Date: March 2022

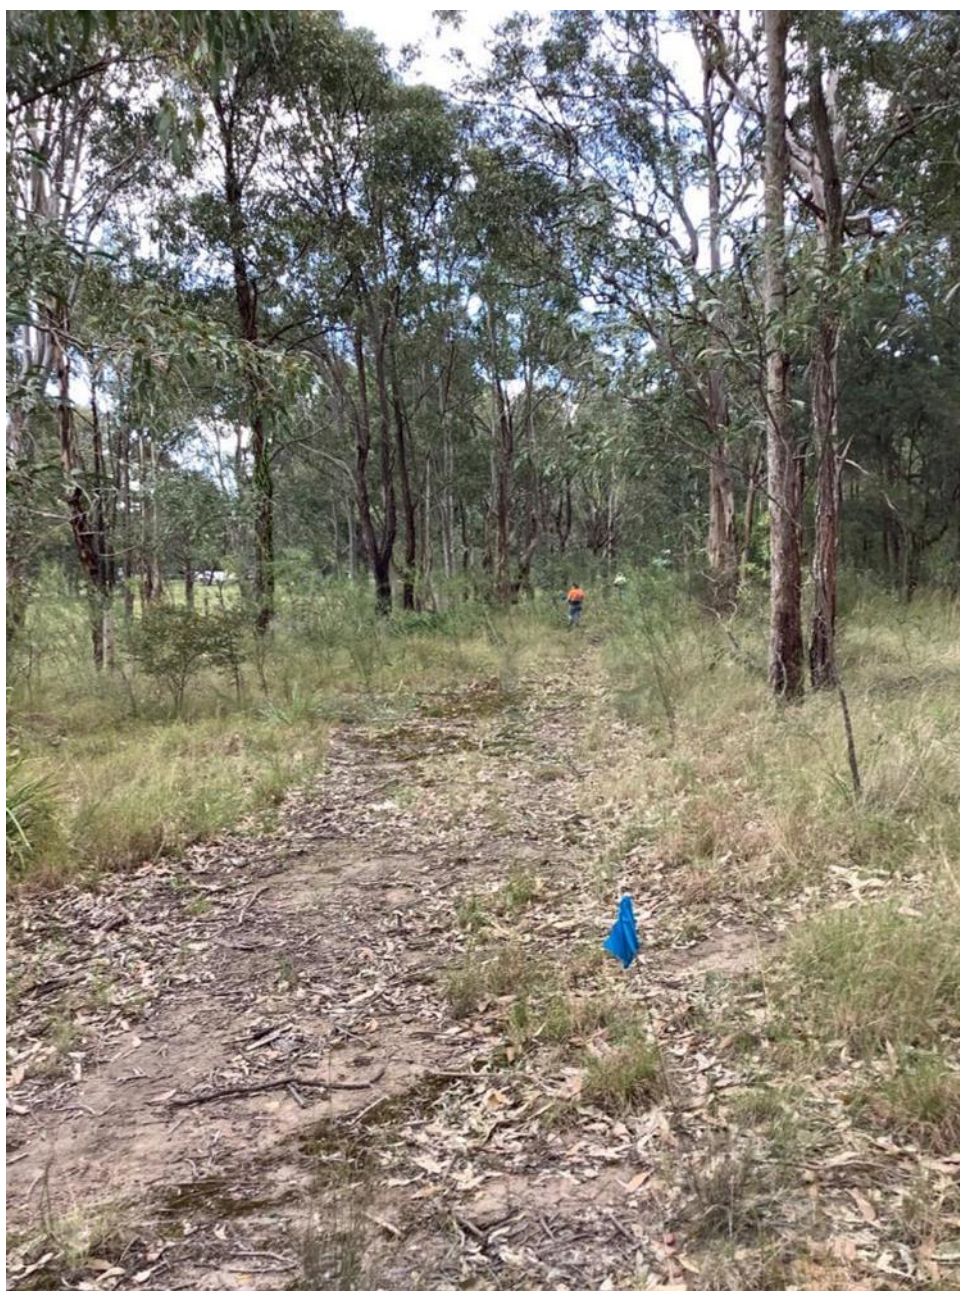
KKLP IA6 is an isolated red silcrete flake located on an access track on the upper slope of a spur (refer to **Photo 6.35** and **Photo 6.36**). The access track had not been used in some time and had begun revegetating. The visibility on the track was low (approximately 10%), being obscured by leaf litter and grasses. The site is located approximately 345m north of Woods Gully. Given the distance from the nearest water source, it is unlikely that the site contains potential for additional subsurface artefacts. A previously recorded archaeological site, Woods Gully (38-4-0410), is located between KKLP IA6 and Woods Gully. An additional area of PAD was recorded adjacent to the Woods Gully Conservation Zone (KKLP PAD1).

**Photo 6.35** KKLP IA6 site location, view approximately west

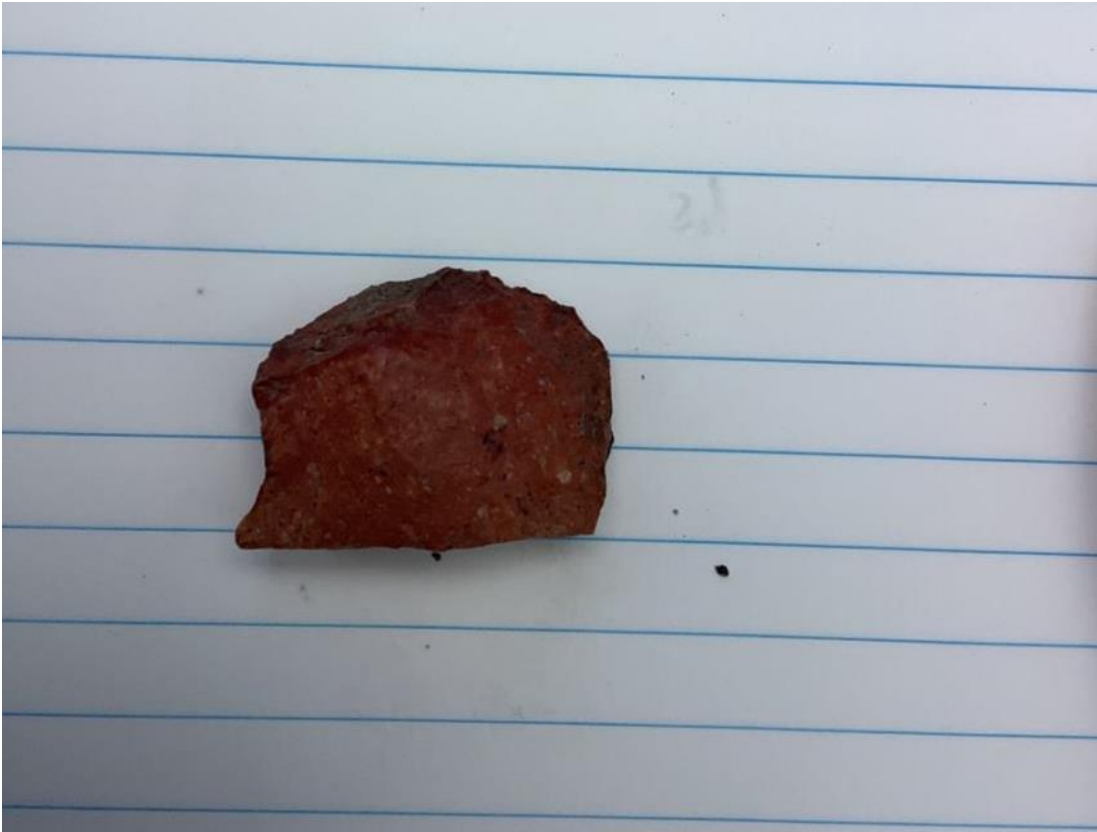
**Photo 6.36**      **KKLP IA6 red silcrete flake**

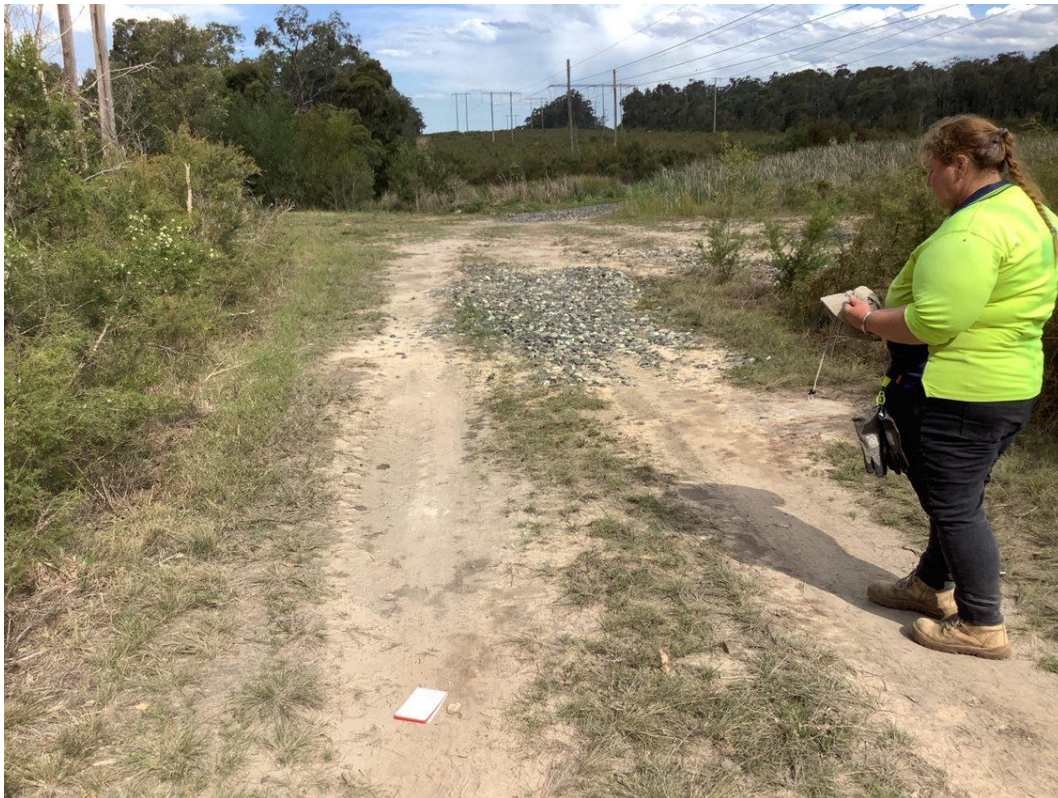
KKLP IA7 is a single yellow mudstone broken flake identified on the access track within a transmission line easement in SU10. The artefact was identified at the intersection of two transmission lines adjacent to a low-lying swampy area. Despite good visibility within the track (as shown in **Photo 6.37** and **Photo 6.38**), no additional artefacts were visible. The site has been highly disturbed as a result of transmission line construction and the use and maintenance of the access track, with dumped gravel present in the adjoining area. This portion of the study area is assessed as having low potential to contain additional artefacts based on the level of disturbance and the nature of the exposed soil profile.

**Photo 6.37**      **KKLP IA7 looking south-east**

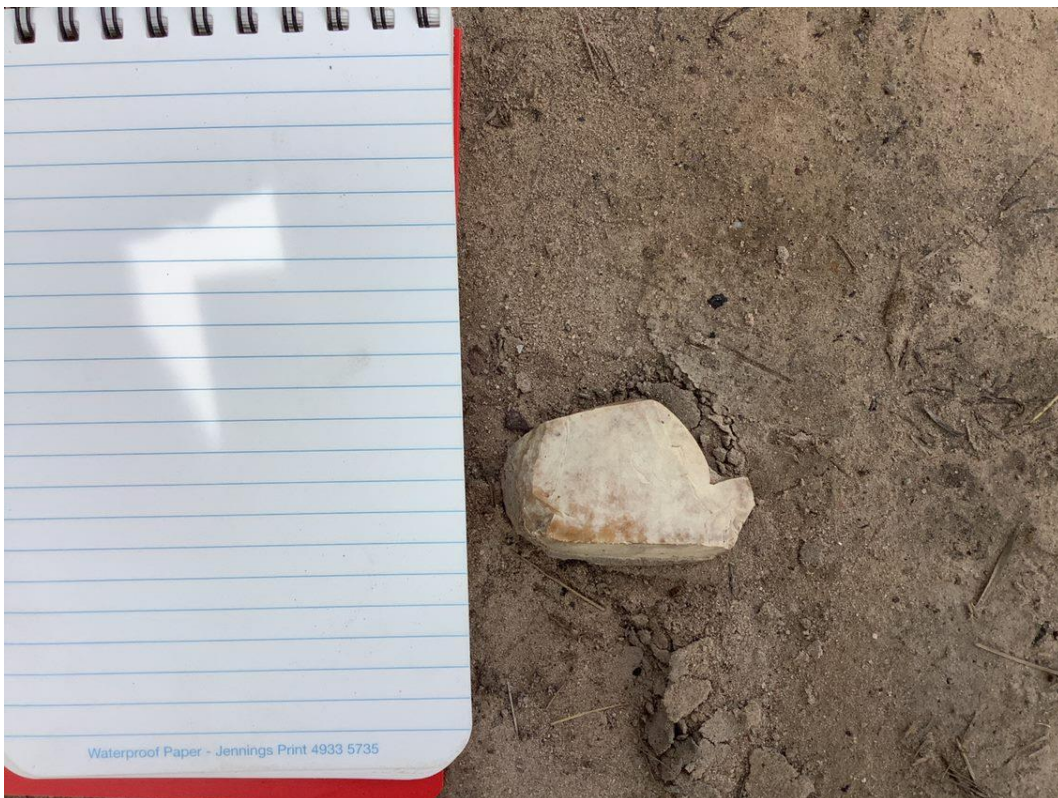
**Photo 6.38**      **Mudstone broken flake – KKLP IA7**

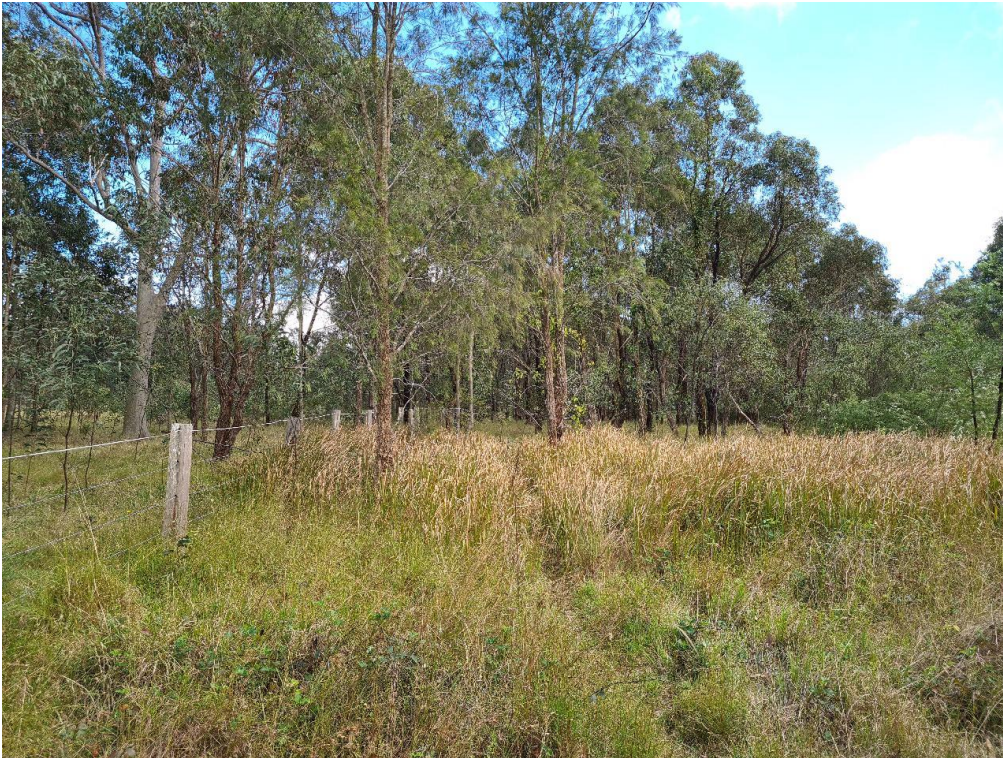
KKLP PAD1 is an extension of the previously recorded site, Woods Gully (38-4-0410). As discussed in section 4.2, the Woods Gully was subject to excavation and contained significant archaeological deposit. Kuskie & Kamminga (2000) assessed the site and PAD and a conservation zone was established within the F3 Freeway road corridor (refer to **Photo 6.39**). The landform that the site and PAD was recorded on continues into the current study area (refer to **Photo 6.40**). The disturbance within KKLP PAD1 is limited to general land clearance and grazing and there is likely to be topsoil remaining in situ. The visibility within the PAD area was low with no exposures recorded. It was assessed that the area has moderate to high archaeological potential, consistent with the results previous excavations in the Woods Gully site.

**Photo 6.39** Woods Gully (38-4-0410) Conservation Zone, view approximately north

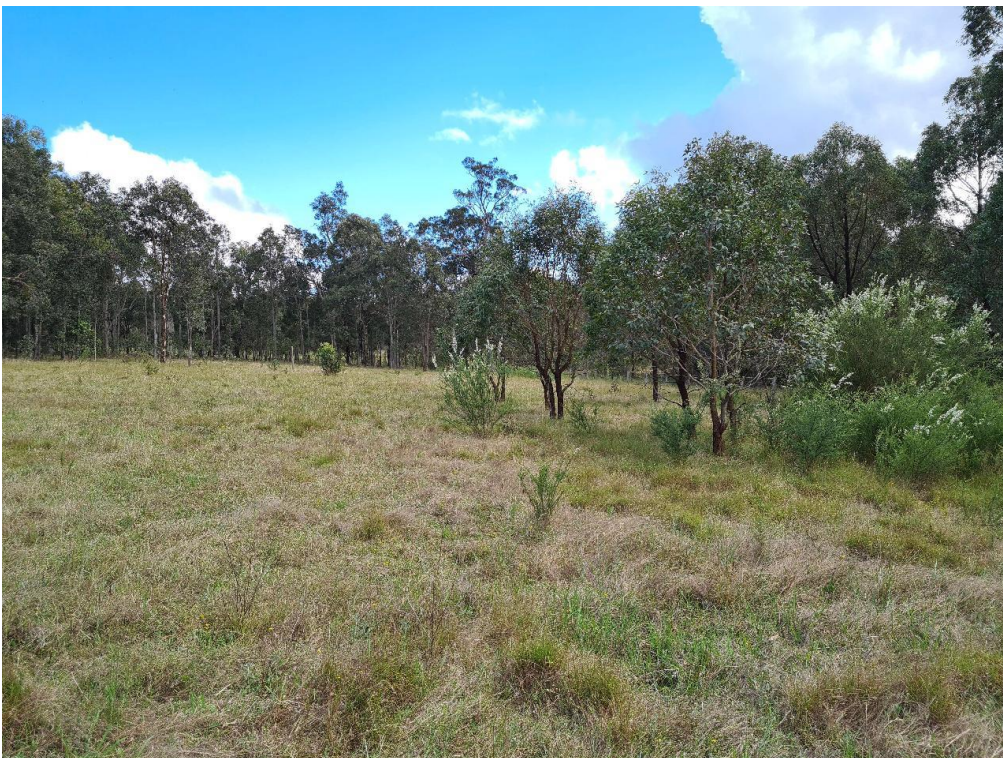
**Photo 6.40** KKLP PAD1 adjacent to existing Conservation Zone, view approximately northeast

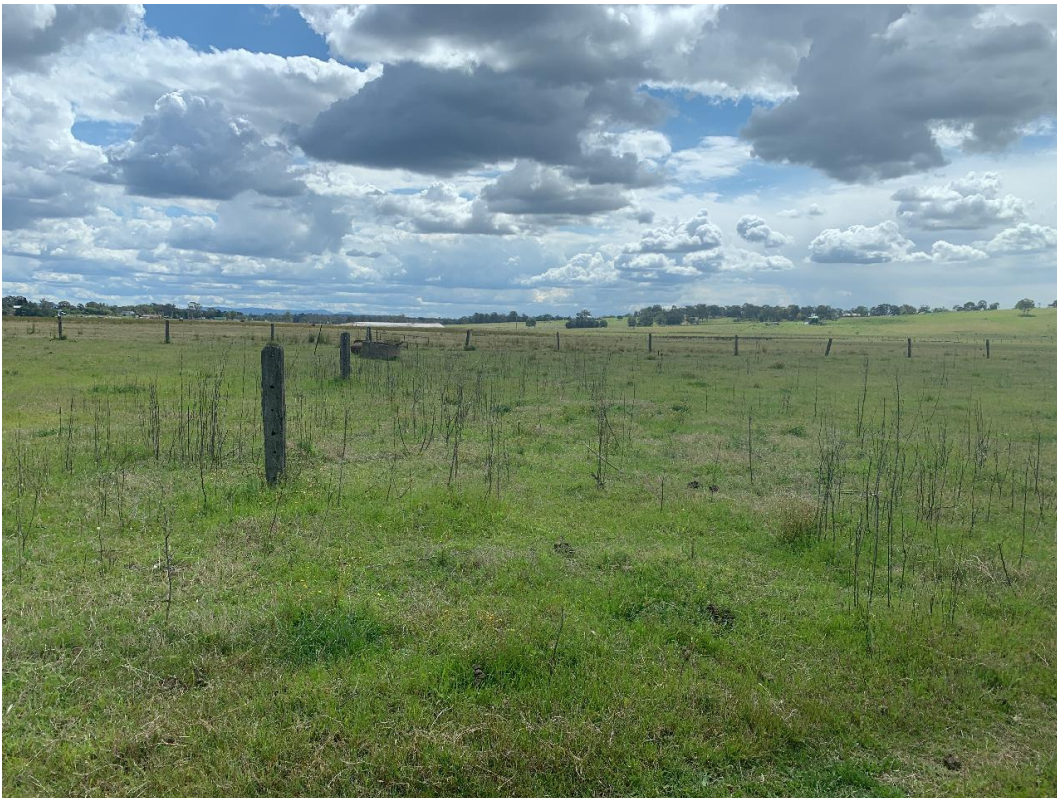
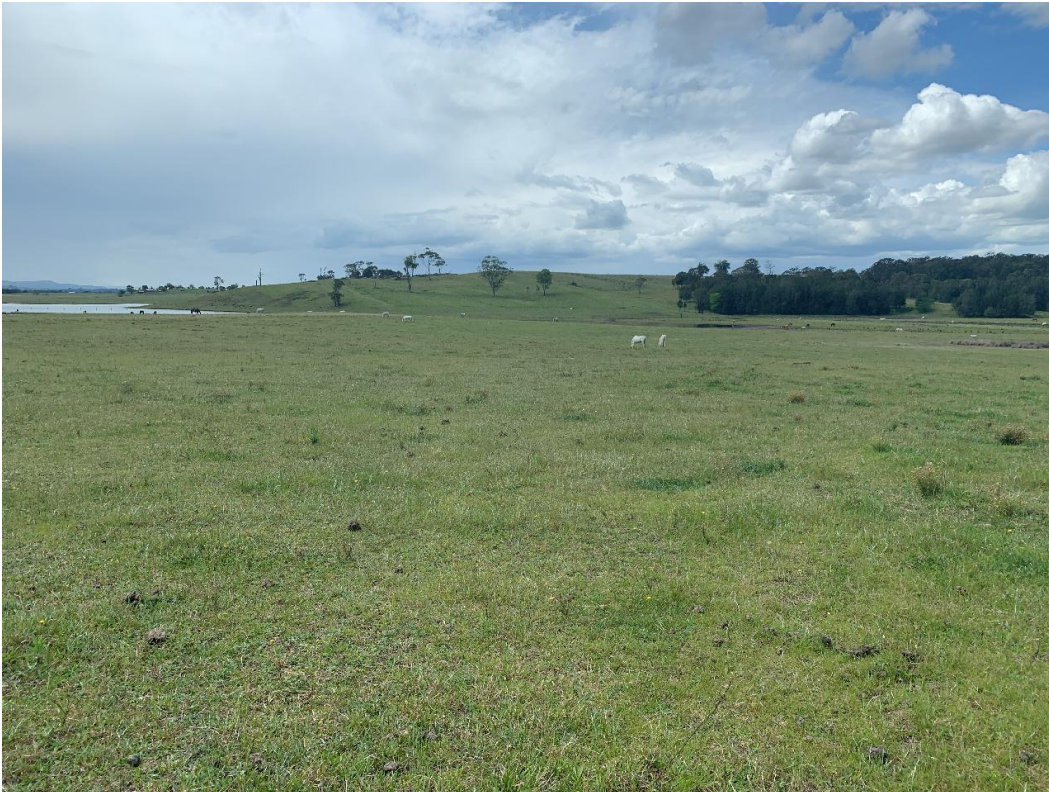
**Photo 6.41** KKLP PAD2 elevated landform between Buttai and Wallis Creeks, view approximately west

**Photo 6.42** KKLP PAD2 elevated landform between Buttai and Wallis Creeks, view approximately north

KKLP PAD2 comprises a near level mid to lower slope between Wallis and Buttai Creeks which run approximately parallel through the study area. The landform provides an elevated area above the regular inundation level of both creeks, which would be suitable for camping and provided direct access to wetland resources on the Wallis Creek floodplain (refer to **Photo 6.41** and **Photo 6.42**). The area has been cleared of vegetation and subject to grazing. One isolated artefact (KKLP IA1) was located within a small exposure within the landform. Generally, the visibility within the PAD area was poor. It was assessed that the area has moderate archaeological potential.

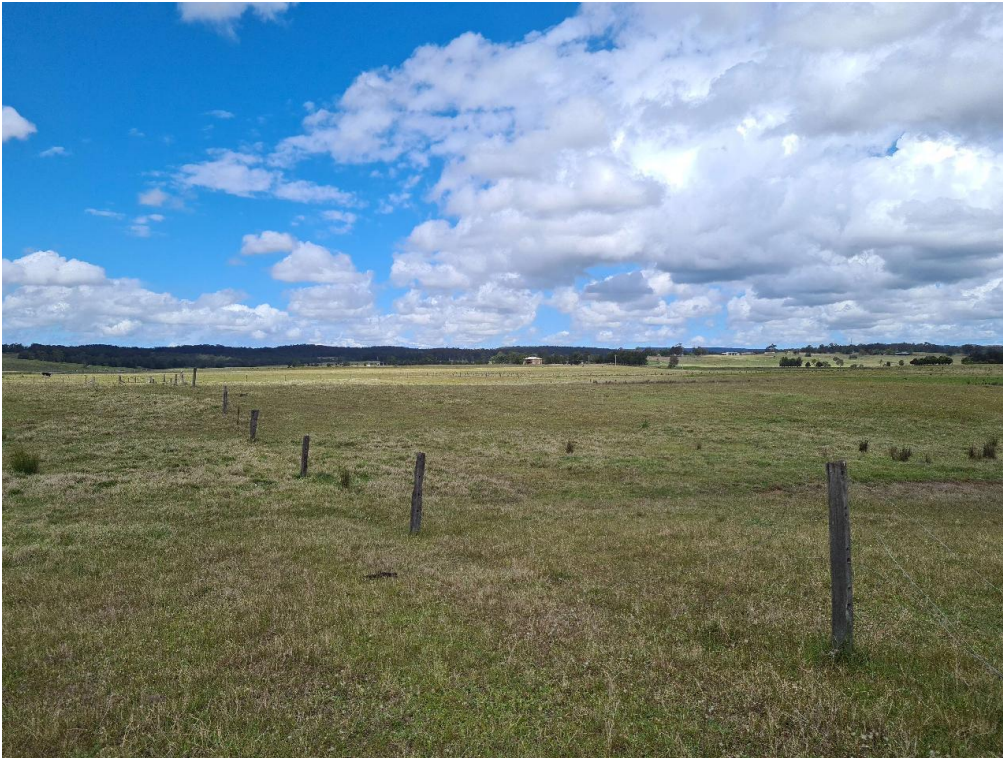
KKLP PAD3 is located on an elevated near level lower slope to the west of Wallis Creek and north of Testers Hollow, which both provide access to permanent water and associated resources (refer to **Photo 6.43**). The disturbance within KKLP PAD3 is limited to general land clearance and grazing and there is likely to be topsoil remaining in situ. The visibility within the PAD area was low with no exposures recorded. The PAD was recorded in the landform adjacent to the previously recorded TH-PAD-01 (38-4-1997), which is in the same environmental context. It was assessed that the area has moderate to high archaeological potential.

**Photo 6.43**      **KKLP PAD3 - on the western side of Wallis Creek, view approximately southeast**

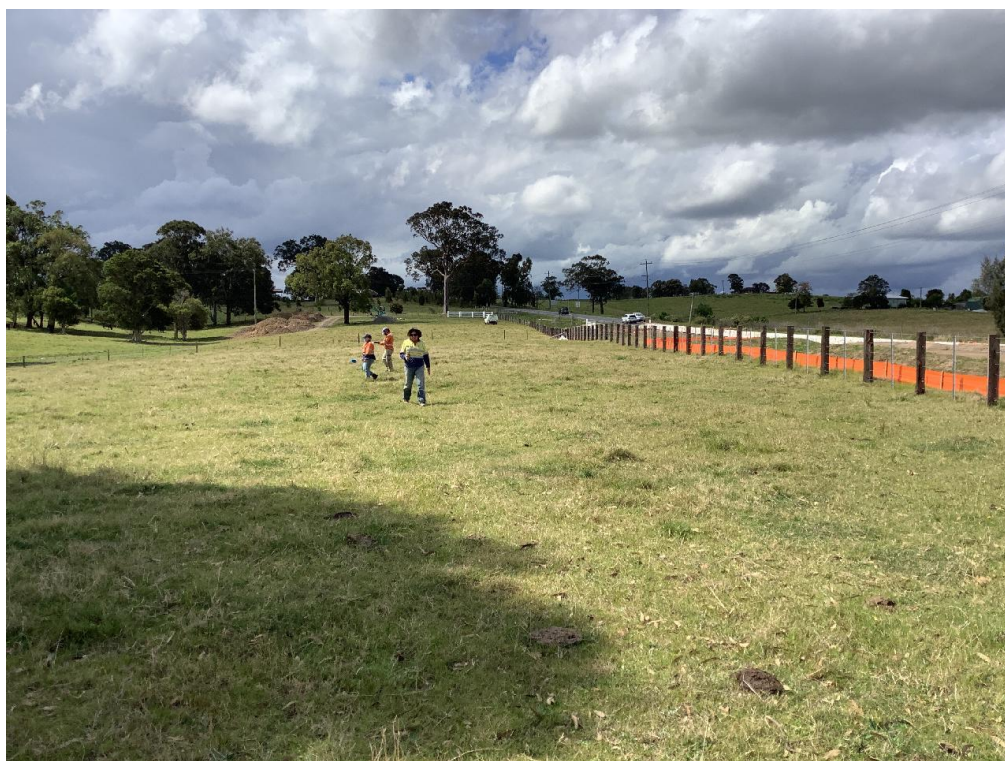
TH-PAD-01 was originally recorded in relation to proposed road upgrade works, was subject to test excavation and subsequently to salvage excavation (Jacobs 2021). TH-PAD-01 was assessed as having high local significance. TH-PAD-01 was recorded on an elevated near level lower slope that provides direct access to Wallis Creek and Testers Hollow. This landform continues into the current study area. As such, the continuation of the landform is identified as an extension of TH-PAD-01 (refer to **Photo 6.44**). The disturbance within the TH-PAD-01 Extension is limited to general land clearance and grazing and there is likely to be topsoil remaining in situ. The visibility within the PAD area was low. Consistent with the assessment for TH-PAD-01, the area is assessed as having moderate to high archaeological potential.

**Photo 6.44** TH-PAD-01 Extension - spur on the northern side of swamp associated with Wallis Creek, view approximately north

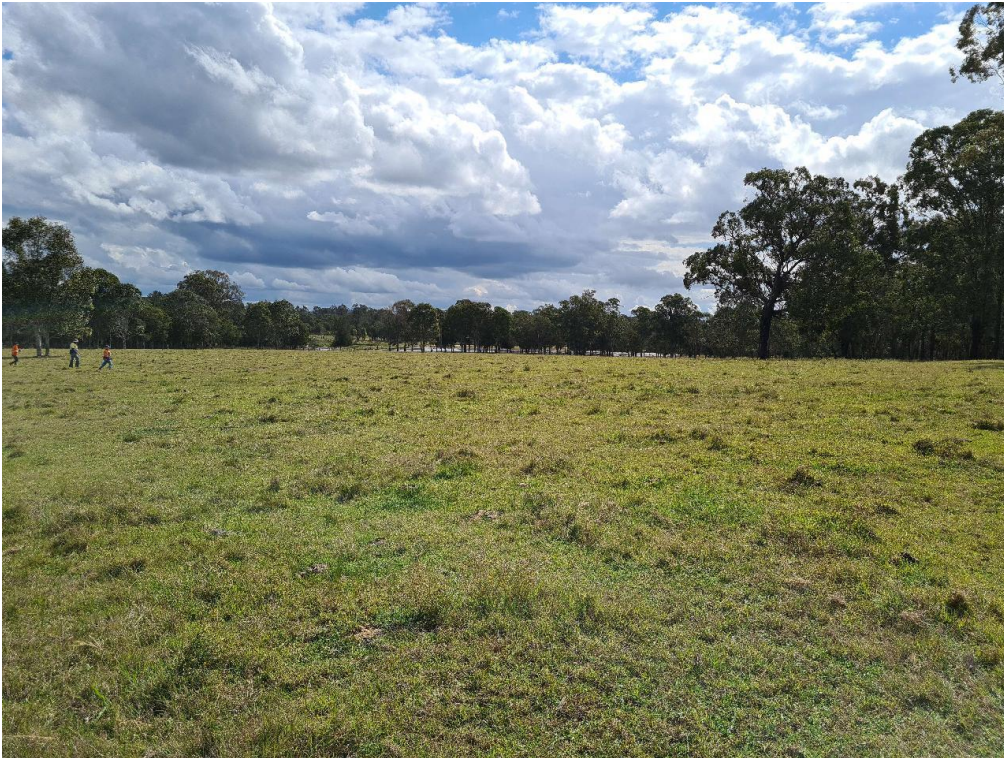
KKLP PAD4 is located on an elevated section of lower slope to the north of Testers Hollow (refer to **Photo 6.45** and **Photo 6.46**). This landform is generally consistent with TH-PAD-01 Extension, which has been demonstrated to contain archaeological deposits of high significance, however KKLP PAD4 provides access to Testers Hollow only (rather than both Testers Hollow and the Wallis Creek floodplain). The disturbance within KKLP PAD4 is limited to general land clearance, with remnant vegetation remaining across half the PAD area. The visibility within the PAD area was low with no exposures recorded. It was assessed that there is topsoil that remains in situ and as such the area contains moderate archaeological potential.

**Photo 6.45** KKLP PAD4 -elevated lower slope on the northern side of Testers Hollow , view approximately southwest

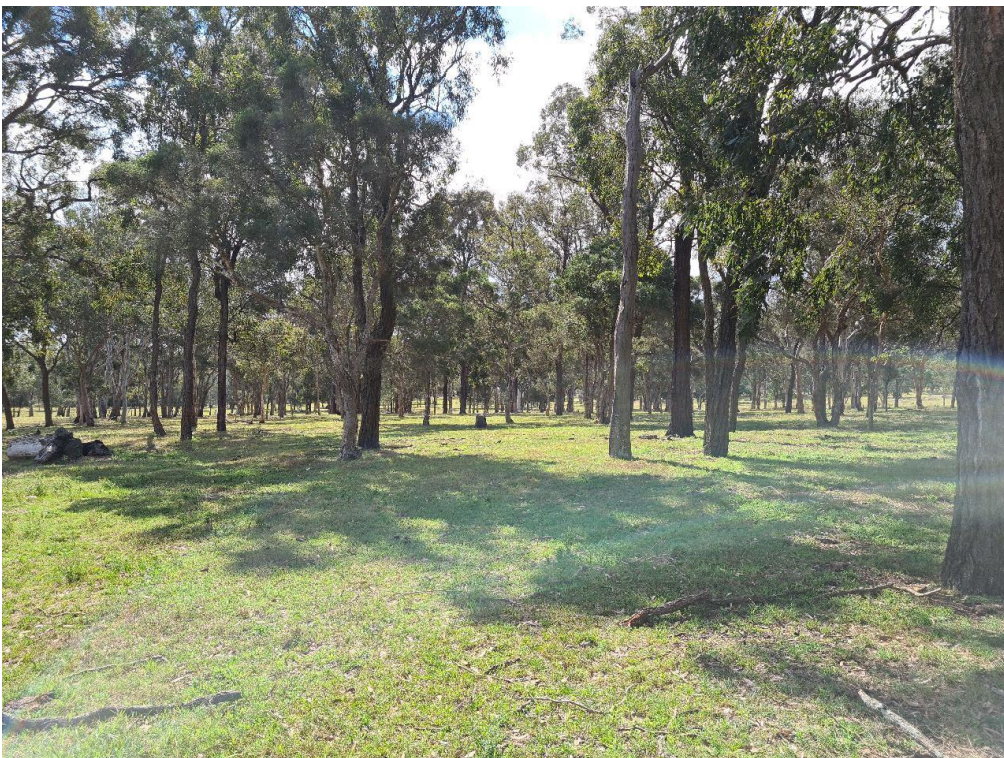
**Photo 6.46** KKLP PAD4 – remnant vegetation, view approximately northwest

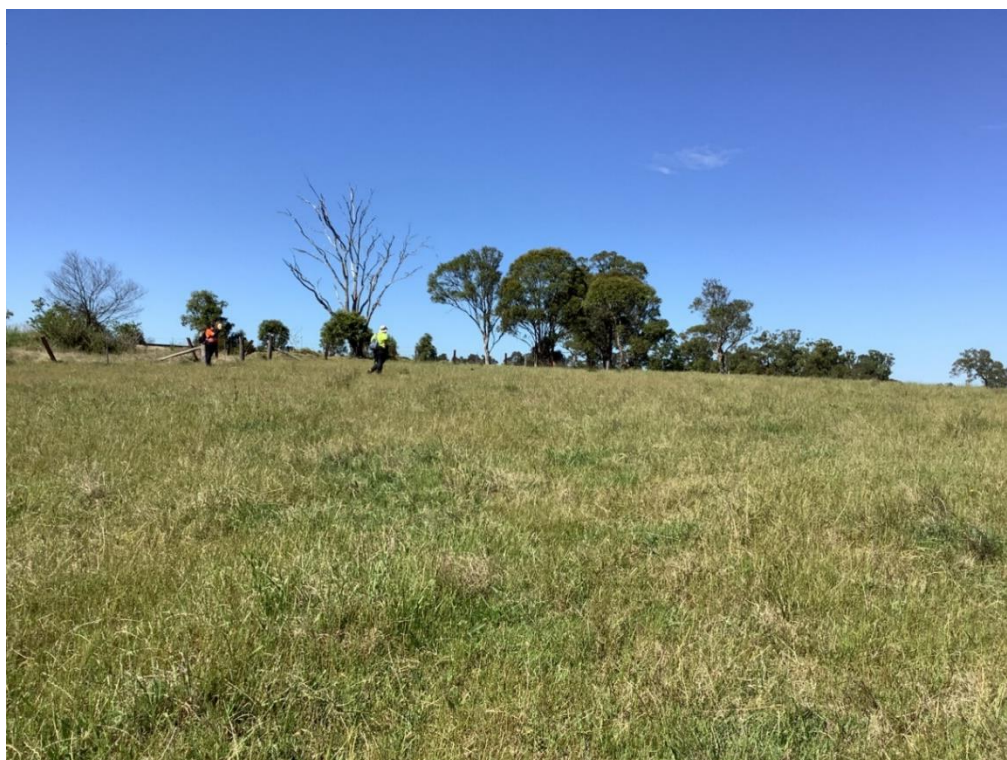
KKLP PAD5 and KKLP PAD6 are located on a low elevation spur located on the eastern edge of the Swamp Creek /Wentworth Swamp (refer to **Photo 6.47** to **Photo 6.50**). The landform provides an elevated area above the height that appears to have been subject to inundation. The area would have provided level, dry ground for camping while also allowing for direct access to wetland resources. The area has been cleared of vegetation and subject to grazing. Generally, the visibility within the PADs was poor. It was assessed that there is likely topsoil that remains in situ and as such these PADs have moderate archaeological potential.

**Photo 6.47** KKLP PAD5, view approximately south

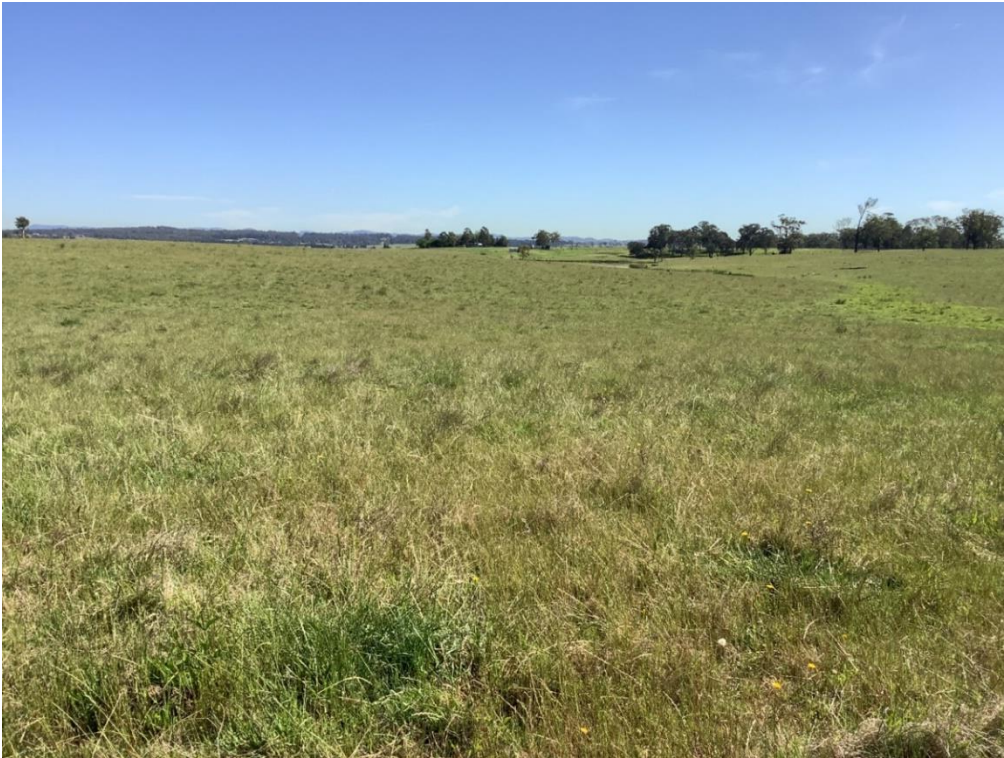
**Photo 6.48**      **KKLP PAD5, view approximately west**

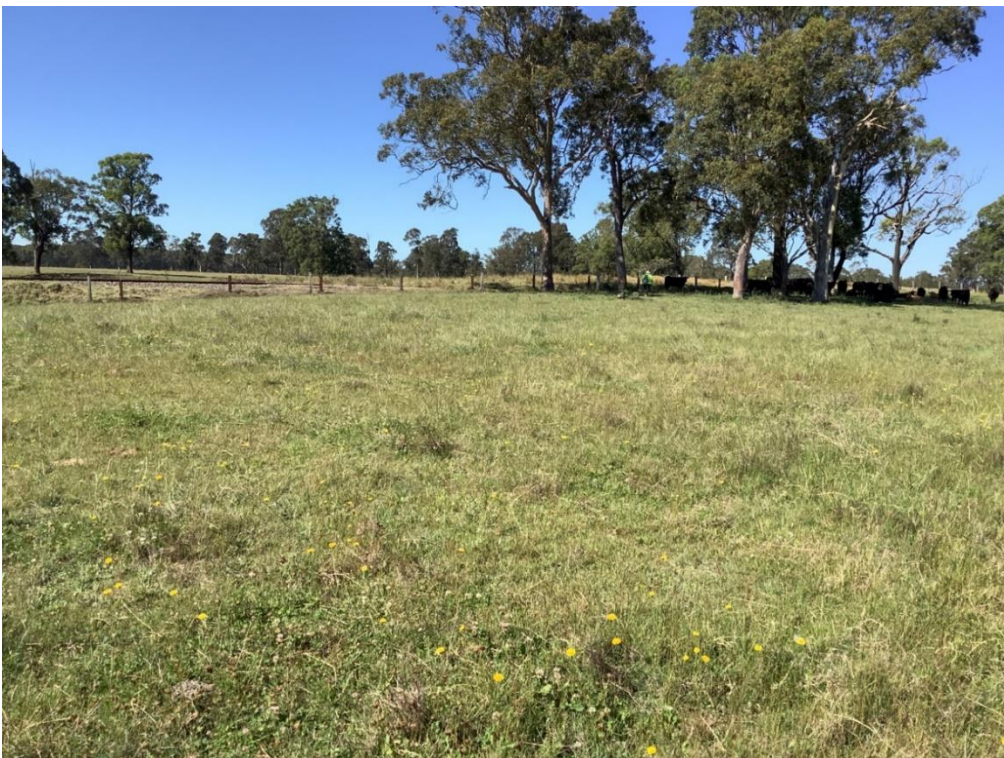
**Photo 6.49**      **KKLP PAD6, view approximately south**

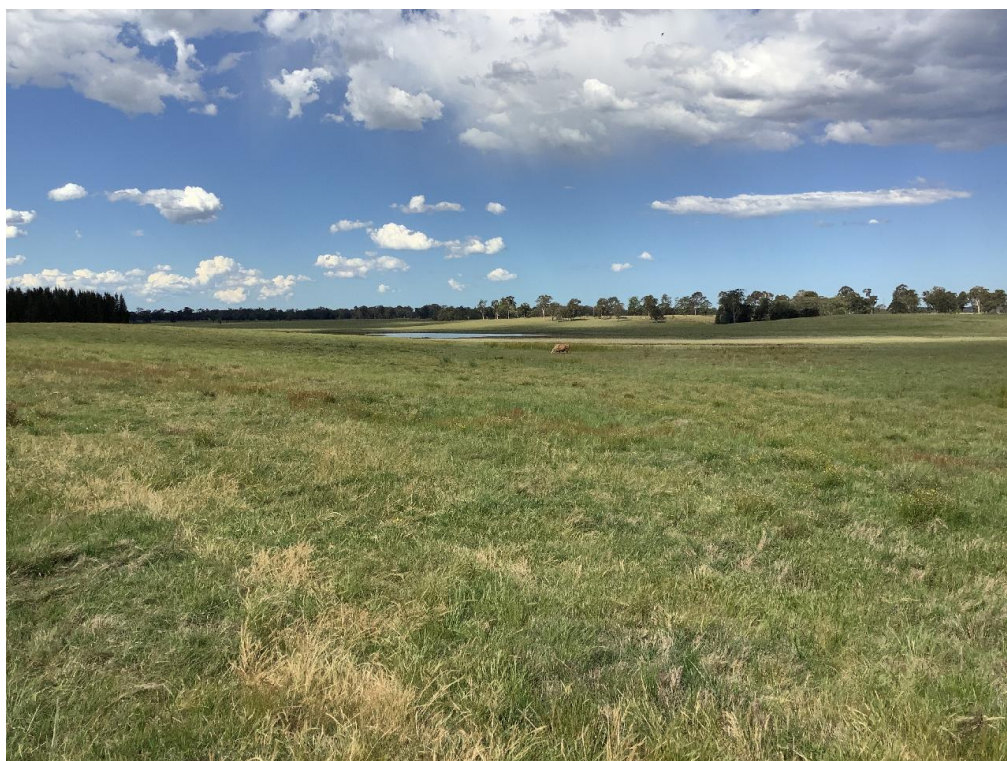
**Photo 6.50**      **KKLP PAD6, view approximately west**

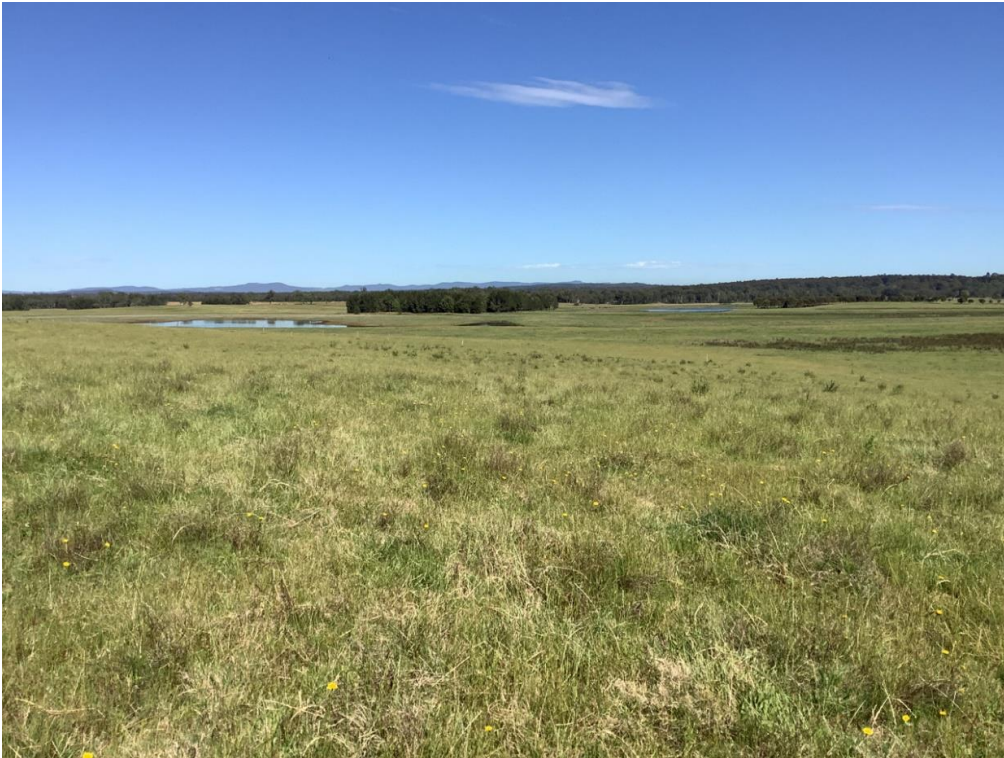
KKLP PAD7 is located on a gently inclined lower slope to the west of Swamp Creek (refer to **Photo 6.51**). The landform provides an elevated area above the high-water line of the creek, which would be suitable for camping and provided access to Swamp Creek and then to Wentworth Swamp. The area has been cleared of vegetation and is subject to grazing. Generally, the visibility within the PAD area was poor. It was assessed that the area has moderate archaeological potential.

**Photo 6.51**      **KKLP PAD7, view approximately northeast**

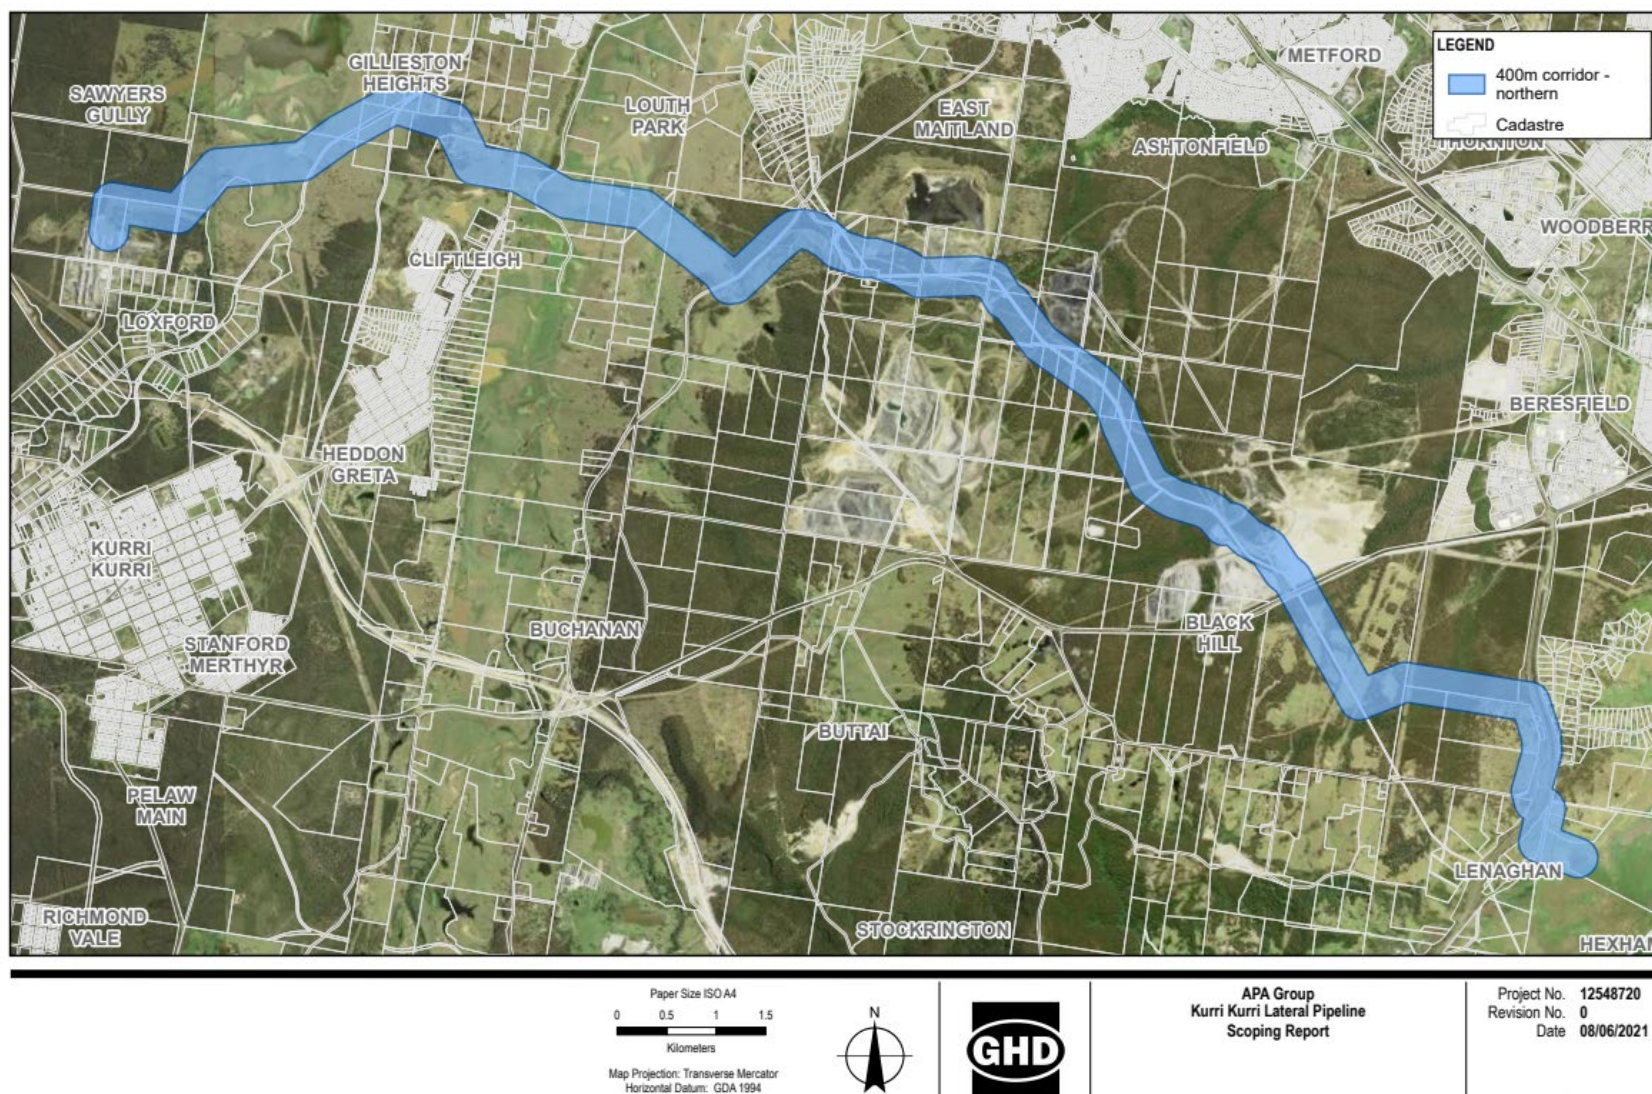
**Figure 1.1 Proposed Transmission Pipeline Alignment**

At this stage, the final alignment for the pipelines has not been finalised. The general alignment of the transmission pipeline, which falls within Cessnock, Maitland and Newcastle Local Government Areas (LGAs), is shown on **Figure 1.1**. The indicative alignment of the storage pipeline is shown on **Figure 1.2**. The routes will be finalised prior to Aboriginal cultural heritage survey being undertaken and will be influenced by a number of factors including previously recorded heritage sites and other environmental considerations.

APA Group (APA) is proposing to develop the proposed Kurri Kurri Lateral Pipeline project in the Hunter region of New South Wales (NSW). The Project will supply gas to the proposed Hunter Power Project (HPP) in Kurri Kurri and will connect to the existing Sydney to Newcastle pipeline near Lenaghan, approximately 15 km northwest of Newcastle. The proposed Project falls within Mindaribba Local Aboriginal Land Council boundary and is within Cessnock, Maitland and Newcastle City Council local government areas (refer to **Figure 1.1**).

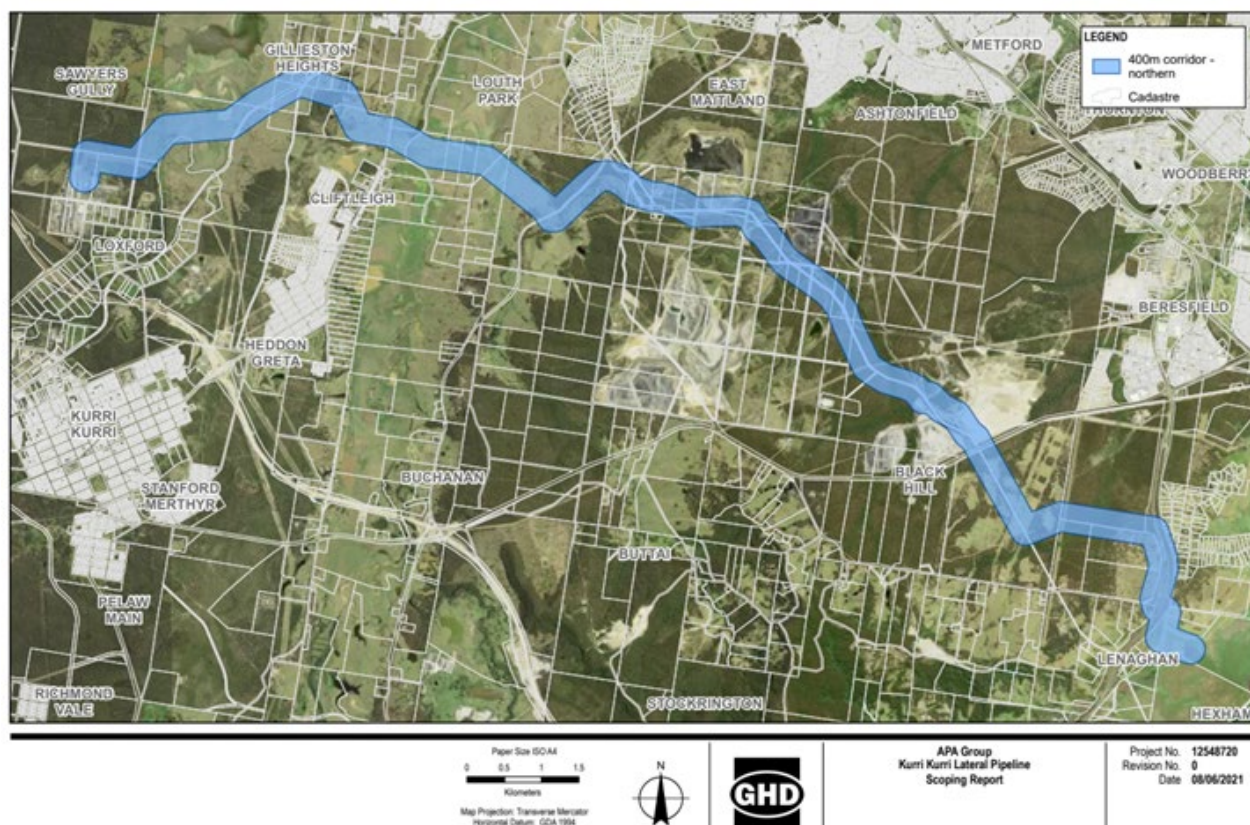
**Figure 1.2** Proposed transmission pipeline route (preliminary)

At this stage, the design and exact location of the transmission and storage pipelines have not been finalised. The general alignment of the transmission pipeline, which falls within Cessnock, Maitland and Newcastle Local Government Areas (LGAs), is shown on **Figure 1.2** as a 400m wide corridor. The indicative alignment of the storage pipeline is shown on **Figure 1.3**. The preliminary layout will be subject to further refinement as engineering design and the environmental, cultural heritage and social impact assessments progress. The Project Area for the ACHA will include a 100m corridor for the transmission pipeline to allow for flexibility in design to minimise potential impact to cultural heritage where possible. The Project Area for the storage pipeline will be determine once the engineering design has progressed further.
