Bridge over Hawkesbury River at Windsor

April 2013

Transport
Roads & Maritime
Services

Windsor Bridge Rehabilitation and Maintenance

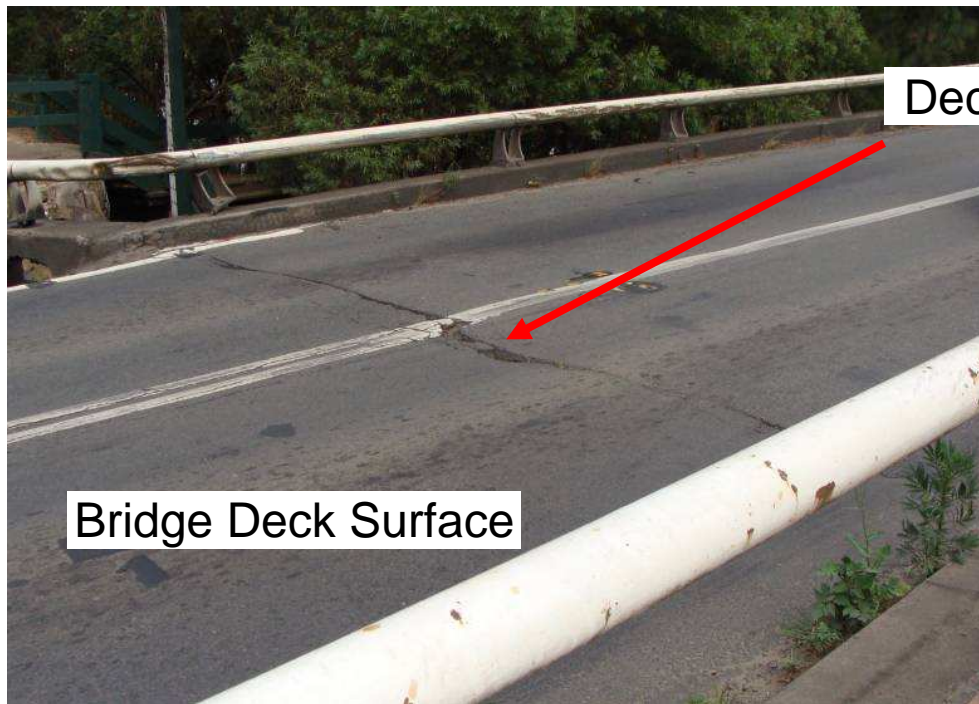
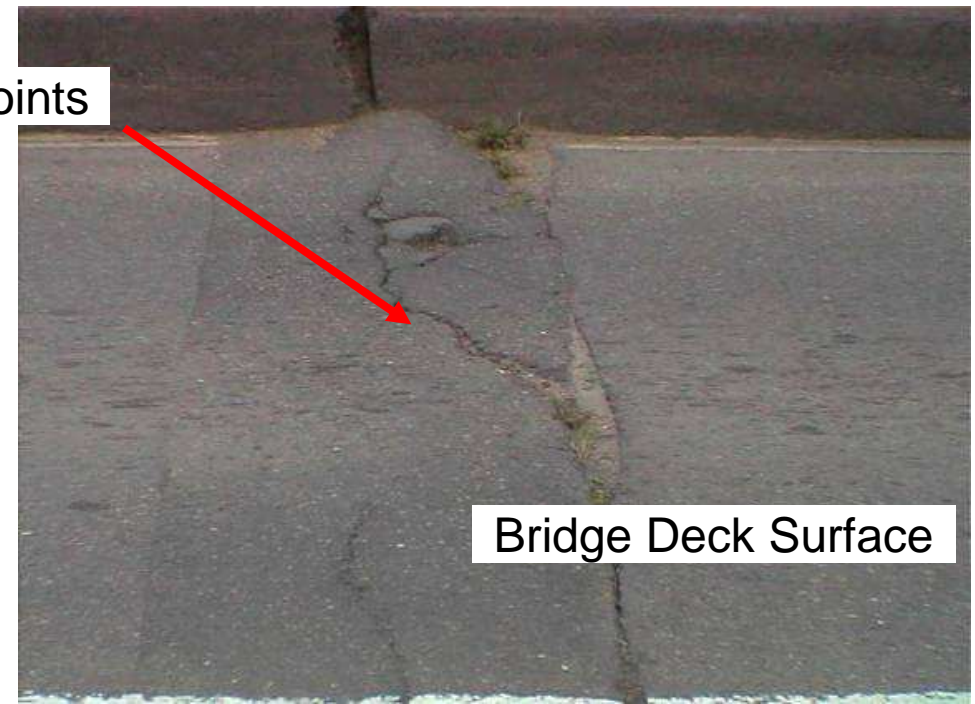
- Deck joints in poor condition and require repair
- Reseal of deck and installation of drainage system required

Cracking and bulging of asphaltic concrete at deck joints

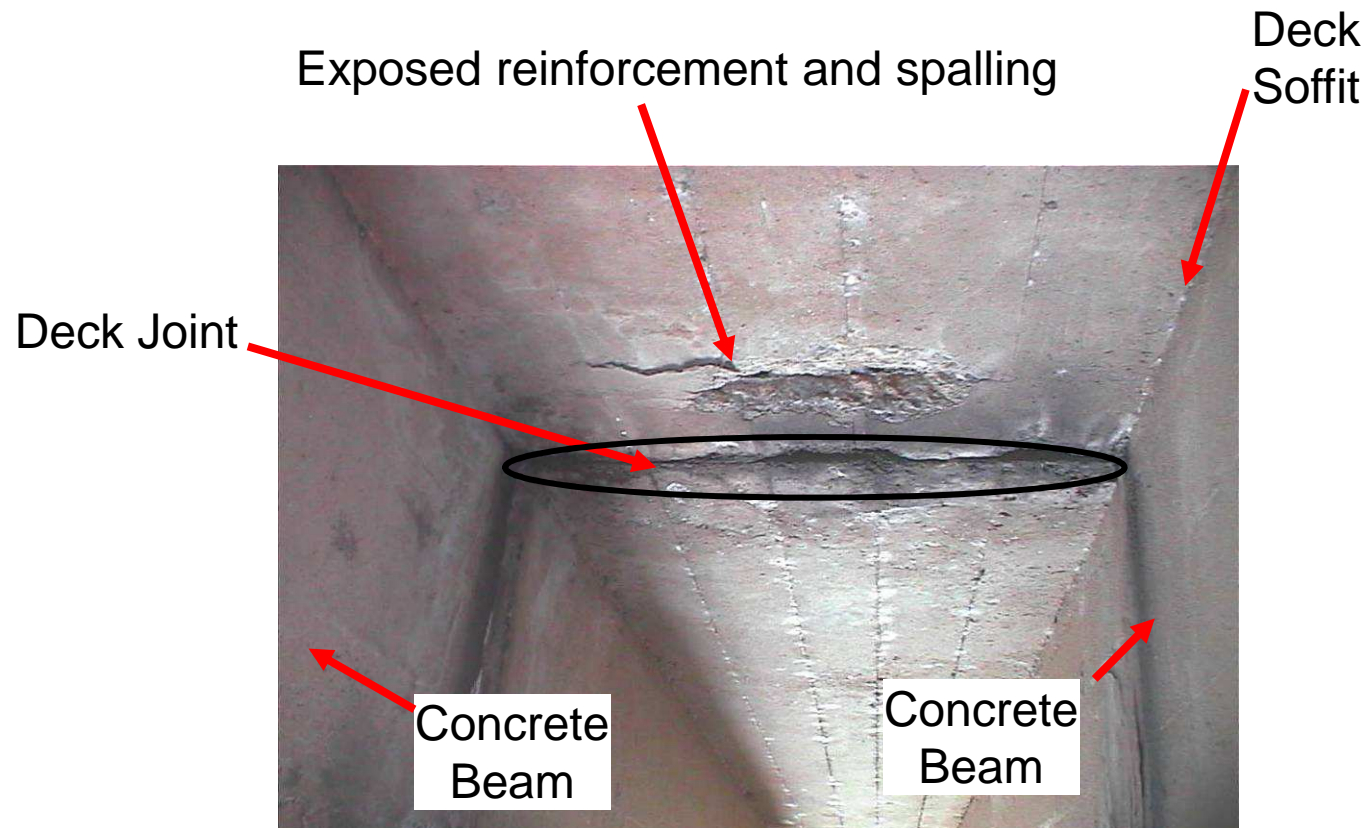
- Cracking in deck slab soffit occurring at bridge joints

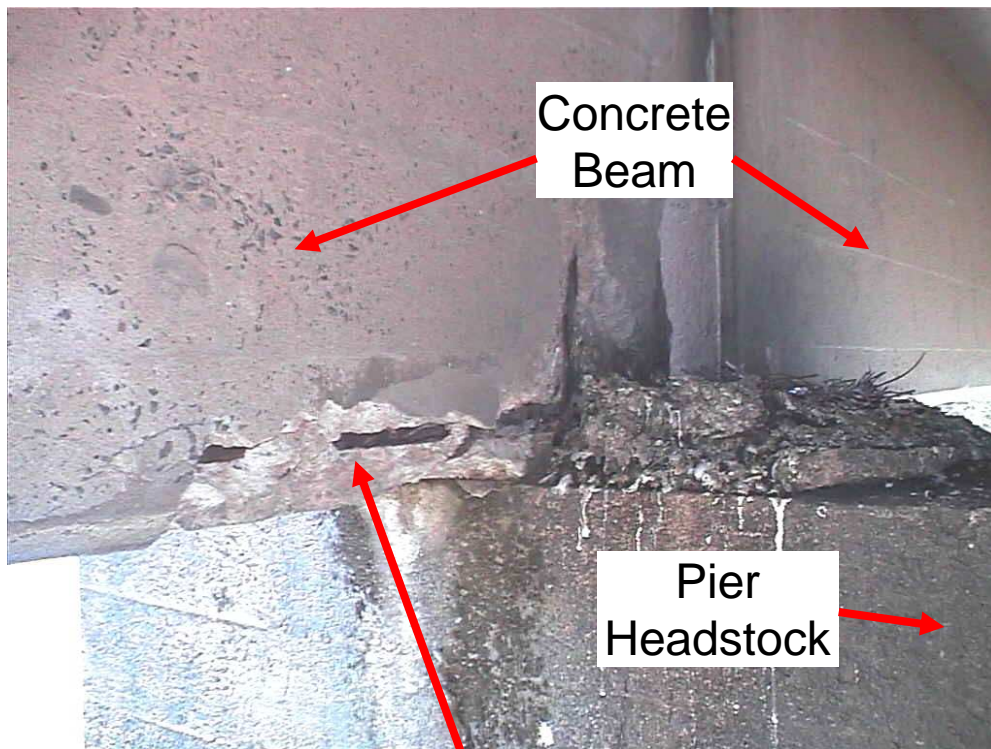
- Cracked and damaged region located 0.5 – 1 m from ends of beams
- 25 locations with damaged beam ends

Pier 4 Beam 1 – Severe spalling and loss of 50% of seating area

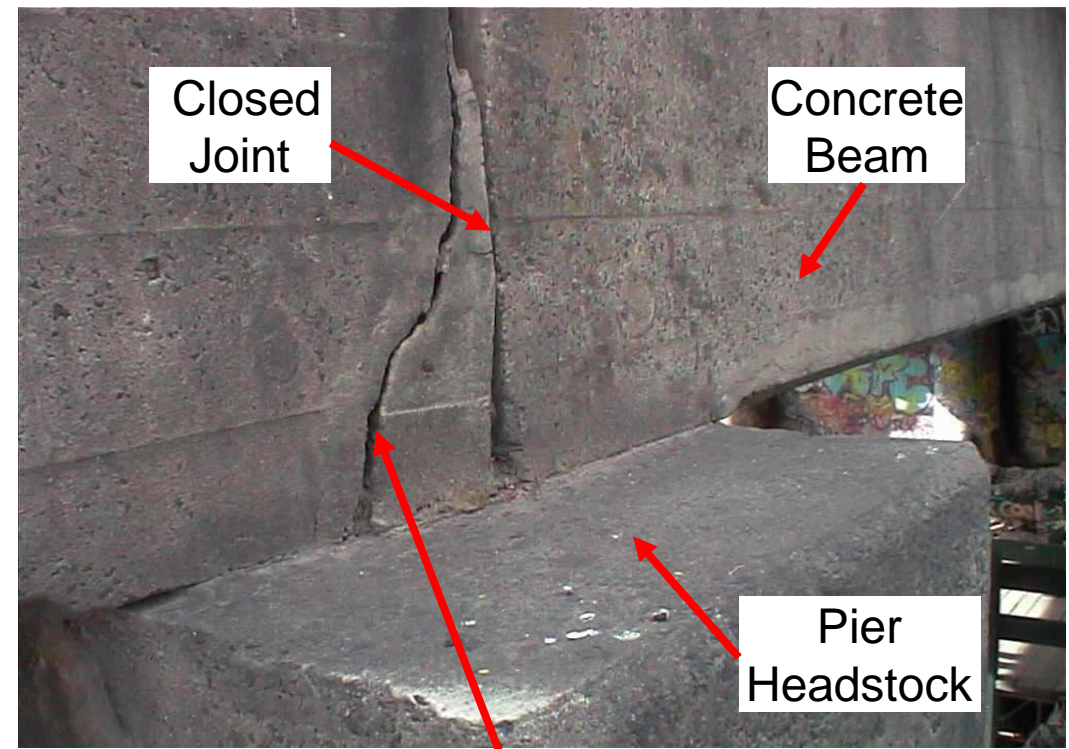
Pier 1 Beam 1 – Wide cracks

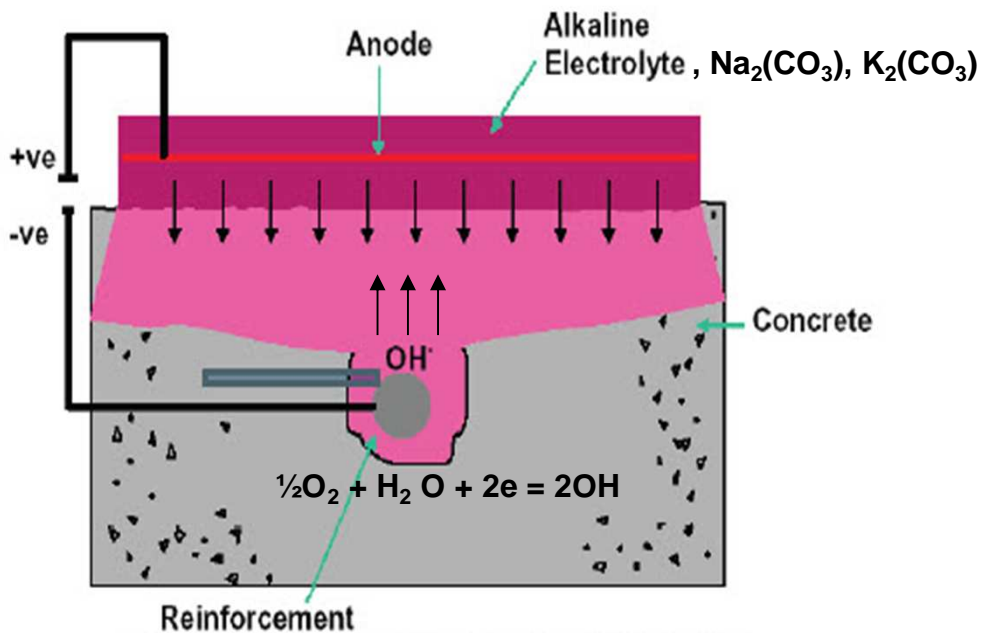
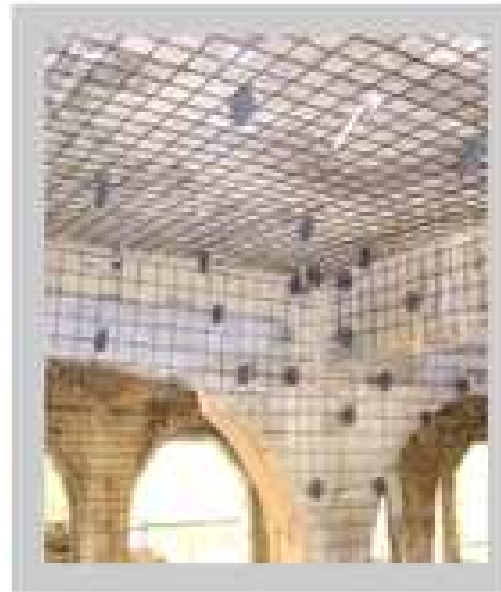
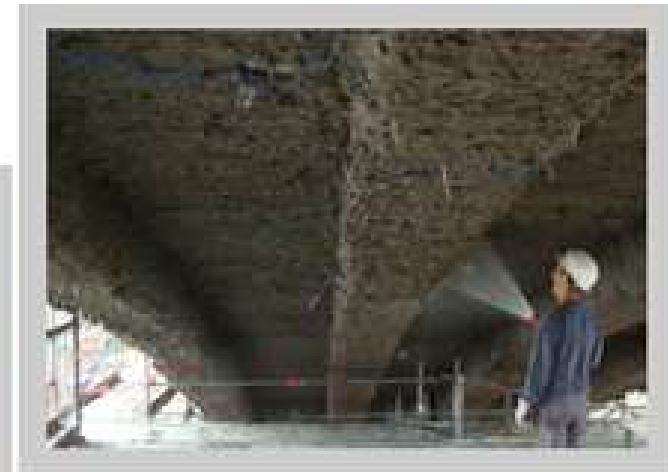
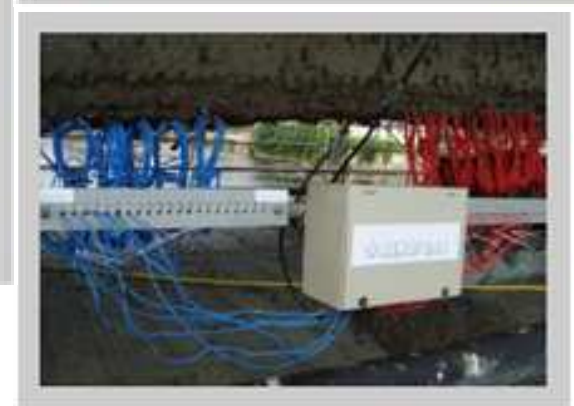
Electrochemical realkalisation

- Bridge over Cooks River at Marrickville - only local full scale application of electrochemical realkalisation in NSW.

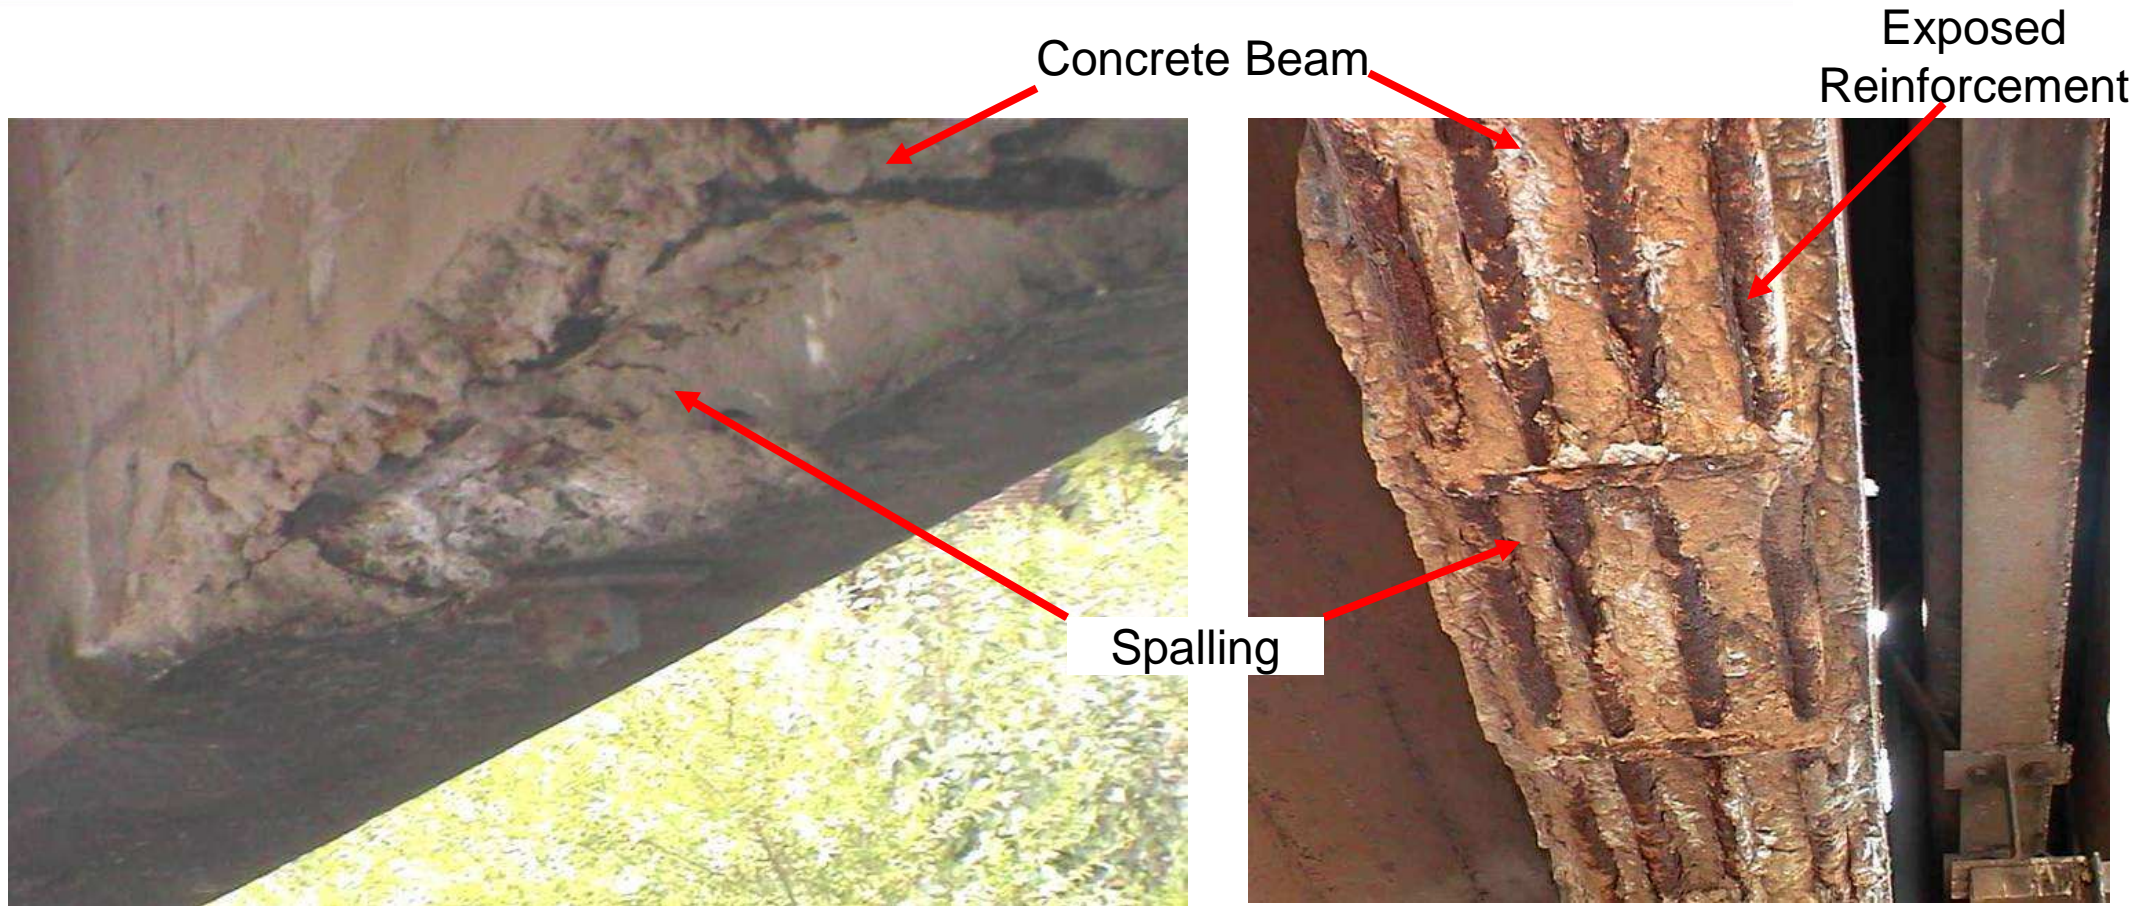
Span 2 Beam 1 – Typical spalling with exposed reinforcement and section loss

Span 4 Beam 8 – Severe spalling with exposed reinforcement and section loss

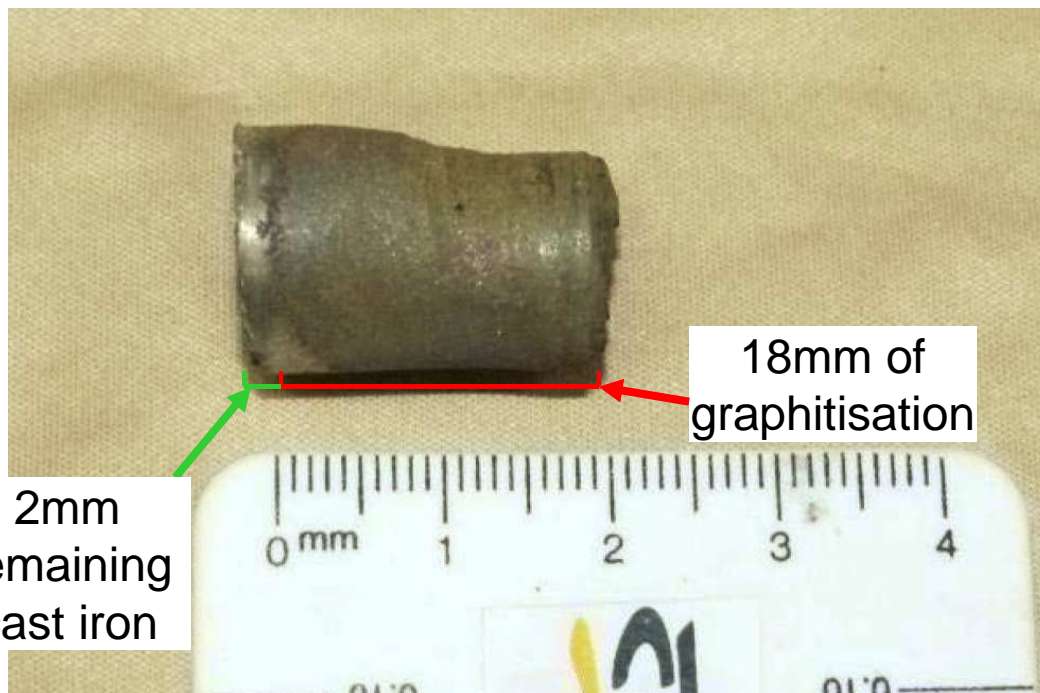
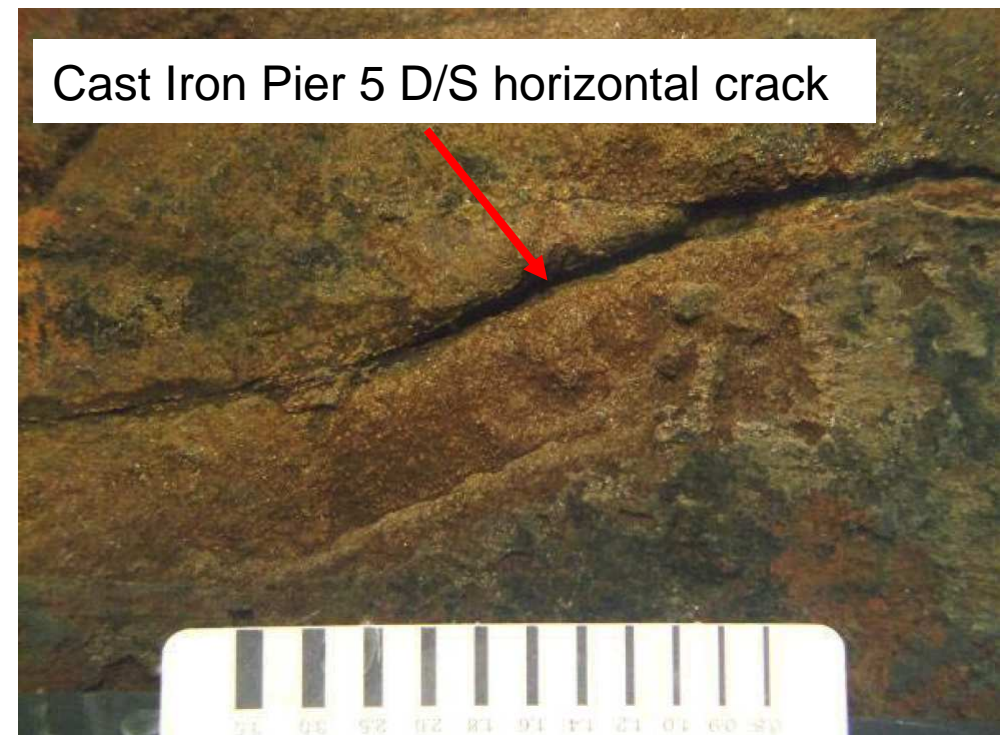
- Cast iron piers in poor condition some with total circumferential cracking and significant graphitisation with section losses
- Core samples show more than 20mm of graphitised material below water
- Average residual structural thickness ~ 15mm (0mm in some areas)

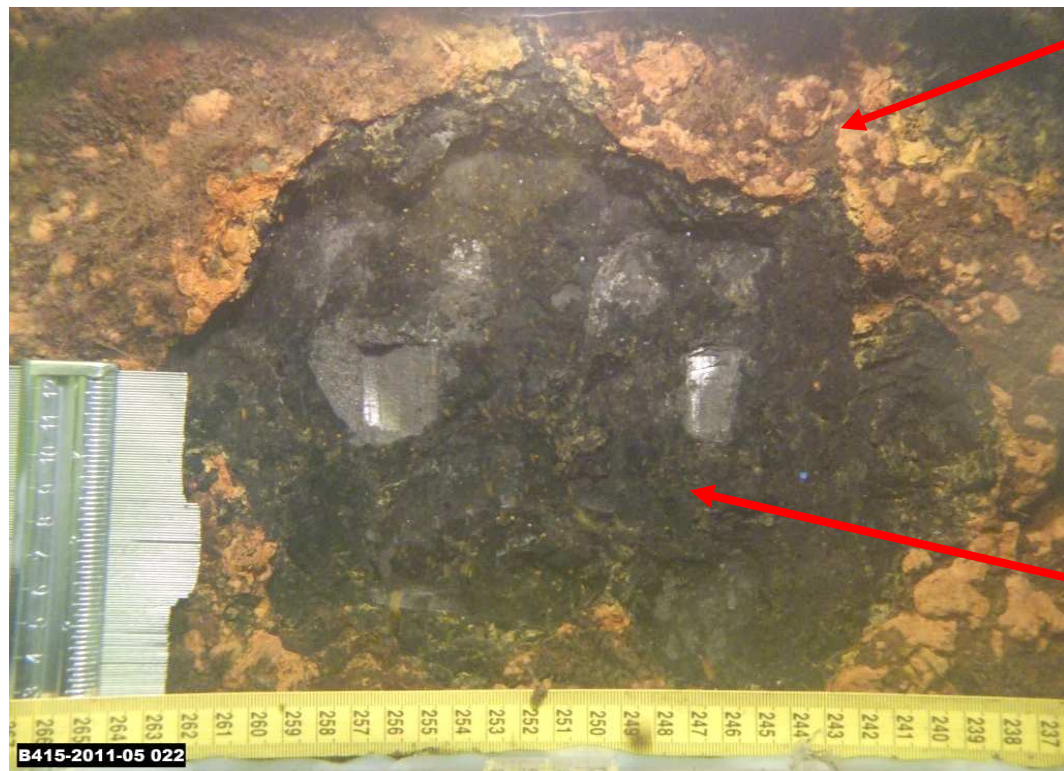
- A form of deterioration of cast iron in which the metallic components are selectively converted to corrosion products leaving the graphite intact (No structural strength).

Corrosion Product

Graphite

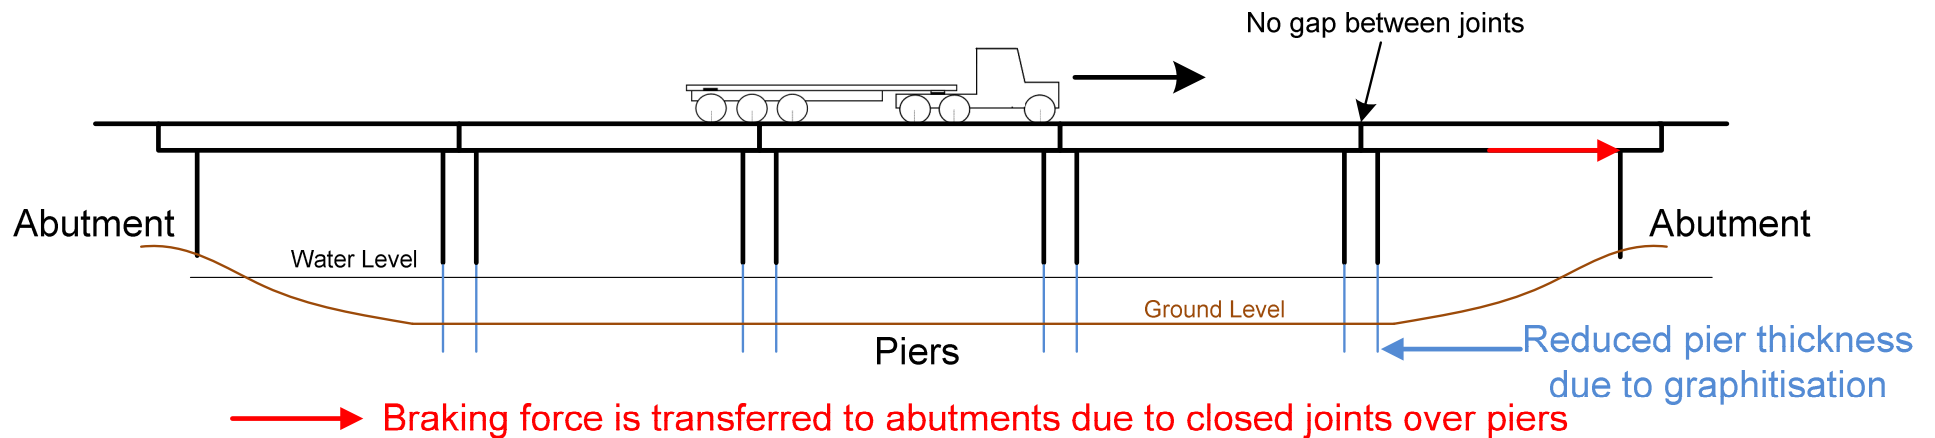
Currently locked up – low loads on piers

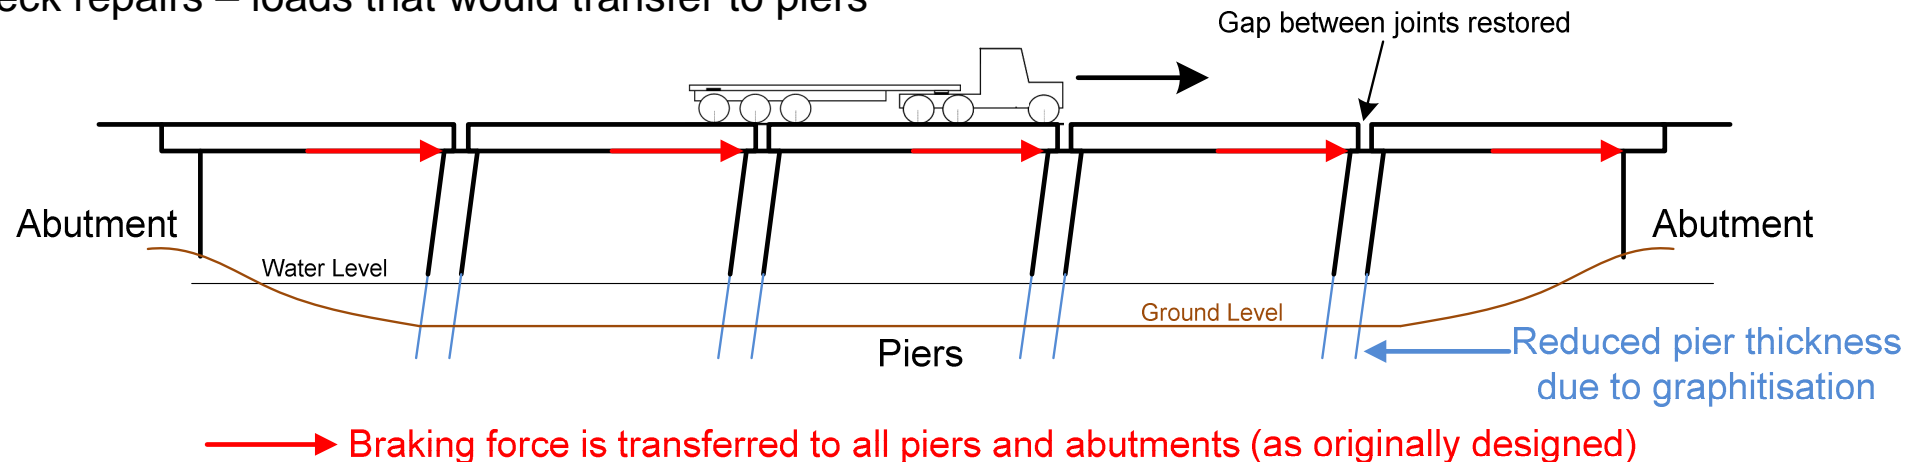
After deck repairs – loads that would transfer to piers

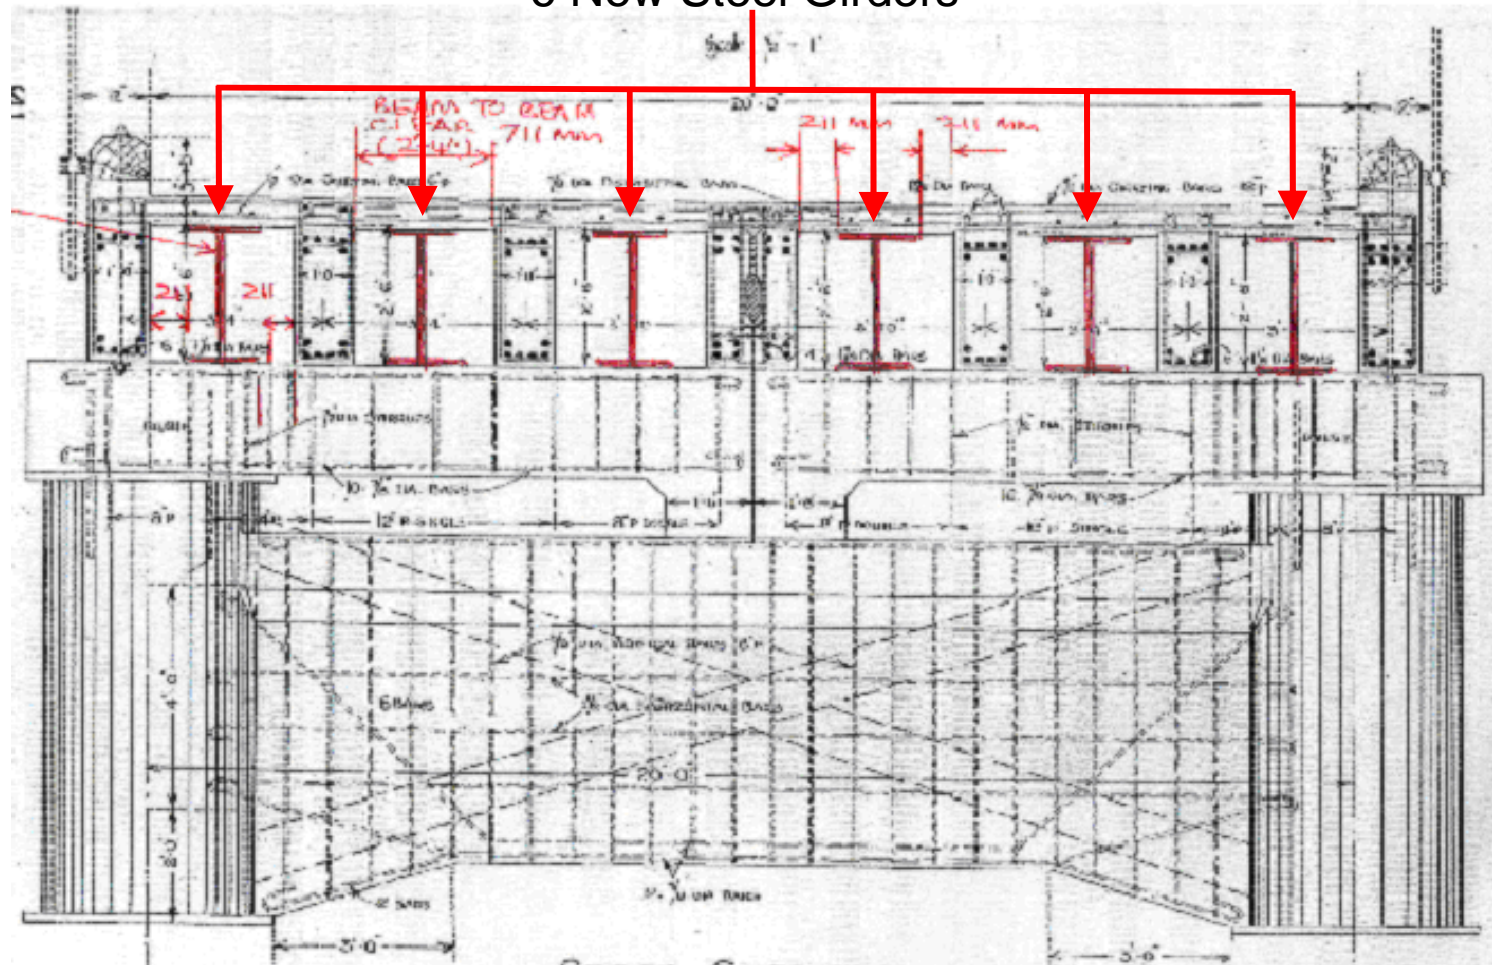
6 New Steel Girders

- Existing bridge does not comply with current standards
- Installation of intermediate steel girders proposed to improve capacity
- T44 Loading as per NAASRA – 1976
- Would require (minimum) one lane operation during construction
