5 HISTORICAL DEVELOPMENT - HAWKESBURY RIVER BRIDGE, WINDSOR

5.1 The Transport Network

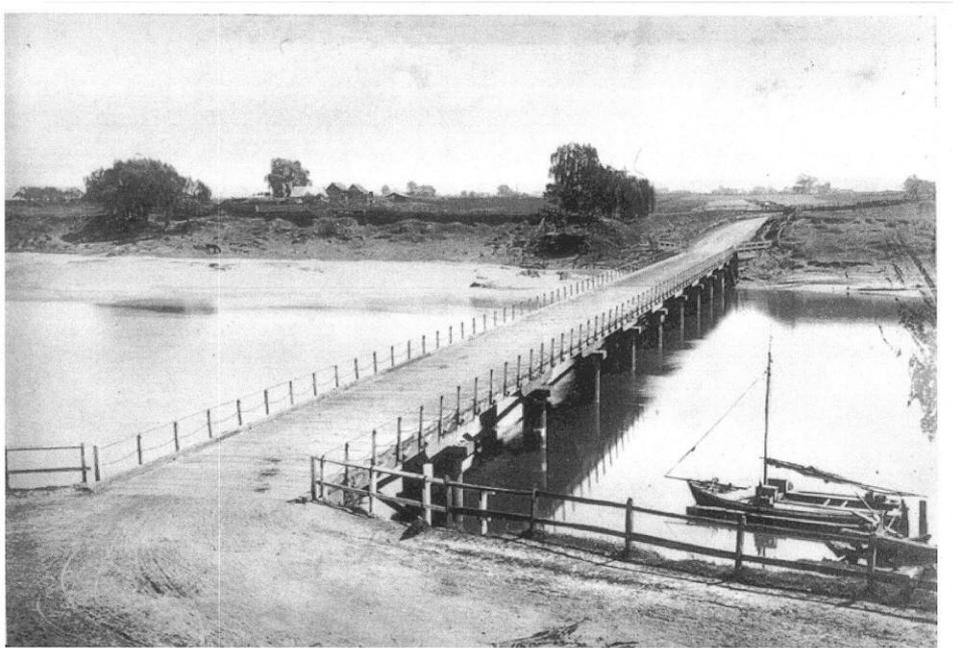
Plate 63: Windsor Bridge, c 1888, in original low level configuration⁴³⁷

The *Hawkesbury Herald* (1902) reported that during the construction of the bridge the Hawkesbury River had been in flood a total of thirteen times, but despite these setbacks, the bridge was completed and opened on on the 20th of August 1874 (Plate 62). Plate 63 shows a photograph of Windsor Bridge in its original configuration. The completion of the bridge was a major achievement and event in the life of Windsor and the surrounding region. The opening was a major day of celebration.

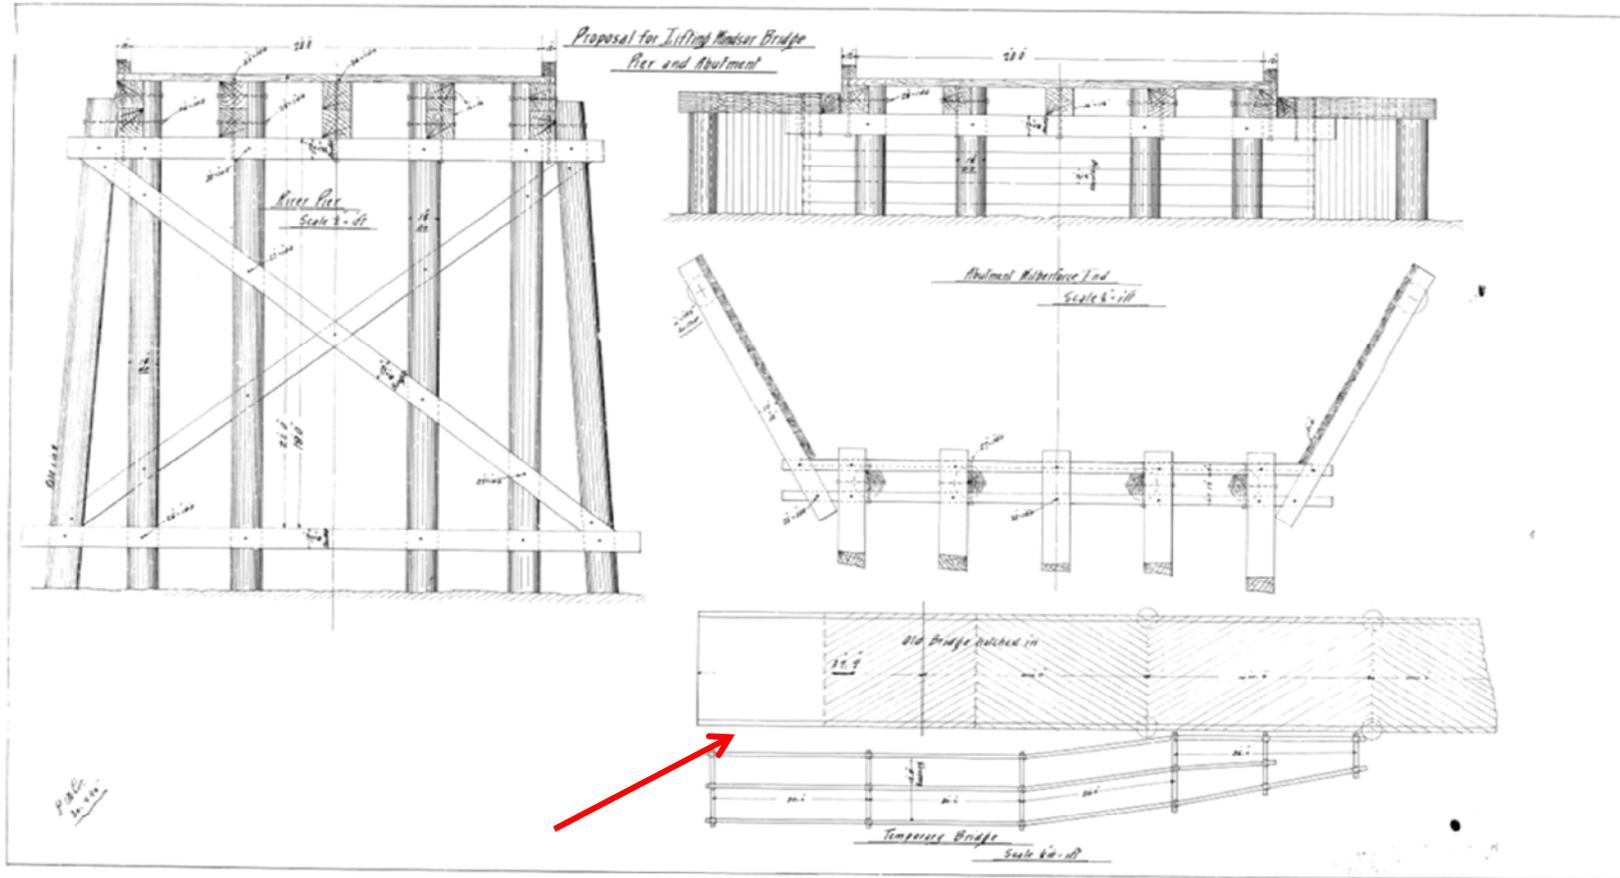
Plate 64: Plan (dated 30.8.95) of the proposed temporary bridge that was built to accommodate traffic during the raising of the existing bridge. The section of decking (indicated) that was added is at the Wilberforce end of the bridge, suggesting that the temporary bridge was on the upstream side.⁴⁴⁷

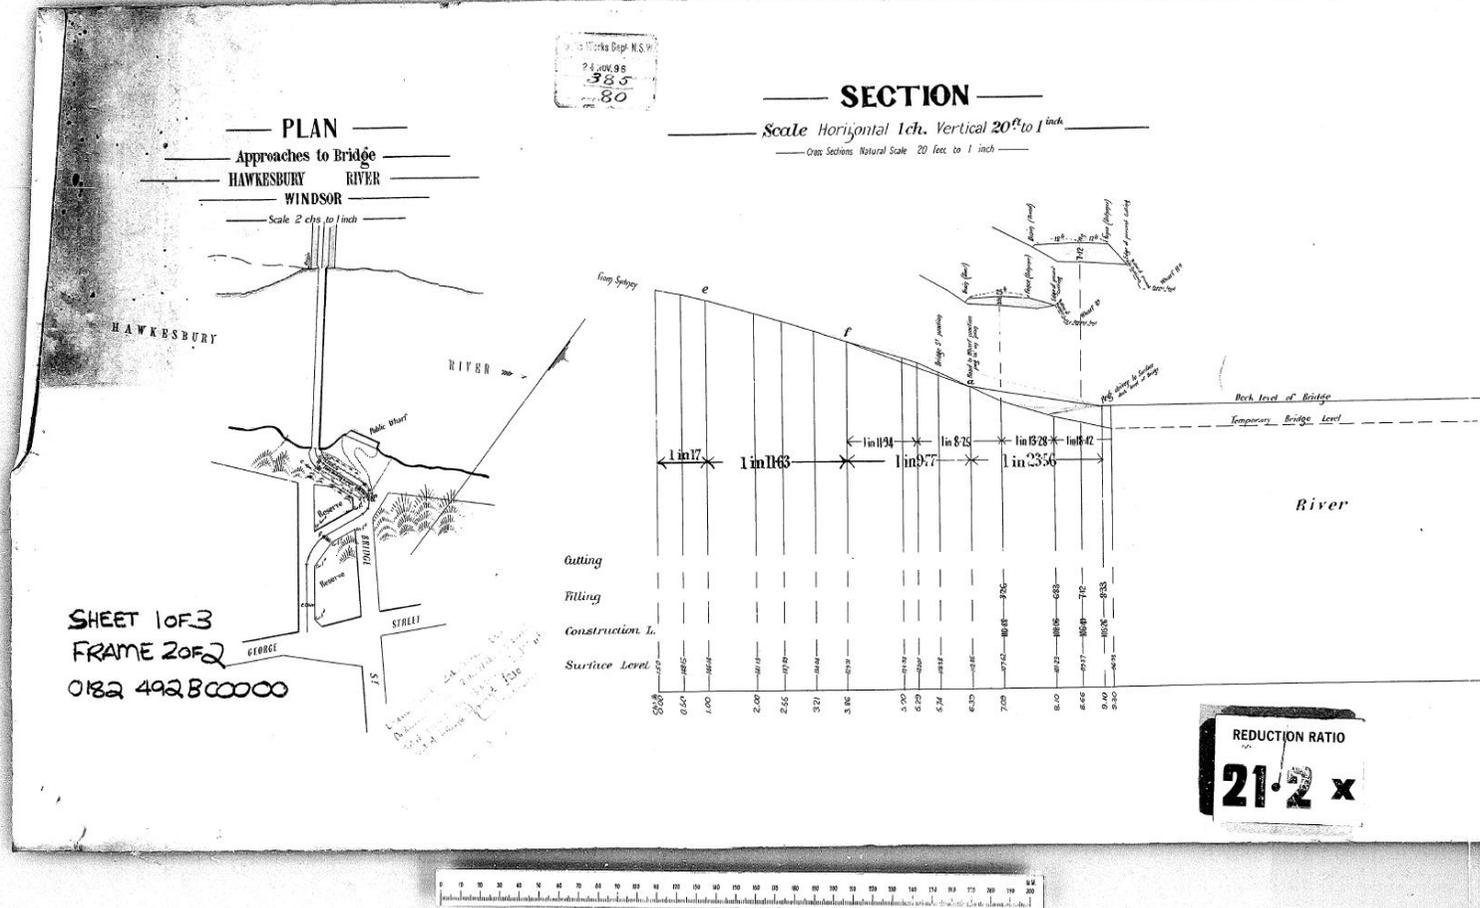
Plate 65: Plan and longitudinal section of the proposed modifications to the bridge showing the level of the temporary bridge in relation to the proposed new level.⁴⁴⁸ Review of the small sections above indicates a steep drop from the road to the old bridge decking, which was to be rectified by the proposed works. Of interest are the words “Drain (paved)” in two locations, the level of “Wharf Road” in relation to the level of road behind the fence. Refer to Plate 66 for detail.

The new height of the road deck was achieved by the installation of new cylinders eight feet in length placed on top of the original cylinders. The new cylinders were filled with concrete, which in 2005 was assessed as of 'good quality'.⁴⁴² The handrails were replaced at this time with a design featuring balance weights, enabling them to be raised and lowered by a single person.⁴⁴³

The higher level of the bridge meant that the deck finished above the existing land on the northern side and to rectify this gap an additional length of twenty feet as well as a new timber piers were added to this end. The number of spans of the bridge remained the same. In addition to raising the height of the deck, the approaches to both sides of the bridge were raised, removing hazards associated with the short, sharp descent to the low level bridge. The impacts of the work with respect to Thompson Square and the approach on the Wilberforce side have been discussed in the historical analysis report presented elsewhere in this document and archaeological evidence for this work is discussed in the archaeological assessment and analysis.

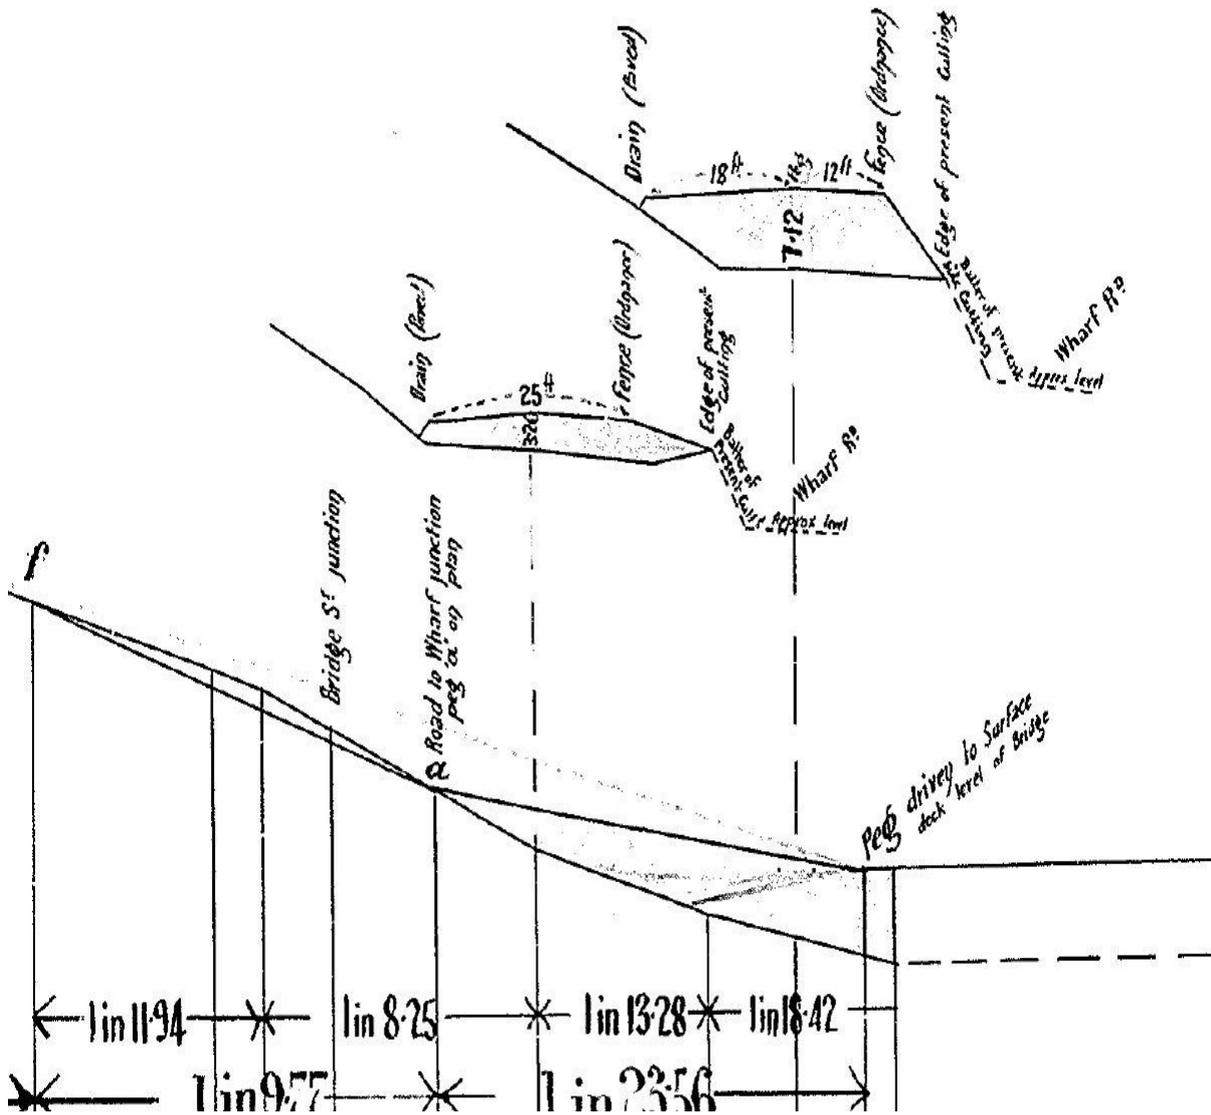
Plate 66: Detail of Plate 65 showing two sections of the topography prior to the modifications associated with raising the deck. Note the locations of "Drain (paved)"; "Fence (ordnance)"; "Edge of present cutting approx level"; "Wharf Rd".⁴⁴⁹

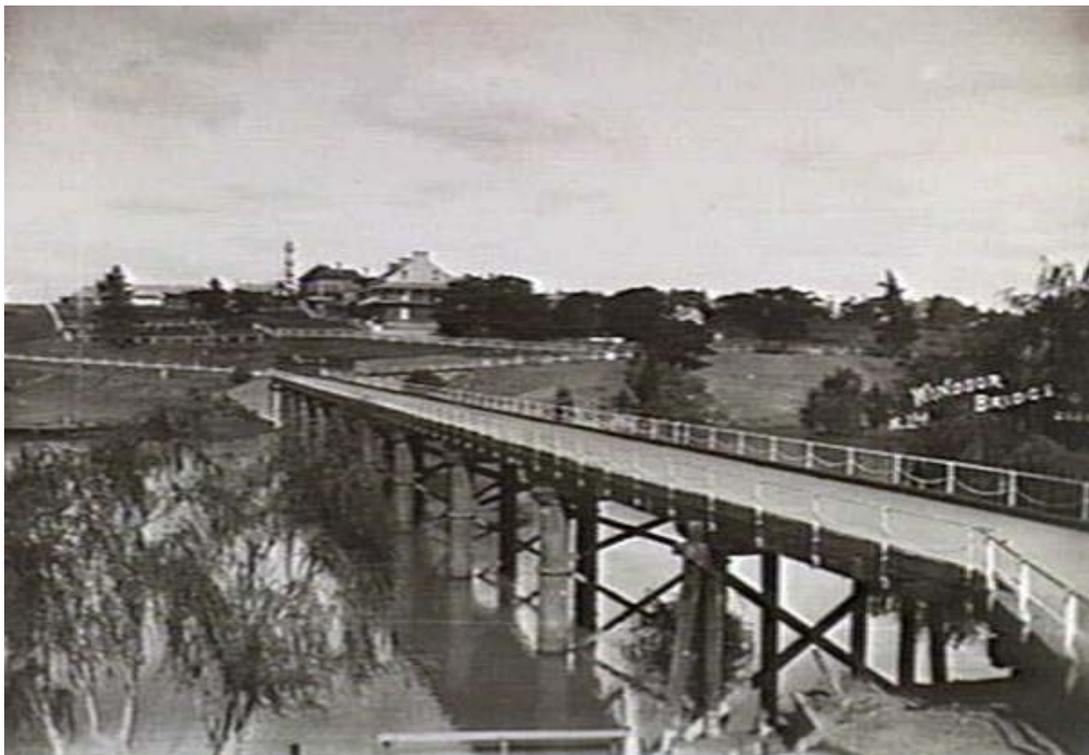
Plate 67: Windsor Bridge, from Wilberforce Side, after raising but prior to concrete replacements and additions 1897-1922⁴⁵⁰

The work was completed in seven months, well ahead of the predicted twelve month construction period.⁴⁴⁶ Plate 67 shows the form of Windsor Bridge after it was raised.

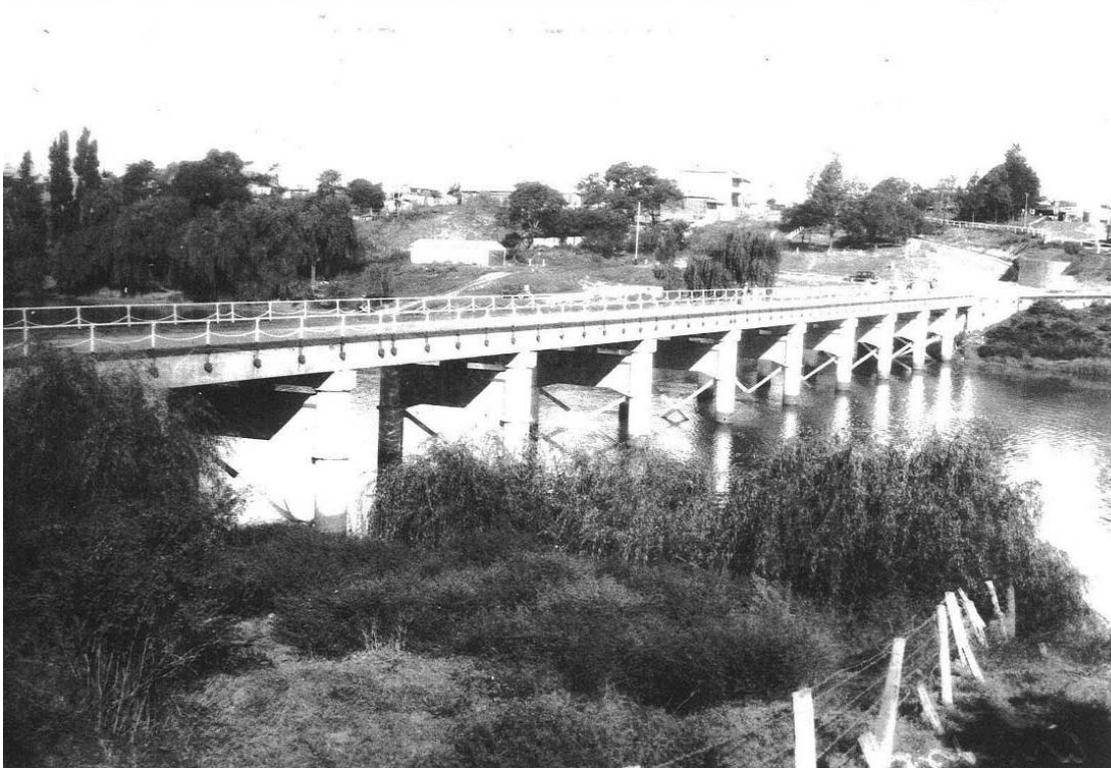
Plate 68: Windsor bridge after concrete deck was installed in 1922⁴⁵⁷

In 1922 the bridge superstructure was replaced, marking its final phase of modification. It involved the installation of new concrete girders and deck on the existing piers. The construction was undertaken by the State Monier Pipe and Reinforced Concrete Works under the supervision of Mr Mitchell, the company's manager⁴⁵² at a cost of £12,925.⁴⁵³ The work caused "a good deal of anxiety" as some of the timbers were over 50 years and it was time for them to be renewed. Upon inspection of the bridge determined that the whole superstructure had to be replaced.⁴⁵⁴

In order to maintain traffic flow, the concrete girders were "...built on the bank and carried into position".⁴⁵⁵ The author of the article goes on to say that "...therefore the design is unique and proves the versatility of Mr Mitchell, manager of the State Monier Pipe and Reinforced Concrete Works, and of Mr Humphreys, foreman of the bridge work."⁴⁵⁶

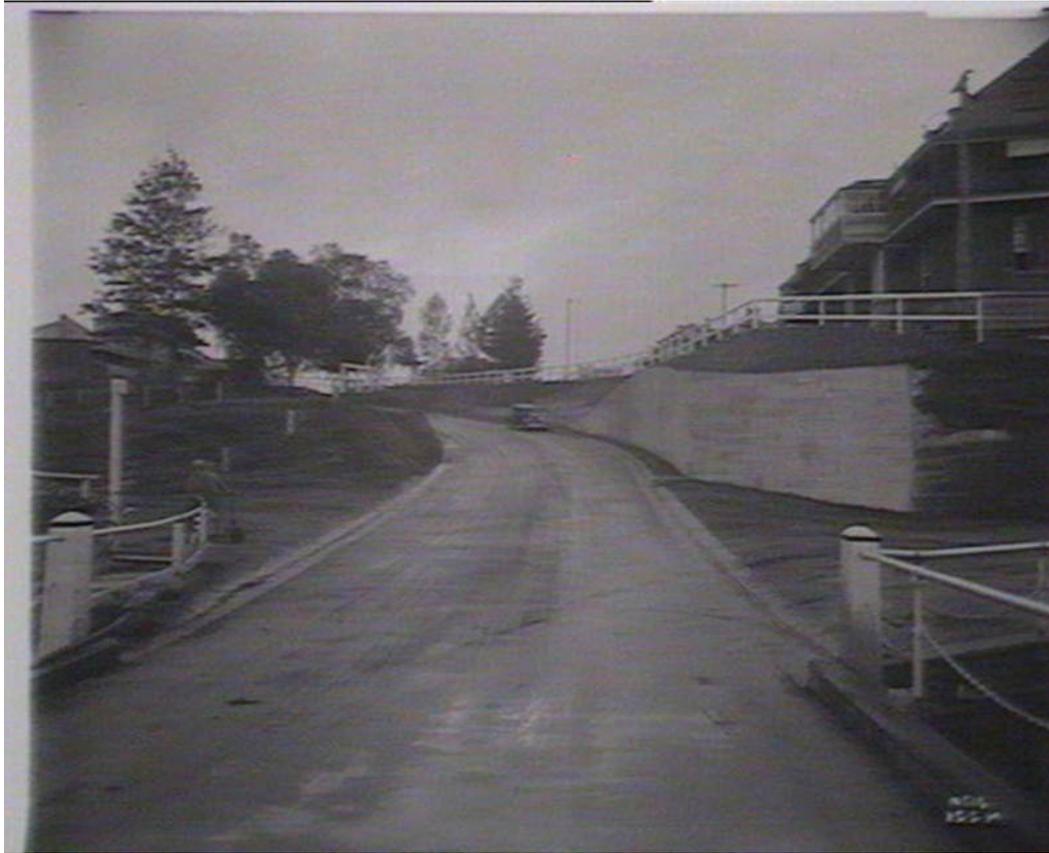
Plate 69: Undated image of 1934 alignment through Thompson Square, thought to be shortly after its opening.

The approaches to the bridge were realigned and reconstructed through Thompson Square in 1934 to provide an easier approach from the Windsor side. Plate 68 shows Windsor Bridge in its post-concrete deck form; Plate 69 shows the cutting, thought to be shortly after construction. Work to install an additional chain on the railing was approved in 1935 but never occurred, and a proposal to install chain link netting on the handrails in the same year also amounted to nothing.

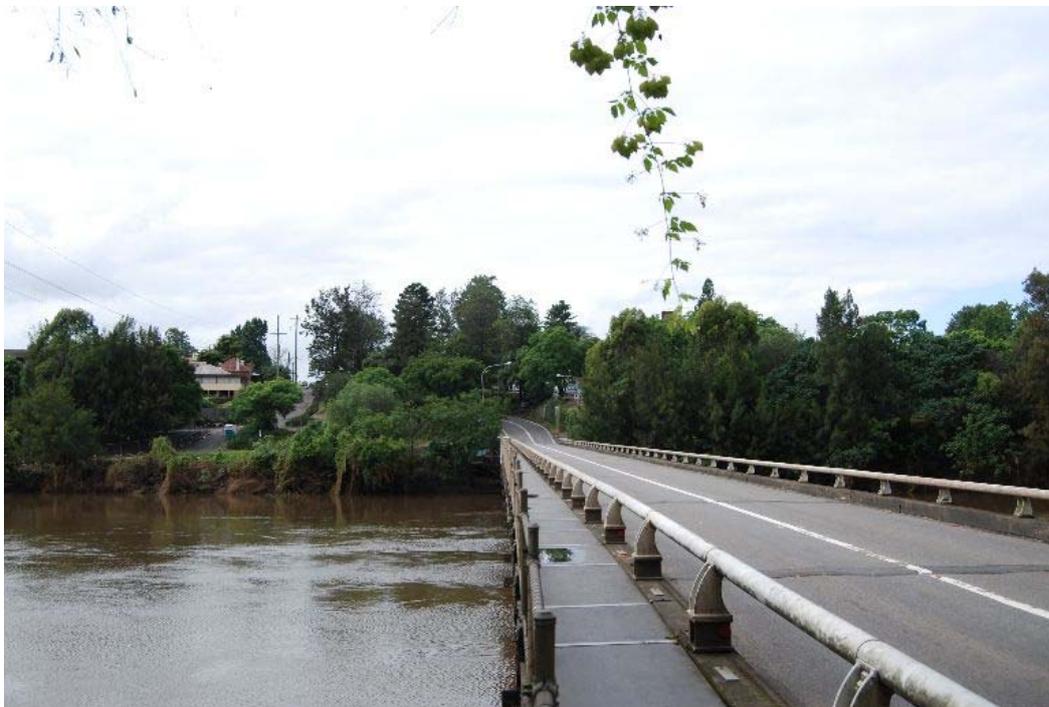
Plate 70: The Footway (left) and replacement crash barriers, in 2012. View to south east to Thompson Square.

The unsafe condition of the collapsible handrail is referred to several times throughout the life of the bridge in RMS files⁴⁶⁷ but was demonstrated in an incident in 1980 when a driver crashed through the collapsible handrail into the Hawkesbury River, resulting in the death of a passenger.⁴⁶⁸ A replacement crash barrier similar to that put in place in 1968 was installed on the downstream side of the bridge when the footway was built in 1980. Concerns over the suitability of the handrail on the footway were also raised not long after and proposals made to replace the old handrail with a new type of collapsible handrail were followed through in 1986.⁴⁶⁹ Plate 70 shows the footway and crash barriers in 2012.

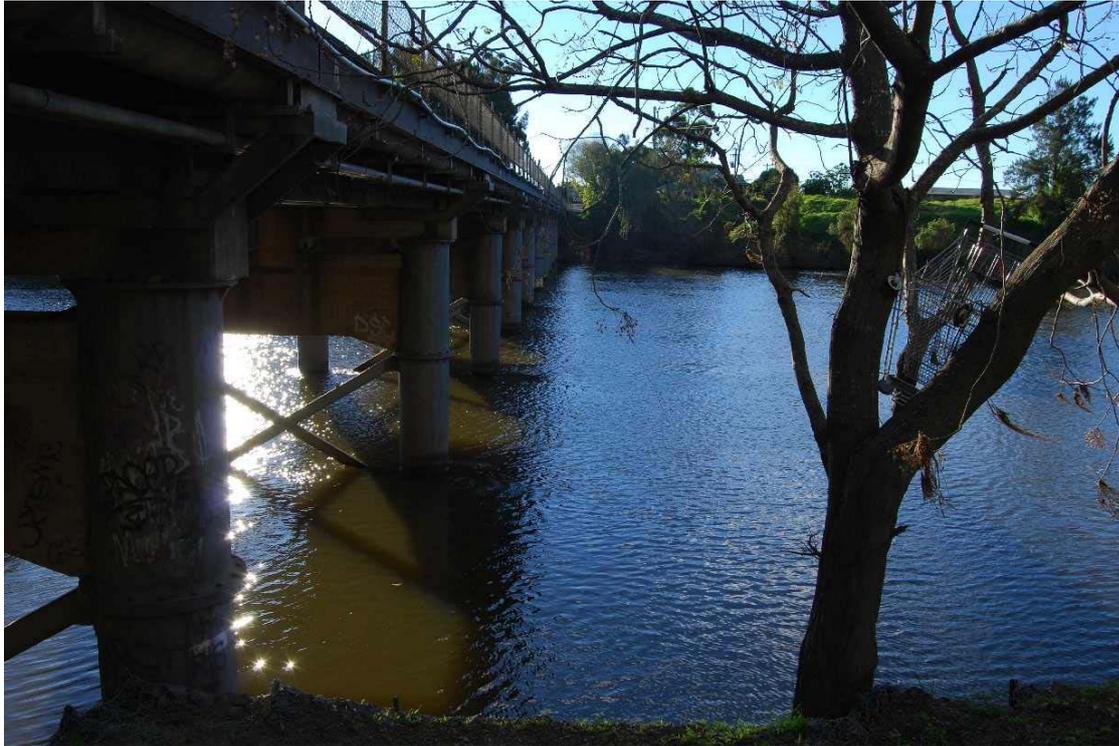
Plate 71: General view of Windsor Bridge from the bridge underpass.

This section identifies the different elements of the bridge, fabric types and evidence of its construction phases. The Windsor Bridge has undergone a number of changes to its form and structure over time. It features elements dating from as early as 1874, with major changes occurring in the 1920s, 1940s and through until 1986. Only metal and concrete elements of the bridge are now present, with the last timber element being for kerb logs which were removed in 1936. A recent photograph of the bridge is shown in Plate 71.

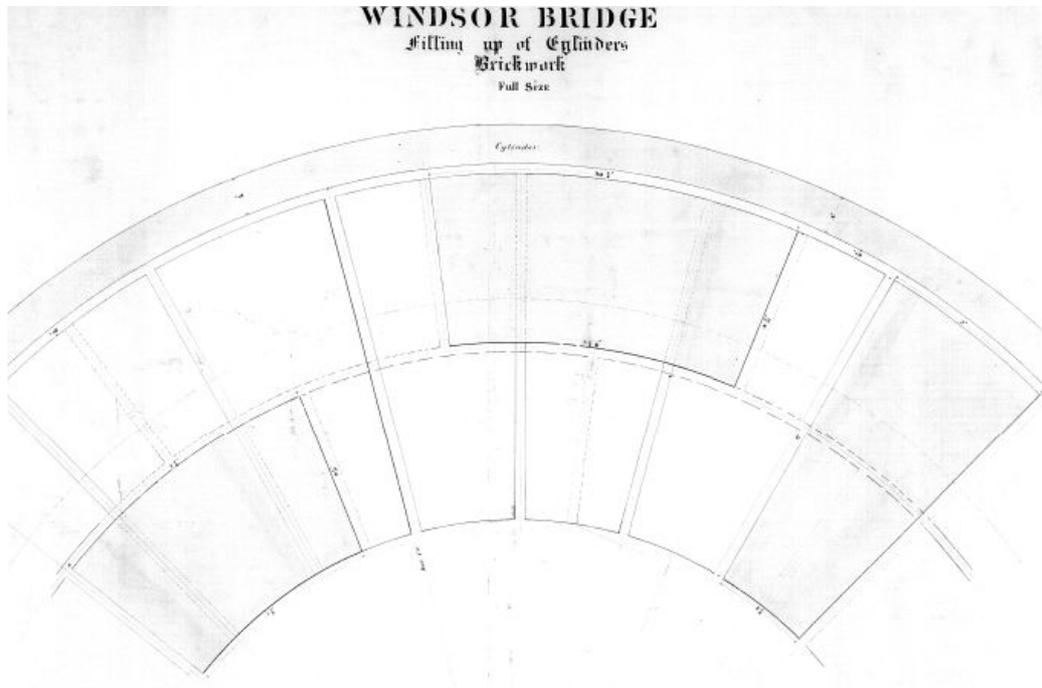
Plate 72: Windsor Bridge: Filling up of Cylinders. Brickwork.⁴⁷⁸

Concerns have been raised over the quality of the fill within the original 1874 cylinders. A technical report prepared by CTI (2005) noted that brick is present behind the iron. This has been interpreted as construction debris, but the piers are actually filled with an arranged ring of bricks 'enclosing a cone of concrete'.⁴⁹⁵ (Refer also to Plate 72).

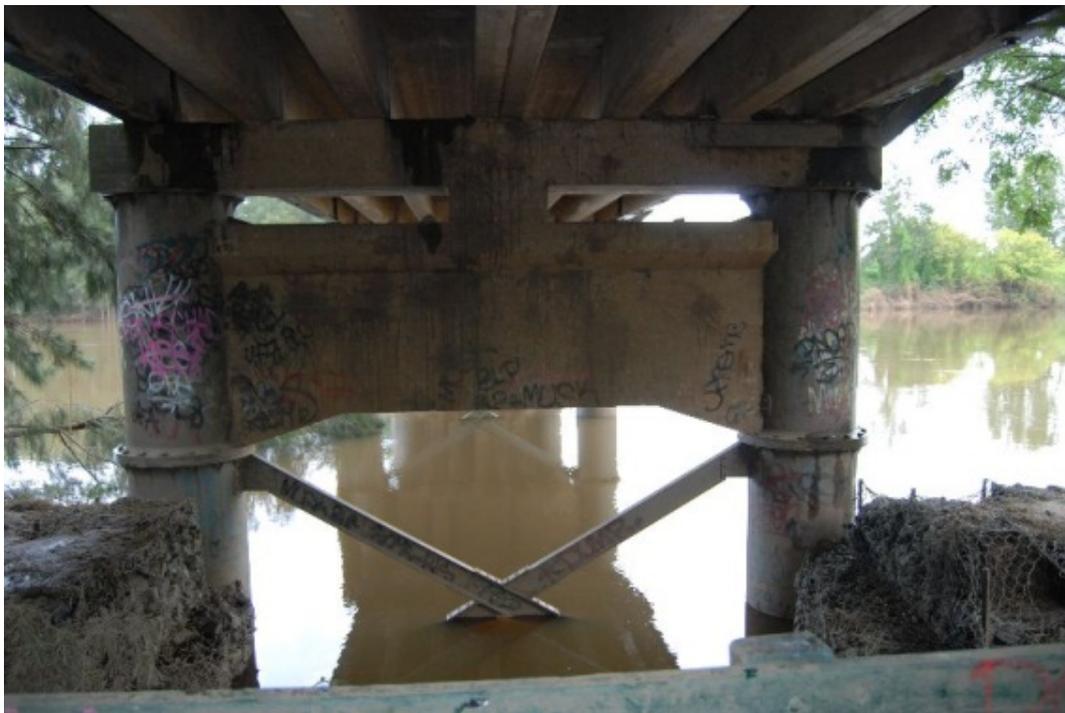
Plate 73: Pier 1 from Windsor bank, showing original 1874 cylinders beneath the 1897 extension, lower level metal cross bracing, concrete cross girder, headstock as well as deck elements.

The piers were originally braced with wrought iron, but the current bracing to have been replaced with steel in 1941, utilising some of the original bridge components. Subsequent inspections state that the bracing was half its original thickness in certain piers and in excellent condition in others, suggesting that bracing was only renewed on select piers. The metal bracing consists of a Rolled Steel Joist (RSJ) transom in piers which have not had bracing replaced. The transom located at or below the waterline and has cross bracing made of channel section steel above.

angles of the cross braces at the top and bottom corners, indicates that the bracing remains within the girders. In addition to the concrete cross girder, a concrete headstock has been cast across the piers to support the bridge girders. This headstock is anchored both to the concrete girders and the piers but no anchoring to the cross girder is shown. The headstocks, like the bridge spans, were cast in two halves. The current state of a typical pier is shown in Plate 73.

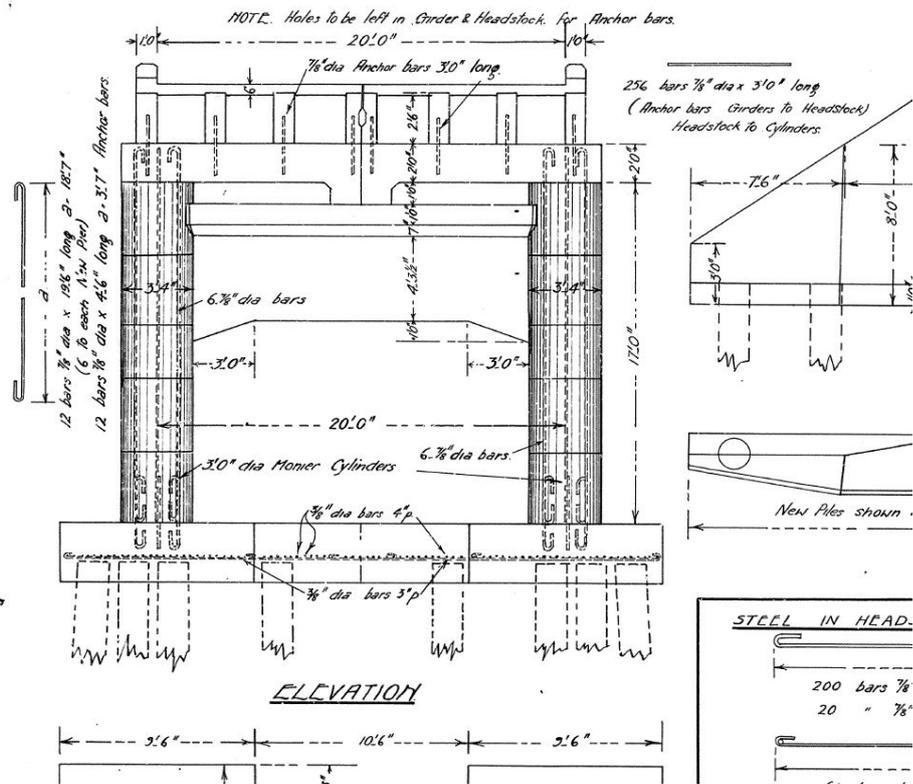
Plate 74: Detail of Department of Public Works "Plan New Concrete Pier – Pier No. 10."⁴⁸¹

The mass concrete pier (Pier 10, also Pier X on the PWD plans) at the northern end of the bridge was installed when the superstructure was re-constructed in reinforced concrete in 1922. The existing timber pier was not considered sufficient to bear the increased weight of the concrete deck and was replaced with concrete. The timber pier was added during construction following scouring of the northern bank, increasing the length of the bridge by adding a new span.⁴⁷⁹

The new pier is built on a concrete base which sits on top of ten piles, six of which were existing piles and four were newly driven. The piers are noted in the plan (Plate 74) as 3 feet (0.914 metres) diameter Monier cylinders, and feature a similar concrete cross girder as those installed on the iron piers during re-construction, with the headstock cast in two halves. A notation on the plan directs holes to be left in the headstock to allow reinforcing steel to be inserted when girders are cast to allow the structure to be anchored together (Plate 74). There is no bracing on the lower levels, however an underwater inspection undertaken by diver R. Hellings in June 1952 described the metal bracing on Pier 10 as being in 'good condition'.⁴⁸⁰ The pier features the same kind of concrete cross girder that was installed on the iron piers at the time of re-decking but it does not have any bracing on the lower levels. The current state of Pier 10 is shown Plate 75.

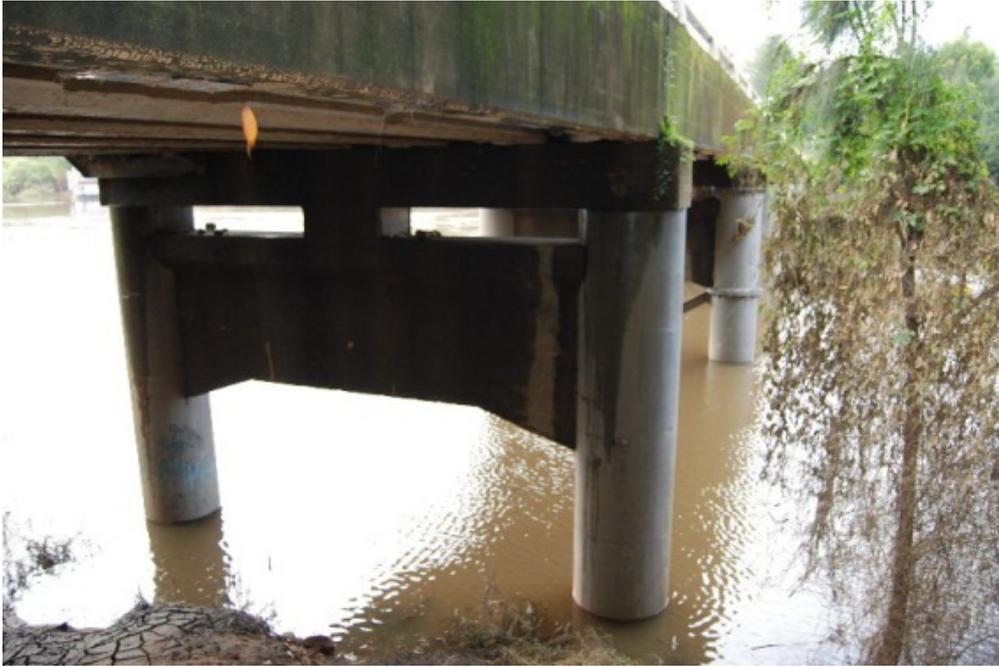
Plate 75: Pier 10 Monier Cylinder, from Wilberforce bank.

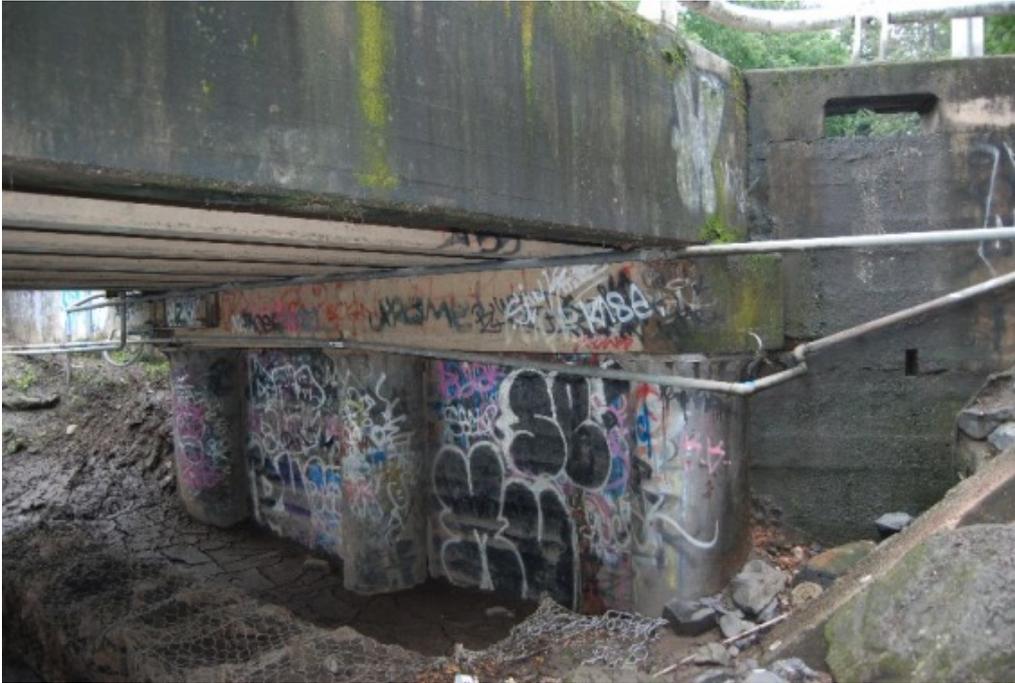
Plate 76: Abutment A showing three small diameter piers, possibly screw piles, utilised in its construction.

Abutment A is at the southern end of the bridge. It comprises three cast-iron cylinder piers with a concrete retaining wall cast behind them. A concrete headstock was installed on Abutment A, probably at the time of the re-construction of the superstructure of the bridge. Like the deck, the headstock on this pier has been cast in two halves. The downstream side of the headstock appears to have been modified to incorporate a RSJ where the footway and services have been installed. The piers are of a smaller diameter than the piers in the stream. Plate 76 and Plate 77 show the current state of Abutment A.

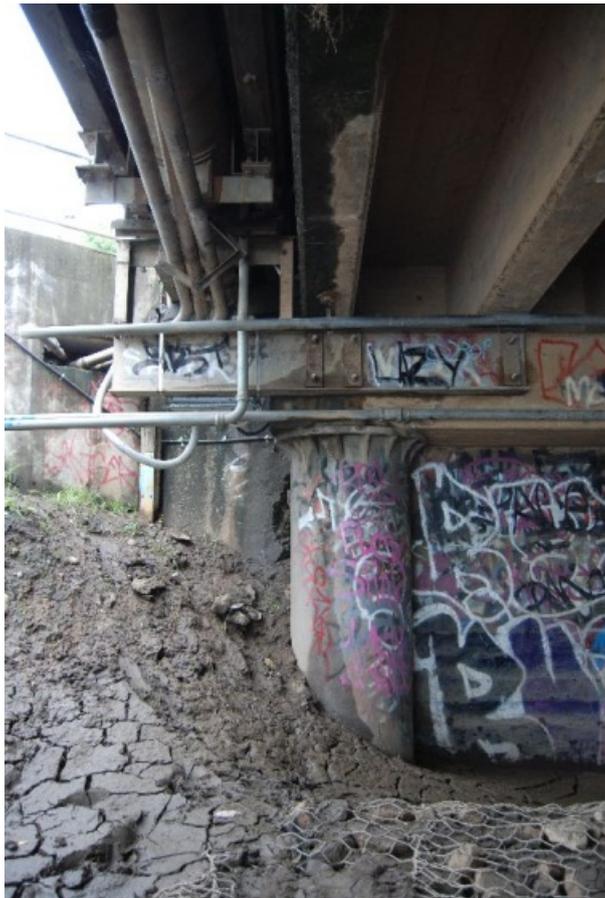
Plate 77: Downstream side of Abutment A showing top of cylinder, and footway additions at left.

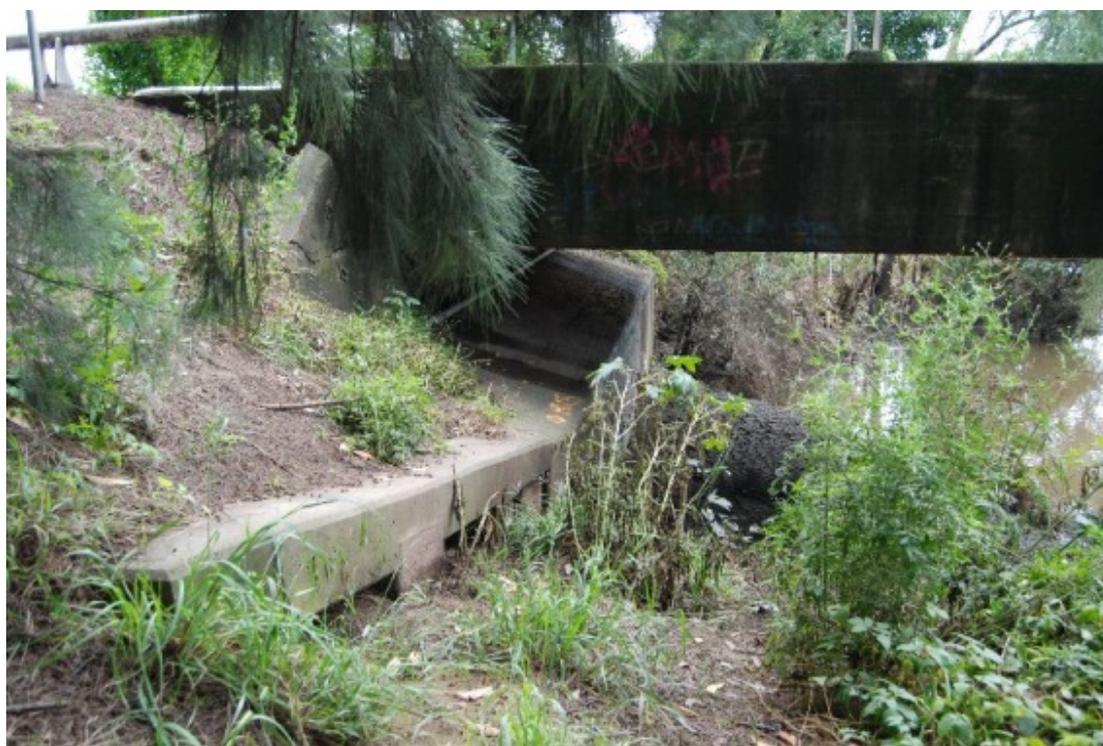
Plate 78: Abutment B looking downstream showing later additions (below) to 1922 cast abutment and wingwalls.

This abutment also features retaining wing-walls cast at the same time as the mass concrete abutment. The abutment has been augmented at a later date by the addition of a concrete apron extending out from the original abutment and wingwall, with driven concrete piles and a cast-in-place headstock. Infill panels are set at a lower level on the upstream side, and steel sheet piles on the down stream side in front of the original wing-walls, as shown in Plate 78.

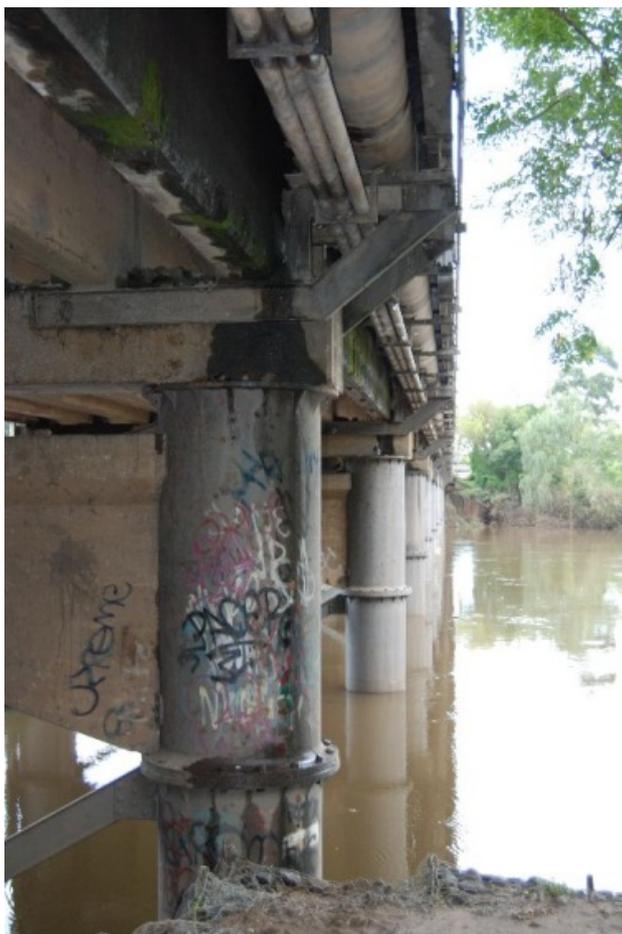
Plate 79: Underside of footway showing services below walkway in addition to means of attaching footway to concrete headstock.

The footway was altered to take a larger water main by the MWS&DB in 1976/1977, with the effect of raising the height of the footpath by 203 mm.⁴⁸⁷

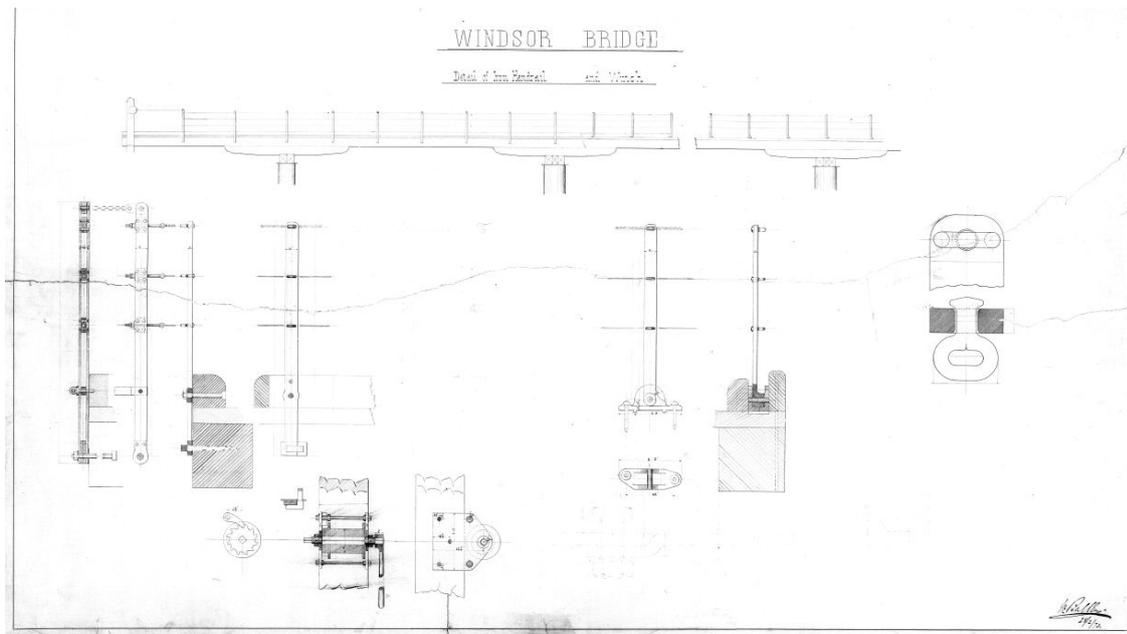
Plate 80: 1873 plan for the collapsible handrail on the Windsor Bridge⁴⁸⁸

When it was opened in 1874, the bridge featured innovative collapsible pipe and chain wire railing that was designed to be lowered during flood to avoid damage. A drawing dated 28/2/[18]73 shows an arrangement using a 4 x 4 inch timber post with hinged base, hinged top metal pipe rail and iron rod middle rail, designed to collapse by folding sideways. A metal bracket stop held the posts in an upright position (Plate 80). The handrail appears to have been redesigned some time between 1896

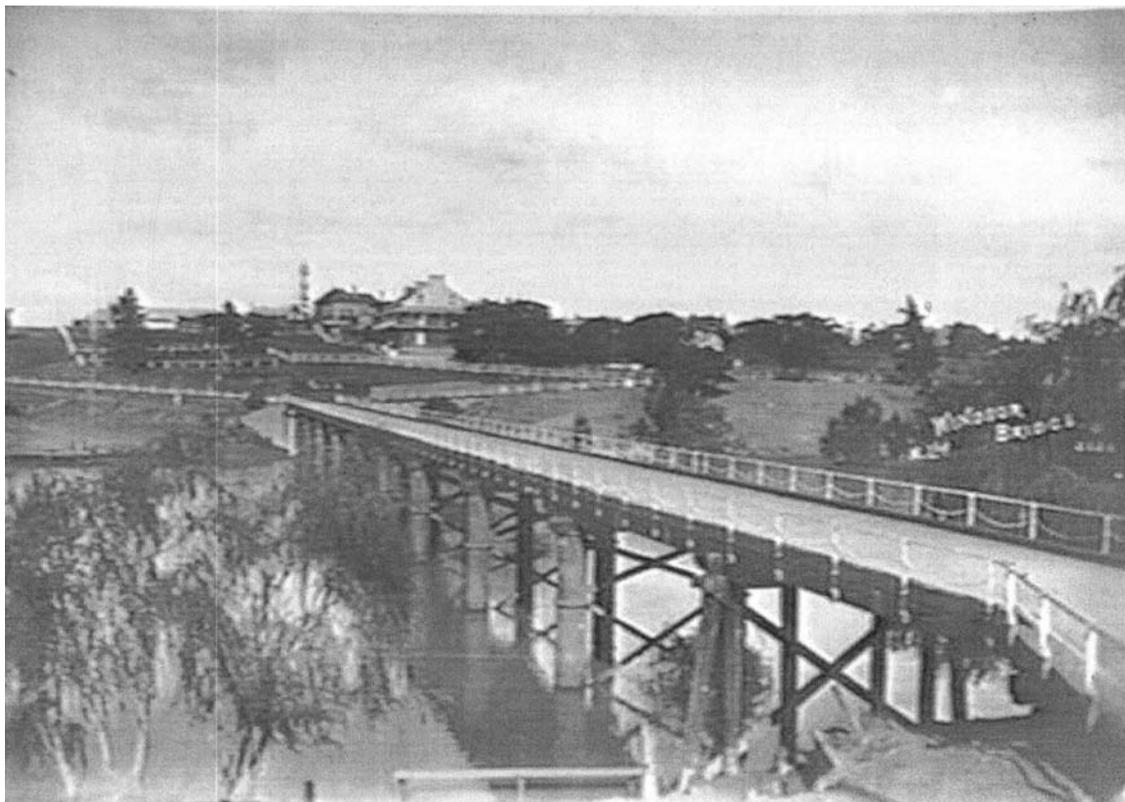
Plate 81: A photograph c 1896-1922 showing collapsible handrails with counterweight on the Windsor Bridge⁴⁸⁹

and 1922 with the addition of a counterbalance – (so it could be raised again by one person). A collapsible rail was consistent with the intent of the low level bridge to survive heavy floods by being submerged below maximum flood level, reducing the chances of floating debris colliding and snagging. When the footway was constructed in 1968 a vehicular pipe crash barrier was installed on the edge between the roadway and footway to prevent cars crashing into the footway. The collapsible footways were retained on the outer edges of the bridge, but they were eventually replaced with a new, more substantial collapsible handrail in 1983; it was designed to be lowered forward onto the footway. A vehicular pipe crash barrier in a similar style to that between the footway and road deck was installed in 1981.

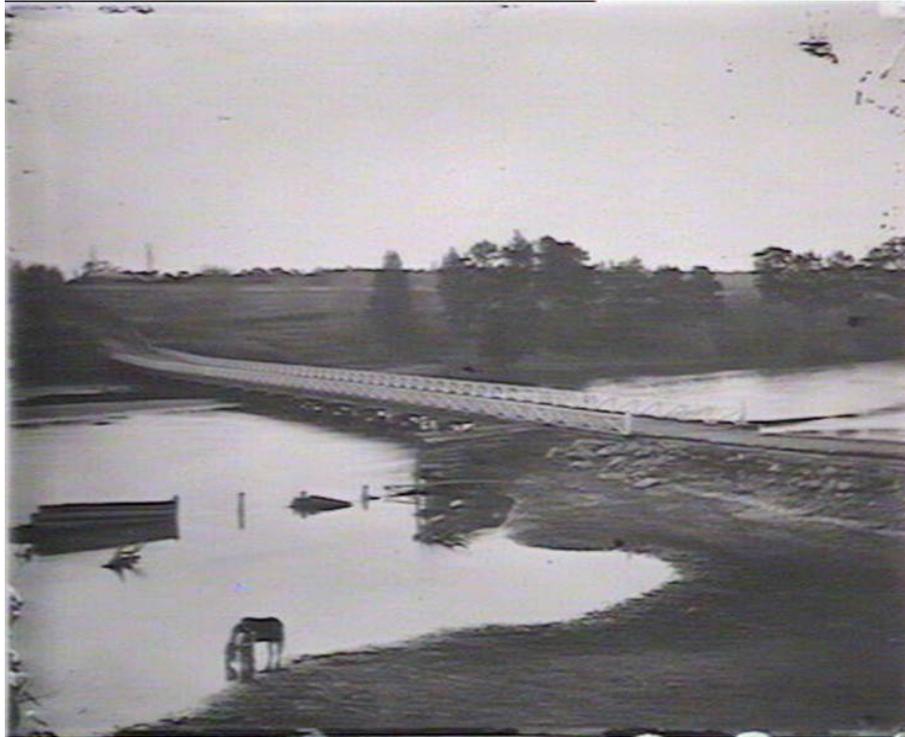
Plate 82: The low level Richmond Bridge, built 1860⁴⁹⁹

- Richmond Bridge, Richmond (demolished)
 - The first crossing of the Hawkesbury constructed in 1860;
 - The now demolished timber bridge was built by the privately-owned Richmond Bridge Company under the supervision of Edward Moriarty, who was the Chief Engineer, and later the Engineer-in-Chief of Harbours and Rivers for the Public Works Department;
 - Constructed as a low level bridge of ironbark it was 28 feet wide with a deck that was 14 feet above the water level;
 - The bridge was built with removable hand rails;
 - The piles were covered in a copper/zinc alloy
 - Replaced 1905 with reinforced concrete arch bridge – still with collapsible handrails (extant)

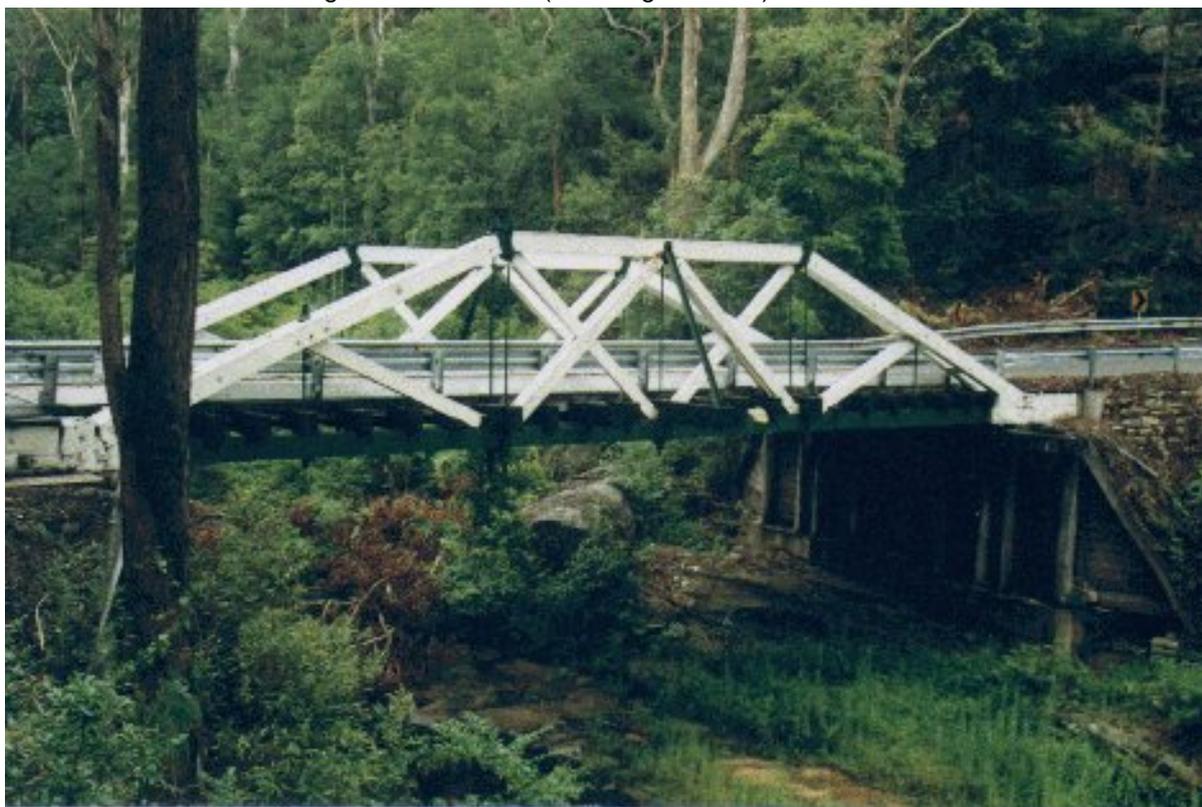
Plate 84: Bridge over Tunks (Pearce's) Creek, Galstone: an example of a McDonald truss bridge.⁵⁰¹

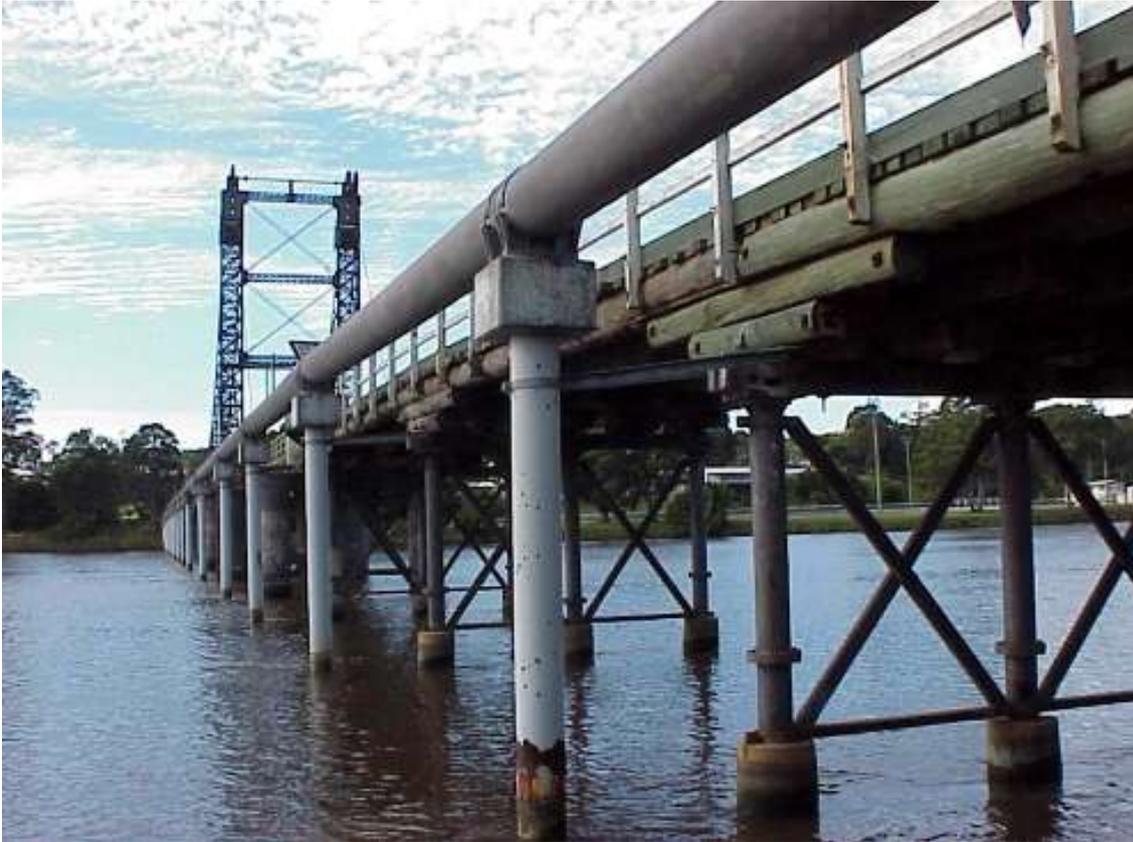
Plate 85: The McFarlane Bridge over the Clarence River at McLean; the bridge was built in 1905/1906 and comprises a predominantly timber deck on cast iron piers. The opening span and tower span are constructed of steel.⁵⁰²
