## Appendix F - Options for archaeological investigation of Thompson Square

# Windsor Bridge Replacement Project: Archaeological Options Paper

**Prepared for Roads and Maritime Services**

**20 March 2013**

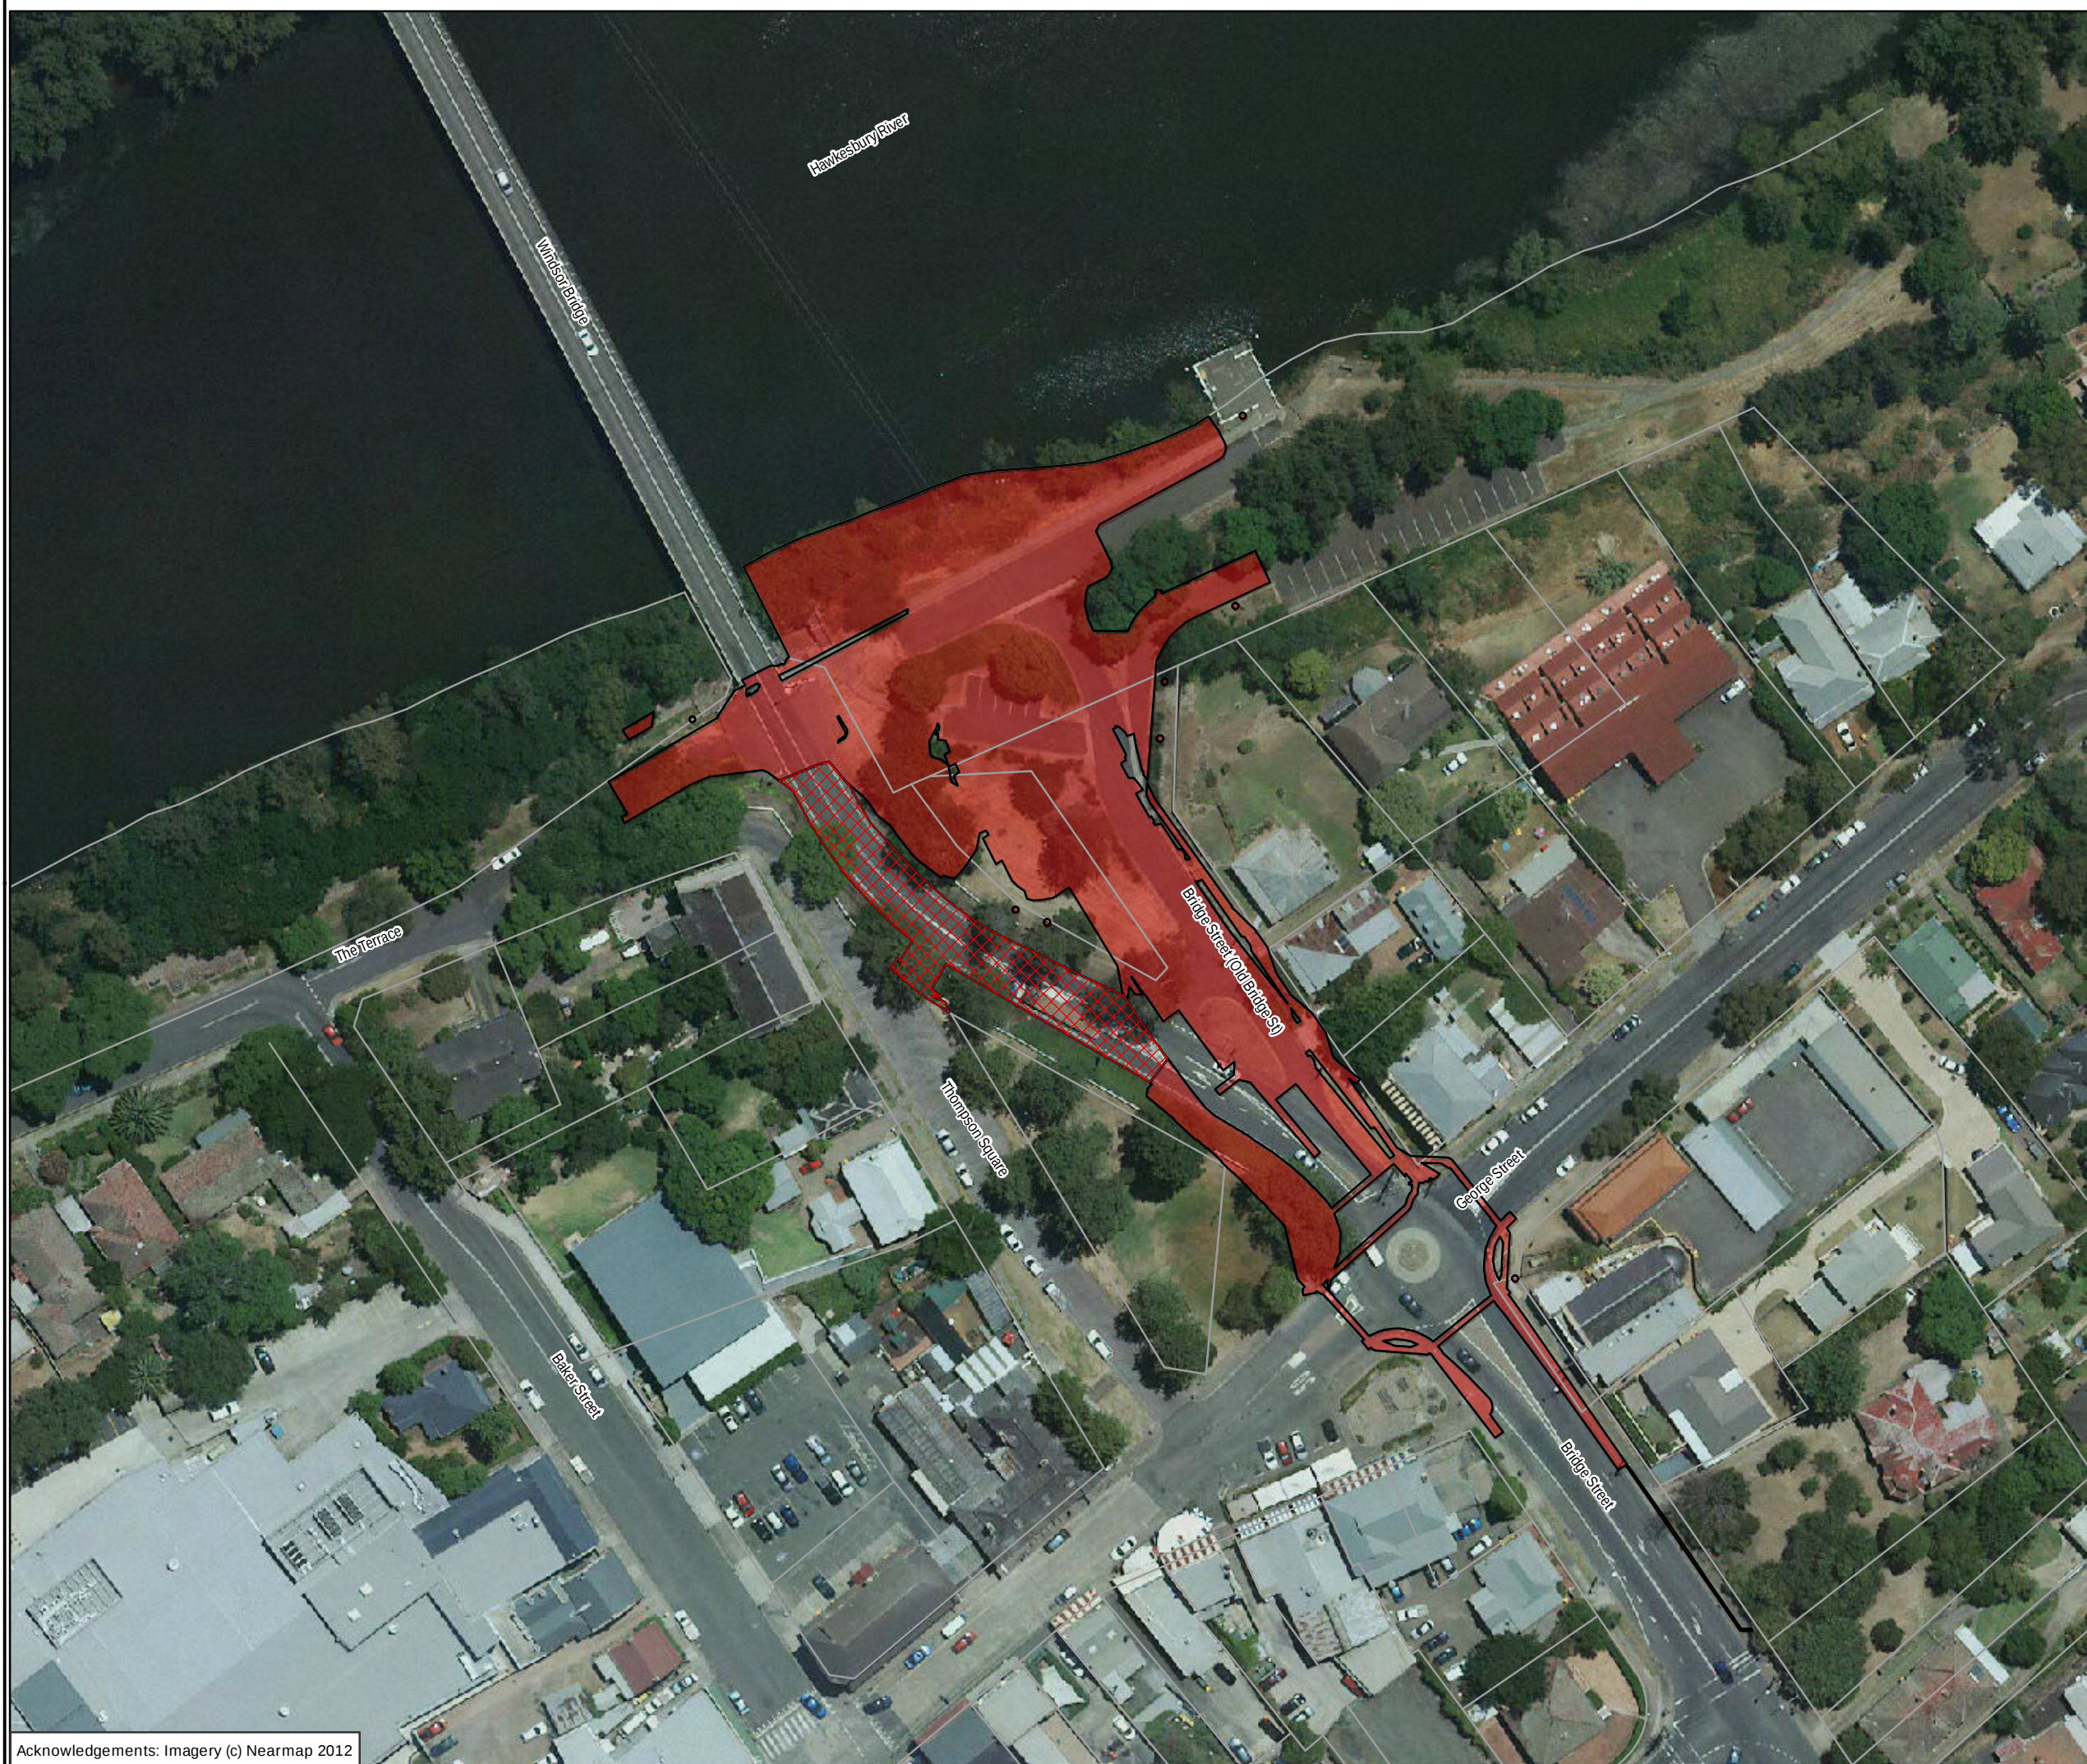
- Area of archaeological excavation
- Subject to further discussion to include in archaeological excavation

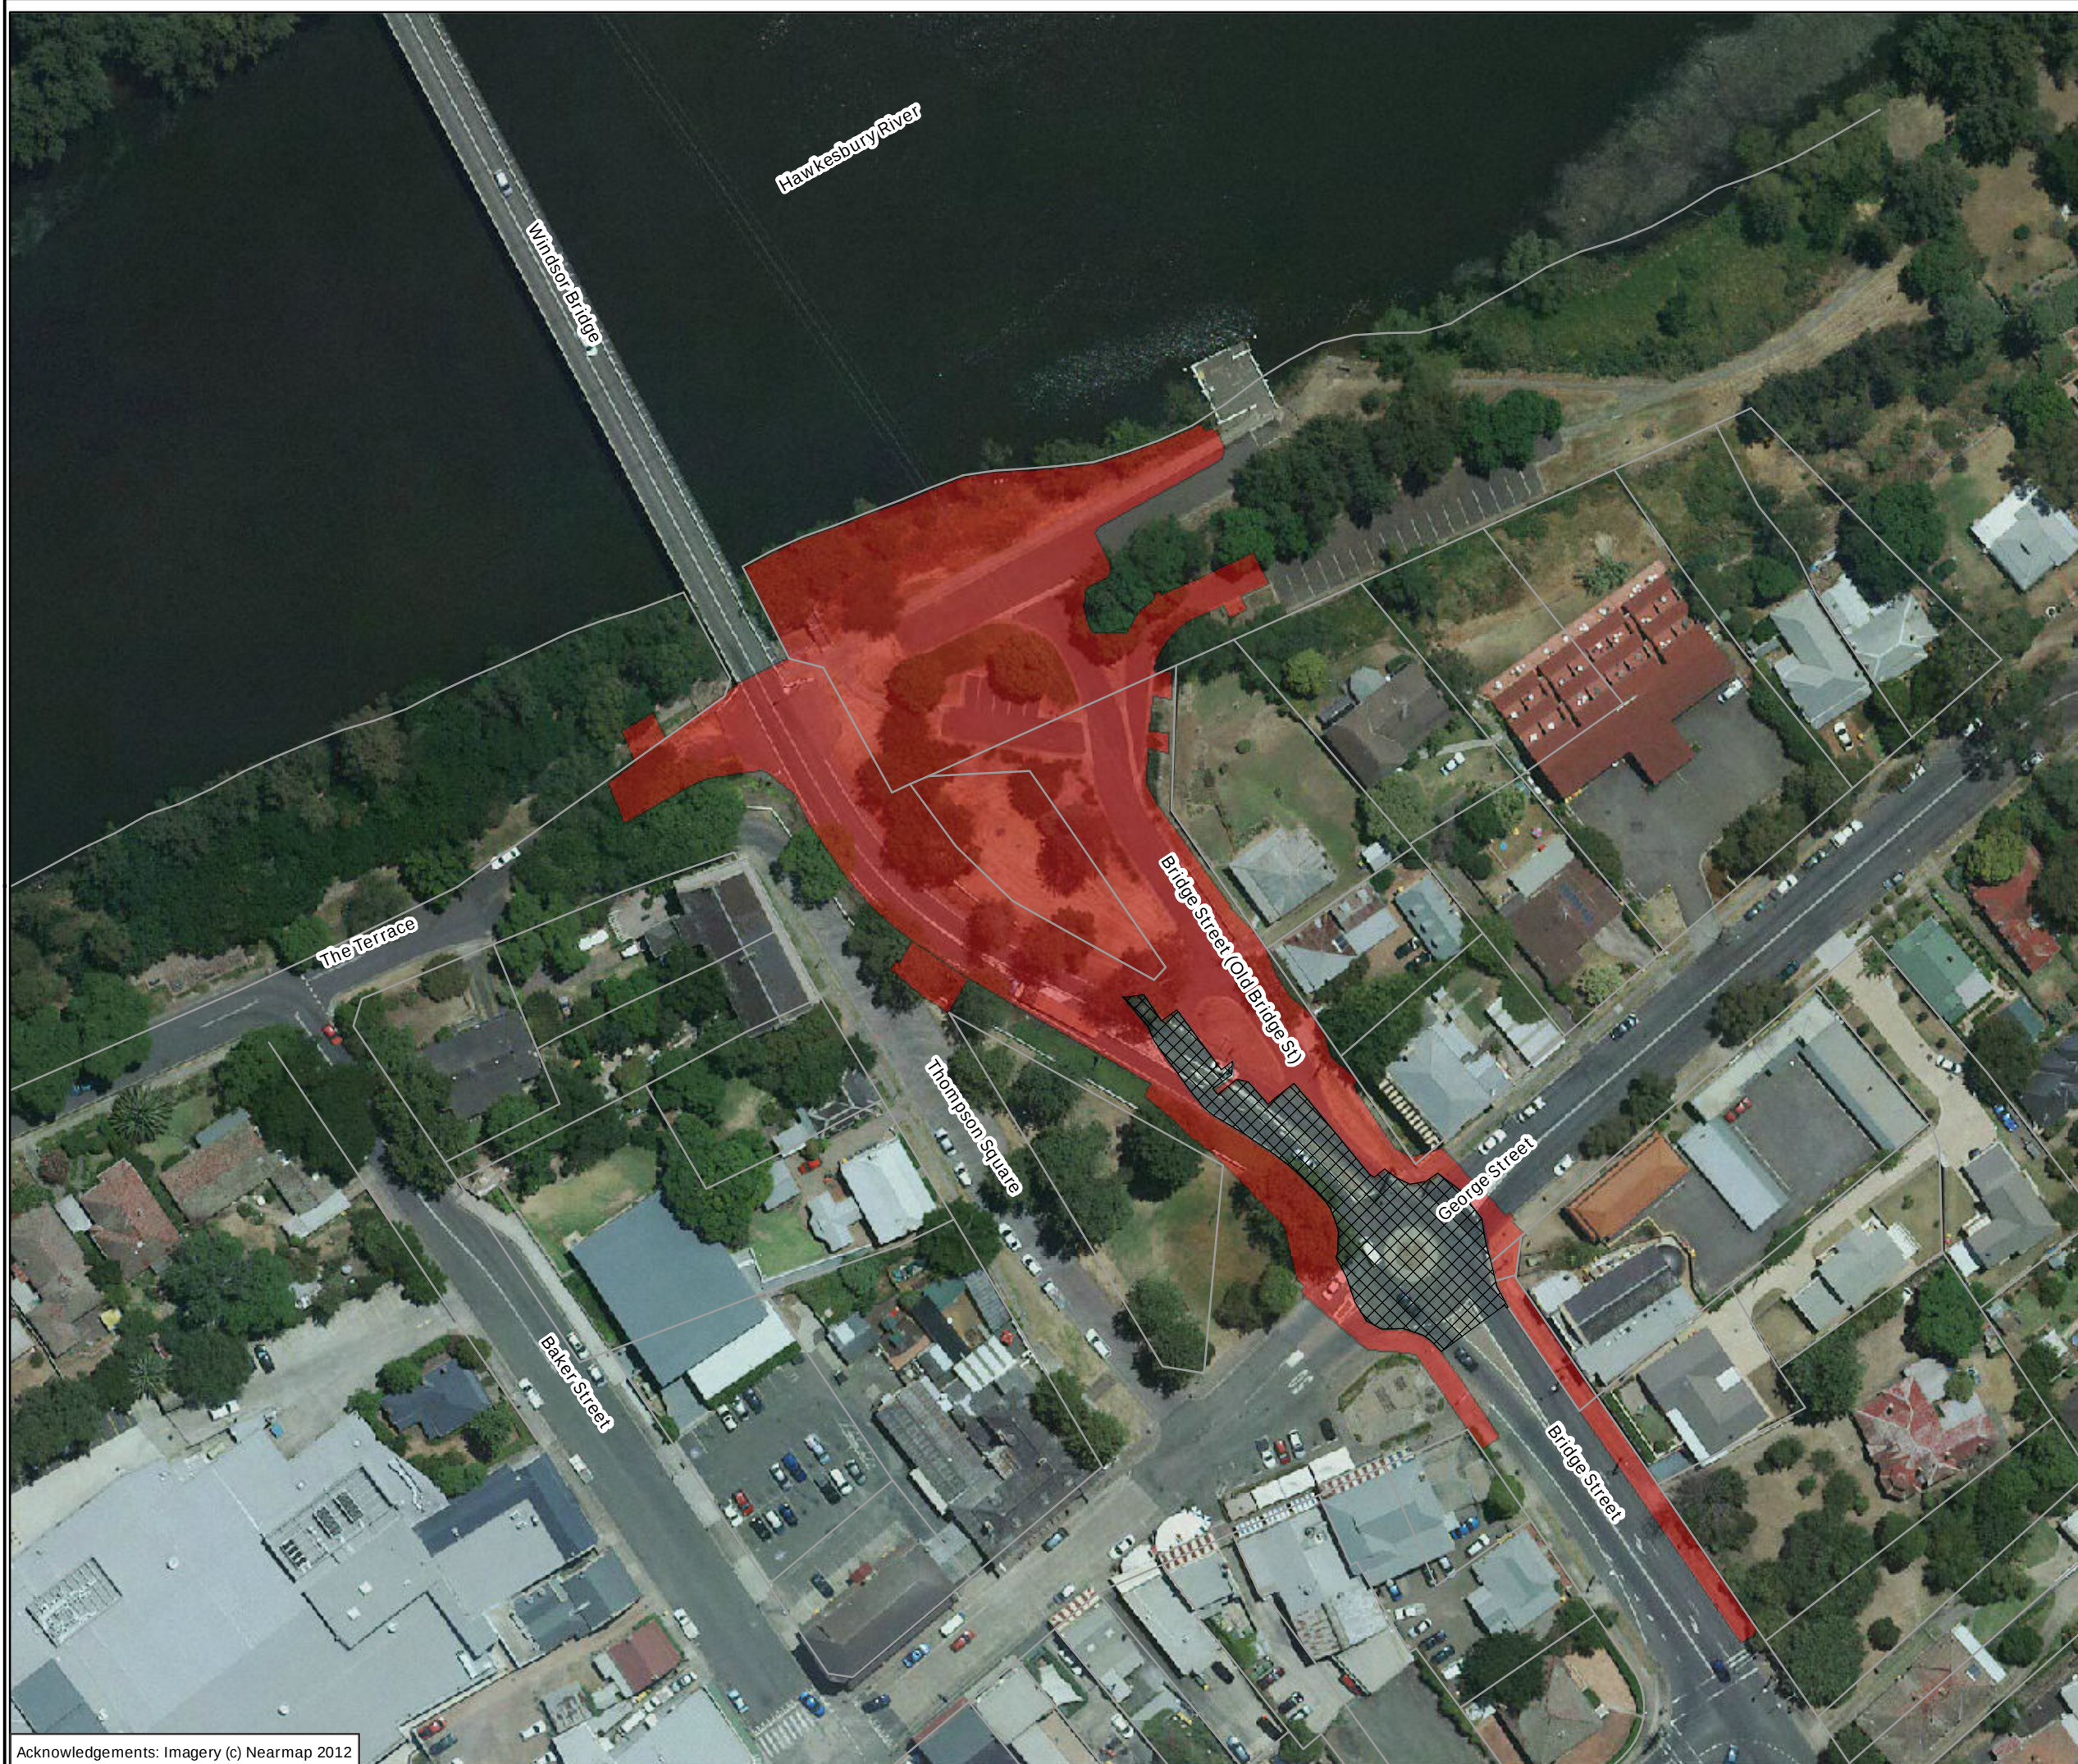
- Area of archaeological excavation
- Subject to further discussion to include in archaeological excavation

This option includes an archaeological salvage program in the same construction footprint as Option 1 but this footprint has been enlarged to incorporate the small, isolated strips of retained profile so that these become part of the salvage excavation program. This option would also include the excavation of the remaining portion of retained lower parkland between the bridge abutment and realigned road. There are also substantial landscape works that will effectively damage a large portion of the profile.

1. On the western side of the realigned road is a roughly L-shaped excavation. Making this a complete square of excavation would engage the trench at the western end into a single unit or zone of excavation.
2. The junction between the lower parkland and the section of Bridge Street that would be retained. The construction footprint requires two narrow and irregularly shaped strips of excavation and Option 2 has these two strips being replaced by a solid zone of excavation. This excavation zone would link the bridge and road. Effectively all the land between the southern portion of Bridge Street (between the bridge and road excavations) would be included to create one large unit of investigation at the northern end of Thompson Square.
