# Windsor Bridge Replacement Project

## Report on Maritime Archaeological Excavation and Survey, June to September 2018

Windsor,  
Hawkesbury River, NSW

September 2021

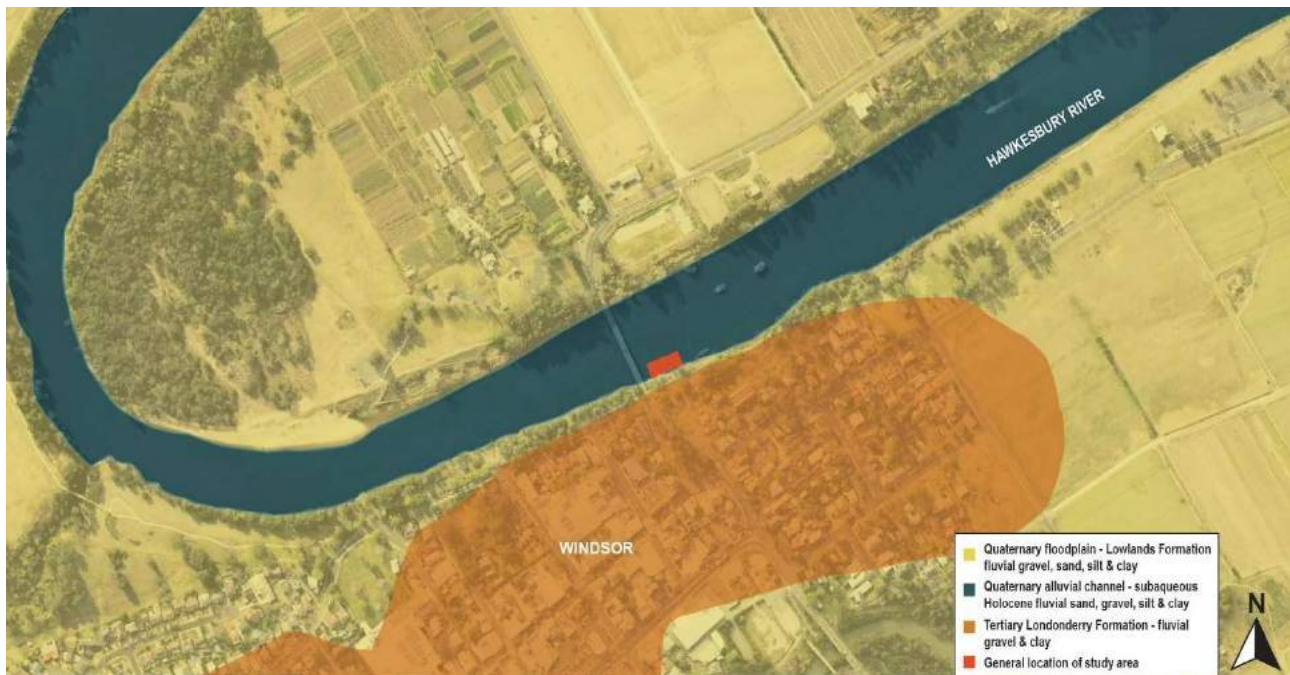
**Figure 4: Geological units across Hawkesbury River valley at Windsor.<sup>14</sup>**

The Hawkesbury River valley landscape at Windsor is formed of Tertiary and Quaternary fluvial deposits overlying Triassic Ashfield Shale / Wianamatta Shale Group bedrock. As identified in NSW geological mapping data (see Figure 4), the southern and northern banks of the Hawkesbury at Windsor consist of late Pleistocene to Holocene Lowlands Formation floodplains of gravel, sand, silt, and clay alluvium. The alluvial floodplain on the southern bank is relatively narrow and abuts an elevated terrace of much older Miocene Londonderry Formation fluvial clay and gravel deposits. The subaqueous sediments in the Hawkesbury River channel along the Windsor reach consist of Quaternary deposits – primarily Holocene fluvial sand, gravel, silt, and clay.<sup>8</sup>

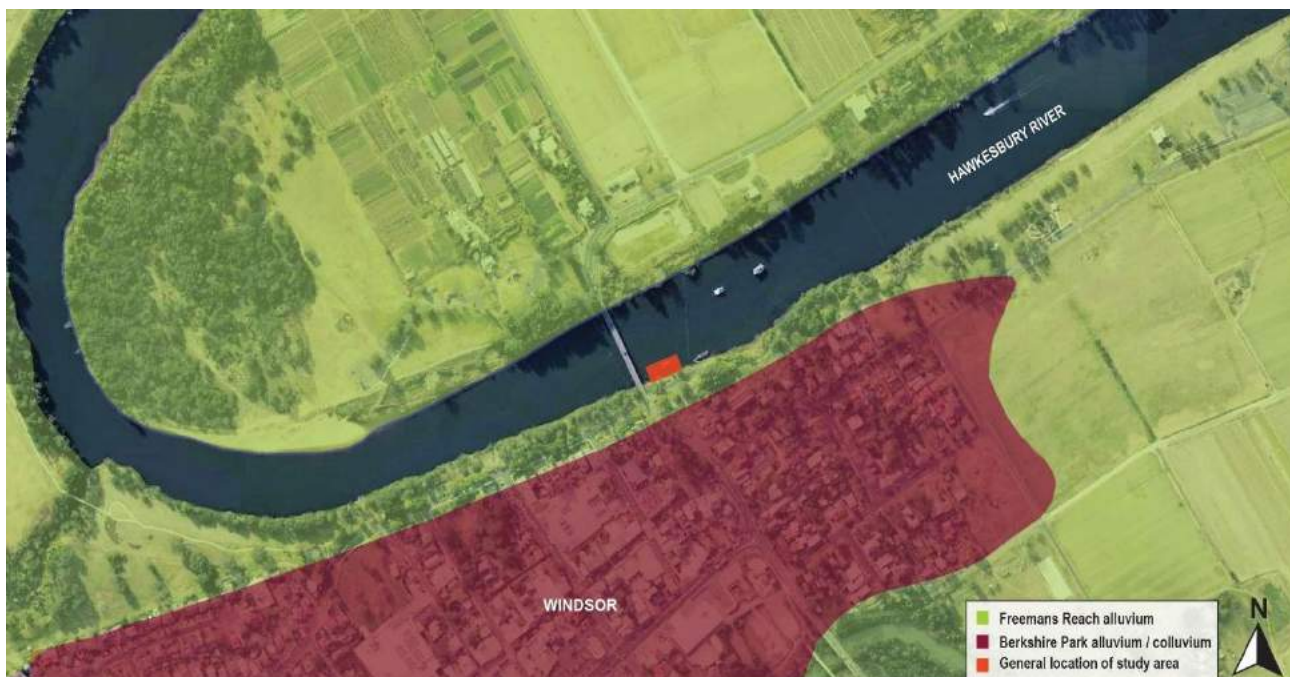
**Figure 5: Soil landscapes across Hawkesbury River valley at Windsor.<sup>15</sup>**

NSW soil mapping data shows two soil landscapes occur adjacent to the Hawkesbury River at Windsor – Freemans Reach across the active river floodplain and Berkshire Park across the elevated Tertiary terrace rising beyond the southern riverbank (Figure 5). The Freemans Reach soil landscape comprises moderately structured deep brown sand and loam alluvium derived from erosion of Hawkesbury Sandstone, Narrabeen Group and Wianamatta Shale Group materials. Freemans Reach is generally a dynamic soil landscape, with streambank and floodplain erosion and deposition regularly occurring. The Berkshire Park soil landscape consists of sandy loam overlying sandy clay and heavy clay alluvium, often mottled with ironstone nodule inclusions and silcrete boulders (up to 200 mm in size). The Berkshire Park soils derive from three depositional phases of sandstone and clay materials of Tertiary alluvial and colluvial origin, with the Londonderry Clay formation being the uppermost phase.<sup>9</sup>

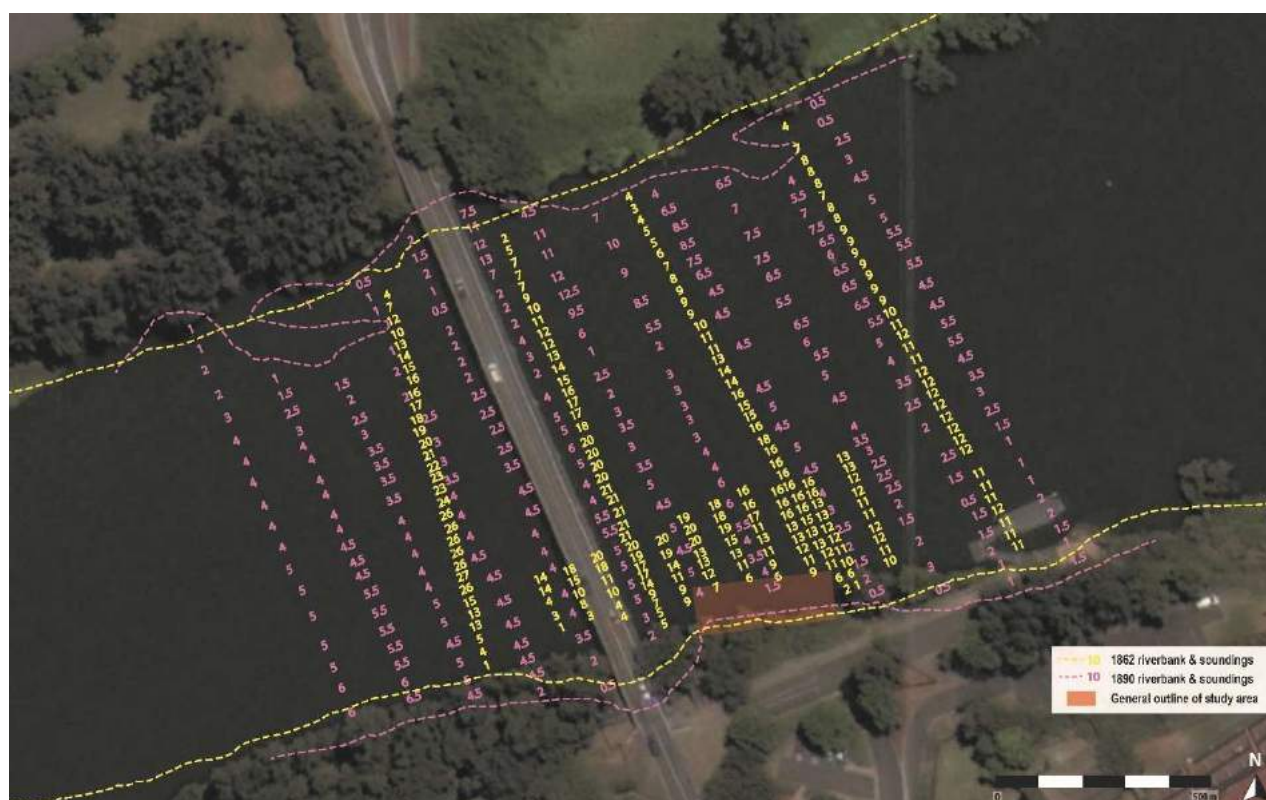
**Figure 10: Riverbank outline and depth soundings taking during 1862 and 1890 hydrographic surveys of the Hawkesbury River at Windsor – soundings are shown in feet and reduced to low water Spring tides – overlain on 2019 aerial photograph.**

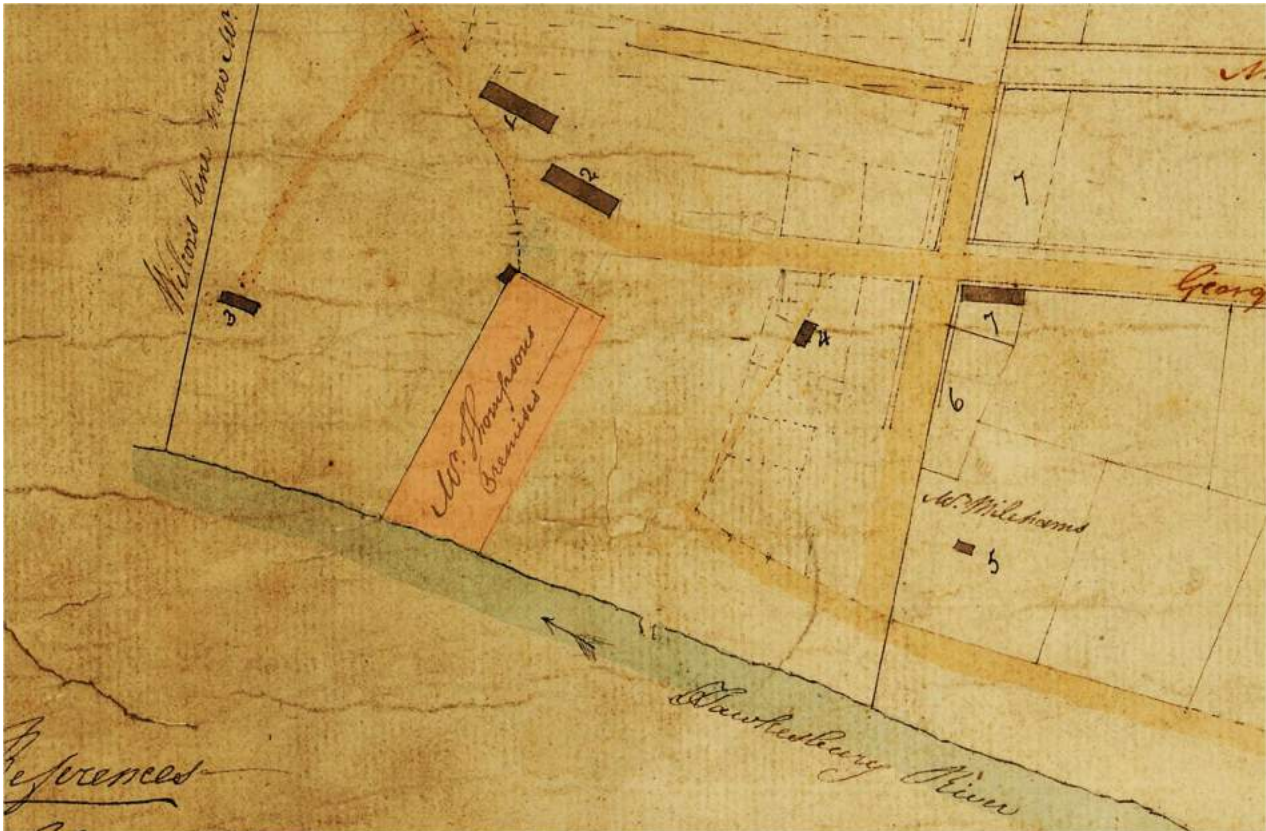
**Figure 11 : Surveyor James Meehan's 1812 plan of Windsor town – showing “Mr. Thompson's Premises” (highlighted red).**

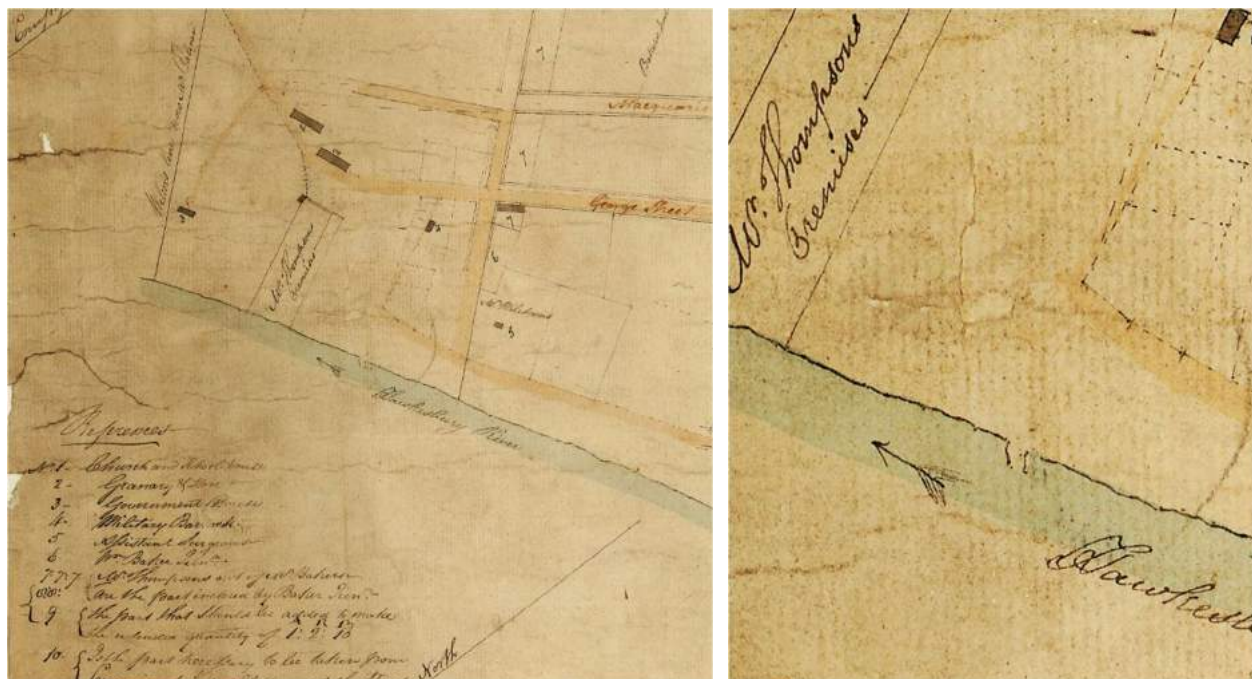
Figure 16: Surveyor James Meehan's 1812 plan of the Town of Windsor.<sup>63</sup> (Enlargement of possible wharf / landing place on the right).

Figure 15 and Figure 12) – however, there is no clear evidence of any built structure. An 1812 plan of the township of Windsor also shows what appears to be a break in the bank of the Hawkesbury in a similar location (Figure 16) – quite possibly representing the wharf as a short projection or a cutting. Together, these images indicate that the Green Hills wharf was situated in the location of the current Windsor Bridge southern abutment (outside the current study area).

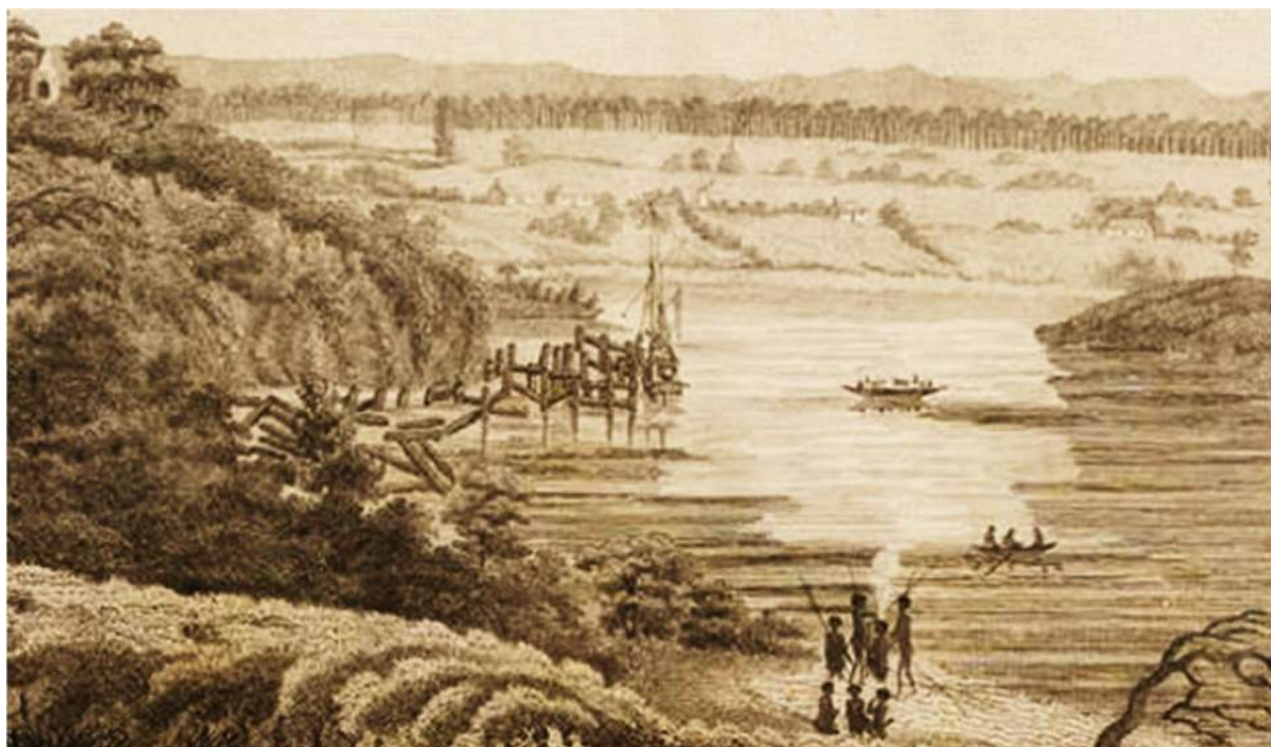
**Figure 17: ca. 1817-1819 engraving of Hawkesbury River showing Windsor wharf destroyed by 1816 flood.**<sup>87</sup>

A ca. 1817-1819 etching and engraving of the Hawkesbury River showing a sailing vessel alongside the ruins of a timber wharf structure (Figure 17) is believed to depict the Windsor wharf as it was after the destruction of the May 1816 flood.

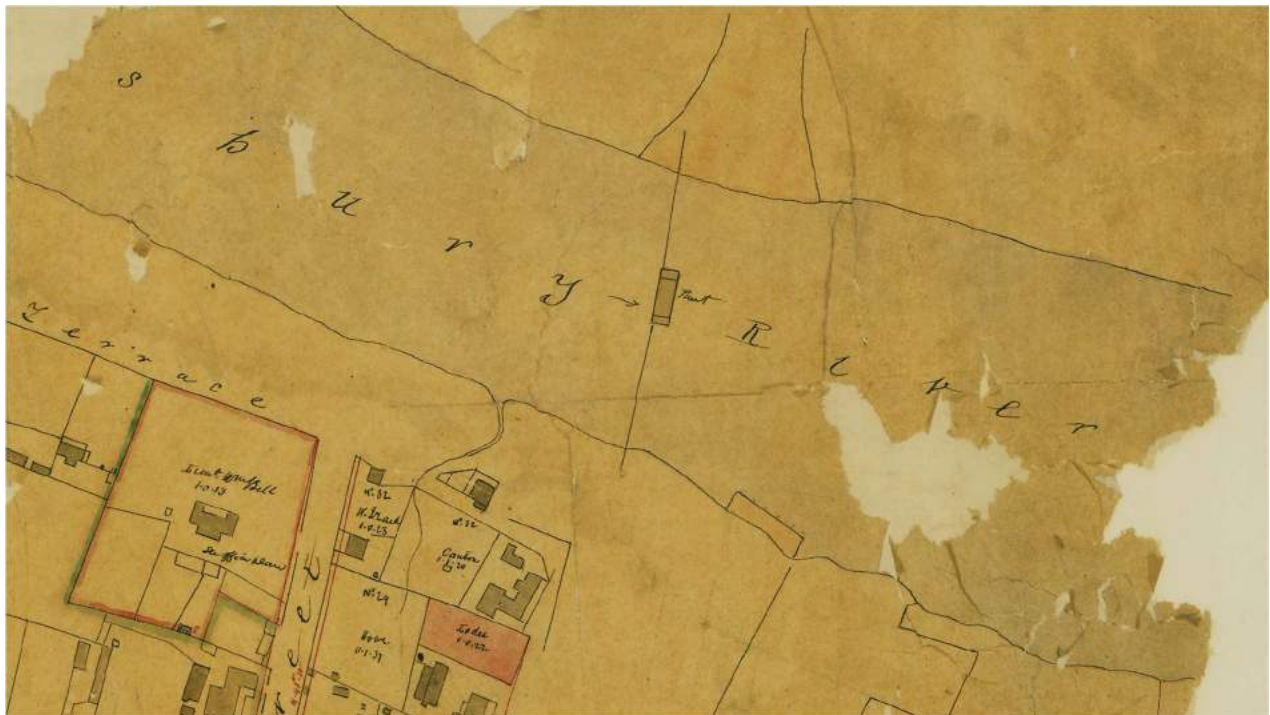
Figure 18: 1835 plan of Windsor township, showing Greenway / Howe & McGrath wharf and cable punt.<sup>96</sup>

Macquarie further states in his 1822 report that “A very convenient Ferry has been established from the same wharf to the north bank of the river by a large punt”<sup>93</sup> – suggesting that once the Windsor Wharf was completed, it served as the southern landing point for the ferry service across the Hawkesbury River that had been established in 1814. In 1832, however, the ferry service was taken over by the Government and Howe’s punt was replaced by a larger cable-operated punt that ran from a southern landing upstream of Windsor Wharf to a northern landing cut into the northern bank of the river<sup>94</sup> – see Figure 18 and Figure 51.

The details of Greenway's Windsor wharf design are not known, and no construction plans appear to have survived. However, the outline of the wharf is shown in a series of 1830s to 1840s survey plans of the township of Windsor (see Figure 18, Figure 19, Figure 20). The 1840s plans appear to use the 1830s plan as a template, however, all three consistently depict the wharf as a rectangular structure extending westward along the riverbank from the eastern boundary of Thompson Square and measuring approximately 85' (25.9 m) in length and 26' (7.9 m) in width. It would thus appear that the idea of constructing a wharf along the whole width of the Thompson Square frontage was abandoned by Greenway, although the wharf was still built in larger dimensions than those in the original 1814 contract. An 1835 survey by Government Assistant Surveyor George Boyle White (Figure 18) further shows a line of six points along the riverward side of the wharf – possibly indicating a row of mooring posts and / or fender piles. Finally, an examination of the wharf in the early 1860s indicates that at least some, if not all, of the timber piles were formed of Australian ironbark (*Eucalyptus* sp.).<sup>95</sup>

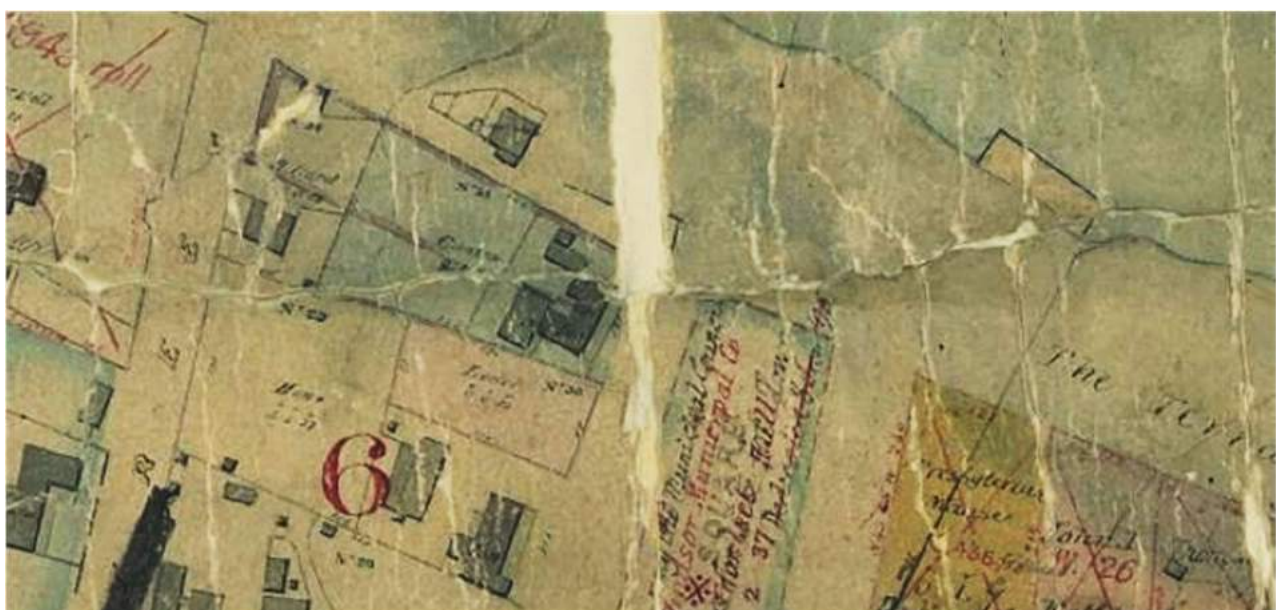
Figure 19: 1841 plan of Windsor township, showing Greenway / Howe & McGrath wharf.<sup>97</sup>

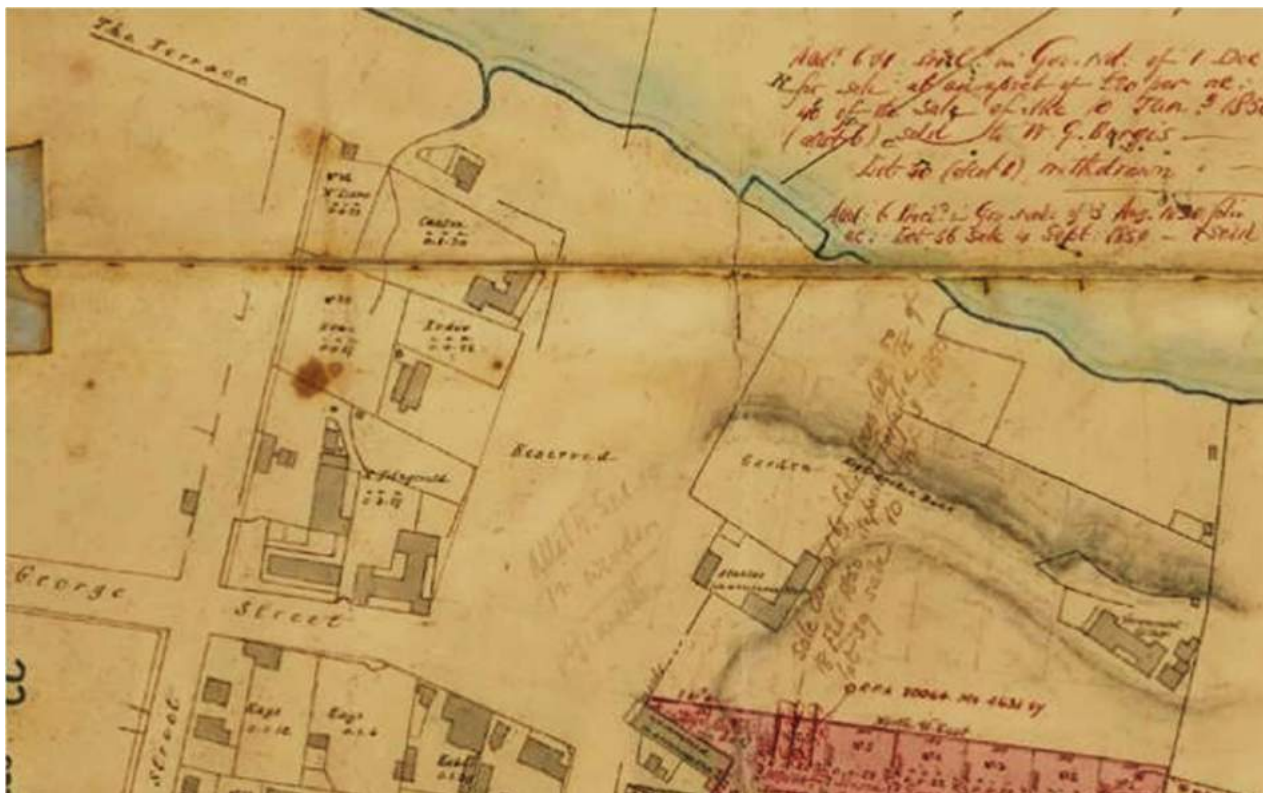
Figure 20: 1848 plan of Windsor township, showing Greenway / Howe & McGrath wharf.<sup>98</sup>

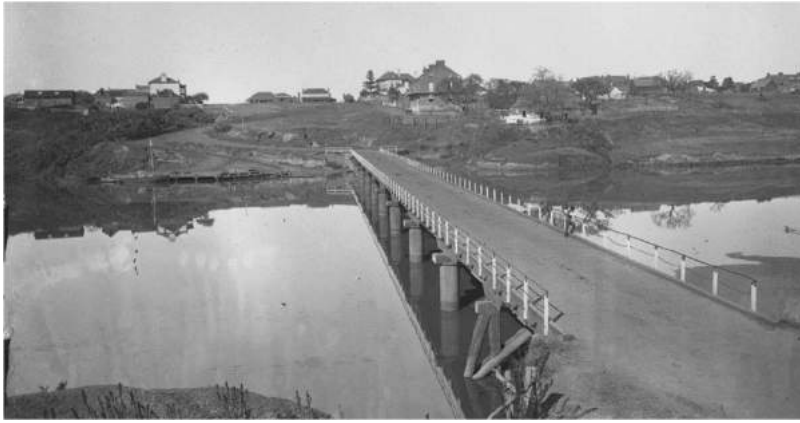
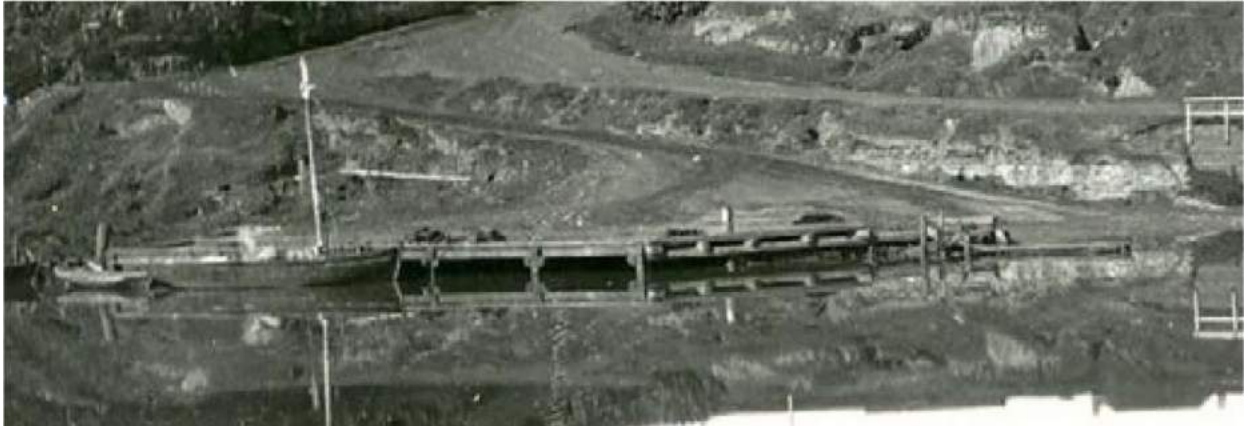
**Figure 26: Windsor Bridge and wharf, ca. 1879 –**

*enlargement of wharf below, clearly showing front edge and angled upstream side.<sup>110</sup>*

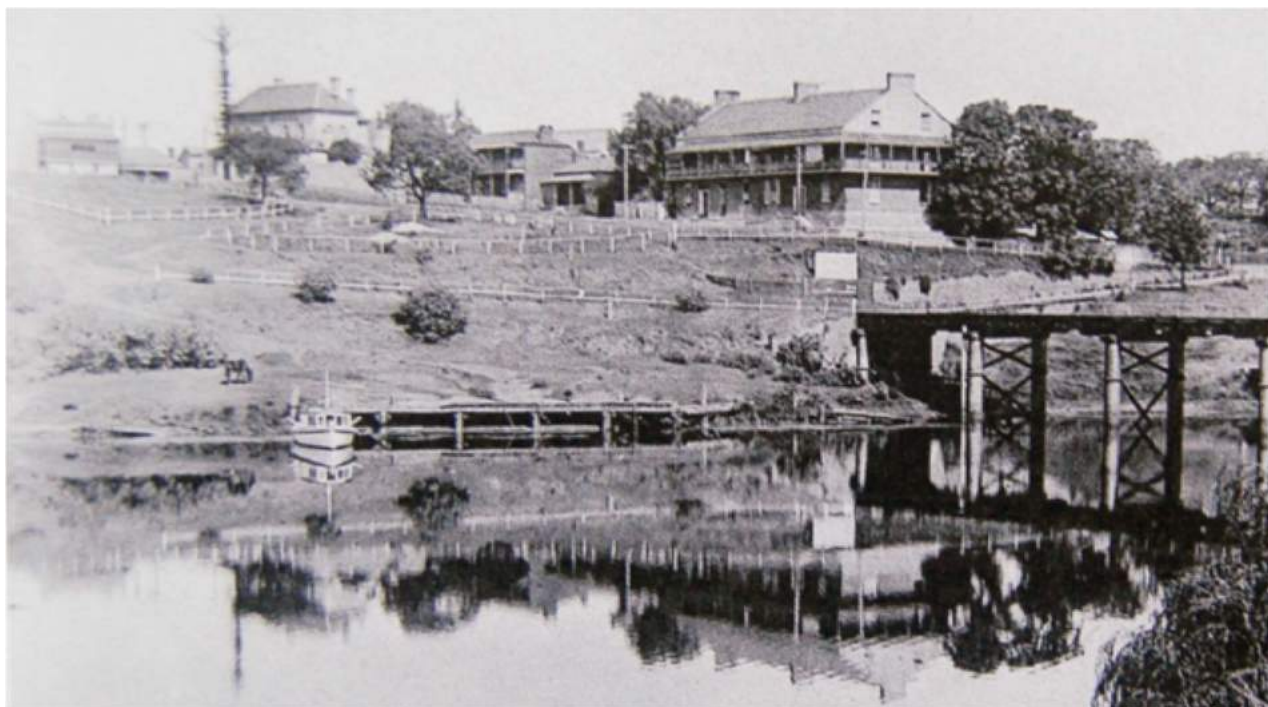
**Figure 29: Windsor wharf, ca. late 1890s – showing what appears to be some deterioration of superstructure elements at the upstream end.<sup>114</sup>**

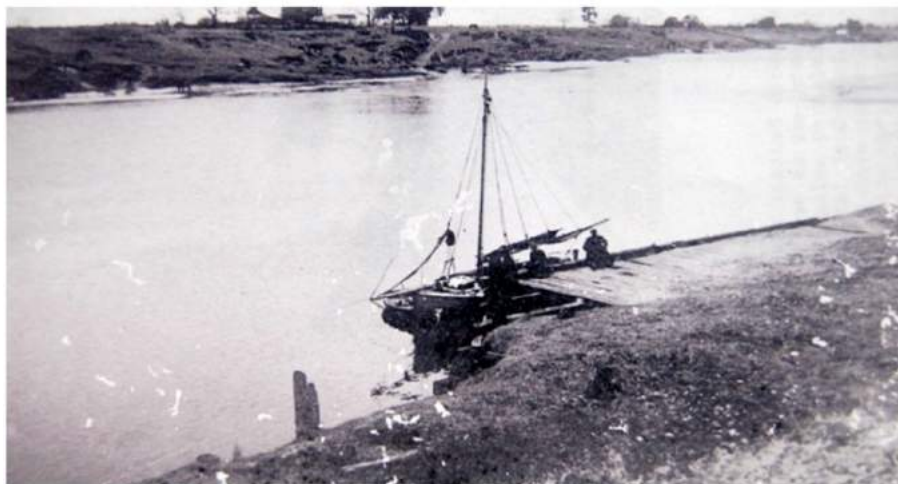
**Figure 33: Windsor wharf, ca. 1920s, missing superstructure at upstream end and remnant pile stump.<sup>120</sup>**

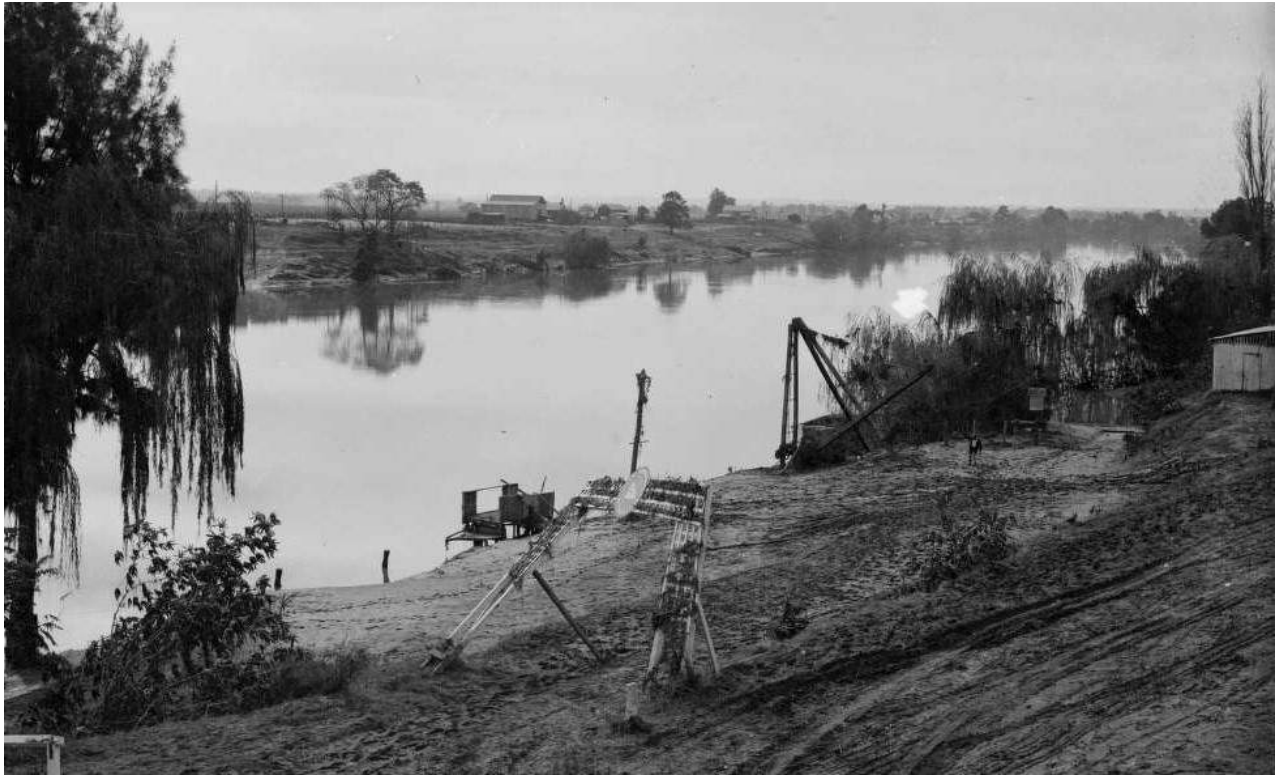
**Figure 36: 1949 photograph of Windsor wharf reserve after a flood – showing pile stumps as the only visible surviving remnants of the wharf.** <sup>125</sup>

The Upper Hawkesbury Motor Club remained as Trustees of the Windsor wharf reserve throughout the 1940s to mid-1950s, carrying out various improvements over the years including erection of boat sheds, clubhouse, riverside viewing stage, boat crane and slipway downstream of the wharf. Although no detail has been found in the historic record, it is possible that further repairs and timber replacements were also made to the Windsor wharf. By the late 1940s, however, photographs show that the wharf had almost entirely disintegrated (Figure 36), and by the late 1950s, almost all visible trace of it had gone (Figure 37).

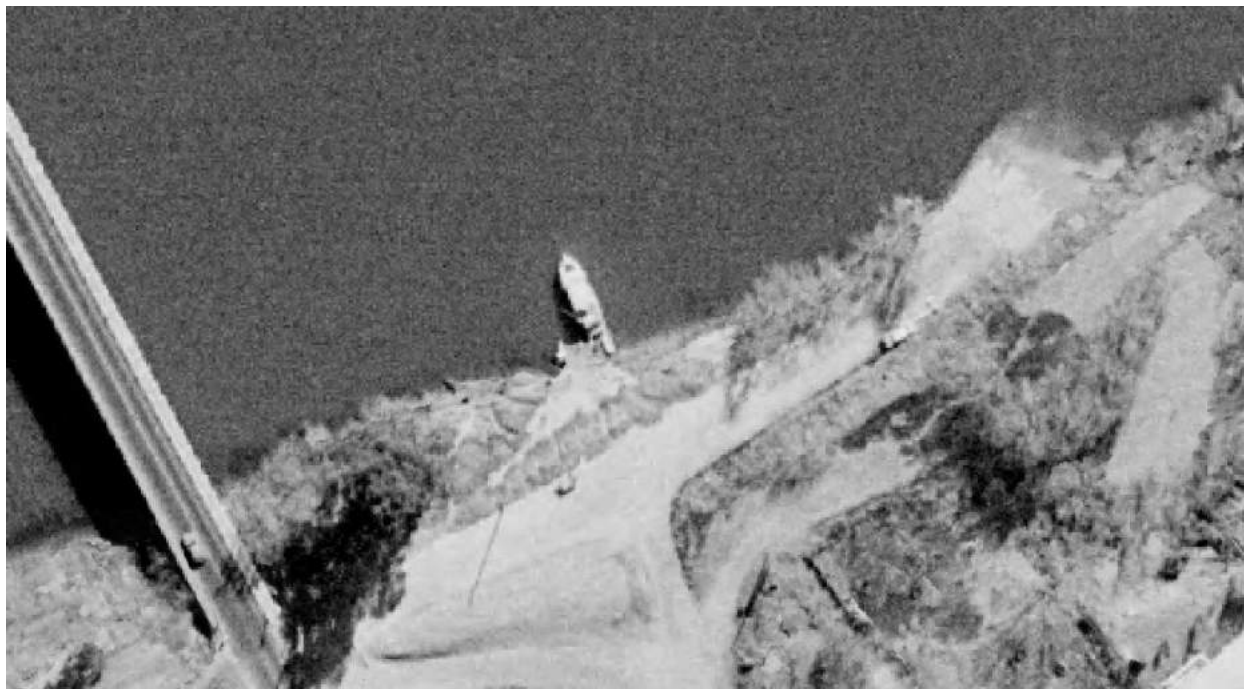
**Figure 38: 1970 aerial photograph showing small boat landing stage constructed within footprint of former Windsor wharf.**<sup>128</sup>

In 1955, under direction from the NSW Department of Lands, trusteeship of the Windsor wharf reserve was reverted back to the Windsor Municipal Council.<sup>127</sup> The reserve continued to be dedicated for public recreation and wharfage, and in the mid-late 1960s, a small reinforced concrete boat landing stage was constructed in the location of the former Windsor wharf – at the downstream end of the former wharf footprint (Figure 38). In the mid to late 1980s, a new wharf was erected further downstream to cater for increased tourist and passenger ferry services – in the location of the current wharf – and the small boat landing was deconstructed and removed (Figure 39).

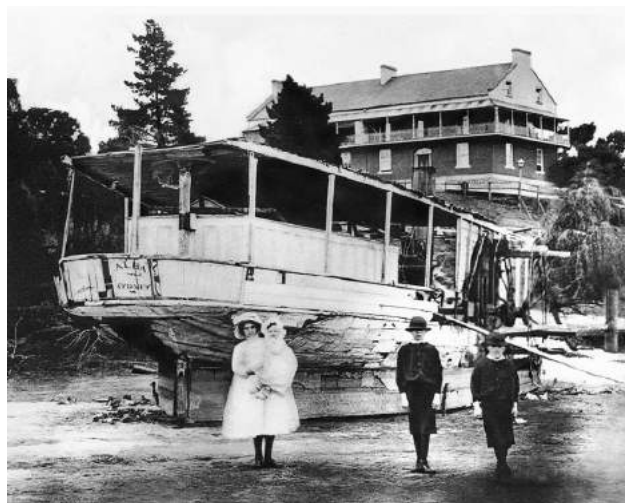
**Figure 54: *St. Albans* beached at low tide below Windsor Wharf, ca. 1889.** <sup>207</sup>

In 1886, an attempt to re-establish steam passenger and freight services between Windsor and the Macdonald and Colo Rivers was made with the introduction of newly constructed *St. Albans* (Figure 53 and Figure 54); a 52 ton steamer specifically designed to draw less than 2' (0.6 m) of water when loaded. In March 1886, *St. Albans* left Windsor wharf laden with passengers and cargo, including three racehorses, bound for St. Albans – the first successful navigation of Windsor reach by a sizeable steamer since the late 1860s.<sup>203</sup> The celebration was somewhat short-lived, however, as in May 1886, *St. Albans* became grounded on a sand bar just below Windsor wharf on the return leg of a passenger excursion.<sup>204</sup> *St. Albans* continued to run occasional pleasure excursions and cargo trips from Windsor wharf throughout the late 1880s to mid-1890s, with trips timed carefully to coincide with high tide at Windsor. However, the risk of grounding was ever present, and on several occasions passengers had to disembark on the riverbank part way along Windsor reach and return to town on foot.<sup>205</sup>

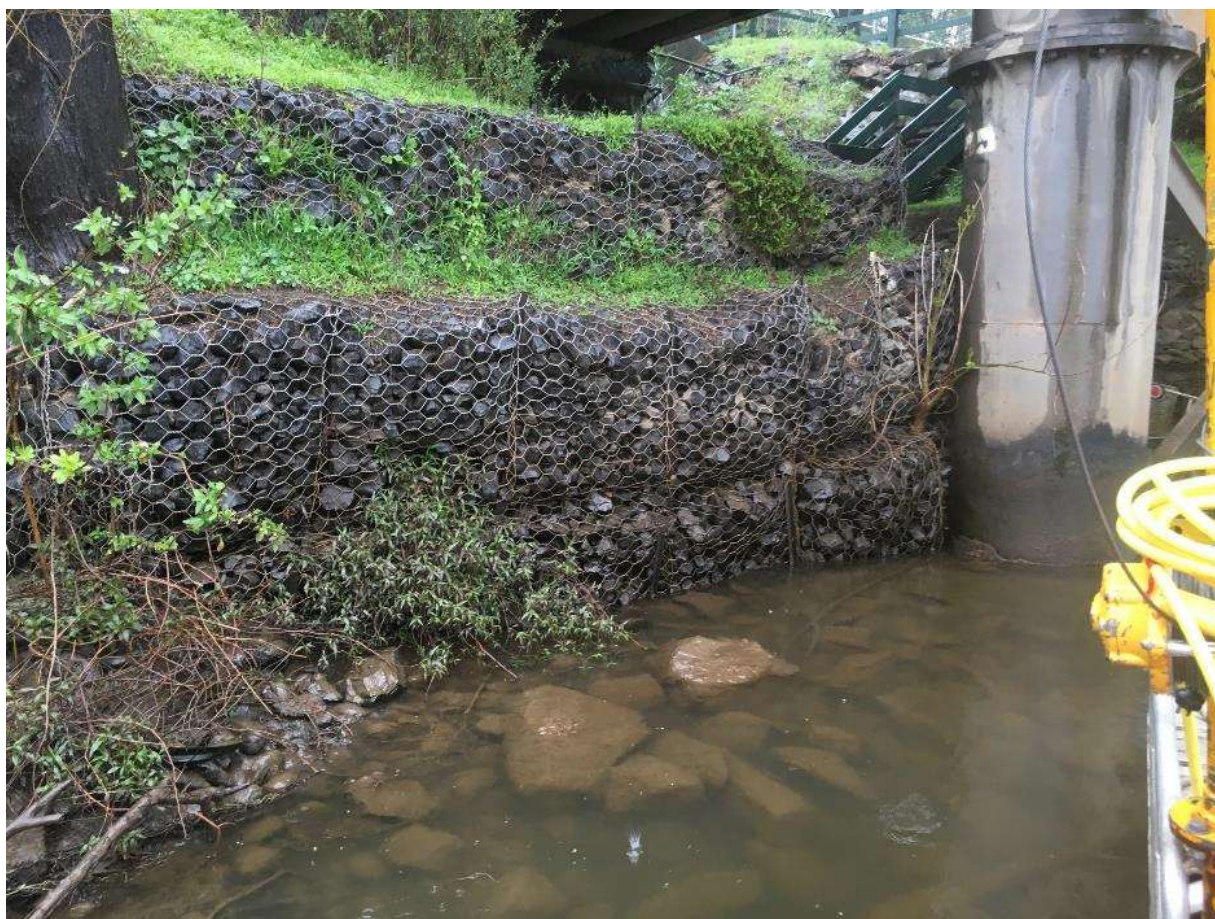
**Figure 64: Gabion baskets shoring up the riverbank and rock armour in the shallow water laid down for stabilisation.**

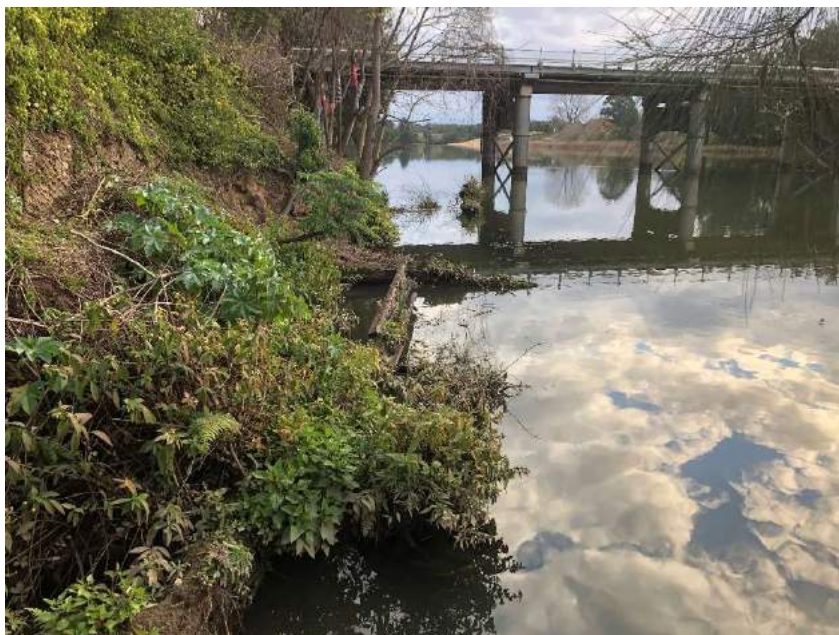
**Figure 65: Overhanging vegetation and the river water level covering the riverbank wharf features.** Water and deck beam visible centre of image, further wharf remains obscured by vegetation at bottom centre of image. (Image taken 16th July 2018, Cosmos Archaeology).

- 1) Since the previous inspection in 2016, the overgrown vegetation within the survey area between the old bridge and the public wharf had been cut back. The remaining vegetation consisted of low grass and bushes providing greater access to the wharf remains. Some overhanging vegetation where the water meets the riverbank did remain (Figure 65).

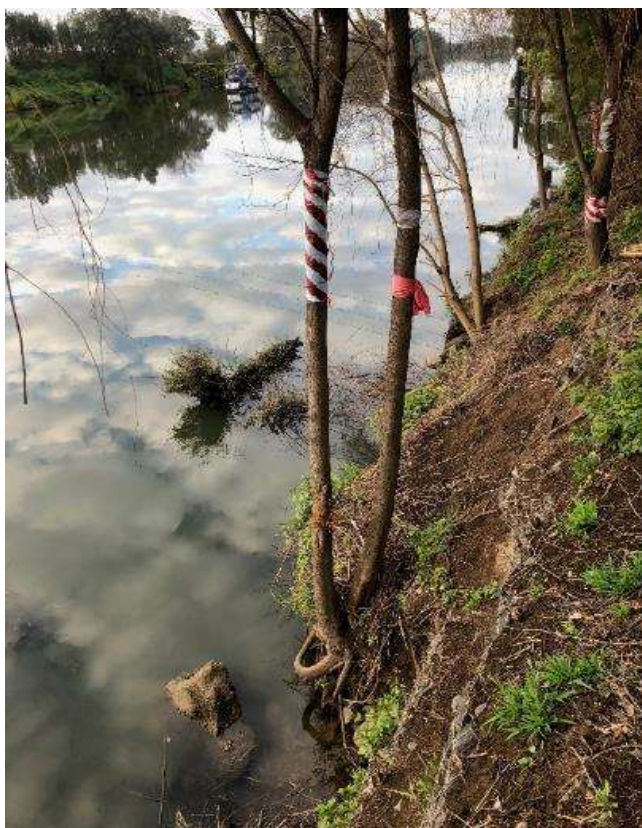
**Figure 66: The steep slope and gradient of the riverbank.** Top of gabion baskets are indicated with red arrows. Image taken 16th July 2018, Cosmos Archaeology).

- 2) The Gabion basket wall installed prior to 2008 means the slope near the old bridge is very steep and the gradient lessens downstream towards the public wharf. This steep slope limited the amount of equipment that could be carried to the site (Figure 66). Basic recording equipment including drawing slates, handheld cameras and scale poles were used for the survey.

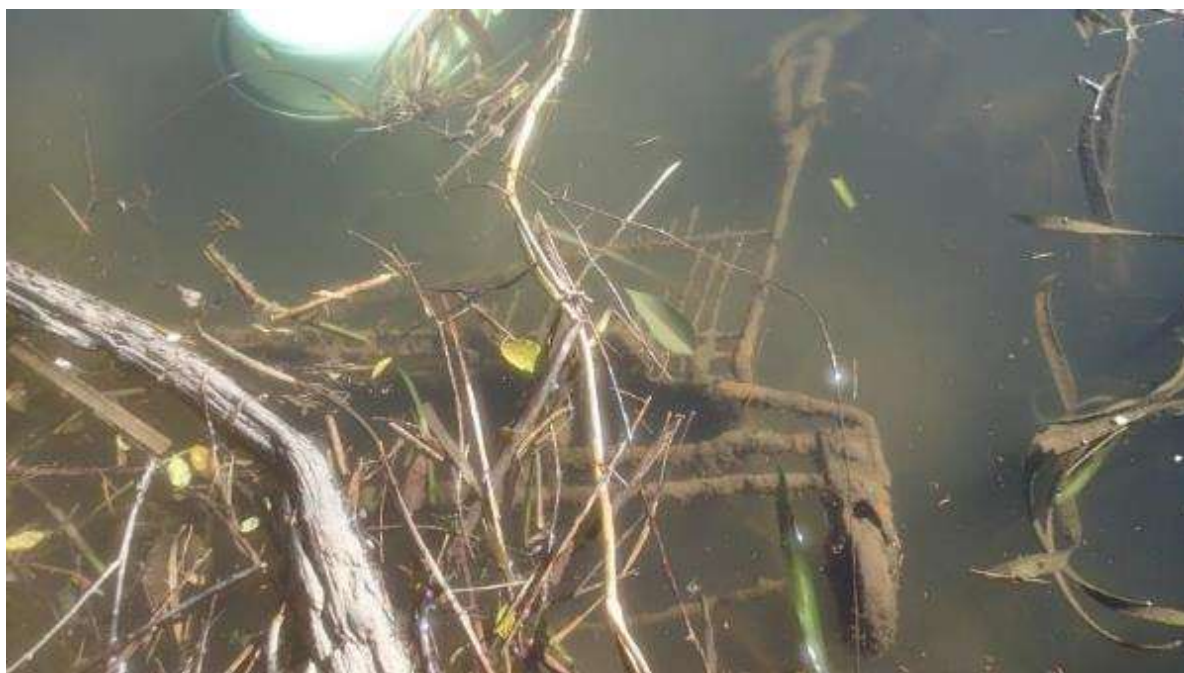
**Figure 67: Modern litter, such as shopping trolleys, present at various locations within the survey area.** (Image taken 16th July 2018, Cosmos Archaeology).

- 3) At high tide the majority of the riverbank wharf features were largely underwater. All inspections had to be conducted at low tide so as to ensure access to as many of the cultural features as possible. This particularly applied to the cut-off piles that protruded from the riverbed for only a short distance.
- 4) The riverbed at the base of the bank consisted of silt with occasional rock rubble. There was also modern litter such as shopping trolleys at varying locations within the survey area

(Figure 67). These larger items made accessing details of wharf features difficult. The river mud decreased any water visibility as soon as it was touched and made detailed observations of cultural features underwater difficult. As a result, underwater features of the riverbank wharf could not be recorded.

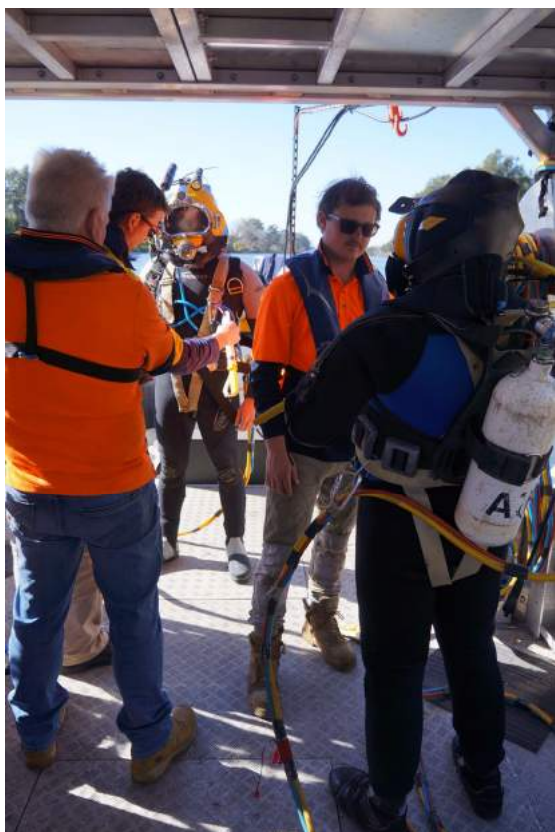
**Figure 68: Divers kitting into SSBA equipment, one diver in water and the second diver above water standby**

The excavation approach followed what was described in Section 12.3 of the MATR-MARD-DSS with minor variations. The excavation was carried out by divers on Surface Supplied Breathing Apparatus (SSBA). Survey work was undertaken on occasion by divers in SCUBA depending on the nature of the task. The divers were tethered to the dive boat and able to communicate via communication lines with the crew on the working platform at all times (Figure 68).

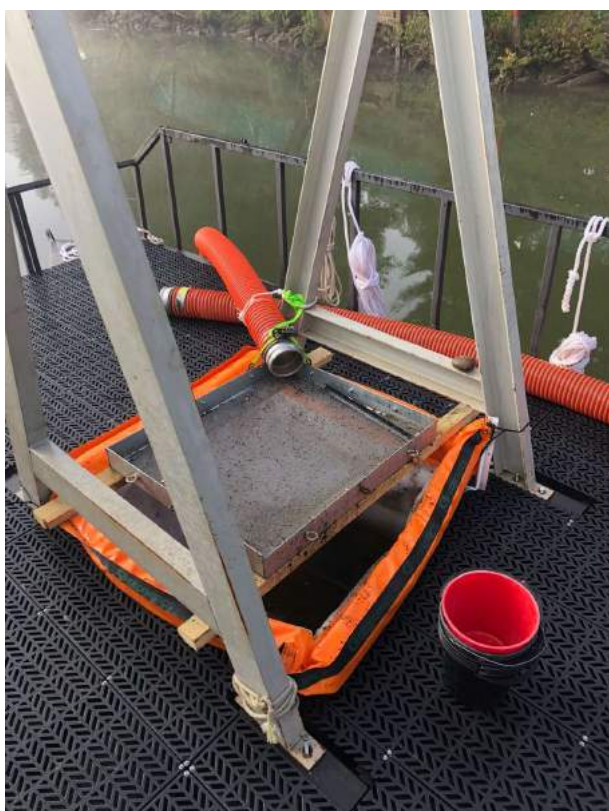
**Figure 69: Set up of the sieve, silt curtain and dredge for sediment on the riverbed.**

**Figure 75 : A typical example of a water dredge used for this Windsor Bridge Replacement Project.** 1 – is the inlet hose which delivers water under pressure to the dredge head. 2 – the curved pipes which directs the water under pressure away from the intake – 3 – through which sediments and artefacts are drawn into. The excavated material is conveyed through the outlet hose – 4 – and carried in this case to the surface to be emptied onto a sieve (Figure 69 and Figure 77).

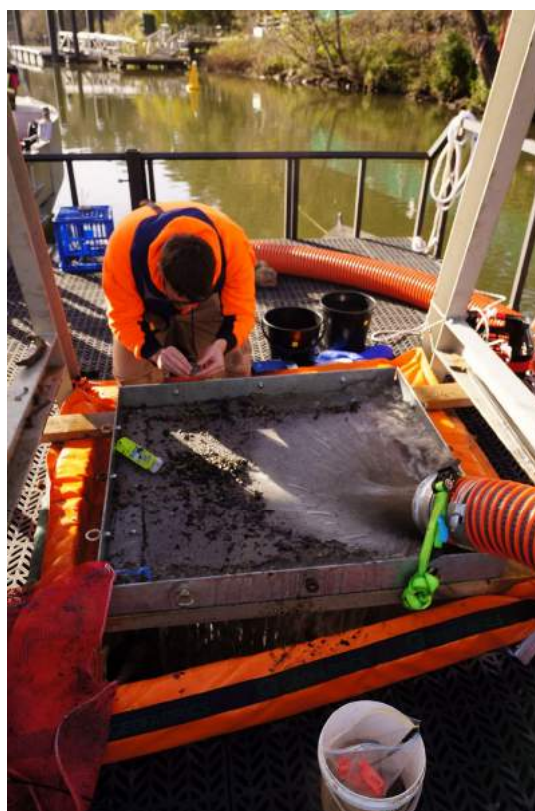
**Figure 70: The collection well, whereby the sediments and other material can be sent onto and passed through a 3.5 mm mesh sieve set in place over the well. Artefacts were collected from the sieve and sorted. A silt curtain lined the inside of the well.**

The working platform was a dumb barge of 8,500 mm x 3,750 mm with a collection well on board, whereby the sediments and other material can be sent onto and passed through a 3.5 mm mesh sieve set in place over the well (Figure 70). Artefacts were collected from the sieve and sorted. A silt curtain lined the inside of the well to prevent turbidity around the work area.

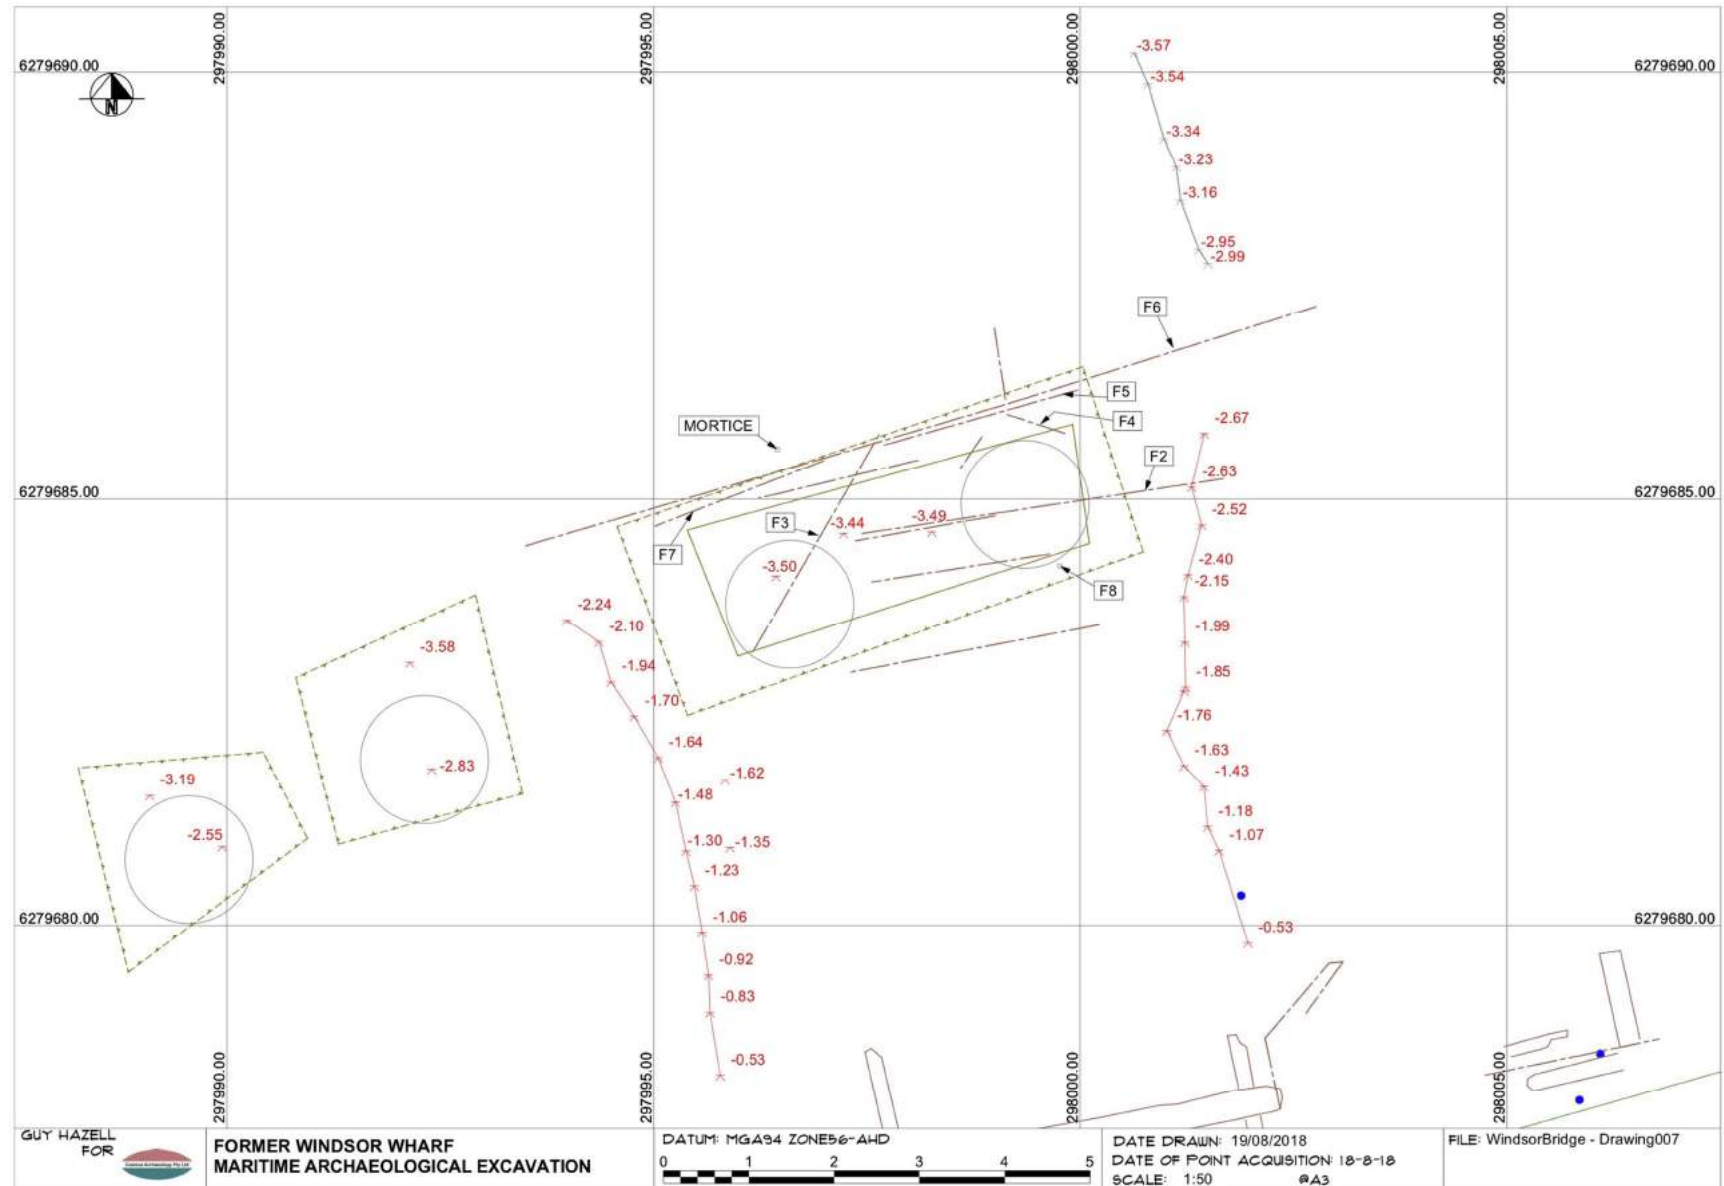
**Figure 74: Survey plan of the underwater excavation as of 19<sup>th</sup> August 2018.**

Each point was obtained with a diver positioning the base of the staff on the feature to be surveyed. Once in position, the diver notified the work boat who informed the surface swimmer who steadied the staff to vertical with the use of a spirit level. Once steady and vertical the surface swimmer signalled to Guy who then took the position and plotted it on a map (Figure 74).
