# Windsor Bridge Replacement Project

## Report on Maritime Archaeological Excavation and Survey, June to September 2018

Windsor,  
Hawkesbury River, NSW

September 2021

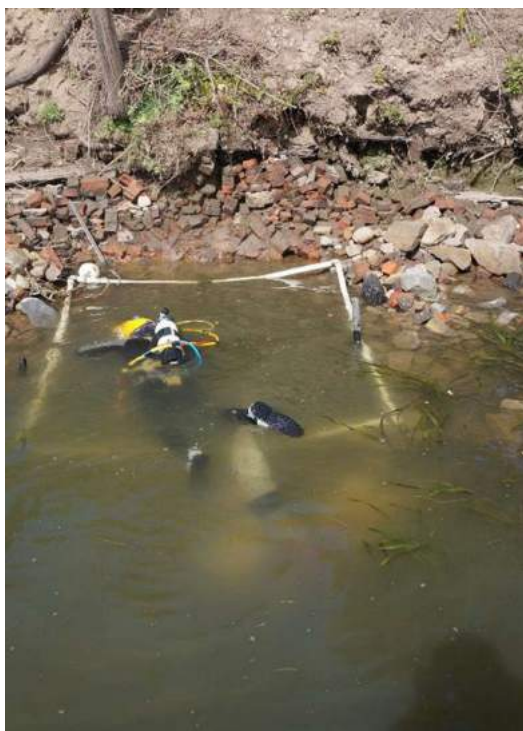
**Figure 76: Diver in ST5 using the dredge.** The trench is marked by a 1m x 1m square grid. The dredge removed sediments and smaller artefacts that were then recovered and recorded on the sieve. (Image source Cosmos Archaeology)

As this diachronic site was underwater, conventional terrestrial excavation techniques with trowel and pan was not possible. Instead, the conventional underwater excavation tool at relatively shallow depths – the water dredge – was used (Figure 75 and Figure 76). The intake of the dredge head was six inches in diameter and driven by a 3" submersible pump capable of delivering up to 2,200 litres per minute to the dredge head which was configured to create suction (known as the venturi effect).

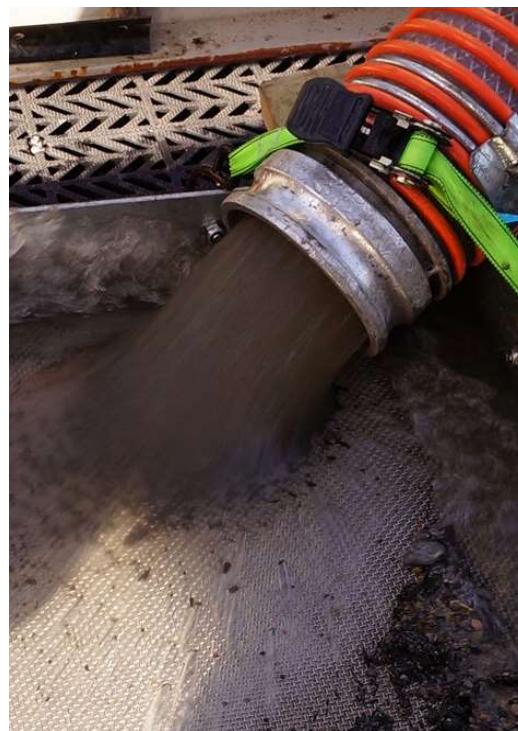
**Figure 77: Detail of the outlet pipe emptying water, sediment and smaller artefacts onto the sieve that were then recovered and recorded.** (Image source Cosmos Archaeology)

**Figure 75 : A typical example of a water dredge used for this Windsor Bridge Replacement Project.** 1 – is the inlet hose which delivers water under pressure to the dredge head. 2 – the curved pipes which directs the water under pressure away from the intake – 3 – through which sediments and artefacts are drawn into. The excavated material is conveyed through the outlet hose – 4 – and carried in this case to the surface to be emptied onto a sieve (Figure 69 and Figure 77).

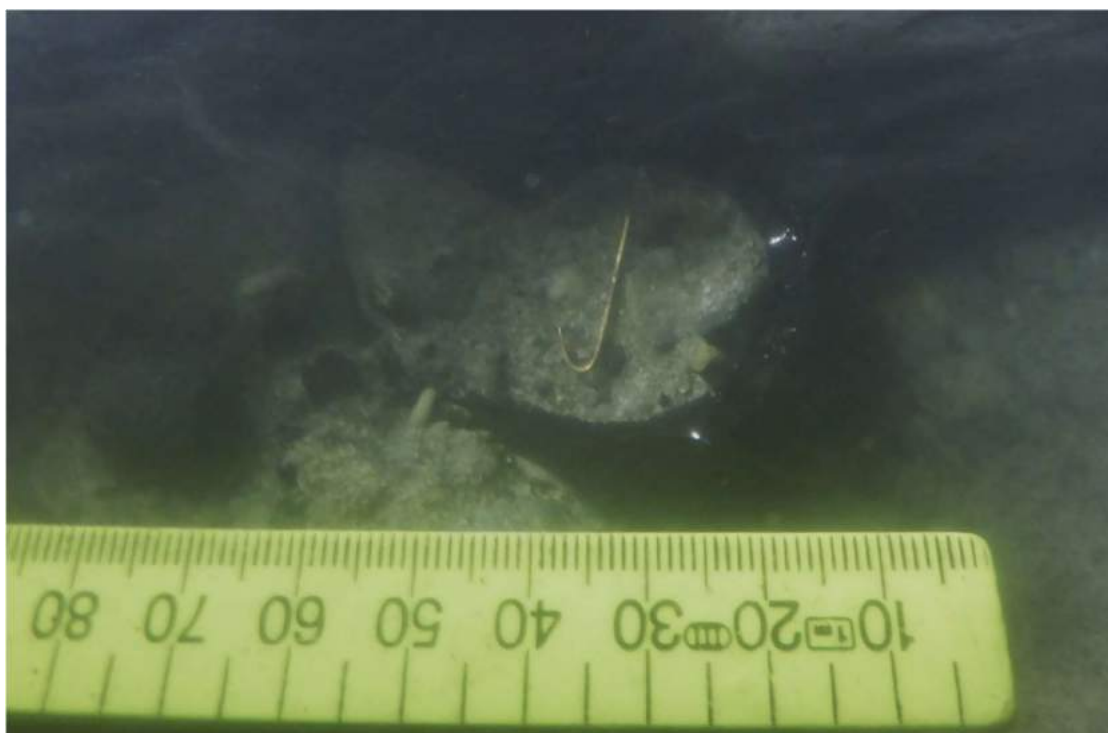
**Figure 78 : Rare occasion where water visibility allowed small objects to be photographed.** Copper alloy pin bent into hook shape resting within a glass fragment next to bedlog UWF06

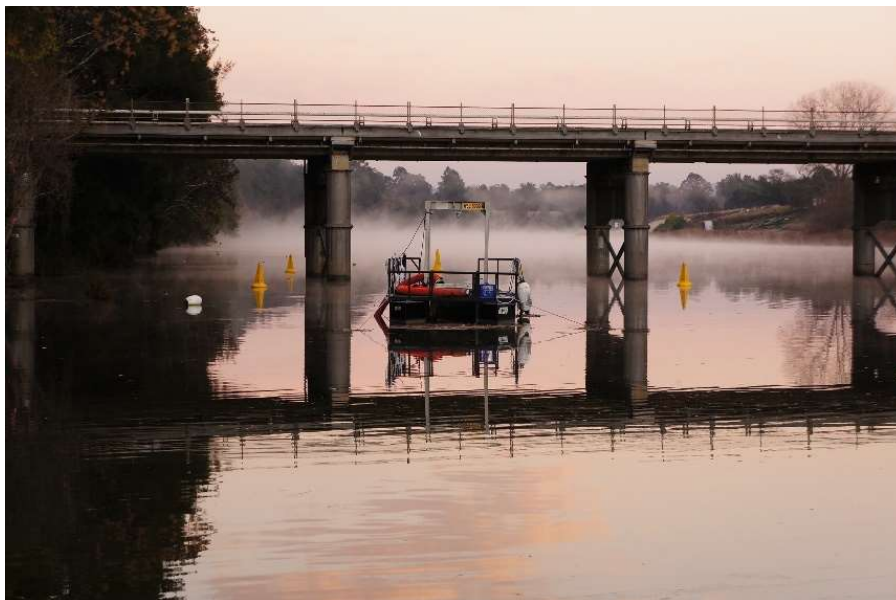
**Figure 82: Permanent location of the barge during the project.** Located inside the exclusion zone, moored on all four corners. (Source image: Cosmos Archaeology)

This 8,500m x 3,750 m vessel was stationed over the worksite for the duration of the excavation (Figure 82). The barge was moored on all four points with the lines set so that it could be manoeuvred short distances by hand.

The primary function of the barge was the initial collection and sorting point for artefacts recovered during the excavation. The main feature of the barge was a 1 m x 1m well in the centre over which the sieve was positioned. The outlet of the water dredge emptied onto the

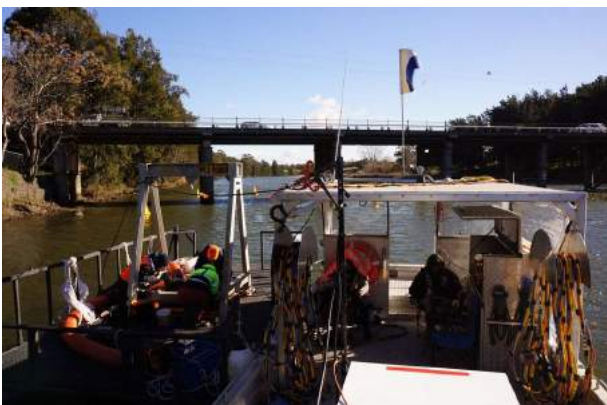
**Figure 83: View to the stern of the Dive boat;** (showing from left to right), barge, dive boat with SSBA dive panel, diver umbilicals, tools and generator in bottom right corner.

All diving operations were conducted from this 11 m long vessel. Located on the vessel was the dive panel, low pressure air compressor, air cylinders, umbilicals, tools and the 33 KVA electrical generator for the pump (Figure 83 and Figure 84). The diver entered the water from the dive vessel and the standby diver was seated next to the dive supervisor who oversaw the dive panel. The supervising archaeologist was stationed next to the surface communication unit.

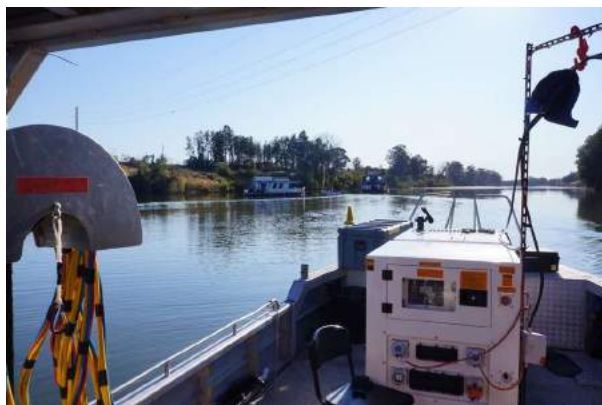
**Figure 84: View to the bow of the Dive Boat;** (showing from left to right), diver umbilical and 33 KVA electrical generator for the pump.

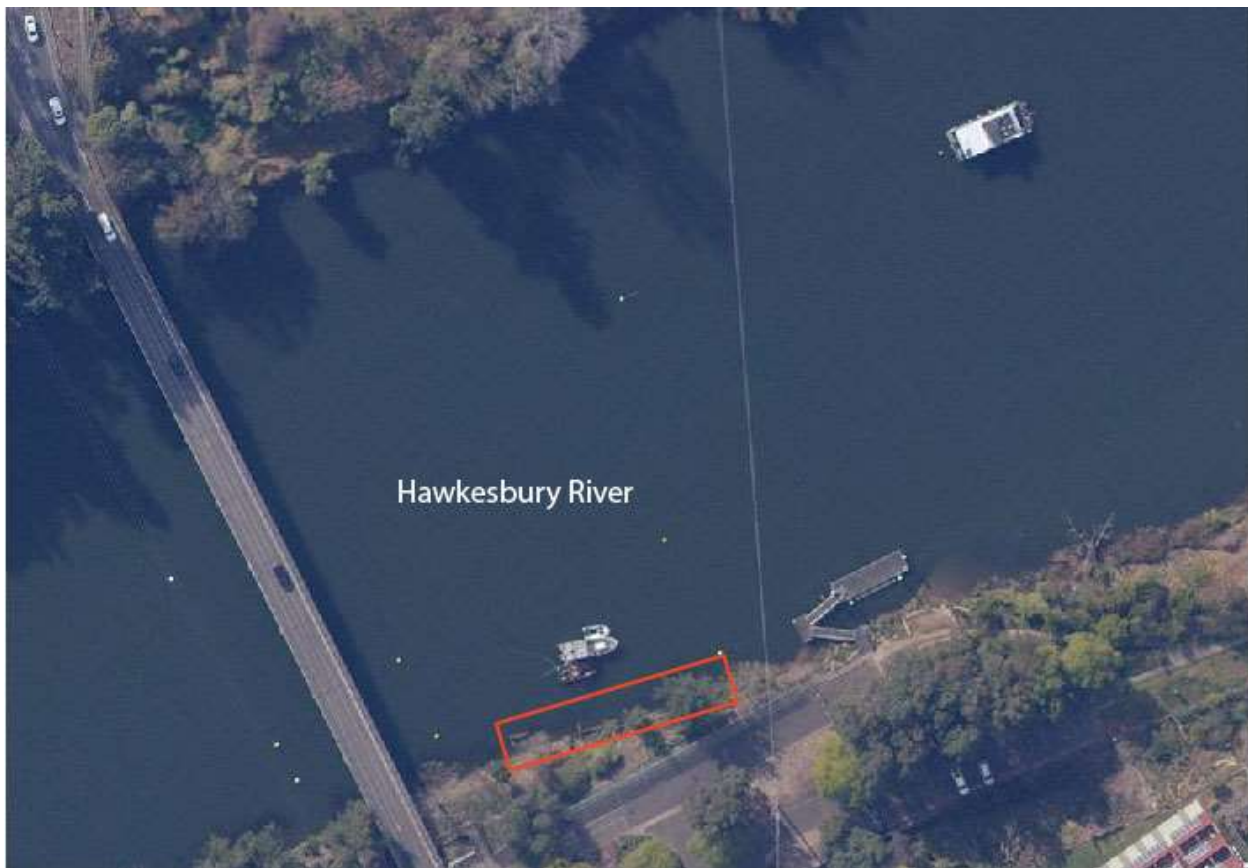
**Figure 89: The wharf survey study area (red rectangle) on the southern side of the Hawkesbury River.** The yellow buoys around the dive marked out the designated work area for the excavation. (Image source: SixMaps).

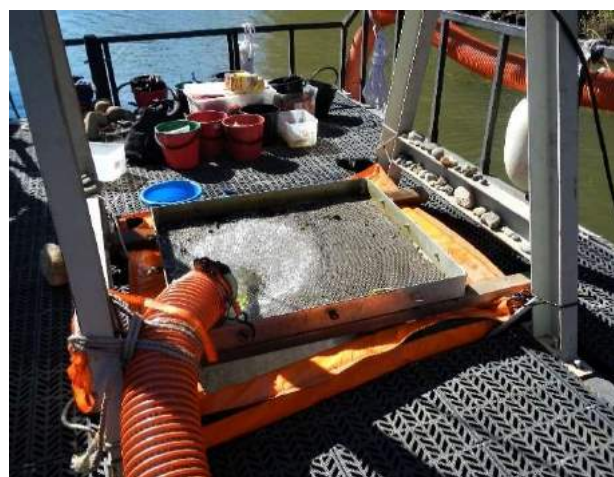
**Figure 97:** Sieve setup showing dredge outlet secured to gantry with water passing through sieve and into the open well lined with a silt curtain.

Throughout the maritime archaeological excavation, the outlet of the diver-operated water dredge was positioned over a 1 x 1 metre sieve with a 3.5 mm mesh situated onboard the project dumb barge. This setup ensured that all excavated deposits passed through the sieve and the fine mesh size enabled even the smallest of artefacts to be recovered. The sieve was attached to a timber framework fitted inside a gantry bolted to the deck of the barge and was positioned over a 1 m x 1 m open deck well, lined with a silt curtain (Figure 96 and Figure 97). The dredge hose was affixed to the barge railing and the deck gantry with ropes and adjustable ratchet straps, allowing the dredge outlet to be securely positioned over the sieve.

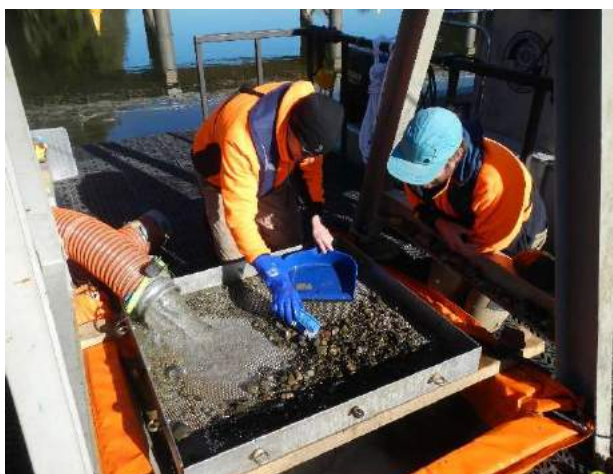
**Figure 98: Sieve in operation with two archaeologists monitoring and clearing river gravels.**

The sieve was monitored by at least one to two archaeologists at all times the dredge was in operation (Figure 98). Excavation of each archaeological unit – context, spit and / or feature – commenced with a cleared dredge hose and a clean sieve. As excavation of each unit progressed, artefacts were collected from the sieve and placed directly into pre-labelled plastic bags filled with river water – thus keeping the artefacts in a similar environment in order to maintain artefact stability throughout the recovery and recording process. In an effort to reduce the risk of galvanic corrosion and streamline the recording process, artefacts from each context were also sorted directly at the sieve into material groups (such as ferrous, copper alloy, lead, glass, ceramic, faunal etc.), with each different material type placed in separate bags. Each bag was labelled with waterproof tags containing provenance information – including site name, trench number, context number and in some cases spit or feature number – and the date of excavation (Figure 99 and see Figure 102).

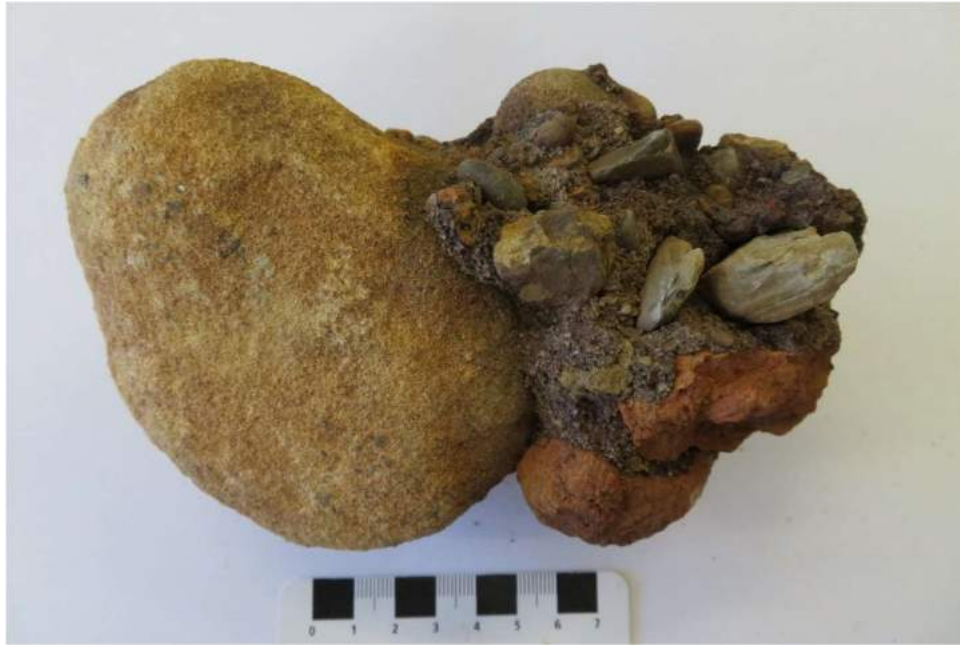
**Figure 110: Example of conglomerate from Cxt 3.**

Also within this context were clumps of compacted gravel and rock, of which more substantial deposits were to be found in Cxt 04 and in Cxt 05 where the whole of the matrix was concreted (see discussion on relevant contexts below). This material, a coarse-grained polymictic orthoconglomerate, is derived from numerous components within the local alluvial gravels as well as material introduced by cultural activity (Figure 110). The matrix itself would have developed *in situ*

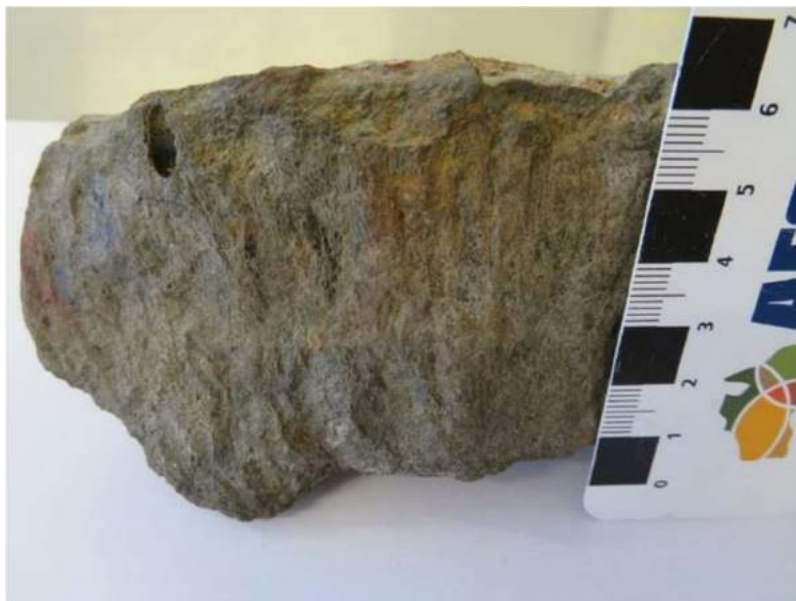
**Figure 116: Sample of slag from Cxt 19, DT 3** (See Annex P – S102).

Cxt 19 was a rocky matrix around 400 mm thick consisting of basalt and sandstone measuring between 150 and 450 mm across and included brick fragments and conglomerate. A number of rock samples were obtained from this context and analysed. Two of the samples were quartzose sandstone very likely derived from the Hawkesbury Sandstone formation (See Annex P – S103 and 104). One of the samples initially thought to be a type of basalt was an iron silicate (fayalite-quartz-magnetite) also known as slag (Figure 116). Crystalline iron silicate slag is produced by smelting for iron from a non-blast furnace (as blast furnace iron slags produce a glassy slag) which would date the material to at least the mid 1800's (See Annex P – S102). Another basalt type rock was identified as a moderately altered and weathered micro-dolerite which was more than likely locally sourced (See Annex P – S102).

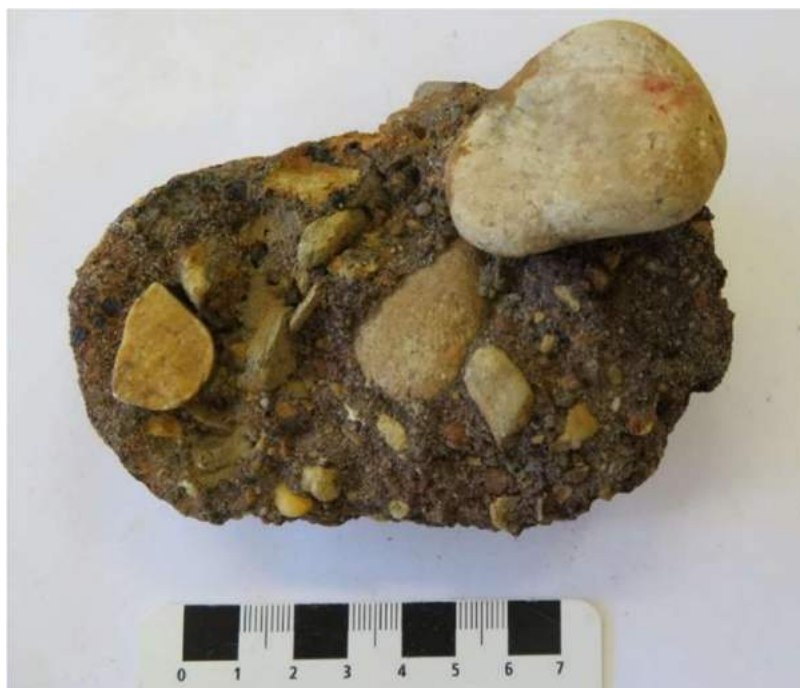
**Figure 117: Sample of conglomerate from Cxt 19, DT 3** (See Annex P – S101).

A fragment of 'conglomerate' was also sampled from this context (Figure 117). Defined as poorly-sorted clast-supported polymictic conglomerate, the wide range in lithic clast compositions and degree of roundness, lack of any sorting and the occurrence of quartzose sandstone clasts (most likely derived from the Hawkesbury Sandstone formation) clearly suggested that this conglomerate is of local derivation (See Annex P – S101).

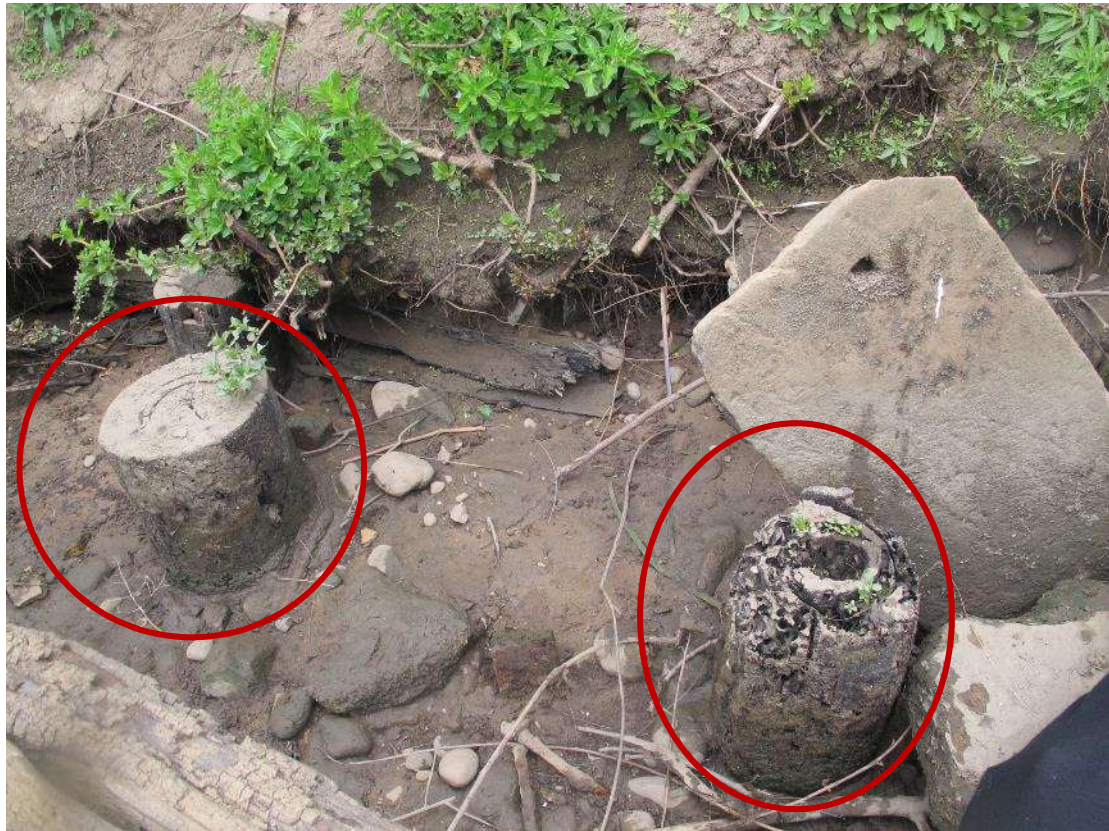
**Figure 120: Cut off piles AWF6/10 and AWF6/11.** Note heavily degraded pile to the right and bolts near the base of these piles.

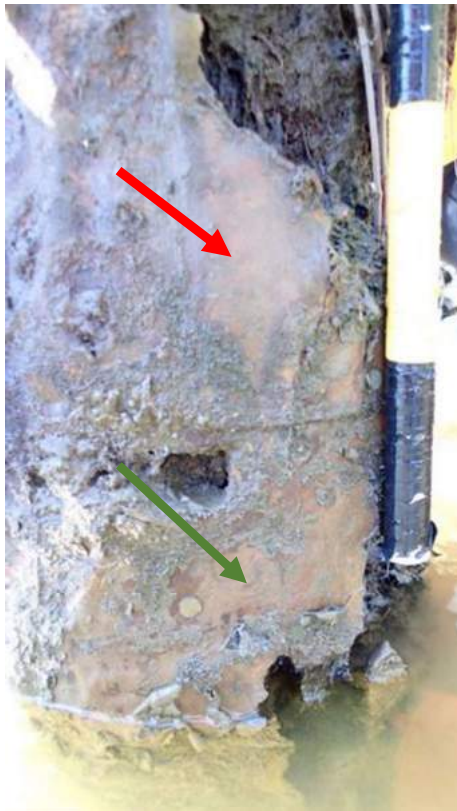
**Figure 121: Remains of copper sheathing on the western side of AWF7.** Red arrow indicated potential sheathing repair and brown arrow indicates sheathing lined notch. Scale in 100 mm increments.

*Figure 118).* What remains are two walers and two deck beams with one degraded pile in the river, AWF7 appears to be located at the NW corner. This pile is protected with copper sheathing, although the much of the sheathing has worn away, particularly on the western side (Figure 121 and Figure 122). There are also three cut off piles in the centre of this feature ranging from 300-330mm in diameter.

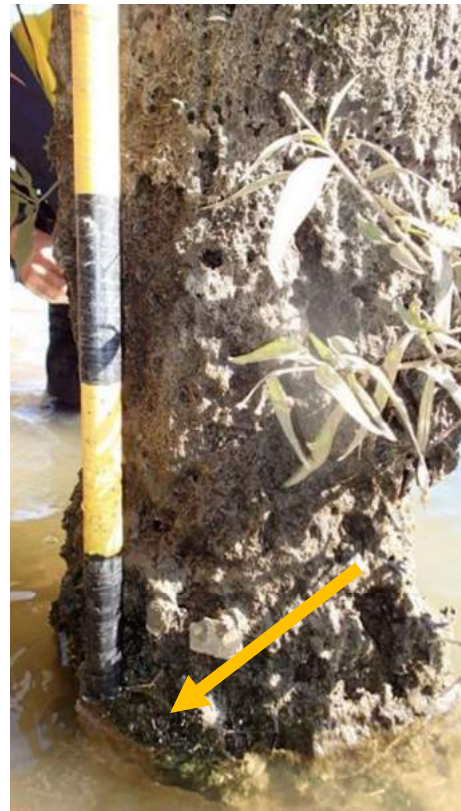
**Figure 122: Only small sections of sheathing survive on the western side of AWF7, indicated by orange arrow.** Scale in 100 mm increments.

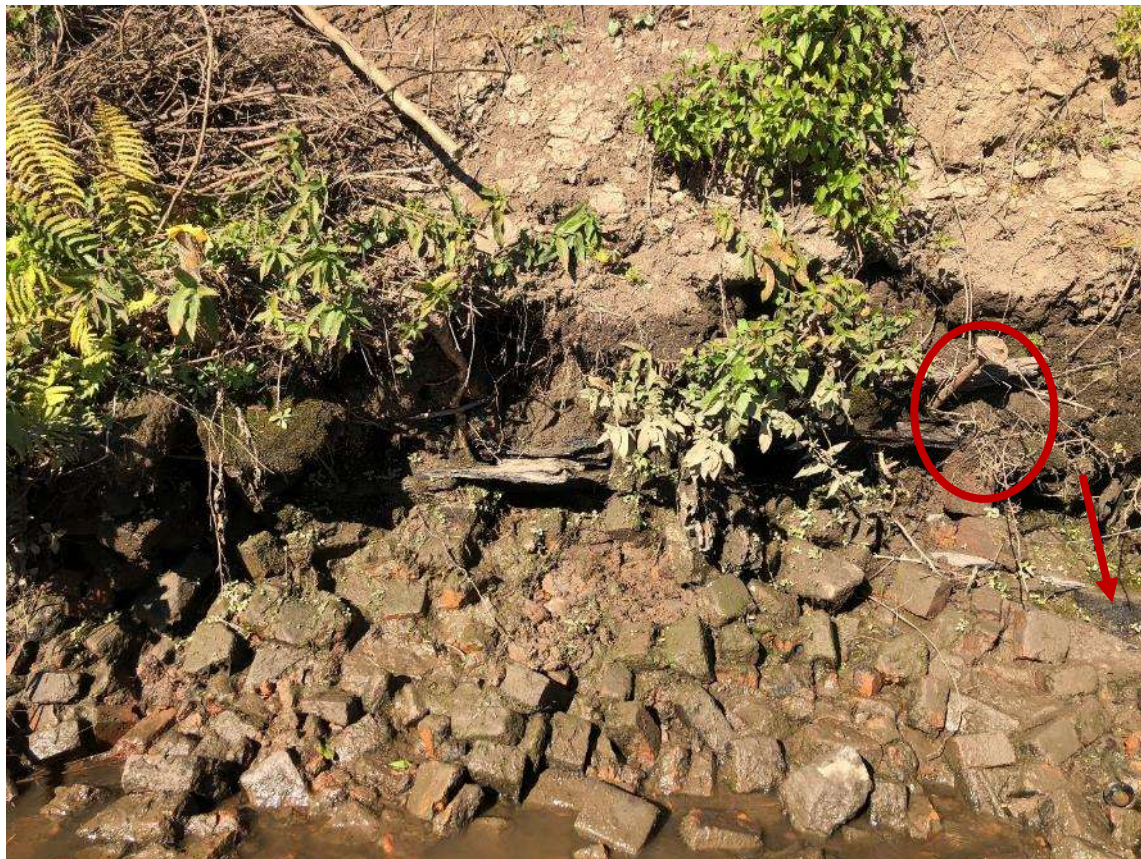
**Figure 123: Section of AWF2, showing timber beam with bolt B11 (red circle) and brick rubble pile (AWF13). A cut off pile (AWF2/4) associated with this feature is lower right of frame (red arrow).**

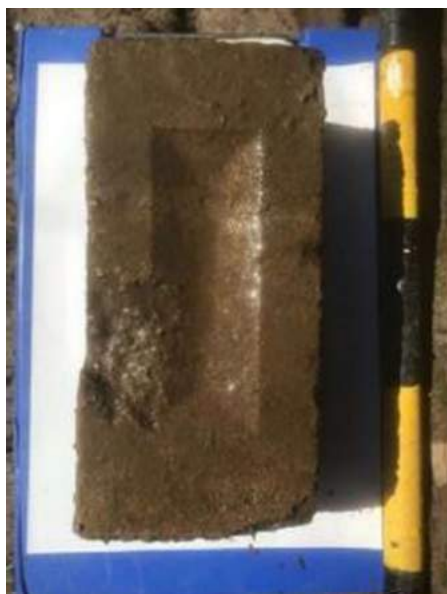
**Figure 124: Dry, pressed shale brick.** Scale in 100 mm increments.

1. Dry, pressed shale with frog, 240 mm long, 120 mm wide and 90 mm thick. The frog measured 140 mm long and 70 mm wide. (Figure 124)
2. Mid brown to red clay likely pressed, 240 mm long, 110 mm wide and 88 mm thick. (Figure 125)
3. Friable red clay sandstock with large frog, no fully extent bricks located, remnant length 150 mm, 110 mm wide and 80 mm thick. (Figure 126).

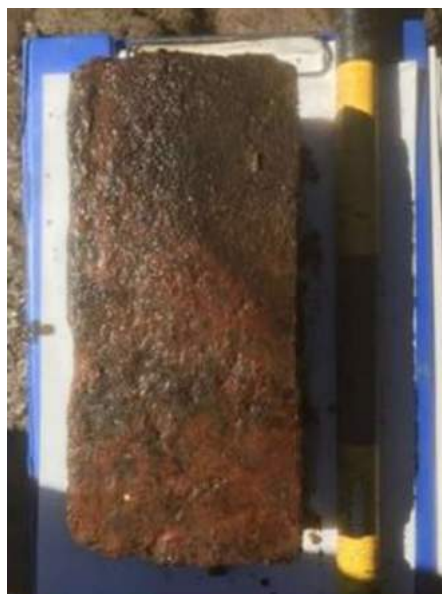
**Figure 125: Mid brown to red clay pressed brick.** Scale in 100 mm increments.

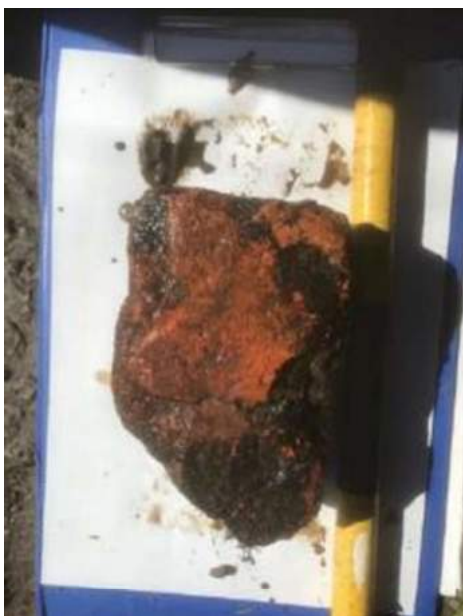
**Figure 126: Fragile, waterworn red clay brick.** Scale in 100 mm increments.

The third type of brick (Figure 126) was contemporary with the construction of the brick barrel drain, but the examined bricks utilised in the construction of the drainage system or found within the fills had no frogs, government Broad Arrows nor other identifying marks.<sup>253</sup>

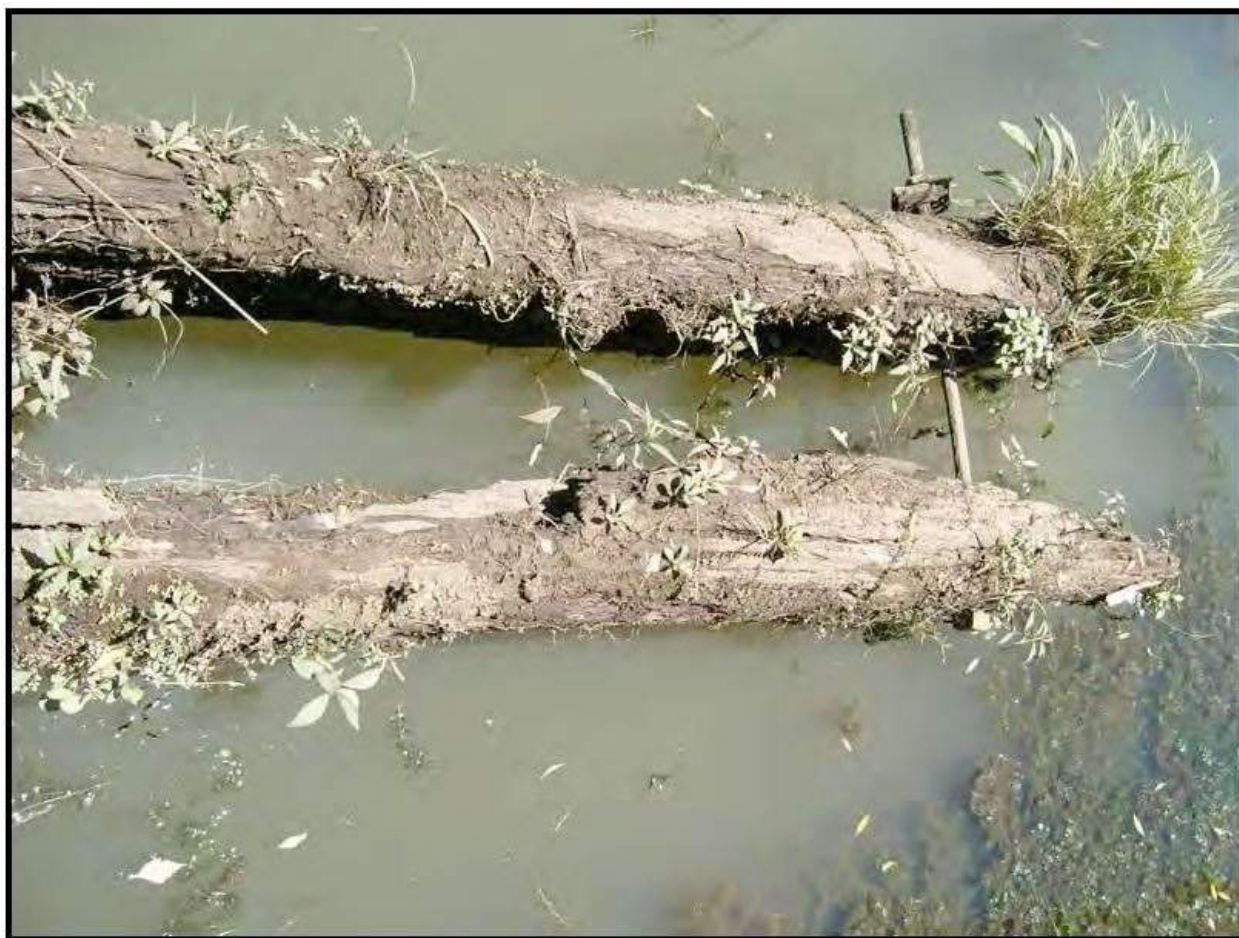
**Figure 128: Bolt connecting two walers, AWF5 and AWF6, in 2008.** Note the bolt appears to be copper alloy rather than ferrous.

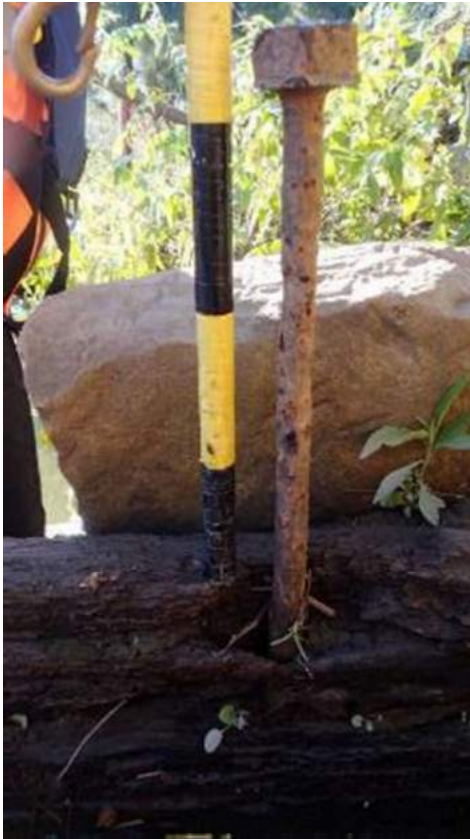
**Figure 129: Through bolt joining deck beams to walers.** This bolt is through waler AWF6/4 with the deck beam no longer present. Scale in 100mm increments.

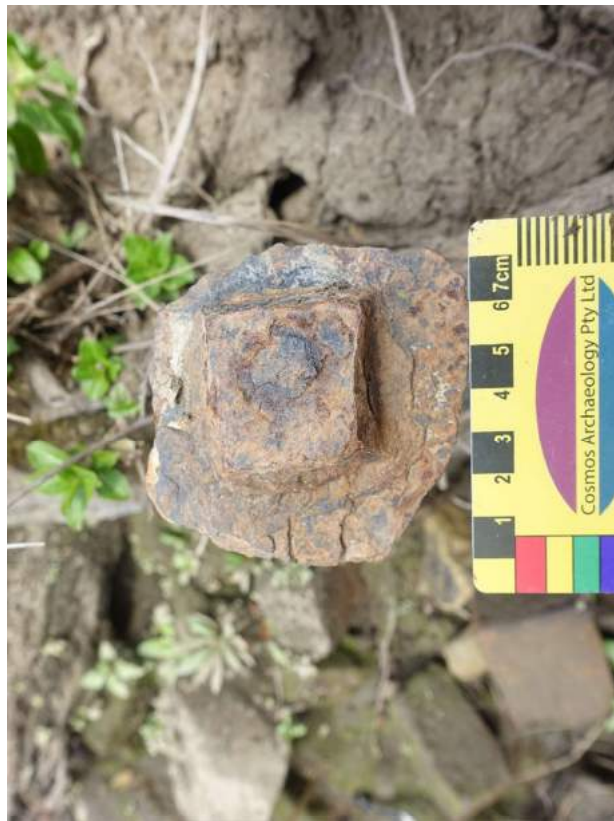
**Figure 130: Bolt head with square washer (AWF2).**

There were observed five through bolts joining deck beams to walers. These are 800 mm long, approximately 25 mm in diameter with square 35 mm heads (Figure 129). There is a square washer underneath one of these heads of 45 mm diameter (Figure 130). At the other end, these bolts are threaded and fastened with a large rectangular washer (120 mm x 40 mm) and 30 mm square nut (Figure 131).

| Feature | Feature Description | Fastening ID | Description |
|---|---|---|---|
| AWF2/1 | Plank | B11 | Appears to be a round through bolt with a 30 mm diameter square head. Heavily corroded square 40 mm washer fused to bolt head. Bolt possibly fastening a deck beam but the nut end disappears into the riverbank. Visible length 500 mm. |

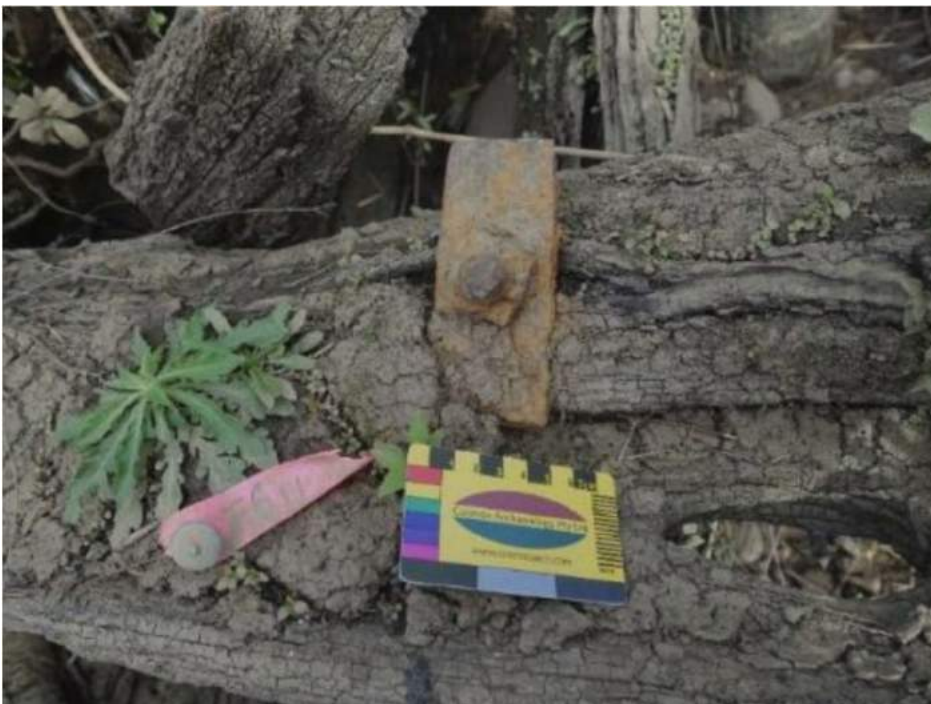
**Figure 131: Bolt end with washer and nut through AWF6/1.**

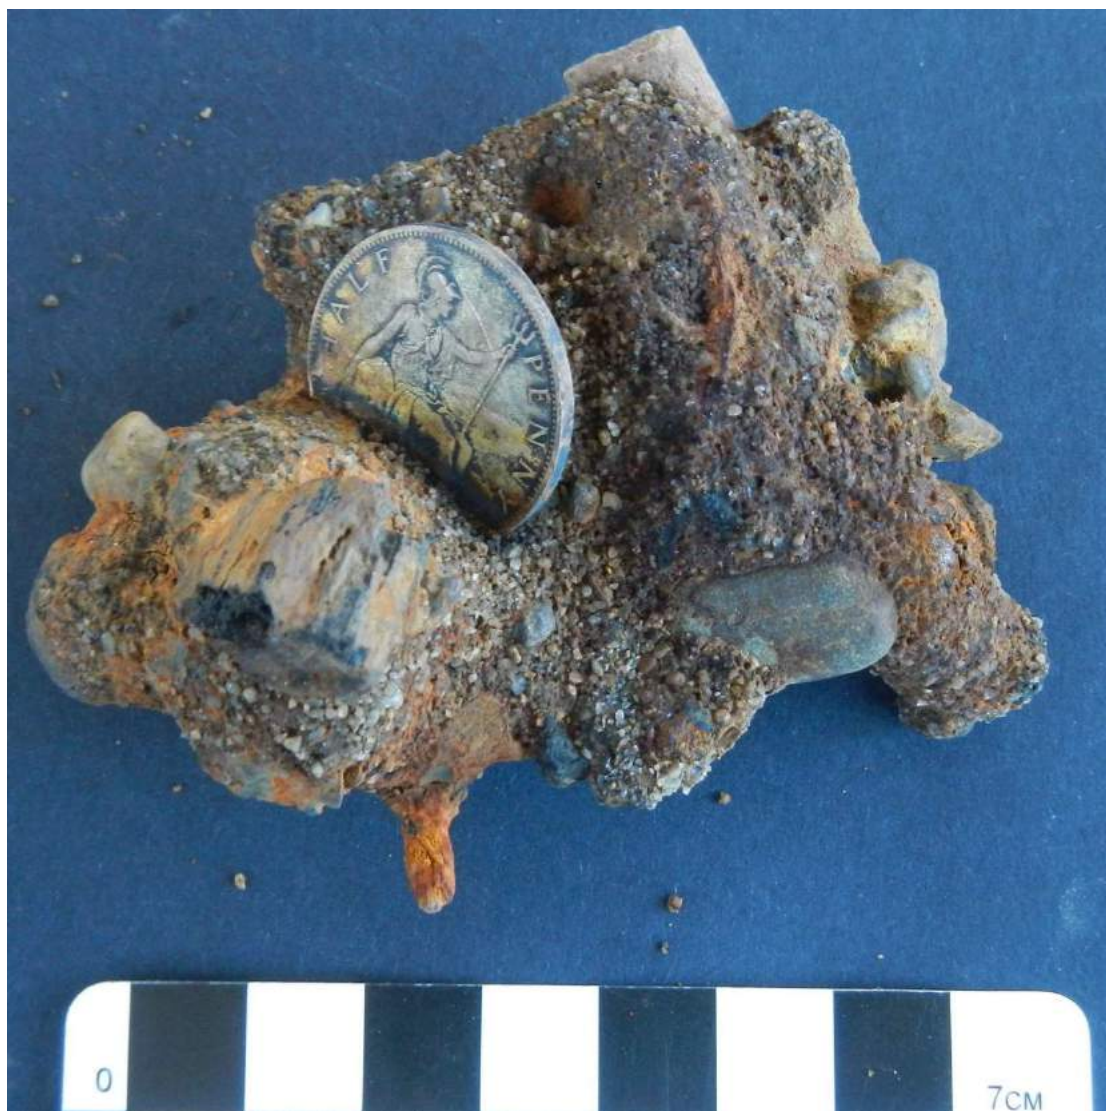
**Figure 134: Example of ‘conglomerate’ with coin concreted within.** This sample is from DT3 Context 3. Note the corroding ferrous nail which would have contributed to the process of concreting / conglomeration.

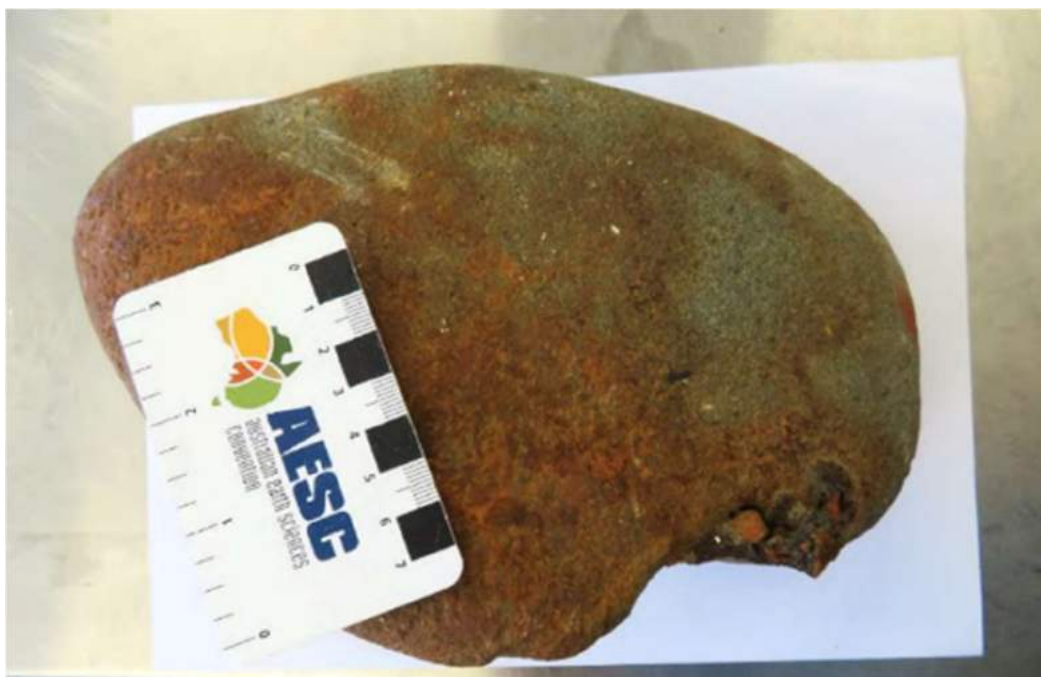
**Figure 138: Partially altered micro-dolerite cobble.** See Annex P - S27.

The rounded cobbles (dolerites) which were common throughout the site which made up a higher proportion of the rock rubble in Cxts 02 and 03 which are associated with the post construction period of the 1862 Moriarty and Musson Wharf (Phase C, Period 3) are very likely to be local (Figure 138). This is supported by the geotechnical studies and historic plans (see Figure 23) which refer to deposits of cobbles or 'round hard stones' on the southern side of the river.<sup>262</sup>

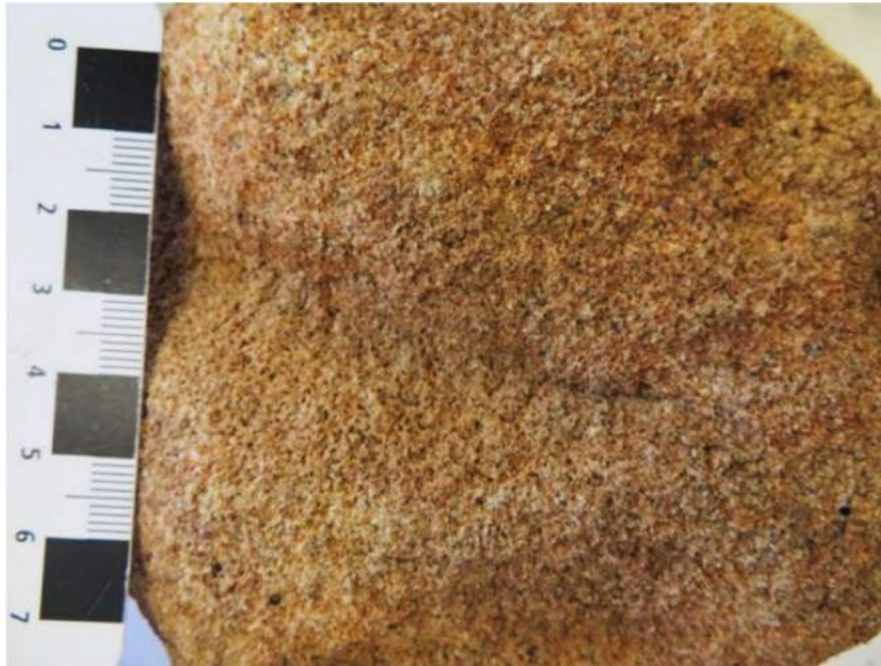
**Figure 139: Example of quartzose sandstone derived from the Hawkesbury Sandstone formation.** See Annex P - S32.

The analysis of the rock samples recovered showed that the angular fragments of sandstone, as opposed to the plate-like local sandstone, was derived from the Hawkesbury Sandstone formation, the nearest direct source being downstream past Pitt Town at Cattai or upstream of Richmond (Table 8 and Figure 139).

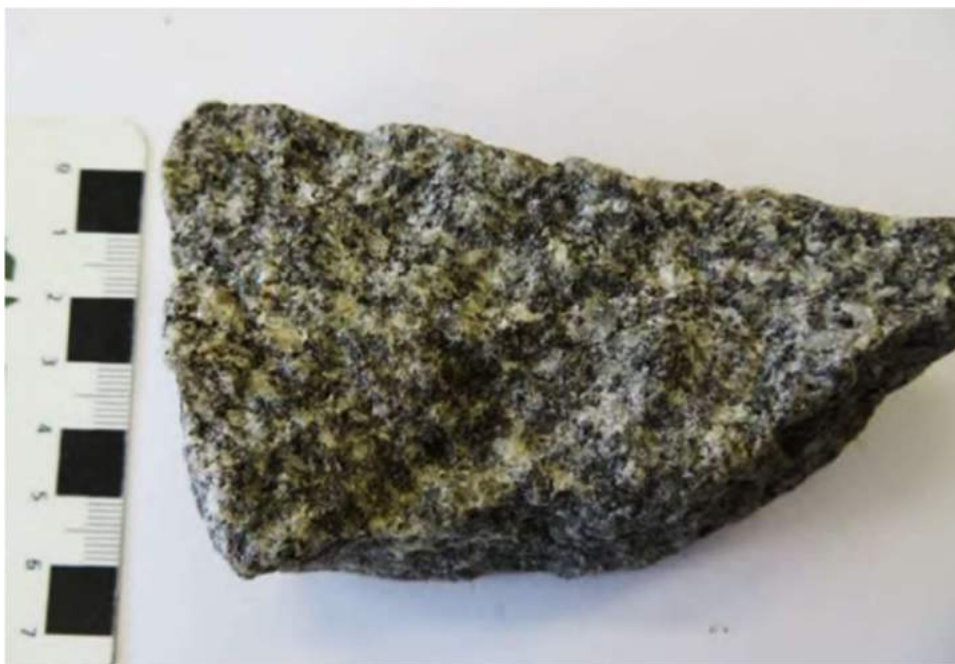
**Figure 140: Foliated biotite granite.** See Annex P - S64.

The most unusual rock sample analysed was a foliated biotite granite which showed no signs of having been in an alluvial system, strongly suggesting it is not of local provenance. The closest granites to the Windsor area are in Bathurst; far to the west of the Blue Mountains. Interestingly, the granite bears a similarity with gneissic granite that has been found in Sydney Harbour and identified as ballast that originated from Rio de Janeiro, Brazil<sup>263</sup> (See Annex P - S64 and Figure 140). Unfortunately, the context from which this rock was recovered was not recorded.

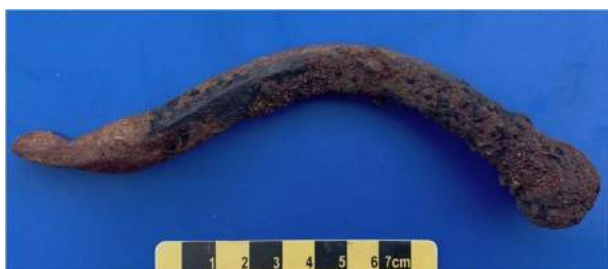
**Figure 141:** Large ferrous spike, likely wharf structural fastener associated with Howe & McGrath / Period 2 wharves (DT3 / C04)

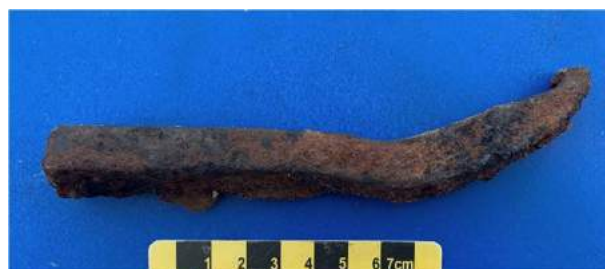
**Figure 142:** Large ferrous spike, likely wharf deck fastener associated with Howe & McGrath / Period 2 wharves (DT3 / C04 / Spit 2).

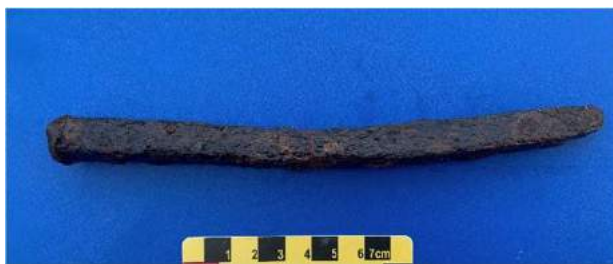
**Figure 143:** Large ferrous spike, likely wharf deck fastener associated with Greenway Wharf (DT1 / SQ5 / C05).

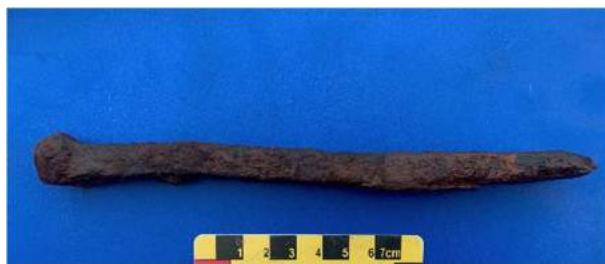
**Figure 144:** Large ferrous spike, likely wharf deck fastener associated with Greenway Wharf (DT1 / SQ2 / C03).

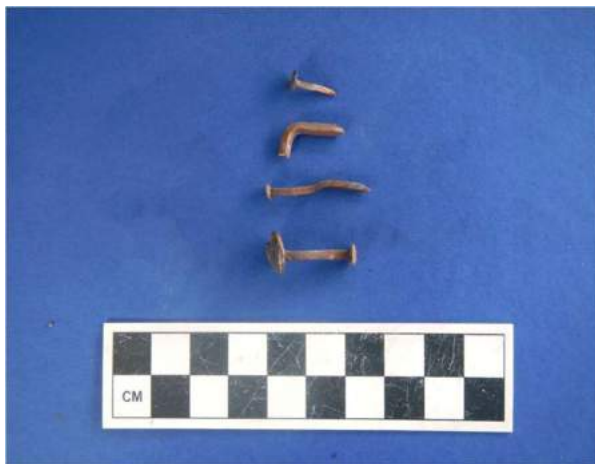
**Figure 145: Copper alloy fasteners including (from top to bottom), one tack, two nails, and one rove (DT1 / SQ1 / C06).**

This sub-category consists primarily of a range of timber boat fasteners and hardware, such as copper alloy cast and wrought nails, screws, rivets, roves, and tacks; many of which show evidence of having been used – see Figure 145 to Figure 148. Of particular interest are a small number of square, wrought copper alloy nails with applied heads that bear a broad arrow stamp on the underside of the heads – a mark used by the British Government to identify government property (Figure 147). This sub-category also includes possible boat building tools such as a copper alloy ruler that appears to have been cut to produce squared roves – see Figure 149, and boat fittings, including two ferrous oarlocks – see Figure 150.

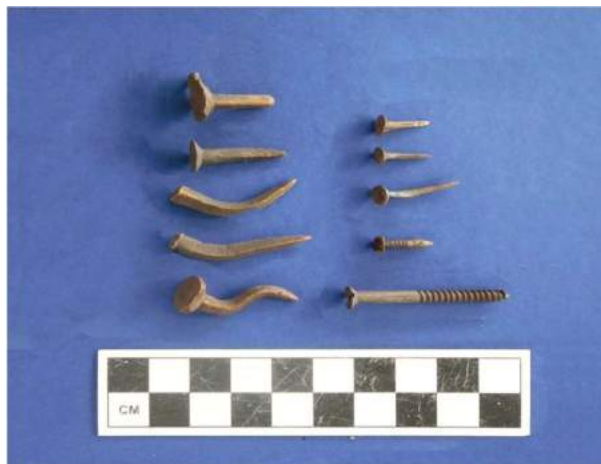
**Figure 146: Copper alloy fasteners including five nails (left), one screw (bottom right) and four tacks (upper right) (DT2 / C07).**

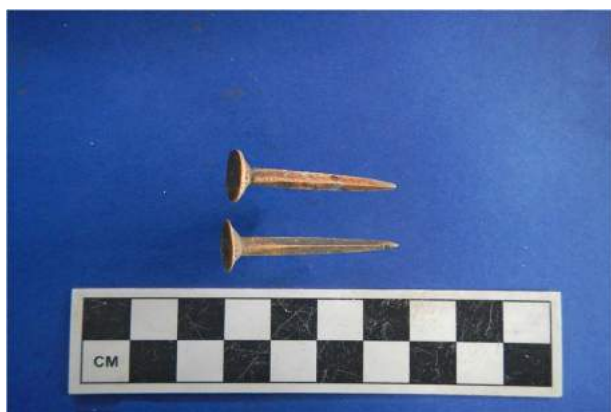
**Figure 147: Square wrought copper alloy nails with applied heads that bear the British Government property broad arrow stamp on the underside of the heads (DT2 / C15).**

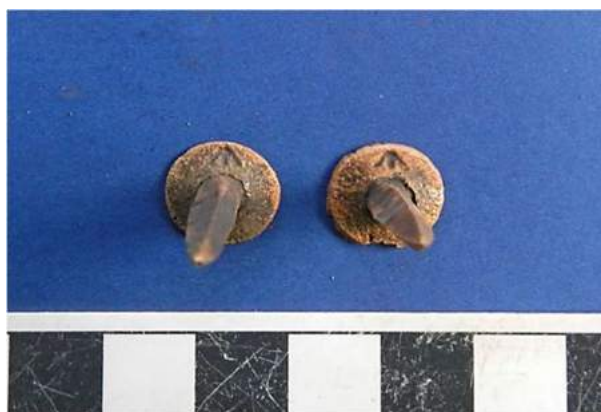
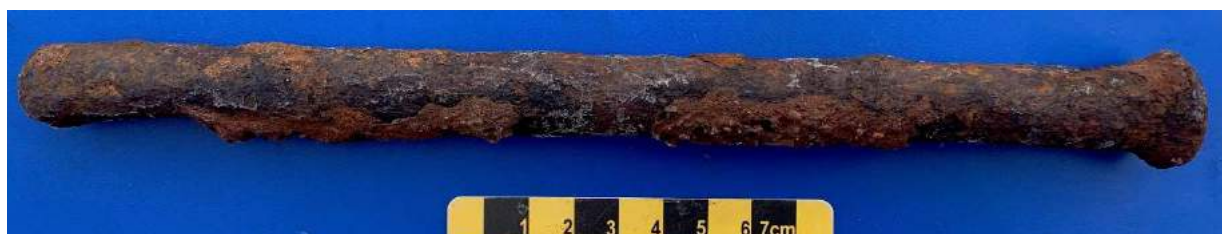
**Figure 148: Dump or bolt hammered at both ends. 242 mm long and 15 mm diameter was possibly a keel bolt for a boat or a frame bolt for a larger vessel (T3 / C04 / Spit 2).**

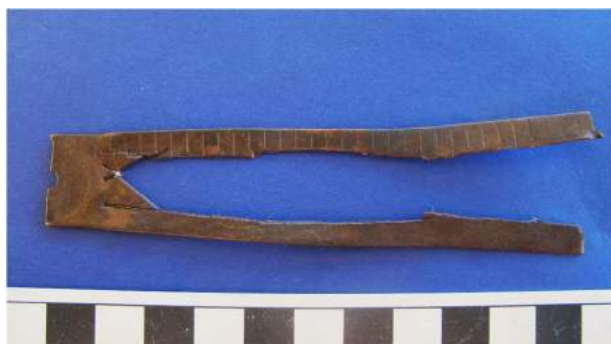
**Figure 149: Copper alloy ruler, possibly fashioned to cut squared roves (DT1/SQ3/C21).**

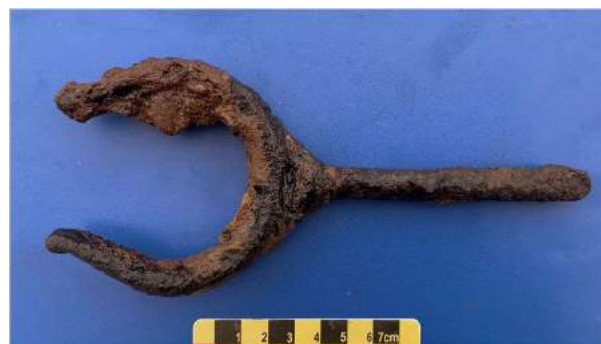
**Figure 150: Ferrous oarlock (DT1 / SQ10 / C05).**

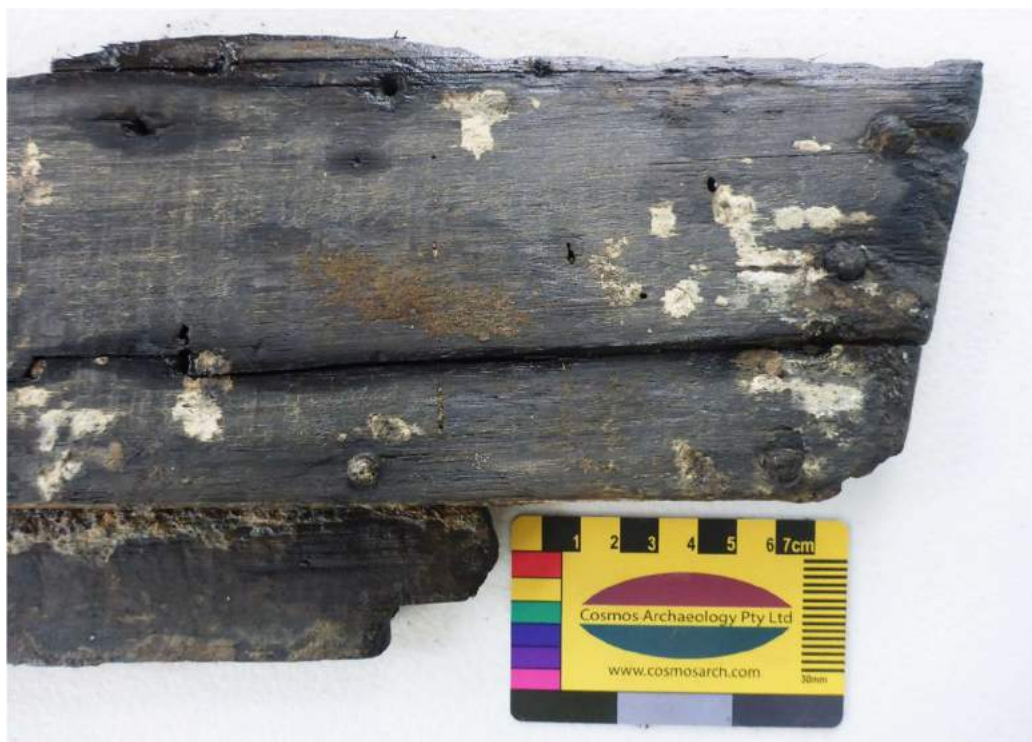
**Figure 151: Exterior view of fragmentary remains of three planks (UWF 17) from a clinker built boat (ST5).**

Finally, small fragments of hull wreckage of a clinker built timber boat (UWF17) were also recovered (ST5) – see Figure 151. These fragments consisted of three thin, overlapping timber planks fastened together by round and square shanked ferrous blunt tipped nails (ca. 40-50 mm diameter), some of which were clenched. Hessian also appears to have been placed between the planks as caulking. The most intact plank measures 110 mm wide with a remnant length of 871 mm.
