# Windsor Bridge Replacement Project

## Report on Maritime Archaeological Excavation and Survey, June to September 2018

Windsor,  
Hawkesbury River, NSW

September 2021

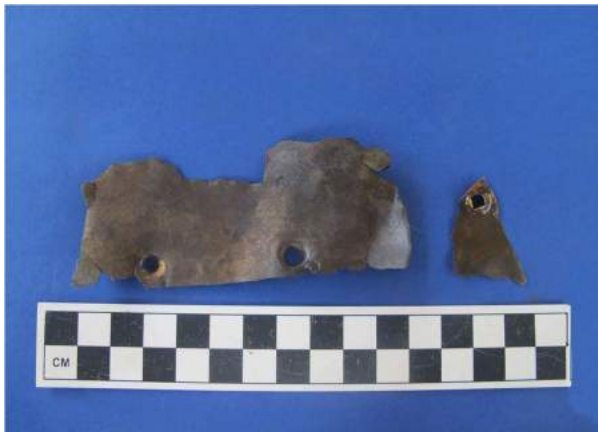
**Figure 152:** Copper alloy sheathing fragment, showing holes where fasteners had been punched through (ST2).

This sub-category consists of a large number copper alloy sheeting or sheathing fragments of various thicknesses from 0.3 mm to 1.6 mm (Figure 152 and Figure 153). From the mid 18<sup>th</sup> to the mid 19<sup>th</sup> century, copper sheathing was used to protect the hulls of timber vessels and below-water sections of maritime structures from marine borers and the corrosive effects of salt water. The copper sheathing fragments in the artefact assemblage are likely to be associated both with timber boat building, repair, and / or maintenance activities, and wharf construction and maintenance. It is quite likely that most of the thicker copper sheathing fragments – particularly one large flat fragment of Muntz Metal, a copper and zinc alloy patented by George Frederick Muntz in 1832 and used widely in vessel sheathing – are associated with boat building, repair, and / or maintenance work, and likely represent sheathing sections or offcuts that were either intentionally discarded or accidentally dropped into the river (Figure 154). Some of the thinner fragments are likely to be associated with the Windsor wharf structures – particularly as records show that the piles of the Moriarty & Musson Wharf constructed in 1862 were copper sheathed, and were most likely deposited on the riverbed as the sheathing, and perhaps the wharf structure, deteriorated – see

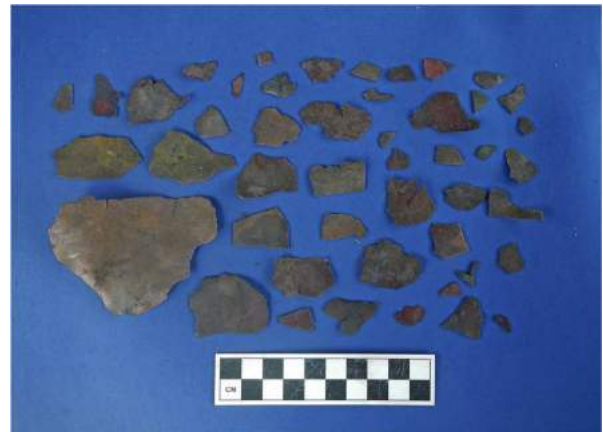
**Figure 153:** Copper alloy sheathing fragments (DT1 / SQ2 / C07).

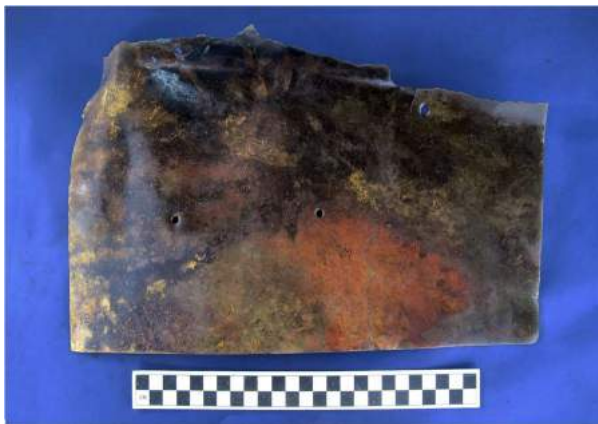
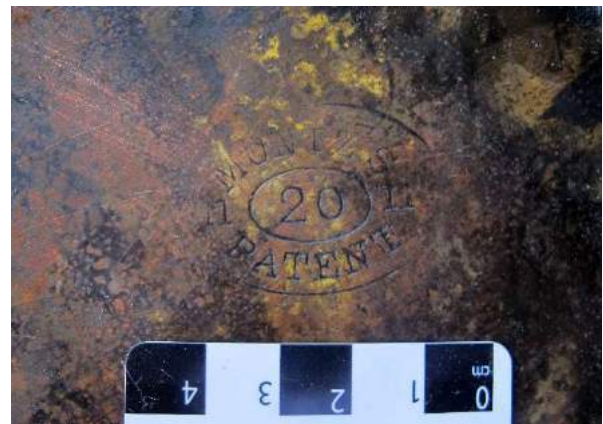
**Figure 154:** Muntz Metal sheathing; stamp (detail on right) reads “MUNTZ PATENT 11 20 11” (DT1/SQ6/C05).

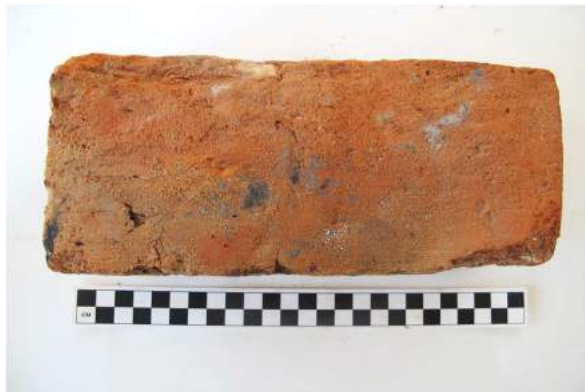
**Figure 155: Complete sandstock brick (DT1 / SQ4 / C04)**

Ca. 30% of the bricks are handmade sandstock bricks manufactured between 1780s-1840s, and ca. 40% are dry-pressed or re-pressed bricks manufactured between 1840s-1880s onwards. Whilst some complete bricks were recovered (Figure 155 and Figure 156), the majority are partial or fragmented.

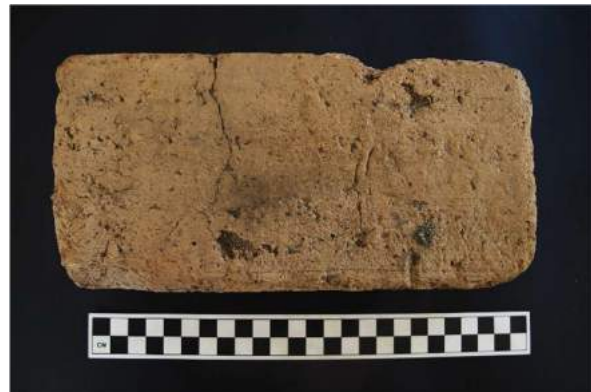
**Figure 156: Complete sandstock brick (DT1 / SQ2 / C03)**

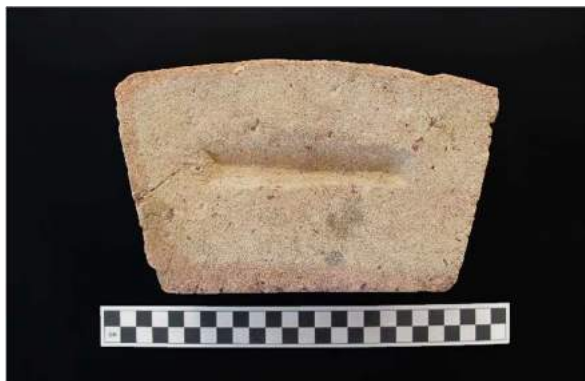
**Figure 157: Complete curved brick – smaller size (DT1 / SQ1 / C06).**

The curved pressed bricks found during the excavation provide a very useful dating marker (see Section 9.4 and Figure 157 to Figure 161). These bricks were used in the construction of the original Windsor Bridge in 1874. They are a very specific type of brick and were likely to have been made specially for the 1874 Windsor Bridge. It would then follow that these bricks would have been deposited onto the riverbed during or just after the construction of the bridge. The distribution of these bricks within the site stratigraphy is instructive (Table 6).

These bricks include various curved and tapered buff-coloured, pressed bricks – see Figure 157 to Figure 160 – and account for over 30% of the overall brick collection. Almost all of these bricks are complete and exhibit no remnants of bonding mortar; suggesting that they are unused bricks. Two slightly different sizes of the curved bricks occurred; a longer type measuring 220-280 mm (8.7-11") long x 110 mm (4.3") wide x 75 mm thick (3"), and a shorter type measuring 210-270 mm (8.3-10.6") long x 110 mm (4.3") wide x 75 mm (3"), thick. The arc measurements of the curved sides indicate an overall external circular diameter of approximately 106 to 110 cm (3'5.7" to 3'7.3"). A single tapered brick with the same curve was also recovered; measuring 140 mm (5.5") maximum width x 75 mm (3"), thick.

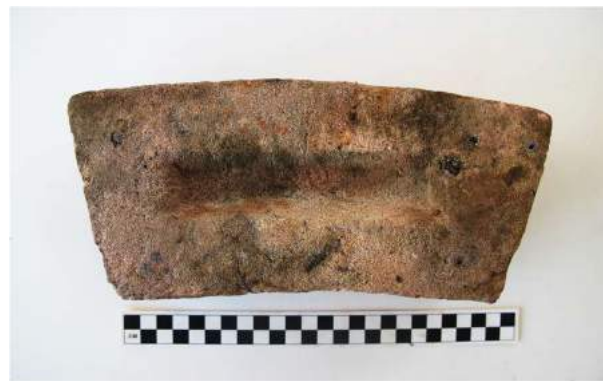
**Figure 158: Complete curved brick – larger size (DT1 / SQ3 / C12)**

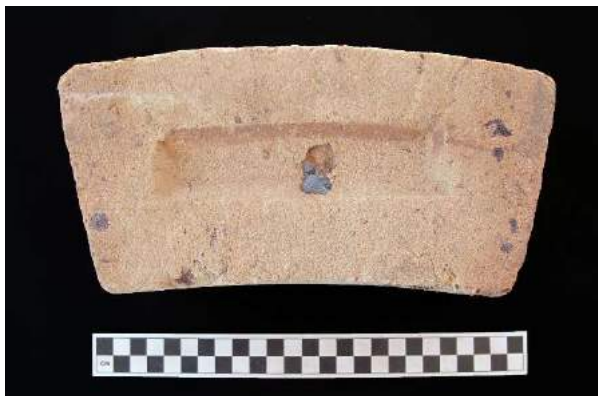
**Figure 159: Complete curved brick – larger size (DT1 / SQ4 / C4)**

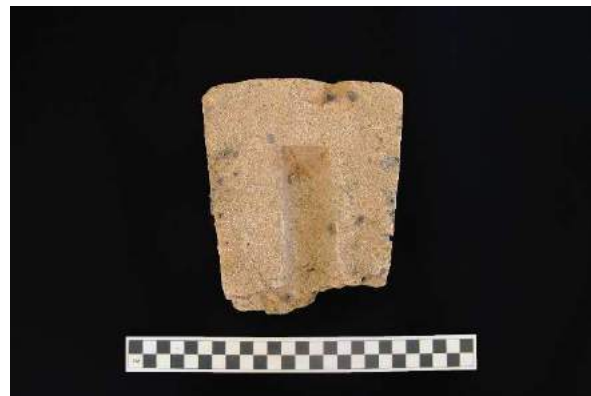
**Figure 160: Tapered curved brick – larger size (DT1 / SQ10 / C5)**

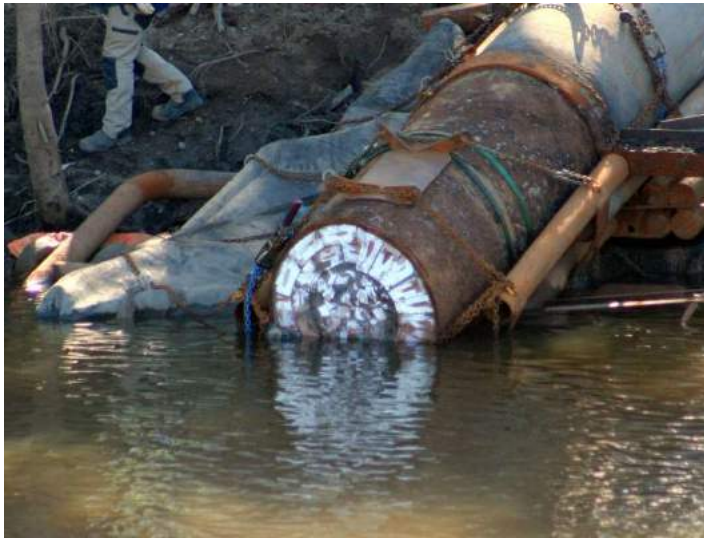
**Figure 162: Iron pier removed from 1874 Windsor Bridge during demolition, showing internal brickwork (photograph by Neil Dand, April 2020).<sup>267</sup>**

Historical records show that the iron cylindrical piers of the 1874 Windsor Bridge were filled with “a ring of 9-inch radiating bricks, enclosing a cone of concrete to the top of the pier.”<sup>265</sup> The original plans for the Windsor Bridge illustrate that these bricks were designed to be laid in two concentric layers – with an outer row of slightly longer curved bricks and an inner row of slightly shorter curved bricks – and alternating tapered bricks set lengthwise across both layers – see Figure 161. Photographs taken during the demolition of the iron piers of the 1874 Windsor Bridge in April 2020 further show that the brick layers were bonded together with what appears to be cement mortar – see Figure 162 to and Figure 164.

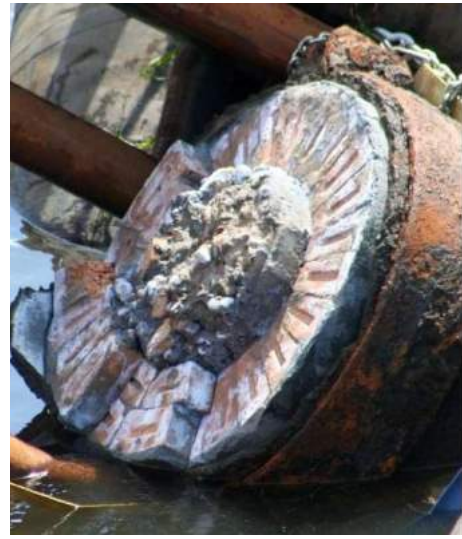
**Figure 163: Detail of 1874 Windsor Bridge pier internal brickwork (photograph by Neil Dand, April 2020).<sup>268</sup>**

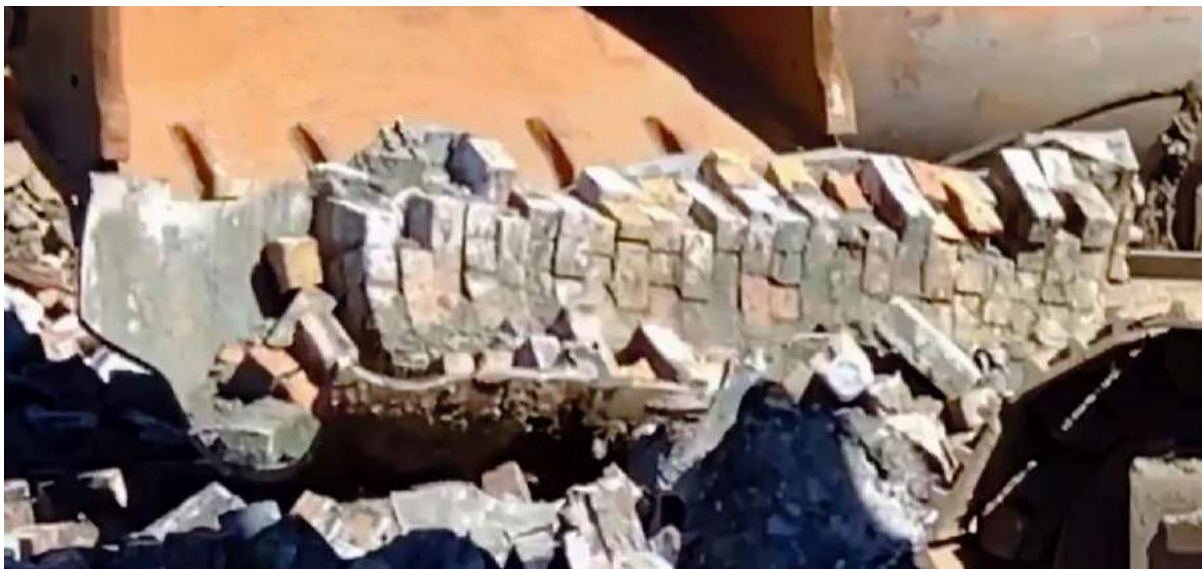
**Figure 164: Demolished iron pier from 1874 Windsor Bridge showing longitudinal view of layered internal brickwork (photograph by Paul Caleo, April 2020).<sup>269</sup>**

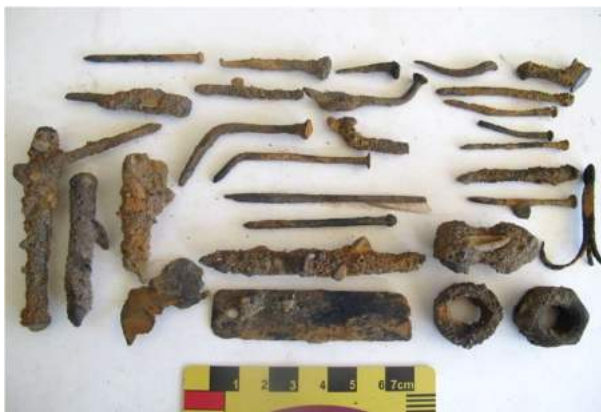
**Figure 165: Various ferrous terrestrial structural fasteners and hardware (DT2 / C14).**

This sub-category comprises over one thousand ferrous fasteners that were identified as terrestrial / architectural fasteners based on size and design. The vast majority of these ferrous fasteners consist of cut nails (pre-1880), wire-drawn nails (post 1860) and wrought nails. The remainder includes a variety of cast screws, wire-drawn and wrought tacks, and cast, wrought and machine-made bolts (see Figure 165 to Figure 168).

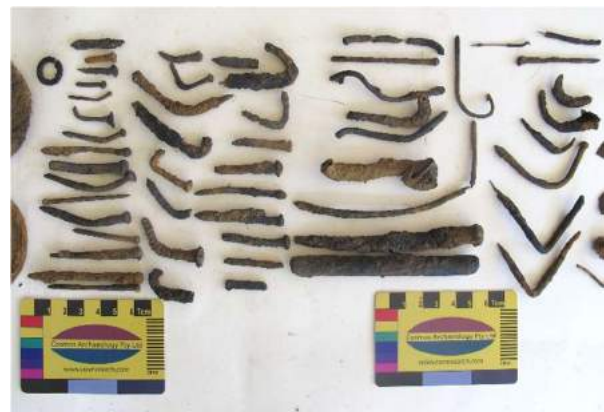
**Figure 166: Various ferrous terrestrial structural fasteners and hardware (DT2 / C03).**

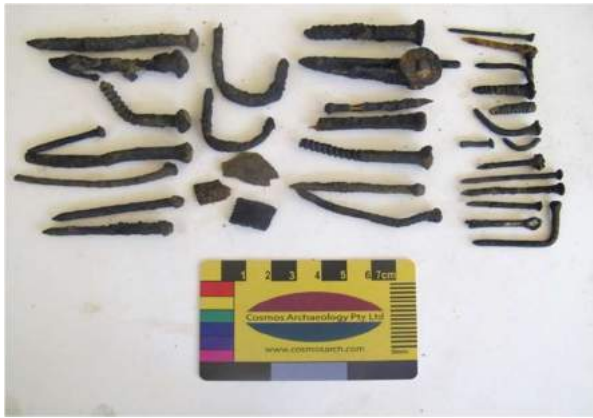
**Figure 167: Various ferrous terrestrial structural fasteners and hardware (DT3 / C02).**

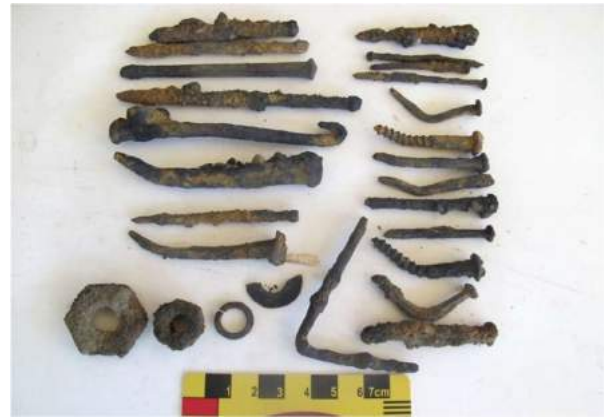
**Figure 168: Various ferrous terrestrial structural fasteners and hardware (DT2 / C03).**

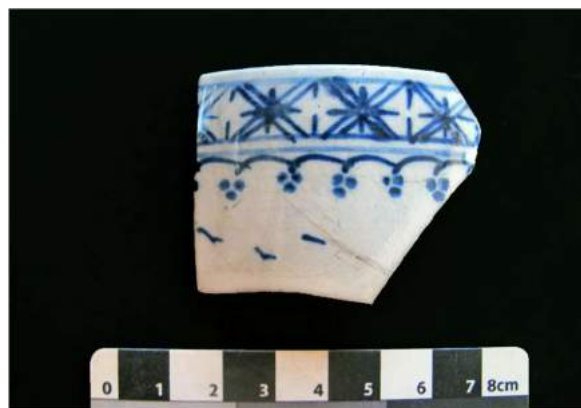
**Figure 178:** Chinese export porcelain cup fragment showing Nanking influenced hand painted decoration, 1780-1830 (T1 / SQ2 / C10).

The food service and consumption category is dominated by fragments of ceramic service ware and tableware, including platters, dishes, jugs, bowls, plates, saucers, egg cups and tea cups. The majority (over 70%) are formed of refined earthenware, including creamware, graniteware, pearlware, whiteware, and red paste, with lower numbers of porcelain, consisting of Chinese export, hard paste and soft paste porcelains, and white paste, salt-glazed and lead-glazed stoneware. A range of decorative types occur, including painted annular banded, gilt / gilt painted, sponge decoration, and flow blue / black and decalcomania transfer printing. See Figure 175 to Figure 182.

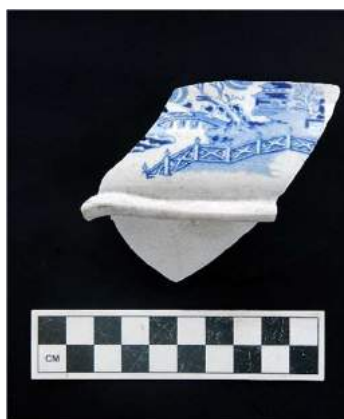
**Figure 179:** Whiteware bowl with transfer printed blue willow pattern decoration on both interior and exterior surfaces, 1820s onwards (DT1 / SQ6 / C04).

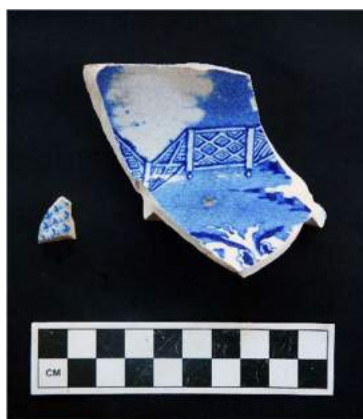
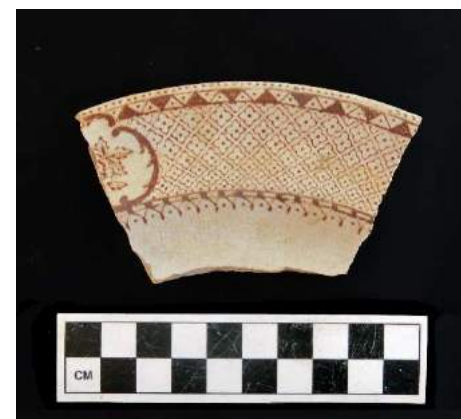
**Figure 180:** Whiteware plate fragment with red willow pattern decoration, 1820s onwards (DT2 / C02).

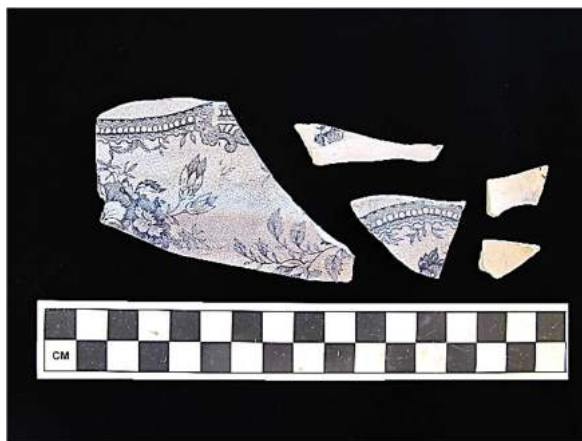
**Figure 181:** Whiteware plate fragments with transfer printed Asiatic pheasant decoration, 1820s onwards (DT1 / SQ9 / C02).

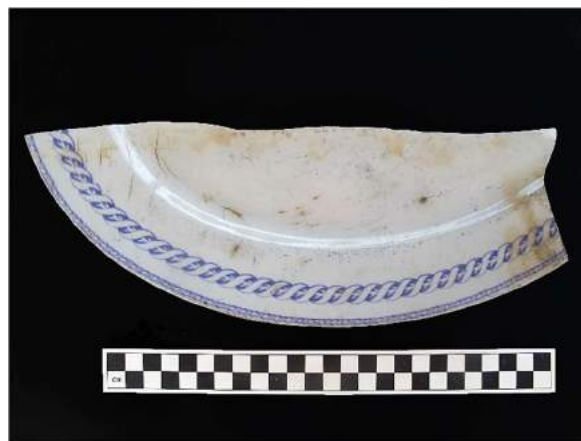
**Figure 182:** Whiteware platter fragment with transfer printed cable patten, 1860s onwards (DT1 / SQ4 / C05).

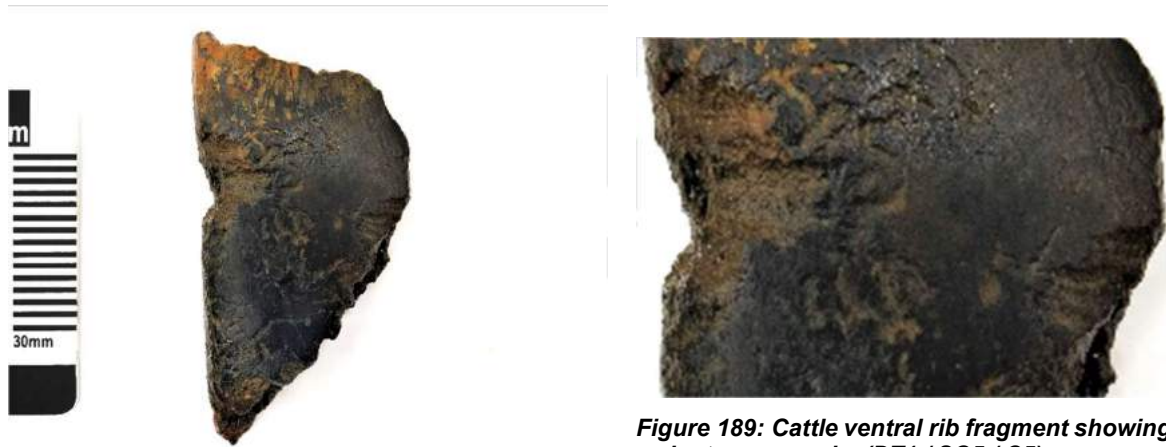
**Figure 189: Cattle ventral rib fragment showing rodent gnaw marks (DT1 / SQ5 / C5)**

The livestock bones and bone fragments include skeletal elements from cattle, sheep, and pig – see Figure 183 to Figure 188. It is possible that some of these bones derive from animals that fell into the river and subsequently drowned, as livestock have been grazed along the banks of the Hawkesbury since the early 19<sup>th</sup> century. However, cultural modification and butchery marks are evident on a substantial proportion of these livestock bones, and it is probable that most, if not all, represent cultural food debris. Some of these livestock bones may represent accidentally lost or dropped cargo – either from salted meat or fresh meat cuts, both of which were occasionally shipped along the Hawkesbury River to and from Windsor. However, it is likely that most were deposited through intentional discard of domestic food refuse into the river, possibly from adjacent residences, or via erosion and slope wash from adjacent bone bearing terrestrial deposits. Indeed, rodent gnawing marks were observed on some of the larger livestock bone fragments, indicating that at least some of these skeletal remains had been exposed on the ground surface for a period of time before being redeposited onto the riverbed (Figure 189). See also Annex I for a detailed examination of the animal bone assemblage.

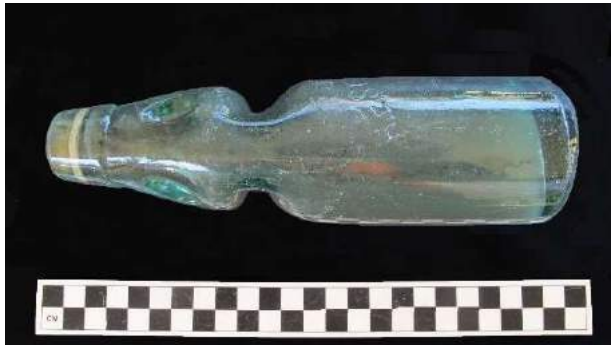
**Figure 196: Codd patent aerated water bottle – H.E. Stevenson, 1890-1907 (DT1 / SQ5 / C03).**

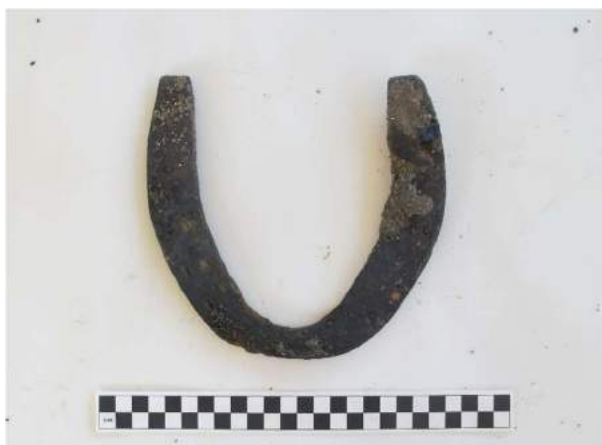
**Figure 200: Forged ferrous horseshoe, 1750-1800 (DT1 / SQ9 / C05).**

The horseshoes, horseshoe nails, horse tie down and cart / carriage components are most likely associated with the horses and carts that were used through the 19<sup>th</sup> century to early 20<sup>th</sup> century to carry goods offloaded from vessels at the former Windsor wharf up the Punt Hill into Windsor township (see Section 3.3 and Figure 49). The motor vehicle components show the continued connection between land transport and the wharf through the 19<sup>th</sup> century, and the car trailer number plate – quite possibly from a boat trailer – also hints at recreational boating uses of the Hawkesbury River from the riverbank and latter 20<sup>th</sup> century boat ramp adjacent to the wharf site.

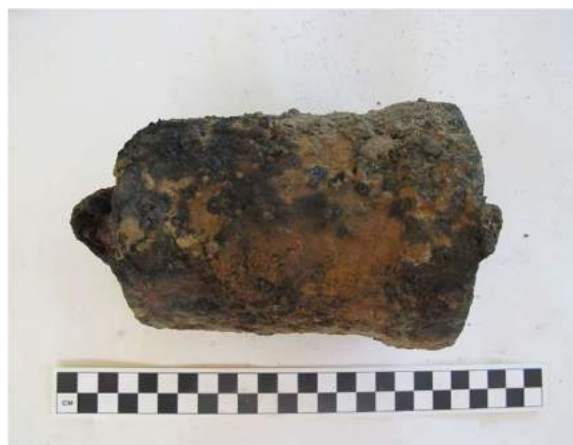
**Figure 201: Ferrous horse tie down / tether weight (DT2 / C04 / Spit 2).**

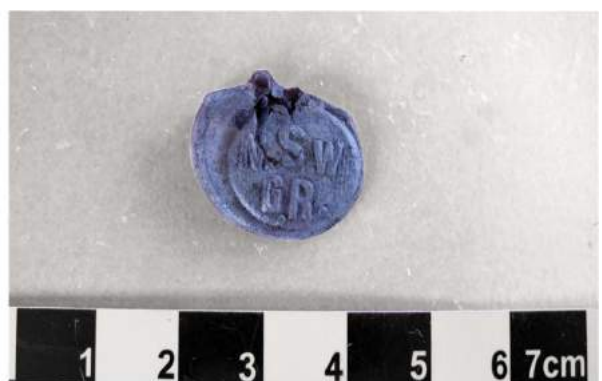
**Figure 202: Lead railway circuit breaker seal, showing NSW Government Rail stamp, 1855-1900 (DT1 / SQ2 / C21).**

The mid to late 19<sup>th</sup> century railway components, including the seal stamped as NSW Government Railways property, are also of particular interest. In 1864, a railway branch line off the main western railway line from Sydney was constructed from Blacktown to Richmond, with a station built at Windsor. The rail connection provided a stimulus for river transport and commerce at the former Windsor wharf, as river traders could now sell produce to Sydney merchants and have it quickly transported to inland markets by rail (see Section 3.3). Various materials and equipment for the construction of the Blacktown to Richmond railway line were undoubtedly shipped to the former Windsor wharf and it is quite likely that the railway components in the assemblage represent incidental losses during unloading and transfer from vessel to wharf.

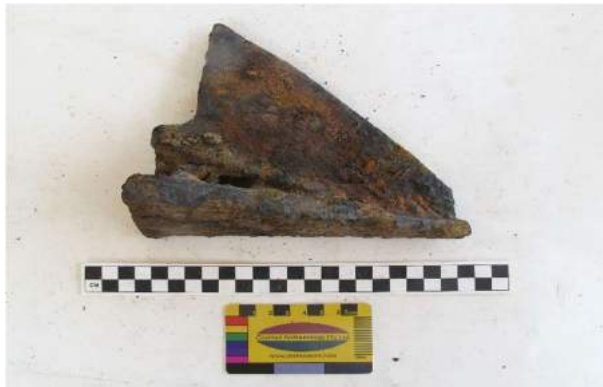
*Figure 206: Horse-drawn plough blade (F12).*

This category includes a range of manual tools and implements including wire cutters, needle nose pliers, drill bits, punches, rasps, files, a claw hammer, a spade, several small spanners and a large spanner of a size generally used for locomotive and railcarriage works, and several horse-drawn plough components including two plough blades – see Figure 206 to Figure 207.

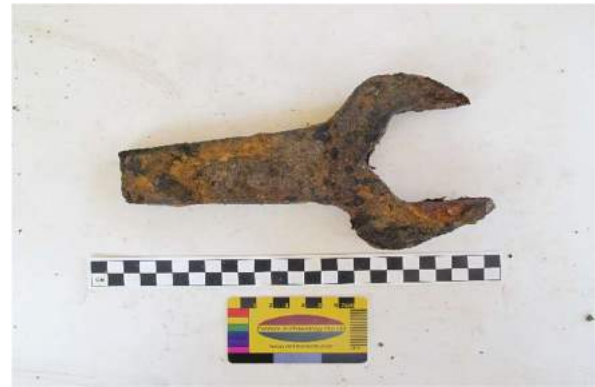
*Figure 207: Railway spanner (F14).*

Several of the small hand tools are potentially associated with cargo handling, manual labour, and possibly maintenance or repair work carried out onboard vessels moored alongside the wharf, and most likely represent objects that were accidentally dropped overboard. The large spanner could possibly be a lost item of a cargo of railway operation and maintenance tools and equipment being shipped up the Hawkesbury River to railway yards on the Blacktown to Richmond line. Similarly, the horse-drawn plough components are perhaps most likely to represent items of cargo lost during transfer between vessel and wharf – either farm implements being shipped from Sydney for sale in Windsor or being transported from stores in Windsor via riverboat to customers on farms along the upper Hawkesbury, Macdonald, and Colo Rivers.

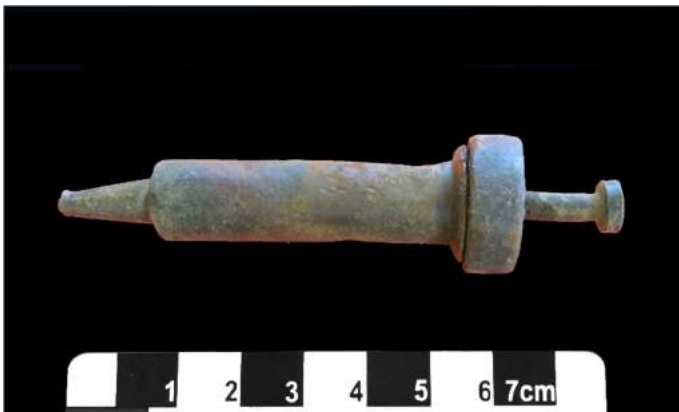
**Figure 215: Muzzleloader pan primer flask.**

The armament category consists of a wide range of firearm ammunition – both fired and unfired, and a firearm accessory. The latter is a pan primer flask for a flintlock muzzle-loaded firearm, used to dispense priming powder into the flash pan (see Figure 215). The ammunition includes musket and pistol / small rifle percussion caps, various different types of rifle, pistol, and revolver cartridges, including .22, .270 and .38 calibres, and 10 gauge brass shotgun shells (Figure 208 to Figure 214). The overall collection of armament artefacts ranges in date of manufacture from the early 19<sup>th</sup> century to the latter 20<sup>th</sup> century.

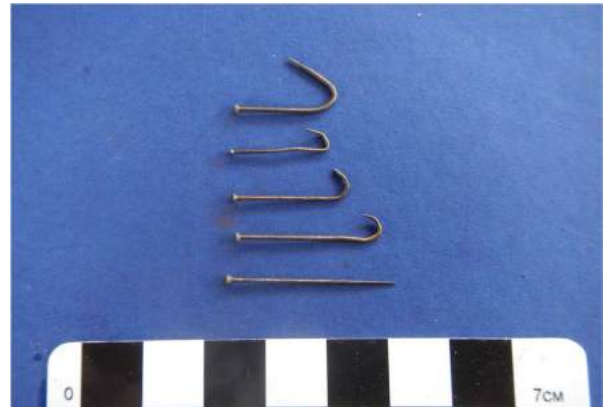
**Figure 218:** Copper alloy straight pins (DT1 / SQ6 / C05), showing several curved into the shape of fish hooks.

However, it also appears that some of the pins may have been used for purposes completely unrelated to sewing or securing fabric. Almost 30% of the straight pins in the assemblage are bent. This is not an altogether uncommon occurrence and bent straight pins – damaged through general wear and tear – are often found in terrestrial domestic archaeological sites. However, a sizeable number of the pins in the maritime assemblage – including both pre and post 1830s types – are bent and curved in a fashion that distinctly resembles the shape of a

fish hook – Figure 217 and Figure 218. Such patterning of damage appears unlikely to have occurred through general use of the pins to secure sections of fabric, and it is quite possible that these pins were intentionally shaped to be used as homemade fish hooks, and were subsequently lost during fishing activities undertaken from the wharf or adjacent riverbank.

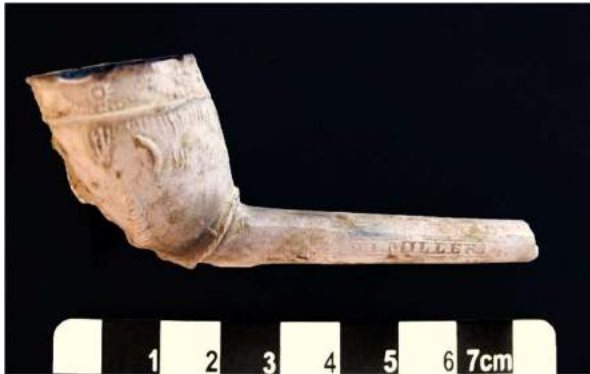
**Figure 228:** Clay tobacco pipe manufactured by David Miller showing figure head in profile on bowl (DT1 / SQ8 / C05).

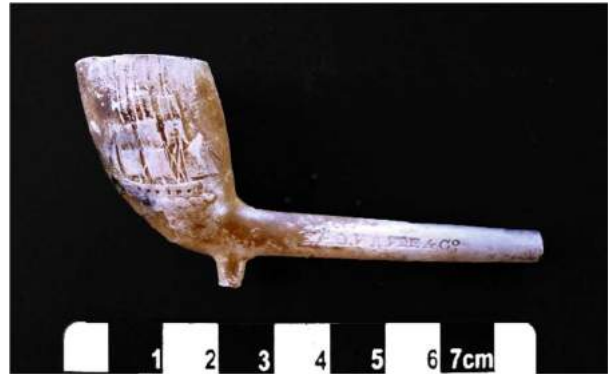
**Figure 229:** Clay tobacco pipe manufactured by Thomas White & Co, showing sailing ship on bowl (DT1 / SQ2 / C10).

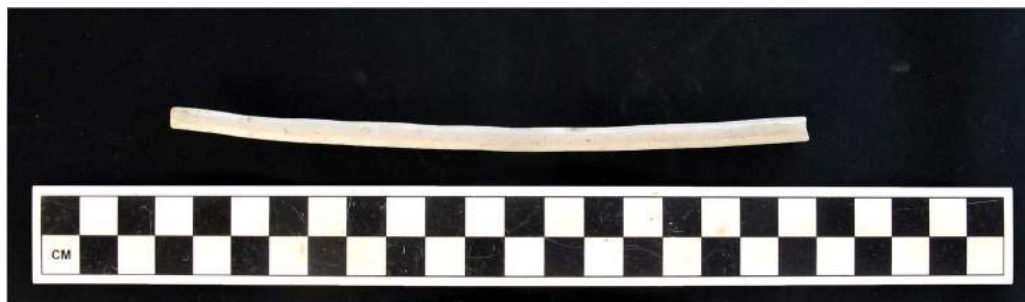
**Figure 230:** Largely intact long stem of clay tobacco pipe (F5)

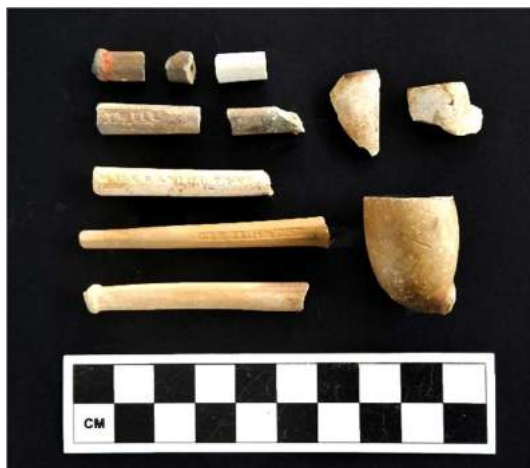
**Figure 231:** Clay pipe fragments including Thomas Saywell (Sydney) pipe (1865-1905), Thomas White and Co (Edinburgh) 1823-1882, and William Murray (Glasgow) pipe (1830-1861) (DT1 / SQ6 / C05).

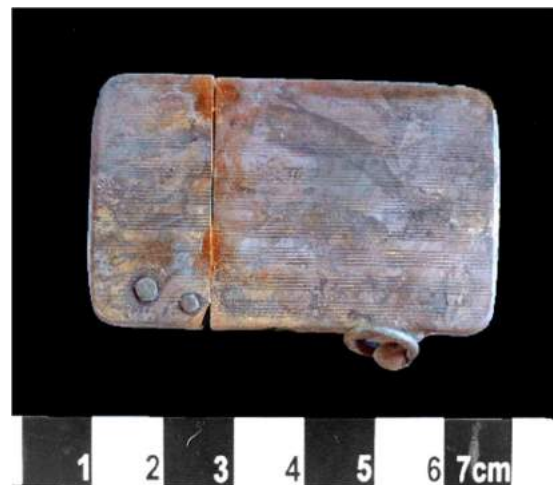
**Figure 232:** Copper alloy reusable pocket lighter (DT1 / SQ6 / C04).

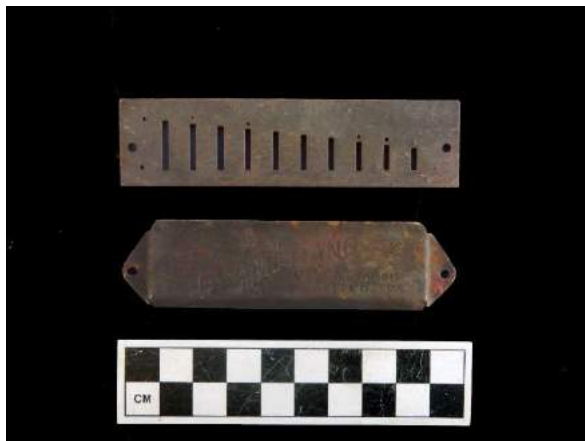
**Figure 254: Albert's Patent "Miniature Boomerang" harmonica (top cover and one reedplate) (DT1 / SQ2 / C07).**

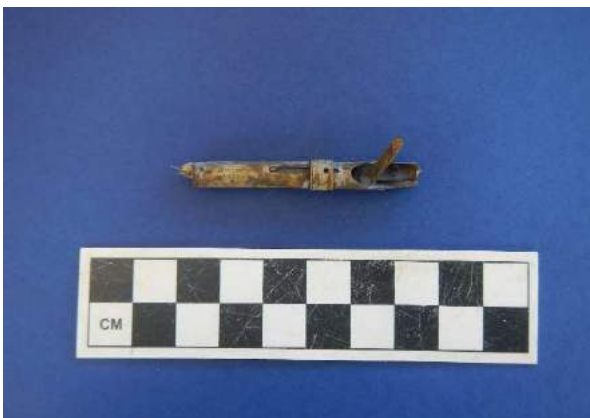
**Figure 256: Hinkswell & Co pen nib holder (DT1 / SQ5 / C05).**

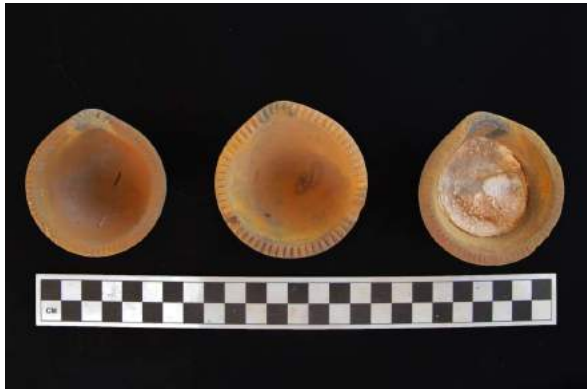
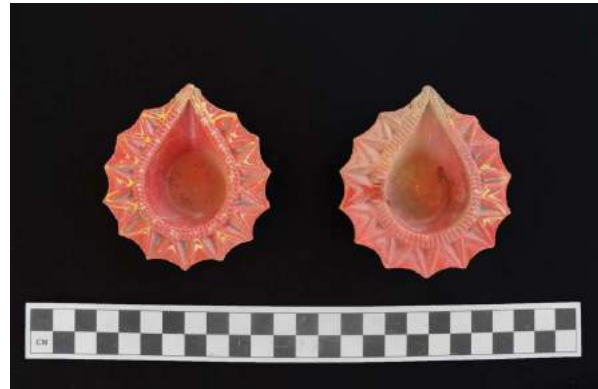
**Figure 261: Clay Diya oil lamps (T2 / C02).**

**Figure 262: Clay Diya oil lamps (T2 / C02).**

A final category of artefacts in the maritime assemblage is the celebration or ceremony category, which consists of nine small Diya clay oil lamps of two different designs – see Figure 261 and Figure 262. Diya lamps are Indian subcontinental cultural objects that are designed as floating oils lamps and are often used in Hindu, Sikh, Jain, and Zoroastrian religious ceremonies, festivals, and funerals. The presence of these lamps on the riverbed suggests they were used in a celebratory or ceremonial context, possibly either festive occasions or sad occasions, carried out from the wharf or on the banks of the Hawkesbury River in the vicinity of the former Windsor wharves site.

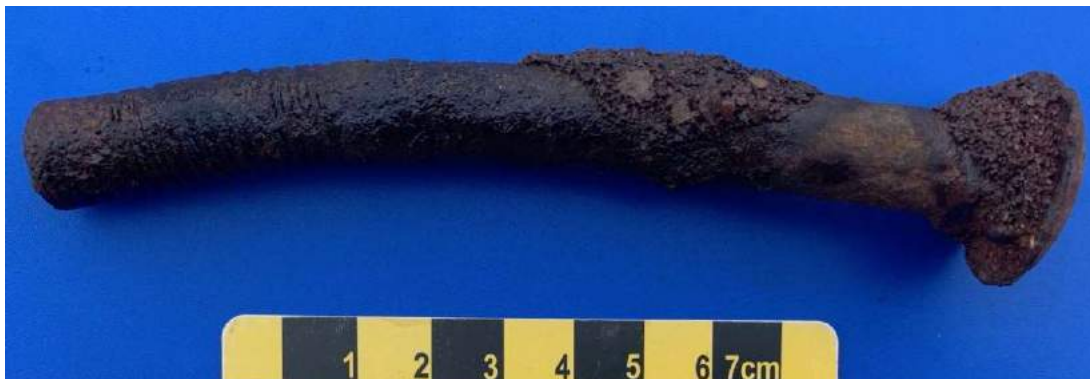
**Figure 264: Threaded bolt with mushroom head, 120 mm long, 38 mm of which is threaded and 15 mm diameter.** Artefact ID 708, DT 1, Sq 5, Cxt 21

A threaded bolt of a similar length – 120 mm – however with a thread of 38 mm in length was found in one of the earliest contexts, Cxt 21, and may have some association with this phase of wharf construction (Figure 264). Threaded bolts were used in maritime applications in the early 19<sup>th</sup> century and in this time were becoming increasingly common.<sup>275</sup>

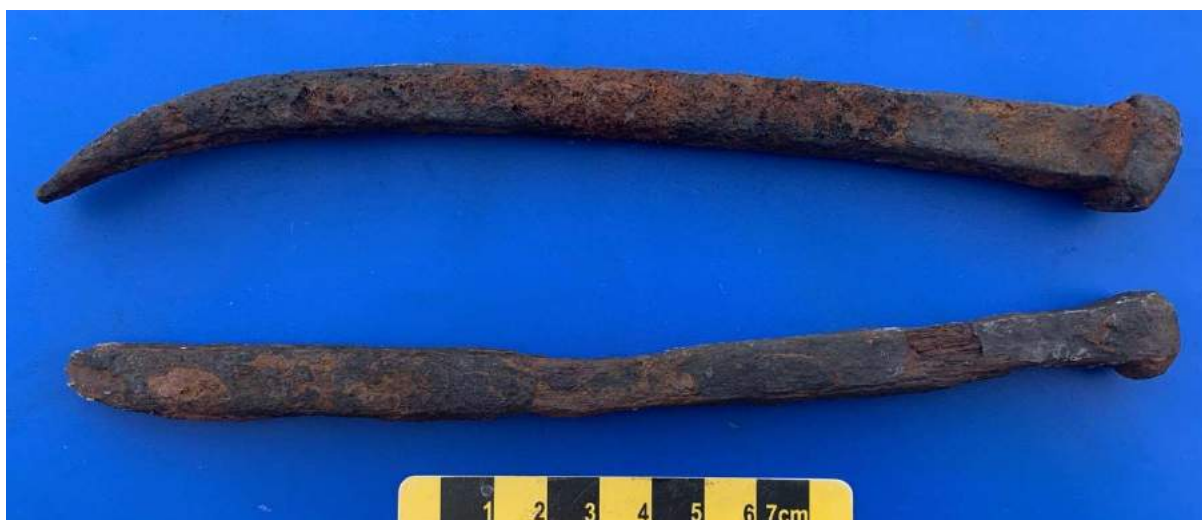
**Figure 265: Wrought (hand forged) ferrous spikes. Note how only two sides taper a point.** Artefact ID 794, DT 3, Cxt 4, Sp2

Additional wrought ferrous fastenings were recovered from contexts considered contemporary of the Period 2a and 2b or in Deep Trench 2 and 3 over which the Greenway Wharf did not extend (see Figure 275). These fastenings were longer – between 165 mm and 205 mm in length than the 127 mm specified in the government documentation (see Figure 265 for example). It is very likely that the specifications indicated a minimum for the size of spikes be used and a variety of shapes and sizes would have been used for differing structural elements such as attaching deck planks to the deck beams (or girders), or walers/cross beams to the piles. These spikes listed in Table appear too large for boat building/repair but it is possible that they, in particular Art. ID #959, could have a connection with Thompson's Shipyard (see Section 9.10).

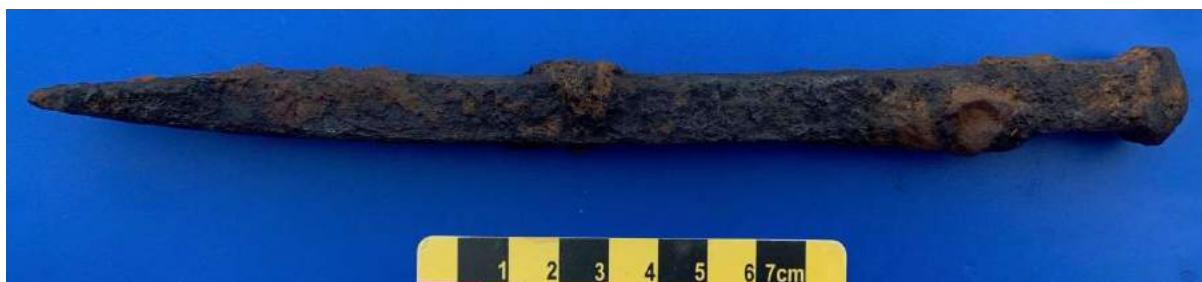
**Figure 266: Wrought (hand forged) ferrous spike.** Artefact ID 959, DT 1, Sq2, Cxt 21

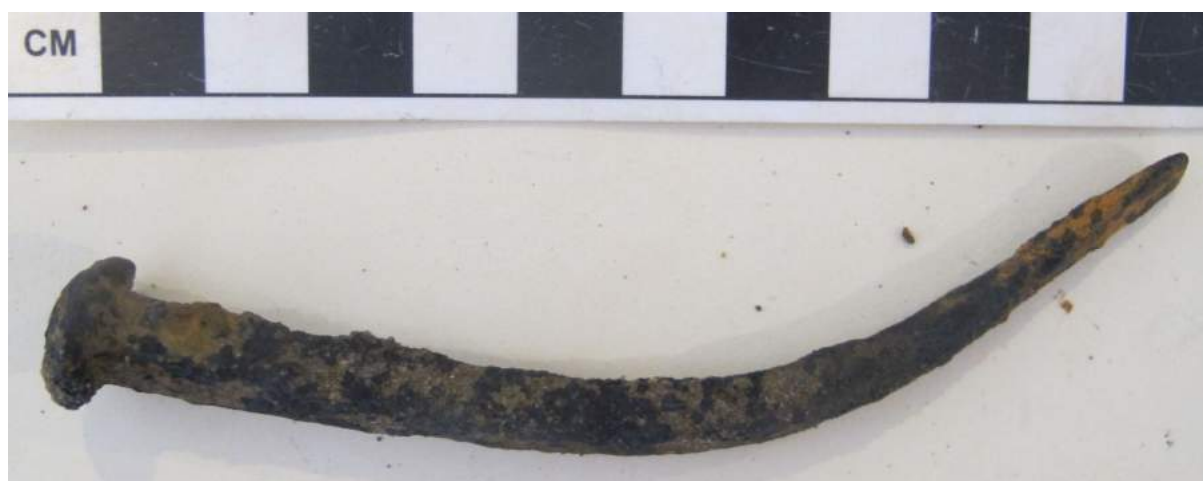
**Figure 267: Wrought (hand forged) ferrous spike.** Artefact ID 2226, DT 2, Cxt 04**Period 2c – Greenway Wharf**

Two ferrous spikes of similar dimensions to what was specified in government documentation had been recovered. One (Art. ID #0922) was found in a context that was near contemporary with the expansion while the other (Art. ID #2226) was found in a later 19<sup>th</sup> century context could have gradually migrated down the riverbed slope having eroded out of the riverbank.

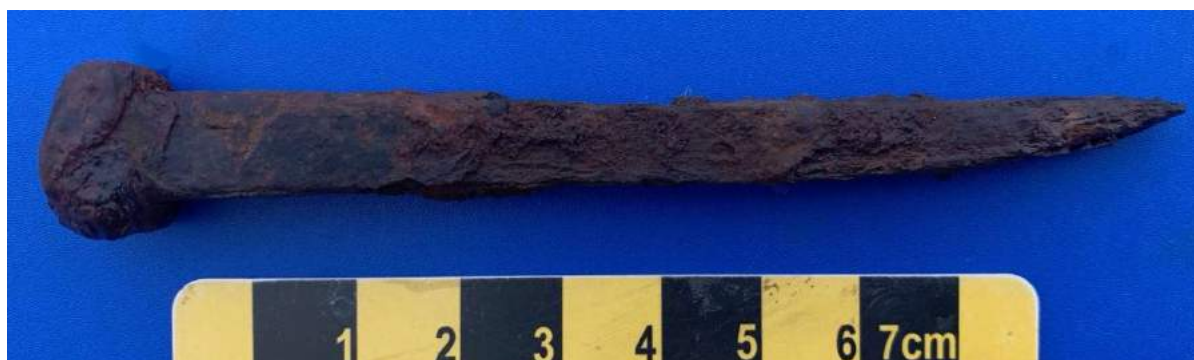
**Figure 269: Wrought (hand forged) ferrous spike, or long nail, 99 mm in length with maximum thickness near the head of 9mm<sup>2</sup>. Artefact ID 720, DT 1, Sq8, Cxt 05.**

The fastenings are square shanked, tapering to a point on two opposite sides. Most – six – range in length from 192 mm to 210 mm. Fastening Art. ID #720 appears to be 'cut' rather than hand forged suggesting a date of manufacture post-dating the 1820s and could represent a later repair. A fastening of 100 mm in length (Art. ID #720) has been attributed to the construction of the wharf though it is at the high end of the range for use in a timber boat hull (Figure 269).

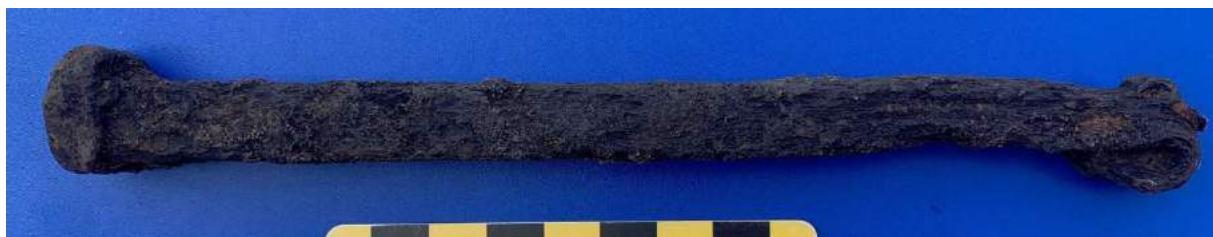
**Figure 270: Wrought (hand forged) ferrous spike, 210 mm unclenched length, clenched over with maximum thickness near the head of 14mm<sup>2</sup>. Artefact ID 5280, ST 1, Cxt 04**

Fastening Art. ID #5280 is clenched over at the end by 20 mm (Figure 270). This indicates that the two timbers it fastened had a combined thickness of 190 mm. This sort of thickness could have some association with deck planking on a deck beam. Given that the planks (UWF04, 07 and 11) attributed to the Greenway Wharf ranged in thickness from 40 mm to 60 mm it would mean that a deck beam would have been around 130 mm (5.1") to 150 mm (5.9") thick. The other spikes of similar length are not clenched indicating that their ends did not protrude from the timbers they fastened.

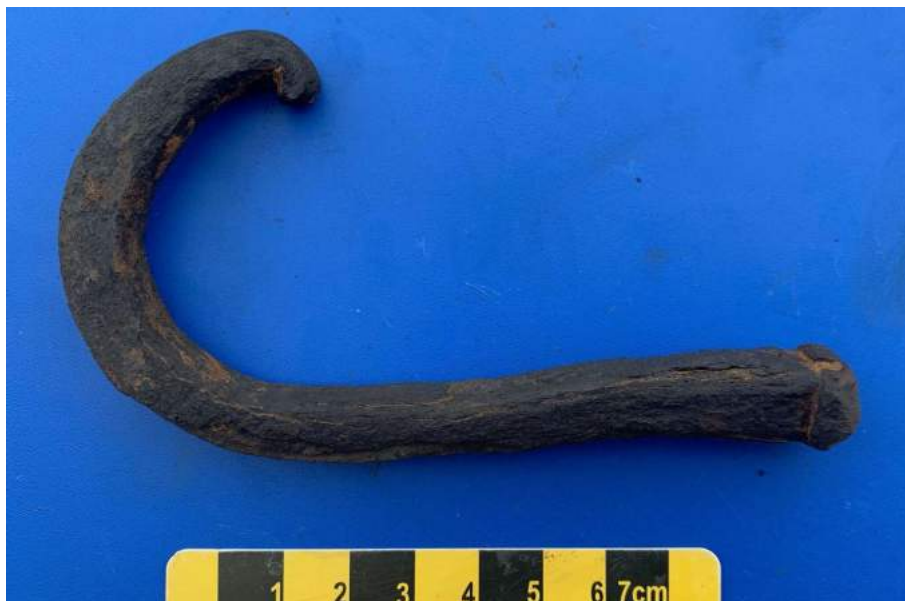
**Figure 271: Wrought (hand forged) ferrous spike, 180 mm unclenched length, clenched over with maximum thickness near the head of 12mm<sup>2</sup>. Artefact ID 719, ST 1, Cxt 08**

A shorter spike of 180 mm in length (Art. ID #719) has been clenched over by 80 mm indicating that it could have fastened to pieces of timber with a combined thickness of 100 mm – unlikely to have fastened a deck plank to a beam (Figure 271). This seemingly unwieldy use of a such a long fastening for the task may say something about the lack of availability of appropriately sized fastenings during the construction of the wharf.

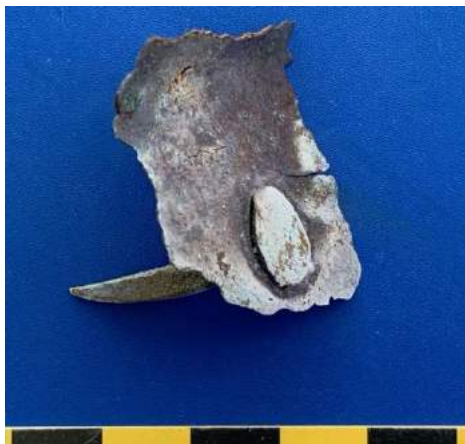
**Figure 272: Copper sheathing tack and remnant sheathing tack. Associated with the 1862 wharf.** Artefact ID 3093, DT 1, Sq 01 Cxt 03.

The piles were sheathed in copper to protect them from marine borers and to a lesser extent abrasion (Figure 272 and Figure 273). The sheathing tacks used to attach the sheathing to the piles have round flat heads 4mm across with a square 15 mm long shank tapering to a point. This was not uncommon in NSW for piles that were not of Turpentine and before the introduction of concrete sleeves and chemical treatments (see Section 9.8).

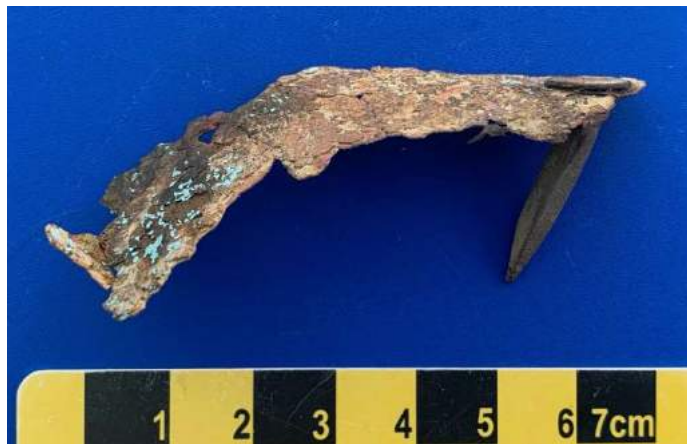
**Figure 273: Copper sheathing tack and remnant sheathing tack from AWF7.** Artefact ID 2998.

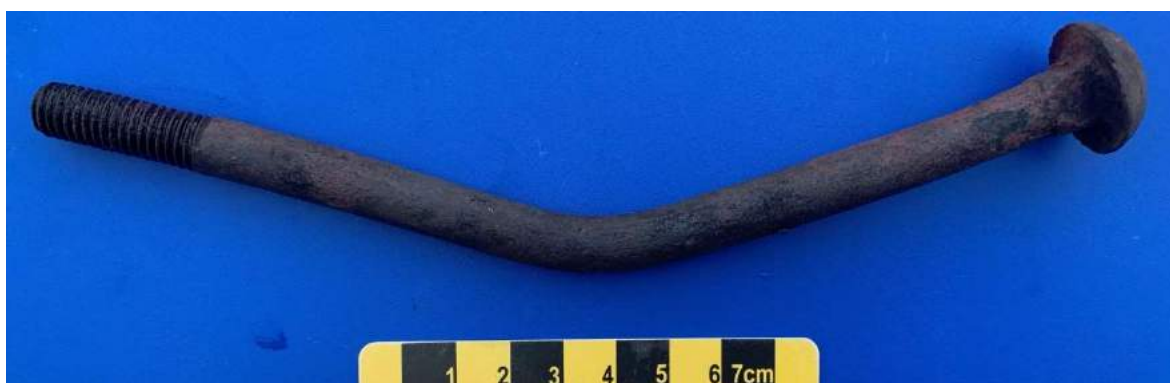
**Figure 274: Threaded through bolt, 11 mm diameter and 180 mm long.** Artefact ID 5279, ST 1, Cxt 04.

In addition, two bolts (Art. ID #5279 and 2181) were recovered during the excavation which had a more likely affiliation with maritime infrastructure than boat construction. They are through bolts with threaded ends. Fastening Art. ID # 5279 (Figure 274) would therefore have fastened two pieces of timber with a combined thickness of 154 mm while Art. ID #2181 would have fastened a combined thickness of 192 mm. Neither bolt would have been of sufficient length to fasten deck planks to the girders as specified in the historical documentation. In addition, the diameter of both bolts is about 33% of what was specified in the documentation. They may be associated with the 1862 wharf but were unlikely used to for the main elements of the structure.

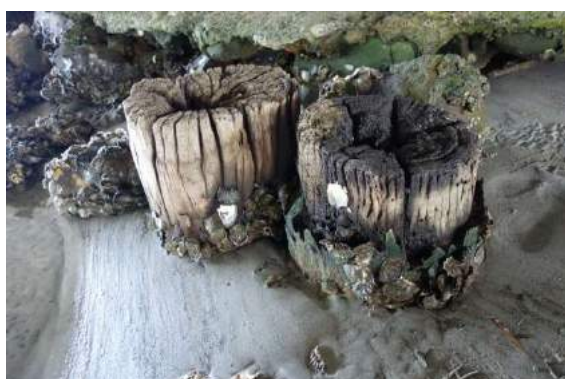
**Figure 277: Timber pile stumps of the former Burrill Lake Bridge.** The stump on right of image is copper sheathed. <sup>283</sup>

In NSW the copper sheathing of timber piles for protection against marine borers was not uncommon. Examples of copper sheathed piles are found at the former Burrill Lake Bridge constructed in 1889 (Figure 277 and Figure 278), the Government Wharf at Coraki built in 1882 which also had copper alloy bolts (Figure 279), Sugar Wharf at Broadwater built in 1881 (Figure 280), and Walsh Bay Pier 2/3 constructed in 1920/21 (Figure 281 and Figure 282).

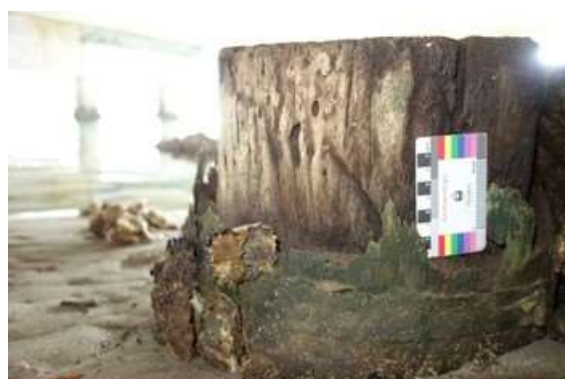
**Figure 278: Copper sheathed pile stump of the former Burrill Lake Bridge.**

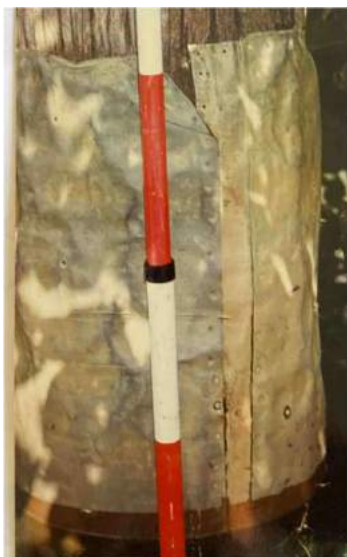
**Figure 279: Copper sheathed pile at Government Wharf, Coraki, Richmond River.<sup>284</sup>** Scale in 200 mm increments.

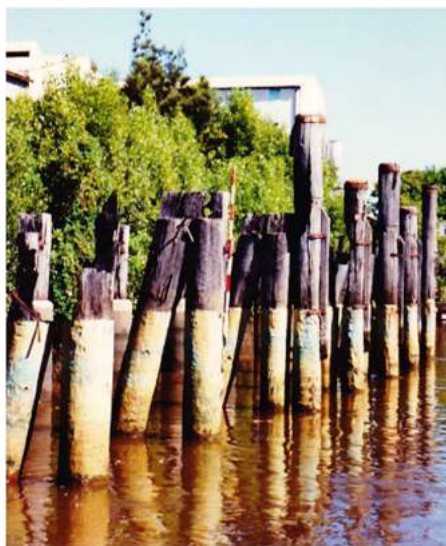
**Figure 280: Piles with sheathing, Sugar Wharf, Broadwater on Richmond River.<sup>285</sup>**

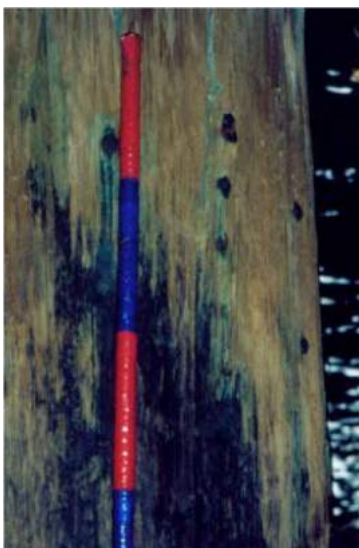
**Figure 281: Sheathing tacks and copper staining on a pile from Walsh Bay 2/3.<sup>286</sup>** Scale in 100 mm increments.

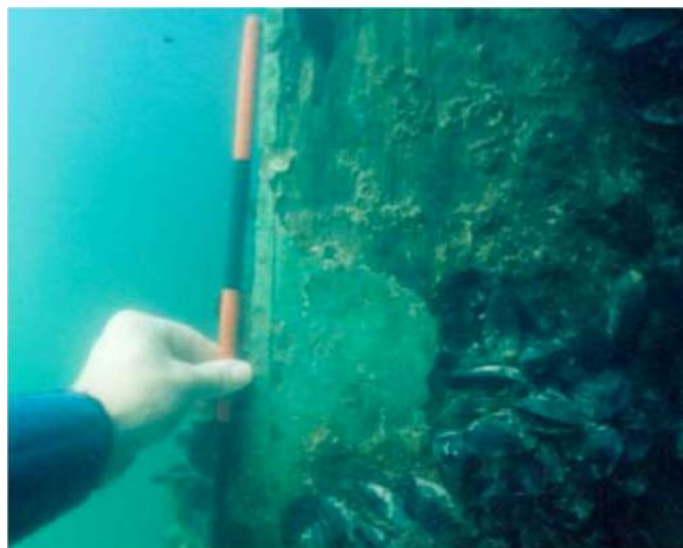
**Figure 282: Remnant sheathing tacks on a pile from Walsh Bay 2/3.** Scale in 100 mm increments.
