# Windsor Bridge Replacement Project

## Report on Maritime Archaeological Excavation and Survey, June to September 2018

Windsor,  
Hawkesbury River, NSW

September 2021

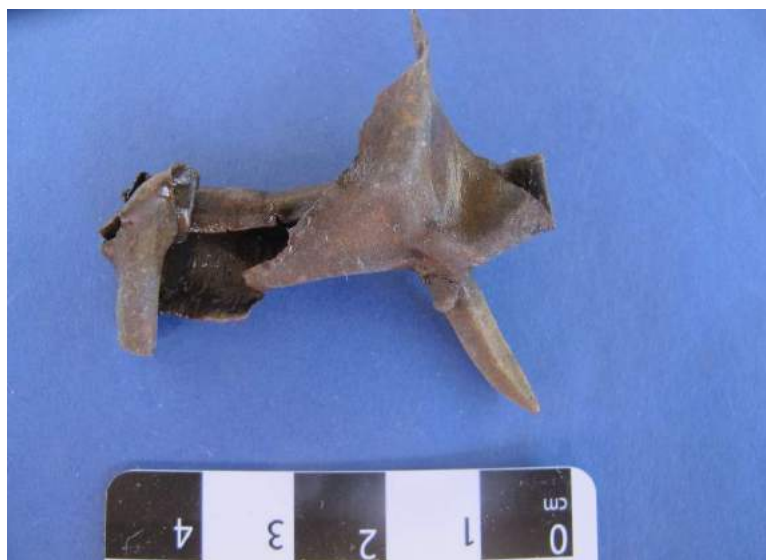
**Figure 284 Copper alloy sheathing fragment with copper alloy nail embedded.** This artefact given its context could be associated with a vessel as opposed to the 1862 Wharf however an analysis of the chemical composition of the copper alloy may be required. Artefact ID 3385, DT 1, Sq 1, Cxt 06.

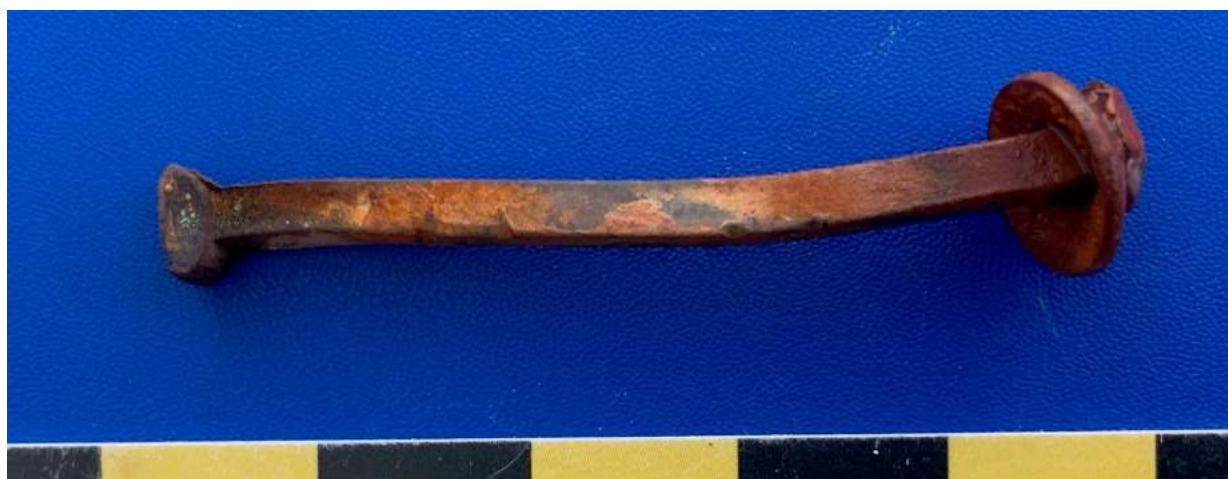
**Figure 285: Copper alloy nail and rove.** A fastening that would have been used in a clinker built vessel. Artefact ID 3809, DT1, Sq 5, Cxt 11. Scale in 10 mm increments.

The presence of a single copper alloy rove does indicate the practice of clenching and clinker boat building tradition. A very good example of utilising whatever is on hand to create fastenings is the discarded copper alloy ruler (Figure 286) which seems to have been cut to possibly create square roves such those shown in Figure 287 and Figure 288.

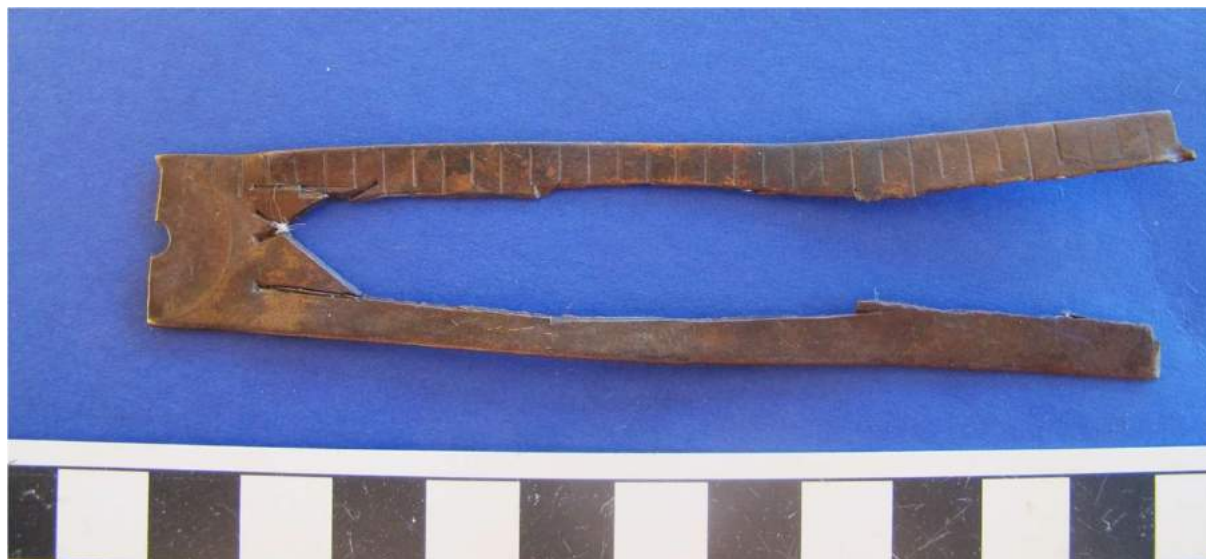
**Figure 286: Copper alloy ruler which has been cut to possibly provide squared roves. # 3677** DT1, Sq 3, Cxt 21. Scale in 10 mm increments.

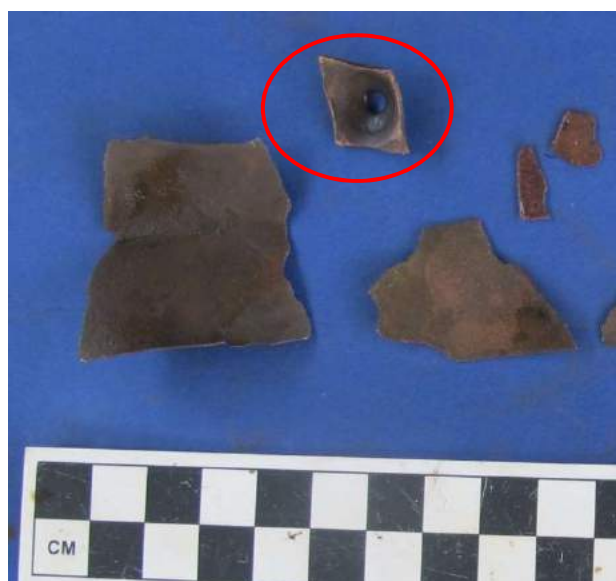
**Figure 287: Square or diamond shaped rove (red circle).** DT3, Cxt19.

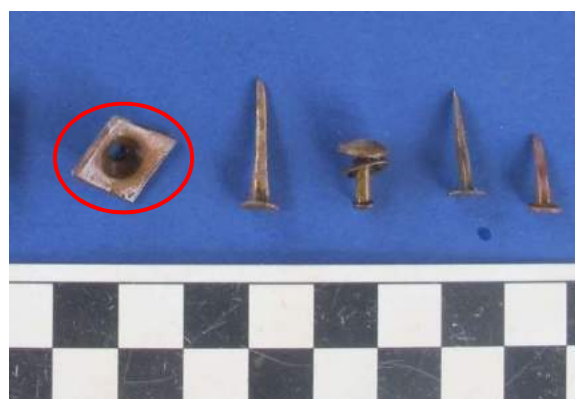
**Figure 288: Square or diamond shaped rove (red circle).** DT1, Sq1,Cxt 06. . Scale in 10 mm increments.

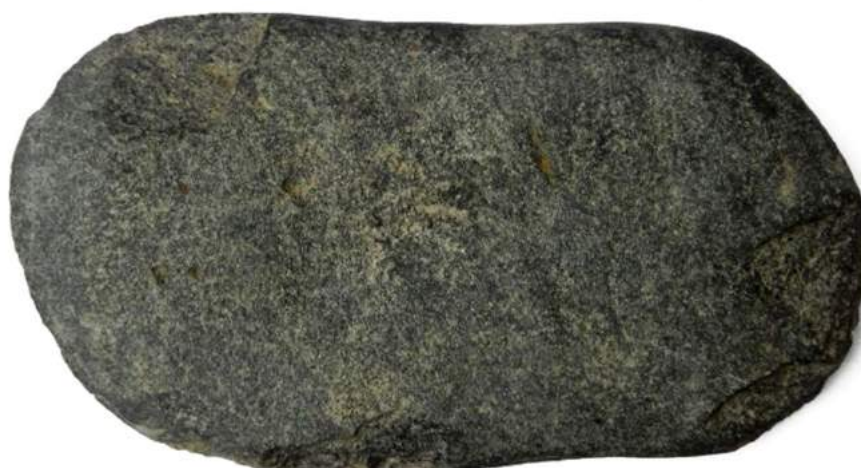
**Figure 294:** Basalt ground-edge axe / unifacial chopper – the ground-edge is visible on the left (DT1 / SQ1 / C07).

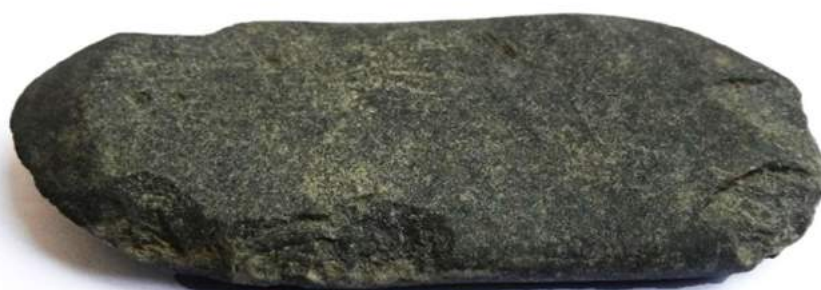
**Figure 295:** Oblique view of basalt ground-edge axe / unifacial chopper (DT1 / SQ1 / C07).

The presence of small silcrete artefacts, including some heat-treated materials, quartz artefacts, and a basalt ground-edge axe in the maritime stone artefact assemblage indicates that at least part of the assemblage is of mid-late Holocene age. However, relatively high proportions of indurated mudstone / tuff and fine-grained siliceous artefacts also tentatively suggests that some of the stone artefacts may be of Pleistocene age. No clear patterning of relative frequencies of raw material types in different contexts and / or depths were observed, however, with each material occurring consistently in each stratigraphic unit. Whilst this may be a factor of small sample size, it may also be an indication that the assemblage represents a post-depositionally mixed collection of Pleistocene and Holocene artefacts.

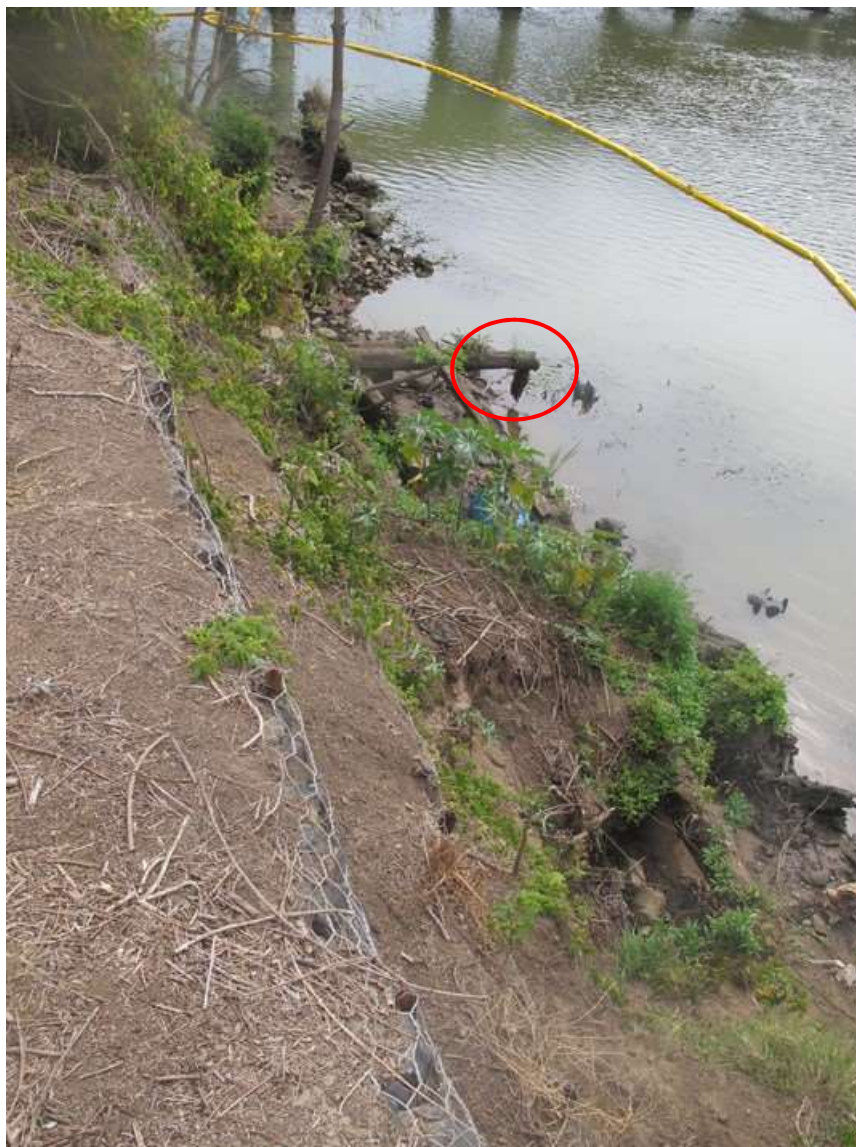
**Figure 297: The timber waler (AWF6/4) associated with the 1882 wharf (Phase 3) that was to be cut as to not further strain the remaining structure (red circle).**

Prior to the installation of granular fill, a section of feature AWF6/4 (AWF6/4) was deemed at risk and to prevent further damage to the remaining structure of the wharf, the timber was to be cut. Monitoring was undertaken by a maritime archaeologist, Milly Bendell. The section of timber from AWF 6/4 was cut on Wednesday 3<sup>rd</sup> October 2018 at 2:15pm with a low tide of 0.5m. AWF 6/4 was cut with a chainsaw back to the junction of AWF 6/1. The timber was then securely wrapped in geo textile material, tapped and placed back underneath the remaining wharf to be buried under the scour protection works. (Figure 299 to 301). After the timber was secured, the laying of the rock armour commenced (Figure 302).

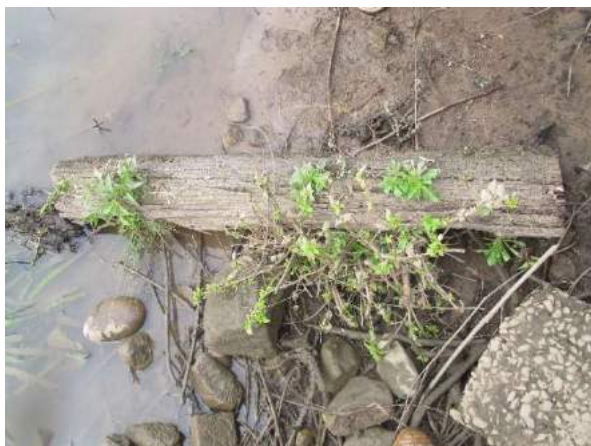
**Figure 299:** Piece of timber AWF 6/4 after it had been cut.

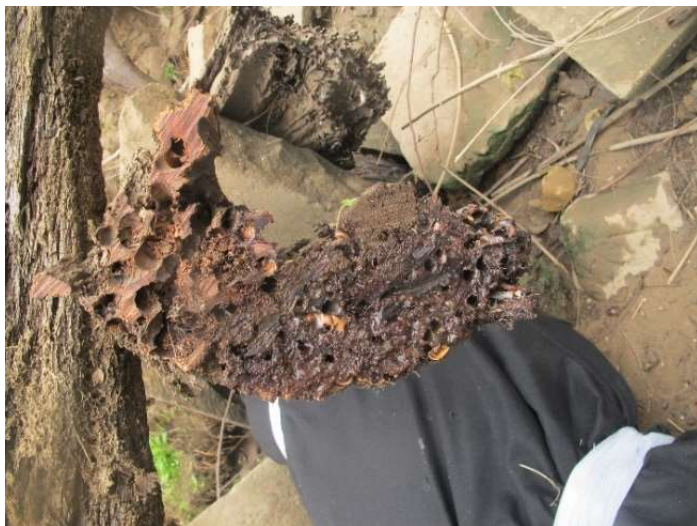
**Figure 301:** A section view of the remaining piece of AWF6/4. Timber piece severely damaged from marine borer activity.

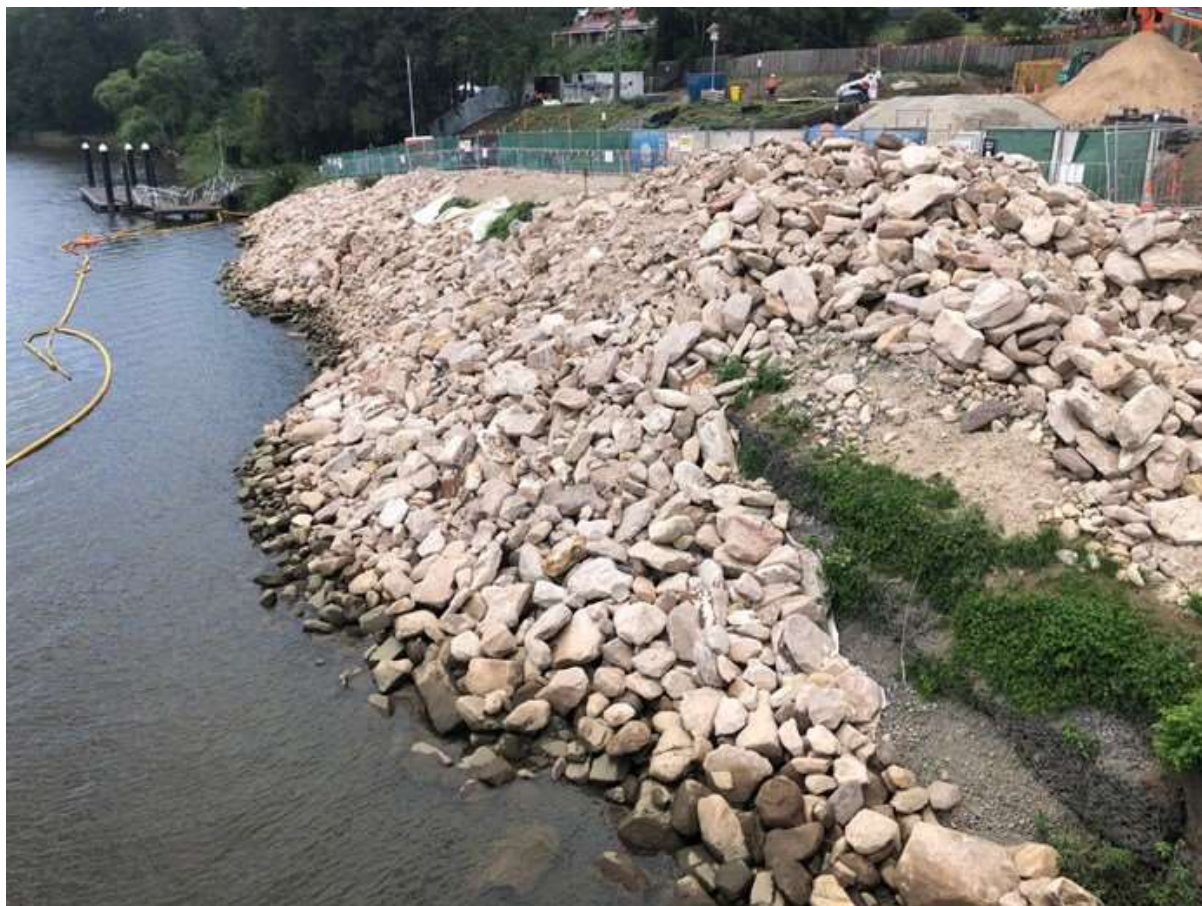
**Figure 302: An in progress shot of the rock armour scour protection being laid.** Taken 14th December 2018. Looking east. The site of the former Windsor Wharf is protected under the scour protection.

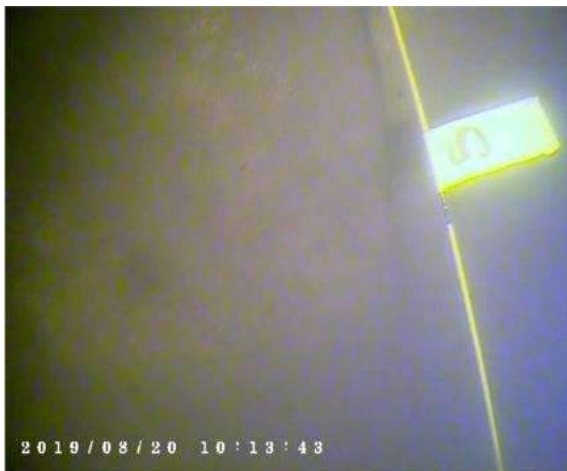
| Distance from downstream, end (m) | Observations | Video timings: WBRP Rock Armour Run 002 |
|---|---|---|
| 5 | Large rocks from rock armour meeting sand (Figure 303) | 01:21 |

**Figure 303: 5 m marker, large rocks and sand under the transect line** (Video: WBRP Rock Armour run 002, still image taken at 01:21)

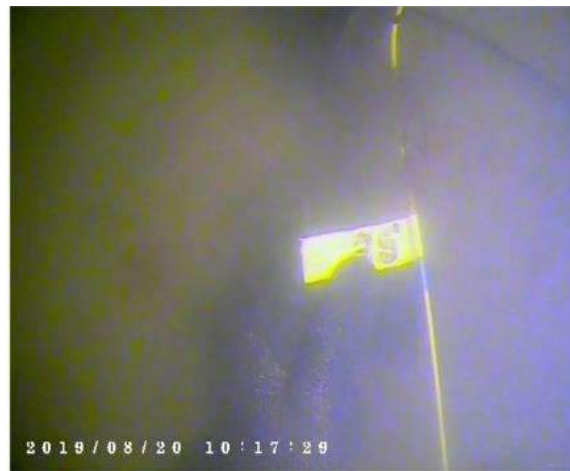
| Distance from downstream, end (m) | Observations | Video timings: WBRP Rock Armour Run 002 |
|---|---|---|
| 25 | Rock armour with sandy edge (Figure 304) | 05:08 |

**Figure 304: 25 m marker, large rocks and sand under the transect line.** (Video: WBRP Rock Armour run 002, still image taken at 05:08)

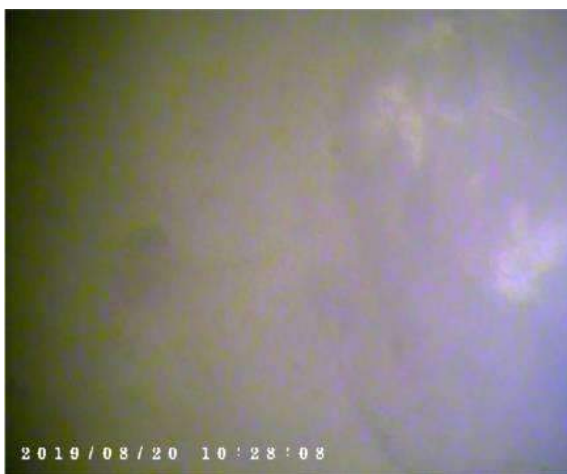
In the first run it was noted that the sand was beginning to move over the edge of the rock armour on this side of the river, making the toe less defined. This sand dusting extended the length of the run until the bridge pier was reached. Timbers associated with a small boat were observed at the 36-37 m marker, with three timbers and smaller fragments lying loose in the sand or caught between rocks. These timbers are associated with the wrecks recorded and recovered in early 2019.<sup>301</sup> One timber was attached to another timber that was buried too deep to be removed. This timber did not appear to have been exposed through scouring action and there was no other evidence of scouring except around the four bridge piles underneath the bridge pier.

| Distance from downstream, end (m) | Observations | Video timings: WBRP Rock Armour Run 002 |
|---|---|---|
| 45 | Rock armour with sandy edge (Figure 305) | 16:58 |

**Figure 305: 45 m marker, large rocks to the right of the transect line under a light dusting of sand.** (Video: WBRP Rock Armour run 002, still image taken at 16:58)

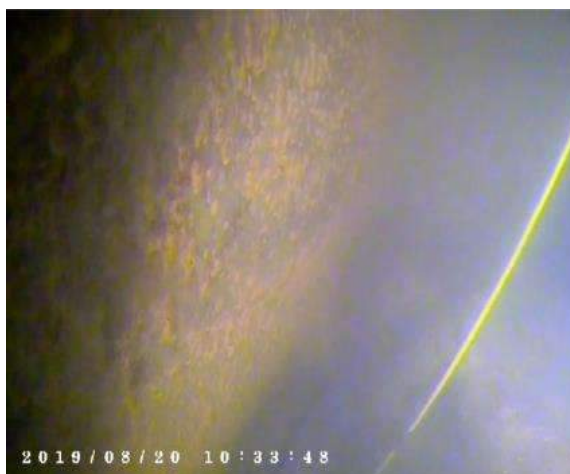
Once the bridge pier was reached the rock armour was abutting the riverbank side of the piles but does not extend around the piles to the river side. Scouring was noted between the piles on the downstream side, approximately 500 mm deep and 1,500 mm in length, running perpendicular to the riverbank. No cultural material was exposed in the scour.

| Distance from downstream, end (m) | Observations | Video timings: WBRP Rock Armour Run 002 |
|---|---|---|
| 65 | Rock armour with sandy edge, meeting the downstream bridge pier pile (Figure 306). | 20:47 |

**Figure 306: 65 m marker, bridge pier 4, pile 1, rocks to the right of the pile.** (Video: WBRP Rock Armour run 002, still image taken at 20:47)

The level of scouring between the four bridge piles underneath the bridge pier should also be monitored during future surveys.

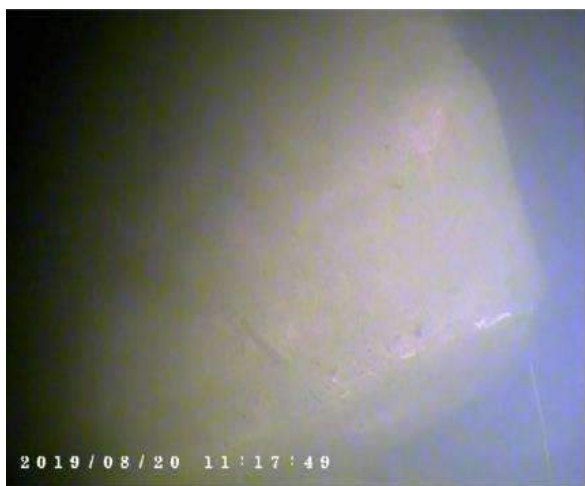
| Distance from downstream end (m) | Observations | Video timings: WBRP Rock Armour run 004 |
|---|---|---|
| 85 | Rock armour with sandy edge (Figure 298) | 01:00 |

**Figure 307: 85 m marker, large rocks to the left and sand to the right of the transect line. (Video: WBRP Rock Armour run 004, still image taken at 00:56)**

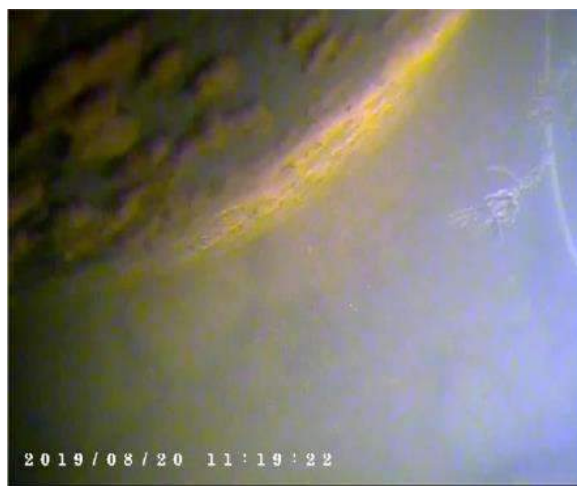
| Distance from downstream end (m) | Observations | Video timings: WBRP Rock Armour run 004 |
|---|---|---|
| 100 | End of 100m transect line at downstream pile of temporary jetty. Markers changed from 5 m to 2 m. Very silty, rock armour can be felt underneath the silt (Figure 299). | 03:09 |

**Figure 308: 100 m marker, temporary jetty pile and large rocks to the right. (Video: WBRP Rock Armour run 004, still image taken at 03:09)**

Upstream of the bridge pier, the area was very silty, reducing visibility to almost zero. While the rock armour could be felt, this silt build up may potentially reduce when the silt curtains and the temporary jetty are removed and should be monitored for future inspections.

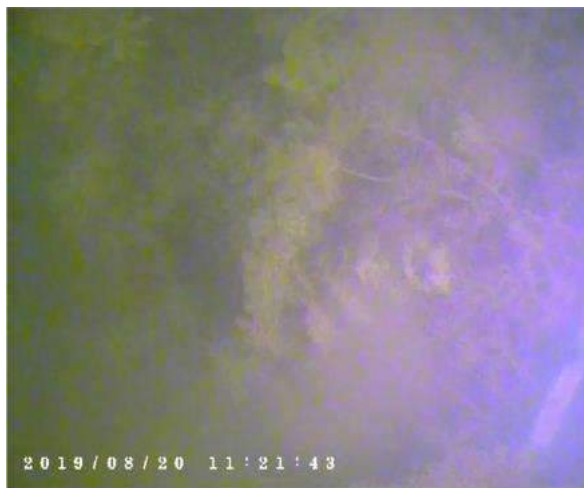
| Distance from downstream end (m) | Observations | Video timings: WBRP Rock Armour run 004 |
|---|---|---|
| 112 | Underneath silt curtain, very silty with natural vegetation. Toe of rock armour can be felt underneath silt (Figure 300). | 04:59 |

**Figure 309: Inside silt curtain, vegetation and silty sand over rock armour. (Video: WBRP Rock Armour run 004, still image taken at 04:59)**

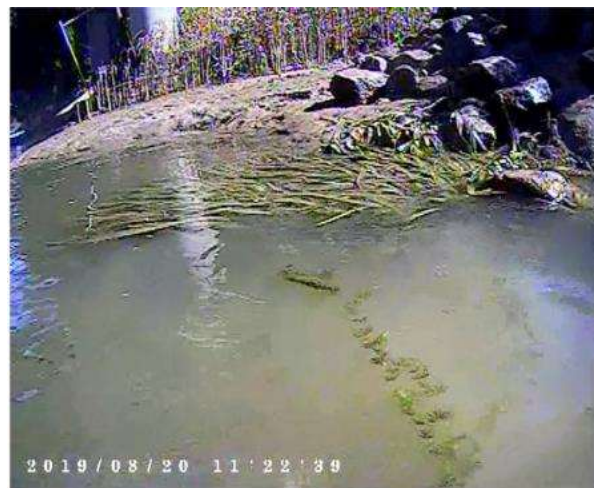
| Distance from downstream end (m) | Observations | Video timings: WBRP Rock Armour run 004 |
|---|---|---|
| 122 | Upstream extent of north side rock armour near shore, changing from rock armour to smaller river stones (Figure 301). | 06:30 |

**Figure 310: Upstream extent of north side rock armour. (Video: WBRP Rock Armour run 004, still image taken at 06:30)**

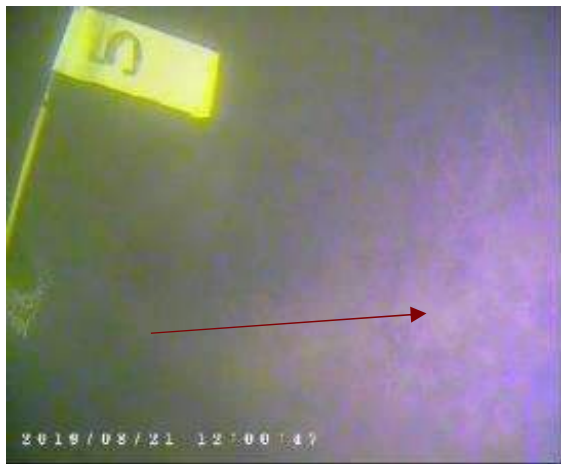
At the downstream and upstream extent of the rock armour, there was exposed geofabric with no rocks over the top (see Figure 313 and Figure 316). This geofabric floated up into the water column, up to approximately 300-400 mm off the riverbed and extends outwards from the edge of the rock armour to approximately 1000 mm.

| Distance from DS end (m) | Observations | Video timings: WBRP Rock Armour run 005 |
|---|---|---|
| 5 | Exposed geofabric stretching past rock armour, larger rocks (Figure 313). | 01:06 |

**Figure 313: uncovered geofabric to the right of the transect line at the 5 m marker.** (Video: WBRP Rock Armour run 005, still image taken at 01:06)

A key feature for future monitoring on the south side transect is the exposed geofabric at both the upstream and downstream extents of the scour protection to ensure there is no scouring as a result of the loose material.

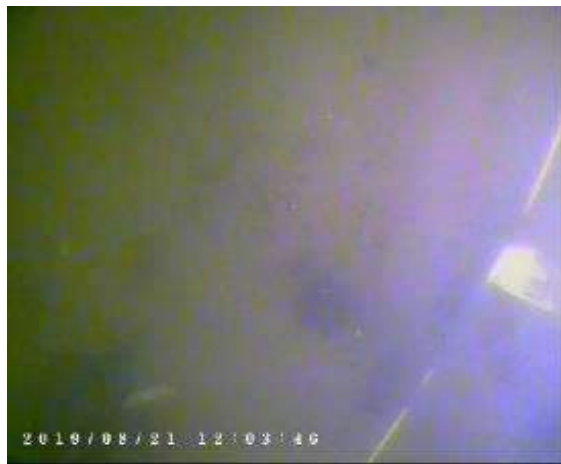
| Distance from DS end (m) | Observations | Video timings: WBRP Rock Armour run 005 |
|---|---|---|
| 30 | Large rocks reaching to the extent of the geofabric. No scouring in sand (Figure 314). | 04:00 |

**Figure 314: large rocks to the left of the transect line at the 30 m marker.** (Video: WBRP Rock Armour run 005, still image taken at 04:00)

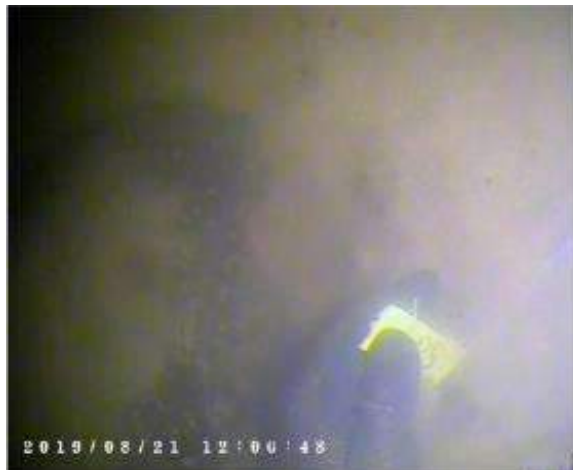
| Distance from DS end (m) | Observations | Video timings: WBRP Rock Armour run 005 |
|---|---|---|
| 50 | Large rocks reaching to the extent of the geofabric. No scouring in sand (Figure 315). | 07:03 |

**Figure 315: Large rocks to the left of the transect line at the 50 m marker.** Video: WBRP Rock Armour run 005, still image taken at 07:03)

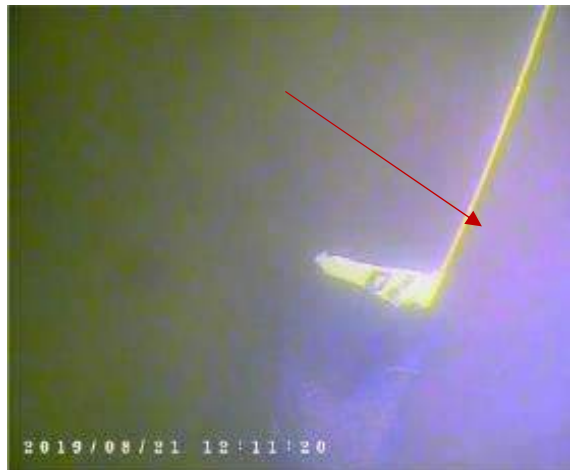
| Distance from DS end (m) | Observations | Video timings: WBRP Rock Armour run 005 |
|---|---|---|
| 70 | Exposed geofabric stretching past rock armour, larger rocks (Figure 316). | 11:34 |

**Figure 316: uncovered geofabric to the right of the transect line at the 70 m marker, large rocks to the left.** (Video: WBRP Rock Armour run 005, still image taken at 11:34)

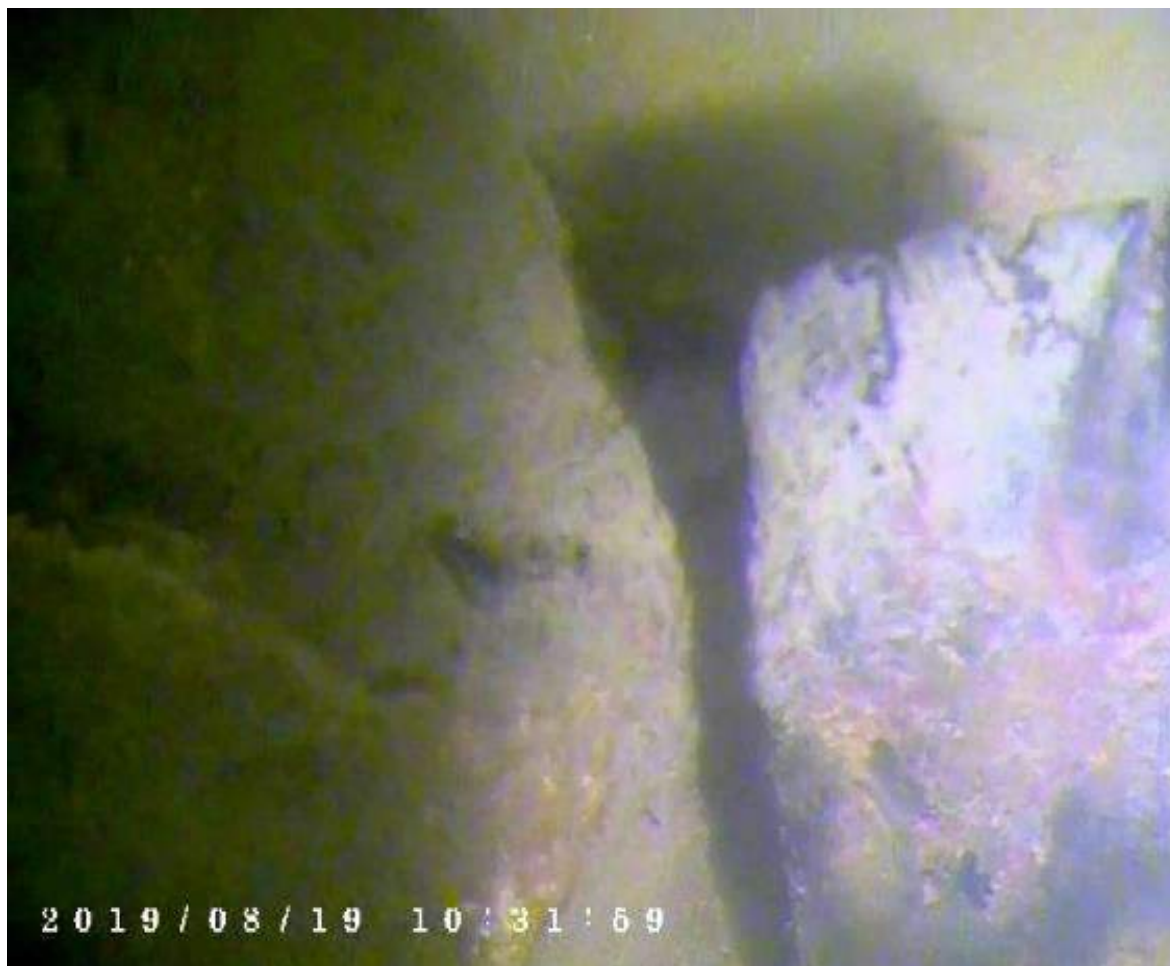
**Figure 320: Timber plank 01-190819 abutting rock armour north side Hawkesbury River, scarph joint visible at top of timber.** Diver facing north. (Video: WBRP Rock Armour run 001, still image taken at 00:08).

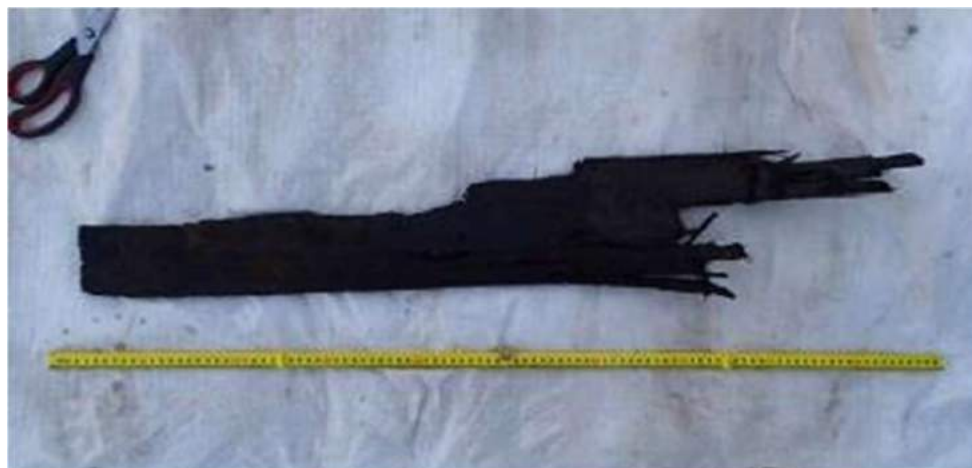
During the first observation dive for the north side survey on 19<sup>th</sup> August 2019, timber fragments were observed. One timber had what appeared to be a scarph joint and was abutting the rock armour (Figure 320). The diver retrieved this timber and another as well as several smaller fragments. These timbers all had evidence of modern breakage at the ends. The long timbers were labelled Plank 01-190819 (Figure 321 and Figure 322) and Plank 02-190819 (Figure 323) and placed in the holding skip which contained wreck timbers associated with UHRW02 to 04.<sup>304</sup> The smaller fragments were discarded as there was not enough timber left for diagnostic purposes.

**Figure 321: Plank 01-190819, note modern breakage at one end and scarph joint at the other. Image taken 23<sup>rd</sup> August at works compound.**

During recording on 23<sup>rd</sup> August, it was determined that all four timbers were likely from the same vessel, as they all displayed similar characteristics. These included dimensions of the planks, canvas sheathing attached by tacks with pitch/tar underneath, ferrous fastenings, saw marks and scarph joints.

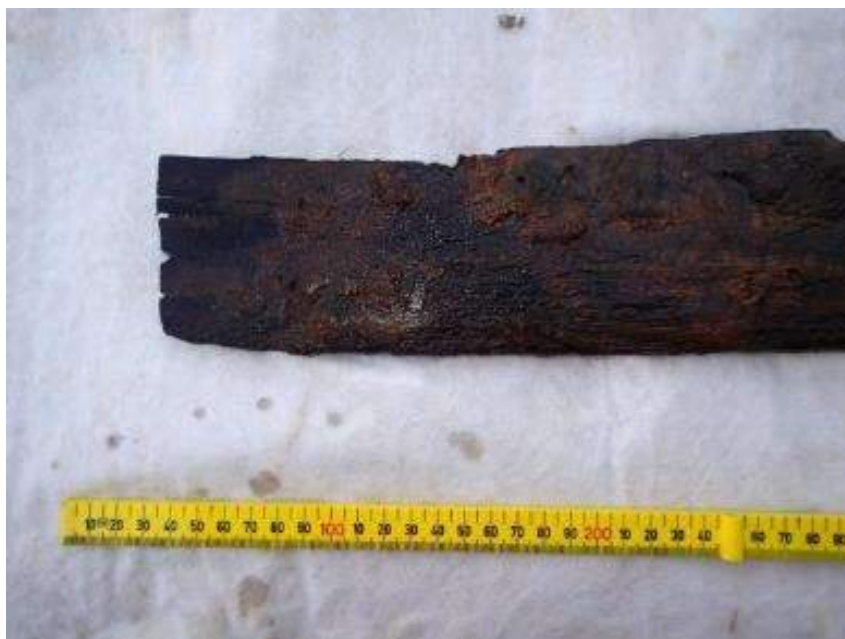
*Figure 322: Detail of scarph joint on Plank 01-190819. Image taken 23<sup>rd</sup> August at works compound.*

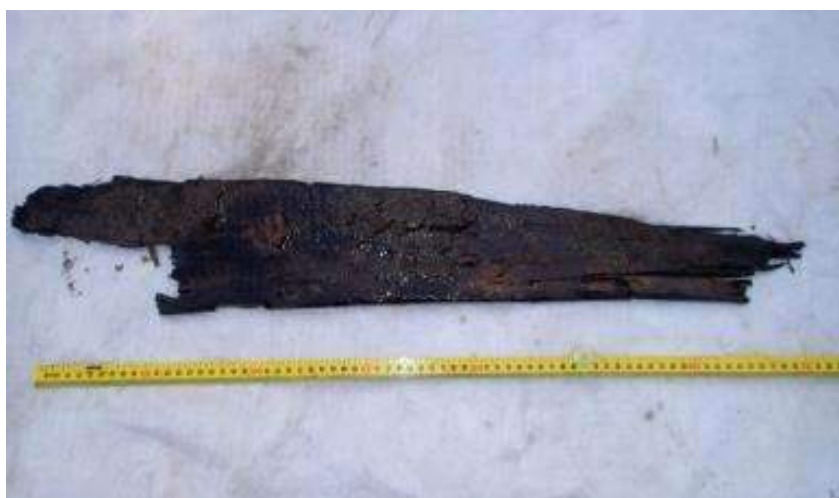
*Figure 323: Plank 02-190819. Image taken 23<sup>rd</sup> August at works compound.*

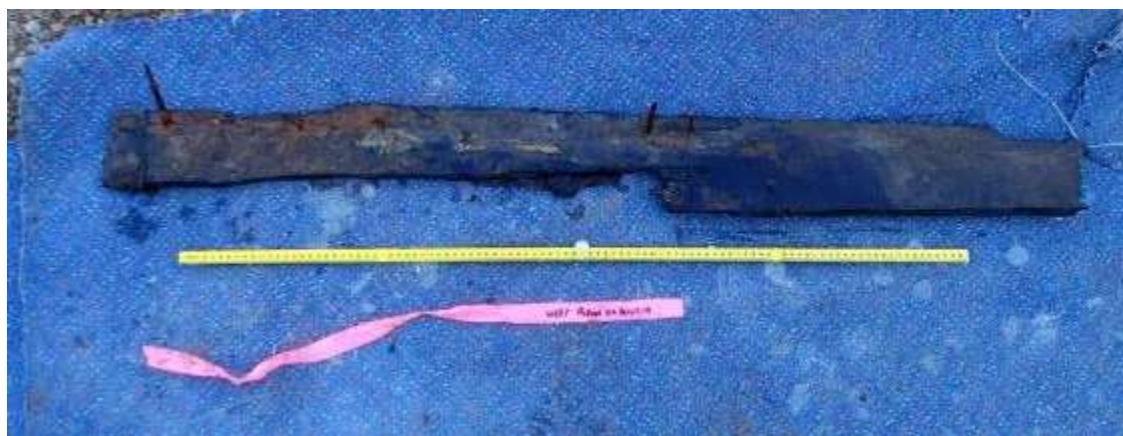
On 20<sup>th</sup> August, the area where the shipwreck timbers were found was again inspected for loose timbers. Diver removed Plank 01-190820 (Figure 324) **Error! Reference source not found.** from this area. The timber had canvas sheathing held to the plank by tacks, ferrous fastenings and a scarph joint at one end. Another plank, 02-190820 (Figure 325), was also removed. This timber had round fastening holes and saw marks, but no evidence of pitch. Both timbers were placed in the skip for future recording.

*Figure 324: Plank 01-190820. Image taken 23<sup>rd</sup> August at works compound.*

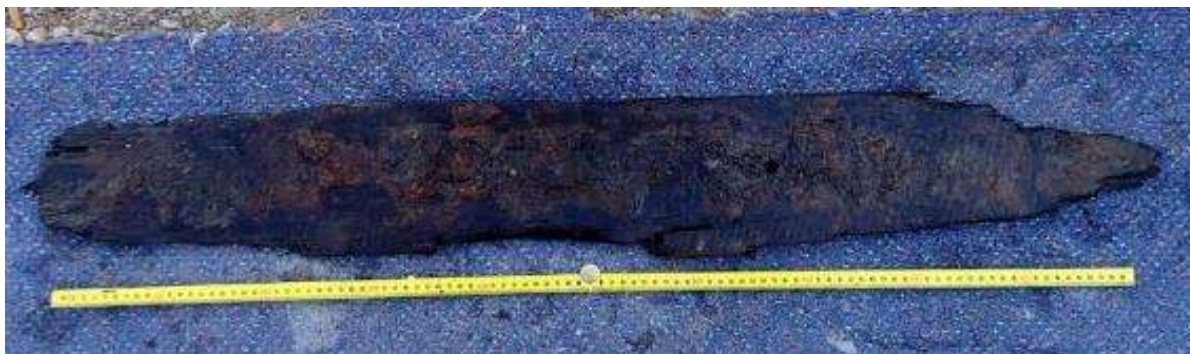
**Figure 325: Plank 02-190820.** Image taken 23<sup>rd</sup> August at works compound.

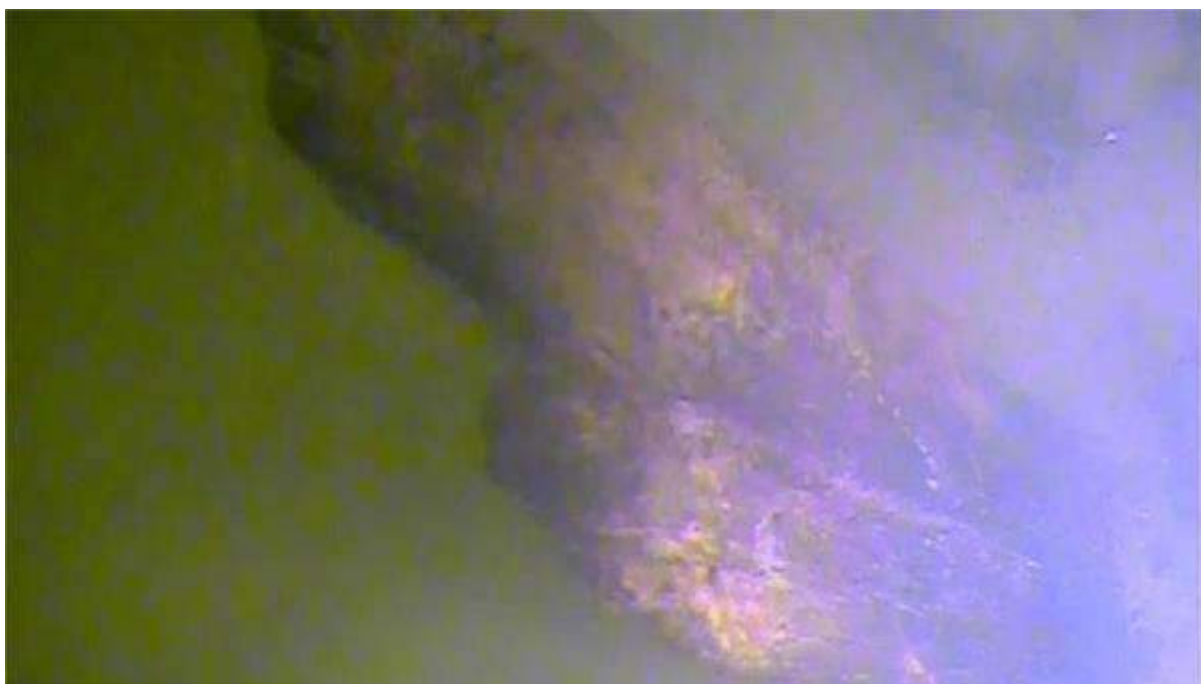
**Figure 326: Timber plank with attached timber underneath the riverbed.** Diver facing downstream. (Video: WBRP Rock Armour run 003, still image taken at 00:35)
