# Woolgoolga to Ballina Pacific Highway Upgrade

**Threatened Frog Monitoring Annual Report  
2020/21**

Version 4.0

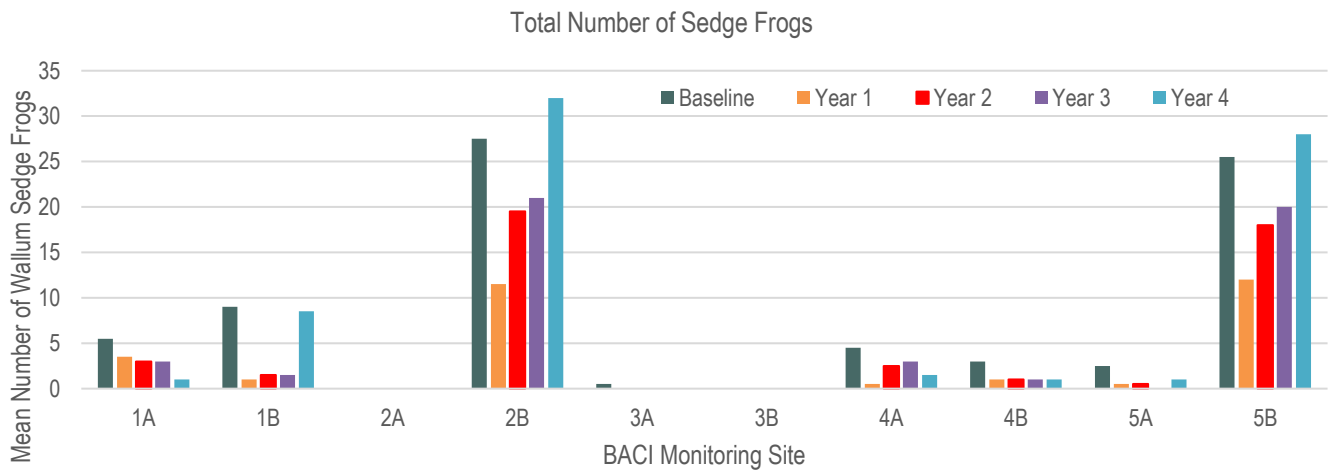
**Figure 3-3.** Total wallum sedge frog counts between baseline survey, Year 1, Year 2, Year 3 and Year 4 monitoring.

Monitoring during Year 4 found fewer sedge frogs than during the baseline surveys conducted in 2014. This trend of fewer sedge frogs has remained relatively consistent over the past four rounds of construction monitoring. During this round of monitoring, surveys were performed a fortnight after heavy flooding rains where the monitoring sites received in excess of 150 mm of rainfall in mid January 2020. Whilst this is thought to have greatly assisted in detecting sedge frogs along the monitoring transects, the overall lower trend in the numbers of frogs is undoubtedly linked to the very low rainfall in the previous winter, spring and first half of summer. During such conditions, sedge frog survival would be lower than during a season of average to above average rainfall.

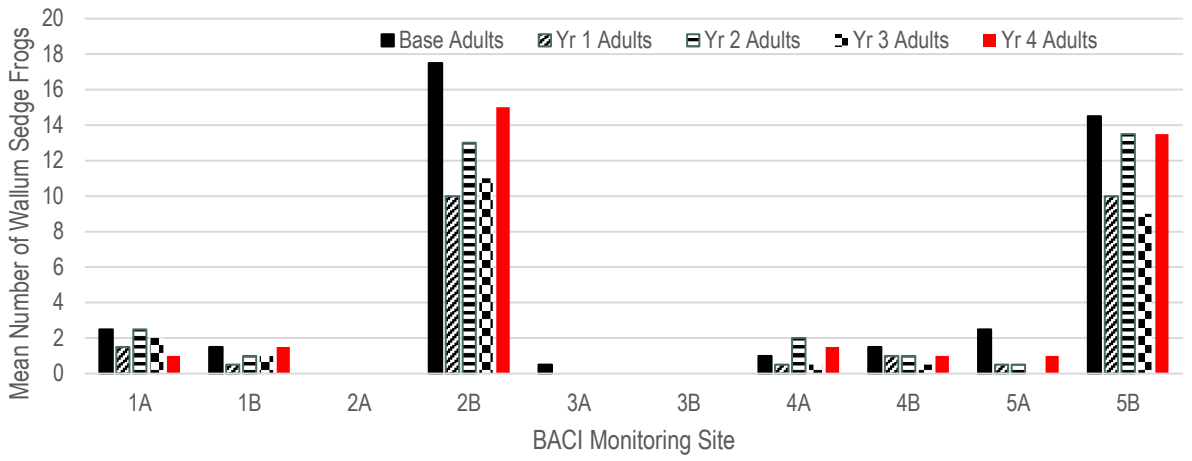
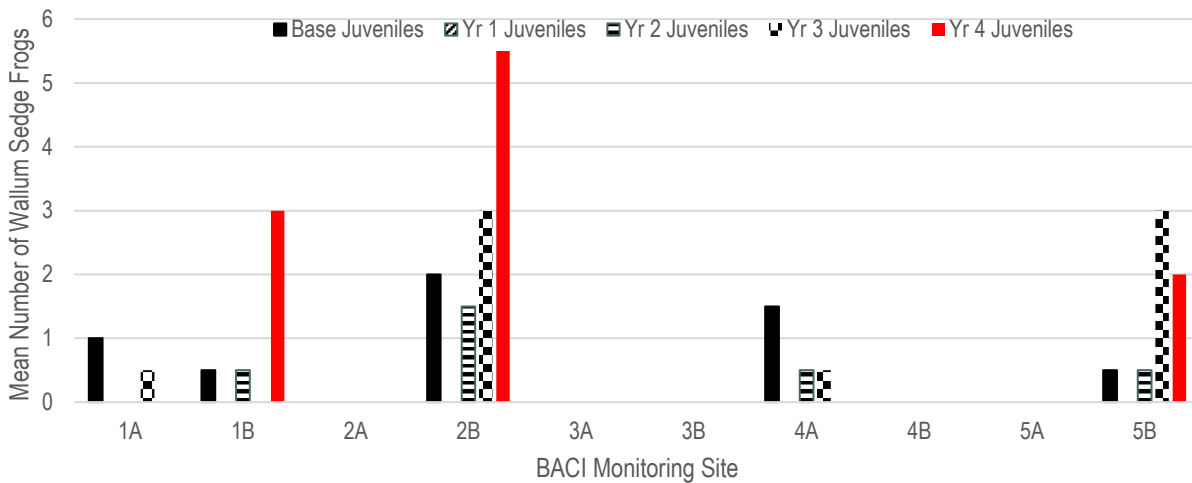
Figure 3-4. Wallum sedge frog counts across three age classes between baseline survey and subsequent monitoring in Year 1, 2, 3 and 4.

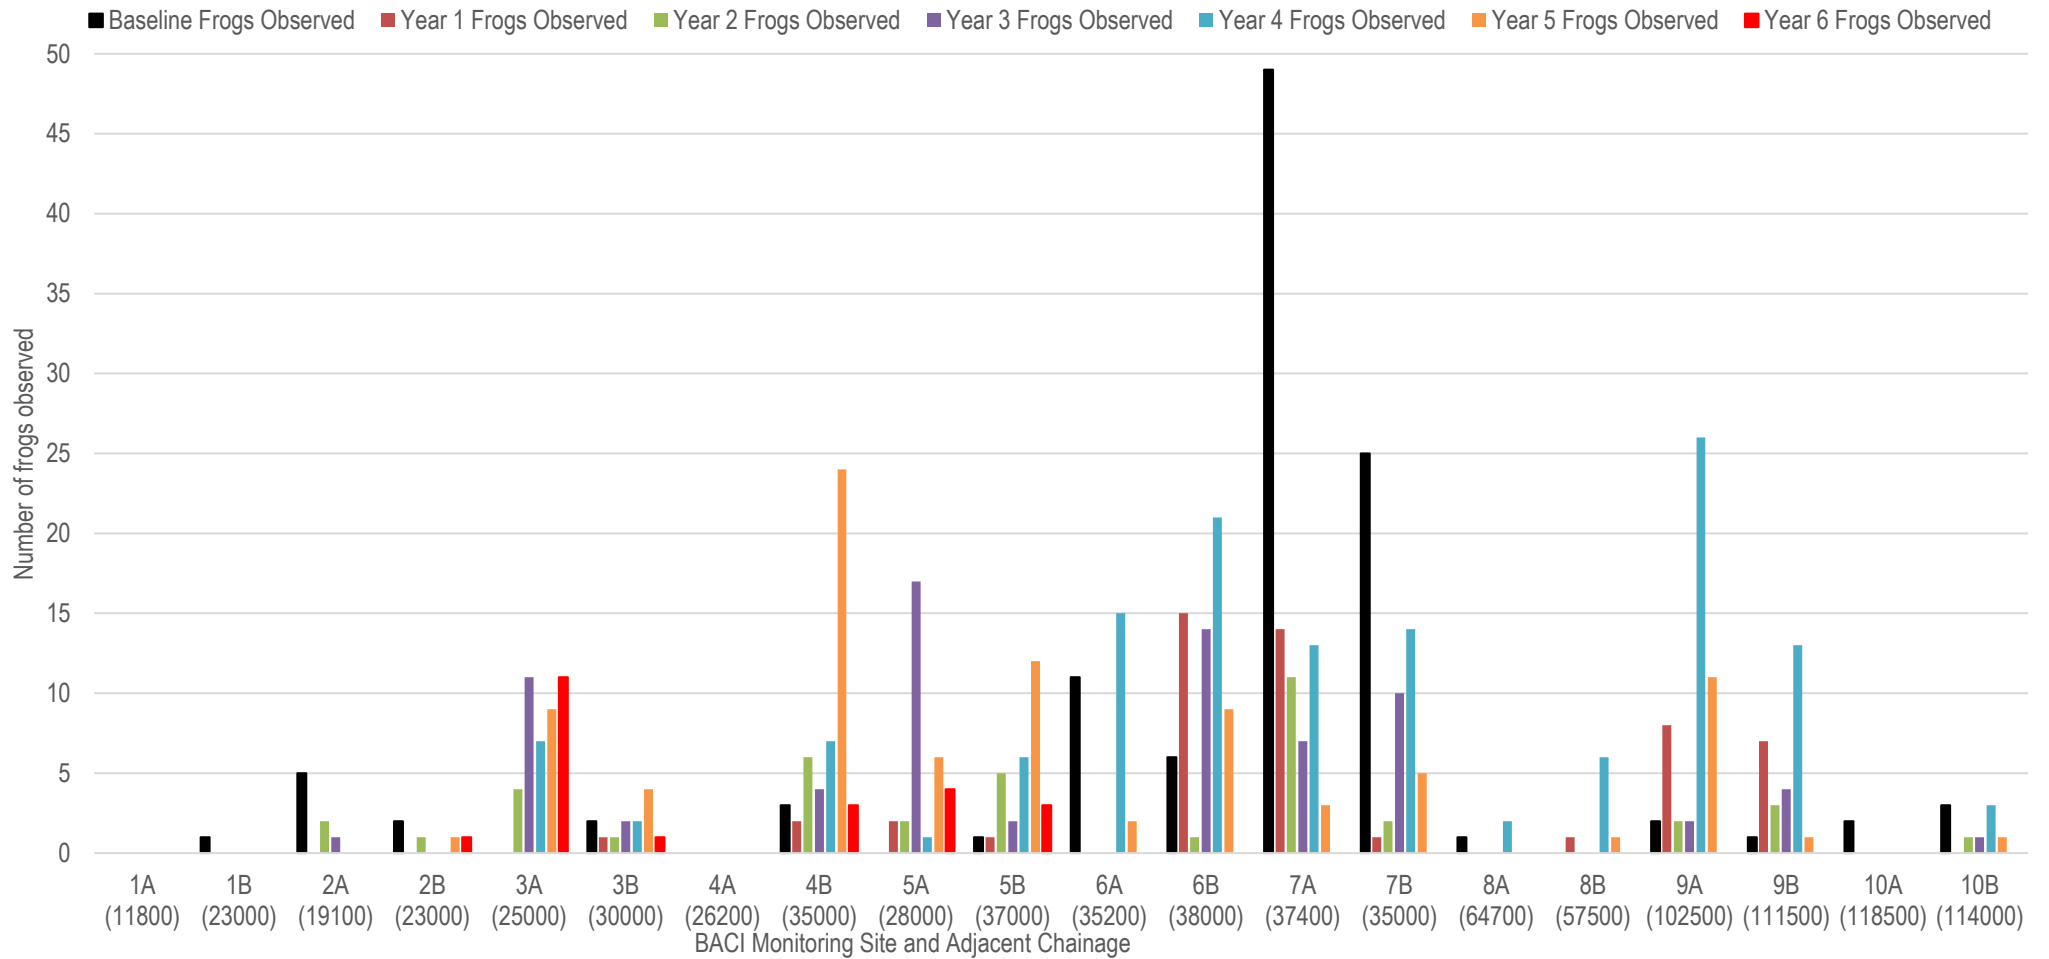
**Figure 4-4.** The number of Green-thighed Frogs spotlighted between the baseline survey, construction and operational monitoring in Years 1-6 at Sites 1-5 and Years 1-5 at Sites 6-10.

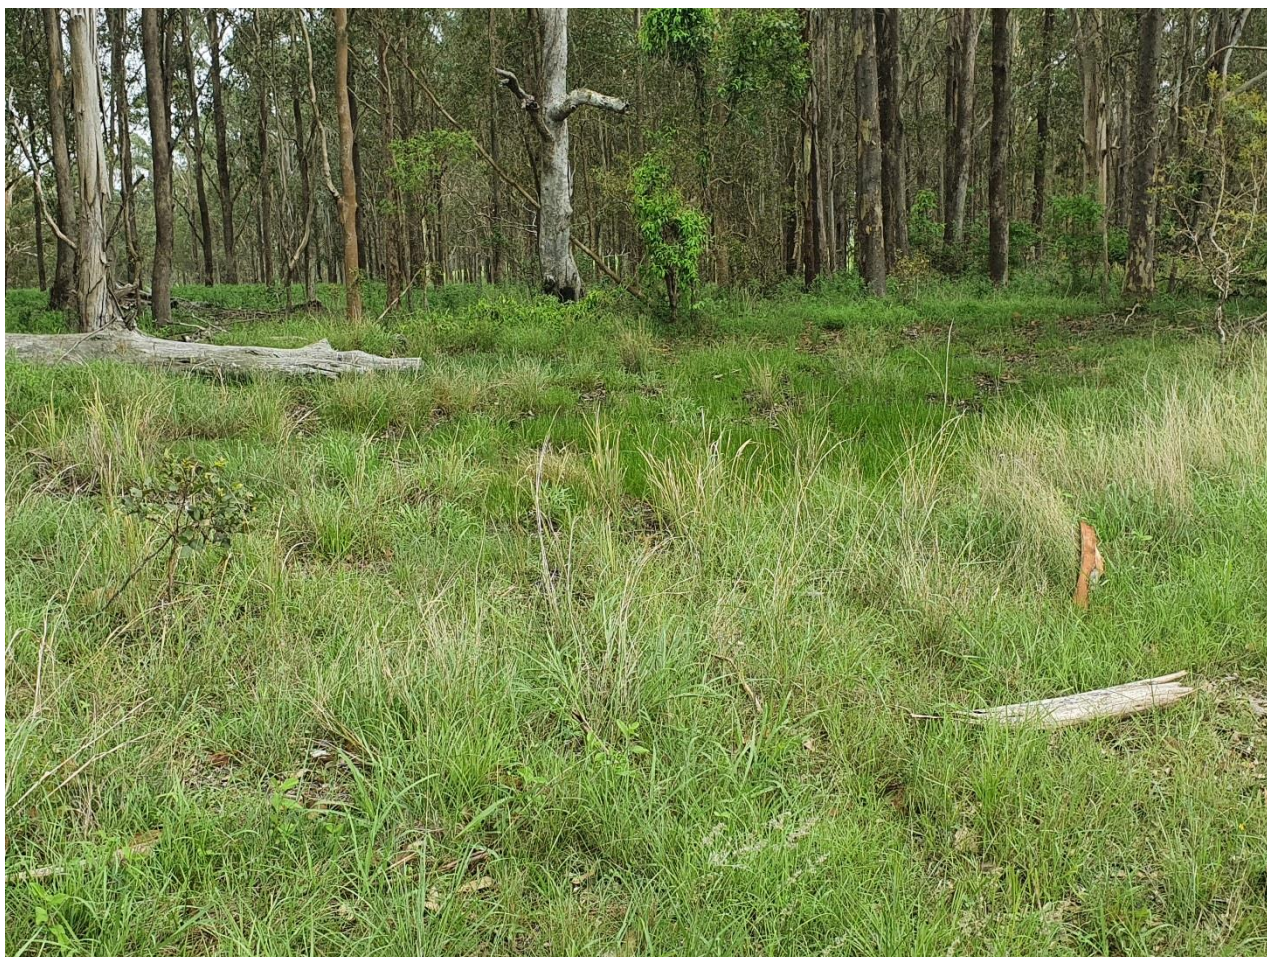
Suitable seasonal conditions in the form of heavy rainfall events exceeding 50 mm in 24 hours or cumulative tallies exceeding 150 mm in 72 hours occurred in mid December 2020 and again in mid March 2021 during this round of monitoring (Table A-2). Rainfall events exceeding 50 mm in 24 hours occurred on the 12<sup>th</sup>, 13<sup>th</sup> and 15<sup>th</sup> December in Section 1-3 and on the 13<sup>th</sup>, 14<sup>th</sup> and 15<sup>th</sup> December in Section 6 and 7 and this was followed up with rainfall events on 22<sup>nd</sup> and 23<sup>rd</sup> March. Although rainfall tallies exceeded 300 mm over five consecutive days in mid December, a number of the breeding sites had dried out by the start of January (Plate 4-4).

**Plate 4-4.** Site 6A (Airport Road) that had dried out only 16 days after heavy rainfall.

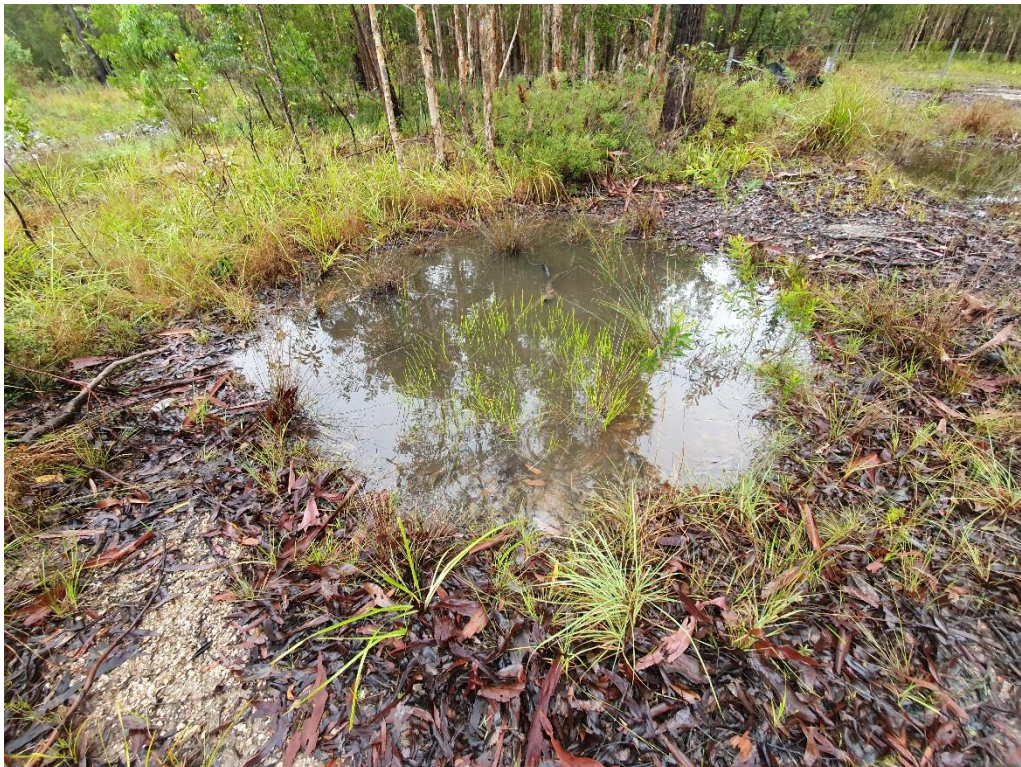
The key finding was the fact that ponds still continue to dry at differing rates, so they continue to align with the design intentions of the Threatened Frog Management Plan (RMS 2015).

**Plate 4-5.** Redbank ponds in mid December 2020 showing 100% capacity and adequate vegetation growth.

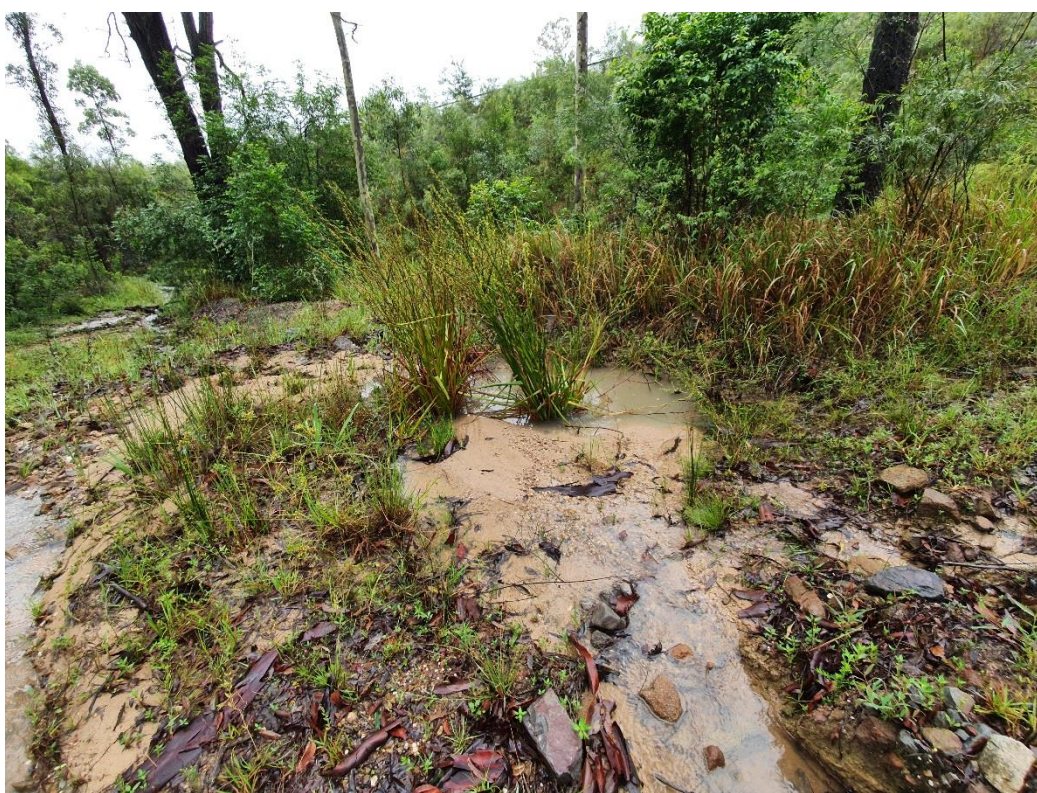
A follow up survey on the 1<sup>st</sup> January showed all five ponds contained water with capacity measured at 25-65% and they were likely to have contained water throughout the past 17 days. A follow up survey on the 24<sup>th</sup> January or around 41 days after the initial site survey found two ponds had almost dried out completely whilst the remaining three ponds contained between 10-35% of their capacity. Only Broad-palmed Frog and Bleating Tree Frog metamorphs and tadpoles were found. Whilst some ponds have shown some increased siltation, ponds were drying out at differing rates and with that, they meet the design intentions of the Threatened Frog Management Plan.

**Plate 4-6.** Pond inspection in mid December 2020 at Falconers (ch.11800) with some showing signs of siltation.

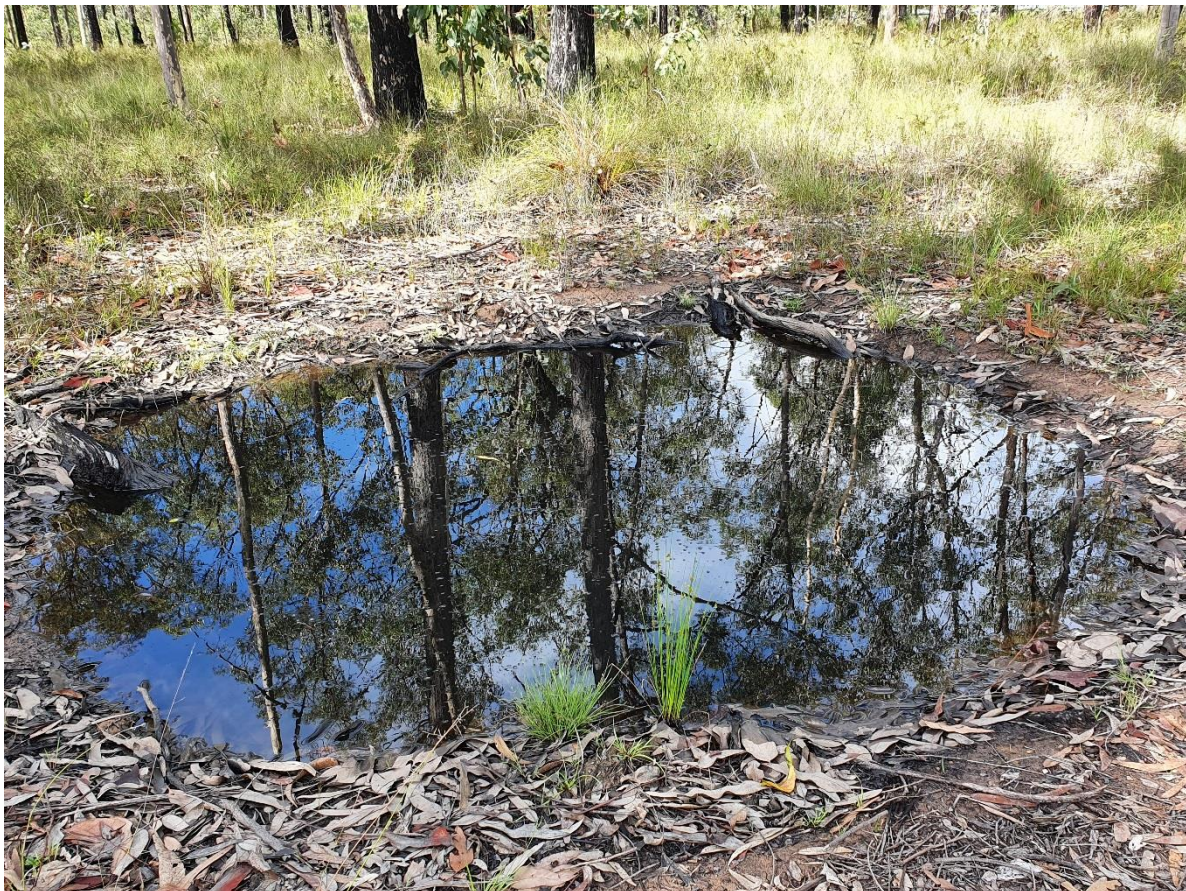
A follow up survey 16 days later on the 1<sup>st</sup> January found all ponds had remained near capacity at 75-90% (Plate 4-7). The following pond survey coincided with stage 2 post breeding surveys on the 23<sup>rd</sup> January when pond levels had receded to between 25-65%. Surveys found metamorphs frogs that were identified as Bleating Tree Frog and Broad-palmed Frog, but no Green-thighed Frog.

Little vegetation still exists around three of the five ponds, however, the ponds dry out at differing rates and this meets the design intend outlined in the Threatened Frog Management Plan (Plate 4-7).

**Plate 4-7.** Constructed ponds at Bald Knob Tick Gate Road (Site 3A) on the 1<sup>st</sup> January 2021 still holding water.

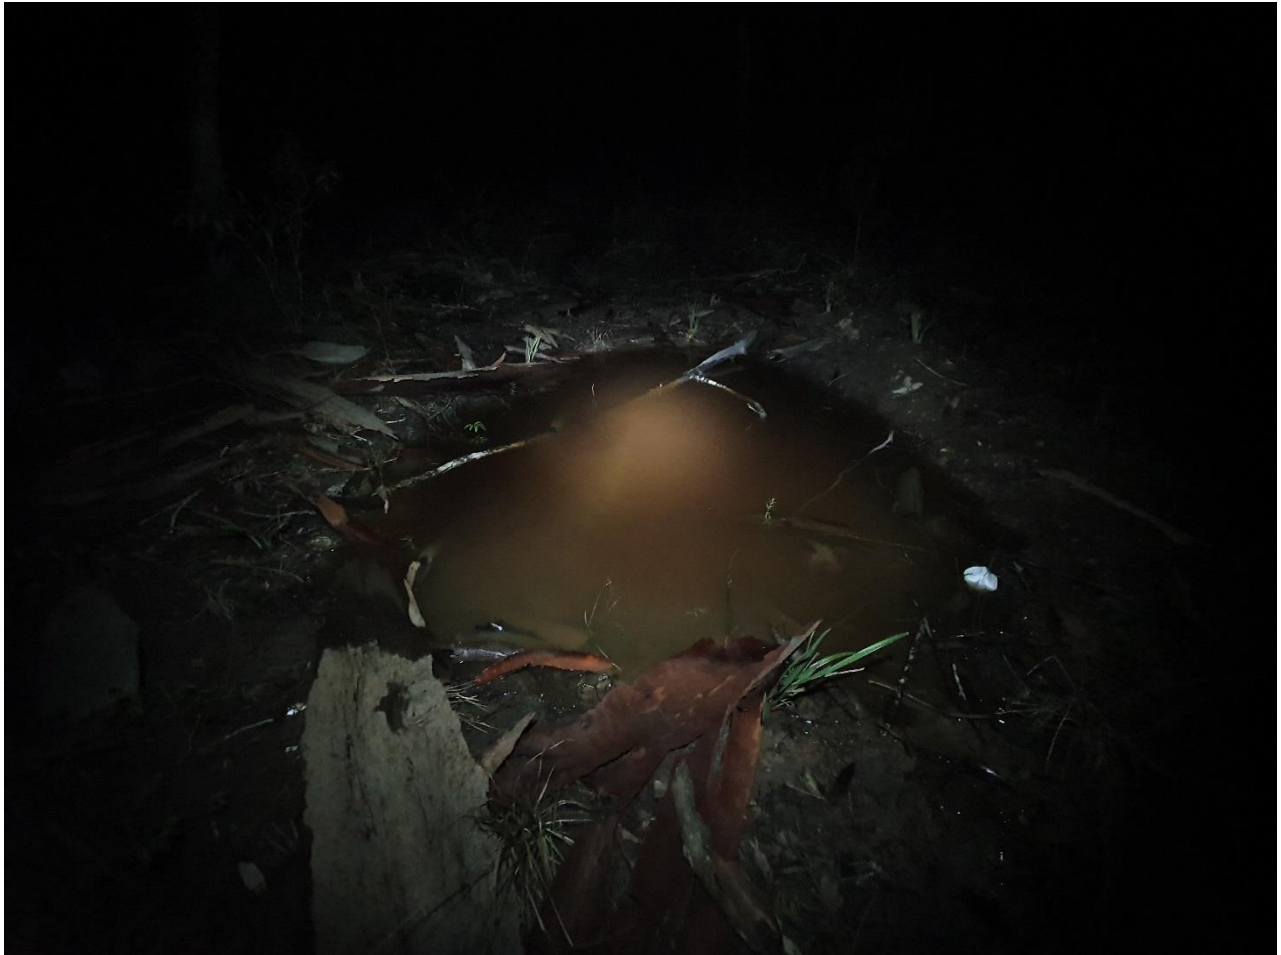
A follow up survey on the 1<sup>st</sup> January found the ponds had receded to between 40-80% of their capacity over the past 16 days. Another inspection on the 24<sup>th</sup> January found one pond contained around 10% capacity whilst the other seven ponds contained between 30-70% of their capacity. It is suspected that some thunderstorm activity may have assisted in the ponds retaining water over the 41 day period. Inspections around the pond edge found metamorphs of both Bleating Tree Frog and Broad-palmed Frog and a number of tadpoles belonging to the same species.

**Plate 4-8.** Constructed ponds at Site 7A (ch.37330) in mid December 2020.

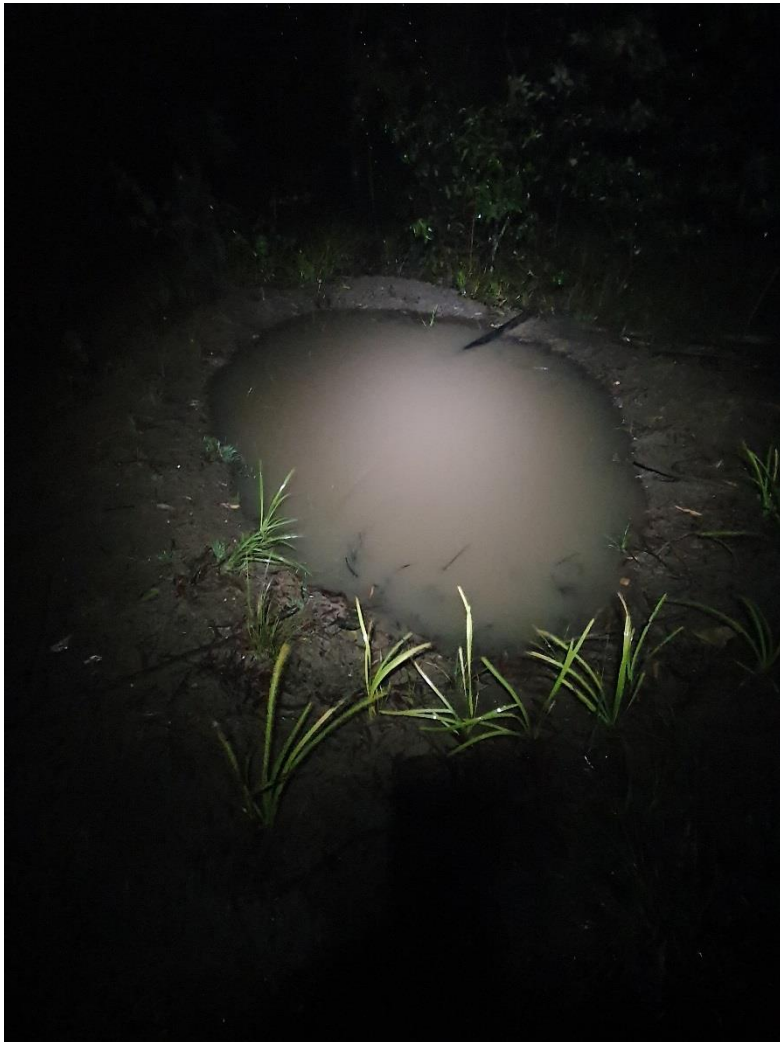
A follow up survey on the 31<sup>st</sup> December found the ponds had receded to between 40-60% of their capacity over the past 15 days. Another inspection on the 24<sup>th</sup> January found one pond contained around 20% capacity whilst the other two ponds contained 40% of their capacity. It is suspected that some thunderstorm activity may have assisted in the ponds retaining water over the 41 day period as this site contains porous substrate. Inspections around the pond edge found no metamorphs and a number of tadpoles were identified as Green-thighed Frog.

**Plate 4-9.** Constructed ponds at Tyndale Site 8A (ch.37330) in mid December 2020.

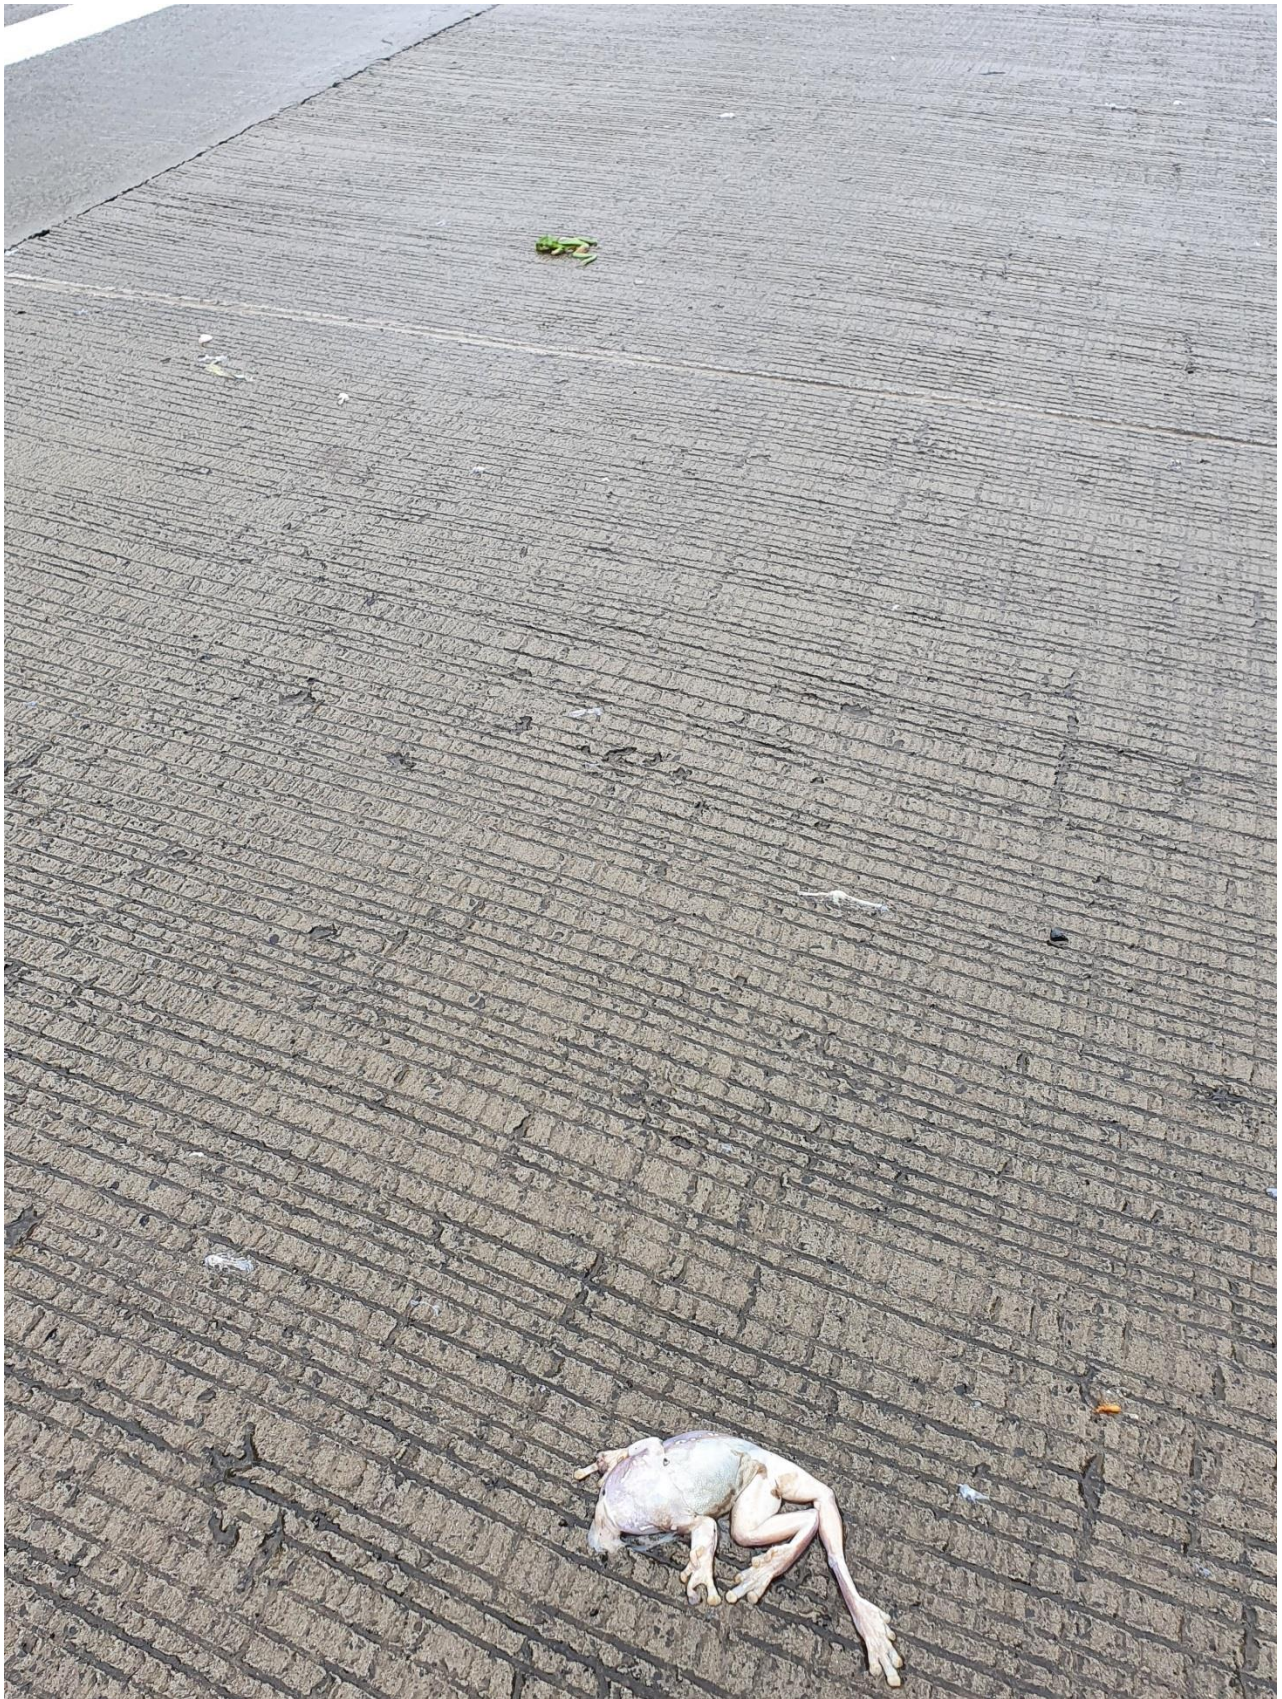
**Plate 4-10.** South bound carriageway at Redbank Creek where many hundreds of road kill frogs were recorded adjacent to constructed frog ponds and permanent frog fence.

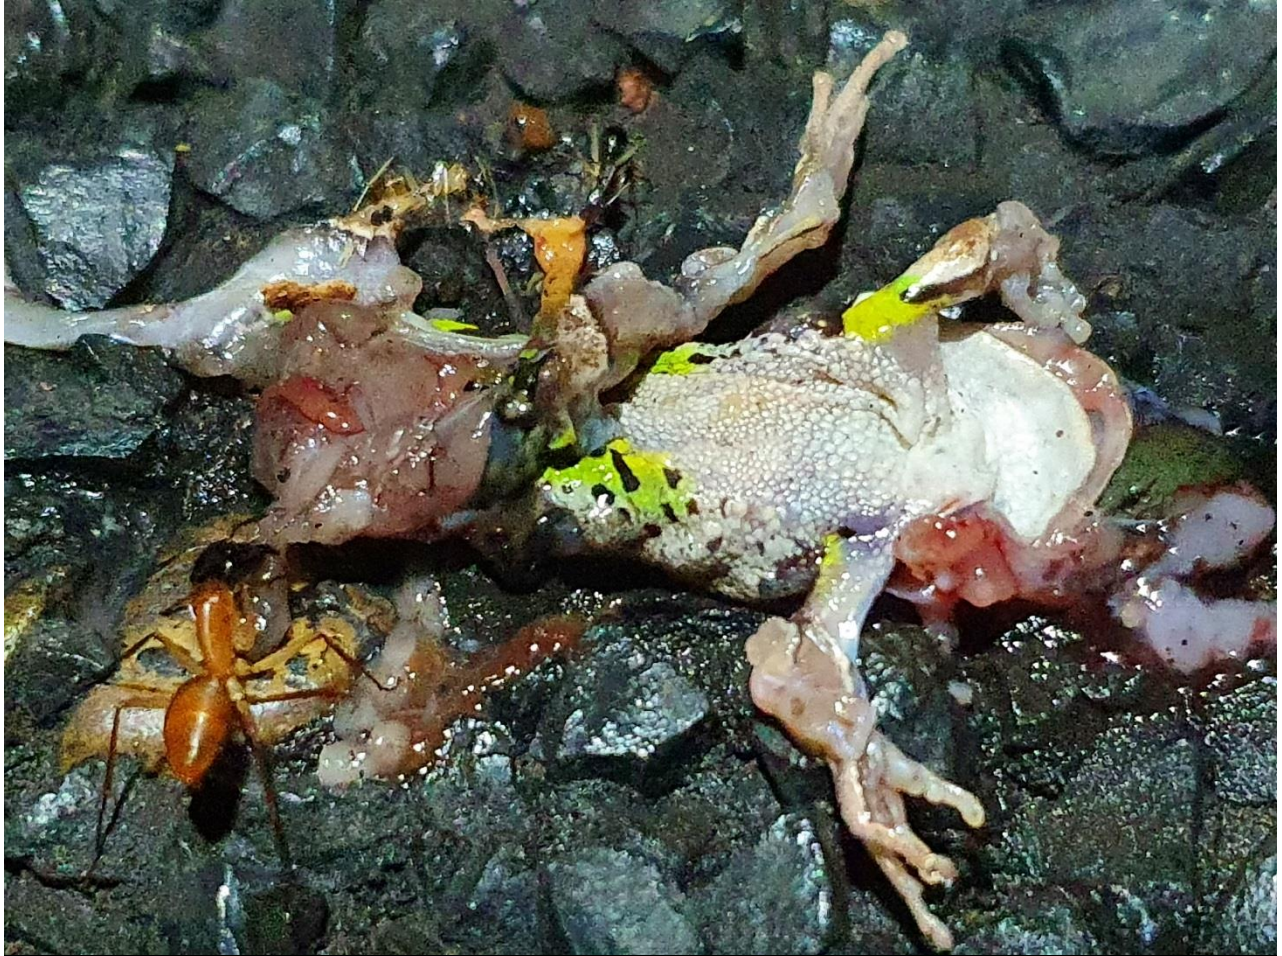
Plate 4-11. Road kill Green-thighed Frog at the reference Site 6B on Airport Road.

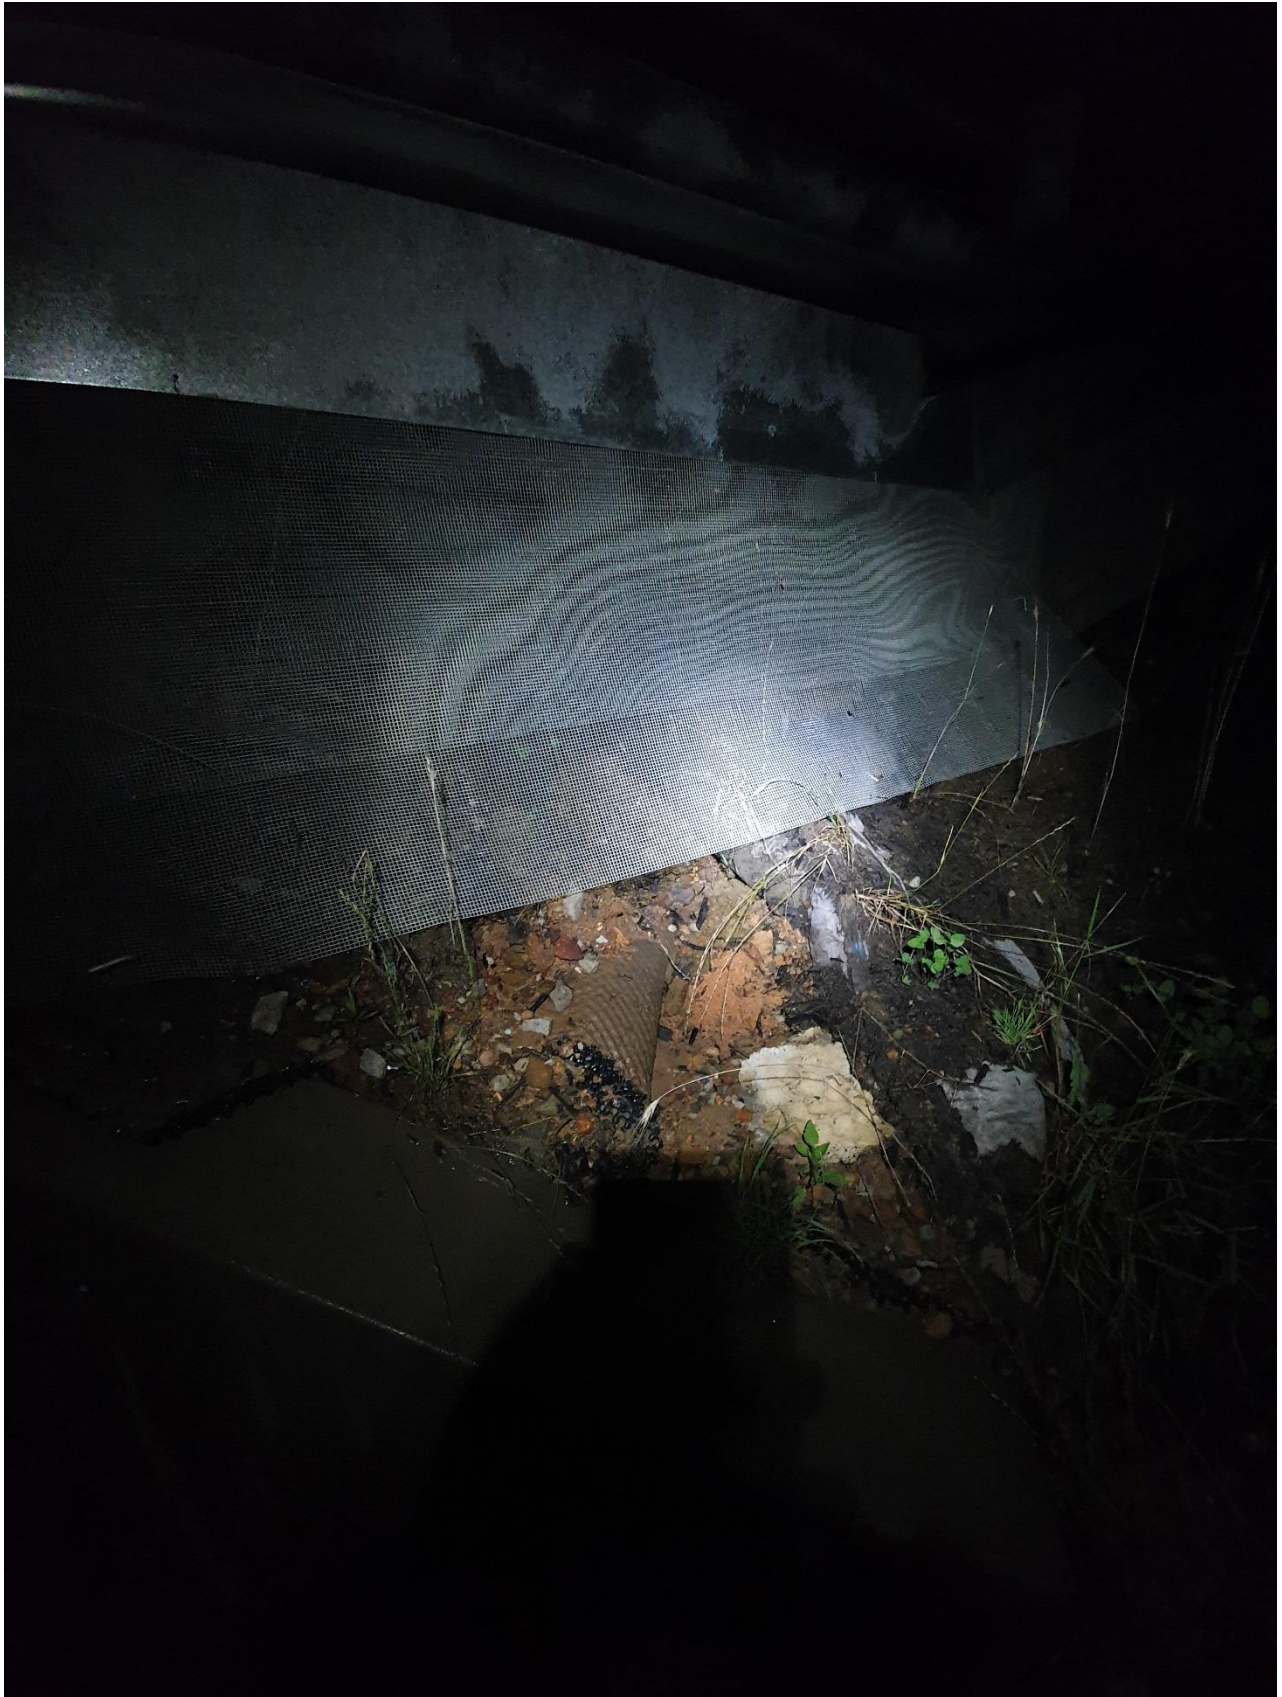
Plate 4-12. Example of a breach point at a monitored connectivity structure: Site 7A ch. 37330 inlet side of wing wall.

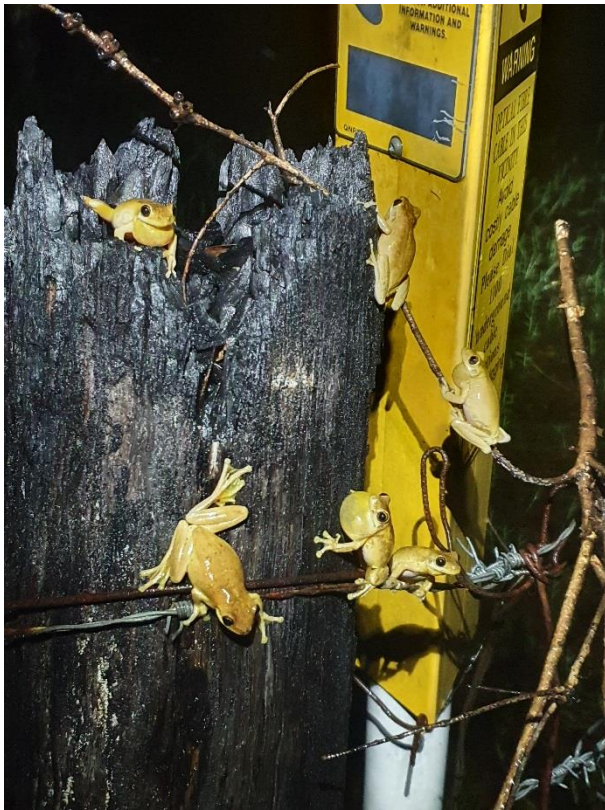
**Plate 4-13.** Example of calling site and calling intensity of non target species at Jackybulbin during mid December surveys. Tylers Tree Frogs.

so the aural range can be drastically reduced. In some cases such as Jackybulbin (Site 9A) there were so many Tylers Tree Frog, Graceful Tree Frog and Bleating Tree Frog that the surveyor had to be within a few metres to hear the call of the Green-thighed Frog (Plate 4-13).
