Woolgoolga to Ballina Pacific Highway upgrade

**Threatened Frog Monitoring Annual Report
2017/18**

Version 5.0

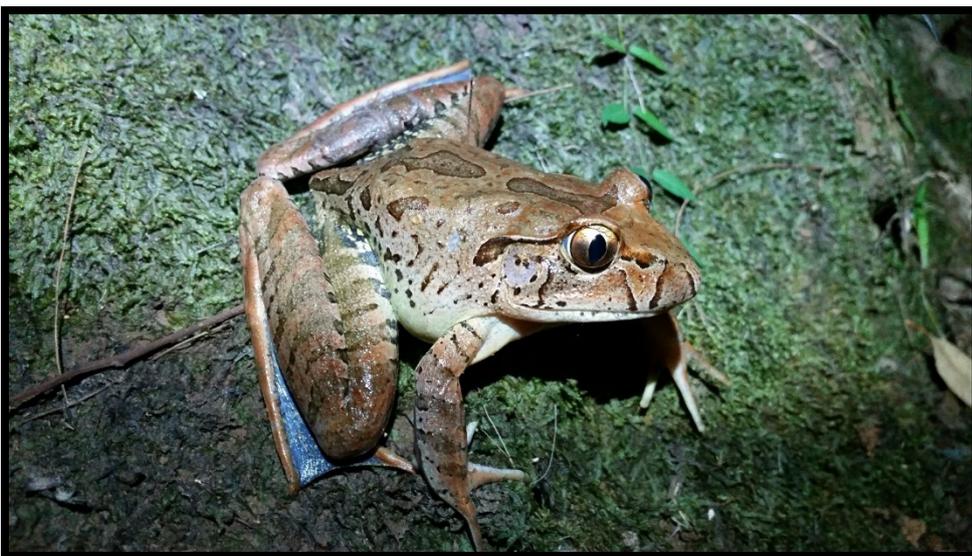
Plate 3-1. Giant Barred Frog (ad) from Corindi Creek.

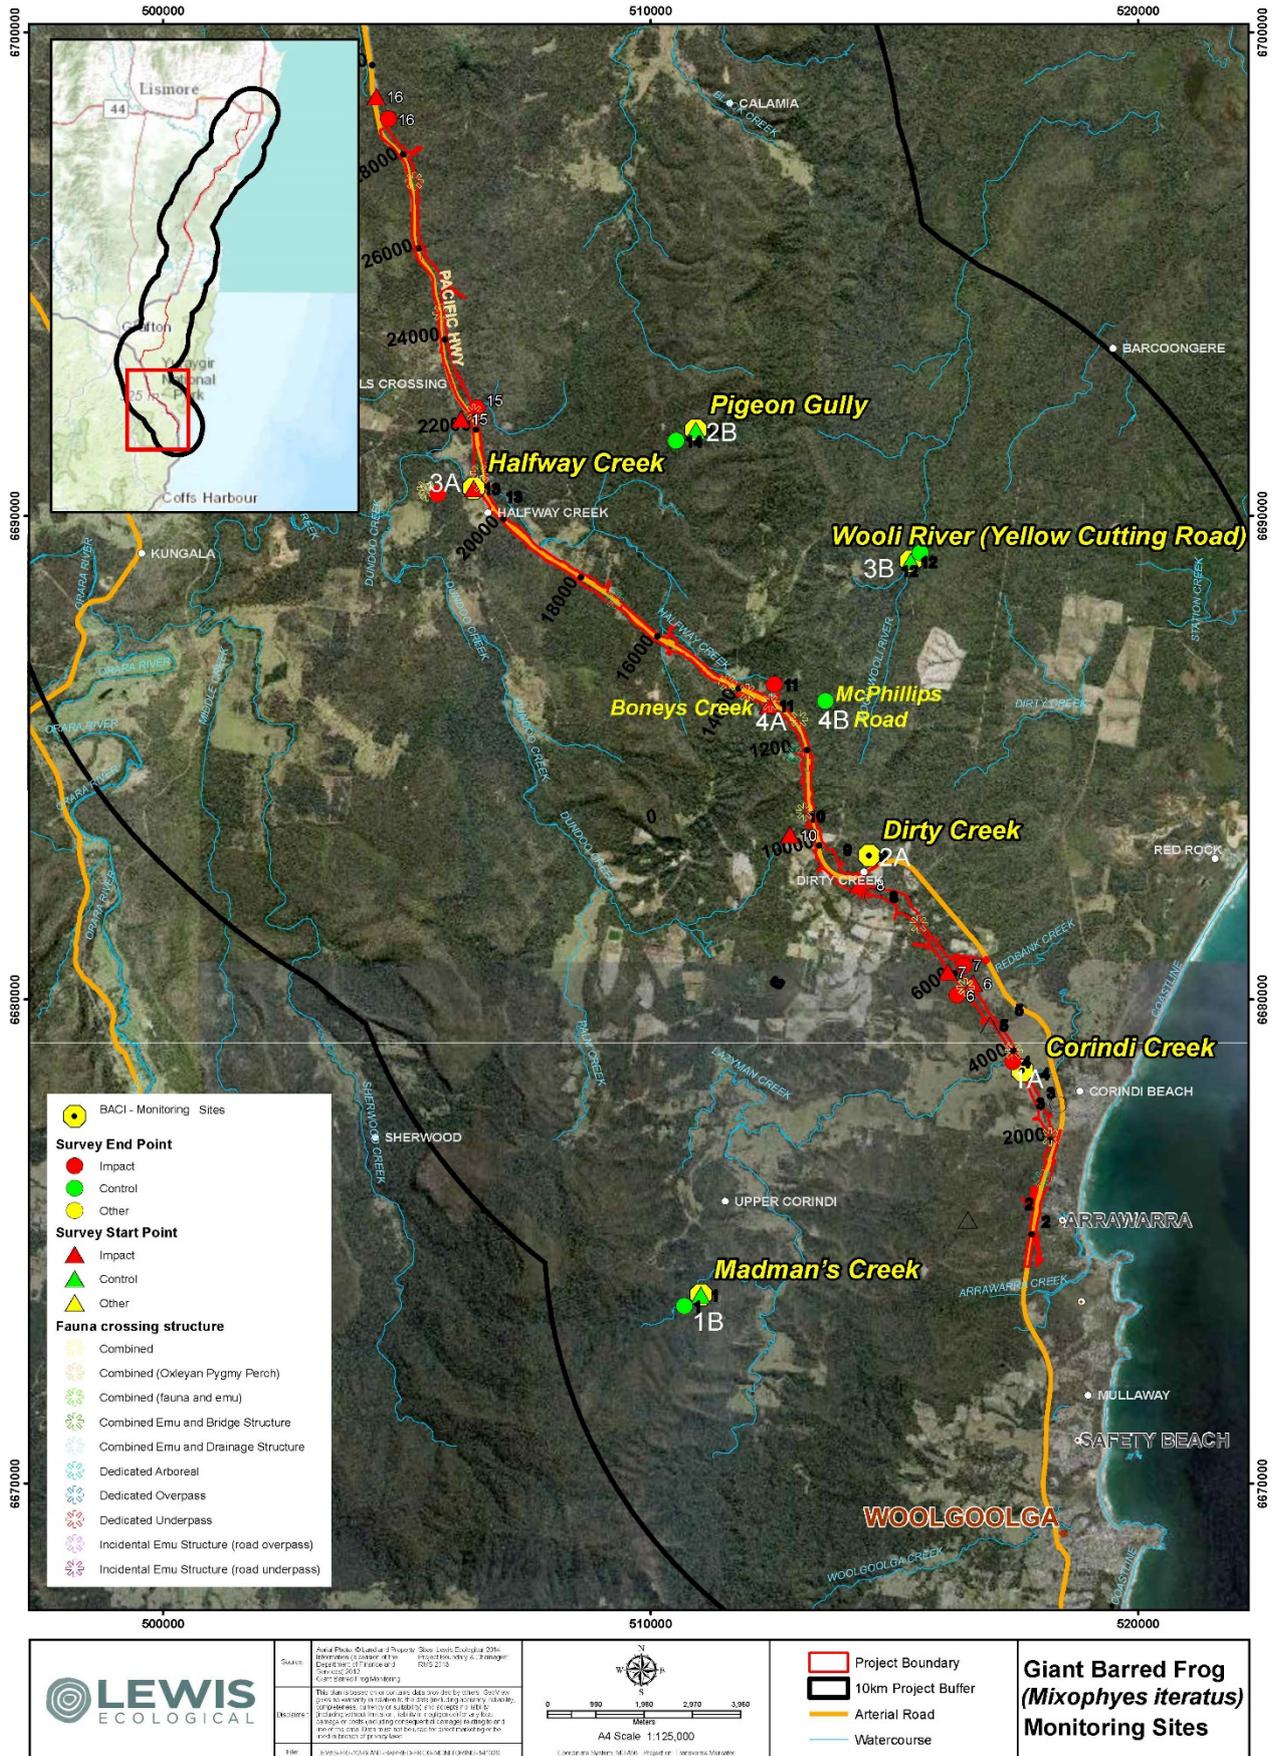
Figure 3-1. Locations of Giant Barred Frog BACI Monitoring Sites 1-4 in Sections 1 and 2 of Woolgoolga to Ballina Upgrade.

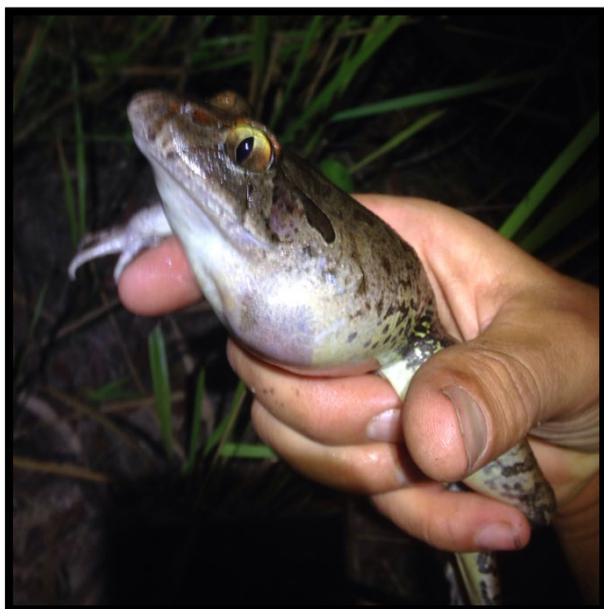
Plate 3-2. Giant Barred Frog with missing limb captured during monitoring surveys at Corindi Creek (Site 1A) in Feb 2018.

In accordance with recommendations outlined in the baseline surveys, captured frogs were microchipped for individual verification during later sampling. Seventy-eight (78) frogs were micro-chipped, whilst the remainder were either recaptures, had very obvious markings such as missing limb (Plate 3-1), had simply eluded capture or were too small to insert microchips (Appendix A).

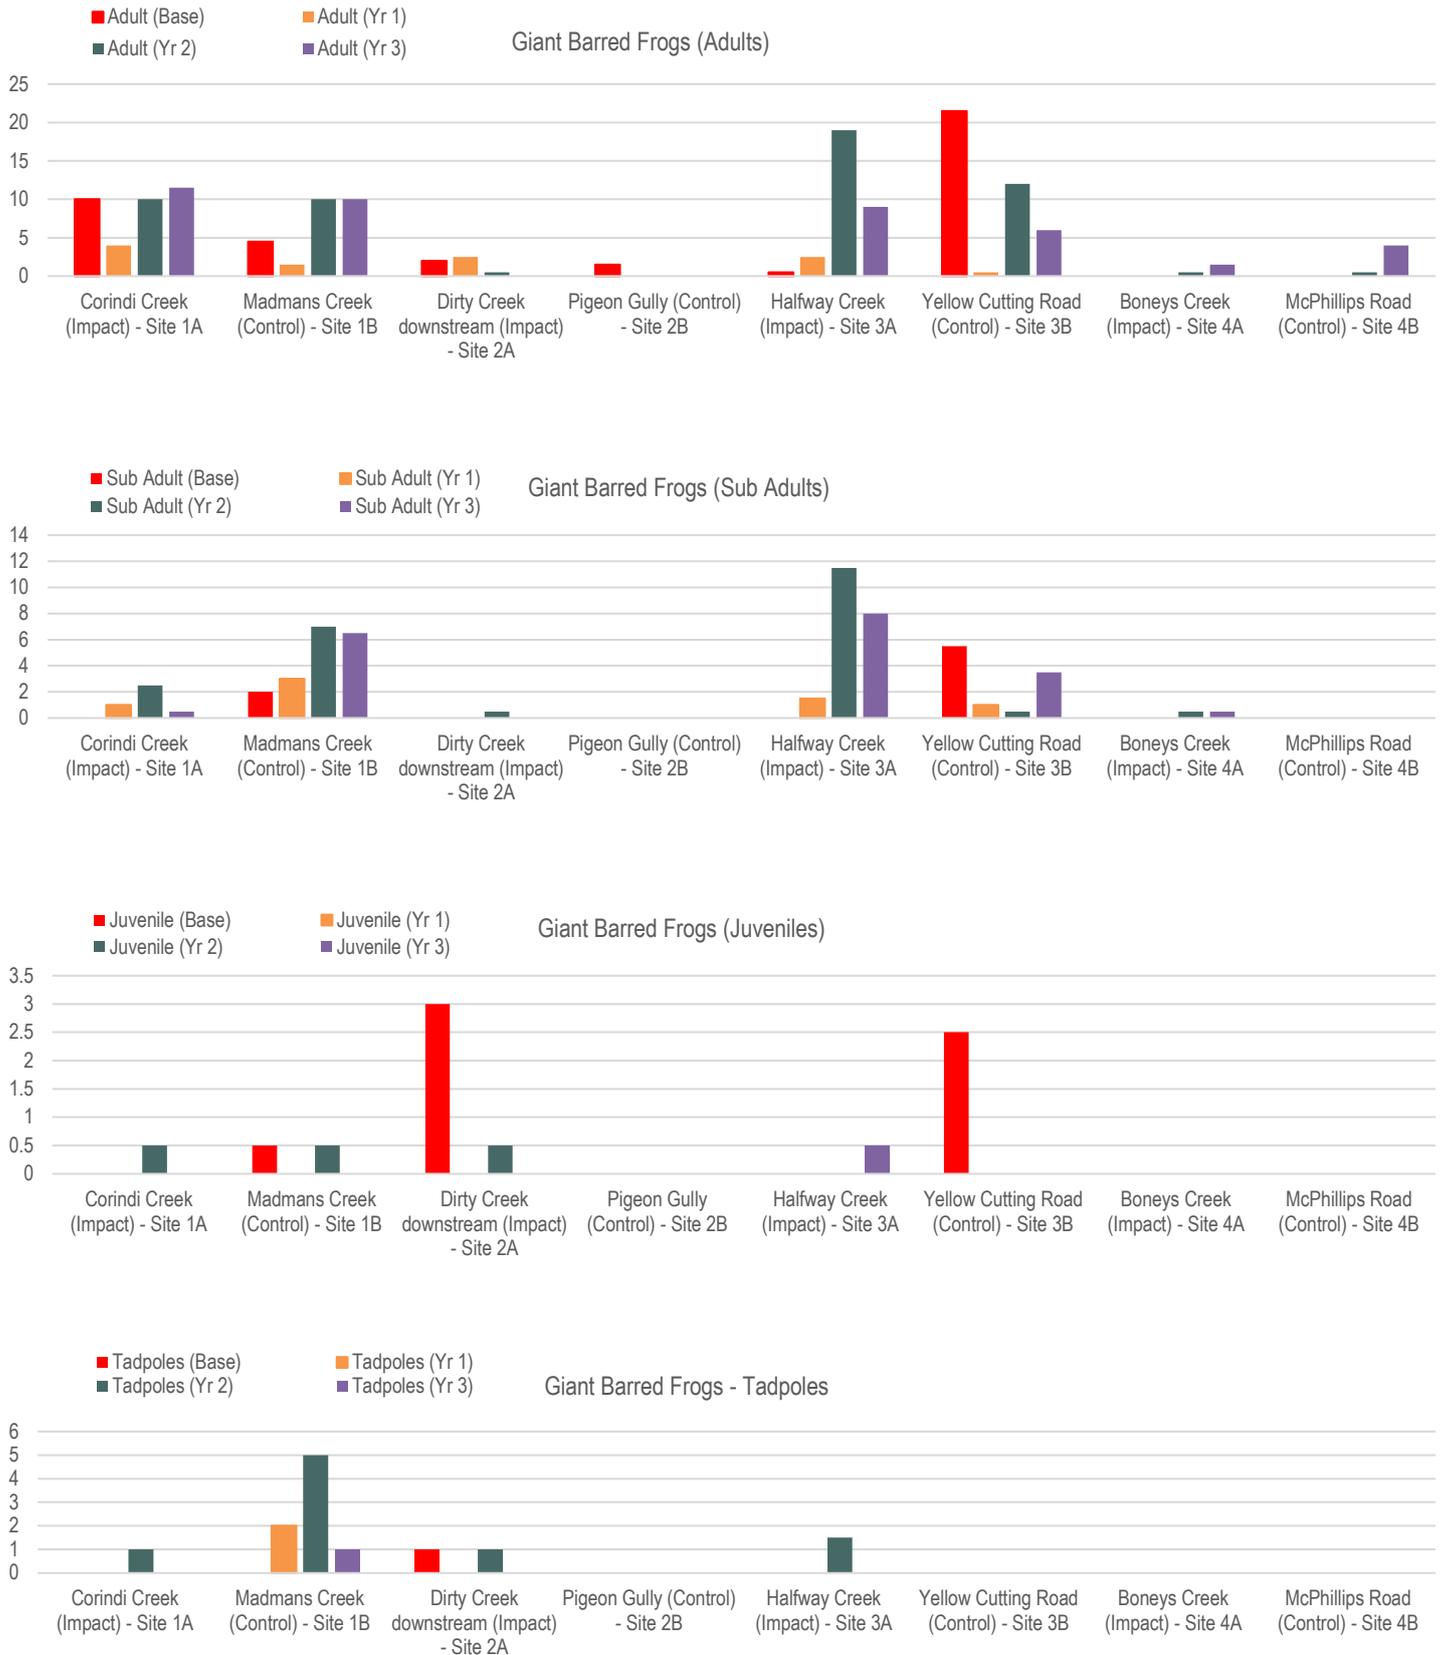
Figure 3-2. The number of Giant Barred Frogs recorded between pre-construction monitoring and construction monitoring Year 1, 2 and 3 according to age class.

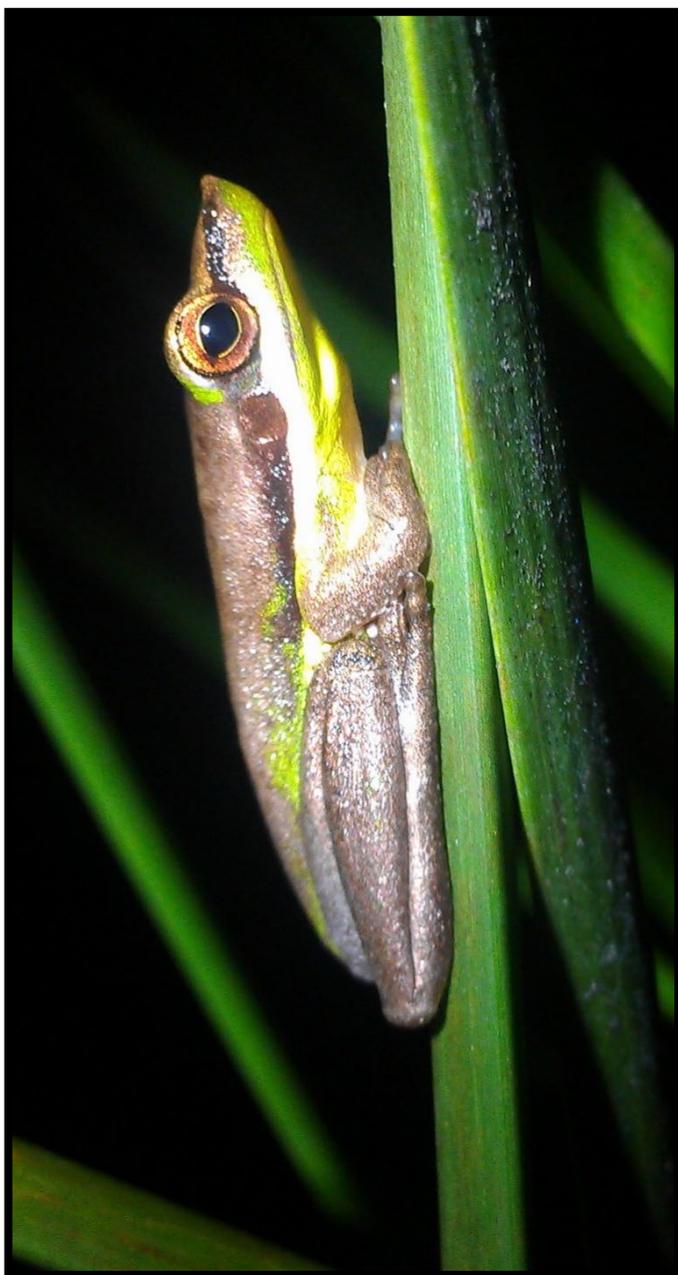
Plate 4-1. Adult Wallum Sedge Frog using *Lepironia* sedges growing in standing water to the east of ch. 146500.

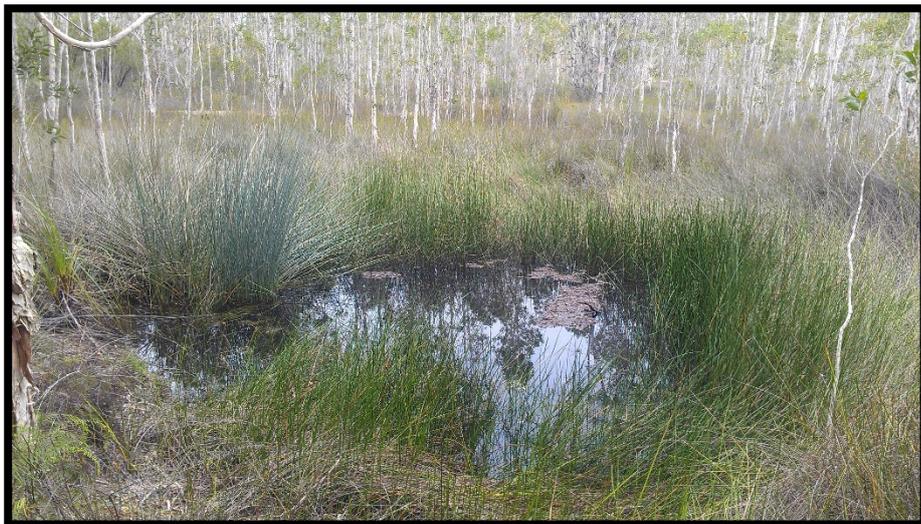
Plate 4-2. Wallum Sedge Frog habitat along the W2B corridor (adjacent ch. 148550).

The Wallum Sedge Frog is an "acid" frog confined to the coastal sandplain wallum swamps. Their life-cycle is adapted to the acidic pH (2.8-5.5) of these wetlands. Frogs are highest in abundance in relatively undisturbed wallum swamps. Breeding habitat is characterised by the presence of emergent sedges, with upright species such as *Baumea* spp. and *Schoenus* spp. preferred by adult frogs for perching. Frogs can be found in breeding habitat throughout the year

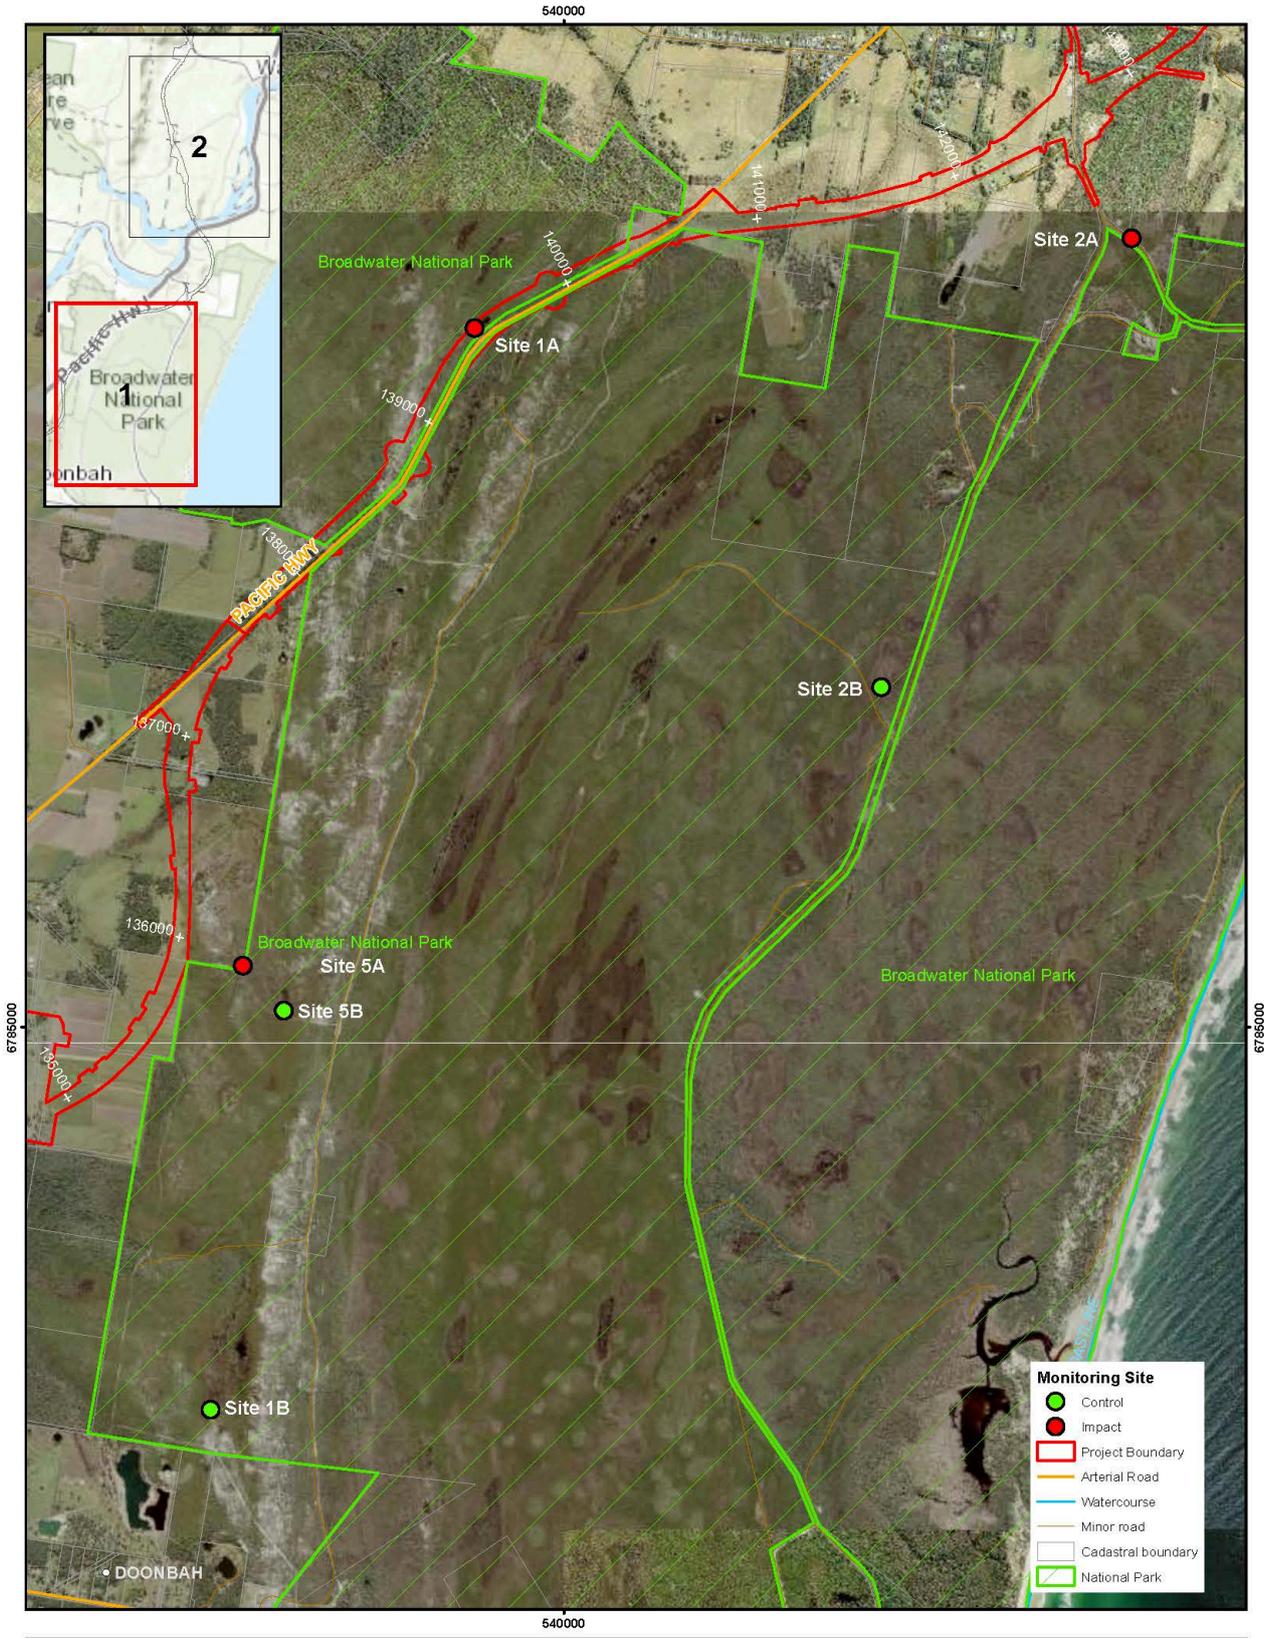
Figure 4-1. Locations of Wallum Sedge Frog BACI Monitoring Sites in Sections 8 and 9 of Woolgoolga to Ballina Upgrade.

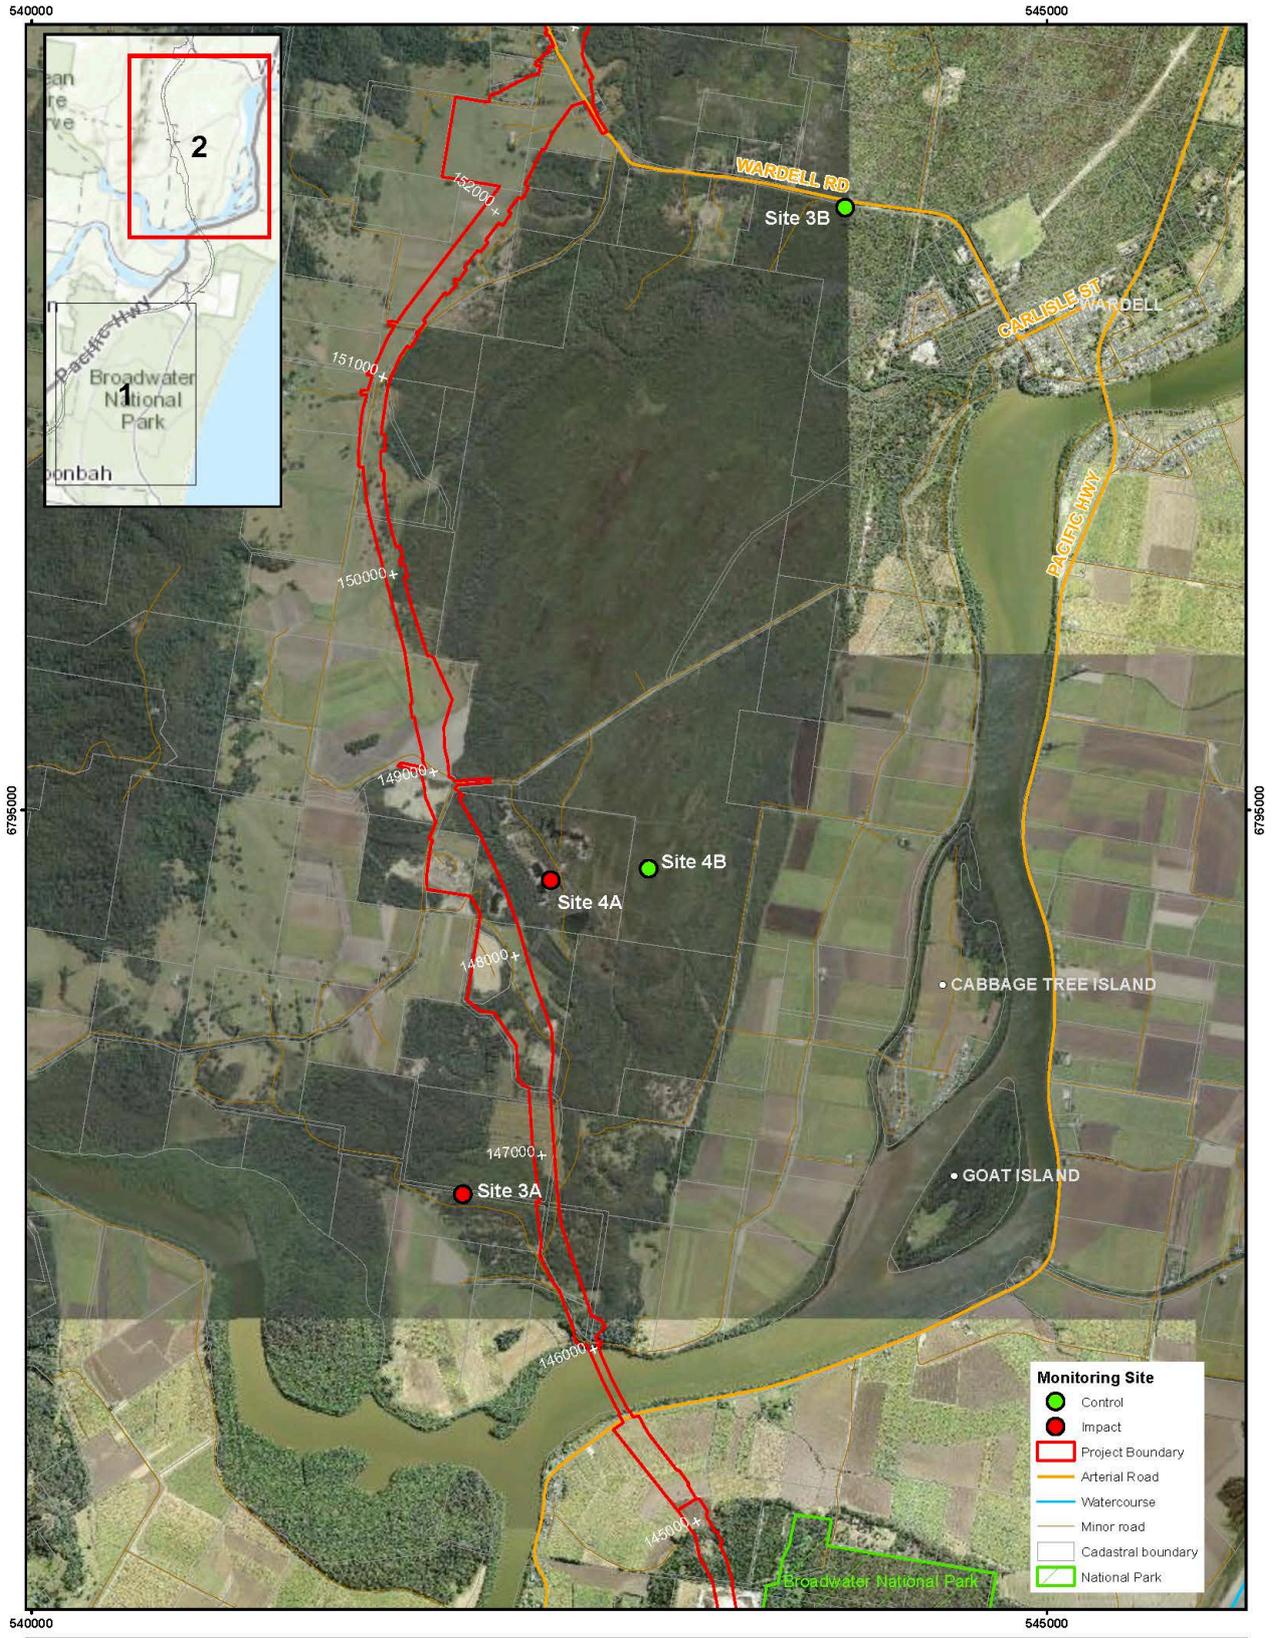
Figure 4-2. Locations of Wallum Sedge Frog BACI Monitoring Sites in Section 10 of the Woolgoolga to Ballina Upgrade.

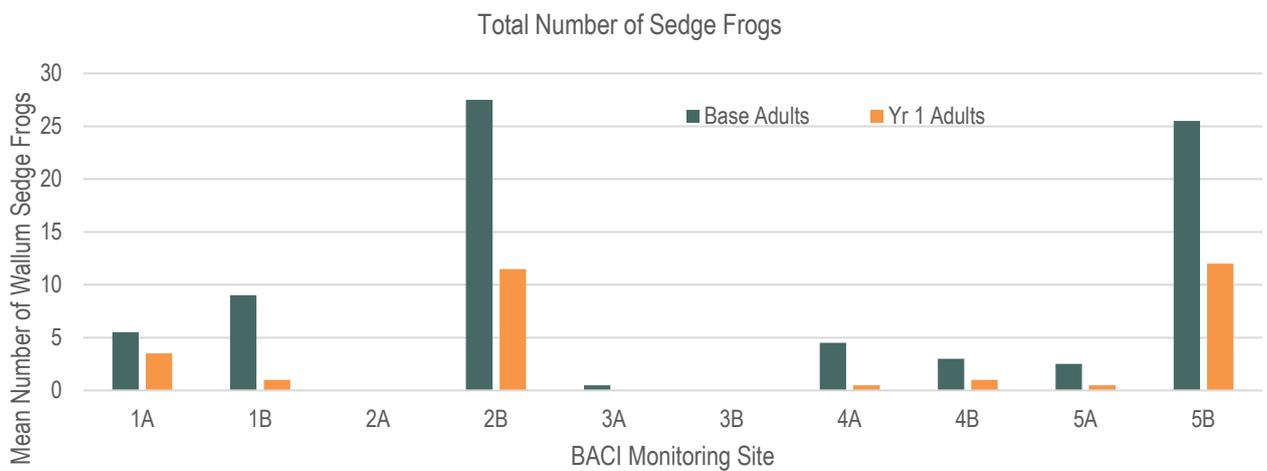
Figure 4-3. Wallum sedge frog counts between baseline survey and Year 1 monitoring.

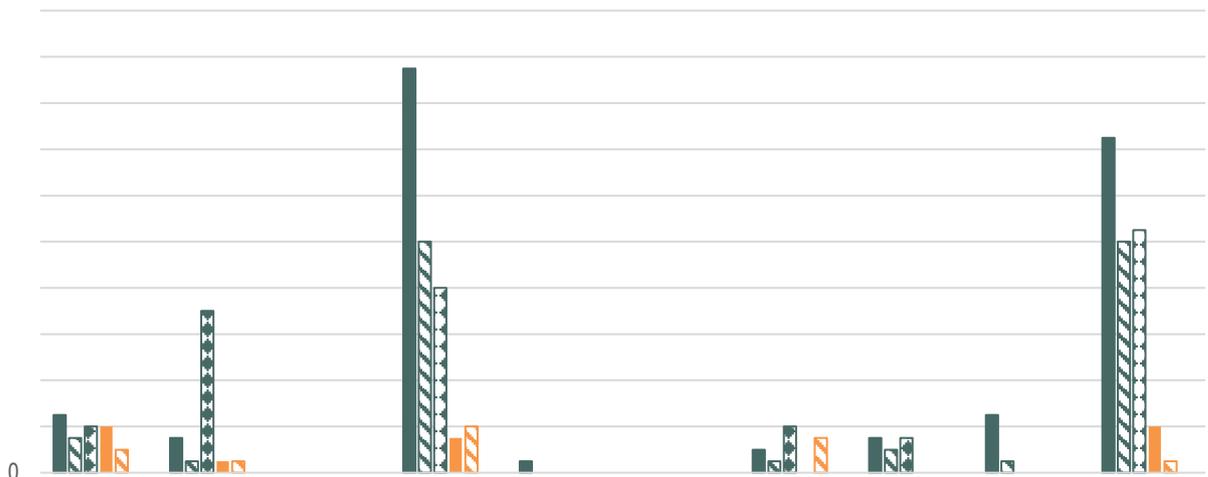
Figure 4-4. Wallum sedge frog counts across three age classes between baseline survey and Year 1 monitoring.

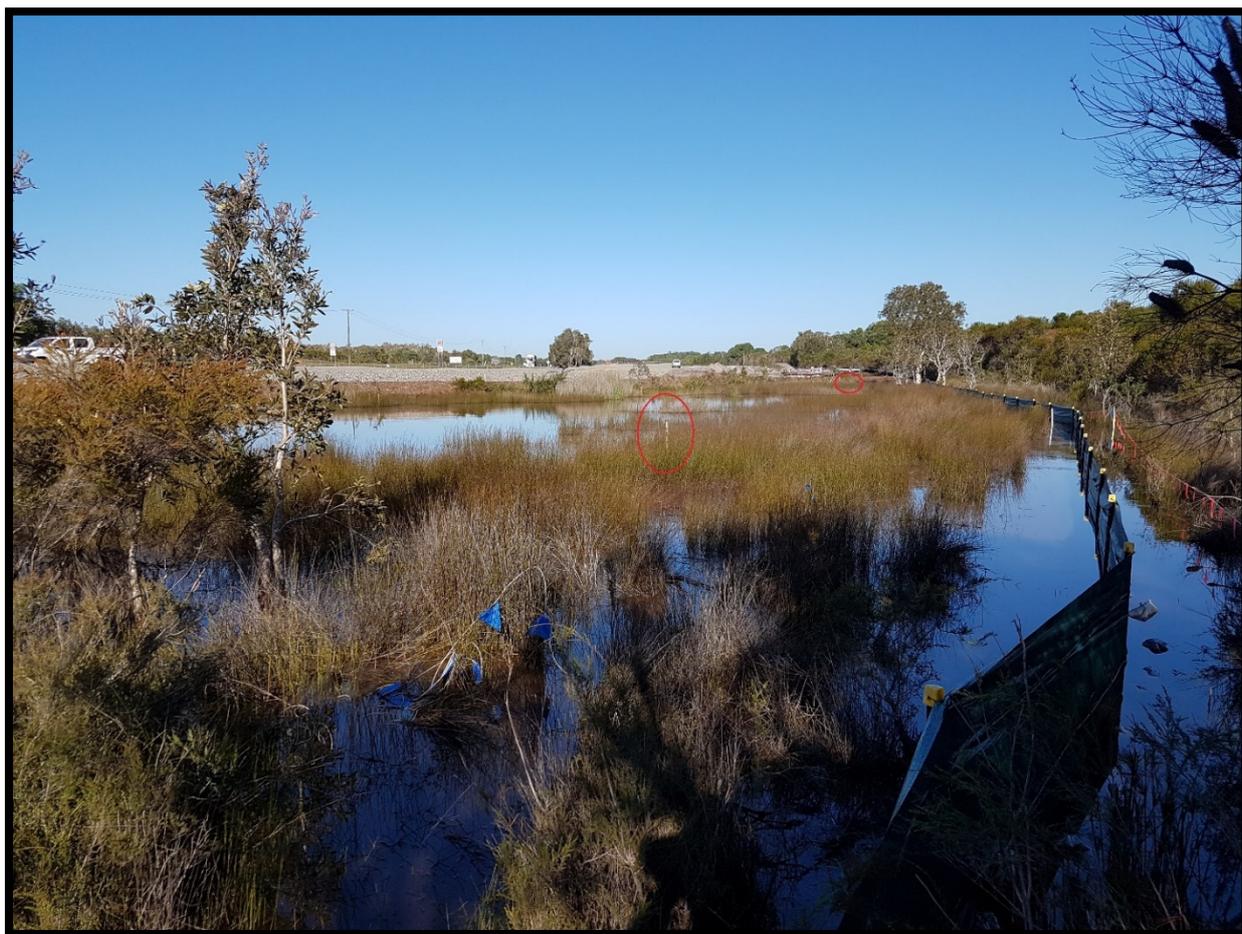
At the time of monitoring, no permanent frog fencing had been installed at sedge frog locations. There was, however, some temporary fencing observed during the winter round of monitoring at Site 1A (Broadwater National Park ch. 139500W) constructed from silt fencing and without a top return lip (Plate 3-1). The frog counts performed at this time would suggest this design had little success at excluding frogs from the construction site, with both adults and sub adults within the construction works area where pre-clearing surveys should have removed individuals prior to clearing.

Plate 4-3. Location of Site 1A monitoring transect (red circles) and installed temporary frog exclusion fence with no return lip for hylid frogs.

Temporary frog fencing in the form of sediment barrier fencing was observed at Site 1A (ch. 139500) during the second round of sampling. The recording of frogs along the transect at this time reflects, one of two things, the pre-clearing surveys were ineffective at capturing and relocating frogs to areas beyond the clearing footprint, or secondly, the fence itself is ineffective at excluding frogs from the construction site. It was noted, the fence did not have a return lip to prevent tree frogs from scaling the fence. Without it, it is almost a pointless mitigation tool apart from providing additional protective measures for the threatened Wallum Froglet (*Crinia tinnula*).

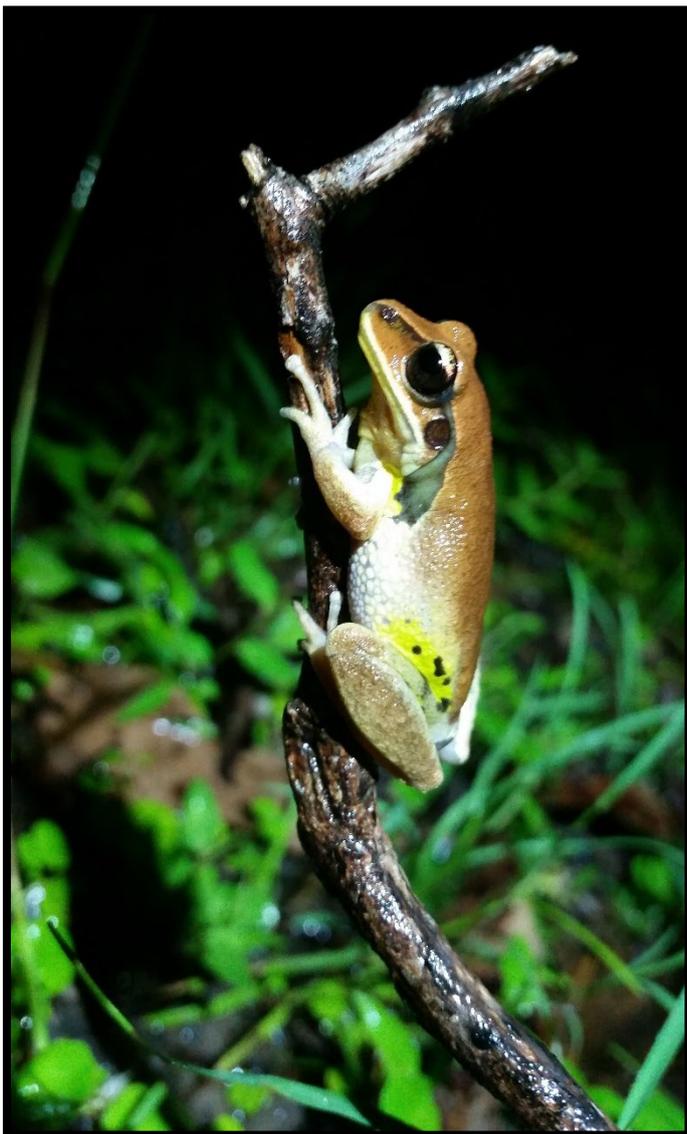
Plate 5-1. Green-thighed Frog.

The Green-thighed Frog is a small to medium sized (max. 47 mm) hylid frog (Barker *et al.* 1995; Cogger 1995; Murphy and Turnbull 1999; Lemckert *et al.* 2006). It is a relatively distinct species with a prominent white upper lip, armpits and groin marked in lime green or yellowish in some instances but always with black markings (Barker *et al.* 1995; Lemckert *et al.* 2006).

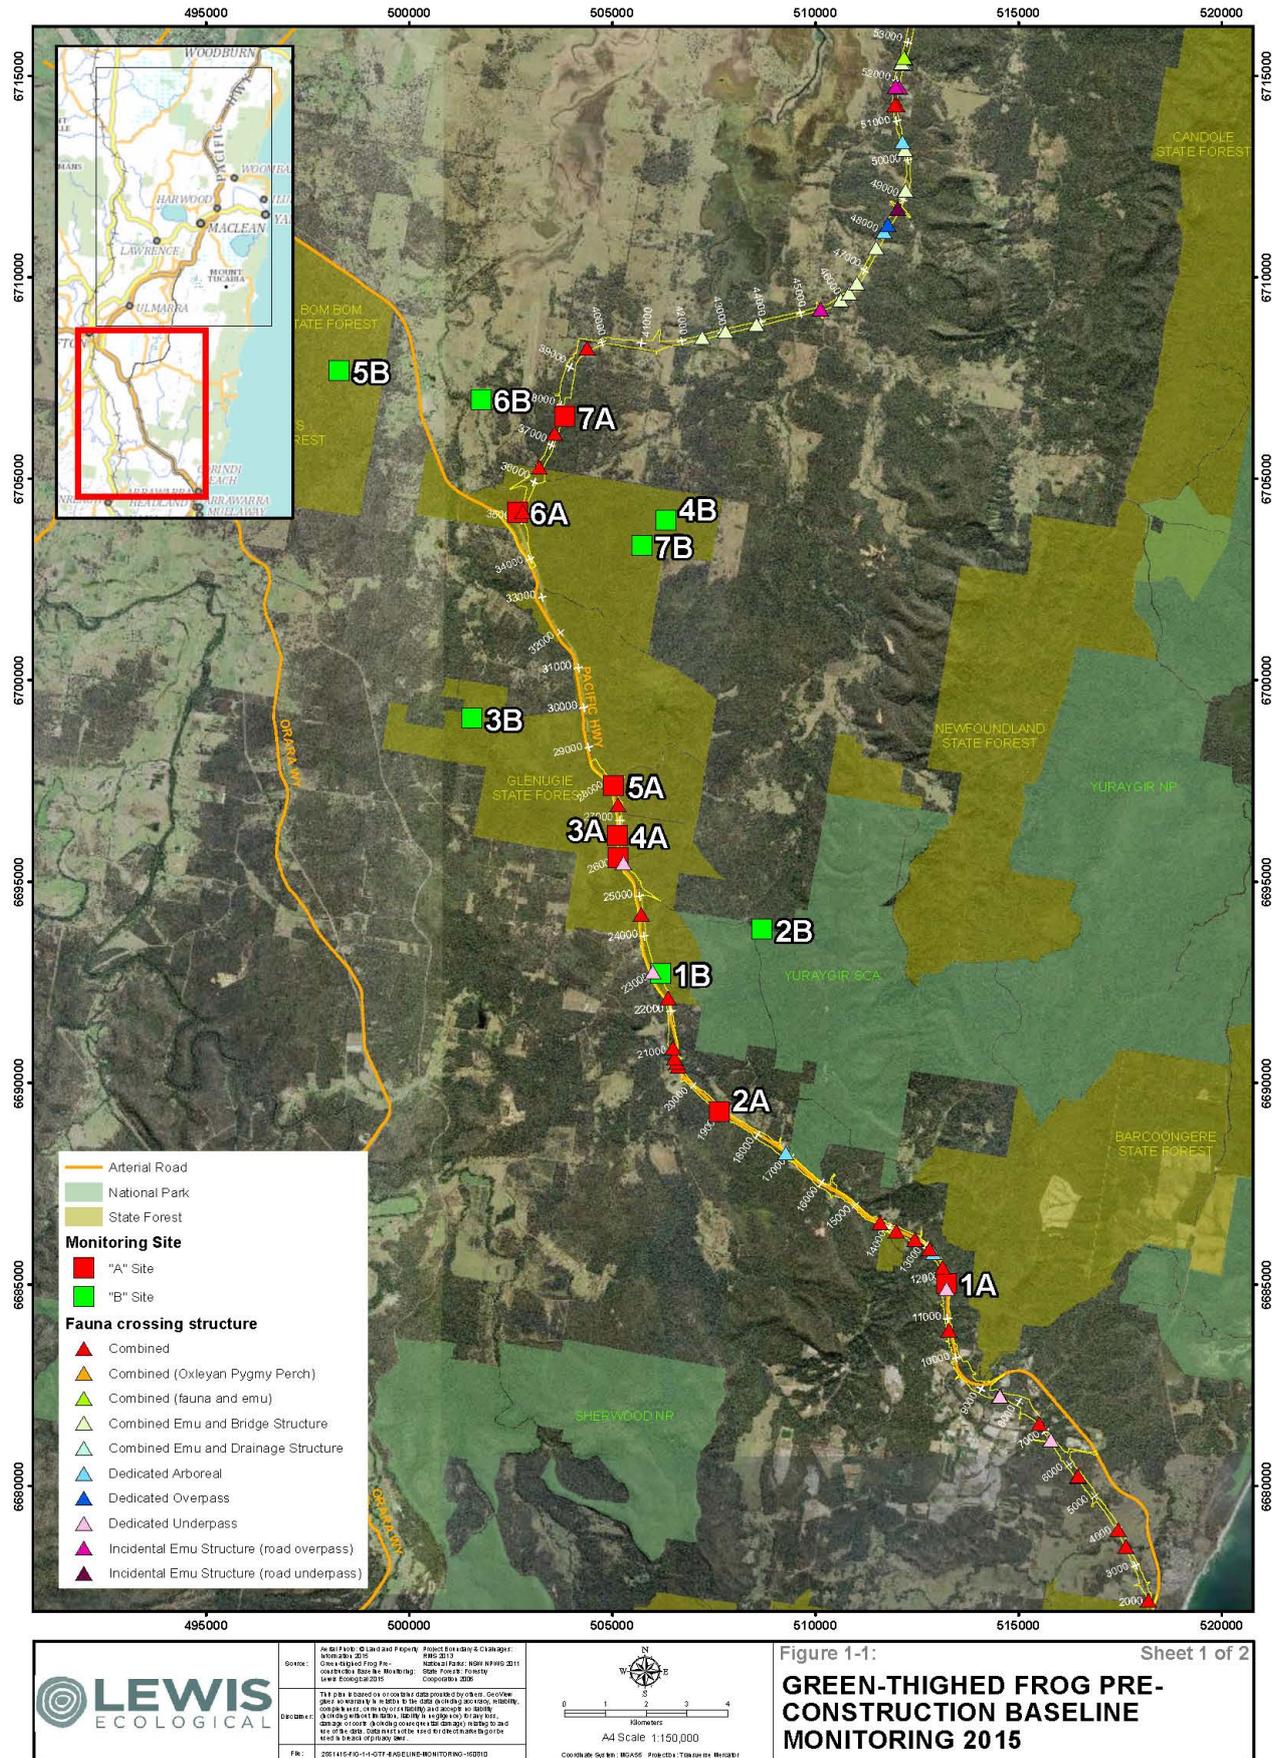
Figure 5-1. Locations of Green-thighed Frog BACI Sites 1-7 between ch.11800–40000.

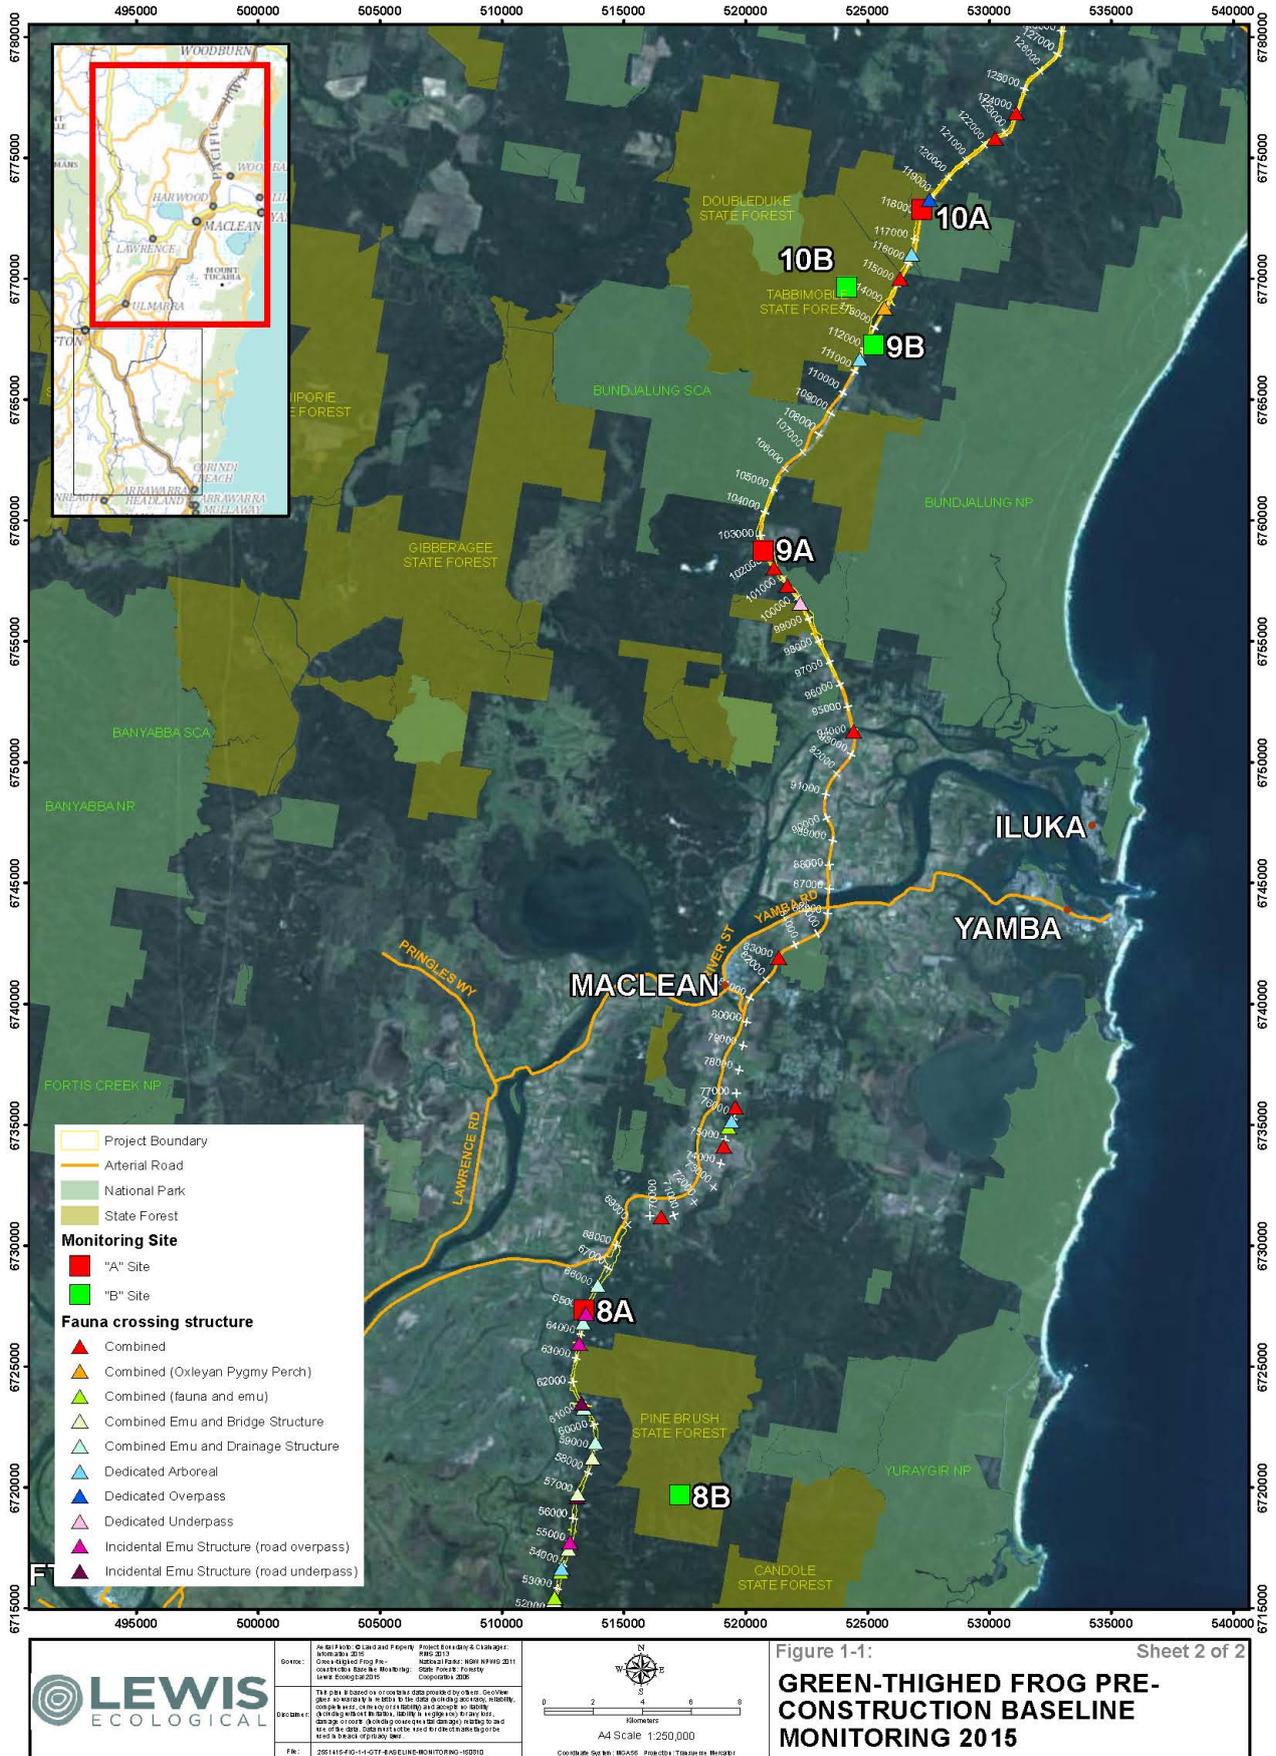
Figure 5-2. Locations of Green-thighed Frog Control and Impact sites between ch. 57500–118500.

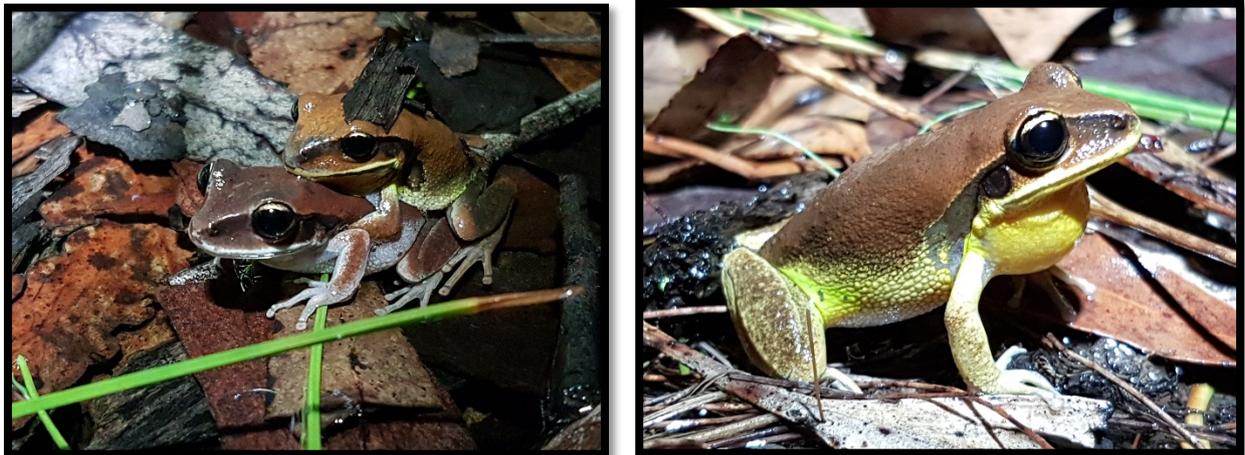
Plate 5-2. Green-thighed Frogs in amplexus (left) from Site 5A (Franklins Road) and a male calling (right) from Site 7A (Six Mile Lane).

Amplexing or mating frogs were recorded from Site 3A (Bald Knob Tick Gate Road) and 5A (Franklins Road) on the 22nd and 23rd December 2017. At these two sites, counts of 11 and 17 frogs were made following summer thunderstorm activity in this area. At the remaining sites, counts were generally of less than five frogs.

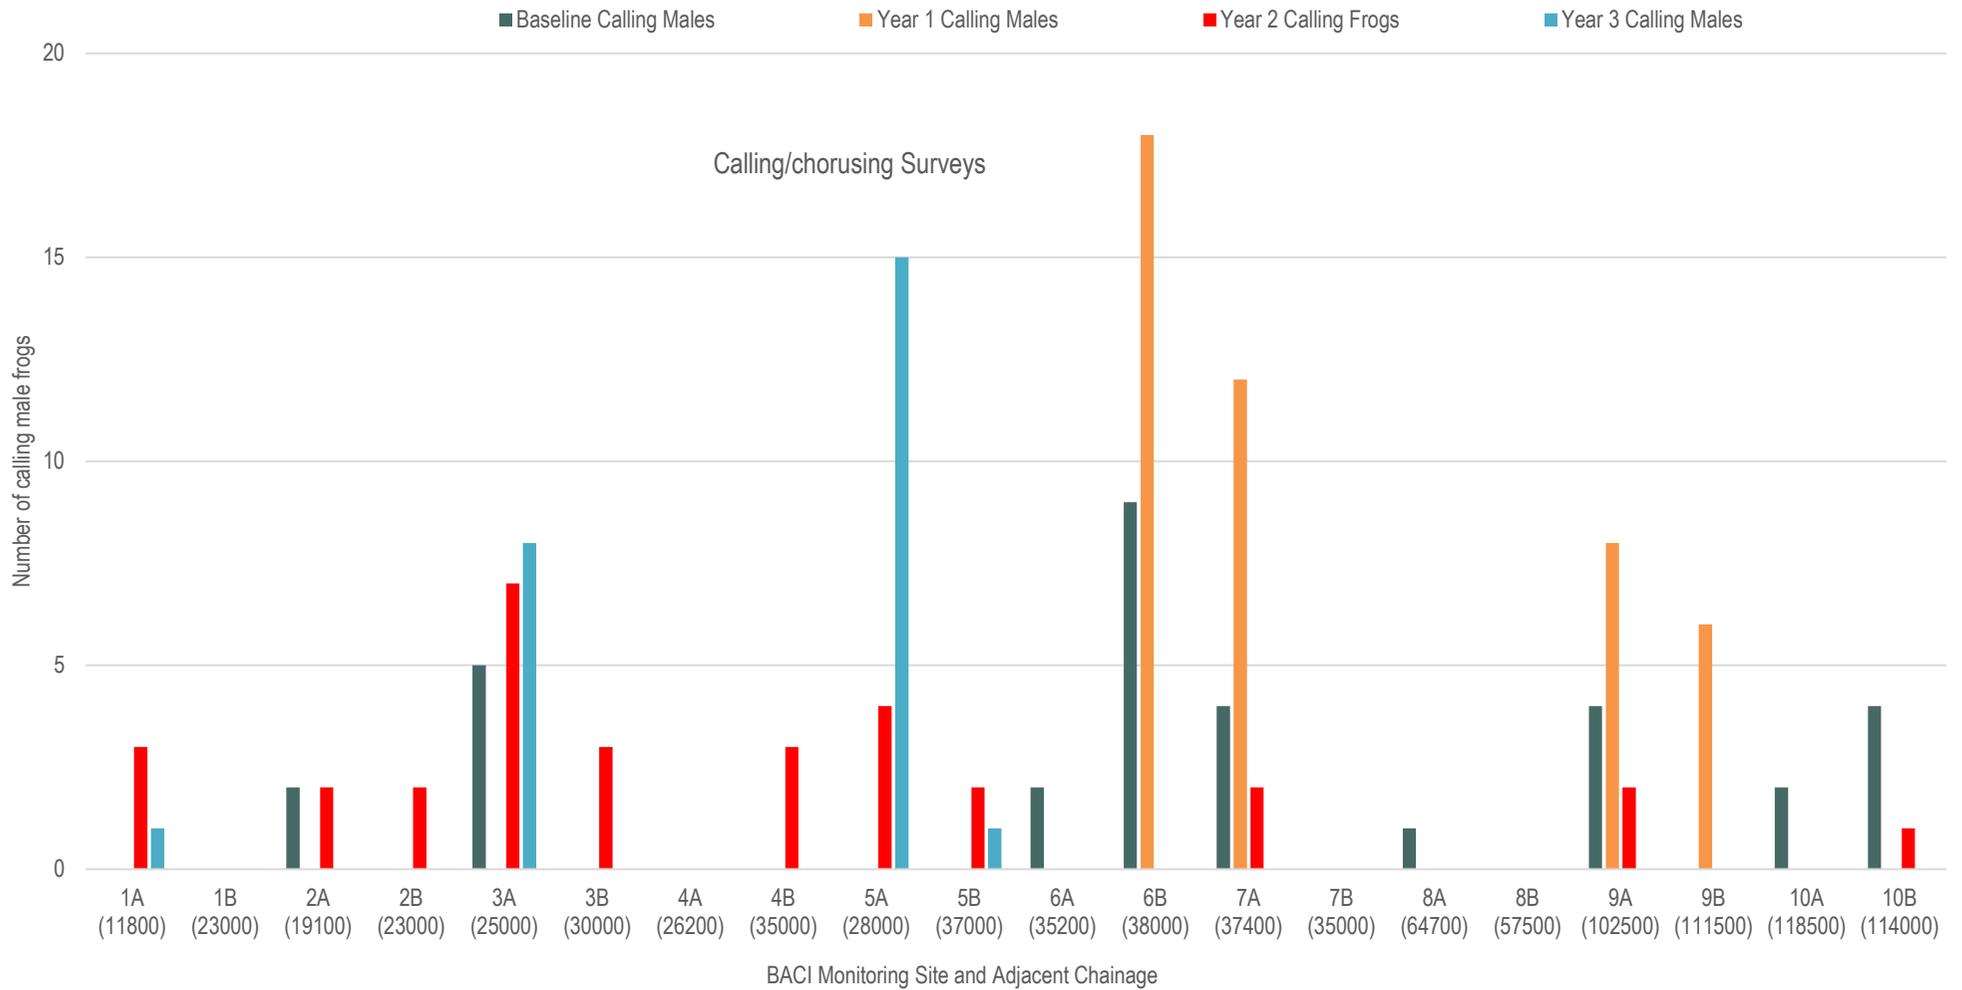
Figure 5-3. The number of calling male Green-thighed Frogs between the pre construction surveys and construction monitoring in Years 1, 2 and 3.
