Woolgoolga to Ballina Pacific Highway upgrade

**Threatened Frog Monitoring Annual Report
2017/18**

Version 5.0

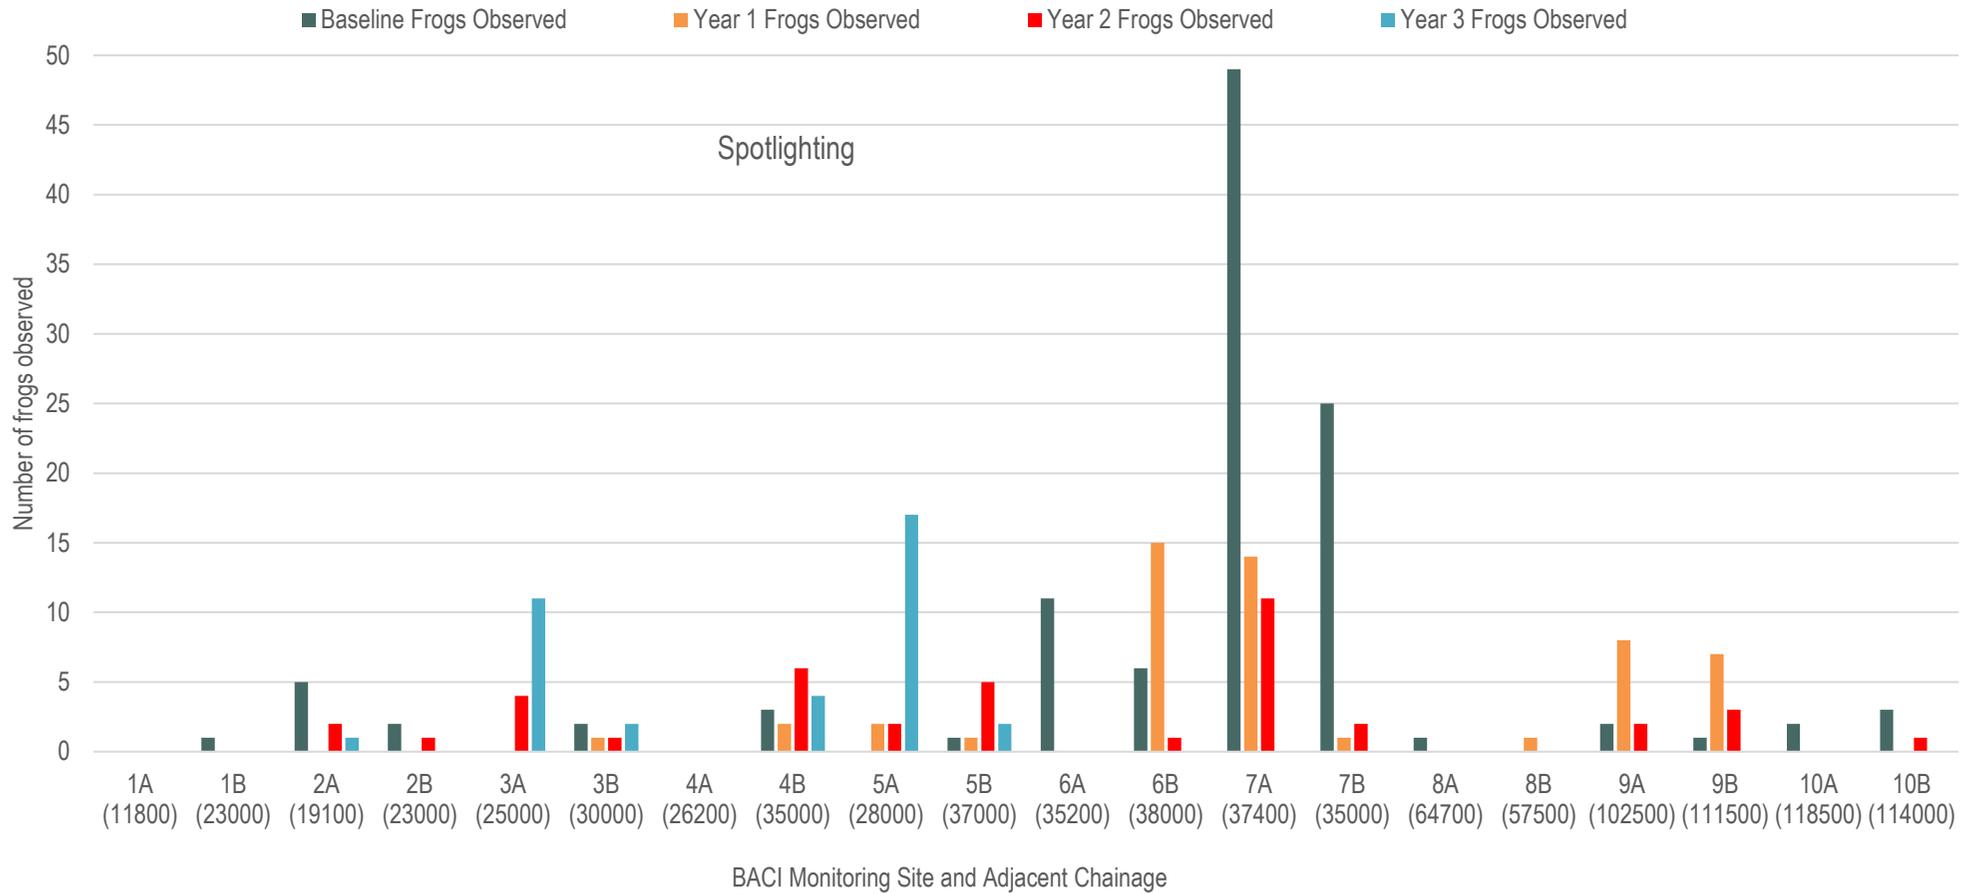
Figure 5-4. The number of Green-thighed Frogs observed between the pre construction surveys and construction monitoring in Years 1, 2 and 3.

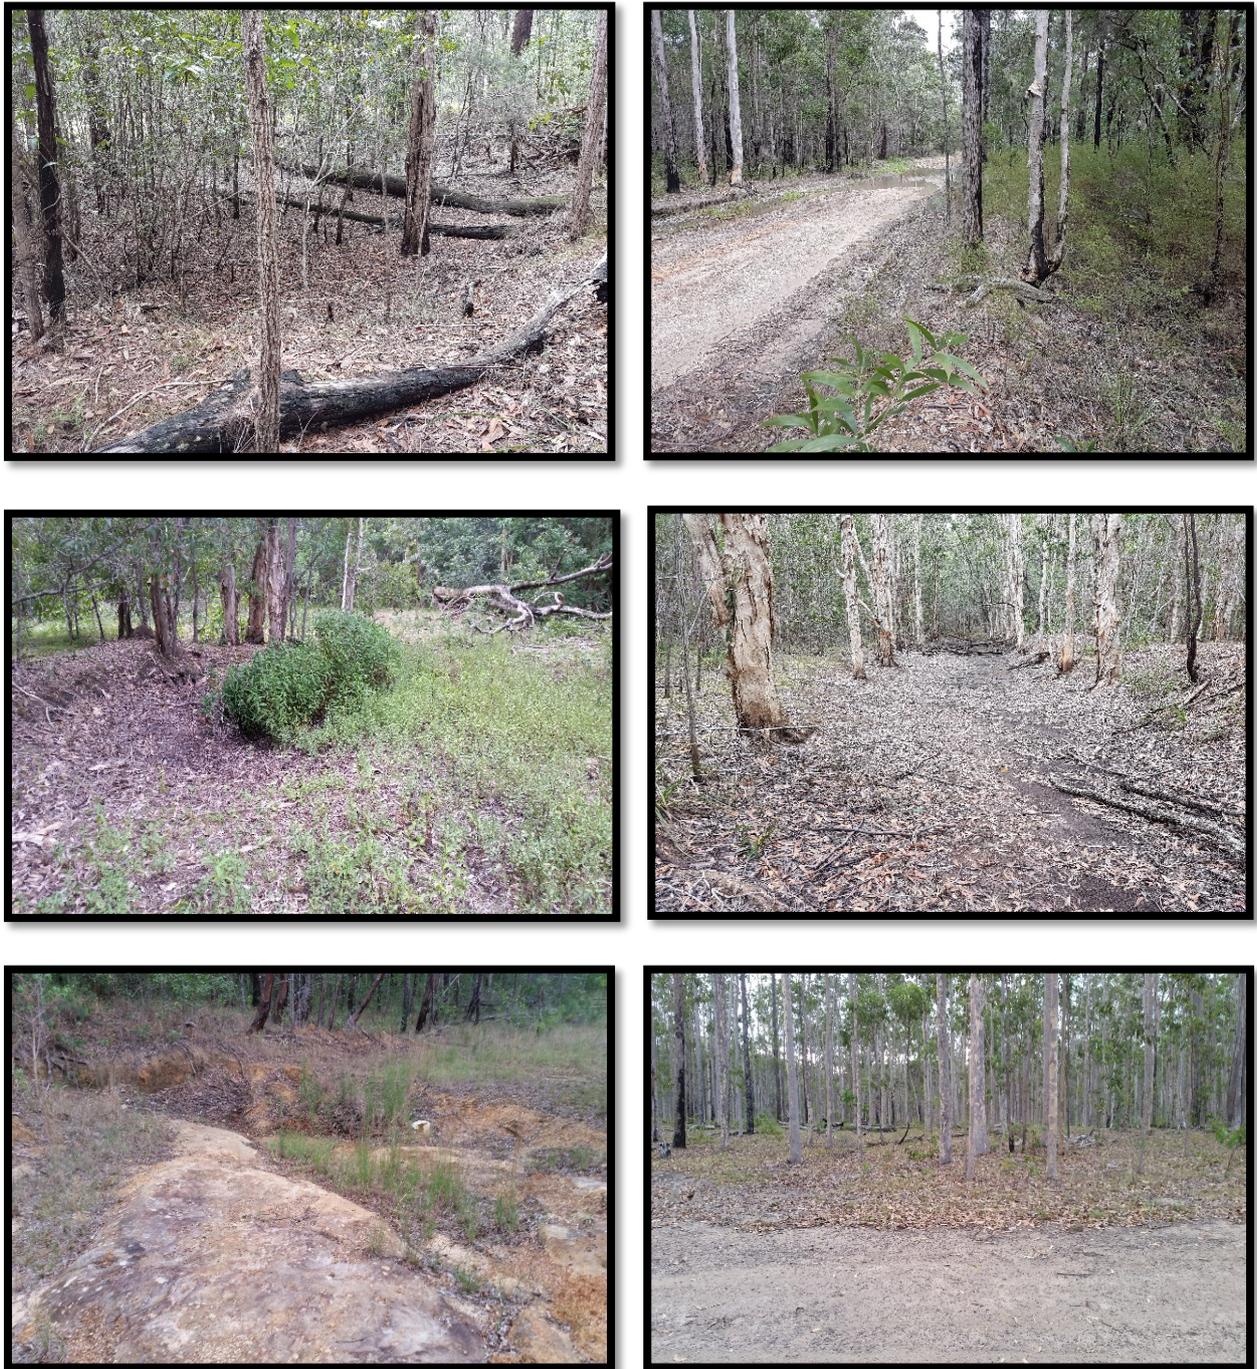
Plate 5-3. Breeding ponds at Site 10A (top left), 10B (top right), Site 9A (bottom left) and 9B (bottom right), 8A (Tyndale Crown) and 8B (Pine Brush State Forest) during the October to December monitoring.
