# Woolgoolga to Ballina Pacific Highway upgrade

## Coastal Emu Monitoring Program Annual Report 2020

Construction Phase (Year 4) and Commencement of Operation

Coastal Emu Monitoring Program – Annual Report (2020)

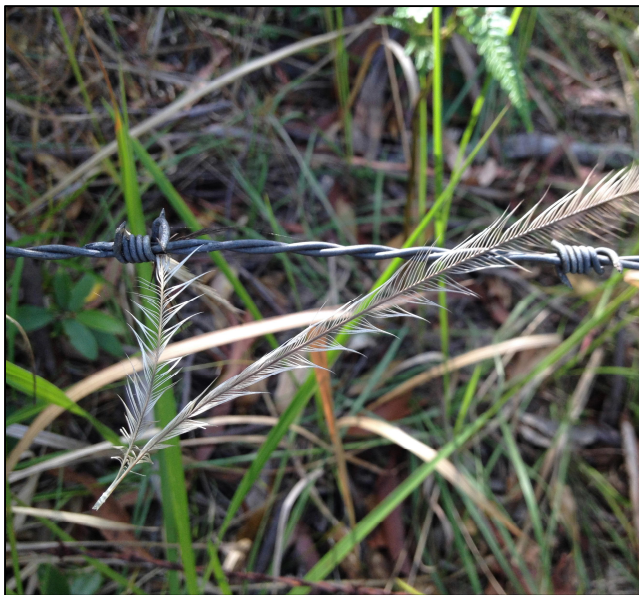
Plate 1. Example of Emu feathers 'snagged' on barbed wire

Where possible transects have been placed along fence lines, and 3 and 4 strand barbed wire fences are particularly effective at 'snagging' feathers from birds, and hence identifying Emu presence. Not all transects were able to be located on suitable fence lines, which is limited where plain wire is present or there is no fence. However, this factor does not affect the long-term comparison of results, as the conditions have not changed from the baseline survey. Occasionally fences have been replaced or sections removed and resulting in a change to the effectiveness of the transect at detecting Emu presence. To overcome this limitation, small changes or additions have been made to the transect, while still maintaining a similar search length and area of the transect as discussed previously.

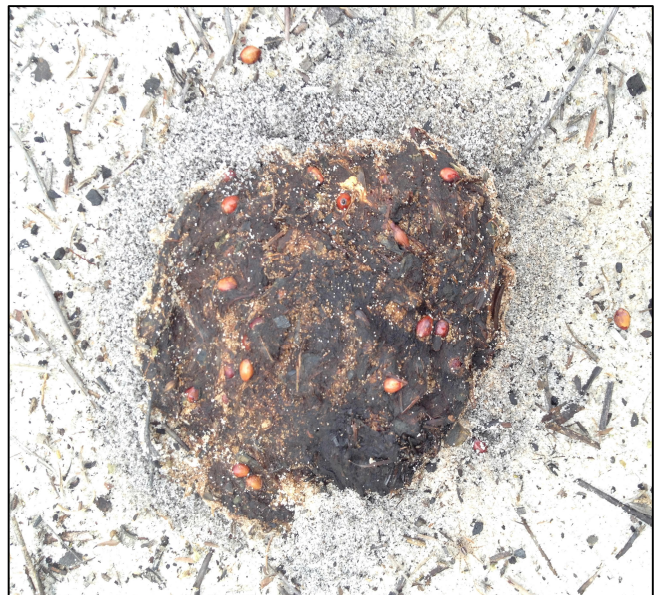
Plate 2. Emu dropping with *Gahnia sieberiana* seed

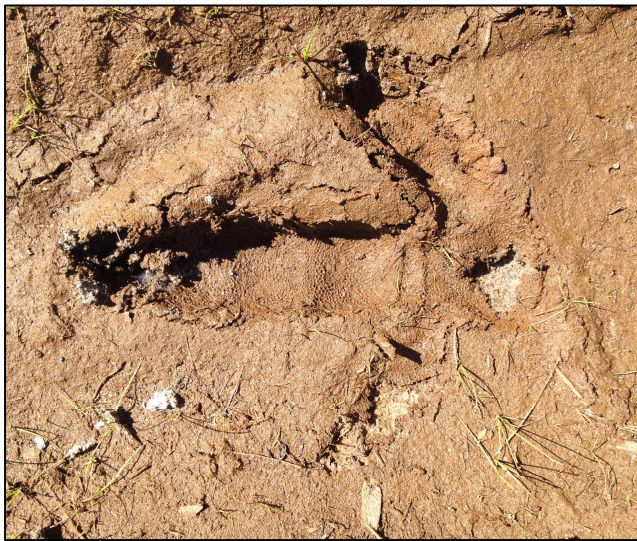
Plate 3. Example of muddy transect where Emu tracks are apparent

The number of signs detected is counted and then removed from each transect. For footprints this means raking over sand and mud and for feathers and droppings removing from the transect. This is done in order to capture fresh sign over the following season and sampling period. In addition to recording signs, any actual observations of Emus in the vicinity of transects during the survey week are recorded and contact with landowners where possible during the course of the survey week to document any observations of Emus made by the property owner since the last monitoring event.

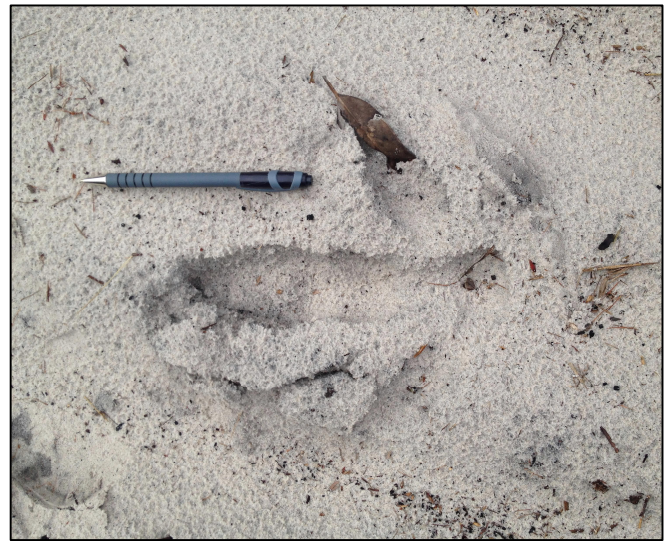
Plate 4. Example of sandy transect where Emu tracks are apparent

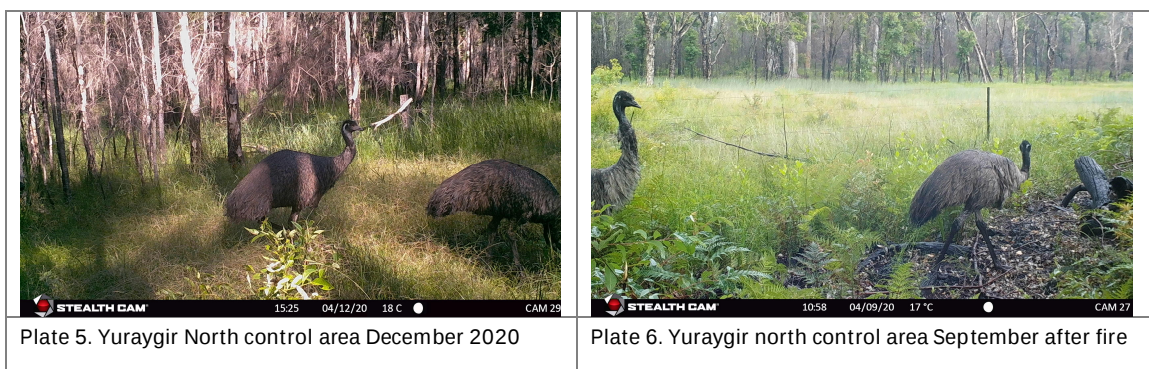
Table 3.3: Camera trap rate (no. Emu photos / 100 trap days) per study area recorded at the three impact study areas for three years pre-construction (2014-16) and three-half years construction (2017-20), and first 6 month of operation (2020)

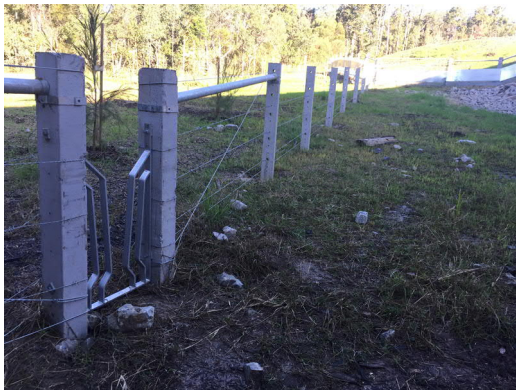
Plate 5. Completed hybrid fence and emu gate Section 3 Chaffin Creek (chainage 52423)

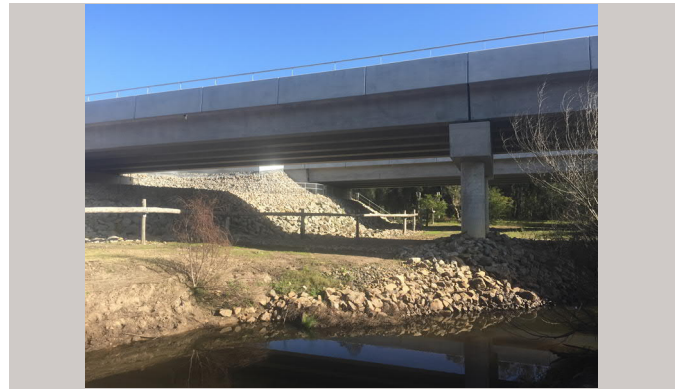
Plate 6. Completed Emu crossing zone Pillar Valley Creek floodplain Section 3 (chainage 47841)

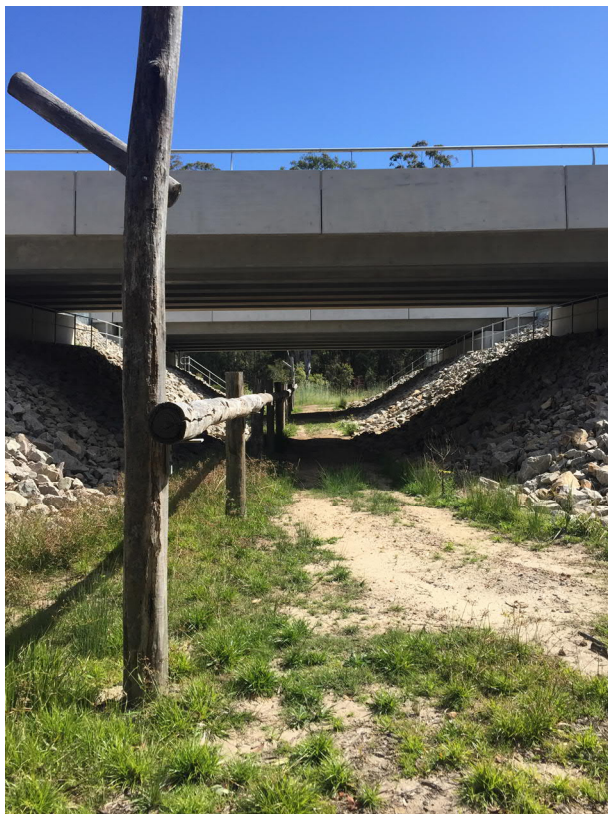
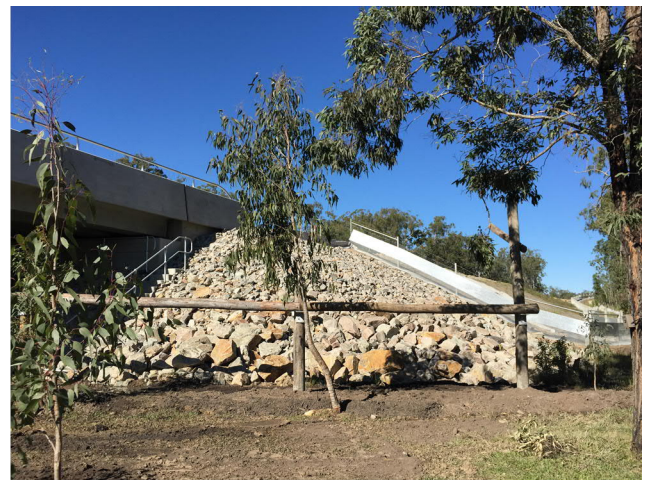
Plates 7 and 8. Completed crossing zones at end of construction showing fauna furniture and exclusion fencing to prevent emus entering the road corridor and direct to crossing zones

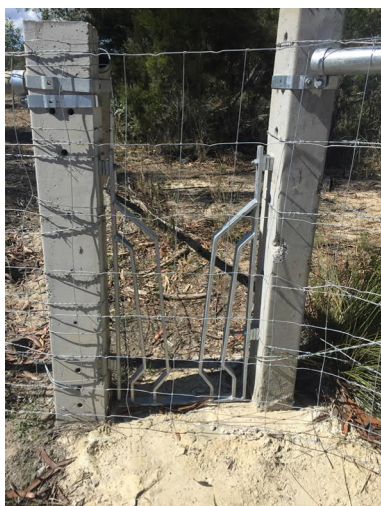
No road killed emus were recorded during the monitoring periods and no damaged exclusion fencing in the vicinity of the crossing locations. A section of hybrid emu fence location in Section 3 at chainage 51.2900 has been modified by the landowner adjoining the fence. Wire mesh fencing has been attached to the fence and emu gate possibly to prevent sheep or goats from leaving the property, this has compromised the ability of Emus to pass through the fence as intended.

Plate 9. Emu gate blocked using mesh fencing wire to keep in sheep or goats.

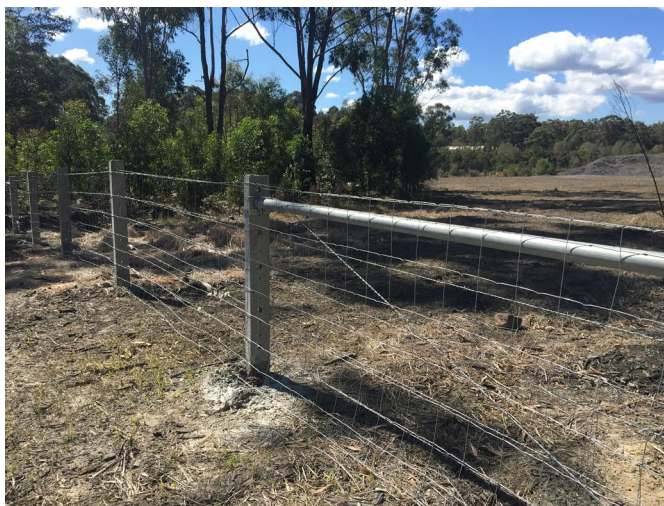
Plate 10. Emu hybrid fence has been compromised with mesh fencing wire to manage sheep or goats on adjoining property
