# Woolgoolga to Ballina Pacific Highway Upgrade

## Threatened Fish Monitoring Program Annual Report 2020

Final Construction Phase Report

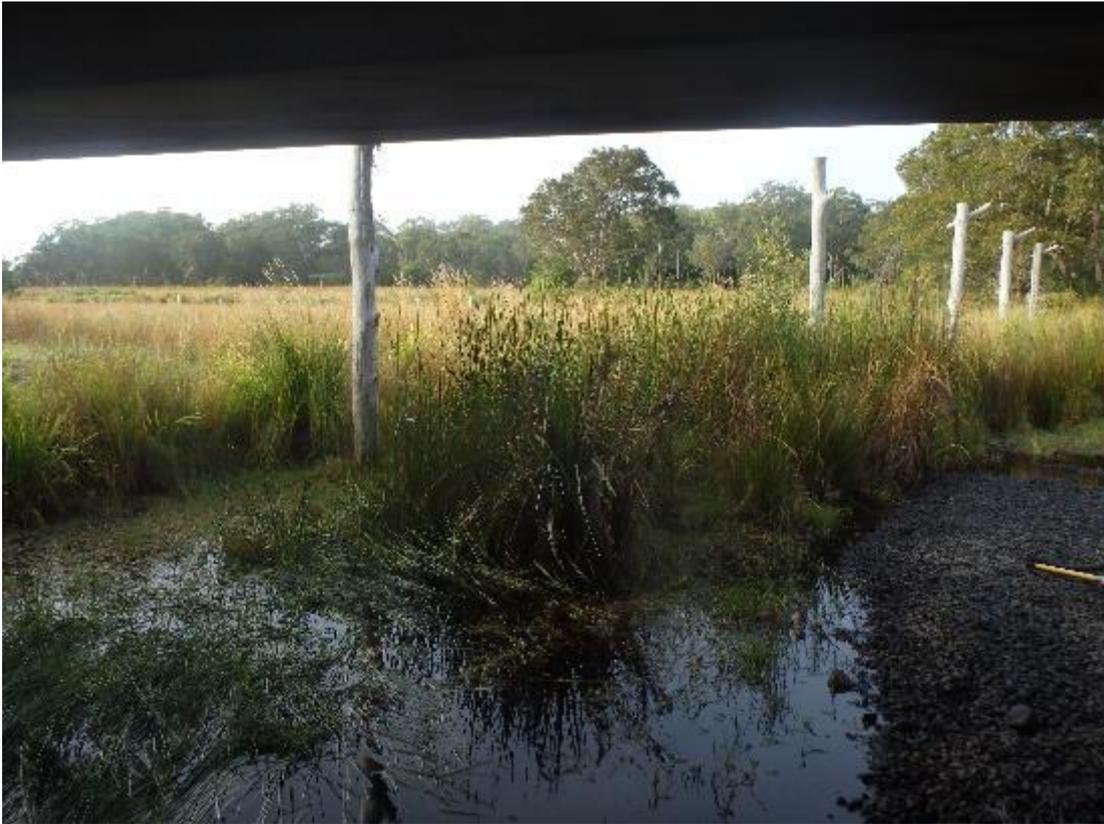
**Plate 4.2** Improved emergent vegetation cover at site 13b.

- Increased cover of emergent vegetation at most impact sites in the construction phase, most notably at sites 10a, 11d and 12a where significant revegetation efforts were undertaken and fencing has reduced pressures from grazing animals. Images of these improvements to stream condition are presented in **Figures 4.x**.

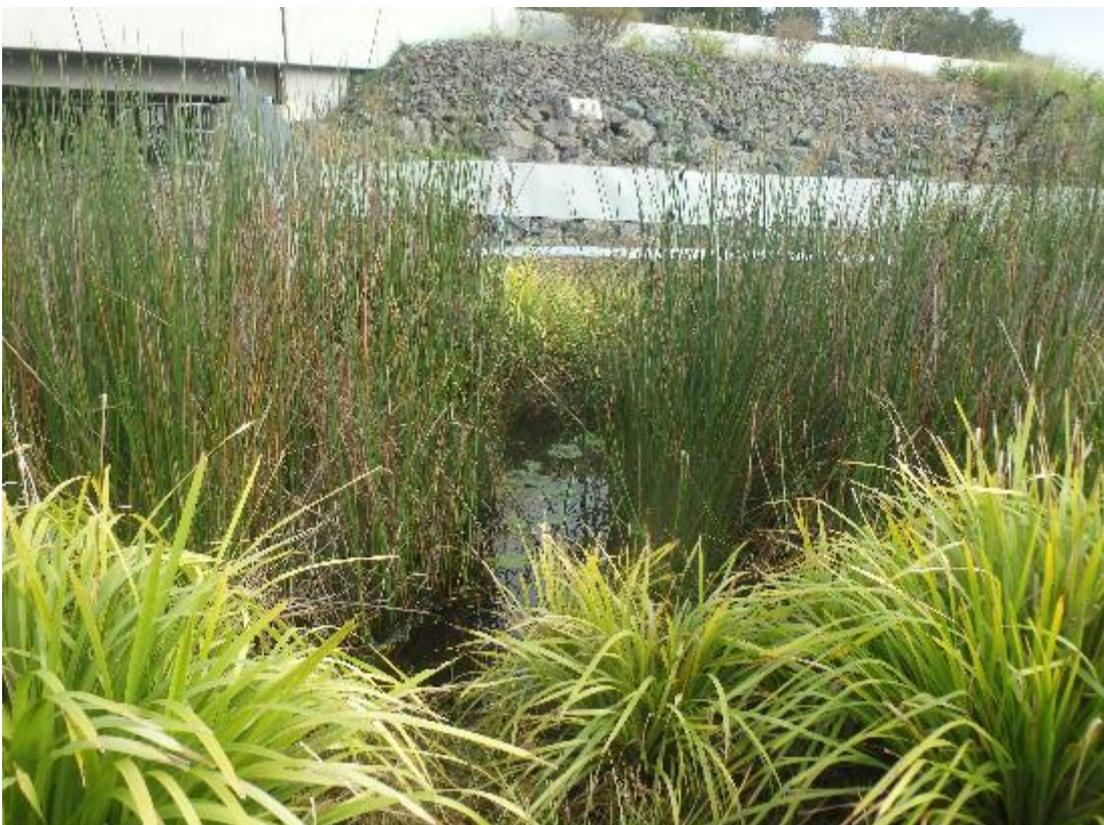
**Plate 4.3** Improved emergent vegetation and riparian cover at site 12a.

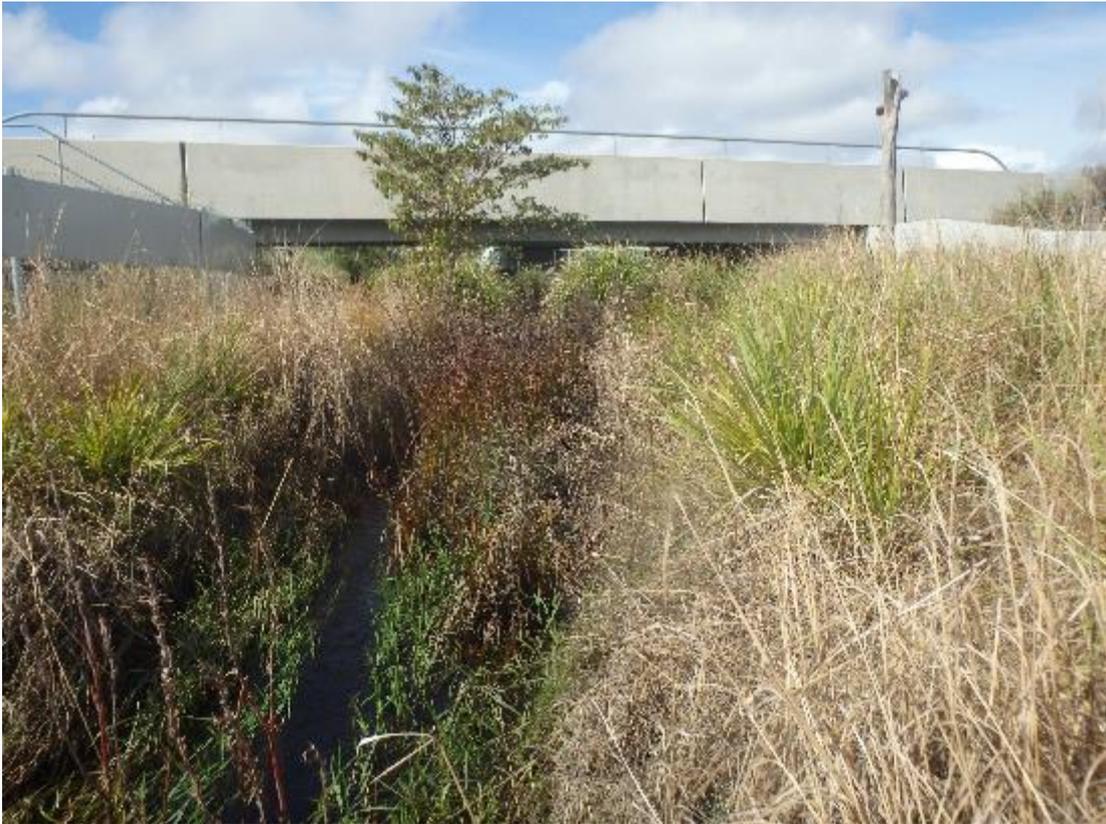
**Plate 4.4** Improved emergent vegetation and riparian cover at site 11d.
