Hexham Relief Roads Project: Test Excavation Report

Prepared by Australian Museum Business Services
for KMH Environmental

Final Report

January 2013

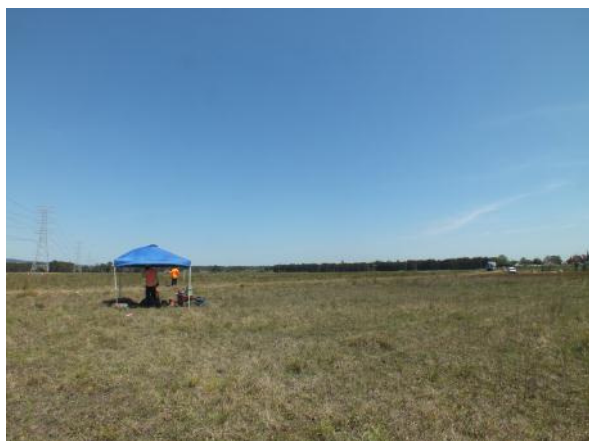
Figure 5.1 Access road excavation area (view to south west).

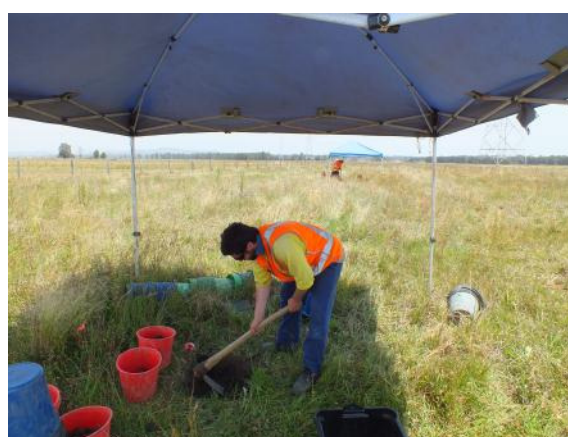
Figure 5.2 Site compound excavation area (view to south west).

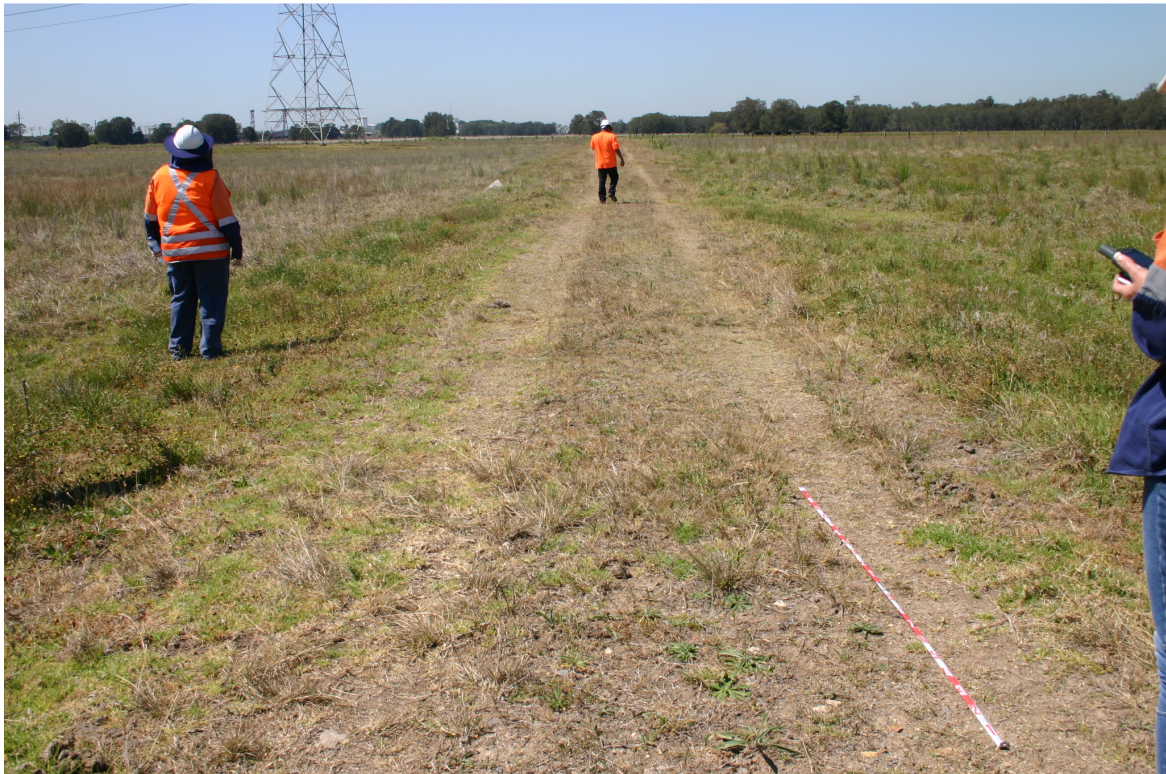
Figure 6.1 View of disused access track where artefacts have been introduced (view to south-east).

During the course of the excavation, Aboriginal site HS1 (AHIMS site #38-4-1478) was identified as extending along a constructed track within the disused Hunter Water easement transected by the proposed Hexham Relief Roads corridor. The track has been constructed above the local ground level to prevent inundation, and comprises pale yellow sandy soils that are unlike any observed elsewhere in the study area, or throughout the archaeological test excavations.

AMBS therefore concludes that the HS1 site comprises artefactual stone material that has been brought to the area during the construction of the track, and that the material is not indicative of the local Aboriginal archaeology. The artefactual stone material identified in November 2011 as HS1 appears to have been spread across the low-lying alluvial plain by vehicles crossing the disused track.

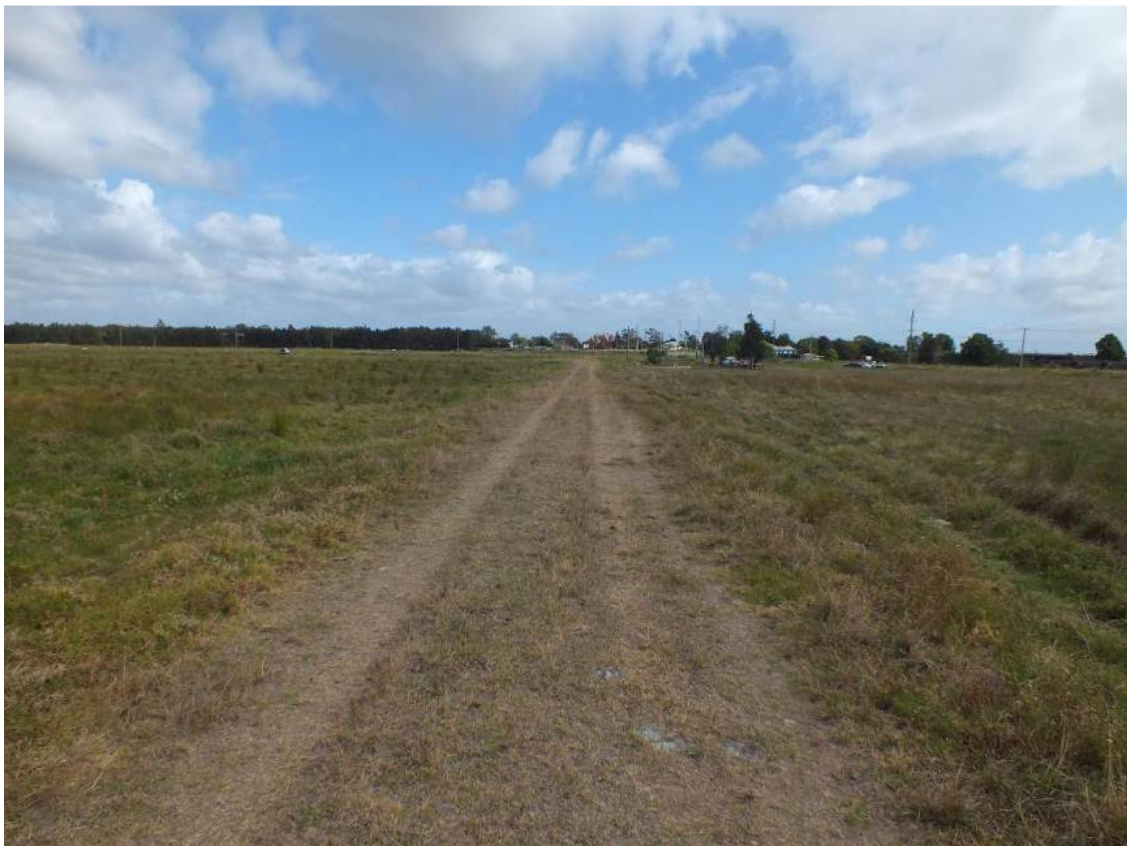
Figure 6.2 View from middle of disused access track where artefacts have been introduced (view to north-west).

Artefactual stone material was identified both on the track surface and as large flaked cobbles set into the verges (Figure 6.1-Figure 6.5). The artefactual stone material comprised grey/orange IMTC, with evidence of heat shatter, platform preparation, and flaking ripples; however, the majority of artefacts showed signs of extensive damage from vehicle use of the track (Figure 6.3, Figure 6.5-Figure 6.6). It is noted that there is an Aboriginal silcrete quarry located near the study area, but none of the artefactual material observed on the track was made of silcrete material. Further, no artefactual material was observed on other access tracks within the study area, suggesting that the material is confined to this particular disused track.

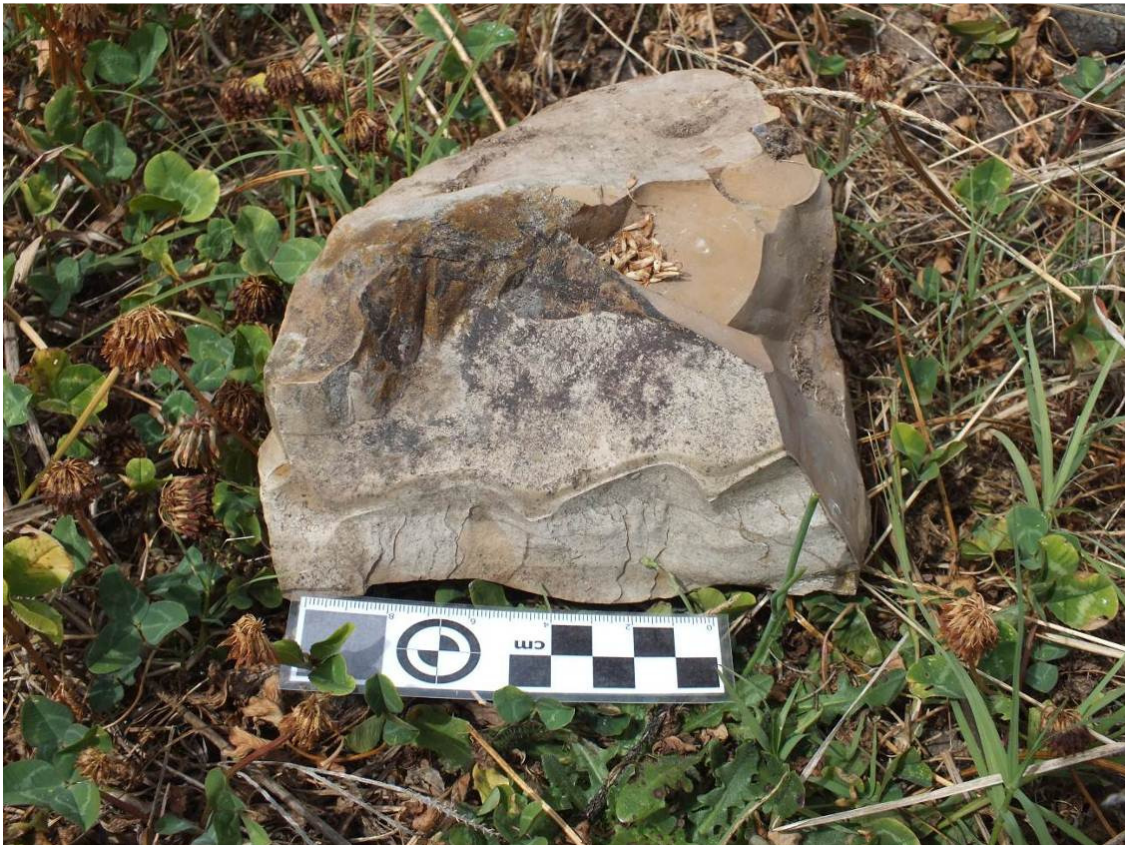
Figure 6.3 IMTC stone core showing old flaking scars (below), and recent damage (upper right corner).

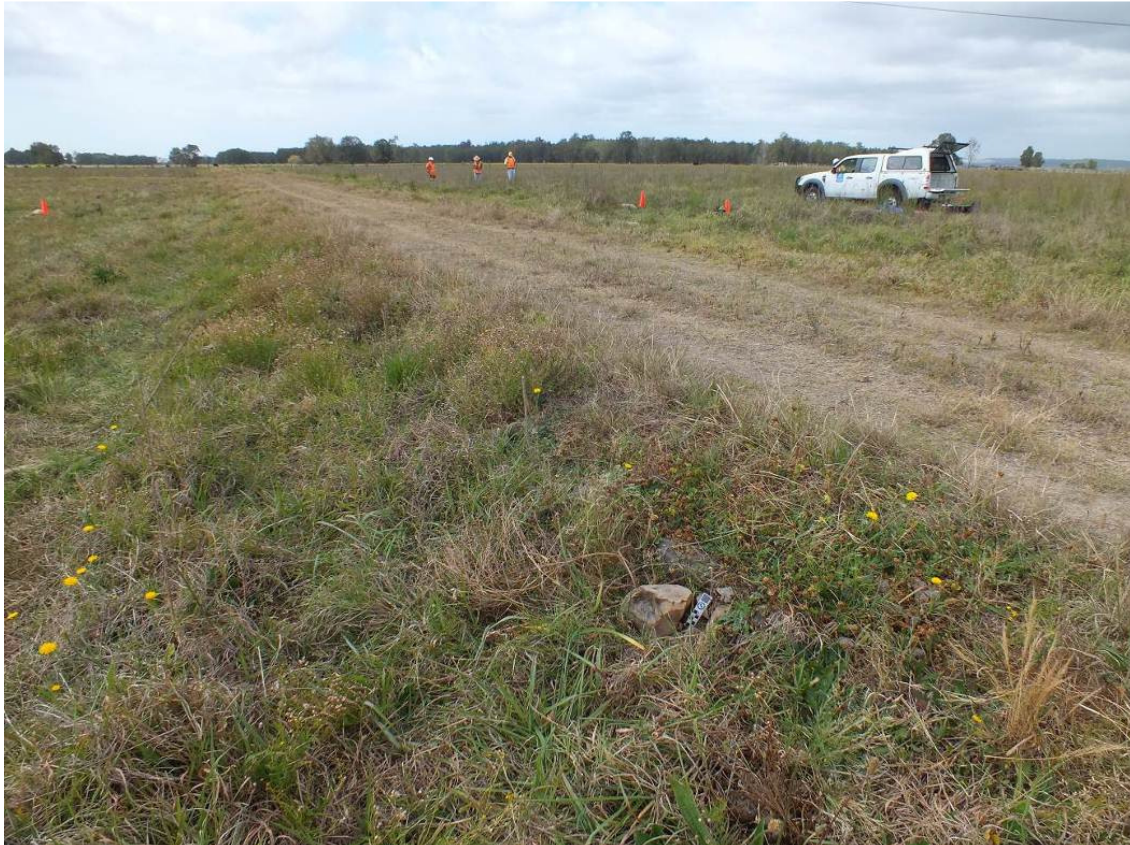
Figure 6.4 IMTC stone core on edge of disused access track (view to south-east).

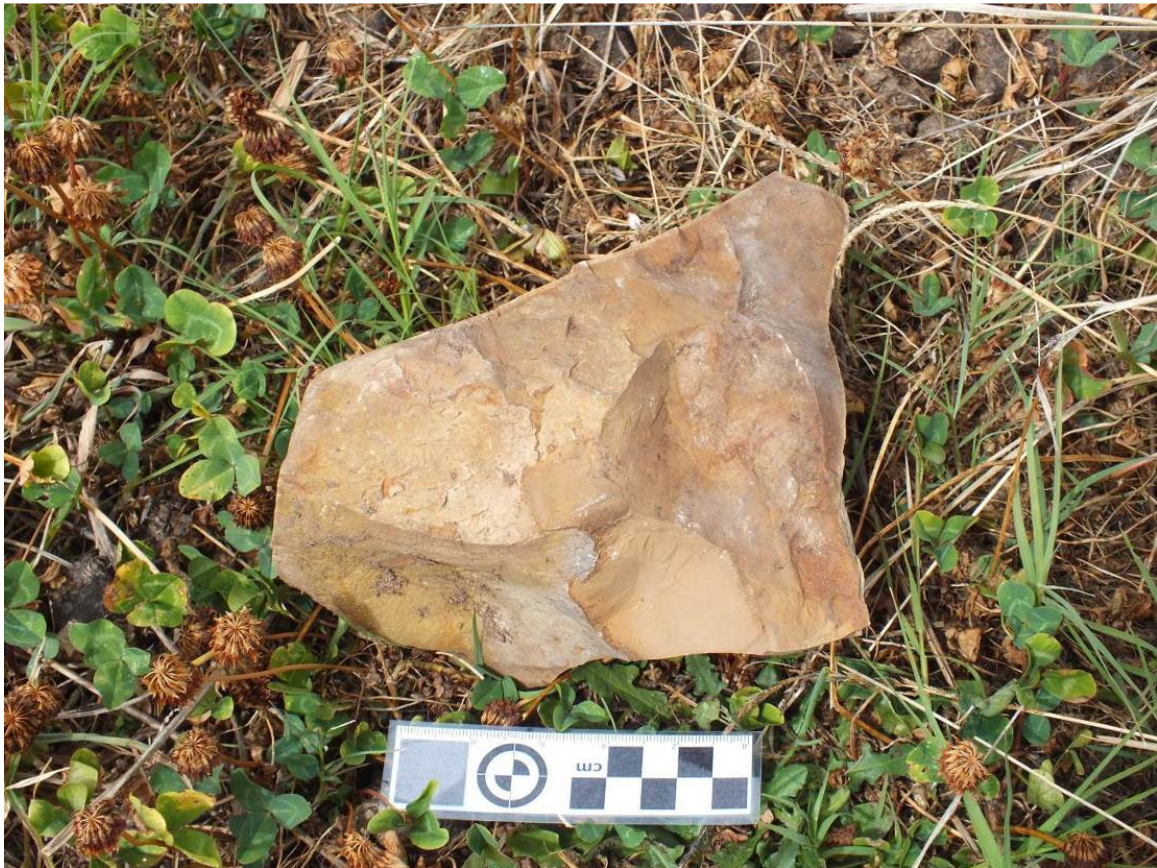
Figure 6.5 IMTC stone core showing old flaking scars (above), and recent damage (below).

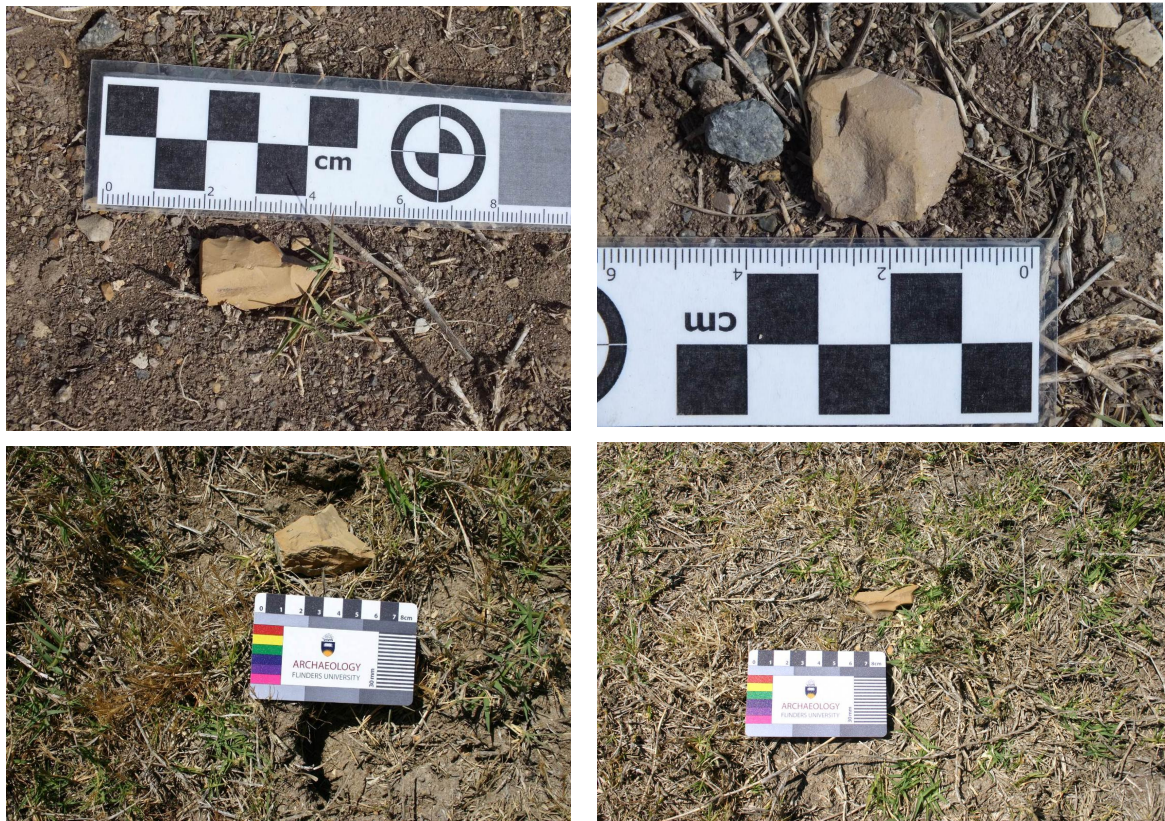
Figure 6.6 IMTC stone artefacts on disused access track.

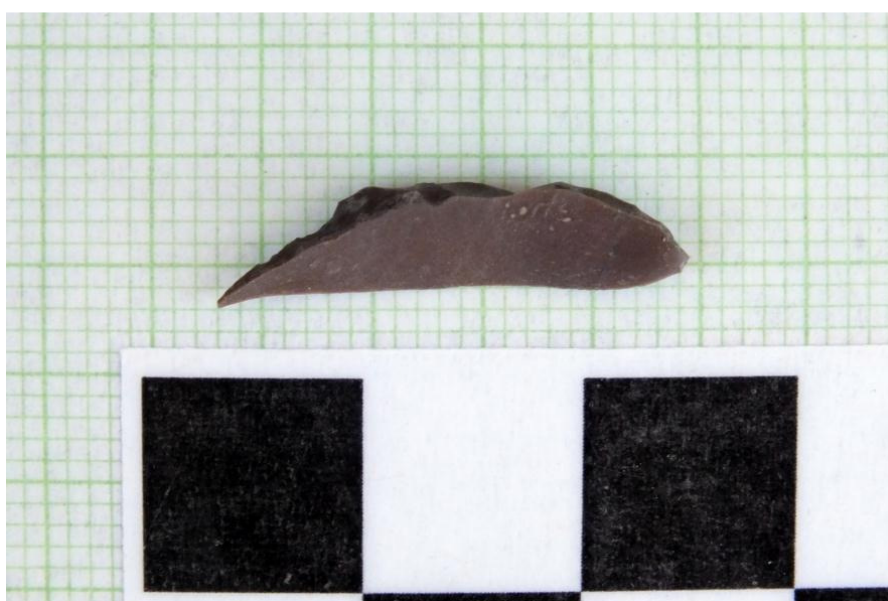
Figure 6.7 Backed artefact recovered in archaeological test pit HRR29.

Square	Unit	Landform	Raw Material	Type	Tool Type	Length (mm)	Width (mm)	Thickness (mm)	% Surface cortex	Weight (g)	Image
HRR29	2	Alluvial plain	IMTC	Backed artefact	Backed blade/ Bondi point	21	5	4	0%	0.34	Figure 6.7
HRR30	2	Alluvial plain	Chert	Retouched flake (broken)		23	17	7	0%	2.14	Figure 6.8 (left)
HRR30	2	Alluvial plain	Fine-grained siliceous	Proximal flake		26	20	7	0%	1.91	Figure 6.8 (right)
