# Hexham Relief Roads Project: Historic Heritage Impact Assessment Addendum

Prepared by Australian Museum Business Services  
for KMH Environmental

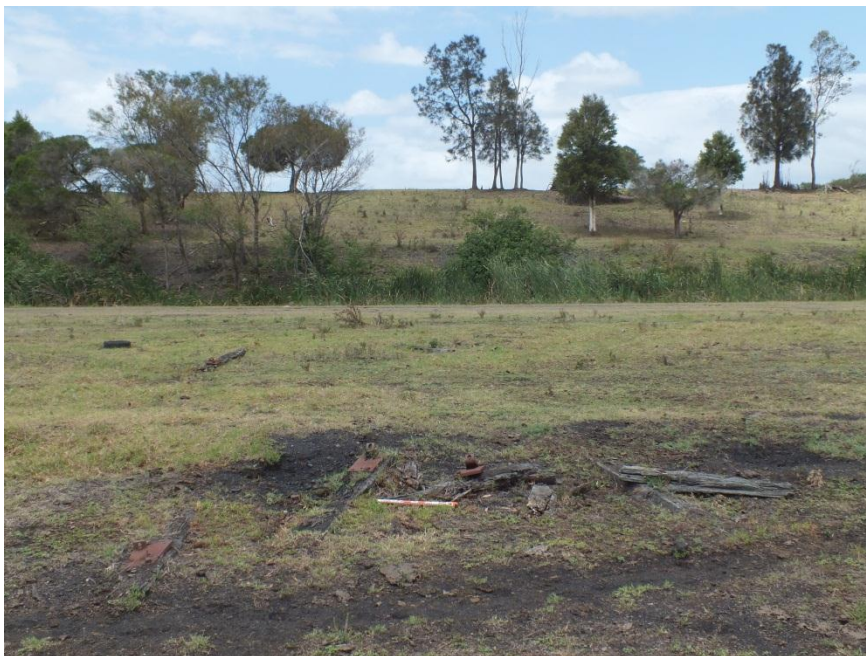
Figure 2.4 Relics associated with the former Minmi – Hexham railway line recorded during field survey; some rubbish such as tyres and other debris were also noted. View south across the railway corridor to the spoil mound.

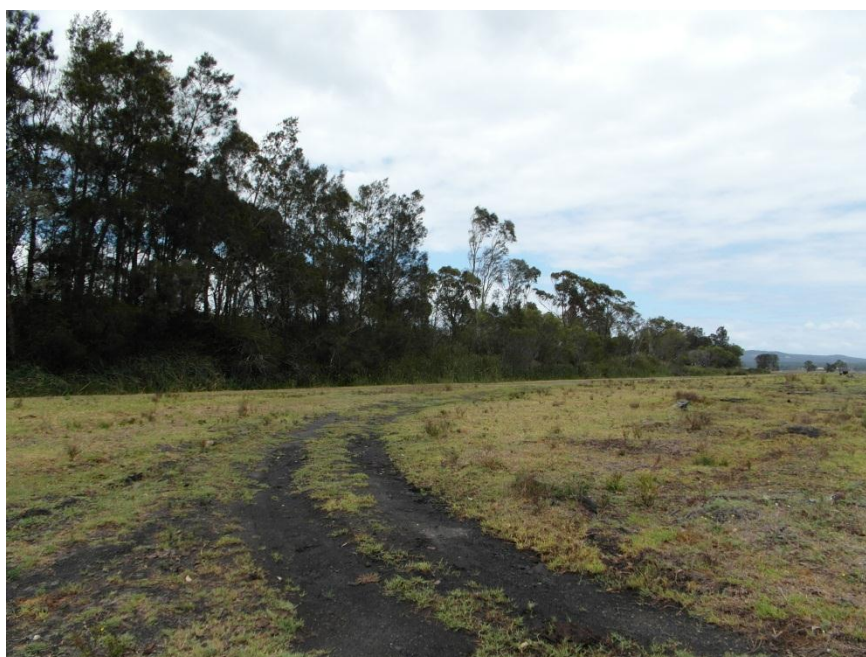
Figure 2.9 Another track curves away from the southern edge of the rail corridor in the direction of the sewage treatment plant.

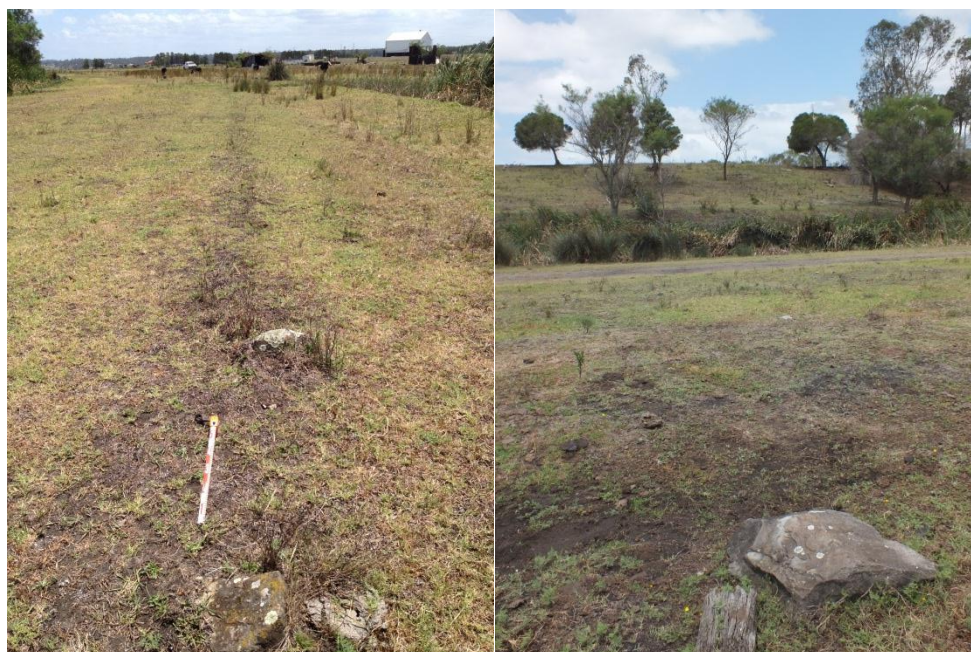
Figure 2.10 Traces of a low stone feature and previous alignment were more visible at surface level at the eastern end of the study area with similar isolated finds further to the west.
