PROPOSED HEXHAM RELIEF ROADS PROJECT, HEXHAM

CONTAMINATION ASSESSMENT

Upper Hunter Valley Alliance

GEOTWARA21045AC-AI.Hexham Contamination
5 July 2012

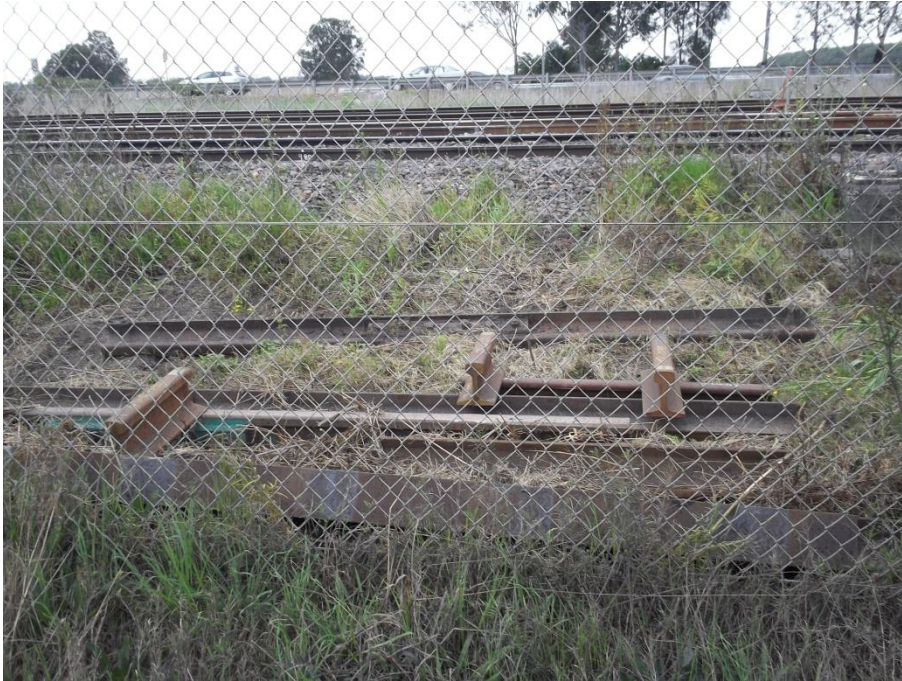
- The existing railway corridor includes four tracks; the Up and Down Main lines on the up (eastern) side and the Up and Down Coal lines on the down (western) side. Railway embankments typically vary from about 1m to 1.5m in height (Photograph 1).

Photograph 1: Railway corridor.

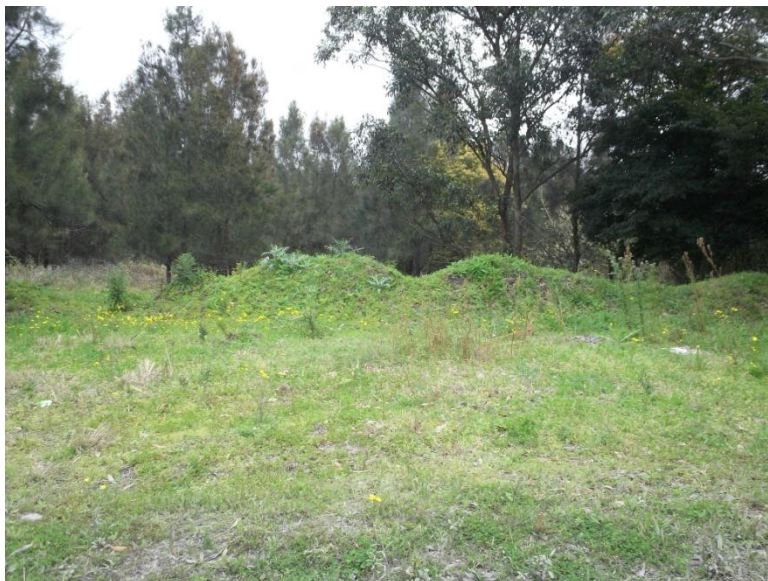
The embankment is overgrown in many locations. Where the embankment material is visible it appears to comprise rail ballast and coal washery reject (Photograph 2).

Photograph 2: Stockpiles of fill.

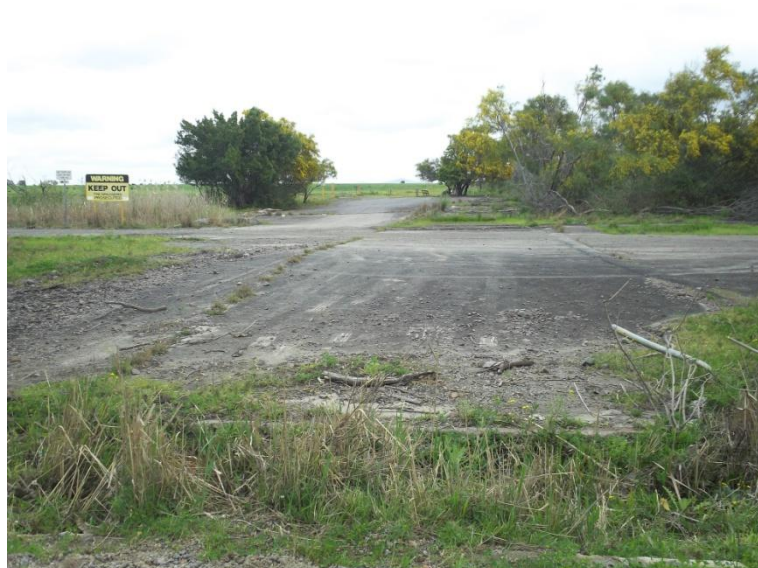
- An area with concrete slabs and bitumen paved areas from former buildings is present on the eastern side of the site, adjacent to approximately 173.725km to 174.865. Some potential asbestos containing material (PACM) fragments were observed in this area (Photograph 3 and 4).

Photograph 3: Area of former buildings, likely associated with the Hexham Coal Preparation Plant

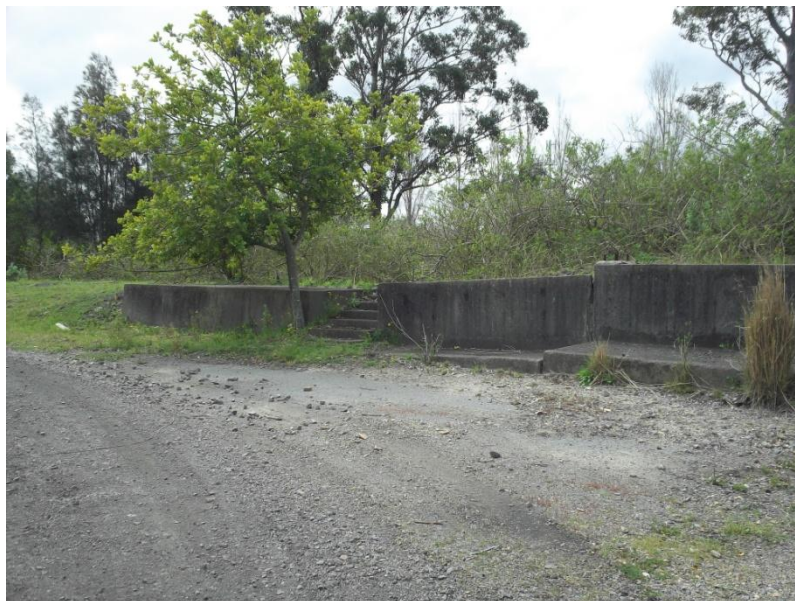
Photograph 4: Area of former buildings, likely associated with the Hexham Coal Preparation Plant

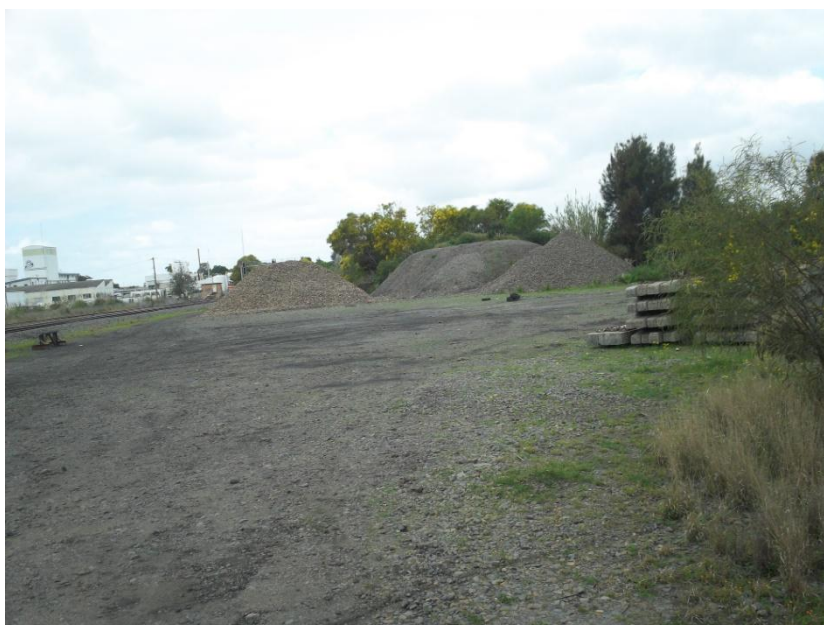
- At the northern end of the Project Area, 176.500km to 176.650km, a compound is present, which at the time of the site visit contained stockpiles of gravel and rail ballast, and concrete sleepers. No machinery or vehicles were observed within the compound (Photograph 5).

Photograph 5: Compound Area in northern portion of Project Area

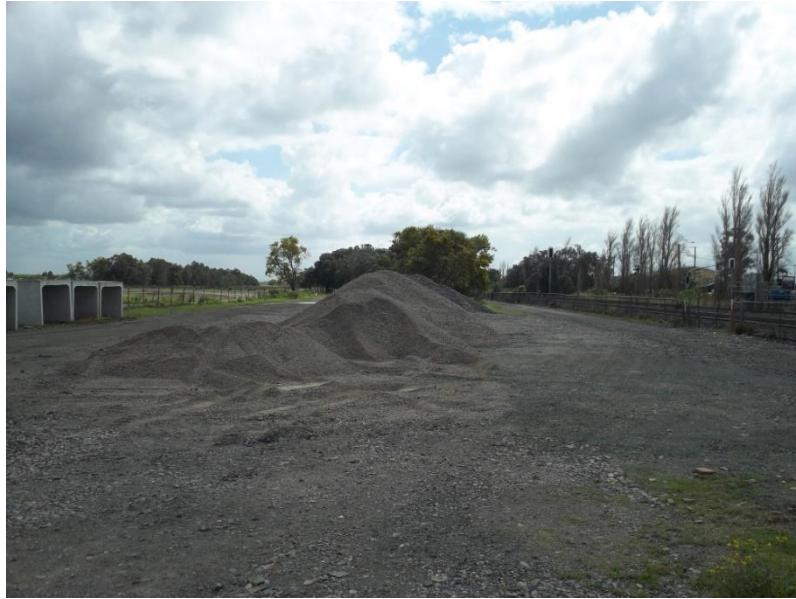
- At the southern end of the Project Area, 174.030km to 174.200km, a gravelled area was present, with some small stockpiles of gravel, a few concrete items and rusted railway track (Photograph 6).

Photograph 6: Gravelled area at southern end of Project Area

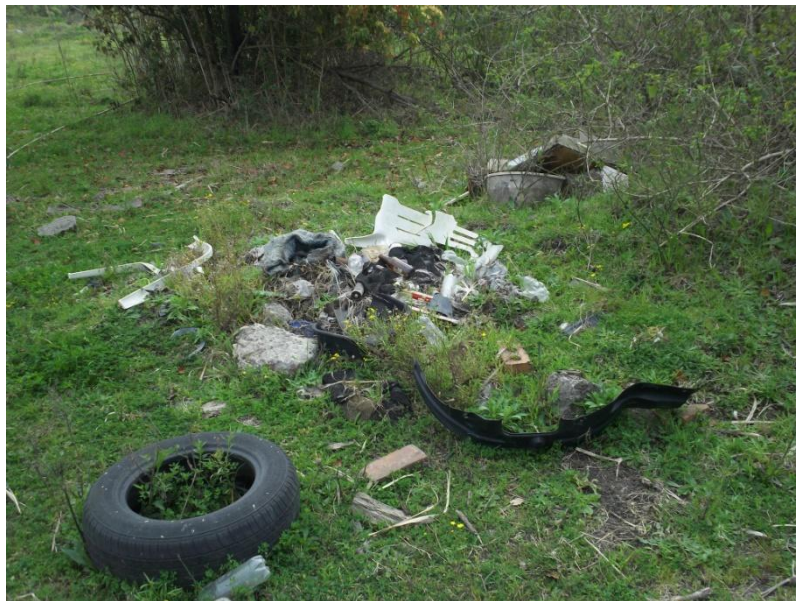
- Several stockpiles of waste materials dumped by the general public are present on the western side of the site. These included concrete, tyres, fibrous sheeting, metal items, and timber (Photographs 7 and 8).

Photograph 7: Illegally dumped waste materials

It is possible stockpiles of waste may be illegally dumped from time to time as the public can access the site. If this occurs, stockpiles of illegally dumped waste (AEC 9) will require waste classification prior to removal from site.

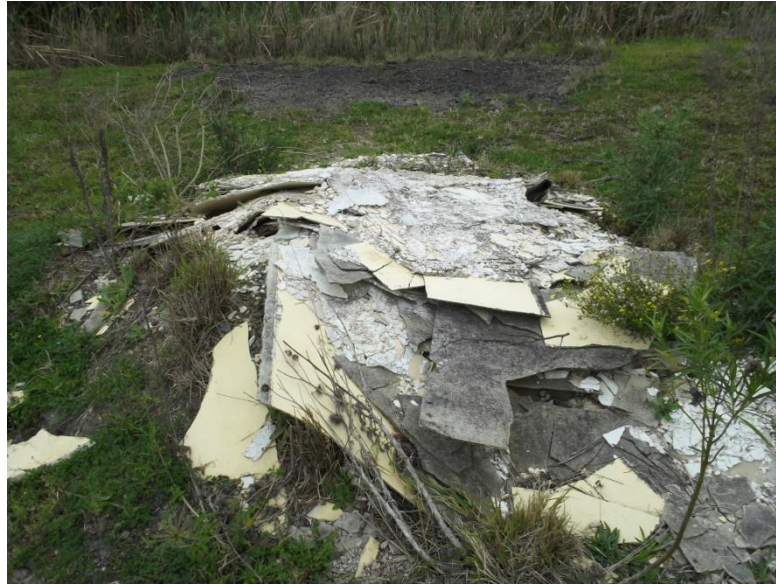
Photograph 8: Illegally dumped waste materials

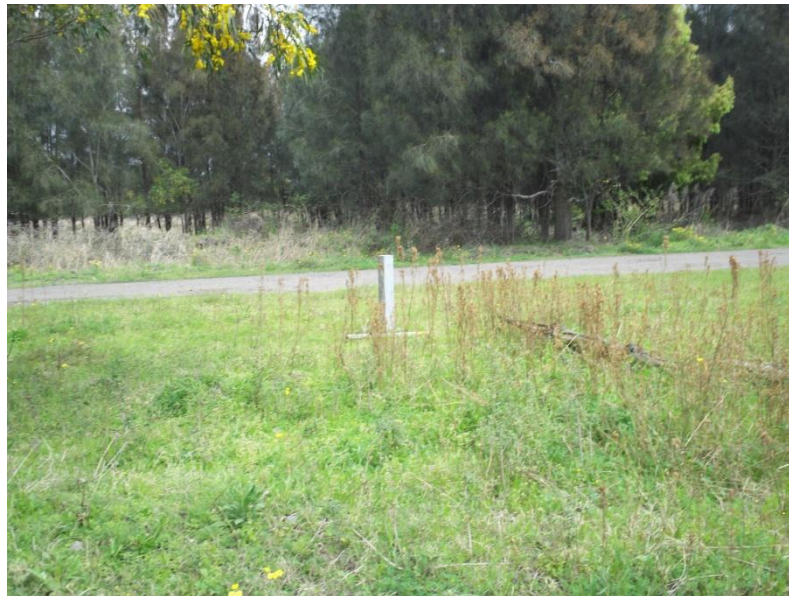
- Several groundwater well monuments were observed in the Project Area. It is assumed these were installed for the Queensland Rail studies (Photograph 9).

Photograph 9: Groundwater well monument

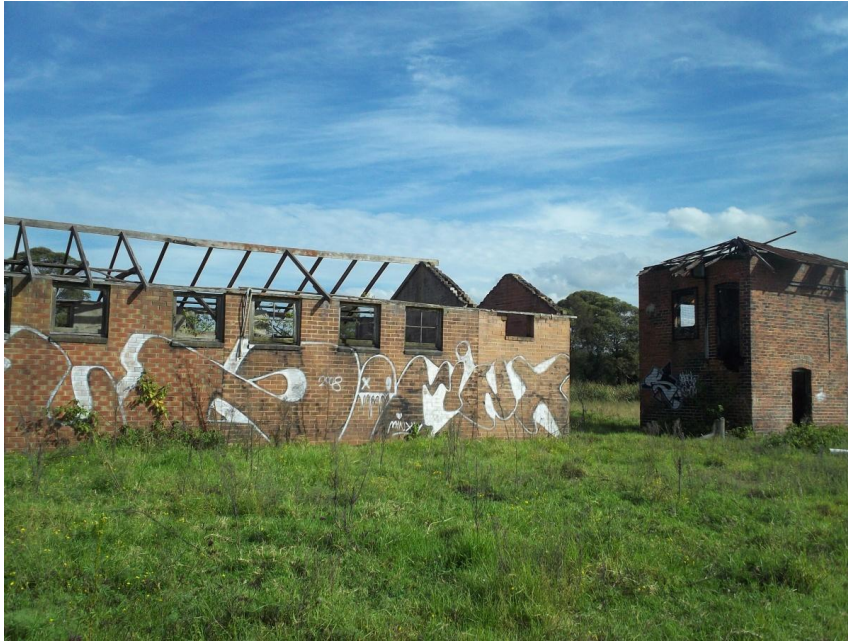
- A high pressure gas main crosses the Project Area at about 175.850km. The gas main is marked with warning signs.
- Two dilapidated buildings are present adjacent to the Project Area, near the high pressure gas main. Fragments of potential asbestos containing material were present around the buildings (Photograph 10).

Photograph 10: Dilapidated building near high pressure gas main

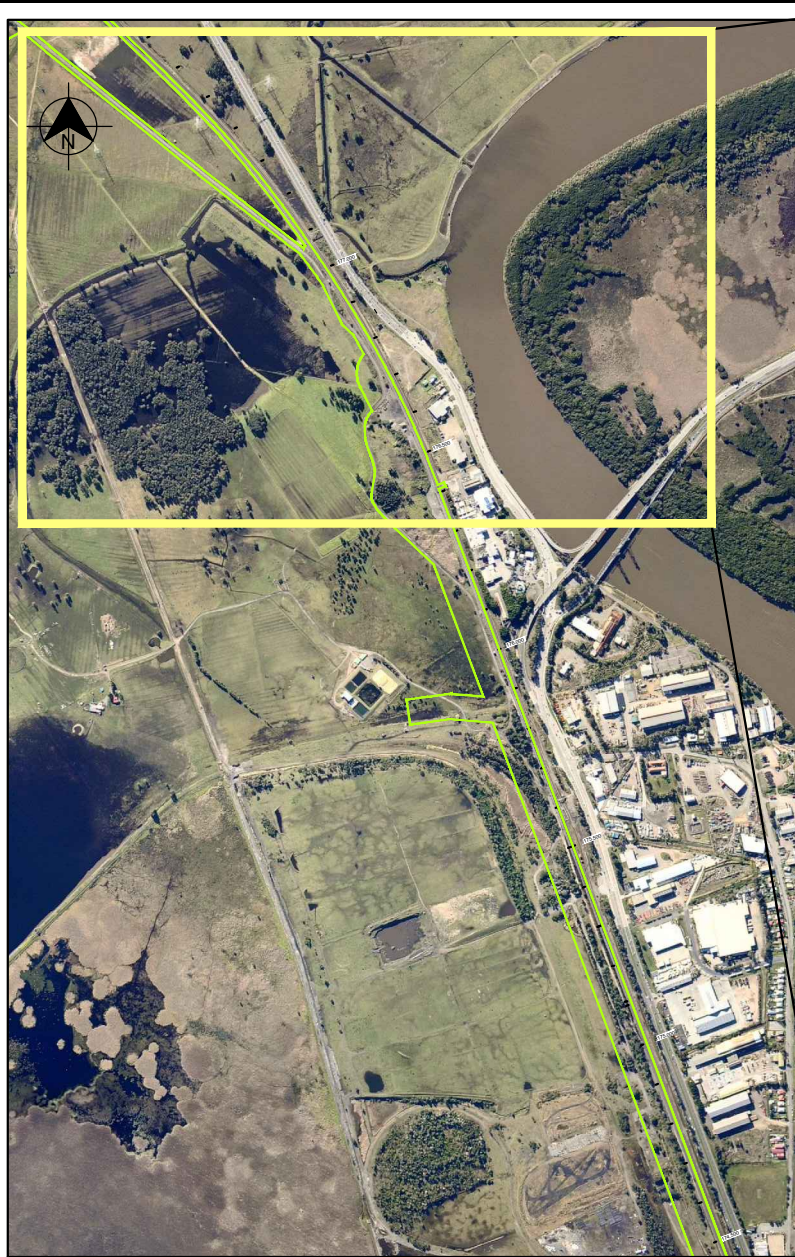
drawn	CGT	client:	UPPER HUNTER VALLEY ALLIANCE
approved		project:	CONTAMINATION ASSESSMENT HEXHAM RELIEF PROJECT
date	04.07.2012	title:	AEC LOCATIONS
scale	AS SHOWN	job no:	GEOTWARA21045AC-D03
original size		figure no:	FIGURE 2A

Based on the site history review and the Project Area walkover, the potential AECs and COCs identified for the Project Area are presented below in Table 4. Figures 2A to 2D show the location of the AECs.
